**Flood Control Project Maintenance
Levee Inspections**
LMA District Cover Sheet
Spring 2015 Levee Inspection Results

Reclamation District No. 0150 Merrit Island

Spring 2015 Levee Inspection Results

Waterway		Bank	Unit Miles
Unit No. 01 Sutter Slough		Left	0.52

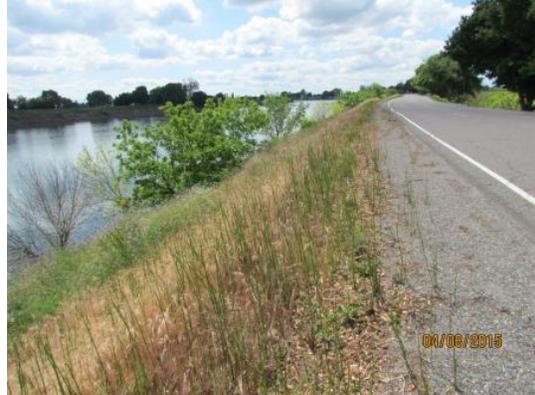
Photo 1 of 1 : SP_2015_RD0150_16_382_20150413_00075.jpg

LM Start	0.00	Rating **	M	Issue No.	382
LM End	7.52	Issue Type +	Ma	Location *	WS
Category	Earthen Levee		GPS Latitude/Longitude		
			Start	End	
Item	Vegetation		38.328196 °	38.410374 °	
			-121.576333 °	-121.520192 °	
DWR ID	DWR_RD0150_02_s_2015_382				
Action/Comments					
Control annual grass and weeds on the levee slopes and easements.

Vegetation on the waterside of the levee looking downstream.

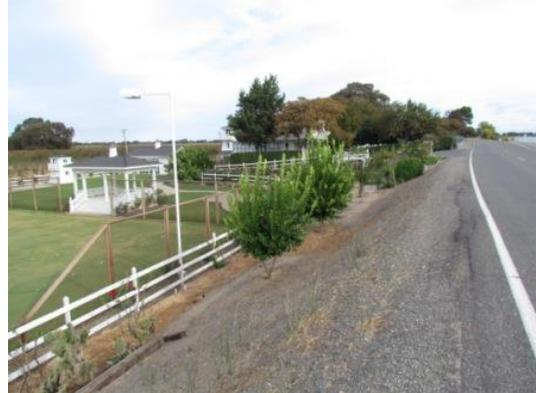
Photo 1 of 1 : SP_2015_RD0150_16_990_20150313_00057.jpg

LM Start	0.17	Rating **	M	Issue No.	990
LM End	0.21	Issue Type +	En	Location *	LS
Category	Earthen Levee			GPS Latitude/Longitude	
				Start	End
Item	Vegetation			38.330173 °	38.330576 °
				-121.574490 °	-121.574093 °
DWR ID	DWR_RD0150_02_s_2012_990				
Action/Comments					
Landscaping

Landscaping was found on the landside of the levee looking upstream.

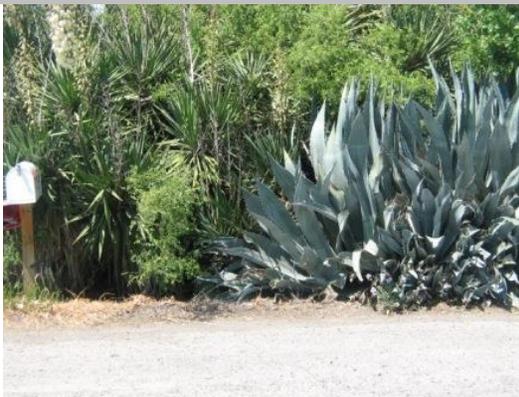
Photo 1 of 1 : SP_2015_RD0150_16_4_20150313_00001.jpg

LM Start	0.25	Rating **	U	Issue No.	4
LM End	0.25	Issue Type +	En	Location *	LS
Category	Earthen Levee		GPS Latitude/Longitude		
			Start	End	
Item	Vegetation		38.331035 °	38.331035 °	
			-121.573502 °	-121.573502 °	
DWR ID	DWR_RD0150_02_s_2012_4				
Action/Comments					
Landscaping

Landscaping on landward slope at LM 0.25 blocking view of levee slope.

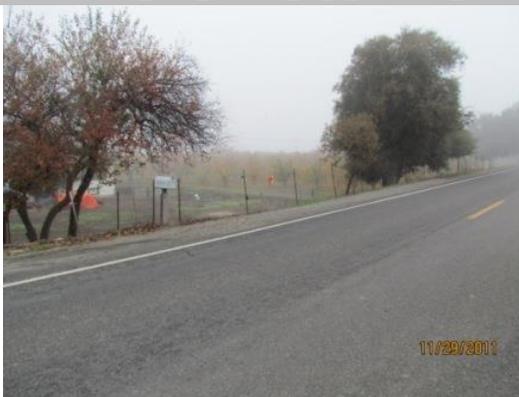
Photo 1 of 1 : SP_2015_RD0150_16_9_20150313_00005.jpg

LM Start	0.34	Rating **	M	Issue No.	9
LM End	0.34	Issue Type +	En	Location *	LS
Category	Earthen Levee		GPS Latitude/Longitude		
			Start	End	
Item	Encroachments		38.332156 °	38.332156 °	
			-121.572580 °	-121.572580 °	
DWR ID	DWR_RD0150_02_s_2012_9				
Action/Comments					
Fence

Fence was found on the landside of the levee looking upstream.

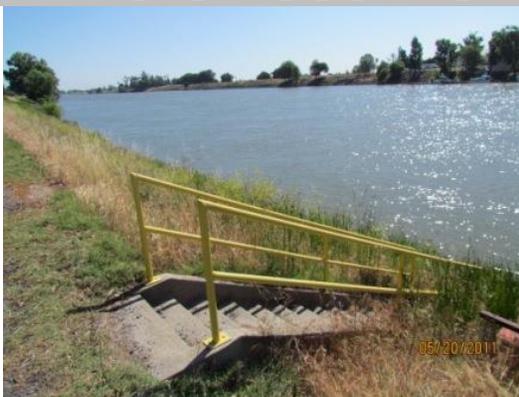
Photo 1 of 1 : SP_2015_RD0150_16_13_20150313_00008.jpg

LM Start	0.38	Rating **	M	Issue No.	13
LM End	0.38	Issue Type +	En	Location *	WS
Category	Earthen Levee		GPS Latitude/Longitude		
			Start	End	
Item	Encroachments		38.332647 °	38.332647 °	
			-121.572140 °	-121.572140 °	
DWR ID	DWR_RD0150_02_s_2012_13				
Action/Comments					
Stairway

A stairway was found on the waterside of the levee. The picture was taken from the crown looking upstream.

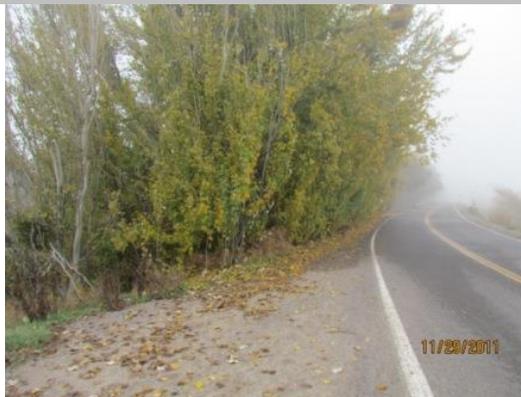
Photo 2 of 2 : SP_2015_RD0150_16_91_20150313_00047.jpg

LM Start	1.32	Rating **	M	Issue No.	91 (cont)
LM End	1.34	Issue Type +	En	Location *	LS
Category	Earthen Levee			GPS Latitude/Longitude	
				Start	End
Item	Vegetation			38.342969 °	38.343252 °
				-121.561196 °	-121.560794 °
DWR ID	DWR_RD0150_02_s_2012_91				
Action/Comments					
Landscaping

Landscaping was found landside of the levee looking upstream.

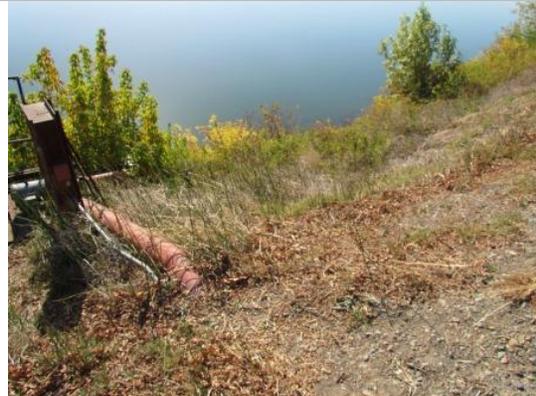
Photo 2 of 5 : SP_2015_RD0150_16_961_20150313_00049.jpg

View of the erosion on the waterside slope of the levee near the pipe looking downstream. This picture was taken during the fall 2013 inspection.

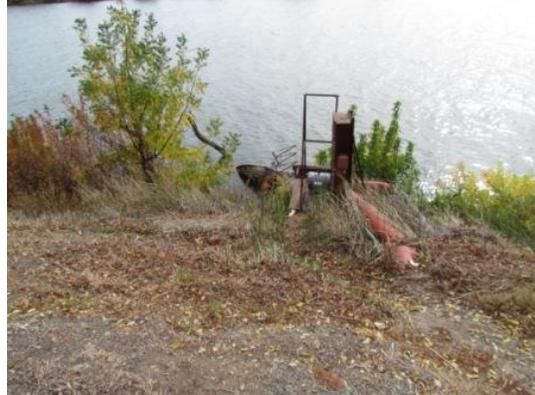
Photo 4 of 5 : SP_2015_RD0150_16_961_20150313_00051.jpg

View of erosion and damaged pipe and abandoned boat on the waterside of the levee looking upstream. This picture was taken during fall 2012 inspection.

LM Start	3.24	Rating **	M	Issue No.	961 (cont)
LM End	3.24	Issue Type +	Ma	Location *	WS
Category	Earthen Levee			GPS Latitude/Longitude	
				Start	End
Item	Erosion / Bank Caving			38.355321 °	38.355321 °
				-121.530902 °	-121.530902 °
DWR ID	DWR_RD0150_02_s_2012_961				
Action/Comments					
Schedule repair of erosion site prior to the next inspection. Inspector Comments: Depressions into the waterward slope can be seen along the waterward slope at this site. Also note the damaged pump support, pump, and pipe just upstream of the site; they may contribute to the erosion in a high water event and should be removed.

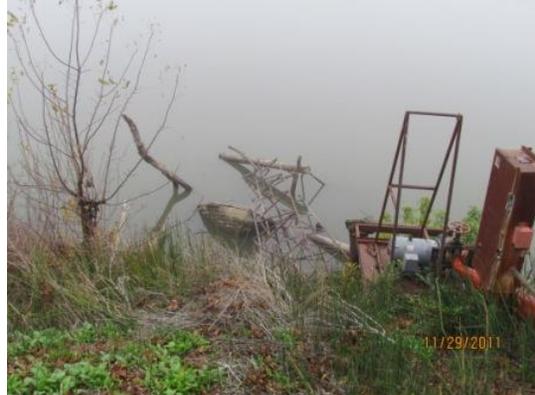
Photo 5 of 5 : SP_2015_RD0150_16_961_20150313_00052.jpg

View of the erosion site, and broken pump support along with a boat on the waterside of the levee. The picture was taken from the crown looking towards the toe of the levee during fall 2011 inspection.

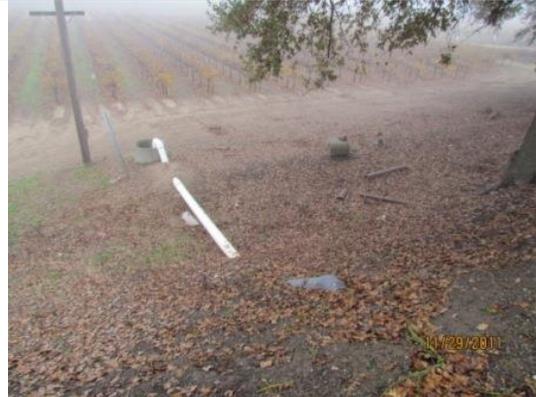
Photo 2 of 2 : SP_2015_RD0150_16_15_20150313_00011.jpg

LM Start	3.51	Rating **	A/W	Issue No.	15 (cont)
LM End	3.51	Issue Type +	En	Location *	CR
Category	Earthen Levee			GPS Latitude/Longitude	
				Start	End
Item	Encroachments			38.358152 °	38.358152 °
				-121.527579 °	-121.527579 °
DWR ID	DWR_RD0150_02_s_2012_15				
Action/Comments					
Pipe Inspector Comments: PVC pipe is sleeving through an old steel pipe. The steel pipe appears to be fine for now, but we should keep an eye on it.

A PVC pipe was used under the levee crown for irrigation purpose. The picture was taken from the crown looking downstream.

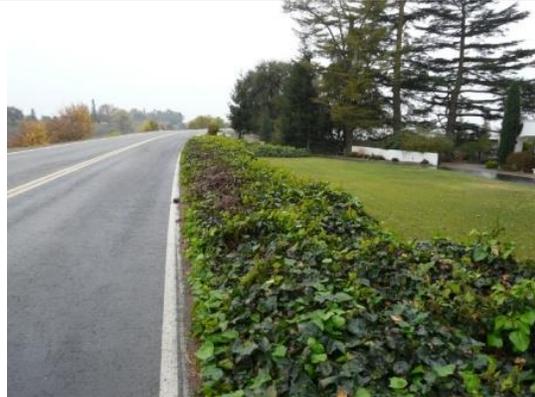
Photo 1 of 1 : SP_2015_RD0150_16_80_20150313_00042.jpg

LM Start	3.84	Rating **	M	Issue No.	80
LM End	3.86	Issue Type +	En	Location *	LS
Category	Earthen Levee		GPS Latitude/Longitude		
			Start	End	
Item	Vegetation		38.361419 °	38.361752 °	
			-121.523225 °	-121.522974 °	
DWR ID	DWR_RD0150_02_s_2012_80				
Action/Comments					
Landscaping

Landscaping in front of a residence on landside of levee from LM 3.90 to LM 3.93. The levee in this location is greater than 100' wide.

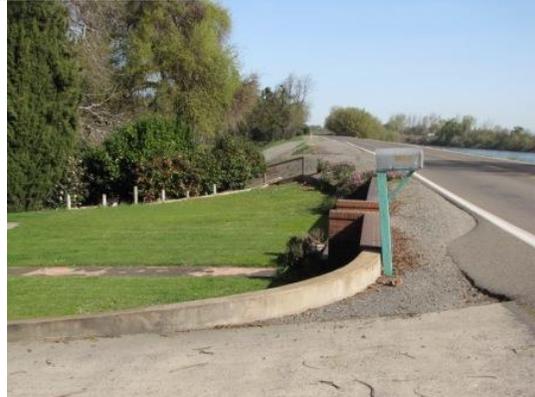
Photo 1 of 1 : SP_2015_RD0150_16_20_20150313_00014.jpg

LM Start	4.08	Rating **	M	Issue No.	20
LM End	4.10	Issue Type +	En	Location *	LS
Category	Earthen Levee		GPS Latitude/Longitude		
			Start	End	
Item	Encroachments		38.364854 °	38.365104 °	
			-121.522378 °	-121.522365 °	
DWR ID	DWR_RD0150_02_s_2012_20				
Action/Comments					
Building Inspector Comments: 3' retaining wall at the landward shoulder.

View of a retaining wall on the landward slope looking upstream.

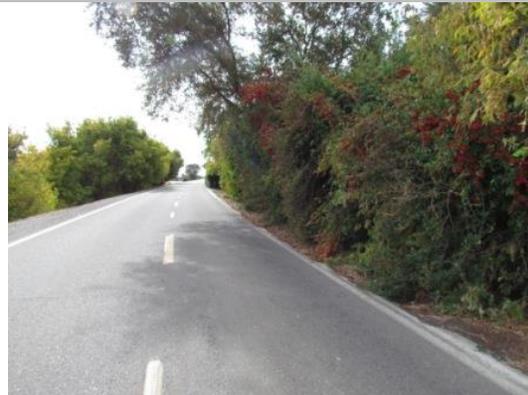
Photo 1 of 1 : SP_2015_RD0150_16_79_20150313_00041.jpg

LM Start	4.30	Rating **	U	Issue No.	79
LM End	4.34	Issue Type +	En	Location *	LS
Category	Earthen Levee		GPS Latitude/Longitude		
			Start	End	
Item	Vegetation		38.368036 °	38.368540 °	
			-121.522611 °	-121.522729 °	
DWR ID	DWR_RD0150_02_s_2012_79				
Action/Comments					
Landscaping

Trees were obstructing the views on the landside slope of the levee looking downstream.

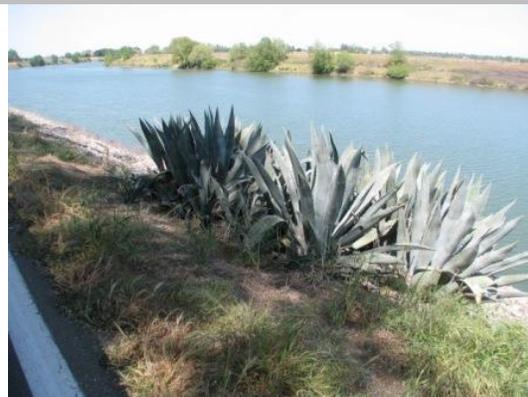
Photo 1 of 1 : SP_2015_RD0150_16_28_20150313_00018.jpg

Century plant on waterward slope at LM 4.76

LM Start	4.69	Rating **	M	Issue No.	28
LM End	4.69	Issue Type +	Ma	Location *	WS
Category	Earthen Levee		GPS Latitude/Longitude		
			Start	End	
Item	Vegetation		38.373485 °	38.373485 °	
			-121.523963 °	-121.523963 °	
DWR ID	DWR_RD0150_02_s_2012_28				
Action/Comments					
Remove the wild growth other than native grasses from the levee slopes.

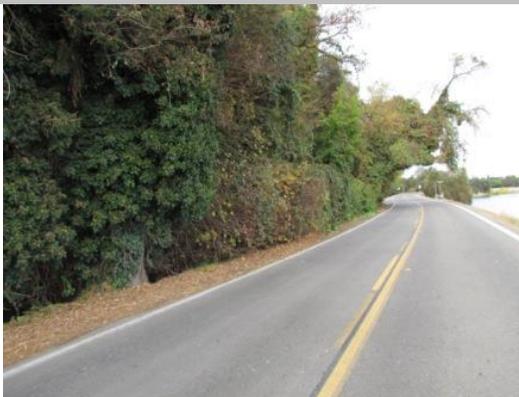
Photo 1 of 1 : SP_2015_RD0150_16_76_20150313_00040.jpg

LM Start	4.70	Rating **	U	Issue No.	76
LM End	4.72	Issue Type +	En	Location *	LS
Category	Earthen Levee		GPS Latitude/Longitude		
			Start	End	
Item	Vegetation		38.373688 °	38.373970 °	
			-121.524280 °	-121.524403 °	
DWR ID	DWR_RD0150_02_s_2012_76				
Action/Comments					
Landscaping

Trees were obstructing the view of the landside slope of the levee looking upstream.

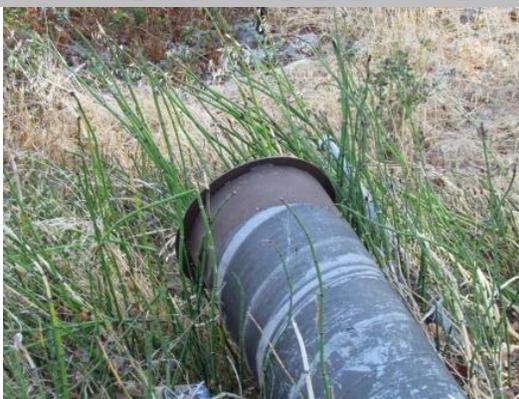
Photo 1 of 1 : SP_2015_RD0150_16_69_20150313_00038.jpg

LM Start	4.85	Rating **	M	Issue No.	69
LM End	4.85	Issue Type +	En	Location *	WS
Category	Earthen Levee		GPS Latitude/Longitude		
			Start	End	
Item	Encroachments		38.375731 °	38.375731 °	
			-121.525245 °	-121.525245 °	
DWR ID	DWR_RD0150_02_f_2013_69				
Action/Comments					
Pipe Inspector Comments: The pipe cover is not a water tight connection. During high water, water may leak through the pipe and get into the landside.

The pipe cover doesn't appear to be water tight on the waterside slope of the levee. The picture was taken from the crown looking towards the toe of the levee during fall 2013 inspection.

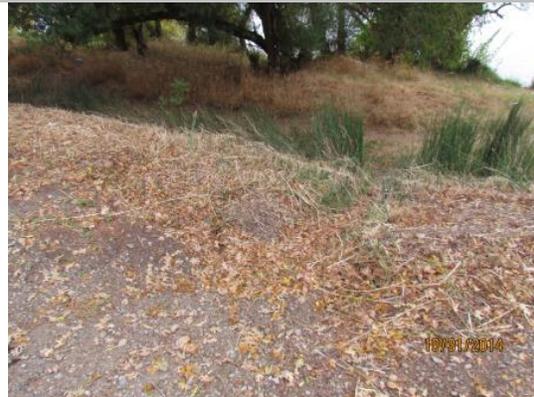
Photo 1 of 1 : SP_2015_RD0150_16_54_20150313_00031.jpg

View of a slope instability on the waterside of the levee looking towards the toe.

LM Start	5.33	Rating **	M	Issue No.	54
LM End	5.33	Issue Type +	Ma	Location *	WS
Category	Earthen Levee			GPS Latitude/Longitude	
				Start	End
Item	Slope Stability			38.382072 °	38.382072 °
				-121.523220 °	-121.523220 °
DWR ID	DWR_RD0150_02_f_2014_54				
Action/Comments					
Repair the levee slope damaged by foot traffic and prevent access where possible.

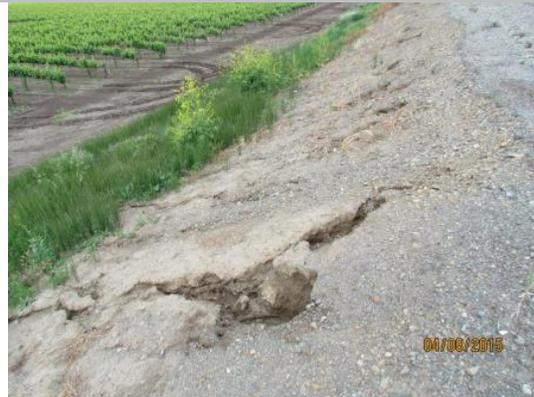
Photo 1 of 1 : SP_2015_RD0150_16_383_20150413_00074.jpg

Slope instability caused by runoff was found on the landside of the levee looking upstream.

LM Start	5.89	Rating **	M	Issue No.	383
LM End	5.89	Issue Type +	Ma	Location *	LS
Category	Earthen Levee		GPS Latitude/Longitude		
			Start	End	
Item	Slope Stability		38.387809 °	38.387809 °	
			-121.516030 °	-121.516030 °	
DWR ID	DWR_RD0150_02_s_2015_383				
Action/Comments					
Repair slope instability. Inspector Comments: Runoff.

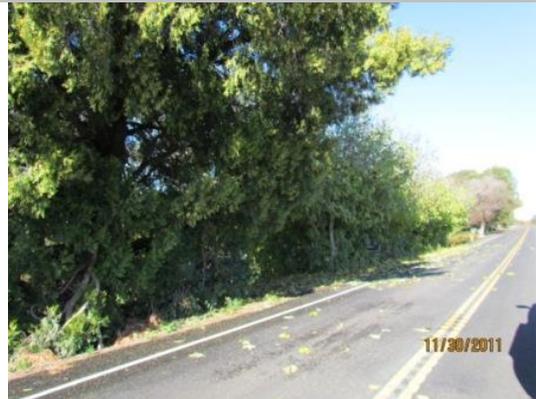
Photo 1 of 1 : SP_2015_RD0150_16_31_20150313_00020.jpg

LM Start	6.36	Rating **	M	Issue No.	31
LM End	6.36	Issue Type +	En	Location *	LS
Category	Earthen Levee		GPS Latitude/Longitude		
			Start	End	
Item	Vegetation		38.394416 °	38.394416 °	
			-121.514590 °	-121.514590 °	
DWR ID	DWR_RD0150_02_s_2012_31				
Action/Comments					
Landscaping

Trees need to be trimmed on the landside of the levee looking upstream.

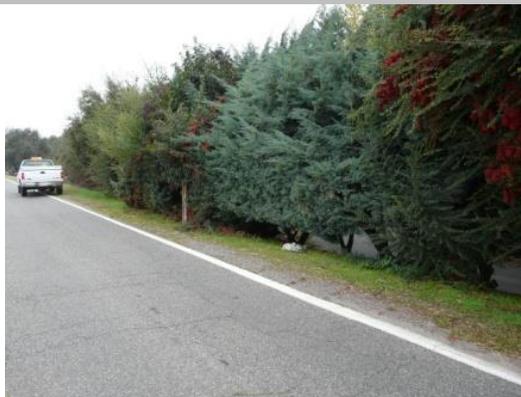
Photo 1 of 1 : SP_2015_RD0150_16_64_20150313_00036.jpg

LM Start	6.56	Rating **	U	Issue No.	64
LM End	6.61	Issue Type +	En	Location *	LS
Category	Earthen Levee		GPS Latitude/Longitude		
			Start	End	
Item	Vegetation		38.397411 °	38.398033 °	
			-121.514681 °	-121.514753 °	
DWR ID	DWR_RD0150_02_s_2012_64				
Action/Comments					
Landscaping

Landscaping providing a screen for a residence on landside of levee from LM 6.68 to LM 6.72

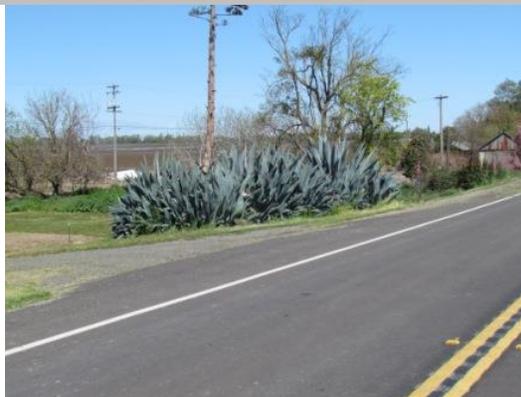
Photo 1 of 1 : SP_2015_RD0150_16_43_20150313_00025.jpg

LM Start	6.64	Rating **	M	Issue No.	43
LM End	6.64	Issue Type +	En	Location *	LS
Category	Earthen Levee		GPS Latitude/Longitude		
			Start	End	
Item	Vegetation		38.398456 °	38.398456 °	
			-121.514735 °	-121.514735 °	
DWR ID	DWR_RD0150_02_s_2012_43				
Action/Comments					
Landscaping Inspector Comments: Century plant on landside of the levee.

Century plants were found on the landside of the levee looking upstream.

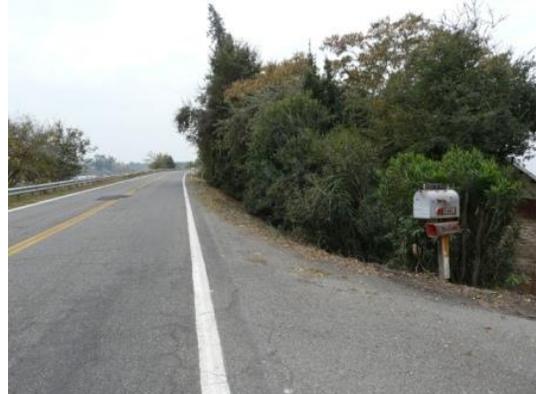
Photo 1 of 1 : SP_2015_RD0150_16_60_20150313_00035.jpg

LM Start	6.81	Rating **	U	Issue No.	60
LM End	6.93	Issue Type +	En	Location *	LS
Category	Earthen Levee			GPS Latitude/Longitude	
				Start	End
Item	Vegetation			38.400936 °	38.402613 °
				-121.515173 °	-121.515863 °
DWR ID	DWR_RD0150_02_s_2012_60				
Action/Comments					
Landscaping

Landscaping providing a screen for a residence on the landside of levee from LM 6.93 to LM 7.05

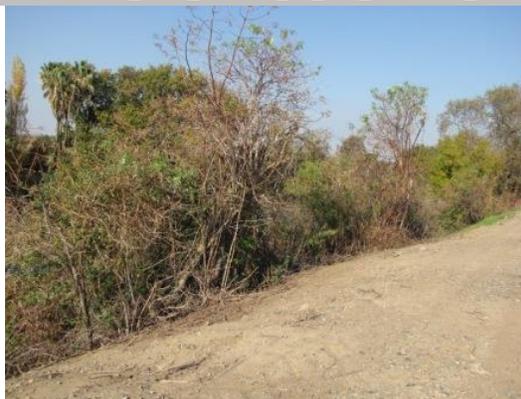
Photo 1 of 1 : SP_2015_RD0150_17_936_20150313_00102.jpg

LM Start	0.11	Rating **	A/W	Issue No.	936
LM End	0.11	Issue Type +	Ma	Location *	WS
Category	Earthen Levee			GPS Latitude/Longitude	
				Start	End
Item	Vegetation			38.334233 °	38.334233 °
				-121.583414 °	-121.583414 °
DWR ID	DWR_RD0150_03_s_2012_936				
Action/Comments					
Elderberries are blocking visibility and flood fight capability.

View of elderberry bush within 20 feet of shoulder blocking visibility and access.

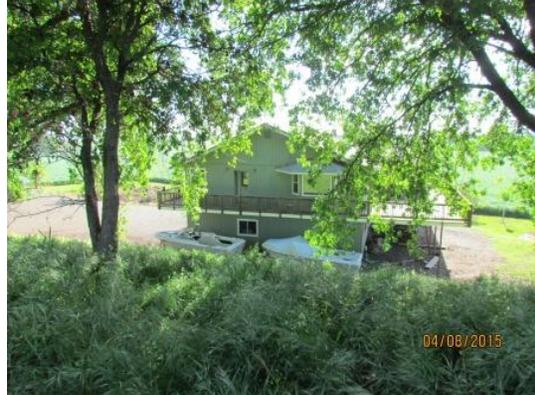
Photo 1 of 2 : SP_2015_RD0150_17_3_20150410_00117.jpg

LM Start	0.35	Rating **	M	Issue No.	3
LM End	0.35	Issue Type +	En	Location *	WS
Category	Earthen Levee		GPS Latitude/Longitude		
			Start	End	
Item	Encroachments		38.337442 °	38.337442 °	
			-121.581628 °	-121.581628 °	
DWR ID	DWR_RD0150_03_s_2012_3				
Action/Comments					
Building Inspector Comments: Steps, water, electricity, and dock on waterward slope.

View of a house on the landside toe of the levee looking upstream.

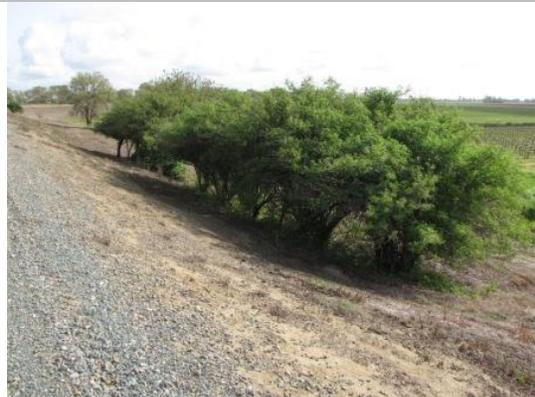
Photo 1 of 1 : SP_2015_RD0150_17_5_20150313_00004.jpg

LM Start	0.91	Rating **	A/W	Issue No.	5
LM End	0.93	Issue Type +	Ma	Location *	LS
Category	Earthen Levee			GPS Latitude/Longitude	
				Start	End
Item	Vegetation			38.345293 °	38.345634 °
				-121.579769 °	-121.579574 °
DWR ID	DWR_RD0150_03_s_2012_5				
Action/Comments					
Elderberries are blocking visibility and flood fight capability.

View of elderberries on the landward slope blocking visibility and access.

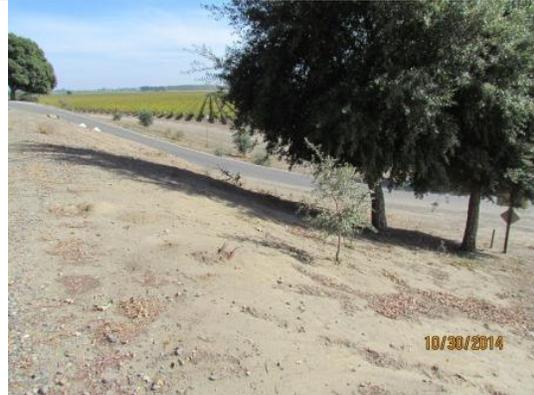
Photo 1 of 1 : SP_2015_RD0150_17_75_20150313_00070.jpg

LM Start	2.24	Rating **	M	Issue No.	75
LM End	2.24	Issue Type +	Ma	Location *	LS
Category	Earthen Levee		GPS Latitude/Longitude		
			Start	End	
Item	Vegetation		38.353811 °	38.353811 °	
			-121.565668 °	-121.565668 °	
DWR ID	DWR_RD0150_03_f_2014_75				
Action/Comments					
Remove the wild growth other than native grasses from the levee slopes. Inspector Comments: Newly planted tree was found on the landside slope of the levee.

View of a few trees that were planted on the landside slope of the levee looking upstream.

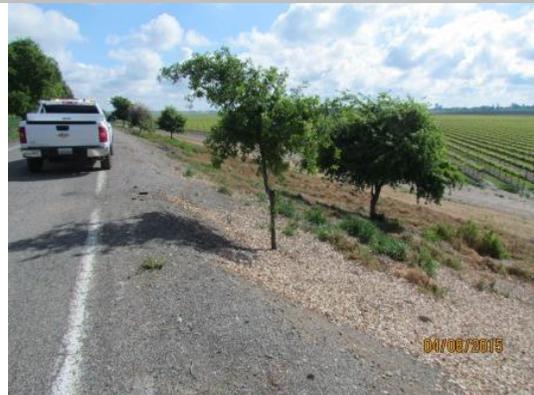
Photo 1 of 5 : SP_2015_RD0150_17_78_20150413_00120.jpg

LM Start	2.31	Rating **	M	Issue No.	78
LM End	2.31	Issue Type +	En	Location *	LS
Category	Earthen Levee		GPS Latitude/Longitude		
			Start	End	
Item	Encroachments		38.354286 °	38.354286 °	
			-121.564494 °	-121.564494 °	
DWR ID	DWR_RD0150_03_s_2012_78				
Action/Comments					
Tree or limb Inspector Comments: New tree was planted on the landside slope.

Updated picture of the trees on the landside of the levee during spring 2015 inspection.

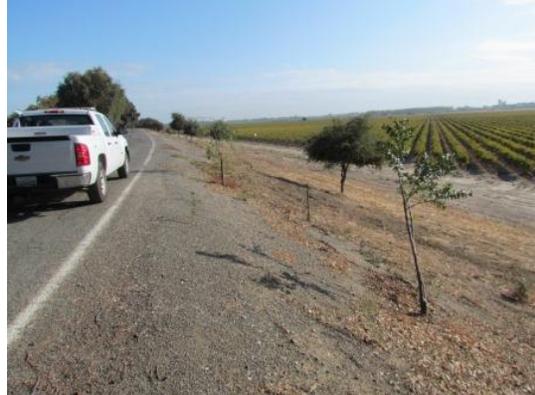
Photo 3 of 5 : SP_2015_RD0150_17_78_20150313_00075.jpg

LM Start	2.31	Rating **	M	Issue No.	78 (cont)
LM End	2.31	Issue Type +	En	Location *	LS
Category	Earthen Levee			GPS Latitude/Longitude	
				Start	End
Item	Encroachments			38.354286 °	38.354286 °
				-121.564494 °	-121.564494 °
DWR ID	DWR_RD0150_03_s_2012_78				
Action/Comments					
Tree or limb Inspector Comments: New tree was planted on the landside slope.

Several newly planted trees were found on the landside slope of the levee looking upstream during the fall 2013 inspection.

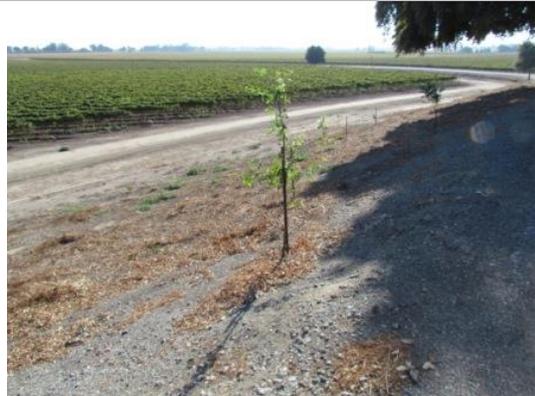
Photo 4 of 5 : SP_2015_RD0150_17_78_20150313_00076.jpg

New tree was found on the landside shoulder of the levee looking downstream. This picture was taken during fall 2012 inspection.

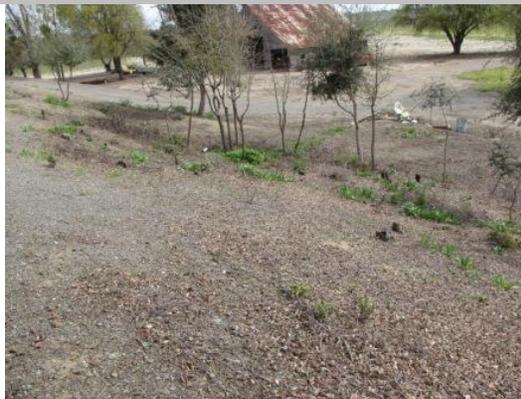
Photo 1 of 1 : SP_2015_RD0150_17_11_20150313_00007.jpg

LM Start	2.55	Rating **	N	Issue No.	11
LM End	2.55	Issue Type +	Ma	Location *	LS
Category	Earthen Levee		GPS Latitude/Longitude		
			Start	End	
Item	Trim / Thin Trees		38.356853 °	38.356853 °	
			-121.561565 °	-121.561565 °	
DWR ID	DWR_RD0150_03_s_2012_11				
Action/Comments					
Tree stumps.

View of tree stumps on the landward slope.

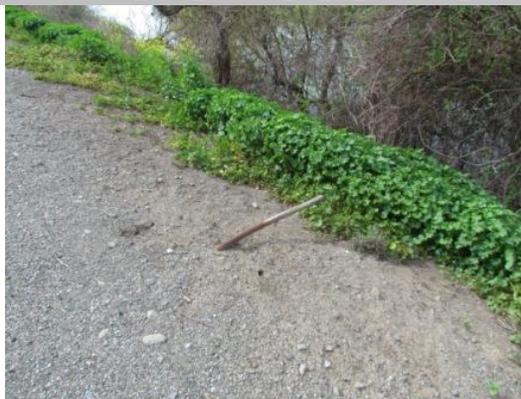
Photo 1 of 1 : SP_2015_RD0150_17_34_20150313_00026.jpg

LM Start	2.66	Rating **	M	Issue No.	34
LM End	2.66	Issue Type +	En	Location *	WS
Category	Earthen Levee		GPS Latitude/Longitude		
			Start	End	
Item	Encroachments		38.358406 °	38.358406 °	
			-121.561300 °	-121.561300 °	
DWR ID	DWR_RD0150_03_s_2013_34				
Action/Comments					
Pipe

A pipe was found on the waterside shoulder of the levee looking downstream during spring 2013 inspection.

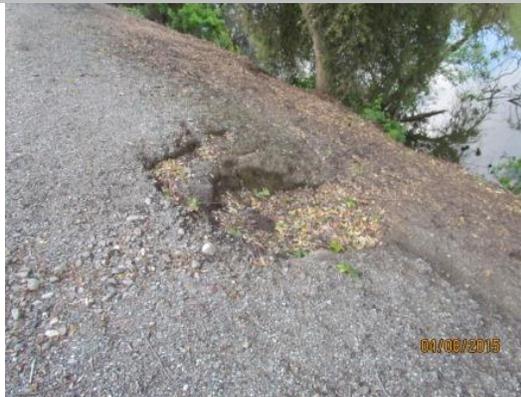
Photo 1 of 3 : SP_2015_RD0150_17_35_20150413_00121.jpg

Updated picture of the erosion on the waterside of the levee during spring 2015 inspection.

LM Start	2.80	Rating **	M	Issue No.	35
LM End	2.80	Issue Type +	Ma	Location *	WS
Category	Earthen Levee		GPS Latitude/Longitude		
			Start	End	
Item	Erosion / Bank Caving		38.360432 °	38.360432 °	
			-121.561644 °	-121.561644 °	
DWR ID	DWR_RD0150_03_s_2013_35				
Action/Comments					
Schedule repair of erosion site prior to the next inspection.

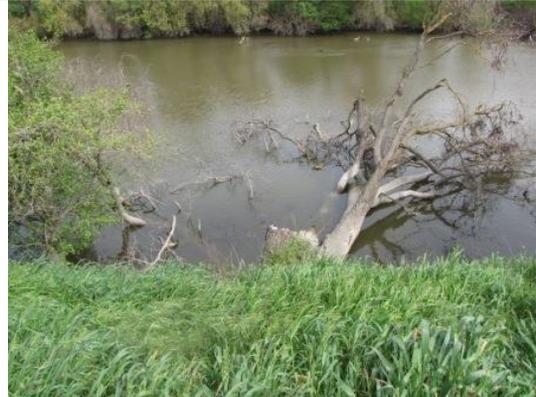
Photo 1 of 1 : SP_2015_RD0150_17_20_20150313_00015.jpg

LM Start	3.15	Rating **	N	Issue No.	20
LM End	3.15	Issue Type +	Ma	Location *	WS
Category	Earthen Levee			GPS Latitude/Longitude	
				Start	End
Item	Trim / Thin Trees			38.363658 °	38.363658 °
				-121.559583 °	-121.559583 °
DWR ID	DWR_RD0150_03_s_2012_20				
Action/Comments					
Tree stumps.

View of tree stumps on the waterward slope.

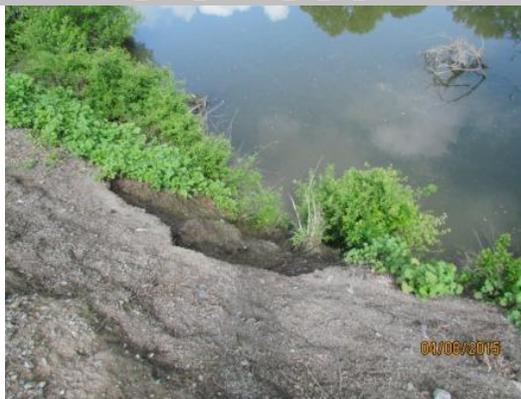
Photo 1 of 3 : SP_2015_RD0150_17_40_20150413_00122.jpg

Updated picture of the erosion on the waterside of the levee during spring 2015 inspection.

LM Start	3.31	Rating **	M	Issue No.	40
LM End	3.31	Issue Type +	Ma	Location *	WS
Category	Earthen Levee		GPS Latitude/Longitude		
			Start	End	
Item	Erosion / Bank Caving		38.363008 °	38.363008 °	
			-121.556751 °	-121.556751 °	
DWR ID	DWR_RD0150_03_s_2013_40				
Action/Comments					
Schedule repair of erosion site prior to the next inspection.

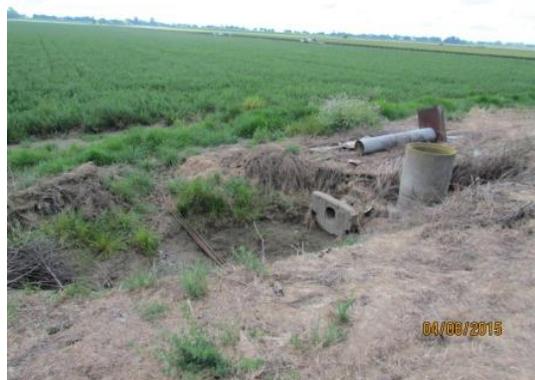
Photo 1 of 2 : SP_2015_RD0150_17_115_20150413_00123.jpg

LM Start	3.39	Rating **	U	Issue No.	115
LM End	3.39	Issue Type +	Ma	Location *	LS
Category	Earthen Levee			GPS Latitude/Longitude	
				Start	End
Item	Erosion / Bank Caving			38.363540 °	38.363540 °
				-121.555554 °	-121.555554 °
DWR ID	DWR_RD0150_03_f_2013_115				
Action/Comments					
Schedule repair of erosion site prior to the next inspection. Inspector Comments: Erosion (ditch) was found on the landside toe of the levee.

Updated picture of the ditch on the landside toe of the levee during spring 2015 inspection.

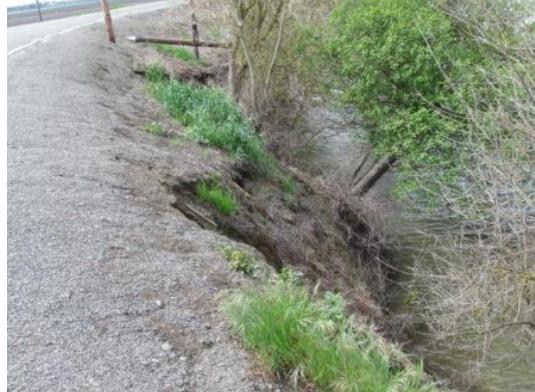
Photo 1 of 1 : SP_2015_RD0150_17_98_20150313_00091.jpg

LM Start	3.41	Rating **	M	Issue No.	98
LM End	3.41	Issue Type +	Ma	Location *	WS
Category	Earthen Levee		GPS Latitude/Longitude		
			Start	End	
Item	Erosion / Bank Caving		38.363803 °	38.363803 °	
			-121.555432 °	-121.555432 °	
DWR ID	DWR_RD0150_03_s_2012_98				
Action/Comments					
Note and monitor erosion site. Inspector Comments: Erosion was located on the waterside of the levee looking downstream.

Erosion was found on the waterside of the levee looking downstream.

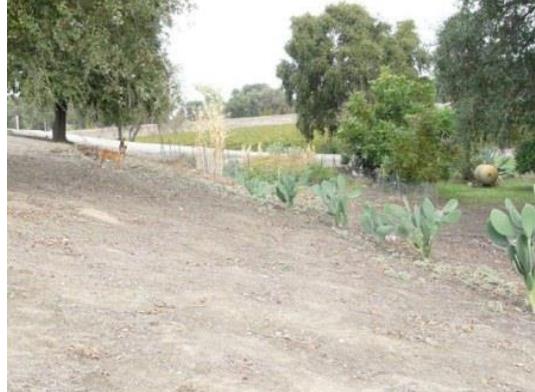
Photo 1 of 1 : SP_2015_RD0150_17_47_20150313_00037.jpg

LM Start	3.44	Rating **	M	Issue No.	47
LM End	3.48	Issue Type +	En	Location *	LS
Category	Earthen Levee		GPS Latitude/Longitude		
			Start	End	
Item	Vegetation		38.364251 °	38.364772 °	
			-121.555321 °	-121.555343 °	
DWR ID	DWR_RD0150_03_s_2012_47				
Action/Comments					
Landscaping

Landscaping & garden on landward slope of levee at LM 3.50 to LM 3.54.

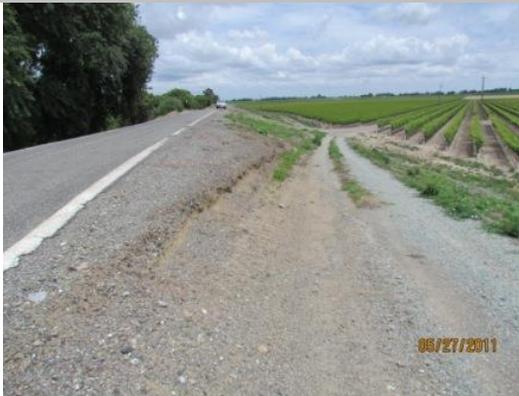
Photo 1 of 2 : SP_2015_RD0150_17_927_20150313_00095.jpg

Slope instability possible due to vehicular traffic on the landside of the levee. The picture was taken from the crown looking upstream during Spring 2011 inspection.

LM Start	3.67	Rating **	A/W	Issue No.	927
LM End	3.67	Issue Type +	Ma	Location *	LS
Category	Earthen Levee			GPS Latitude/Longitude	
				Start	End
Item	Slope Stability			38.367305 °	38.367305 °
				-121.554984 °	-121.554984 °
DWR ID	DWR_RD0150_03_s_2012_927				
Action/Comments					
Repair the levee slope damaged by vehicle traffic and prevent access where possible.

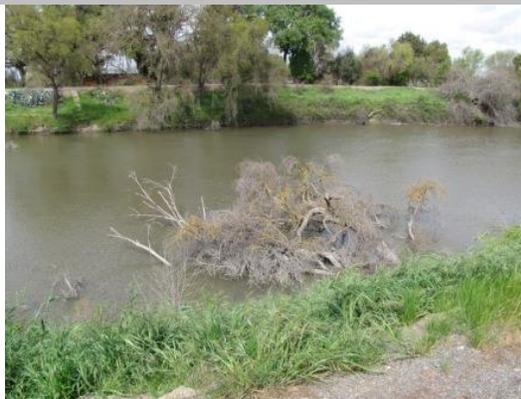
Photo 1 of 1 : SP_2015_RD0150_17_37_20150313_00030.jpg

LM Start	4.28	Rating **	N	Issue No.	37
LM End	4.28	Issue Type +	Ma	Location *	WS
Category	Earthen Levee			GPS Latitude/Longitude	
				Start	End
Item	Trim / Thin Trees			38.373319 °	38.373319 °
				-121.550836 °	-121.550836 °
DWR ID	DWR_RD0150_03_s_2012_37				
Action/Comments					
Tree stumps.

View of tree stumps on the waterward slope.

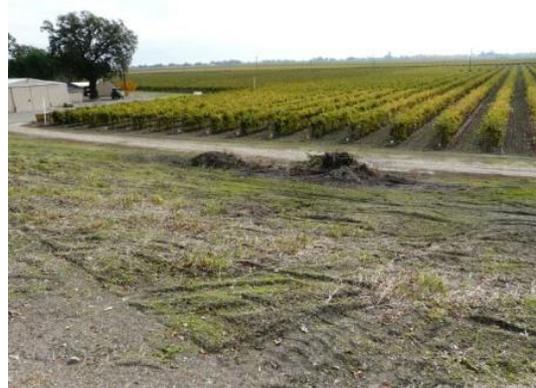
Photo 1 of 4 : SP_2015_RD0150_17_51_20150313_00041.jpg

LM Start	4.38	Rating **	M	Issue No.	51
LM End	4.38	Issue Type +	Ma	Location *	LS
Category	Earthen Levee			GPS Latitude/Longitude	
				Start	End
Item	Encroachments			38.374269 °	38.374269 °
				-121.549385 °	-121.549385 °
DWR ID	DWR_RD0150_03_s_2012_51				
Action/Comments					
Prunings

Remove pruning pile on landward slope at LM 4.46.

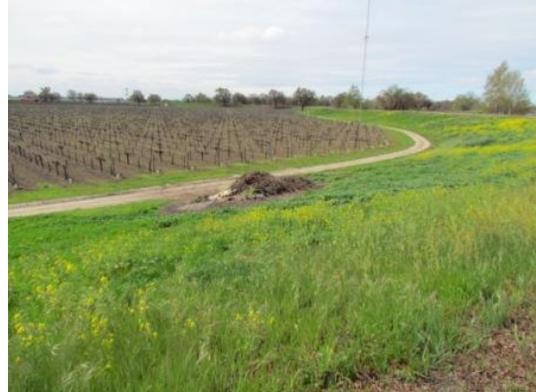
Photo 2 of 4 : SP_2015_RD0150_17_51_20150313_00042.jpg

Prunings were found on the landside of the levee looking downstream.

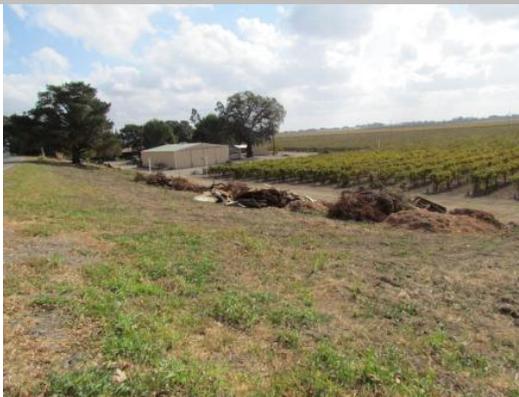
Photo 4 of 4 : SP_2015_RD0150_17_51_20150313_00044.jpg

Updated picture of the pruning pile on the landside of the levee looking upstream during the fall 2013 inspection.

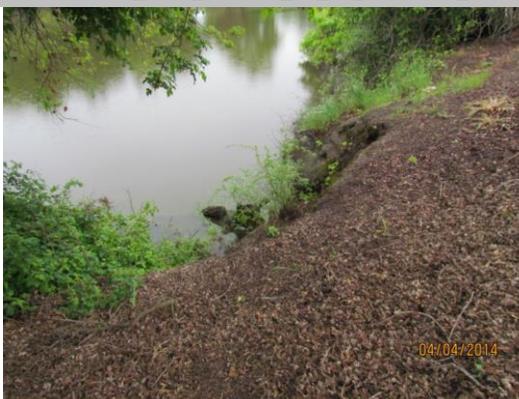
Photo 1 of 1 : SP_2015_RD0150_17_80_20150313_00079.jpg

View of an erosion site on the waterside toe of the levee looking upstream.

LM Start	4.49	Rating **	M	Issue No.	80
LM End	4.49	Issue Type +	Ma	Location *	WS
Category	Earthen Levee			GPS Latitude/Longitude	
				Start	End
Item	Erosion / Bank Caving			38.374355 °	38.374355 °
				-121.547436 °	-121.547436 °
DWR ID	DWR_RD0150_03_s_2014_80				
Action/Comments					
Schedule repair of erosion site prior to the next inspection.

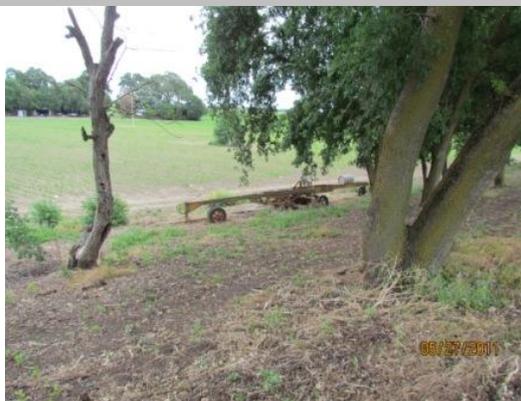
Photo 1 of 1 : SP_2015_RD0150_17_9_20150313_00006.jpg

Equipment on the landside toe of the levee. The picture was taken from crown looking downstream.

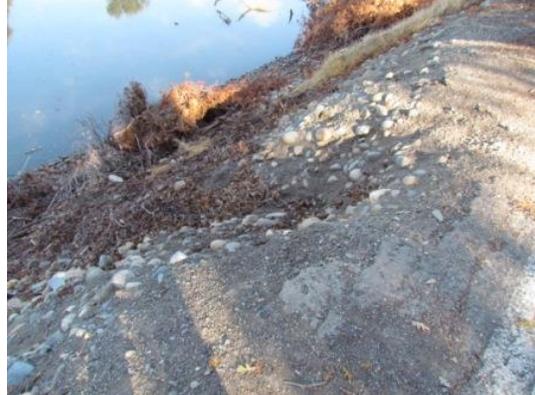
Photo 1 of 1 : SP_2015_RD0150_17_36_20150313_00029.jpg

Slope instability was found on the waterside of the levee looking upstream.

LM Start	4.99	Rating **	M	Issue No.	36
LM End	4.99	Issue Type +	Ma	Location *	WS
Category	Earthen Levee			GPS Latitude/Longitude	
				Start	End
Item	Slope Stability			38.378771 °	38.378771 °
				-121.540538 °	-121.540538 °
DWR ID	DWR_RD0150_03_f_2012_36				
Action/Comments					
Repair slope instability.

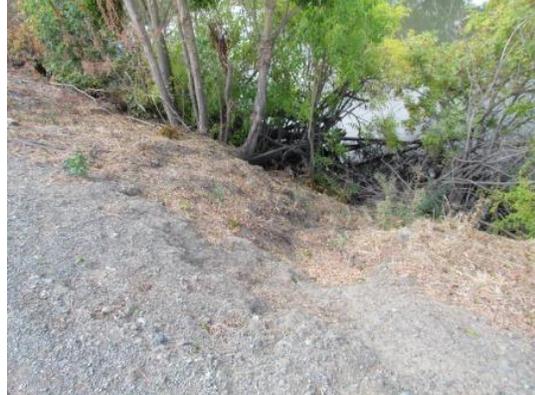
Photo 1 of 2 : SP_2015_RD0150_17_4_20150313_00002.jpg

Updated picture of the slope instability on the waterside slope of the levee looking downstream during the fall 2013 inspection.

LM Start	5.04	Rating **	M	Issue No.	4
LM End	5.04	Issue Type +	Ob	Location *	WS
Category	Earthen Levee			GPS Latitude/Longitude	
				Start	End
Item	Slope Stability			38.379456 °	38.379456 °
				-121.540147 °	-121.540147 °
DWR ID	DWR_RD0150_03_s_2012_4				
Action/Comments					
Repair slope instability.

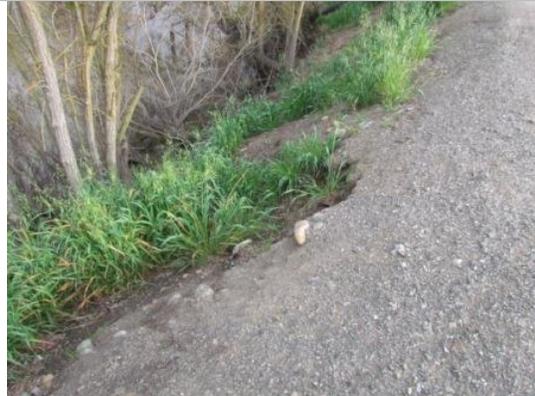
Photo 2 of 2 : SP_2015_RD0150_17_4_20150313_00003.jpg

Slope instability was found on the waterside of the levee looking upstream.

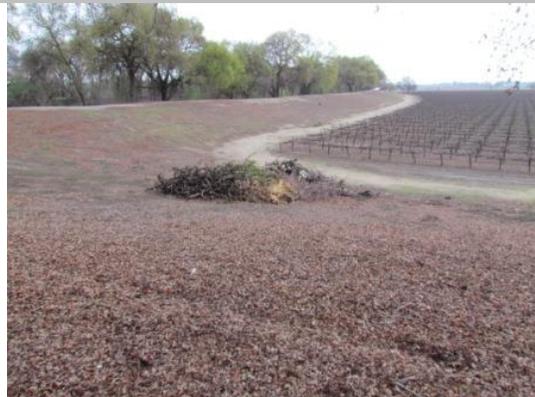
Photo 1 of 4 : SP_2015_RD0150_17_12_20150313_00008.jpg

Prunings were found on the landside of the levee looking upstream.

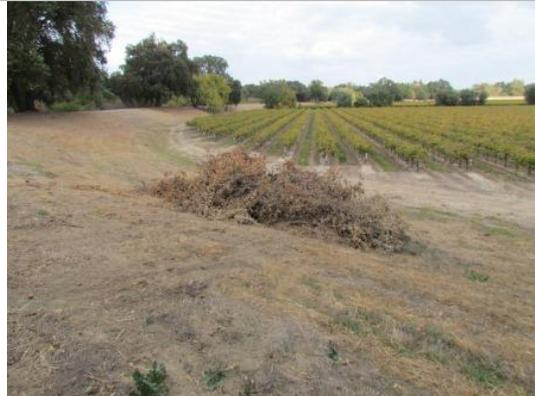
Photo 2 of 4 : SP_2015_RD0150_17_12_20150313_00009.jpg

Updated picture of pruning pile on the landside toe of the levee looking upstream during the fall 2013 inspection.

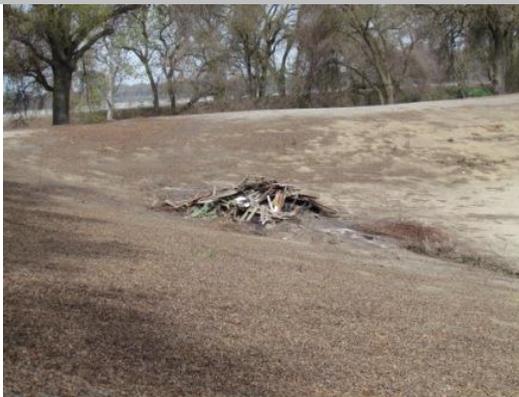
Photo 3 of 4 : SP_2015_RD0150_17_12_20150313_00010.jpg

Updated picture of debris and pruning on the landside toe of the levee looking upstream. This picture was taken during spring 2013 inspection.

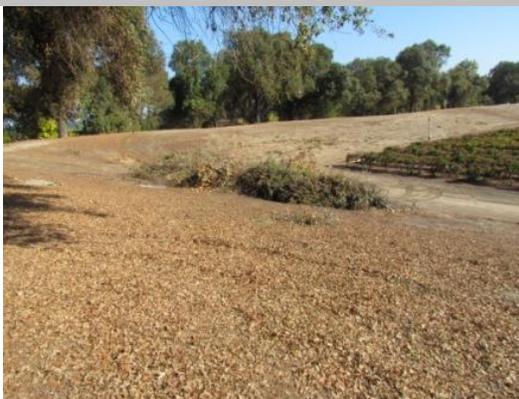
Photo 4 of 4 : SP_2015_RD0150_17_12_20150313_00011.jpg

Pruning was found on the landside toe of the levee looking upstream. This picture was taken during fall 2012 inspection.

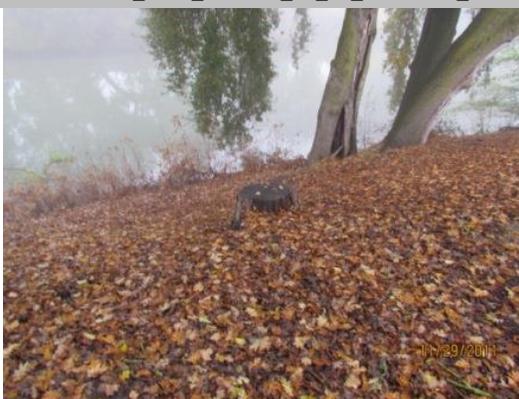
Photo 1 of 1 : SP_2015_RD0150_17_68_20150313_00066.jpg

Tree stump was found on the waterside of the levee looking upstream.

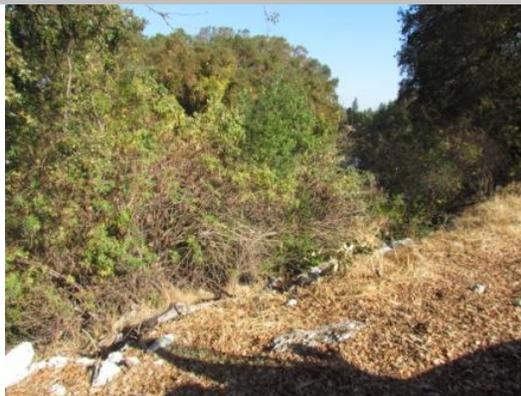
Photo 1 of 1 : SP_2015_RD0150_17_28_20150313_00020.jpg

Wild growth was found on the waterside slope of the levee looking upstream.

LM Start	5.78	Rating **	M	Issue No.	28
LM End	5.78	Issue Type +	Ma	Location *	WS
Category	Earthen Levee		GPS Latitude/Longitude		
			Start	End	
Item	Vegetation		38.384333 °	38.384333 °	
			-121.541310 °	-121.541310 °	
DWR ID	DWR_RD0150_03_s_2012_28				
Action/Comments					
Remove the wild growth other than native grasses from the levee slopes.

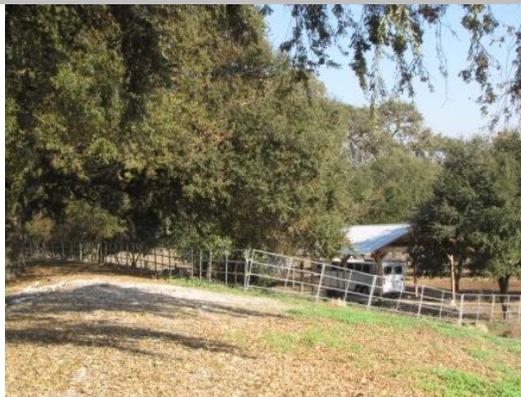
Photo 1 of 1 : SP_2015_RD0150_17_56_20150313_00047.jpg

View of fence around a horse pen along the shoulder of the levee and the landward slope.

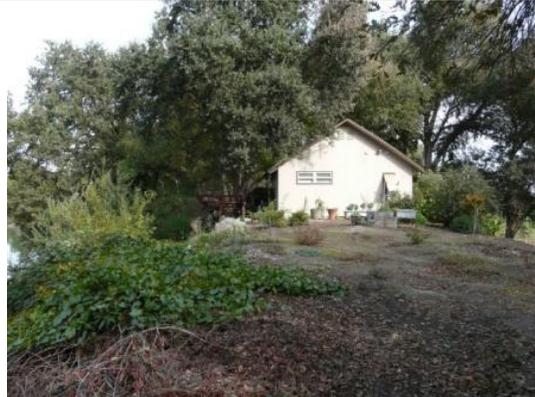
Photo 1 of 1 : SP_2015_RD0150_17_58_20150313_00049.jpg

Building & associated landscaping on levee crown at LM 5.93.

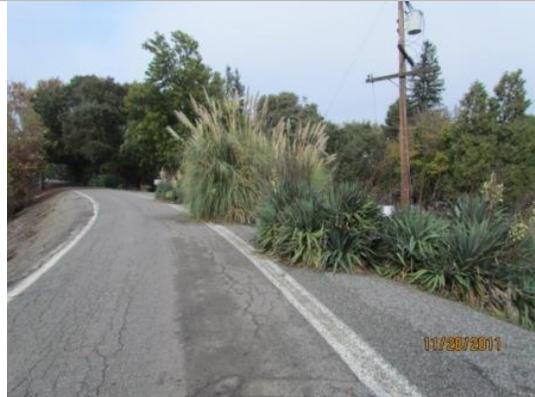
Photo 1 of 1 : SP_2015_RD0150_17_21_20150313_00016.jpg

Landscaping was found on the landside of the levee looking upstream.

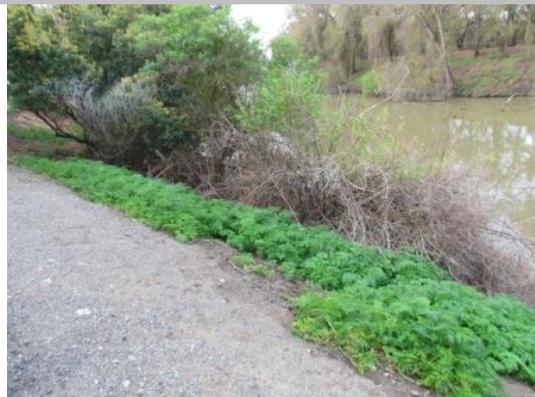
Photo 1 of 1 : SP_2015_RD0150_17_33_20150313_00025.jpg

Tree trunks and vegetation was obstructing the visibility on the waterside slope of the levee looking downstream.

LM Start	5.95	Rating **	M	Issue No.	33
LM End	5.95	Issue Type +	Ma	Location *	WS
Category	Earthen Levee		GPS Latitude/Longitude		
			Start	End	
Item	Trim / Thin Trees		38.386351 °	38.386351 °	
			-121.539828 °	-121.539828 °	
DWR ID	DWR_RD0150_03_s_2012_33				
Action/Comments					
Thin trees to allow visibility of the ground and room to flood fight.

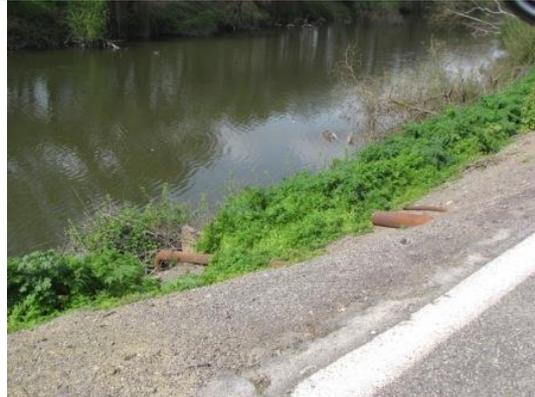
Photo 1 of 1 : SP_2015_RD0150_17_46_20150313_00036.jpg

LM Start	5.96	Rating **	M	Issue No.	46
LM End	5.96	Issue Type +	Ma	Location *	WS
Category	Earthen Levee		GPS Latitude/Longitude		
			Start	End	
Item	Encroachments		38.386422 °	38.386422 °	
			-121.539861 °	-121.539861 °	
DWR ID	DWR_RD0150_03_s_2012_46				
Action/Comments					
Pipe Inspector Comments: Improperly abandoned pipe through the levee.

View of an improperly abandoned pipe through the levee looking upstream.

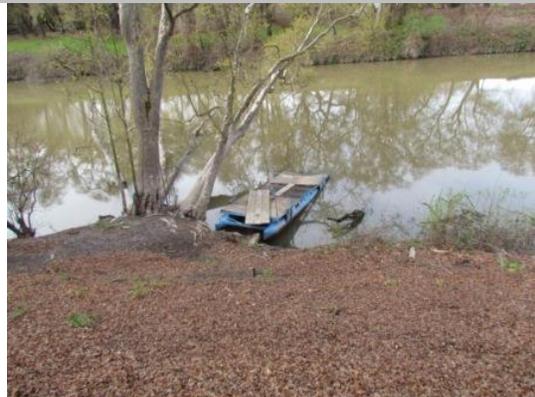
Photo 1 of 1 : SP_2015_RD0150_17_44_20150313_00035.jpg

LM Start	6.03	Rating **	M	Issue No.	44
LM End	6.03	Issue Type +	En	Location *	WS
Category	Earthen Levee		GPS Latitude/Longitude		
			Start	End	
Item	Encroachments		38.387295 °	38.387295 °	
			-121.540612 °	-121.540612 °	
DWR ID	DWR_RD0150_03_s_2012_44				
Action/Comments					
Abandoned vehicles Inspector Comments: It appeared to be an abandoned dock.

An abandoned dock was found on the waterside of the levee looking upstream.

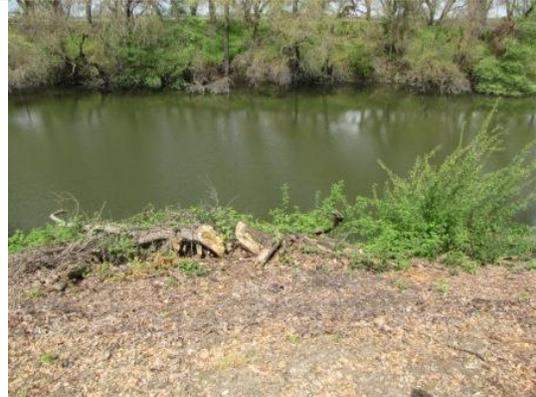
Photo 1 of 1 : SP_2015_RD0150_17_49_20150313_00038.jpg

View of tree stumps on the waterward slope.

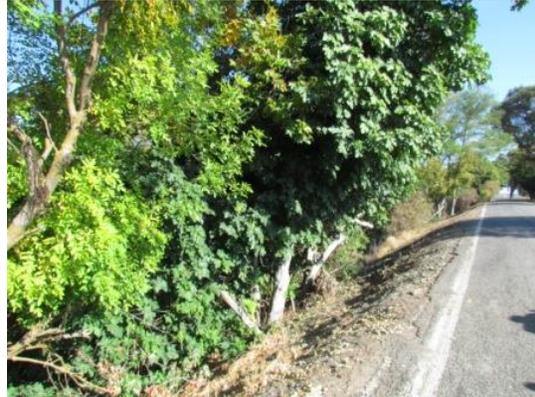
Photo 1 of 2 : SP_2015_RD0150_17_62_20150313_00056.jpg

Tree was blocking the visibility on the waterside of the levee looking upstream. This picture was taken during fall 2012 inspection.

LM Start	6.38	Rating **	M	Issue No.	62
LM End	6.38	Issue Type +	Ma	Location *	WS
Category	Earthen Levee		GPS Latitude/Longitude		
			Start	End	
Item	Trim / Thin Trees		38.390935 °	38.390935 °	
			-121.539369 °	-121.539369 °	
DWR ID	DWR_RD0150_03_s_2012_62				
Action/Comments					
Trim and thin trees to allow visibility of the ground and room to flood fight.

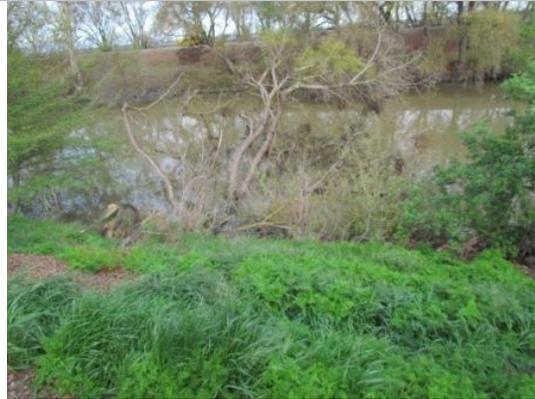
Photo 2 of 2 : SP_2015_RD0150_17_62_20150313_00057.jpg

Vegetation on the waterside of the levee looking downstream.

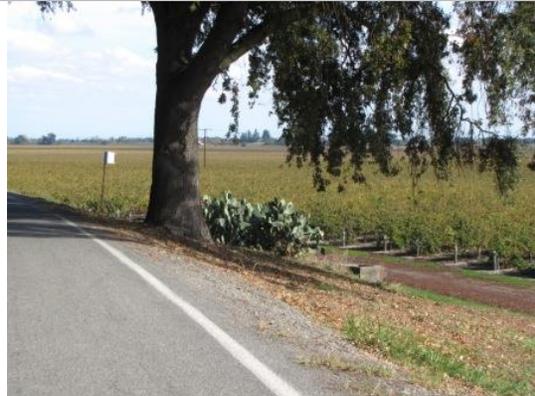
Photo 1 of 1 : SP_2015_RD0150_17_60_20150313_00051.jpg

View of landscaping along the landward slope.

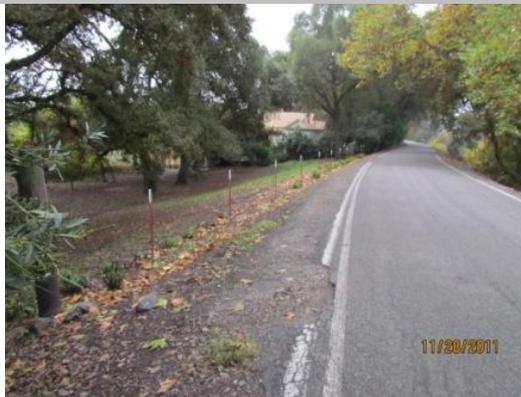
Photo 1 of 1 : SP_2015_RD0150_17_13_20150313_00012.jpg

Fence was found on the landside of the levee looking downstream.

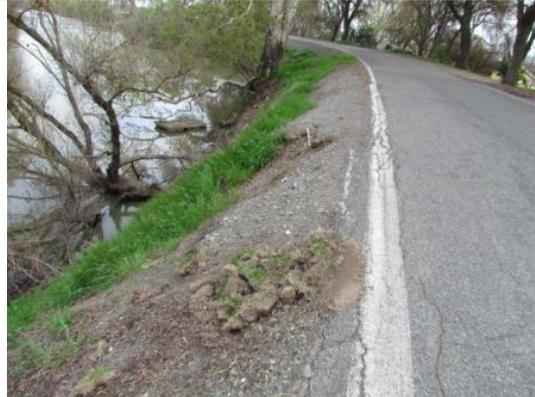
Photo 3 of 4 : SP_2015_RD0150_17_61_20150313_00053.jpg

Erosion on the waterside of the levee looking upstream. This picture was taken during spring 2012 inspection.

LM Start	6.90	Rating **	M	Issue No.	61 (cont)
LM End	6.90	Issue Type +	Ma	Location *	WS
Category	Earthen Levee			GPS Latitude/Longitude	
				Start	End
Item	Erosion / Bank Caving			38.396655 °	38.396655 °
				-121.535485 °	-121.535485 °
DWR ID	DWR_RD0150_03_s_2012_61				
Action/Comments					
Note and monitor erosion site.

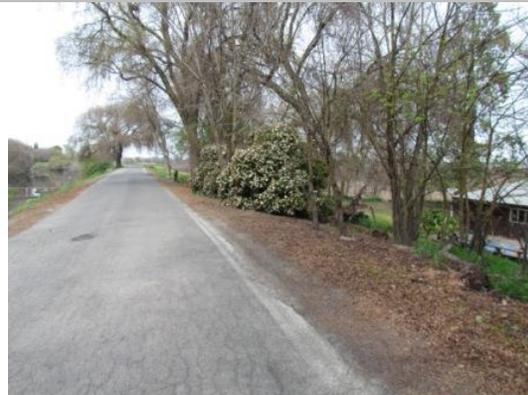
Photo 1 of 1 : SP_2015_RD0150_17_31_20150313_00022.jpg

Landscaping was found on the landside shoulder of the levee looking upstream.

LM Start	6.93	Rating **	M	Issue No.	31
LM End	6.97	Issue Type +	En	Location *	LS
Category	Earthen Levee		GPS Latitude/Longitude		
			Start	End	
Item	Vegetation		38.397021 °	38.397540 °	
			-121.535151 °	-121.535183 °	
DWR ID	DWR_RD0150_03_s_2012_31				
Action/Comments					
Landscaping

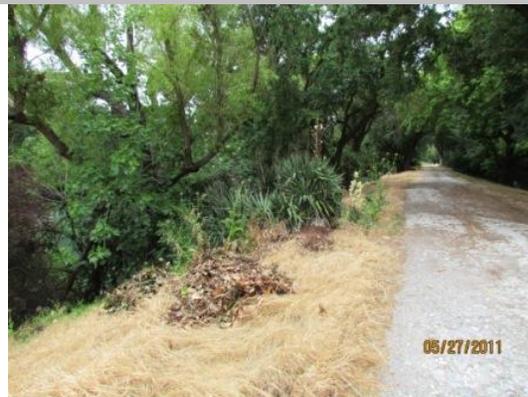
Photo 1 of 1 : SP_2015_RD0150_17_64_20150313_00059.jpg

Landscaping on the waterside of the levee. The picture was taken from the crown looking upstream.

LM Start	7.26	Rating **	M	Issue No.	64
LM End	7.26	Issue Type +	En	Location *	WS
Category	Earthen Levee		GPS Latitude/Longitude		
			Start	End	
Item	Vegetation		38.401481 °	38.401481 °	
			-121.536876 °	-121.536876 °	
DWR ID	DWR_RD0150_03_s_2012_64				
Action/Comments					
Landscaping

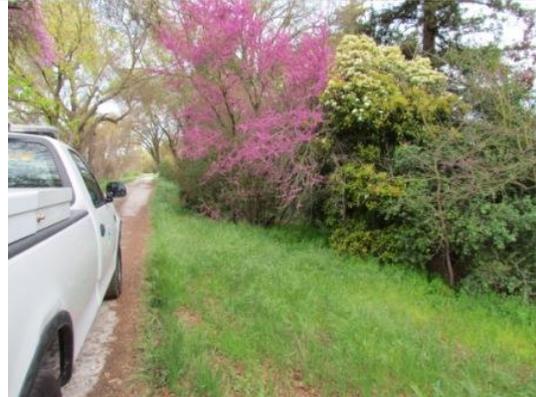
Photo 1 of 2 : SP_2015_RD0150_17_32_20150313_00023.jpg

Vegetation on the landside of the levee looking upstream. This picture was taken during spring 2012 inspection.

LM Start	7.29	Rating **	M	Issue No.	32
LM End	7.34	Issue Type +	En	Location *	LS
Category	Earthen Levee			GPS Latitude/Longitude	
				Start	End
Item	Vegetation			38.401738 °	38.402296 °
				-121.537127 °	-121.537678 °
DWR ID	DWR_RD0150_03_s_2012_32				
Action/Comments					
Landscaping

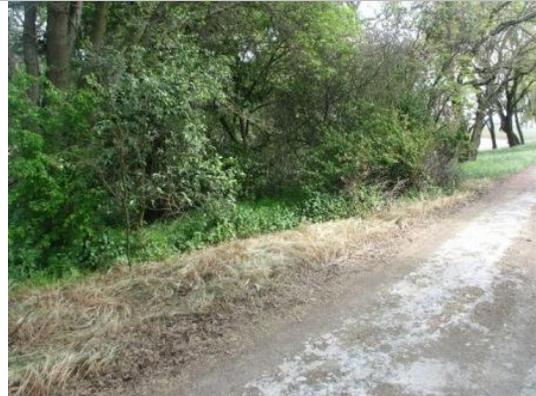
Photo 2 of 2 : SP_2015_RD0150_17_32_20150313_00024.jpg

Landscaping on landward slope blocking view from LM 7.42 to 7.47

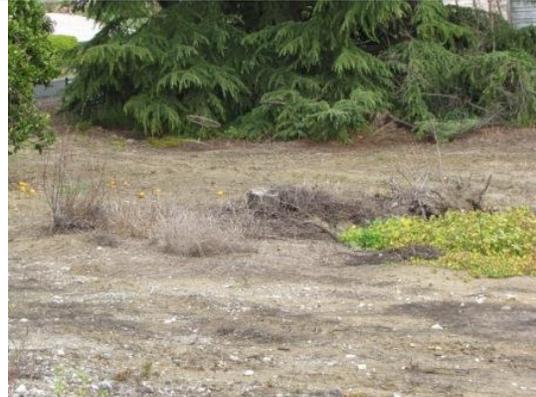
Photo 1 of 1 : SP_2015_RD0150_17_63_20150313_00058.jpg

LM Start	7.38	Rating **	N	Issue No.	63
LM End	7.38	Issue Type +	Ma	Location *	LS
Category	Earthen Levee			GPS Latitude/Longitude	
				Start	End
Item	Trim / Thin Trees			38.402779 °	38.402779 °
				-121.538197 °	-121.538197 °
DWR ID	DWR_RD0150_03_s_2012_63				
Action/Comments					
Tree stumps.

View of a tree stump on the landward slope.
