**Flood Control Project Maintenance
Levee Inspections**
LMA District Cover Sheet
Spring 2015 Levee Inspection Results

Reclamation District No. 0150 Merrit Island

Spring 2015 Levee Inspection Results

Waterway		Bank	Unit Miles
Unit No. 01 Sutter Slough		Left	0.52

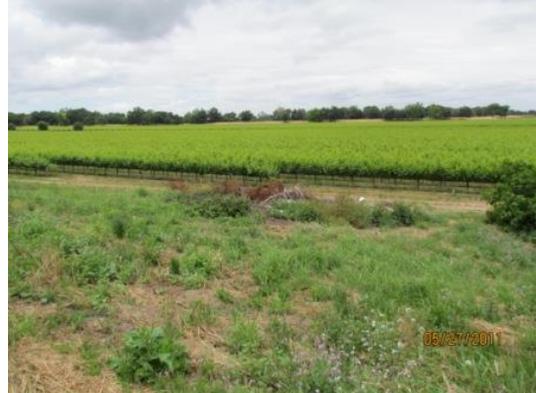
Photo 1 of 3 : SP_2015_RD0150_17_935_20150313_00099.jpg

Prunings located on the toe of landward side of the levee. The picture was taken from the crown looking upstream.

LM Start	7.47	Rating **	M	Issue No.	935
LM End	7.47	Issue Type +	Ma	Location *	LS
Category	Earthen Levee			GPS Latitude/Longitude	
				Start	End
Item	Encroachments			38.403795 °	38.403795 °
				-121.539205 °	-121.539205 °
DWR ID	DWR_RD0150_03_s_2012_935				
Action/Comments					
Prunings

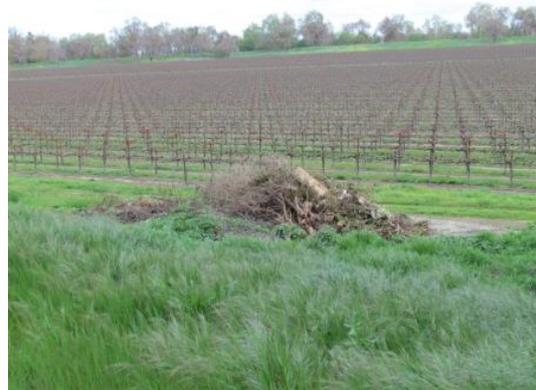
Photo 2 of 3 : SP_2015_RD0150_17_935_20150313_00100.jpg

Prunings were found on the landside of the levee looking upstream.

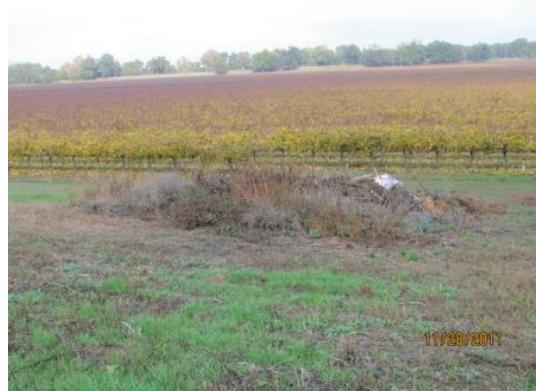
Photo 3 of 3 : SP_2015_RD0150_17_935_20150313_00101.jpg

Prunings were found on the landside of the levee looking upstream. This picture was taken during fall 2011 inspection.

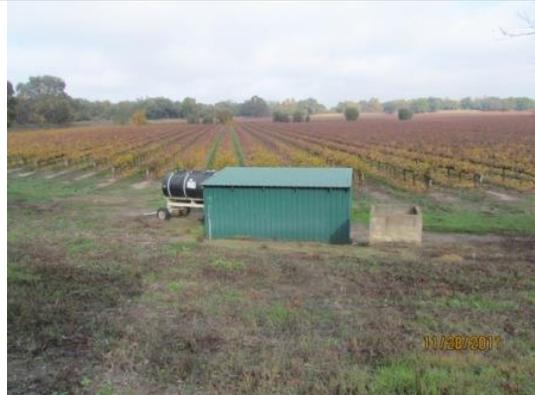
Photo 1 of 1 : SP_2015_RD0150_17_16_20150313_00013.jpg

Equipment was found on the landside of the levee looking upstream.

LM Start	7.68	Rating **	M	Issue No.	16
LM End	7.68	Issue Type +	En	Location *	LS
Category	Earthen Levee			GPS Latitude/Longitude	
				Start	End
Item	Encroachments			38.405342 °	38.405342 °
				-121.542553 °	-121.542553 °
DWR ID	DWR_RD0150_03_s_2012_16				
Action/Comments					
Equipment

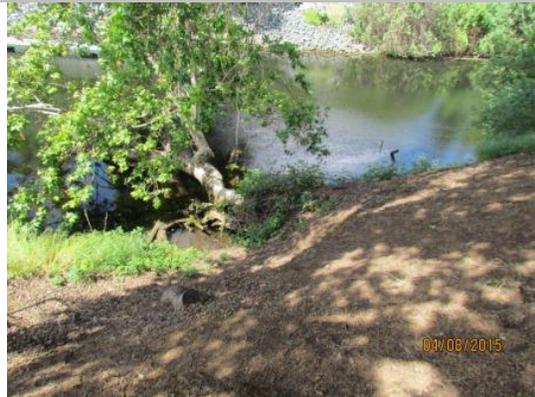
Photo 1 of 1 : SP_2015_RD0150_17_396_20150413_00125.jpg

Slope instability was found on the waterside toe of the levee looking upstream.

LM Start	7.74	Rating **	M	Issue No.	396
LM End	7.74	Issue Type +	Ma	Location *	WS
Category	Earthen Levee			GPS Latitude/Longitude	
				Start	End
Item	Slope Stability			38.406098 °	38.406098 °
				-121.543028 °	-121.543028 °
DWR ID	DWR_RD0150_03_s_2015_396				
Action/Comments					
Repair slope instability. Inspector Comments: Slope instability caused by a tree.

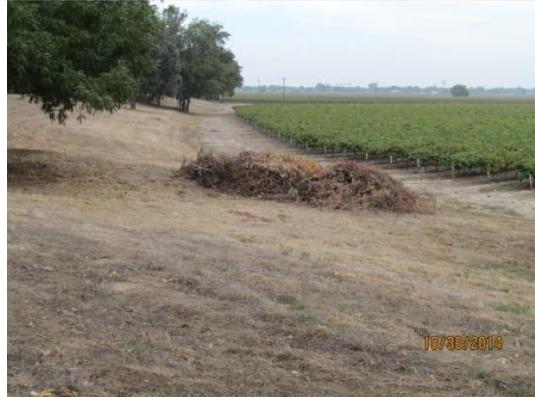
Photo 1 of 1 : SP_2015_RD0150_17_82_20150313_00081.jpg

Prunings were found on the landside toe of the levee looking upstream.

LM Start	8.05	Rating **	M	Issue No.	82
LM End	8.05	Issue Type +	Ma	Location *	LS
Category	Earthen Levee			GPS Latitude/Longitude	
				Start	End
Item	Encroachments			38.409224 °	38.409224 °
				-121.539350 °	-121.539350 °
DWR ID	DWR_RD0150_03_f_2013_82				
Action/Comments					
Prunings

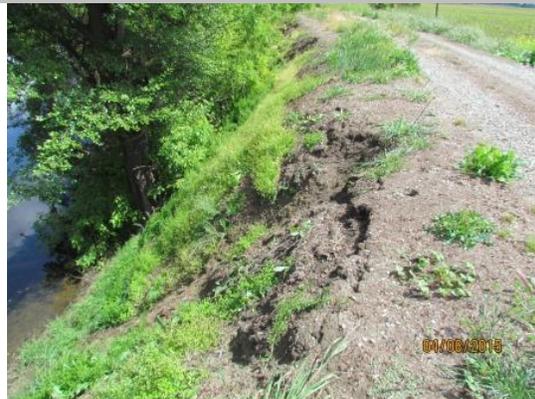
Photo 1 of 2 : SP_2015_RD0150_17_66_20150413_00127.jpg

Updated picture of the erosion on the waterside of the levee during spring 2015 inspection.

LM Start	8.31	Rating **	M	Issue No.	66
LM End	8.31	Issue Type +	Ma	Location *	WS
Category	Earthen Levee			GPS Latitude/Longitude	
				Start	End
Item	Erosion / Bank Caving			38.407960 °	38.407960 °
				-121.534898 °	-121.534898 °
DWR ID	DWR_RD0150_03_s_2012_66				
Action/Comments					
Note and monitor erosion site.

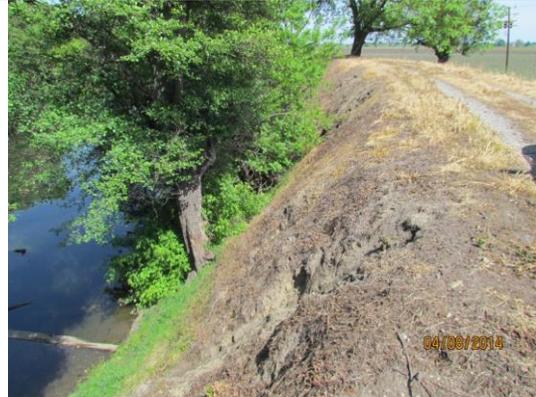
Photo 1 of 3 : SP_2015_RD0150_17_67_20150313_00063.jpg

Updated picture of the slope instability on the waterside shoulder looking upstream during spring 2014 inspection.

LM Start	8.33	Rating **	M	Issue No.	67
LM End	8.33	Issue Type +	Ma	Location *	WS
Category	Earthen Levee			GPS Latitude/Longitude	
				Start	End
Item	Erosion / Bank Caving			38.407958 °	38.407958 °
				-121.534583 °	-121.534583 °
DWR ID	DWR_RD0150_03_s_2012_67				
Action/Comments					
Note and monitor erosion site.

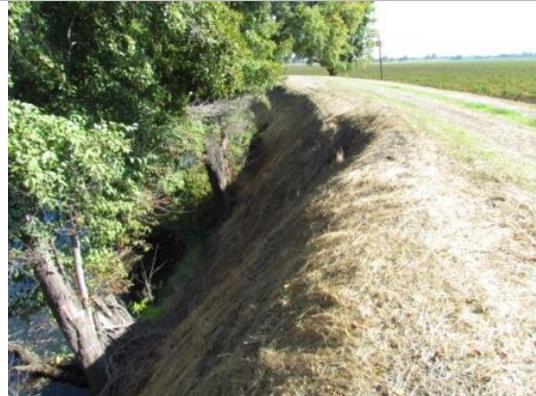
Photo 2 of 3 : SP_2015_RD0150_17_67_20150313_00064.jpg

Slope instability was found on the waterside shoulder of the levee looking upstream. This picture was taken during fall 2012 inspection.

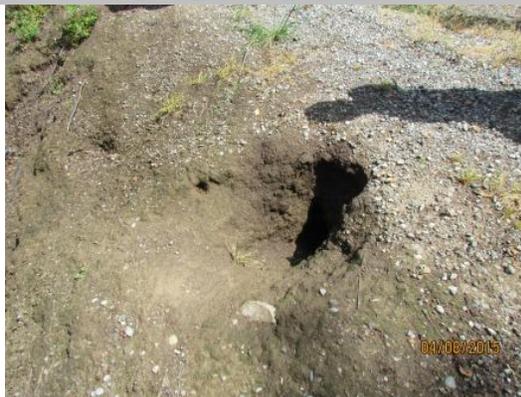
Photo 1 of 3 : SP_2015_RD0150_17_89_20150413_00128.jpg

Updated picture of a rodent hole on the waterside shoulder of the levee during spring 2015 inspection.

LM Start	8.37	Rating **	M	Issue No.	89
LM End	8.37	Issue Type +	Ma	Location *	WS
Category	Earthen Levee			GPS Latitude/Longitude	
				Start	End
Item	Animal Control			38.408153 °	38.408153 °
				-121.533980 °	-121.533980 °
DWR ID	DWR_RD0150_03_s_2012_89				
Action/Comments					
Exterminate rodents and backfill and compact or grout burrows.

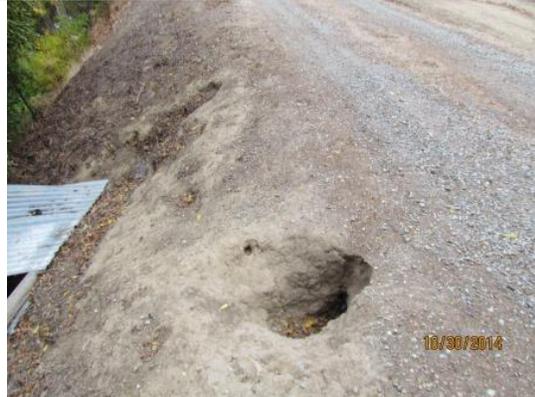
Photo 2 of 3 : SP_2015_RD0150_17_89_20150313_00085.jpg

Updated picture of a rodent hole on the waterside shoulder of the levee during fall 2014 inspection.

LM Start	8.37	Rating **	M	Issue No.	89 (cont)
LM End	8.37	Issue Type +	Ma	Location *	WS
Category	Earthen Levee			GPS Latitude/Longitude	
				Start	End
Item	Animal Control			38.408153 °	38.408153 °
				-121.533980 °	-121.533980 °
DWR ID	DWR_RD0150_03_s_2012_89				
Action/Comments					
Exterminate rodents and backfill and compact or grout burrows.

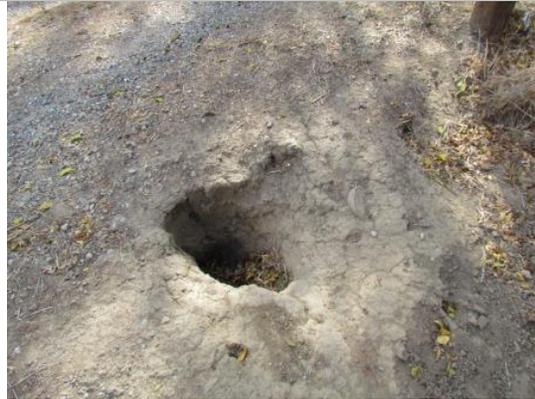
Photo 3 of 3 : SP_2015_RD0150_17_89_20150313_00086.jpg

View of the rodent hole on the waterside shoulder of the levee looking downstream during the fall 2013 inspection.

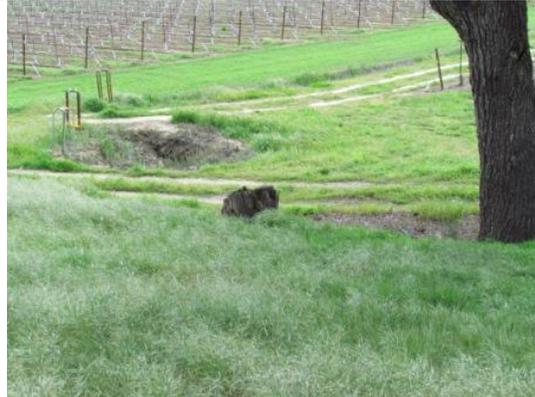
Photo 1 of 1 : SP_2015_RD0150_17_90_20150313_00087.jpg

LM Start	8.46	Rating **	N	Issue No.	90
LM End	8.46	Issue Type +	Ma	Location *	LS
Category	Earthen Levee		GPS Latitude/Longitude		
			Start	End	
Item	Trim / Thin Trees		38.409220 °	38.409220 °	
			-121.532801 °	-121.532801 °	
DWR ID	DWR_RD0150_03_s_2012_90				
Action/Comments					
Tree stumps.

A tree stump was found on the landside of the levee looking upstream.

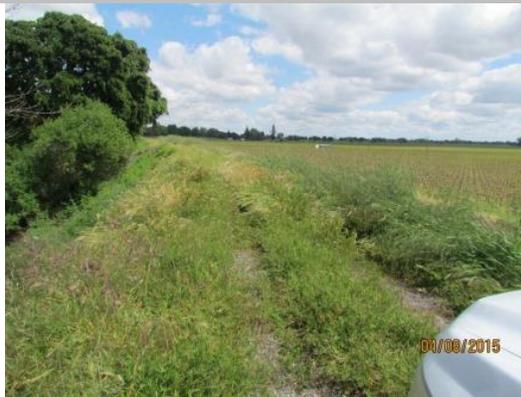
Photo 1 of 1 : SP_2015_RD0150_17_397_20150413_00129.jpg

Vegetation was found on the crown of the levee looking upstream.

LM Start	8.53	Rating **	M	Issue No.	397
LM End	9.04	Issue Type +	Ma	Location *	CR
Category	Earthen Levee			GPS Latitude/Longitude	
				Start	End
Item	Vegetation			38.409818 °	38.415272 °
				-121.531778 °	-121.527902 °
DWR ID	DWR_RD0150_03_s_2015_397				
Action/Comments					
Control annual grass and weeds on the levee slopes and easements.

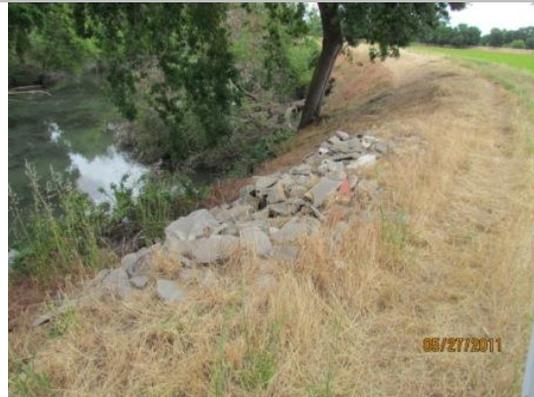
Photo 1 of 1 : SP_2015_RD0150_17_7_20150313_00005.jpg

Broken concrete pipe was left on the waterside slope of the levee. The picture was taken from the crown looking upstream.

LM Start	8.72	Rating **	M	Issue No.	7
LM End	8.72	Issue Type +	Ma	Location *	WS
Category	Earthen Levee			GPS Latitude/Longitude	
				Start	End
Item	Encroachments			38.411593 °	38.411593 °
				-121.529143 °	-121.529143 °
DWR ID	DWR_RD0150_03_s_2012_7				
Action/Comments					
Debris

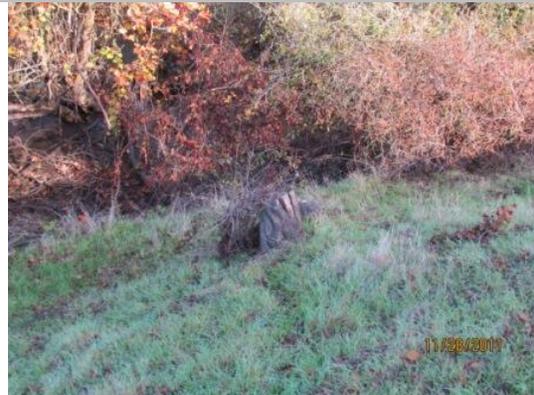
Photo 1 of 1 : SP_2015_RD0150_17_59_20150313_00050.jpg

LM Start	9.21	Rating **	N	Issue No.	59
LM End	9.21	Issue Type +	Ma	Location *	WS
Category	Earthen Levee			GPS Latitude/Longitude	
				Start	End
Item	Trim / Thin Trees			38.413268 °	38.413268 °
				-121.525929 °	-121.525929 °
DWR ID	DWR_RD0150_03_s_2012_59				
Action/Comments					
Tree stumps.

A tree stump was found on the waterside of the levee looking upstream.

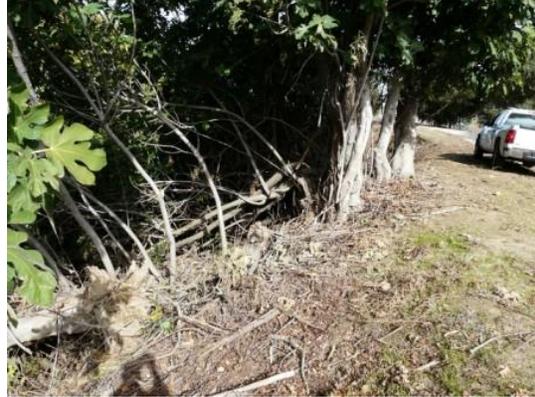
Photo 1 of 1 : SP_2015_RD0150_17_73_20150313_00068.jpg

Thin/trim trees to allow for visibility of top 20' of waterward slope at LM 9.51.

LM Start	9.35	Rating **	M	Issue No.	73
LM End	9.35	Issue Type +	Ma	Location *	WS
Category	Earthen Levee			GPS Latitude/Longitude	
				Start	End
Item	Trim / Thin Trees			38.413169 °	38.413169 °
				-121.523707 °	-121.523707 °
DWR ID	DWR_RD0150_03_s_2012_73				
Action/Comments					
Trim and thin trees to allow visibility of the ground and room to flood fight.

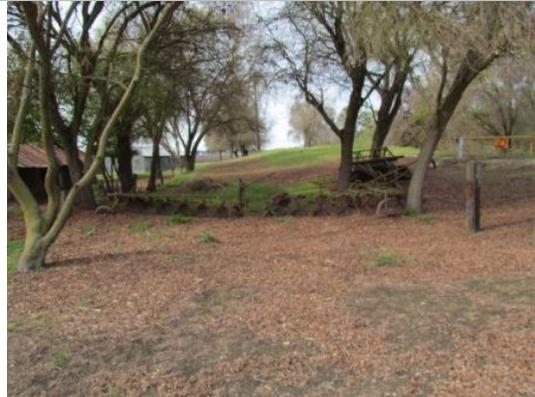
Photo 1 of 1 : SP_2015_RD0150_17_950_20150313_00104.jpg

LM Start	9.39	Rating **	M	Issue No.	950
LM End	9.39	Issue Type +	En	Location *	LS
Category	Earthen Levee			GPS Latitude/Longitude	
				Start	End
Item	Encroachments			38.413560 °	38.413560 °
				-121.522936 °	-121.522936 °
DWR ID	DWR_RD0150_03_s_2012_950				
Action/Comments					
Equipment

Equipment was found on the landside of the levee looking downstream.
