**Flood Control Project Maintenance
Levee Inspections**

Maintenance Issue Types Only, Levee Inspection Report By Mile - Spring 2015

Reclamation District No. 0150 Merrit Island

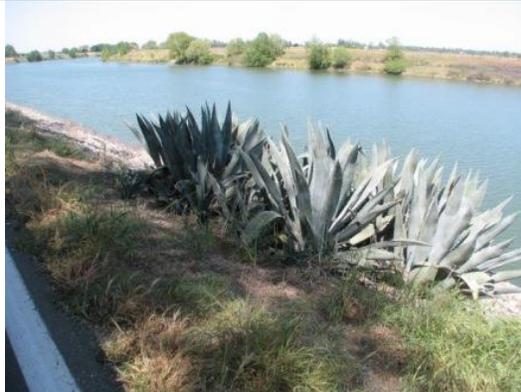
Photo 1 of 1 : SP_2015_RD0150_16_28_20150313_00018.jpg

Century plant on waterward slope at LM 4.76

LM Start	4.69	Rating **	M	Issue No.	28
LM End	4.69	Issue Type +	Ma	Location *	WS
Category	Earthen Levee			GPS Latitude/Longitude	
				Start	End
Item	Vegetation			38.373485 °	38.373485 °
				-121.523963 °	-121.523963 °
DWR ID	DWR_RD0150_02_s_2012_28				
Action/Comments					
Remove the wild growth other than native grasses from the levee slopes.

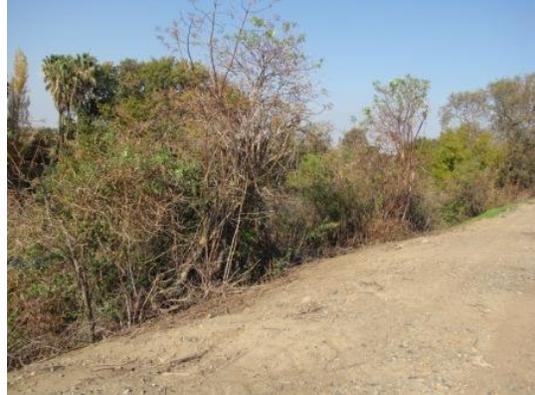
Photo 1 of 1 : SP_2015_RD0150_17_936_20150313_00102.jpg

LM Start	0.11	Rating **	A/W	Issue No.	936
LM End	0.11	Issue Type +	Ma	Location *	WS
Category	Earthen Levee			GPS Latitude/Longitude	
				Start	End
Item	Vegetation			38.334233 °	38.334233 °
				-121.583414 °	-121.583414 °
DWR ID	DWR_RD0150_03_s_2012_936				
Action/Comments					
Elderberries are blocking visibility and flood fight capability.

View of elderberry bush within 20 feet of shoulder blocking visibility and access.

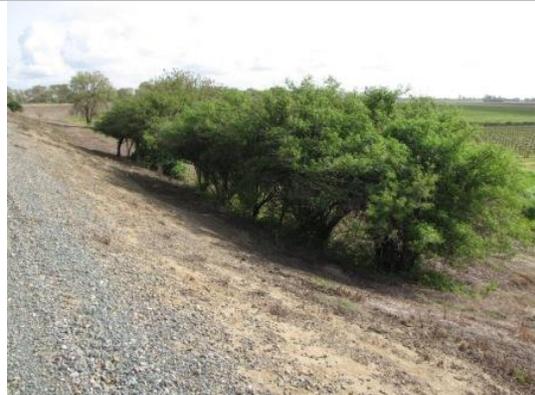
Photo 1 of 1 : SP_2015_RD0150_17_5_20150313_00004.jpg

LM Start	0.91	Rating **	A/W	Issue No.	5
LM End	0.93	Issue Type +	Ma	Location *	LS
Category	Earthen Levee		GPS Latitude/Longitude		
			Start	End	
Item	Vegetation		38.345293 °	38.345634 °	
			-121.579769 °	-121.579574 °	
DWR ID	DWR_RD0150_03_s_2012_5				
Action/Comments					
Elderberries are blocking visibility and flood fight capability.

View of elderberries on the landward slope blocking visibility and access.

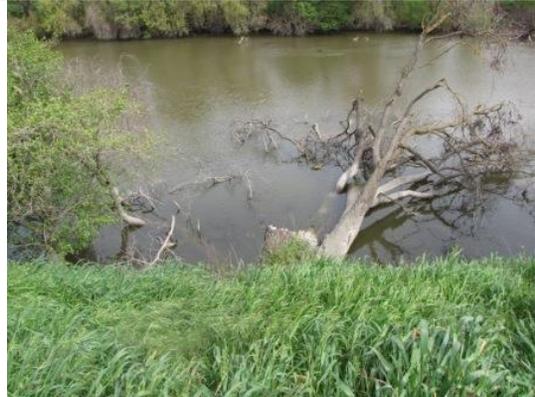
Photo 1 of 1 : SP_2015_RD0150_17_20_20150313_00015.jpg

LM Start	3.15	Rating **	N	Issue No.	20
LM End	3.15	Issue Type +	Ma	Location *	WS
Category	Earthen Levee			GPS Latitude/Longitude	
				Start	End
Item	Trim / Thin Trees			38.363658 °	38.363658 °
				-121.559583 °	-121.559583 °
DWR ID	DWR_RD0150_03_s_2012_20				
Action/Comments					
Tree stumps.

View of tree stumps on the waterward slope.

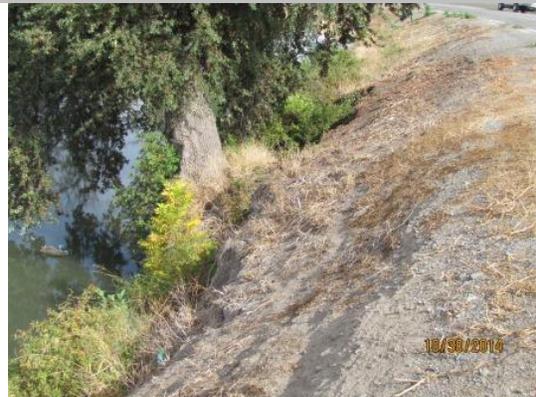
Photo 2 of 3 : SP_2015_RD0150_17_40_20150313_00032.jpg

Updated picture of the erosion on the waterside of the levee looking upstream during fall 2014 inspection.

LM Start	3.31	Rating **	M	Issue No.	40
LM End	3.31	Issue Type +	Ma	Location *	WS
Category	Earthen Levee			GPS Latitude/Longitude	
				Start	End
Item	Erosion / Bank Caving			38.363008 °	38.363008 °
				-121.556751 °	-121.556751 °
DWR ID	DWR_RD0150_03_s_2013_40				
Action/Comments					
Schedule repair of erosion site prior to the next inspection.

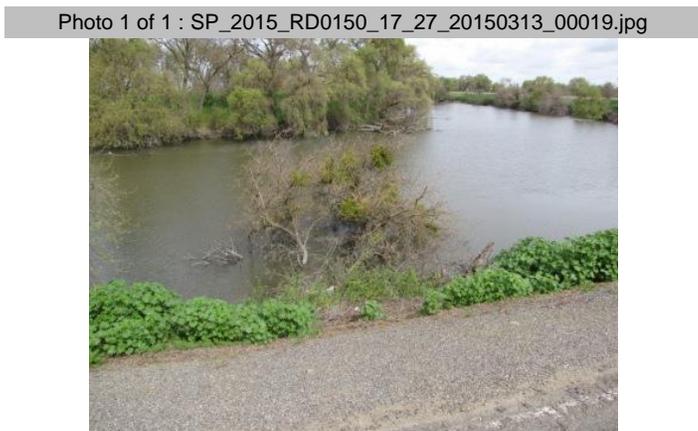
LM Start	3.34	Rating **	N	Issue No.	27
LM End	3.34	Issue Type +	Ma	Location *	WS
Category	Earthen Levee		GPS Latitude/Longitude		
			Start	End	
Item	Trim / Thin Trees		38.363147 °	38.363147 °	
			-121.556190 °	-121.556190 °	
DWR ID	DWR_RD0150_03_s_2012_27				
Action/Comments					
Tree stumps.

View of tree stumps on the waterside slope looking upstream.

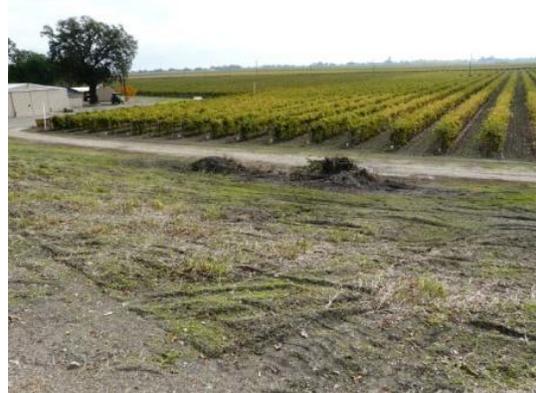
Photo 1 of 4 : SP_2015_RD0150_17_51_20150313_00041.jpg

Remove pruning pile on landward slope at LM 4.46.

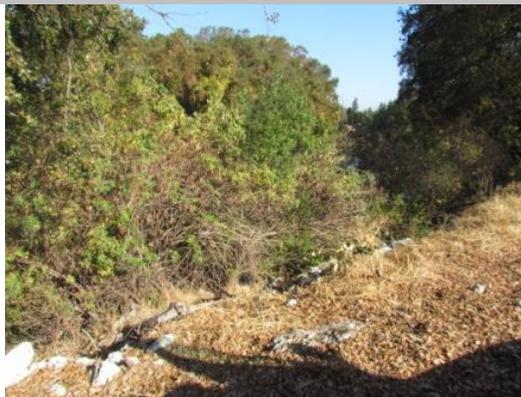
Photo 1 of 1 : SP_2015_RD0150_17_28_20150313_00020.jpg

Wild growth was found on the waterside slope of the levee looking upstream.

LM Start	5.78	Rating **	M	Issue No.	28
LM End	5.78	Issue Type +	Ma	Location *	WS
Category	Earthen Levee		GPS Latitude/Longitude		
			Start	End	
Item	Vegetation		38.384333 °	38.384333 °	
			-121.541310 °	-121.541310 °	
DWR ID	DWR_RD0150_03_s_2012_28				
Action/Comments					
Remove the wild growth other than native grasses from the levee slopes.

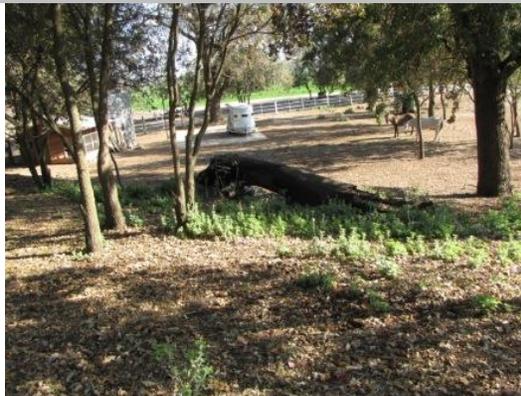
Photo 1 of 1 : SP_2015_RD0150_17_57_20150313_00048.jpg

View of a tree trunk lying on the landward slope blocking visibility.

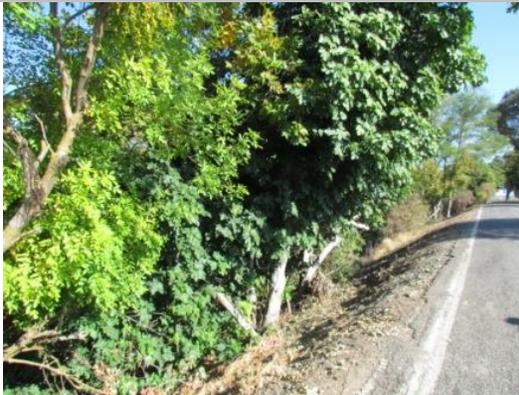
Photo 1 of 2 : SP_2015_RD0150_17_62_20150313_00056.jpg

Tree was blocking the visibility on the waterside of the levee looking upstream. This picture was taken during fall 2012 inspection.

LM Start	6.38	Rating **	M	Issue No.	62
LM End	6.38	Issue Type +	Ma	Location *	WS
Category	Earthen Levee		GPS Latitude/Longitude		
			Start	End	
Item	Trim / Thin Trees		38.390935 °	38.390935 °	
			-121.539369 °	-121.539369 °	
DWR ID	DWR_RD0150_03_s_2012_62				
Action/Comments					
Trim and thin trees to allow visibility of the ground and room to flood fight.

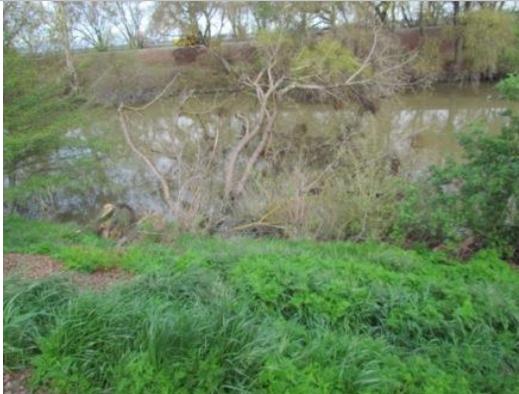
Photo 2 of 2 : SP_2015_RD0150_17_62_20150313_00057.jpg

Vegetation on the waterside of the levee looking downstream.

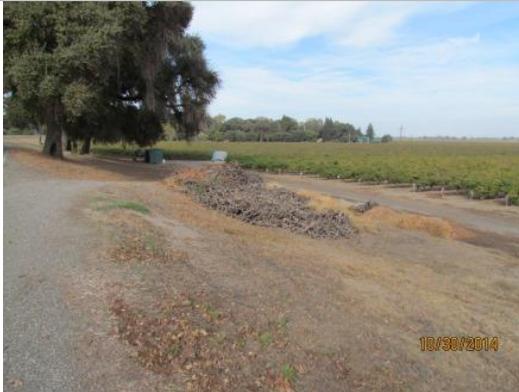
Photo 1 of 1 : SP_2015_RD0150_17_83_20150313_00082.jpg

Prunings were found on the landside toe of the levee looking upstream.

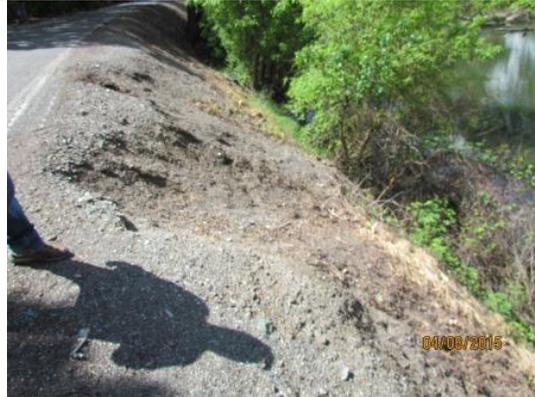
Photo 1 of 4 : SP_2015_RD0150_17_61_20150413_00124.jpg

Updated picture of the erosion on the waterside of the levee during spring 2015 inspection.

LM Start	6.90	Rating **	M	Issue No.	61
LM End	6.90	Issue Type +	Ma	Location *	WS
Category	Earthen Levee			GPS Latitude/Longitude	
				Start	End
Item	Erosion / Bank Caving			38.396655 °	38.396655 °
				-121.535485 °	-121.535485 °
DWR ID	DWR_RD0150_03_s_2012_61				
Action/Comments					
Note and monitor erosion site.

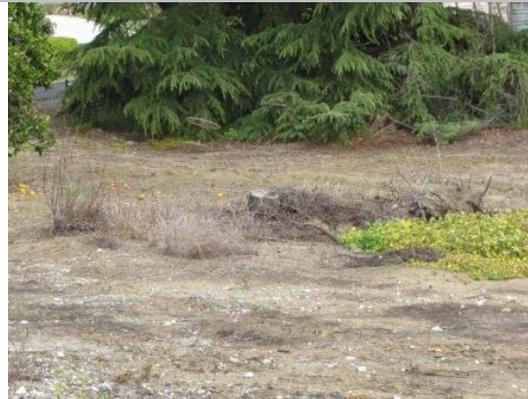
Photo 1 of 1 : SP_2015_RD0150_17_63_20150313_00058.jpg

LM Start	7.38	Rating **	N	Issue No.	63
LM End	7.38	Issue Type +	Ma	Location *	LS
Category	Earthen Levee		GPS Latitude/Longitude		
			Start	End	
Item	Trim / Thin Trees		38.402779 °	38.402779 °	
			-121.538197 °	-121.538197 °	
DWR ID	DWR_RD0150_03_s_2012_63				
Action/Comments					
Tree stumps.

View of a tree stump on the landward slope.

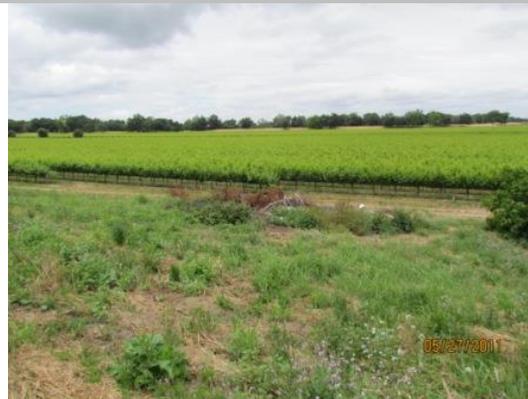
Photo 1 of 3 : SP_2015_RD0150_17_935_20150313_00099.jpg

Prunings located on the toe of landward side of the levee. The picture was taken from the crown looking upstream.

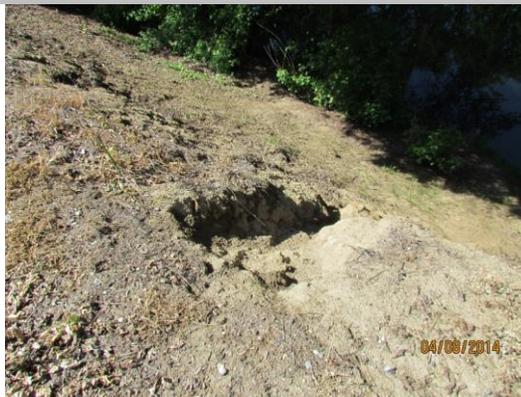
Photo 2 of 2 : SP_2015_RD0150_17_92_20150313_00090.jpg

A slope instability was found on the waterside of the levee looking downstream.

LM Start	8.02	Rating **	M	Issue No.	92 (cont)
LM End	8.02	Issue Type +	Ma	Location *	WS
Category	Earthen Levee			GPS Latitude/Longitude	
				Start	End
Item	Slope Stability			38.409130 °	38.409130 °
				-121.539971 °	-121.539971 °
DWR ID	DWR_RD0150_03_s_2014_92				
Action/Comments					
Repair slope instability.

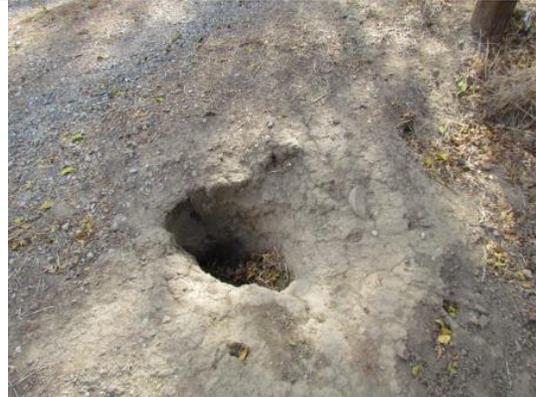
Photo 3 of 3 : SP_2015_RD0150_17_89_20150313_00086.jpg

View of the rodent hole on the waterside shoulder of the levee looking downstream during the fall 2013 inspection.

LM Start	8.37	Rating **	M	Issue No.	89 (cont)
LM End	8.37	Issue Type +	Ma	Location *	WS
Category	Earthen Levee		GPS Latitude/Longitude		
			Start	End	
Item	Animal Control		38.408153 °	38.408153 °	
			-121.533980 °	-121.533980 °	
DWR ID	DWR_RD0150_03_s_2012_89				
Action/Comments					
Exterminate rodents and backfill and compact or grout burrows.
