**Flood Control Project Maintenance
Levee Inspections
LMA District Cover Sheet
Spring 2011 Levee Inspection Results**

Reclamation District No. 0150 Merrit Island

Spring 2011 Levee Inspection Results

Waterway	Bank	Unit Miles
Unit No. 01 Sutter Slough	Left	0.54

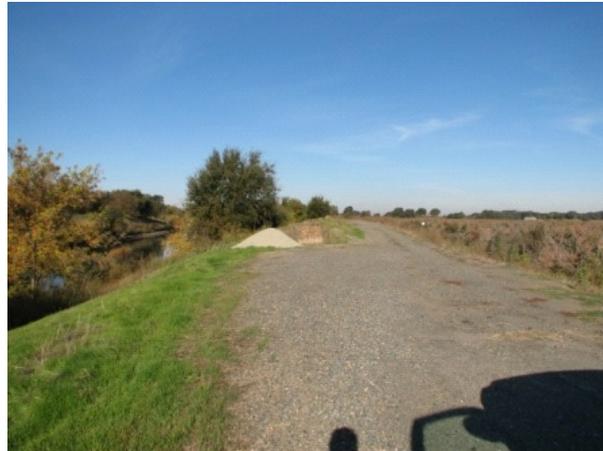
Levee Mile Report Line	2
Start Levee Mile	0.33
End Levee Mile	0.33
Location	Crown
Category	Earthen Levee
Item	Encroachments
<p>View of a hay bale target on the crown of the levee looking west.</p>	
<p>pkazi_s_20110328_384.jpg</p>

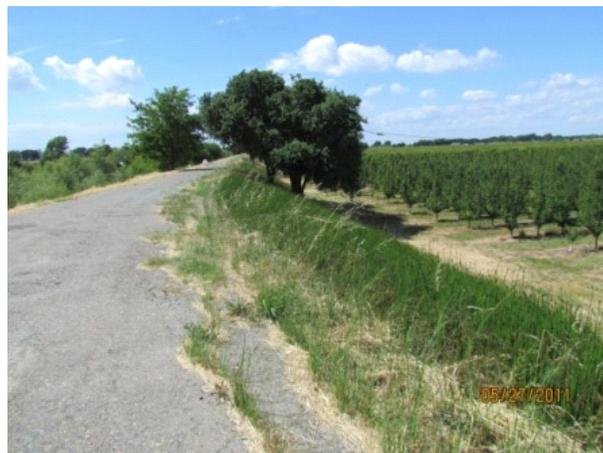
Levee Mile Report Line	3
Start Levee Mile	0.34
End Levee Mile	0.51
Location	Land Side
Category	Earthen Levee
Item	Vegetation
<p>Annual vegetation control is required on the landside of the levee. The picture was taken from the crown looking upstream.</p>	
<p>pkazi_s_20110531_692.jpg</p>

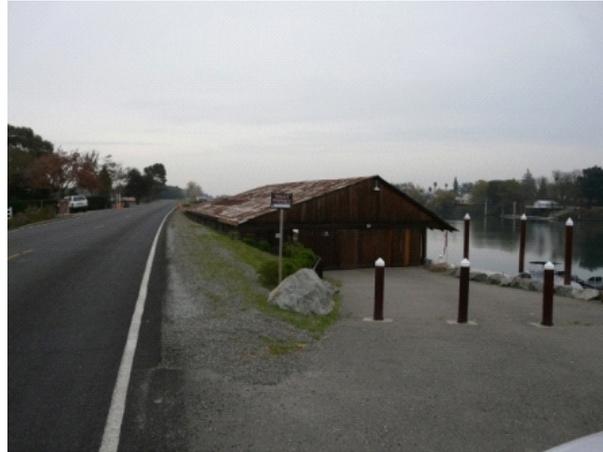
Levee Mile Report Line	1
Start Levee Mile	0.16
End Levee Mile	0.16
Location	Water Side
Category	Earthen Levee
Item	Encroachments
Building located on waterside of levee at LM 0.16	
pkazi_s_20110328_399.JPG

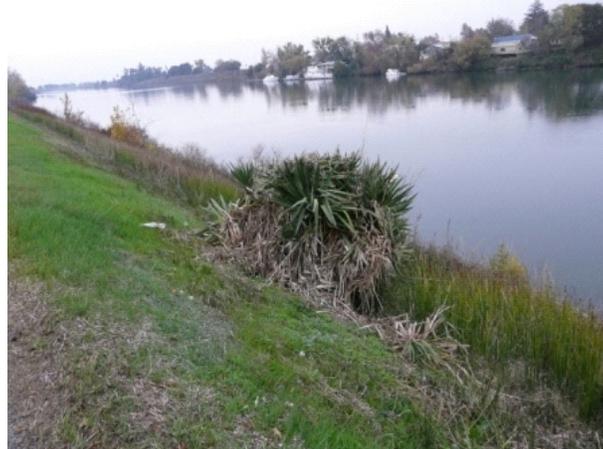
Levee Mile Report Line	3
Start Levee Mile	0.24
End Levee Mile	0.24
Location	Water Side
Category	Earthen Levee
Item	Vegetation
Remove century plant within 20' of waterside shoulder on waterside of the levee at LM 0.24	
pkazi_s_20110328_400.JPG

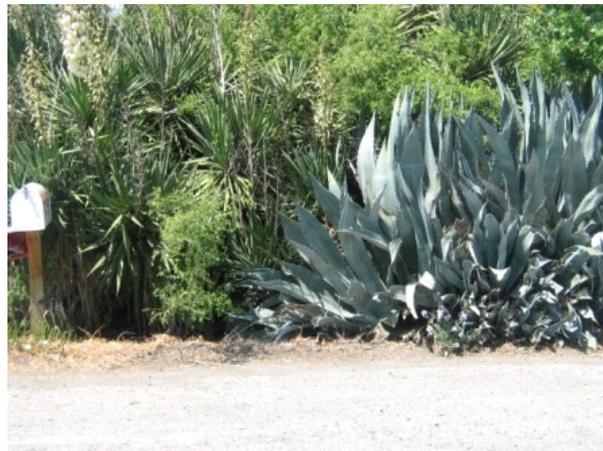
Levee Mile Report Line	4
Start Levee Mile	0.25
End Levee Mile	0.25
Location	Land Side
Category	Earthen Levee
Item	Encroachments
Landscaping on landward slope at LM 0.25 blocking view of levee slope.	
pkazi_s_20110328_386.jpg

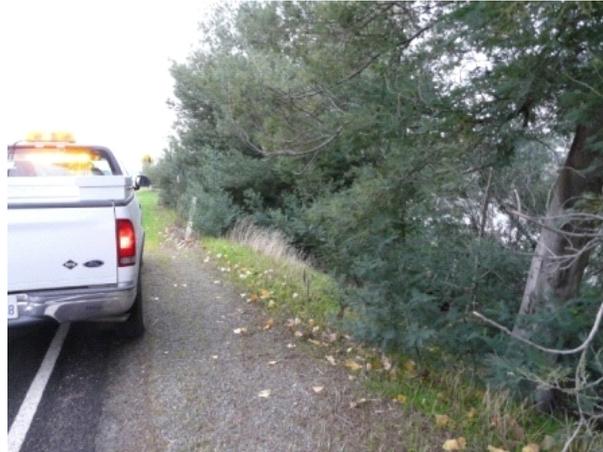
Levee Mile Report Line	10
Start Levee Mile	0.59
End Levee Mile	0.59
Location	Water Side
Category	Earthen Levee
Item	Trim / Thin Trees
Trim trees above 5' from surface of the wateside of the levee within 20' from shoulder at LM 0.59	
pkazi_s_20110328_401.JPG

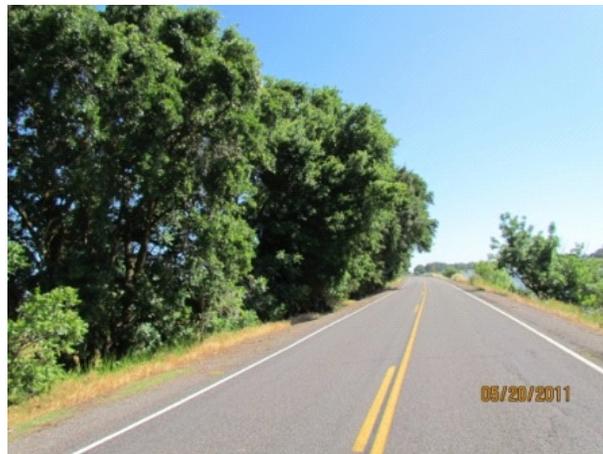
Levee Mile Report Line	15
Start Levee Mile	1.11
End Levee Mile	1.11
Location	Land Side
Category	Earthen Levee
Item	Trim / Thin Trees
Trees needed to be trimmed to allow landside visibility of the levee. The picture was taken from the crown looking upstream.	
pkazi_s_20110531_655.jpg

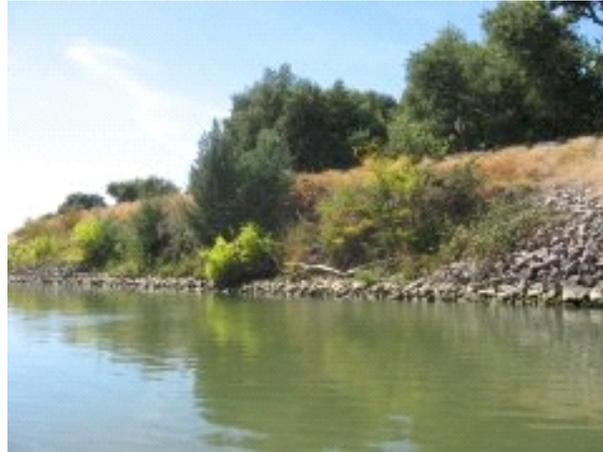
Levee Mile Report Line	17
Start Levee Mile	1.24
End Levee Mile	1.28
Location	Water Side
Category	Supplemental
Item	USACE Erosion Survey
2009: no berm, 1.5:1 slope, no stability issues, clays and silts, 5.89 ft/s [2009 SiteID:SAC_35-3_R]	
pkazi_s_20110328_394.JPG

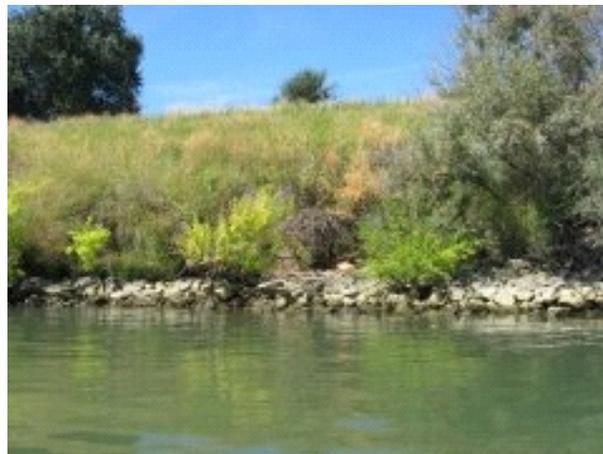
Levee Mile Report Line	20
Start Levee Mile	1.42
End Levee Mile	1.45
Location	Water Side
Category	Supplemental
Item	USACE Erosion Survey
2009: no berm, 2:1 slope, holes and slumping, clays and silts, 6.52 ft/s [2009 SiteID:SAC_35-4_R]	
pkazi_s_20110328_395.JPG

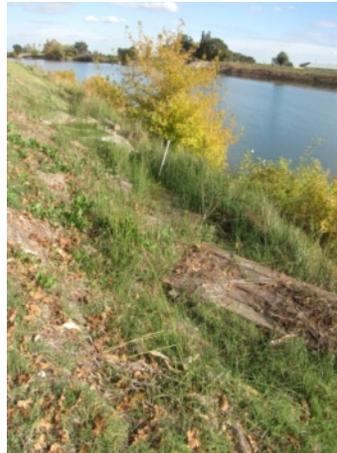
31	2.46	2.46	Earthen Levee	Encroachments	WS	M	Debris Inspector Comments: A platform and sitting/fishing area has been cut into the waterward slope. The encroachment should be removed and the slope repaired	38.347614 ° -121.541988 °	38.347614 ° -121.541988 °	960 Y
32	2.48	2.49	Earthen Levee	Encroachments	LS	PO	Landscaping	38.347720 ° -121.541737 °	38.347800 ° -121.541435 °	983
33	2.55	2.55	Earthen Levee	Encroachments	LS	C	Prunings	38.348087 ° -121.540476 °	38.348087 ° -121.540476 °	12
34	2.80	2.80	Earthen Levee	Trim / Thin Trees	LS	N	Tree stumps.	38.350041 ° -121.536853 °	38.350041 ° -121.536853 °	14 Y
35	2.82	2.82	Earthen Levee	Encroachments	LS	PO	Landscaping	38.350324 ° -121.536488 °	38.350324 ° -121.536488 °	16

Levee Mile Report Line	31
Start Levee Mile	2.46
End Levee Mile	2.46
Location	Water Side
Category	Earthen Levee
Item	Encroachments
<p>View of debris located on the waterward slope looking upstream.</p>	
<p>pkazi_s_20110328_413.jpg</p>

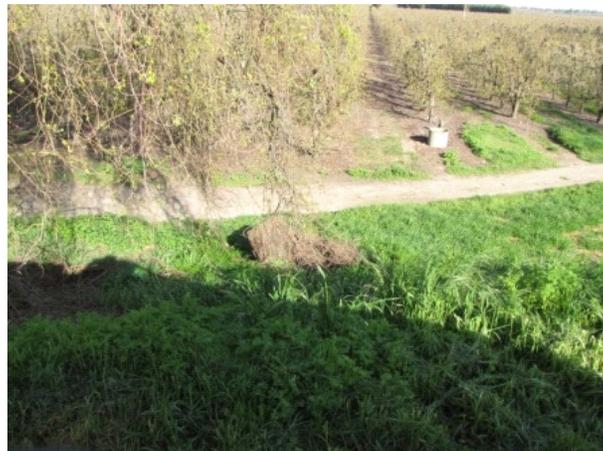
Levee Mile Report Line	34
Start Levee Mile	2.80
End Levee Mile	2.80
Location	Land Side
Category	Earthen Levee
Item	Trim / Thin Trees
<p>View of a tree stump on the landward slope.</p>	
<p>pkazi_s_20110328_388.jpg</p>

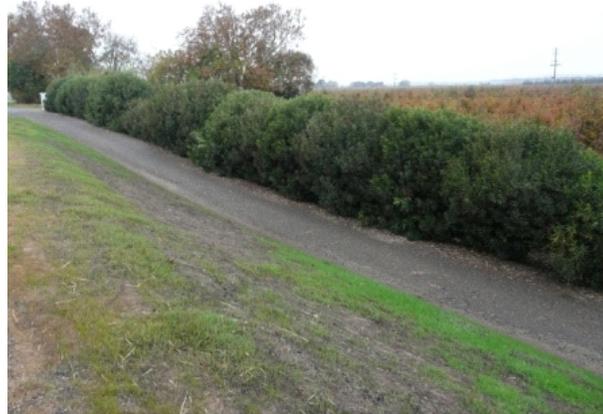
Levee Mile Report Line	37
Start Levee Mile	3.02
End Levee Mile	3.06
Location	Land Side
Category	Earthen Levee
Item	Encroachments
Landscaping providing a screen for a residence on landside of levee from LM 3.02 to LM 3.06	
pkazi_s_20110328_411.JPG

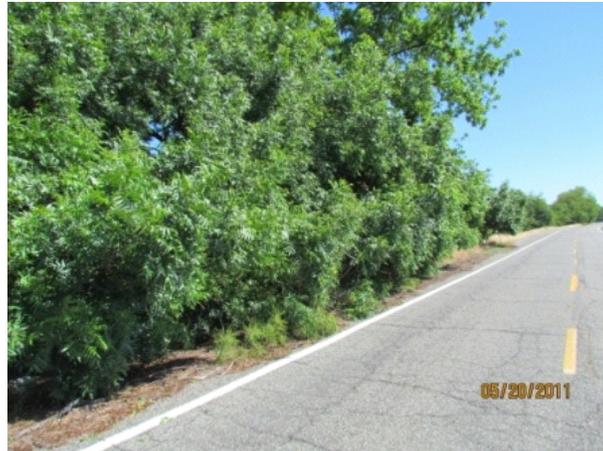
Levee Mile Report Line	38
Start Levee Mile	3.13
End Levee Mile	3.13
Location	Land Side
Category	Earthen Levee
Item	Trim / Thin Trees
Tree branches were obstruction the visibility of the landside slope of the levee. The picture was taken from the crown looking upstream.	
pkazi_s_20110531_658.jpg

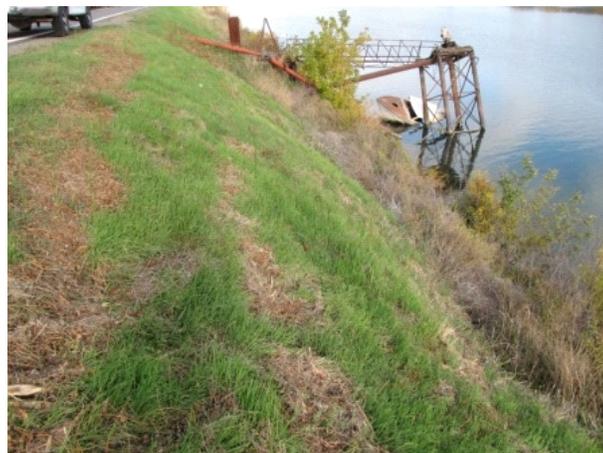
Levee Mile Report Line	40
Start Levee Mile	3.29
End Levee Mile	3.29
Location	Water Side
Category	Earthen Levee
Item	Erosion / Bank Caving
View of erosion on the waterward slope looking upstream. Depressions into the slope can be seen in several places.	
pkazi_s_20110328_414.jpg

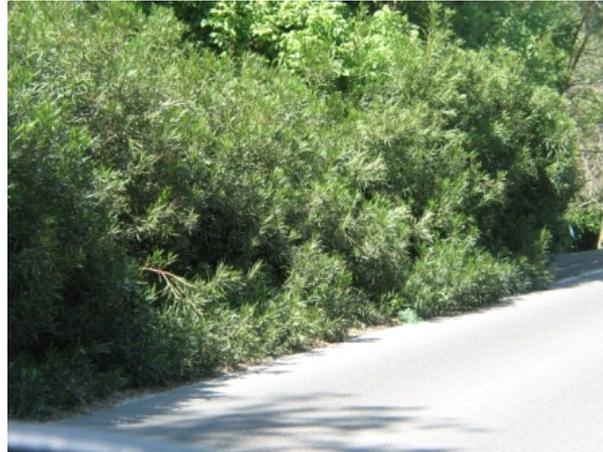
Levee Mile Report Line	51
Start Levee Mile	4.33
End Levee Mile	4.35
Location	Land Side
Category	Earthen Levee
Item	Encroachments
Landscaping (Oleander) on landward slope from 4.33 to 4.35	
pkazi_s_20110328_391.jpg

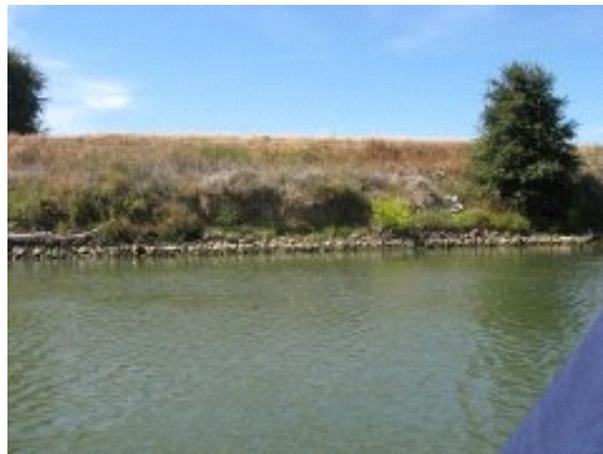
Levee Mile Report Line	55
Start Levee Mile	4.57
End Levee Mile	4.64
Location	Water Side
Category	Supplemental
Item	USACE Erosion Survey
2009: 5 ft berm, 1.5:1 slope, slumping, clays and silts, 5.46 ft/s [2009 SiteID:SAC_38-5_R]	
pkazi_s_20110328_396.JPG

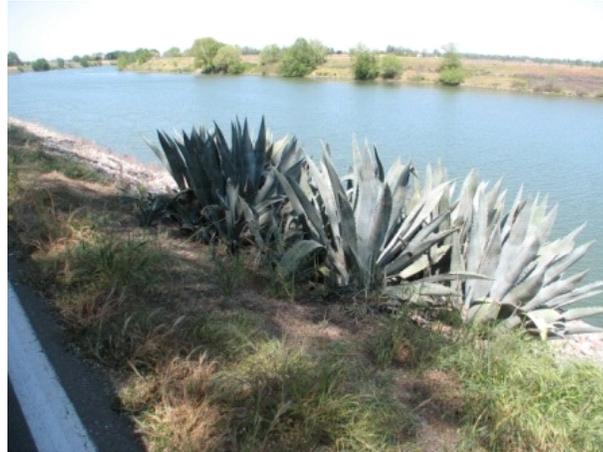
Levee Mile Report Line	57
Start Levee Mile	4.76
End Levee Mile	4.76
Location	Water Side
Category	Earthen Levee
Item	Vegetation
Century plant on waterward slope at LM 4.76	
pkazi_s_20110328_392.jpg

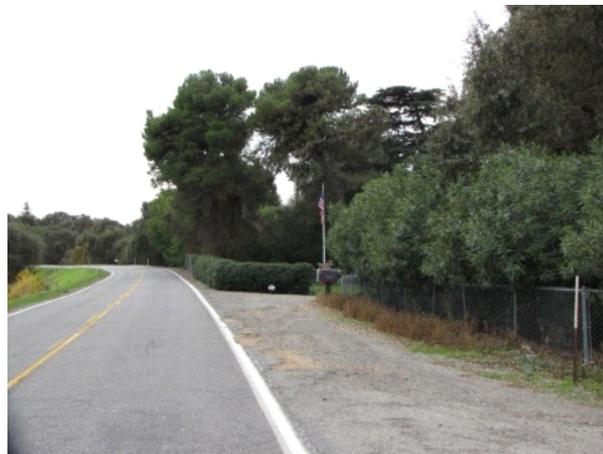
Levee Mile Report Line	62
Start Levee Mile	5.17
End Levee Mile	5.22
Location	Land Side
Category	Earthen Levee
Item	Encroachments
View of landscaping along the landward shoulder and slope looking downstream.	
pkazi_s_20110328_409.jpg

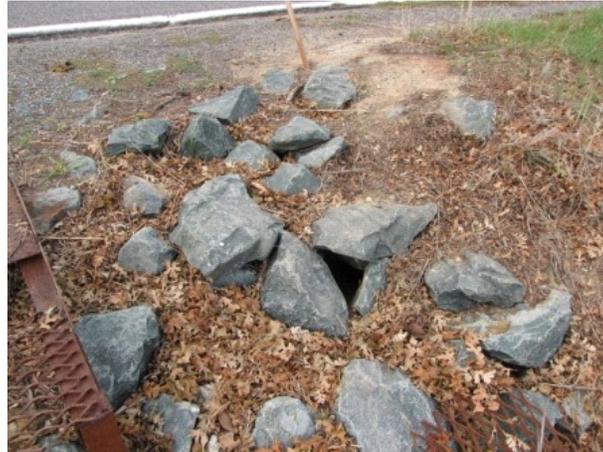
64	5.33	5.33	Earthen Levee	Slope Stability	WS	M	Repair slope instability. Inspector Comments: Cavity located under rock rip rap on waterward slope at the shoulder over an irrigation pipe.	38.381126 ° -121.524208 °	38.381126 ° -121.524208 °	976 Y
65	5.33	5.33	Earthen Levee	Slope Stability	LS	M	Repair slope instability. Inspector Comments: Depression in the landward slope at the shoulder over an irrigation pipe.	38.381126 ° -121.524207 °	38.381126 ° -121.524207 °	975 Y
66	5.37	5.37	Earthen Levee	Encroachments	LS	C	Prunings	38.381617 ° -121.523832 °	38.381617 ° -121.523832 °	23
67	5.42	5.42	Earthen Levee	Encroachments	LS	M	Prunings	38.382167 ° -121.523178 °	38.382167 ° -121.523178 °	25
68	5.47	5.49	Earthen Levee	Encroachments	LS	PO	Landscaping	38.382675 ° -121.522367 °	38.382793 ° -121.522164 °	74
69	5.55	5.55	Earthen Levee	Encroachments	LS	C	Equipment	38.383323 ° -121.521344 °	38.383323 ° -121.521344 °	26

Levee Mile Report Line	64
Start Levee Mile	5.33
End Levee Mile	5.33
Location	Water Side
Category	Earthen Levee
Item	Slope Stability
View of rock placed on a pipe penetration on the waterward slope. Cavities can be seen under the rocks.	
pkazi_s_20110328_420.jpg

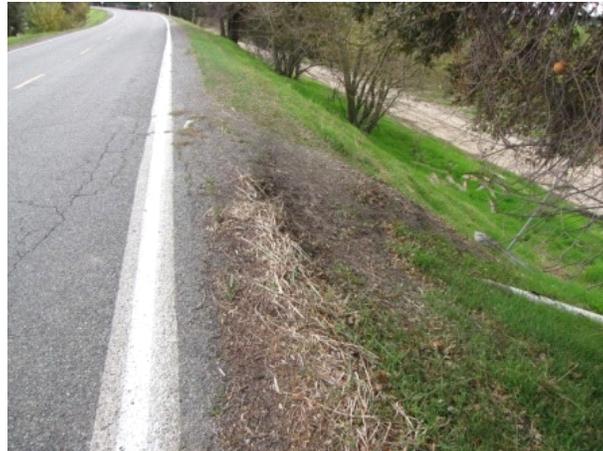
Levee Mile Report Line	65
Start Levee Mile	5.33
End Levee Mile	5.33
Location	Land Side
Category	Earthen Levee
Item	Slope Stability
View of a minor depression along the landward slope of the levee over a pipe penetration looking downstream.	
pkazi_s_20110328_419.jpg

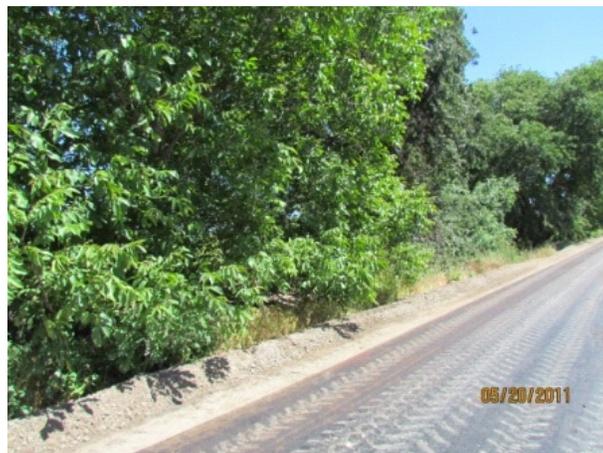
Levee Mile Report Line	70
Start Levee Mile	5.55
End Levee Mile	5.57
Location	Land Side
Category	Earthen Levee
Item	Trim / Thin Trees
Tree branches were obstruction the visibility of the landside slope of the levee. The picture was taken from the crown looking upstream.	
pkazi_s_20110531_660.jpg

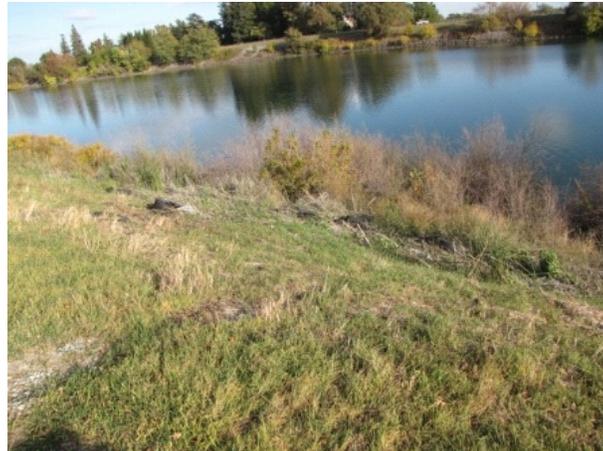
Levee Mile Report Line	73
Start Levee Mile	5.81
End Levee Mile	5.81
Location	Water Side
Category	Earthen Levee
Item	Encroachments
<p>View of several tires along the waterward slope.</p>	
<p>pkazi_s_20110328_417.jpg</p>

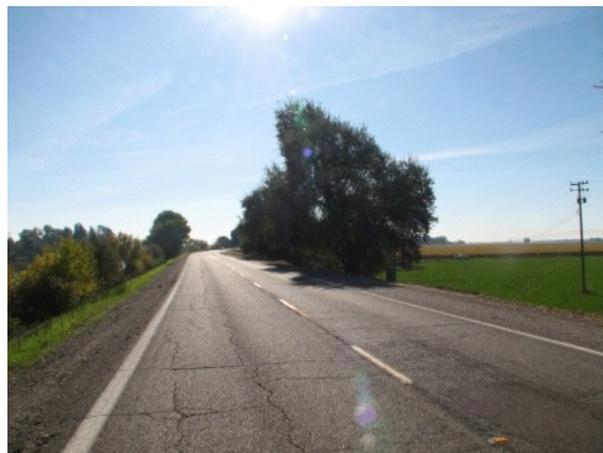
Levee Mile Report Line	74
Start Levee Mile	6.18
End Levee Mile	6.27
Location	Land Side
Category	Earthen Levee
Item	Trim / Thin Trees
<p>View of the trees that need to be trimmed up 5 feet.</p>	
<p>pkazi_s_20110328_385.jpg</p>

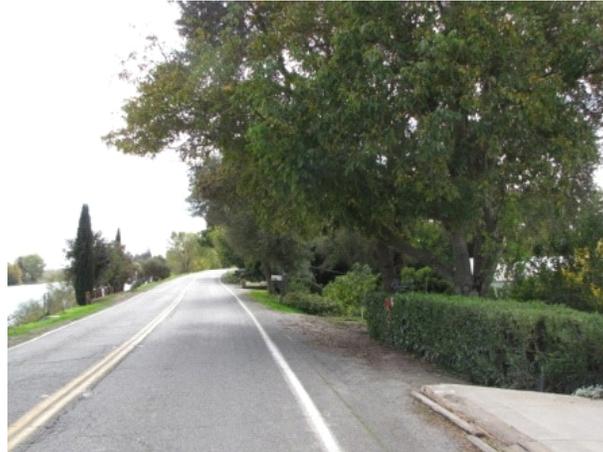
Levee Mile Report Line	82
Start Levee Mile	6.50
End Levee Mile	6.57
Location	Land Side
Category	Earthen Levee
Item	Encroachments
View of landscaping along the waterward shoulder and slope looking downstream.	
pkazi_s_20110328_407.jpg

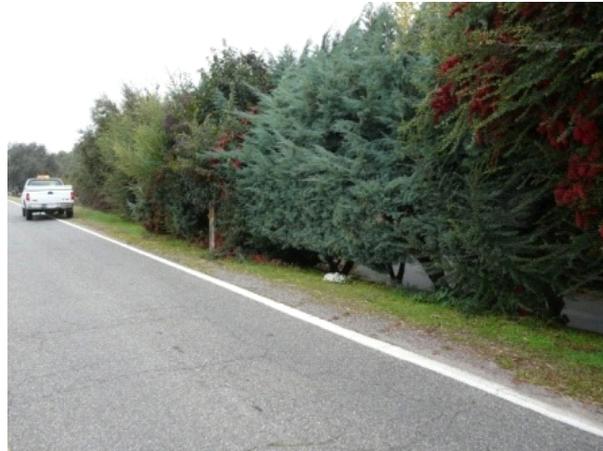
Levee Mile Report Line	84
Start Levee Mile	6.67
End Levee Mile	6.72
Location	Land Side
Category	Earthen Levee
Item	Encroachments
Landscaping providing a screen for a residence on landside of levee from LM 6.68 to LM 6.72	
pkazi_s_20110328_406.JPG

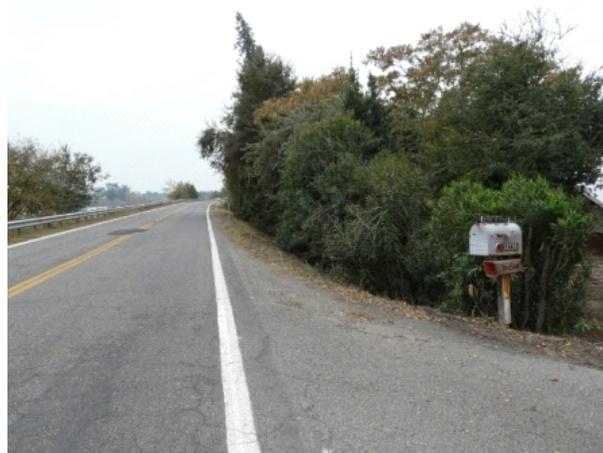
Levee Mile Report Line	88
Start Levee Mile	6.93
End Levee Mile	7.05
Location	Land Side
Category	Earthen Levee
Item	Encroachments
Landscaping providing a screen for a residence on landside of levee from LM 6.93 to LM 7.05	
pkazi_s_20110328_405.JPG

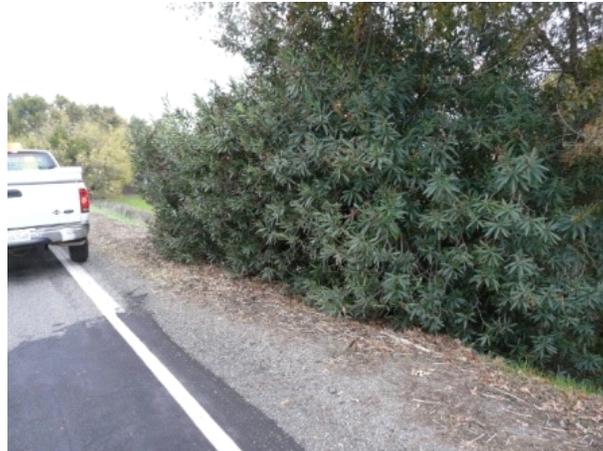
Levee Mile Report Line	91
Start Levee Mile	7.12
End Levee Mile	7.12
Location	Land Side
Category	Earthen Levee
Item	Encroachments
<p>Landscaping providing a screen for a residence on landside of levee at LM 7.12</p>	
<p>pkazi_s_20110328_404.JPG</p>

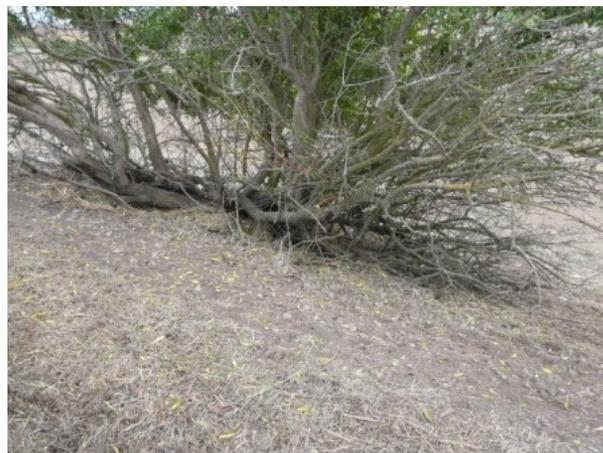
Levee Mile Report Line	93
Start Levee Mile	7.25
End Levee Mile	7.25
Location	Land Side
Category	Earthen Levee
Item	Trim / Thin Trees
<p>Trim or remove brush to allow for visibility on landside of levee at LM 7.25</p>	
<p>pkazi_s_20110328_397.JPG</p>

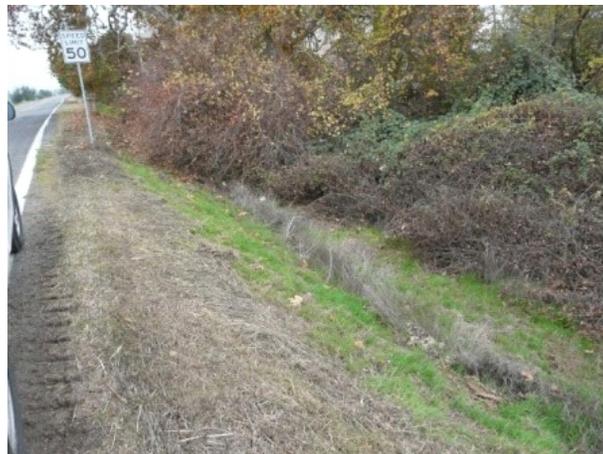
pkazi_s_20110328_398.JPG

Trim/thin trees and brush on landside of levee from LM 7.36 to LM 7.41

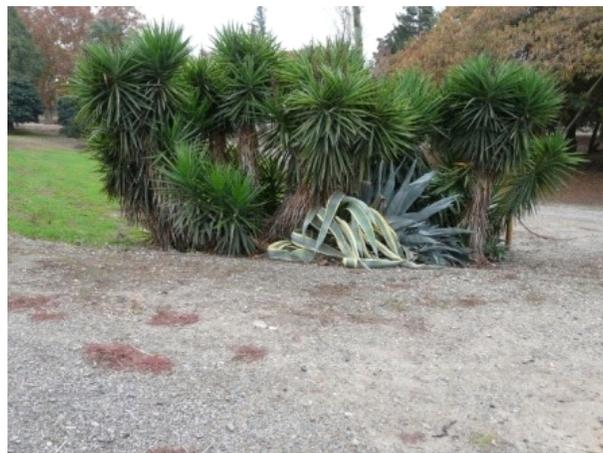
pkazi_s_20110328_402.JPG

Levee Mile Report Line	99
Start Levee Mile	7.92
End Levee Mile	7.92
Location	Land Side
Category	Earthen Levee
Item	Encroachments

Landscaping on landside of levee at LM 7.92

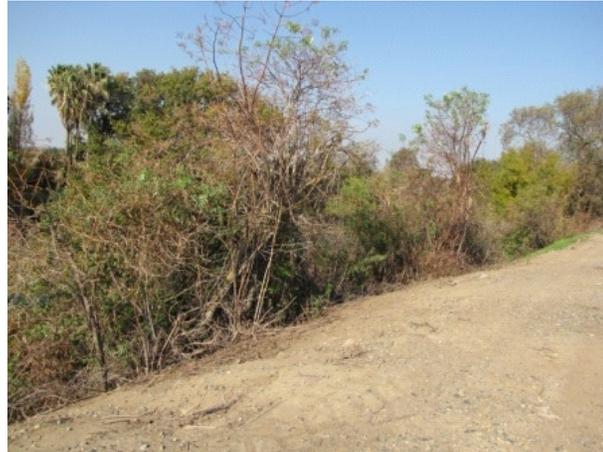
pkazi_s_20110328_465.jpg

View of elderberry bush within 20 feet of shoulder blocking visibility and access.

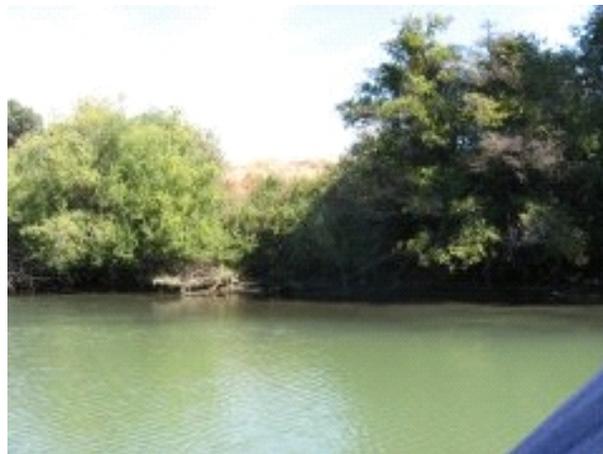
pkazi_s_20110328_463.JPG

Levee Mile Report Line	2
Start Levee Mile	0.20
End Levee Mile	0.21
Location	Water Side
Category	Supplemental
Item	USACE Erosion Survey

2009: no berm, 1:1 slope, tree hazards, clays and cobbles, 3 ft/s [2009 SiteID:ELK_0-2_L]

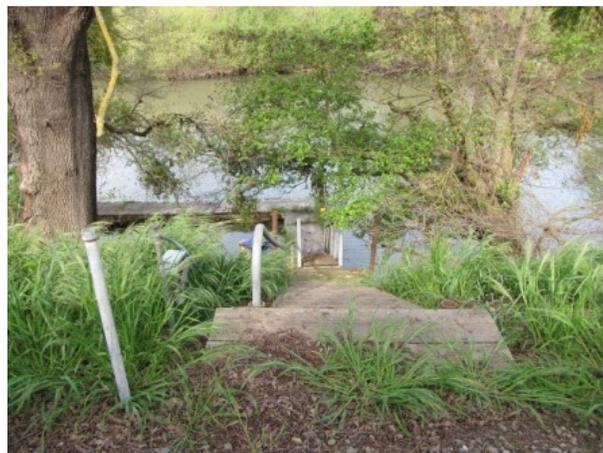
pkazi_s_20110328_423.jpg

View of steps, a dock, and associated utilities on the waterward slope.

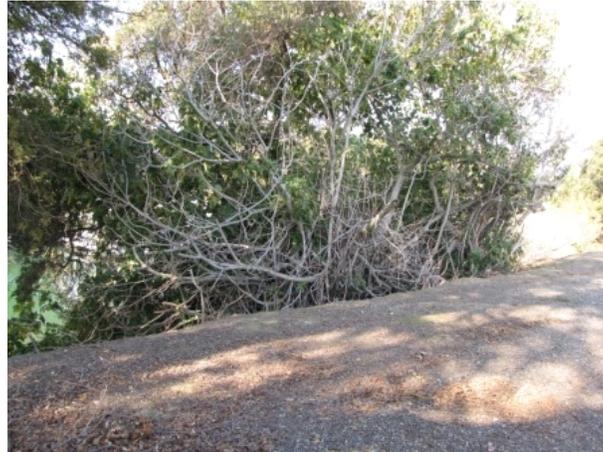
Levee Mile Report Line	5
Start Levee Mile	0.56
End Levee Mile	0.56
Location	Water Side
Category	Earthen Levee
Item	Trim / Thin Trees
View of trees and bushes within 20 feet of the shoulder blocking visibility and access.	
pkazi_s_20110328_466.jpg

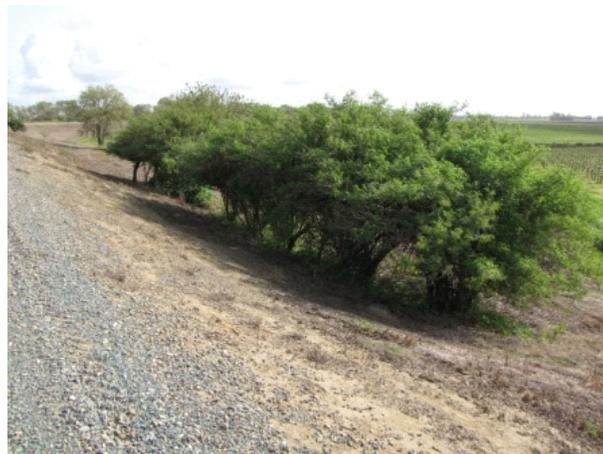
Levee Mile Report Line	6
Start Levee Mile	0.92
End Levee Mile	0.95
Location	Land Side
Category	Earthen Levee
Item	Vegetation
View of elderberries on the landward slope blocking visibility and access.	
pkazi_s_20110328_424.jpg

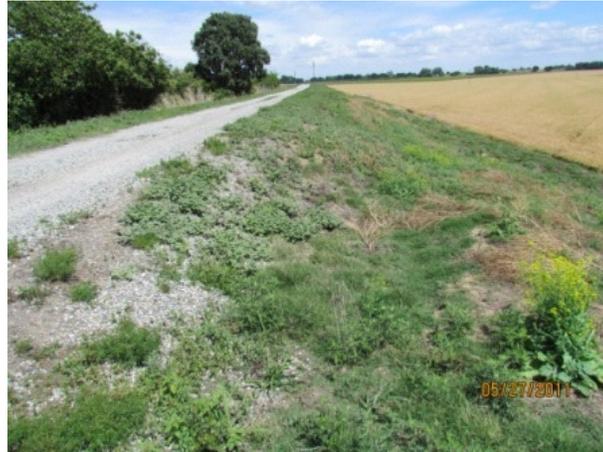
Levee Mile Report Line	7
Start Levee Mile	1.23
End Levee Mile	1.23
Location	Land Side
Category	Earthen Levee
Item	Slope Stability
Erosion couldn't be seen due to vegetation during Spring 2011 inspection. The picture was taken from the crown looking upstream.	
pkazi_s_20110531_691.jpg

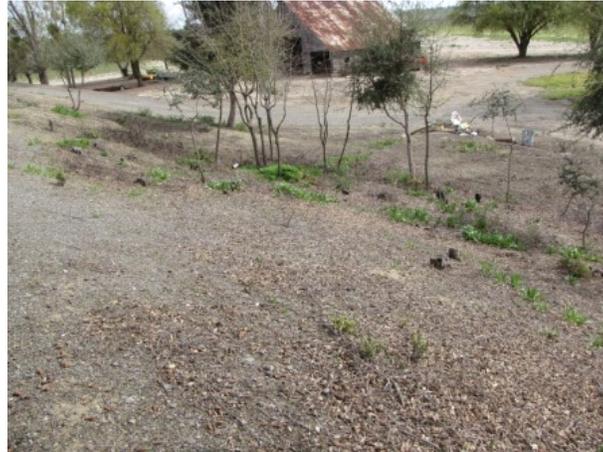
Levee Mile Report Line	12
Start Levee Mile	2.60
End Levee Mile	2.60
Location	Land Side
Category	Earthen Levee
Item	Trim / Thin Trees
View of tree stumps on the landward slope.	
pkazi_s_20110328_426.jpg

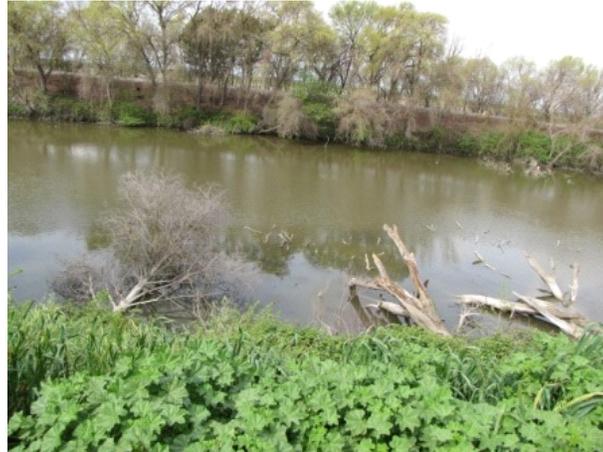
Levee Mile Report Line	16
Start Levee Mile	3.01
End Levee Mile	3.01
Location	Water Side
Category	Earthen Levee
Item	Trim / Thin Trees
View of tree stumps on the waterward slope.	
pkazi_s_20110328_433.jpg

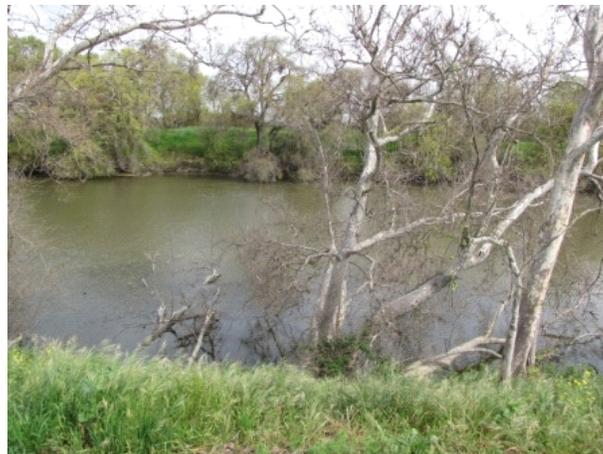
Levee Mile Report Line	17
Start Levee Mile	3.18
End Levee Mile	3.18
Location	Water Side
Category	Earthen Levee
Item	Trim / Thin Trees
View of tree stumps on the waterward slope.	
pkazi_s_20110328_434.jpg

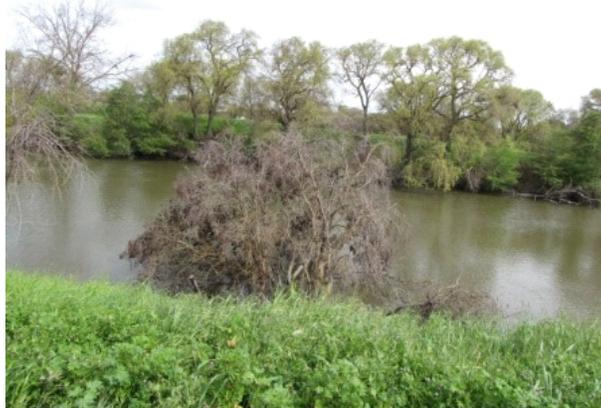
Levee Mile Report Line	19
Start Levee Mile	3.26
End Levee Mile	3.26
Location	Water Side
Category	Earthen Levee
Item	Trim / Thin Trees
View of tree stumps on the waterward slope.	
pkazi_s_20110328_436.jpg

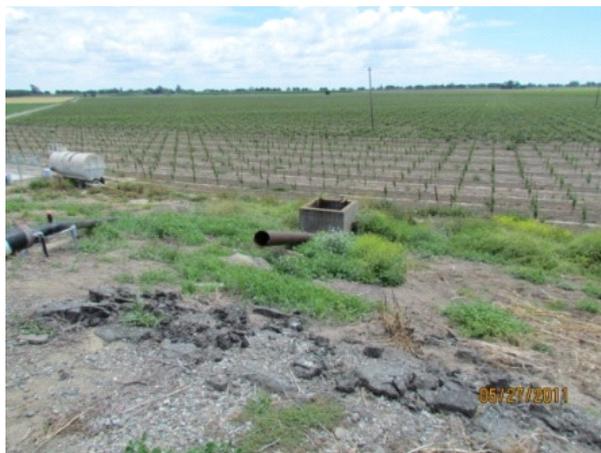
Levee Mile Report Line	21
Start Levee Mile	3.34
End Levee Mile	3.34
Location	Land Side
Category	Earthen Levee
Item	Encroachments
An abandon pipe was located on the landside of the levee. The picture was taken from the crown looking downstream.	
pkazi_s_20110531_686.jpg

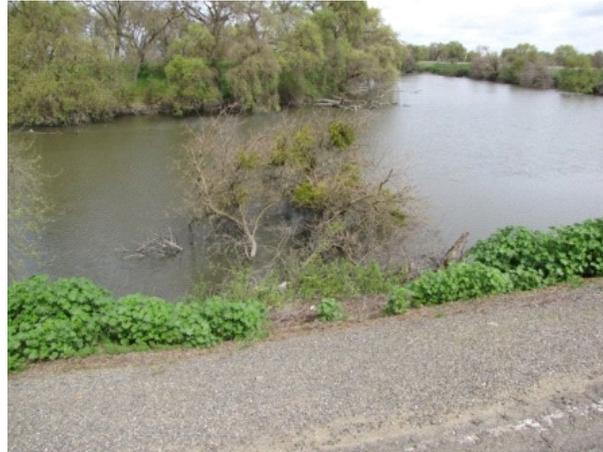
Levee Mile Report Line	22
Start Levee Mile	3.41
End Levee Mile	3.41
Location	Water Side
Category	Earthen Levee
Item	Trim / Thin Trees
View of tree stumps on the waterward slope.	
pkazi_s_20110328_439.jpg

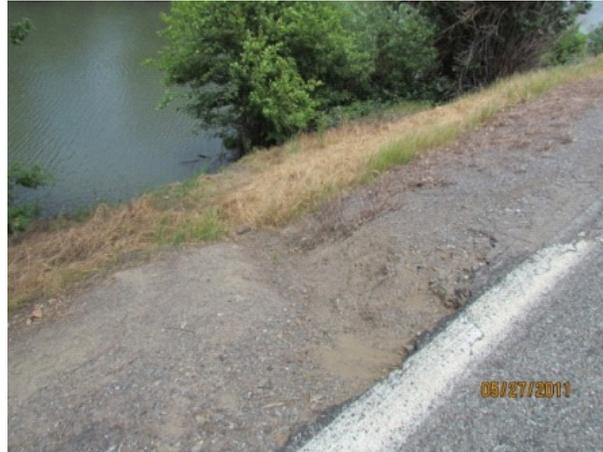
Levee Mile Report Line	27
Start Levee Mile	3.77
End Levee Mile	3.77
Location	Water Side
Category	Earthen Levee
Item	Slope Stability
Updated picture of the erosion on the waterside slope of the levee during Spring 2011 inspection.	
pkazi_s_20110531_683.jpg

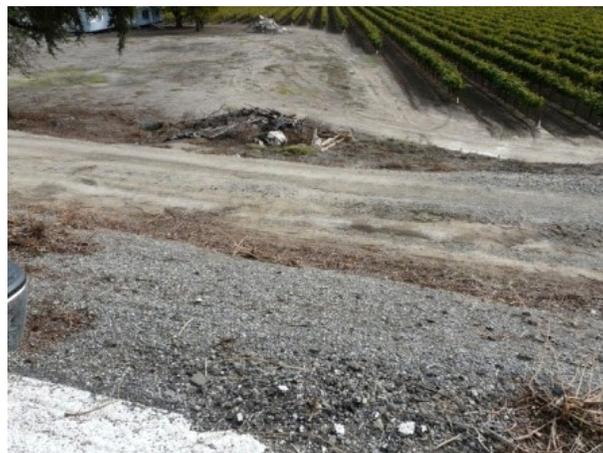
Levee Mile Report Line	29
Start Levee Mile	3.95
End Levee Mile	3.95
Location	Land Side
Category	Earthen Levee
Item	Encroachments
Debris pile on landward slope at LM 3.95.	
pkazi_s_20110328_449.JPG

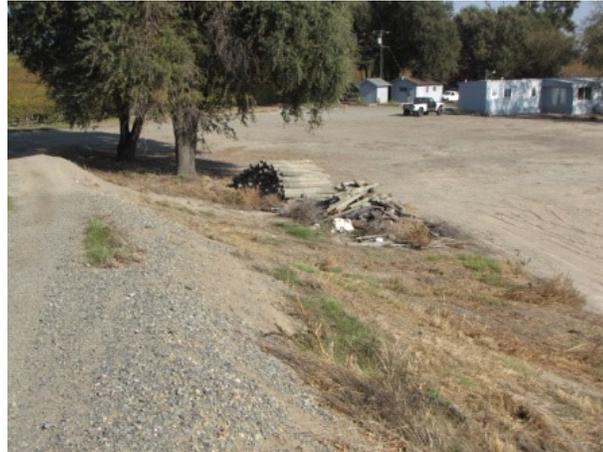
Levee Mile Report Line	29
Start Levee Mile	3.95
End Levee Mile	3.95
Location	Land Side
Category	Earthen Levee
Item	Encroachments
Updated view of material piled at the toe of the levee as of fall 2009.	
pkazi_s_20110328_450.jpg

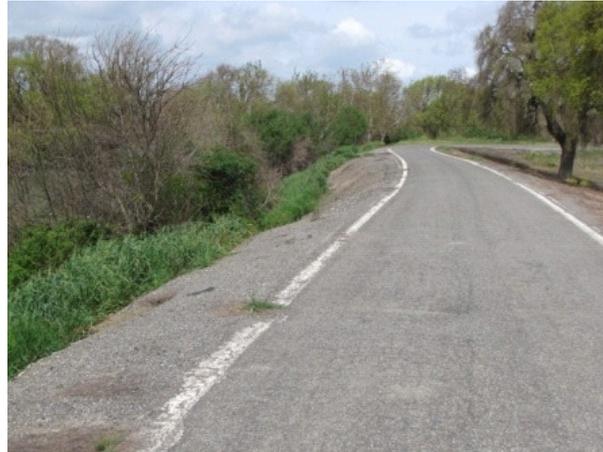
Levee Mile Report Line	31
Start Levee Mile	4.06
End Levee Mile	4.06
Location	Crown
Category	Earthen Levee
Item	Crown Surface / Depressions / Rutting
View of depressions in the roadway looking upstream.	
pkazi_s_20110328_443.jpg

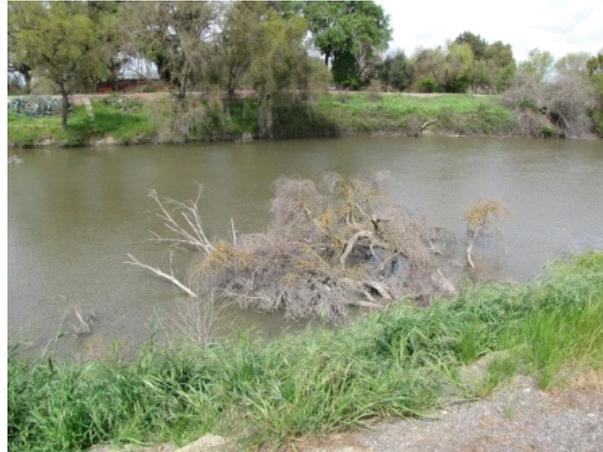
Levee Mile Report Line	34
Start Levee Mile	4.35
End Levee Mile	4.35
Location	Water Side
Category	Earthen Levee
Item	Trim / Thin Trees
View of tree stumps on the waterward slope.	
pkazi_s_20110328_444.jpg

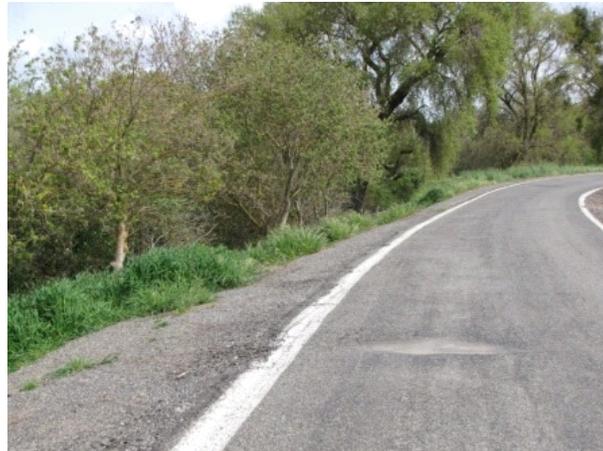
Levee Mile Report Line	35
Start Levee Mile	4.39
End Levee Mile	4.39
Location	Crown
Category	Earthen Levee
Item	Crown Surface / Depressions / Rutting
View of depressions in the crown roadway looking upstream.	
pkazi_s_20110328_445.jpg

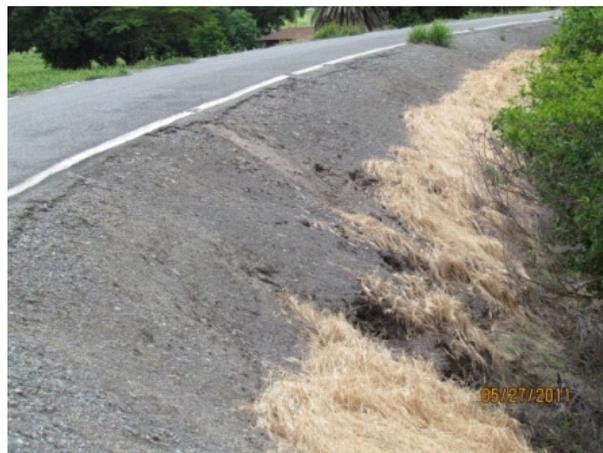
Levee Mile Report Line	40
Start Levee Mile	4.70
End Levee Mile	4.70
Location	Water Side
Category	Earthen Levee
Item	Slope Stability
<p>Slope instability on the shoulder of waterside slope of the levee. The picture was taken from the crown looking downstream.</p>	
<p>pkazi_s_20110531_674.jpg</p>

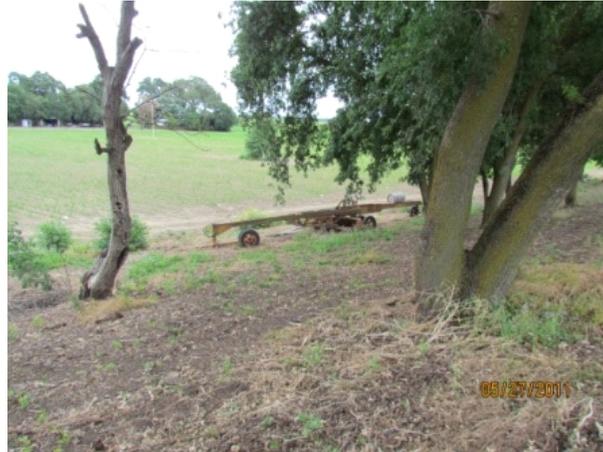
Levee Mile Report Line	42
Start Levee Mile	4.98
End Levee Mile	4.98
Location	Land Side
Category	Earthen Levee
Item	Encroachments
Equipments on the landside toe of the levee. The picture was taken from crown looking downstream.	
pkazi_s_20110531_673.jpg

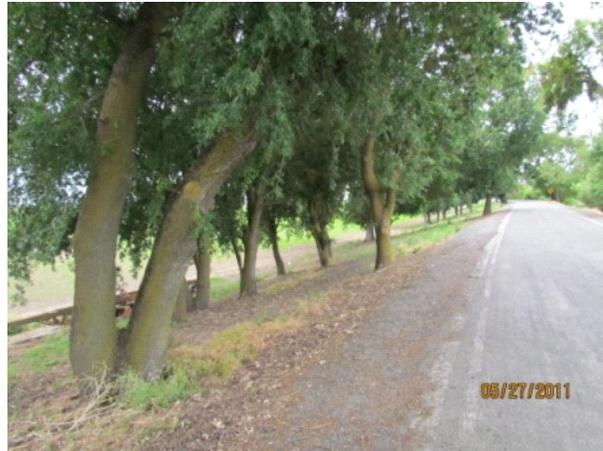
Levee Mile Report Line	44
Start Levee Mile	4.99
End Levee Mile	4.99
Location	Land Side
Category	Earthen Levee
Item	Trim / Thin Trees
Trees were trimmed to see the visibility of the landward slope of the levee. The picture was taken from the crown looking downstream.	
pkazi_s_20110531_672.jpg

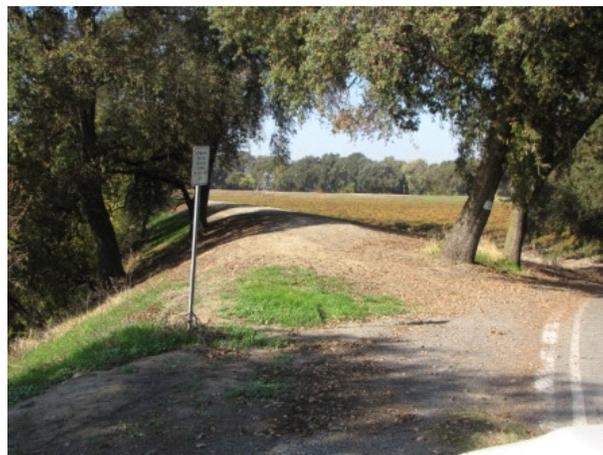
Levee Mile Report Line	46
Start Levee Mile	5.22
End Levee Mile	5.22
Location	Crown
Category	Earthen Levee
Item	Crown Surface / Depressions / Rutting
View of varying elevations in the crown of the levee at the transition from county road to access road.	
pkazi_s_20110328_468.jpg

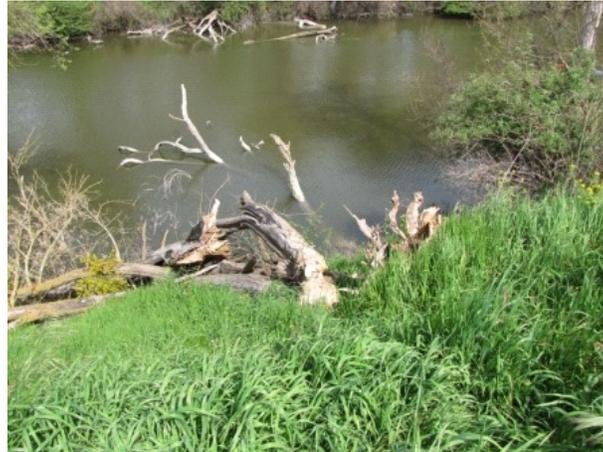
Levee Mile Report Line	47
Start Levee Mile	5.80
End Levee Mile	5.80
Location	Water Side
Category	Earthen Levee
Item	Trim / Thin Trees
View of a tree stump on the waterward slope.	
pkazi_s_20110328_446.jpg

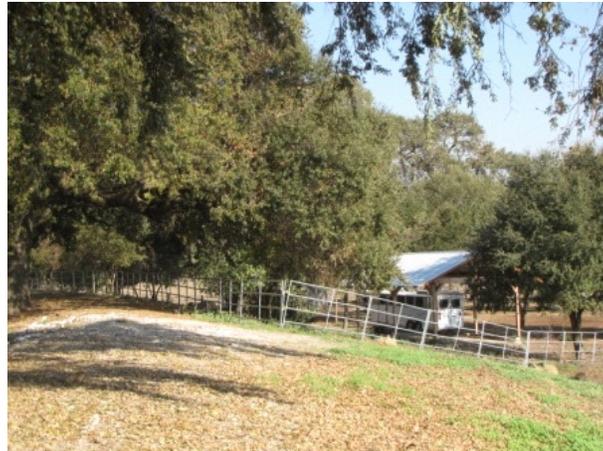
Levee Mile Report Line	48
Start Levee Mile	5.89
End Levee Mile	5.94
Location	Land Side
Category	Earthen Levee
Item	Encroachments
View of fence around a horse pen along the shoulder of the levee and the landward slope.	
pkazi_s_20110328_454.jpg

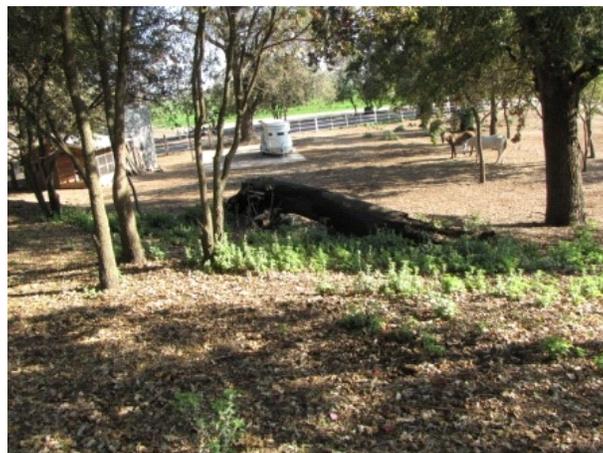
Levee Mile Report Line	49
Start Levee Mile	5.93
End Levee Mile	5.93
Location	Land Side
Category	Earthen Levee
Item	Encroachments
View of a tree trunk lying on the landward slope blocking visibility.	
pkazi_s_20110328_455.jpg

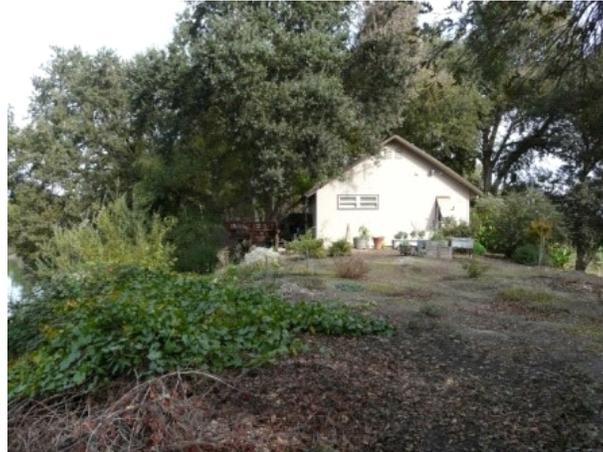
Levee Mile Report Line	50
Start Levee Mile	5.93
End Levee Mile	5.93
Location	Crown
Category	Earthen Levee
Item	Encroachments
Building & associated landscaping on levee crown at LM 5.93.	
pkazi_s_20110328_456.JPG

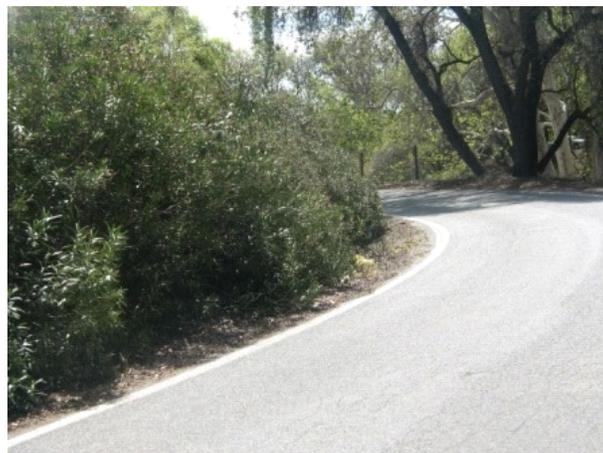
Levee Mile Report Line	54
Start Levee Mile	6.24
End Levee Mile	6.31
Location	Land Side
Category	Earthen Levee
Item	Encroachments
Oleander on landward slope blocking view of levee from LM 6.24 to 6.32	
pkazi_s_20110328_437.jpg

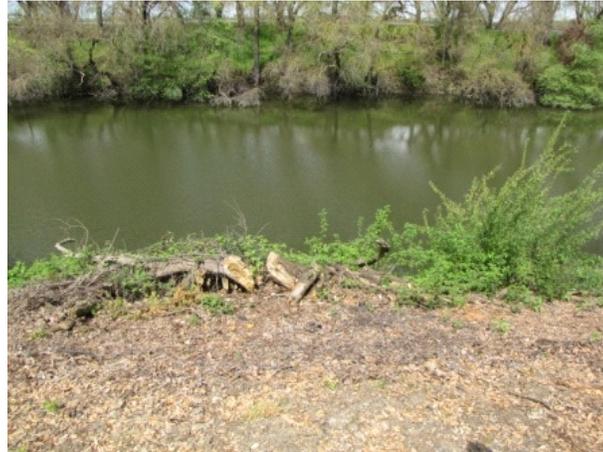
Levee Mile Report Line	55
Start Levee Mile	6.34
End Levee Mile	6.34
Location	Water Side
Category	Earthen Levee
Item	Trim / Thin Trees
View of tree stumps on the waterward slope.	
pkazi_s_20110328_451.jpg

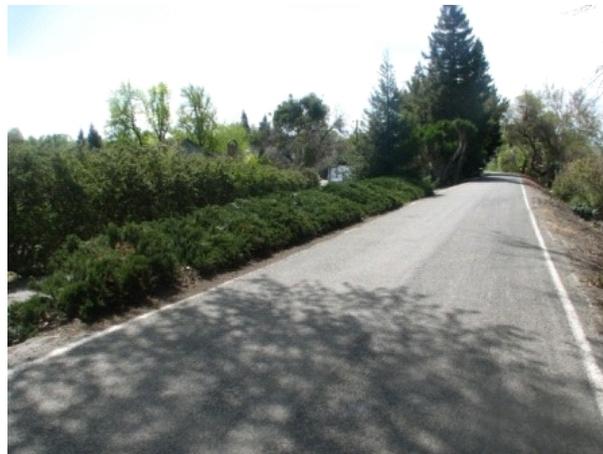
Levee Mile Report Line	57
Start Levee Mile	6.37
End Levee Mile	6.40
Location	Land Side
Category	Earthen Levee
Item	Encroachments
Landscaping on landward slope blocking view from LM 6.37 to 6.40	
pkazi_s_20110328_438.jpg

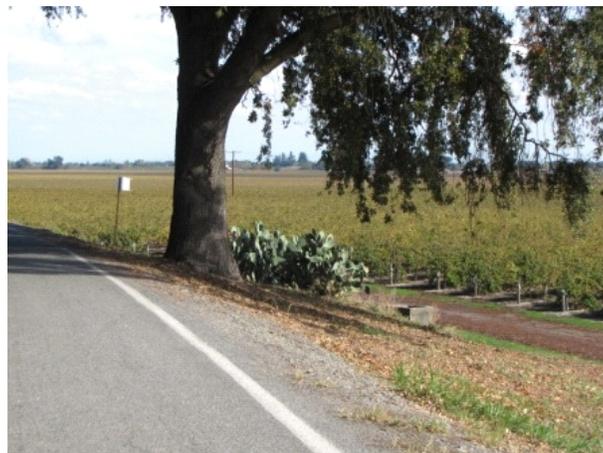
Levee Mile Report Line	58
Start Levee Mile	6.56
End Levee Mile	6.56
Location	Land Side
Category	Earthen Levee
Item	Encroachments
View of landscaping along the landward slope.	
pkazi_s_20110328_457.jpg

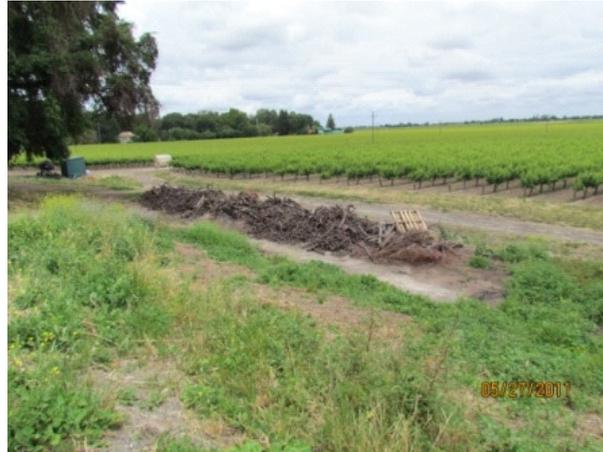
Levee Mile Report Line	59
Start Levee Mile	6.63
End Levee Mile	6.63
Location	Land Side
Category	Earthen Levee
Item	Encroachments
Pruning on the landside toe of the levee. The picture was taken from the crown looking upstream.	
pkazi_s_20110531_671.jpg

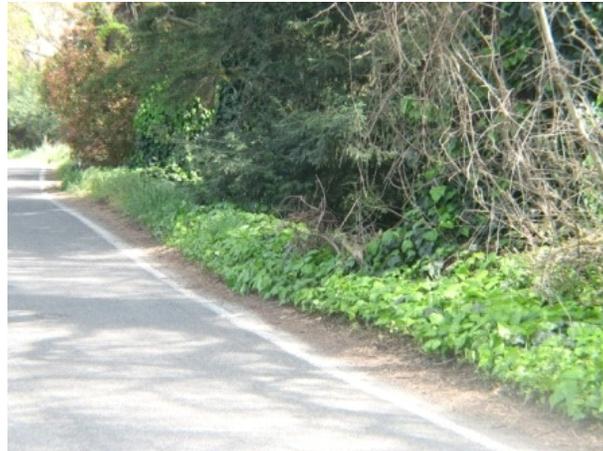
Levee Mile Report Line	60
Start Levee Mile	6.87
End Levee Mile	6.95
Location	Land Side
Category	Earthen Levee
Item	Encroachments
Landscaping on landward slope blocking view from LM 6.87 to 6.95	
pkazi_s_20110328_440.jpg

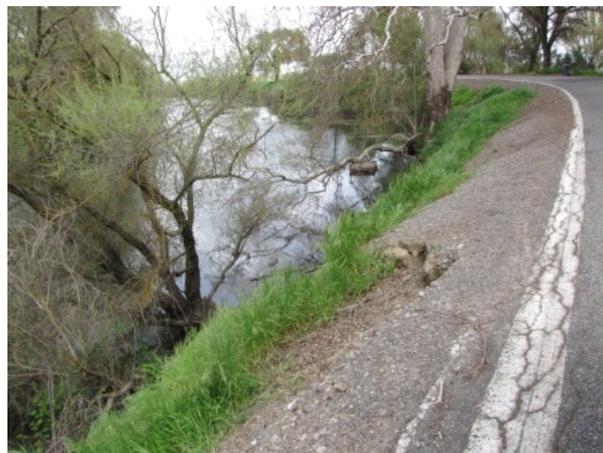
Levee Mile Report Line	62
Start Levee Mile	7.02
End Levee Mile	7.02
Location	Water Side
Category	Earthen Levee
Item	Erosion / Bank Caving
View of erosion on the waterward shoulder looking upstream.	
pkazi_s_20110328_458.jpg

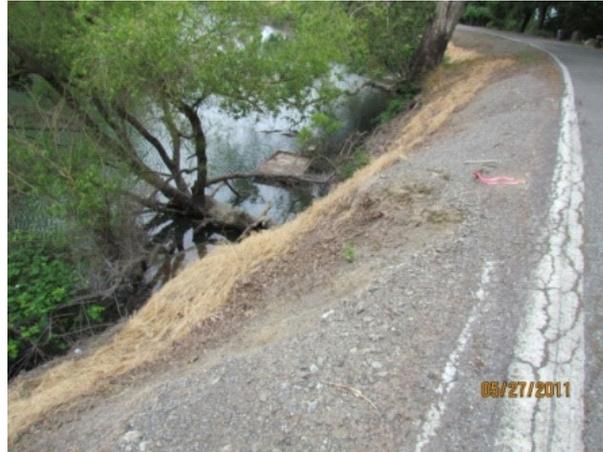
Levee Mile Report Line	62
Start Levee Mile	7.02
End Levee Mile	7.02
Location	Water Side
Category	Earthen Levee
Item	Erosion / Bank Caving
Updated erosion site picture on the waterside slope of the levee looking upstream during Spring 2011 inspection.	
pkazi_s_20110531_670.jpg

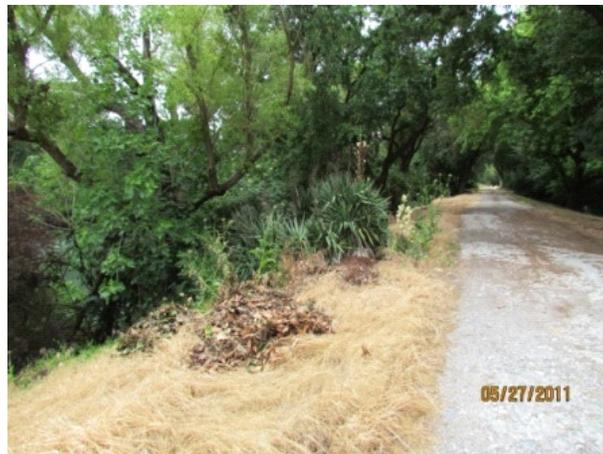
Levee Mile Report Line	65
Start Levee Mile	7.39
End Levee Mile	7.39
Location	Water Side
Category	Earthen Levee
Item	Encroachments
Landscaping on the waterside of the levee. The picture was taken from the crown looking upstream.	
pkazi_s_20110531_663.jpg

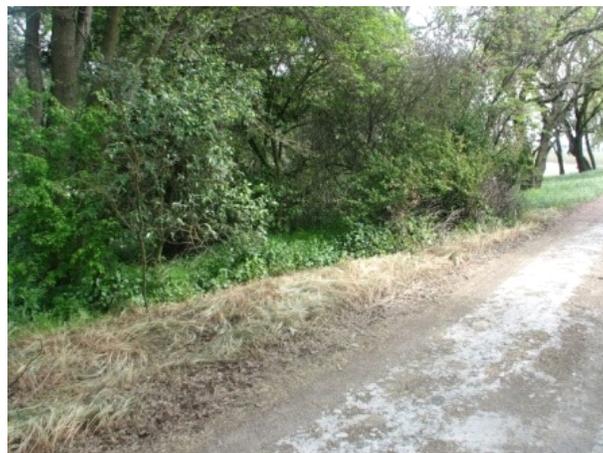
Levee Mile Report Line	66
Start Levee Mile	7.42
End Levee Mile	7.47
Location	Land Side
Category	Earthen Levee
Item	Encroachments
Landscaping on landward slope blocking view from LM 7.42 to 7.47	
pkazi_s_20110328_441.jpg
