**Flood Control Project Maintenance
Levee Inspections
LMA District Cover Sheet
Spring 2011 Levee Inspection Results**

Reclamation District No. 0150 Merrit Island

Spring 2011 Levee Inspection Results

Waterway	Bank	Unit Miles
Unit No. 01 Sutter Slough	Left	0.54

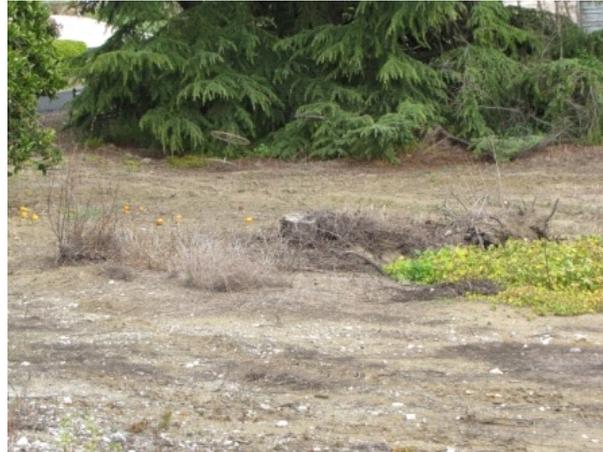
Levee Mile Report Line	67
Start Levee Mile	7.50
End Levee Mile	7.50
Location	Land Side
Category	Earthen Levee
Item	Trim / Thin Trees
View of a tree stump on the landward slope.	
pkazi_s_20110328_459.jpg

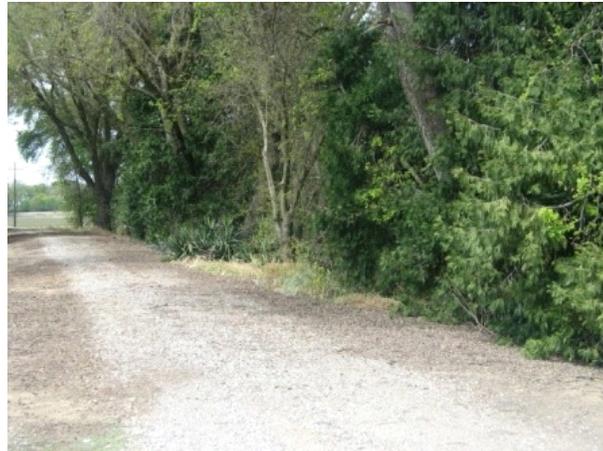
Levee Mile Report Line	68
Start Levee Mile	7.55
End Levee Mile	7.55
Location	Land Side
Category	Earthen Levee
Item	Encroachments
Landscaping on landward slope blocking view from LM 7.52 to 7.58	
pkazi_s_20110328_442.jpg

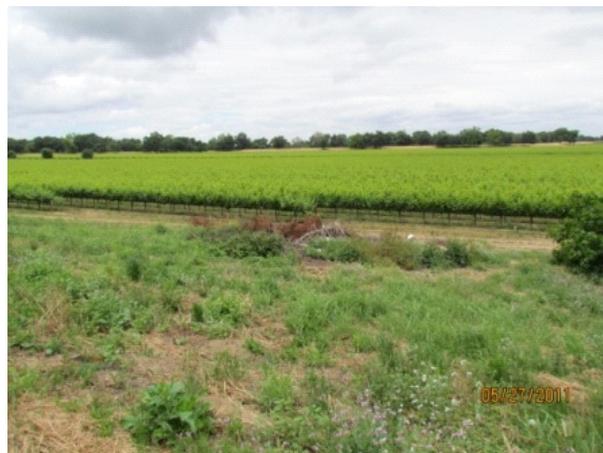
Levee Mile Report Line	70
Start Levee Mile	7.60
End Levee Mile	7.60
Location	Land Side
Category	Earthen Levee
Item	Encroachments
Pruning located on the toe of landward side of the levee. The picture was taken from the crown looking upstream.	
pkazi_s_20110531_664.jpg

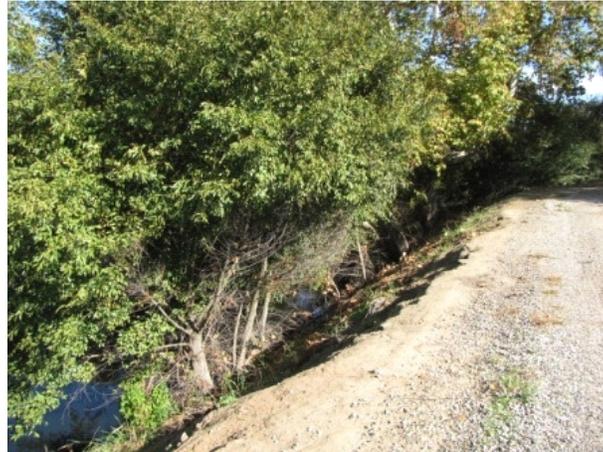
Levee Mile Report Line	72
Start Levee Mile	8.21
End Levee Mile	8.21
Location	Water Side
Category	Earthen Levee
Item	Erosion / Bank Caving
View of erosion occurring along the waterward slope.	
pkazi_s_20110328_469.jpg

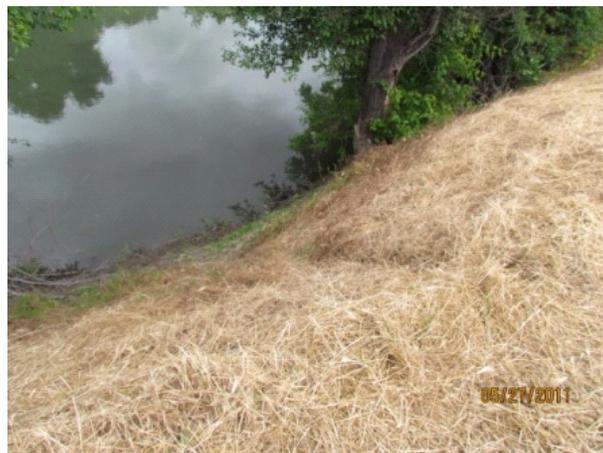
Levee Mile Report Line	74
Start Levee Mile	8.48
End Levee Mile	8.48
Location	Water Side
Category	Earthen Levee
Item	Erosion / Bank Caving
Slope instability on the waterside slope of the levee. The picture was taken from the crown looking upstream.	
pkazi_s_20110531_665.jpg

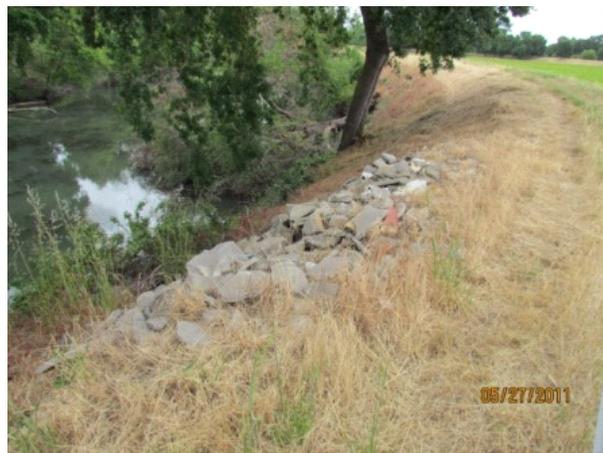
Levee Mile Report Line	78
Start Levee Mile	8.87
End Levee Mile	8.87
Location	Water Side
Category	Earthen Levee
Item	Encroachments
<p>Broken concrete pipe was left on the waterside slope of the levee. The picture was taken from the crown looking upstream.</p>	
<p>pkazi_s_20110531_668.jpg</p>

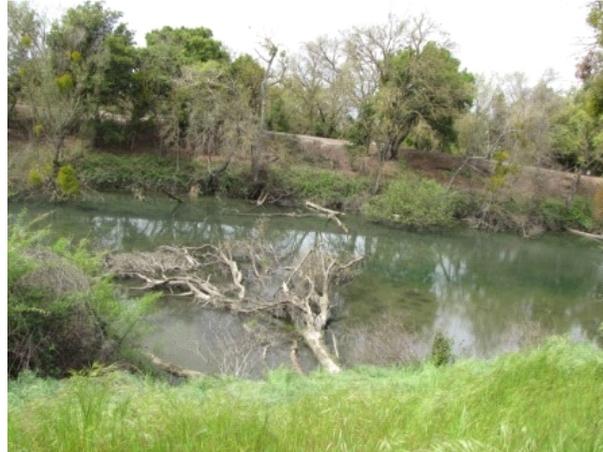
Levee Mile Report Line	79
Start Levee Mile	9.10
End Levee Mile	9.10
Location	Water Side
Category	Earthen Levee
Item	Trim / Thin Trees
View of a tree stump on the waterward slope.	
pkazi_s_20110328_462.jpg

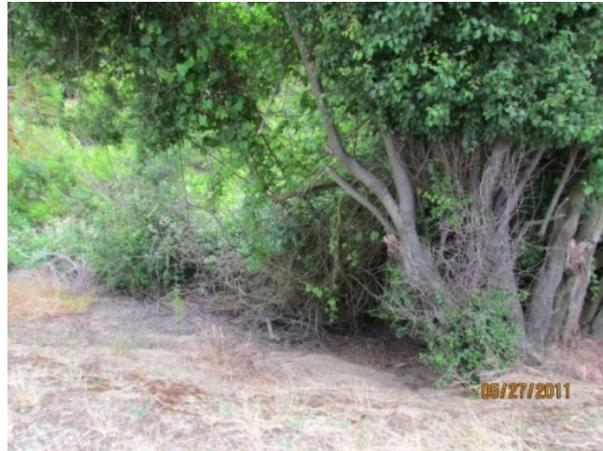
Levee Mile Report Line	81
Start Levee Mile	9.35
End Levee Mile	9.35
Location	Water Side
Category	Earthen Levee
Item	Trim / Thin Trees
Trees needed to be trimmed for visibility of the waterside slope of the levee. The picture was taken from the crown looking towards the slough.	
pkazi_s_20110531_669.jpg

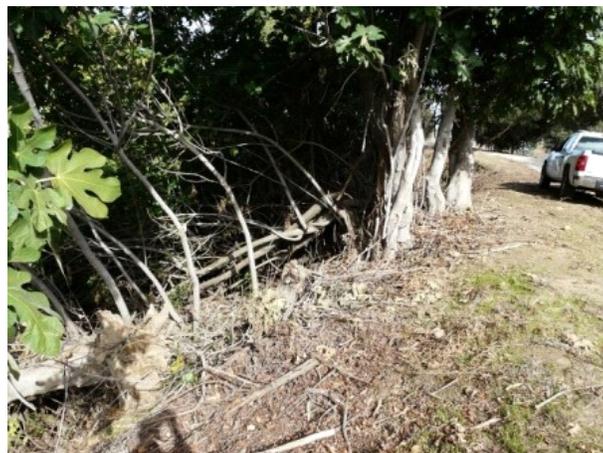
Levee Mile Report Line	82
Start Levee Mile	9.51
End Levee Mile	9.51
Location	Water Side
Category	Earthen Levee
Item	Trim / Thin Trees
Thin/trim trees to allow for visibility of top 20' of waterward slope at LM 9.51.	
pkazi_s_20110328_461.JPG
