**Flood Control Project Maintenance  
Levee Inspections**

**Fall 2013 Levee Maintenance Deficiency Summary Report**

**Reclamation District No. 0307 Lisbon**

Waterway		Bank	Unit Miles
Unit No. 01 Sacramento River		Right	6.65
	Spring (March - May)	Summer (June - August)	(September - November) Fall Winter (December - February)
Unit Maintenance Rating (Fall Only)			<b>U</b>
Date of Inspection	03/07/2013 - 03/07/2013		10/02/2013 - 10/02/2013
DWR Inspector	Herman Phillips		Herman Phillips
Accompanied By	Pete Dweyer RD 307

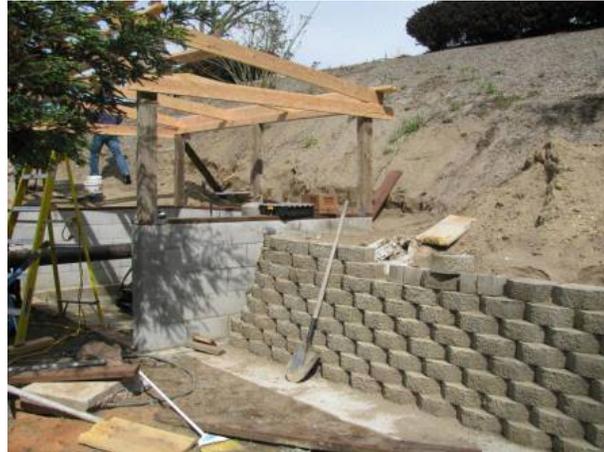
phillips\_f\_20130925\_836.JPG

RD 307 Levee mile 4.36 Retaining wall in the levee toe. Photo taken spring of 2013. Inspection 10-02-2013, no new photo taken of the wall and pump structure. No permit application received for the remodeled pump structure and headwall.
