**Flood Control Project Maintenance
Levee Inspections**
LMA District Cover Sheet
Spring 2014 Levee Inspection Results

Reclamation District No. 0307 Lisbon

Spring 2014 Levee Inspection Results

Waterway	Bank	Unit Miles
Unit No. 01 Sacramento River	Right	6.65

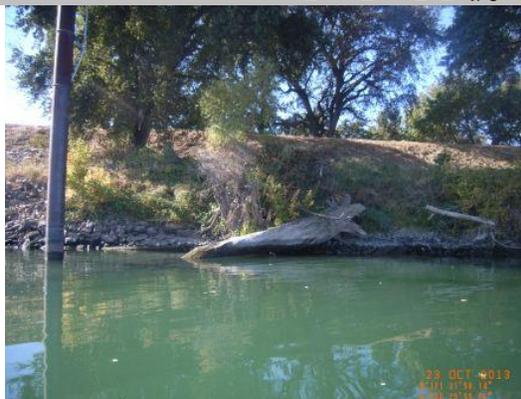
Photo 1 of 1 : USACE2013A_SAC_43-2_R_5.jpg

LM Start	6.26	Rating **	M	Issue No.	7
LM End	6.42	Issue Type +	Ma	Location *	WS
Category	Supplemental		GPS Latitude/Longitude		
			Start	End	
Item	USACE Erosion Survey		38.434560 °	38.432287 °	
			-121.531159 °	-121.532978 °	
DWR ID					
Action/Comments					
Inspector Comments: 2008 - Large rotational failure in bank and well into the levee slope. Could be a significant problem in the next high flow event. 2009 - Minimal new erosion, site extended upstream. 2010 - Minor new erosion. 2011 - Tree popout has left a large hole. Large slump area. Rock on the bank is failing in some locations. 2012 - The toe appears to be scouring out. 2013: No observed changes. [2013 Site ID: SAC_43-2_R]

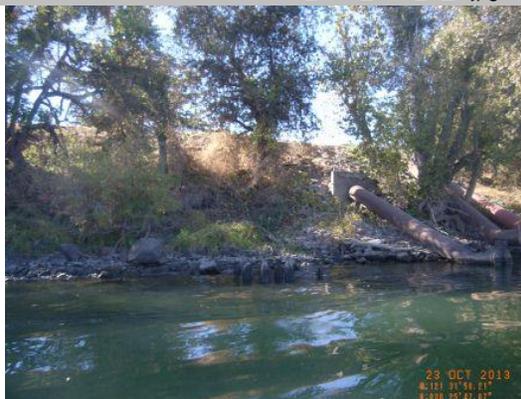
Photo 1 of 1 : USACE2013A_SAC_43-1_R_6.jpg

LM Start	6.38	Rating **	M	Issue No.	6
LM End	6.49	Issue Type +	Ma	Location *	WS
Category	Supplemental		GPS Latitude/Longitude		
			Start	End	
Item	USACE Erosion Survey		38.431726 °	38.429957 °	
			-121.533200 °	-121.533035 °	
DWR ID					
Action/Comments					
Inspector Comments: 2011 - Erosion pockets likely from tree popouts. This site has been in the inventory before and been fixed with emergency bank rock but continues to fail. 2013: No observed changes. [2013 Site ID: SAC_43-1_R]
