**Flood Control Project Maintenance
Levee Inspections**
LMA District Cover Sheet
Spring 2014 Levee Inspection Results

Reclamation District No. 0341 Sherman Island

Spring 2014 Levee Inspection Results

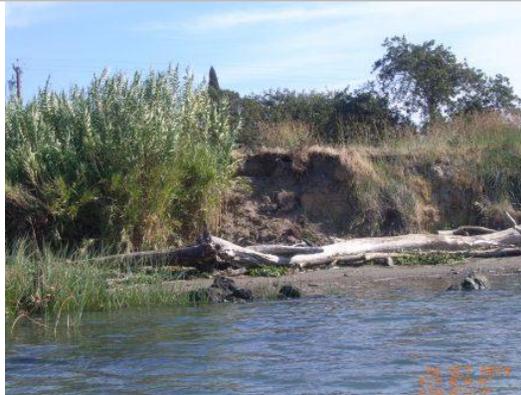
Photo 1 of 1 : USACE2013A_SAC_8-0_L_2.jpg

LM Start	4.52	Rating **	U	Issue No.	7
LM End	4.60	Issue Type +	Ma	Location *	WS
Category	Supplemental		GPS Latitude/Longitude		
			Start	End	
Item	USACE Erosion Survey		38.090620 °	38.088572 °	
			-121.706684 °	-121.707127 °	
DWR ID					
Action/Comments					
Inspector Comments: 1999 - New small slump in eroded bank. 2005 - Reach extended because of vertical bank along the roadway upstream. 2011 - More slumping since last year. 2012 - Site upgraded to critical. Very steep slope which may be effecting the highway on top of the levee. 2013: New erosion towards downstream end of site. [2013 Site ID: SAC_8-0_L]

USACE 2013 Photo #1

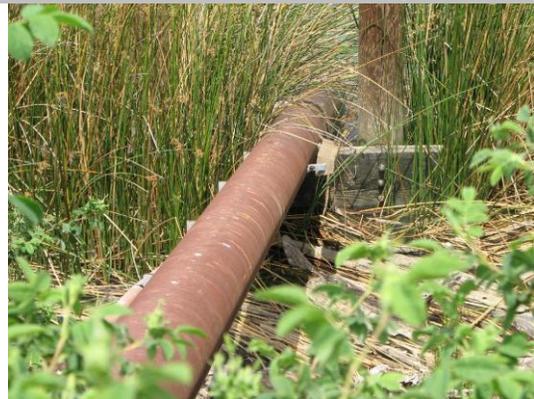
Photo 1 of 1 : UCIP_2914.jpg

LM Start	6.12	Rating **	M	Issue No.	83
LM End	6.12	Issue Type +	En	Location *	LS
Category	Supplemental			GPS Latitude/Longitude	
				Start	End
Item	DWR UCIP Field Study			38.080591 °	38.080591 °
				-121.731249 °	-121.731249 °
DWR ID	DWR_RD0341_02_s_2014_83				
Action/Comments					
Inspector Comments: FS_ID:22260 EP_NO: 11116 Repair Type: Crossing Status: UCIP Comments: Need to contact owner to determine status of crossing. If crossing is no longer used will need to meet Title 23 requirements. Hole present in pipe section. Debris on waterward side--10-inch pipe section abandoned on slope. Dense vegetation limits the inspector's visibility to identify signs of pipe failure (leaks) along the slope. Recommend removing vegetation along pipe alignment to conduct proper inspection of structure and appurtenances. FIELD_STRUCT_DESC: 12-inch pipe sleeved through 14-inch pipe through levee, 4.0 feet below crown. Annular gap grouted. Slide gate in distribution box on landward side. (USACE-1962). This entry matches the Drainage or Irrigation Structure referenced in O&M manual (HLM 6.12). This pipe was retained under ABO No. 11116 (1975). Distributon box installed and pipe along landward slope removed and replaced with longer 16-inch steel pipe under Permit No. 15372 (1993). FS Date: 5/6/2009

Pipe section on waterward side.

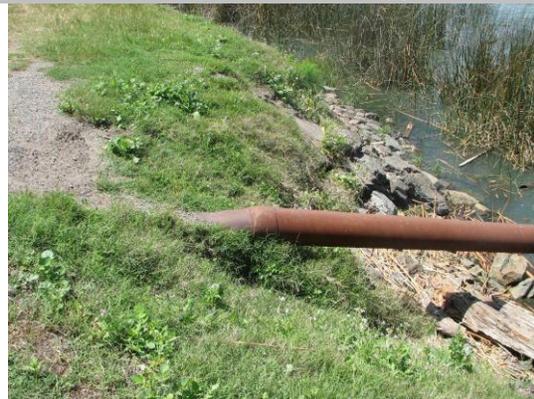
Photo 1 of 1 : UCIP_2921.jpg

LM Start	6.45	Rating **	M	Issue No.	84
LM End	6.45	Issue Type +	En	Location *	WS
Category	Supplemental		GPS Latitude/Longitude		
			Start	End	
Item	DWR UCIP Field Study		38.082718 °	38.082718 °	
			-121.736635 °	-121.736635 °	
DWR ID	DWR_RD0341_02_s_2014_84				
Action/Comments					
Inspector Comments: FS_ID:22261 EP_NO: 11116 Repair Type: Crossing Status: UCIP Comments: Dense vegetation limits the inspector's visibility to identify signs of pipe failure (leaks) along the slope. Recommend removing vegetation along pipe alignment to conduct proper inspection of structure and appurtenances. FIELD_STRUCT_DESC: 12-inch pipe through the levee, 2.0 feet below the crown. Siphon breaker on landward slope. Rock revetment on waterward slope. (USACE-1962). This entry matches the Drainage or Irrigation Structure referenced in O&M manual (HLM 6.31). This pipe was retained under ABO No. 11116 (1975). FS Date: 5/6/2009

Side view of pipe on waterward side.

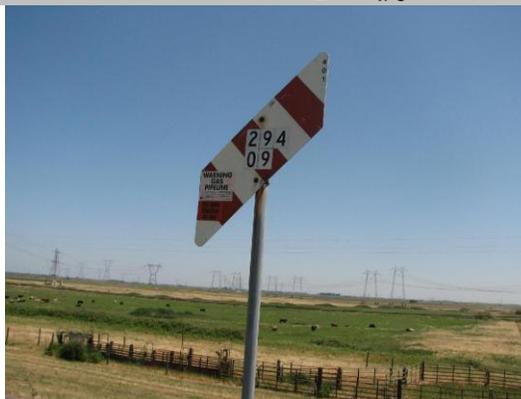
Photo 1 of 1 : UCIP_2931.jpg

LM Start	7.02	Rating **	M	Issue No.	88
LM End	7.02	Issue Type +	En	Location *	WS
Category	Supplemental		GPS Latitude/Longitude		
			Start	End	
Item	DWR UCIP Field Study		38.080277 °	38.080277 °	
			-121.745407 °	-121.745407 °	
DWR ID	DWR_RD0341_02_s_2014_88				
Action/Comments					
Inspector Comments: FS_ID:22267 EP_NO: 15777 Repair Type: Crossing Status: UCIP Comments: Need to contact owner to determine status of crossing. Need date of last inspection and confirmation that crossing is still in operable condition. Multiple crossings in general area need to clarify which pipes are in this levee section. FIELD_STRUCT_DESC: 42-inch steel gas pipeline through the levee, approximately 30.0 feet below the crown. (Permit No. 15777-1993) Utility marker contact information includes Contact prior to Excavation call 1-800-227-2600 or Emergency Contact 1-800-811-4111. FS Date: 5/6/2009

Marker located on landward side.

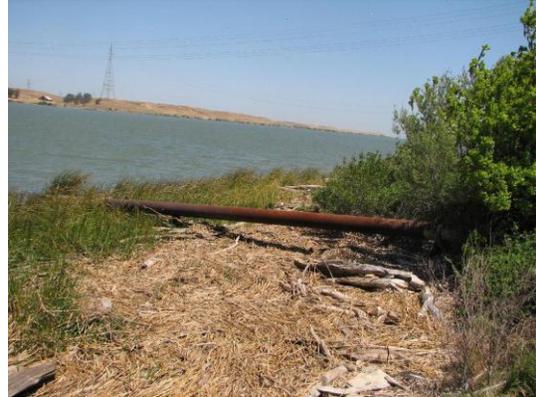
Photo 1 of 1 : UCIP_2942.jpg

LM Start	7.53	Rating **	M	Issue No.	90
LM End	7.53	Issue Type +	En	Location *	WS
Category	Supplemental			GPS Latitude/Longitude	
				Start	End
Item	DWR UCIP Field Study			38.076229 °	38.076229 °
				-121.753363 °	-121.753363 °
DWR ID	DWR_RD0341_02_s_2014_90				
Action/Comments					
Inspector Comments: FS_ID:22293 EP_NO: 1915 Repair Type: Crossing Status: UCIP Comments: Will need to contact owner. Need to obtain maintenance records and clarify modifications made at to crossing (size). Also important to note that DWR DOE was out in the field during our pipe inspection they were conducting pipe evaluation for pipe replacement. Need to contact DWR DOE to determine location of pipe replacement. FIELD_STRUCT_DESC: 18-inch (not 12-inch as noted in historical records) steel irrigation pipe through the levee, 3.0 feet below the crown. Concrete pipe riser on landward side. (Permit No. 1352-1948) Siphon breaker on landward side installed under Permit No. 1915 (1954). Pipe removed and replaced by 12-inch steel pipe under Permit No. 10799 (1977). FS Date: 5/6/2009

View of crossing located on waterward side.

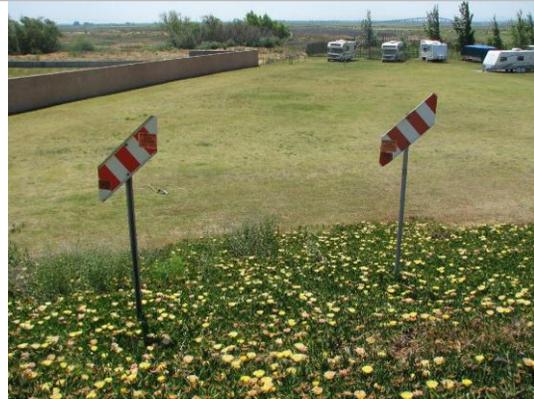
Photo 1 of 1 : UCIP_2961.jpg

LM Start	8.33	Rating **	M	Issue No.	95
LM End	8.33	Issue Type +	En	Location *	LS
Category	Supplemental			GPS Latitude/Longitude	
				Start	End
Item	DWR UCIP Field Study			38.070678 °	38.070678 °
				-121.766206 °	-121.766206 °
DWR ID	DWR_RD0341_02_s_2014_95				
Action/Comments					
Inspector Comments: FS_ID:22307 EP_NO: 3494 Repair Type: Crossing Status: UCIP Comments: Need to contact owner to determine status of crossing. Need date of last inspection and confirmation that crossing is still in operable condition. FIELD_STRUCT_DESC: 2 of 2: 26-inch concrete encased steel gas line through the levee, 5.1 feet below the crown. Concrete cutoff wall around pipe at center of levee. Location sign on waterward shoulder. Rock revetment on waterward slope. (Permit No. 3494-1961) Contact number provided on marker out in the field 1-800-811-4111. FS Date: 5/6/2009

Gas line markers located on landward side.

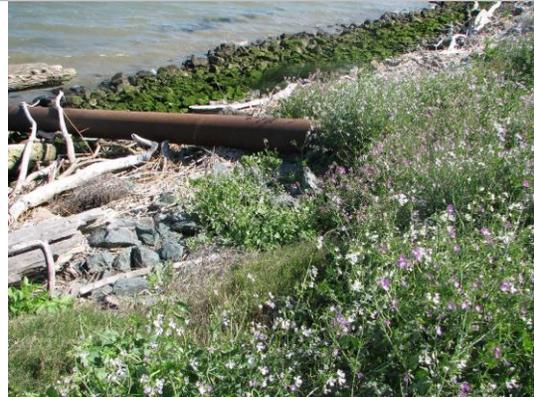
Photo 1 of 1 : UCIP_2974.jpg

LM Start	9.01	Rating **	M	Issue No.	98
LM End	9.01	Issue Type +	En	Location *	LS
Category	Supplemental			GPS Latitude/Longitude	
				Start	End
Item	DWR UCIP Field Study			38.064563 °	38.064563 °
				-121.776153 °	-121.776153 °
DWR ID	DWR_RD0341_02_s_2014_98				
Action/Comments					
Inspector Comments: FS_ID:22324 EP_NO: 11114 Repair Type: Crossing Status: UCIP Comments: Dense vegetation limits the inspector's visibility to identify signs of pipe failure (leaks) along the slope. Recommend removing vegetation along pipe alignment to conduct proper inspection of structure and appurtenances. FIELD_STRUCT_DESC: 14-inch pipe through the levee, 4.0 feet below the crown. Concrete standpipe with slide gate on landward side. Rock revetment on waterward slope. This pipe was retained under ABO No. 11114 (1975). FS Date: 5/6/2009

Overview of waterward side.
