**Flood Control Project Maintenance  
Levee Inspections**

**Fall 2014 Levee Maintenance Deficiency Summary Report**

**Flood Control Project Maintenance  
Levee Inspections**  
**LMA District Cover Sheet**  
**Fall 2014 Levee Inspection Results**

**Reclamation District No. 0349 Sutter Island**

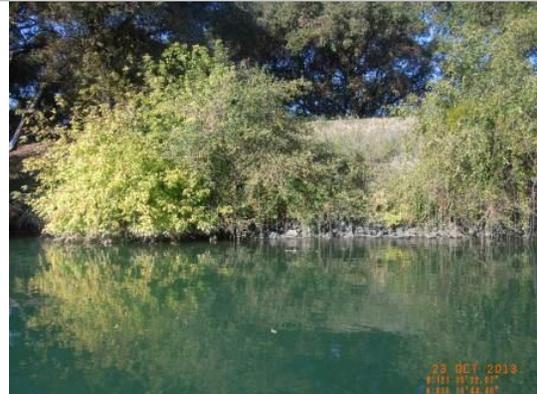
Photo 1 of 1 : FA\_2014\_RD0349\_205\_21\_20141008\_00009.jpg

LM Start	<b>2.00</b>	Rating **	M	Issue No.	<b>21</b>
LM End	<b>2.15</b>	Issue Type +	Ma	Location *	WS
Category	Supplemental		GPS Latitude/Longitude		
			Start	End	
Item	USACE Erosion Survey		38.279017 °	38.278597 °	
			-121.589615 °	-121.589854 °	
DWR ID	DWR_RD0349_02_f_2014_21				
Action/Comments					
Inspector Comments: 1997 - Top right bank has retreated into the levee. Site is between two rock sites. 1999 - Downstream half of the reach repaired with rock. 2000 - Trees leaning into the water. 2010 - Site appears worse. 2011 - New erosion at the toe. 2013: Short vertical sections observed at upstream end. [2013 Site ID: STM_23-9_R]

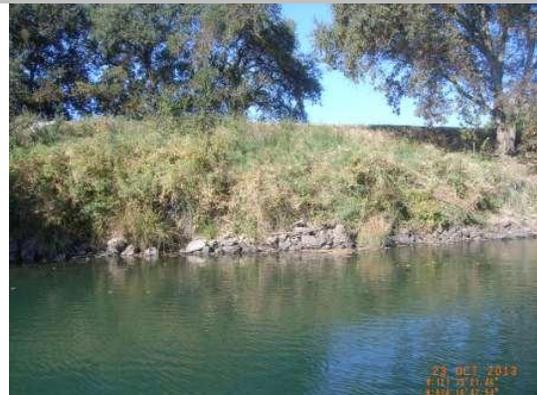
Photo 1 of 1 : FA\_2014\_RD0349\_205\_23\_20141008\_00010.jpg

LM Start	<b>2.05</b>	Rating **	M	Issue No.	<b>23</b>
LM End	<b>2.05</b>	Issue Type +	Ma	Location *	WS
Category	Supplemental		GPS Latitude/Longitude		
			Start	End	
Item	USACE Erosion Survey		38.280069 °	38.279919 °	
			-121.589443 °	-121.589438 °	
DWR ID	DWR_RD0349_02_f_2014_23				
Action/Comments					
Inspector Comments: 2011 - Small scallop caused by erosion and wave wash. 2013: No observed changes. [2013 Site ID: STM_24-1_R]

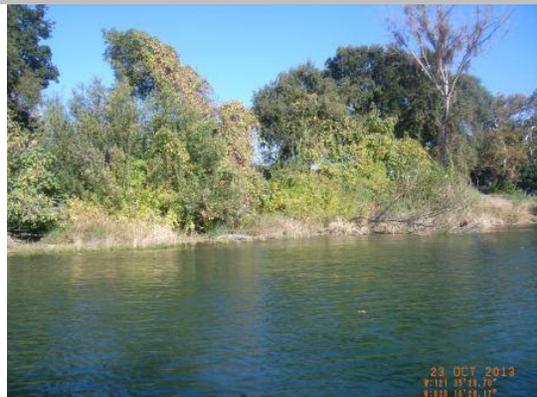
Photo 1 of 2 : FA\_2014\_RD0349\_205\_19\_20141008\_00007.jpg

LM Start	<b>2.46</b>	Rating **	M	Issue No.	<b>19</b>
LM End	<b>2.70</b>	Issue Type +	Ma	Location *	WS
Category	Supplemental		GPS Latitude/Longitude		
			Start	End	
Item	USACE Erosion Survey		38.273854 °	38.271998 °	
			-121.588745 °	-121.589424 °	
DWR ID	DWR_RD0349_02_f_2014_19				
Action/Comments					
Inspector Comments: 2011 - Toe scour at the tidal zone. 2013: No observed changes. [2013 Site ID: STM_23-6_R]

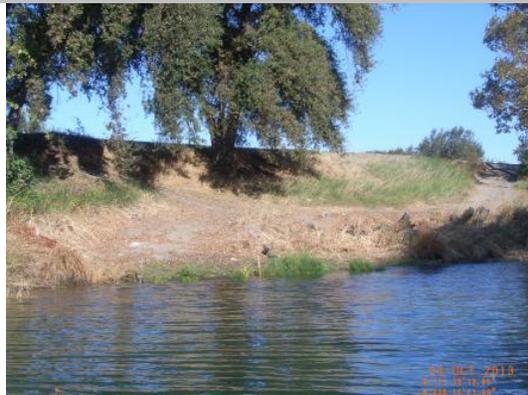
Photo 2 of 2 : FA\_2014\_RD0349\_205\_19\_20141008\_00008.jpg

LM Start	<b>2.46</b>	Rating **	M	Issue No.	<b>19 (cont)</b>
LM End	<b>2.70</b>	Issue Type +	Ma	Location *	WS
Category	Supplemental			GPS Latitude/Longitude	
				Start	End
Item	USACE Erosion Survey			38.273854 °	38.271998 °
				-121.588745 °	-121.589424 °
DWR ID	DWR_RD0349_02_f_2014_19				
Action/Comments					
Inspector Comments: 2011 - Toe scour at the tidal zone. 2013: No observed changes. [2013 Site ID: STM_23-6_R]

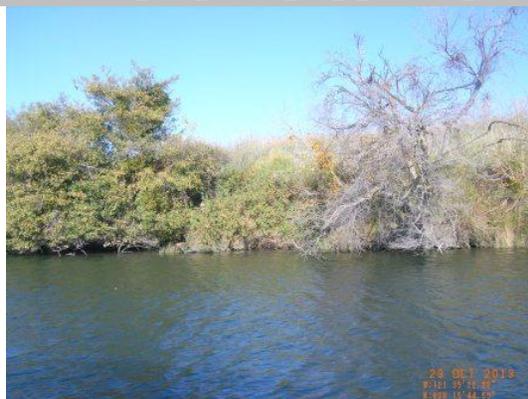
Photo 1 of 1 : FA\_2014\_RD0349\_205\_3\_20141008\_00003.jpg

LM Start	<b>3.25</b>	Rating **	M	Issue No.	<b>3</b>
LM End	<b>3.47</b>	Issue Type +	Ma	Location *	WS
Category	Supplemental		GPS Latitude/Longitude		
			Start	End	
Item	USACE Erosion Survey		38.262510 °	38.262533 °	
			-121.589481 °	-121.591690 °	
DWR ID	DWR_RD0349_02_f_2014_3				
Action/Comments					
Inspector Comments: 2010 - Slumping sections on the lower bank, appears to be scouring around the trees. 2011 - Soil beach at toe. 2013: No observed changes. [2013 Site ID: STM_22-8_R]

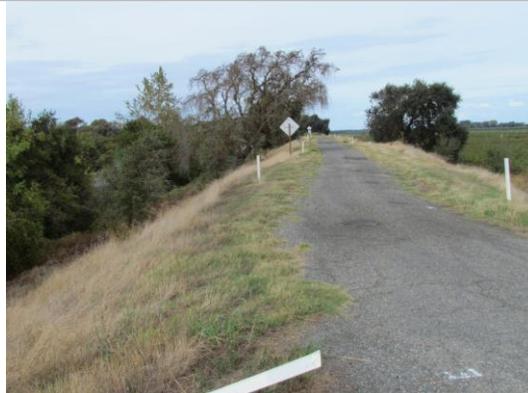
Photo 1 of 1 : FA\_2014\_RD0349\_206\_1\_20141112\_00035.jpg

Looking downstream from levee mile 0.00 waterside.

LM Start	<b>0.02</b>	Rating **	M	Issue No.	<b>1</b>
LM End	<b>0.02</b>	Issue Type +	Ma	Location *	WS
Category	Earthen Levee		GPS Latitude/Longitude		
			Start	End	
Item	Vegetation		38.255094 °	38.255108 °	
			-121.600101 °	-121.600095 °	
DWR ID	DWR_RD0349_03_s_2013_1				
Action/Comments					
Remove the wild growth other than native grasses from the levee slopes.
