**Flood Control Project Maintenance  
Levee Inspections**

**Fall 2015 Levee Maintenance Deficiency Summary Report  
Overall LMA & Unit Ratings, including USACE Erosion Survey**

**Reclamation District No. 0349 Sutter Island**

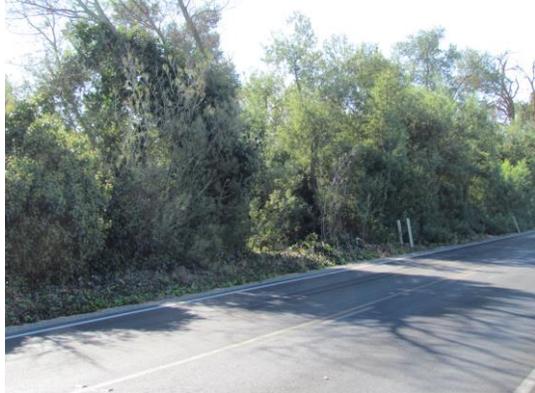
Photo 1 of 1 : FA\_2015\_RD0349\_204\_2\_20151012\_00010.jpg

LM Start	<b>0.01</b>	Rating **	U	Issue No.	<b>2</b>
LM End	<b>0.75</b>	Issue Type +	Ma	Location *	WS
Category	Earthen Levee		GPS Latitude/Longitude		
			Start	End	
Item	Vegetation		38.327037 °	38.316518 °	
			-121.576978 °	-121.579135 °	
DWR ID	DWR_RD0349_01_f_2014_2				
Action/Comments					
Remove the wild growth other than native grasses from the levee slopes. Inspector Comments: This wild growth needs to be removed from the waterward levee shoulder and slope.

Unsatisfactory woody tree growth on the water side levee shoulder and slope

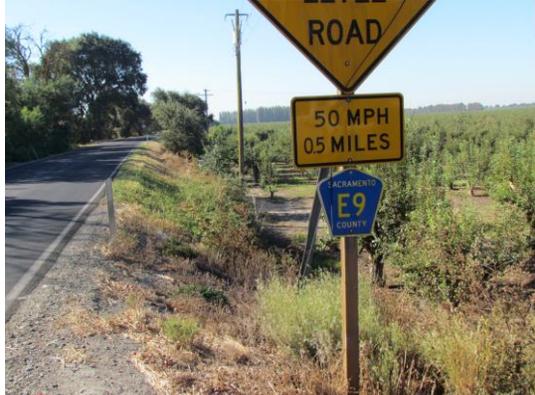
Photo 1 of 1 : FA\_2015\_RD0349\_204\_1\_20151012\_00011.jpg

LM Start	<b>0.01</b>	Rating **	U	Issue No.	<b>1</b>
LM End	<b>0.97</b>	Issue Type +	Ma	Location *	LS
Category	Earthen Levee		GPS Latitude/Longitude		
			Start	End	
Item	Vegetation		38.327037 °	38.313367 °	
			-121.576978 °	-121.578807 °	
DWR ID	DWR_RD0349_01_f_2014_1				
Action/Comments					
Remove the wild growth other than native grasses from the levee slopes. Inspector Comments: Tall weeds need to be removed from levee section.

Unsatisfactory growth of wild weeds present on the landside levee slope and toe.

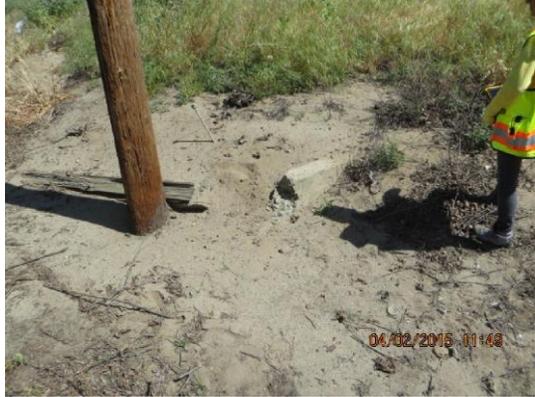
Photo 3 of 3 : UCIP\_FA\_2015\_5893.jpg

LM Start	<b>0.08</b>	Rating **	M	Issue No.	<b>22 (cont)</b>
LM End	<b>0.08</b>	Issue Type +	En	Location *	WS
Category	Supplemental			GPS Latitude/Longitude	
				Start	End
Item	DWR UCIP Field Study			38.326133 °	38.326133 °
				-121.577141 °	-121.577141 °
DWR ID					
Action/Comments					
Inspector Comments: FS_ID:44303 DS_ID:24137 EP_NO: N/A FS_HLM: 0.0621 Repair Type: Non-Urgent Crossing Status: Indicator Found

Deteriated concrete distribution box on LS toe next to power pole.

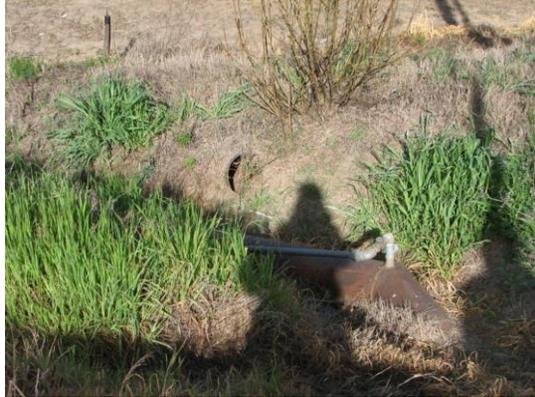
Photo 1 of 2 : UCIP\_FA\_2015\_0709.jpg

Item	DWR UCIP Field Study			38.320476 °	38.320476 °
				-121.578616 °	-121.578616 °
DWR ID					
Action/Comments					
Inspector Comments: FS_ID:39871 DS_ID:24139 EP_NO: N/A FS_HLM: 0.466 Repair Type: Urgent Crossing Status: Found UCIP Comments: Exposed section of levee slope on landward side--need to contact owner and DWR inspector. Burrow activity noticed at crossing 10 inch holes. Dense vegetation limits the inspector's visibility to identify signs of pipe failure (leaks) along the slope. Recommend removing vegetation along pipe alignment to conduct proper inspection of structure and appurtenances. Note date on photos should be 3/18/09 not 7/26/08 camera metadata is incorrect. FIELD_STRUCT_DESC: 8-inch steel pipe measured (instead of 10-inch) sleeved through a 12-inch steel pipe, 6.6 feet below the crown. Annular gap grouted at both ends. Active centrifugal pump on platform at landward toe. Inactive slant pump on steel platform on waterward slope. Exposed section pipe on waterward slope. Service pole on the landward slope. (USACE-1959). This entry matches the Drainage or Irrigation Structure referenced in O&M manual (HLM 0.5). 10-inch pipe sleeved through pre-existing pipe under Permit No. 3382 (1960). 12-inch pipe sleeved was authorized under Permint No. 951 in 1944. FS Date: 03/18/2009

View of pipe on landward side--open cut section.

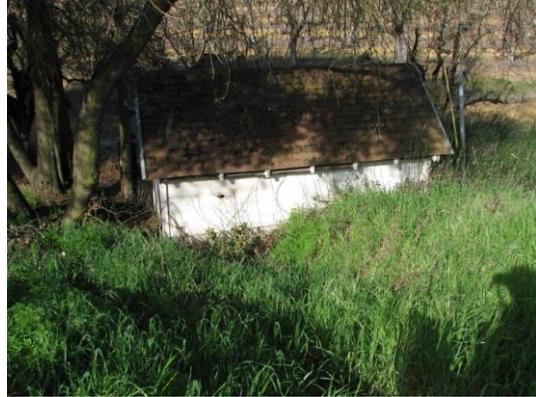
Photo 1 of 3 : UCIP\_FA\_2015\_0717.jpg

Inspector Comments: FS\_ID:21572  
 DS\_ID:24521  
 EP\_NO: N/A  
 FS\_HLM: 0.873  
 Repair Type: Non-Urgent  
 Crossing Status: Found  
 UCIP Comments: No records were found during intial desk study--need to contact owner to obtain permit number authorizing work. If crossing is no longer used by owner, the owner will need to coordinate with DWR Inspector and CVFPB to remove crossing according to Title 23 requirements. Dense vegetation limits the inspector's visibility to identify signs of pipe failure (leaks) along the slope. Recommend removing vegetation along pipe alignment to conduct proper inspection of structure and appurtenances. Note date on photos should be 3/18/09 not 7/26/08 camera metadata is incorrect.  
 FIELD\_STRUCT\_DESC: Abandoned 8-inch pipe through the levee, 13.9 feet below the crown. Pump on platform at landward toe. Service pole on landward slope.  
 FS Date: 03/18/2009

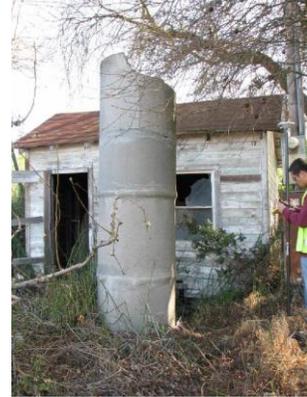
Photo 3 of 3 : UCIP\_FA\_2015\_0719.jpg

LM Start	0.88	Rating **	M	Issue No.	24 (cont)
LM End	0.88	Issue Type +	En	Location *	WS
Category	Supplemental			GPS Latitude/Longitude	
				Start	End
Item	DWR UCIP Field Study			38.314672 °	38.314672 °
DWR ID				-121.579102 °	-121.579102 °
Action/Comments					
Inspector Comments: FS_ID:21572 DS_ID:24521 EP_NO: N/A FS_HLM: 0.873 Repair Type: Non-Urgent Crossing Status: Found UCIP Comments: No records were found during intial desk study--need to contact owner to obtain permit number authorizing work. If crossing is no longer used by owner, the owner will need to coordinate with DWR Inspector and CVFPB to remove crossing according to Title 23 requirements. Dense vegetation limits the inspector's visibility to identify signs of pipe failure (leaks) along the slope. Recommend removing vegetation along pipe alignment to conduct proper inspection of structure and appurtenances. Note date on photos should be 3/18/09 not 7/26/08 camera metadata is incorrect. FIELD_STRUCT_DESC: Abandoned 8-inch pipe through the levee, 13.9 feet below the crown. Pump on platform at landward toe. Service pole on landward slope. FS Date: 03/18/2009

View of pump house, concrete stand pipe, and utility pole.

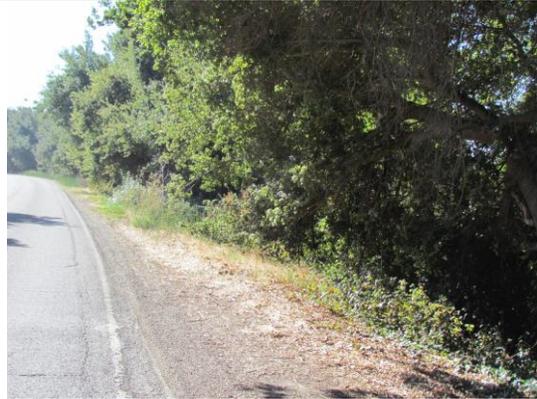
Photo 1 of 1 : FA\_2015\_RD0349\_204\_5\_20151012\_00016.jpg

LM Start	<b>1.11</b>	Rating **	U	Issue No.	<b>5</b>
LM End	<b>1.27</b>	Issue Type +	Ma	Location *	LS
Category	Earthen Levee			GPS Latitude/Longitude	
				Start	End
Item	Vegetation			38.311360 °	38.309287 °
				-121.578240 °	-121.577065 °
DWR ID	DWR_RD0349_01_f_2015_5				
Action/Comments					
Remove the wild growth other than native grasses from the levee slopes. Inspector Comments: The woody tree growth need to be removed and or thinned so the levee can be inspected.

Unsatisfactory woody tree growth blocking view of levee slope.

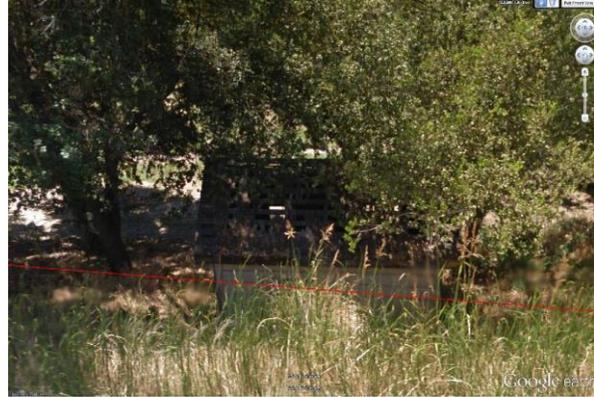
Photo 2 of 3 : UCIP\_FA\_2015\_5894.jpg

Pumphouse on LS toe (From google view)

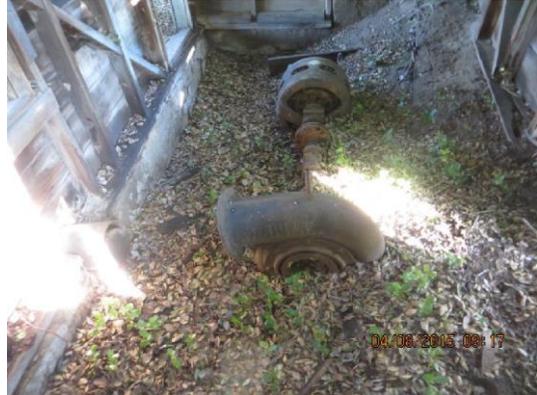
Photo 3 of 3 : UCIP\_FA\_2015\_5895.jpg

Pump and motor inside pumphouse at LS toe. No pipe visible.

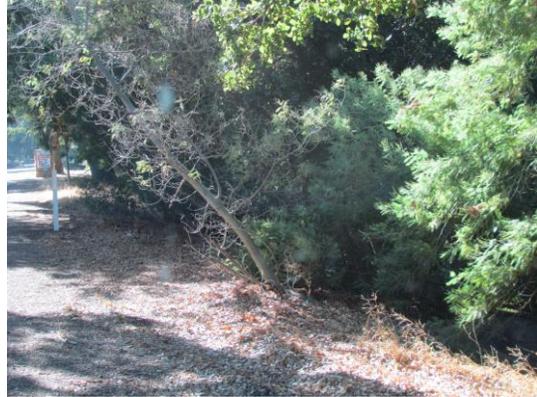
Photo 1 of 1 : FA\_2015\_RD0349\_204\_6\_20151012\_00015.jpg

LM Start	<b>1.38</b>	Rating **	U	Issue No.	<b>6</b>
LM End	<b>1.41</b>	Issue Type +	Ma	Location *	LS
Category	Earthen Levee		GPS Latitude/Longitude		
			Start	End	
Item	Vegetation		38.307880 °	38.307453 °	
			-121.576068 °	-121.575735 °	
DWR ID	DWR_RD0349_01_f_2015_6				
Action/Comments					
Remove the wild growth other than native grasses from the levee slopes. Inspector Comments: Remove the woody tree growth from the landside levee slope and toe.

Unsatisfactory woody tree growth on the landside levee slope.

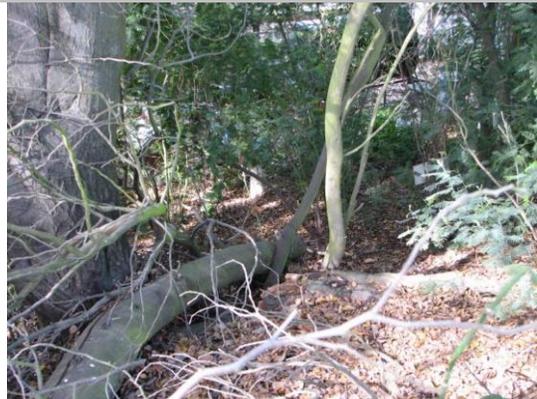
Photo 3 of 3 : UCIP\_FA\_2015\_0716.jpg

View of landward side.

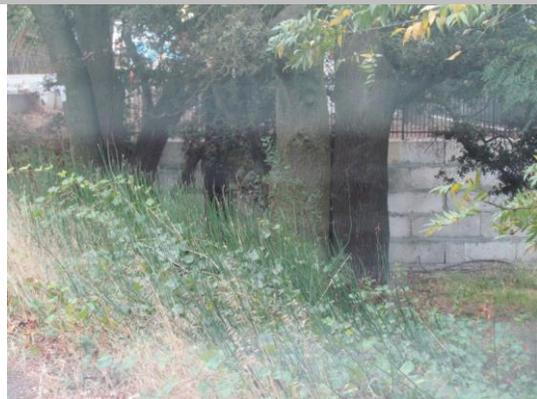
Photo 1 of 1 : FA\_2015\_RD0349\_204\_12\_20150915\_00004.jpg

LM Start	<b>1.54</b>	Rating **	U	Issue No.	<b>12</b>
LM End	<b>1.54</b>	Issue Type +	En	Location *	LS
Category	Earthen Levee		GPS Latitude/Longitude		
			Start	End	
Item	Encroachments		38.305722 °	38.305722 °	
			-121.574695 °	-121.574695 °	
DWR ID	DWR_RD0349_01_f_2014_12				
Action/Comments					
Retaining Wall Inspector Comments: This issue is under review with the CVFPB.

Looking downstream at levee mile 1.55 unauthorized block wall placed on landward levee section, no CVFPB Permit.

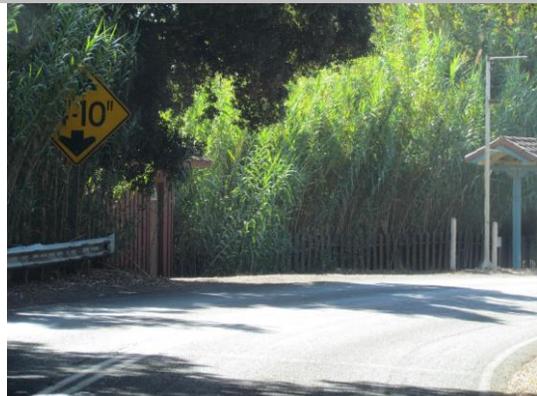
Photo 1 of 1 : FA\_2015\_RD0349\_204\_13\_20151012\_00014.jpg

LM Start	<b>1.56</b>	Rating **	U	Issue No.	<b>13</b>
LM End	<b>1.58</b>	Issue Type +	Ma	Location *	WS
Category	Earthen Levee		GPS Latitude/Longitude		
			Start	End	
Item	Vegetation		38.305450 °	38.305162 °	
			-121.574687 °	-121.574750 °	
DWR ID	DWR_RD0349_01_f_2014_13				
Action/Comments					
Remove the wild growth other than native grasses from the levee slopes. Inspector Comments: This Arundo present on the waterward section is blocking the view of the levee section.

Unsatisfactory arundo completely covering the waterside shoulder and slope.

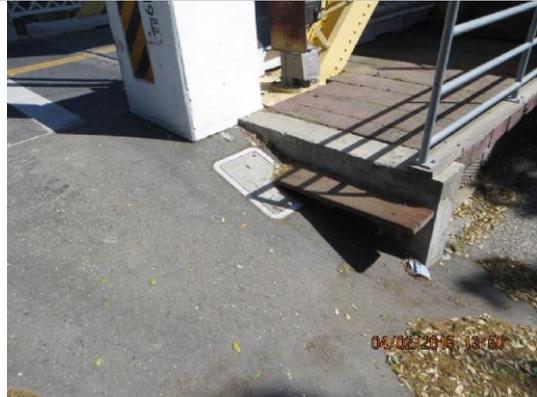
Photo 2 of 3 : UCIP\_FA\_2015\_5976.jpg

Christy box on WS shoulder.

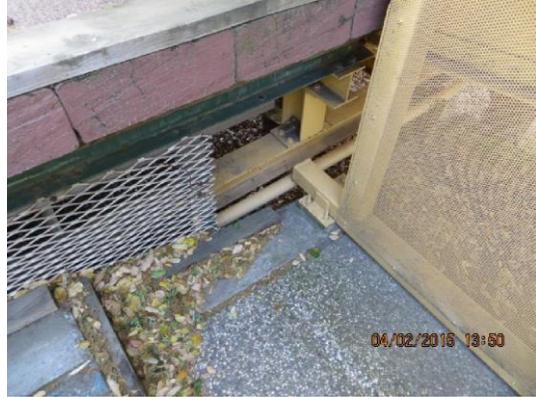
Photo 3 of 3 : UCIP\_FA\_2015\_5977.jpg

Pipe visible next to bridge on WS shoulder.

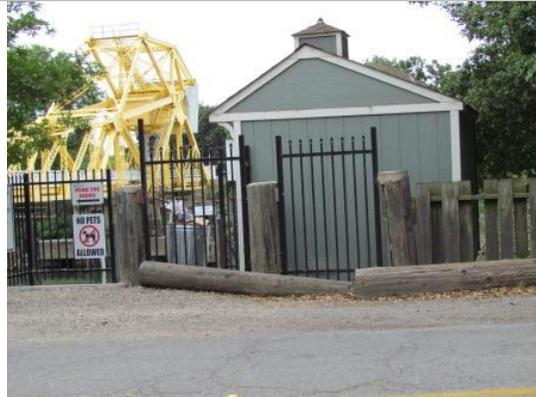
Photo 1 of 2 : FA\_2015\_RD0349\_205\_4\_20150915\_00005.jpg

LM Start	<b>0.01</b>	Rating **	U	Issue No.	<b>4</b>
LM End	<b>0.01</b>	Issue Type +	En	Location *	WS
Category	Earthen Levee			GPS Latitude/Longitude	
				Start	End
Item	Encroachments			38.304870 °	38.304870 °
				121.574730 °	121.574730 °
DWR ID	DWR_RD0349_02_s_2012_4				
Action/Comments					
Building Inspector Comments: This encroachment is along the waterward shoulder and was not authorized by the CVFPB. There are multiple encroachments at this site. Owner was working with CVFPB to get permits as of 11-2013. This issue is still pending as of 2014.

Unauthorized building waterside shoulder; Unit 2 Sutter Slough.

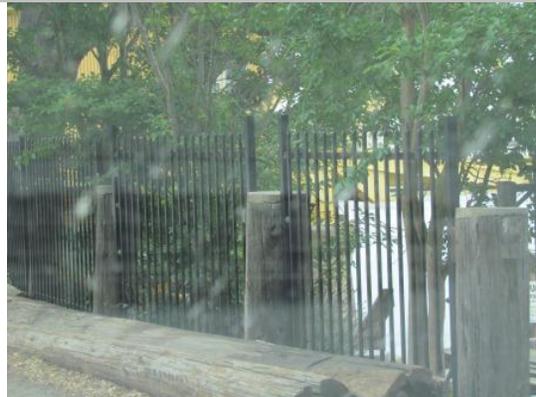
Photo 2 of 2 : FA\_2015\_RD0349\_205\_4\_20150915\_00007.jpg

Unauthorized fence adjacent to building waterside Sutter Slough.

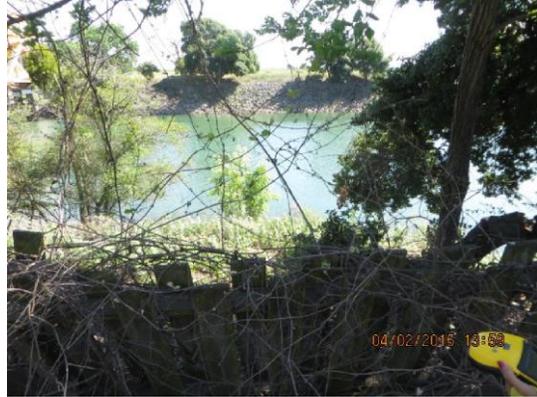
Photo 2 of 3 : UCIP\_FA\_2015\_5979.jpg

Fence on WS shoulder.

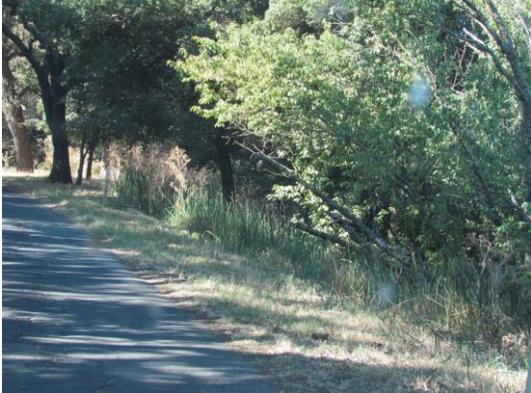
Photo 1 of 1 : FA\_2015\_RD0349\_205\_52\_20151012\_00051.jpg

LM Start	<b>0.05</b>	Rating **	U	Issue No.	<b>52</b>
LM End	<b>0.20</b>	Issue Type +	Ma	Location *	LS
Category	Earthen Levee			GPS Latitude/Longitude	
				Start	End
Item	Vegetation			38.304853 °	38.303738 °
				-121.575475 °	-121.577828 °
DWR ID	DWR_RD0349_02_f_2015_52				
Action/Comments					
Control annual grass and weeds on the levee slopes and easements. Inspector Comments: Mow the slope to remove the tall weeds and vegetation from the levee slope.

Looking downstream from landside shoulder at tall snapgrass and other vegetation on slope.

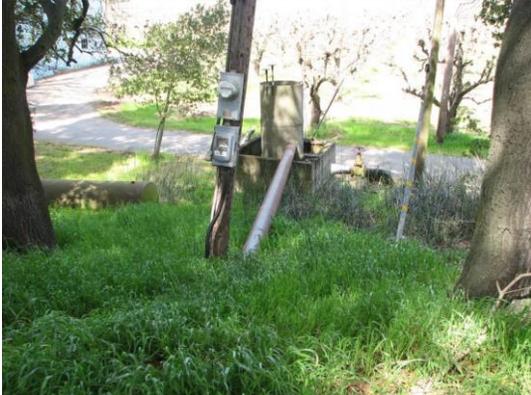
Photo 1 of 3 : UCIP\_FA\_2015\_0740.jpg

Item	DWR UCIP Field Study			38.304606 °	38.304606 °
				-121.576323 °	-121.576323 °
DWR ID					
Action/Comments					
Inspector Comments: FS_ID:21576 DS_ID:24145 EP_NO: N/A FS_HLM: 0.096 Repair Type: Non-Urgent Crossing Status: Found UCIP Comments: No connection present--need to contact owner to determine if owner plans to use. If crossing is no longer in use owner will need to coordinate with DWR inspector and CVFPB to remove according to Title 23 requirements. Dense vegetation limits the inspector's visibility to identify signs of pipe failure (leaks) along the slope. Recommend removing vegetation along pipe alignment to conduct proper inspection of structure and appurtenances. Unable to determine if crossing is in use. Note date on photos should be 3/18/09 not 7/26/08 camera metadata is incorrect. FIELD_STRUCT_DESC: Abandoned 10-inch pipe through the levee, 6.0 feet below the crown. Pump and slide gate on the waterward slope. Concrete pipe riser and distribution box at the landward toe. Service pole and anchor on the landward slope. FS Date: 03/18/2009

Multiple appurtenances found on landward side-standpipe, electrical pole, valve, concrete distribution box.

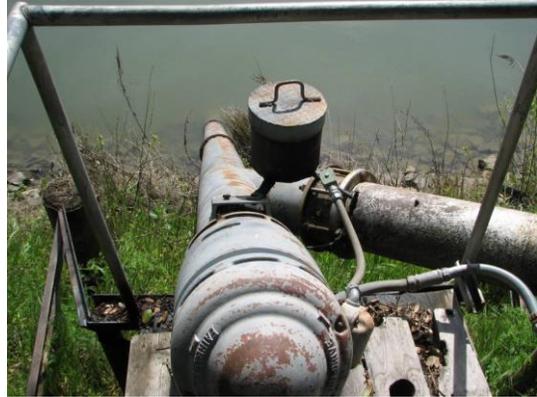
Photo 1 of 3 : UCIP\_FA\_2015\_2410.jpg

Item	DWR UCIP Field Study			38.304606 °	38.304606 °
				-121.576323 °	-121.576323 °
DWR ID					
Action/Comments					
Inspector Comments: FS_ID:21577 DS_ID:24146 EP_NO: 2480 FS_HLM: 0.096 Repair Type: Non-Urgent Crossing Status: Found UCIP Comments: Dense vegetation limits the inspector's visibility to identify signs of pipe failure (leaks) along the landward slope. Recommend removing vegetation along pipe alignment to conduct proper inspection of structure and appurtenances. Unable to determine if crossing is in use. Note date on photos should be 3/18/09 not 7/26/08 camera metadata is incorrect. FIELD_STRUCT_DESC: 10-inch steel pipe through the levee, 6.0 feet below the crown. Pump and slide gate on the waterward slope. Concrete pipe riser and distribution box with gate valve at the landward toe. Service pole and anchor on the landward slope. (Permit No. 2480-1959) FS Date: 03/18/2009

View of waterward side--pump and raised platform.

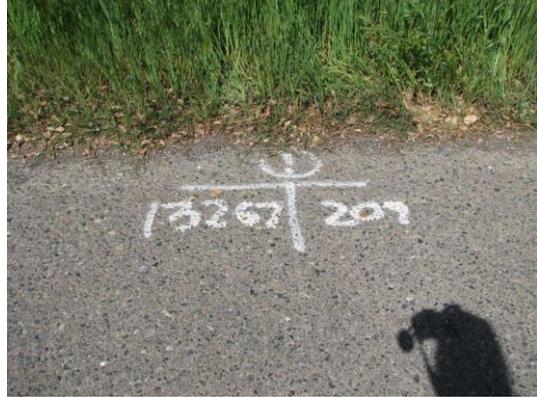
Photo 1 of 2 : UCIP\_FA\_2015\_2520.jpg

Item	DWR UCIP Field Study			38.304345 °	38.304345 °
				-121.576824 °	-121.576824 °
DWR ID					
Action/Comments					
Inspector Comments: FS_ID:21613 DS_ID:24147 EP_NO: N/A FS_HLM: 0.129 Repair Type: Non-Urgent Crossing Status: Found UCIP Comments: Dense vegetation limits the inspector's visibility to identify signs of pipe failure (leaks) along the slope. Recommend removing vegetation along pipe alignment to conduct proper inspection of structure and appurtenances. Note date on photos should be 3/18/09 not 7/26/08 camera metadata is incorrect. FIELD_STRUCT_DESC: 3-inch pipe through the levee, 3.3 feet below the crown. Gate valve on landward side. (USACE-1959). This entry matches the Drainage or Irrigation Structure referenced in O&M manual (HLM 0.1). FS Date: 03/18/2009

Underground service alert (USA) marking on levee crown.

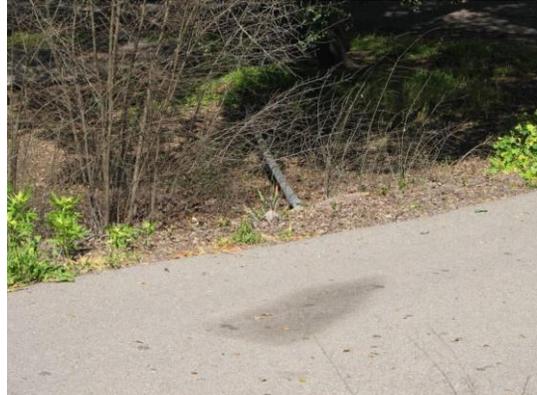
Photo 2 of 2 : UCIP\_FA\_2015\_2521.jpg

View of crossing on landward side.

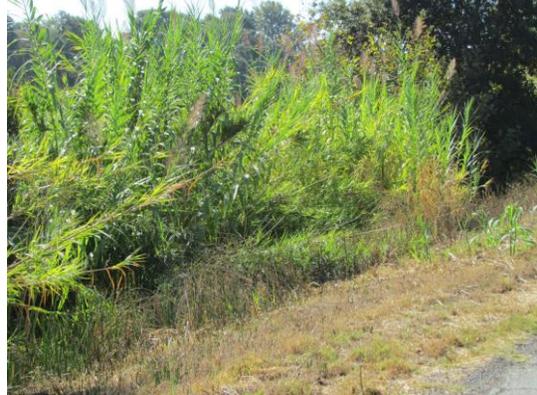
Photo 1 of 1 : FA\_2015\_RD0349\_205\_68\_20151012\_00054.jpg

Landside levee slope and toe covered with arundo.

LM Start	<b>0.27</b>	Rating **	U	Issue No.	<b>68</b>
LM End	<b>0.51</b>	Issue Type +	Ma	Location *	LS
Category	Earthen Levee		GPS Latitude/Longitude		
			Start	End	
Item	Vegetation		38.303122 °	38.300208 °	
			-121.579010 °	-121.580965 °	
DWR ID	DWR_RD0349_02_f_2015_68				
Action/Comments					
Control annual grass and weeds on the levee slopes and easements. Inspector Comments: Remove the arundo from the landside slope and toe.

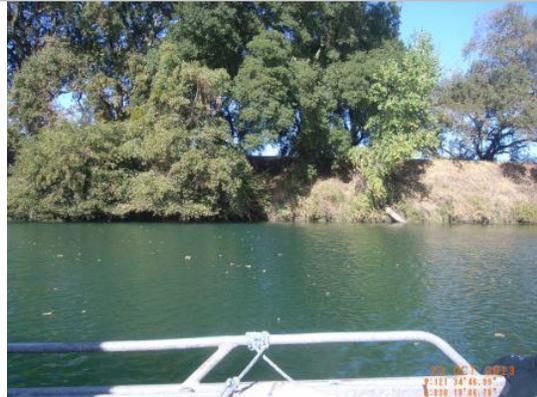
Photo 1 of 1 : USACE2013A\_STM\_25-8\_R\_2.jpg

LM Start	0.34	Rating **	M	Issue No.	9
LM End	0.39	Issue Type +	Ma	Location *	WS
Category	Supplemental			GPS Latitude/Longitude	
	Start		End		
Item	2015 USACE Erosion Survey, DRAFT			38.302358 °	38.301772 °
				-121.579707 °	-121.580093 °
DWR ID					
Action/Comments					
Inspector Comments: 2007 - Slow erosion, probably due to wave wash and fluvial erosion. Site has likely been here for awhile but was unseen due to boats parked in front. 2015: Large tree popout, scarp reaches crown of levee. [2015 Site ID: STM_25-8_R]

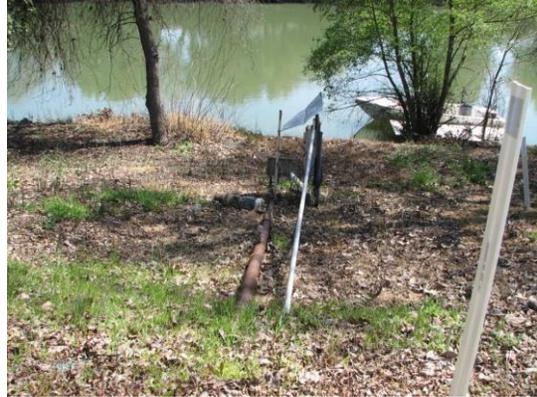
Photo 1 of 3 : UCIP\_FA\_2015\_0706.jpg

Item	DWR UCIP Field Study			38.299353 °	38.299353 °
				-121.581525 °	-121.581525 °
DWR ID					
Action/Comments					
Inspector Comments: FS_ID:21615 DS_ID:24149 EP_NO: N/A FS_HLM: 0.577 Repair Type: Non-Urgent Crossing Status: Found UCIP Comments: Need to contact owner (Permit No. 3678) to determine if crossing is still in use. If crossing is not in use will need to coordinate with DWR Inspector and CVFPB to remove pipe according to Title 23 requirements. Note date on photos should be 3/18/09 not 7/26/08 camera metadata is incorrect. FIELD_STRUCT_DESC: 6-inch irrigation pipe through the levee, 2.5 feet below the crown. Pump on waterward slope. Service pole at landward shoulder. 3-inch conduit through levee to service pump. (USACE-1959). This entry matches the Drainage or Irrigation Structure referenced in O&M manual (HLM 0.6). Pump replaced and placed on concrete pad on waterward slope under Permit No. 3678 (1961). FS Date: 03/18/2009

View of pipe and pump on waterward side.

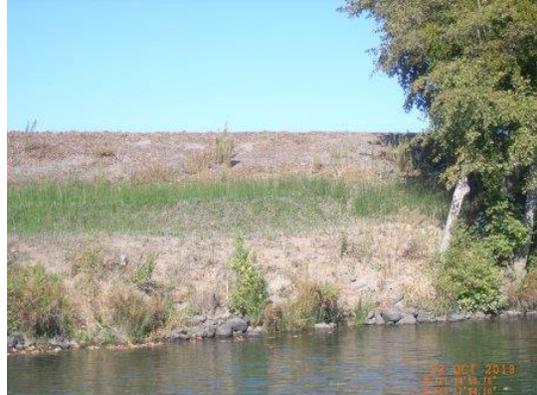
Photo 1 of 1 : USACE2013A\_STM\_25-5\_R\_7.jpg

LM Start	0.60	Rating **	M	Issue No.	13
LM End	0.72	Issue Type +	Ma	Location *	WS
Category	Supplemental			GPS Latitude/Longitude	
			Start	End	
Item	2015 USACE Erosion Survey, DRAFT			38.298897 °	38.297384 °
				-121.581571 °	-121.582176 °
DWR ID					
Action/Comments					
Inspector Comments: 2010 - Small maintenance, erosion into the toe. 2011 - Minor new erosion at toe. 2015: Minor new erosion at toe, new tree popout. [2015 Site ID: STM_25-5_R]

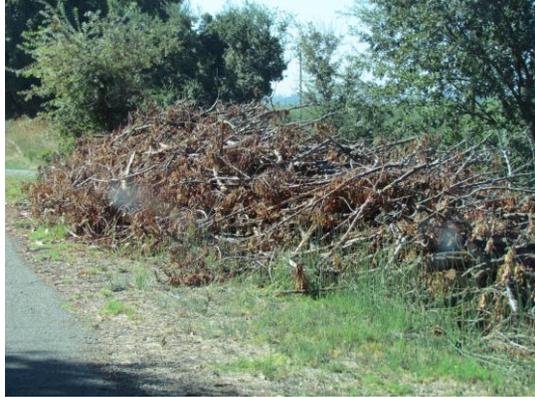
Photo 1 of 1 : FA\_2015\_RD0349\_205\_79\_20151012\_00055.jpg

Under the brush pile is some erosion along the landside slope.

LM Start	<b>1.00</b>	Rating **	U	Issue No.	<b>79</b>
LM End	<b>1.06</b>	Issue Type +	Ma	Location *	LS
Category	Earthen Levee		GPS Latitude/Longitude		
			Start	End	
Item	Slope Stability		38.293383 °	38.292592 °	
			-121.583570 °	-121.583861 °	
DWR ID	DWR_RD0349_02_s_2014_79				
Action/Comments					
Repair slope instability. Inspector Comments: There is some erosion present under this brush pile The district needs to bring in some material to make repairs as needed.

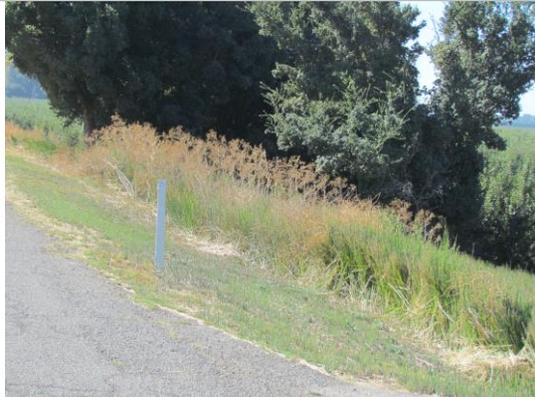
Photo 1 of 1 : FA\_2015\_RD0349\_205\_14\_20151012\_00060.jpg

Looking downstream from levee mile 1.07 to 1.30 snap grasses covering landward slope.

LM Start	<b>1.07</b>	Rating **	U	Issue No.	<b>14</b>
LM End	<b>1.30</b>	Issue Type +	Ma	Location *	LS
Category	Earthen Levee		GPS Latitude/Longitude		
			Start	End	
Item	Vegetation		38.292457 °	38.289063 °	
			-121.583898 °	-121.584057 °	
DWR ID	DWR_RD0349_02_f_2015_14				
Action/Comments					
Control annual grass and weeds on the levee slopes and easements. Inspector Comments: Remove the snap grass from the landward slope.

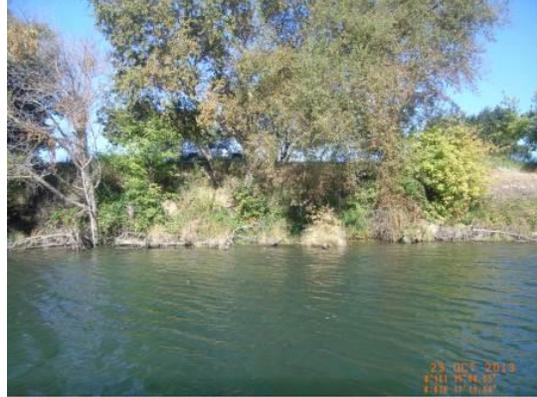
Photo 1 of 1 : USACE2013A\_STM\_24-7\_R\_2.jpg

Item	2015 USACE Erosion Survey, DRAFT			38.288727 °	38.286475 °
				-121.583823 °	-121.585026 °
DWR ID					
Action/Comments					
Inspector Comments: 1997 - Erosion of very sandy levee behind large stand of riparian vegetation on top right bank. Dry ravel of sand. 1999 - Quarry waste rock was dumped down the levee slope; poor repair job; still eroding in places. Eroding at midslope off fabric. 2005 - Length revised, only the middle 150 - 200 ft are eroding. 2006 - Some rock/small material dumped down the bank but it is slowly unraveling. Upstream end is unraveling faster. Steep slope with poor gradation so fines are washing out. 2010 - Lots of overhanging trees and erosion pockets. 2011 - This site is upgraded to CRITICAL. Near vertical bank at the downstream end. New erosion at various locations throughout the site. 2015: No observed changes. [2015 Site ID: STM_24-7_R]

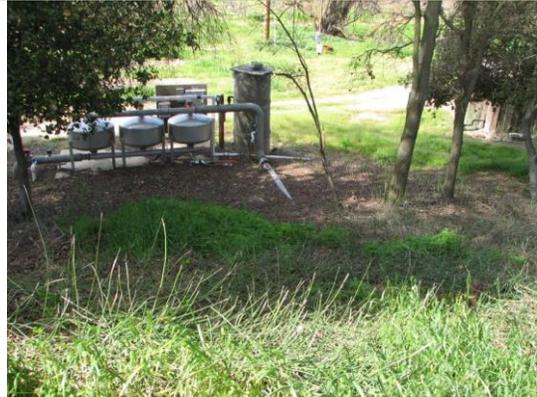
Photo 1 of 3 : UCIP\_FA\_2015\_2498.jpg

Item	DWR UCIP Field Study			38.285573 °	38.285573 °
				-121.586986 °	-121.586986 °
DWR ID					
Action/Comments					
Inspector Comments: FS_ID:21607 DS_ID:24155 EP_NO: 1116 FS_HLM: 1.627 Repair Type: Non-Urgent Crossing Status: Found UCIP Comments: Dense vegetation limits the inspector's visibility to identify signs of pipe failure (leaks) along the landward slope. Recommend removing vegetation along pipe alignment to conduct proper inspection of structure and appurtenances. Note date on photos should be 3/18/09 not 7/26/08 camera metadata is incorrect. FIELD_STRUCT_DESC: 8-inch steel irrigation pipe through the levee, 4.7 feet below the crown. Two concrete cutoff walls under each shoulder. Pressure breaker in concrete riser at levee shoulder. Pump on waterward side. (USACE-1959). This entry matches the Drainage or Irrigation Structure referenced in O&M manual (HLM 1.7). Pipe reconstructed under Permit No. 1116 (1974). FS Date: 03/18/2009

Filter system, control panel, and stand pipe located at the landward toe.

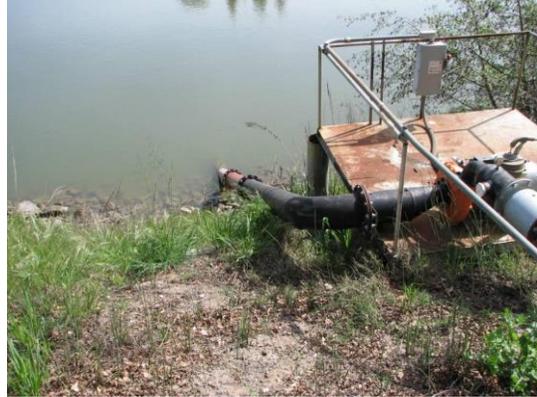
Photo 2 of 3 : UCIP\_FA\_2015\_2499.jpg

Pipe at the waterward toe.

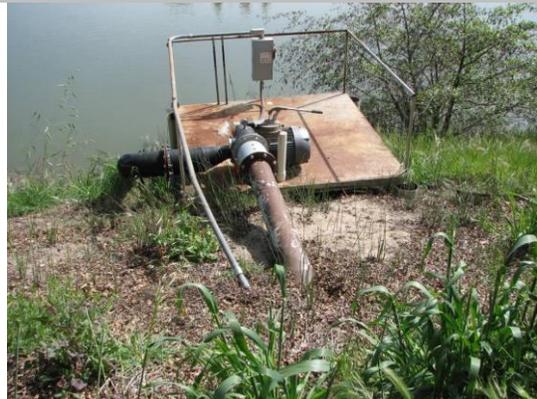
Photo 3 of 3 : UCIP\_FA\_2015\_2500.jpg

View of waterward side.

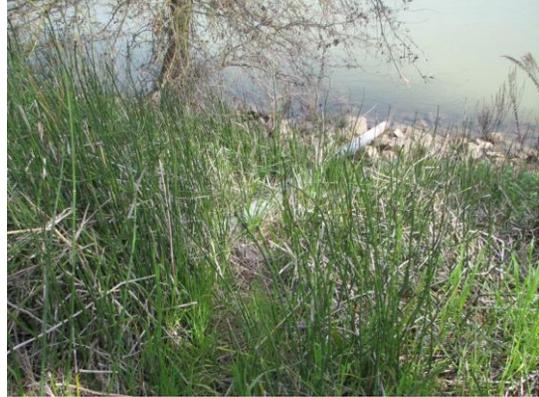
Photo 1 of 3 : UCIP\_FA\_2015\_2501.jpg

LM Start	<b>1.82</b>	Rating **	M	Issue No.	<b>97</b>
LM End	<b>1.82</b>	Issue Type +	En	Location *	LS
Category	Supplemental			GPS Latitude/Longitude	
				Start	End
Item	DWR UCIP Field Study			38.283238 °	38.283238 °
				-121.589337 °	-121.589337 °
DWR ID					
<b>Action/Comments</b>					
Inspector Comments: FS_ID:21608 DS_ID:24156 EP_NO: N/A FS_HLM: 1.836 Repair Type: Non-Urgent Crossing Status: Found

View of pipe on waterward slope.

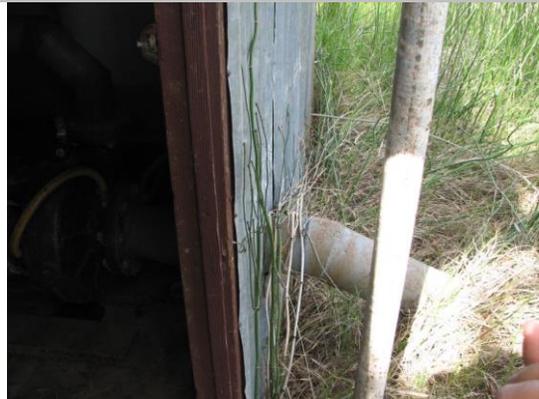
Photo 2 of 3 : UCIP\_FA\_2015\_2502.jpg

View of pipe daylight at shed on waterward side.

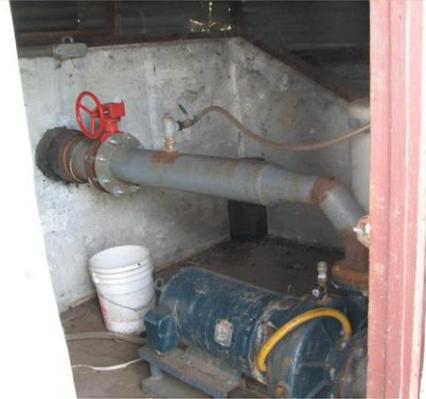
Photo 3 of 3 : UCIP\_FA\_2015\_2503.jpg

View inside pump house of pipe crossing coming out of levee.

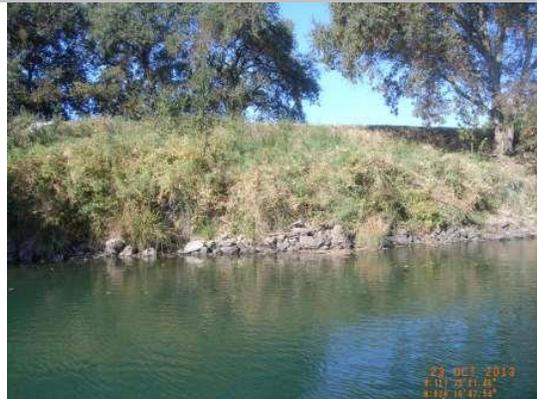
Photo 1 of 1 : USACE2013A\_STM\_24-1\_R\_1.jpg

LM Start	<b>2.04</b>	Rating **	M	Issue No.	<b>19</b>
LM End	<b>2.05</b>	Issue Type +	Ma	Location *	WS
Category	Supplemental			GPS Latitude/Longitude	
				Start	End
Item	2015 USACE Erosion Survey, DRAFT			38.280069 °	38.279919 °
				-121.589443 °	-121.589438 °
DWR ID					
Action/Comments					
Inspector Comments: 2011 - Small scallop caused by erosion and wave wash. 2015: No observed changes. [2015 Site ID: STM_24-1_R]

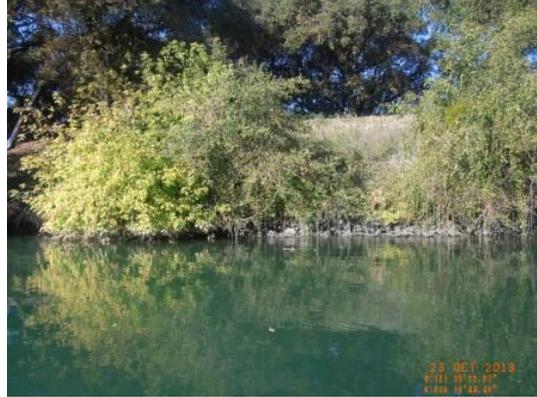
Photo 1 of 1 : USACE2013A\_STM\_23-9\_R\_5.jpg

LM Start	<b>2.11</b>	Rating **	M	Issue No.	<b>16</b>
LM End	<b>2.14</b>	Issue Type +	Ma	Location *	WS
Category	Supplemental			GPS Latitude/Longitude	
				Start	End
Item	2015 USACE Erosion Survey, DRAFT			38.279017 °	38.278597 °
				-121.589615 °	-121.589854 °
DWR ID					
<b>Action/Comments</b>					
Inspector Comments: 1997 - Top right bank has retreated into the levee. Site is between two rock sites. 1999 - Downstream half of the reach repaired with rock. 2000 - Trees leaning into the water. 2010 - Site appears worse. 2011 - New erosion at the toe. 2013 - Short vertical sections observed at upstream end. 2015: Minor new erosion. [2015 Site ID: STM_23-9_R]

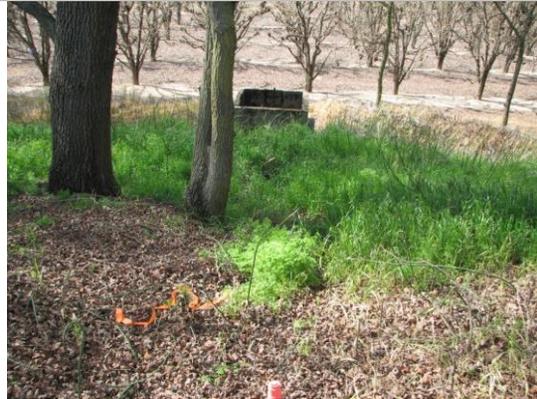
Photo 1 of 3 : UCIP\_FA\_2015\_2510.jpg

Item	DWR UCIP Field Study			38.278682 °	38.278682 °
				-121.590104 °	-121.590104 °
DWR ID					
<b>Action/Comments</b>					
Inspector Comments: FS_ID:21609 DS_ID:24157 EP_NO: N/A FS_HLM: 2.159 Repair Type: Non-Urgent Crossing Status: Found UCIP Comments: Debris scattered--need to contact owner. If crossing is not in used will need to coordinate with DWR Inspector and CVFPB to remove per Title 23 requirements. Dense vegetation limits the inspector's visibility to identify signs of pipe failure (leaks) along the slope. Recommend removing vegetation along pipe alignment to conduct proper inspection of structure and appurtenances. Note date on photos should be 3/18/09 not 7/26/08 camera metadata is incorrect. FIELD_STRUCT_DESC: 8-inch pipe sleeved through 12-inch pipe through the levee, 4.0 feet below the crown. Annular gap not grouted. Service pole on the waterward shoulder. Pump on the waterward side. Concrete distribution box at landward toe. (USACE-1959). This entry matches the Drainage or Irrigation Structure referenced in O&M manual (HLM 2.3). FS Date: 03/18/2009

Overview of landward side--distribution box located at toe.

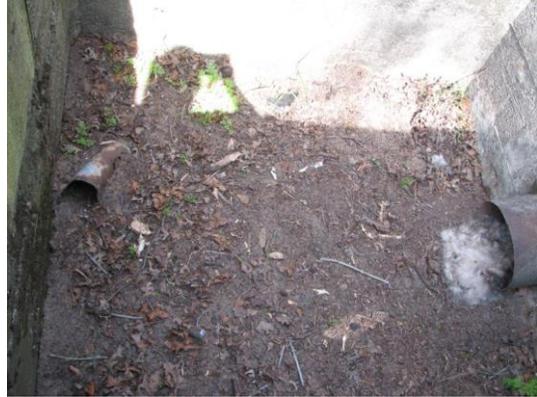
Photo 3 of 3 : UCIP\_FA\_2015\_2512.jpg

LM Start	2.14	Rating **	M	Issue No.	98 (cont)
LM End	2.14	Issue Type +	En	Location *	WS
Category	Supplemental			GPS Latitude/Longitude	
				Start	End
Item	DWR UCIP Field Study			38.278682 °	38.278682 °
DWR ID				-121.590104 °	-121.590104 °
Action/Comments					
Inspector Comments: FS_ID:21609 DS_ID:24157 EP_NO: N/A FS_HLM: 2.159 Repair Type: Non-Urgent Crossing Status: Found UCIP Comments: Debris scattered--need to contact owner. If crossing is not in used will need to coordinate with DWR Inspector and CVFPB to remove per Title 23 requirements. Dense vegetation limits the inspector's visibility to identify signs of pipe failure (leaks) along the slope. Recommend removing vegetation along pipe alignment to conduct proper inspection of structure and appurtenances. Note date on photos should be 3/18/09 not 7/26/08 camera metadata is incorrect. FIELD_STRUCT_DESC: 8-inch pipe sleeved through 12-inch pipe through the levee, 4.0 feet below the crown. Annular gap not grouted. Service pole on the waterward shoulder. Pump on the waterward side. Concrete distribution box at landward toe. (USACE-1959). This entry matches the Drainage or Irrigation Structure referenced in O&M manual (HLM 2.3). FS Date: 03/18/2009

Inside view of distribution box located on landward side.

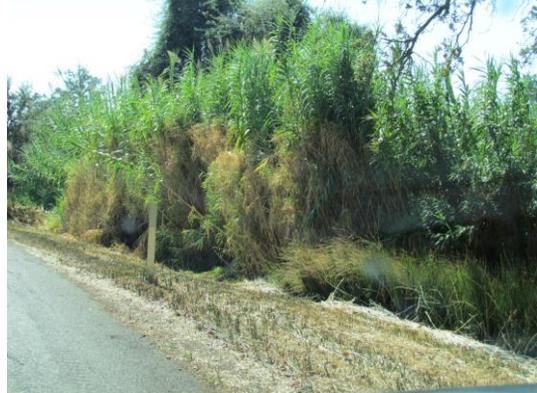
Photo 1 of 1 : FA\_2015\_RD0349\_205\_75\_20151012\_00053.jpg

Looking downstream from levee mile 2.37-2.40 arundo has completely covered the landward levee section

LM Start	<b>2.37</b>	Rating **	U	Issue No.	<b>75</b>
LM End	<b>2.40</b>	Issue Type +	Ma	Location *	LS
Category	Earthen Levee			GPS Latitude/Longitude	
				Start	End
Item	Vegetation			38.275708 °	38.275345 °
				-121.591382 °	-121.591130 °
DWR ID	DWR_RD0349_02_f_2015_75				
Action/Comments					
Remove the wild growth other than native grasses from the levee slopes. Inspector Comments: Remove this section of arundo from the levee slope and shoulder.

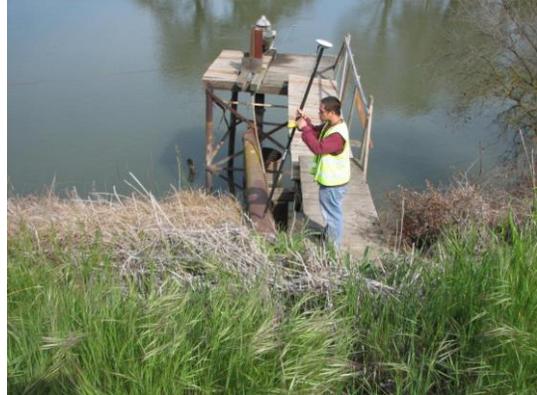
Photo 1 of 2 : UCIP\_FA\_2015\_2513.jpg

Item	DWR UCIP Field Study			38.275493 °	38.275493 °
				-121.591208 °	-121.591208 °
DWR ID					
Action/Comments					
Inspector Comments: FS_ID:39873 DS_ID:24158 EP_NO: N/A FS_HLM: 2.401 Repair Type: Non-Urgent Crossing Status: Found UCIP Comments: Dense vegetation limit the inspector's visibility to identify signs of pipe failure (leaks) through the levee slopes. Recommend removing vegetation along pipe alignment to conduct proper inspection of structure and appurtenances. FIELD_STRUCT_DESC: 12-inch pipe through the levee, 4.0 feet below the crown. Pump on pile structure on waterward side, walkway to pump. Concrete distribution box and power pole with anchor at landward toe. Concrete standpipe on landward side. (Permit No. 946, 1944). This entry matches the Drainage or Irrigation Structure referenced in O&M manual (HLM 2.5). FS Date: 03/18/2009

Overview of waterward side--dense vegetation limits slope inspection.

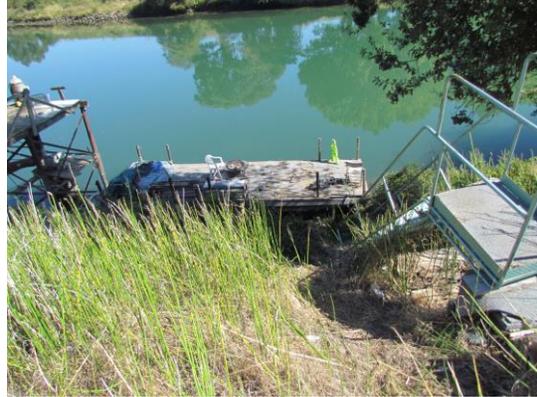
Photo 2 of 2 : FA\_2015\_RD0349\_205\_1\_20151012\_00059.jpg

LM Start	<b>2.39</b>	Rating **	U	Issue No.	<b>1 (cont)</b>
LM End	<b>2.39</b>	Issue Type +	Ma	Location *	WS
Category	Earthen Levee			GPS Latitude/Longitude	
				Start	End
Item	Encroachments			38.275403 °	38.275403 °
				-121.591229 °	-121.591229 °
DWR ID	DWR_RD0349_02_f_2013_1				
Action/Comments					
Stairway Inspector Comments: The landowner has installed steps on the waterside slope and has an unauthorized boat dock anchored to the waterside slope.

Unauthorized boat dock remains on the waterward toe.

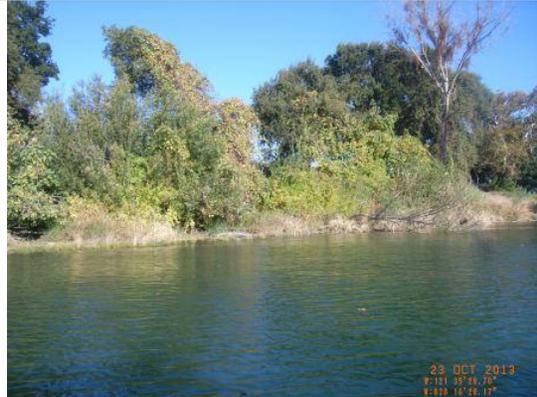
Photo 1 of 2 : USACE2013A\_STM\_23-6\_R\_4.jpg

LM Start	<b>2.56</b>	Rating **	M	Issue No.	<b>3</b>
LM End	<b>2.69</b>	Issue Type +	Ma	Location *	WS
Category	Supplemental			GPS Latitude/Longitude	
				Start	End
Item	2015 USACE Erosion Survey, DRAFT			38.273854 °	38.271998 °
				-121.588745 °	-121.589424 °
DWR ID					
Action/Comments					
Inspector Comments: 2011 - Toe scour at the tidal zone. 2015: New tree popout and minor new erosion. [2015 Site ID: STM_23-6_R]

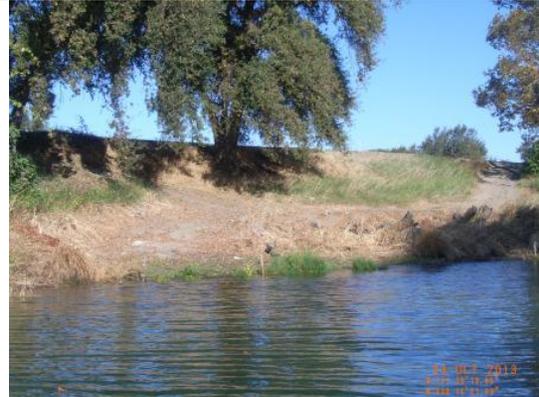
Photo 2 of 2 : USACE2013A\_STM\_23-6\_R\_5.jpg

LM Start	<b>2.56</b>	Rating **	M	Issue No.	<b>3 (cont)</b>
LM End	<b>2.69</b>	Issue Type +	Ma	Location *	WS
Category	Supplemental			GPS Latitude/Longitude	
				Start	End
Item	2015 USACE Erosion Survey, DRAFT			38.273854 °	38.271998 °
				-121.588745 °	-121.589424 °
DWR ID					
<b>Action/Comments</b>					
Inspector Comments: 2011 - Toe scour at the tidal zone. 2015: New tree popout and minor new erosion. [2015 Site ID: STM_23-6_R]

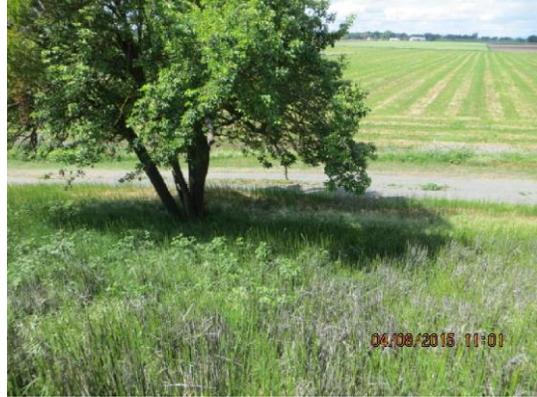
Photo 1 of 3 : UCIP\_FA\_2015\_5903.jpg

LM Start	<b>2.93</b>	Rating **	M	Issue No.	<b>100</b>
LM End	<b>2.93</b>	Issue Type +	En	Location *	WS
Category	Supplemental			GPS Latitude/Longitude	
				Start	End
Item	DWR UCIP Field Study			38.268674 °	38.268674 °
				-121.589419 °	-121.589419 °
DWR ID					
Action/Comments					
Inspector Comments: FS_ID:44328 DS_ID:24159 EP_NO: N/A FS_HLM: 2.947 Repair Type: Non-Urgent Crossing Status: Found UCIP Comments: Pipe appears abandoned and should be done so properly. FIELD_STRUCT_DESC: Abandoned 6-inch pipe through the levee, 1.5 feet below the crown. (USACE-1959). This entry matches the Drainage or Irrigation Structure referenced in O&M manual (HLM 3.1). FS Date: 04/08/2015

No pipe visible on LS toe.

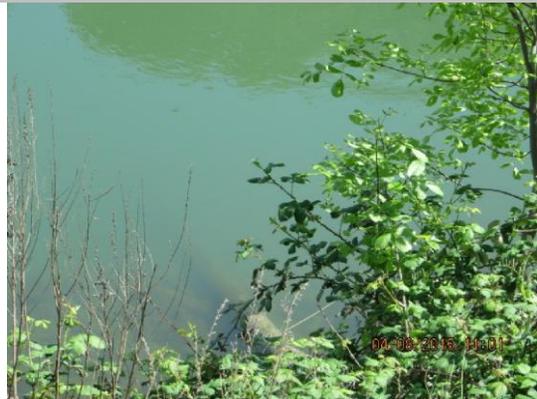
Photo 2 of 3 : UCIP\_FA\_2015\_5904.jpg

Pipe visible in water at WS toe.

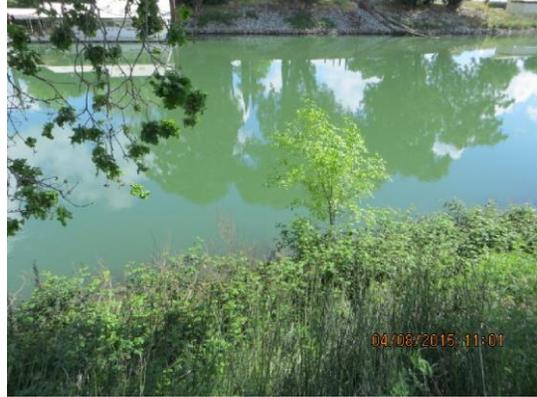
Photo 3 of 3 : UCIP\_FA\_2015\_5905.jpg

LM Start	<b>2.93</b>	Rating **	M	Issue No.	<b>100 (cont)</b>
LM End	<b>2.93</b>	Issue Type +	En	Location *	WS
Category	Supplemental			GPS Latitude/Longitude	
				Start	End
Item	DWR UCIP Field Study			38.268674 °	38.268674 °
				-121.589419 °	-121.589419 °
DWR ID					
Action/Comments					
Inspector Comments: FS_ID:44328 DS_ID:24159 EP_NO: N/A FS_HLM: 2.947 Repair Type: Non-Urgent Crossing Status: Found

Pipe visible in water at WS toe.

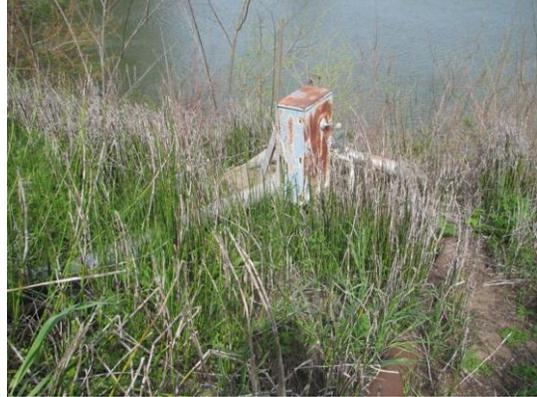
Photo 1 of 2 : UCIP\_FA\_2015\_2515.jpg

Inspector Comments: FS\_ID:44332  
 DS\_ID:24199  
 EP\_NO: 5350  
 FS\_HLM: 3.041  
 Repair Type: Non-Urgent  
 Crossing Status: Found  
 UCIP Comments: Need to contact owner to determine if crossing is still in use. If crossing is no longer in use owner will need to coordinate with DWR inspector and CVFPB to remove according to Title 23 requirements. Debris scattered on slopes--remove. Dense vegetation limits the inspector's visibility to identify signs of pipe failure (leaks) along the slope. Recommend removing vegetation along pipe alignment to conduct proper inspection of structure and appurtenances. Unable to determine if crossing is in use. Note date on photos should be 3/18/09 not 7/26/08 camera metadata is incorrect.  
 FIELD\_STRUCT\_DESC: 6-inch steel pipe and 2-inch iron electrical conduit through the levee, both 3.7 feet below the crown. Siphon breaker in pipe riser on waterward slope. Pump, switch panel, and butterfly valve on concrete blocks on the waterward slope. Service pole on landward slope (Permit No. 5350-1966).

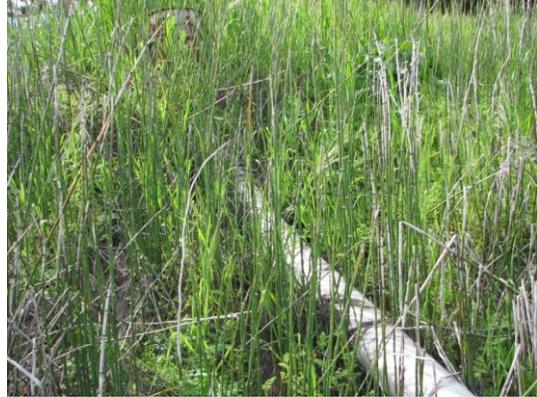
Photo 2 of 2 : UCIP\_FA\_2015\_2516.jpg

LM Start	3.02	Rating **	M	Issue No.	102 (cont)
LM End	3.02	Issue Type +	En	Location *	WS
Category	Supplemental			GPS Latitude/Longitude	
				Start	End
Item	DWR UCIP Field Study			38.267453 °	38.267453 °
				-121.588668 °	-121.588668 °
DWR ID					
Action/Comments					
Inspector Comments: FS_ID:44332 DS_ID:24199 EP_NO: 5350 FS_HLM: 3.041 Repair Type: Non-Urgent Crossing Status: Found UCIP Comments: Need to contact owner to determine if crossing is still in use. If crossing is no longer in use owner will need to coordinate with DWR inspector and CVFPB to remove according to Title 23 requirements. Debris scattered on slopes--remove. Dense vegetation limits the inspector's visibility to identify signs of pipe failure (leaks) along the slope. Recommend removing vegetation along pipe alignment to conduct proper inspection of structure and appurtenances. Unable to determine if crossing is in use. Note date on photos should be 3/18/09 not 7/26/08 camera metadata is incorrect. FIELD_STRUCT_DESC: 6-inch steel pipe and 2-inch iron electrical conduit through the levee, both 3.7 feet below the crown. Siphon breaker in pipe riser on waterward slope. Pump, switch panel, and butterfly valve on concrete blocks on the waterward slope. Service pole on landward slope (Permit No. 5350-1966). FS Date: 04/08/2015

Pipe and Steel riser on WS slope.

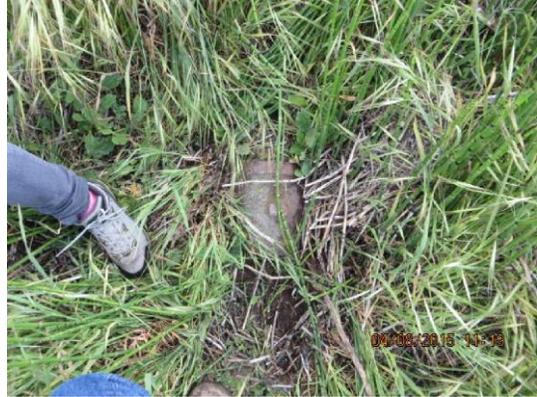
Photo 1 of 3 : UCIP\_FA\_2015\_5981.jpg

LM Start	<b>3.15</b>	Rating **	M	Issue No.	<b>103</b>
LM End	<b>3.15</b>	Issue Type +	En	Location *	LS
Category	Supplemental			GPS Latitude/Longitude	
				Start	End
Item	DWR UCIP Field Study			38.265608 °	38.265608 °
				-121.588391 °	-121.588391 °
DWR ID					
Action/Comments					
Inspector Comments: FS_ID:46172 DS_ID:25099 EP_NO: N/A FS_HLM: 3.17 Repair Type: Non-Urgent Crossing Status: Found UCIP Comments: Appears abandoned and if so should be verified as having been done so properly. FIELD_STRUCT_DESC: Abandoned 6-inch pipe through the levee, 4.5 feet below the crown. Service pole at landward toe. FS Date: 04/02/2015

Pipe just visible on LS slope.

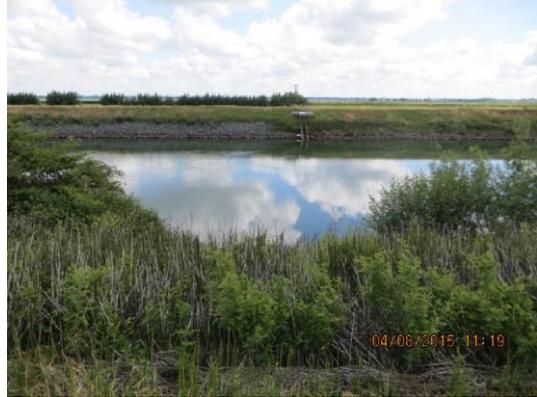
Photo 2 of 3 : UCIP\_FA\_2015\_5982.jpg

View of WS from shoulder at crossing. Pipe not found on WS.

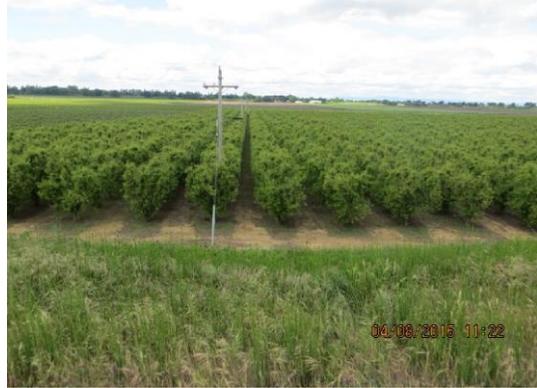
Photo 3 of 3 : UCIP\_FA\_2015\_5983.jpg

Approximate pipe alignment on LS.

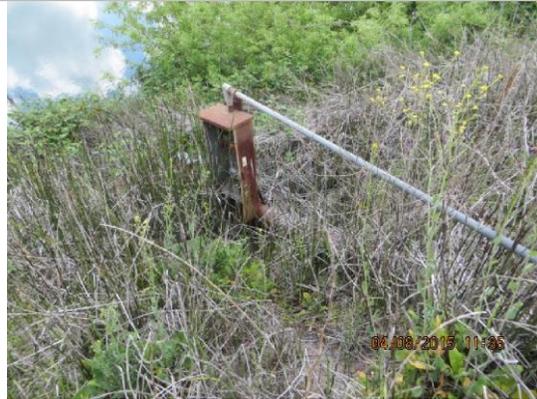
Photo 1 of 3 : UCIP\_FA\_2015\_5908.jpg

LM Start	<b>3.31</b>	Rating **	M	Issue No.	<b>104</b>
LM End	<b>3.31</b>	Issue Type +	En	Location *	LS
Category	Supplemental			GPS Latitude/Longitude	
				Start	End
Item	DWR UCIP Field Study			38.263359 °	38.263359 °
				-121.588721 °	-121.588721 °
DWR ID					
Action/Comments					
Inspector Comments: FS_ID:44333 DS_ID:24161 EP_NO: N/A FS_HLM: 3.33 Repair Type: Non-Urgent Crossing Status: Found UCIP Comments: Pipe appears abandoned and if so should be done so properly. FIELD_STRUCT_DESC: Abandoned 6-inch pipe through the levee, 4.5 feet below the crown. Pump and switch panel on the waterward slope. Service pole and concrete distribution box at landward toe. (USACE-1959). This entry matches the Drainage or Irrigation Structure referenced in O&M manual (HLM 3.5). FS Date: 04/08/2015

Pipe and electrical conduit visible on WS slope.

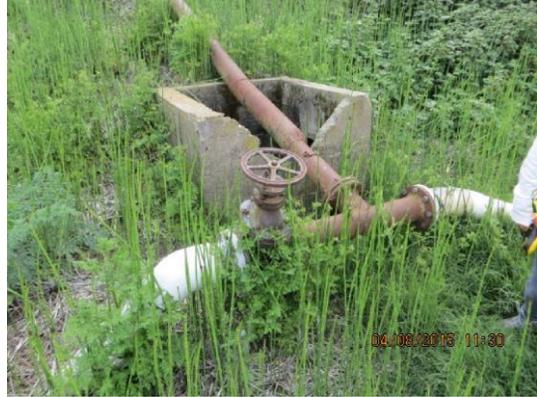
Photo 2 of 3 : UCIP\_FA\_2015\_5909.jpg

distribution box and pipe visible on LS toe.

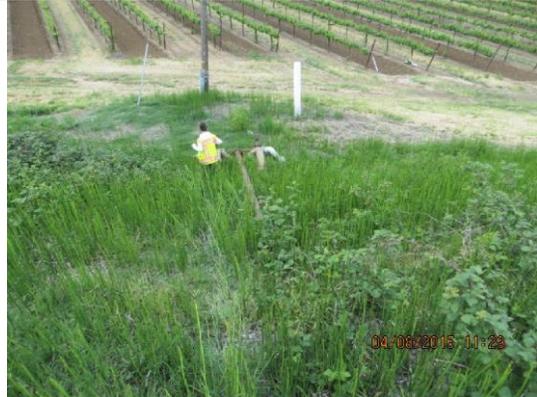
Photo 3 of 3 : UCIP\_FA\_2015\_5910.jpg

Pipe, distribution box, and power pole visible on LS slope/toe.

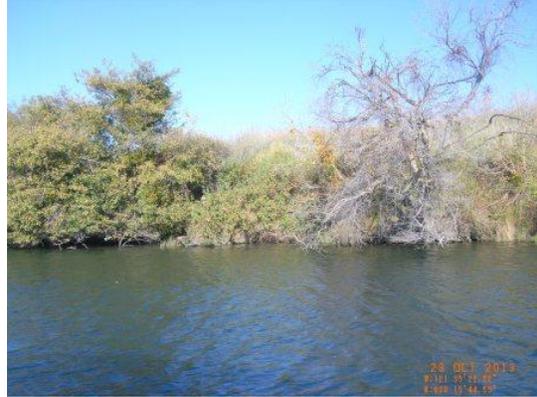
Photo 1 of 1 : USACE2013A\_STM\_22-8\_R\_6.jpg

LM Start	<b>3.38</b>	Rating **	M	Issue No.	<b>11</b>
LM End	<b>3.49</b>	Issue Type +	Ma	Location *	WS
Category	Supplemental			GPS Latitude/Longitude	
				Start	End
Item	2015 USACE Erosion Survey, DRAFT			38.262510 °	38.262533 °
				-121.589481 °	-121.591690 °
DWR ID					
Action/Comments					
Inspector Comments: 2010 - Slumping sections on the lower bank, appears to be scouring around the trees. 2011 - Soil beach at toe. 2015: No observed changes. [2015 Site ID: STM_22-8_R]

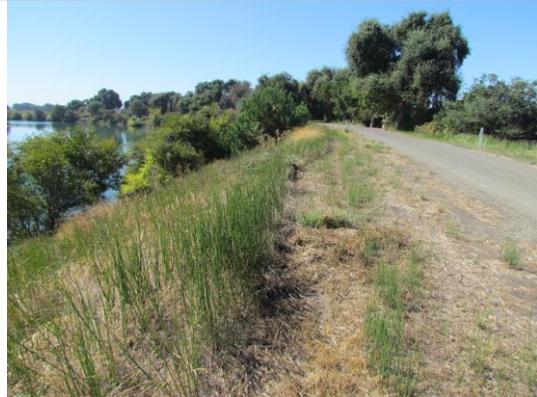
Photo 1 of 1 : FA\_2015\_RD0349\_205\_84\_20151012\_00062.jpg

LM Start	<b>3.58</b>	Rating **	U	Issue No.	<b>84</b>
LM End	<b>4.31</b>	Issue Type +	Ma	Location *	WS
Category	Earthen Levee			GPS Latitude/Longitude	
				Start	End
Item	Vegetation			38.262588 °	38.254733 °
				-121.593328 °	-121.599963 °
DWR ID	DWR_RD0349_02_f_2015_84				
Action/Comments					
Remove the wild growth other than native grasses from the levee slopes. Inspector Comments: Remove the snap grasses from the waterside levee slope.

Tall snap grasses covering the waterward slope.

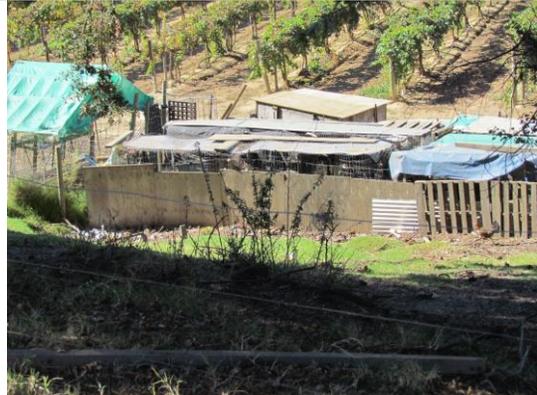
Photo 1 of 2 : FA\_2015\_RD0349\_205\_59\_20151012\_00064.jpg

LM Start	<b>3.76</b>	Rating **	U	Issue No.	<b>59</b>
LM End	<b>3.91</b>	Issue Type +	En	Location *	LS
Category	Earthen Levee			GPS Latitude/Longitude	
				Start	End
Item	Encroachments			38.260596 °	38.258426 °
				-121.592160 °	-121.595125 °
DWR ID	DWR_RD0349_02_f_2013_59				
Action/Comments					
Fence Inspector Comments: Inside the fenced off area are several pet shelters and pens for chickens and goats on the landside levee slope and toe. This need to be taken off the levee section. In the event of a flood fight this area would cause delays in response time.

Unauthorized electric wire fence, solid board fence and animal storages within the 10-foot easement landside levee toe.

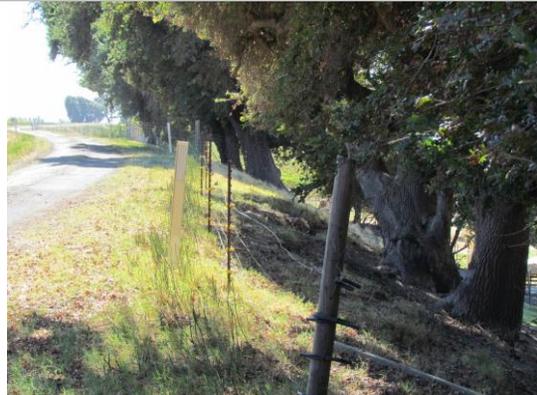
Photo 2 of 2 : FA\_2015\_RD0349\_205\_59\_20151012\_00065.jpg

Unauthorized electric wire fence installed along the shoulder and levee slope.
