**Flood Control Project Maintenance  
Levee Inspections**

**Fall 2015 Levee Maintenance Deficiency Summary Report  
Overall LMA & Unit Ratings, including USACE Erosion Survey**

**Reclamation District No. 0349 Sutter Island**

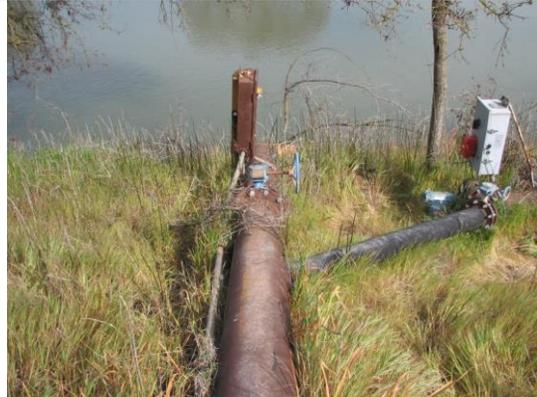
Photo 1 of 3 : UCIP\_FA\_2015\_2517.jpg

LM Start	<b>3.80</b>	Rating **	M	Issue No.	<b>105</b>
LM End	<b>3.80</b>	Issue Type +	En	Location *	LS
Category	Supplemental			GPS Latitude/Longitude	
				Start	End
Item	DWR UCIP Field Study			38.260007 °	38.260007 °
				-121.595273 °	-121.595273 °
DWR ID					
Action/Comments					
Inspector Comments: FS_ID:21612 DS_ID:24162 EP_NO: 8188 FS_HLM: 3.825 Repair Type: Non-Urgent Crossing Status: Found

View of crossing on waterward side.

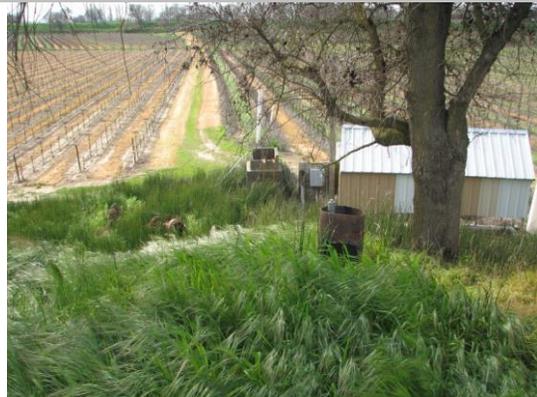
Photo 2 of 3 : UCIP\_FA\_2015\_2518.jpg

Overview of lanward side--appurtenances include distribution box, stand pipe, pump house, and control panel.

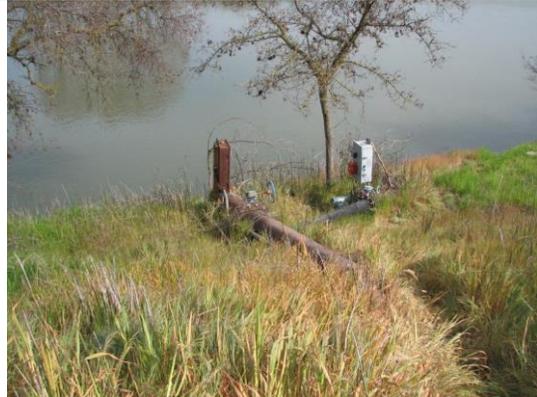
Photo 3 of 3 : UCIP\_FA\_2015\_2519.jpg

Overview of waterward side--2 crossings.

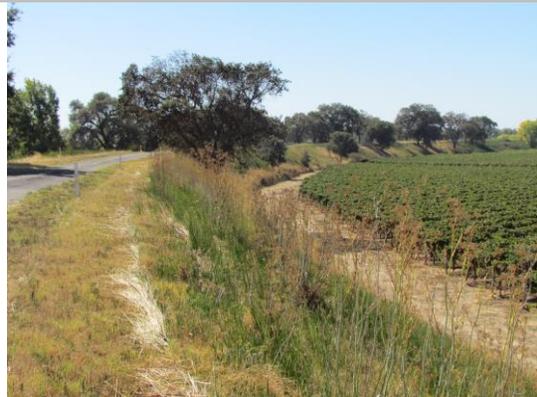
Photo 1 of 1 : FA\_2015\_RD0349\_205\_87\_20151012\_00066.jpg

Unsatisfactory tall snap grasses and sweet anise weeds on landside slope.

LM Start	<b>3.99</b>	Rating **	U	Issue No.	<b>87</b>
LM End	<b>4.31</b>	Issue Type +	Ma	Location *	LS
Category	Earthen Levee			GPS Latitude/Longitude	
				Start	End
Item	Vegetation			38.257252 °	38.254733 °
				-121.595403 °	-121.599963 °
DWR ID	DWR_RD0349_02_f_2015_87				
Action/Comments					
Control annual grass and weeds on the levee slopes and easements. Inspector Comments: Remove the unsatisfactory wild growth from the landside slope.

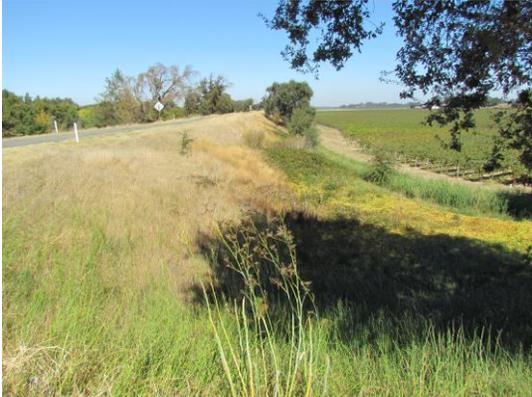
Photo 1 of 1 : FA\_2015\_RD0349\_206\_51\_20151012\_00040.jpg

Looking downstream from levee mile 0.00 to levee mile 1.53 landside slope covered with tall weeds and berries.

LM Start	<b>0.00</b>	Rating **	U	Issue No.	<b>51</b>
LM End	<b>1.53</b>	Issue Type +	Ma	Location *	LS
Category	Earthen Levee		GPS Latitude/Longitude		
			Start	End	
Item	Vegetation		38.254733 °	38.276008 °	
			-121.599963 °	-121.601003 °	
DWR ID	DWR_RD0349_03_f_2015_51				
Action/Comments					
Control annual grass and weeds on the levee slopes and easements. Inspector Comments: Remove the unwanted wild growth from the landside levee slope and toe.

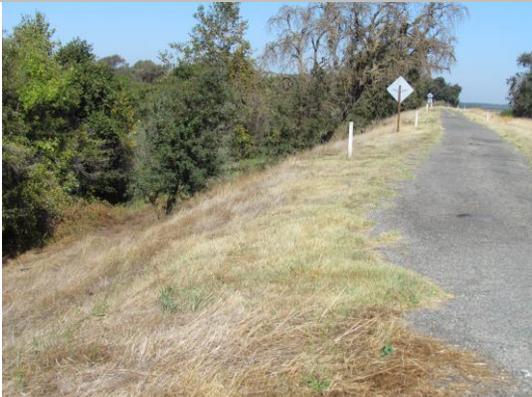
Photo 1 of 1 : FA\_2015\_RD0349\_206\_1\_20151012\_00038.jpg

Looking downstream from levee mile 0.00 waterside.

LM Start	<b>0.03</b>	Rating **	U	Issue No.	<b>1</b>
LM End	<b>1.16</b>	Issue Type +	Ma	Location *	WS
Category	Earthen Levee		GPS Latitude/Longitude		
			Start	End	
Item	Vegetation		38.255094 °	38.271075 °	
			-121.600101 °	-121.603527 °	
DWR ID	DWR_RD0349_03_s_2013_1				
Action/Comments					
Remove the wild growth other than native grasses from the levee slopes. Inspector Comments: Mow the waterside levee slope.

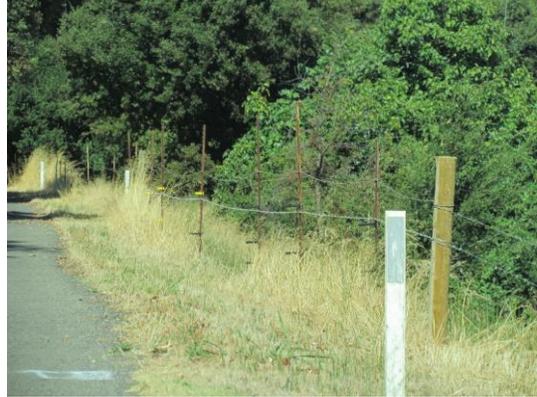
Photo 1 of 1 : FA\_2015\_RD0349\_206\_53\_20151012\_00042.jpg

Unauthorized electric wire fence on the shoulder and slope landside.

LM Start	<b>0.69</b>	Rating **	U	Issue No.	<b>53</b>
LM End	<b>0.80</b>	Issue Type +	En	Location *	LS
Category	Earthen Levee		GPS Latitude/Longitude		
			Start	End	
Item	Encroachments		38.264615 °	38.266097 °	
			-121.601382 °	-121.601822 °	
DWR ID	DWR_RD0349_03_f_2015_53				
Action/Comments					
Fence Inspector Comments: Remove the unauthorized fence from the levee section.

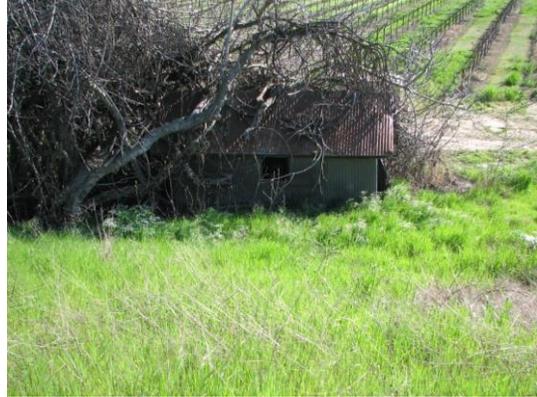
Photo 2 of 3 : UCIP\_FA\_2015\_2533.jpg

Pump house located at the landward toe.

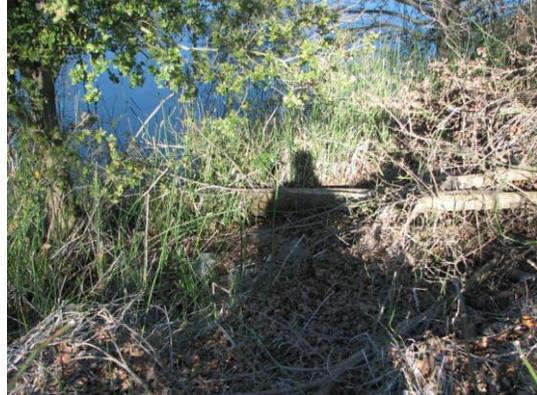
Photo 3 of 3 : UCIP\_FA\_2015\_2534.jpg

View of waterward side--portion of pipe exposed on slope.

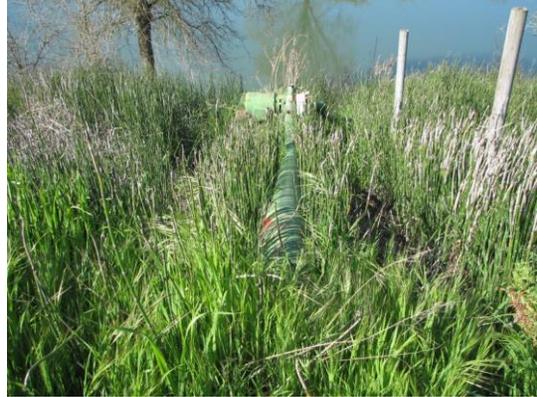
Photo 1 of 3 : UCIP\_FA\_2015\_2360.jpg

View of waterward side--pipe and pump.

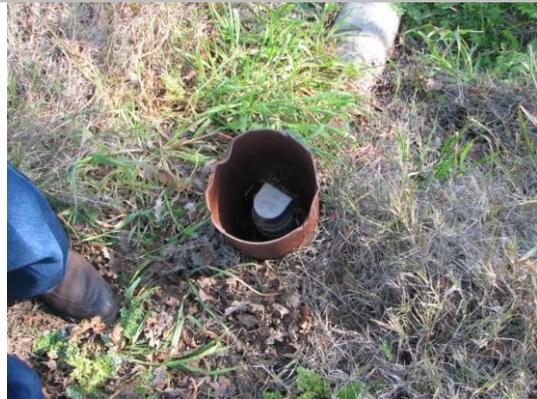
Photo 2 of 3 : UCIP\_FA\_2015\_2361.jpg

View of siphon breaker.

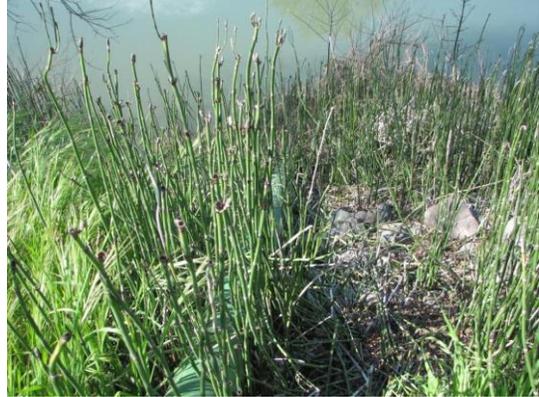
Photo 3 of 3 : UCIP\_FA\_2015\_2362.jpg

View of pipe crossing past pump station.

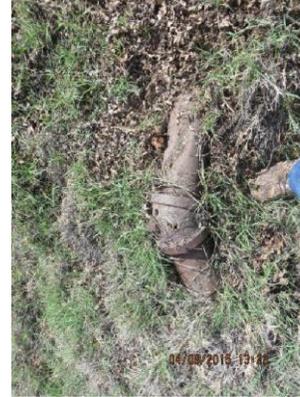
Photo 1 of 2 : UCIP\_FA\_2015\_5911.jpg

Pipe visible on LS slope.

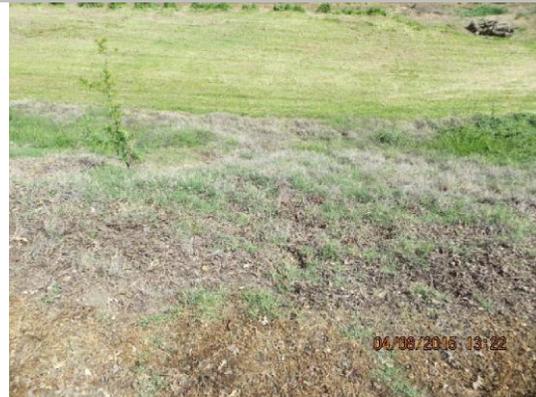
Photo 2 of 2 : UCIP\_FA\_2015\_5912.jpg

Pipe visible on LS slope.

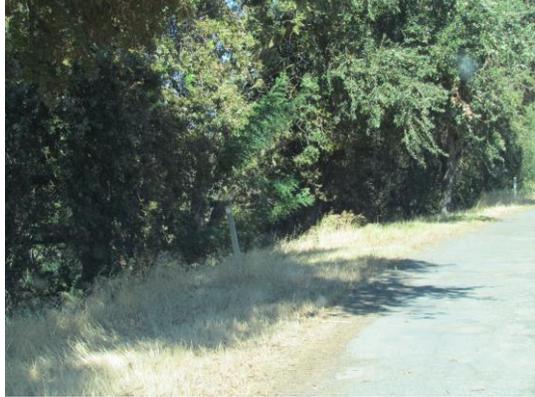
Photo 1 of 1 : FA\_2015\_RD0349\_206\_54\_20151012\_00044.jpg

Looking downstream from the waterside levee shoulder and slope woody tree growth blocking the view of the levee section.

LM Start	<b>1.22</b>	Rating **	U	Issue No.	<b>54</b>
LM End	<b>1.69</b>	Issue Type +	Ma	Location *	WS
Category	Earthen Levee		GPS Latitude/Longitude		
			Start	End	
Item	Vegetation		38.271910 °	38.278318 °	
			-121.603358 °	-121.600343 °	
DWR ID	DWR_RD0349_03_f_2015_54				
Action/Comments					
Control annual grass and weeds on the levee slopes and easements. Inspector Comments: Remove the unwanted woody tree growth from the waterside levee section.

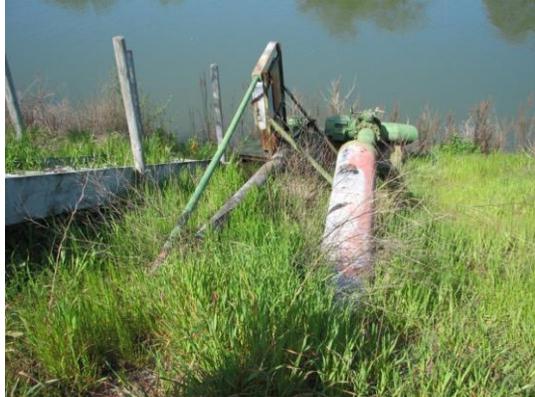
Photo 1 of 1 : UCIP\_FA\_2015\_2366.jpg

Item	DWR UCIP Field Study		38.272515 °	38.272515 °	
			-121.603048 °	-121.603048 °	
DWR ID					
Action/Comments					
Inspector Comments: FS_ID:43461 DS_ID:24169 EP_NO: 11744 FS_HLM: 1.28 Repair Type: Non-Urgent Crossing Status: Found UCIP Comments: Dense vegetation limits the inspector's visibility to identify signs of pipe failure (leaks) through the levee slopes. Recommend removing vegetation along pipe alignment to conduct proper inspection of structure and appurtenances. Note date on photos should be 3/18/09 not 7/26/08 camera metadata is incorrect. FIELD_STRUCT_DESC: 2 of 2: 8-inch pipe through the levee, 3.7 feet below the crown. 8-inch pipe is reduced to 3-inch pipe on waterward side. Steel cutoff wall around pipe at center of levee. Siphon breaker at landward shoulder. Siphon breaker at landward shoulder. Slant pump on waterward side. Discharge structure at landward toe. Rock revetment on waterward slope. (Permit No. 11744-1976) FS Date: 03/19/2009

View of pipe, control panel, and stairs. 2 pipes go through levee 14-inch and 8-inch.

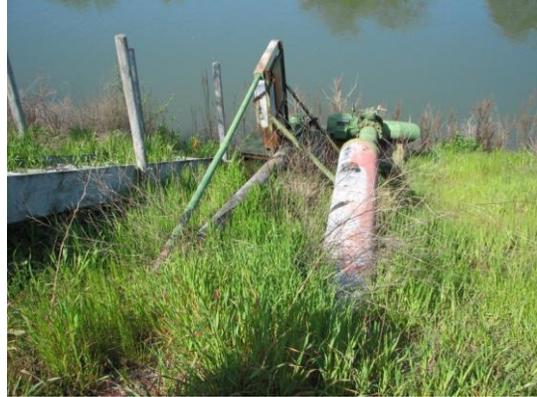
Photo 1 of 3 : UCIP\_FA\_2015\_2363.jpg

Inspector Comments: FS\_ID:21675  
 DS\_ID:24168  
 EP\_NO: 11744  
 FS\_HLM: 1.267  
 Repair Type: Non-Urgent  
 Crossing Status: Found  
 UCIP Comments: Dense vegetation limits the inspector's visibility to identify signs of pipe failure (leaks) through the levee slopes. Recommend removing vegetation along pipe alignment to conduct proper inspection of structure and appurtenances. Note date on photos should be 3/18/09 not 7/26/08 camera metadata is incorrect.  
 FIELD\_STRUCT\_DESC: 1 of 2: 14-inch steel irrigation pipe and 2-inch electric conduit through the levee, both 4.4 feet below the crown. Reduced to 12-inch steel pipe under both levee slopes. Steel cutoff wall around pipe at center of levee. Siphon breaker at landward shoulder. Slant pump on waterward side with staircase access. Discharge structure at landward toe. Rock revetment on waterward slope. (Permit No. 11744-1976)  
 FS Date: 03/19/2009

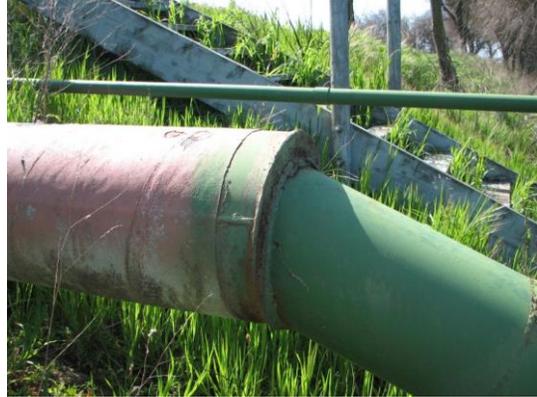
Photo 2 of 3 : UCIP\_FA\_2015\_2364.jpg

Inspector Comments: FS\_ID:21675  
 DS\_ID:24168  
 EP\_NO: 11744  
 FS\_HLM: 1.267  
 Repair Type: Non-Urgent  
 Crossing Status: Found  
 UCIP Comments: Dense vegetation limits the inspector's visibility to identify signs of pipe failure (leaks) through the levee slopes. Recommend removing vegetation along pipe alignment to conduct proper inspection of structure and appurtenances. Note date on photos should be 3/18/09 not 7/26/08 camera metadata is incorrect.  
 FIELD\_STRUCT\_DESC: 1 of 2: 14-inch steel irrigation pipe and 2-inch electric conduit through the levee, both 4.4 feet below the crown. Reduced to 12-inch steel pipe under both levee slopes. Steel cutoff wall around pipe at center of levee. Siphon breaker at landward shoulder. Slant pump on waterward side with staircase access. Discharge structure at landward toe. Rock revetment on waterward slope. (Permit No. 11744-1976)  
 FS Date: 03/19/2009

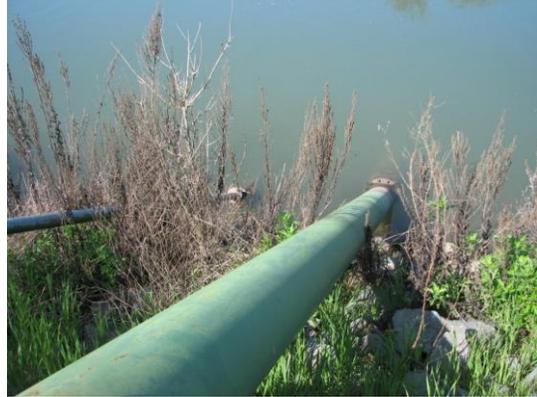
Photo 3 of 3 : UCIP\_FA\_2015\_2365.jpg

Rip rap along the waterward toe.

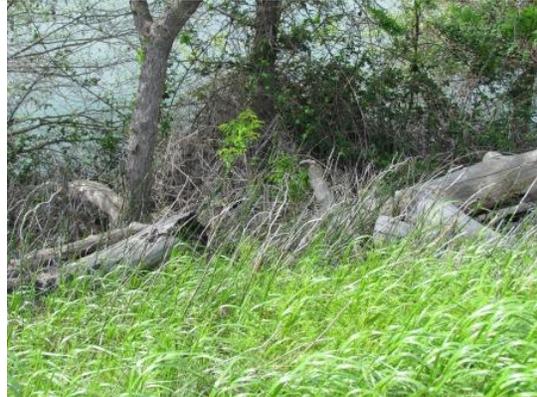
Photo 1 of 1 : FA\_2015\_RD0349\_206\_64\_20150915\_00008.jpg

Cut up fallen tree on waterside slope.

LM Start	<b>1.47</b>	Rating **	U	Issue No.	<b>64</b>
LM End	<b>1.47</b>	Issue Type +	En	Location *	WS
Category	Earthen Levee		GPS Latitude/Longitude		
			Start	End	
Item	Encroachments		38.275332 °	38.275332 °	
			-121.601359 °	-121.601359 °	
DWR ID	DWR_RD0349_03_s_2014_64				
Action/Comments					
Tree or limb Inspector Comments: Cut up tree on waterward slope.

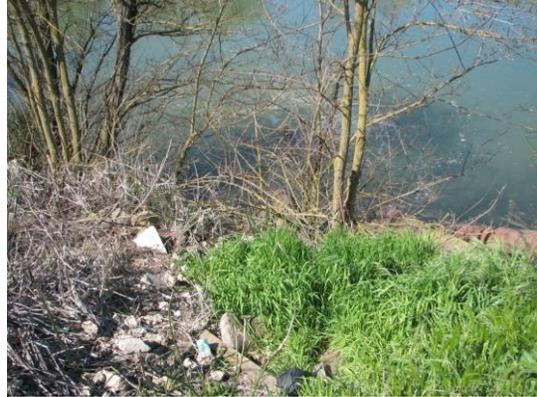
Photo 2 of 2 : UCIP\_FA\_2015\_2536.jpg

LM Start	1.49	Rating **	M	Issue No.	977 (cont)
LM End	1.49	Issue Type +	En	Location *	WS
Category	Supplemental			GPS Latitude/Longitude	
				Start	End
Item	DWR UCIP Field Study			38.275532 °	38.275532 °
DWR ID				-121.601225 °	-121.601225 °
Action/Comments					
Inspector Comments: FS_ID:43446 DS_ID:24229 EP_NO: 2954 FS_HLM: 1.498 Repair Type: Non-Urgent Crossing Status: Found UCIP Comments: Dense vegetation limits the inspector's visibility to identify signs of pipe failure (leaks) through the levee slopes. Recommend removing vegetation along pipe alignment to conduct proper inspection of structure and appurtenances. Note date on photos should be 3/18/09 not 7/26/08 camera metadata is incorrect. FIELD_STRUCT_DESC: [R.D. No. 349 Drainage Pumping Plant] 1 of 3: 18-inch pipe through the levee, 7.8 feet below the crown. Siphon breakers on waterward slope. Pumps on platform on landward side. FS Date: 03/19/2009

View of all 3 pipes through levee and visible on waterward toe.

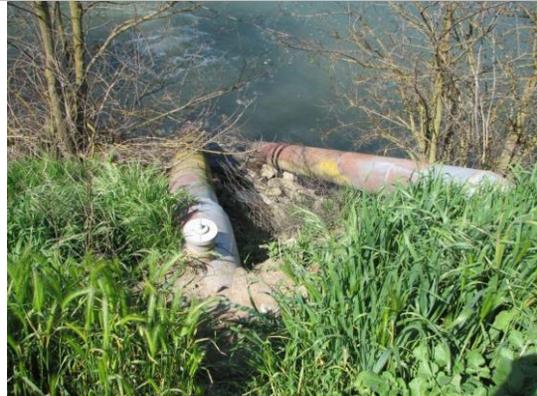
Photo 1 of 3 : UCIP\_FA\_2015\_2537.jpg

LM Start	1.49	Rating **	M	Issue No.	978
LM End	1.49	Issue Type +	En	Location *	WS
Category	Supplemental			GPS Latitude/Longitude	
				Start	End
Item	DWR UCIP Field Study			38.275546 °	38.275546 °
DWR ID				-121.601218 °	-121.601218 °
Action/Comments					
Inspector Comments: FS_ID:43445 DS_ID:24228 EP_NO: 2954 FS_HLM: 1.499 Repair Type: Non-Urgent Crossing Status: Found UCIP Comments: Dense vegetation limits the inspector's visibility to identify signs of pipe failure (leaks) along the slope. Recommend removing vegetation along pipe alignment to conduct proper inspection of structure and appurtenances. Note date on photos should be 3/18/09 not 7/26/08 camera metadata is incorrect. FIELD_STRUCT_DESC: [R.D. No. 349 Drainage Pumping Plant] 2 of 3: 24-inch pipe through the levee, 7.8 feet below the crown. Siphon breakers on waterward slope. Pumps on platform on landward side. FS Date: 03/19/2009

View of pipe on waterward side--pipe running. Siphon breaker visible on pipe.

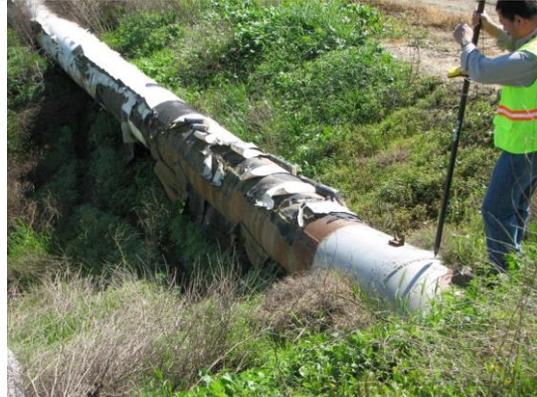
Photo 2 of 3 : UCIP\_FA\_2015\_2538.jpg

Inspector Comments: FS\_ID:43445  
 DS\_ID:24228  
 EP\_NO: 2954  
 FS\_HLM: 1.499  
 Repair Type: Non-Urgent  
 Crossing Status: Found  
 UCIP Comments: Dense vegetation limits the inspector's visibility to identify signs of pipe failure (leaks) along the slope. Recommend removing vegetation along pipe alignment to conduct proper inspection of structure and appurtenances. Note date on photos should be 3/18/09 not 7/26/08 camera metadata is incorrect.  
 FIELD\_STRUCT\_DESC: [R.D. No. 349 Drainage Pumping Plant] 2 of 3: 24-inch pipe through the levee, 7.8 feet below the crown. Siphon breakers on waterward slope. Pumps on platform on landward side.  
 FS Date: 03/19/2009

Pipe is wrapped--unwrapped coating.

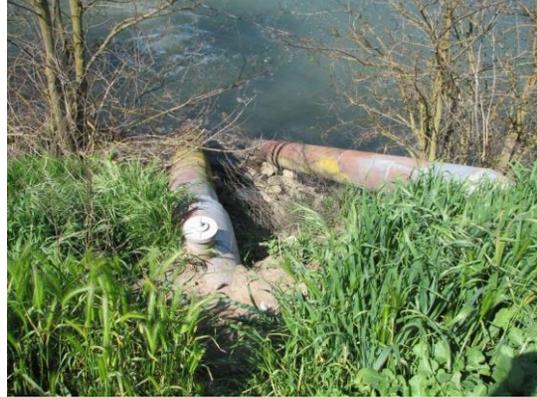
Photo 1 of 3 : UCIP\_FA\_2015\_2540.jpg

LM Start	<b>1.49</b>	Rating **	M	Issue No.	<b>979</b>
LM End	<b>1.49</b>	Issue Type +	En	Location *	WS
Category	Supplemental			GPS Latitude/Longitude	
				Start	End
Item	DWR UCIP Field Study			38.275570 °	38.275570 °
				-121.601222 °	-121.601222 °
DWR ID					
Action/Comments					
Inspector Comments: FS_ID:21632 DS_ID:24171 EP_NO: 2954 FS_HLM: 1.501 Repair Type: Non-Urgent Crossing Status: Found

View of waterward side--2-24 inch pipes.

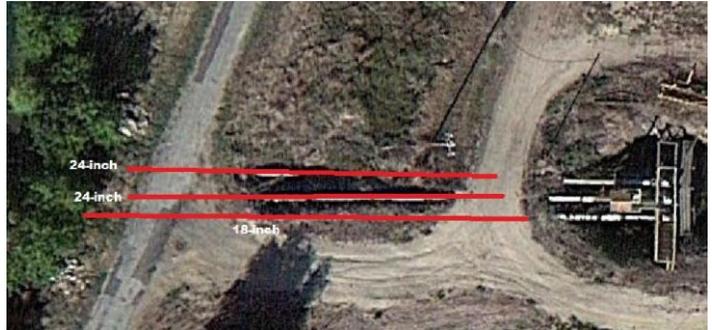
Photo 2 of 3 : UCIP\_FA\_2015\_2541.jpg

Aerial view of all 3 pipes through levee.

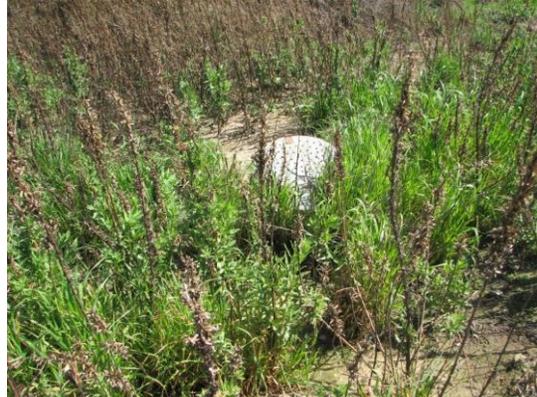
Photo 1 of 3 : UCIP\_FA\_2015\_2543.jpg

Item	DWR UCIP Field Study			38.280199 °	38.280199 °
				-121.600500 °	-121.600500 °
DWR ID					
Action/Comments					
Inspector Comments: FS_ID:43447 DS_ID:24172 EP_NO: N/A FS_HLM: 1.833 Repair Type: Non-Urgent Crossing Status: Found UCIP Comments: Dense vegetation limits the inspector's visibility to identify signs of pipe failure (leaks) through the levee slopes. Recommend removing vegetation along pipe alignment to conduct proper inspection of structure and appurtenances. Note date on photos should be 3/18/09 not 7/26/08 camera metadata is incorrect. FIELD_STRUCT_DESC: 2 of 2: 12-inch pipe and 2-inch electrical conduit through the levee, both 8.0 feet below the crown. Siphon breaker in pipe riser on landward slope. Concrete standpipe at landward toe. Pump on waterward side with stairway access. FS Date: 03/19/2009

Stand pipe located on landward shoulder--pipe locked.

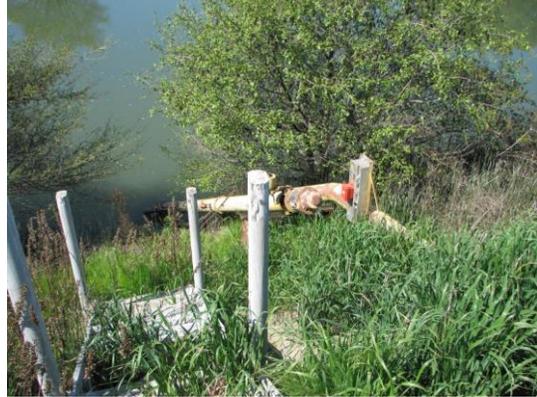
Photo 2 of 3 : UCIP\_FA\_2015\_2544.jpg

View of waterward side--pump, pipe, control panel, and stairway.

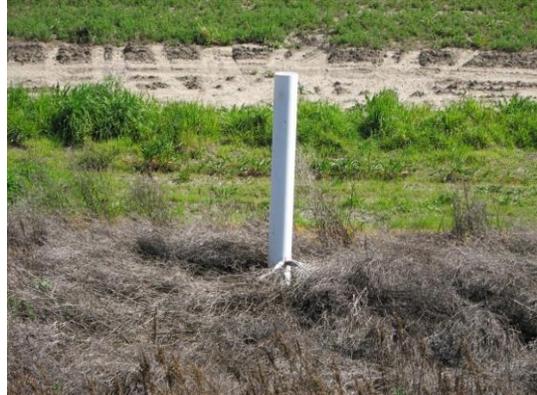
Photo 3 of 3 : UCIP\_FA\_2015\_2545.jpg

Tall thin stand pipe located on landward side--unable to find pipe.

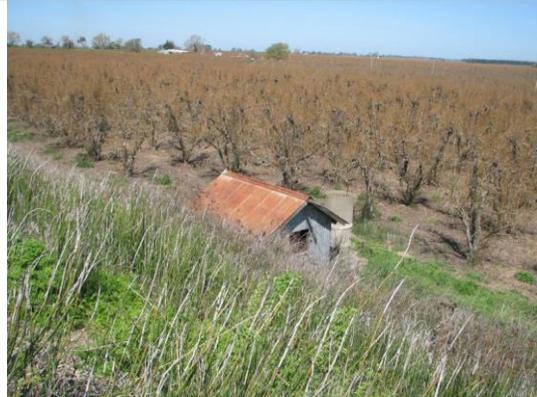
Photo 1 of 1 : UCIP\_FA\_2015\_2546.jpg

Item	DWR UCIP Field Study			38.282498 °	38.282498 °
				-121.601758 °	-121.601758 °
DWR ID					
Action/Comments					
Inspector Comments: FS_ID:21634 DS_ID:24173 EP_NO: N/A FS_HLM: 2.007 Repair Type: Non-Urgent Crossing Status: Found UCIP Comments: Dense vegetation limits the inspector's visibility to identify signs of pipe failure (leaks) through the levee slopes. Recommend removing vegetation along pipe alignment to conduct proper inspection of structure and appurtenances. Note date on photos should be 3/18/09 not 7/26/08 camera metadata is incorrect. FIELD_STRUCT_DESC: 8-inch pipe through the levee, 6.7 feet below the crown. Pump in pumphouse and concrete standpipe at the landward toe. (USACE-1959). This entry matches the Drainage or Irrigation Structure referenced in O&M manual (HLM 2.1). FS Date: 03/19/2009

View of landward side--pump house and stand pipe.

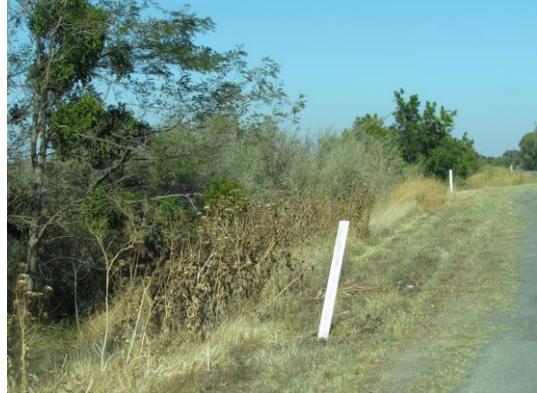
Photo 1 of 1 : FA\_2015\_RD0349\_206\_67\_20151012\_00045.jpg

LM Start	<b>2.52</b>	Rating **	U	Issue No.	<b>67</b>
LM End	<b>2.72</b>	Issue Type +	Ma	Location *	WS
Category	Earthen Levee		GPS Latitude/Longitude		
			Start	End	
Item	Vegetation		38.288948 °	38.291873 °	
			-121.603282 °	-121.603645 °	
DWR ID	DWR_RD0349_03_f_2015_67				
Action/Comments					
Control annual grass and weeds on the levee slopes and easements. Inspector Comments: Remove this unsatisfactory growth of vegetation.

Looking downstream waterside shoulder and slope at unsatisfactory tall weeds blocking the view of the levee section.

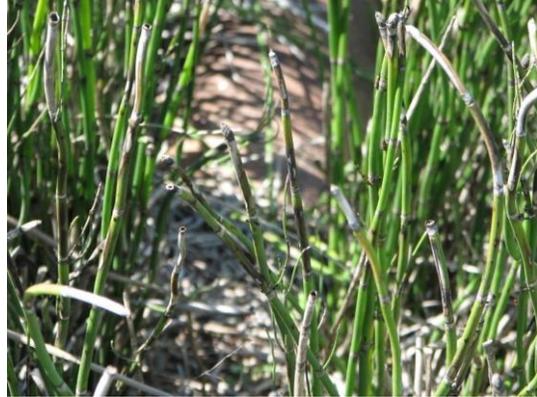
Photo 1 of 3 : UCIP\_FA\_2015\_2367.jpg

Action/Comments					
Inspector Comments: FS_ID:43423 DS_ID:24176 EP_NO: N/A FS_HLM: 2.581 Repair Type: Non-Urgent Crossing Status: Found UCIP Comments: Need to contact owner--If crossing is no longer used by owner, the owner will need to coordinate with DWR Inspector and CVFPB to remove crossing according to Title 23 requirements. Dense vegetation limits the inspector's visibility to identify signs of pipe failure (leaks) through the levee slopes. Recommend removing vegetation along pipe alignment to conduct proper inspection of structure and appurtenances. Note date on photos should be 3/18/09 not 7/26/08 camera metadata is incorrect. FIELD_STRUCT_DESC: Abandoned 10-inch pipe through the levee, 8.2 feet below the crown. Pipe has plate welded on the waterward end. 3-inch galvanized pipe runs parallel to 10-inch pipe. Abandoned tank on waterward slope. Distribution box and concrete standpipe at landward toe. (USACE-1959). This entry matches the Drainage or Irrigation Structure referenced in O&M manual (HLM 2.7). FS Date: 03/19/2009

Pipe visible on waterward side.

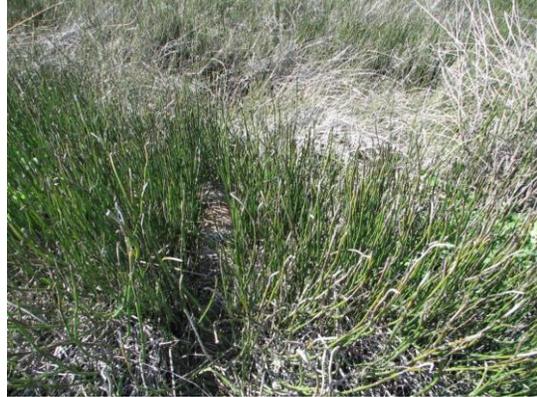
Photo 2 of 3 : UCIP\_FA\_2015\_2368.jpg

Action/Comments					
Inspector Comments: FS_ID:43423 DS_ID:24176 EP_NO: N/A FS_HLM: 2.581 Repair Type: Non-Urgent Crossing Status: Found UCIP Comments: Need to contact owner--If crossing is no longer used by owner, the owner will need to coordinate with DWR Inspector and CVFPB to remove crossing according to Title 23 requirements. Dense vegetation limits the inspector's visibility to identify signs of pipe failure (leaks) through the levee slopes. Recommend removing vegetation along pipe alignment to conduct proper inspection of structure and appurtenances. Note date on photos should be 3/18/09 not 7/26/08 camera metadata is incorrect. FIELD_STRUCT_DESC: Abandoned 10-inch pipe through the levee, 8.2 feet below the crown. Pipe has plate welded on the waterward end. 3-inch galvanized pipe runs parallel to 10-inch pipe. Abandoned tank on waterward slope. Distribution box and concrete standpipe at landward toe. (USACE-1959). This entry matches the Drainage or Irrigation Structure referenced in O&M manual (HLM 2.7). FS Date: 03/19/2009

View of waterward side--dense vegetation covers slope.

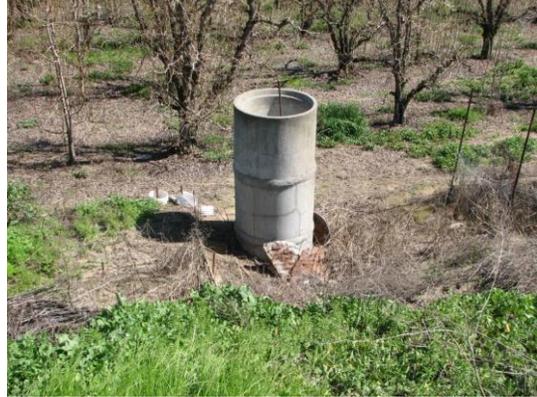
Photo 3 of 3 : UCIP\_FA\_2015\_2369.jpg

Action/Comments					
Inspector Comments: FS_ID:43423 DS_ID:24176 EP_NO: N/A FS_HLM: 2.581 Repair Type: Non-Urgent Crossing Status: Found UCIP Comments: Need to contact owner--If crossing is no longer used by owner, the owner will need to coordinate with DWR Inspector and CVFPB to remove crossing according to Title 23 requirements. Dense vegetation limits the inspector's visibility to identify signs of pipe failure (leaks) through the levee slopes. Recommend removing vegetation along pipe alignment to conduct proper inspection of structure and appurtenances. Note date on photos should be 3/18/09 not 7/26/08 camera metadata is incorrect. FIELD_STRUCT_DESC: Abandoned 10-inch pipe through the levee, 8.2 feet below the crown. Pipe has plate welded on the waterward end. 3-inch galvanized pipe runs parallel to 10-inch pipe. Abandoned tank on waterward slope. Distribution box and concrete standpipe at landward toe. (USACE-1959). This entry matches the Drainage or Irrigation Structure referenced in O&M manual (HLM 2.7). FS Date: 03/19/2009

Stand pipe located on landward toe.

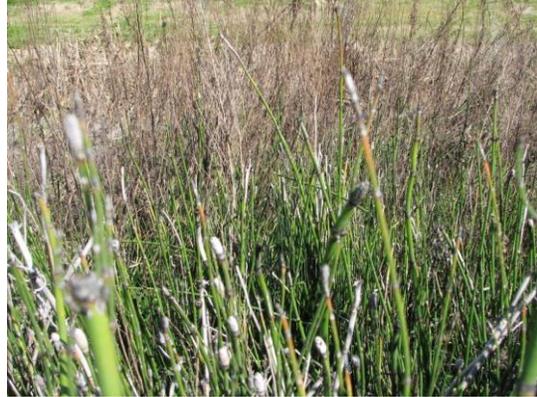
Photo 1 of 3 : UCIP\_FA\_2015\_2370.jpg

Inspector Comments: FS\_ID:43424  
 DS\_ID:24177  
 EP\_NO: N/A  
 FS\_HLM: 2.787  
 Repair Type: Non-Urgent  
 Crossing Status: Found  
 UCIP Comments: 2007 Erosion Repair Site location?--Need to contact owner to determine if crossing is still in use. If crossing is no longer used by owner, the owner will need to coordinate with DWR Inspector and CVFPB to remove crossing according to Title 23 requirements. Dense vegetation limits the inspector's visibility to identify signs of pipe failure (leaks) through the levee slopes. Recommend removing vegetation along pipe alignment to conduct proper inspection of structure and appurtenances. Note date on photos should be 3/18/09 not 7/26/08 camera metadata is incorrect.  
 FIELD\_STRUCT\_DESC: Abandoned 8-inch pipe through the levee, 8.7 feet below the crown. Headwall and gate valve on the landward side.  
 FS Date: 03/19/2009

View of landward side--dense vegetation on slope limits inspection.

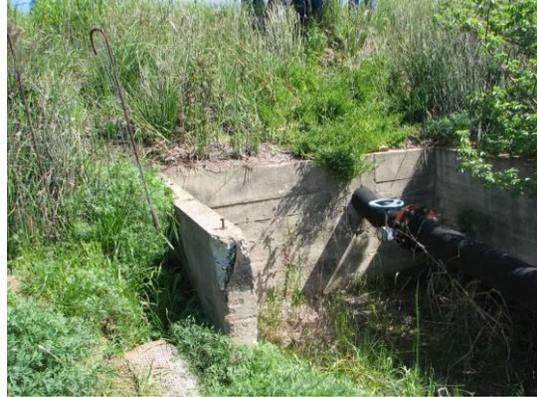
Photo 3 of 3 : UCIP\_FA\_2015\_2372.jpg

LM Start	<b>2.77</b>	Rating **	M	Issue No.	<b>983 (cont)</b>
LM End	<b>2.77</b>	Issue Type +	En	Location *	WS
Category	Supplemental			GPS Latitude/Longitude	
				Start	End
Item	DWR UCIP Field Study			38.292557 °	38.292557 °
				-121.603767 °	-121.603767 °
DWR ID					
Action/Comments					
Inspector Comments: FS_ID:43424 DS_ID:24177 EP_NO: N/A FS_HLM: 2.787 Repair Type: Non-Urgent Crossing Status: Found

View of waterward side--headwall, pipe, and gate valve.

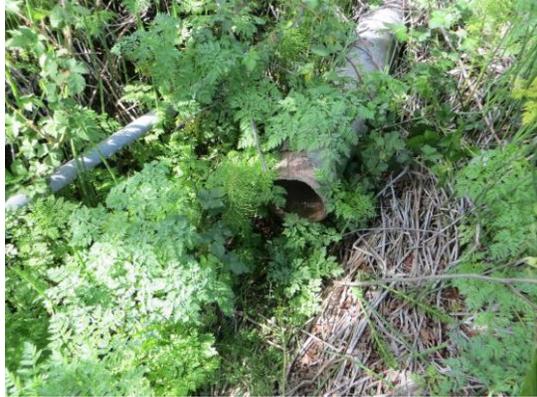
Photo 2 of 3 : UCIP\_FA\_2015\_5914.jpg

LM Start	2.88	Rating **	U	Issue No.	984 (cont)
LM End	2.88	Issue Type +	En	Location *	WS
Category	Supplemental			GPS Latitude/Longitude	
				Start	End
Item	DWR UCIP Field Study			38.294080 °	38.294080 °
				-121.604260 °	-121.604260 °
DWR ID					
Action/Comments					
Inspector Comments: FS_ID:44387 DS_ID:24178 EP_NO: 6321 FS_HLM: 2.896 Repair Type: Urgent Crossing Status: Found UCIP Comments: Appears abandoned and if so should be done so properly. Pipe open at LS toe. Unable to verify if plate is welded over WS end. FIELD_STRUCT_DESC: Abandoned 8-inch steel irrigation pipe through the levee, 4.5 feet below the crown. CM cutoff wall around pipe at center of levee. Siphon breaker on waterward shoulder. Pump on landward side. Gate valve on the waterward side. 1.5-inch filler pipe at same location. Plate welded to waterward end (Permit No. 6321-1969). FS Date: 04/09/2015

1.5-inch filler pipe and 8-inch steel irrigation pipe at LS toe.

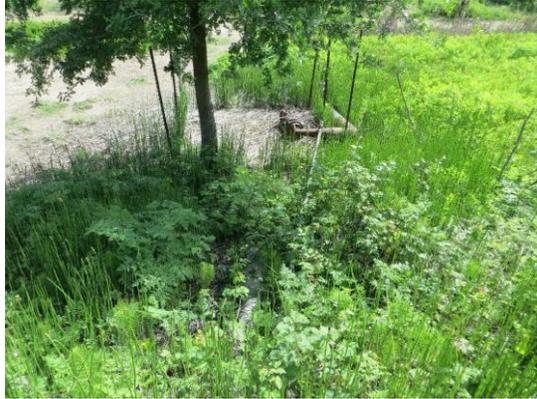
Photo 3 of 3 : UCIP\_FA\_2015\_5915.jpg

Pipe and pump platform on LS toe.

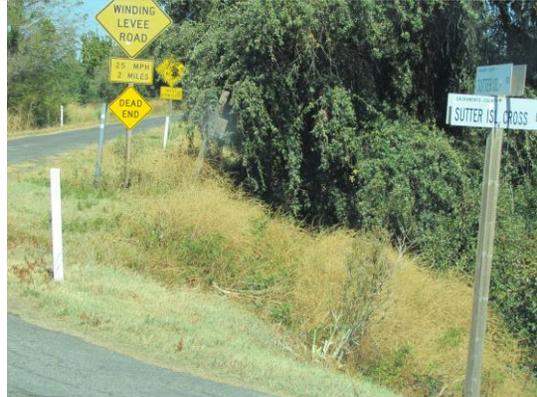
Photo 1 of 1 : FA\_2015\_RD0349\_206\_72\_20151009\_00037.jpg

LM Start	<b>3.00</b>	Rating **	U	Issue No.	<b>72</b>
LM End	<b>6.50</b>	Issue Type +	Ma	Location *	LS
Category	Earthen Levee		GPS Latitude/Longitude		
			Start	End	
Item	Vegetation		38.295798 °	38.327002 °	
			-121.604735 °	-121.576920 °	
DWR ID	DWR_RD0349_03_f_2015_72				
Action/Comments					
Control annual grass and weeds on the levee slopes and easements. Inspector Comments: This section hasn't been maintained and is completely overgrown.

Unsatisfactory tall weeds and vegetation on the landside levee slope and shoulder

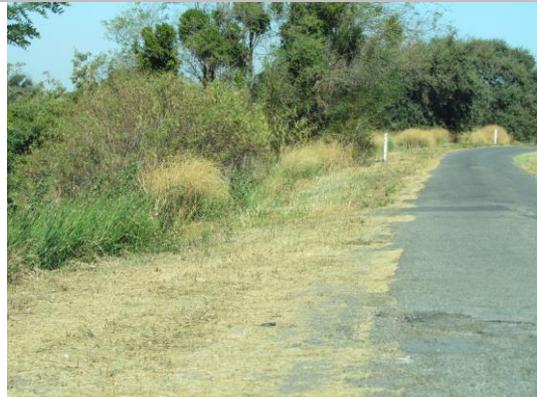
Photo 1 of 1 : FA\_2015\_RD0349\_206\_74\_20151012\_00046.jpg

LM Start	<b>3.01</b>	Rating **	U	Issue No.	<b>74</b>
LM End	<b>6.50</b>	Issue Type +	Ma	Location *	WS
Category	Earthen Levee		GPS Latitude/Longitude		
			Start	End	
Item	Vegetation		38.296030 °	38.327002 °	
			-121.604710 °	-121.576920 °	
DWR ID	DWR_RD0349_03_f_2015_74				
Action/Comments					
Control annual grass and weeds on the levee slopes and easements. Inspector Comments: Looking downstream from the waterside levee slope at unsatisfactory vegetation.

Looking downstream waterside, unsatisfactory tall vegetation blocking view of the levee slope.

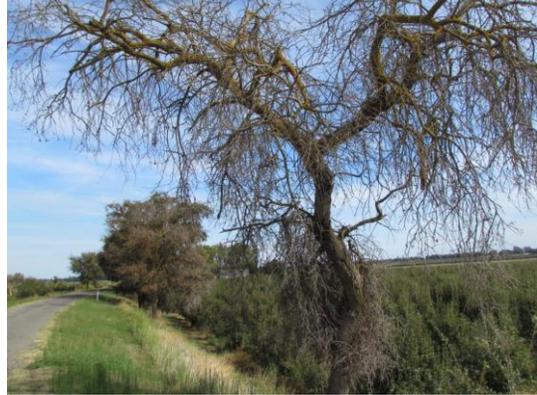
Photo 2 of 2 : FA\_2015\_RD0349\_206\_73\_20150915\_00013.jpg

LM Start	<b>3.19</b>	Rating **	U	Issue No.	<b>73 (cont)</b>
LM End	<b>3.19</b>	Issue Type +	Ma	Location *	LS
Category	Earthen Levee			GPS Latitude/Longitude	
				Start	End
Item	Trim / Thin Trees			38.298223 °	38.298223 °
				-121.603240 °	-121.603240 °
DWR ID	DWR_RD0349_03_f_2014_73				
Action/Comments					
Trim trees over roadway to at least 12 feet above ground level. Inspector Comments: This tree on the landside slope is rotten and could possibly fall across levee section.

Dead tree above crown roadway landward.

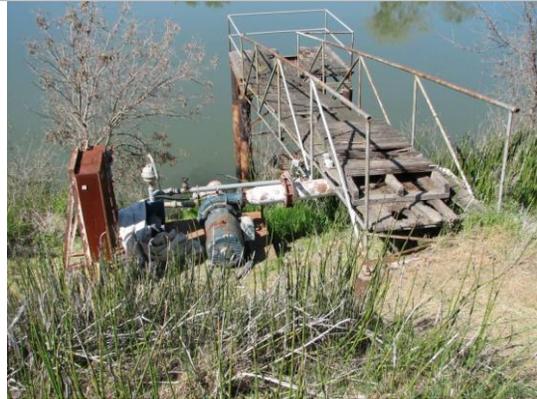
Photo 1 of 3 : UCIP\_FA\_2015\_2373.jpg

LM Start	<b>3.34</b>	Rating **	M	Issue No.	<b>985</b>
LM End	<b>3.34</b>	Issue Type +	En	Location *	LS
Category	Supplemental			GPS Latitude/Longitude	
				Start	End
Item	DWR UCIP Field Study			38.299703 °	38.299703 °
				-121.601112 °	-121.601112 °
DWR ID					
Action/Comments					
Inspector Comments: FS_ID:44389 DS_ID:24179 EP_NO: N/A FS_HLM: 3.363 Repair Type: Non-Urgent Crossing Status: Found UCIP Comments: Crossing altered--need to contact owner to obtain permit number authorizing work. Dense vegetation limits the inspector's visibility to identify signs of pipe failure (leaks) along the slope. Recommend removing vegetation along pipe alignment to conduct proper inspection of structure and appurtenances. Note date on photos should be 3/18/09 not 7/26/08 camera metadata is incorrect. FIELD_STRUCT_DESC: *DELETE* FS Date: 04/09/2015

View of waterward side--pump, control panel, pipe, and walkway.

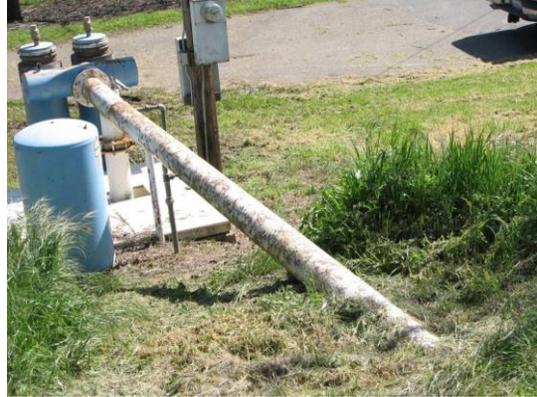
Photo 2 of 3 : UCIP\_FA\_2015\_2374.jpg

View of landward side.

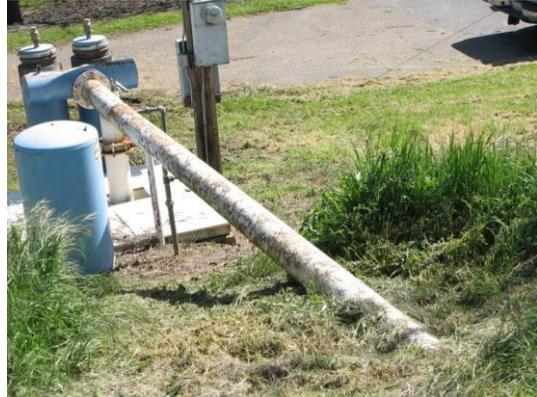
Photo 1 of 2 : UCIP\_FA\_2015\_6835.jpg

LM Start	<b>3.34</b>	Rating **	M	Issue No.	<b>986</b>
LM End	<b>3.34</b>	Issue Type +	En	Location *	LS
Category	Supplemental			GPS Latitude/Longitude	
				Start	End
Item	DWR UCIP Field Study			38.299718 °	38.299718 °
				-121.601095 °	-121.601095 °
DWR ID					
Action/Comments					
Inspector Comments: FS_ID:44390 DS_ID:24214 EP_NO: N/A FS_HLM: 3.364 Repair Type: Non-Urgent Crossing Status: Found

Pipe, filter system, powerpole, and distribution box at LS toe.

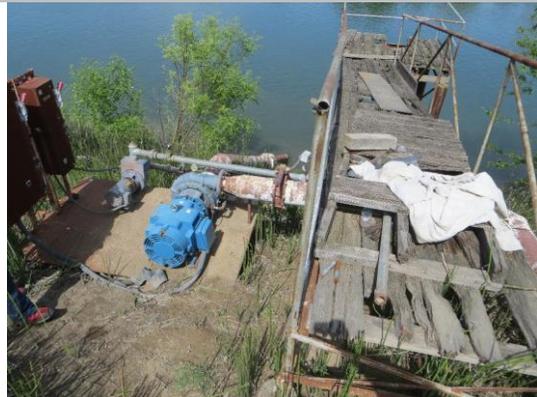
Photo 2 of 2 : UCIP\_FA\_2015\_6836.jpg

Pump, electrical panel, butterfly valve, and walkway on WS slope.

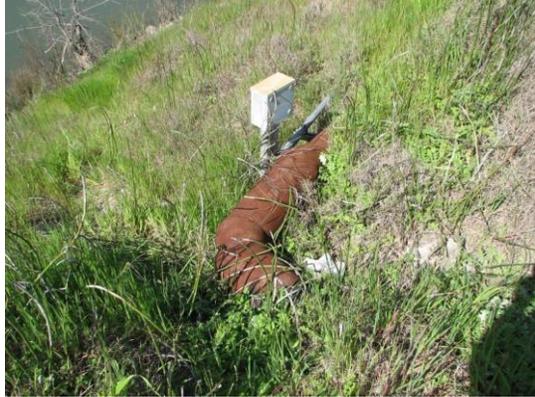
Photo 1 of 3 : UCIP\_FA\_2015\_2309.jpg

LM Start	<b>3.77</b>	Rating **	M	Issue No.	<b>987</b>
LM End	<b>3.77</b>	Issue Type +	En	Location *	LS
Category	Supplemental			GPS Latitude/Longitude	
				Start	End
Item	DWR UCIP Field Study			38.305300 °	38.305300 °
				-121.598620 °	-121.598620 °
DWR ID					
Action/Comments					
Inspector Comments: FS_ID:21644 DS_ID:24180 EP_NO: 9290 FS_HLM: 3.799 Repair Type: Non-Urgent Crossing Status: Found

90 elbow at daylight and continues along slope and connects to pump.

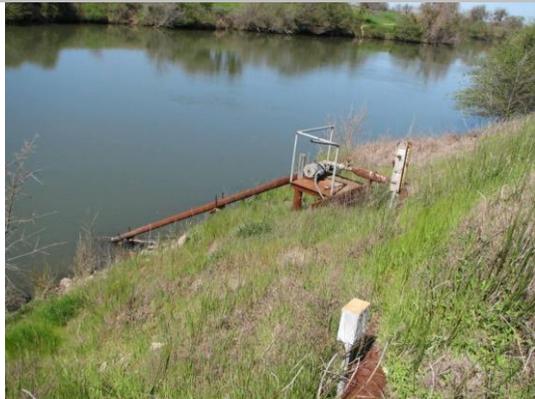
Photo 2 of 3 : UCIP\_FA\_2015\_2310.jpg

View of waterward side.

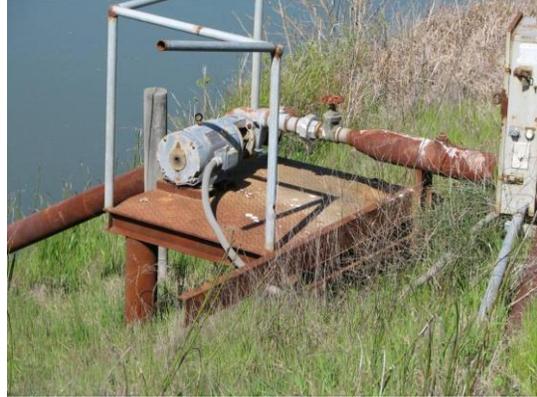
Photo 3 of 3 : UCIP\_FA\_2015\_2311.jpg

Appurtenances located on waterward slope.

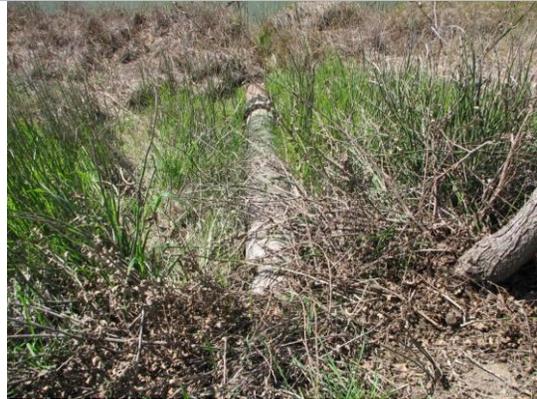
Photo 1 of 2 : UCIP\_FA\_2015\_2312.jpg

Item	DWR UCIP Field Study			38.307533 °	38.307533 °
				-121.596881 °	-121.596881 °
DWR ID					
Action/Comments					
Inspector Comments: FS_ID:43455 DS_ID:24201 EP_NO: 15503 FS_HLM: 3.987 Repair Type: Non-Urgent Crossing Status: Found UCIP Comments: Dense vegetation limits the inspector's visibility to identify signs of pipe failure (leaks) through the levee slopes. Recommend removing vegetation along pipe alignment to conduct proper inspection of structure and appurtenances. Note date on photos should be 3/18/09 not 7/26/08 camera metadata is incorrect. FIELD_STRUCT_DESC: 10-inch steel irrigation pipe through the levee, 3.0 feet below the crown. Steel cutoff wall around pipe 24-inches landward of levee center. Pump and gate valve in pumphouse at the landward toe. Pipe is exposed along waterward slope. (Permit No. 15503-1990) FS Date: 03/19/2009

View of waterward side.

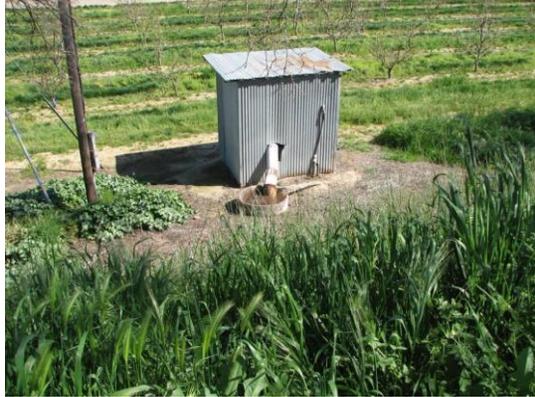
Photo 2 of 2 : UCIP\_FA\_2015\_2313.jpg

Pump house located on landward side.

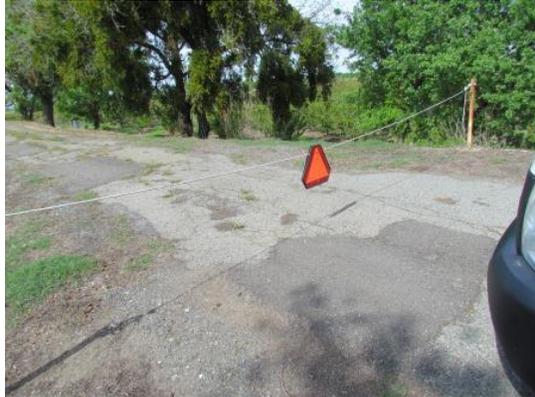
Photo 1 of 1 : FA\_2015\_RD0349\_206\_25\_20150915\_00004.jpg

LM Start	<b>3.99</b>	Rating **	U	Issue No.	<b>25</b>
LM End	<b>3.99</b>	Issue Type +	En	Location *	LS
Category	Earthen Levee			GPS Latitude/Longitude	
				Start	End
Item	Encroachments			38.307997 °	38.307997 °
				-121.597039 °	-121.597039 °
DWR ID	DWR_RD0349_03_s_2012_25				
Action/Comments					
Fence Inspector Comments: Unauthorized cable gate crossing levee. Cable gates crossing the levee crown have been prohibited. There is no CVFPB permit for this crossing. This encroachment should be removed.

Cable crossings has been banned. They are unauthorized. No new photo.

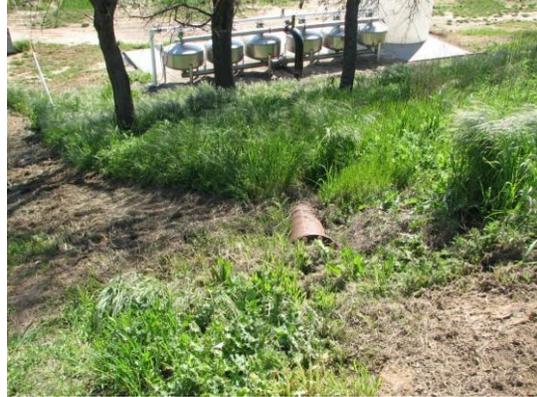
Photo 1 of 3 : UCIP\_FA\_2015\_2314.jpg

LM Start	<b>4.26</b>	Rating **	M	Issue No.	<b>992</b>
LM End	<b>4.26</b>	Issue Type +	En	Location *	LS
Category	Supplemental			GPS Latitude/Longitude	
				Start	End
Item	DWR UCIP Field Study			38.310905 °	38.310905 °
				-121.596226 °	-121.596226 °
DWR ID

Inspector Comments: FS\_ID:43457  
 DS\_ID:24184  
 EP\_NO: 8681  
 FS\_HLM: 4.288  
 Repair Type: Non-Urgent  
 Crossing Status: Found  
 UCIP Comments: Need to contact owner. Is filter sytem located on landward side part of crossing. If so need permit number authorizing work. Also if crossing is no longer used by owner, the owner will need to coordinate with DWR Inspector and CVFPB to remove crossing according to Title 23 requirements. Dense vegetation limits the inspector's visibility to identify signs of pipe failure (leaks) through the levee slopes. Recommend removing vegetation along pipe alignment to conduct proper inspection of structure and appurtenances. Note date on photos should be 3/18/09 not 7/26/08 camera metadata is incorrect.  
 FIELD\_STRUCT\_DESC: 2 of 2: 12-inch steel irrigation pipe through the levee, 4.3 feet feet below the crown. Steel cutoff wall around pipe at center of levee. Pump on platform and gate valve on the waterward slope. Exposed suction pipe from pump to channel. Rock revetment on waterward slope. (Permit No. 8681-1973)

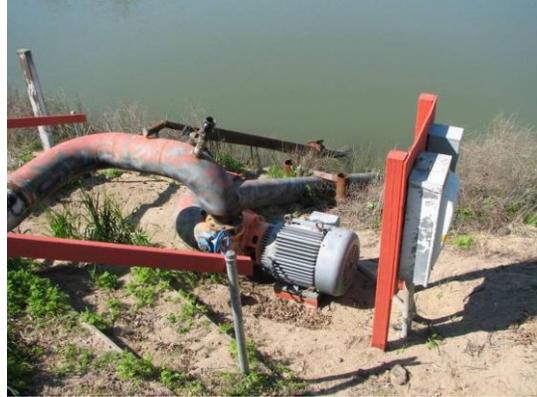
Photo 2 of 3 : UCIP\_FA\_2015\_2315.jpg

Inspector Comments: FS\_ID:43457  
 DS\_ID:24184  
 EP\_NO: 8681  
 FS\_HLM: 4.288  
 Repair Type: Non-Urgent  
 Crossing Status: Found  
 UCIP Comments: Need to contact owner. Is filter sytem located on landward side part of crossing. If so need permit number authorizing work. Also if crossing is no longer used by owner, the owner will need to coordinate with DWR Inspector and CVFPB to remove crossing according to Title 23 requirements. Dense vegetation limits the inspector's visibility to identify signs of pipe failure (leaks) through the levee slopes. Recommend removing vegetation along pipe alignment to conduct proper inspection of structure and appurtenances. Note date on photos should be 3/18/09 not 7/26/08 camera metadata is incorrect.  
 FIELD\_STRUCT\_DESC: 2 of 2: 12-inch steel irrigation pipe through the levee, 4.3 feet feet below the crown. Steel cutoff wall around pipe at center of levee. Pump on platform and gate valve on the waterward slope. Exposed suction pipe from pump to channel. Rock revetment on waterward slope. (Permit No. 8681-1973)

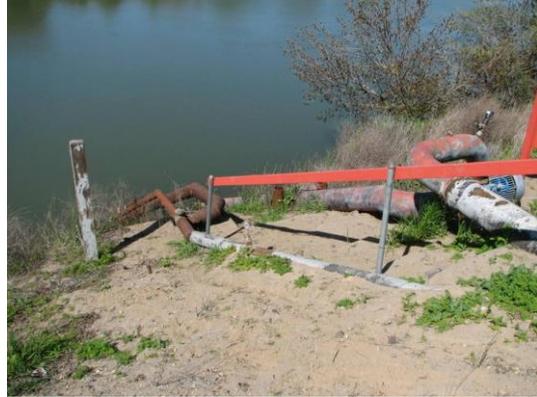
Photo 3 of 3 : UCIP\_FA\_2015\_2316.jpg

LM Start	4.26	Rating **	M	Issue No.	992 (cont)
LM End	4.26	Issue Type +	En	Location *	LS
Category	Supplemental			GPS Latitude/Longitude	
				Start	End
Item	DWR UCIP Field Study			38.310905 °	38.310905 °
				-121.596226 °	-121.596226 °
DWR ID					
Action/Comments					
Inspector Comments: FS_ID:43457 DS_ID:24184 EP_NO: 8681 FS_HLM: 4.288 Repair Type: Non-Urgent Crossing Status: Found UCIP Comments: Need to contact owner. Is filter sytem located on landward side part of crossing. If so need permit number authorizing work. Also if crossing is no longer used by owner, the owner will need to coordinate with DWR Inspector and CVFPB to remove crossing according to Title 23 requirements. Dense vegetation limits the inspector's visibility to identify signs of pipe failure (leaks) through the levee slopes. Recommend removing vegetation along pipe alignment to conduct proper inspection of structure and appurtenances. Note date on photos should be 3/18/09 not 7/26/08 camera metadata is incorrect. FIELD_STRUCT_DESC: 2 of 2: 12-inch steel irrigation pipe through the levee, 4.3 feet feet below the crown. Steel cutoff wall around pipe at center of levee. Pump on platform and gate valve on the waterward slope. Exposed suction pipe from pump to channel. Rock revetment on waterward slope. (Permit No. 8681-1973) FS Date: 03/19/2009

View of waterward side. 2 crossing visible 12-inch and 6-inch pipes.

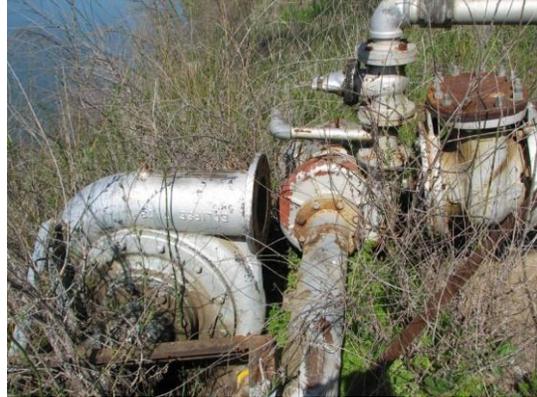
Photo 1 of 3 : UCIP\_FA\_2015\_2317.jpg

LM Start	<b>4.55</b>	Rating **	M	Issue No.	<b>993</b>
LM End	<b>4.55</b>	Issue Type +	En	Location *	CR
Category	Supplemental			GPS Latitude/Longitude	
				Start	End
Item	DWR UCIP Field Study			38.313659 °	38.313659 °
				-121.592159 °	-121.592159 °
DWR ID					
<b>Action/Comments</b>					
Inspector Comments: FS_ID:43459 DS_ID:24185 EP_NO: N/A FS_HLM: 4.583 Repair Type: Non-Urgent Crossing Status: Found

Pump located on waterward side is not connected.

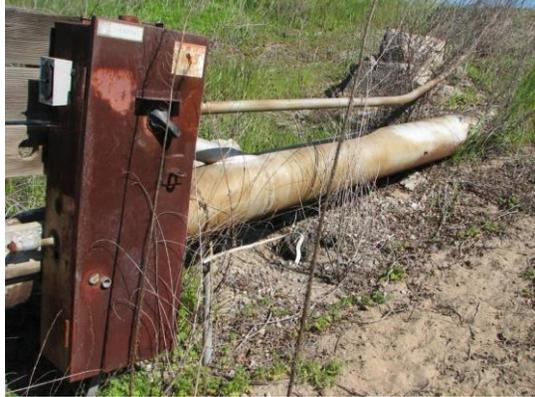
Photo 3 of 3 : UCIP\_FA\_2015\_2319.jpg

Pipe on waterward side.

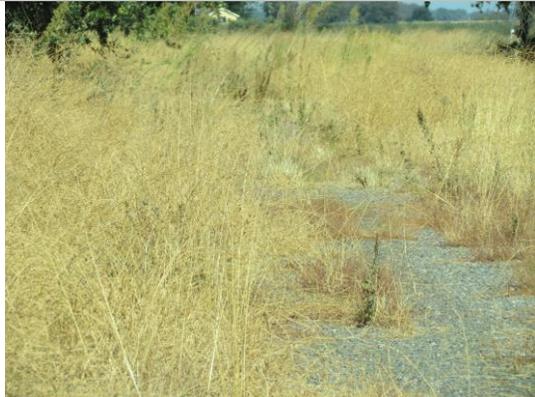
Photo 1 of 1 : FA\_2015\_RD0349\_206\_80\_20151009\_00036.jpg

LM Start	<b>4.74</b>	Rating **	U	Issue No.	<b>80</b>
LM End	<b>6.30</b>	Issue Type +	Ma	Location *	CR
Category	Earthen Levee			GPS Latitude/Longitude	
				Start	End
Item	Vegetation			38.316183 °	38.329088 °
				-121.590735 °	-121.579400 °
DWR ID	DWR_RD0349_03_f_2015_80				
Action/Comments					
Keep the crown roadway free of vegetation. Inspector Comments: Unable to continue from this point, the vegetation growth present on crown road way presented an extreme fire hazard to vehicles equipped with catalytic converter

RD 349 Levee mile 4.74 looking at overgrown crown roadway. Weeds are taller than four feet. Extreme fire hazard.

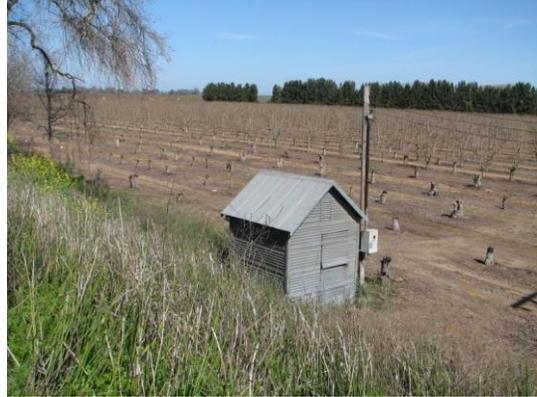
Photo 1 of 3 : UCIP\_FA\_2015\_2320.jpg

Item	DWR UCIP Field Study			38.316968 °	38.316968 °
				-121.590219 °	-121.590219 °
DWR ID					
Action/Comments					
Inspector Comments: FS_ID:43431 DS_ID:24186 EP_NO: 15359 FS_HLM: 4.838 Repair Type: Non-Urgent Crossing Status: Found UCIP Comments: Dense vegetation limits the inspector's visibility to identify signs of pipe failure (leaks) through the levee slopes. Recommend removing vegetation along pipe alignment to conduct proper inspection of structure and appurtenances. Note date on photos should be 3/18/09 not 7/26/08 camera metadata is incorrect. FIELD_STRUCT_DESC: 10-inch steel irrigation pipe through the levee, 6.0 feet below the crown. Siphon breaker in protective house at levee shoulder. Pump in pumphouse and power pole at landward toe. Pipe connected to 8-inch exposed pipe at landward shoulder, extending to pumphouse. Filter screen in channel at waterward toe. (Permit No. 15359-1990) FS Date: 03/19/2009

View of landward side.

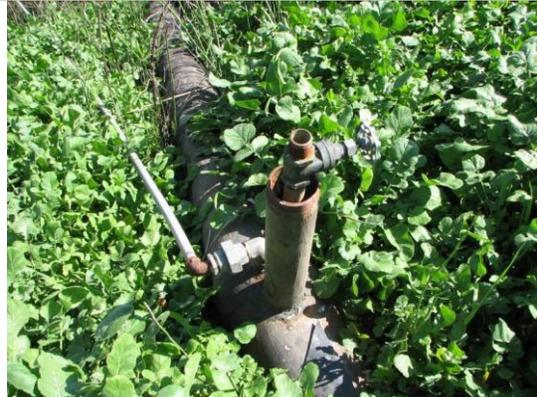
Photo 2 of 3 : UCIP\_FA\_2015\_2321.jpg

Air vent located on pipe on landward.

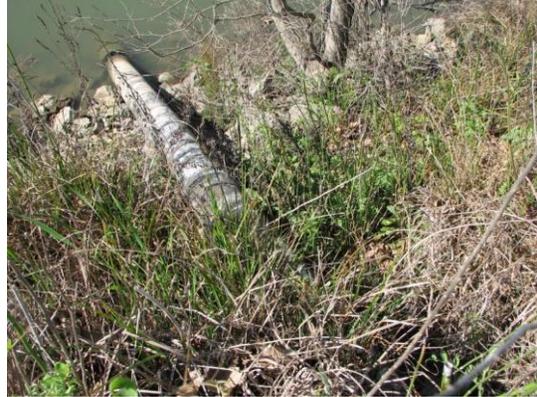
Photo 3 of 3 : UCIP\_FA\_2015\_2322.jpg

Pipe located on waterward side.

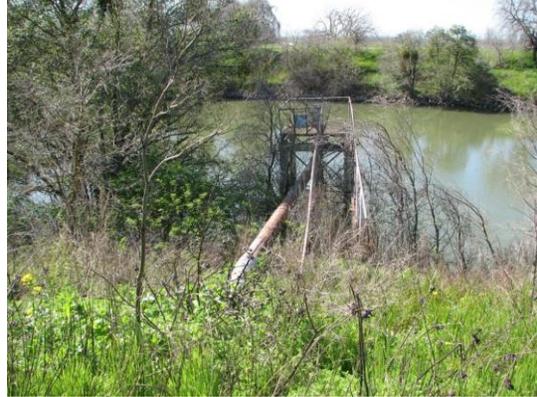
Photo 1 of 2 : UCIP\_FA\_2015\_4373.jpg

Item	DWR UCIP Field Study			38.322448 °	38.322448 °
				-121.589675 °	-121.589675 °
DWR ID					
<b>Action/Comments</b>					
Inspector Comments: FS_ID:43433 DS_ID:24188 EP_NO: N/A FS_HLM: 5.229 Repair Type: Non-Urgent Crossing Status: Found UCIP Comments: Walkway is no longer functional. Need to contact owner--if crossing is no longer used owner will need to coordinate with DWR Inspector and CVFPB. Dense vegetation limits the inspector's visibility to identify signs of pipe failure (leaks) through the levee slopes. Recommend removing vegetation along pipe alignment to conduct proper inspection of structure and appurtenances. Note date on photos should be 3/18/09 not 7/26/08 camera metadata is incorrect. FIELD_STRUCT_DESC: 12-inch pipe through the levee, 6.2 feet below the crown. Pump and control panel on piling structure in stream, with walkway. Service pole and concrete standpipe on the landward slope. (USACE-1959). This entry matches the Drainage or Irrigation Structure referenced in O&M manual (HLM 5.5). FS Date: 03/19/2009

View of waterward side--pipe and remaining appurtenances.
