**Flood Control Project Maintenance  
Levee Inspections**

**Fall 2015 Levee Maintenance Deficiency Summary Report  
Overall LMA & Unit Ratings, including USACE Erosion Survey**

**Reclamation District No. 0349 Sutter Island**

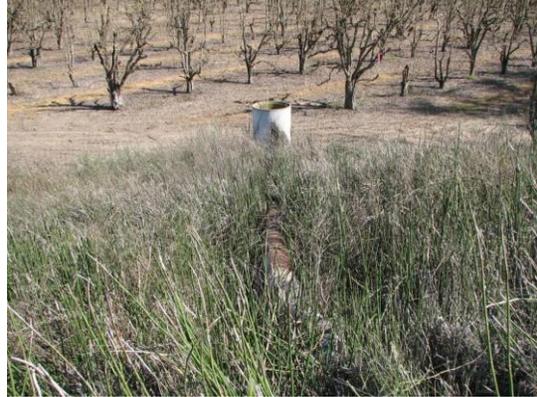
Photo 2 of 2 : UCIP\_FA\_2015\_4374.jpg

Item	DWR UCIP Field Study			38.322448 °	38.322448 °
				-121.589675 °	-121.589675 °
DWR ID					
<b>Action/Comments</b>					
Inspector Comments: FS_ID:43433 DS_ID:24188 EP_NO: N/A FS_HLM: 5.229 Repair Type: Non-Urgent Crossing Status: Found UCIP Comments: Walkway is no longer functional. Need to contact owner--if crossing is no longer used owner will need to coordinate with DWR Inspector and CVFPB. Dense vegetation limits the inspector's visibility to identify signs of pipe failure (leaks) through the levee slopes. Recommend removing vegetation along pipe alignment to conduct proper inspection of structure and appurtenances. Note date on photos should be 3/18/09 not 7/26/08 camera metadata is incorrect. FIELD_STRUCT_DESC: 12-inch pipe through the levee, 6.2 feet below the crown. Pump and control panel on piling structure in stream, with walkway. Service pole and concrete standpipe on the landward slope. (USACE-1959). This entry matches the Drainage or Irrigation Structure referenced in O&M manual (HLM 5.5). FS Date: 03/19/2009

View of landwar side--pipe and stand pipe visible.

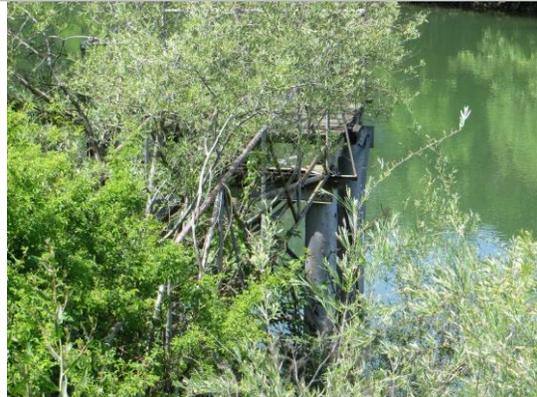
Photo 1 of 3 : UCIP\_FA\_2015\_6837.jpg

LM Start	<b>5.19</b>	Rating **	M	Issue No.	<b>996</b>
LM End	<b>5.19</b>	Issue Type +	En	Location *	WS
Category	Supplemental			GPS Latitude/Longitude	
				Start	End
Item	DWR UCIP Field Study			38.322460 °	38.322460 °
				-121.589690 °	-121.589690 °
DWR ID					
<b>Action/Comments</b>					
Inspector Comments: FS_ID:44391 DS_ID:24189 EP_NO: N/A FS_HLM: 5.23 Repair Type: Non-Urgent Crossing Status: Found UCIP Comments: Appears abandoned and if so should be done so properly. FIELD_STRUCT_DESC: 4-inch pipe through the levee, 3.3 feet below the crown. Gate and pump on platform at the landward toe (missing). Platform on the waterward side. (USACE-1959). This entry matches the Drainage or Irrigation Structure referenced in O&M manual (HLM 5.6). FS Date: 04/09/2015

Pier on WS toe.

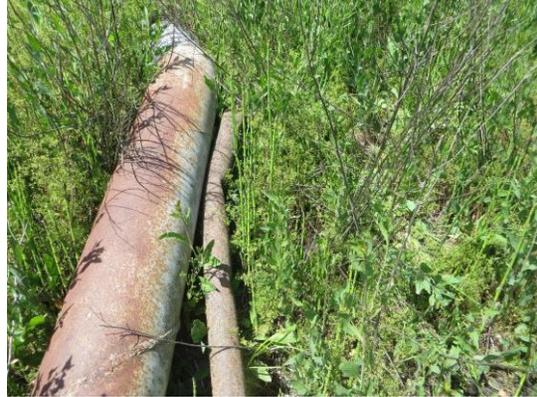
Photo 2 of 3 : UCIP\_FA\_2015\_6838.jpg

Inspector Comments: FS\_ID:44391  
 DS\_ID:24189  
 EP\_NO: N/A  
 FS\_HLM: 5.23  
 Repair Type: Non-Urgent  
 Crossing Status: Found  
 UCIP Comments: Appears abandoned and if so should be done so properly.  
 FIELD\_STRUCT\_DESC: 4-inch pipe through the levee, 3.3 feet below the crown. Gate and pump on platform at the landward toe (missing). Platform on the waterward side. (USACE-1959). This entry matches the Drainage or Irrigation Structure referenced in O&M manual (HLM 5.6).  
 FS Date: 04/09/2015

4-inch pipe next to larger pipe on LS slope.

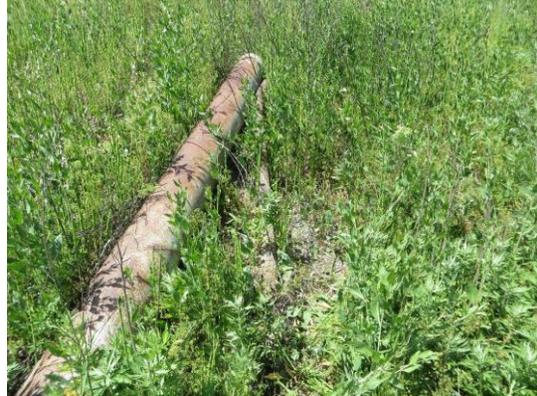
Photo 3 of 3 : UCIP\_FA\_2015\_6839.jpg

4-inch pipe next to larger pipe on LS slope.

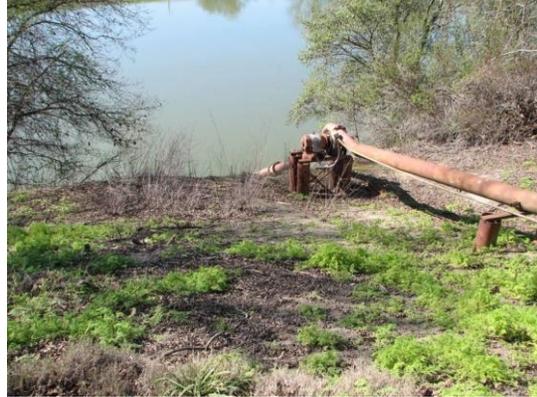
Photo 2 of 2 : UCIP\_FA\_2015\_2359.jpg

LM Start	5.58	Rating **	U	Issue No.	998 (cont)
LM End	5.58	Issue Type +	En	Location *	LS
Category	Supplemental			GPS Latitude/Longitude	
			Start	End	
Item	DWR UCIP Field Study			38.326096 °	38.326096 °
				-121.584747 °	-121.584747 °
DWR ID					
Action/Comments					
Inspector Comments: FS_ID:43436 DS_ID:24190 EP_NO: 16077 FS_HLM: 5.626 Repair Type: Urgent Crossing Status: Found UCIP Comments: Soil disturbed on landward slope--need to contact owner. Also vegetation limits the inspector's visibility to identify signs of pipe failure (leaks) along the slope. Recommend removing vegetation along pipe alignment to conduct proper inspection of structure and appurtenances. Note date on photos should be 3/18/09 not 7/26/08 camera metadata is incorrect. FIELD_STRUCT_DESC: 10-inch pipe through the levee, 3.8 feet below the crown. Pump in pumphouse on waterward side. Service pole on waterward slope. Concrete standpipe and distribution box at waterward toe. Pipe is exposed on both slopes. (USACE-1959). This entry matches the Drainage or Irrigation Structure referenced in O&M manual (HLM 5.9). Section of pipe under crown, between shoulders, removed and replaced with 10-inch steel pipe under Permit No. 16077 (2000). FS Date: 03/19/2009

View of pipe and pump along waterward slope.
