**Flood Control Project Maintenance
Levee Inspections**
LMA District Cover Sheet
Spring 2015 Levee Inspection Results

Reclamation District No. 0349 Sutter Island

Spring 2015 Levee Inspection Results

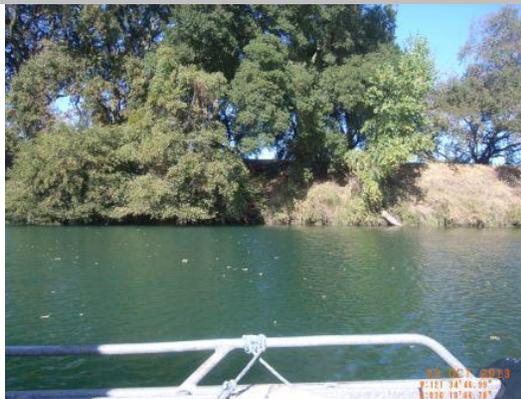
Photo 1 of 1 : SP_2015_RD0349_205_28_20150312_00015.jpg

LM Start	0.34	Rating **	M	Issue No.	28
LM End	0.39	Issue Type +	Ma	Location *	WS
Category	Supplemental			GPS Latitude/Longitude	
				Start	End
Item	USACE Erosion Survey			38.302358 °	38.301772 °
				-121.579707 °	-121.580093 °
DWR ID	DWR_RD0349_02_f_2014_28				
Action/Comments					
Inspector Comments: 2007 - Slow erosion, probably due to wave wash and fluvial erosion. Site has likely been here for awhile but was unseen due to boats parked in front. 2013: No observed changes. [2013 Site ID: STM_25-8_R]

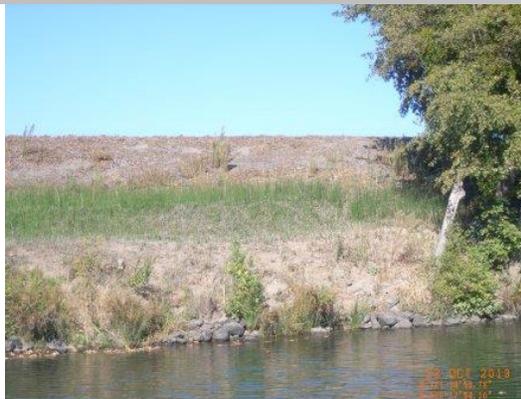
Photo 1 of 1 : SP_2015_RD0349_205_27_20150312_00014.jpg

LM Start	0.60	Rating **	M	Issue No.	27
LM End	0.72	Issue Type +	Ma	Location *	WS
Category	Supplemental			GPS Latitude/Longitude	
				Start	End
Item	USACE Erosion Survey			38.298897 °	38.297384 °
				-121.581571 °	-121.582176 °
DWR ID	DWR_RD0349_02_f_2014_27				
Action/Comments					
Inspector Comments: 2010 - Small maintenance, erosion into the toe. 2011 - Minor new erosion at toe. 2013: No observed changes. [2013 Site ID: STM_25-5_R]

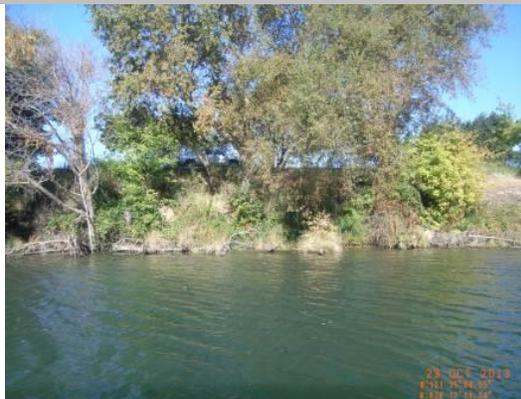
Photo 1 of 1 : SP_2015_RD0349_205_26_20150312_00013.jpg

LM Start	1.33	Rating **	U	Issue No.	26
LM End	1.49	Issue Type +	Ma	Location *	WS
Category	Supplemental			GPS Latitude/Longitude	
				Start	End
Item	USACE Erosion Survey			38.288727 °	38.286475 °
				-121.583823 °	-121.585026 °
DWR ID	DWR_RD0349_02_f_2014_26				
Action/Comments					
Inspector Comments: 1997 - Erosion of very sandy levee behind large stand of riparian vegetation on top right bank. Dry ravel of sand. 1999 - Quarry waste rock was dumped down the levee slope; poor repair job; still eroding in places. Eroding at midslope off fabric. 2005 - Length revised, only the middle 150 - 200 ft are eroding. 2006 - Some rock/small material dumped down the bank but it is slowly unraveling. Upstream end is unraveling faster. Steep slope with poor gradation so fines are washing out. 2010 - Lots of overhanging trees and erosion pockets. 2011 - This site is upgraded to CRITICAL. Near vertical bank at the downstream end. New erosion at various locations throughout the site. 2013: No observed changes. [2013 Site ID: STM_24-7_R]

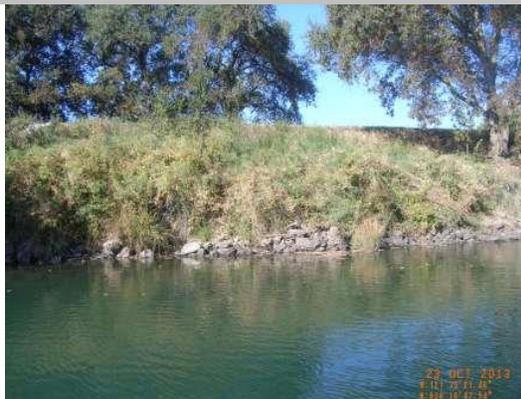
Photo 1 of 1 : SP_2015_RD0349_205_23_20150312_00012.jpg

LM Start	2.04	Rating **	M	Issue No.	23
LM End	2.05	Issue Type +	Ma	Location *	WS
Category	Supplemental			GPS Latitude/Longitude	
				Start	End
Item	USACE Erosion Survey			38.280069 °	38.279919 °
				-121.589443 °	-121.589438 °
DWR ID	DWR_RD0349_02_f_2014_23				
Action/Comments					
Inspector Comments: 2011 - Small scallop caused by erosion and wave wash. 2013: No observed changes. [2013 Site ID: STM_24-1_R]

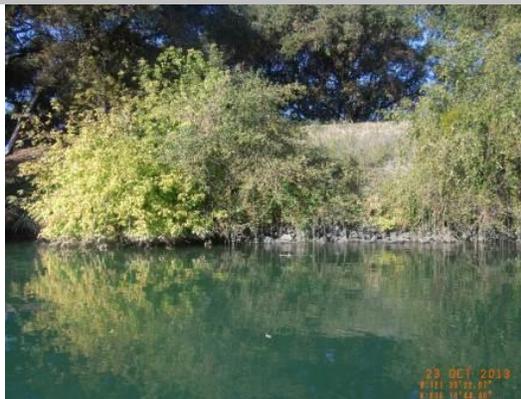
Photo 1 of 1 : SP_2015_RD0349_205_21_20150312_00011.jpg

LM Start	2.11	Rating **	M	Issue No.	21
LM End	2.14	Issue Type +	Ma	Location *	WS
Category	Supplemental			GPS Latitude/Longitude	
				Start	End
Item	USACE Erosion Survey			38.279017 °	38.278597 °
				-121.589615 °	-121.589854 °
DWR ID	DWR_RD0349_02_f_2014_21				
Action/Comments					
Inspector Comments: 1997 - Top right bank has retreated into the levee. Site is between two rock sites. 1999 - Downstream half of the reach repaired with rock. 2000 - Trees leaning into the water. 2010 - Site appears worse. 2011 - New erosion at the toe. 2013: Short vertical sections observed at upstream end. [2013 Site ID: STM_23-9_R]

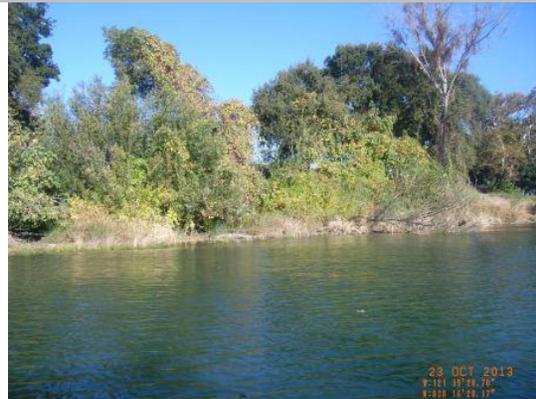
Photo 1 of 2 : SP_2015_RD0349_205_19_20150312_00009.jpg

LM Start	2.56	Rating **	M	Issue No.	19
LM End	2.69	Issue Type +	Ma	Location *	WS
Category	Supplemental		GPS Latitude/Longitude		
			Start	End	
Item	USACE Erosion Survey		38.273854 °	38.271998 °	
			-121.588745 °	-121.589424 °	
DWR ID	DWR_RD0349_02_f_2014_19				
Action/Comments					
Inspector Comments: 2011 - Toe scour at the tidal zone. 2013: No observed changes. [2013 Site ID: STM_23-6_R]

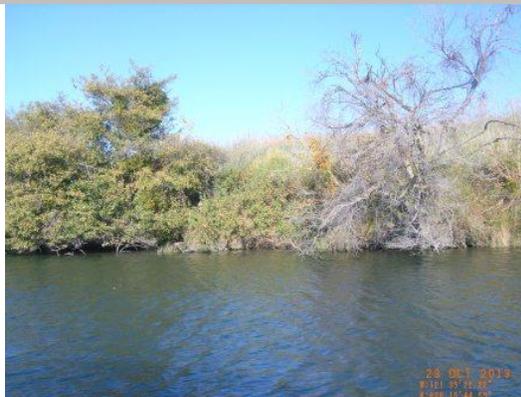
Photo 1 of 1 : SP_2015_RD0349_205_3_20150312_00004.jpg

LM Start	3.37	Rating **	M	Issue No.	3
LM End	3.49	Issue Type +	Ma	Location *	WS
Category	Supplemental			GPS Latitude/Longitude	
				Start	End
Item	USACE Erosion Survey			38.262510 °	38.262533 °
				-121.589481 °	-121.591690 °
DWR ID	DWR_RD0349_02_f_2014_3				
Action/Comments					
Inspector Comments: 2010 - Slumping sections on the lower bank, appears to be scouring around the trees. 2011 - Soil beach at toe. 2013: No observed changes. [2013 Site ID: STM_22-8_R]
