**Flood Control Project Maintenance
Levee Inspections**

Fall 2011 Levee Maintenance Deficiency Summary Report

**Flood Control Project Maintenance
Levee Inspections
LMA District Cover Sheet
Fall 2011 Levee Inspection Results**

Reclamation District No. 0501 Ryer Island

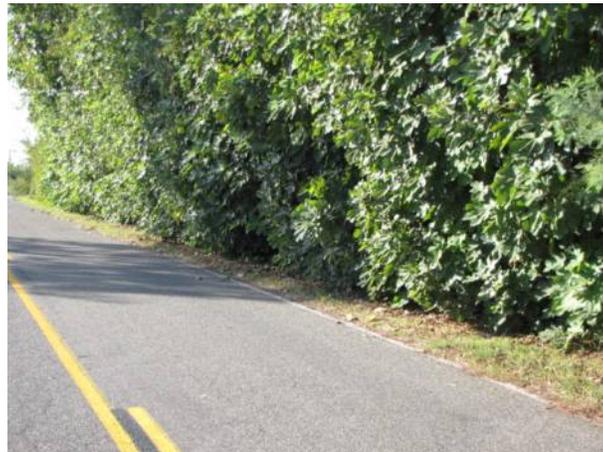
Levee Mile Report Line	9
Start Levee Mile	0.26
End Levee Mile	0.28
Location	Land Side
Category	Earthen Levee
Item	Trim / Thin Trees
This is a view of unsatisfactory fig growth on the levee section land side looking downstream from levee mile 0.26 to 0.28. This photo was taken 11-03-2010. No change since last inspection.	
phillips_f_20110929_109.jpg

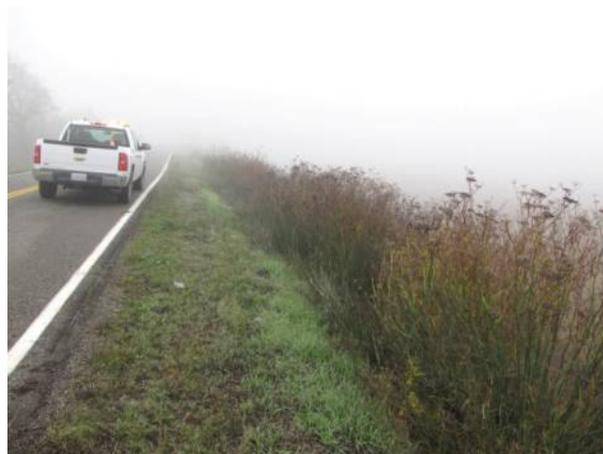
Levee Mile Report Line	20
Start Levee Mile	0.75
End Levee Mile	0.94
Location	Land Side
Category	Earthen Levee
Item	Vegetation
New photo for levee mile 0.75-0.94 RD 501 Unit 1. Photo taken 11-29-2011.	
phillips_f_20111206_098.jpg

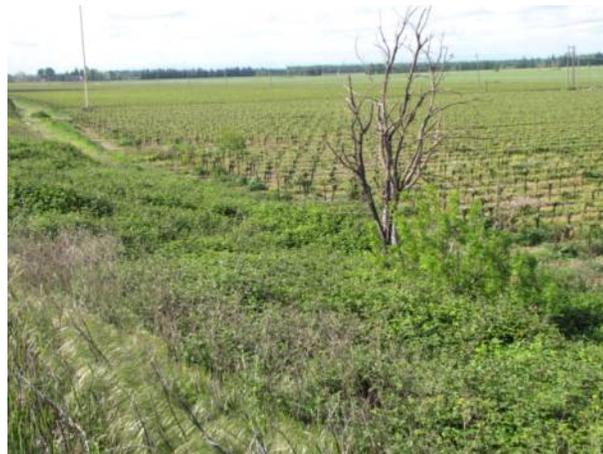
Levee Mile Report Line	24
Start Levee Mile	1.55
End Levee Mile	1.74
Location	Land Side
Category	Earthen Levee
Item	Vegetation
Another view of the unsatisfactory growth on landside slope. Photo taken 4-19-11.	
phillips_f_20110929_116.jpg

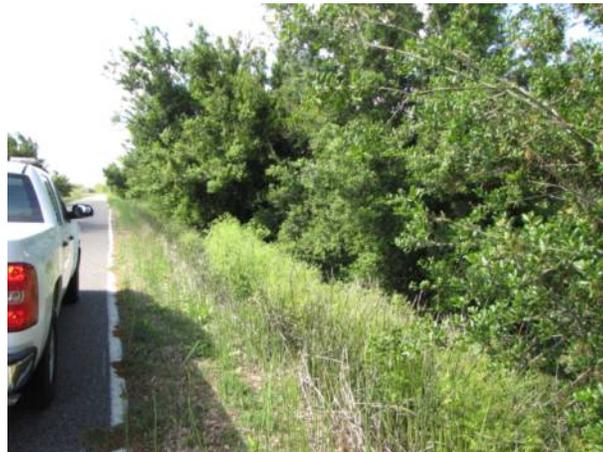
Levee Mile Report Line	38
Start Levee Mile	3.34
End Levee Mile	3.36
Location	Land Side
Category	Earthen Levee
Item	Trim / Thin Trees
Another photo of the unsatisfactory growth on levee slope from levee mile 3.34 to 3.36. Photo taken 4-19-11.	
phillips_f_20110929_123.jpg

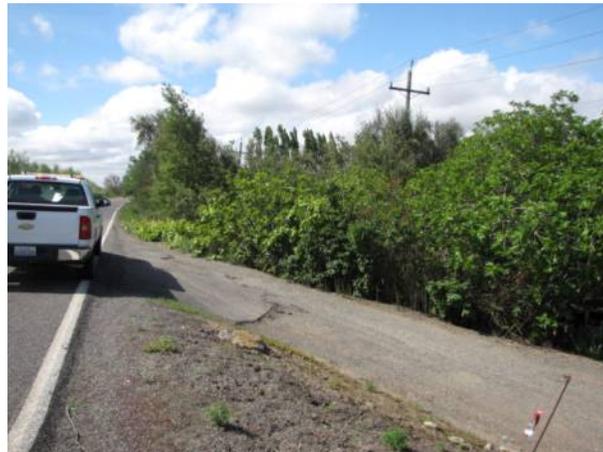
Levee Mile Report Line	47
Start Levee Mile	3.80
End Levee Mile	4.14
Location	Land Side
Category	Earthen Levee
Item	Vegetation
New photo of unsatisfactory growth landward levee mile 3.80-4.14. Photo taken 4-19-11.	
phillips_f_20110929_118.jpg

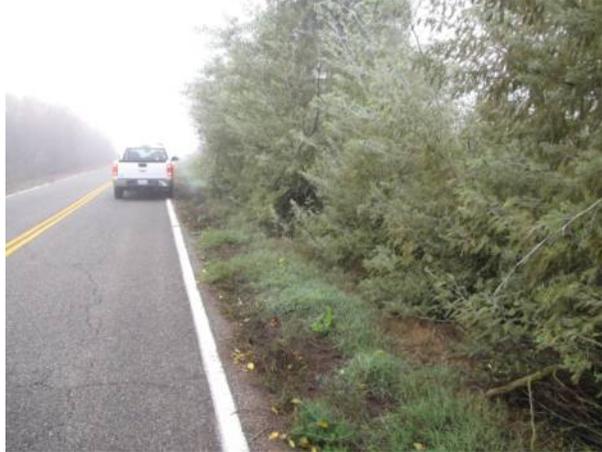
phillips_f_20111206_099.jpg

Photo of unsatisfactory wild growth on landward shoulder and slope levee miles 3.78-4.13. Photo taken 11-29-2011.

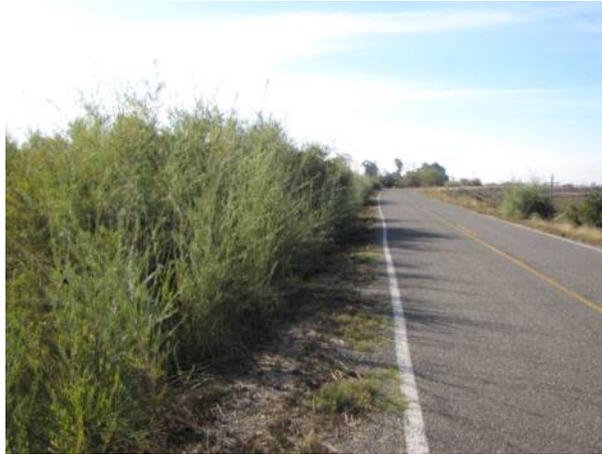
phillips_f_20110929_112.jpg

Looking downstream from levee mile 4.00 waterside sand willows block view of slope. 11-03-2010

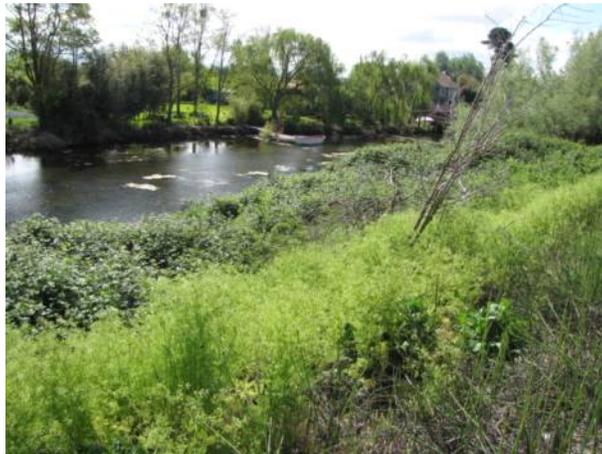
phillips_f_20110929_113.jpg

Looking downstream at waterside unsatisfactory growth on the levee slope. No change from fall inspection. Photo taken 4-19-11.

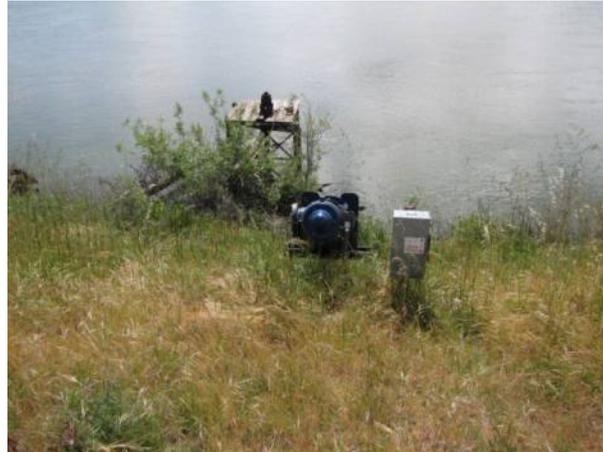
phillips_f_20110929_119.jpg

Photo of unauthorized pipe, pump and electrical box placed on waterward slope.

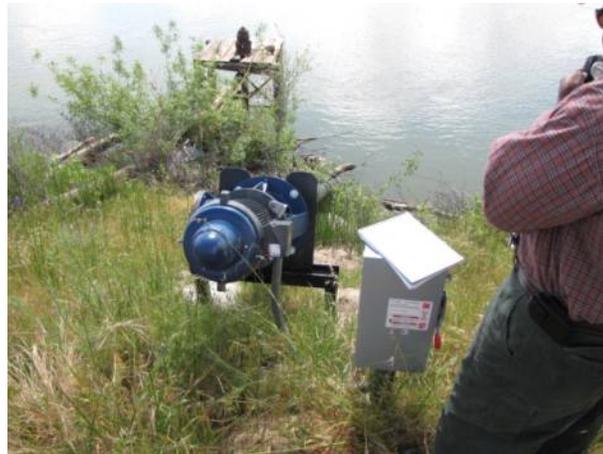
phillips_f_20110929_120.jpg

Another view of the unauthorized pipe. At levee mile 5.93. Unit 1 RD 501. Photo taken 4-19-11.

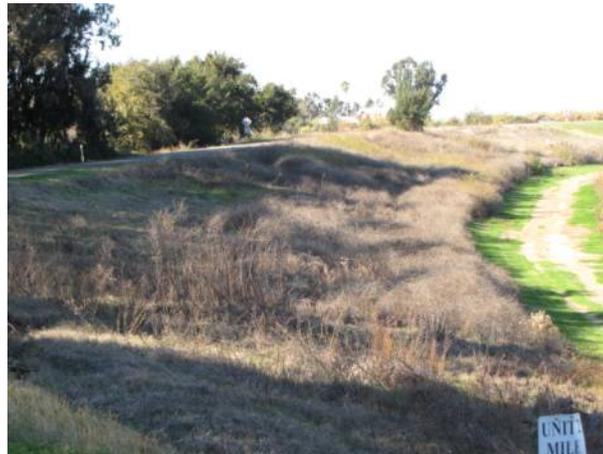
Levee Mile Report Line	3
Start Levee Mile	0.44
End Levee Mile	0.44
Location	Land Side
Category	Earthen Levee
Item	Vegetation
RD 501 Unit 2 looking downstream landside. Photo taken 11-29-2011.	
phillips_f_20111205_081.jpg

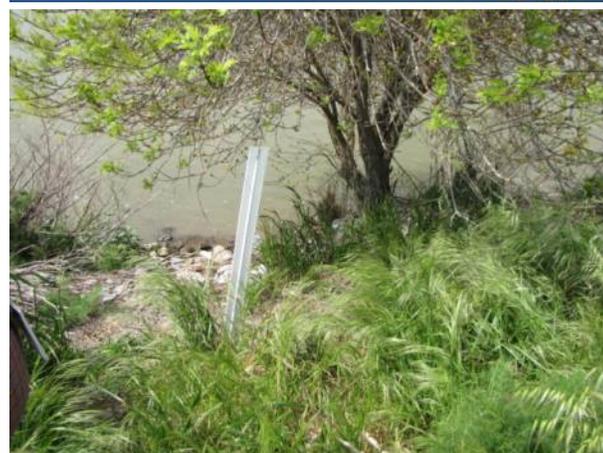
Levee Mile Report Line	6
Start Levee Mile	1.03
End Levee Mile	1.03
Location	Water Side
Category	Earthen Levee
Item	Erosion / Bank Caving
Down at the base of the tree and the stake in view is bank erosion. This site was discovered 2-11 by a resident of the Hester property on the landside of the levee. The District has placed material in the eroded area however more is needed. Photo was taken 4-19-11.	
phillips_f_20110929_125.jpg

6	1.03	1.03	Earthen Levee	Erosion / Bank Caving	WS W	Schedule repair of erosion site prior to the next inspection.		38.198153 ° -121.655614 °	38.198153 ° -121.655614 °	10 Y
7	1.07	1.11	Earthen Levee	Vegetation	WS M	Remove the wild growth other than native grasses from the levee slopes.		38.198602 ° -121.655605 °	38.199148 ° -121.655490 °	8
8	1.98	3.02	Earthen Levee	Vegetation	WS M	Remove the wild growth other than native grasses from the levee slopes.		38.226175 ° -121.604013 °	38.212626 ° -121.609959 °	3
9	1.98	3.02	Earthen Levee	Vegetation	LS M	Remove the wild growth other than native grasses from the levee slopes.		38.207621 ° -121.656219 °	38.220184 ° -121.670834 °	5
10	2.92	2.93	Earthen Levee	Animal Control	LS M	Exterminate rodents and backfill and compact or grout burrows.		38.218890 ° -121.669934 °	38.218997 ° -121.669988 °	4
11	3.43	3.43	Earthen Levee	Trim / Thin Trees	LS M	Trim trees to at least five feet above ground level.		38.225823 ° -121.672837 °	38.225823 ° -121.672837 °	16

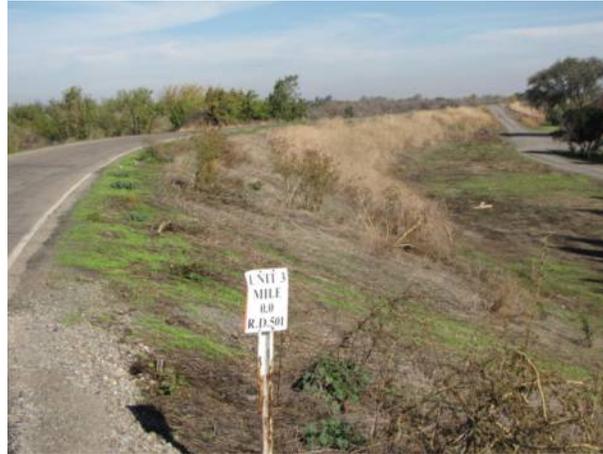
phillips_f_20110929_129.jpg

Levee mile 0,00 Unit 3 looking downstream on land side. Taken 11-03-2010

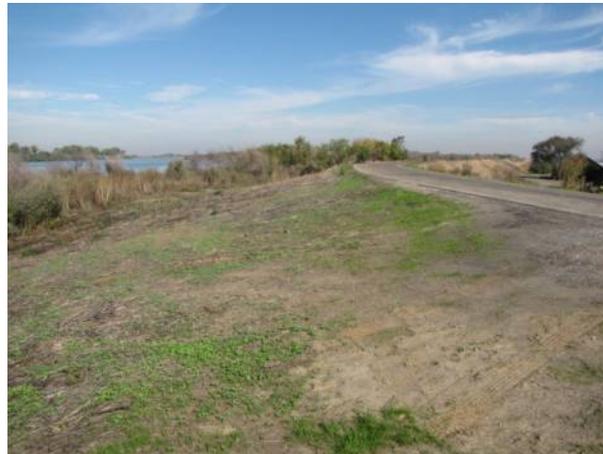
phillips_f_20110929_130.jpg

Standing on waterside levee slope Unit 3 RD 501 Levee mile 0.00 looking downstream at levee. Taken 11-03-2010

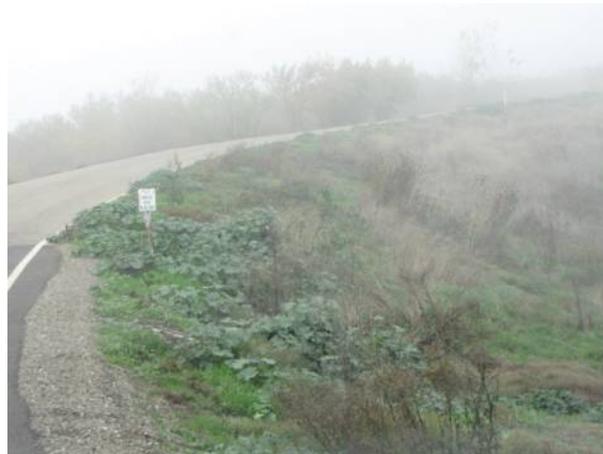
phillips_f_20111205_082.jpg

RD 501 Unit 3 looking downstream from levee mile 0.00 landside slope. Photo taken 11-29-2011

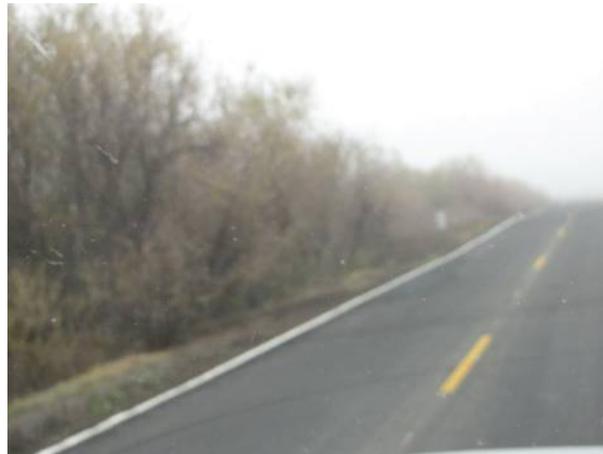
Levee Mile Report Line	7
Start Levee Mile	2.66
End Levee Mile	2.78
Location	Water Side
Category	Earthen Levee
Item	Vegetation
RD 501 Unit 3 levee mile 2.66-2.78 waterside looking downstream. Photo taken 11-29-2011.	
phillips_f_20111205_080.jpg

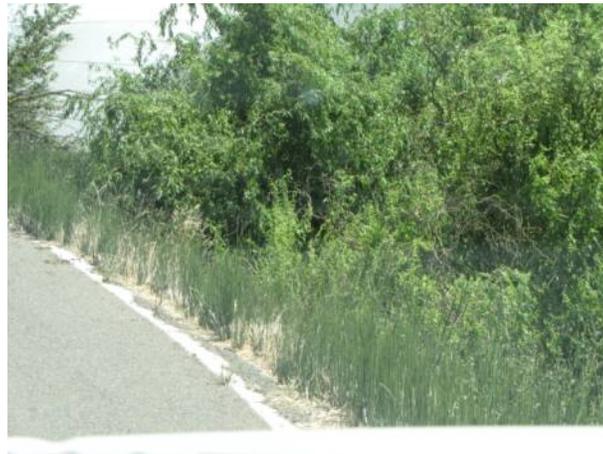
Levee Mile Report Line	8
Start Levee Mile	3.52
End Levee Mile	3.55
Location	Water Side
Category	Earthen Levee
Item	Trim / Thin Trees
Levee mile 3.55 land side tree growth on slope, you can't see the slope for wild growth. These trees has not been trimmed. Photo taken 11-03-2010	
phillips_f_20110929_138.jpg

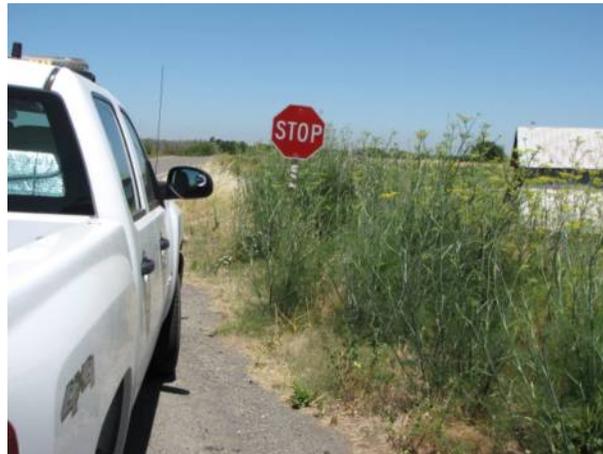
Levee Mile Report Line	10
Start Levee Mile	3.69
End Levee Mile	3.70
Location	Land Side
Category	Earthen Levee
Item	Trim / Thin Trees
Looking downstream from 3.70 tall growth continues down stream from this point. Taken 11-03-2010	
phillips_f_20110929_141.jpg

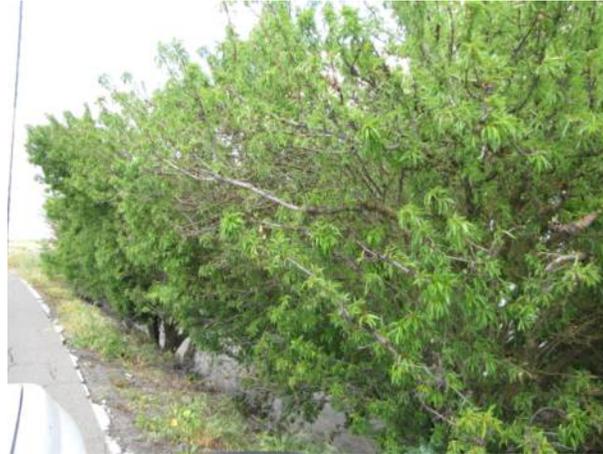
phillips_f_20110929_142.jpg

Levee mile 3.69 to 3.70 new photo of the unsatisfactory growth on the landside levee slope. Photo taken 4-19-11.

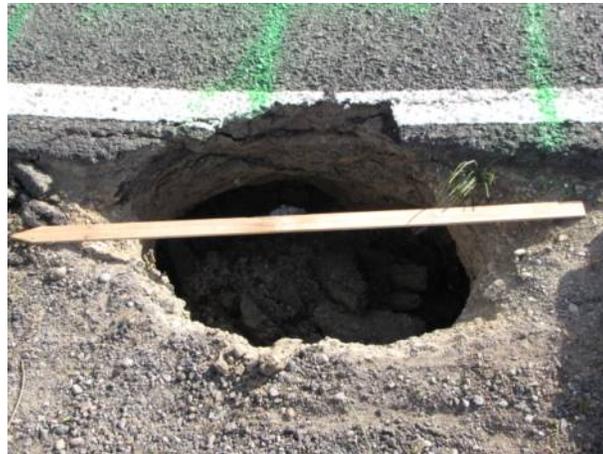
phillips_f_20111205_077.jpg

The photo here shows caving due to a bad irrigation pipe within levee section. Photo taken 11-07-2011

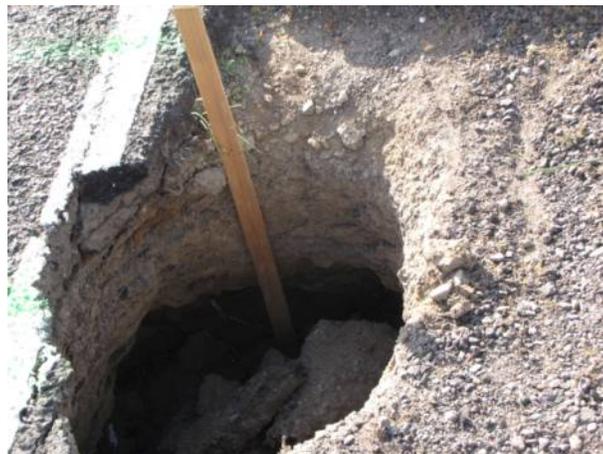
phillips_f_20111205_078.jpg

Another photo taken of the same. Photo taken 11-07-2011

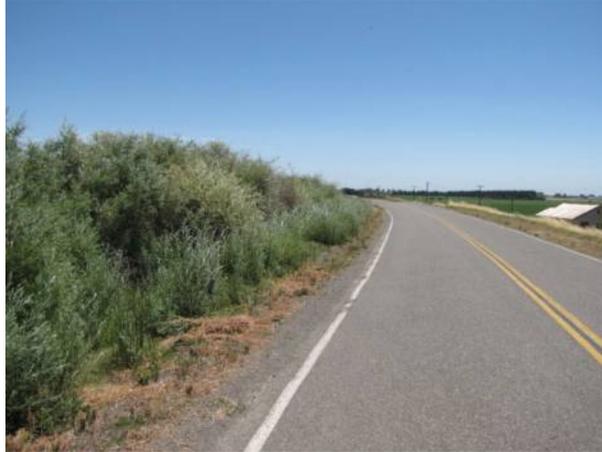
phillips_f_20110929_131.jpg

Levee mile 6.43 water side the wild growth blocks view of water ward slope, looking downstream. You can't see the levee section for the wild growth.

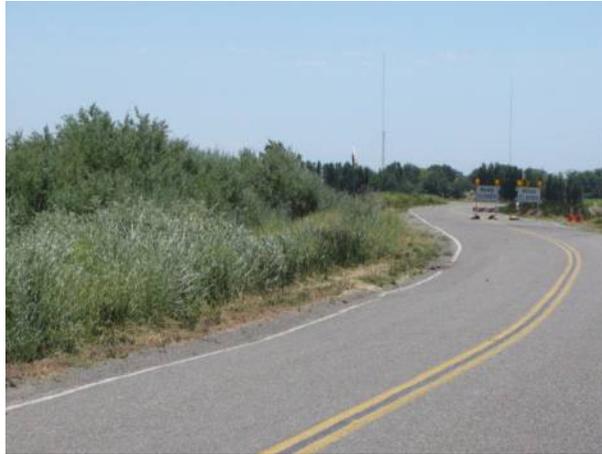
phillips_f_20110929_132.jpg

Wild growth continues downstream, levee section blocked by growth.

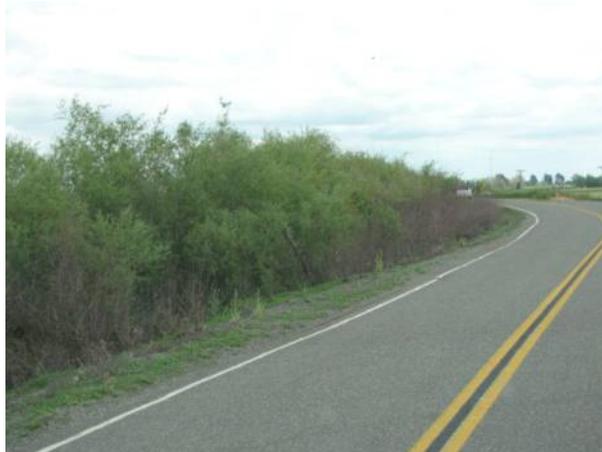
phillips_f_20110929_133.jpg

New photo of waterside unsatisfactory growth levee mile 6.43 to 6.55 looking downstream. Photo taken 4-19-11.

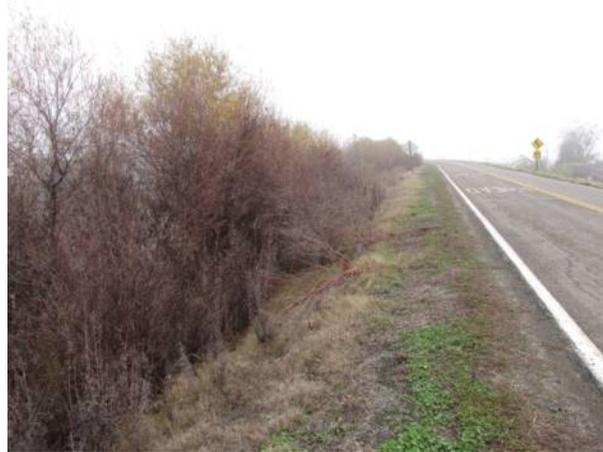
Levee Mile Report Line	15
Start Levee Mile	6.43
End Levee Mile	6.52
Location	Water Side
Category	Earthen Levee
Item	Trim / Thin Trees
New photo of trees. Photo taken 11-29-2011	
phillips_f_20111205_083.jpg

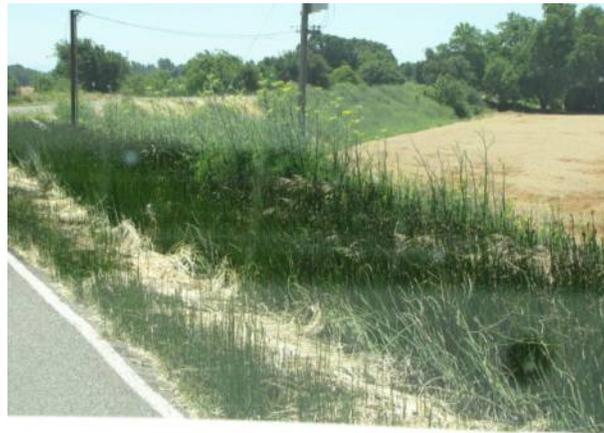
Levee Mile Report Line	4
Start Levee Mile	0.50
End Levee Mile	1.15
Location	Land Side
Category	Earthen Levee
Item	Vegetation
Looking downstream land side wild growth taking over the slope continuing onward downstream to levee mile 1.15.	
phillips_f_20110929_145.jpg

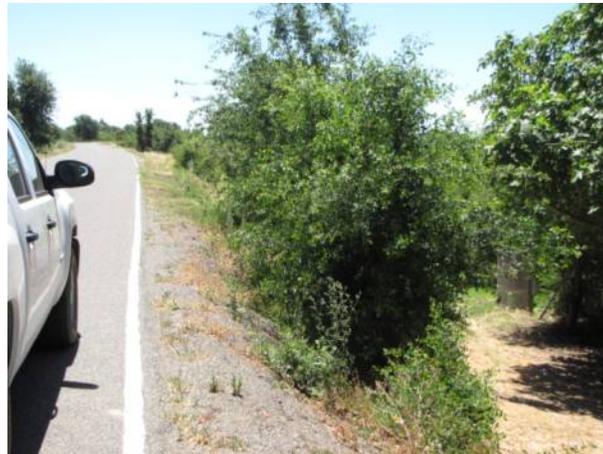
Levee Mile Report Line	12
Start Levee Mile	1.84
End Levee Mile	1.87
Location	Land Side
Category	Earthen Levee
Item	Trim / Thin Trees
<p>Looking back upstream from landside the fig trees has not been maintained, they block the shoulder and slope of the levee section as well as hanging over the levee.</p>	
<p>phillips_f_20110929_149.jpg</p>

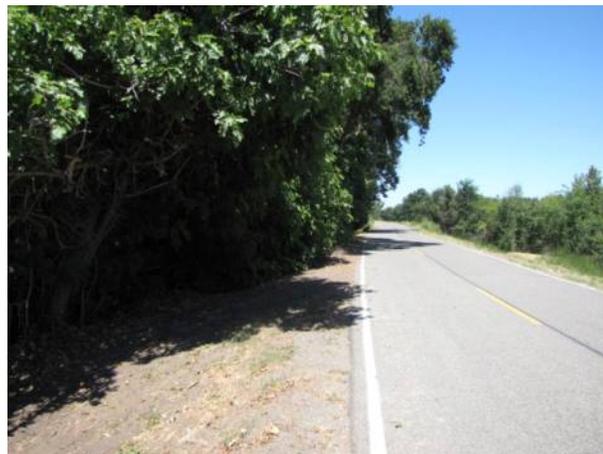
New photo of unsatisfactory growth landside levee mile 1.84. Photo taken 4-19-11.

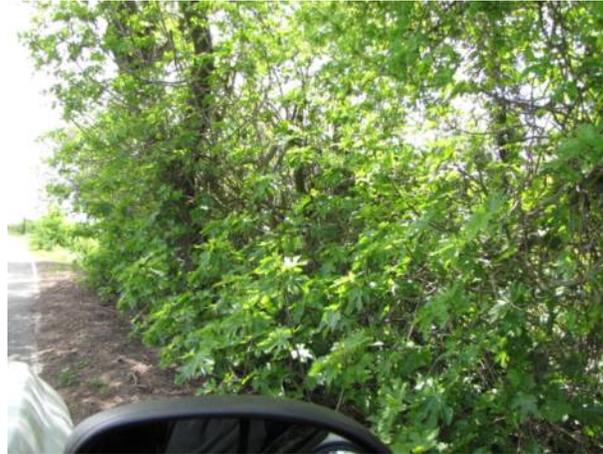
Levee Mile Report Line	12
Start Levee Mile	1.84
End Levee Mile	1.87
Location	Land Side
Category	Earthen Levee
Item	Trim / Thin Trees

RD 501 Unit 4 levee mile 184-1.87 looking downstream landside. Photo taken 11-29-2011.

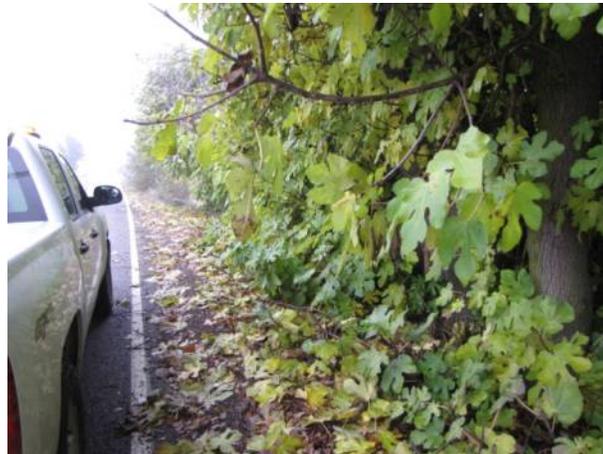
Levee Mile Report Line	14
Start Levee Mile	2.05
End Levee Mile	2.11
Location	Land Side
Category	Earthen Levee
Item	Vegetation

Standing up stream of levee mile 2.05 looking downstream at unsatisfactory growth of wild berries on landside slope toe and shoulder of levee section. Taken 11-03-2010.

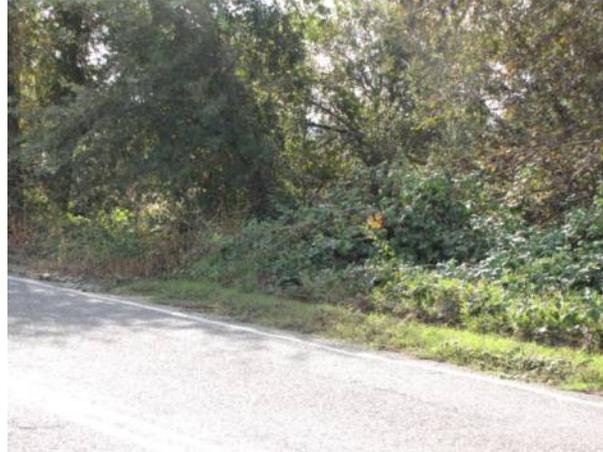
Levee Mile Report Line	14
Start Levee Mile	2.05
End Levee Mile	2.11
Location	Land Side
Category	Earthen Levee
Item	Vegetation
<p>Downstream view of the wild growth of berries on the landside slope unit 4 RD 501, levee mile 2.11. This wild makes impossible to inspect the levee slope. Taken 11-03-2010</p>	
<p>phillips_f_20110929_144.jpg</p>
