**Flood Control Project Maintenance  
Levee Inspections**

**Fall 2013 Levee Maintenance Deficiency Summary Report**

**Reclamation District No. 0501 Ryer Island**

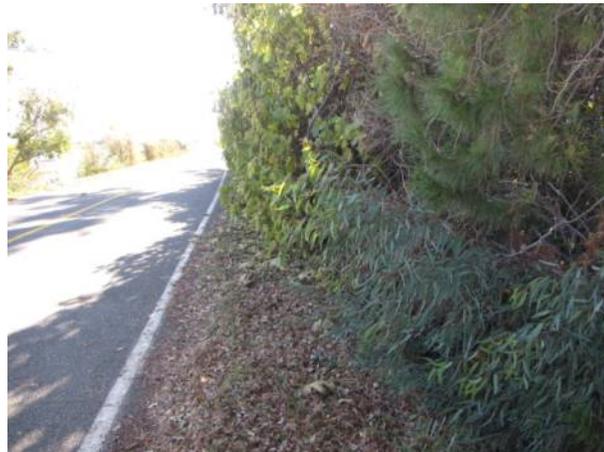
Levee Mile Report Line	6
Start Levee Mile	0.02
End Levee Mile	0.03
Location	Land Side
Category	Earthen Levee
Item	Vegetation
Unsatisfactory woody vegetation blocking visibility of levee section. Photo taken 11-22-2013.	
phillips_f_20131203_751.JPG

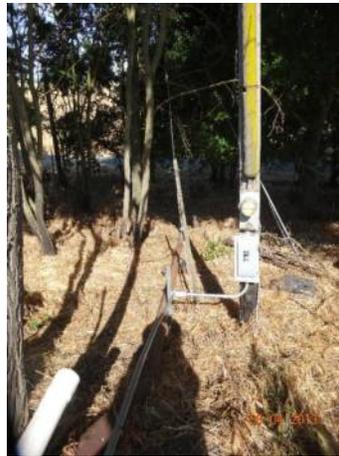
UCIP\_10574.jpg

Overview of landward side--electrical controls, conduit, pipe, and new sleeved PVC line.

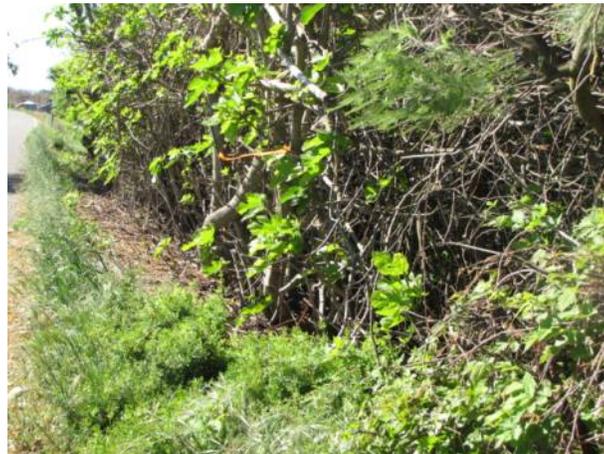
Levee Mile Report Line	27
Start Levee Mile	0.26
End Levee Mile	0.28
Location	Land Side
Category	Earthen Levee
Item	Trim / Thin Trees

Unsatisfactory growth of fig trees that has the slope covered past the landward toe, unable to see the levee section. Photo taken 4-9-2013. No new photo taken 11-22-2013.

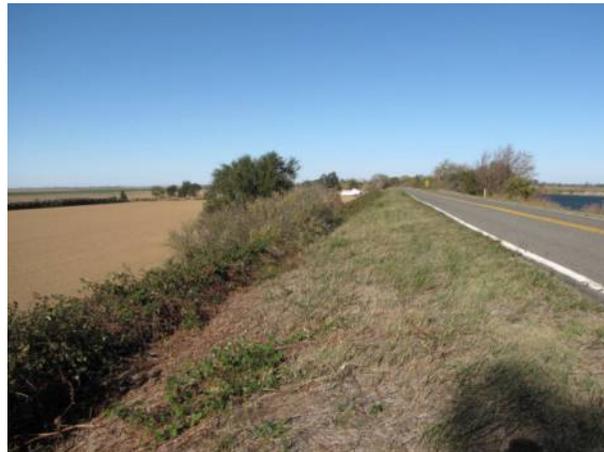
Levee Mile Report Line	51
Start Levee Mile	0.75
End Levee Mile	0.94
Location	Land Side
Category	Earthen Levee
Item	Vegetation
Unsatisfactory growth of blackberries on slope and toe. Photo taken 11-22-2013.	
phillips_f_20131203_755.JPG

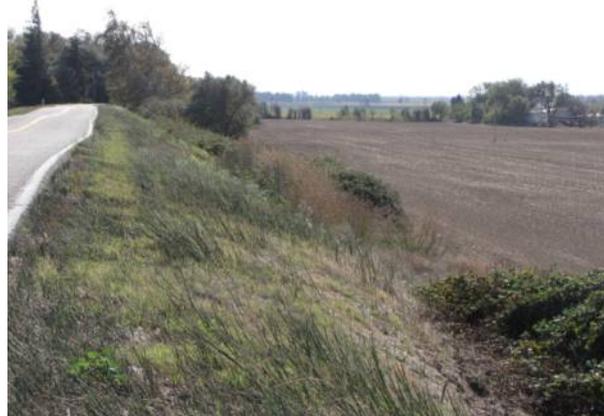
Levee Mile Report Line	52
Start Levee Mile	0.98
End Levee Mile	1.04
Location	Land Side
Category	Earthen Levee
Item	Vegetation
Wild growth of berries on landward slope and toe. Photo taken 11-22-2013.	
phillips_f_20131203_756.JPG

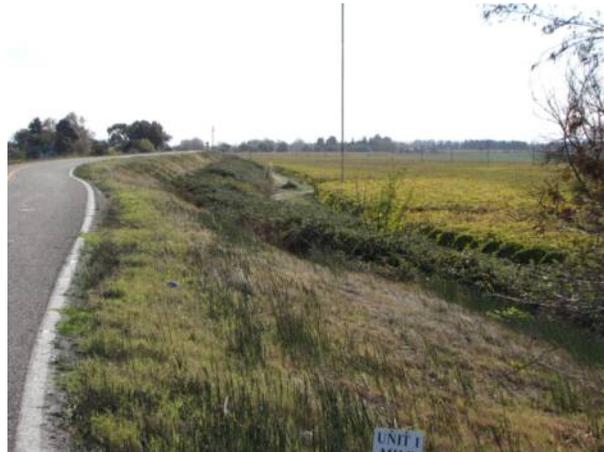
Levee Mile Report Line	56
Start Levee Mile	1.02
End Levee Mile	1.02
Location	Land Side
Category	Earthen Levee
Item	Vegetation
Looking downstream from levee mile 1.02 landside toe and slope at wild berries. Photo taken 11-22-2013.	
phillips_f_20131203_758.JPG

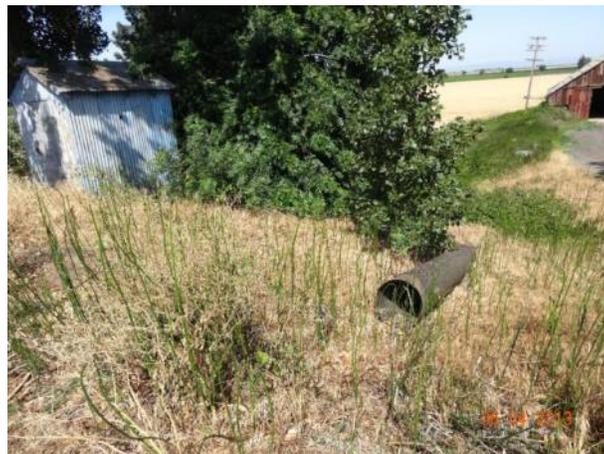
Levee Mile Report Line	73
Start Levee Mile	2.83
End Levee Mile	2.83
Location	Land Side
Category	Supplemental
Item	DWR UCIP Field Study
Pump house on landward slope. A abandoned pipe section on landward slope.	
UCIP_10597.jpg

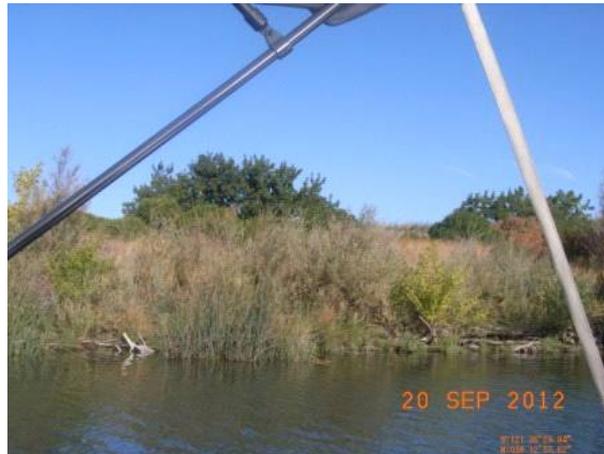
Levee Mile Report Line	82
Start Levee Mile	2.85
End Levee Mile	2.93
Location	Water Side
Category	Supplemental
Item	USACE Erosion Survey
USACE 2012 Photo #3	
USACE2013_STM_18-9_R_3.jpg

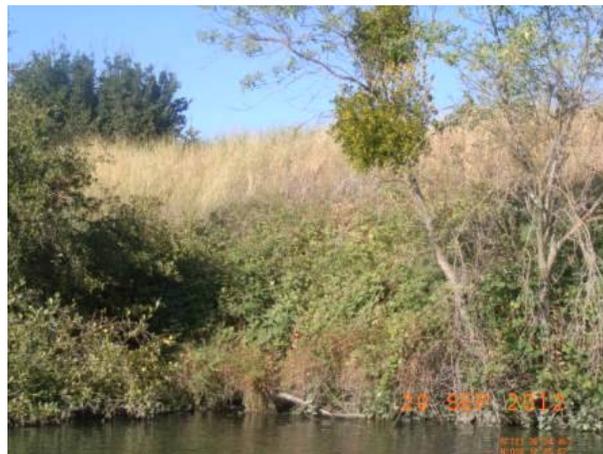
Levee Mile Report Line	85
Start Levee Mile	3.02
End Levee Mile	3.09
Location	Water Side
Category	Supplemental
Item	USACE Erosion Survey
USACE 2012 Photo #3	
USACE2013_STM_18-8_R_3.jpg

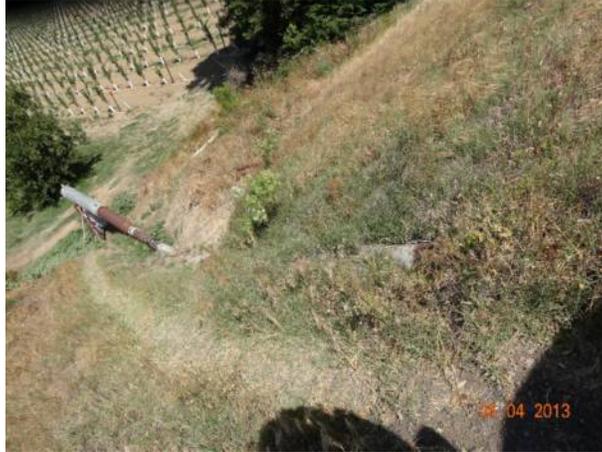
UCIP\_10031.jpg

Overview of landside

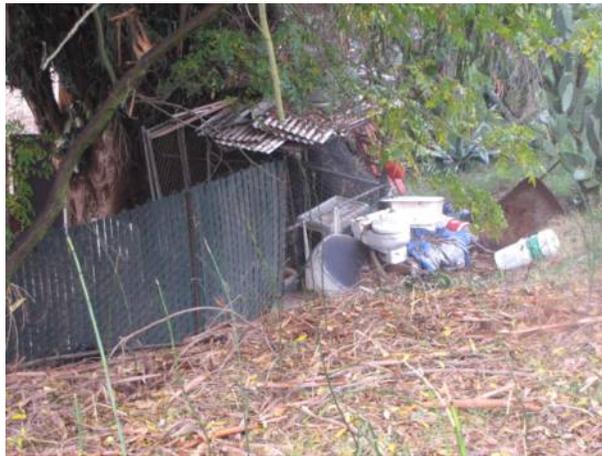
phillips\_f\_20130925\_887.jpg

RD 501, equipment and materials placed along the toe and slope landward looking back upstream. Photo taken 11-26-2012. No change during my inspection 4-9-2013. No new photo taken.

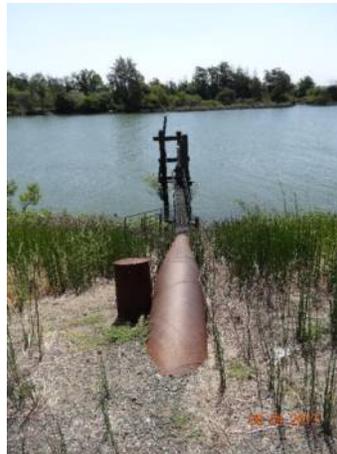
Levee Mile Report Line	103
Start Levee Mile	3.47
End Levee Mile	3.47
Location	Land Side
Category	Supplemental
Item	DWR UCIP Field Study
<p>View of waterward side--siphon breaker, walkway, platform, pump, and control panel.</p>	
<p>UCIP_10628.jpg</p>

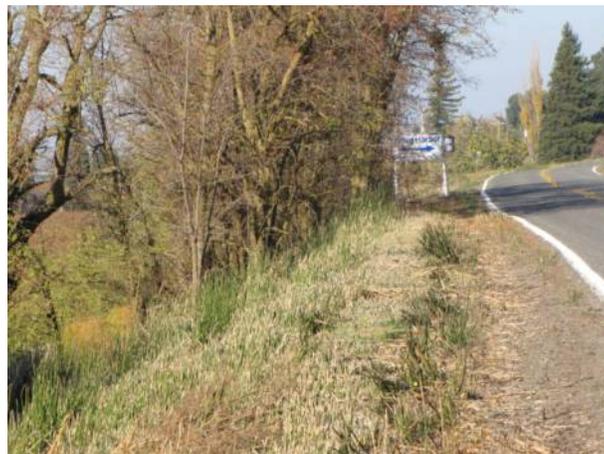
Levee Mile Report Line	105
Start Levee Mile	3.49
End Levee Mile	3.60
Location	Land Side
Category	Earthen Levee
Item	Vegetation
<p>Looking back upstream from landside slope wild growth of black Locust trees on slope. Photo taken 11-22-2013.</p>	
<p>phillips_f_20131203_754.JPG</p>

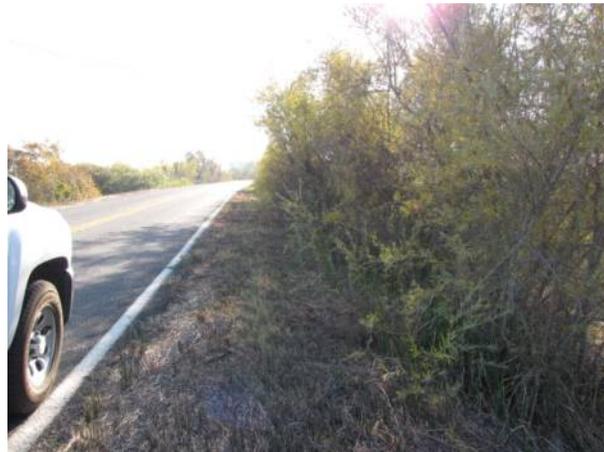
Levee Mile Report Line	118
Start Levee Mile	3.96
End Levee Mile	4.03
Location	Land Side
Category	Earthen Levee
Item	Vegetation
<p>Woody growth landside slope blocking visibility. Photo taken 11-22-2013.</p>	
<p>phillips_f_20131203_761.JPG</p>

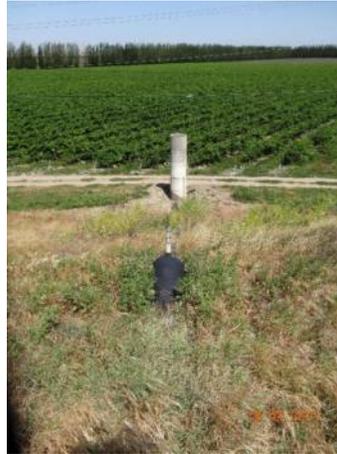
Levee Mile Report Line	121
Start Levee Mile	4.29
End Levee Mile	4.29
Location	Water Side
Category	Supplemental
Item	DWR UCIP Field Study
Standpipe, air vent and 14-inch steel pipe.	
UCIP_10084.jpg

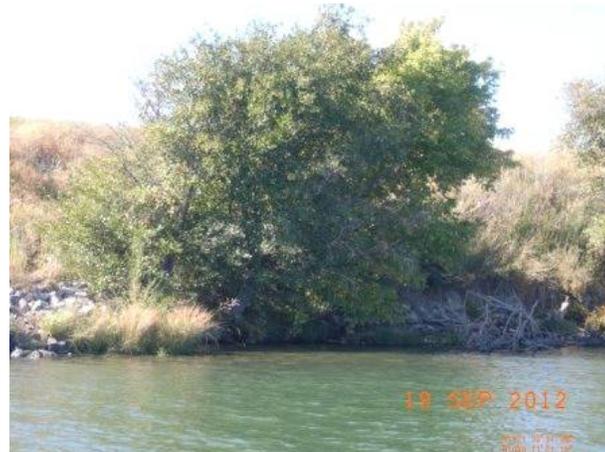
Levee Mile Report Line	134
Start Levee Mile	5.75
End Levee Mile	5.82
Location	Water Side
Category	Supplemental
Item	USACE Erosion Survey
USACE 2012 Photo #2	
USACE2013_STM_15-7_R_2.jpg

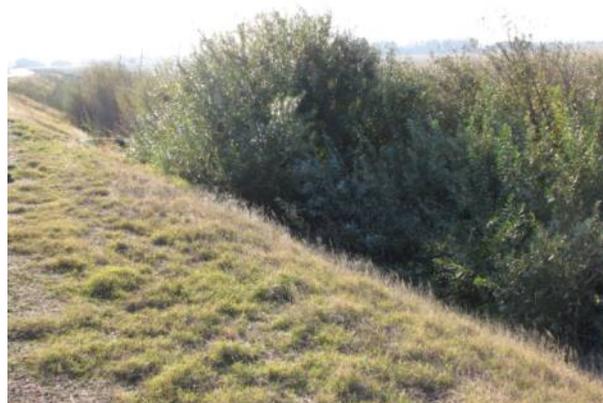
Levee Mile Report Line	135
Start Levee Mile	5.91
End Levee Mile	5.92
Location	Land Side
Category	Earthen Levee
Item	Vegetation
Woody growth blocking levee slope and toe. Photo taken 11-22-2013.	
phillips_f_20131203_762.JPG

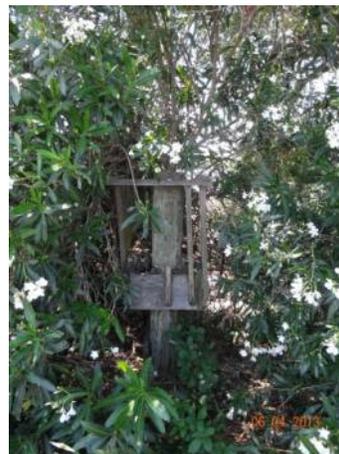
Levee Mile Report Line	140
Start Levee Mile	6.70
End Levee Mile	6.70
Location	Land Side
Category	Supplemental
Item	DWR UCIP Field Study
Electrical box visible on landward toe.	
UCIP_10652.jpg

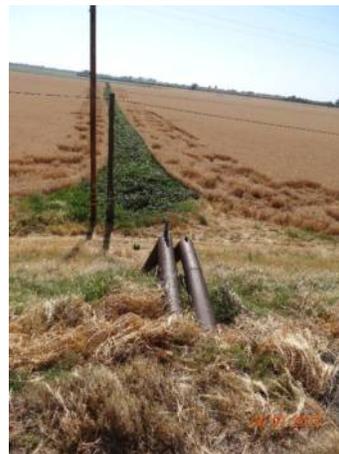
UCIP\_10099.jpg

Overview of two steel pipe on landside. Air vent missed parts. Power pole on landside toe.

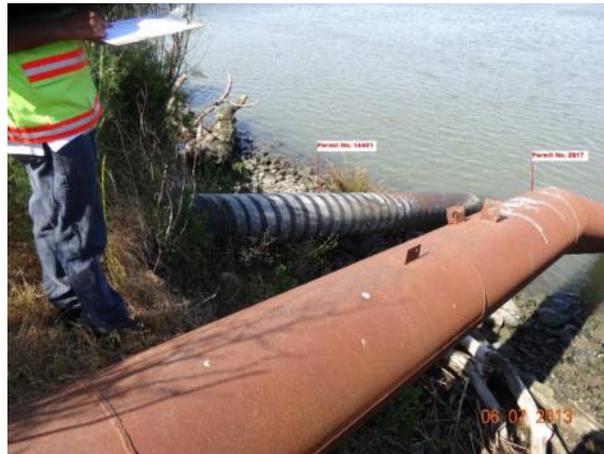
Levee Mile Report Line	26
Start Levee Mile	1.15
End Levee Mile	1.15
Location	Water Side
Category	Supplemental
Item	DWR UCIP Field Study
Waterward side--2-24 inch pipe inlets.	
UCIP_10725.jpg

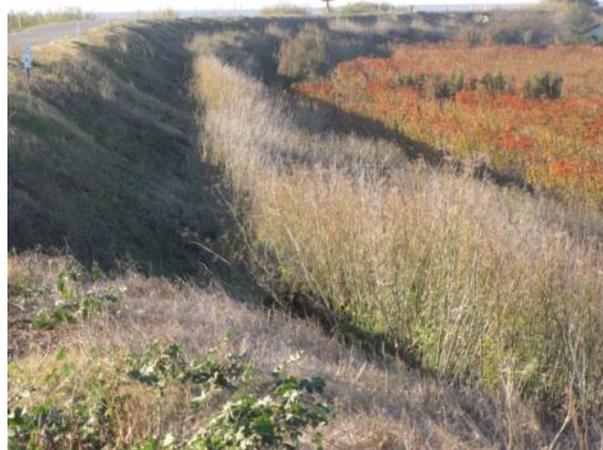
Levee Mile Report Line	34
Start Levee Mile	1.67
End Levee Mile	2.43
Location	Land Side
Category	Earthen Levee
Item	Vegetation
Weeds are taller than 4-foot bottom of slope and toe landside. Photo taken 11-25-2013.	
phillips_f_20131203_765.JPG

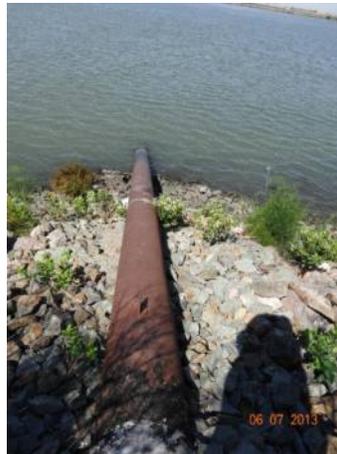
Levee Mile Report Line	35
Start Levee Mile	1.70
End Levee Mile	1.70
Location	Land Side
Category	Supplemental
Item	DWR UCIP Field Study
Photo of pipe looking from berm edge to river edge.	
UCIP_10769.jpg

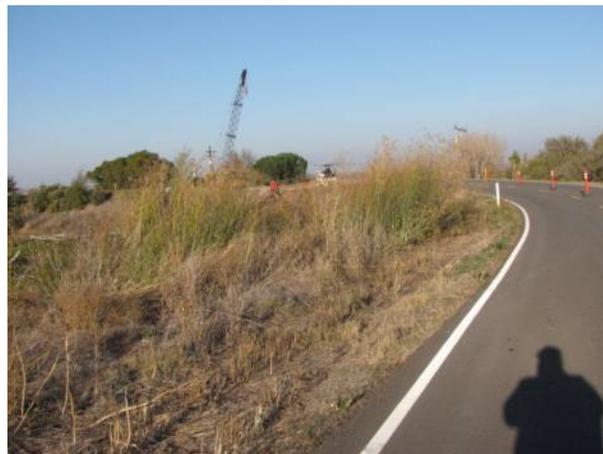
Levee Mile Report Line	38
Start Levee Mile	1.75
End Levee Mile	1.89
Location	Water Side
Category	Earthen Levee
Item	Vegetation
Unwanted wild growth on waterside slope. Photo taken 11-25-2013.	
phillips_f_20131203_764.JPG

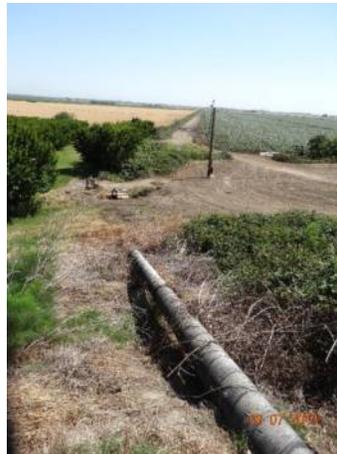
Levee Mile Report Line	56
Start Levee Mile	2.45
End Levee Mile	2.45
Location	Water Side
Category	Supplemental
Item	DWR UCIP Field Study
<p>View of exposed section of pipe along landward slope. Distribution box and possible closure device located near landward toe.</p>	
<p>UCIP_10201.jpg</p>

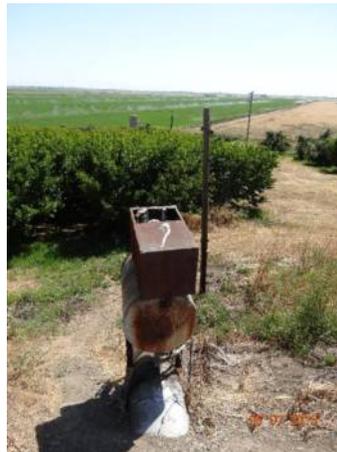
Levee Mile Report Line	59
Start Levee Mile	2.81
End Levee Mile	2.81
Location	Water Side
Category	Supplemental
Item	DWR UCIP Field Study
<p>Close up of pump system located near crown. Standpipe located approximately 100 from levee toe.</p>	
<p>UCIP_10204.jpg</p>

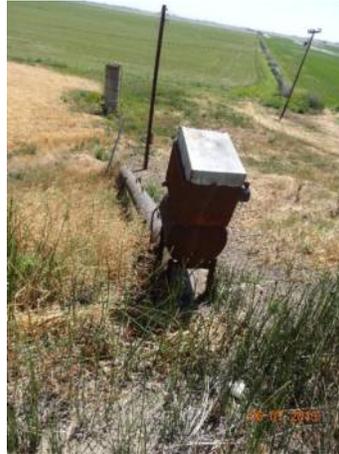
Levee Mile Report Line	68
Start Levee Mile	3.09
End Levee Mile	3.09
Location	Water Side
Category	Supplemental
Item	DWR UCIP Field Study
Overview of landward side, includes view of exposed pipe, pump, and standpipe.	
UCIP_10824.jpg

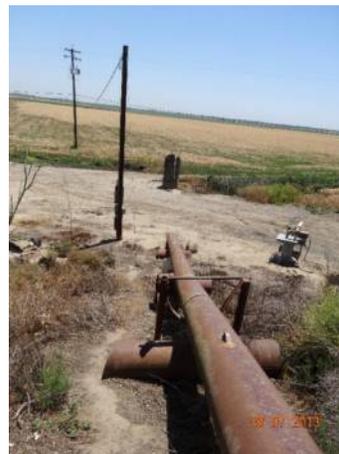
Levee Mile Report Line	11
Start Levee Mile	0.65
End Levee Mile	0.65
Location	Water Side
Category	Supplemental
Item	DWR UCIP Field Study
View of landward side--exposed pipe section, pipe support system, power pole, and stand pipe.	
UCIP_10847.jpg

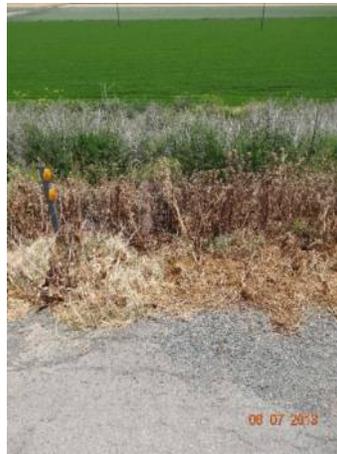
Levee Mile Report Line	22
Start Levee Mile	1.93
End Levee Mile	1.93
Location	Water Side
Category	Supplemental
Item	DWR UCIP Field Study
Overview of landward side. Pipe is visible however dense vegetation limits proper inspection.	
UCIP_10246.jpg

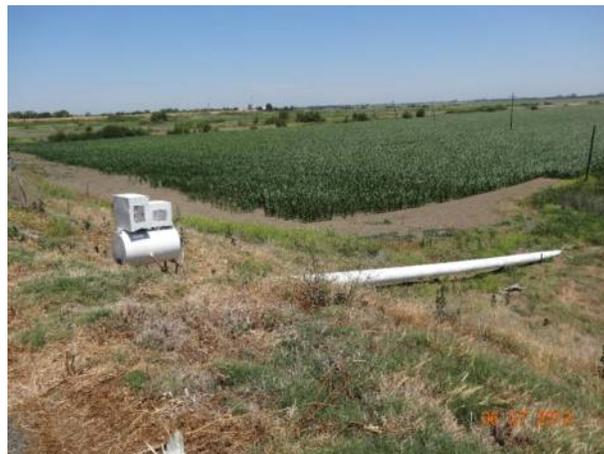
Levee Mile Report Line	30
Start Levee Mile	2.57
End Levee Mile	2.57
Location	Water Side
Category	Supplemental
Item	DWR UCIP Field Study
Overview of landward side. Pump stations, pipe section, positive closure device at landward toe.	
UCIP_10256.jpg

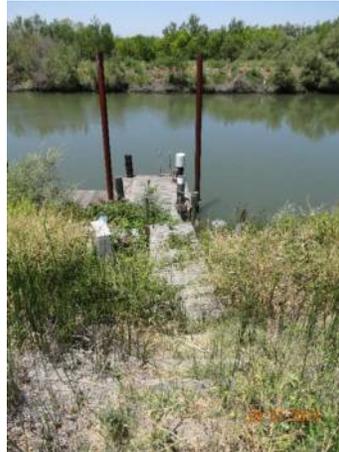
Levee Mile Report Line	37
Start Levee Mile	3.58
End Levee Mile	3.58
Location	Land Side
Category	Supplemental
Item	DWR UCIP Field Study
View of waterward side. Dense vegetation throughout waterward side. Walkway visible and support piles.	
UCIP_10269.jpg

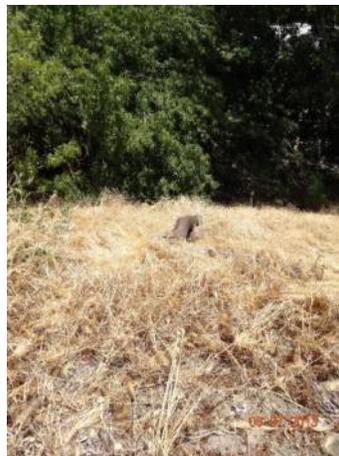
Levee Mile Report Line	45
Start Levee Mile	3.69
End Levee Mile	3.69
Location	Land Side
Category	Supplemental
Item	DWR UCIP Field Study
View of landward side showing a small section of pipe exposed.	
UCIP_10276.jpg

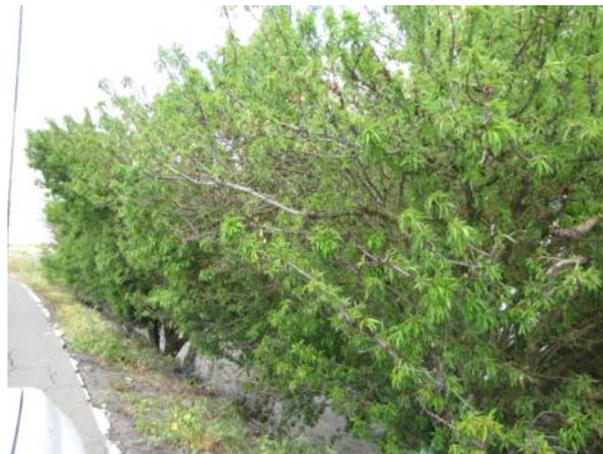
Levee Mile Report Line	47
Start Levee Mile	3.69
End Levee Mile	3.70
Location	Land Side
Category	Earthen Levee
Item	Trim / Thin Trees
Levee mile 3.69 to 3.70, this issue still remains no new photo was taken. 11-25-2013.	
phillips_f_20130925_892.jpg

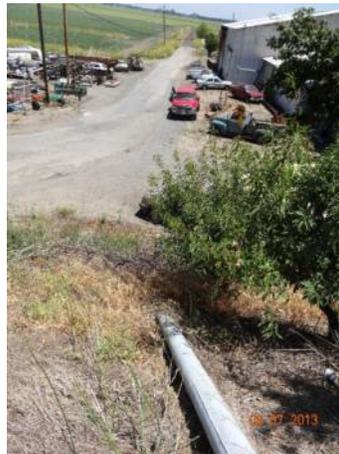
Levee Mile Report Line	63
Start Levee Mile	3.77
End Levee Mile	3.77
Location	Land Side
Category	Supplemental
Item	DWR UCIP Field Study
Pipe section is buried near levee toe.	
UCIP_10901.jpg

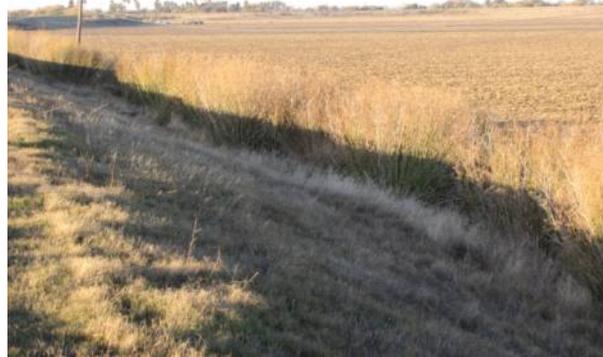
Levee Mile Report Line	65
Start Levee Mile	3.79
End Levee Mile	4.57
Location	Land Side
Category	Earthen Levee
Item	Vegetation
Tall weed growth on lower section of slope and toe of levee. Photo taken 11-25-2013.	
phillips_f_20131203_768.JPG

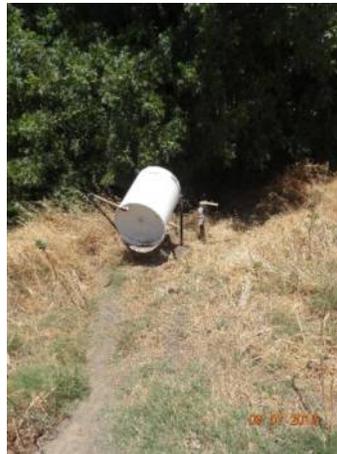
Levee Mile Report Line	71
Start Levee Mile	4.39
End Levee Mile	4.39
Location	Land Side
Category	Supplemental
Item	DWR UCIP Field Study
Pump system and gate located on landward slope--midway.	
UCIP_10315.jpg

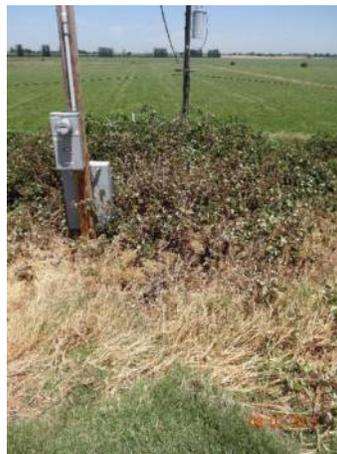
Levee Mile Report Line	76
Start Levee Mile	4.84
End Levee Mile	4.84
Location	Land Side
Category	Supplemental
Item	DWR UCIP Field Study
View of landward side. Power source and control box on landward side.	
UCIP_10907.jpg

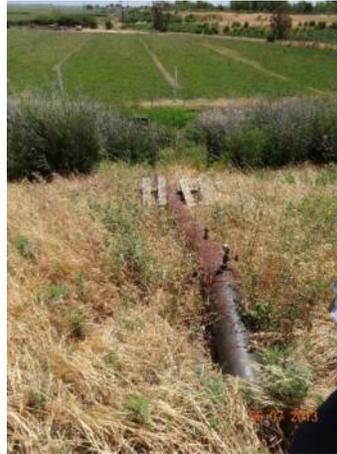
Levee Mile Report Line	83
Start Levee Mile	5.51
End Levee Mile	5.51
Location	Land Side
Category	Supplemental
Item	DWR UCIP Field Study
View of pipe on landward side. Dry vegetation covers landward slope.	
UCIP_10321.jpg

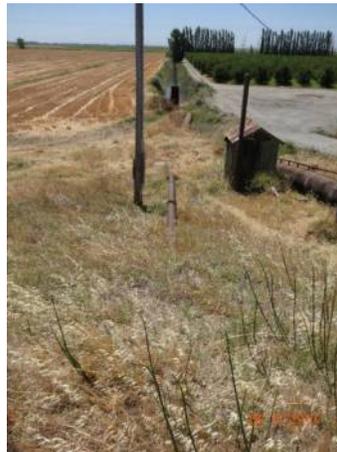
Levee Mile Report Line	91
Start Levee Mile	6.50
End Levee Mile	6.50
Location	Land Side
Category	Supplemental
Item	DWR UCIP Field Study
View of pipe located on landward side. Dry vegetation along levee slope.	
UCIP_10331.jpg

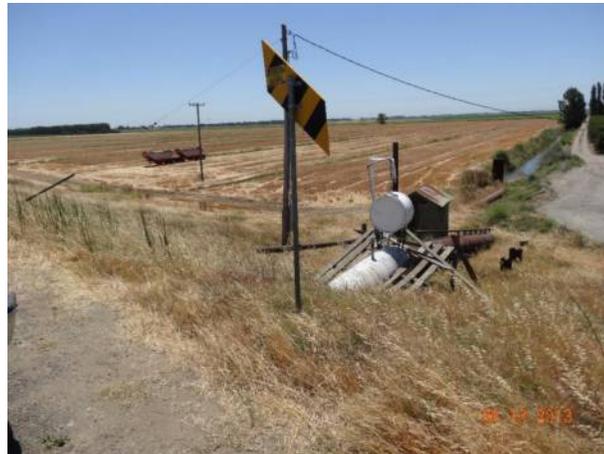
UCIP\_10364.jpg

Overview of crossing located on landward side.

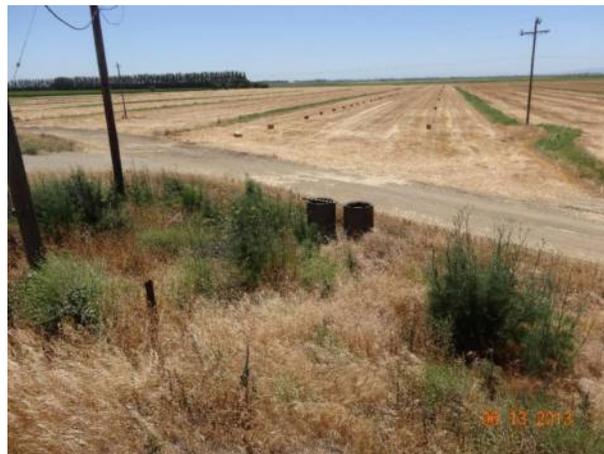
UCIP\_10405.jpg

Dry vegetation throughout the landward slope.

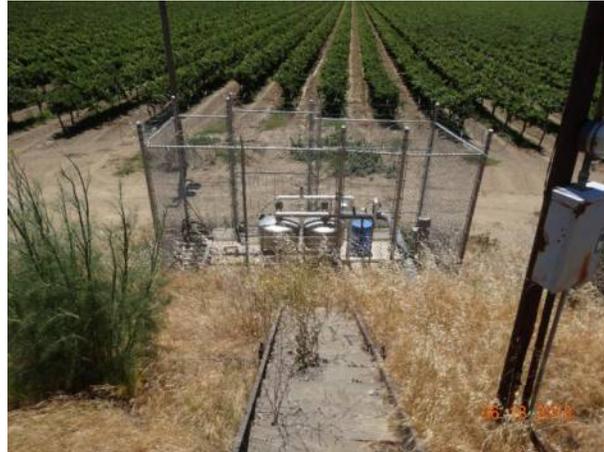
Levee Mile Report Line	113
Start Levee Mile	7.35
End Levee Mile	7.35
Location	Land Side
Category	Supplemental
Item	DWR UCIP Field Study
Pipe line connects to sytem located at the toe of the levee.	
UCIP_10424.jpg

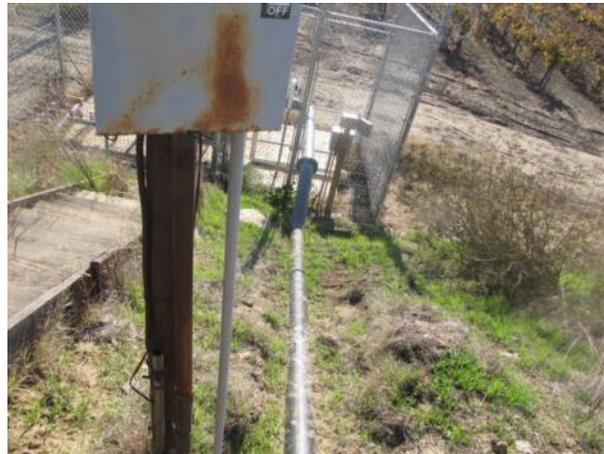
Levee Mile Report Line	117
Start Levee Mile	7.35
End Levee Mile	7.35
Location	Land Side
Category	Earthen Levee
Item	Encroachments
Unauthorized pipe, 11-26-2012.	
phillips_f_20130925_894.jpg

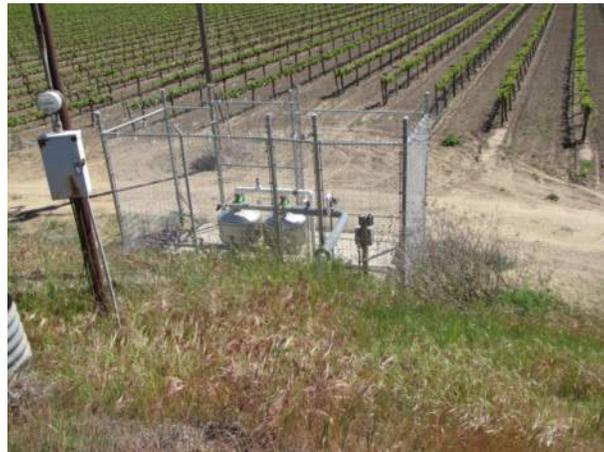
Levee Mile Report Line	117
Start Levee Mile	7.35
End Levee Mile	7.35
Location	Land Side
Category	Earthen Levee
Item	Encroachments
This encroachment still remains unresolved, no permit for this structure. Photo taken 4-9-2013. No new photo 11-25-2013.	
phillips_f_20130925_895.JPG

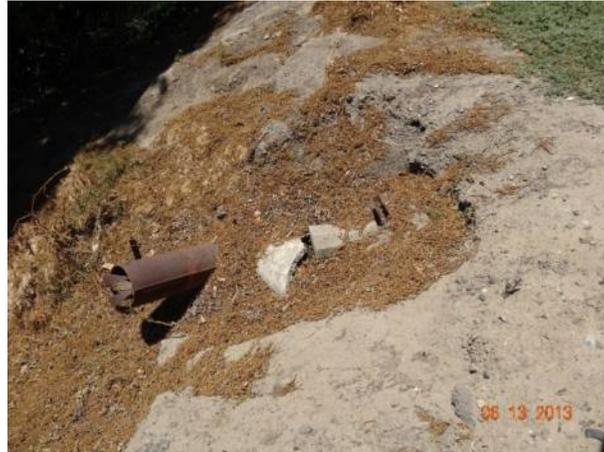
UCIP\_10432.jpg

View of pipe exposed on landward side.

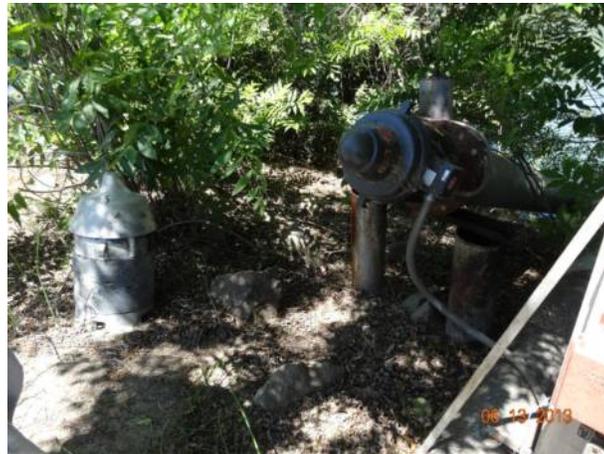
UCIP\_10441.jpg

Slant pump located on waterward side. An abandoned pump was left on waterward side.

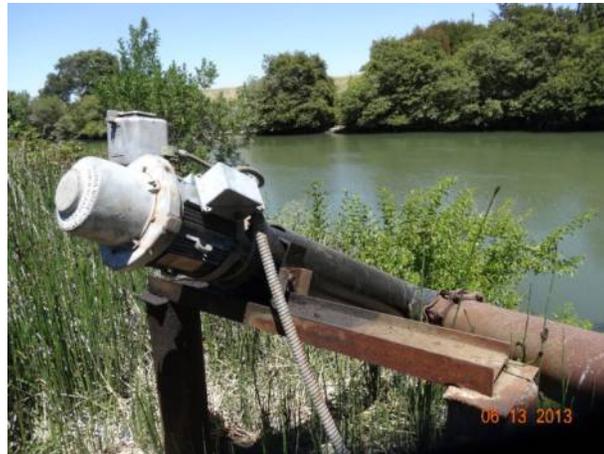
UCIP\_11031.jpg

Slant pump located on waterward side. 10 inch pipe connects at an angle to tar coated pipe.

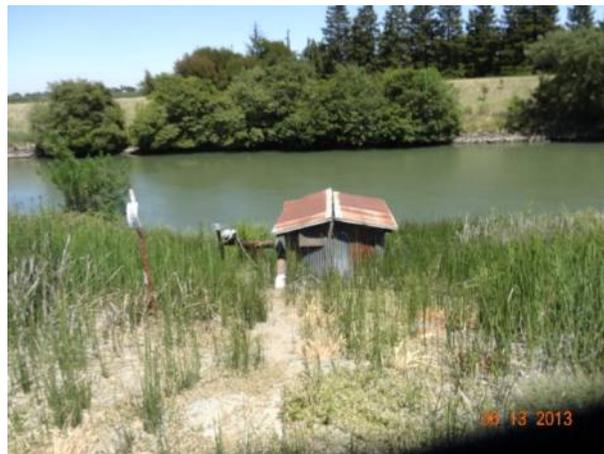
UCIP\_11024.jpg

Overview of waterward side. Two crossings, 10 inch and 8 inch pipelines, less than 5 feet apart.

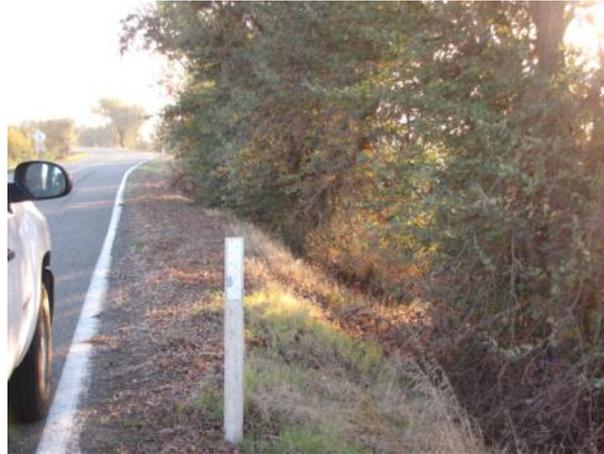
Levee Mile Report Line	13
Start Levee Mile	0.82
End Levee Mile	0.85
Location	Land Side
Category	Earthen Levee
Item	Vegetation
Woody growth blocking slope and toe of levee section. Photo taken 11-25-2013.	
phillips_f_20131203_770.JPG

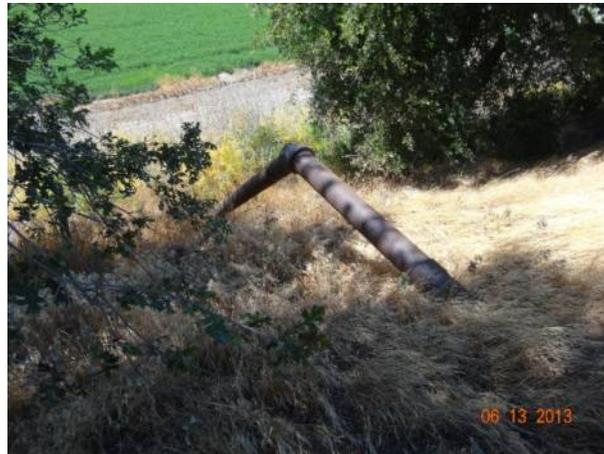
16	1.06	1.06	Supplemental	DWR UCIP Field Study	LS	U En	Inspector Comments: FS_ID:19085 EP_NO: N/A Repair Type: Urgent Crossing Status: Found UCIP Comments: Pipe has deteriorated. Owner needs to be abandon properly. Dense vegetation limits the inspector's visibility to identify signs of pipe failure (leaks) along the waterward slope. Recommend removing vegetation along pipe alignment to conduct proper inspection of structure and appurtances. FIELD_STRUCT_DESC: Abandoned 8-inch steel pipe through the levee, 2.7 feet below the crown. Pump on waterward side. Steel plate welded on waterward end. (USACE-1959). This entry matches the Drainage or Irrigation Structure referenced in O&M manual (HLM 1.10). FS Date: 6/13/2013	38.272053 °	38.272053 °	20
								-121.604176 °	-121.604176 °	
DWR ID: DWR_RD0501_04_f_2013_20

Levee Mile Report Line	18
Start Levee Mile	1.06
End Levee Mile	1.06
Location	Land Side
Category	Supplemental
Item	DWR UCIP Field Study
View of crossing on landward side.	
UCIP_10490.jpg

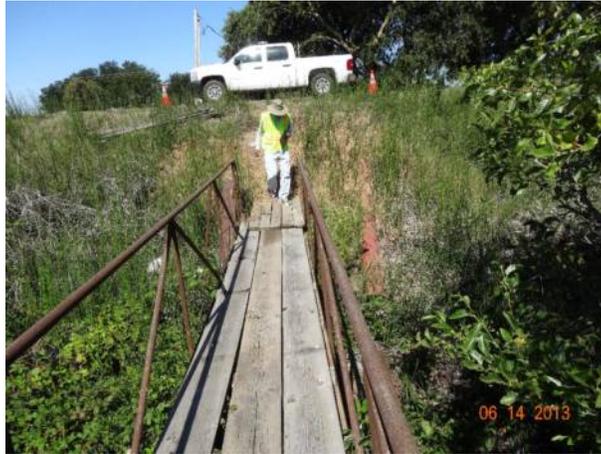
UCIP\_11109.jpg

Abandoned pipe to the right of walkway.

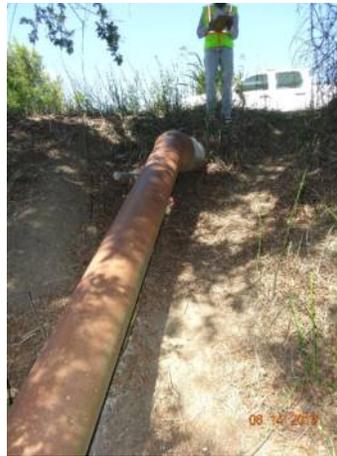
UCIP\_11114.jpg

Waterward side-pipe along slope.

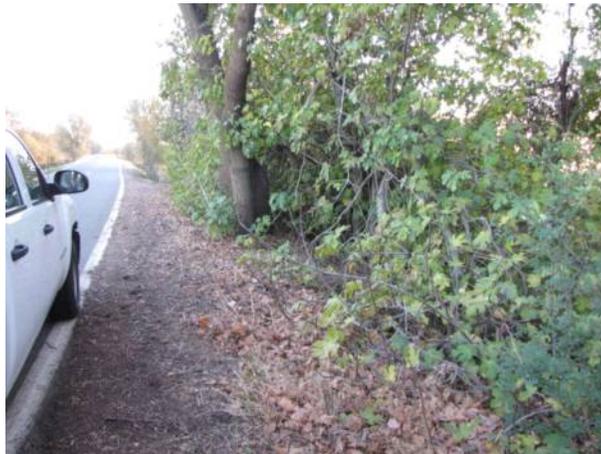
phillips\_f\_20131203\_771.JPG

Unsatisfactory woody growth on the landside slope and toe, unable to see levee section. Photo taken 11-25-2013.

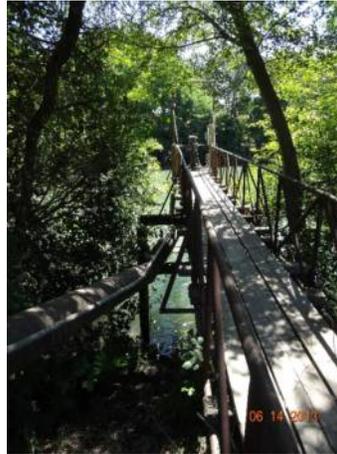
Levee Mile Report Line	49
Start Levee Mile	1.90
End Levee Mile	1.90
Location	Land Side
Category	Supplemental
Item	DWR UCIP Field Study
Waterward side--catwalk, conduit line, pump, and support piles.	
UCIP_10540.jpg

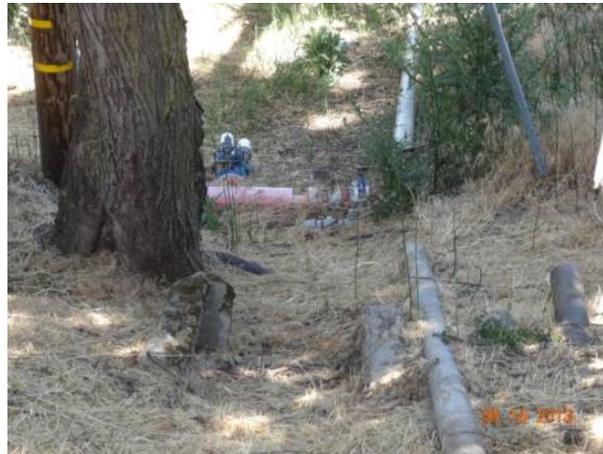
Levee Mile Report Line	57
Start Levee Mile	2.18
End Levee Mile	2.18
Location	Land Side
Category	Supplemental
Item	DWR UCIP Field Study
Crossing is split in multiple directions. Debris scattered near crossing.	
UCIP_10554.jpg

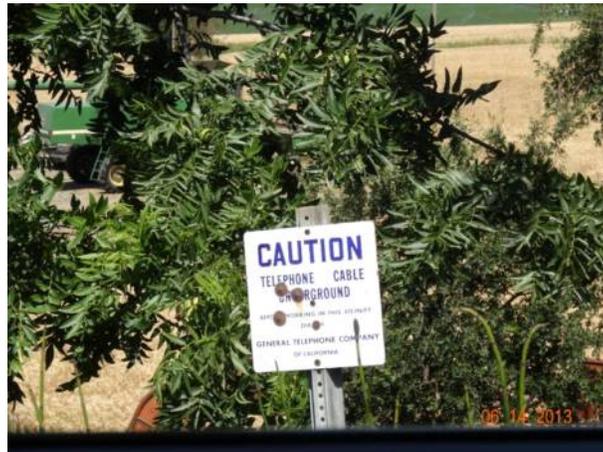
Levee Mile Report Line	65
Start Levee Mile	2.33
End Levee Mile	2.33
Location	Land Side
Category	Supplemental
Item	DWR UCIP Field Study
Marker visible on landward side.	
UCIP_10560.jpg
