**Flood Control Project Maintenance  
Levee Inspections**

**Fall 2010 Levee Maintenance Deficiency Summary Report**

**Reclamation District No. 0524 Middle Roberts Island**

Waterway		Bank	Unit Miles
Unit No. 01 San Joaquin River		Left	6.26

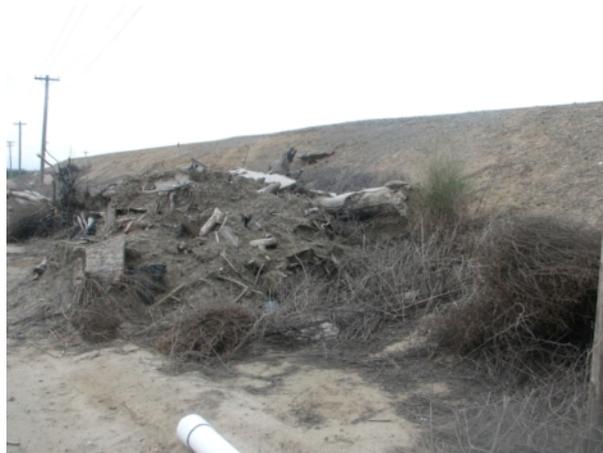
Levee Mile Report Line	3
Start Levee Mile	0.36
End Levee Mile	0.36
Location	Land Side
Category	Earthen Levee
Item	Encroachments
Garbage pile at landward toe at LM 0.36	
richard_f_20100921_108.jpg

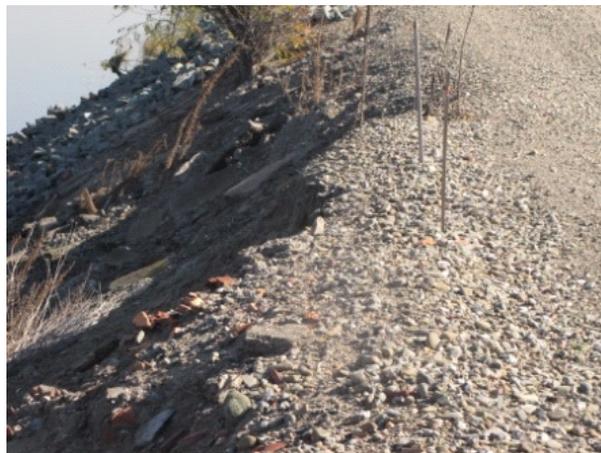
Levee Mile Report Line	6
Start Levee Mile	0.48
End Levee Mile	0.49
Location	Water Side
Category	Earthen Levee
Item	Erosion / Bank Caving
Update of erosion site at LM 0.48 to 0.49	
richard_f_20100921_093.jpg

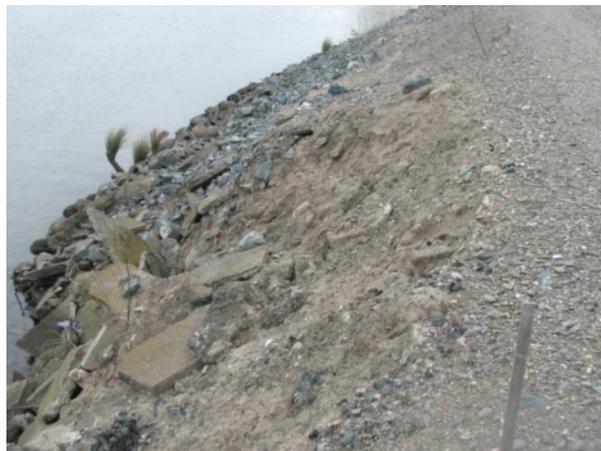
Levee Mile Report Line	7
Start Levee Mile	0.51
End Levee Mile	0.52
Location	Water Side
Category	Earthen Levee
Item	Erosion / Bank Caving
Erosion from LM 0.51 to 0.52	
richard_f_20100921_096.jpg

7	0.51	0.52	Earthen Levee	Erosion / Bank Caving	WS	U	Schedule repair of erosion site prior to the next inspection.	37.938682 ° -121.338518 °	37.938657 ° -121.338425 °	7 Y
8	0.53	0.60	Supplemental	DWR Erosion Survey	WS	U	Inspector Comments: 09/07/2010: No significant changes observed on site. Some emergent vegetation at the lower and middle slope. Existing revetment is no longer adequately protecting the oversteepened slope. Some of the broken concrete used as revetment has slid, dragging levee materials away from the slope and creating notches. [2010 SiteID: RD0524U01RM41.15]	37.938895 ° -121.337602 °	37.938895 ° -121.337602 °	1 Y
9	0.63	0.63	Earthen Levee	Slope Stability	WS	M	Repair the levee slope damaged by foot traffic and prevent access where possible.	37.938247 ° -121.336503 °	37.938247 ° -121.336503 °	10 Y
10	0.63	0.64	Earthen Levee	Vegetation	WS	U	Remove the wild growth other than native grasses from the levee slopes.	37.938247 ° -121.336503 °	37.938197 ° -121.336405 °	11 Y

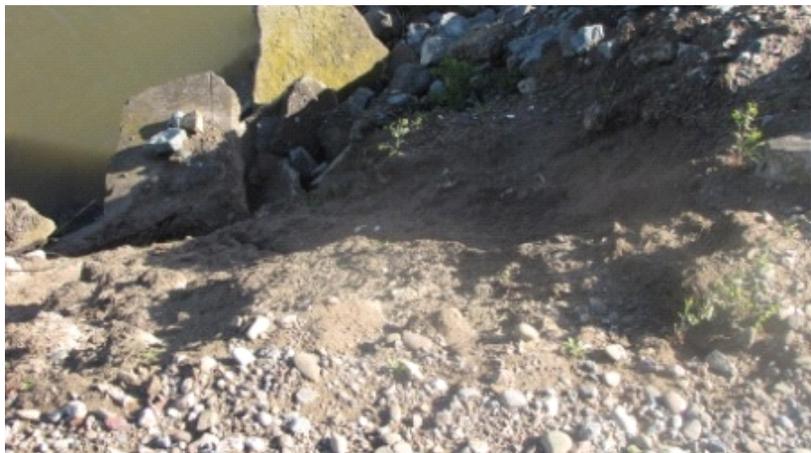
Levee Mile Report Line	7
Start Levee Mile	0.51
End Levee Mile	0.52
Location	Water Side
Category	Earthen Levee
Item	Erosion / Bank Caving
Looking at erosion from the top of the levee. No change as of 4/2010	
richard_f_20100921_099.jpg

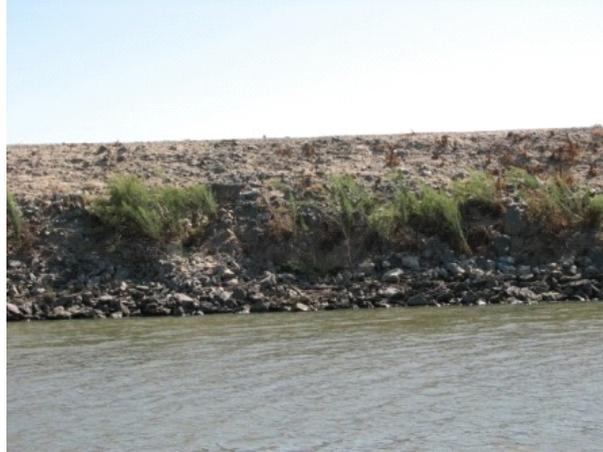
Levee Mile Report Line	8
Start Levee Mile	0.53
End Levee Mile	0.60
Location	Water Side
Category	Supplemental
Item	DWR Erosion Survey

Direct view of site showing emergent vegetation growing at the midslope.

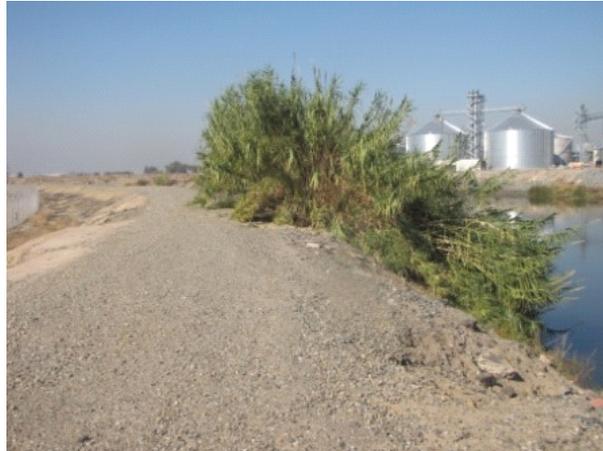
Levee Mile Report Line	10
Start Levee Mile	0.63
End Levee Mile	0.64
Location	Water Side
Category	Earthen Levee
Item	Vegetation

Looking north at bamboo on waterside slope.

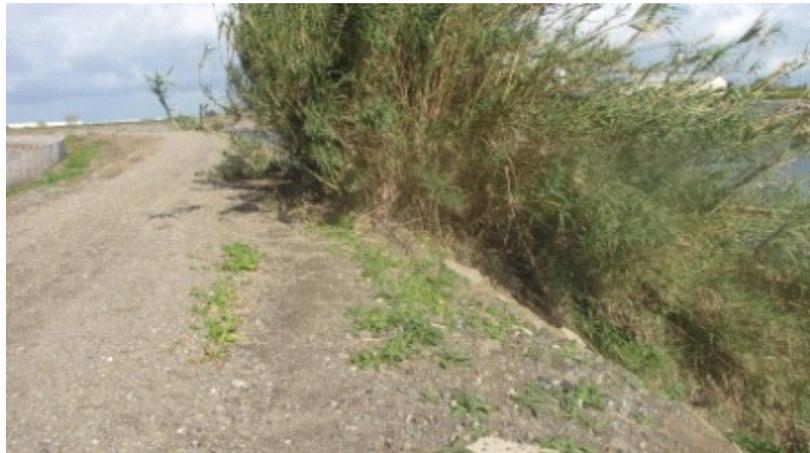
Levee Mile Report Line	10
Start Levee Mile	0.63
End Levee Mile	0.64
Location	Water Side
Category	Earthen Levee
Item	Vegetation

Looking north at bamboo on waterside slope as of 4/2010 no change.

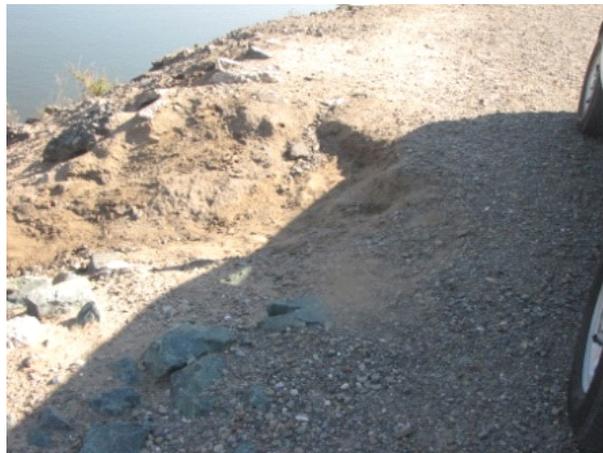
Levee Mile Report Line	12
Start Levee Mile	0.65
End Levee Mile	0.66
Location	Water Side
Category	Earthen Levee
Item	Slope Stability
Update of erosion site at LM 0.65 to 0.66	
richard_f_20100921_104.jpg

11	0.64	0.64	Earthen Levee	Crown Surface / Depressions / Rutting	CR	M	Regrade the crown roadway for proper drainage.	37.938198 ° -121.336407 °	37.938198 ° -121.336407 °	12 Y
12	0.65	0.66	Earthen Levee	Slope Stability	WS	M	Repair slope instability.	37.938105 ° -121.336288 °	37.938023 ° -121.336173 °	13 Y
13	0.68	0.68	Earthen Levee	Vegetation	WS	U	Remove the wild growth other than native grasses from the levee slopes.	37.937808 ° -121.335913 °	37.937808 ° -121.335913 °	14 Y
14	0.79	0.79	Earthen Levee	Trim / Thin Trees	LS	M	Trim trees to at least five feet above ground level.	37.936444 ° -121.334797 °	37.936444 ° -121.334797 °	76 Y
15	0.81	0.81	Earthen Levee	Erosion / Bank Caving	WS	M	Note and monitor erosion site.	37.936217 ° -121.334698 °	37.936217 ° -121.334698 °	16 Y
16	0.94	1.02	Earthen Levee	Trim / Thin Trees	LS	M	Trim trees to at least five feet above ground level.	37.935259 ° -121.332864 °	37.935049 ° -121.331334 °	77 Y

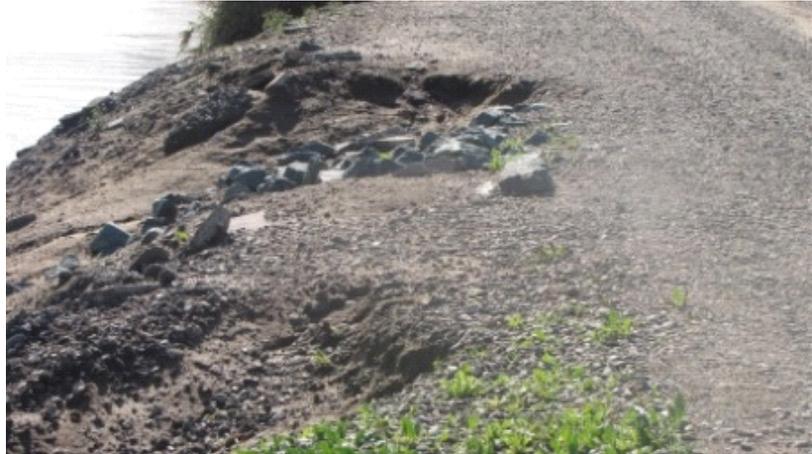
Looking south at erosion on waterside shoulder.

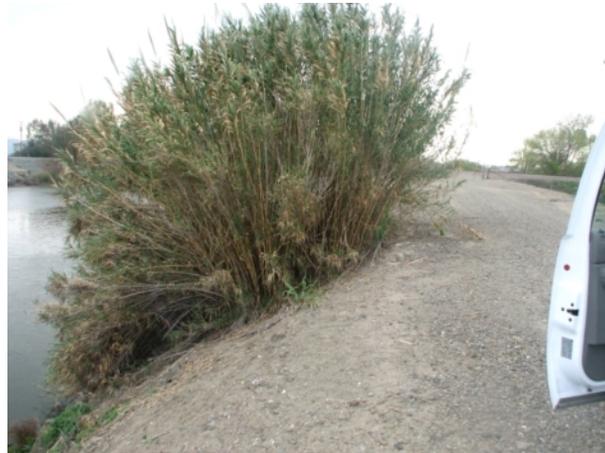
Levee Mile Report Line	13
Start Levee Mile	0.68
End Levee Mile	0.68
Location	Water Side
Category	Earthen Levee
Item	Vegetation

Bamboo on waterward slope at LM 0.68

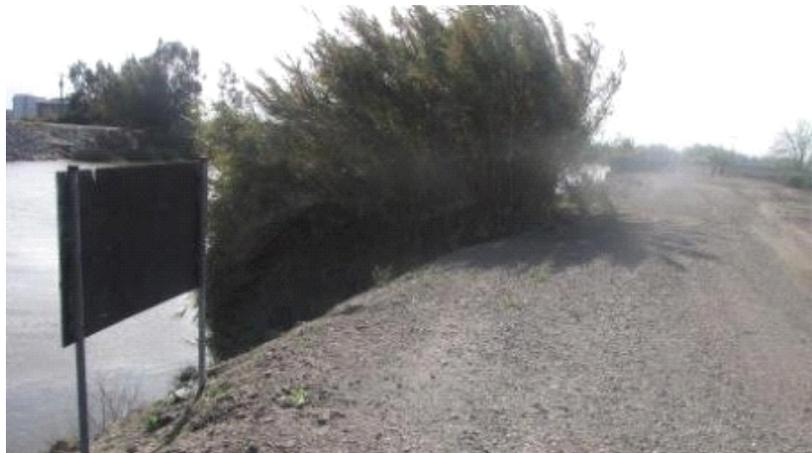
Levee Mile Report Line	13
Start Levee Mile	0.68
End Levee Mile	0.68
Location	Water Side
Category	Earthen Levee
Item	Vegetation

Looking southeast at bamboo on waterside shoulder as of 4/2010.

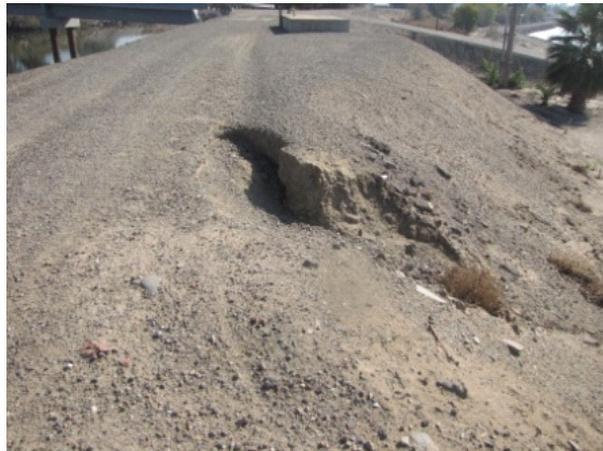
Levee Mile Report Line	18
Start Levee Mile	1.09
End Levee Mile	1.09
Location	Land Side
Category	Earthen Levee
Item	Slope Stability
Updated picture of erosion site on landside shoulder.	
richard_f_20100921_111.jpg

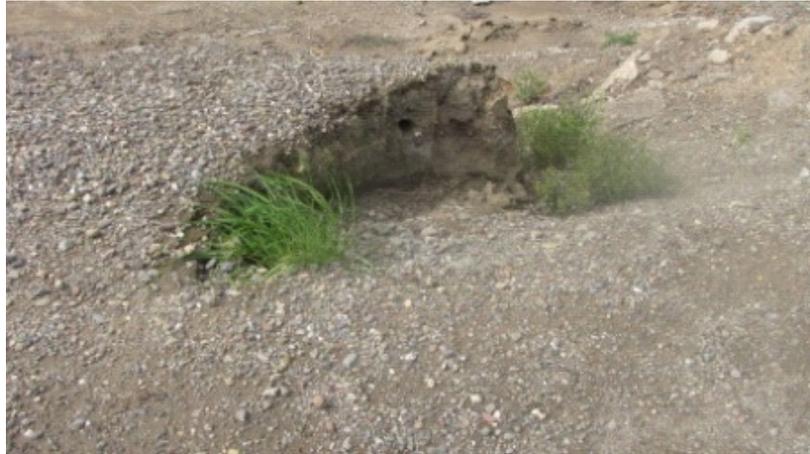
Update of above slope stability.

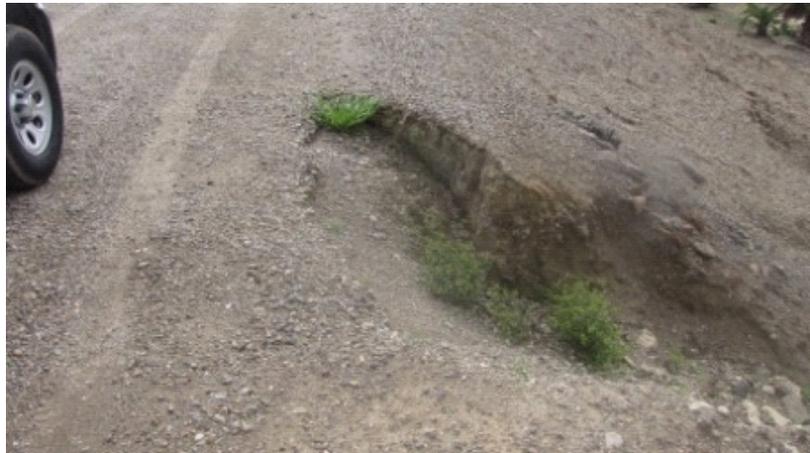
Levee Mile Report Line	18
Start Levee Mile	1.09
End Levee Mile	1.09
Location	Land Side
Category	Earthen Levee
Item	Slope Stability

Looking at updated slope stability as 4/2010

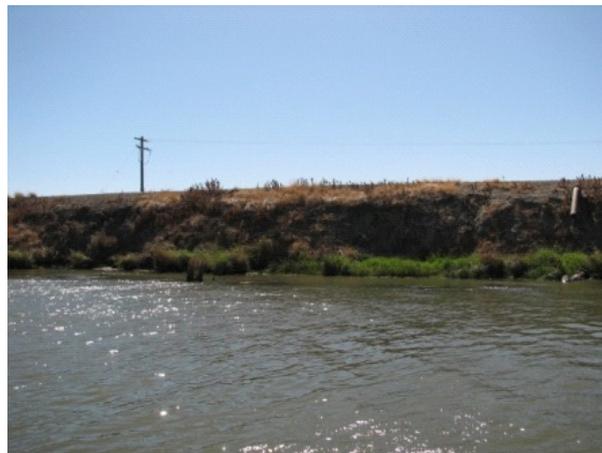
Levee Mile Report Line	20
Start Levee Mile	1.16
End Levee Mile	1.24
Location	Water Side
Category	Supplemental
Item	DWR Erosion Survey

Upstream view of site where sloughing is occurring.

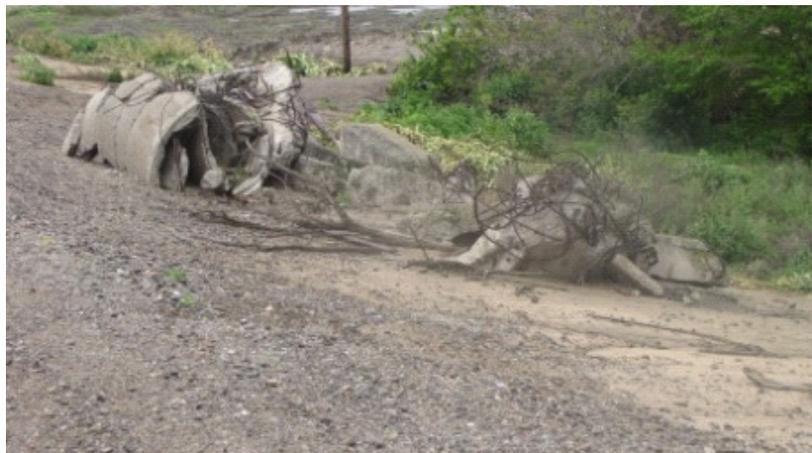
Levee Mile Report Line	22
Start Levee Mile	1.25
End Levee Mile	1.25
Location	Land Side
Category	Earthen Levee
Item	Encroachments
Looking south at concrete rubble on landside slope.	
richard_f_20100921_115.jpg

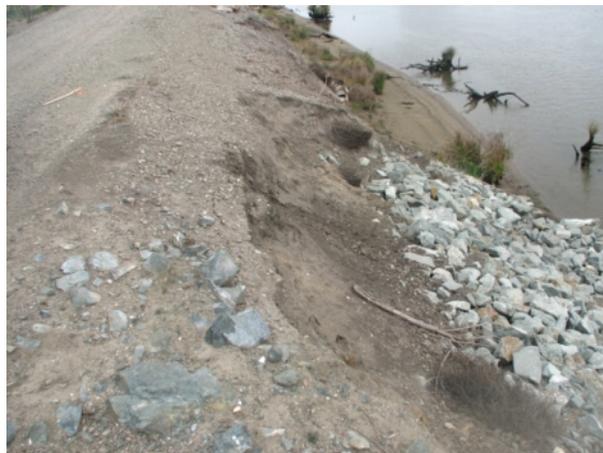
Levee Mile Report Line	24
Start Levee Mile	1.32
End Levee Mile	1.33
Location	Water Side
Category	Earthen Levee
Item	Erosion / Bank Caving
Erosion from LM 1.32 to 1.33	
richard_f_20100921_116.jpg

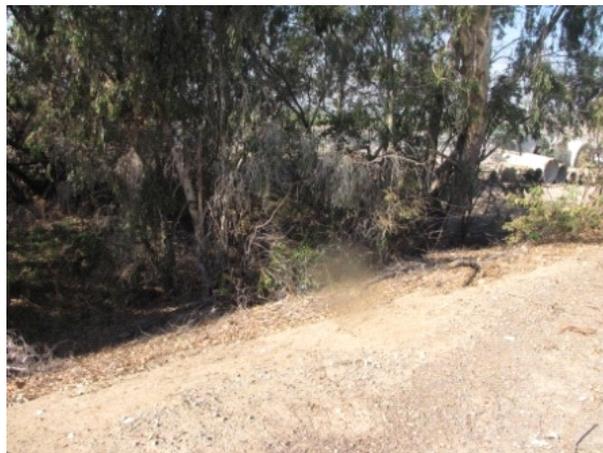
Levee Mile Report Line	26
Start Levee Mile	1.51
End Levee Mile	1.51
Location	Land Side
Category	Earthen Levee
Item	Trim / Thin Trees
Dense vegetation on landside toe.	
richard_f_20100921_140.jpg

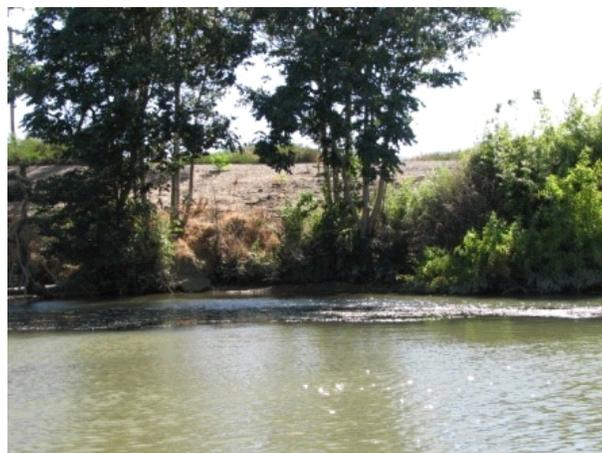
Levee Mile Report Line	28
Start Levee Mile	1.58
End Levee Mile	1.64
Location	Water Side
Category	Supplemental
Item	DWR Erosion Survey
Front view of site where undermining has occurred.	
SJR2010_RM42.20U1LM1.61LBa.jpg

27	1.56	1.74	Earthen Levee	Encroachments	LS	CO	Landscaping	37.928352 ° -121.328307 °	37.926497 ° -121.326248 °	23 Y
28	1.58	1.64	Supplemental	DWR Erosion Survey	WS	U	Inspector Comments: 09/07/2010: No significant changes observed on site. The concern here is the undermining of the levee toe where most of trees are. There are erosion pockets lined along the lower slope and at the base of the trees, exposing tree roots. There is minimal slope protection. [2010 SiteID: RD0524U01RM42.2]	37.927770 ° -121.327870 °	37.927770 ° -121.327870 °	79 Y
29	1.62	1.63	Earthen Levee	Vegetation	WS	U	Remove the wild growth other than native grasses from the levee slopes.	37.927635 ° -121.327812 °	37.927540 ° -121.327648 °	24 Y
30	1.62	1.63	Earthen Levee	Vegetation	WS	U	Remove the wild growth other than native grasses from the levee slopes.	37.927635 ° -121.327812 °	37.927540 ° -121.327648 °	25 Y

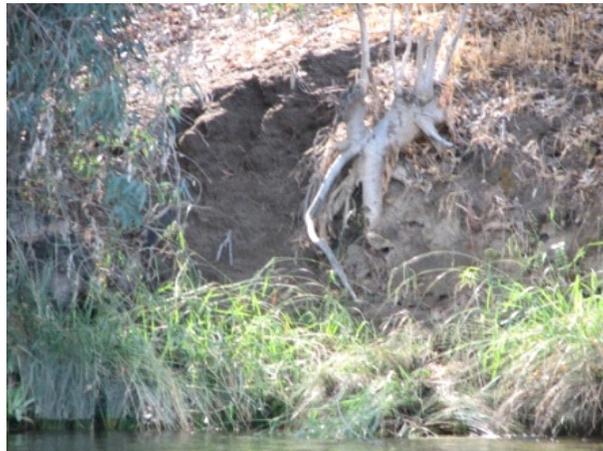
Levee Mile Report Line	28
Start Levee Mile	1.58
End Levee Mile	1.64
Location	Water Side
Category	Supplemental
Item	DWR Erosion Survey
<p>Close up view of a pocket erosion that is directly affecting the base of a tree. Note the exposed tree roots. This image was taken on 09/29/2009.</p>	
<p>SJR2010_RM42.20U1LM1.61LBd.jpg</p>

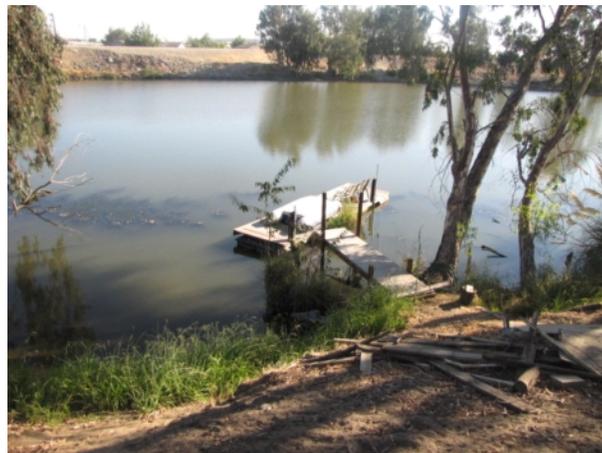
Levee Mile Report Line	32
Start Levee Mile	1.64
End Levee Mile	1.64
Location	Water Side
Category	Earthen Levee
Item	Encroachments
Looking east at non-permitted boat dock.	
richard_f_20101001_318.jpg

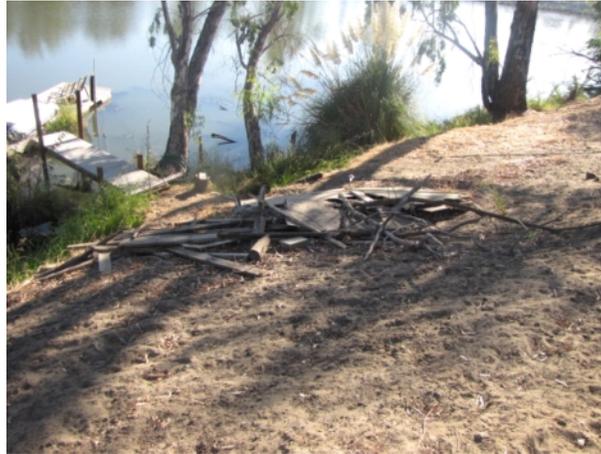
Looking at garbage on waterside slope.

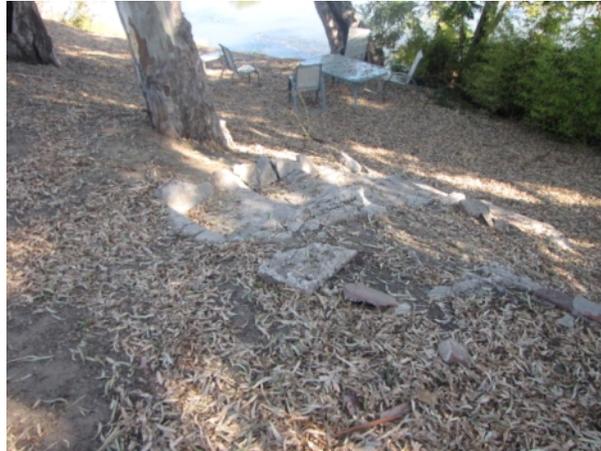
Levee Mile Report Line	34
Start Levee Mile	1.69
End Levee Mile	1.69
Location	Water Side
Category	Earthen Levee
Item	Encroachments

Looking northeast on non-permitted concrete stairs on waterside slope.

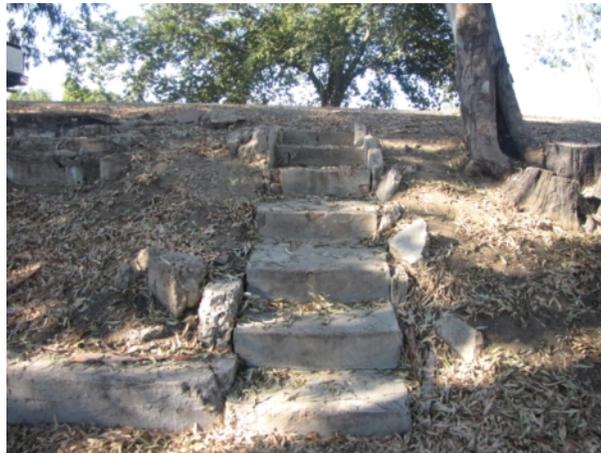
Levee Mile Report Line	34
Start Levee Mile	1.69
End Levee Mile	1.69
Location	Water Side
Category	Earthen Levee
Item	Encroachments

Looking west at concrete stairs on waterside slope.

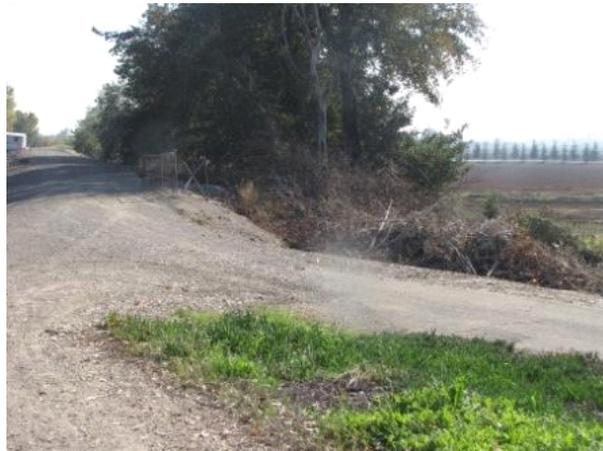
Levee Mile Report Line	36
Start Levee Mile	1.75
End Levee Mile	1.75
Location	Land Side
Category	Earthen Levee
Item	Encroachments
Looking at updated trash pile on landside slope and toe.	
richard_f_20100921_122.jpg

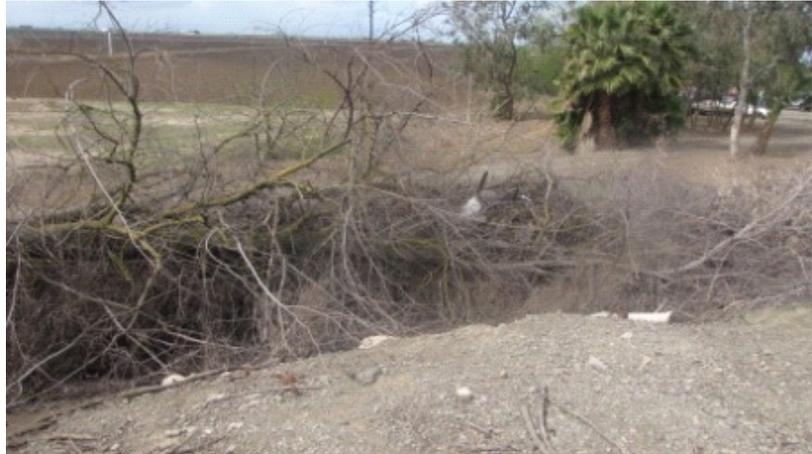
Looking west at prunings on landside toe.

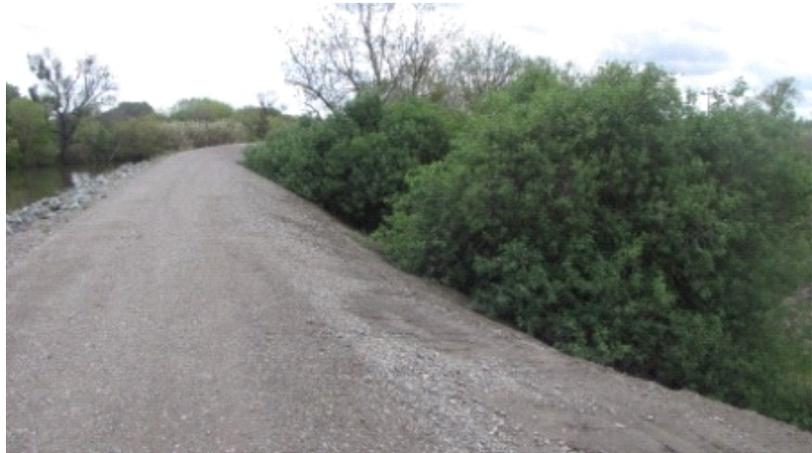
Levee Mile Report Line	41
Start Levee Mile	2.29
End Levee Mile	2.31
Location	Land Side
Category	Earthen Levee
Item	Vegetation

Looking south at dense veg on landside slope and toe.

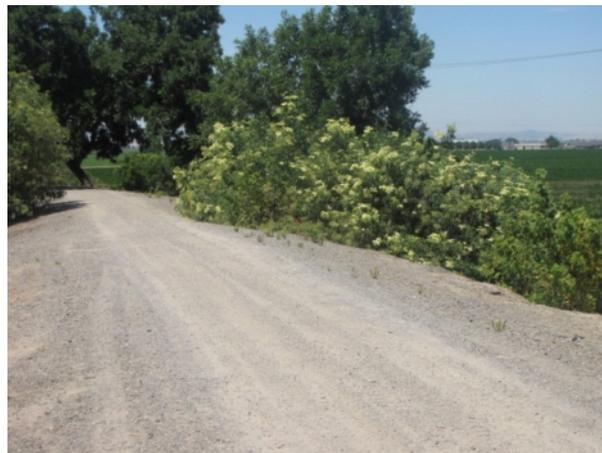
Levee Mile Report Line	46
Start Levee Mile	2.52
End Levee Mile	2.52
Location	Land Side
Category	Earthen Levee
Item	Vegetation

Looking south at elderberry on landside slope.

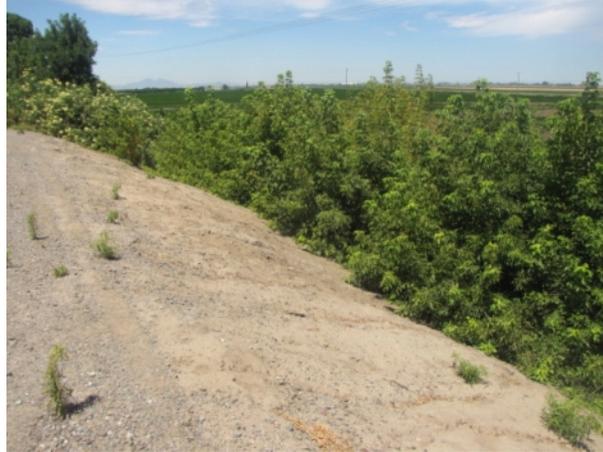
Levee Mile Report Line	46
Start Levee Mile	2.52
End Levee Mile	2.52
Location	Land Side
Category	Earthen Levee
Item	Vegetation
Looking southwest at trees along levee landside toe.	
richard_f_20100921_126.jpg

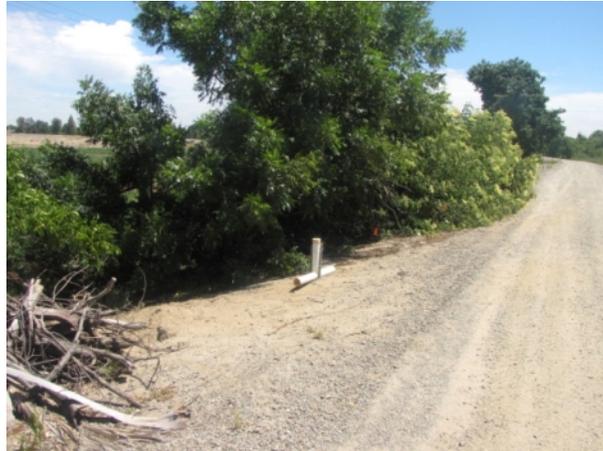
Levee Mile Report Line	46
Start Levee Mile	2.52
End Levee Mile	2.52
Location	Land Side
Category	Earthen Levee
Item	Vegetation
Looking north at elderberry and trees on landside slope.	
richard_f_20100921_127.jpg

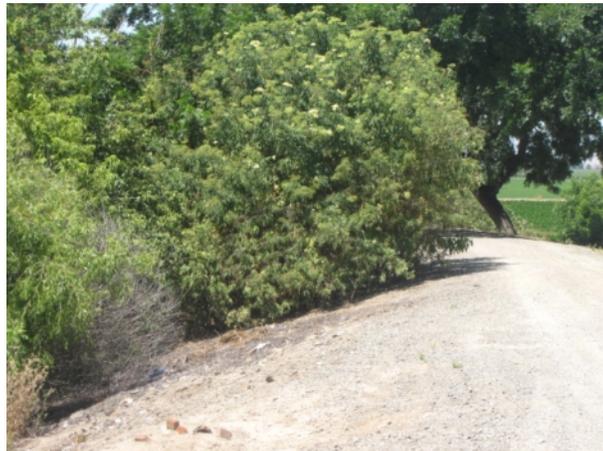
Levee Mile Report Line	47
Start Levee Mile	2.53
End Levee Mile	2.53
Location	Water Side
Category	Earthen Levee
Item	Vegetation
Looking south at elderberry on waterside slope.	
richard_f_20100921_128.jpg

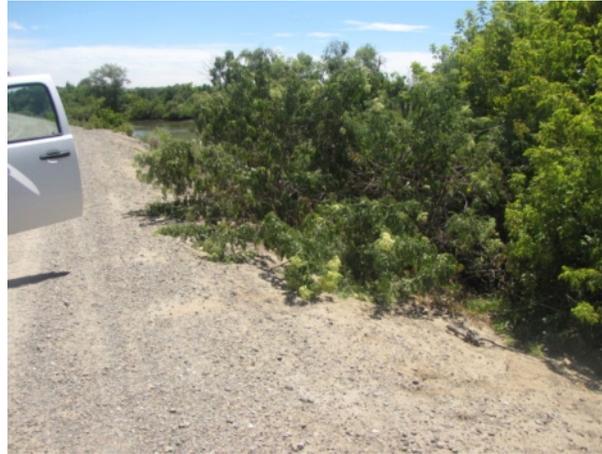
Levee Mile Report Line	47
Start Levee Mile	2.53
End Levee Mile	2.53
Location	Water Side
Category	Earthen Levee
Item	Vegetation

Looking north at elderberry on waterside slope.

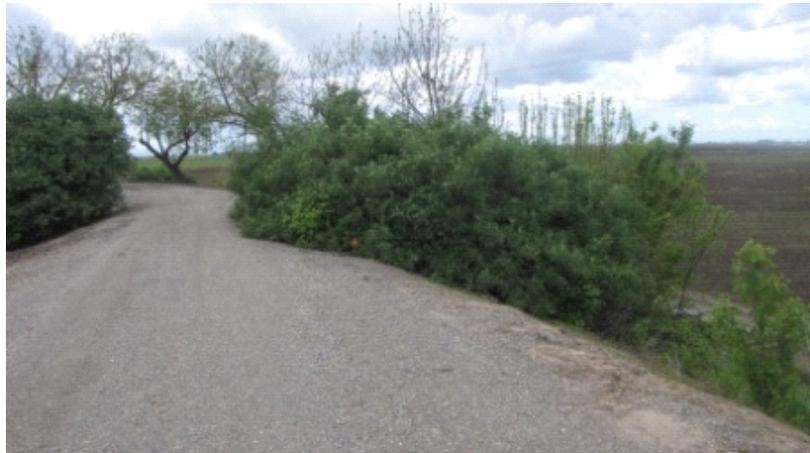
Levee Mile Report Line	50
Start Levee Mile	2.59
End Levee Mile	2.59
Location	Land Side
Category	Earthen Levee
Item	Encroachments

Looking southwest at elderberries on landside slope.

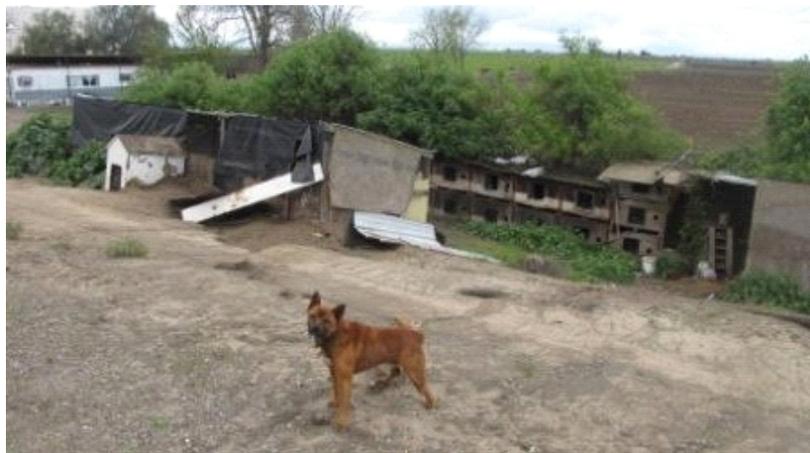
Levee Mile Report Line	54
Start Levee Mile	2.66
End Levee Mile	2.66
Location	Land Side
Category	Earthen Levee
Item	Vegetation

Looking southwest at structures on landside.

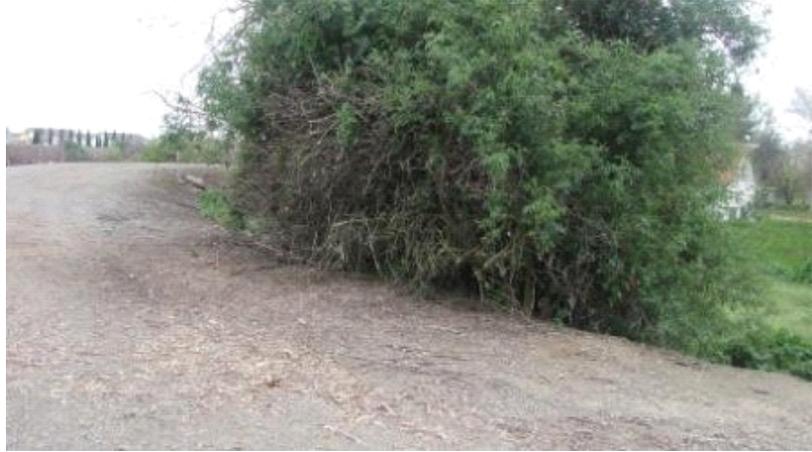
Levee Mile Report Line	61
Start Levee Mile	2.79
End Levee Mile	2.81
Location	Land Side
Category	Earthen Levee
Item	Slope Stability
Looking southwest at elderberry on landside slope.	
richard_f_20100921_132.jpg

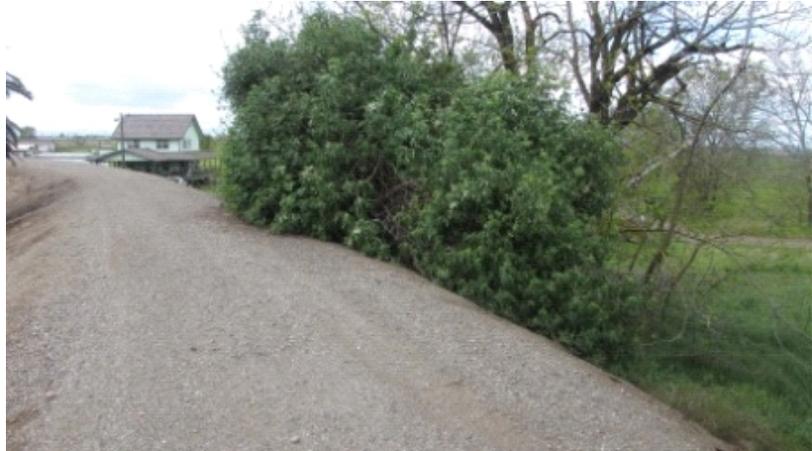
Levee Mile Report Line	63
Start Levee Mile	2.82
End Levee Mile	2.82
Location	Land Side
Category	Earthen Levee
Item	Vegetation
Looking south at elderberry on landside slope.	
richard_f_20100921_133.jpg

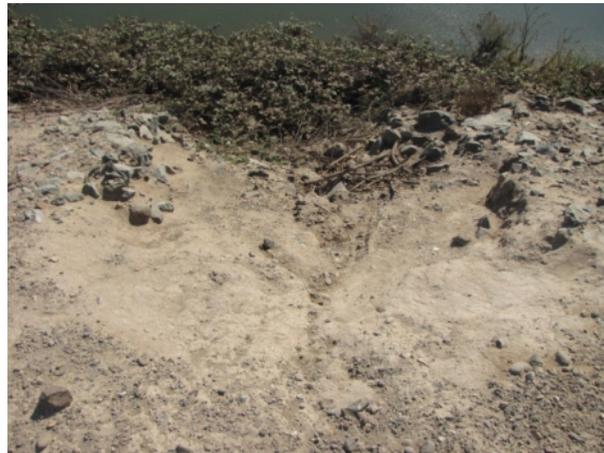
LMR No.	Levee Mile		Category	Item	* Location	** Rating	Action/Comment	GPS Latitude/Longitude		Issue No. Photo
	Start	End						Start	End	
68	2.98	2.98	Earthen Levee	Erosion / Bank Caving	WS	M	Note and monitor erosion site.	37.913010 ° -121.324497 °	37.913010 ° -121.324497 °	922 Y
69	3.04	3.04	Earthen Levee	Animal Control	LS	M	Repair the levee slope damaged by livestock and prevent large animal access.	37.912163 ° -121.324702 °	37.912163 ° -121.324702 °	924
70	3.10	3.12	Earthen Levee	Animal Control	LS	M	Exterminate rodents and backfill and compact or grout burrows.	37.911382 ° -121.324928 °	37.911088 ° -121.325113 °	925
71	3.33	3.35	Earthen Levee	Trim / Thin Trees	LS	M	Trim trees to at least five feet above ground level.	37.908158 ° -121.325418 °	37.907872 ° -121.325443 °	926
72	3.37	3.40	Earthen Levee	Trim / Thin Trees	LS	M	Trim trees to at least five feet above ground level.	37.907645 ° -121.325442 °	37.907157 ° -121.325408 °	52

Levee Mile Report Line	68
Start Levee Mile	2.98
End Levee Mile	2.98
Location	Water Side
Category	Earthen Levee
Item	Erosion / Bank Caving
Looking east at erosion on waterside toe.	
richard_f_20101001_324.jpg

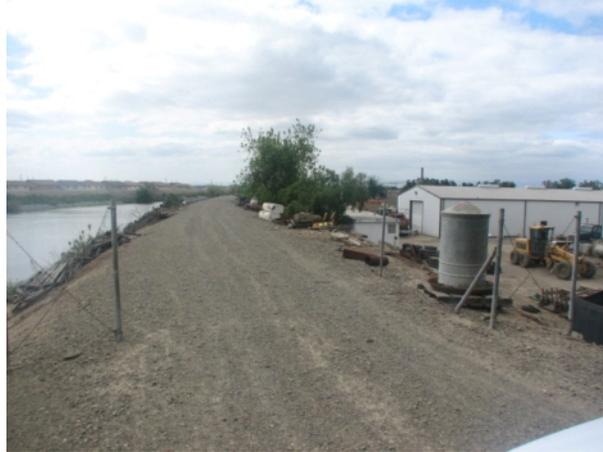
Levee Mile Report Line	84
Start Levee Mile	3.89
End Levee Mile	4.01
Location	Land Side
Category	Earthen Levee
Item	Encroachments
Looking upstream at equipment on landside shoulder	
richard_f_20100921_135.jpg

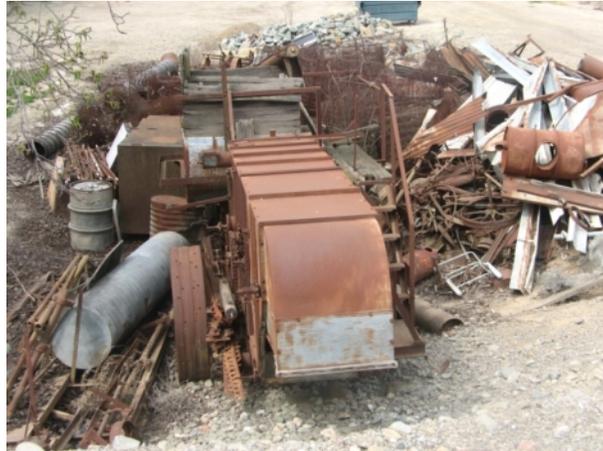
Levee Mile Report Line	90
Start Levee Mile	4.64
End Levee Mile	4.64
Location	Land Side
Category	Earthen Levee
Item	Encroachments
Garbage at landward toe next to ramp at LM 4.64	
richard_f_20100921_136.jpg

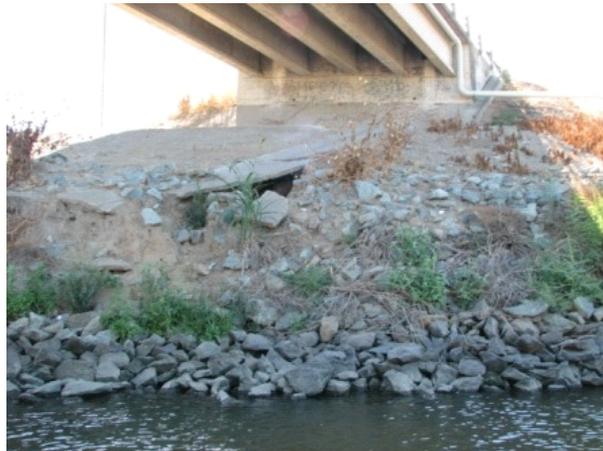
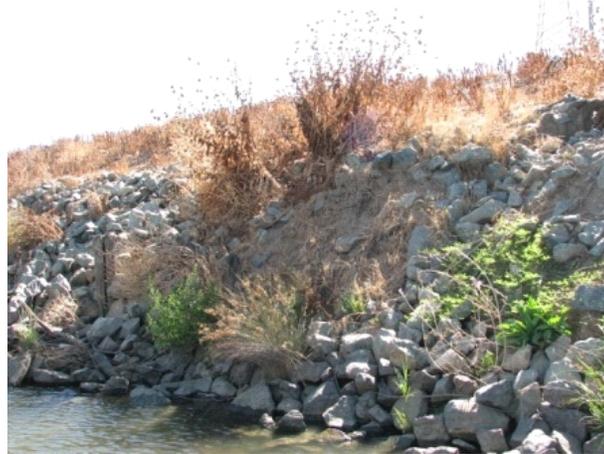
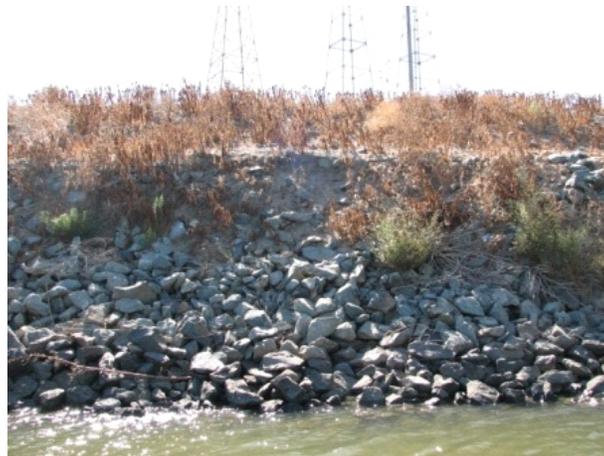
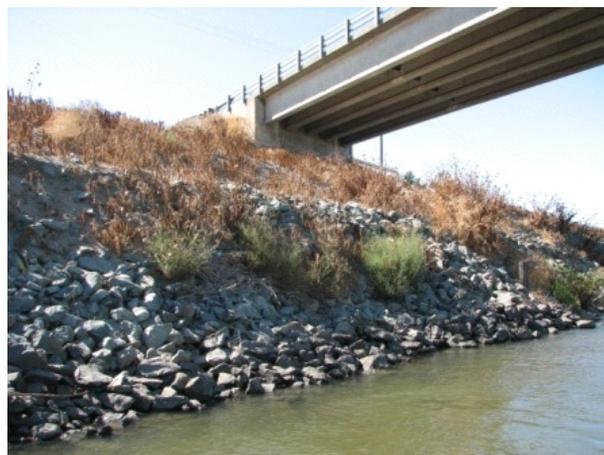
LMR No.	Levee Mile		Category	Item	* Location	** Rating	Action/Comment	GPS Latitude/Longitude		Issue No. Photo
	Start	End						Start	End	
103	5.65	5.66	Supplemental	DWR Erosion Survey	WS	M	Inspector Comments: 09/07/2010: No significant changes observed on site. Erosion site is located beneath Howard Road Bridge. Majority of the existing rip rap has slipped, dragging away levee materials and exposing the underlying soft soil. 08/06/2010: Recommend for annual assessment and monitoring during flood events, per CLRO. [2010 SiteID: RD0524U01RM46.12]	37.877880 ° -121.332550 °	37.877880 ° -121.332550 °	90 Y
104	5.86	5.86	Earthen Levee	Animal Control	LS	M	No rodents visible, but rodent burrows visible; need to backfill and compact or grout borrows.	37.875073 ° -121.333168 °	37.875073 ° -121.333168 °	69
105	5.92	5.94	Earthen Levee	Animal Control	WS	M	No rodents visible, but rodent burrows visible; need to backfill and compact or grout borrows.	37.874240 ° -121.333187 °	37.874002 ° -121.333027 °	75

Levee Mile Report Line	103
Start Levee Mile	5.65
End Levee Mile	5.66
Location	Water Side
Category	Supplemental
Item	DWR Erosion Survey
Sloughing rip rap just below the Howard Bridge abutment.	
SJR2010_RM46.12U1LM5.65LBa.jpg

Levee Mile Report Line	103
Start Levee Mile	5.65
End Levee Mile	5.66
Location	Water Side
Category	Supplemental
Item	DWR Erosion Survey
Upstream view of the sloughing rip rap adjacent to Howard Bridge.	
SJR2010_RM46.12U1LM5.65LBb.jpg

Levee Mile Report Line	103
Start Levee Mile	5.65
End Levee Mile	5.66
Location	Water Side
Category	Supplemental
Item	DWR Erosion Survey
Front view of sloughing rip rap.	
SJR2010_RM46.12U1LM5.65LBc.jpg

Levee Mile Report Line	103
Start Levee Mile	5.65
End Levee Mile	5.66
Location	Water Side
Category	Supplemental
Item	DWR Erosion Survey
Downstream view of the site.	
SJR2010_RM46.12U1LM5.65LBd.jpg

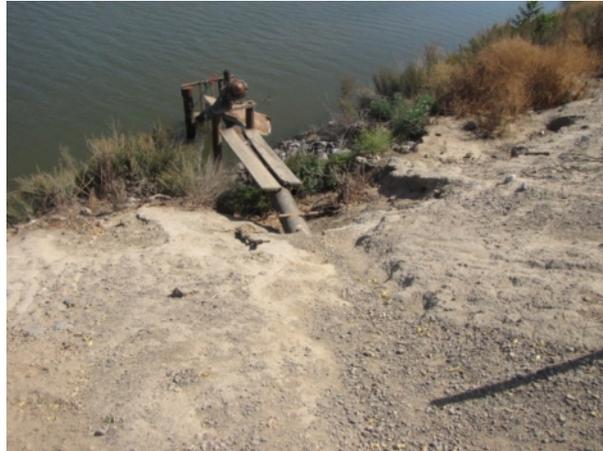
Levee Mile Report Line	106
Start Levee Mile	5.92
End Levee Mile	5.92
Location	Water Side
Category	Earthen Levee
Item	Erosion / Bank Caving
Looking southeast at erosion around pipe.	
richard_f_20101001_325.jpg

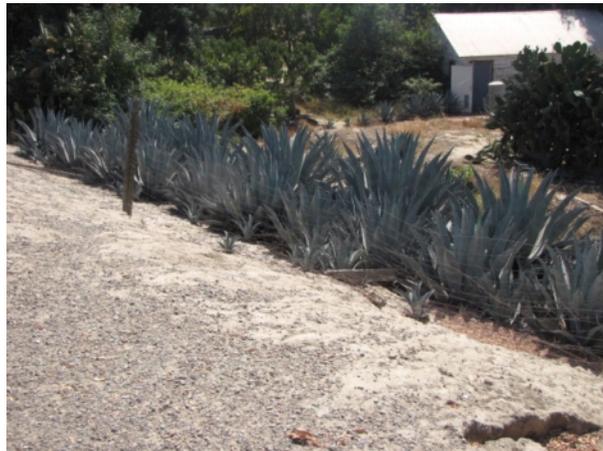
Levee Mile Report Line	109
Start Levee Mile	5.99
End Levee Mile	6.00
Location	Land Side
Category	Earthen Levee
Item	Encroachments
Looking southeast at fence and cactus on landside slope and toe.	
richard_f_20101001_326.jpg

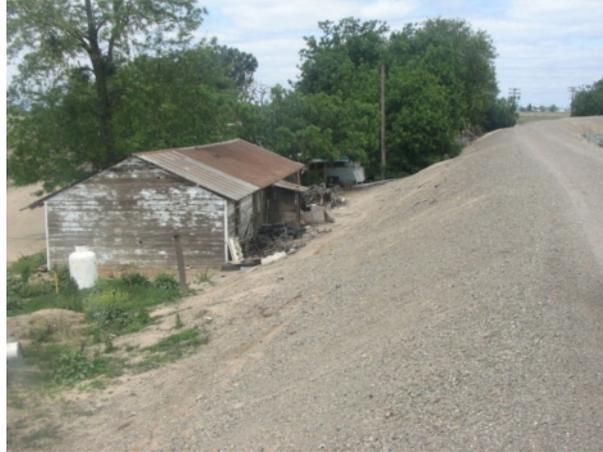
Levee Mile Report Line	110
Start Levee Mile	6.01
End Levee Mile	6.05
Location	Land Side
Category	Earthen Levee
Item	Encroachments
Looking downstream at building on landside toe.	
richard_f_20100921_138.jpg
