**Flood Control Project Maintenance  
Levee Inspections**

**Fall 2011 Levee Maintenance Deficiency Summary Report**

***San Joaquin River Basin***

**Reclamation District No. 0524 Middle Roberts Island**

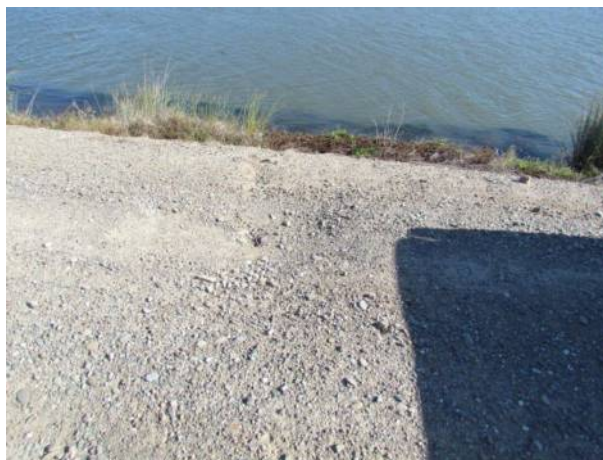
richard\_f\_20111028\_360.jpg

Looking east at 3" depression on levee crown near waterward shoulder.

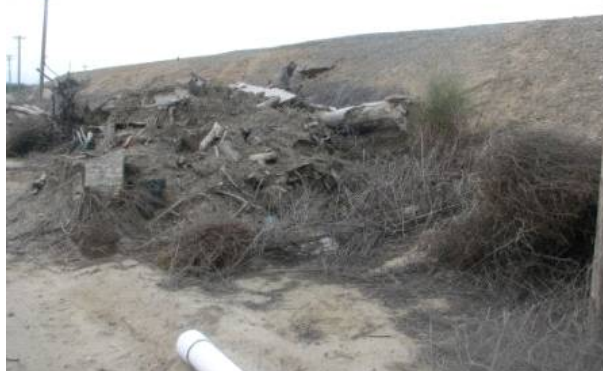
Levee Mile Report Line	2
Start Levee Mile	0.36
End Levee Mile	0.36
Location	Land Side
Category	Earthen Levee
Item	Encroachments

Garbage pile at landward toe at LM 0.36

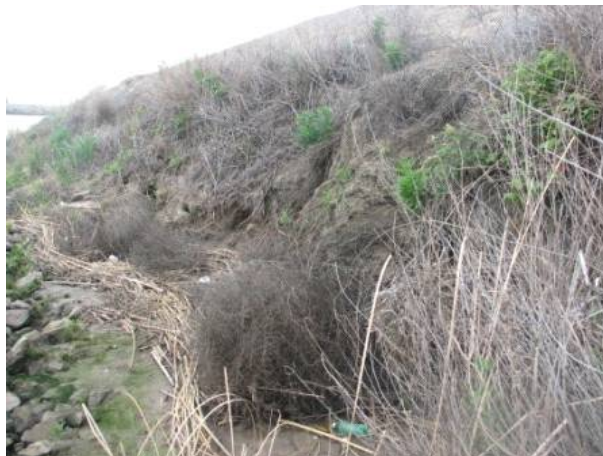
Levee Mile Report Line	3
Start Levee Mile	0.38
End Levee Mile	0.39
Location	Water Side
Category	Earthen Levee
Item	Erosion / Bank Caving

Minor erosion from LM 0.38 to 0.39

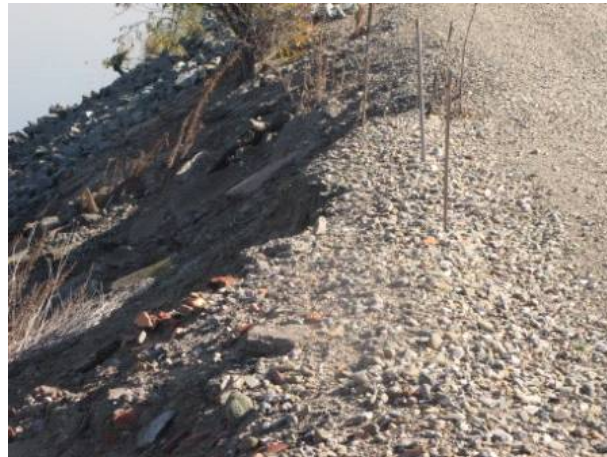
Levee Mile Report Line	4
Start Levee Mile	0.48
End Levee Mile	0.49
Location	Water Side
Category	Earthen Levee
Item	Erosion / Bank Caving

Update of erosion site at LM 0.48 to 0.49

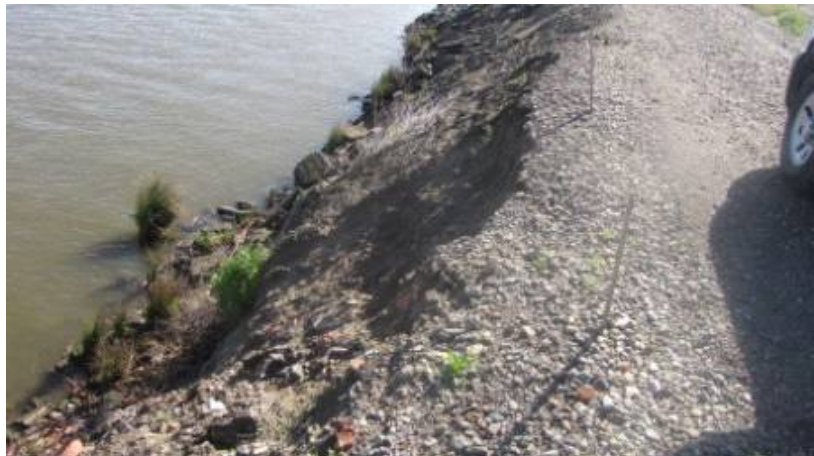
Levee Mile Report Line	4
Start Levee Mile	0.48
End Levee Mile	0.49
Location	Water Side
Category	Earthen Levee
Item	Erosion / Bank Caving

Looking southeast at erosion (no change as 4/2010)

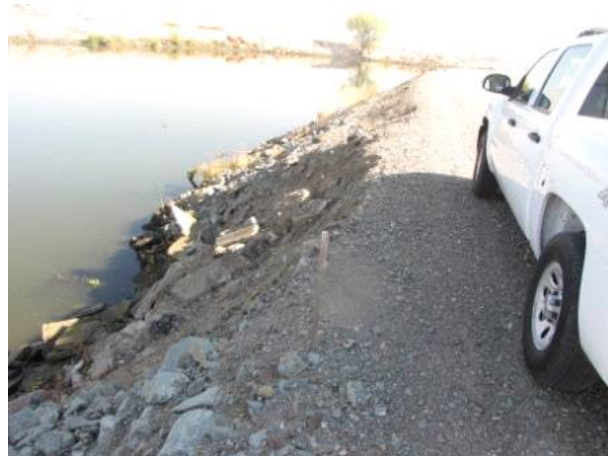
Levee Mile Report Line	5
Start Levee Mile	0.51
End Levee Mile	0.52
Location	Water Side
Category	Earthen Levee
Item	Erosion / Bank Caving

Update of erosion site at LM 0.51 to 0.52

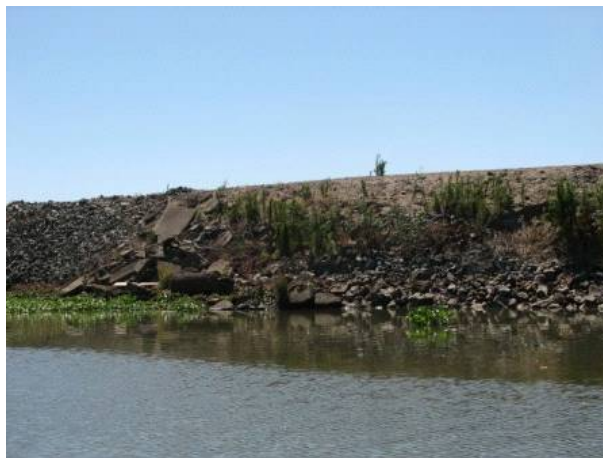
Levee Mile Report Line	6
Start Levee Mile	0.53
End Levee Mile	0.60
Location	Water Side
Category	Supplemental
Item	DWR Erosion Survey

6	0.53	0.60	Supplemental	DWR Erosion Survey	WS	U	Inspector Comments: 08/23/2011: No significant changes observed on site.09/07/2010: No significant changes observed on site. Some emergent vegetation at the lower and middle slope. Existing revetment is no longer adequately protecting the oversteepened slope. Some of the broken concrete used as revetment has slid, dragging levee materials away from the slope and creating notches.  09/29/2009: Erosion site extends from RM 41.11 to 41.18; existing revetment is no longer adequately protecting the oversteepened slope.2008: Existing concrete slabs were placed as temporary fix; some of the slabs have started to slide, dragging levee materials away from the slope and creating notches; note that a sewage treatment plant is located on the landside of the levee. [2011 Site ID:RD0524U01RM41.15]	37.938895 ° -121.337602 °	37.938895 ° -121.337602 °	79 Y
7	0.63	0.63	Earthen Levee	Slope Stability	WS	M	Repair the levee slope damaged by foot traffic and prevent access where possible.	37.938247 ° -121.336503 °	37.938247 ° -121.336503 °	10

Upstream view of the site. Broken concrete used as revetment is sliding, dragging down levee materials.

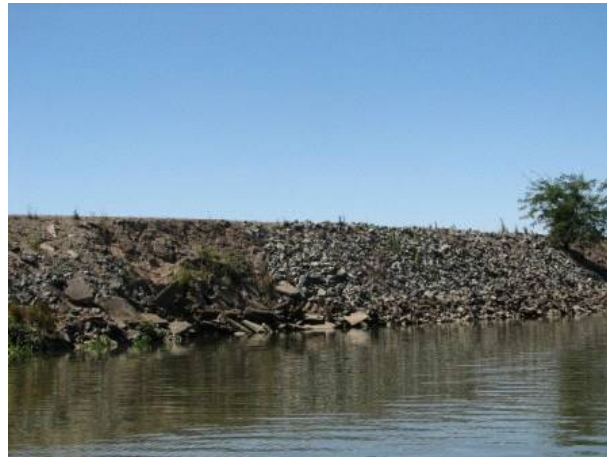
Upstream view. Sloughing mid-slope possibly caused by sliding of the revetment.

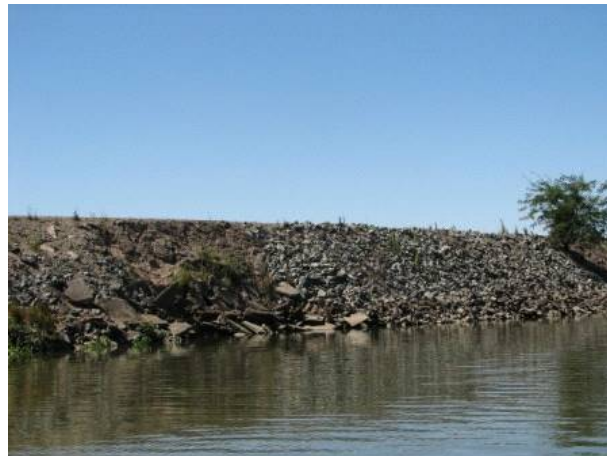
Levee Mile Report Line	6
Start Levee Mile	0.53
End Levee Mile	0.60
Location	Water Side
Category	Supplemental
Item	DWR Erosion Survey

Direct view of the site showing emergent vegetation growing at the midslope.

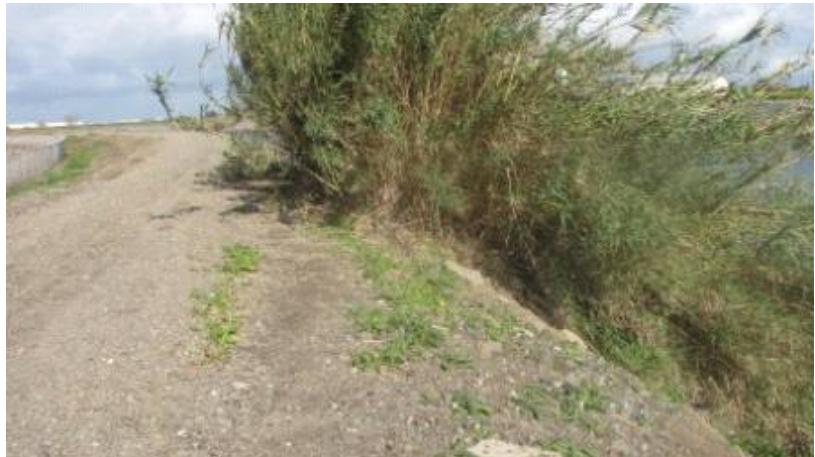
Looking north at bamboo on waterside slope as of 4/2010 no change.

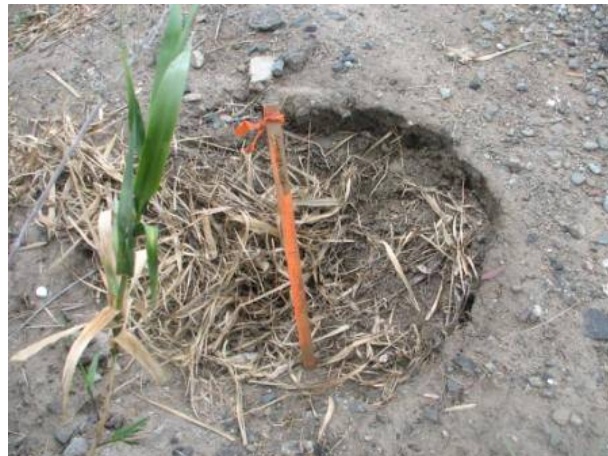
Levee Mile Report Line	9
Start Levee Mile	0.64
End Levee Mile	0.64
Location	Crown
Category	Earthen Levee
Item	Crown Surface / Depressions / Rutting

Large hole 3 x 3 on levee crown near waterside shoulder at LM 0.64

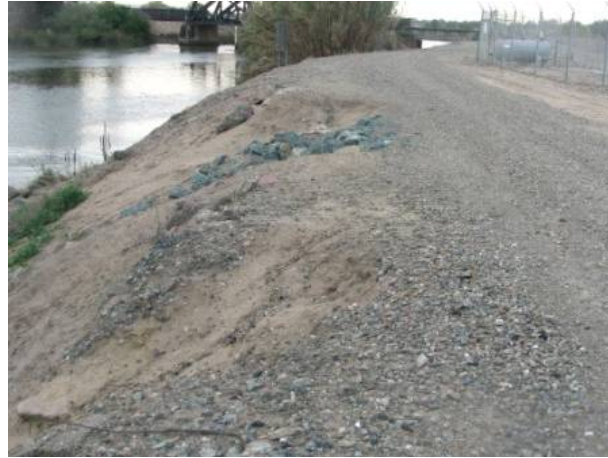
Erosion from LM 0.65 to 0.66

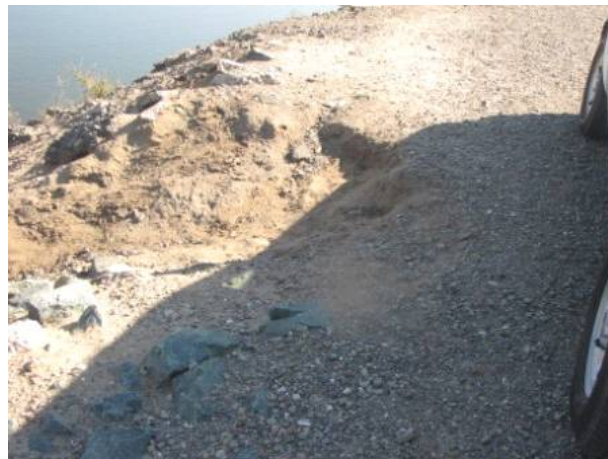
Levee Mile Report Line	10
Start Levee Mile	0.65
End Levee Mile	0.66
Location	Water Side
Category	Earthen Levee
Item	Slope Stability

Update of erosion site at LM 0.65 to 0.66

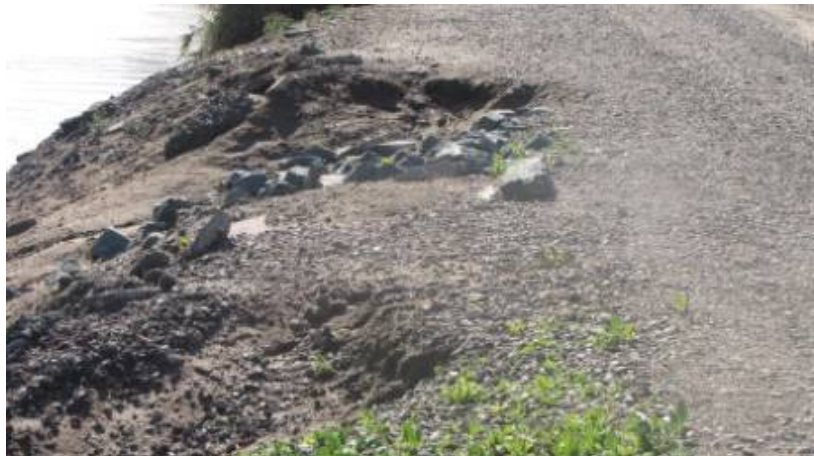
Levee Mile Report Line	10
Start Levee Mile	0.65
End Levee Mile	0.66
Location	Water Side
Category	Earthen Levee
Item	Slope Stability

Looking south at erosion on waterside shoulder.

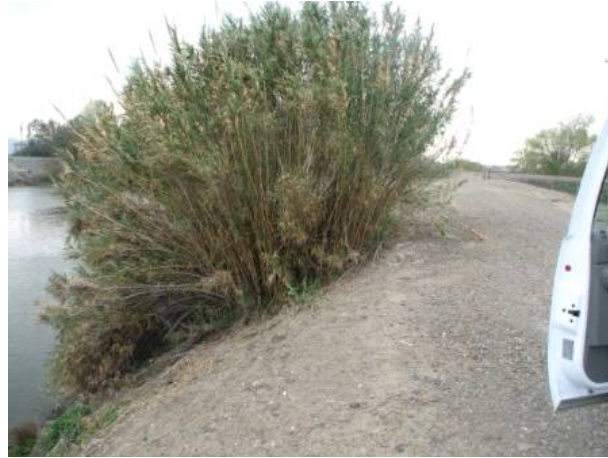
Bamboo on waterward slope at LM 0.68

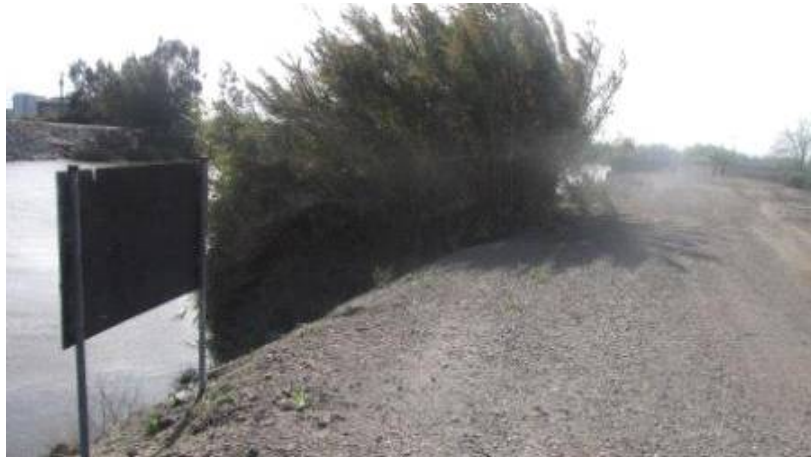
Levee Mile Report Line	11
Start Levee Mile	0.68
End Levee Mile	0.68
Location	Water Side
Category	Earthen Levee
Item	Vegetation

Looking southeast at bamboo on waterside shoulder as of 4/2010.

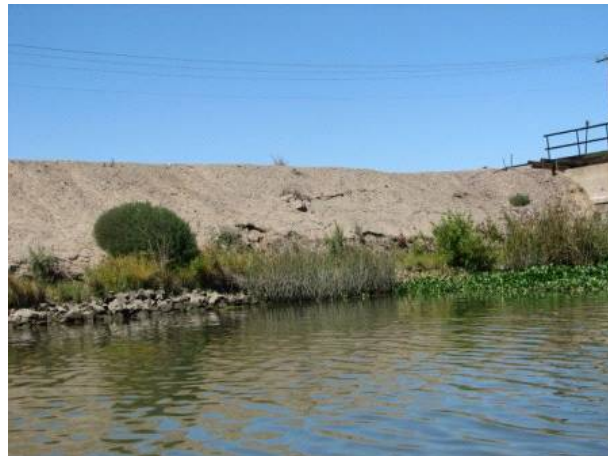
Levee Mile Report Line	12
Start Levee Mile	0.77
End Levee Mile	0.78
Location	Water Side
Category	Supplemental
Item	DWR Erosion Survey

Upstream view of the erosion site. Note the railroad bridge.

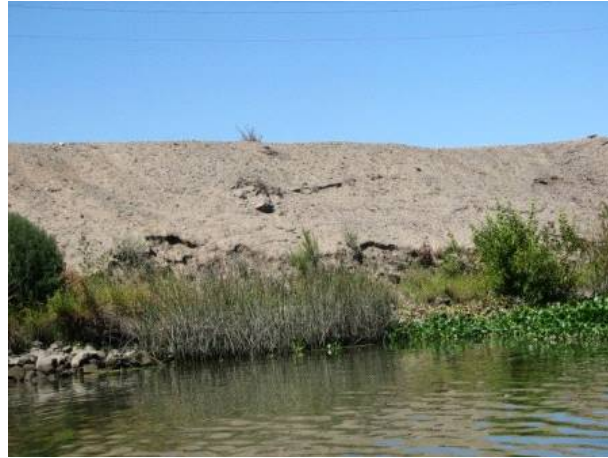
Front view of the erosion site. Vegetation visible

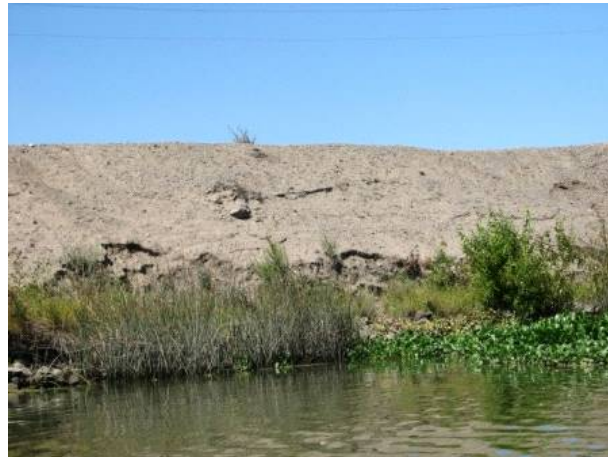
Levee Mile Report Line	12
Start Levee Mile	0.77
End Levee Mile	0.78
Location	Water Side
Category	Supplemental
Item	DWR Erosion Survey

Front view of erosion

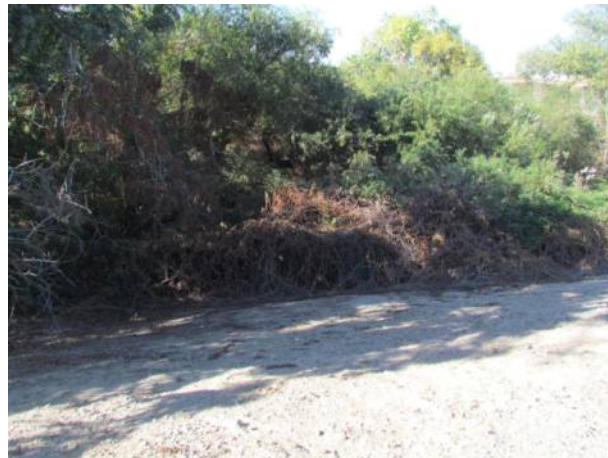
Levee Mile Report Line	13
Start Levee Mile	0.78
End Levee Mile	0.78
Location	Land Side
Category	Earthen Levee
Item	Vegetation

Looking west at dense vegetation on landside toe.

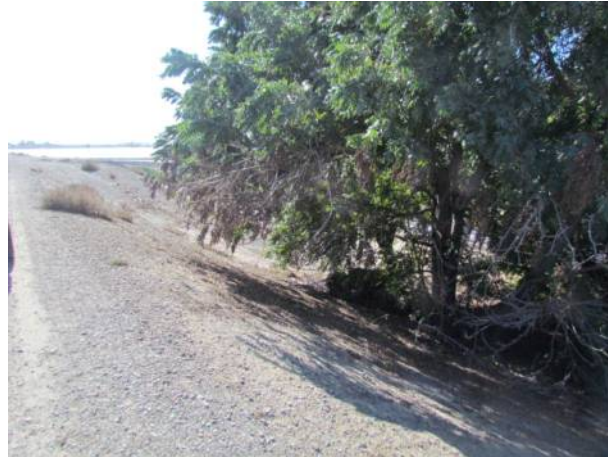
Looking southwest at low hanging tree branches at landside toe.

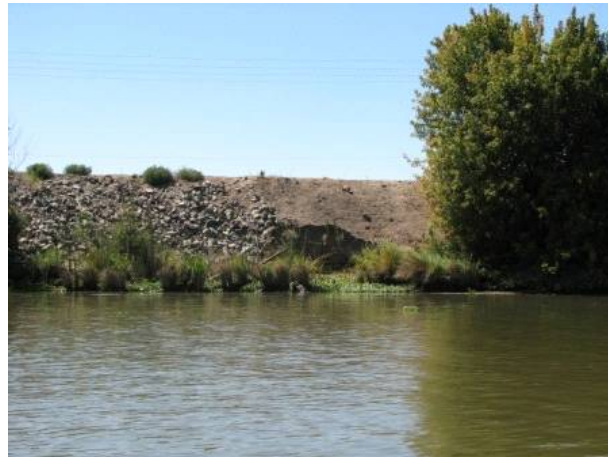
Levee Mile Report Line	16
Start Levee Mile	0.91
End Levee Mile	0.91
Location	Water Side
Category	Supplemental
Item	DWR Erosion Survey

Front view of the erosion. Not the riprap protection near the site

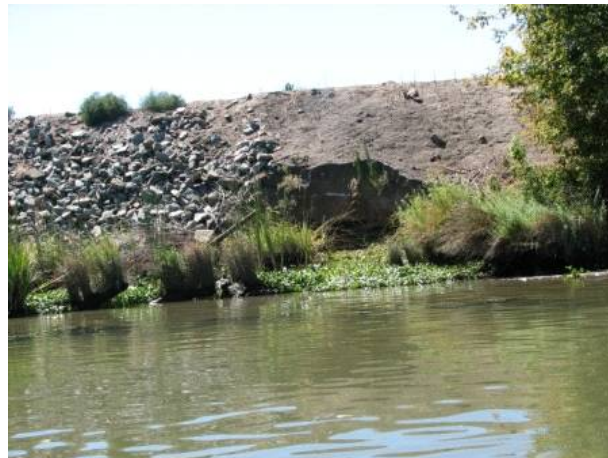
Levee Mile Report Line	16
Start Levee Mile	0.91
End Levee Mile	0.91
Location	Water Side
Category	Supplemental
Item	DWR Erosion Survey

A close view of the erosion

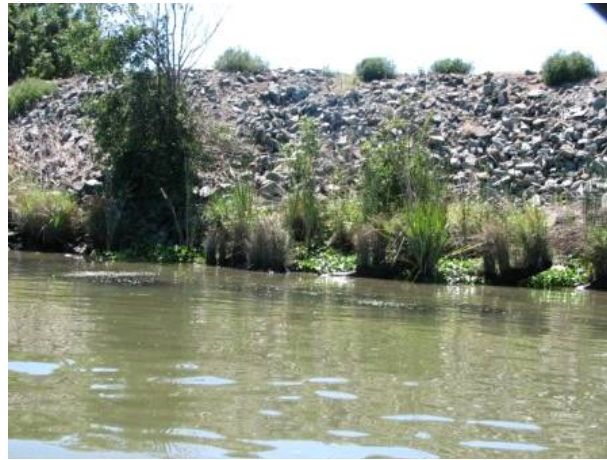
Front view of the upstream riprap protection.

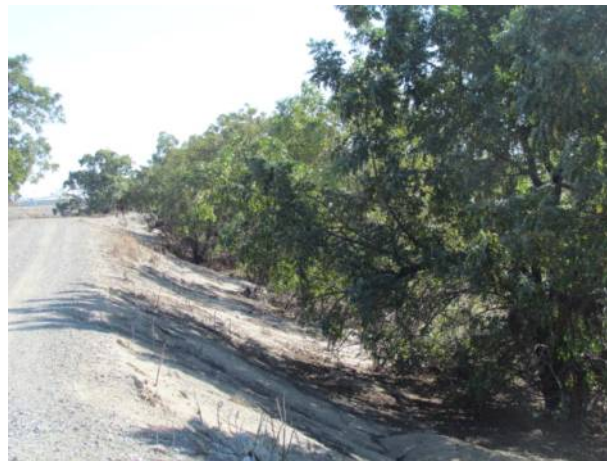
Levee Mile Report Line	17
Start Levee Mile	0.94
End Levee Mile	1.02
Location	Land Side
Category	Earthen Levee
Item	Trim / Thin Trees

Looking south at low hanging tree branches at landside toe.

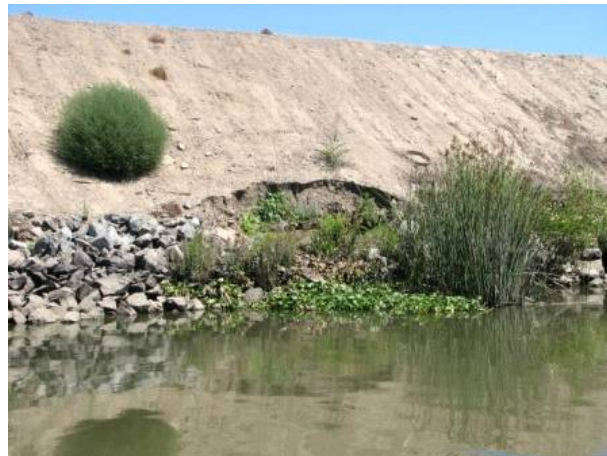
Levee Mile Report Line	18
Start Levee Mile	1.00
End Levee Mile	1.01
Location	Water Side
Category	Supplemental
Item	DWR Erosion Survey

Close view of the erosion. Note that the riprap protection next to the erosion.

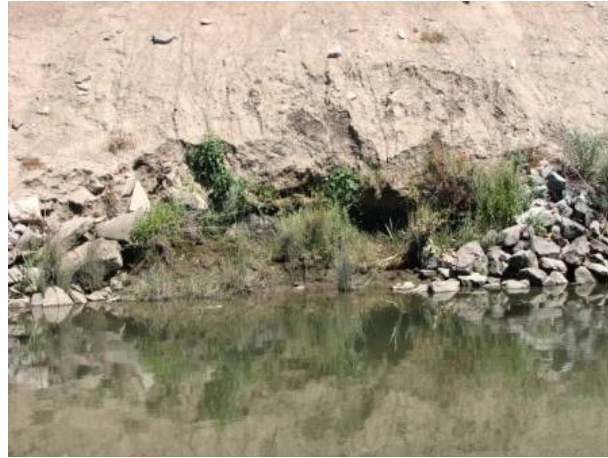
Close view of the erosion. The protection has been washed away.

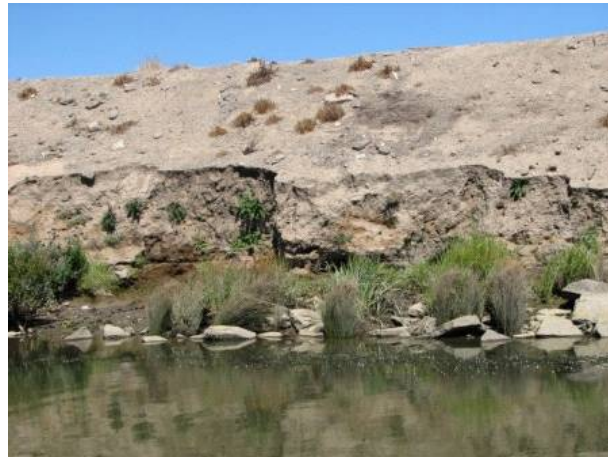
Levee Mile Report Line	18
Start Levee Mile	1.00
End Levee Mile	1.01
Location	Water Side
Category	Supplemental
Item	DWR Erosion Survey

Front view of the erosion

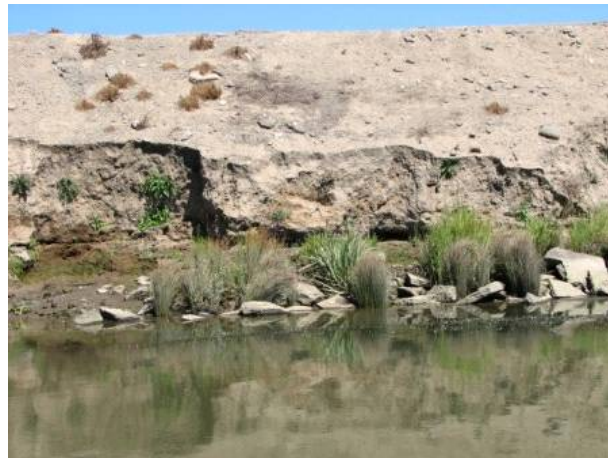
Levee Mile Report Line	18
Start Levee Mile	1.00
End Levee Mile	1.01
Location	Water Side
Category	Supplemental
Item	DWR Erosion Survey

Front view of the erosion

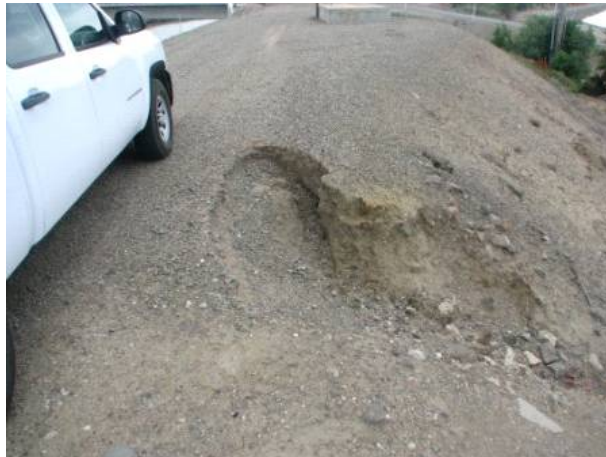
Landward slope damage at LM 1.09

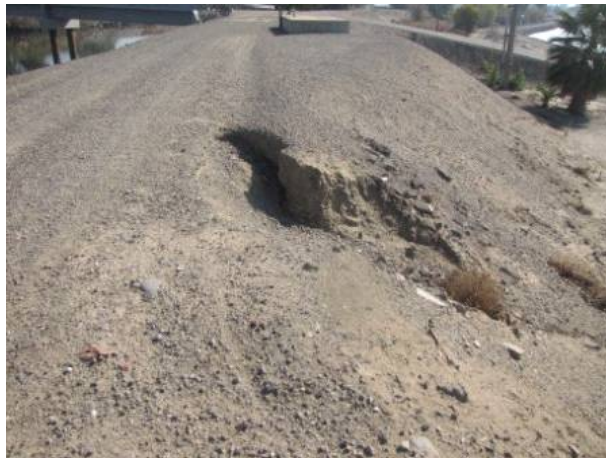
Levee Mile Report Line	20
Start Levee Mile	1.09
End Levee Mile	1.09
Location	Land Side
Category	Earthen Levee
Item	Slope Stability

Updated picture of erosion site on landside shoulder.

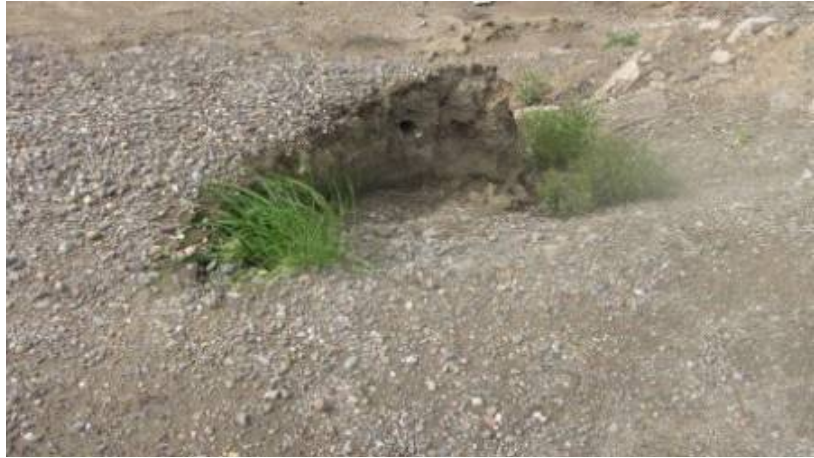
Update of above slope stability.

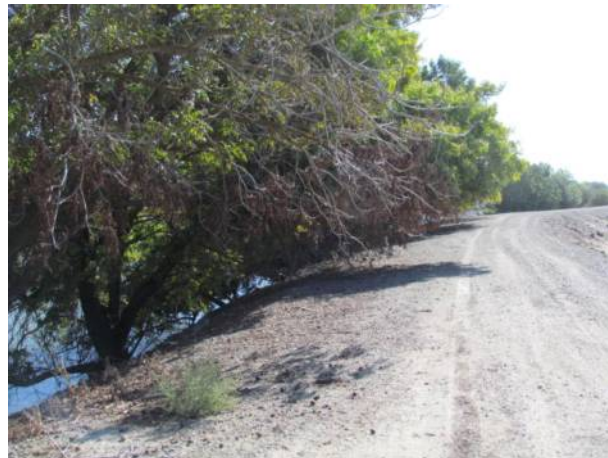
Looking northwest at low hanging tree branches at waterside toe.

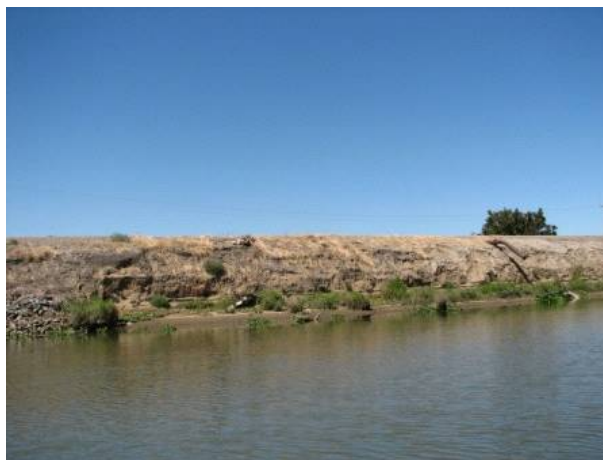
LMR No.	Levee Mile		Category	Item	Location *	Rating **	Action/Comment	GPS Latitude/Longitude		Issue No.
	Start	End						Start	End	
22	1.16	1.24	Supplemental	DWR Erosion Survey	WS	U	Inspector Comments: 08/23/2011: No significant changes observed on site. 9/07/2010: No significant changes observed on site. Some emergent vegetation at the water line. There is an exposed pipe discharge partially hanging at the mid-slope, possibly still used for discharging irrigation/runoff water. There is minimal rip rap protection along the bank, and what's left of it is no longer adequately protecting the bank. 9/29/2009: Site consists of a 400-foot long eroding bank with minimal vegetation and protection; the existing rip rap has sloughed, rendering it useless; note that there is an exposed section of a pipe. 10/18/2006: There is extensive loss of rip rap on some sections; sewage disposal pond is on the landside of the levee; there is an exposed pipe outlet "hanging" from the upper slope. [2011 Site ID: RD0524U01RM41.79]	37.933347 ° -121.329110 °	37.933347 ° -121.329110 °	2 Y

Downstream view of the site where sloughing is occurring.

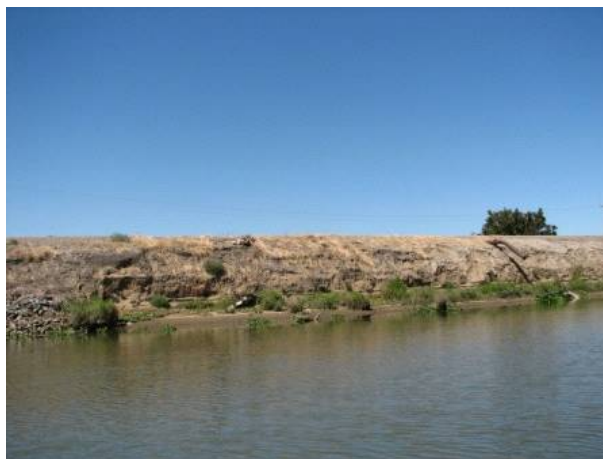
Levee Mile Report Line	22
Start Levee Mile	1.16
End Levee Mile	1.24
Location	Water Side
Category	Supplemental
Item	DWR Erosion Survey

Upstream view of the site.

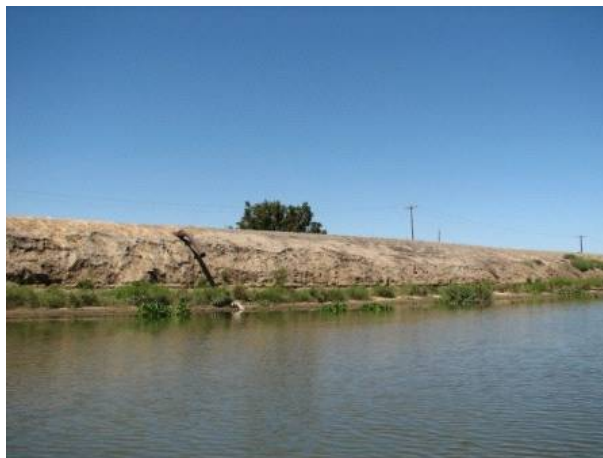
Levee Mile Report Line	22
Start Levee Mile	1.16
End Levee Mile	1.24
Location	Water Side
Category	Supplemental
Item	DWR Erosion Survey

Direct view of the site.

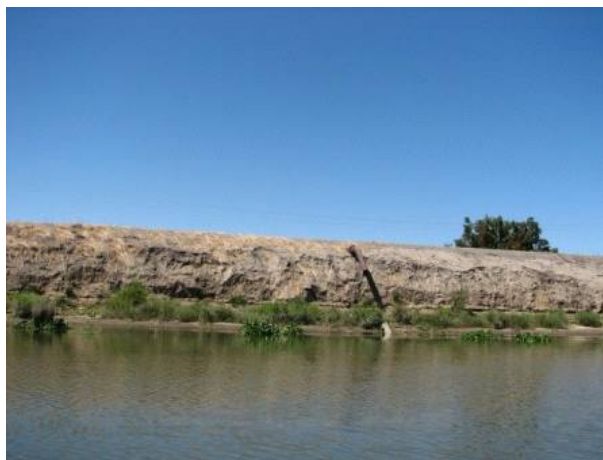
Direct view of the site.

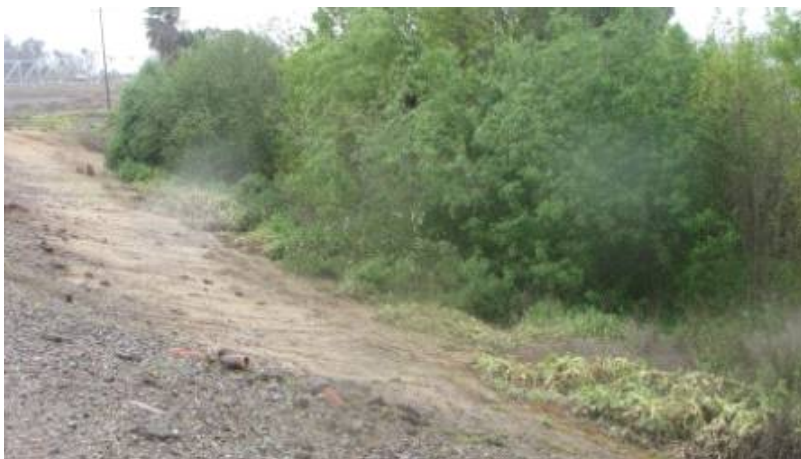
Levee Mile Report Line	23
Start Levee Mile	1.17
End Levee Mile	1.25
Location	Land Side
Category	Earthen Levee
Item	Vegetation

Looking southwest at dense veg. on landside toe.

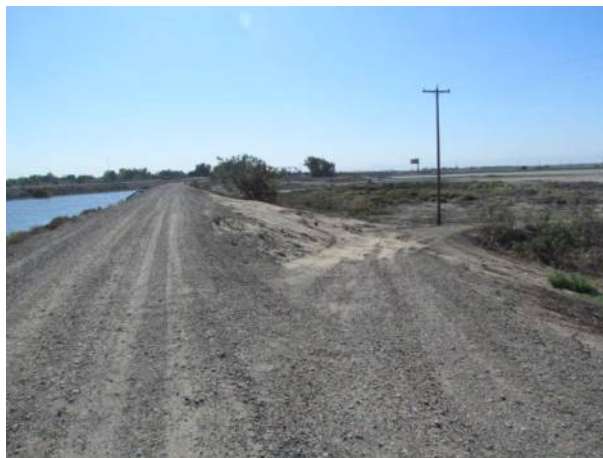
Levee Mile Report Line	25
Start Levee Mile	1.26
End Levee Mile	1.26
Location	Land Side
Category	Earthen Levee
Item	Encroachments

Looking south at unauthorized ramp on landside slope.

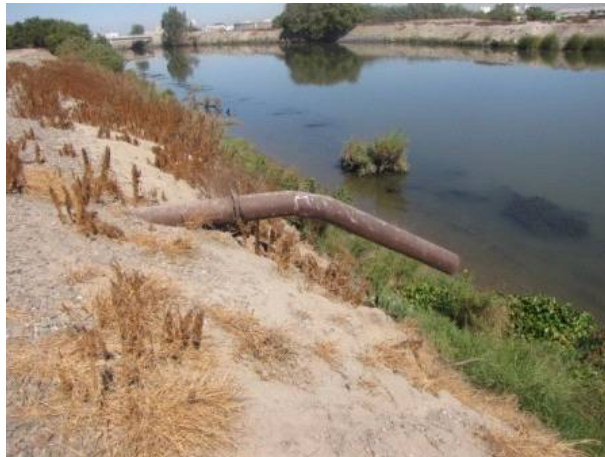
Looking north at broken pipe.

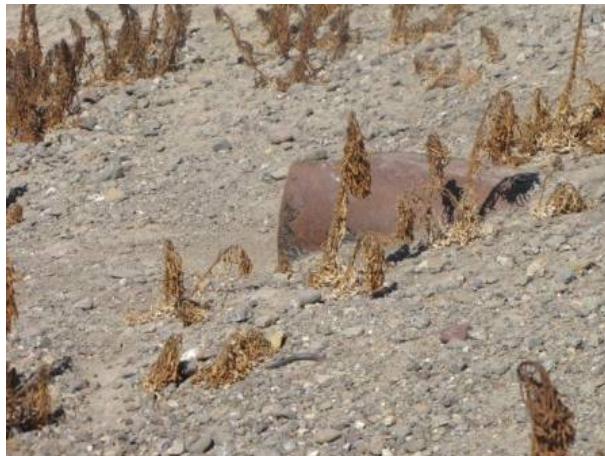
richard\_f\_20111014\_487.jpg

Looking west at pipe on landside slope.

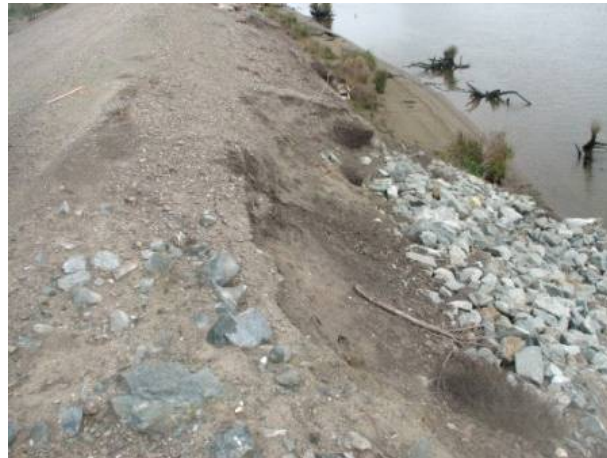
Levee Mile Report Line	27
Start Levee Mile	1.32
End Levee Mile	1.33
Location	Water Side
Category	Earthen Levee
Item	Erosion / Bank Caving

Erosion from LM 1.32 to 1.33

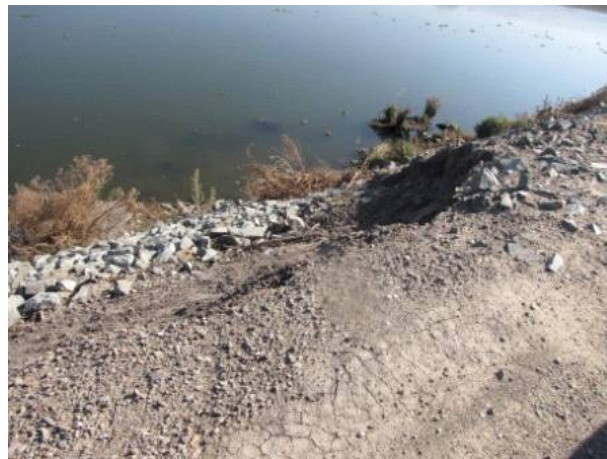
Levee Mile Report Line	27
Start Levee Mile	1.32
End Levee Mile	1.33
Location	Water Side
Category	Earthen Levee
Item	Erosion / Bank Caving

Looking at erosion from top of levee

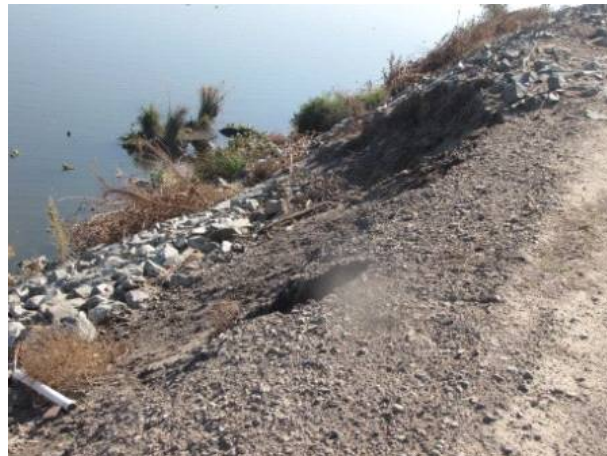
Levee Mile Report Line	27
Start Levee Mile	1.32
End Levee Mile	1.33
Location	Water Side
Category	Earthen Levee
Item	Erosion / Bank Caving

Looking at update of erosion site at LM 1.32 to 1.33

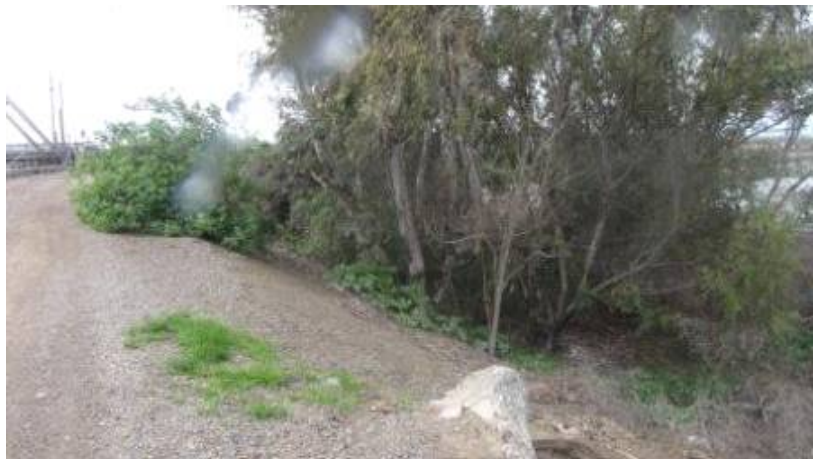
Levee Mile Report Line	29
Start Levee Mile	1.51
End Levee Mile	1.51
Location	Land Side
Category	Earthen Levee
Item	Trim / Thin Trees

Looking south at dense veg. on landside slope and toe.

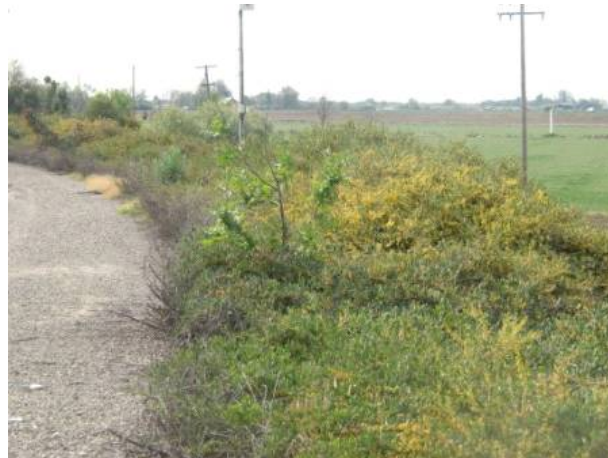
Levee Mile Report Line	30
Start Levee Mile	1.56
End Levee Mile	1.74
Location	Land Side
Category	Earthen Levee
Item	Vegetation

Overgrown landscaping on landward slope from LM 1.56 to 1.74

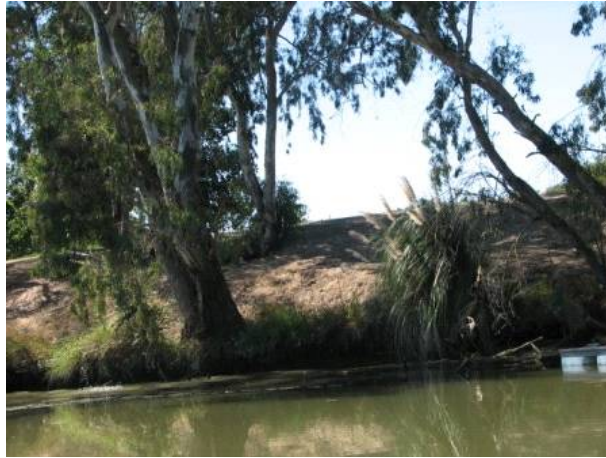
Levee Mile Report Line	31
Start Levee Mile	1.58
End Levee Mile	1.64
Location	Water Side
Category	Supplemental
Item	DWR Erosion Survey

Front view of the site where undermining has occurred.

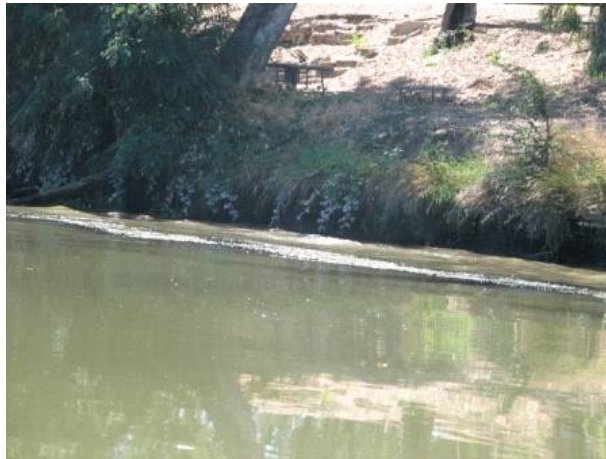
Levee Mile Report Line	31
Start Levee Mile	1.58
End Levee Mile	1.64
Location	Water Side
Category	Supplemental
Item	DWR Erosion Survey

Large trees along the levee toe. There is minimal slope protection. The erosion near tree visible.

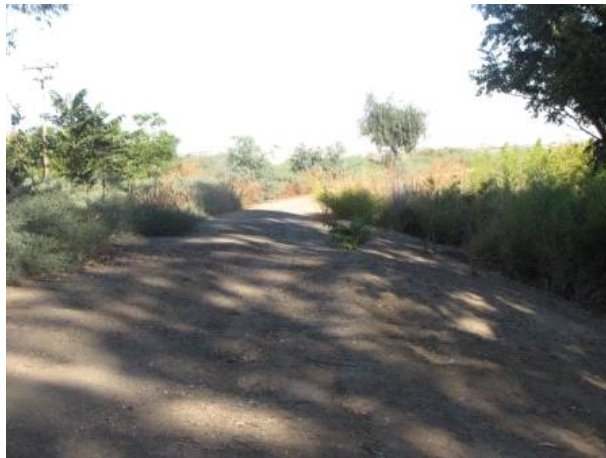
Levee Mile Report Line	32
Start Levee Mile	1.62
End Levee Mile	1.63
Location	Land Side
Category	Earthen Levee
Item	Vegetation

Looking north at dense veg on landside and waterside slopes.

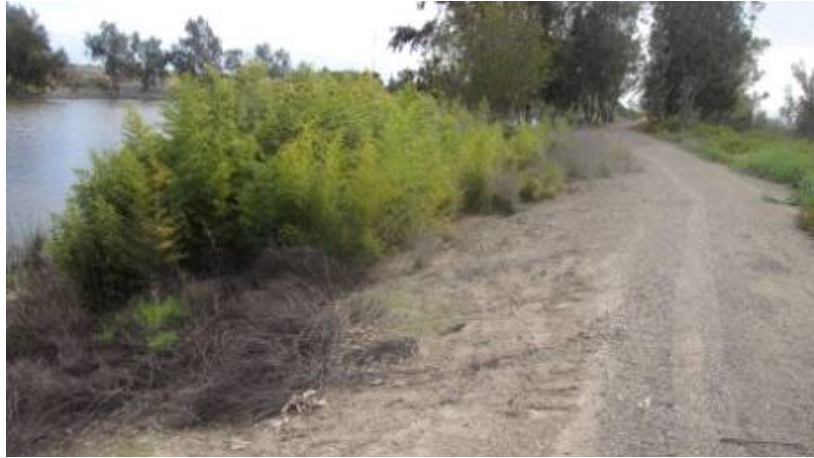
Levee Mile Report Line	33
Start Levee Mile	1.62
End Levee Mile	1.63
Location	Water Side
Category	Earthen Levee
Item	Vegetation

Looking southeast at dense veg. on waterside slope.

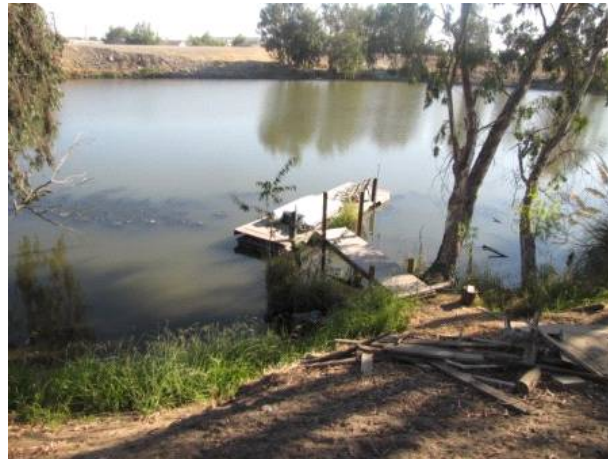
Levee Mile Report Line	35
Start Levee Mile	1.64
End Levee Mile	1.64
Location	Water Side
Category	Earthen Levee
Item	Encroachments

Looking east at non-permitted boat dock.

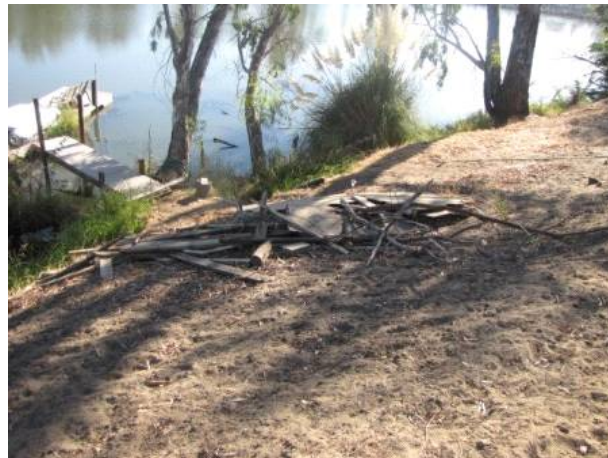
Levee Mile Report Line	35
Start Levee Mile	1.64
End Levee Mile	1.64
Location	Water Side
Category	Earthen Levee
Item	Encroachments

Looking at garbage on waterside slope.

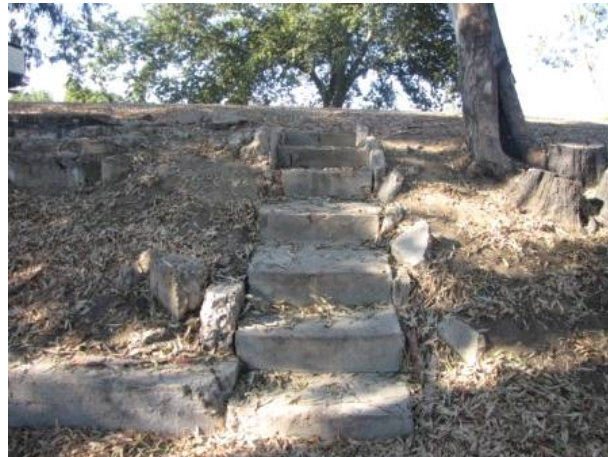
Levee Mile Report Line	37
Start Levee Mile	1.69
End Levee Mile	1.69
Location	Water Side
Category	Earthen Levee
Item	Encroachments
Looking west at concrete stairs on waterside slope.	
richard_f_20111014_498.jpg

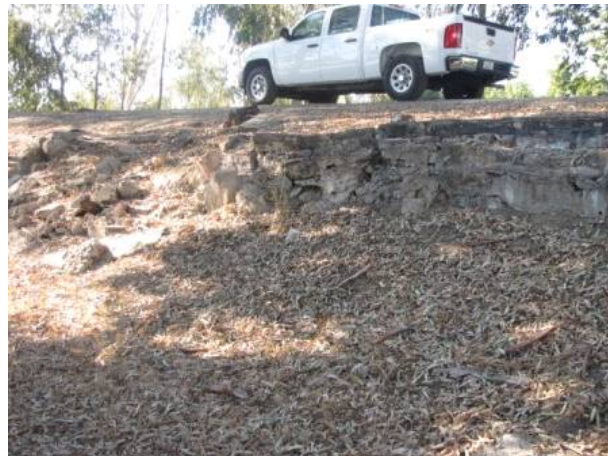
Levee Mile Report Line	37
Start Levee Mile	1.69
End Levee Mile	1.69
Location	Water Side
Category	Earthen Levee
Item	Encroachments
Looking southwest at retaining wall connect to concrete stairs.	
richard_f_20111014_499.jpg

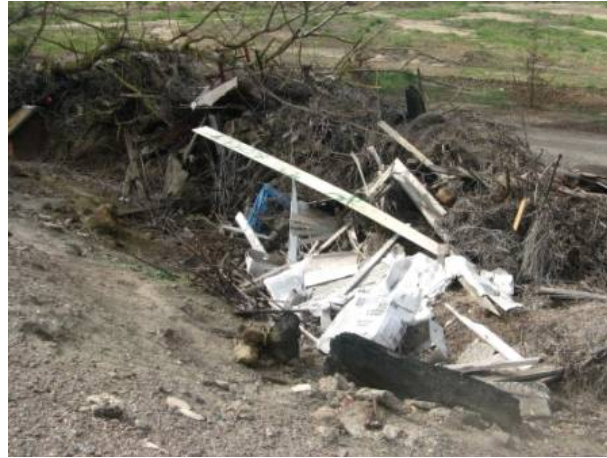
richard\_f\_20111014\_482.jpg

Garbage on landward toe from LM 1.75 to 1.76

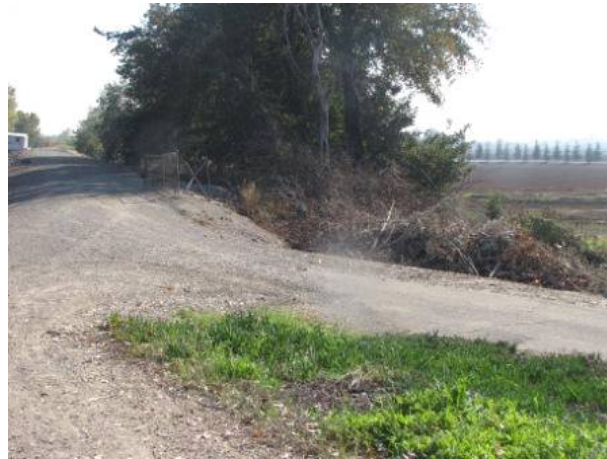
Levee Mile Report Line	39
Start Levee Mile	1.75
End Levee Mile	1.75
Location	Land Side
Category	Earthen Levee
Item	Encroachments

Looking at updated trash pile on landside slope and toe.

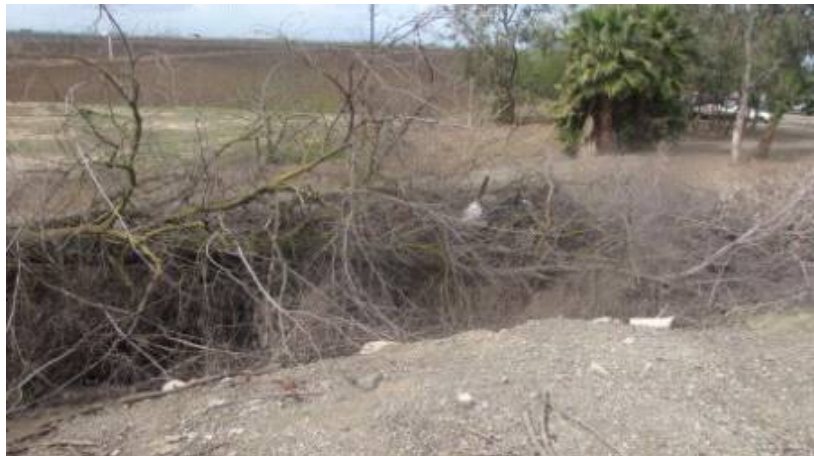
Levee Mile Report Line	39
Start Levee Mile	1.75
End Levee Mile	1.75
Location	Land Side
Category	Earthen Levee
Item	Encroachments

Looking west at prunings on landside toe.

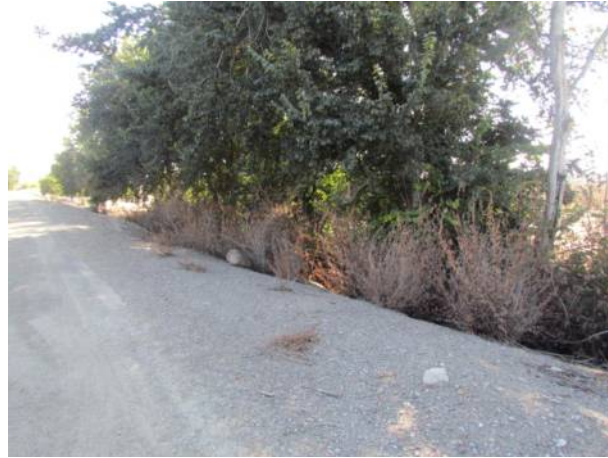
richard\_f\_20111028\_367.jpg

Looking southwest at dense vegetation and low hanging tree branches on landside slope and toe.

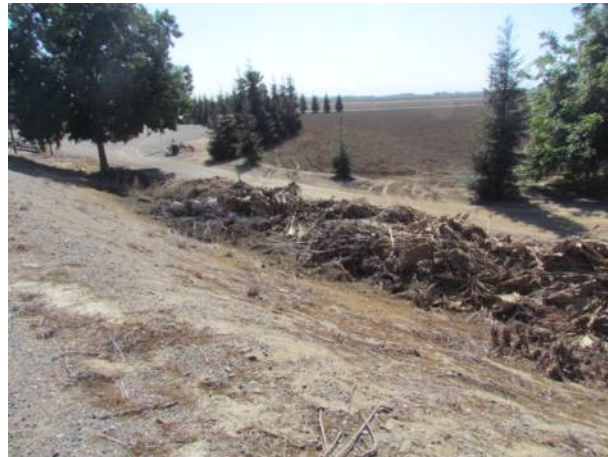
Levee Mile Report Line	41
Start Levee Mile	1.80
End Levee Mile	1.80
Location	Land Side
Category	Earthen Levee
Item	Encroachments

Looking southwest at prunings on landside toe.

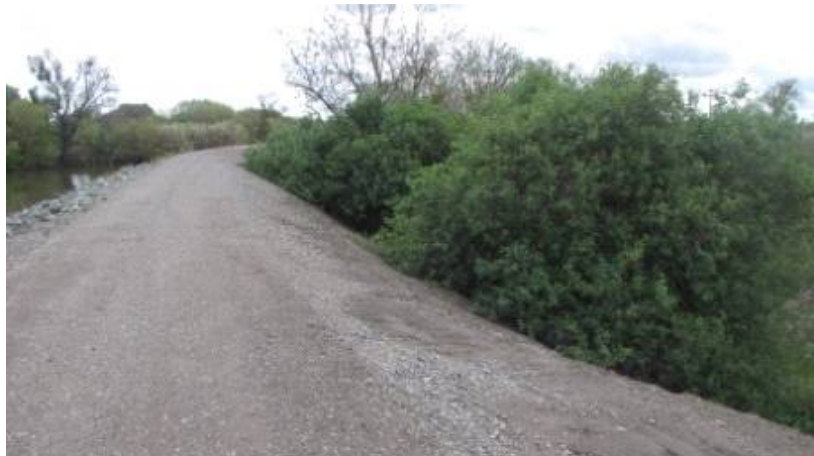
Levee Mile Report Line	45
Start Levee Mile	2.29
End Levee Mile	2.31
Location	Land Side
Category	Earthen Levee
Item	Vegetation

Looking south at dense veg on landside slope and toe.

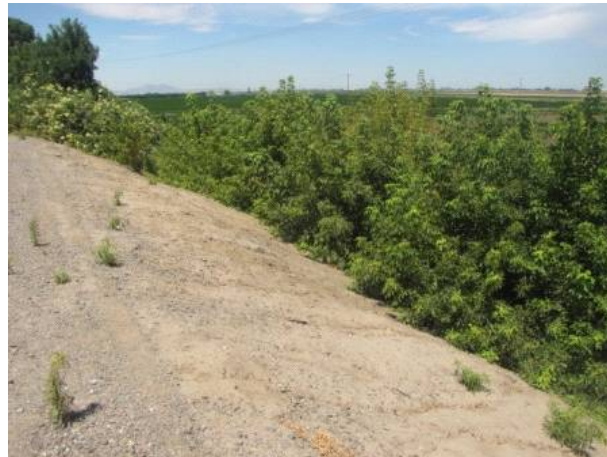
richard\_f\_20111014\_489.jpg

Looking southwest at trees along levee landside toe.

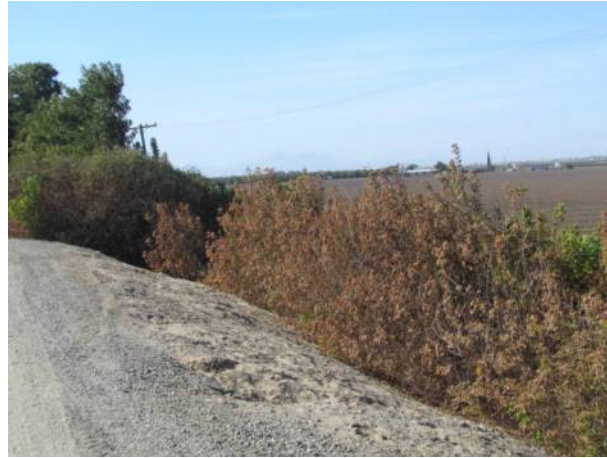
richard\_f\_20111028\_369.jpg

Looking southwest at dense vegetation on landside toe.

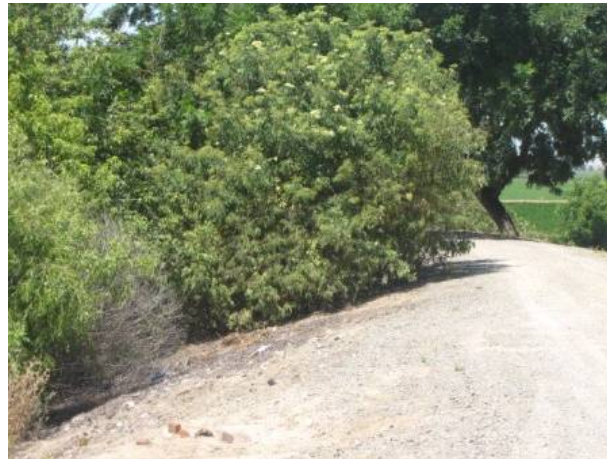
Levee Mile Report Line	51
Start Levee Mile	2.53
End Levee Mile	2.53
Location	Water Side
Category	Earthen Levee
Item	Vegetation

Looking south at elderberry on waterside slope.

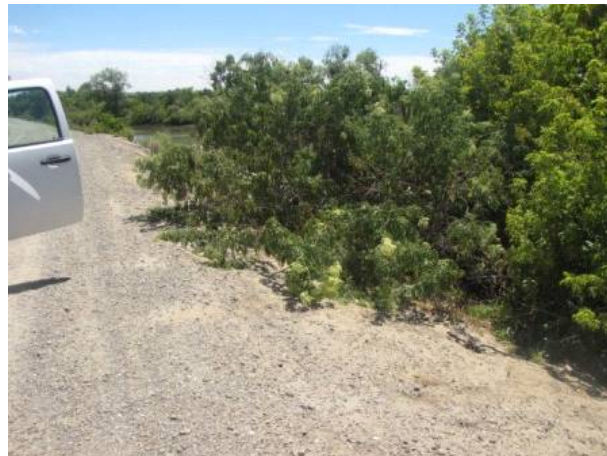
Levee Mile Report Line	51
Start Levee Mile	2.53
End Levee Mile	2.53
Location	Water Side
Category	Earthen Levee
Item	Vegetation

Looking north at elderberry on waterside slope.

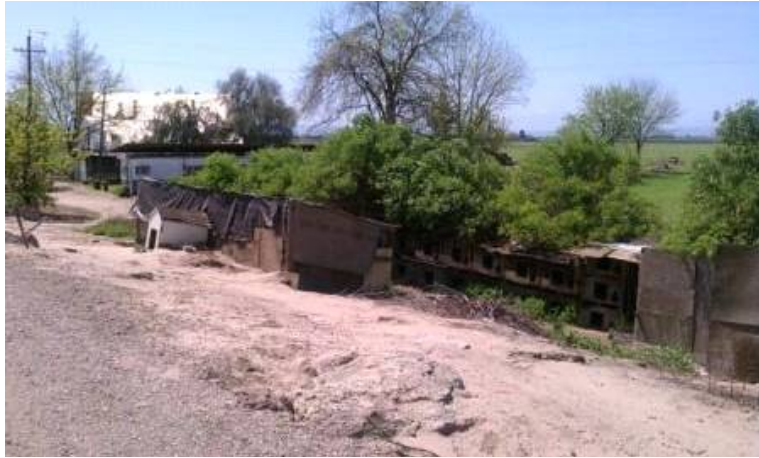
richard\_f\_20111014\_495.jpg

Looking at animal pens on landside slope and toe.

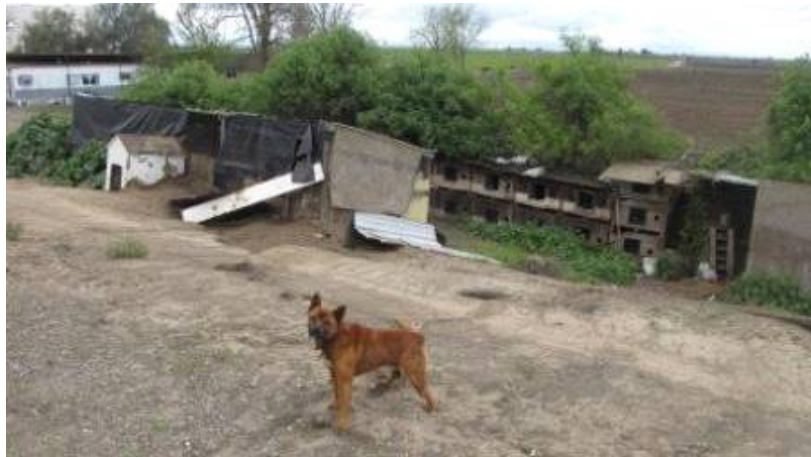
Levee Mile Report Line	58
Start Levee Mile	2.66
End Levee Mile	2.66
Location	Land Side
Category	Earthen Levee
Item	Vegetation

Looking southwest at structures on landside.

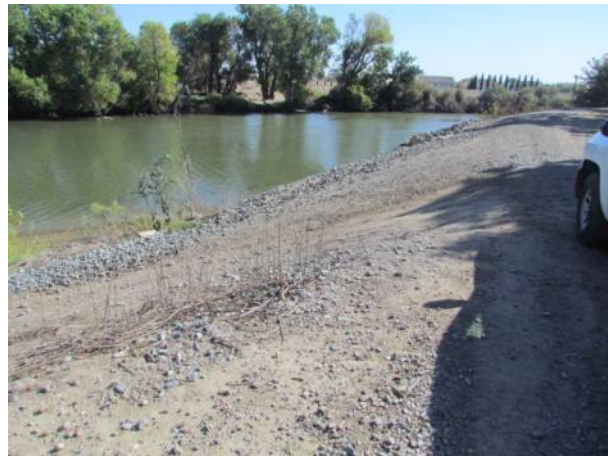
Levee Mile Report Line	60
Start Levee Mile	2.67
End Levee Mile	2.67
Location	Water Side
Category	Earthen Levee
Item	Encroachments

Looking southeast at unauthorized ramp on waterside slope.
