**Flood Control Project Maintenance  
Levee Inspections**

**Fall 2011 Levee Maintenance Deficiency Summary Report**

***San Joaquin River Basin***

**Reclamation District No. 0524 Middle Roberts Island**

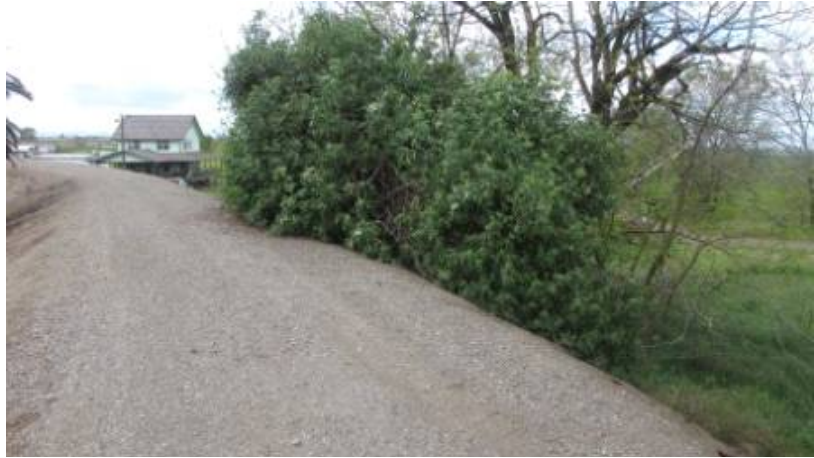
richard\_f\_20111014\_500.jpg

Looking south at elderberry on landside slope.

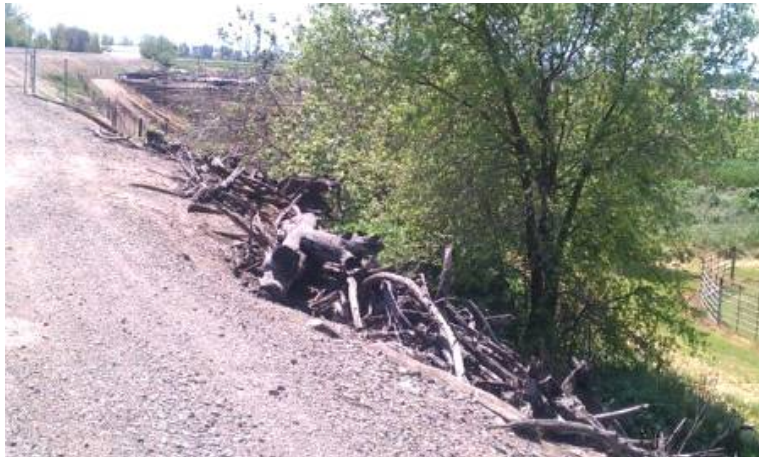
Levee Mile Report Line	70
Start Levee Mile	2.93
End Levee Mile	2.95
Location	Land Side
Category	Earthen Levee
Item	Encroachments

Looking southwest at prunings on landside slope.

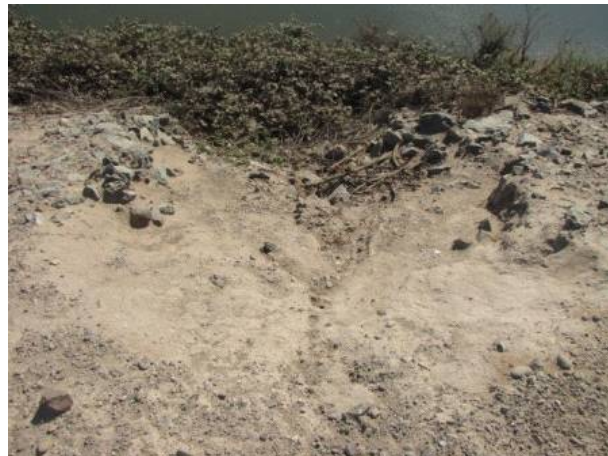
Levee Mile Report Line	72
Start Levee Mile	2.98
End Levee Mile	2.98
Location	Water Side
Category	Earthen Levee
Item	Erosion / Bank Caving

Looking east at erosion on waterside toe.

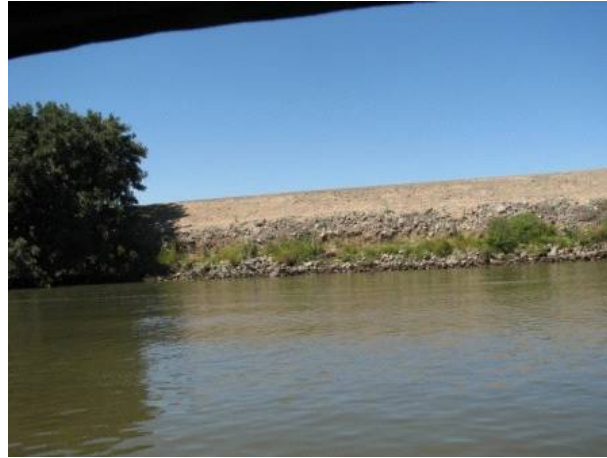
SJR2011\_RD0524U01RM43.83\_1.jpg

Direct view of the site.

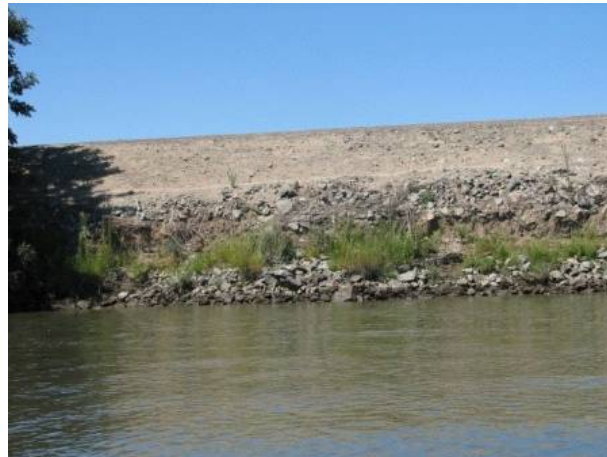
Levee Mile Report Line	75
Start Levee Mile	3.23
End Levee Mile	3.31
Location	Water Side
Category	Supplemental
Item	DWR Erosion Survey

A closer view of the erosion

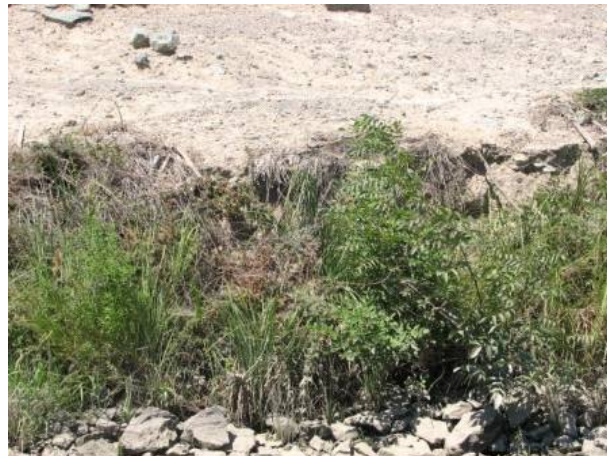
Levee Mile Report Line	75
Start Levee Mile	3.23
End Levee Mile	3.31
Location	Water Side
Category	Supplemental
Item	DWR Erosion Survey

Closer view of the erosion

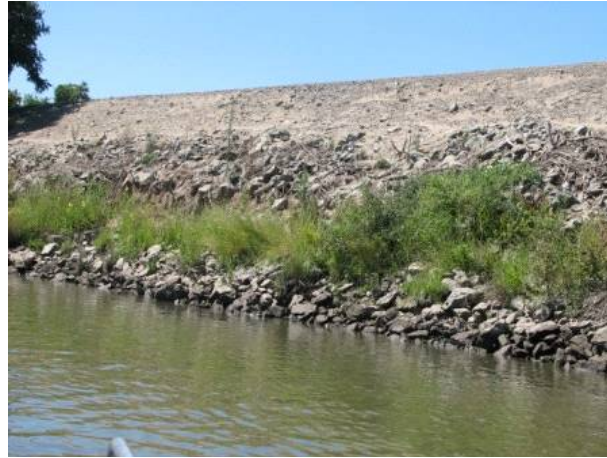
SJR2011\_RD0524U01RM43.83\_4.jpg

Front view of the erosion

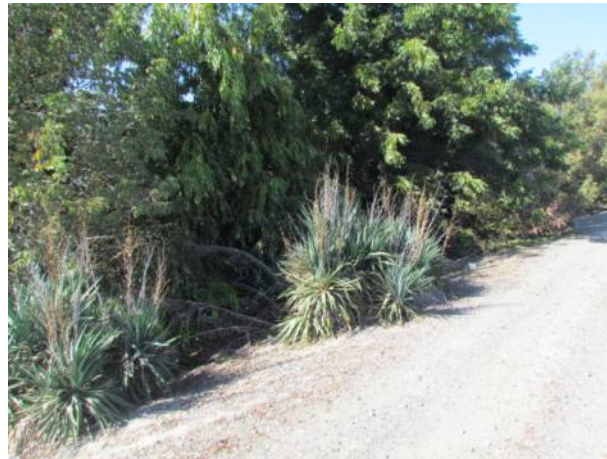
Levee Mile Report Line	80
Start Levee Mile	3.43
End Levee Mile	3.49
Location	Land Side
Category	Earthen Levee
Item	Trim / Thin Trees

Looking northwest at dense vegetation on landside slope.

LMR No.	Levee Mile		Category	Item	Location *	Rating **	Action/Comment	GPS Latitude/Longitude		Issue No. Photo
	Start	End						Start	End	
80	3.43	3.49	Earthen Levee	Trim / Thin Trees	LS	U	Trim and thin trees to allow visibility of the ground and room to flood fight.	37.906747 ° -121.325248 °	37.906192 ° -121.324543 °	54 Y
81	3.45	3.45	Earthen Levee	Encroachments	LS	M	Material Inspector Comments: Broken concrete pipes	37.906540 ° -121.325015 °	37.906540 ° -121.325015 °	56 Y
82	3.47	3.47	Earthen Levee	Trim / Thin Trees	LS	U	Trim and thin trees to allow visibility of the ground and room to flood fight.	37.906265 ° -121.324643 °	37.906265 ° -121.324643 °	93 Y
83	3.53	3.53	Earthen Levee	Encroachments	LS	CO	Ramp Inspector Comments: Unauthorized ramp on landside slope.	37.905552 ° -121.323847 °	37.905552 ° -121.323847 °	265
84	3.54	3.64	Earthen Levee	Trim / Thin Trees	LS	M	Trim and thin trees to allow visibility of the ground and room to flood fight.	37.905638 ° -121.323892 °	37.904430 ° -121.324570 °	57

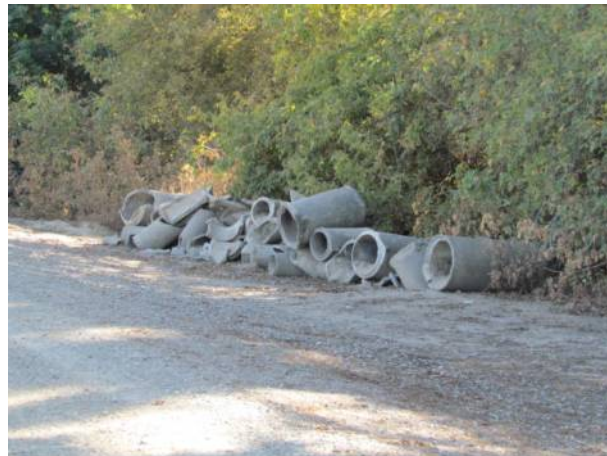
Levee Mile Report Line	81
Start Levee Mile	3.45
End Levee Mile	3.45
Location	Land Side
Category	Earthen Levee
Item	Encroachments

Looking southwest at concrete pipes on landside toe.

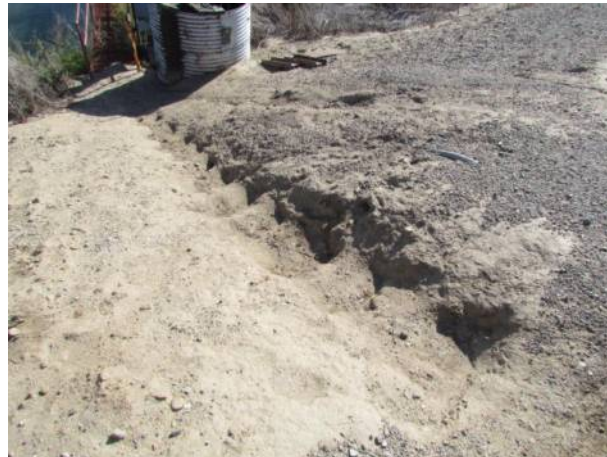
richard\_f\_20111028\_374.jpg

Looking southeast steps cut into waterside slope.

85	3.68	3.68	Earthen Levee	Slope Stability	WS	M	Repair the levee slope damaged by foot traffic and prevent access where possible. Inspector Comments: Landowner cut steps into waterside slope.	37.904113 ° -121.325080 °	37.904113 ° -121.325080 °	58 Y
86	3.80	3.80	Earthen Levee	Trim / Thin Trees	LS	M	Trim trees to at least five feet above ground level.	37.902645 ° -121.326340 °	37.902645 ° -121.326340 °	927
87	3.82	3.82	Earthen Levee	Trim / Thin Trees	LS	W	Trim trees to at least five feet above ground level.	37.902417 ° -121.326482 °	37.902417 ° -121.326482 °	59
88	3.82	3.82	Earthen Levee	Encroachments	CR	M	Equipment Inspector Comments: Landowner installed temporary piping system without permit.	37.902365 ° -121.326453 °	37.902365 ° -121.326453 °	266 Y
89	3.84	3.85	Earthen Levee	Trim / Thin Trees	LS	W	Trim trees to at least five feet above ground level.	37.902155 ° -121.326523 °	37.902002 ° -121.326550 °	928

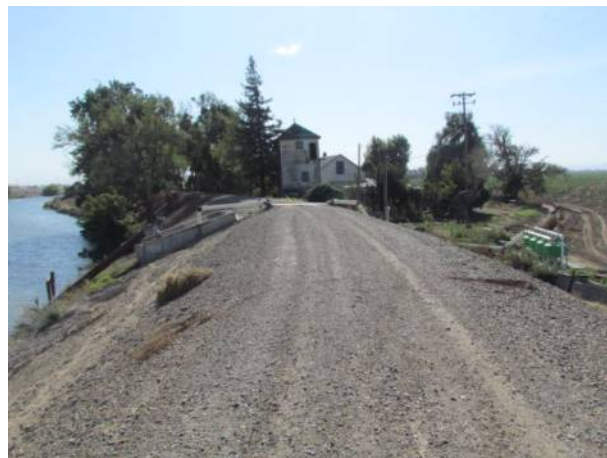
Levee Mile Report Line	88
Start Levee Mile	3.82
End Levee Mile	3.82
Location	Crown
Category	Earthen Levee
Item	Encroachments

Looking south at unauthorized irrigation pipe across levee and water filtration system at landside toe.

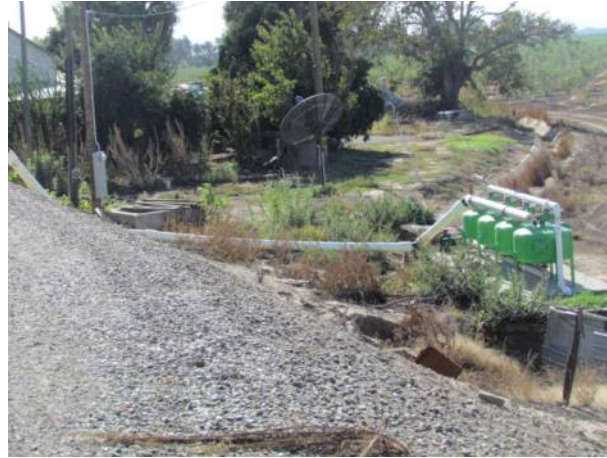
richard\_f\_20111028\_376.jpg

Looking west at water filtration system on landside toe.

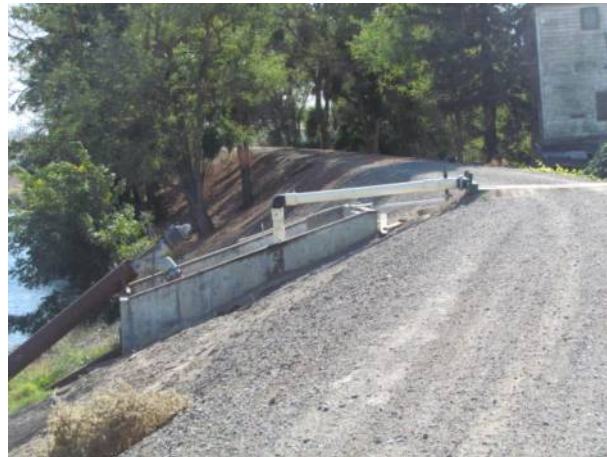
richard\_f\_20111028\_377.jpg

Looking south unauthorized pvc irrigation pipe across the levee crown.

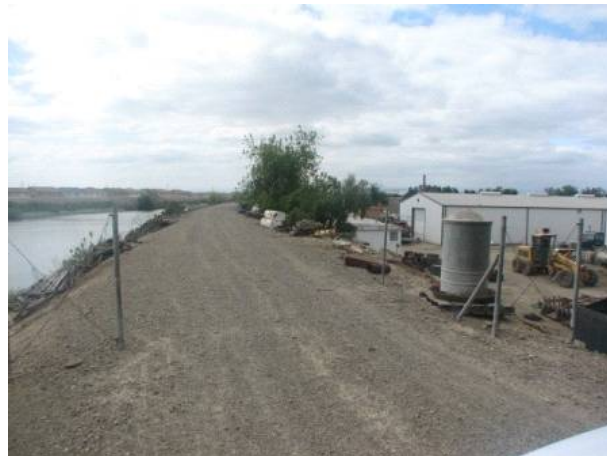
Levee Mile Report Line	90
Start Levee Mile	3.89
End Levee Mile	4.01
Location	Land Side
Category	Earthen Levee
Item	Encroachments

Looking upstream at equipment on landside shoulder

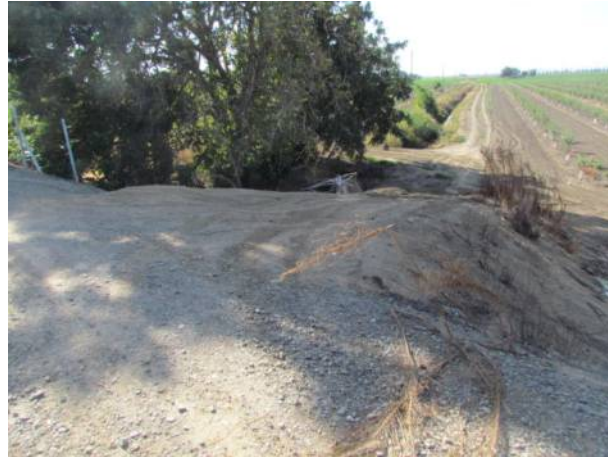
richard\_f\_20111028\_378.jpg

Looking west at unauthorized ramp on landside slope.

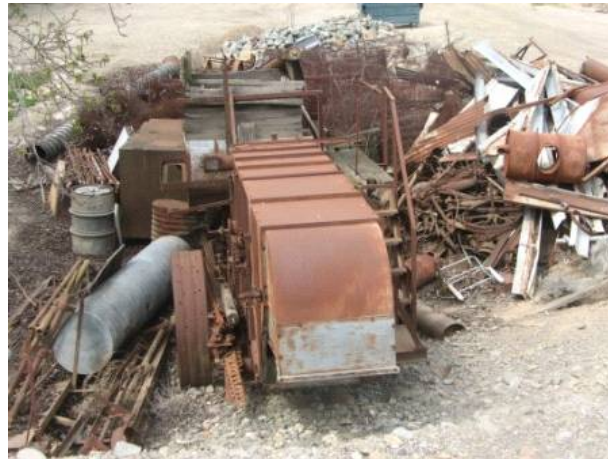
Levee Mile Report Line	99
Start Levee Mile	4.64
End Levee Mile	4.64
Location	Land Side
Category	Earthen Levee
Item	Encroachments

Garbage at landward toe next to ramp at LM 4.64

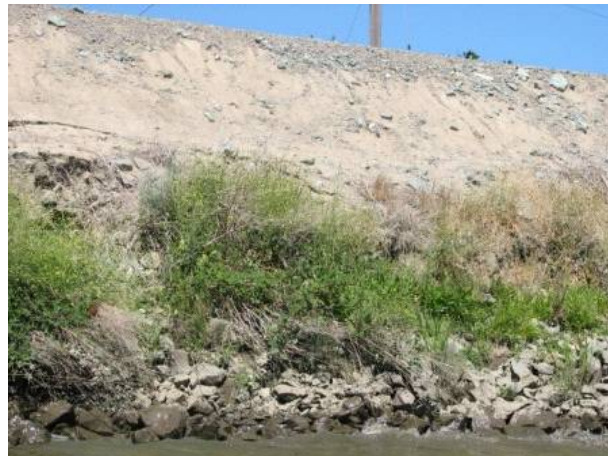
Levee Mile Report Line	101
Start Levee Mile	4.71
End Levee Mile	4.71
Location	Water Side
Category	Supplemental
Item	DWR Erosion Survey

101	4.71	4.71	Supplemental	DWR Erosion Survey	WS	U	Inspector Comments: 08/23/2011: Cracking erosion along the levee bank. Erosion appears to be caused by river flows. [2011 Site ID:RD0524U01RM45.27]	37.889809 ° -121.329342 °	37.889809 ° -121.329342 °	47 Y
102	4.74	4.74	Earthen Levee	Trim / Thin Trees	LS	M	Trim trees to at least five feet above ground level.	37.890108 ° -121.329523 °	37.890108 ° -121.329523 °	67
103	4.95	4.95	Earthen Levee	Trim / Thin Trees	LS	M	Trim trees to at least five feet above ground level. Inspector Comments: Down tree laying on landside toe.	37.887578 ° -121.331237 °	37.887578 ° -121.331237 °	95
104	4.98	4.98	Earthen Levee	Trim / Thin Trees	LS	M	Trim trees to at least five feet above ground level.	37.887277 ° -121.331609 °	37.887277 ° -121.331609 °	84
105	5.11	5.11	Earthen Levee	Trim / Thin Trees	LS	M	Trim trees to at least five feet above ground level.	37.885400 ° -121.332153 °	37.885400 ° -121.332153 °	68

Front view of the erosion site

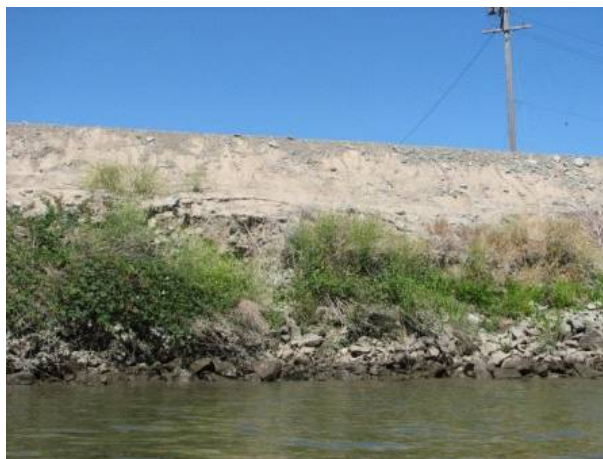
SJR2011\_RD0524U01RM45.27\_3.jpg

Front view of the site.

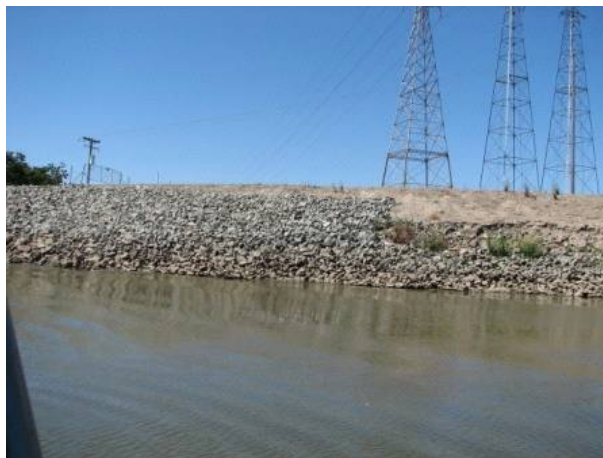
Levee Mile Report Line	113
Start Levee Mile	5.65
End Levee Mile	5.66
Location	Water Side
Category	Supplemental
Item	DWR Erosion Survey

LMR No.	Levee Mile		Category	Item	Location *	Rating **	Action/Comment	GPS Latitude/Longitude		Issue No. Photo
	Start	End						Start	End	
113	5.65	5.66	Supplemental	DWR Erosion Survey	WS	M	Inspector Comments: 08/23/2011: No significant changes observed on site.09/07/2010: No significant changes observed on site. Erosion site is located beneath Howard Road Bridge. Majority of the existing rip rap has slipped, dragging away levee materials and exposing the underlying soft soil.08/06/2010: Recommend for annual assessment and monitoring during flood events, per CLRO.09/30/2009: No major changes observed since the last visit; upper portion of existing revetment has slipped, exposing the degrading bank; note that site # is the same as RM46.30, LM5.69 found in the CLRO CES Evaluation 2008 Report; site was previously rated "M".11/04/2008: Previously repaired using rock revetment; upper portion of th revetment is sliding, causing deformation on the levee slope; site is upstream of Howards Road Bridge. [2011 Site ID:RD0524U01RM46.12]	37.877880 ° -121.332550 °	37.877880 ° -121.332550 °	55 Y

Sloughing rip rap just below the Howard Bridge abutment.

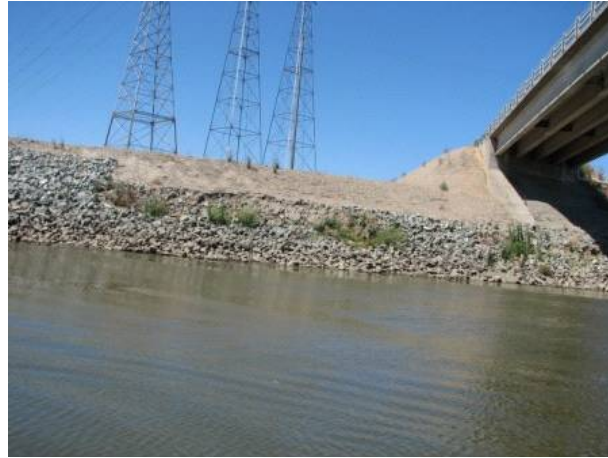
SJR2011\_RD0524U01RM46.12\_2.jpg

Sloughing rip rap adjacent to Howard Bridge.

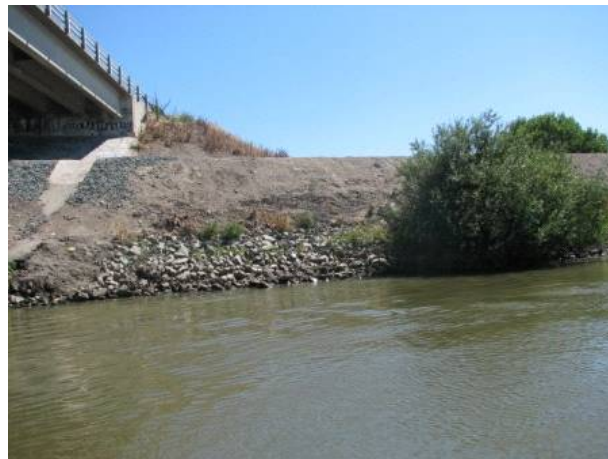
Levee Mile Report Line	113
Start Levee Mile	5.65
End Levee Mile	5.66
Location	Water Side
Category	Supplemental
Item	DWR Erosion Survey

Upstream view of sloughing rip rap.

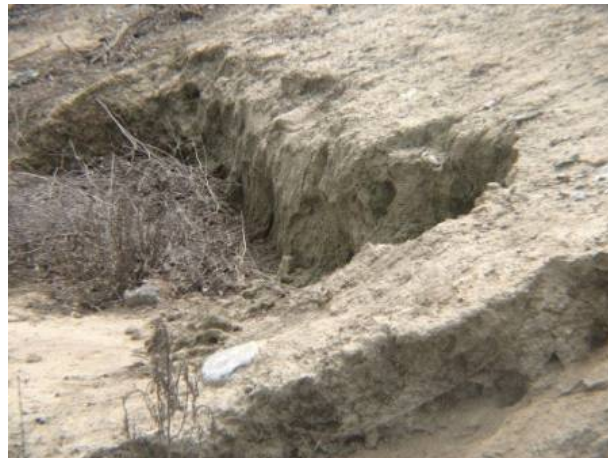
Levee Mile Report Line	117
Start Levee Mile	5.92
End Levee Mile	5.92
Location	Water Side
Category	Earthen Levee
Item	Erosion / Bank Caving

Erosion at waterward toe and around irrigation pipe at LM 5.92

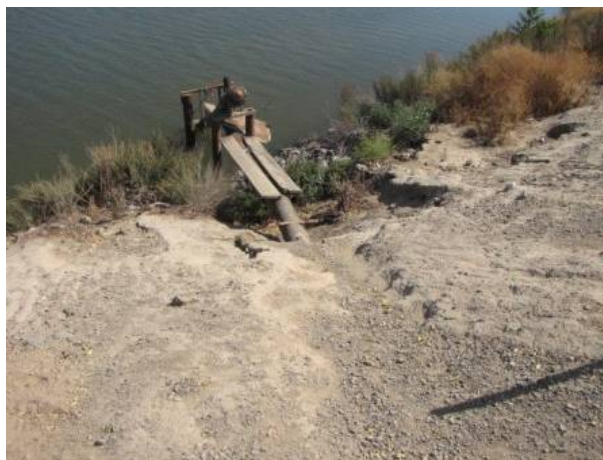
richard\_f\_20111014\_505.jpg

Looking southeast at erosion around pipe.

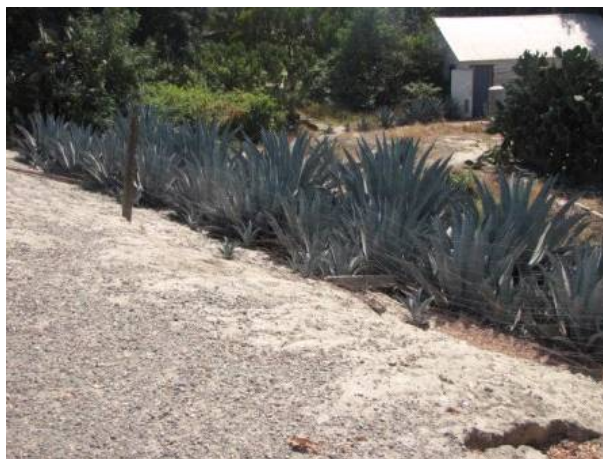
Levee Mile Report Line	120
Start Levee Mile	5.99
End Levee Mile	6.00
Location	Land Side
Category	Earthen Levee
Item	Encroachments

120	5.99	6.00	Earthen Levee	Encroachments	LS	CO	Landscaping Inspector Comments: Cactus	37.873543 ° -121.332308 °	37.873445 ° -121.332127 °	88 Y
121	6.01	6.05	Earthen Levee	Encroachments	LS	CO	Buildings	37.873377 ° -121.331977 °	37.873102 ° -121.331382 °	89 Y
122	6.02	6.02	Earthen Levee	Trim / Thin Trees	LS	M	Trim trees to at least five feet above ground level.	37.873300 ° -121.331928 °	37.873300 ° -121.331928 °	81
123	6.05	6.05	Earthen Levee	Erosion / Bank Caving	WS	M	Schedule repair of erosion site prior to the next inspection.	37.873047 ° -121.331408 °	37.873047 ° -121.331408 °	933

Looking southeast at fence and cactus on landside slope and toe.

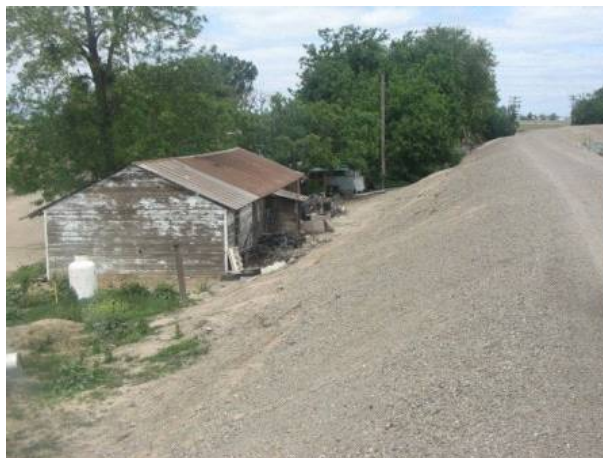
Levee Mile Report Line	121
Start Levee Mile	6.01
End Levee Mile	6.05
Location	Land Side
Category	Earthen Levee
Item	Encroachments

Looking downstream at building on landside toe.

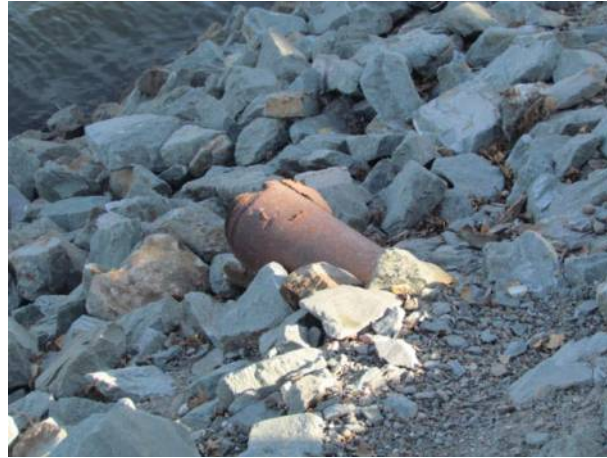
richard\_f\_20111028\_379.jpg

Looking southeast at abandoned pipe on waterside slope.
