**Flood Control Project Maintenance
Levee Inspections**

Fall 2012 Levee Maintenance Deficiency Summary Report

Reclamation District No. 0524 Middle Roberts Island

Waterway			Bank	Unit Miles
Unit No. 01 San Joaquin River			Left	6.26
	Spring (March - May)	Summer (June - August)	(September - November) Fall	Winter (December - February)
Unit Maintenance Rating (Fall Only)			U	
Date of Inspection	05/08/2012 - 05/09/2012		10/09/2012 - 10/11/2012	
DWR Inspector	Richard Willoughby		Richard Willoughby	
Accompanied By	Mario Jaques RD 524		Mario Jaques RD 524

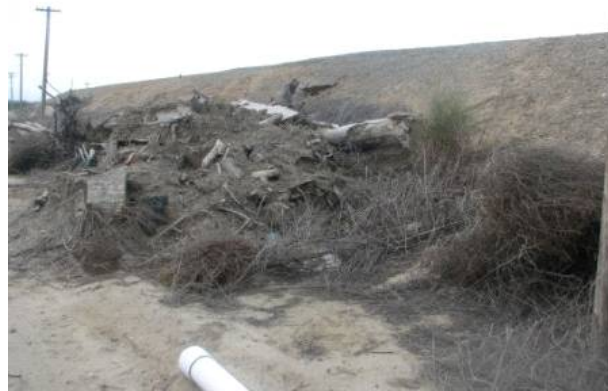
richard_f_20121008_075.jpg

Garbage pile at landward toe at LM 0.36

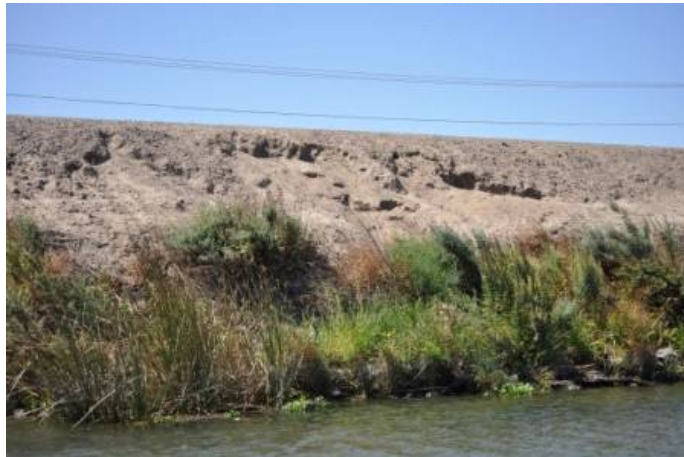
Levee Mile Report Line	6
Start Levee Mile	0.40
End Levee Mile	0.40
Location	Water Side
Category	Supplemental
Item	DWR Erosion Survey

Front view of erosion site. Note the vegetation at the levee toe and lower slope

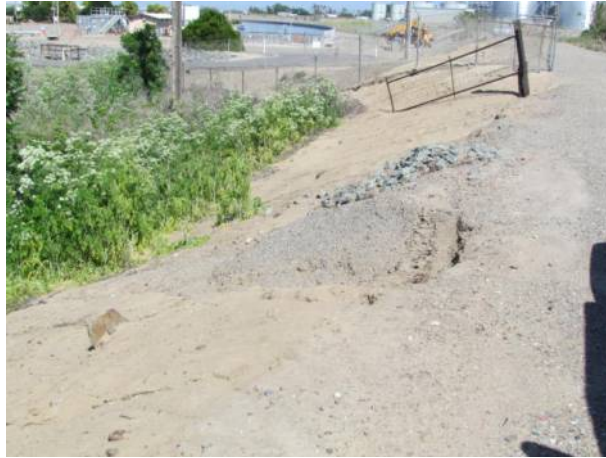
richard_f_20121008_085.jpg

Looking northwest at landside caving near levee shoulder.

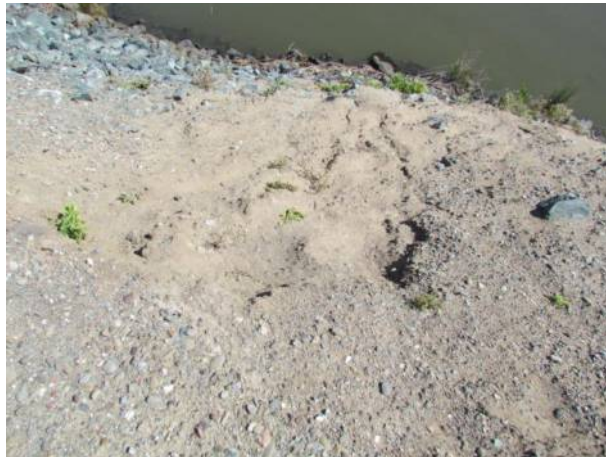
Levee Mile Report Line	9
Start Levee Mile	0.63
End Levee Mile	0.63
Location	Water Side
Category	Earthen Levee
Item	Slope Stability

Looking east at waterside erosion appears to be caused by runoff.

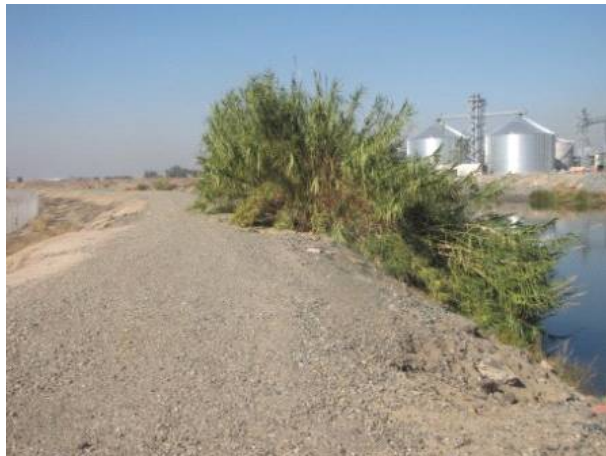
Levee Mile Report Line	10
Start Levee Mile	0.63
End Levee Mile	0.64
Location	Water Side
Category	Earthen Levee
Item	Vegetation

Looking north at bamboo on waterside slope.

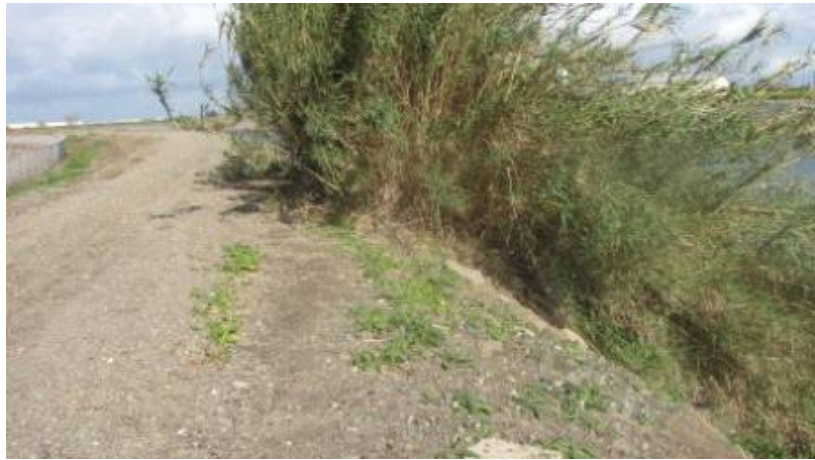
richard_f_20121008_068.jpg

Looking north at bamboo on waterside slope. As of 4/2010 no change.

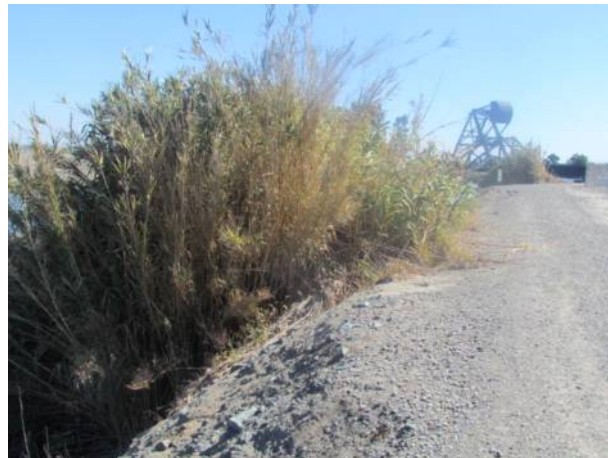
richard_f_20121015_877.JPG

Looking south at bamboo on waterside slope. (Fall Inspection 2012)

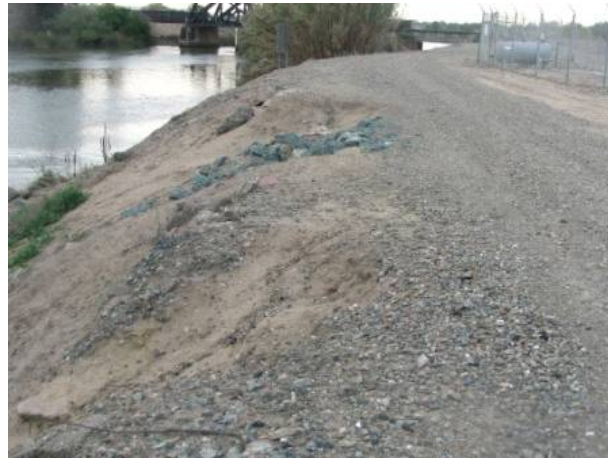
richard_f_20121008_070.jpg

Erosion from LM 0.65 to 0.66

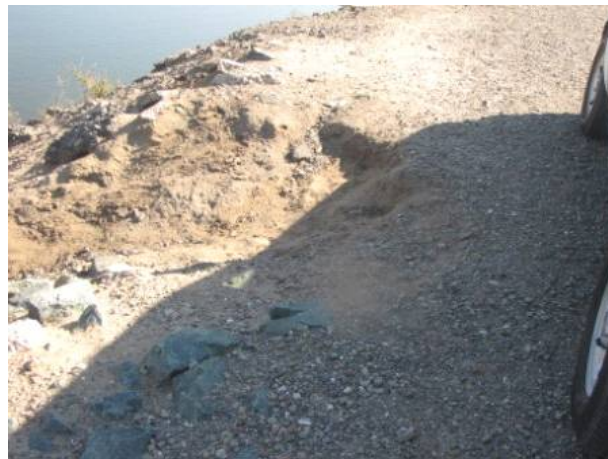
Levee Mile Report Line	11
Start Levee Mile	0.65
End Levee Mile	0.66
Location	Water Side
Category	Earthen Levee
Item	Slope Stability

Update of erosion site at LM 0.65 to 0.66

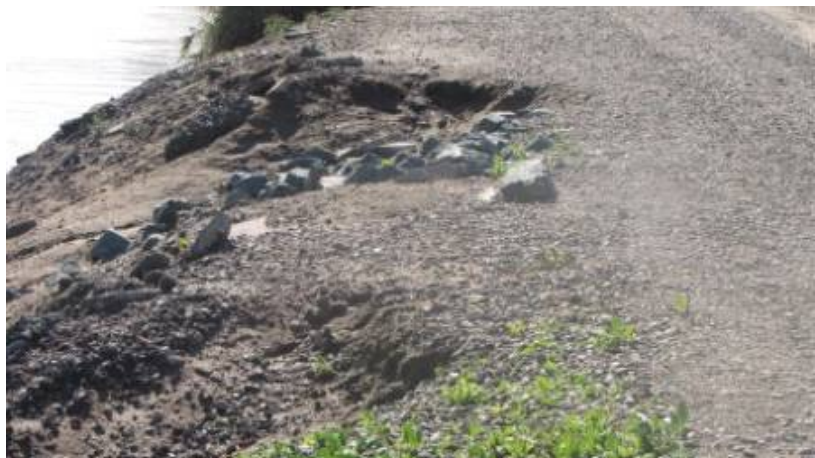
Levee Mile Report Line	11
Start Levee Mile	0.65
End Levee Mile	0.66
Location	Water Side
Category	Earthen Levee
Item	Slope Stability

Looking south at erosion on waterside shoulder.

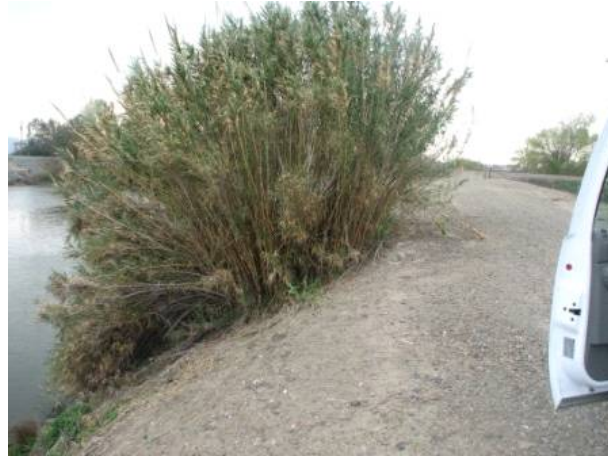
richard_f_20121008_073.jpg

Bamboo on waterward slope at LM 0.68

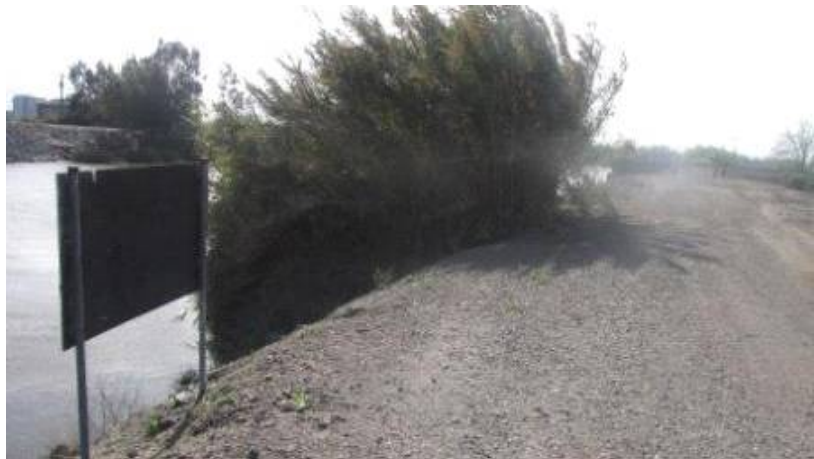
Levee Mile Report Line	12
Start Levee Mile	0.68
End Levee Mile	0.68
Location	Water Side
Category	Earthen Levee
Item	Vegetation

Looking southeast at bamboo on waterside shoulder as of 4/2010.

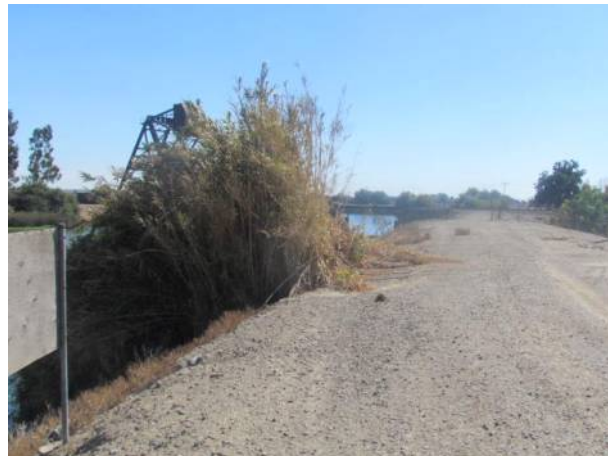
Levee Mile Report Line	12
Start Levee Mile	0.68
End Levee Mile	0.68
Location	Water Side
Category	Earthen Levee
Item	Vegetation

Looking south at bamboo on waterside slope. (Fall 2012)

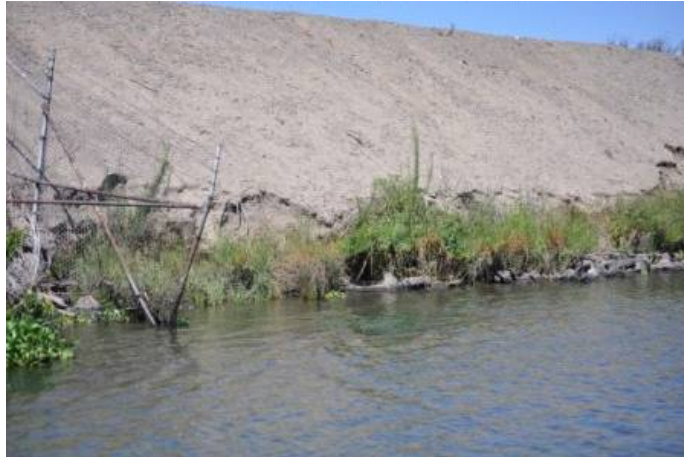
SJR2012_RD0524U01RM41.39_1.jpg

Upstream view of the erosion site. Note the railroad bridge.

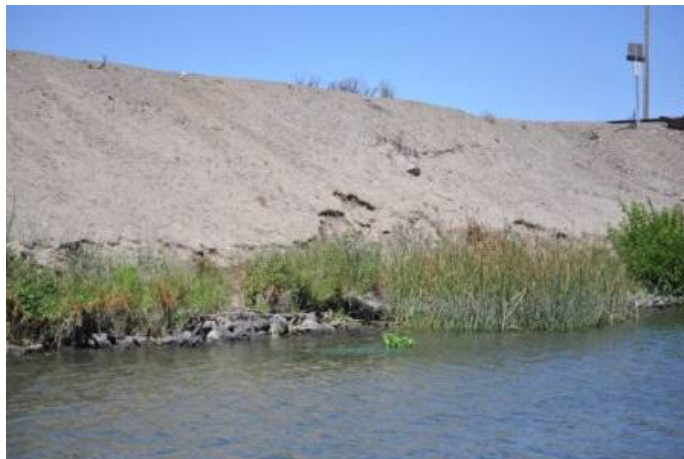
Levee Mile Report Line	13
Start Levee Mile	0.77
End Levee Mile	0.78
Location	Water Side
Category	Supplemental
Item	DWR Erosion Survey

Front view of the erosion site. Vegetation visible

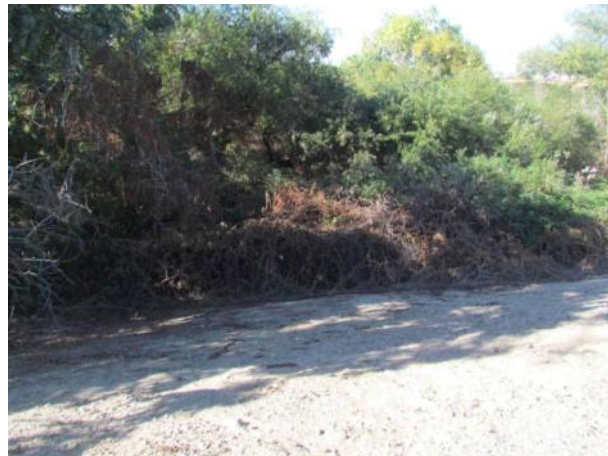
Levee Mile Report Line	14
Start Levee Mile	0.78
End Levee Mile	0.78
Location	Land Side
Category	Earthen Levee
Item	Vegetation

Looking west at dense vegetation on landside toe.

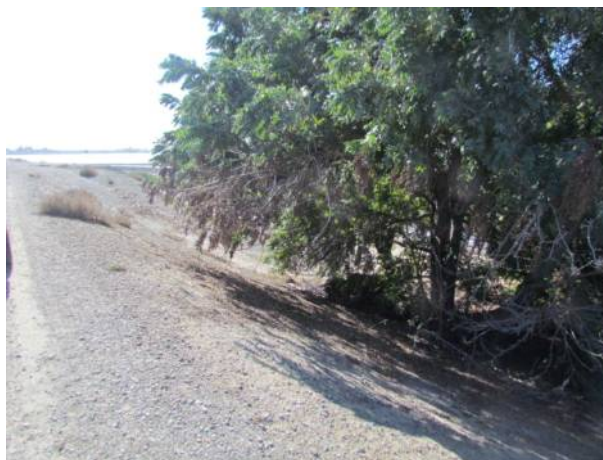
richard_f_20121008_137.jpg

Looking southwest at low hanging tree branches at landside toe.

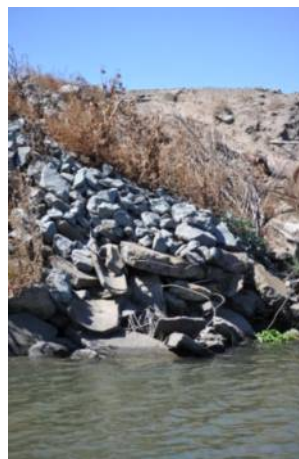
Levee Mile Report Line	17
Start Levee Mile	0.91
End Levee Mile	0.91
Location	Water Side
Category	Supplemental
Item	DWR Erosion Survey

Front view of the erosion. Note the riprap protection near the site

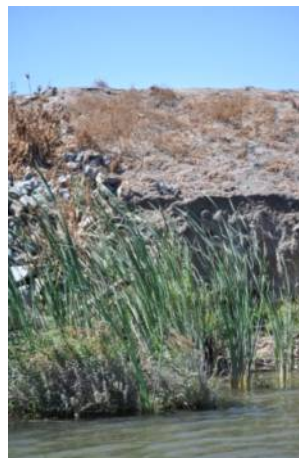
Levee Mile Report Line	17
Start Levee Mile	0.91
End Levee Mile	0.91
Location	Water Side
Category	Supplemental
Item	DWR Erosion Survey

A close view of the erosion

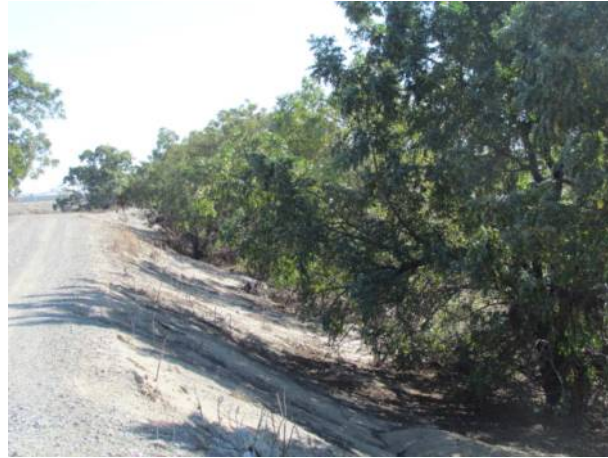
richard_f_20121008_138.jpg

Looking south at low hanging tree branches at landside toe.

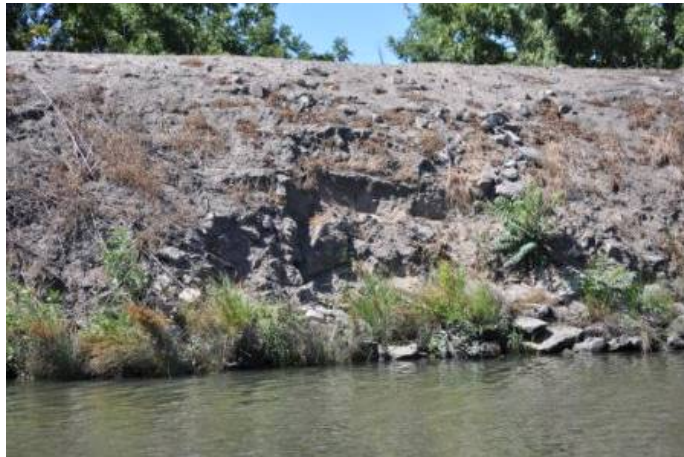
Levee Mile Report Line	20
Start Levee Mile	1.00
End Levee Mile	1.00
Location	Water Side
Category	Supplemental
Item	DWR Erosion Survey

Front view of erosion

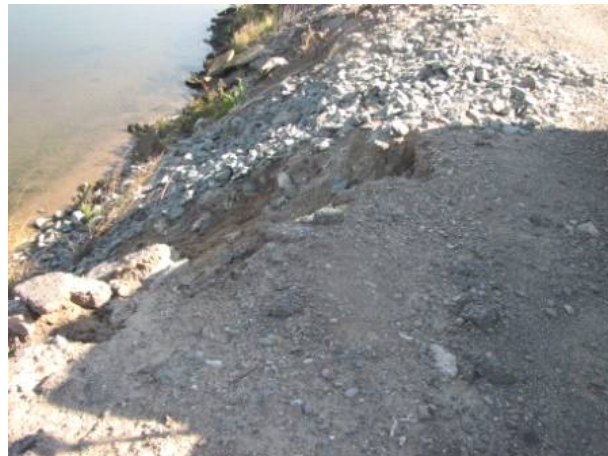
Levee Mile Report Line	21
Start Levee Mile	1.03
End Levee Mile	1.03
Location	Water Side
Category	Earthen Levee
Item	Erosion / Bank Caving

Looking upstream (south) at erosion site.

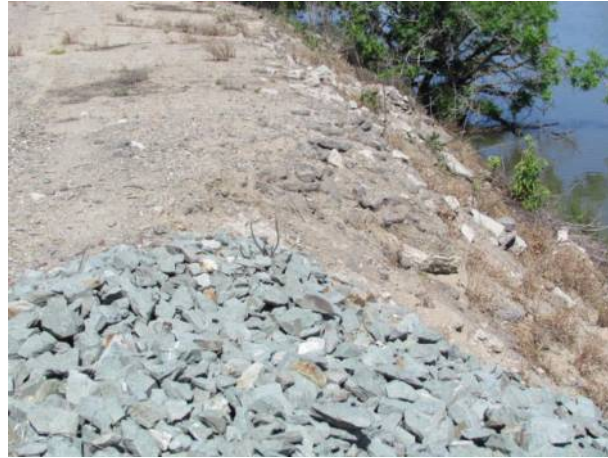
richard_f_20121008_077.jpg

Looking north at erosion site next to repaired site.(Spring 2012)

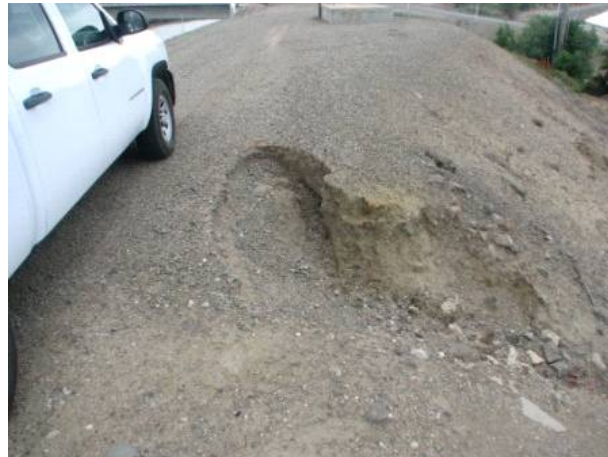
Levee Mile Report Line	22
Start Levee Mile	1.09
End Levee Mile	1.09
Location	Land Side
Category	Earthen Levee
Item	Slope Stability

Landward slope damage at LM 1.09

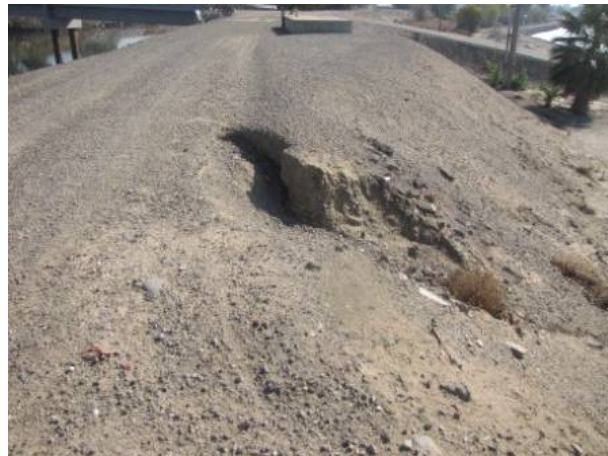
Levee Mile Report Line	22
Start Levee Mile	1.09
End Levee Mile	1.09
Location	Land Side
Category	Earthen Levee
Item	Slope Stability

Updated picture of erosion site on landside shoulder.

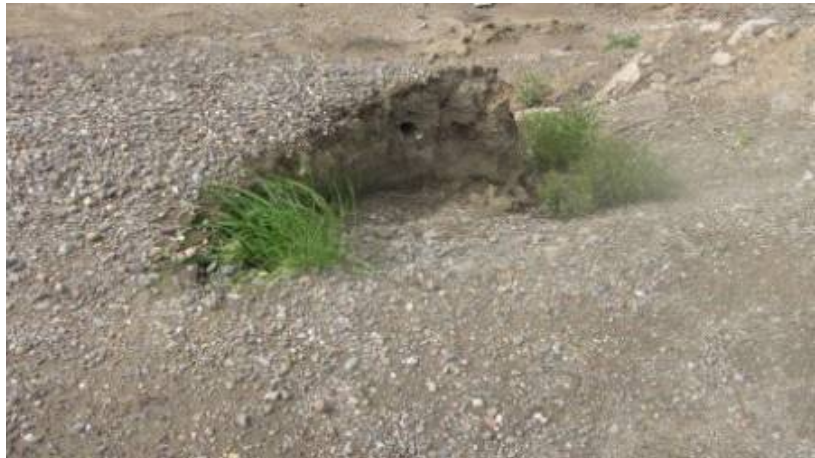
richard_f_20121008_080.jpg

Update of above slope stability.

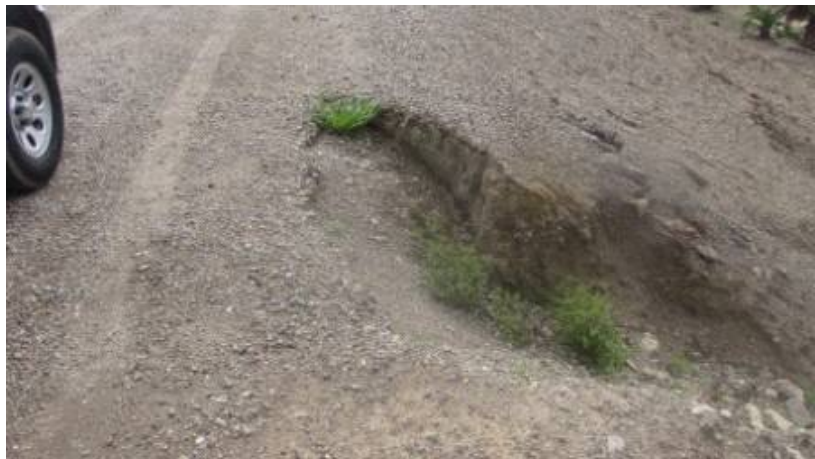
Levee Mile Report Line	22
Start Levee Mile	1.09
End Levee Mile	1.09
Location	Land Side
Category	Earthen Levee
Item	Slope Stability

Looking at updated slope stability as 4/2010

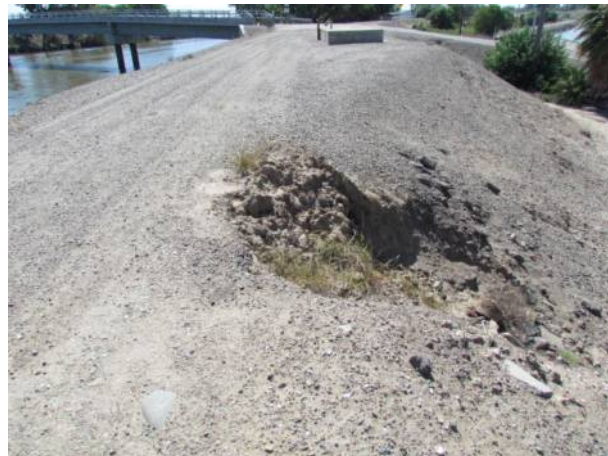
Levee Mile Report Line	22
Start Levee Mile	1.09
End Levee Mile	1.09
Location	Land Side
Category	Earthen Levee
Item	Slope Stability

Looking south at caving on landside shoulder.
(Spring 2012)

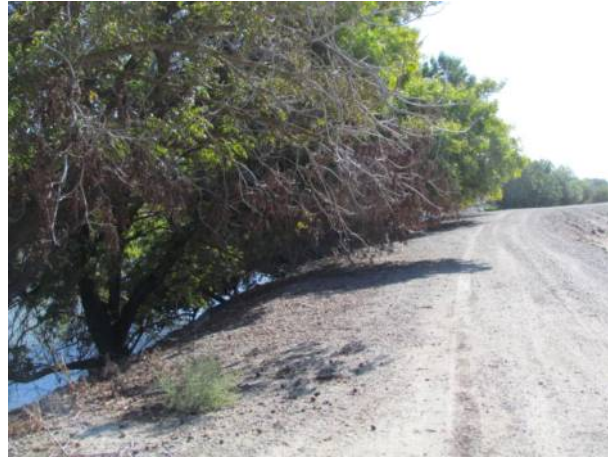
richard_f_20121008_083.jpg

Looking northwest at low hanging tree branches at waterside toe.

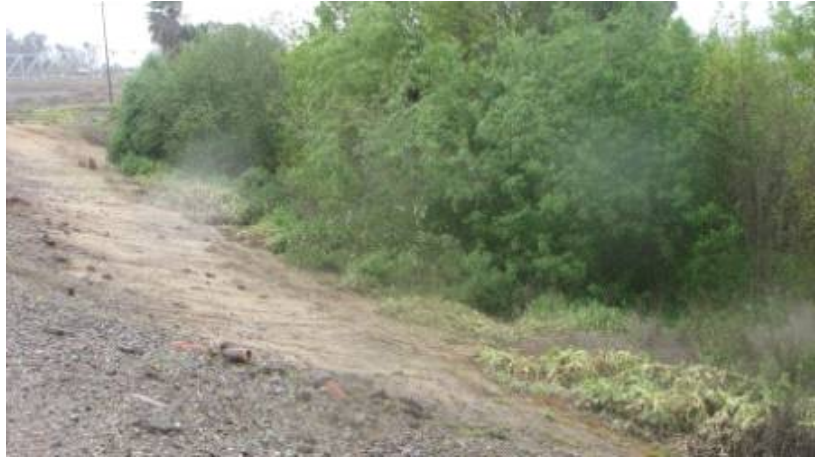
richard_f_20121008_182.jpg

Looking southwest at dense veg. on landside toe.

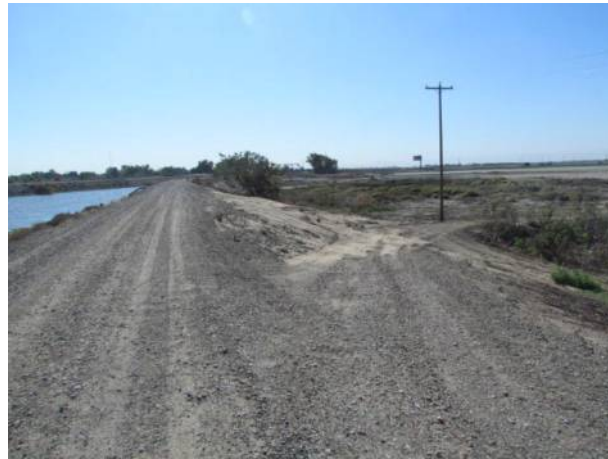
Levee Mile Report Line	26
Start Levee Mile	1.26
End Levee Mile	1.26
Location	Land Side
Category	Earthen Levee
Item	Encroachments

Looking south at unauthorized ramp on landside slope.

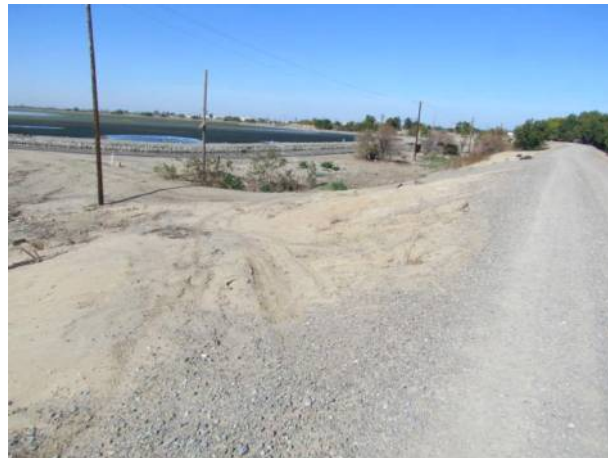
Levee Mile Report Line	26
Start Levee Mile	1.26
End Levee Mile	1.26
Location	Land Side
Category	Earthen Levee
Item	Encroachments

Looking northwest at unauthorized ramp on landside slope.

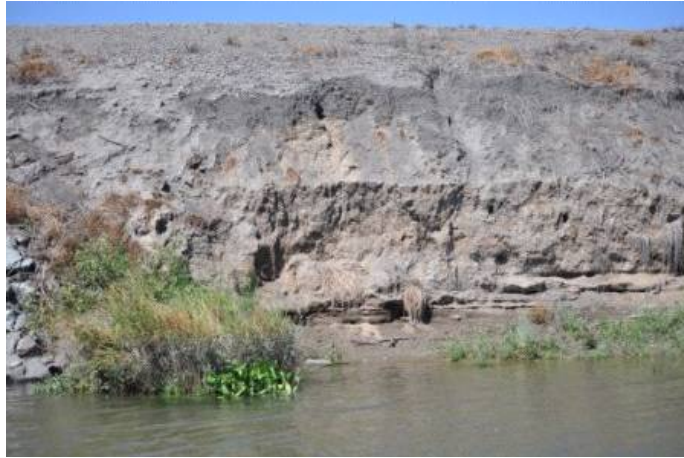
SJR2012_RD0524U01RM41.92_1.jpg

close view of the erosion

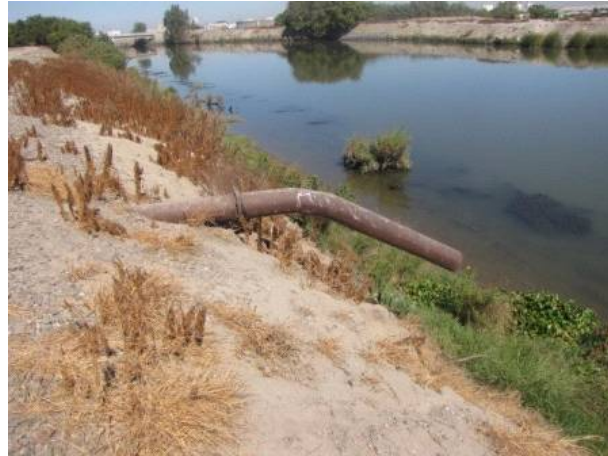
richard_f_20121008_101.jpg

Looking north at broken pipe.

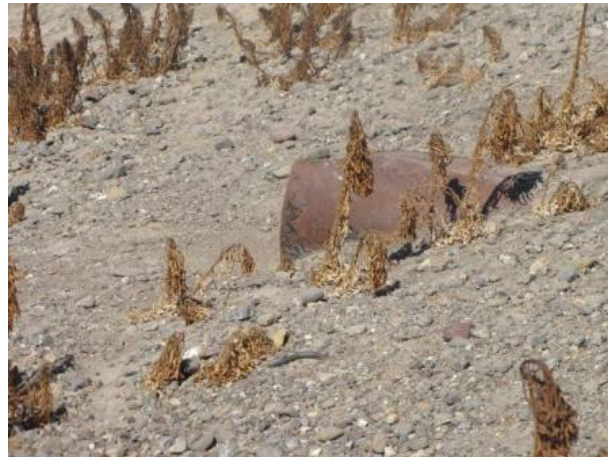
richard_f_20121008_102.jpg

Looking west at pipe on landside slope.

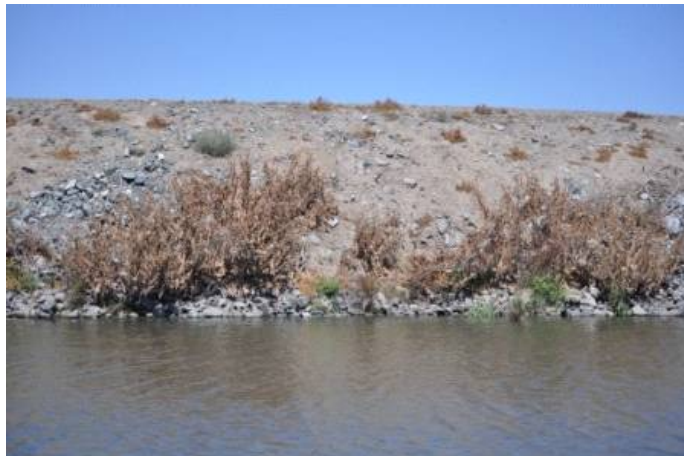
Levee Mile Report Line	29
Start Levee Mile	1.39
End Levee Mile	1.39
Location	Water Side
Category	Supplemental
Item	DWR Erosion Survey

Upstream view of the erosion

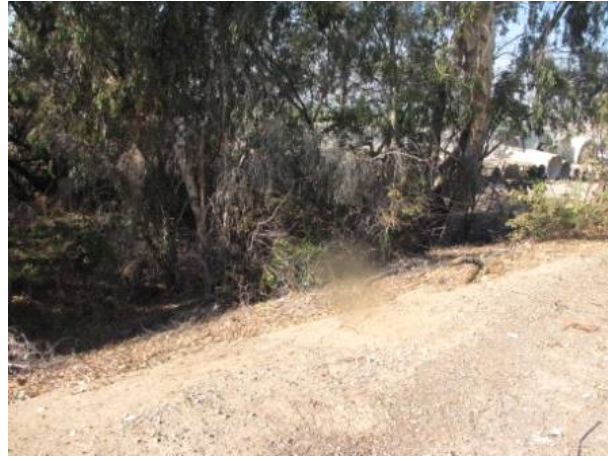
richard_f_20121008_183.jpg

Dense vegetation on landside toe.

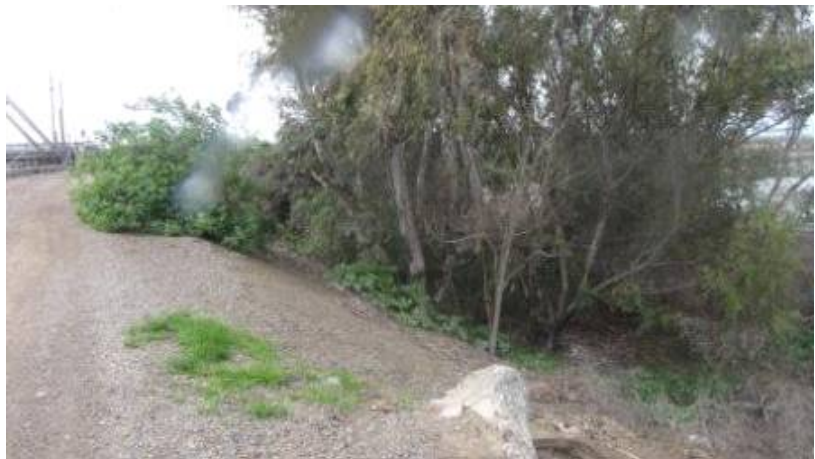
Levee Mile Report Line	31
Start Levee Mile	1.51
End Levee Mile	1.51
Location	Land Side
Category	Earthen Levee
Item	Trim / Thin Trees

Looking south at dense veg. on landside slope and toe.

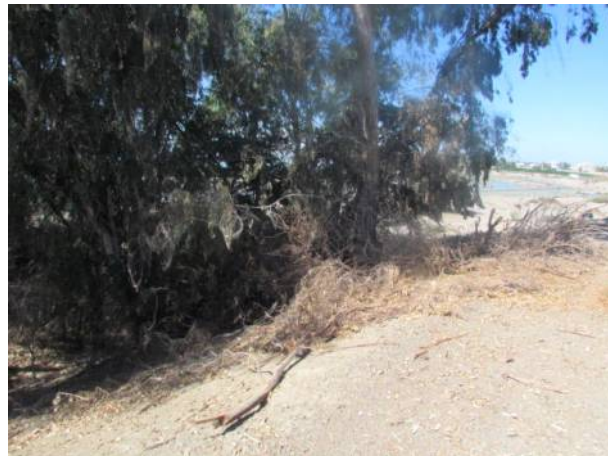
Levee Mile Report Line	31
Start Levee Mile	1.51
End Levee Mile	1.51
Location	Land Side
Category	Earthen Levee
Item	Trim / Thin Trees

Looking south at trees on landside slope. (Fall 2012)

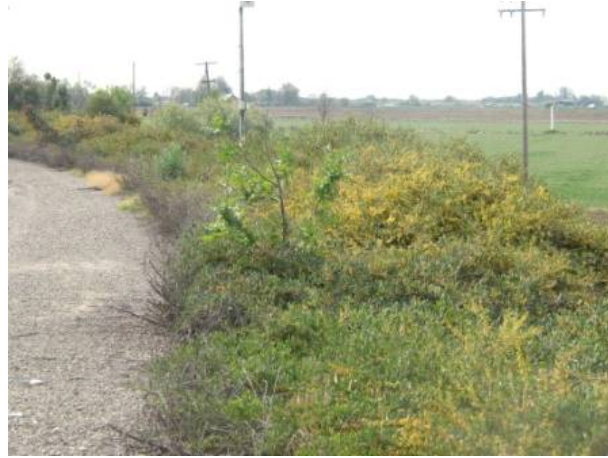
Levee Mile Report Line	32
Start Levee Mile	1.56
End Levee Mile	1.74
Location	Land Side
Category	Earthen Levee
Item	Vegetation
Overgrown landscaping on landward slope from LM 1.56 to 1.74	
richard_f_20121008_089.jpg

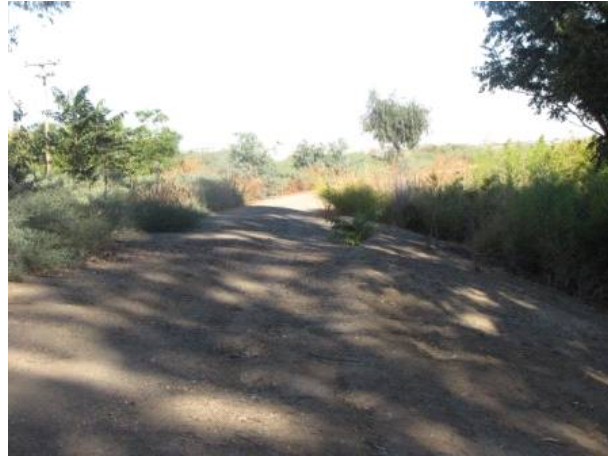
richard_f_20121008_090.jpg

Looking north at dense veg on landside and waterside slopes.

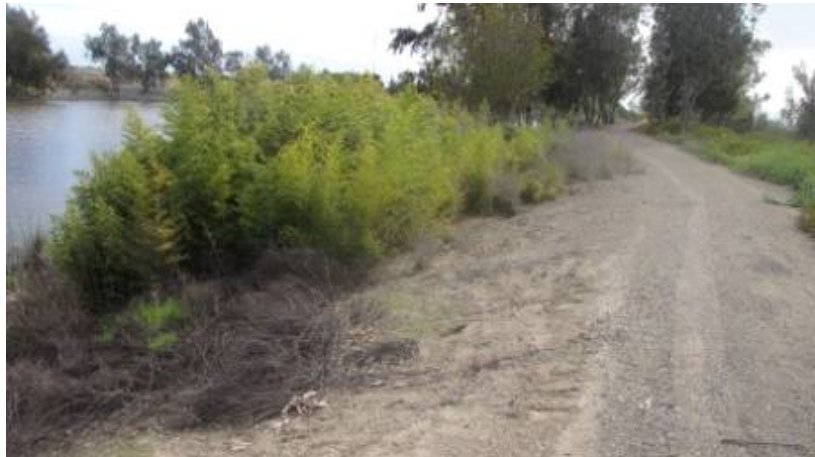
Levee Mile Report Line	35
Start Levee Mile	1.62
End Levee Mile	1.63
Location	Water Side
Category	Earthen Levee
Item	Vegetation

Looking southeast at dense veg. on waterside slope.

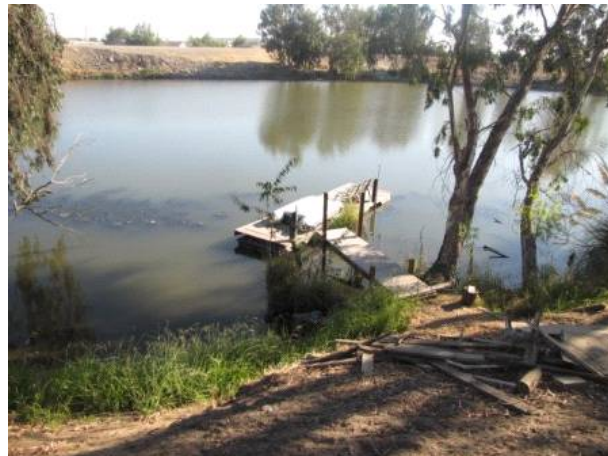
Levee Mile Report Line	37
Start Levee Mile	1.64
End Levee Mile	1.64
Location	Water Side
Category	Earthen Levee
Item	Encroachments

Looking east at non-permitted boat dock.

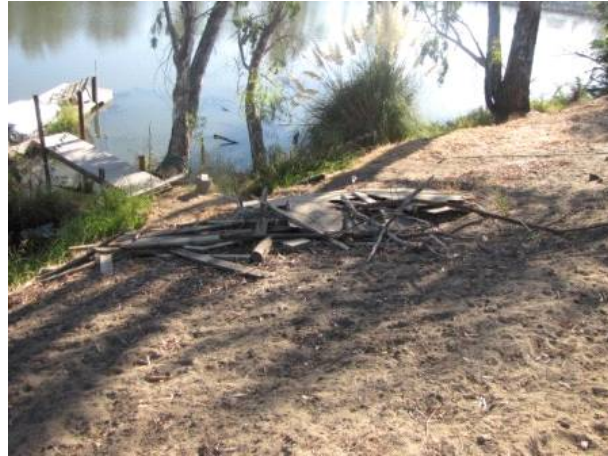
richard_f_20121008_110.jpg

Looking at garbage on waterside slope.

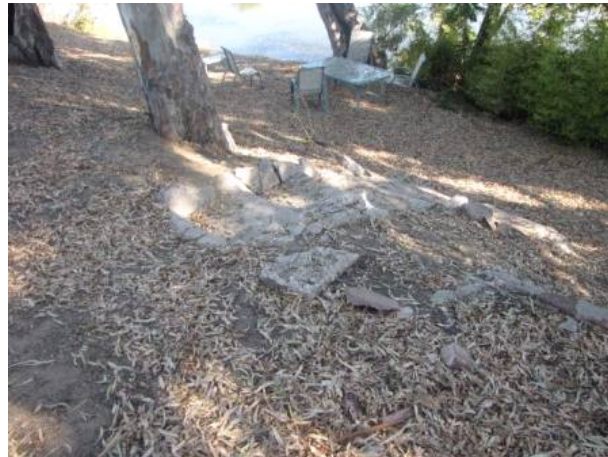
Levee Mile Report Line	39
Start Levee Mile	1.69
End Levee Mile	1.69
Location	Water Side
Category	Earthen Levee
Item	Encroachments

Looking northeast on non-permitted concrete stairs on waterside slope.

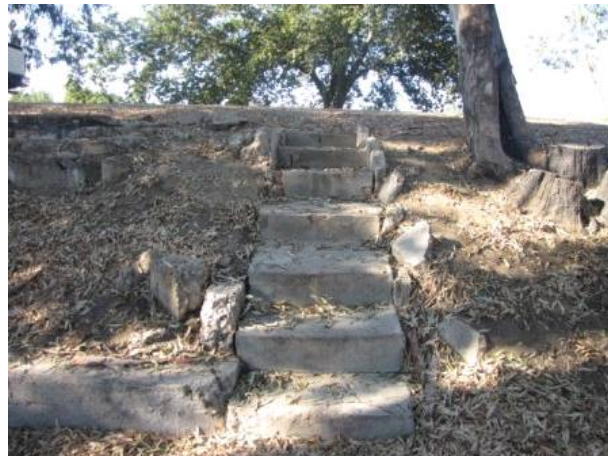
Levee Mile Report Line	39
Start Levee Mile	1.69
End Levee Mile	1.69
Location	Water Side
Category	Earthen Levee
Item	Encroachments

Looking west at concrete stairs on waterside slope.

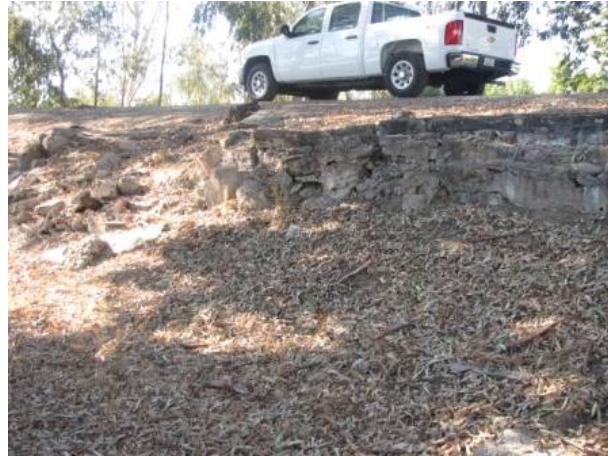
richard_f_20121008_116.jpg

Looking southwest at retaning wall connected to concrete stairs.

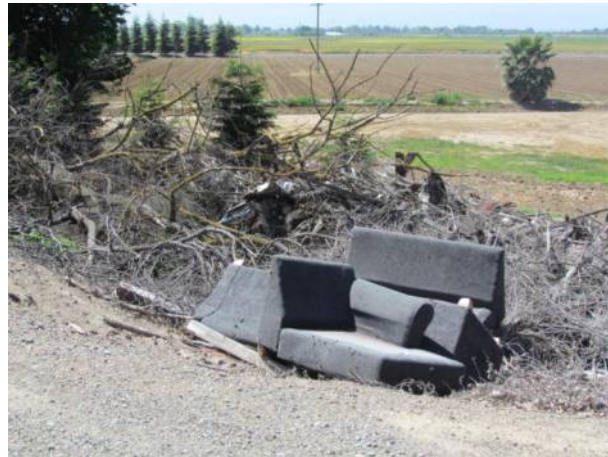
Levee Mile Report Line	41
Start Levee Mile	1.75
End Levee Mile	1.75
Location	Land Side
Category	Earthen Levee
Item	Encroachments

Looking southwest at garbage pile on landside toe. (Spring 2012)

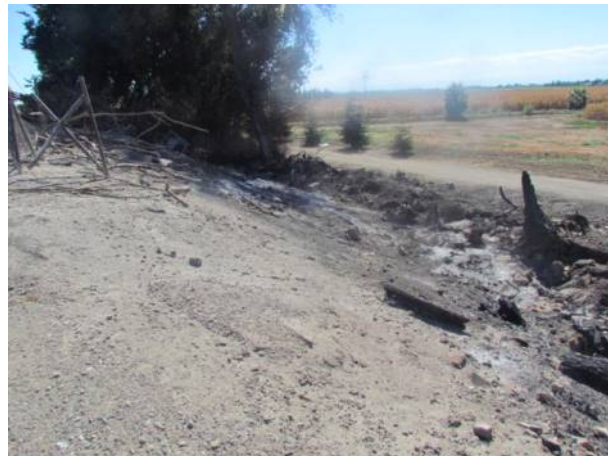
Levee Mile Report Line	41
Start Levee Mile	1.75
End Levee Mile	1.75
Location	Land Side
Category	Earthen Levee
Item	Encroachments

Looking southwest at burned pruning pile on landside slope.

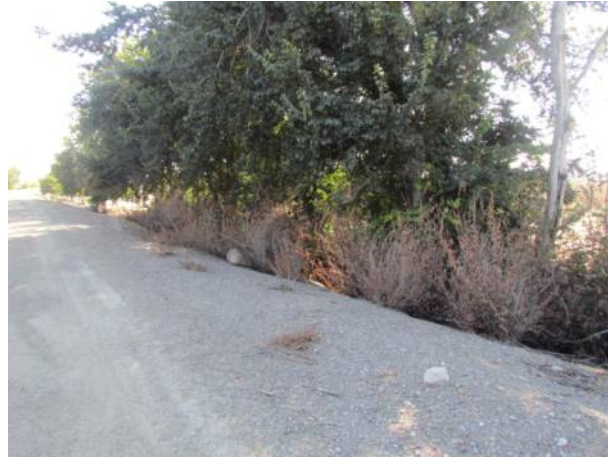
richard_f_20121008_117.jpg

Looking southwest at dense vegetation and low hanging tree branches on landside slope and toe.

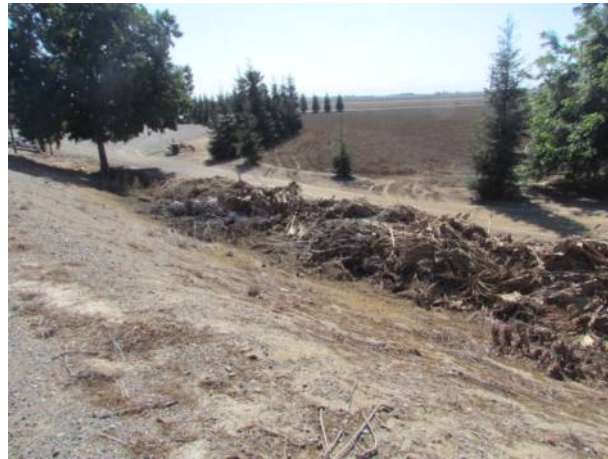
Levee Mile Report Line	43
Start Levee Mile	1.80
End Levee Mile	1.80
Location	Land Side
Category	Earthen Levee
Item	Encroachments

Looking southwest at prunings on landside toe.

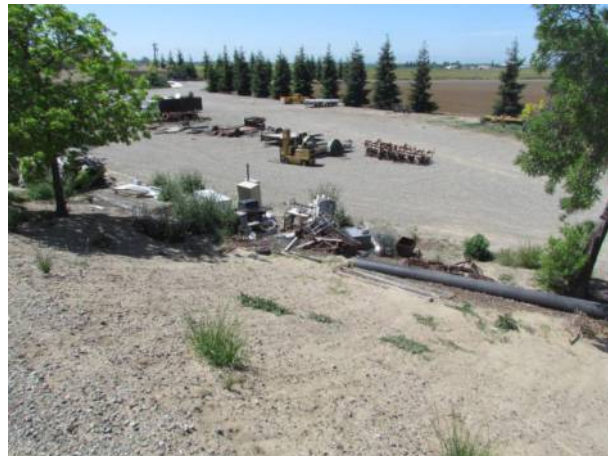
Levee Mile Report Line	44
Start Levee Mile	1.82
End Levee Mile	1.82
Location	Land Side
Category	Earthen Levee
Item	Encroachments

Looking west at garbage and equipment at landside toe.

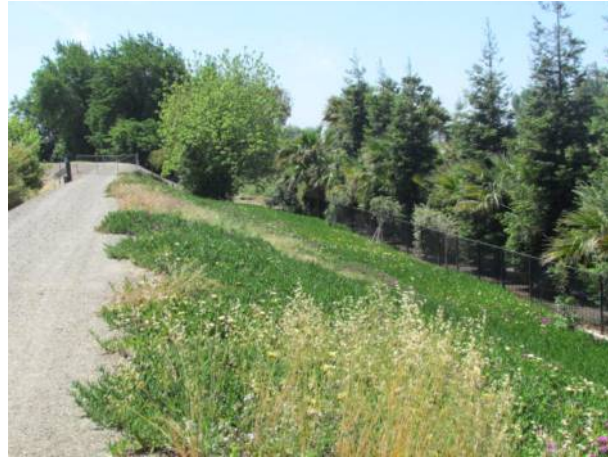
richard_f_20121008_139.jpg

Looking southwest at landscaping on landside slope. (Spring 2012)

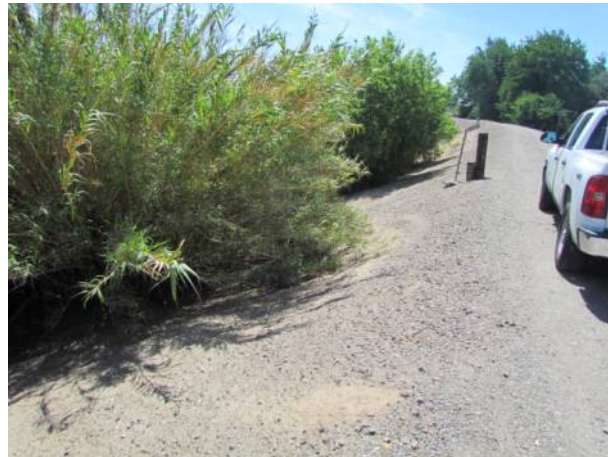
Levee Mile Report Line	46
Start Levee Mile	1.95
End Levee Mile	1.95
Location	Water Side
Category	Earthen Levee
Item	Vegetation

Looking southeast at bamboo on waterside slope.

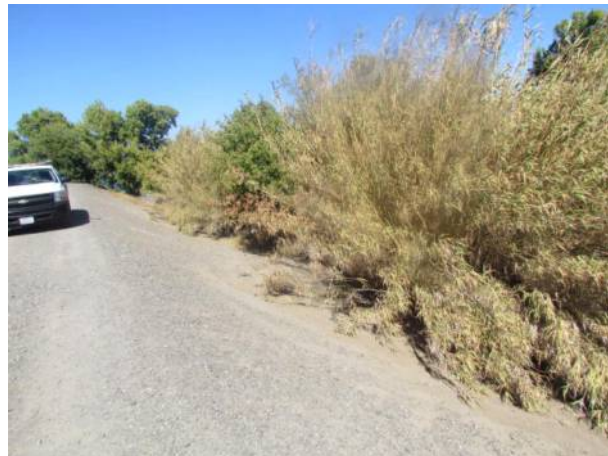
Levee Mile Report Line	46
Start Levee Mile	1.95
End Levee Mile	1.95
Location	Water Side
Category	Earthen Levee
Item	Vegetation

Looking northeast at sprayed bamboo on waterside slope. (Fall 2012)

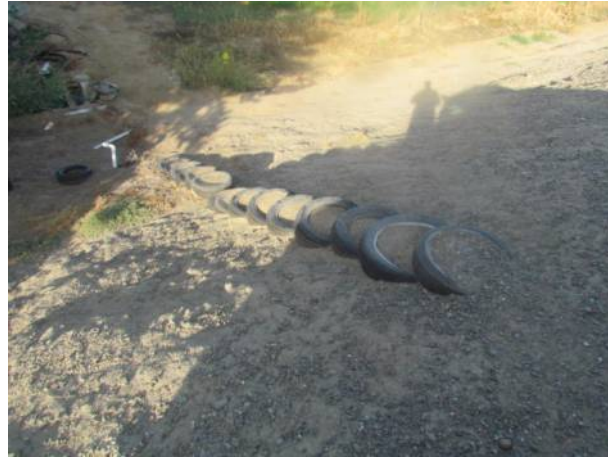
richard_f_20121015_882.JPG

Looking west at rubber tires being used as stairs on landside slope.

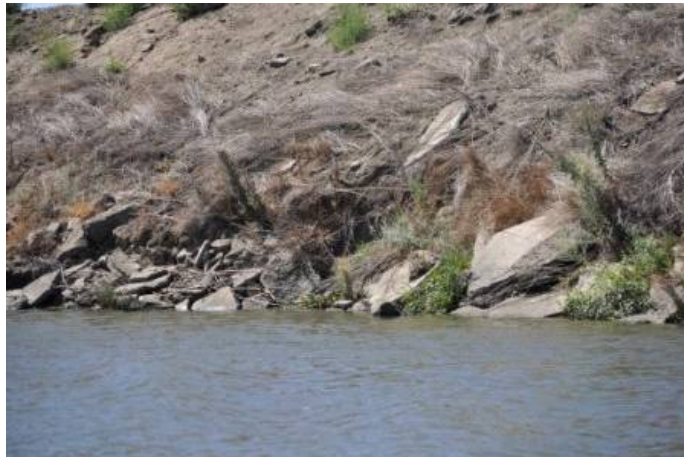
Levee Mile Report Line	52
Start Levee Mile	2.19
End Levee Mile	2.19
Location	Water Side
Category	Supplemental
Item	DWR Erosion Survey

Close view of the pocket erosion

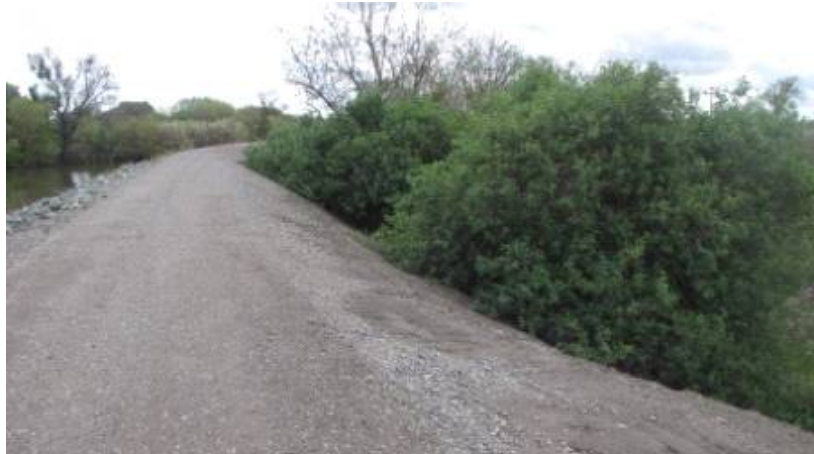
Levee Mile Report Line	54
Start Levee Mile	2.29
End Levee Mile	2.31
Location	Land Side
Category	Earthen Levee
Item	Vegetation

Looking south at dense veg on landside slope and toe.

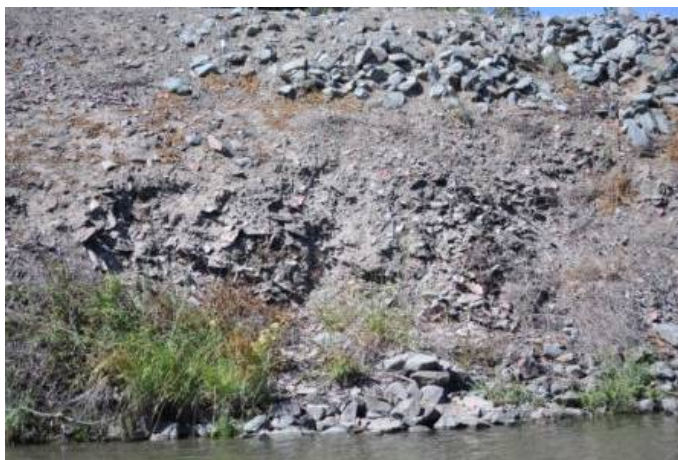
SJR2012_RD0524U01RM42.93_1.jpg

Close look of the site.

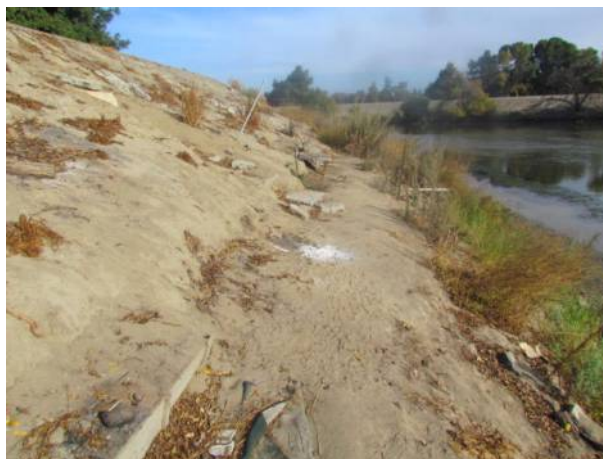
Levee Mile Report Line	56
Start Levee Mile	2.34
End Levee Mile	2.35
Location	Water Side
Category	Earthen Levee
Item	Slope Stability

Looking northeast at damage slope possible caused by human activity.

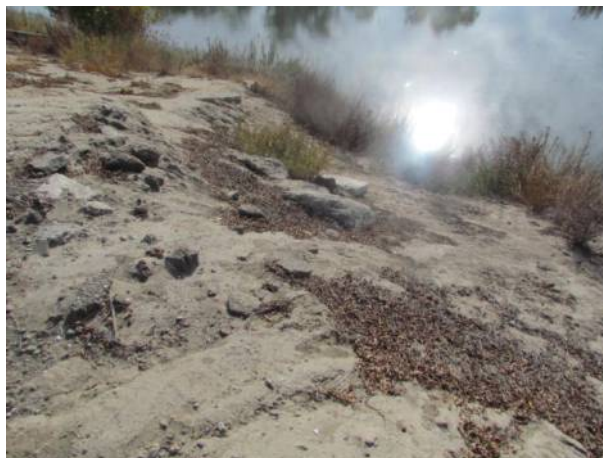
Levee Mile Report Line	59
Start Levee Mile	2.46
End Levee Mile	2.50
Location	Water Side
Category	Earthen Levee
Item	Erosion / Bank Caving

Looking east at erosion on waterside slope.

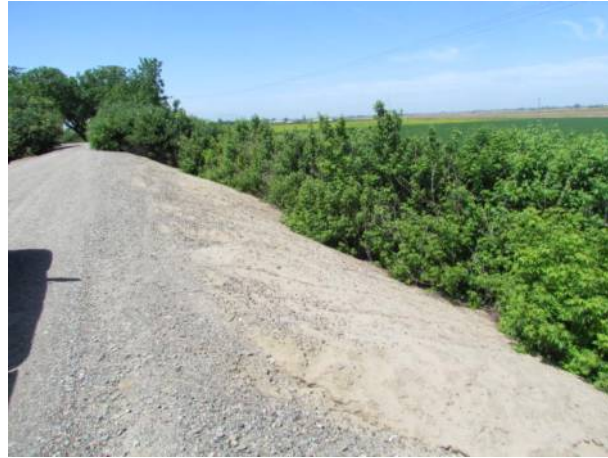
richard_f_20121008_144.jpg

Looking southwest at dense vegetation on landside toe.

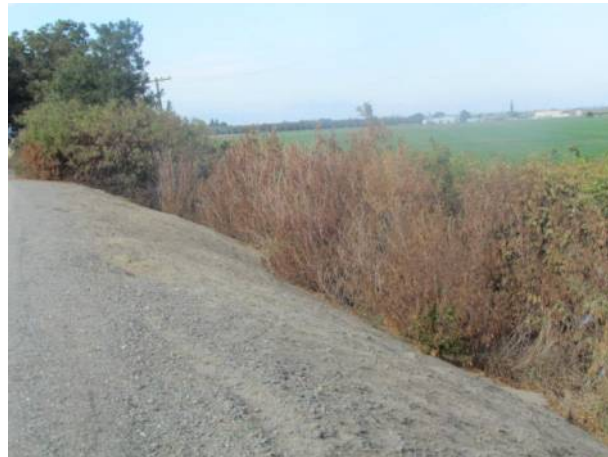
Levee Mile Report Line	60
Start Levee Mile	2.48
End Levee Mile	2.48
Location	Land Side
Category	Earthen Levee
Item	Trim / Thin Trees

Looking southwest at dense vegetation and trees on landside slope. (Fall 2012)

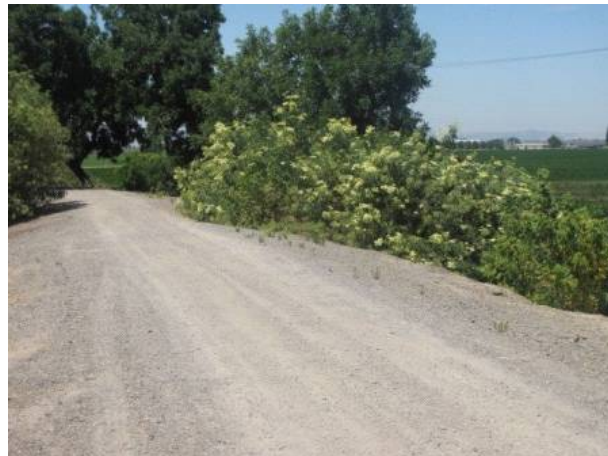
Levee Mile Report Line	61
Start Levee Mile	2.52
End Levee Mile	2.52
Location	Land Side
Category	Earthen Levee
Item	Vegetation

Looking south at elderberry on landside slope.

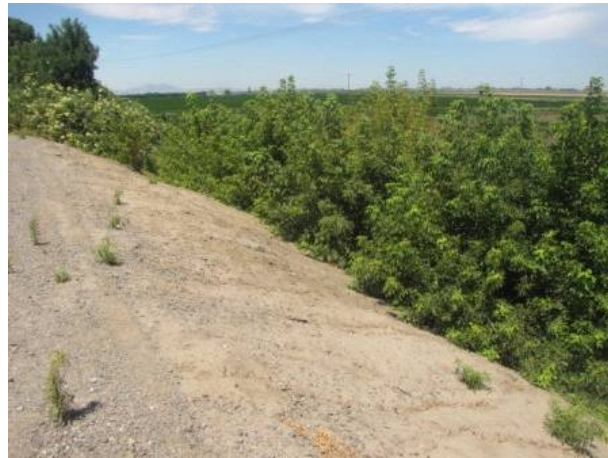
richard_f_20121008_104.jpg

Looking southwest at trees along levee landside toe.

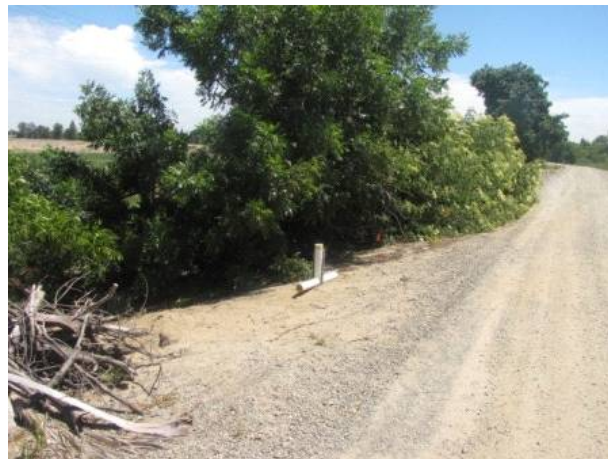
Levee Mile Report Line	61
Start Levee Mile	2.52
End Levee Mile	2.52
Location	Land Side
Category	Earthen Levee
Item	Vegetation

Looking north at elderberry and trees on landside slope.

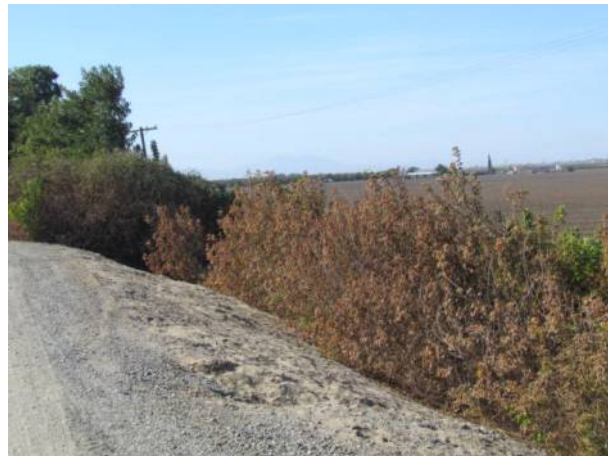
Levee Mile Report Line	61
Start Levee Mile	2.52
End Levee Mile	2.52
Location	Land Side
Category	Earthen Levee
Item	Vegetation

Looking southwest at dense vegetation on landside toe.

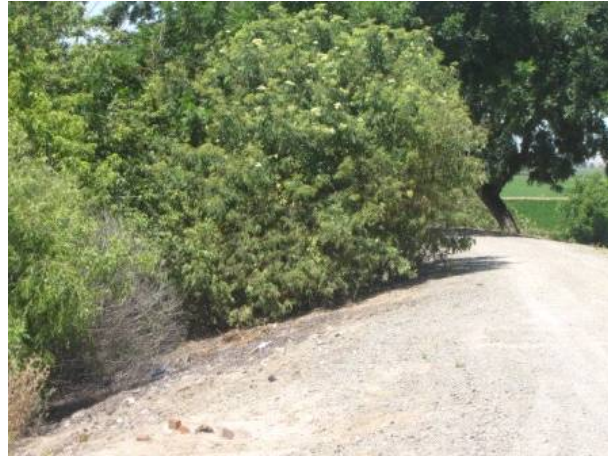
richard_f_20121008_107.jpg

Looking south at elderberry on waterside slope.

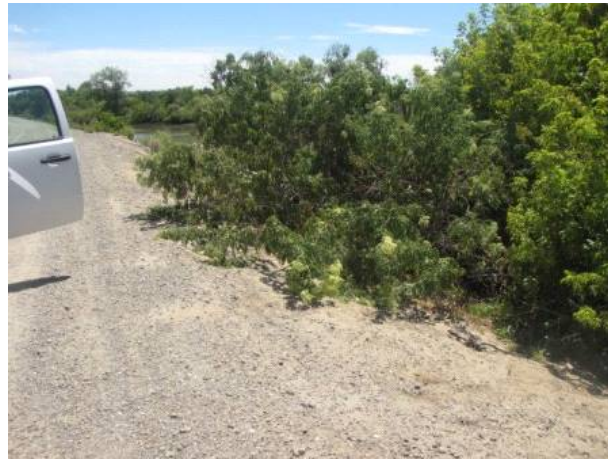
Levee Mile Report Line	62
Start Levee Mile	2.53
End Levee Mile	2.53
Location	Water Side
Category	Earthen Levee
Item	Vegetation

Looking north at elderberry on waterside slope.
