**Flood Control Project Maintenance
Levee Inspections**

Fall 2012 Levee Maintenance Deficiency Summary Report

Reclamation District No. 0524 Middle Roberts Island

Waterway			Bank	Unit Miles
Unit No. 01 San Joaquin River			Left	6.26
	Spring (March - May)	Summer (June - August)	(September - November) Fall	Winter (December - February)
Unit Maintenance Rating (Fall Only)			U	
Date of Inspection	05/08/2012 - 05/09/2012		10/09/2012 - 10/11/2012	
DWR Inspector	Richard Willoughby		Richard Willoughby	
Accompanied By	Mario Jaques RD 524		Mario Jaques RD 524

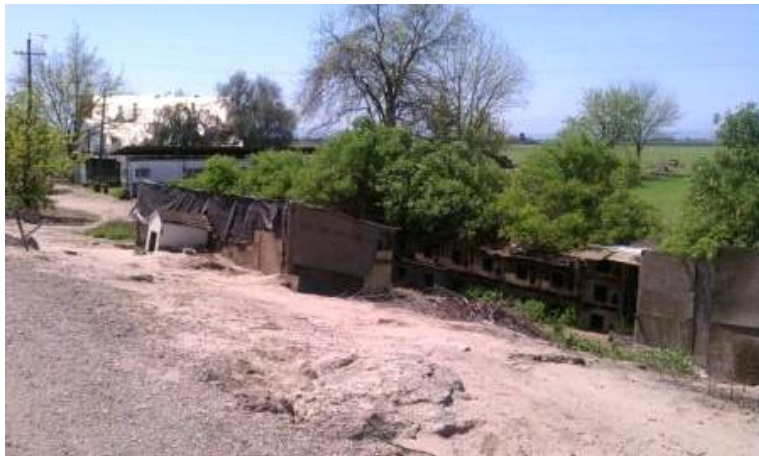
Levee Mile Report Line	66
Start Levee Mile	2.59
End Levee Mile	2.59
Location	Water Side
Category	Earthen Levee
Item	Encroachments

Looking at animal pens on landside slope and toe.

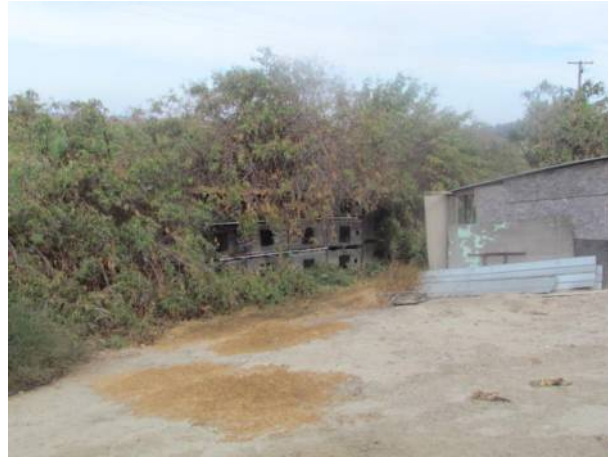
richard_f_20121015_886.JPG

Looking west at animal pens on landside toe.
(Fall 2012)

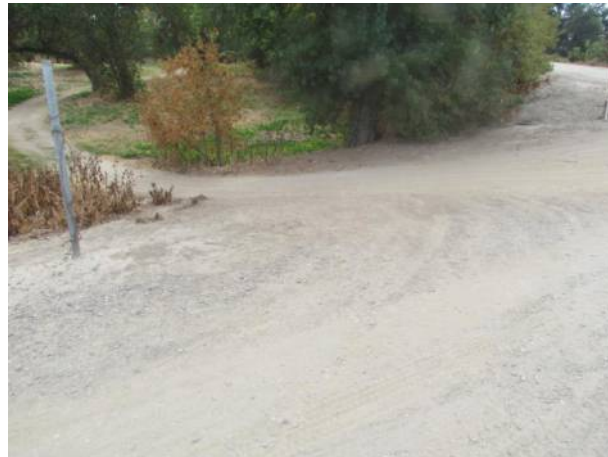
Levee Mile Report Line	67
Start Levee Mile	2.59
End Levee Mile	2.59
Location	Water Side
Category	Earthen Levee
Item	Encroachments

Looking southeast at unauthorized ramp on
waterside slope.

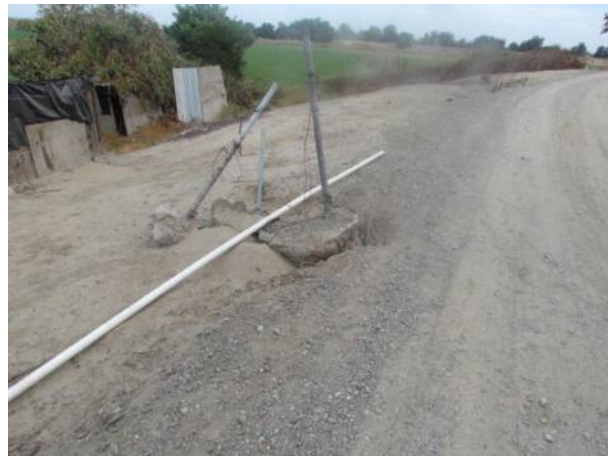
Levee Mile Report Line	68
Start Levee Mile	2.60
End Levee Mile	2.60
Location	Land Side
Category	Earthen Levee
Item	Encroachments

Looking northwest at fence poles on landside
shoulder.

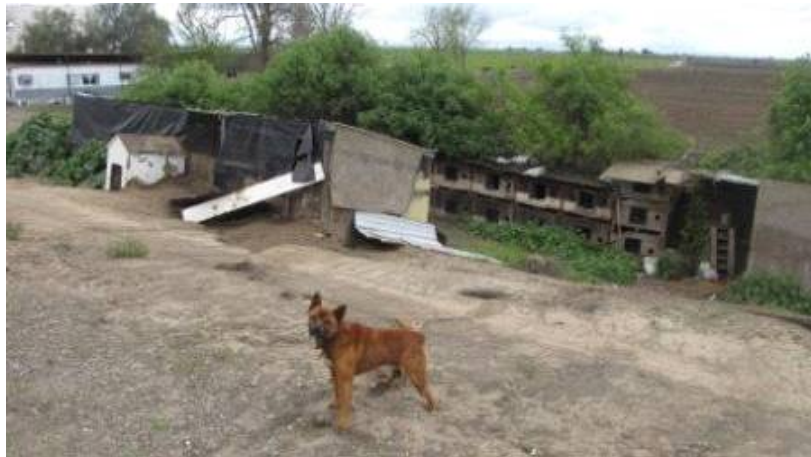
richard_f_20121008_112.jpg

Looking southwest at structures on landside.

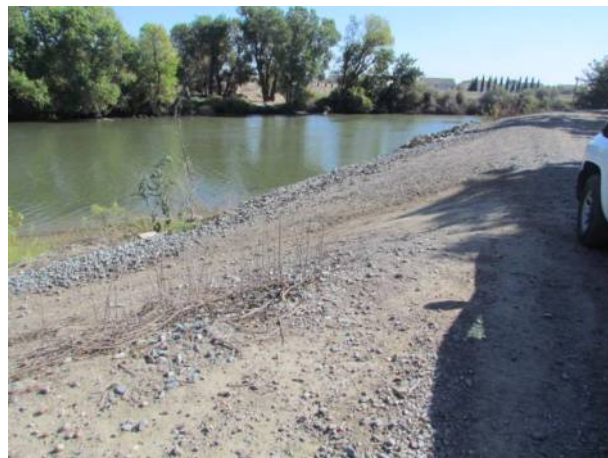
Levee Mile Report Line	74
Start Levee Mile	2.67
End Levee Mile	2.67
Location	Water Side
Category	Earthen Levee
Item	Encroachments

Looking southeast at unauthorized ramp on waterside slope.

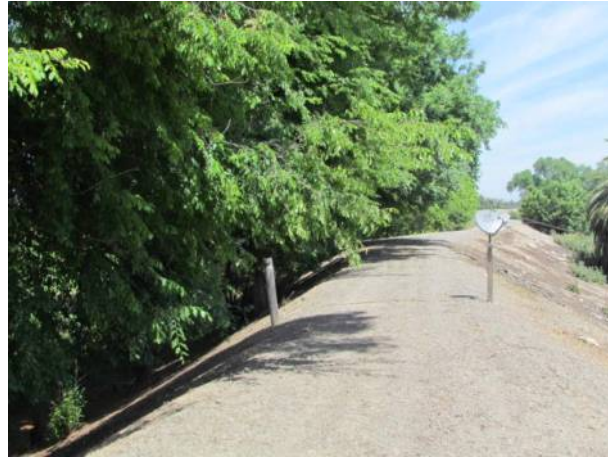
richard_f_20121008_113.jpg

Looking north at dense trees overhanging levee crown.

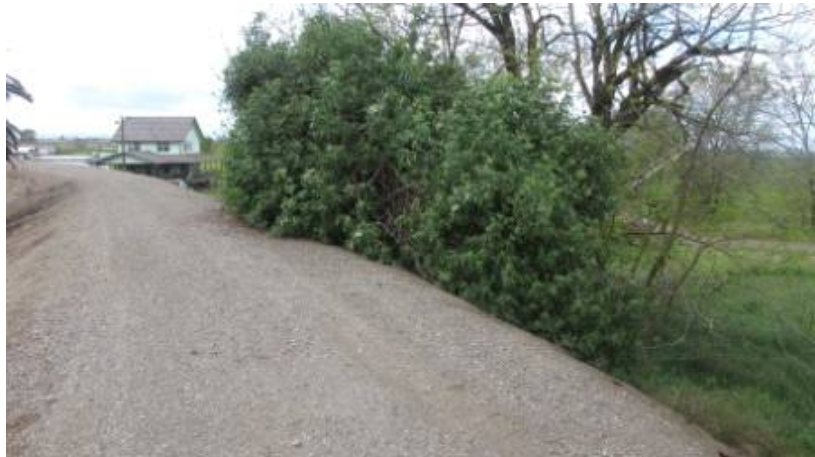
Levee Mile Report Line	81
Start Levee Mile	2.82
End Levee Mile	2.82
Location	Land Side
Category	Earthen Levee
Item	Vegetation

Looking south at elderberry on landside slope.(Spring 2011)

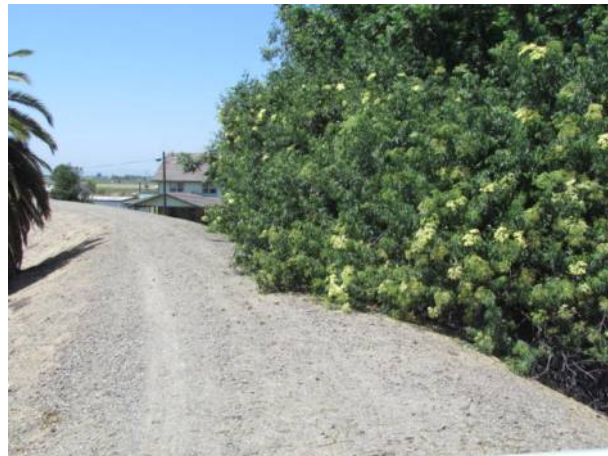
Levee Mile Report Line	81
Start Levee Mile	2.82
End Levee Mile	2.82
Location	Land Side
Category	Earthen Levee
Item	Vegetation

Looking south at dense elderberry on landside slope.(Spring 2012)

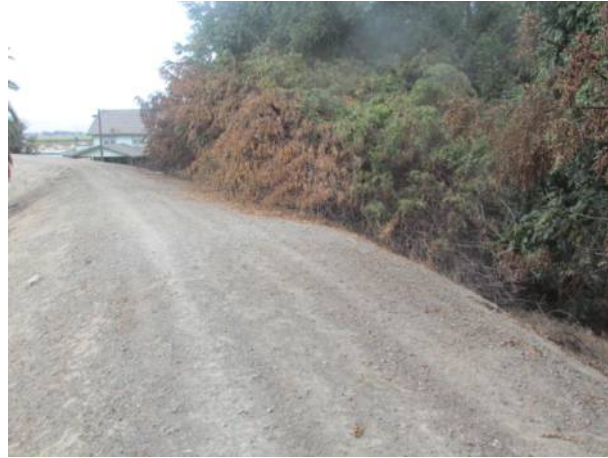
richard_f_20121015_889.JPG

Looking southwest at dense vegetation on landside slope.

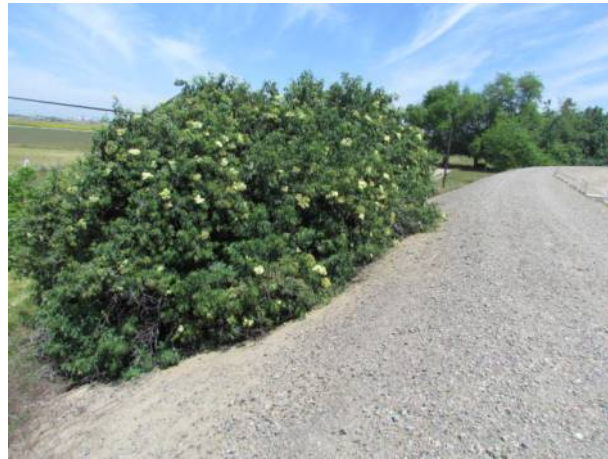
Levee Mile Report Line	83
Start Levee Mile	2.88
End Levee Mile	2.88
Location	Land Side
Category	Earthen Levee
Item	Vegetation

Looking northwest at elderberry on landside slope.

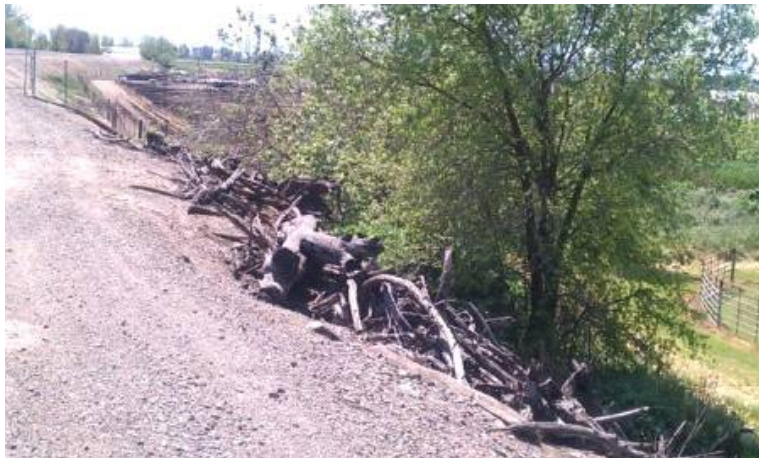
Levee Mile Report Line	84
Start Levee Mile	2.93
End Levee Mile	2.95
Location	Land Side
Category	Earthen Levee
Item	Encroachments

Looking southwest at prunings on landside slope.

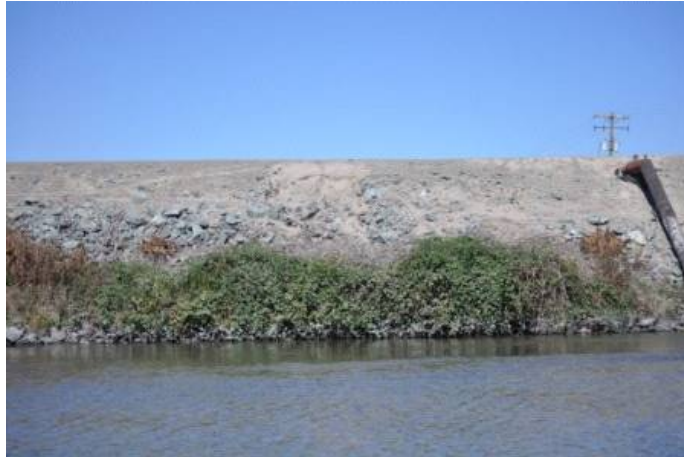
SJR2012_RD0524U01RM43.52_1.jpg

Front view of erosion

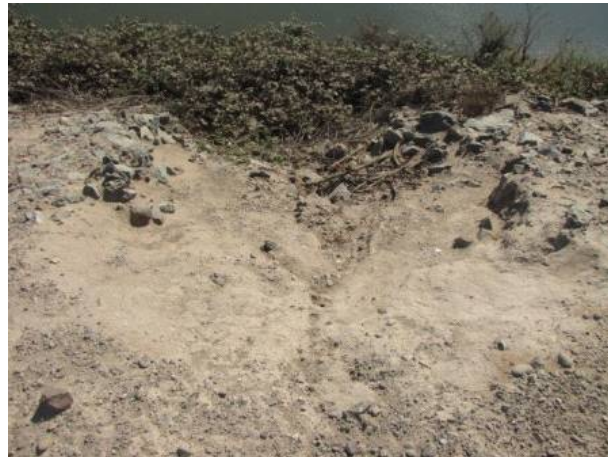
Levee Mile Report Line	87
Start Levee Mile	2.98
End Levee Mile	2.98
Location	Water Side
Category	Earthen Levee
Item	Erosion / Bank Caving

Looking east at erosion on waterside toe.

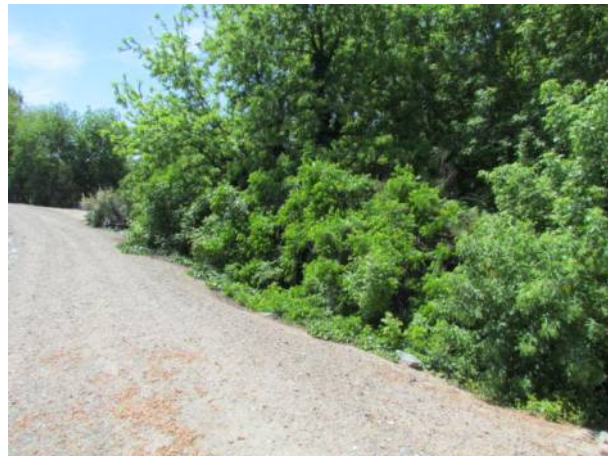
Levee Mile Report Line	93
Start Levee Mile	3.38
End Levee Mile	3.39
Location	Land Side
Category	Earthen Levee
Item	Vegetation

Looking southwest at dense landscaping on landside slope.

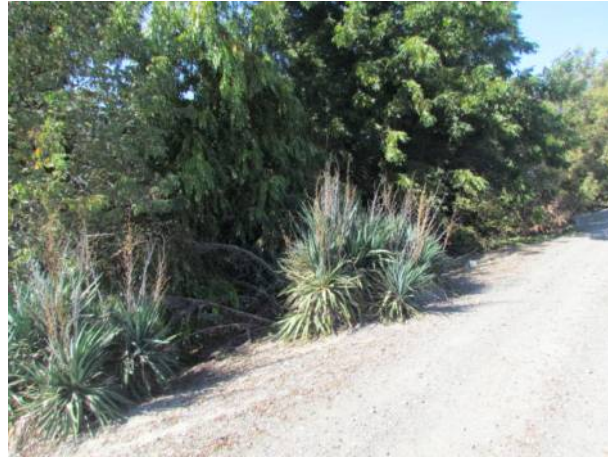
richard_f_20121008_125.jpg

Looking northwest at dense vegetation on landside slope.

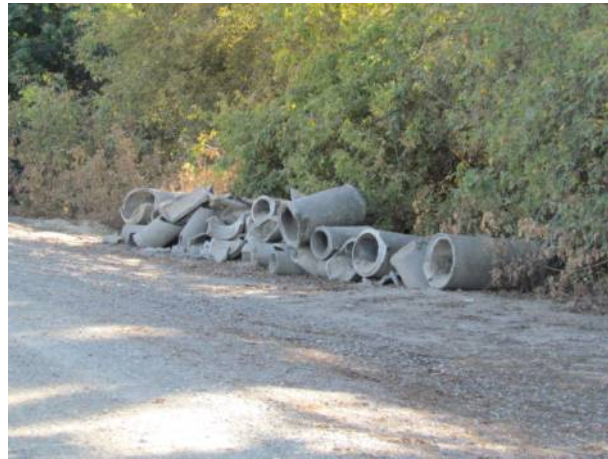
Levee Mile Report Line	96
Start Levee Mile	3.45
End Levee Mile	3.45
Location	Land Side
Category	Earthen Levee
Item	Encroachments

Looking southwest at concrete pipes on landside toe.

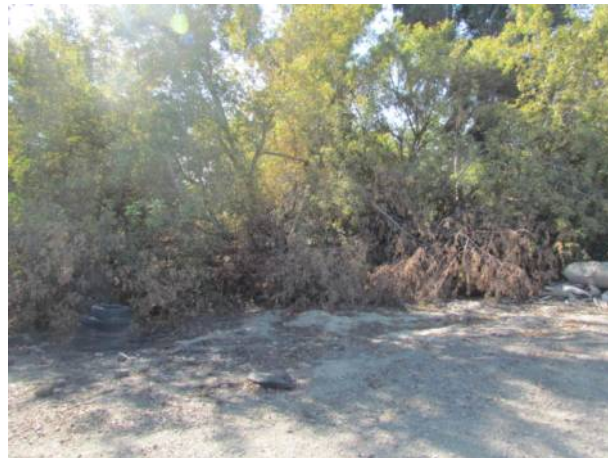
Levee Mile Report Line	97
Start Levee Mile	3.47
End Levee Mile	3.47
Location	Land Side
Category	Earthen Levee
Item	Trim / Thin Trees

Looking northwest at low hanging tree branches on landside slope and toe.

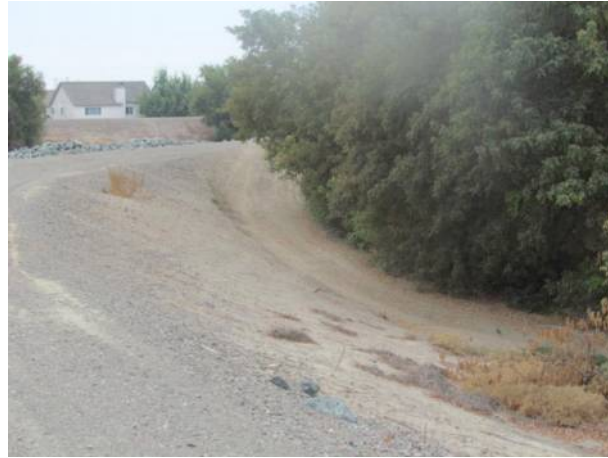
richard_f_20121015_890.JPG

Looking southeast at unauthorized ramp on landside slope and toe.

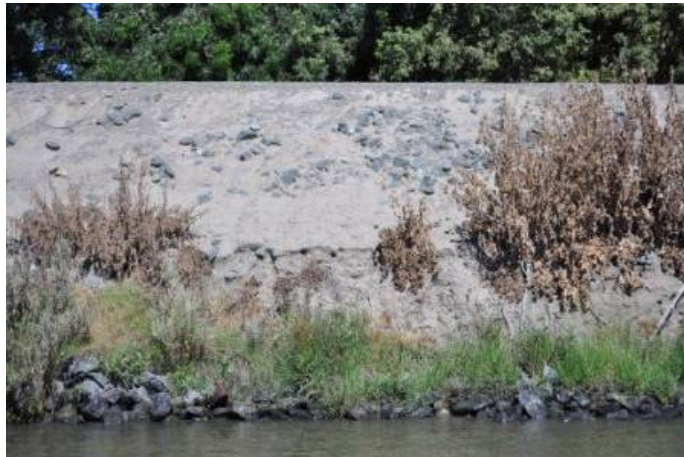
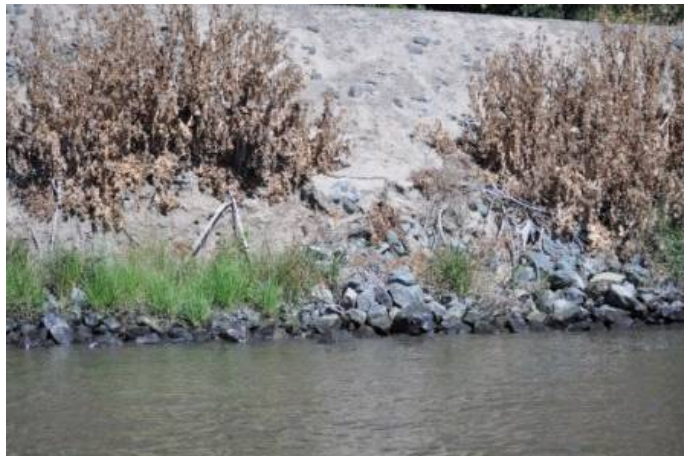
Levee Mile Report Line	100
Start Levee Mile	3.55
End Levee Mile	3.58
Location	Water Side
Category	Supplemental
Item	DWR Erosion Survey

Front view of erosion

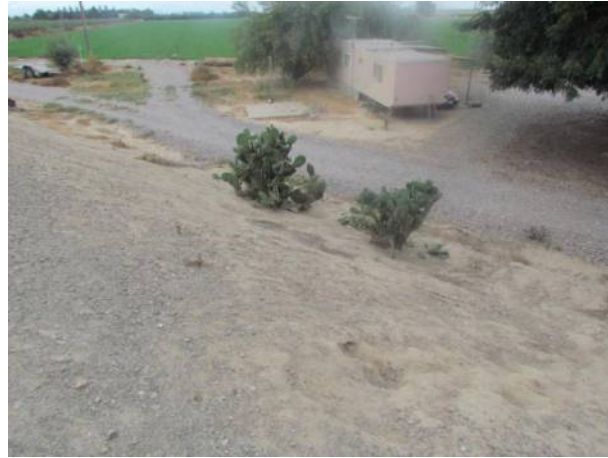
richard_f_20121015_891.JPG

Looking west at cactus on landside toe.

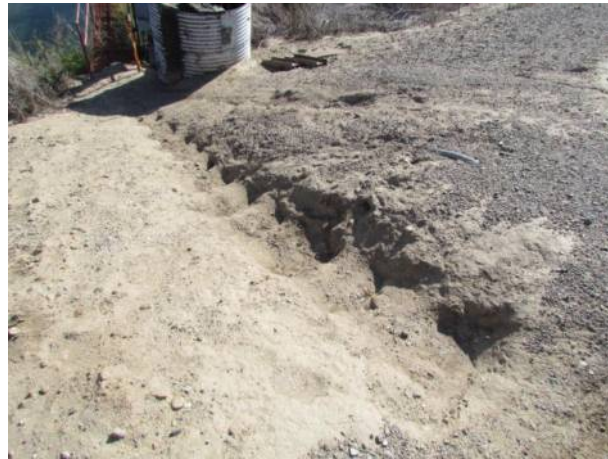
Levee Mile Report Line	102
Start Levee Mile	3.68
End Levee Mile	3.68
Location	Water Side
Category	Earthen Levee
Item	Slope Stability

Looking southeast steps cut into waterside slope.

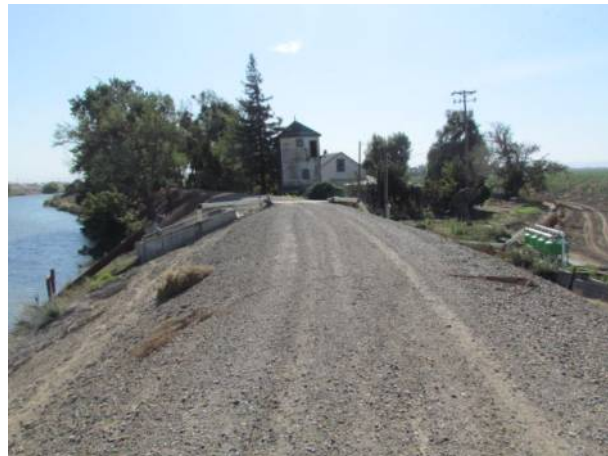
Levee Mile Report Line	105
Start Levee Mile	3.82
End Levee Mile	3.82
Location	Crown
Category	Earthen Levee
Item	Encroachments

Looking south at unauthorized irrigation pipe across levee and water filtration system at landside toe.

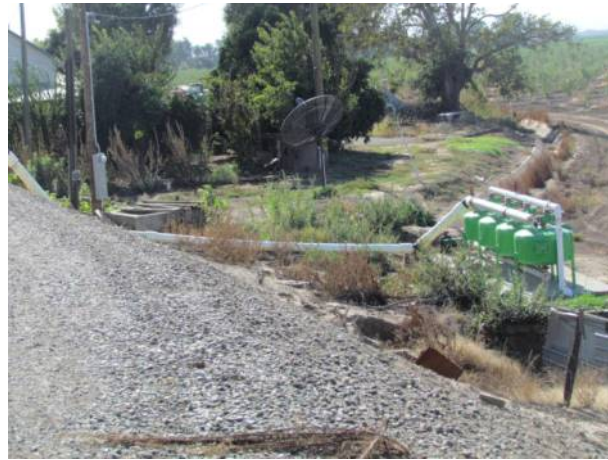
richard_f_20121008_179.jpg

Looking west at water filtration system on landside toe.

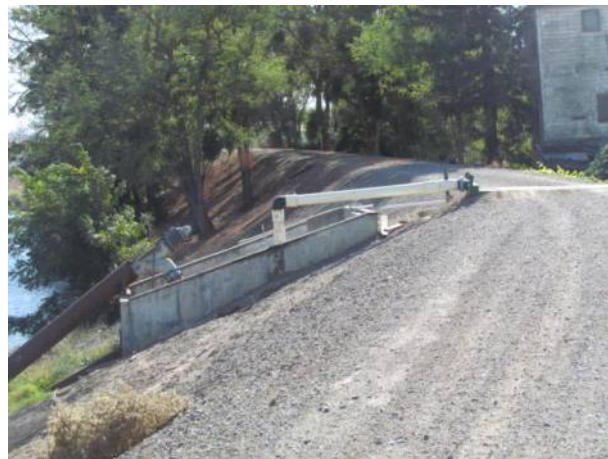
Levee Mile Report Line	105
Start Levee Mile	3.82
End Levee Mile	3.82
Location	Crown
Category	Earthen Levee
Item	Encroachments

Looking south unauthorized pvc irrigation pipe across the levee crown.

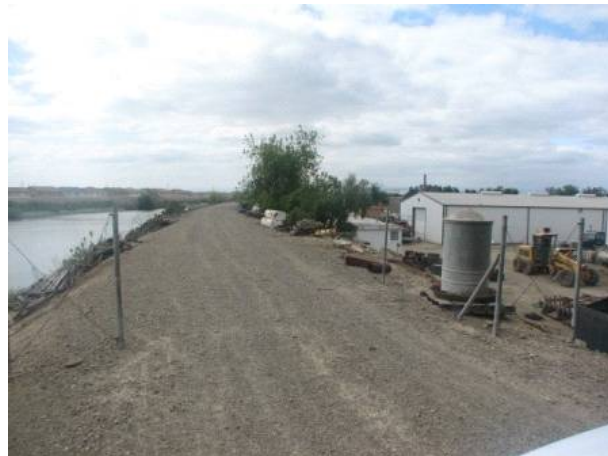
Levee Mile Report Line	107
Start Levee Mile	3.89
End Levee Mile	4.01
Location	Land Side
Category	Earthen Levee
Item	Encroachments

Looking upstream at equipment on landside shoulder

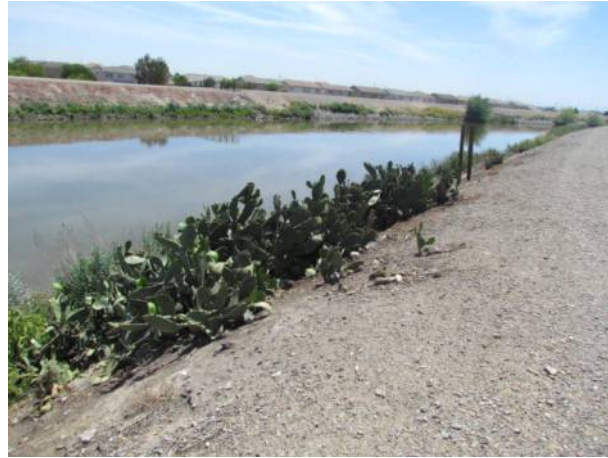
richard_f_20121008_153.jpg

Looking southeast at cactus on waterside slope.

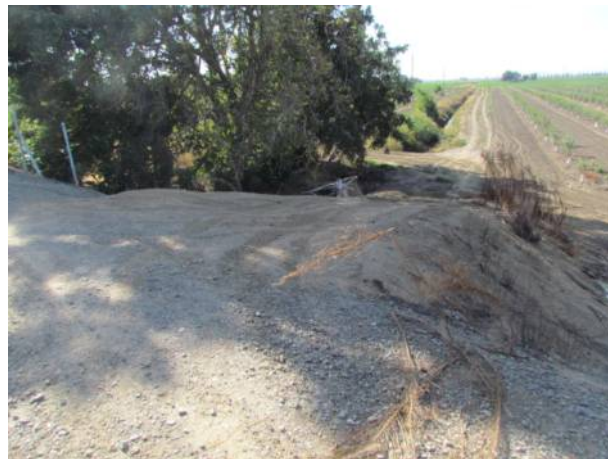
Levee Mile Report Line	110
Start Levee Mile	4.06
End Levee Mile	4.06
Location	Land Side
Category	Earthen Levee
Item	Encroachments

Looking west at unauthorized ramp on landside slope.

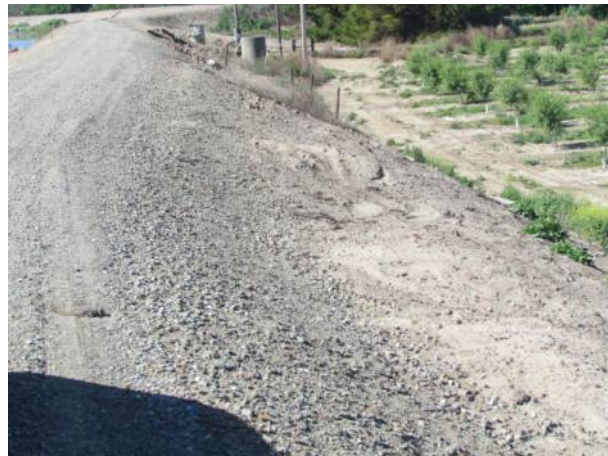
Levee Mile Report Line	113
Start Levee Mile	4.13
End Levee Mile	4.13
Location	Land Side
Category	Earthen Levee
Item	Slope Stability

Looking southwest at caving slope on landside of levee.

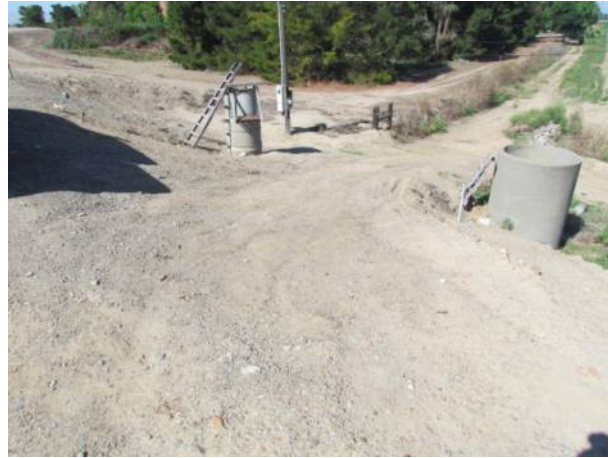
richard_f_20121008_166.jpg

Looking southwest at unauthorized ramp on landside slope.

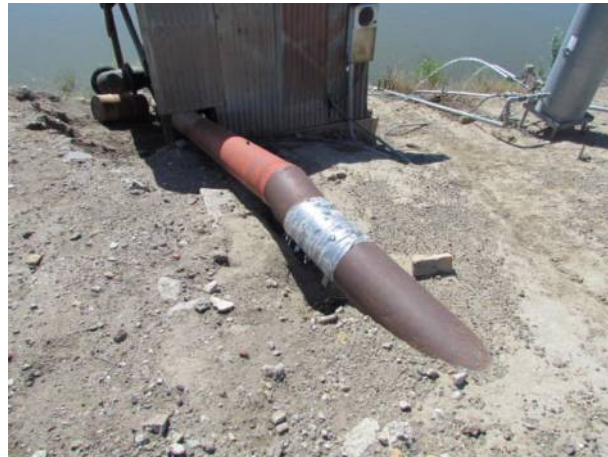
Levee Mile Report Line	115
Start Levee Mile	4.19
End Levee Mile	4.19
Location	Water Side
Category	Interior Drainage & Piping Systems
Item	Metal Pipes

Looking east at damaged pipe on waterside slope.(Spring 2012)

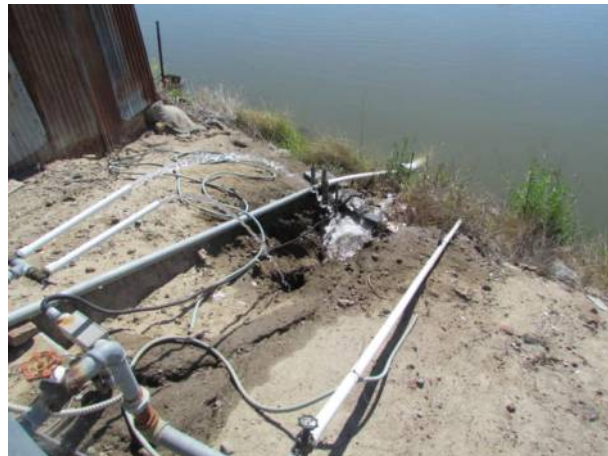
Levee Mile Report Line	115
Start Levee Mile	4.19
End Levee Mile	4.19
Location	Water Side
Category	Interior Drainage & Piping Systems
Item	Metal Pipes

Looking east at irrigation system damaging waterside toe.

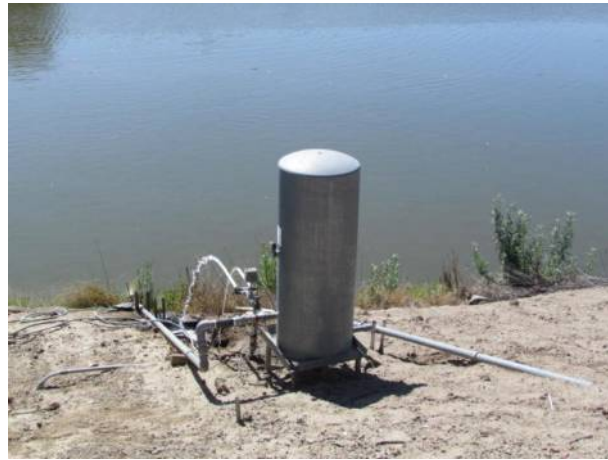
richard_f_20121008_164.jpg

Looking east at irrigation system on waterside slope.

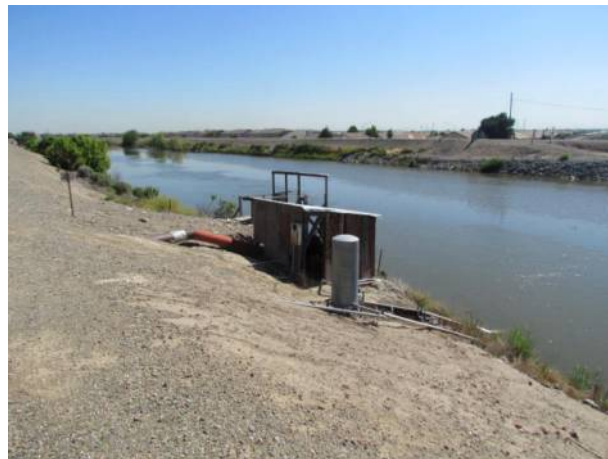
Levee Mile Report Line	115
Start Levee Mile	4.19
End Levee Mile	4.19
Location	Water Side
Category	Interior Drainage & Piping Systems
Item	Metal Pipes

Looking northeast at overview of irrigation system on waterside slope.

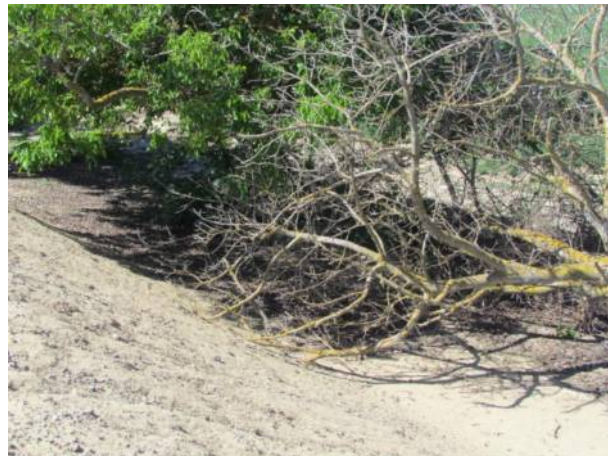
Levee Mile Report Line	117
Start Levee Mile	4.42
End Levee Mile	4.42
Location	Land Side
Category	Earthen Levee
Item	Encroachments

Looking west at dead tree at landside toe.

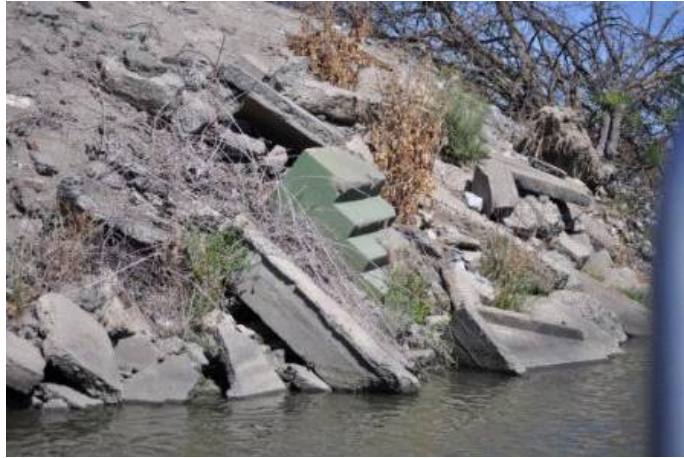
SJR2012_RD0524U01RM45.07_1.jpg

Front view of the site. Note the loosely placed concrete blocks.

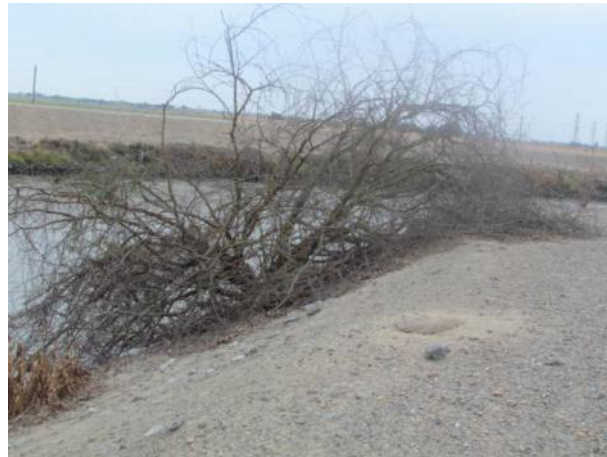
Levee Mile Report Line	120
Start Levee Mile	4.57
End Levee Mile	4.57
Location	Water Side
Category	Earthen Levee
Item	Encroachments

Looking southeast at dead tree on waterside slope.

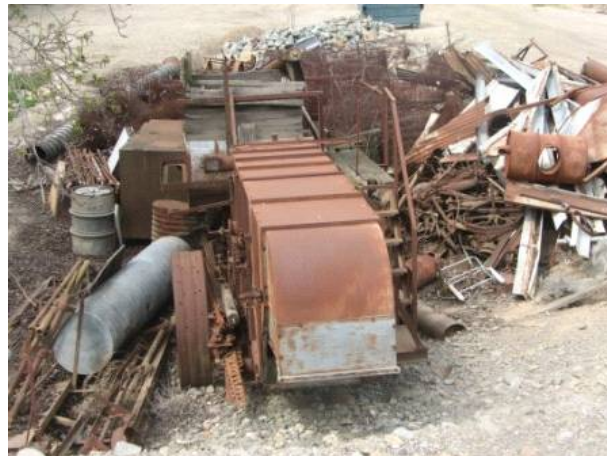
Levee Mile Report Line	121
Start Levee Mile	4.64
End Levee Mile	4.64
Location	Land Side
Category	Earthen Levee
Item	Encroachments

Garbage at landward toe next to ramp at LM 4.64

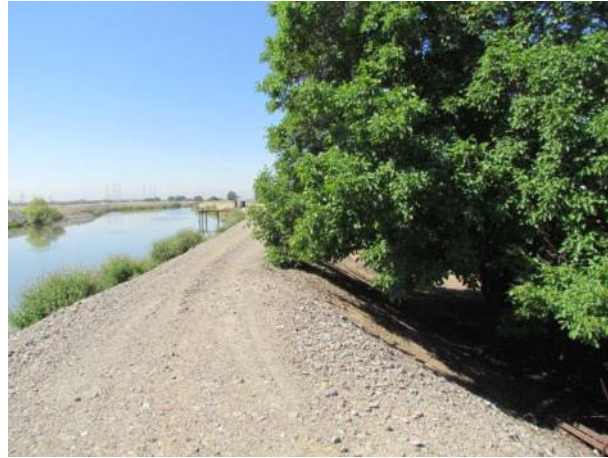
richard_f_20121008_132.jpg

Looking south at dense trees on landside slope.

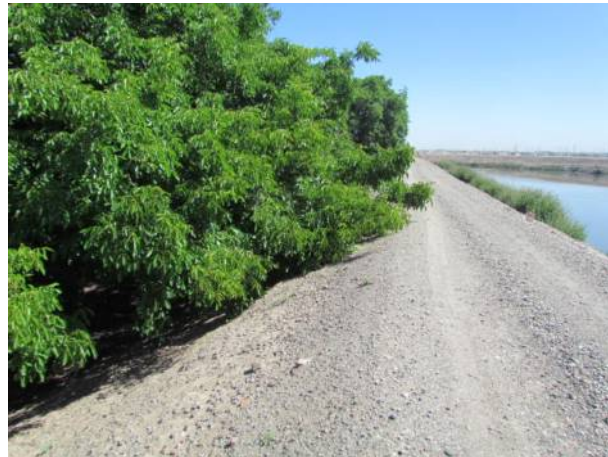
Levee Mile Report Line	123
Start Levee Mile	4.67
End Levee Mile	4.67
Location	Land Side
Category	Earthen Levee
Item	Trim / Thin Trees

Looking north at dense trees on landside slope.

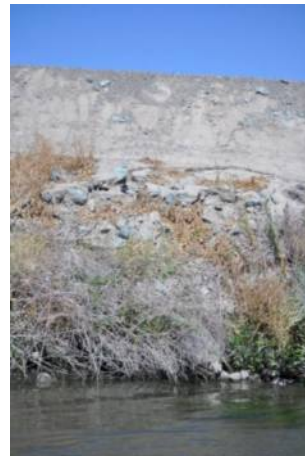
Levee Mile Report Line	124
Start Levee Mile	4.71
End Levee Mile	4.71
Location	Water Side
Category	Supplemental
Item	DWR Erosion Survey

Front view of the erosion site

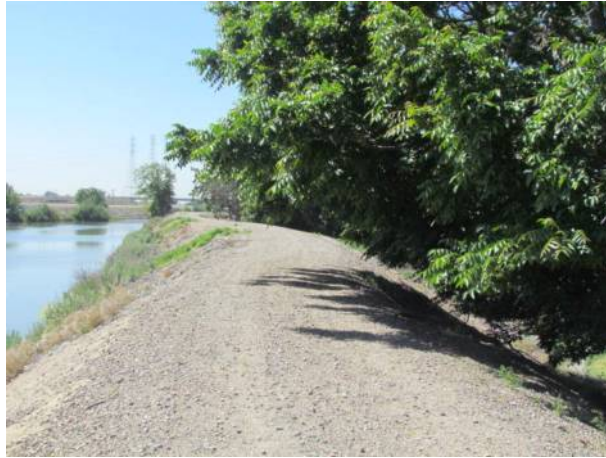
richard_f_20121008_134.jpg

Looking south at overhanging trees.

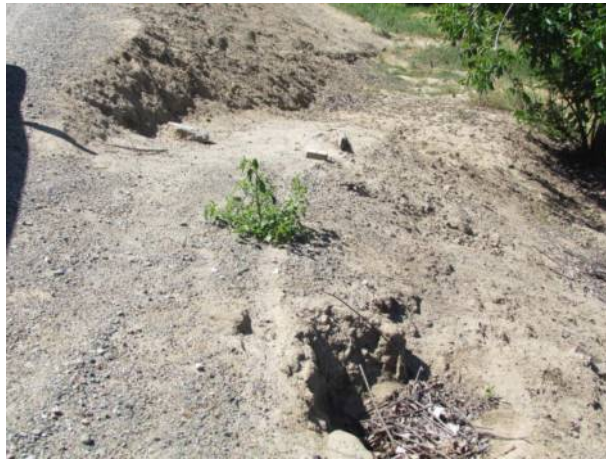
Levee Mile Report Line	135
Start Levee Mile	5.41
End Levee Mile	5.41
Location	Land Side
Category	Earthen Levee
Item	Erosion / Bank Caving

Looking southeast at slope damage and ramp on landside slope.

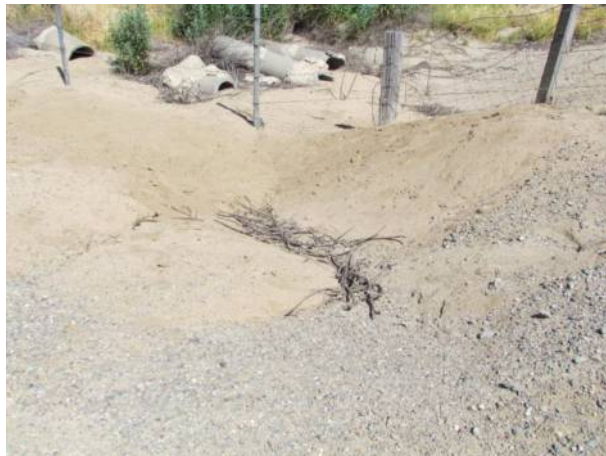
richard_f_20121008_170.jpg

Looking west a slope damage on landside slope.

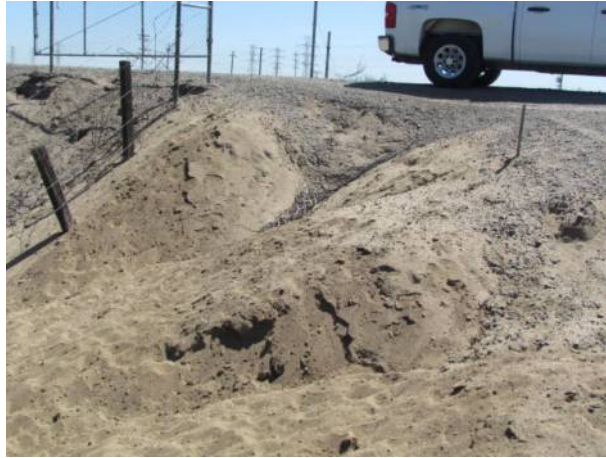
richard_f_20121008_171.jpg

Looking east at slope caving on landside slope.

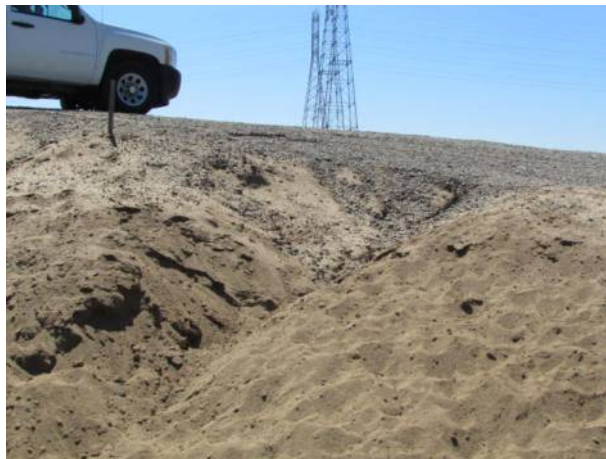
richard_f_20121008_172.jpg

Levee Mile Report Line	138
Start Levee Mile	5.47
End Levee Mile	5.47
Location	Land Side
Category	Earthen Levee
Item	Slope Stability

Looking southeast at damaged slope.

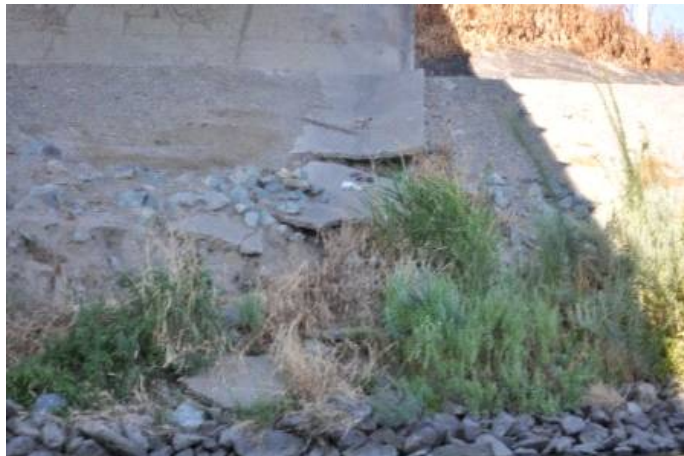
SJR2012_RD0524U01RM46.12_1.jpg

Levee Mile Report Line	141
Start Levee Mile	5.65
End Levee Mile	5.66
Location	Water Side
Category	Supplemental
Item	DWR Erosion Survey

Sloughing rip rap just below the Howard Bridge abutment.

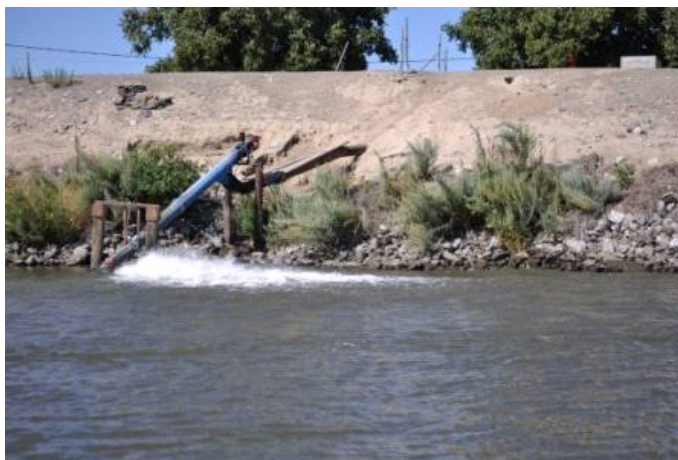
SJR2012_RD0524U01RM46.39_1.jpg

Front view of the site

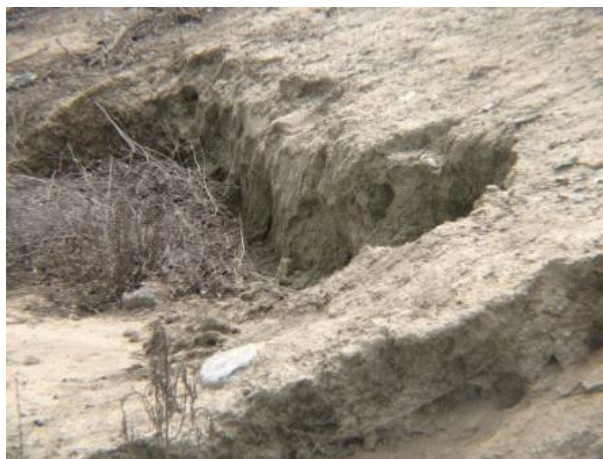
richard_f_20121008_135.jpg

Levee Mile Report Line	146
Start Levee Mile	5.92
End Levee Mile	5.92
Location	Water Side
Category	Earthen Levee
Item	Erosion / Bank Caving

Erosion at waterward toe and around irrigation pipe at LM 5.92

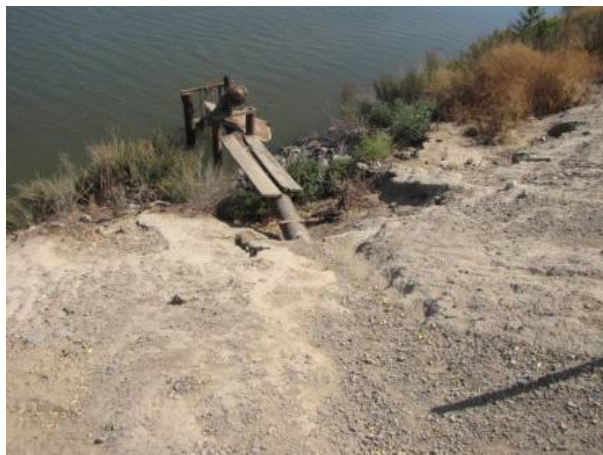
richard_f_20121008_136.jpg

Levee Mile Report Line	146
Start Levee Mile	5.92
End Levee Mile	5.92
Location	Water Side
Category	Earthen Levee
Item	Erosion / Bank Caving

Looking southeast at erosion around pipe.

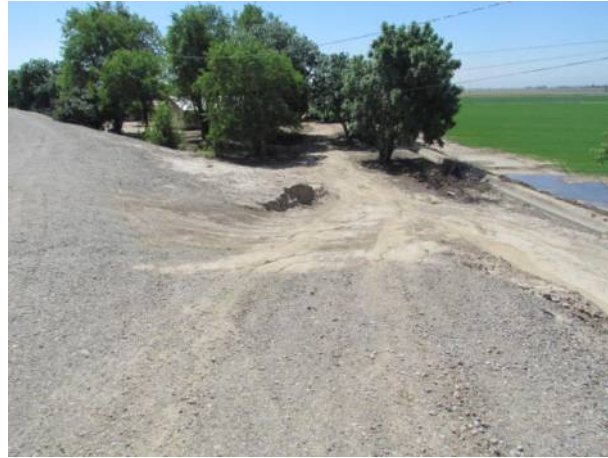
richard_f_20121008_173.jpg

Looking southwest at damage slope and ramp on landside slope.

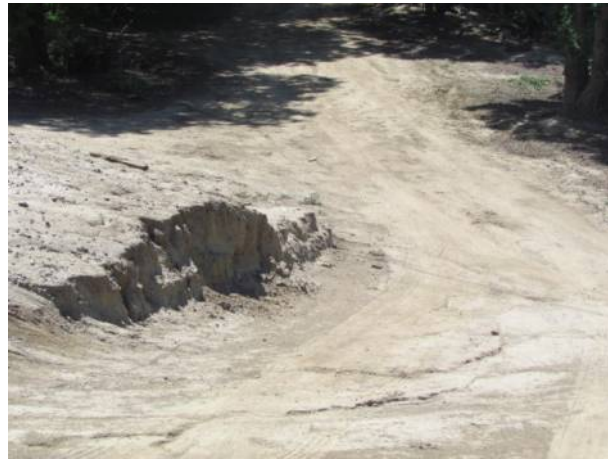
richard_f_20121008_174.jpg

Levee Mile Report Line	147
Start Levee Mile	5.93
End Levee Mile	5.93
Location	Land Side
Category	Earthen Levee
Item	Slope Stability

Looking west at unauthorized ramp and landside slope damage.

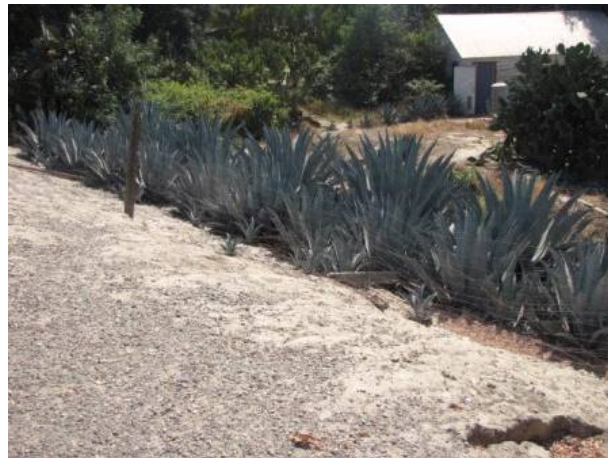
richard_f_20121008_145.jpg

Levee Mile Report Line	150
Start Levee Mile	5.99
End Levee Mile	6.00
Location	Land Side
Category	Earthen Levee
Item	Vegetation

Looking southeast at fence and cactus on landside slope and toe.

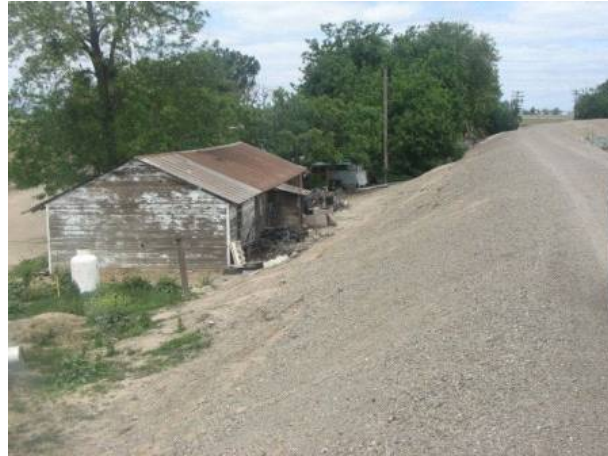
richard_f_20121008_146.jpg

Looking downstream at building on landside toe.

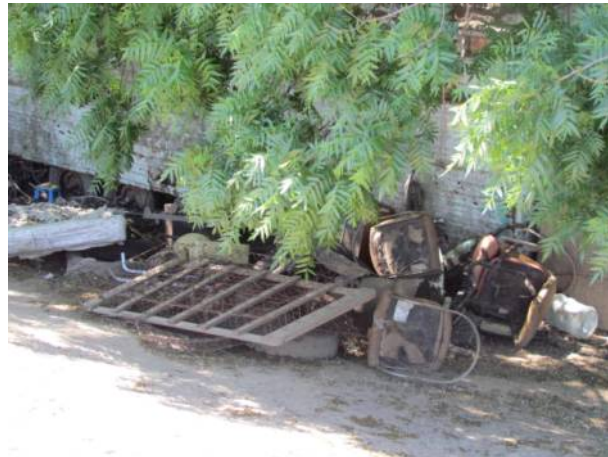
richard_f_20121008_147.jpg

Levee Mile Report Line	152
Start Levee Mile	6.01
End Levee Mile	6.05
Location	Land Side
Category	Earthen Levee
Item	Encroachments

Looking west at garbage on landside toe next to abandoned trailer.

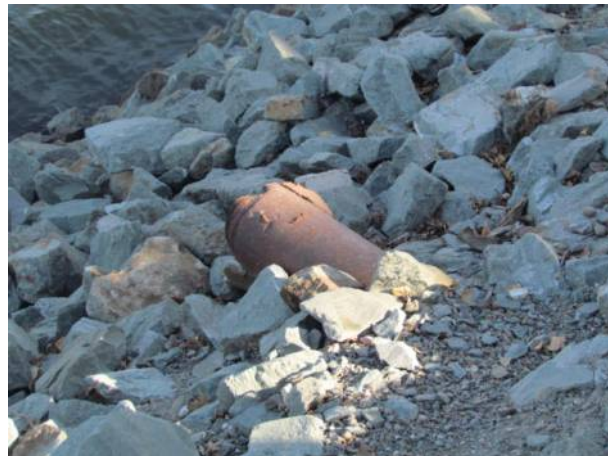
richard_f_20121008_181.jpg

Levee Mile Report Line	155
Start Levee Mile	6.21
End Levee Mile	6.21
Location	Water Side
Category	Earthen Levee
Item	Encroachments

Looking southeast at abandoned pipe on waterside slope.
