**Flood Control Project Maintenance
Levee Inspections**

Fall 2013 Levee Maintenance Deficiency Summary Report

San Joaquin River Basin

Reclamation District No. 0524 Middle Roberts Island

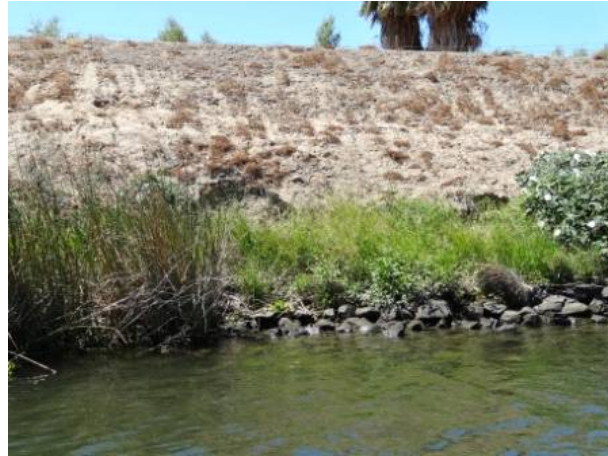
SJR2013_RD0524U01RM40.85_2.jpg

Front view of erosion.

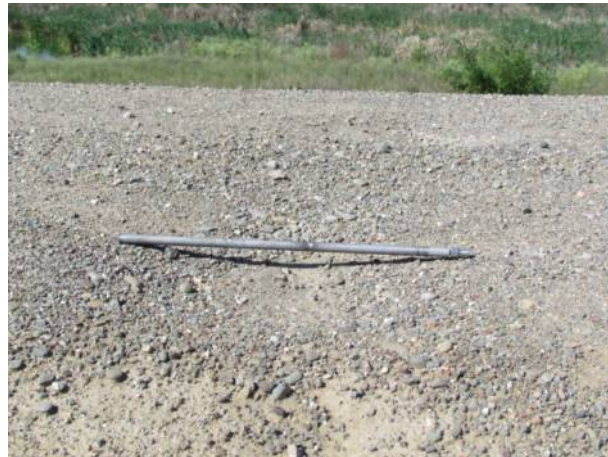
Levee Mile Report Line	5
Start Levee Mile	0.22
End Levee Mile	0.22
Location	Crown
Category	Earthen Levee
Item	Crown Surface / Depressions / Rutting

Looking west at 3" depression on levee crown.
(Spring 2012)

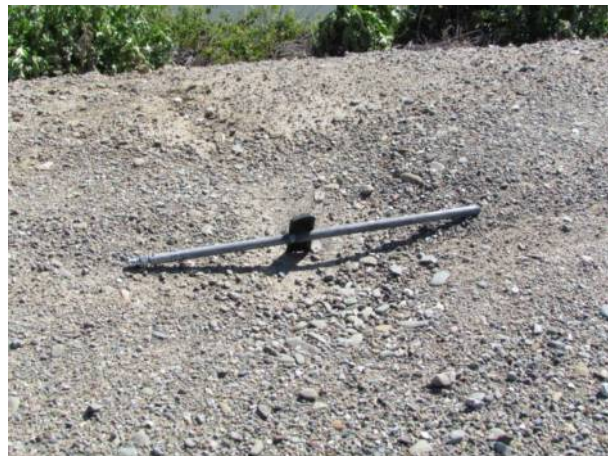
Levee Mile Report Line	5
Start Levee Mile	0.22
End Levee Mile	0.22
Location	Crown
Category	Earthen Levee
Item	Crown Surface / Depressions / Rutting

Looking east at 3" depression on levee crown.
(Spring 2012)

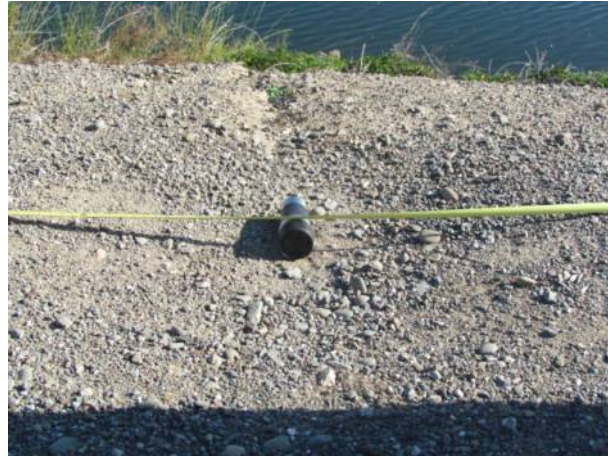
Looking west at depression on levee crown near waterward shoulder.

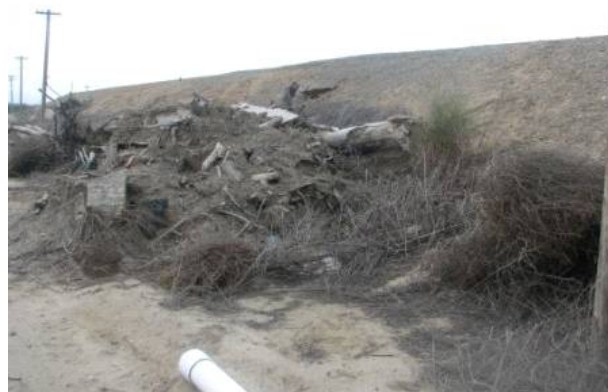
Levee Mile Report Line	6
Start Levee Mile	0.36
End Levee Mile	0.36
Location	Land Side
Category	Earthen Levee
Item	Encroachments

Garbage pile at landward toe at LM 0.36.

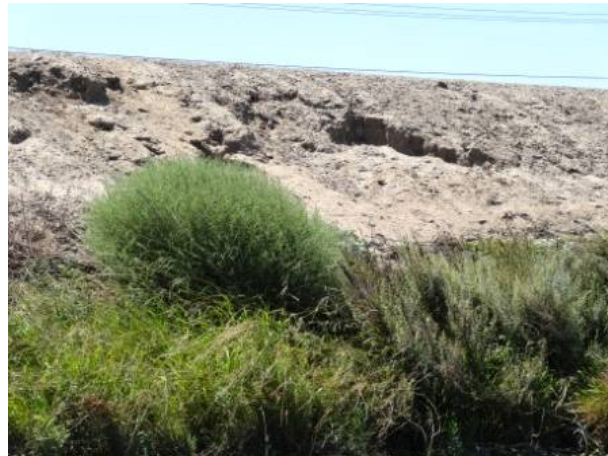
Levee Mile Report Line	7
Start Levee Mile	0.40
End Levee Mile	0.40
Location	Water Side
Category	Supplemental
Item	DWR Erosion Survey

Front view of erosion site. Note the vegetation at the levee toe and lower slope.

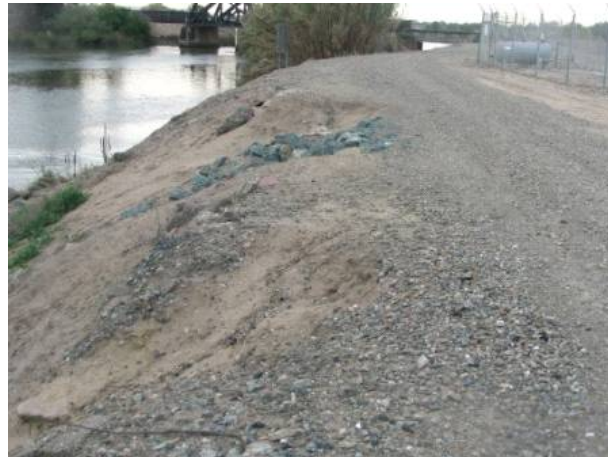
Erosion from LM 0.65 to 0.66

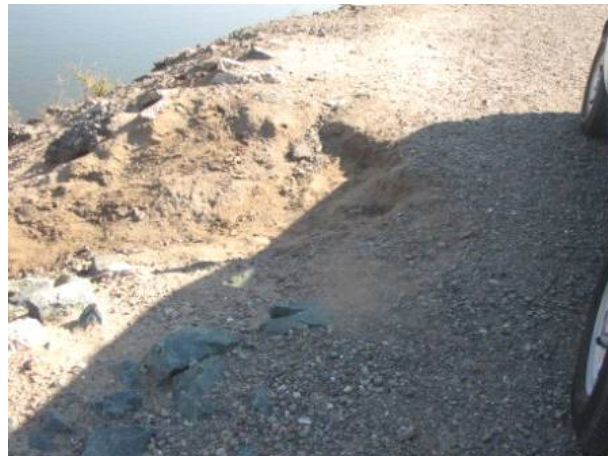
Levee Mile Report Line	11
Start Levee Mile	0.65
End Levee Mile	0.66
Location	Water Side
Category	Earthen Levee
Item	Slope Stability

Update of erosion site at LM 0.65 to 0.66

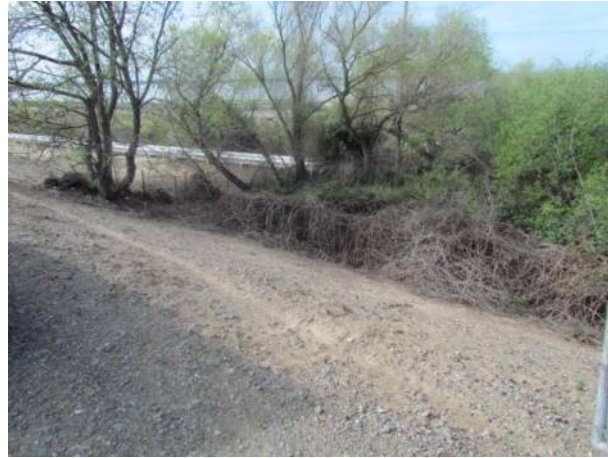
Looking southwest at vegetation on landward slope and toe. (Spring 2013)

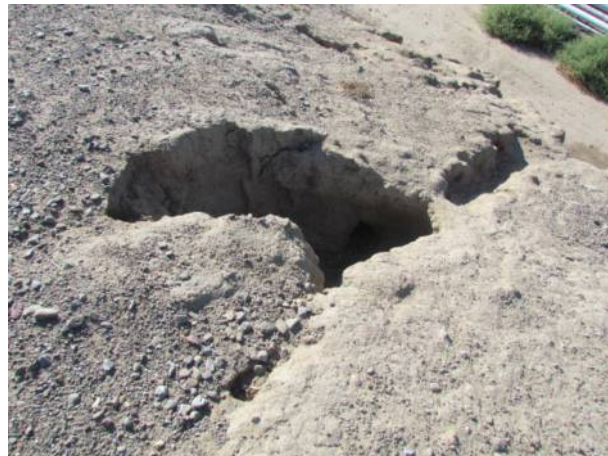
Looking southwest at hole on landward shoulder.

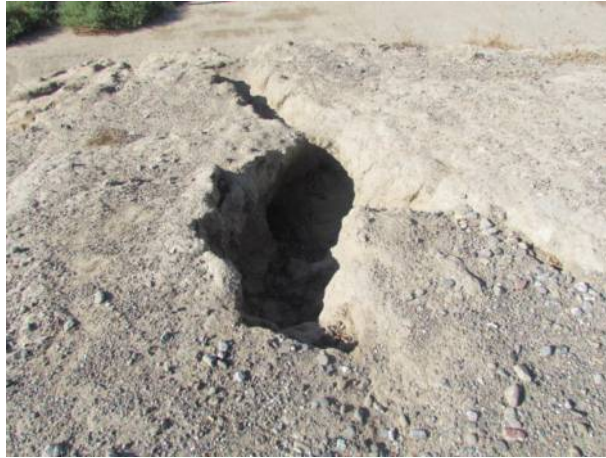
Looking west at hole on landward shoulder.

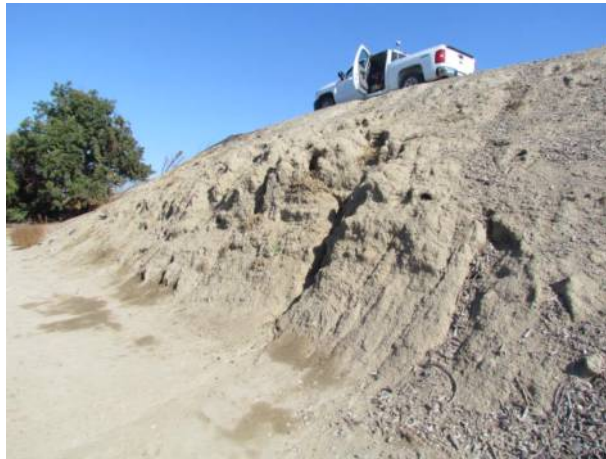
Levee Mile Report Line	16
Start Levee Mile	0.82
End Levee Mile	0.82
Location	Land Side
Category	Earthen Levee
Item	Erosion / Bank Caving

Looking northeast at several finger erosion on landward slope.

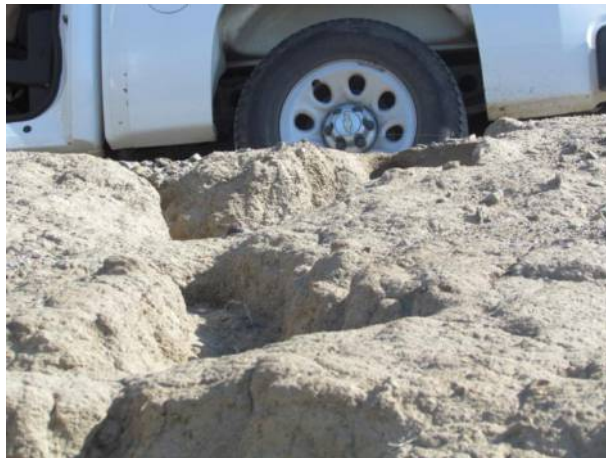
Levee Mile Report Line	16
Start Levee Mile	0.82
End Levee Mile	0.82
Location	Land Side
Category	Earthen Levee
Item	Erosion / Bank Caving

Looking east at erosion on landward slope.

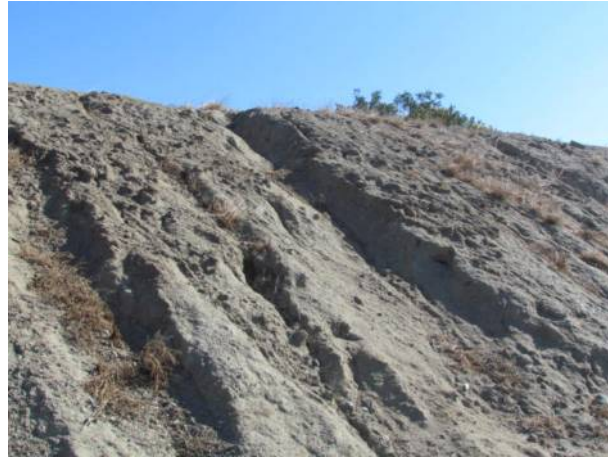
Looking southeast at finger erosion on landward slope.

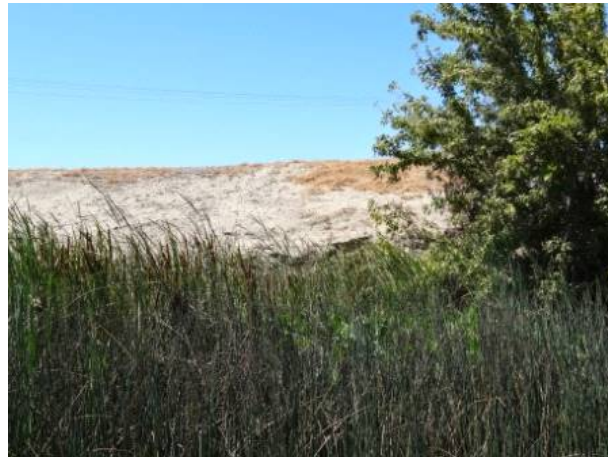
Levee Mile Report Line	17
Start Levee Mile	0.83
End Levee Mile	0.84
Location	Water Side
Category	Supplemental
Item	DWR Erosion Survey

Front view of the erosion. The tree and vegetation blocks the view of the site.

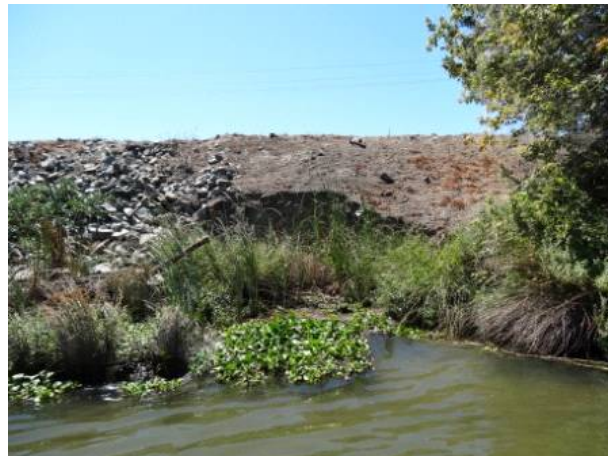
Levee Mile Report Line	18
Start Levee Mile	0.91
End Levee Mile	0.91
Location	Water Side
Category	Supplemental
Item	DWR Erosion Survey

Front view of the erosion. Note the riprap protection near the site.

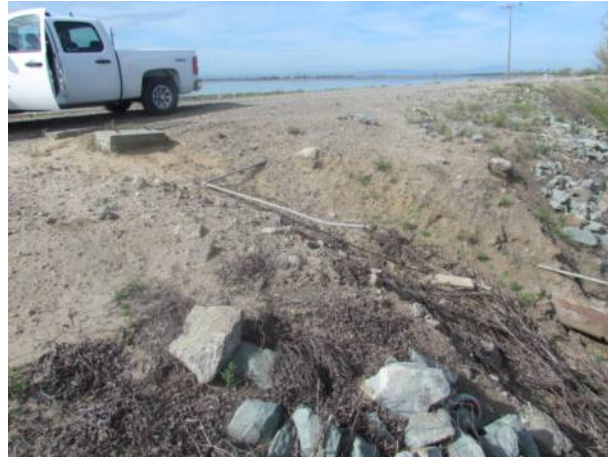
Looking northwest at inch and half metal pipe on waterward slope.

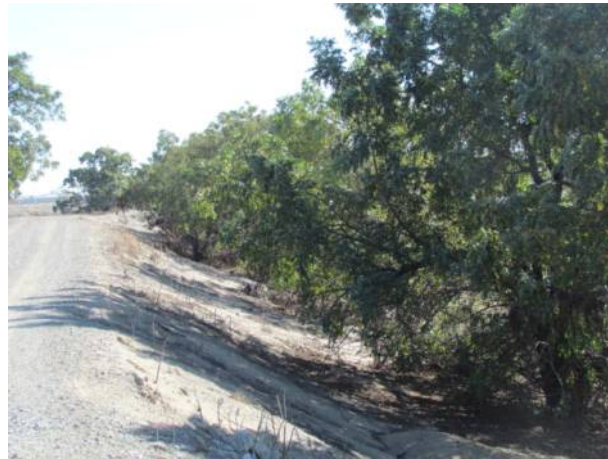
Levee Mile Report Line	20
Start Levee Mile	0.94
End Levee Mile	1.02
Location	Land Side
Category	Earthen Levee
Item	Trim / Thin Trees

Looking south at low hanging tree branches at landside toe.

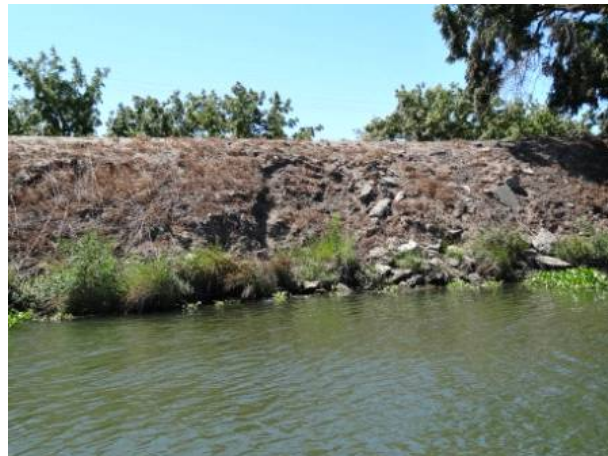
Levee Mile Report Line	23
Start Levee Mile	1.00
End Levee Mile	1.00
Location	Water Side
Category	Supplemental
Item	DWR Erosion Survey

Front view of erosion.

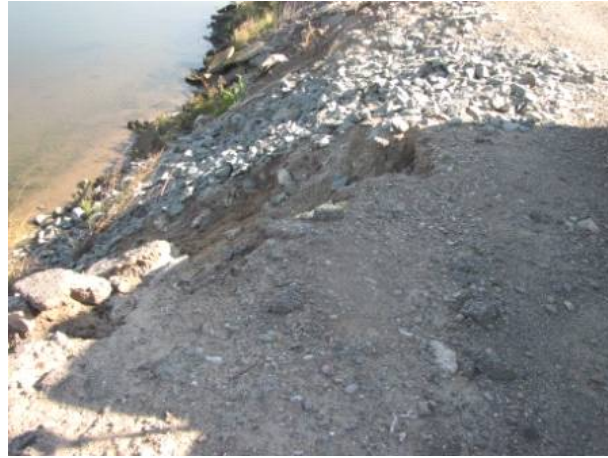
Looking upstream (south) at erosion site.

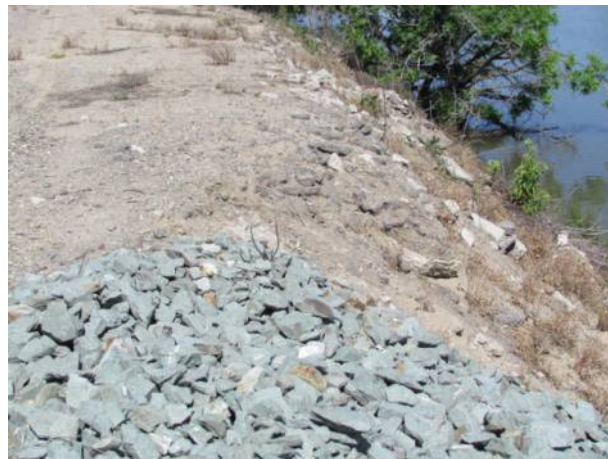
Levee Mile Report Line	24
Start Levee Mile	1.03
End Levee Mile	1.03
Location	Water Side
Category	Earthen Levee
Item	Erosion / Bank Caving

Looking north at erosion site next to repaired site.
(Spring 2012)

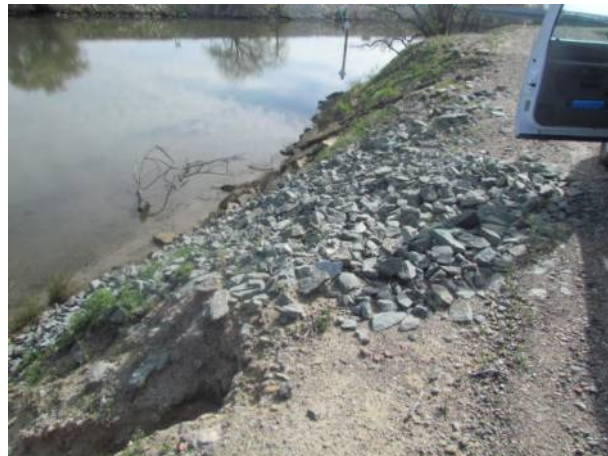
Levee Mile Report Line	24
Start Levee Mile	1.03
End Levee Mile	1.03
Location	Water Side
Category	Earthen Levee
Item	Erosion / Bank Caving

Looking southeast at erosion next to repaired site
on waterward slope (Spring 2013)

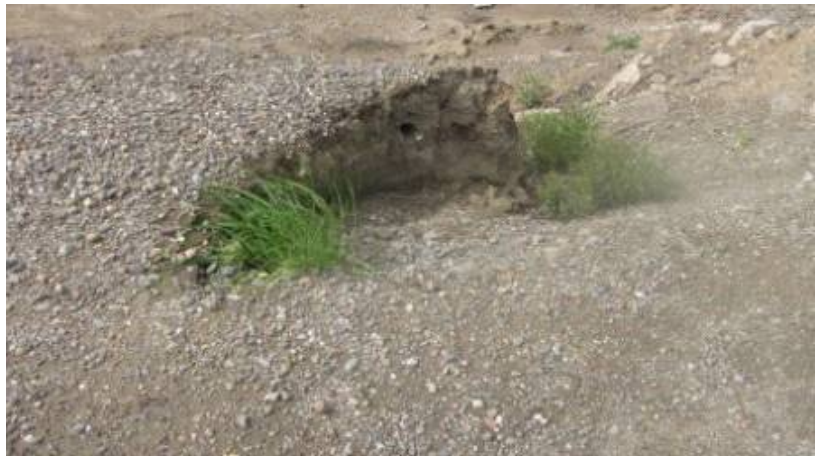
Updated view from above the slope stability.

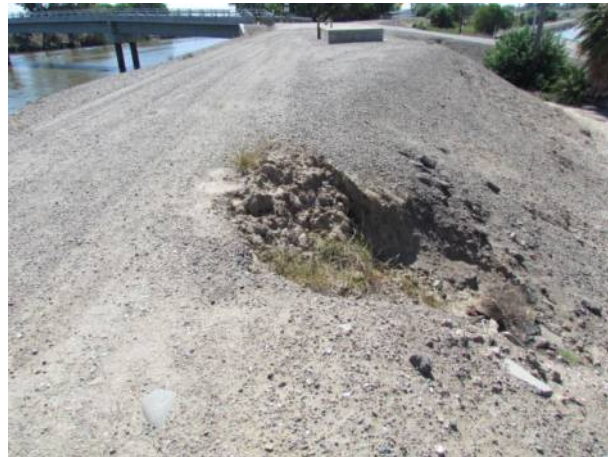
Looking south at caving on landside shoulder.
(Spring 2012)

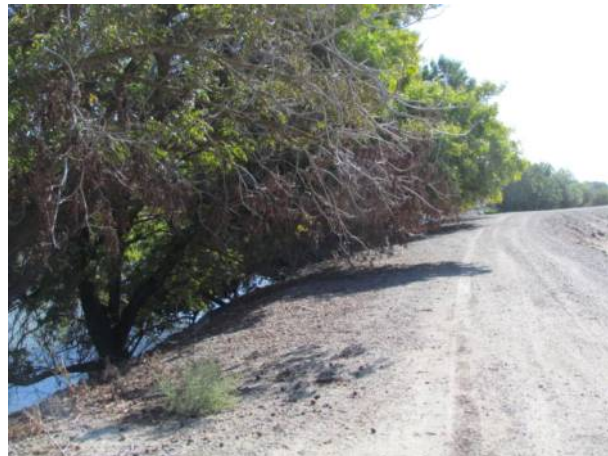
Levee Mile Report Line	26
Start Levee Mile	1.14
End Levee Mile	1.17
Location	Water Side
Category	Earthen Levee
Item	Trim / Thin Trees

Looking northwest at low hanging tree branches
at waterside toe.

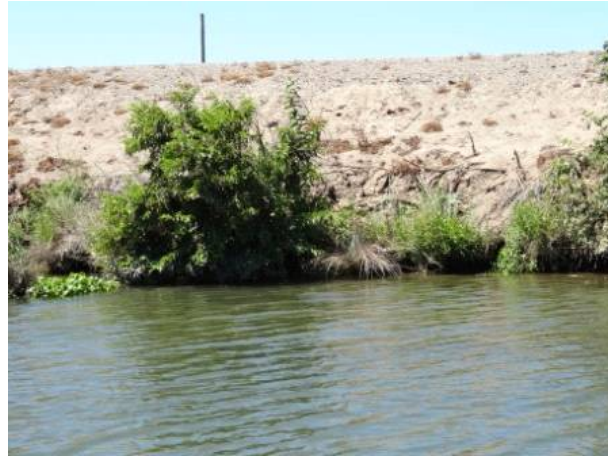
Direct view of the site.

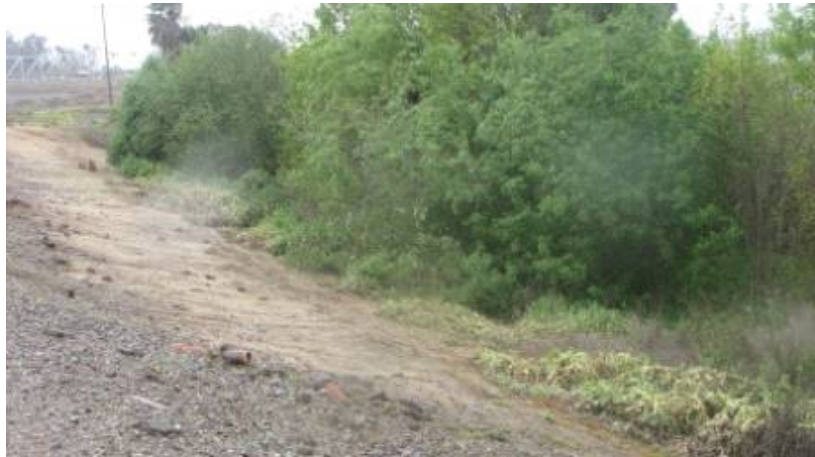
Levee Mile Report Line	28
Start Levee Mile	1.17
End Levee Mile	1.25
Location	Land Side
Category	Earthen Levee
Item	Vegetation

Looking southwest at dense veg. on landside toe.

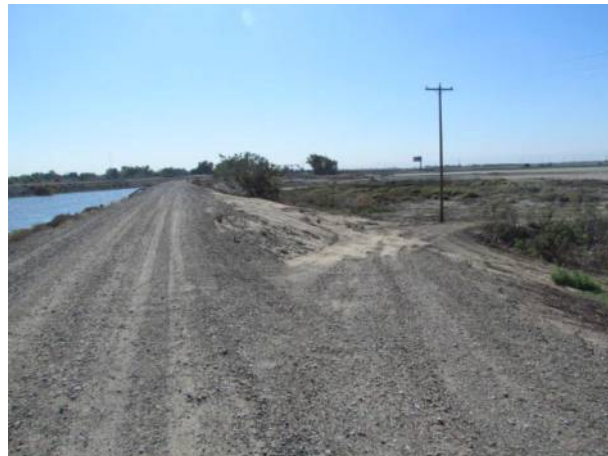
Levee Mile Report Line	29
Start Levee Mile	1.26
End Levee Mile	1.26
Location	Land Side
Category	Earthen Levee
Item	Encroachments

Looking south at unauthorized ramp on landside slope.

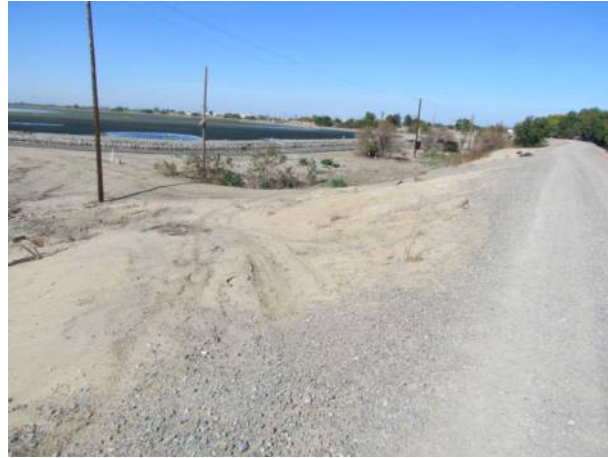
Looking northwest at unauthorized ramp on landside slope.

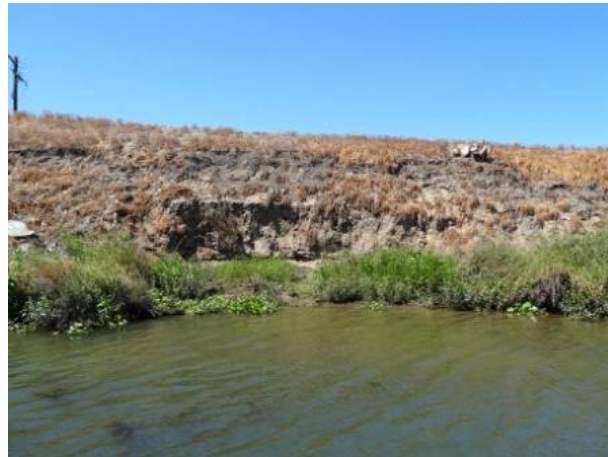
Levee Mile Report Line	30
Start Levee Mile	1.29
End Levee Mile	1.32
Location	Water Side
Category	Supplemental
Item	DWR Erosion Survey

Front view of the erosion.

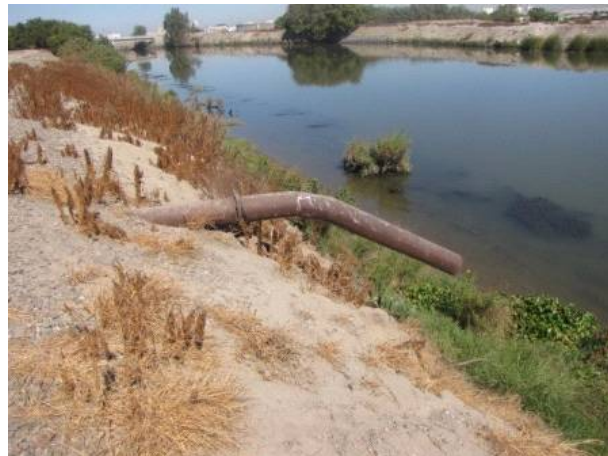
Levee Mile Report Line	31
Start Levee Mile	1.31
End Levee Mile	1.31
Location	Water Side
Category	Earthen Levee
Item	Encroachments

Looking north at broken pipe.

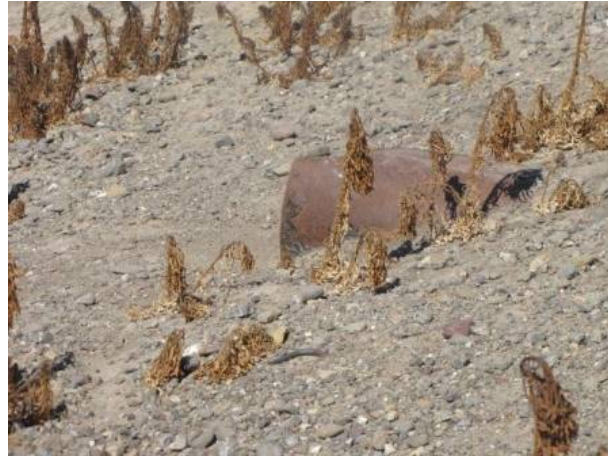
Looking west at pipe on landside slope.

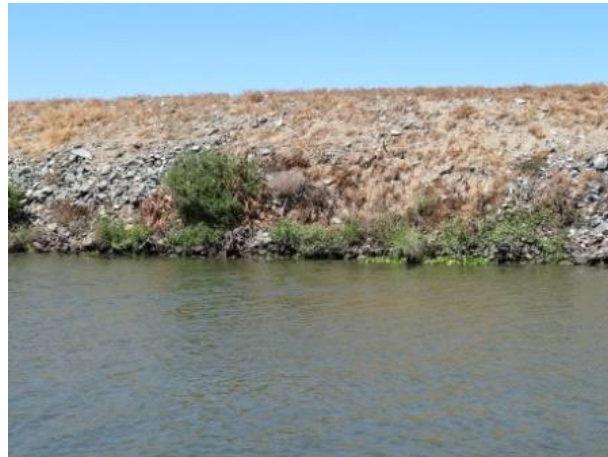
Levee Mile Report Line	33
Start Levee Mile	1.39
End Levee Mile	1.39
Location	Water Side
Category	Supplemental
Item	DWR Erosion Survey

Front view of the erosion.

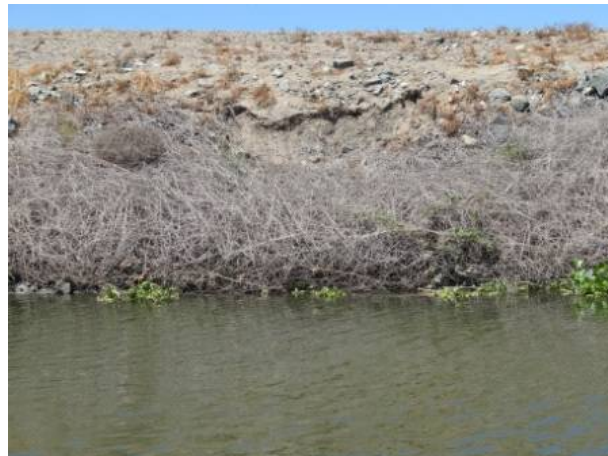
Levee Mile Report Line	34
Start Levee Mile	1.45
End Levee Mile	1.47
Location	Water Side
Category	Supplemental
Item	DWR Erosion Survey

Front view of erosion site.

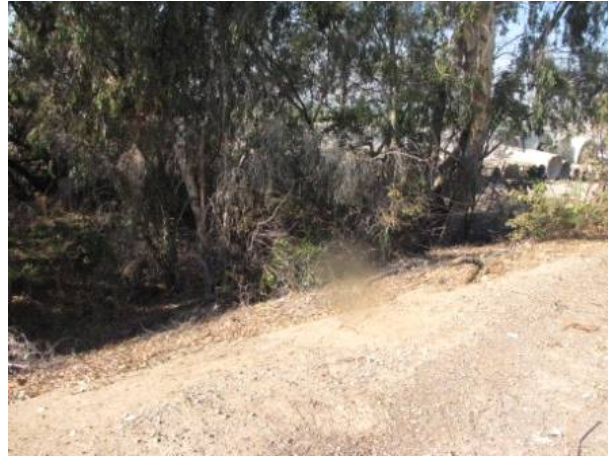
Dense vegetation on landside toe.

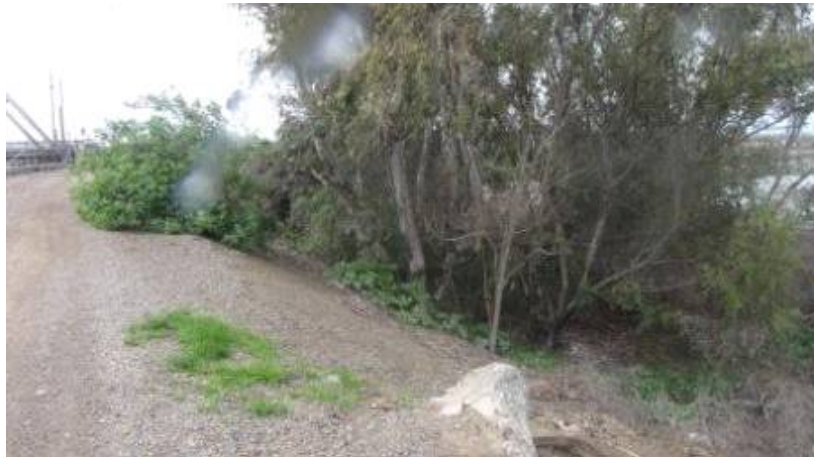
Levee Mile Report Line	35
Start Levee Mile	1.51
End Levee Mile	1.51
Location	Land Side
Category	Earthen Levee
Item	Trim / Thin Trees

Looking south at dense veg. on landside slope and toe.

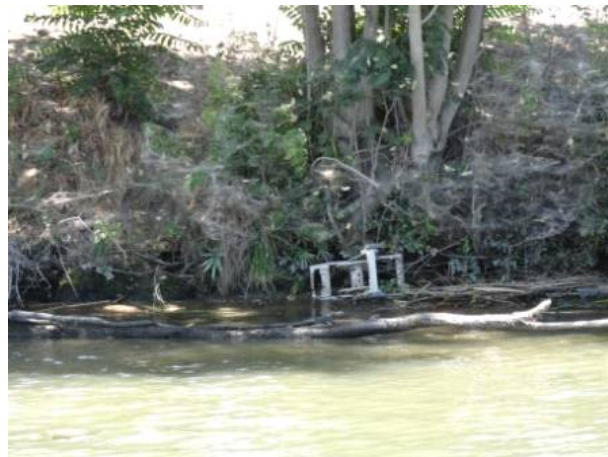
Levee Mile Report Line	37
Start Levee Mile	1.58
End Levee Mile	1.64
Location	Water Side
Category	Supplemental
Item	DWR Erosion Survey
Front view of erosion. Dense vegetation is visible.	
SJR2013_RD0524U01RM42.2_3.jpg

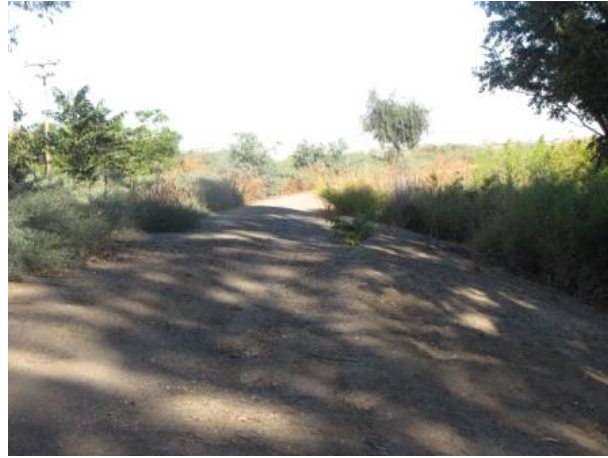
richard_f_20130930_811.jpg

Looking north at dense vegetation on the landside and waterside slopes.

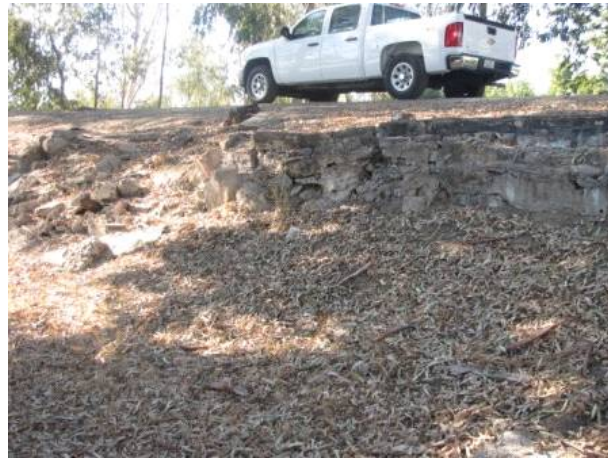
richard_f_20130930_837.jpg

Looking southwest at retaning wall connected to concrete stairs.

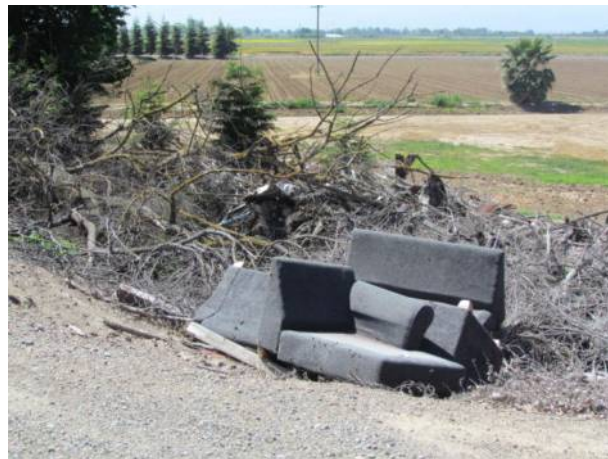
Levee Mile Report Line	46
Start Levee Mile	1.75
End Levee Mile	1.75
Location	Land Side
Category	Earthen Levee
Item	Encroachments

Looking southwest at garbage pile on landside toe. (Spring 2012)

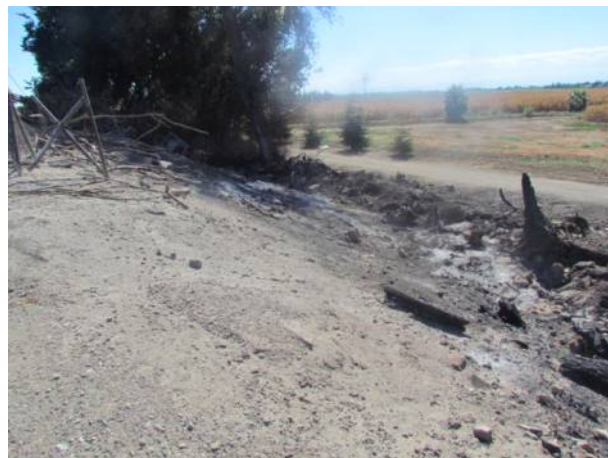
Levee Mile Report Line	46
Start Levee Mile	1.75
End Levee Mile	1.75
Location	Land Side
Category	Earthen Levee
Item	Encroachments

Looking southwest at burned pruning pile on landside slope.

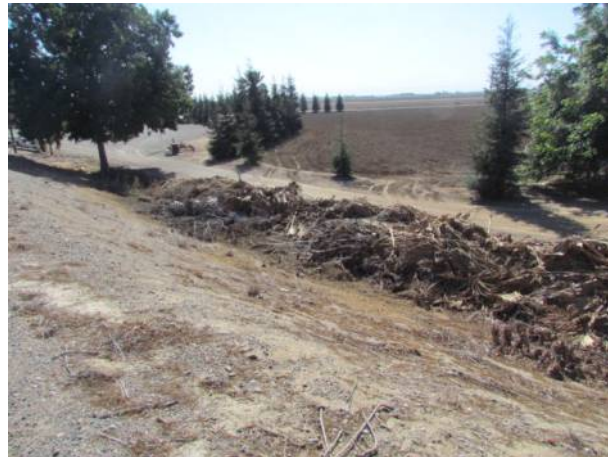
Levee Mile Report Line	48
Start Levee Mile	1.80
End Levee Mile	1.80
Location	Land Side
Category	Earthen Levee
Item	Encroachments

Looking southwest at prunings on landside toe.

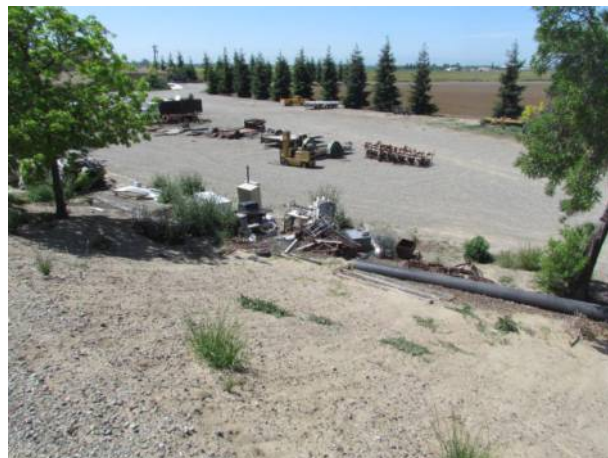
Levee Mile Report Line	49
Start Levee Mile	1.82
End Levee Mile	1.82
Location	Land Side
Category	Earthen Levee
Item	Encroachments

Looking west at garbage and equipment at landside toe.

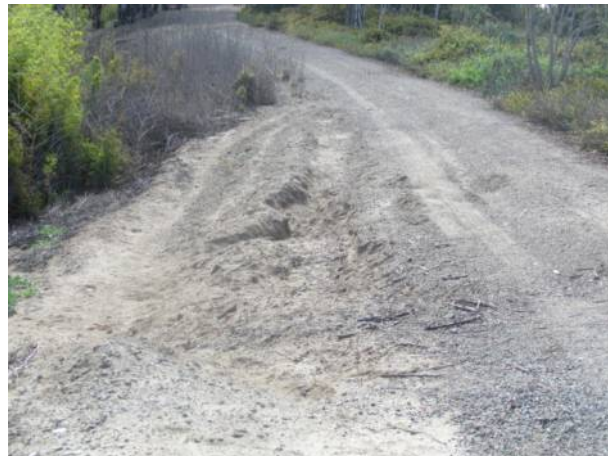
Levee Mile Report Line	58
Start Levee Mile	2.22
End Levee Mile	2.28
Location	Water Side
Category	Earthen Levee
Item	Slope Stability

Looking south slope damage on waterward shoulder and slope.

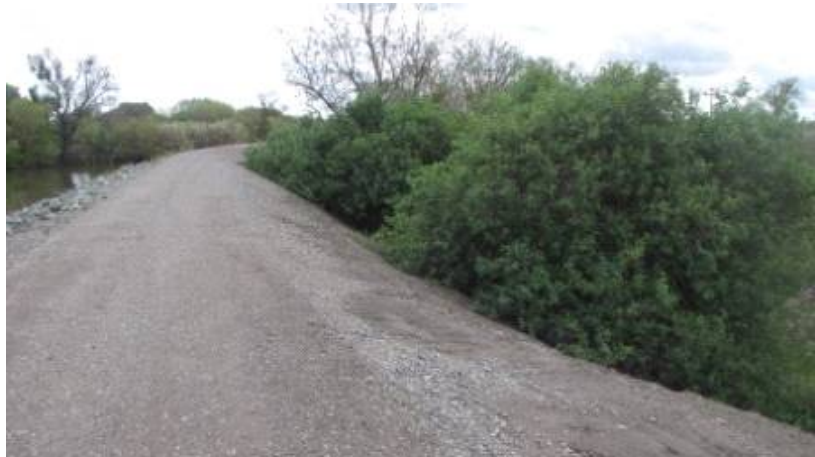
Levee Mile Report Line	60
Start Levee Mile	2.29
End Levee Mile	2.31
Location	Land Side
Category	Earthen Levee
Item	Vegetation

Looking south at dense veg on landside slope and toe.

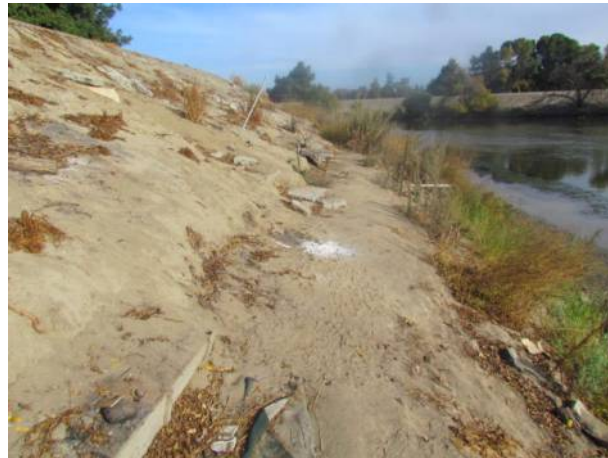
richard_f_20130930_821.JPG

Looking northeast at damage to the slope possibly caused by human activity.

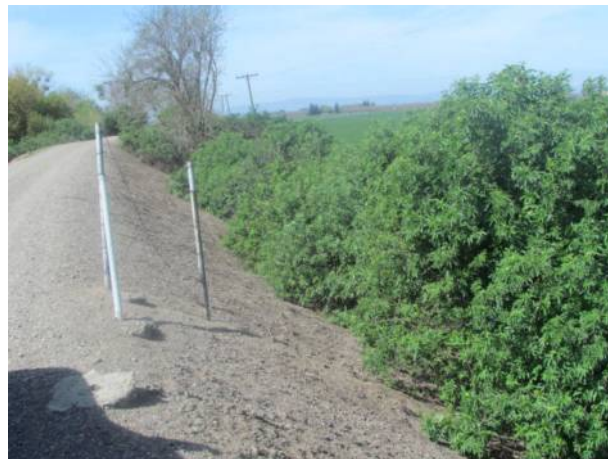
Levee Mile Report Line	64
Start Levee Mile	2.44
End Levee Mile	2.48
Location	Land Side
Category	Earthen Levee
Item	Vegetation

Looking southwest at dense vegetation on landward toe.

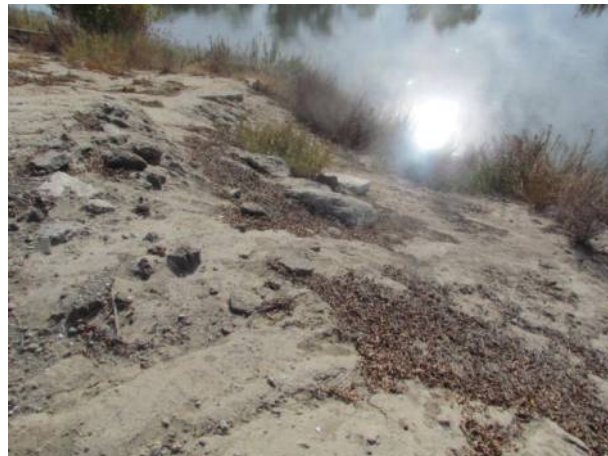
Levee Mile Report Line	65
Start Levee Mile	2.46
End Levee Mile	2.50
Location	Water Side
Category	Earthen Levee
Item	Erosion / Bank Caving

Looking east at erosion on waterside slope.

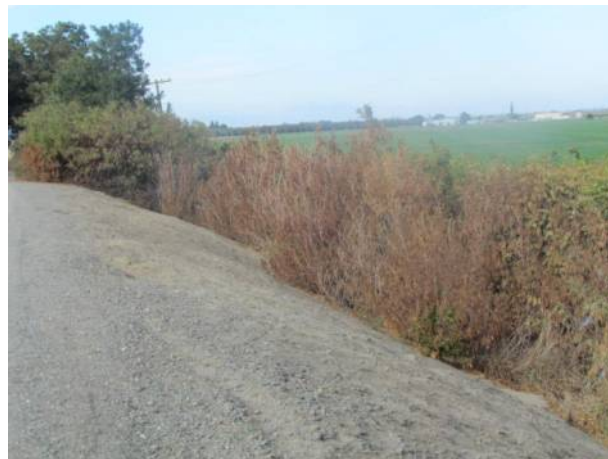
Levee Mile Report Line	66
Start Levee Mile	2.48
End Levee Mile	2.48
Location	Land Side
Category	Earthen Levee
Item	Trim / Thin Trees

Looking southwest at dense vegetation and trees on landside slope. (Fall 2012)

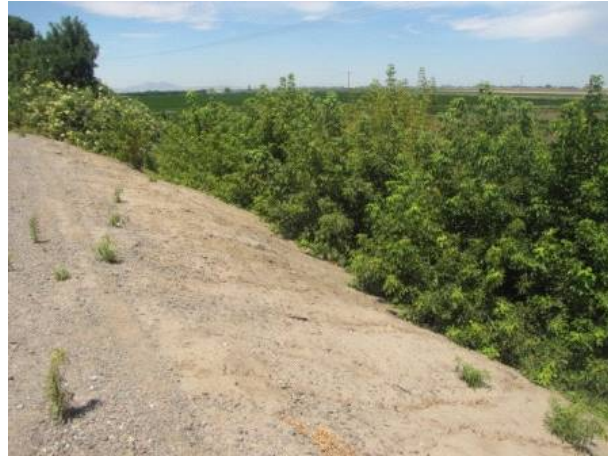
richard_f_20130930_825.jpg

Looking southwest at trees along levee landside toe.

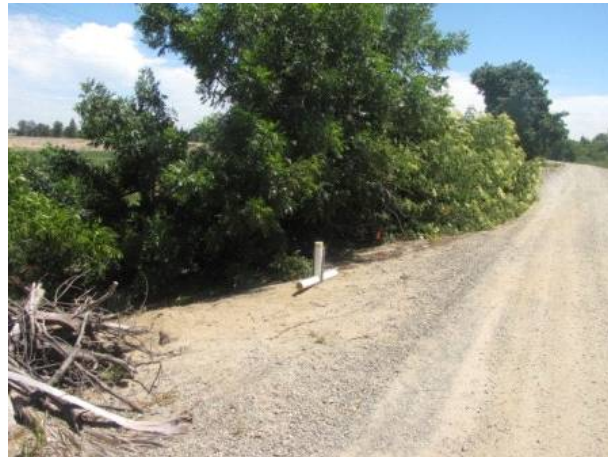
Levee Mile Report Line	67
Start Levee Mile	2.52
End Levee Mile	2.52
Location	Land Side
Category	Earthen Levee
Item	Vegetation

Looking north at elderberry and trees on landside slope.

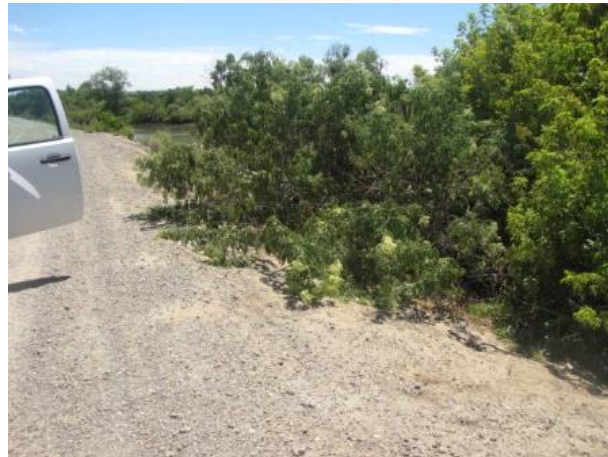
Levee Mile Report Line	68
Start Levee Mile	2.53
End Levee Mile	2.53
Location	Water Side
Category	Earthen Levee
Item	Vegetation

Looking north at elderberry on waterside slope.

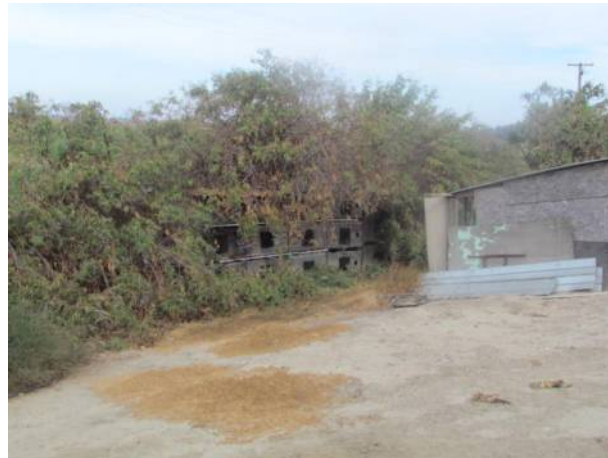
richard_f_20130930_833.JPG

Looking west at animal pens on landside toe.
(Fall 2012)

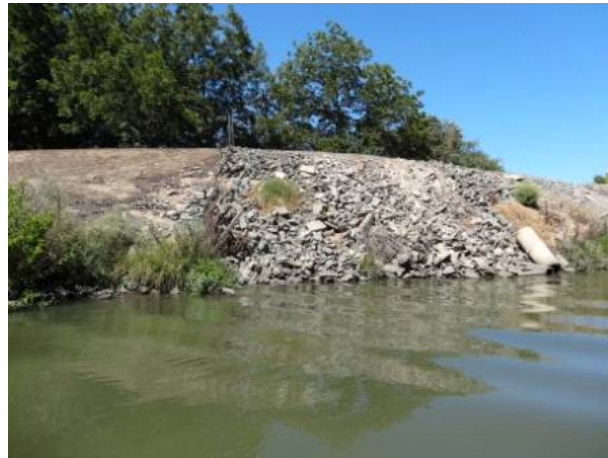
SJR2013_RD0524U01RM43.23_1.jpg

Upstream view of erosion. Levee slope protection present upstream of the site.

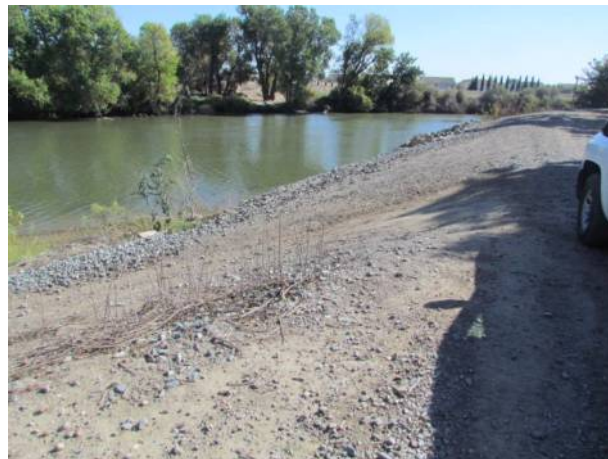
Levee Mile Report Line	80
Start Levee Mile	2.67
End Levee Mile	2.67
Location	Water Side
Category	Earthen Levee
Item	Encroachments

Looking southeast at unauthorized ramp on waterside slope.

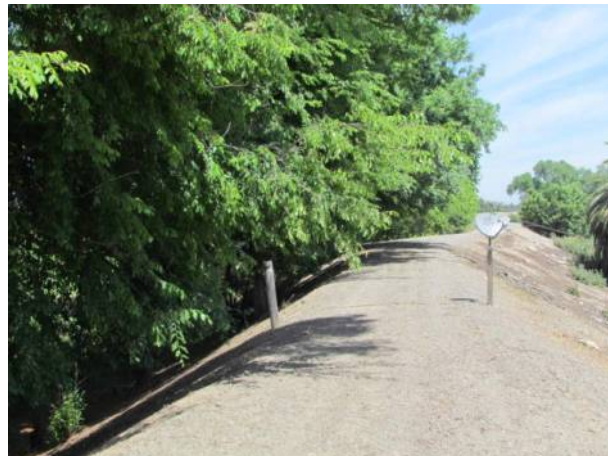
Levee Mile Report Line	82
Start Levee Mile	2.69
End Levee Mile	2.80
Location	Land Side
Category	Earthen Levee
Item	Trim / Thin Trees

Looking north at dense trees overhanging levee crown.

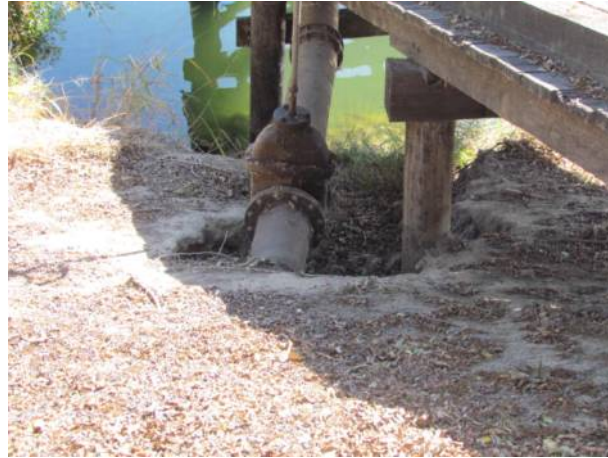
richard_f_20131024_125.JPG

Looking east at erosion around irrigation pipe on waterward slope.

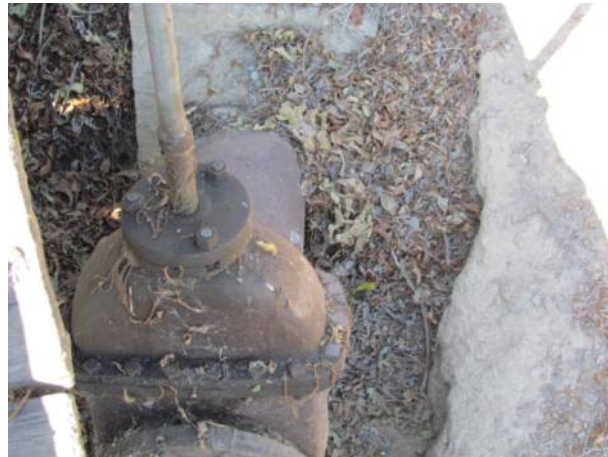
Levee Mile Report Line	83
Start Levee Mile	2.71
End Levee Mile	2.71
Location	Water Side
Category	Earthen Levee
Item	Erosion / Bank Caving

Looking at erosion around irrigation pipe on waterward slope.

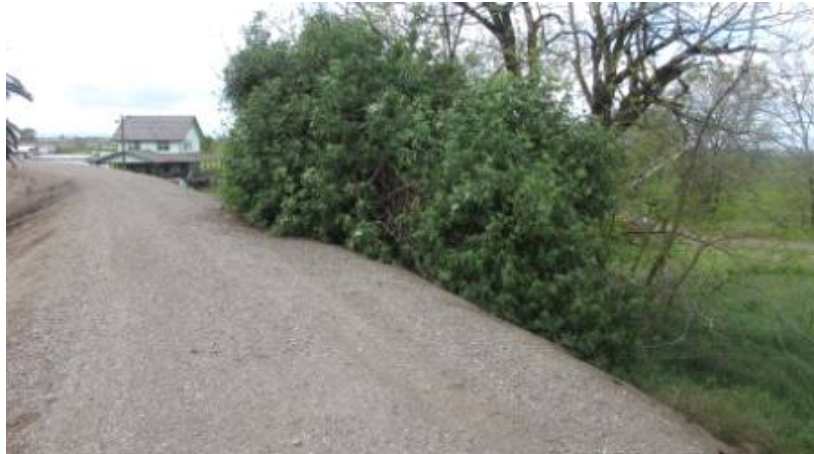
richard_f_20130930_841.jpg

Looking south at elderberry on landside slope.(Spring 2011)

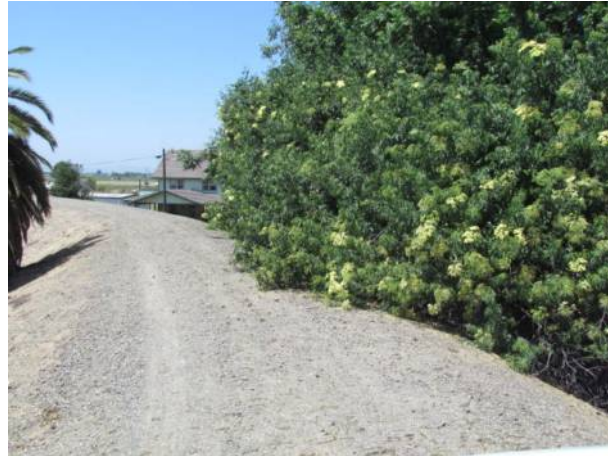
richard_f_20130930_842.jpg

Looking south at dense elderberry on landside slope.(Spring 2012)

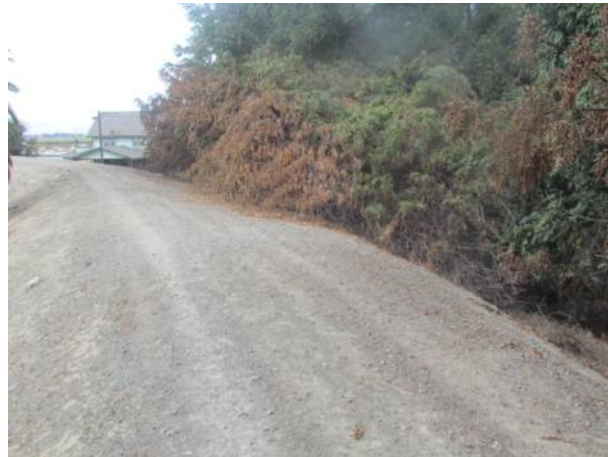
Levee Mile Report Line	89
Start Levee Mile	2.83
End Levee Mile	2.83
Location	Land Side
Category	Earthen Levee
Item	Trim / Thin Trees

Looking southwest at dense vegetation on landside slope.

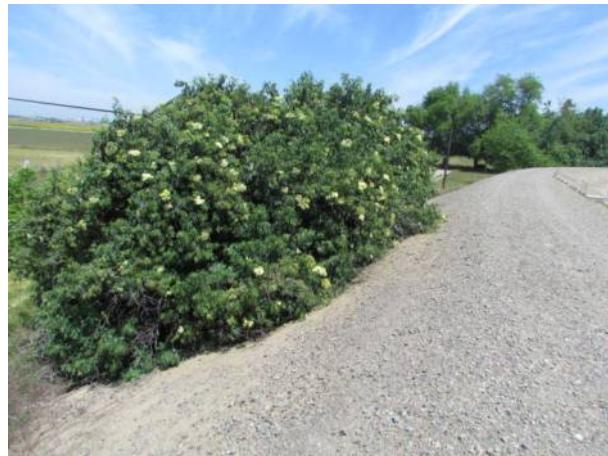
Levee Mile Report Line	90
Start Levee Mile	2.88
End Levee Mile	2.88
Location	Land Side
Category	Earthen Levee
Item	Vegetation

Looking northwest at elderberry on landside slope.

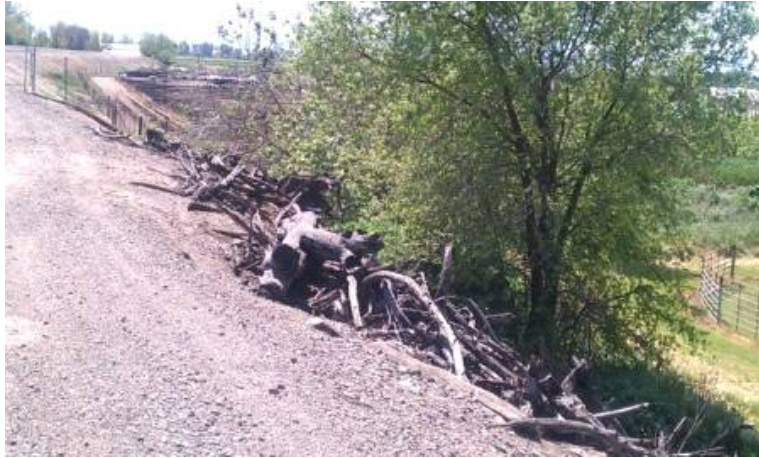
richard_f_20130930_844.jpg

Looking southwest at prunings on landside slope.

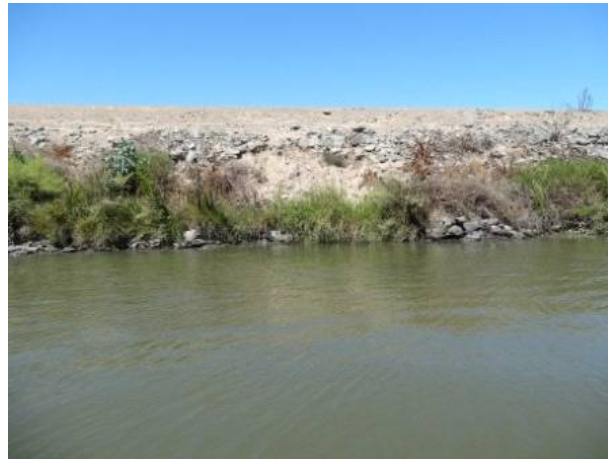
Levee Mile Report Line	93
Start Levee Mile	2.96
End Levee Mile	2.96
Location	Water Side
Category	Supplemental
Item	DWR Erosion Survey

Front view of erosion.

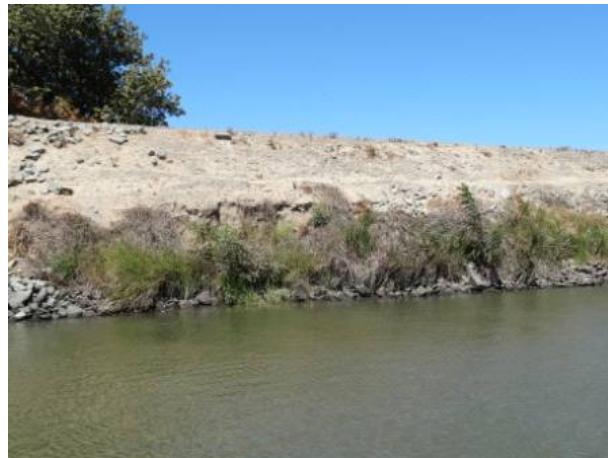
Levee Mile Report Line	97
Start Levee Mile	3.29
End Levee Mile	3.31
Location	Water Side
Category	Supplemental
Item	DWR Erosion Survey

Front view of erosion.

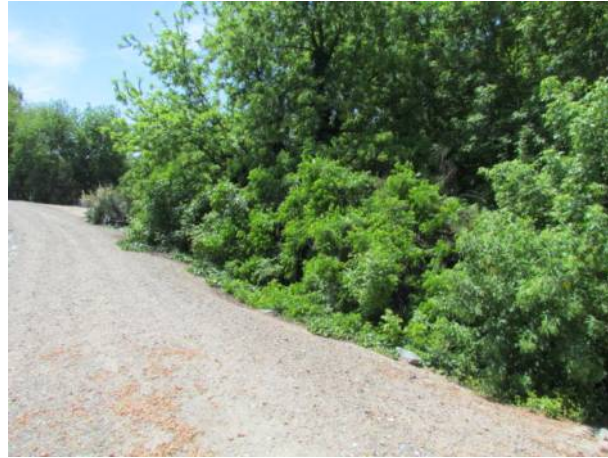
richard_f_20130930_870.jpg

Looking southwest at dense landscaping on landside slope.

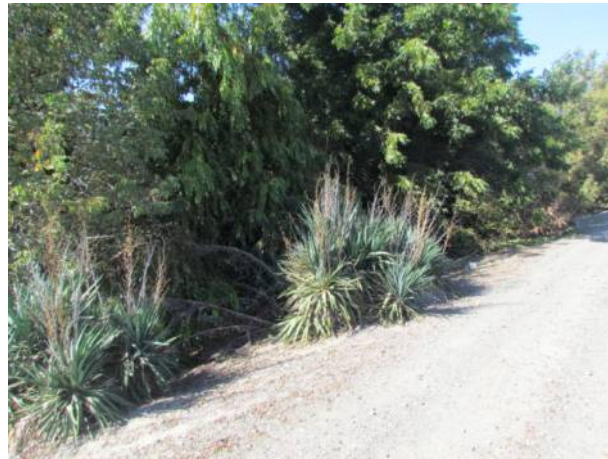
Levee Mile Report Line	102
Start Levee Mile	3.43
End Levee Mile	3.49
Location	Land Side
Category	Earthen Levee
Item	Trim / Thin Trees

Looking northwest at dense vegetation on landside slope.

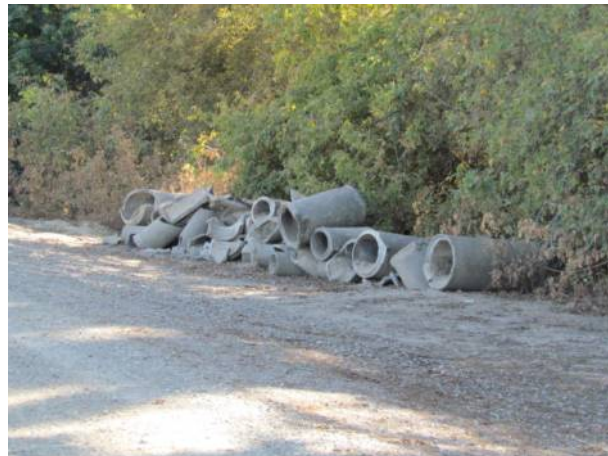
Levee Mile Report Line	103
Start Levee Mile	3.45
End Levee Mile	3.45
Location	Land Side
Category	Earthen Levee
Item	Encroachments

Looking southwest at concrete pipes on landside toe.

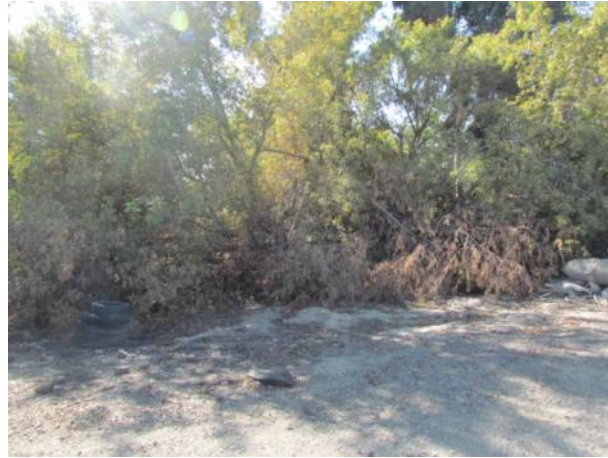
richard_f_20130930_871.jpg

Looking northwest at low hanging tree branches on landside slope and toe.

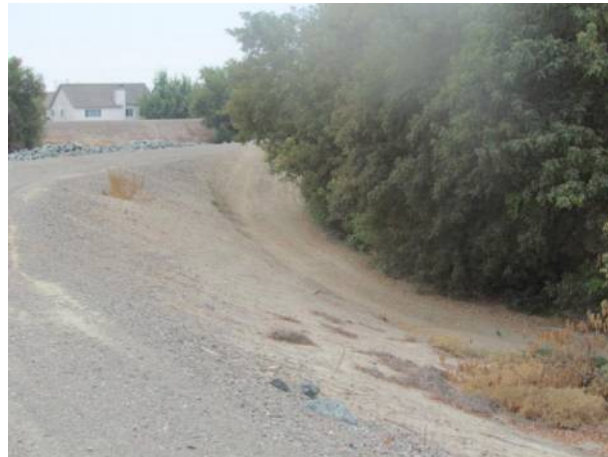
Levee Mile Report Line	105
Start Levee Mile	3.53
End Levee Mile	3.53
Location	Land Side
Category	Earthen Levee
Item	Encroachments

Looking southeast at unauthorized ramp on landside slope and toe.

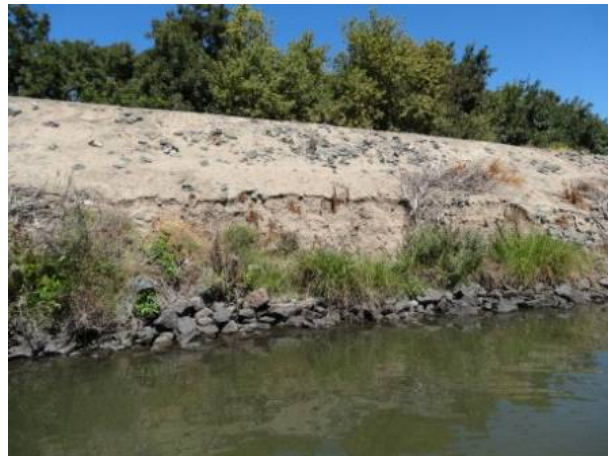
Levee Mile Report Line	107
Start Levee Mile	3.55
End Levee Mile	3.58
Location	Water Side
Category	Supplemental
Item	DWR Erosion Survey

Front view of erosion.
