**Flood Control Project Maintenance
Levee Inspections**

Fall 2013 Levee Maintenance Deficiency Summary Report

San Joaquin River Basin

Reclamation District No. 0524 Middle Roberts Island

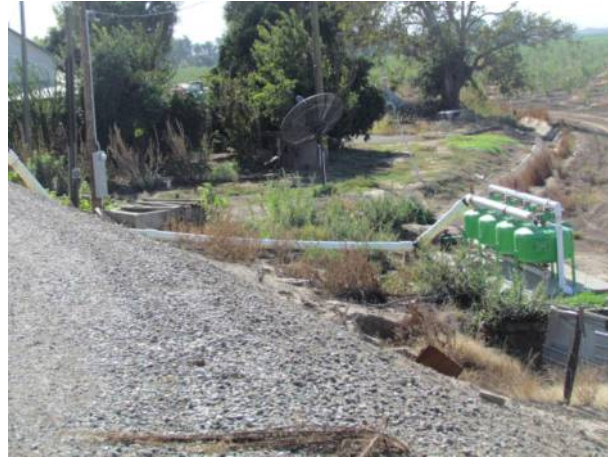
richard_f_20130930_914.jpg

Looking west at water filtration system on landside toe.

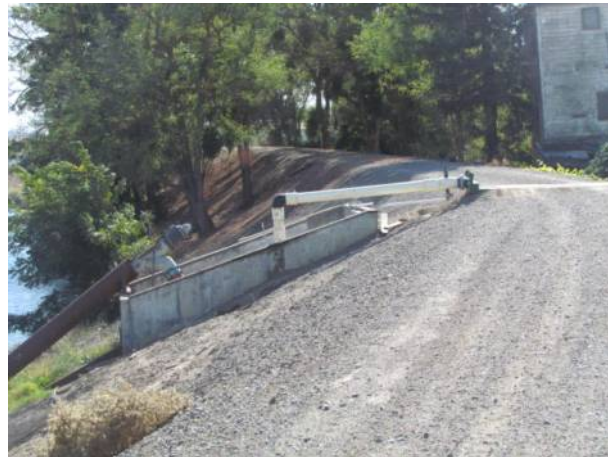
Levee Mile Report Line	112
Start Levee Mile	3.82
End Levee Mile	3.82
Location	Crown
Category	Earthen Levee
Item	Encroachments

Looking south unauthorized pvc irrigation pipe across the levee crown.

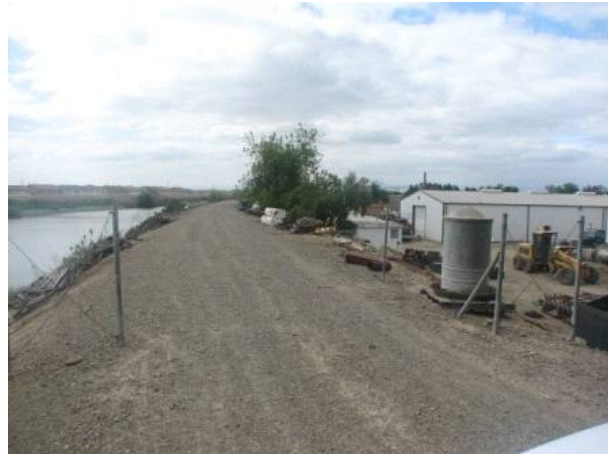
Levee Mile Report Line	114
Start Levee Mile	3.89
End Levee Mile	4.01
Location	Land Side
Category	Earthen Levee
Item	Encroachments

Looking upstream at equipment on landside shoulder

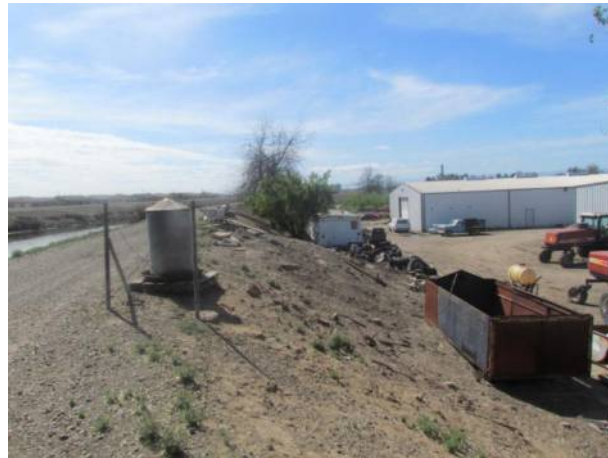
richard_f_20130930_850.JPG

Looking south at northend of equipment stored at landward slope and toe.

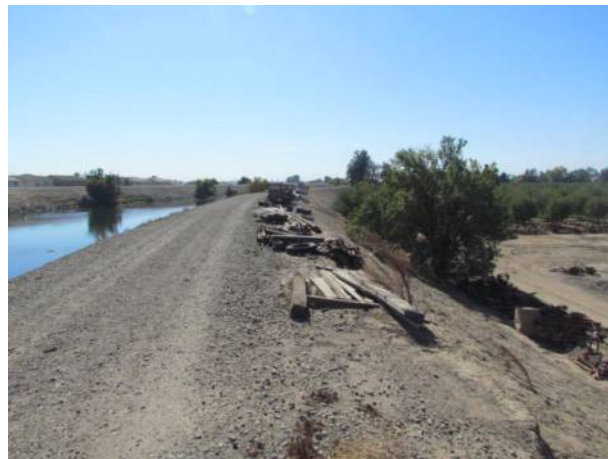
Levee Mile Report Line	115
Start Levee Mile	3.91
End Levee Mile	3.94
Location	Land Side
Category	Earthen Levee
Item	Encroachments

Looking south at farm equipment stored on landward shoulder and toe.

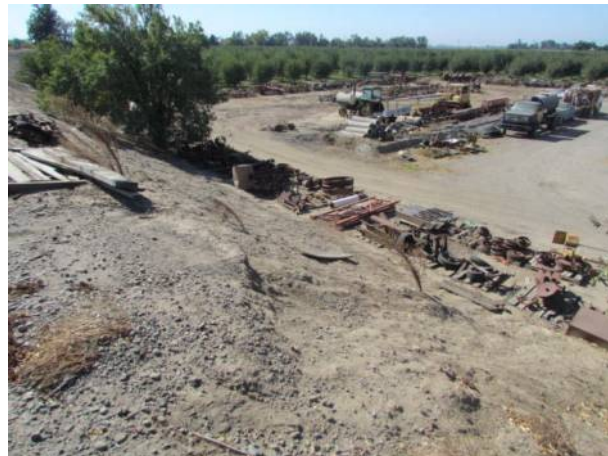
Levee Mile Report Line	115
Start Levee Mile	3.91
End Levee Mile	3.94
Location	Land Side
Category	Earthen Levee
Item	Encroachments

Looking west at farm equipment stored at landward toe.

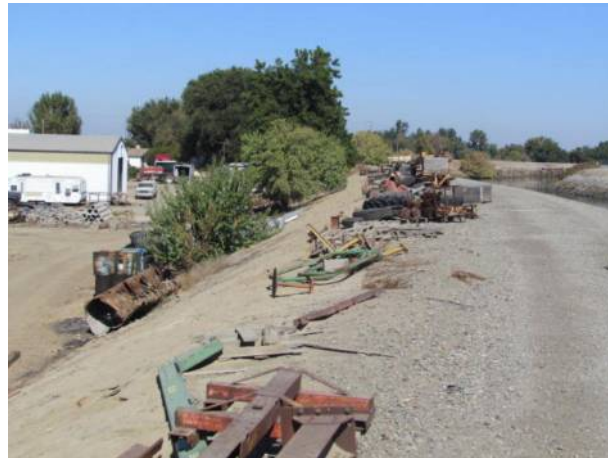
richard_f_20131024_129.JPG

Looking north at farm equipment stored on landward shoulder.

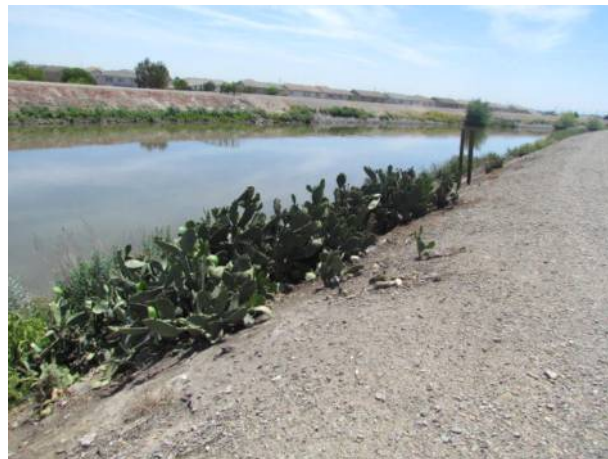
Levee Mile Report Line	116
Start Levee Mile	3.92
End Levee Mile	3.92
Location	Water Side
Category	Earthen Levee
Item	Vegetation

Looking southeast at cactus on waterside slope.

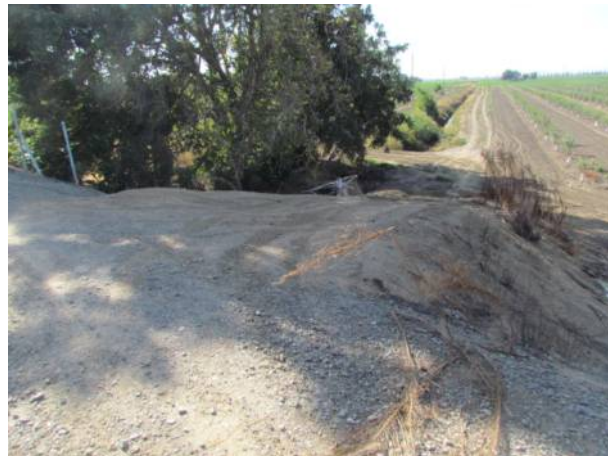
Levee Mile Report Line	118
Start Levee Mile	4.06
End Levee Mile	4.06
Location	Land Side
Category	Earthen Levee
Item	Encroachments

Looking west at unauthorized ramp on landside slope.

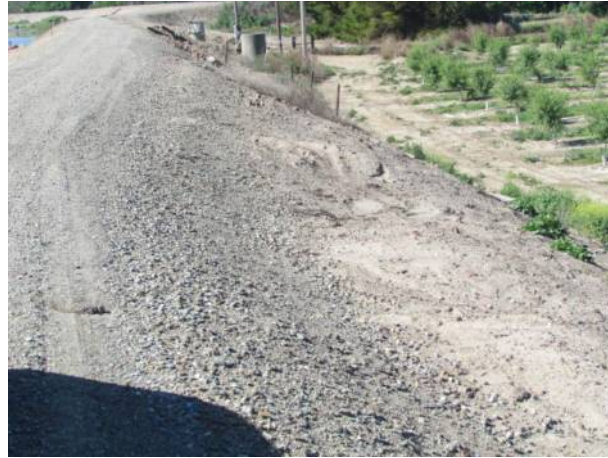
richard_f_20130930_880.jpg

Looking southwest at caving slope on landside of levee.

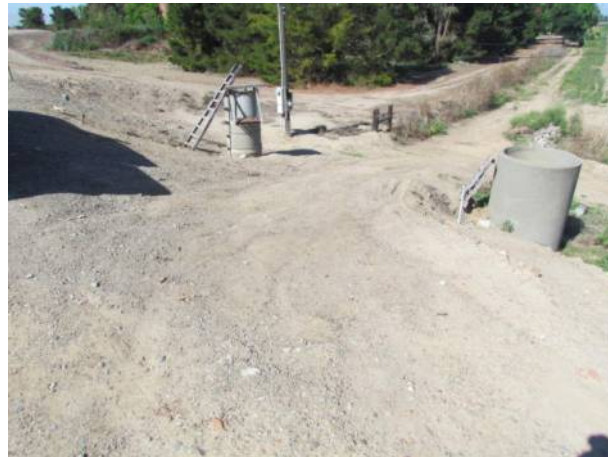
Levee Mile Report Line	123
Start Levee Mile	4.19
End Levee Mile	4.19
Location	Land Side
Category	Earthen Levee
Item	Encroachments

Looking southwest at an unauthorized ramp on landside slope.

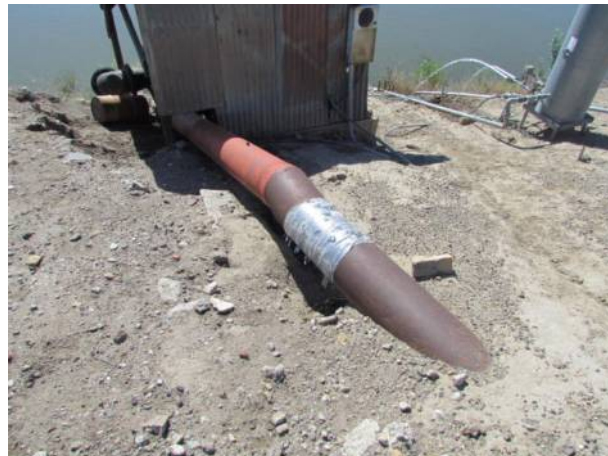
Levee Mile Report Line	124
Start Levee Mile	4.19
End Levee Mile	4.19
Location	Water Side
Category	Interior Drainage & Piping Systems
Item	Metal Pipes

Looking east at damaged pipe on waterside slope. (Spring 2012)

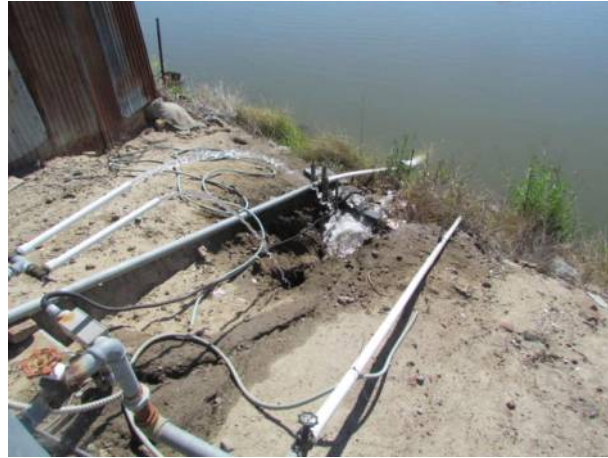
richard_f_20130930_882.jpg

Looking east at irrigation system damaging waterside toe.

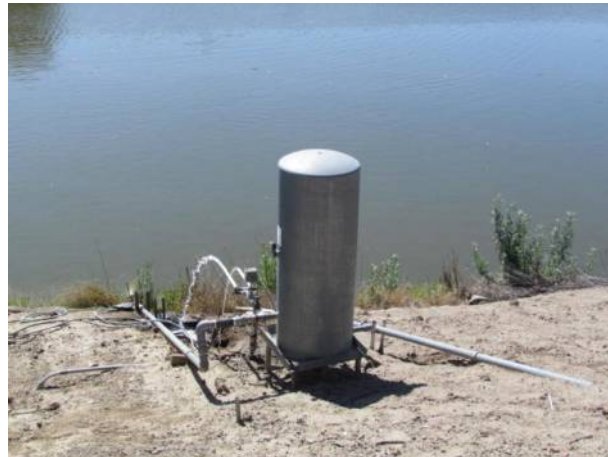
Levee Mile Report Line	124
Start Levee Mile	4.19
End Levee Mile	4.19
Location	Water Side
Category	Interior Drainage & Piping Systems
Item	Metal Pipes

Looking east at irrigation system on waterside slope.

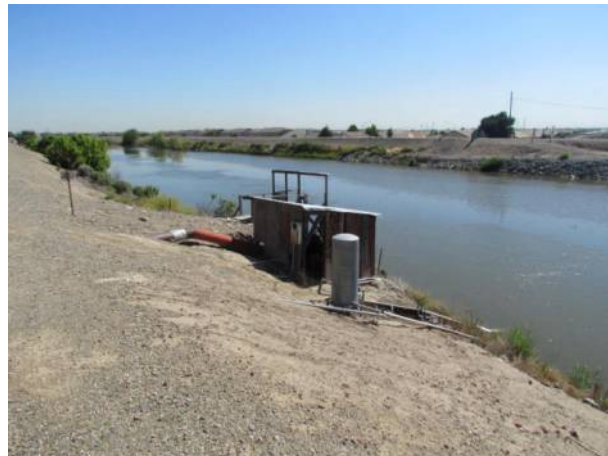
Levee Mile Report Line	124
Start Levee Mile	4.19
End Levee Mile	4.19
Location	Water Side
Category	Interior Drainage & Piping Systems
Item	Metal Pipes

Looking northeast at overview of irrigation system on waterside slope.

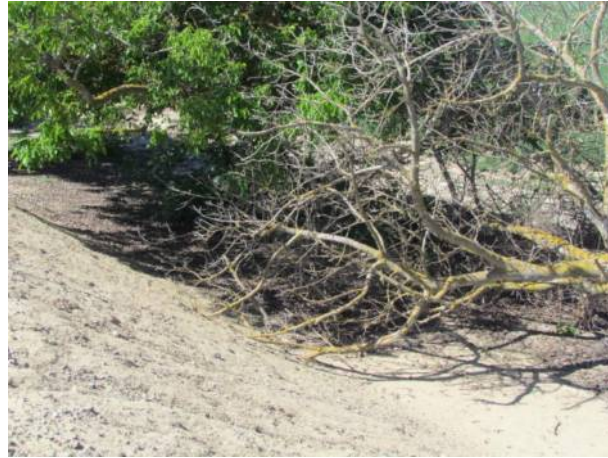
richard_f_20130930_886.jpg

Looking west at dead tree at landside toe.

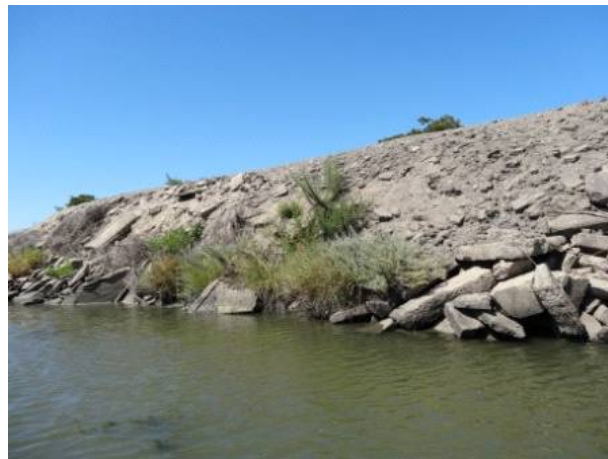
Levee Mile Report Line	128
Start Levee Mile	4.53
End Levee Mile	4.54
Location	Water Side
Category	Supplemental
Item	DWR Erosion Survey

Upstream view of erosion site.

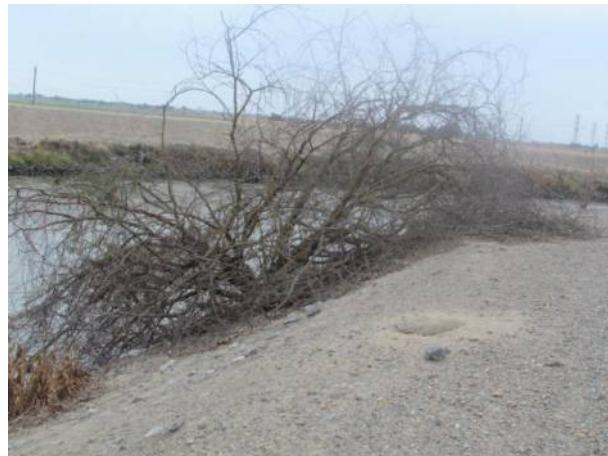
Levee Mile Report Line	129
Start Levee Mile	4.57
End Levee Mile	4.57
Location	Water Side
Category	Earthen Levee
Item	Encroachments

Looking southeast at dead tree on waterside slope.

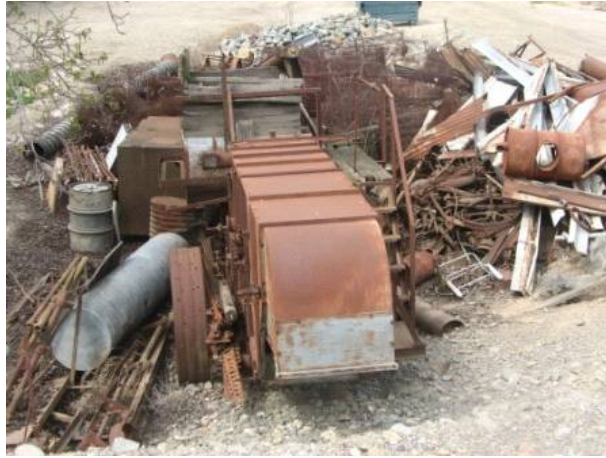
richard_f_20130930_852.jpg

Garbage at landward toe next to ramp at LM 4.64

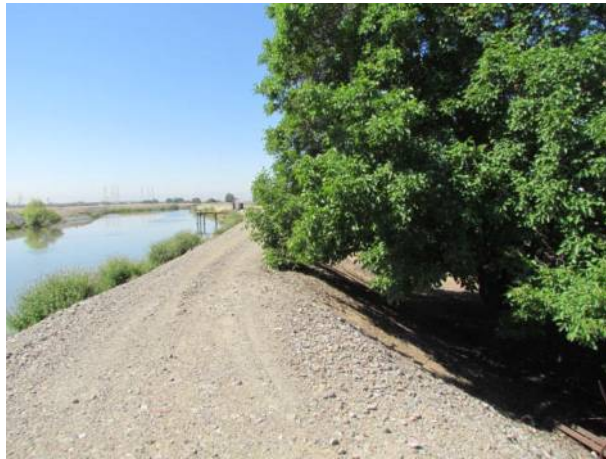
Levee Mile Report Line	131
Start Levee Mile	4.65
End Levee Mile	4.65
Location	Land Side
Category	Earthen Levee
Item	Trim / Thin Trees

Looking south at dense trees on landside slope.

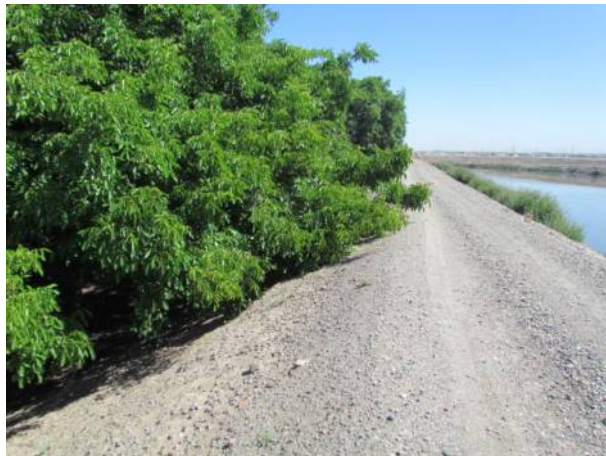
Levee Mile Report Line	132
Start Levee Mile	4.67
End Levee Mile	4.67
Location	Land Side
Category	Earthen Levee
Item	Trim / Thin Trees

Looking north at dense trees on landside slope.

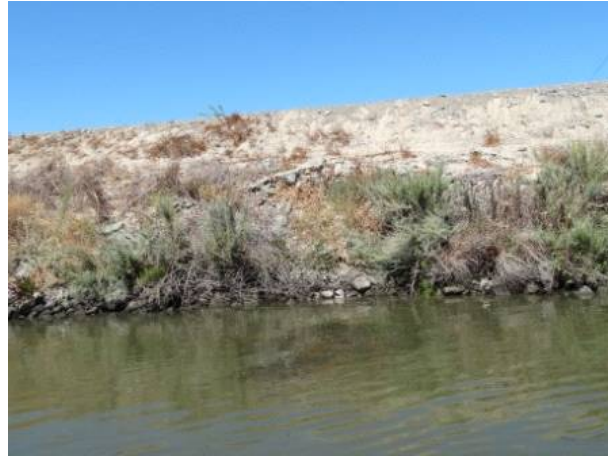
SJR2013_RD0524U01RM45.27_2.jpg

Front view of the erosion.

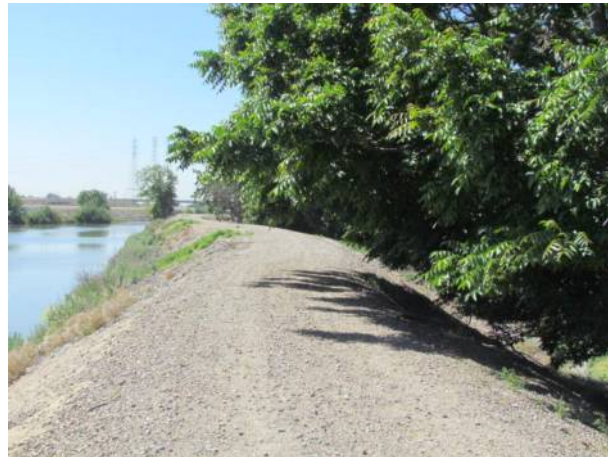
Levee Mile Report Line	137
Start Levee Mile	5.11
End Levee Mile	5.11
Location	Land Side
Category	Earthen Levee
Item	Trim / Thin Trees

Looking south at overhanging trees.

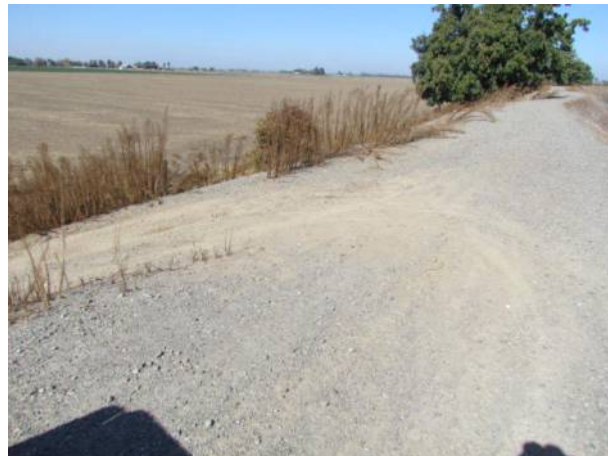
Levee Mile Report Line	140
Start Levee Mile	5.24
End Levee Mile	5.24
Location	Land Side
Category	Earthen Levee
Item	Slope Stability

Looking northwest at slope damage on landward slope.

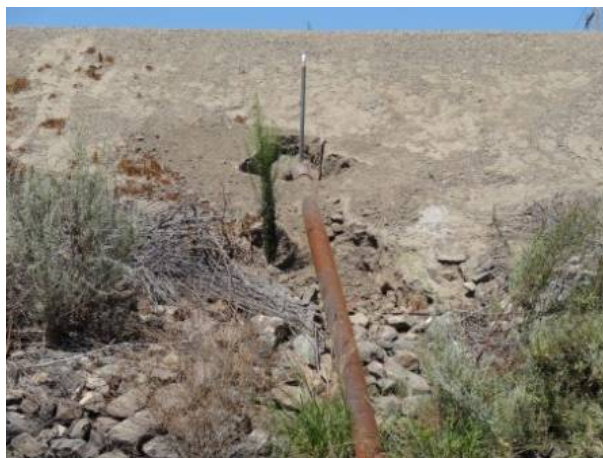
SJR2013_RD0524U01RM45.97_2.jpg

Front view of the site.

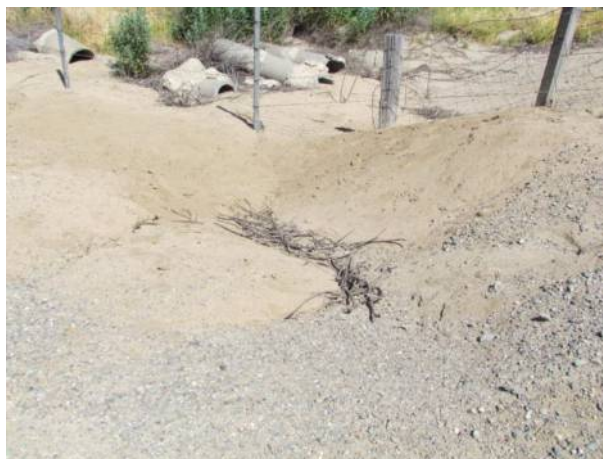
richard_f_20130930_888.jpg

Levee Mile Report Line	146
Start Levee Mile	5.47
End Levee Mile	5.47
Location	Land Side
Category	Earthen Levee
Item	Slope Stability

Looking west at slope damage on landside slope.

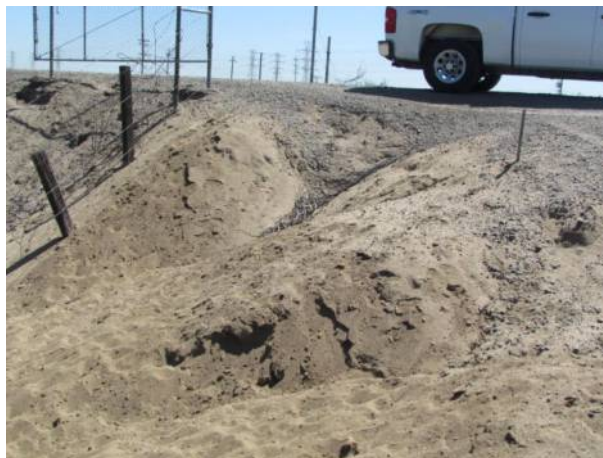
richard_f_20130930_889.jpg

Levee Mile Report Line	146
Start Levee Mile	5.47
End Levee Mile	5.47
Location	Land Side
Category	Earthen Levee
Item	Slope Stability

Looking east at slope caving on landside slope.

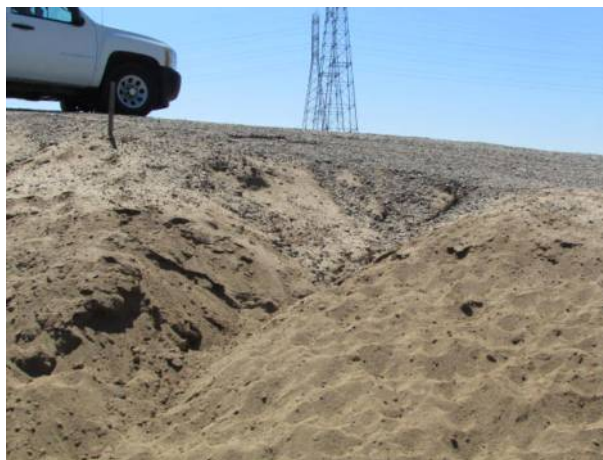
richard_f_20130930_890.jpg

Looking southeast at damaged slope.

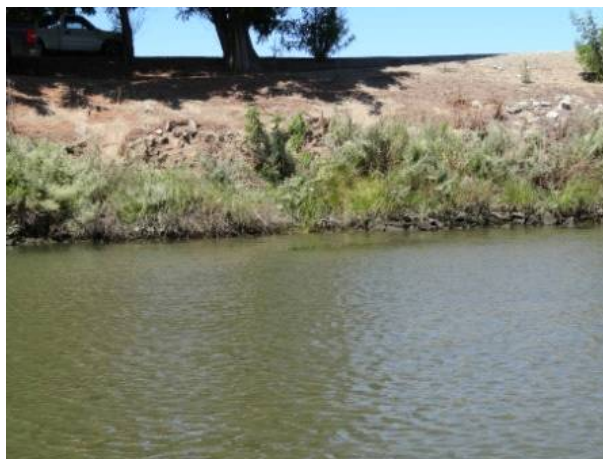
SJR2013_RD0524U01RM46.06_1.jpg

Levee Mile Report Line	149
Start Levee Mile	5.61
End Levee Mile	5.61
Location	Water Side
Category	Supplemental
Item	DWR Erosion Survey

Front view of the erosion.

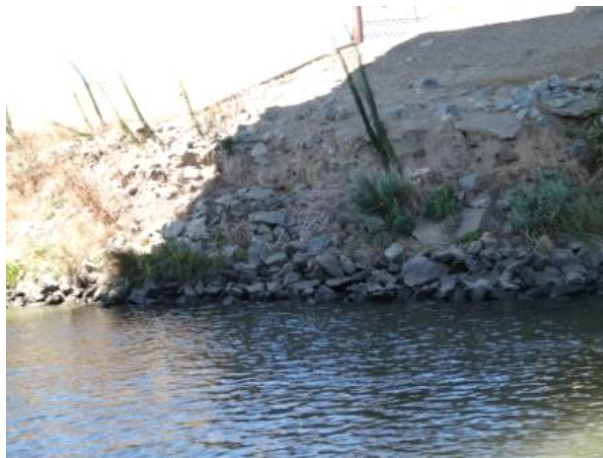
SJR2013_RD0524U01RM46.12_2.jpg

Levee Mile Report Line	150
Start Levee Mile	5.65
End Levee Mile	5.66
Location	Water Side
Category	Supplemental
Item	DWR Erosion Survey

Sloughing rip rap adjacent to Howard Bridge.

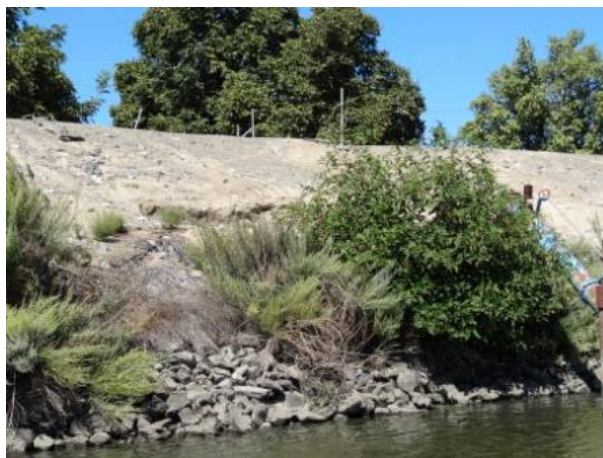
SJR2013_RD0524U01RM46.39_3.jpg

Closer view of the erosion.

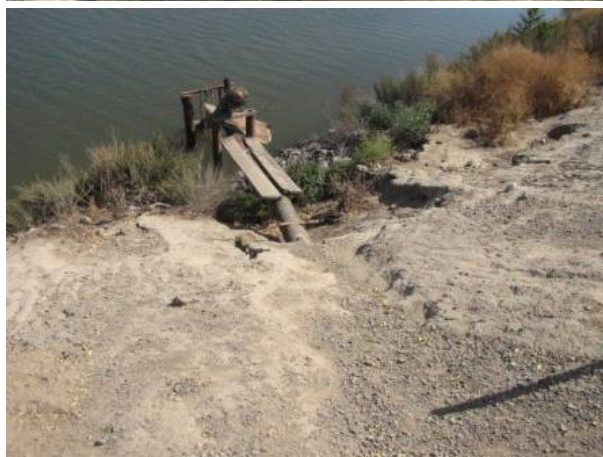
richard_f_20130930_855.jpg

Levee Mile Report Line	156
Start Levee Mile	5.92
End Levee Mile	5.92
Location	Water Side
Category	Earthen Levee
Item	Erosion / Bank Caving

Looking southeast at erosion around pipe.

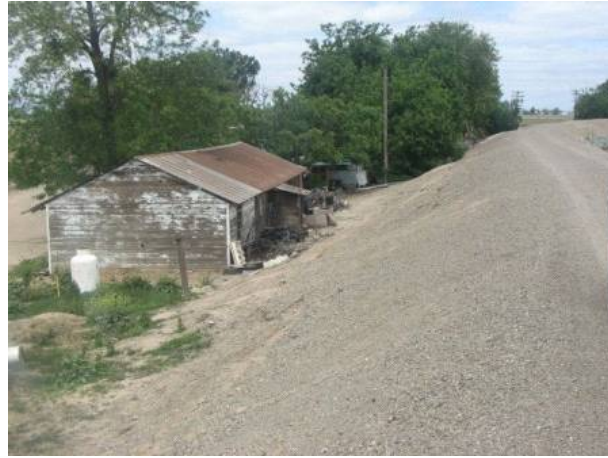
richard_f_20130930_864.jpg

Looking downstream at building on landside toe.

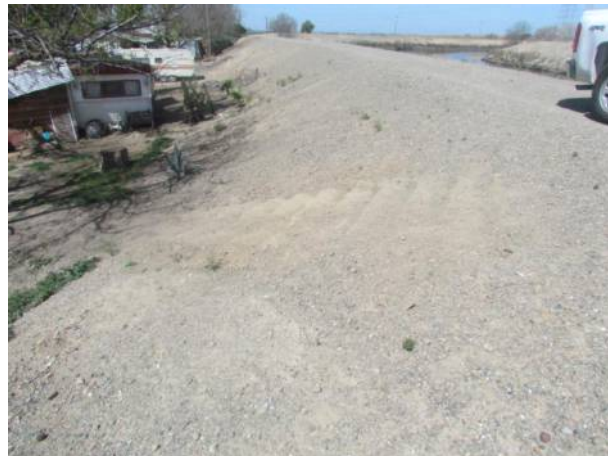
richard_f_20130930_923.JPG

Levee Mile Report Line	164
Start Levee Mile	6.05
End Levee Mile	6.05
Location	Land Side
Category	Earthen Levee
Item	Slope Stability

Looking north at steps cut into landward slope.

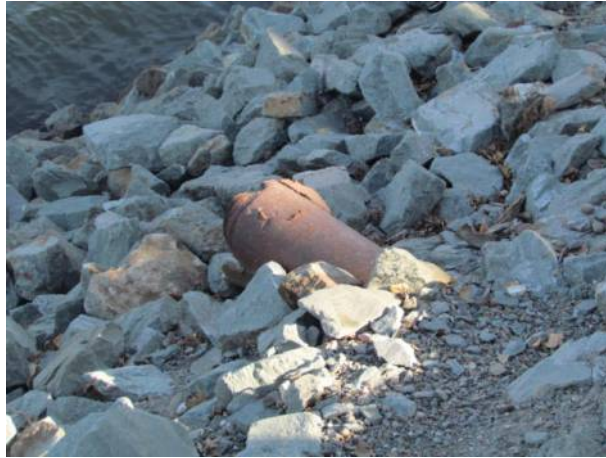
richard_f_20130930_916.jpg

Looking southeast at abandoned pipe on waterside slope.
