**Flood Control Project Maintenance  
Levee Inspections**

**Fall 2014 Levee Maintenance Deficiency Summary Report**

**Reclamation District No. 0524 Middle Roberts Island**

Waterway			Bank	Unit Miles
Unit No. 01 San Joaquin River			Left	6.20
	Spring (March - May)	Summer (June - August)	(September - November) Fall	Winter (December - February)
Unit Maintenance Rating (Fall Only)			<b>U</b>	
Date of Inspection	04/08/2014 - 04/08/2014		10/20/2014 - 10/20/2014	
DWR Inspector	Richard Willoughby		Richard Willoughby	
Accompanied By	Mario Jaques RD 524		Mario Jaques RD 524

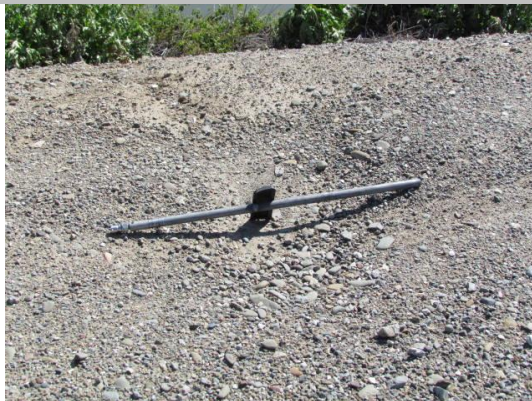
Photo 3 of 3 : FA\_2014\_RD0524\_107\_3\_20141020\_00009.jpg

Looking east at 3" depression on levee crown. (Spring 2012)

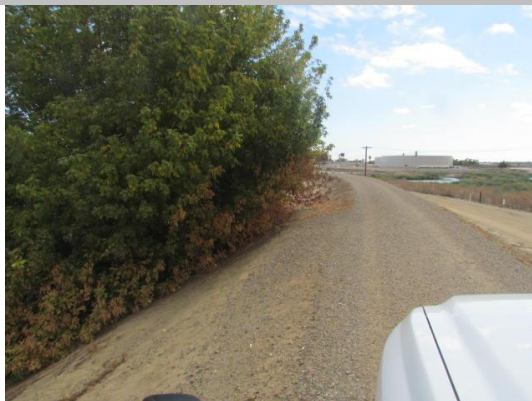
Photo 1 of 1 : FA\_2014\_RD0524\_107\_179\_20141023\_00189.jpg

Looking south at untrimmed tree on waterward slope.

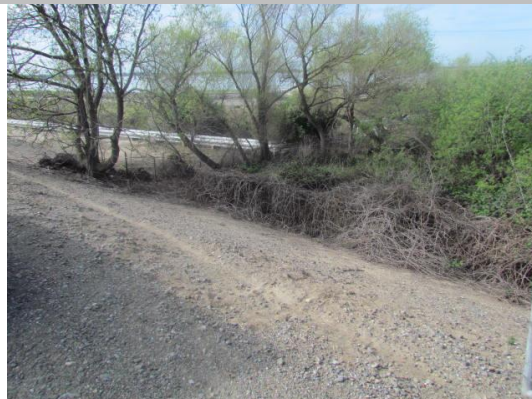
Photo 1 of 2 : FA\_2014\_RD0524\_107\_262\_20141020\_00142.jpg

LM Start	0.78	Rating **	M	Issue No.	262
LM End	0.78	Issue Type +	Ma	Location *	LS
Category	Earthen Levee			GPS Latitude/Longitude	
				Start	End
Item	Vegetation			37.936555 °	37.936555 °
				-121.334847 °	-121.334847 °
DWR ID	DWR_RD0524_01_s_2012_262				
Action/Comments					
Remove the wild growth other than native grasses from the levee slopes.					
Inspector Comments: Dense vegetation at landside toe along fence line.

Looking southwest at vegetation on landward slope and toe. (Spring 2013)

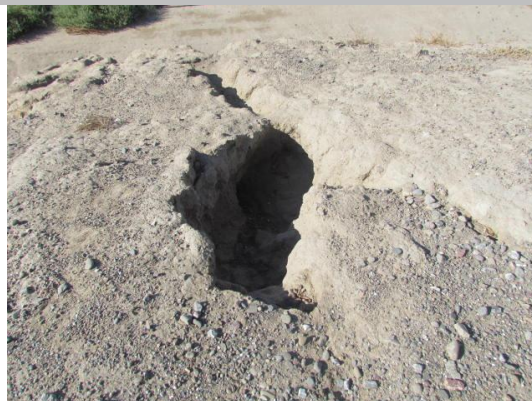
Photo 2 of 5 : FA\_2014\_RD0524\_107\_2\_20141020\_00003.jpg

LM Start	0.82	Rating **	U	Issue No.	2
LM End	0.82	Issue Type +	Ma	Location *	LS
Category	Earthen Levee			GPS Latitude/Longitude	
				Start	End
Item	Erosion / Bank Caving			37.936093 °	37.936004 °
				-121.334648 °	-121.334615 °
DWR ID	DWR_RD0524_01_f_2013_2				
Action/Comments					
Schedule repair of erosion site prior to the next inspection. Inspector Comments: Several holes and finger erosions on landward slope.

Looking west at hole on landward shoulder.

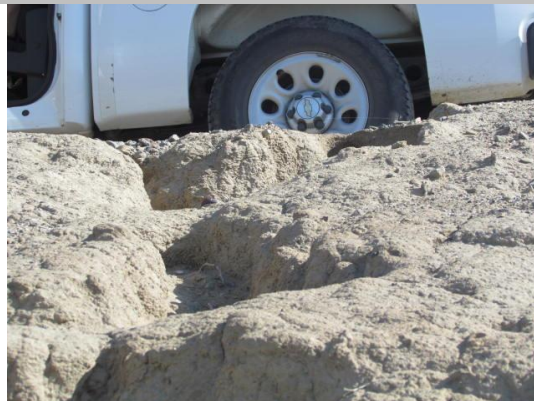
Photo 4 of 5 : FA\_2014\_RD0524\_107\_2\_20141020\_00005.jpg

Looking east at erosion on landward slope.

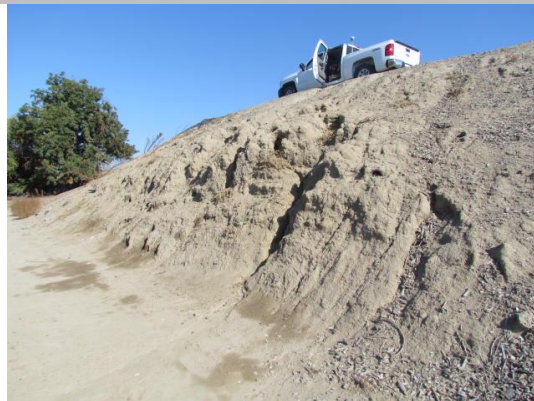
Photo 5 of 5 : FA\_2014\_RD0524\_107\_2\_20141020\_00006.jpg

Looking northeast at several finger erosion on landward slope.

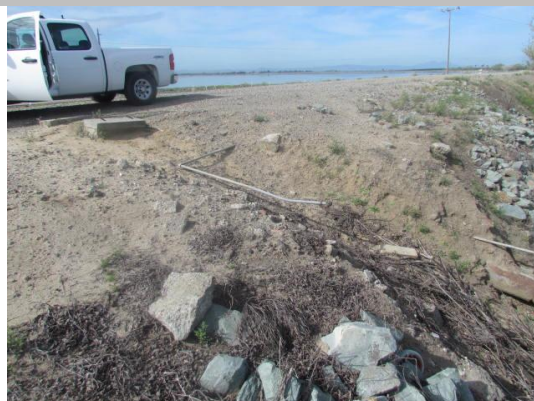
Photo 1 of 1 : FA\_2014\_RD0524\_107\_122\_20141020\_00113.jpg

LM Start	0.92	Rating **	M	Issue No.	122
LM End	0.92	Issue Type +	Ma	Location *	WS
Category	Earthen Levee			GPS Latitude/Longitude	
				Start	End
Item	Encroachments			37.935267 °	37.935267 °
				-121.332985 °	-121.332985 °
DWR ID	DWR_RD0524_01_s_2013_122				
Action/Comments					
Pipe					
Inspector Comments: Inch and half metal pipe should be removed.

Looking northwest at inch and half metal pipe on waterward slope.

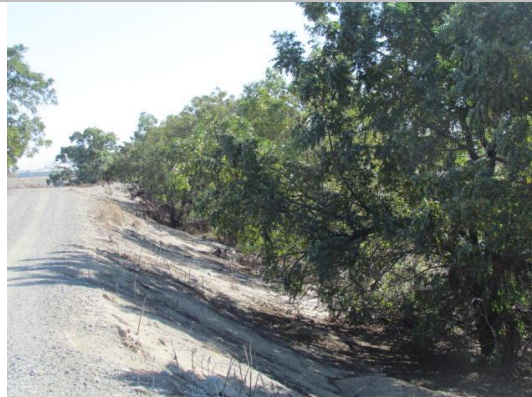
Photo 1 of 1 : FA\_2014\_RD0524\_107\_77\_20141020\_00079.jpg

Looking south at low hanging tree branches at landside toe.

LM Start	0.94	Rating **	M	Issue No.	77
LM End	1.02	Issue Type +	Ma	Location *	LS
Category	Earthen Levee			GPS Latitude/Longitude	
				Start	End
Item	Trim / Thin Trees			37.935259 °	37.935049 °
				-121.332864 °	-121.331334 °
DWR ID	DWR_RD0524_01_s_2012_77				
Action/Comments					
Trim trees to at least five feet above ground level.

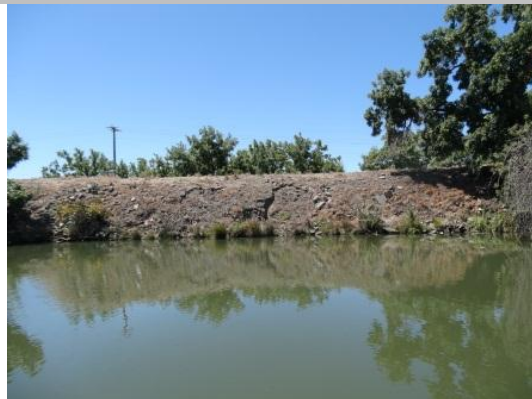
Photo 1 of 1 : SJR2014\_RD0524U01RM41.58\_1.jpg

Close view of the erosion.

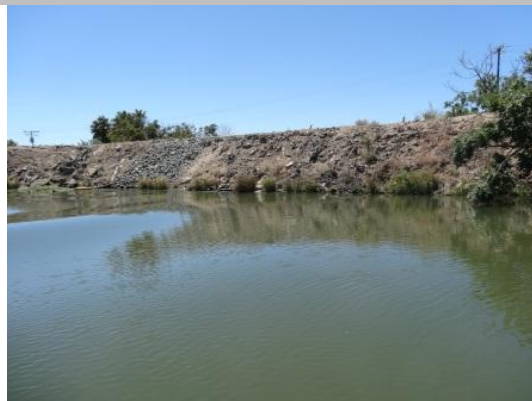
Photo 1 of 1 : SJR2014\_RD0524U01RM41.59\_1.jpg

Front view of the site.

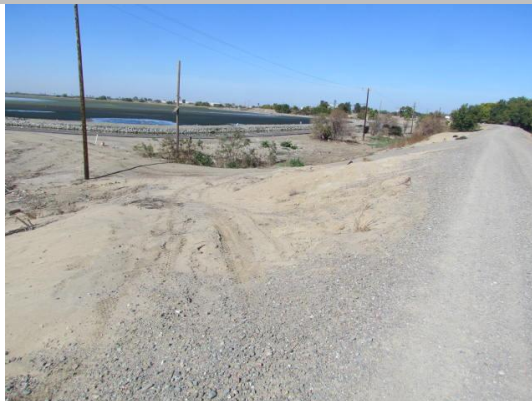
Photo 1 of 2 : FA\_2014\_RD0524\_107\_263\_20141020\_00144.jpg

Looking northwest at unauthorized ramp on landside slope.

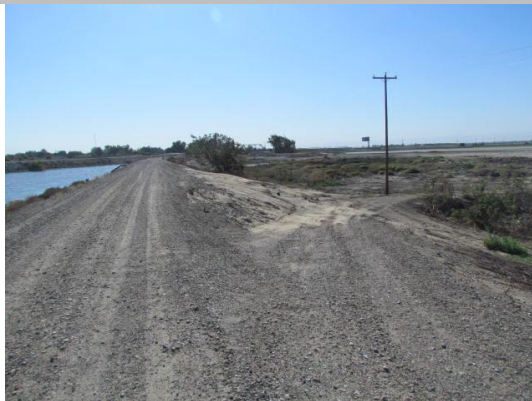
Photo 2 of 2 : FA\_2014\_RD0524\_107\_263\_20141020\_00145.jpg

Looking south at unauthorized ramp on landside slope.

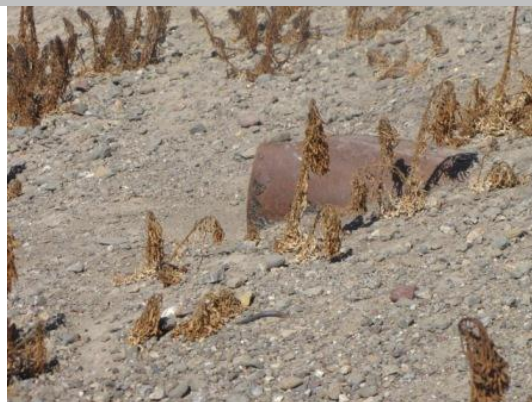
Photo 1 of 2 : FA\_2014\_RD0524\_107\_33\_20141020\_00041.jpg

LM Start	1.31	Rating **	M	Issue No.	33
LM End	1.31	Issue Type +	Ma	Location *	WS
Category	Earthen Levee			GPS Latitude/Longitude	
				Start	End
Item	Encroachments			37.931948 °	37.931948 °
				-121.328387 °	-121.328387 °
DWR ID	DWR_RD0524_01_s_2012_33				
Action/Comments					
Pipe Inspector Comments: Pipe is not in use and should be properly abandoned.

Looking west at pipe on landside slope.

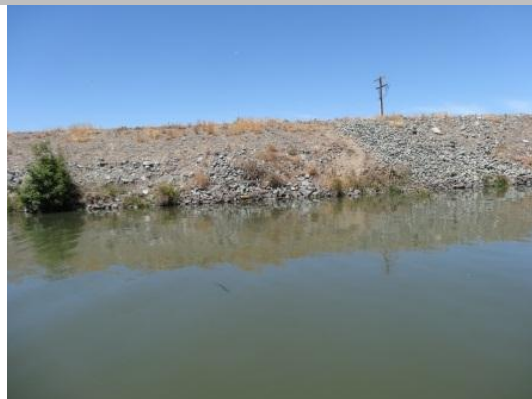
Photo 1 of 1 : SJR2014\_RD0524U01RM42.03\_1.jpg

Front view of the erosion.

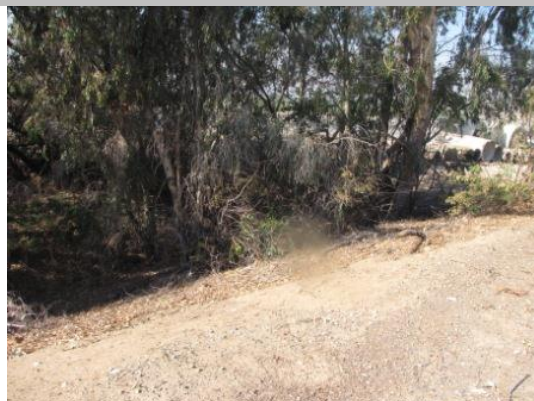
Photo 1 of 3 : FA\_2014\_RD0524\_107\_916\_20141020\_00152.jpg

Dense vegetation on landside toe.

LM Start	1.51	Rating **	M	Issue No.	916
LM End	1.51	Issue Type +	Ma	Location *	LS
Category	Earthen Levee			GPS Latitude/Longitude	
				Start	End
Item	Trim / Thin Trees			37.929118 °	37.929118 °
				-121.328368 °	-121.328368 °
DWR ID	DWR_RD0524_01_s_2012_916				
Action/Comments					
Trim and thin trees to allow visibility of the ground and room to flood fight.

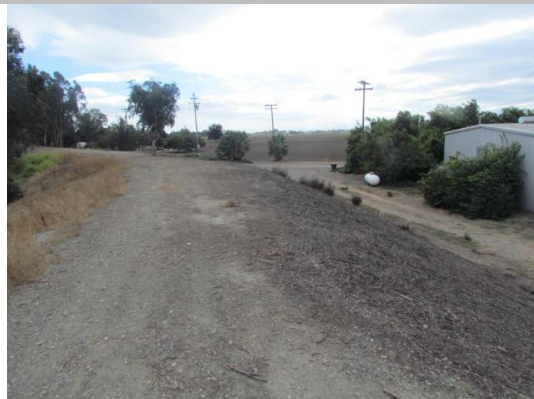
Photo 4 of 5 : FA\_2014\_RD0524\_107\_23\_20141023\_00197.jpg

Looking south from levee crown at corrected site.

LM Start	1.55	Rating **	A/W	Issue No.	23 (cont)
LM End	1.60	Issue Type +	Ma	Location *	LS
Category	Earthen Levee			GPS Latitude/Longitude	
				Start	End
Item	Vegetation			37.928388 °	37.927797 °
				-121.328280 °	-121.327854 °
DWR ID	DWR_RD0524_01_s_2012_23				
Action/Comments					
Remove the wild growth other than native grasses from the levee slopes.

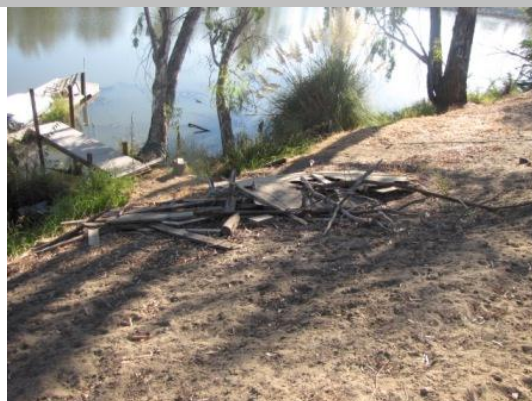
Photo 1 of 2 : FA\_2014\_RD0524\_107\_39\_20141020\_00052.jpg

LM Start	1.64	Rating **	U	Issue No.	39
LM End	1.64	Issue Type +	En	Location *	WS
Category	Earthen Levee			GPS Latitude/Longitude	
				Start	End
Item	Encroachments			37.927372 °	37.927372 °
				-121.327278 °	-121.327278 °
DWR ID	DWR_RD0524_01_s_2012_39				
Action/Comments					
Pole					
Inspector Comments: Landowner constructed boat dock without permission from the CVFPB.

Looking at garbage on waterside slope.

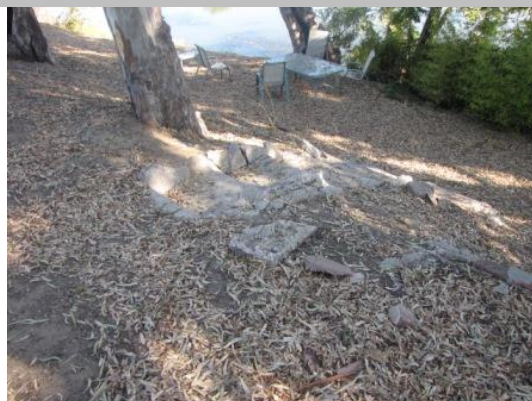
Photo 1 of 3 : FA\_2014\_RD0524\_107\_45\_20141020\_00057.jpg

Looking northeast at non-permitted concrete stairs on waterside slope.

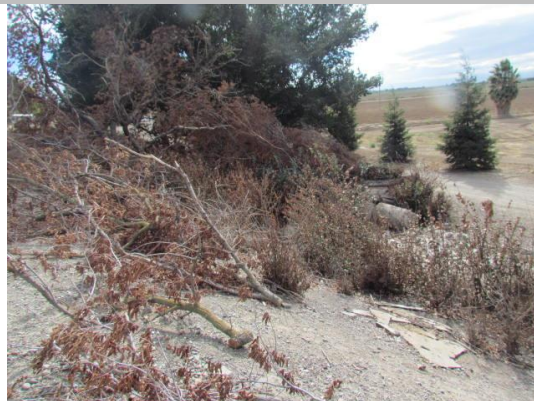
Photo 2 of 4 : FA\_2014\_RD0524\_107\_46\_20141023\_00202.jpg

LM Start	1.77	Rating **	U	Issue No.	46 (cont)
LM End	1.77	Issue Type +	Ma	Location *	N/A
Category	Earthen Levee			GPS Latitude/Longitude	
				Start	End
Item	Encroachments			37.925993 °	37.926152 °
				-121.325777 °	-121.325927 °
DWR ID	DWR_RD0524_01_s_2012_46				
Action/Comments					
Tree or limb					
Inspector Comments: Downed tree limbs on landward slope.

Looking southwest at tree limbs on landward slope.

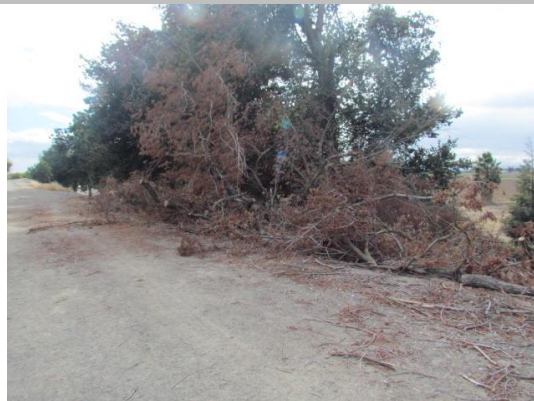
Photo 3 of 4 : FA\_2014\_RD0524\_107\_46\_20141023\_00203.jpg

Looking south at tree limbs on landward slope.

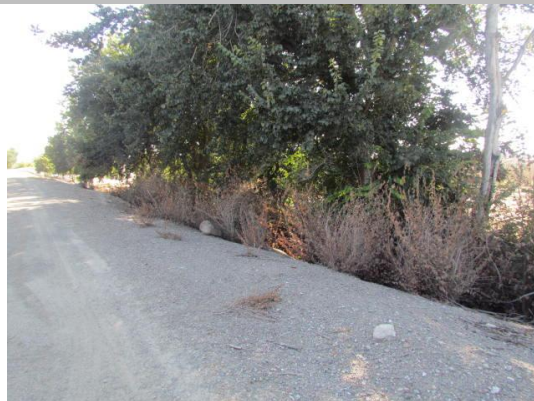
Photo 4 of 4 : FA\_2014\_RD0524\_107\_46\_20141020\_00060.jpg

Looking southwest at dense vegetation and low hanging tree branches on landside slope and toe.

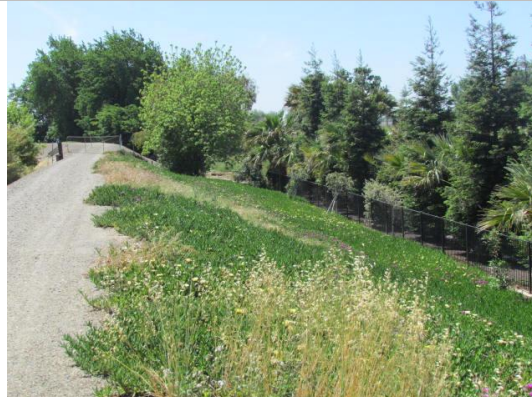
Photo 1 of 1 : FA\_2014\_RD0524\_107\_78\_20141020\_00080.jpg

Looking southwest at landscaping on landside slope. (Spring 2012)

LM Start	1.90	Rating **	M	Issue No.	78
LM End	1.95	Issue Type +	En	Location *	LS
Category	Earthen Levee			GPS Latitude/Longitude	
				Start	End
Item	Vegetation			37.924364 °	37.923805 °
				-121.324473 °	-121.324238 °
DWR ID	DWR_RD0524_01_s_2012_78				
Action/Comments					
Landscaping

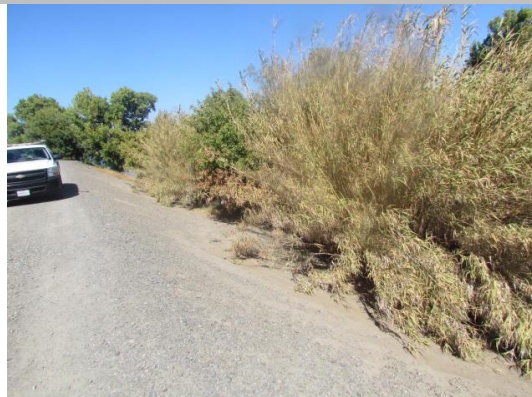
Photo 1 of 2 : FA\_2014\_RD0524\_107\_104\_20141020\_00096.jpg

LM Start	1.95	Rating **	A/W	Issue No.	104
LM End	1.95	Issue Type +	En	Location *	WS
Category	Earthen Levee			GPS Latitude/Longitude	
				Start	End
Item	Vegetation			37.923808 °	37.923808 °
				-121.324260 °	-121.324260 °
DWR ID	DWR_RD0524_01_s _ 2012_104				
Action/Comments					
Remove the wild growth other than native grasses from the levee slopes. Inspector Comments: Bamboo outside of the twenty foot vegetation zone.

Looking northeast at sprayed bamboo on waterside slope. (Fall 2012)

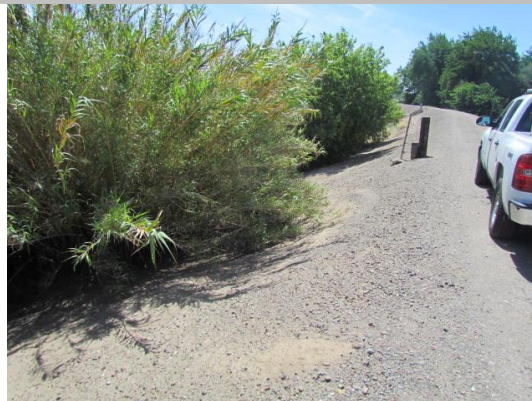
Photo 2 of 2 : FA\_2014\_RD0524\_107\_104\_20141020\_00097.jpg

Looking southeast at bamboo on waterside slope.

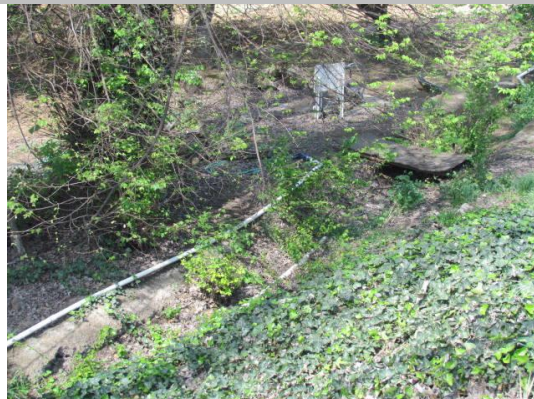
Photo 1 of 2 : FA\_2014\_RD0524\_107\_182\_20141020\_00138.jpg

LM Start	2.03	Rating **	M	Issue No.	182
LM End	2.06	Issue Type +	En	Location *	N/A
Category	Earthen Levee			GPS Latitude/Longitude	
				Start	End
Item	Encroachments			37.922837 °	37.922514 °
				-121.323785 °	-121.323504 °
DWR ID	DWR_RD0524_01_s_2014_182				
Action/Comments					
Ditch Inspector Comments: Old irrigation ditch at the landward toe should be removed.

Looking northwest at an old irrigation ditch at landward toe.

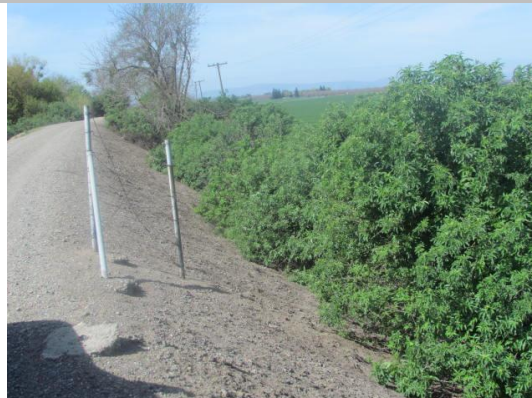
Photo 1 of 1 : FA\_2014\_RD0524\_107\_35\_20141020\_00044.jpg

LM Start	2.44	Rating **	U	Issue No.	35
LM End	2.48	Issue Type +	Ma	Location *	LS
Category	Earthen Levee			GPS Latitude/Longitude	
				Start	End
Item	Vegetation			37.918498 °	37.918515 °
				-121.321078 °	-121.321110 °
DWR ID	DWR_RD0524_01_s_2012_35				
Action/Comments					
Elderberries are blocking visibility and flood fight capability.

Looking southwest at dense vegetation on landward toe.

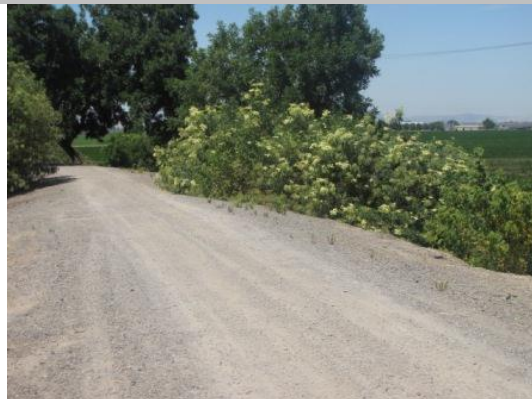
Photo 1 of 4 : FA\_2014\_RD0524\_107\_37\_20141020\_00046.jpg

LM Start	2.52	Rating **	U	Issue No.	37
LM End	2.52	Issue Type +	Ma	Location *	LS
Category	Earthen Levee			GPS Latitude/Longitude	
				Start	End
Item	Vegetation			37.918345 °	37.918302 °
				-121.321765 °	-121.321923 °
DWR ID	DWR_RD0524_01_s_2012_37				
Action/Comments					
Elderberries are blocking visibility and flood fight capability.

Looking south at elderberry on landside slope.

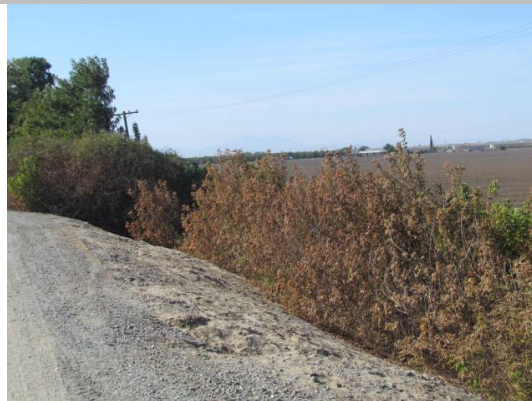
Photo 2 of 4 : FA\_2014\_RD0524\_107\_37\_20141020\_00047.jpg

Looking southwest at dense vegetation on landside toe.

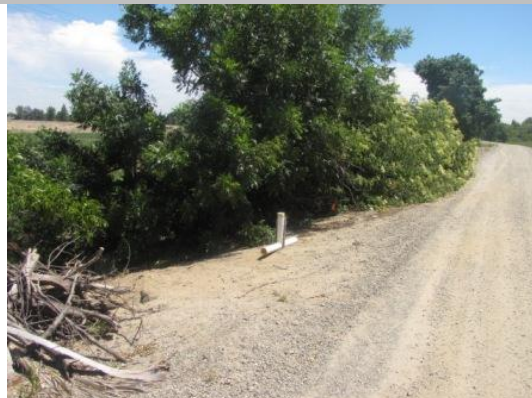
Photo 3 of 4 : FA\_2014\_RD0524\_107\_37\_20141020\_00048.jpg

Looking north at elderberry and trees on landside slope.

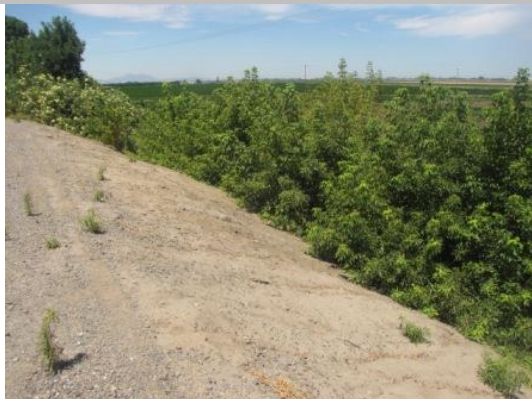
Photo 4 of 4 : FA\_2014\_RD0524\_107\_37\_20141020\_00049.jpg

LM Start	2.52	Rating **	U	Issue No.	37 (cont)	
LM End	2.52	Issue Type +	Ma	Location *	LS	
Category	Earthen Levee			GPS Latitude/Longitude		
				Start		End
Item	Vegetation			37.918345 °		37.918302 °
				-121.321765 °		-121.321923 °
DWR ID	DWR_RD0524_01_s_2012_37					
Action/Comments						
Elderberries are blocking visibility and flood fight capability.

Looking southwest at trees along levee landside toe.

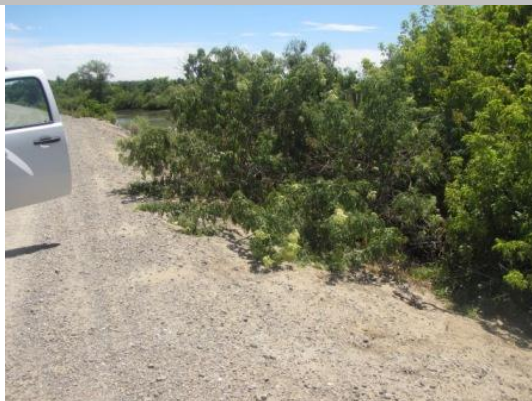
Photo 1 of 2 : FA\_2014\_RD0524\_107\_38\_20141020\_00050.jpg

LM Start	2.53	Rating **	U	Issue No.	38
LM End	2.53	Issue Type +	Ma	Location *	WS
Category	Earthen Levee			GPS Latitude/Longitude	
				Start	End
Item	Vegetation			37.918287 °	37.918287 °
				-121.321980 °	-121.321980 °
DWR ID	DWR_RD0524_01_s_2012_38				
Action/Comments					
Elderberries are blocking visibility and flood fight capability.

Looking north at elderberry on waterside slope.

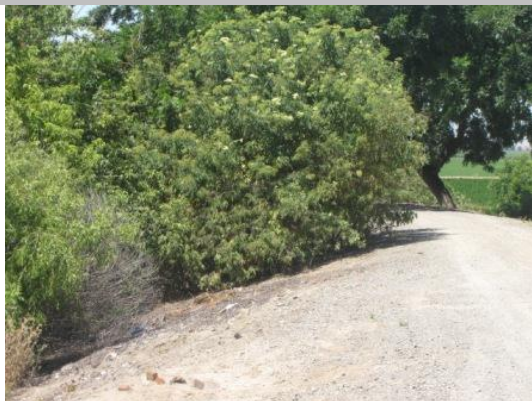
Photo 2 of 2 : FA\_2014\_RD0524\_107\_38\_20141020\_00051.jpg

LM Start	<b>2.53</b>	Rating **	U	Issue No.	<b>38 (cont)</b>
LM End	<b>2.53</b>	Issue Type +	Ma	Location *	WS

Looking south at elderberry on waterside slope.

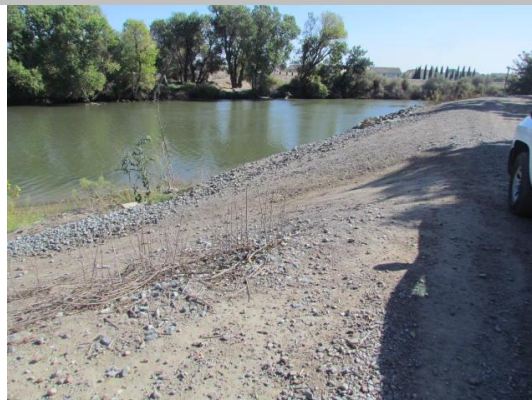
Photo 1 of 1 : FA\_2014\_RD0524\_107\_920\_20141020\_00155.jpg

LM Start	2.67	Rating **	U	Issue No.	920
LM End	2.67	Issue Type +	En	Location *	WS
Category	Earthen Levee			GPS Latitude/Longitude	
				Start	End
Item	Encroachments			37.916698 °	37.916698 °
				-121.322007 °	-121.322007 °
DWR ID	DWR_RD0524_01_s_2012_920				
Action/Comments					
Ramp

Looking southeast at unauthorized ramp on waterside slope.

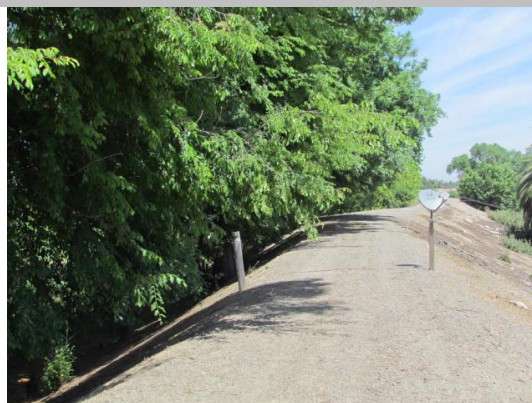
Photo 1 of 1 : FA\_2014\_RD0524\_107\_44\_20141020\_00056.jpg

Looking north at dense trees overhanging levee crown.

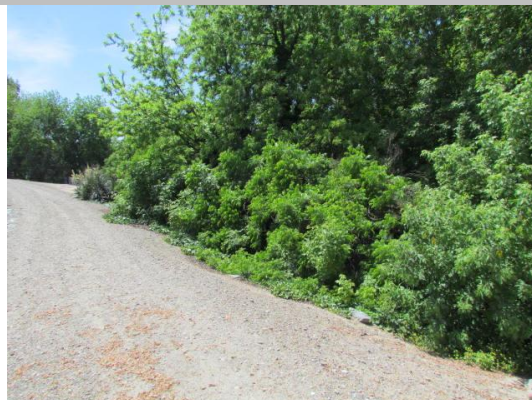
Photo 1 of 1 : FA\_2014\_RD0524\_107\_92\_20141020\_00087.jpg

LM Start	3.38	Rating **	U	Issue No.	92
LM End	3.39	Issue Type +	En	Location *	LS
Category	Earthen Levee			GPS Latitude/Longitude	
				Start	End
Item	Vegetation			37.907407 °	37.907177 °
				-121.325435 °	-121.325392 °
DWR ID	DWR_RD0524_01_s_2012_92				
Action/Comments					
Landscaping

Looking southwest at dense landscaping on landside slope.

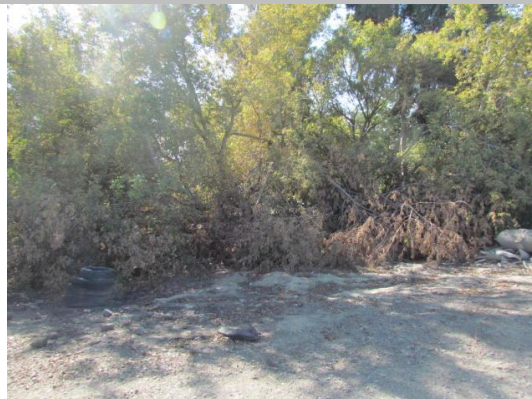
Photo 1 of 1 : FA\_2014\_RD0524\_107\_93\_20141020\_00088.jpg

LM Start	3.47	Rating **	U	Issue No.	93
LM End	3.47	Issue Type +	Ma	Location *	LS
Category	Earthen Levee			GPS Latitude/Longitude	
				Start	End
Item	Trim / Thin Trees			37.906265 °	37.906265 °
				-121.324643 °	-121.324643 °
DWR ID	DWR_RD0524_01_s_2012_93				
Action/Comments					
Trim and thin trees to allow visibility of the ground and room to flood fight.

Looking northwest at low hanging tree branches on landside slope and toe.

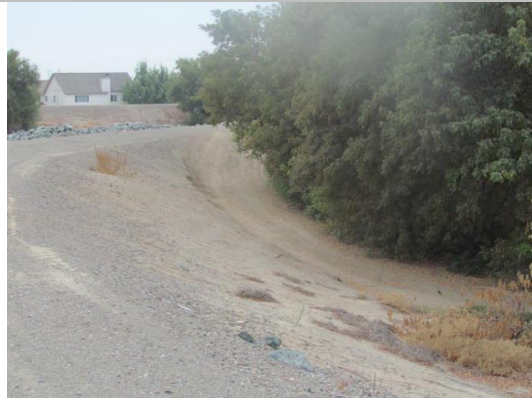
Photo 1 of 1 : FA\_2014\_RD0524\_107\_265\_20141020\_00146.jpg

LM Start	3.53	Rating **	M	Issue No.	265
LM End	3.53	Issue Type +	En	Location *	LS
Category	Earthen Levee			GPS Latitude/Longitude	
				Start	End
Item	Encroachments			37.905552 °	37.905552 °
				-121.323847 °	-121.323847 °
DWR ID	DWR_RD0524_01_s_2012_265				
Action/Comments					
Ramp					
Inspector Comments: Unauthorized ramp on landside slope.

Looking southeast at unauthorized ramp on landside slope and toe.

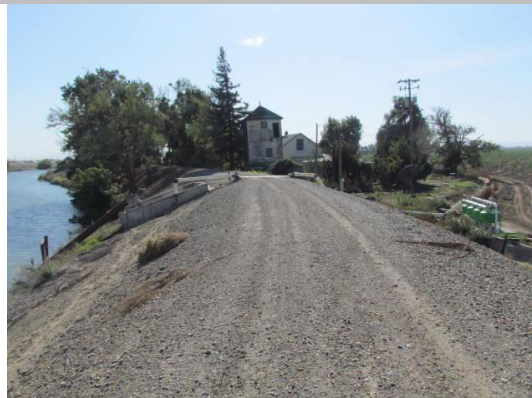
Photo 1 of 3 : FA\_2014\_RD0524\_107\_266\_20141020\_00147.jpg

LM Start	3.82	Rating **	M	Issue No.	266
LM End	3.82	Issue Type +	En	Location *	CR
Category	Earthen Levee			GPS Latitude/Longitude	
				Start	End
Item	Encroachments			37.902365 °	37.902365 °
				-121.326453 °	-121.326453 °
DWR ID	DWR_RD0524_01_s_2012_266				
Action/Comments					
Equipment					
Inspector Comments: Landowner installed water filter piping system without permit.

Looking south at unauthorized irrigation pipe across levee and water filtration system at landside toe.

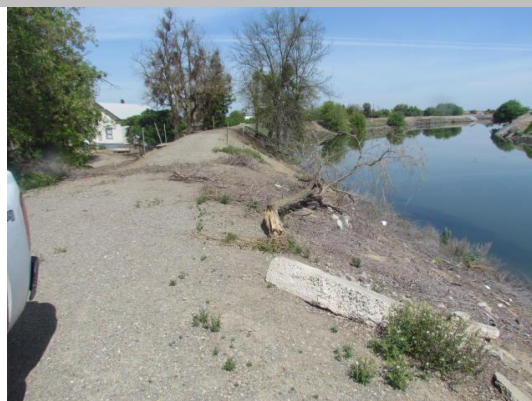
Photo 1 of 1 : FA\_2014\_RD0524\_107\_187\_20141020\_00140.jpg

LM Start	3.89	Rating **	M	Issue No.	187
LM End	3.89	Issue Type +	Ma	Location *	WS
Category	Earthen Levee			GPS Latitude/Longitude	
				Start	End
Item	Encroachments			37.901447 °	37.901447 °
				-121.326500 °	-121.326500 °
DWR ID	DWR_RD0524_01_s_2014_187				
Action/Comments					
Tree or limb					
Inspector Comments: Tree limb on waterward shoulder.

Looking northeast at tree limb on waterward slope.

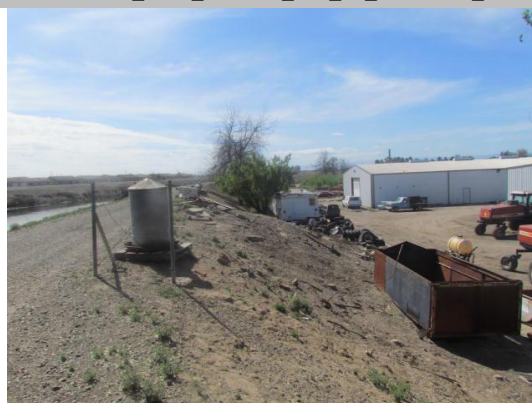
Photo 1 of 2 : FA\_2014\_RD0524\_107\_62\_20141020\_00070.jpg

LM Start	3.89	Rating **	M	Issue No.	62
LM End	4.01	Issue Type +	En	Location *	LS
Category	Earthen Levee			GPS Latitude/Longitude	
				Start	End
Item	Encroachments			37.901375 °	37.899745 °
				-121.326507 °	-121.326630 °
DWR ID	DWR_RD0524_01_s_2012_62				
Action/Comments					
Equipment

Looking south at northend of equipment stored at landward slope and toe.

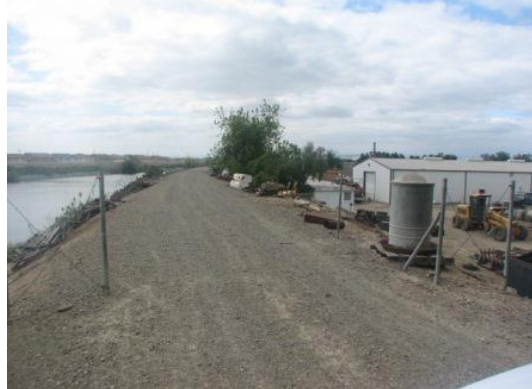
Photo 2 of 2 : FA\_2014\_RD0524\_107\_62\_20141020\_00071.jpg

LM Start	3.89	Rating **	M	Issue No.	62 (cont)	
LM End	4.01	Issue Type +	En	Location *	LS	
Category	Earthen Levee			GPS Latitude/Longitude		
				Start		End
Item	Encroachments			37.901375 °		37.899745 °
				-121.326507 °		-121.326630 °
DWR ID	DWR_RD0524_01_s_2012_62					
Action/Comments						
Equipment

Looking upstream at equipment on landside shoulder

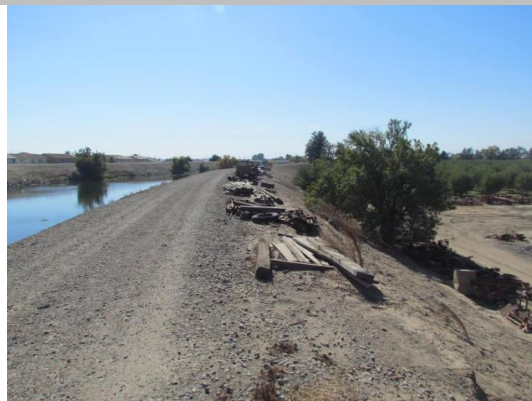
Photo 1 of 3 : FA\_2014\_RD0524\_107\_95\_20141020\_00090.jpg

LM Start	3.91	Rating **	U	Issue No.	95
LM End	3.94	Issue Type +	En	Location *	LS
Category	Earthen Levee			GPS Latitude/Longitude	
				Start	End
Item	Encroachments			37.901147 °	37.900735 °
				-121.326453 °	-121.326425 °
DWR ID	DWR_RD0524_01_f_2013_95				
Action/Comments					
Equipment					
Inspector Comments: Landowner is storing equipment on landward shoulder and landward toe.

Looking south at farm equipment stored on landward shoulder and toe.

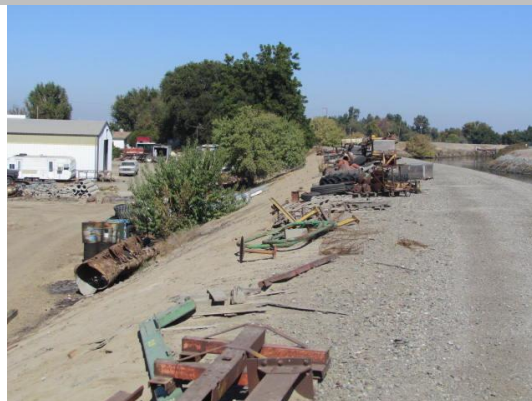
Photo 2 of 3 : FA\_2014\_RD0524\_107\_95\_20141020\_00091.jpg

LM Start	<b>3.91</b>	Rating **	U	Issue No.	<b>95 (cont)</b>
LM End	<b>3.94</b>	Issue Type +	En	Location *	LS

Looking north at farm equipment stored on landward shoulder.

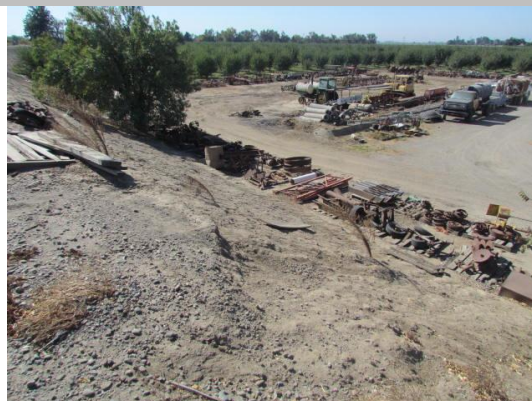
Photo 3 of 3 : FA\_2014\_RD0524\_107\_95\_20141020\_00092.jpg

LM Start	3.91	Rating **	U	Issue No.	95 (cont)
LM End	3.94	Issue Type +	En	Location *	LS
Category	Earthen Levee			GPS Latitude/Longitude	
				Start	End
Item	Encroachments			37.901147 °	37.900735 °
				-121.326453 °	-121.326425 °
DWR ID	DWR_RD0524_01_f_2013_95				
Action/Comments					
Equipment					
Inspector Comments: Landowner is storing equipment on landward shoulder and landward toe.

Looking west at farm equipment stored at landward toe.

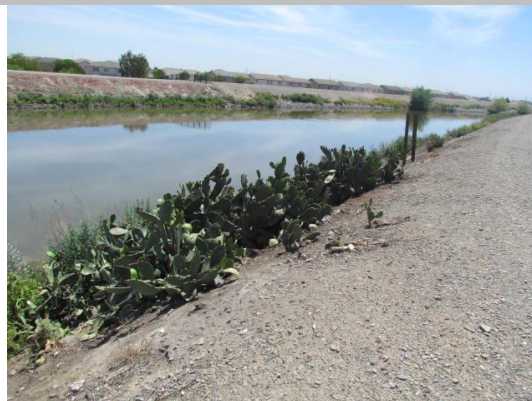
Photo 1 of 1 : FA\_2014\_RD0524\_107\_94\_20141020\_00089.jpg

LM Start	3.92	Rating **	M	Issue No.	94
LM End	3.92	Issue Type +	Ma	Location *	WS
Category	Earthen Levee			GPS Latitude/Longitude	
				Start	End
Item	Vegetation			37.900952 °	37.900952 °
				-121.326443 °	-121.326443 °
DWR ID	DWR_RD0524_01_s_2012_94				
Action/Comments					
Remove the wild growth other than native grasses from the levee slopes.					
Inspector Comments: Remove cactus

Looking southeast at cactus on waterside slope.

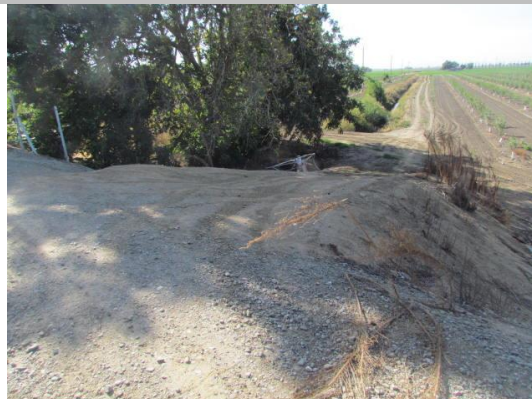
Photo 1 of 1 : FA\_2014\_RD0524\_107\_101\_20141020\_00094.jpg

LM Start	4.06	Rating **	U	Issue No.	101
LM End	4.06	Issue Type +	En	Location *	LS
Category	Earthen Levee			GPS Latitude/Longitude	
				Start	End
Item	Encroachments			37.899027 °	37.899027 °
				-121.326982 °	-121.326982 °
DWR ID	DWR_RD0524_01_s _ 2012_101				
Action/Comments					
Ramp Inspector Comments: Unauthorized ramp. Ramp does not meet Title 23 standard.

Looking west at unauthorized ramp on landside slope.

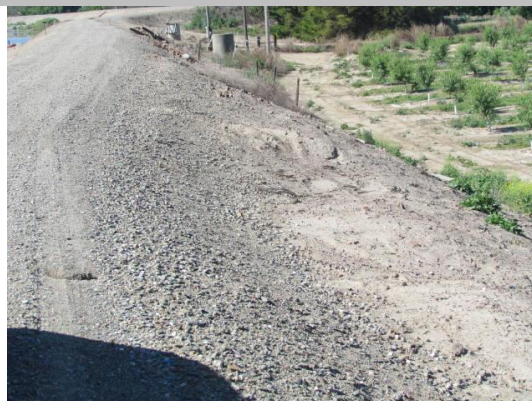
Photo 1 of 1 : FA\_2014\_RD0524\_107\_108\_20141020\_00099.jpg

Looking southwest at caving slope on landside of levee.

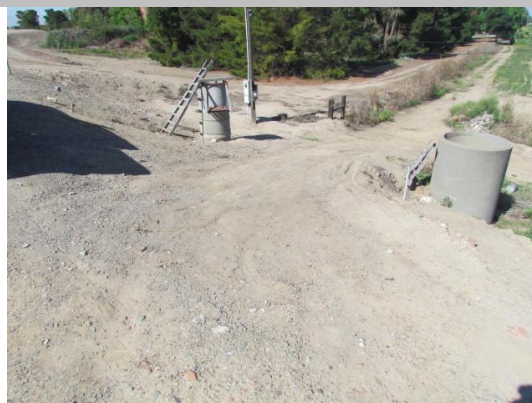
Photo 1 of 1 : FA\_2014\_RD0524\_107\_110\_20141020\_00104.jpg

Looking southwest at an unauthorized ramp on landside slope.

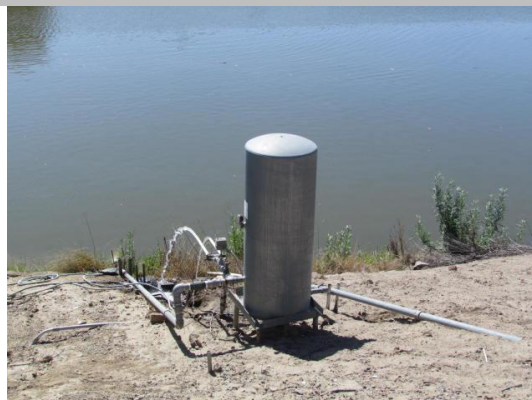
Photo 4 of 5 : FA\_2014\_RD0524\_107\_109\_20141020\_00102.jpg

Looking east at irrigation system on waterside slope.

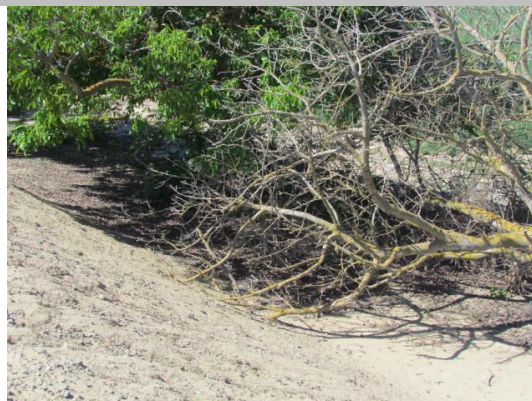
Photo 1 of 1 : FA\_2014\_RD0524\_107\_111\_20141020\_00105.jpg

LM Start	4.42	Rating **	M	Issue No.	111
LM End	4.42	Issue Type +	En	Location *	LS
Category	Earthen Levee			GPS Latitude/Longitude	
				Start	End
Item	Encroachments			37.894258 °	37.894258 °
				-121.329247 °	-121.329247 °
DWR ID	DWR_RD0524_01_s_2012_111				
Action/Comments					
Tree or limb Inspector Comments: Dead tree at landside toe should be removed from levee toe.

Looking west at dead tree at landside toe.

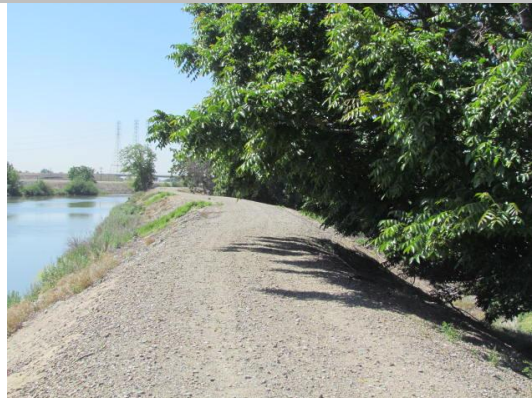
Photo 1 of 1 : FA\_2014\_RD0524\_107\_68\_20141020\_00074.jpg

LM Start	5.11	Rating **	U	Issue No.	68
LM End	5.11	Issue Type +	Ma	Location *	LS
Category	Earthen Levee			GPS Latitude/Longitude	
				Start	End
Item	Trim / Thin Trees			37.885400 °	37.885400 °
				-121.332153 °	-121.332153 °
DWR ID	DWR_RD0524_01_s_2012_68				
Action/Comments					
Trim trees over roadway to at least 12 feet above ground level.

Looking south at overhanging trees.

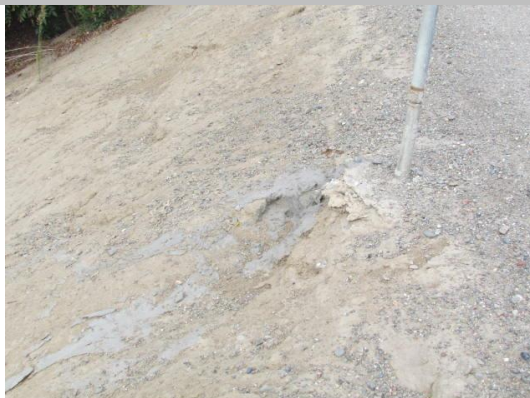
Photo 1 of 2 : FA\_2014\_RD0524\_107\_931\_20141023\_00213.jpg

LM Start	5.46	Rating **	A/W	Issue No.	931
LM End	5.46	Issue Type +	Ma	Location *	LS
Category	Earthen Levee			GPS Latitude/Longitude	
				Start	End
Item	Animal Control			37.880575 °	37.880575 °
				-121.332890 °	-121.332890 °
DWR ID	DWR_RD0524_01_s_2012_931				
Action/Comments					
Exterminate rodents and backfill and compact or grout burrows. Inspector Comments: LMA grouted rodent holes.

Looking north at typical view of grouted rodent holes on landward shoulder and slope.

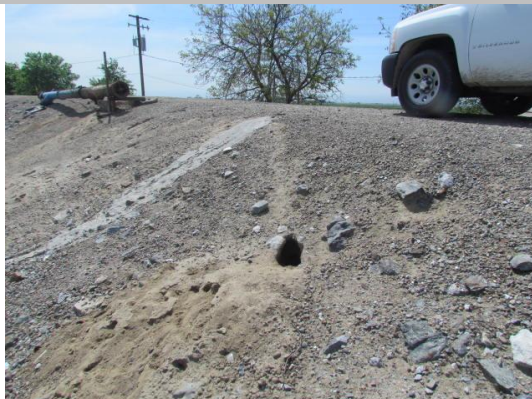
Photo 1 of 2 : FA\_2014\_RD0524\_107\_75\_20141020\_00077.jpg

Looking southwest at typical rodent holes on waterward slope.

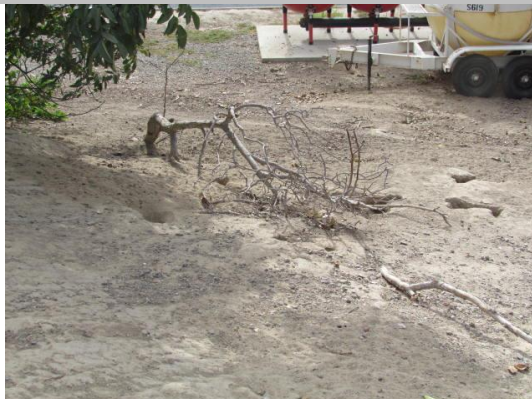
Photo 2 of 2 : FA\_2014\_RD0524\_107\_75\_20141023\_00217.jpg

Looking typical view of several rodent holes on landward slope and toe.

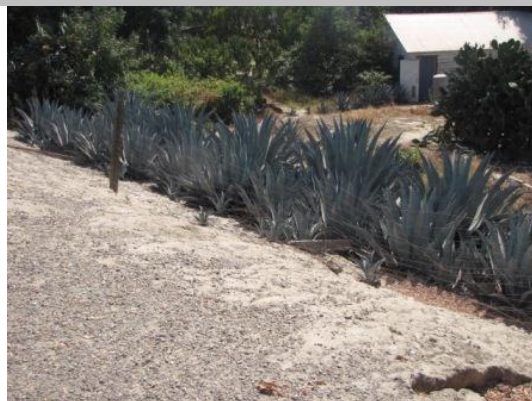
Photo 1 of 1 : FA\_2014\_RD0524\_107\_88\_20141020\_00084.jpg

LM Start	5.99	Rating **	U	Issue No.	88
LM End	6.00	Issue Type +	En	Location *	LS
Category	Earthen Levee			GPS Latitude/Longitude	
				Start	End
Item	Vegetation			37.873543 °	37.873445 °
				-121.332308 °	-121.332127 °
DWR ID	DWR_RD0524_01_s _ 2012_88				
Action/Comments					
Landscaping					
Inspector Comments: Cactus

Looking southeast at fence and cactus on landside slope and toe.
