**Flood Control Project Maintenance
Levee Inspections**

Fall 2015 Levee Maintenance Deficiency Summary Report

San Joaquin River Basin

Reclamation District No. 0524 Middle Roberts Island

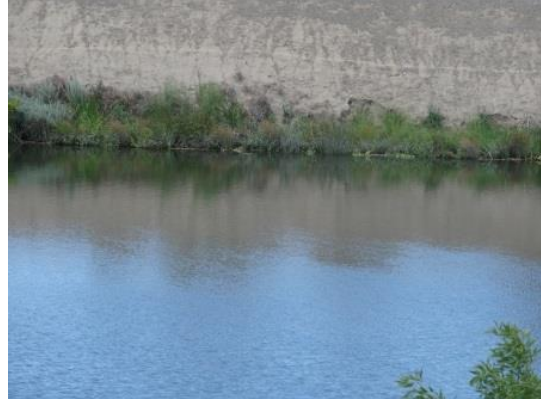
Photo 1 of 2 : SJR2015_RD0524U01RM40.85_2.JPG

LM Start	0.19	Rating **	U	Issue No.	129
LM End	0.19	Issue Type +	Ma	Location *	WS
Category	Supplemental			GPS Latitude/Longitude	
				Start	End
Item	DWR Erosion Survey			37.939085 °	37.939085 °
				-121.343917 °	-121.343917 °
DWR ID					
Action/Comments					
Inspector Comments: 06/24/2015: No significant change observed. 6/19/2014: No significant change observed. 08/13/2013: The erosion was discovered during 2013 spring levee inspection. Inspector comment: Erosion is located along the lower level of water-ward slope. [2015 Site ID:RD0524U01RM40.85]

Front view of the erosion.

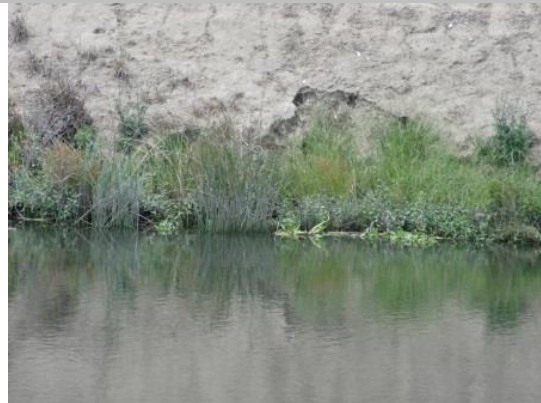
Photo 2 of 2 : SJR2015_RD0524U01RM40.85_5.JPG

Close view of the erosion.

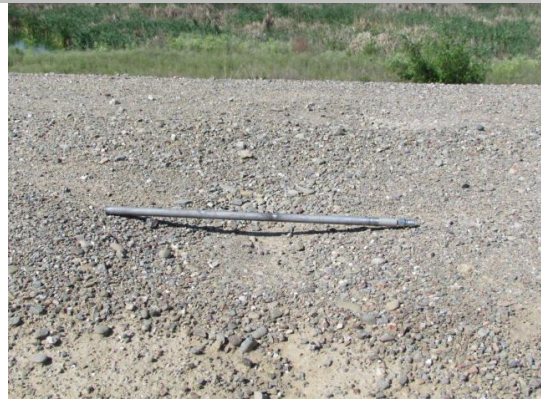
Photo 1 of 3 : FA_2015_RD0524_107_3_20150914_00006.jpg

Looking west at 3" depression on levee crown. (Spring 2012)

LM Start	0.21	Rating **	M	Issue No.	3
LM End	0.21	Issue Type +	Ma	Location *	CR
Category	Earthen Levee			GPS Latitude/Longitude	
				Start	End
Item	Crown Surface / Depressions / Rutting			37.938890 °	37.938890 °
				-121.343657 °	-121.343657 °
DWR ID	DWR_RD0524_01_s_2012_3				
Action/Comments					
Repair depressions or ruts in the crown or slope.					
Inspector Comments: No change in status.

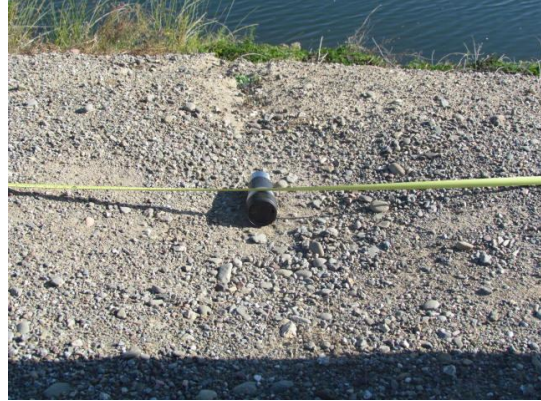
Photo 2 of 3 : FA_2015_RD0524_107_3_20150914_00007.jpg

Looking west at depression on levee crown near waterward shoulder.

LM Start	0.21	Rating **	M	Issue No.	3 (cont)
LM End	0.21	Issue Type +	Ma	Location *	CR
Category	Earthen Levee			GPS Latitude/Longitude	
				Start	End
Item	Crown Surface / Depressions / Rutting			37.938890 °	37.938890 °
				-121.343657 °	-121.343657 °
DWR ID	DWR_RD0524_01_s _ 2012_3				
Action/Comments					
Repair depressions or ruts in the crown or slope.					
Inspector Comments: No change in status.

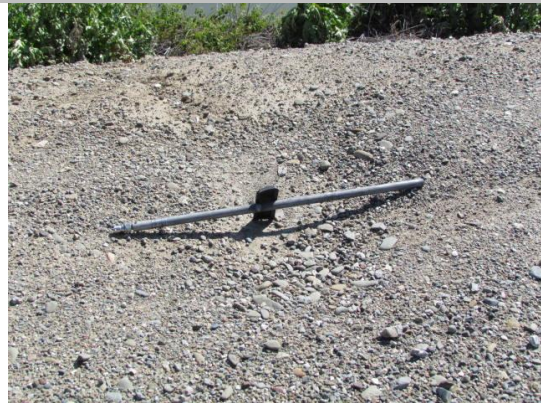
Photo 3 of 3 : FA_2015_RD0524_107_3_20150914_00008.jpg

Looking east at 3" depression on levee crown. (Spring 2012)

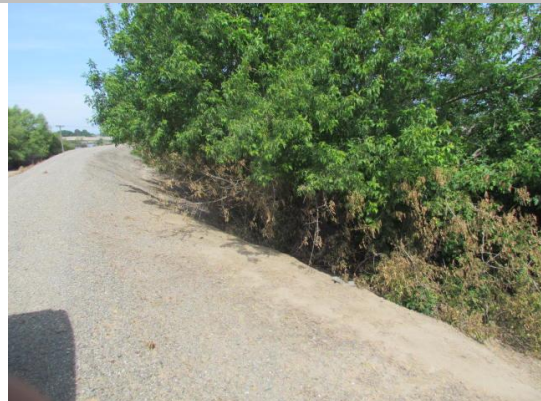
Photo 1 of 2 : FA_2015_RD0524_107_179_20150914_00169.jpg

Looking north at untrimmed tree on waterward slope. (Spring 2015)

LM Start	0.27	Rating **	U	Issue No.	179
LM End	0.27	Issue Type +	Ma	Location *	WS
Category	Earthen Levee			GPS Latitude/Longitude	
				Start	End
Item	Trim / Thin Trees			37.938438 °	37.938438 °
				-121.342883 °	-121.342883 °
DWR ID	DWR_RD0524_01_s _ 2014_179				
Action/Comments					
Thin trees to allow visibility of the ground and room to flood fight.

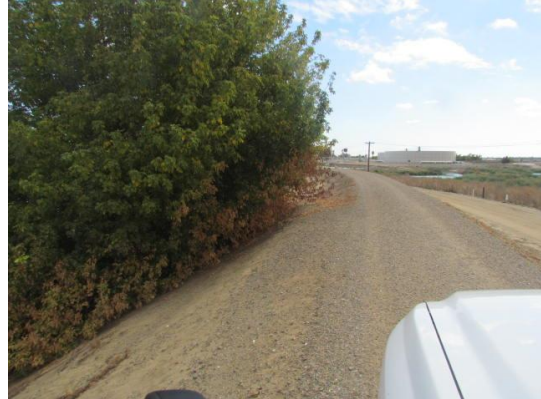
Photo 2 of 2 : FA_2015_RD0524_107_179_20150914_00170.jpg

Looking south at untrimmed tree on waterward slope. (Fall 2014)

LM Start	0.27	Rating **	U	Issue No.	179 (cont)
LM End	0.27	Issue Type +	Ma	Location *	WS
Category	Earthen Levee			GPS Latitude/Longitude	
				Start	End
Item	Trim / Thin Trees			37.938438 °	37.938438 °
				-121.342883 °	-121.342883 °
DWR ID	DWR_RD0524_01_s_2014_179				
Action/Comments					
Thin trees to allow visibility of the ground and room to flood fight.

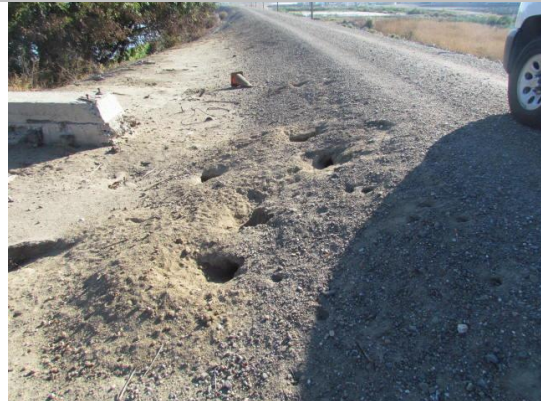
Photo 1 of 3 : FA_2015_RD0524_107_174_20151023_00240.jpg

Looking southeast at several rodent holes on waterward slope Fall 2015.

LM Start	0.30	Rating **	U	Issue No.	174
LM End	0.30	Issue Type +	Ma	Location *	WS
Category	Earthen Levee			GPS Latitude/Longitude	
				Start	End
Item	Animal Control			37.938382 °	37.938382 °
				-121.342352 °	-121.342352 °
DWR ID	DWR_RD0524_01_f_2014_174				
Action/Comments					
No rodents visible, but rodent burrows visible; need to backfill and compact or grout burrows.					
Inspector Comments: Several rodent holes present at this site.

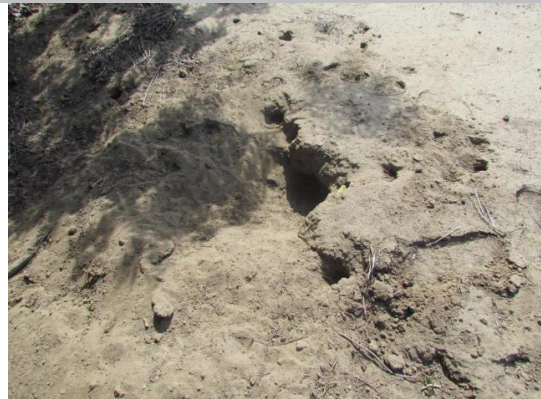
Photo 2 of 3 : FA_2015_RD0524_107_174_20150914_00164.jpg

Looking west at several rodent holes on waterward shoulder. (Spring 2015)

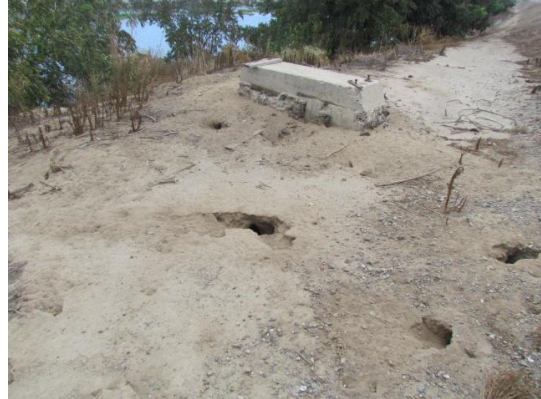
Photo 3 of 3 : FA_2015_RD0524_107_174_20150914_00165.jpg

Looking southeast at several rodent holes on waterward slope.

LM Start	0.30	Rating **	U	Issue No.	174 (cont)
LM End	0.30	Issue Type +	Ma	Location *	WS
Category	Earthen Levee			GPS Latitude/Longitude	
				Start	End
Item	Animal Control			37.938382 °	37.938382 °
				-121.342352 °	-121.342352 °
DWR ID	DWR_RD0524_01_f_2014_174				
Action/Comments					
No rodents visible, but rodent burrows visible; need to backfill and compact or grout burrows.					
Inspector Comments: Several rodent holes present at this site.

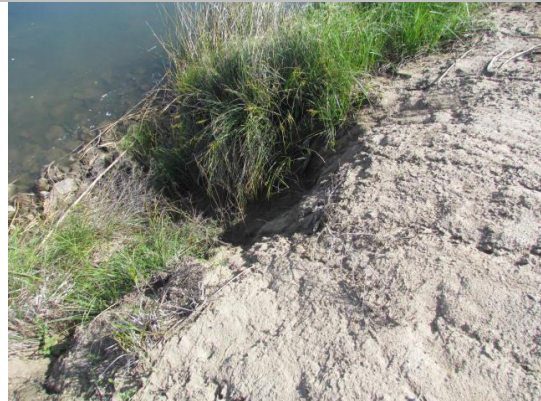
Photo 1 of 2 : FA_2015_RD0524_107_180_20150914_00171.jpg

Looking southeast at erosion on waterward toe.

LM Start	0.34	Rating **	M	Issue No.	180
LM End	0.34	Issue Type +	Ma	Location *	WS
Category	Earthen Levee			GPS Latitude/Longitude	
				Start	End
Item	Erosion / Bank Caving			37.938461 °	37.938461 °
				-121.341626 °	-121.341626 °
DWR ID	DWR_RD0524_01_s_2014_180				
Action/Comments					
Schedule repair of erosion site prior to the next inspection. Inspector Comments: Erosion is located along the lower level of waterward slope.

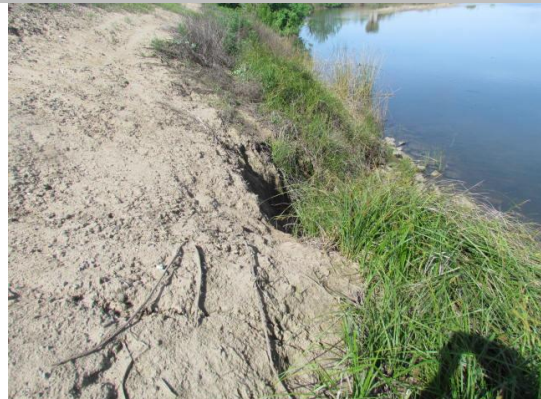
Photo 2 of 2 : FA_2015_RD0524_107_180_20150914_00172.jpg

Looking northeast at erosion on waterward toe.

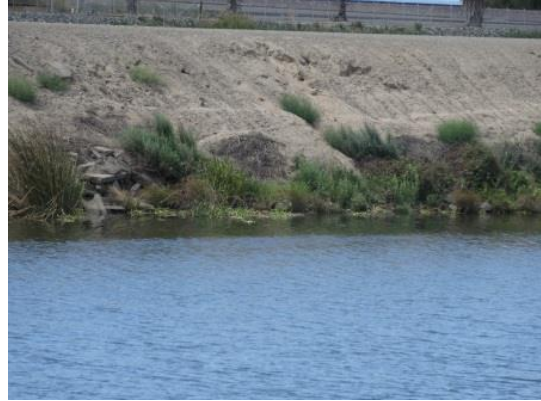
Photo 1 of 2 : SJR2015_RD0524U01RM40.99_1.jpg

LM Start	0.40	Rating **	U	Issue No.	131
LM End	0.40	Issue Type +	Ma	Location *	WS
Category	Supplemental			GPS Latitude/Longitude	
				Start	End
Item	DWR Erosion Survey			37.938870 °	37.938870 °
				-121.340460 °	-121.340460 °
DWR ID					
Action/Comments					
Inspector Comments: 06/24/2015: No significant change observed. 6/19/2014: No significant change observed. 08/13/2013: No significant change at this site. 8/7/2012: The erosion is at the upper levee slope, and likely caused by slope slip. The lower levee slope is covered with dense vegetation. [2015 Site ID:RD0524U01RM40.99]

Front view of the erosion site. Note the vegetation at the levee toe and on the lower slope.

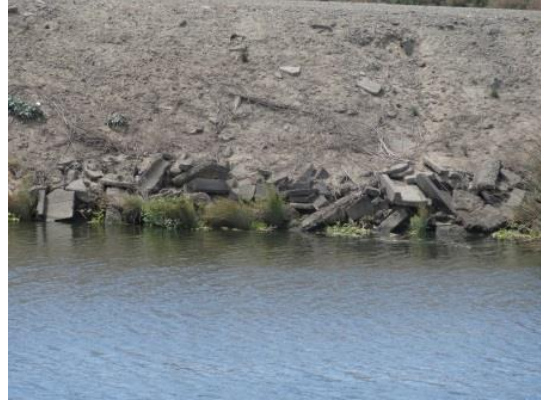
Photo 2 of 2 : SJR2015_RD0524U01RM40.99_5.jpg

Close view of the erosion.

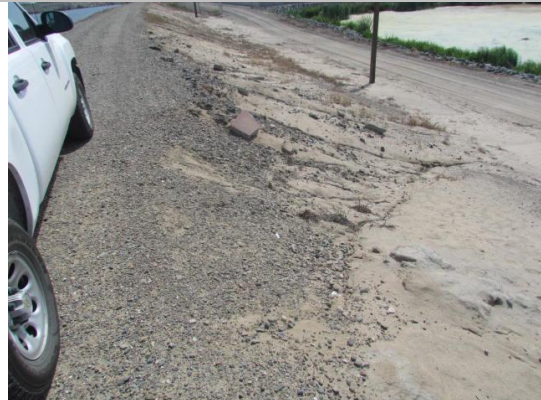
Photo 1 of 2 : FA_2015_RD0524_107_170_20150914_00158.jpg

Looking south at slope damage on waterward shoulder.

LM Start	0.41	Rating **	M	Issue No.	170
LM End	0.45	Issue Type +	Ma	Location *	WS
Category	Earthen Levee			GPS Latitude/Longitude	
				Start	End
Item	Slope Stability			37.938628 °	37.938688 °
				-121.340385 °	-121.339627 °
DWR ID	DWR_RD0524_01_s_2015_170				
Action/Comments					
Repair slope instability.					
Inspector Comments: Several slope instabilities within this reach.

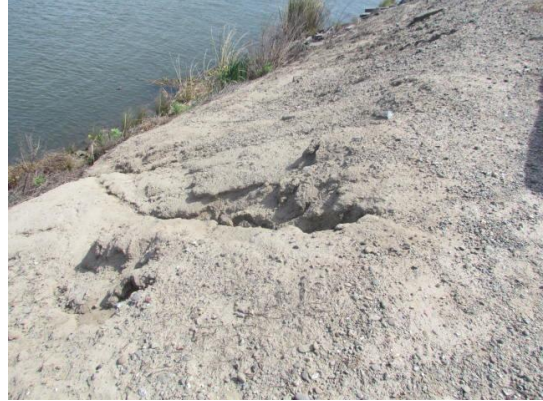
Photo 2 of 2 : FA_2015_RD0524_107_170_20150914_00159.jpg

Looking west at waterward slope erosion.

LM Start	0.41	Rating **	M	Issue No.	170 (cont)
LM End	0.45	Issue Type +	Ma	Location *	WS
Category	Earthen Levee			GPS Latitude/Longitude	
				Start	End
Item	Slope Stability			37.938628 °	37.938688 °
				-121.340385 °	-121.339627 °
DWR ID	DWR_RD0524_01_s_2015_170				
Action/Comments					
Repair slope instability.					
Inspector Comments: Several slope instabilities within this reach.

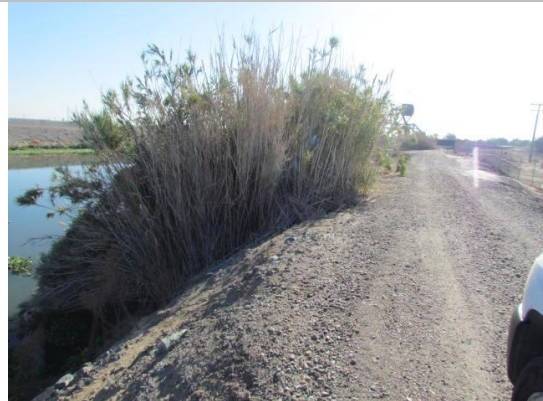
Photo 1 of 4 : FA_2015_RD0524_107_11_20151023_00241.jpg

Looking south at bamboo on waterside slope. (Fall 2015)

LM Start	0.62	Rating **	U	Issue No.	11
LM End	0.63	Issue Type +	Ma	Location *	WS
Category	Earthen Levee			GPS Latitude/Longitude	
				Start	End
Item	Vegetation			37.938278 °	37.938247 °
				-121.336524 °	-121.336503 °
DWR ID	DWR_RD0524_01_s_2012_11				
Action/Comments					
Remove the wild growth other than native grasses from the levee slopes.					
Inspector Comments: Bamboo on waterward slope.

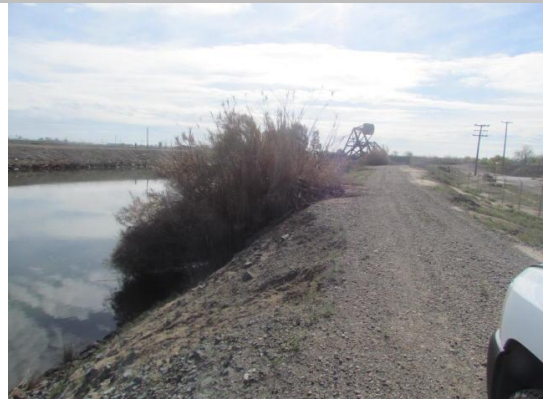
Photo 2 of 4 : FA_2015_RD0524_107_11_20150914_00014.jpg

Looking south at dying bamboo on waterward slope. (Spring 2013)

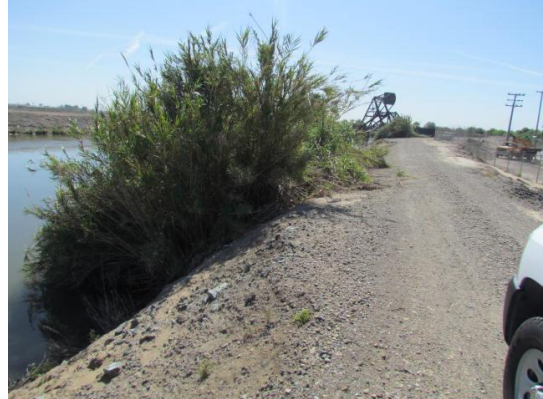
Photo 3 of 4 : FA_2015_RD0524_107_11_20150914_00013.jpg

Looking southeast at bamboo on waterside slope. (Spring 2012)

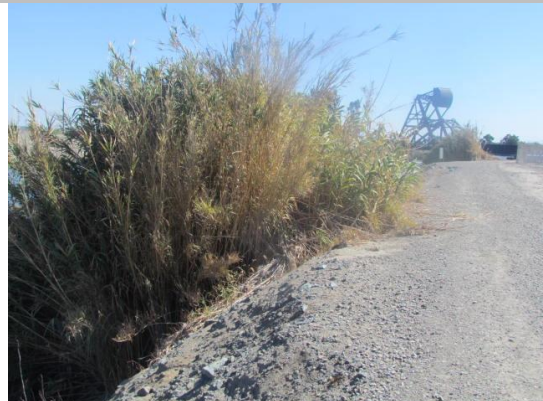
Photo 4 of 4 : FA_2015_RD0524_107_11_20150914_00015.jpg

Looking south at bamboo on waterside slope. (Fall Inspection 2012)

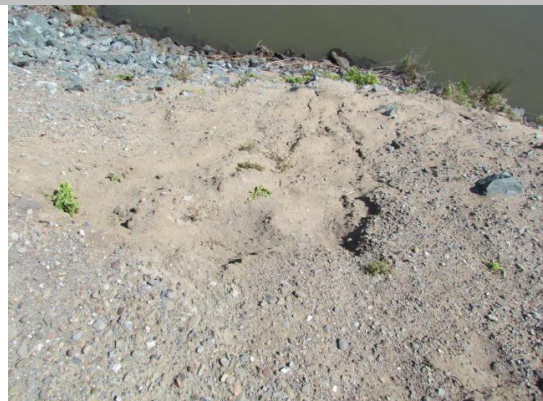
Photo 1 of 1 : FA_2015_RD0524_107_10_20150914_00012.jpg

Looking east at waterside erosion appears to be caused by runoff.

LM Start	0.63	Rating **	U	Issue No.	10
LM End	0.63	Issue Type +	Ma	Location *	WS
Category	Earthen Levee			GPS Latitude/Longitude	
				Start	End
Item	Slope Stability			37.938247 °	37.938247 °
				-121.336503 °	-121.336503 °
DWR ID	DWR_RD0524_01_f _ 2015_10				
Action/Comments					
Repair the levee slope damaged by foot traffic and prevent access where possible.

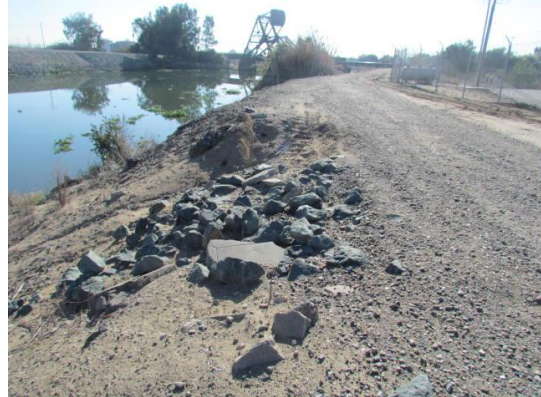
Photo 1 of 4 : FA_2015_RD0524_107_13_20151023_00243.jpg

LM Start	0.64	Rating **	M	Issue No.	13
LM End	0.65	Issue Type +	Ma	Location *	WS
Category	Earthen Levee			GPS Latitude/Longitude	
				Start	End
Item	Slope Stability			37.938105 °	37.938023 °
				-121.336288 °	-121.336173 °
DWR ID	DWR_RD0524_01_s_2012_13				
Action/Comments					
Repair slope instability. Inspector Comments: Depression extend from shoulder to mid levee slope two site with this section.

Looking southeast at depression on waterward shoulder fall 2015

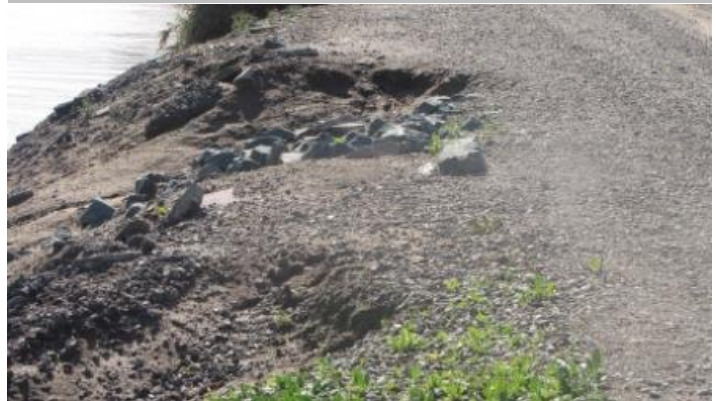
Photo 2 of 4 : FA_2015_RD0524_107_13_20150914_00018.jpg

Looking south at erosion on waterside shoulder.

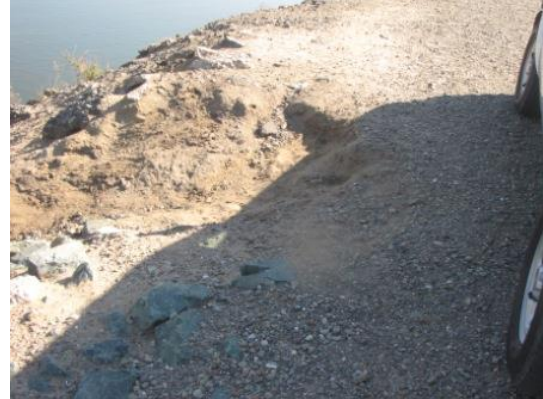
Photo 4 of 4 : FA_2015_RD0524_107_13_20150914_00019.jpg

Update view of the erosion site.

LM Start	0.64	Rating **	M	Issue No.	13 (cont)
LM End	0.65	Issue Type +	Ma	Location *	WS
Category	Earthen Levee			GPS Latitude/Longitude	
				Start	End
Item	Slope Stability			37.938105 °	37.938023 °
				-121.336288 °	-121.336173 °
DWR ID	DWR_RD0524_01_s_2012_13				
Action/Comments					
Repair slope instability. Inspector Comments: Depression extend from shoulder to mid levee slope two site with this section.

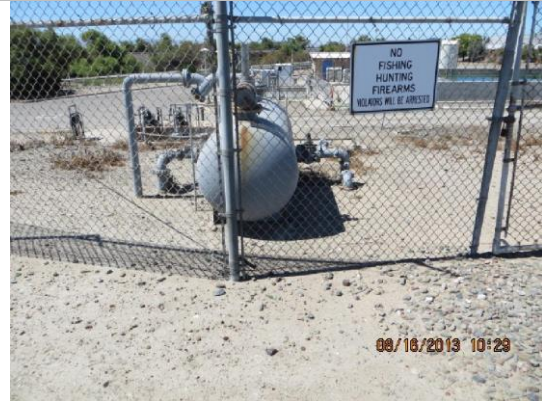
Photo 2 of 3 : UCIP_FA_2015_1533.jpg

Inspector Comments: FS_ID:17563
 DS_ID:20592
 EP_NO: 6035
 FS_HLM: 0.672
 Repair Type: Non-Urgent
 Crossing Status: Found
 UCIP Comments: Flows from primer tank causing erosion on LS slope.
 FIELD_STRUCT_DESC: 48-inch pipe through levee 7.3 feet below crown. Siphon pumps and primer tank enclosed by cyclone fence on the landward shoulder. Gate valve at inlet sump 100-feet off LS toe. One concrete cutoff wall. (Permit No. 6035, 1968).
 FS Date: 08/16/2013

Siphon Priming tank and associated pipes on LS shoulder.

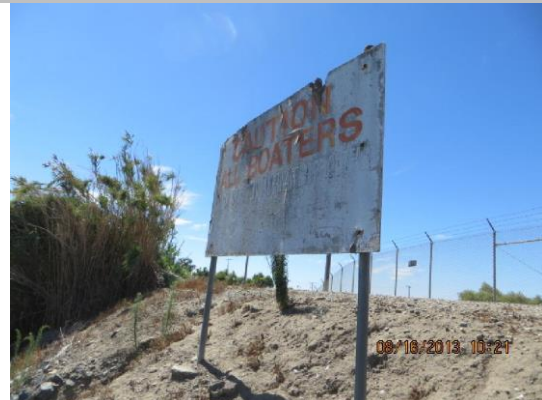
Photo 3 of 3 : UCIP_FA_2015_1534.jpg

Signage for effluent pipe on WS shoulder.

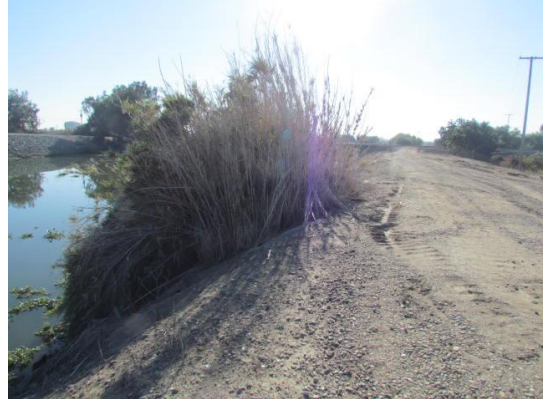
Photo 1 of 3 : FA_2015_RD0524_107_14_20151023_00244.jpg

Looking south at dying bamboo on waterward slope. Fall 2015

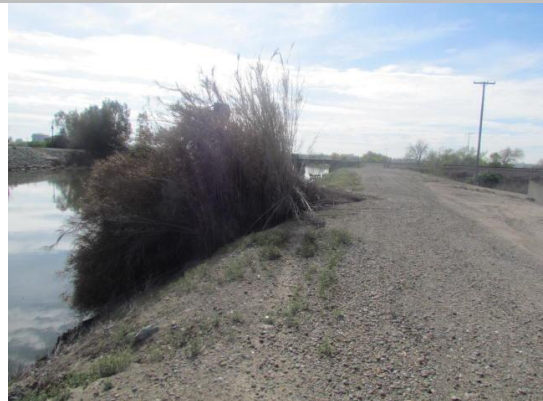
Photo 2 of 3 : FA_2015_RD0524_107_14_20150914_00021.jpg

Looking south at dying bamboo on waterward slope. (Spring 2013)

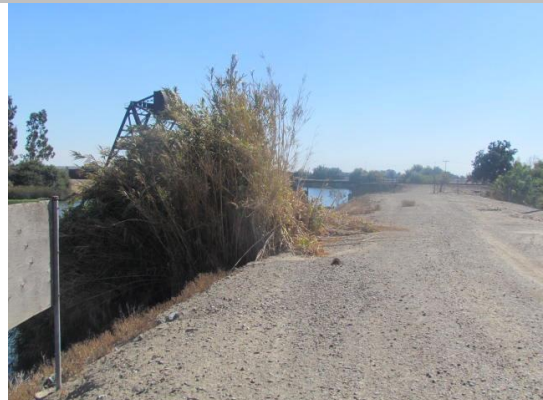
Photo 3 of 3 : FA_2015_RD0524_107_14_20150914_00022.jpg

Looking south at bamboo on waterside slope. (Fall 2012)

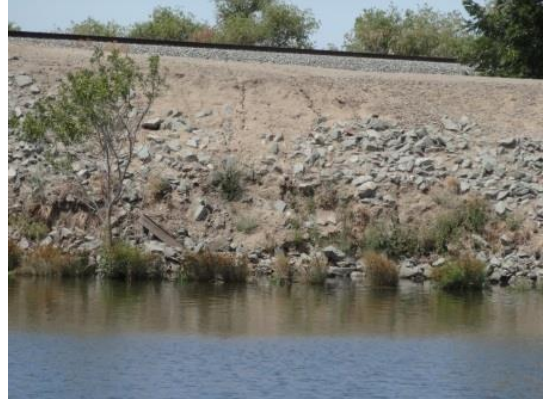
Photo 1 of 2 : SJR2015_RD0524U01RM41.36_4.JPG

LM Start	0.71	Rating **	M	Issue No.	132
LM End	0.73	Issue Type +	Ma	Location *	WS
Category	Supplemental			GPS Latitude/Longitude	
				Start	End
Item	DWR Erosion Survey			37.937222 °	37.937222 °
				-121.335277 °	-121.335277 °
DWR ID					
Action/Comments					
Inspector Comments: 06/24/2015: The ersoion site is immediatley downstream of the RR bridge. [2015 Site ID:RD0524U01RM41.36]

Close view of the erosion.

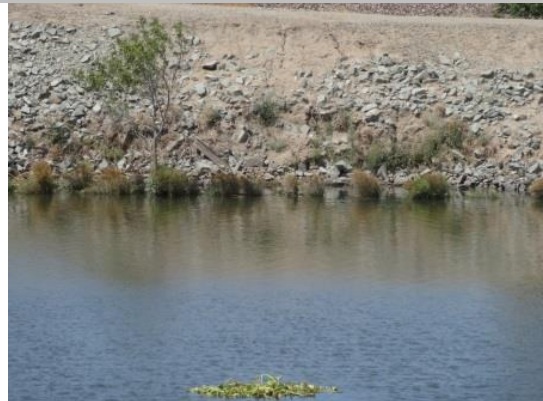
Photo 2 of 2 : SJR2015_RD0524U01RM41.36_7.JPG

Front view of the erosion.

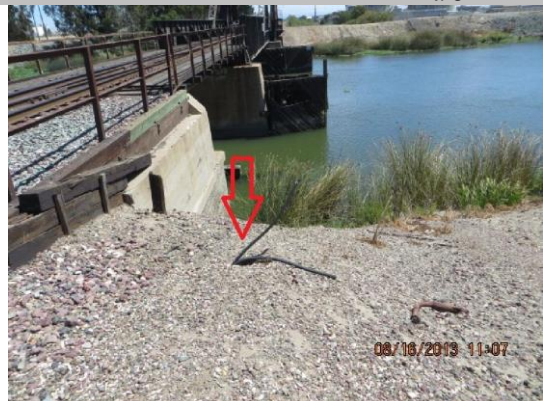
Photo 1 of 1 : UCIP_FA_2015_1535.jpg

LM Start	0.74	Rating **	M	Issue No.	935
LM End	0.74	Issue Type +	En	Location *	WS
Category	Supplemental			GPS Latitude/Longitude	
				Start	End
Item	DWR UCIP Field Study			37.936951 °	37.936951 °
				-121.335132 °	-121.335132 °
DWR ID					
Action/Comments					
Inspector Comments: FS_ID:41463					
DS_ID:20595					
EP_NO: N/A					
FS_HLM: 0.751					
Repair Type: Non-Urgent					
Crossing Status: Indicator Found

Conduit visible on WS shoulder next to bridge abutment. Cable appears to be abandoned.

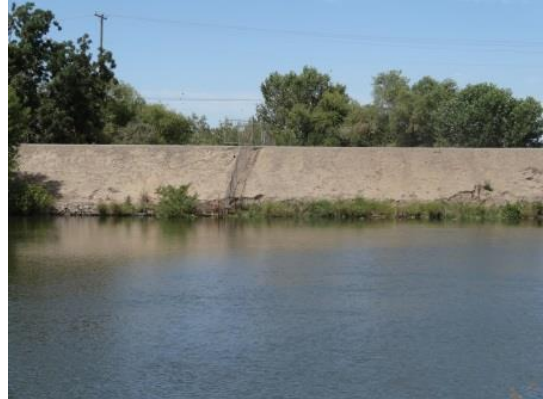
Photo 1 of 2 : SJR2015_RD0524U01RM41.39_1.jpg

LM Start	0.76	Rating **	U	Issue No.	133
LM End	0.77	Issue Type +	Ma	Location *	WS
Category	Supplemental			GPS Latitude/Longitude	
				Start	End
Item	DWR Erosion Survey			37.936821 °	37.936821 °
				-121.334582 °	-121.334582 °
DWR ID					
Action/Comments					
Inspector Comments: 06/24/2015: No significant change observed. 06/19/2014: No significant change observed. 08/13/2013: No significant change at this site. 08/07/2012: The site has been visited by boat survey. No significant change observed. 08/23/2011: The site is located immediately upstream of a Railroad bridge. Dense vegetation at the water line blocks the view of erosion. [2015 Site ID:RD0524U01RM41.39]

Front view of the erosion site.

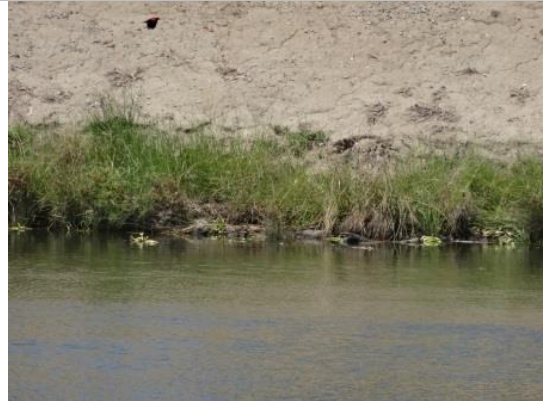
Photo 2 of 2 : SJR2015_RD0524U01RM41.39_4.jpg

Front view of the erosion site. Vegetation is visible.

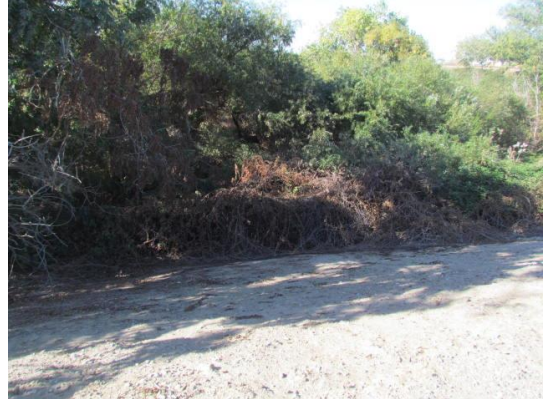
Photo 2 of 3 : FA_2015_RD0524_107_262_20150914_00188.jpg

LM Start	0.77	Rating **	U	Issue No.	262
LM End	0.77	Issue Type +	Ma	Location *	LS
Category	Earthen Levee			GPS Latitude/Longitude	
				Start	End
Item	Vegetation			37.936555 °	37.936555 °
				-121.334847 °	-121.334847 °
DWR ID	DWR_RD0524_01_s_2012_262				
Action/Comments					
Remove the wild growth other than native grasses from the levee slopes.					
Inspector Comments: Dense vegetation at landside toe along fence line.

Looking west at dense vegetation on landside toe. Spring 2014

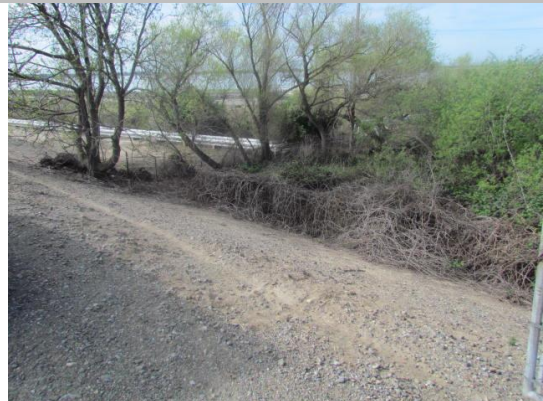
Photo 3 of 3 : FA_2015_RD0524_107_262_20150914_00187.jpg

Looking southwest at vegetation on landward slope and toe. (Spring 2013)

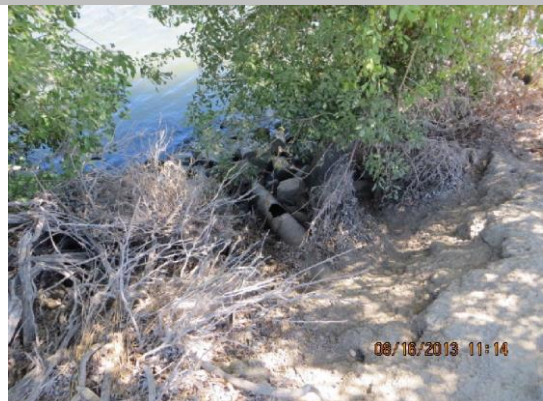
Photo 1 of 2 : UCIP_FA_2015_1536.jpg

Large hole in pipe at WS toe.

Inspector Comments: FS_ID:17571
 DS_ID:20596
 EP_NO: N/A
 FS_HLM: 0.788
 Repair Type: Non-Urgent
 Crossing Status: Found
 UCIP Comments: Large hole in pipe at WS toe. Appears abandoned and should be done so properly.
 FIELD_STRUCT_DESC: 8-inch steel drain pipe through the levee 4.0 feet below the crown. Pump at the toe of the landward slope (not found 8/16/13). Siphon breaker in 24-inch cmp Riser on the waterward slope. Originally included in the 1964 O&M manual.
 FS Date: 08/16/2013

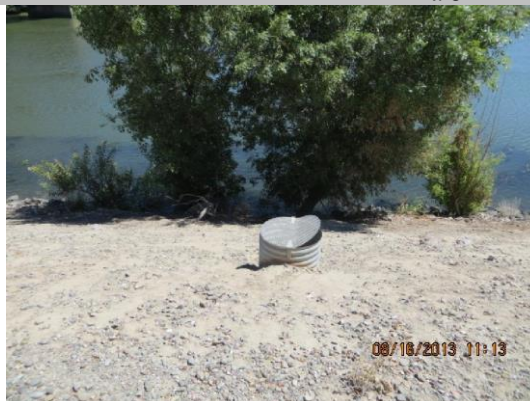
Photo 2 of 2 : UCIP_FA_2015_1537.jpg

Siphon breaker in 24-inch cmp riser on WS slope.

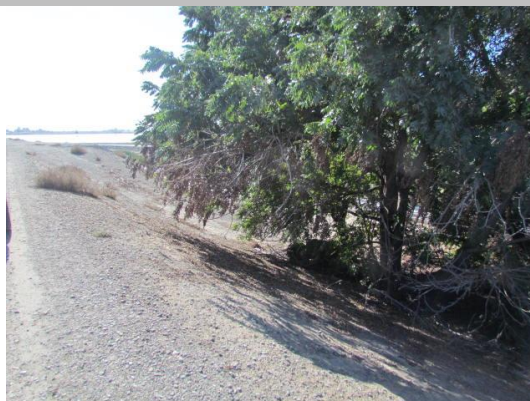
Photo 1 of 1 : FA_2015_RD0524_107_76_20150914_00099.jpg

Looking southwest at low hanging tree branches at landside toe.

Trim trees to at least five feet above ground level.

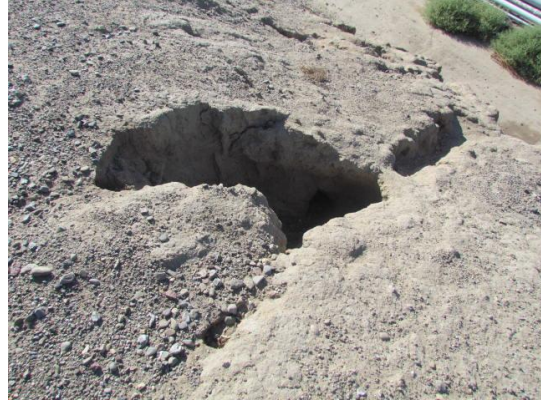
Photo 1 of 5 : FA_2015_RD0524_107_2_20150914_00001.jpg

LM Start	0.81	Rating **	U	Issue No.	2
LM End	0.81	Issue Type +	Ma	Location *	LS
Category	Earthen Levee			GPS Latitude/Longitude	
				Start	End
Item	Erosion / Bank Caving			37.936093 °	37.936004 °
				-121.334648 °	-121.334615 °
DWR ID	DWR_RD0524_01_f_2013_2				
Action/Comments					
Schedule repair of erosion site prior to the next inspection. Inspector Comments: One large hole. Hole is over 12" deep and 12" wide and several holes and finger erosions on landward slope.

Looking southwest at hole on landward shoulder.

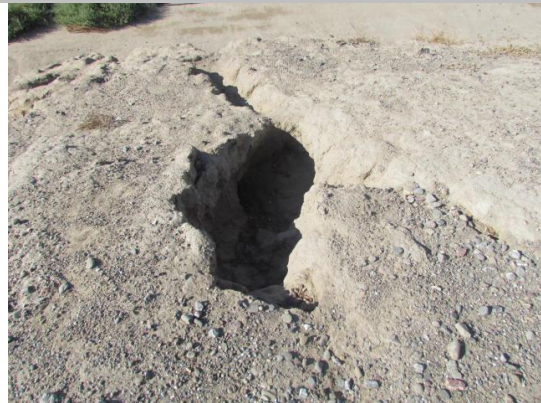
Photo 2 of 5 : FA_2015_RD0524_107_2_20150914_00002.jpg

Looking west at hole on landward shoulder.

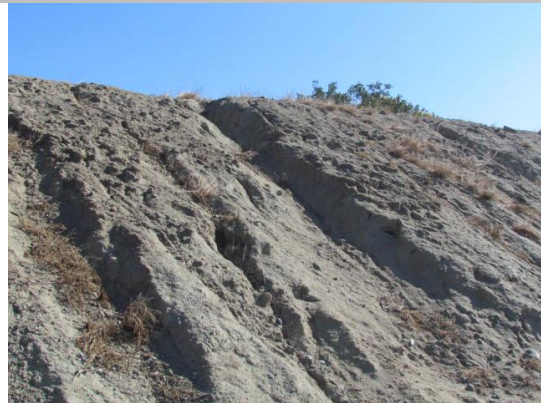
Photo 3 of 5 : FA_2015_RD0524_107_2_20150914_00003.jpg

Looking southeast at finger erosion on landward slope.

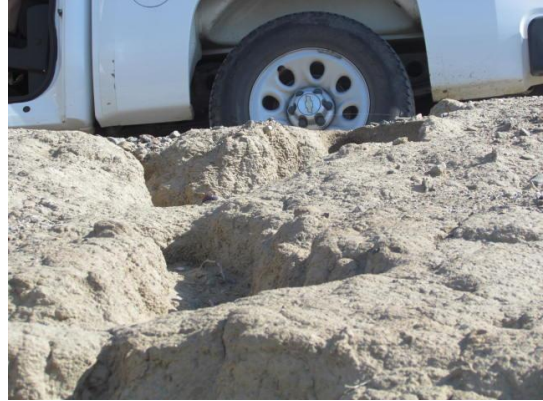
Photo 4 of 5 : FA_2015_RD0524_107_2_20150914_00004.jpg

LM Start	0.81	Rating **	U	Issue No.	2 (cont)	
LM End	0.81	Issue Type +	Ma	Location *	LS	
Category	Earthen Levee			GPS Latitude/Longitude		
				Start		End
Item	Erosion / Bank Caving			37.936093 °		37.936004 °
				-121.334648 °		-121.334615 °
DWR ID	DWR_RD0524_01_f_2013_2					
Action/Comments						
Schedule repair of erosion site prior to the next inspection. Inspector Comments: One large hole. Hole is over 12" deep and 12" wide and several holes and finger erosions on landward slope.

Looking east at erosion on landward slope.

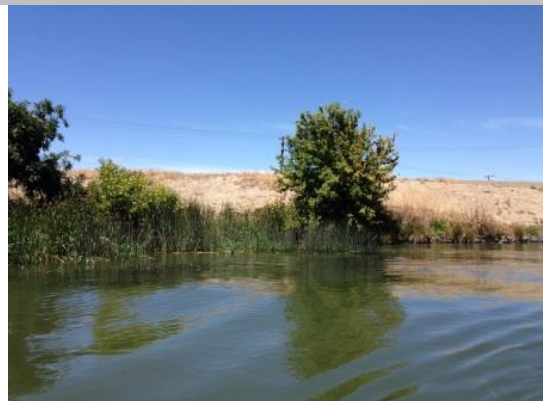
Photo 1 of 2 : SJR2015_RD0524U01RM41.44_1.JPG

LM Start	0.83	Rating **	U	Issue No.	134
LM End	0.84	Issue Type +	Ma	Location *	WS
Category	Supplemental			GPS Latitude/Longitude	
				Start	End
Item	DWR Erosion Survey			37.935930 °	37.935930 °
				-121.334133 °	-121.334133 °
DWR ID					
Action/Comments					
Inspector Comments: 06/24/2015: No significant change observed. 06/19/2014: No significant change observed. 08/13/2013: Site was discovered during boat survey. The dense vegetation blocks a clear view of the erosion. Size of erosion site was very roughly estimated. [2015 Site ID:RD0524U01RM41.44]

Front view of the erosion. The tree and vegetation block the view of the site.

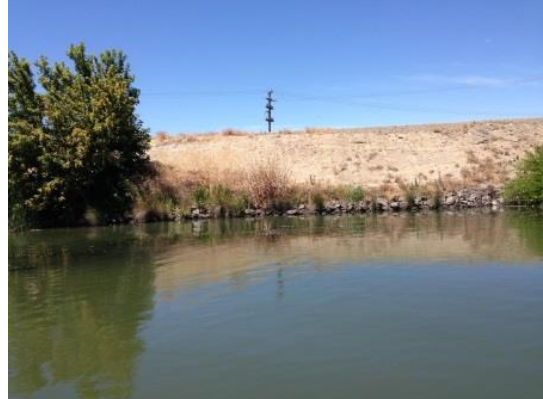
Photo 2 of 2 : SJR2015_RD0524U01RM41.44_2.JPG

The erosion is invisible because of the dense vegetation.

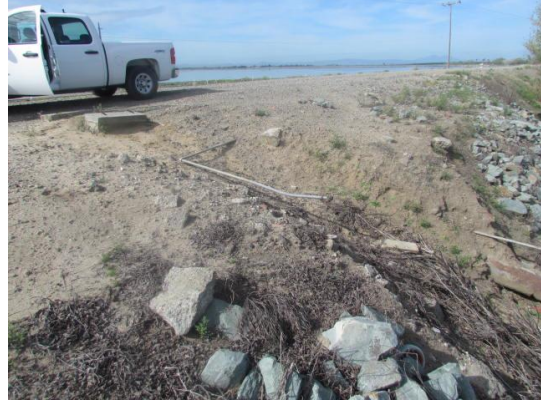
Photo 1 of 1 : FA_2015_RD0524_107_122_20150914_00137.jpg

LM Start	0.92	Rating **	M	Issue No.	122
LM End	0.92	Issue Type +	Ma	Location *	WS
Category	Earthen Levee			GPS Latitude/Longitude	
				Start	End
Item	Encroachments			37.935267 °	37.935267 °
				-121.332985 °	-121.332985 °
DWR ID	DWR_RD0524_01_s _ 2013_122				
Action/Comments					
Pipe					
Inspector Comments: Inch and half metal pipe should be removed.

Looking northwest at inch and half metal pipe on waterward slope.

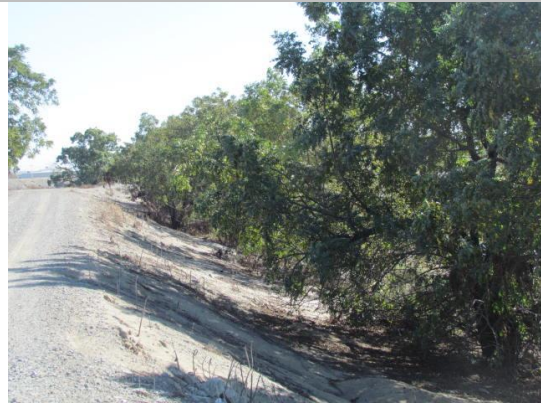
Photo 1 of 1 : FA_2015_RD0524_107_77_20150914_00100.jpg

Looking south at low hanging tree branches at landside toe.

LM Start	0.93	Rating **	U	Issue No.	77
LM End	1.01	Issue Type +	Ma	Location *	LS
Category	Earthen Levee			GPS Latitude/Longitude	
				Start	End
Item	Trim / Thin Trees			37.935259 °	37.935049 °
				-121.332864 °	-121.331334 °
DWR ID	DWR_RD0524_01_s _ 2012_77				
Action/Comments					
Trim trees to at least five feet above ground level.

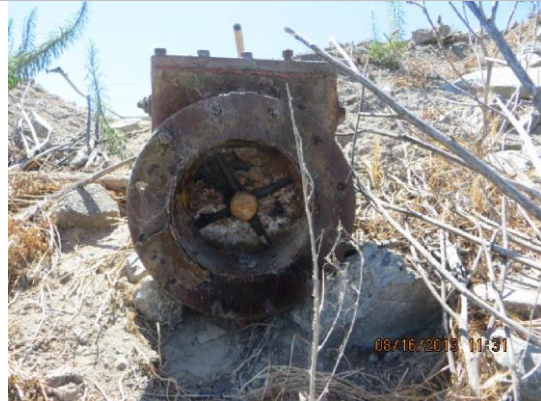
Photo 1 of 3 : UCIP_FA_2015_2487.jpg

Inspector Comments: FS_ID:22724
 DS_ID:20597
 EP_NO: N/A
 FS_HLM: 0.983
 Repair Type: Non-Urgent
 Crossing Status: Found
 UCIP Comments: Pipe abandoned and should be done so properly.
 FIELD_STRUCT_DESC: *Abandoned* 14-inch pipe through the levee 6.0 feet below the crown. Concrete pad for pump on WS shoulder. No pump or other appurtances remain. Originally included in the 1964 O&M manual.
 FS Date: 08/16/2013

One way check valve closed on WS slope.

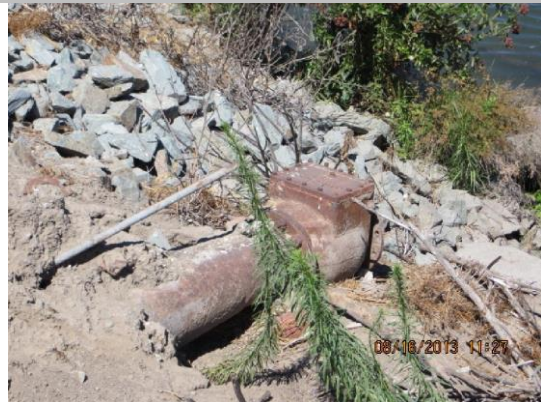
Photo 2 of 3 : UCIP_FA_2015_2488.jpg

Pipe visible on WS slope.

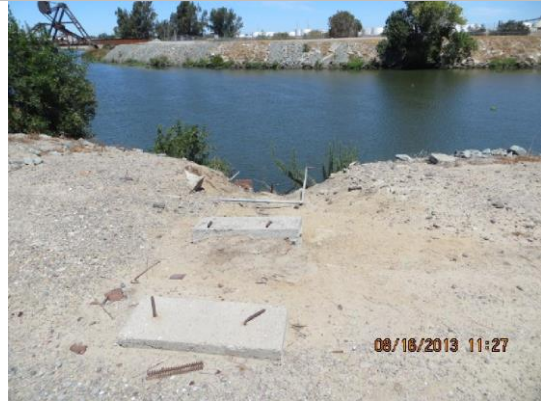
Photo 3 of 3 : UCIP_FA_2015_2489.jpg

Concrete pad for pump mount on WS shoulder.

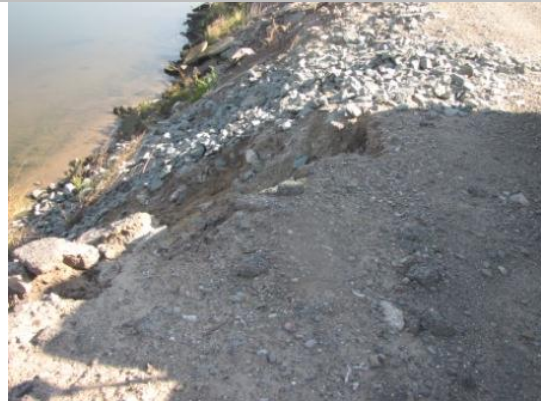
Photo 1 of 3 : FA_2015_RD0524_107_17_20150914_00023.jpg

LM Start	1.00	Rating **	M	Issue No.	17
LM End	1.02	Issue Type +	Ma	Location *	WS
Category	Earthen Levee			GPS Latitude/Longitude	
				Start	End
Item	Erosion / Bank Caving			37.935098 °	37.935018 °
				-121.331645 °	-121.331248 °
DWR ID	DWR_RD0524_01_s_2012_17				
Action/Comments					
Schedule repair of erosion site prior to the next inspection.					
Inspector Comments: Minor erosion was noted next to repaired site.

Looking upstream (south) at erosion site.

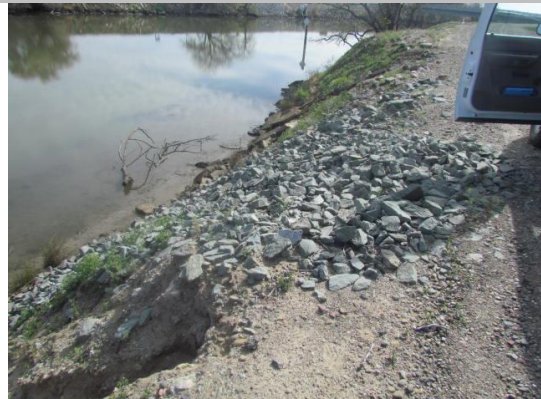
Photo 2 of 3 : FA_2015_RD0524_107_17_20150914_00024.jpg

Looking southeast at erosion next to repaired site on waterward slope (Spring 2013)

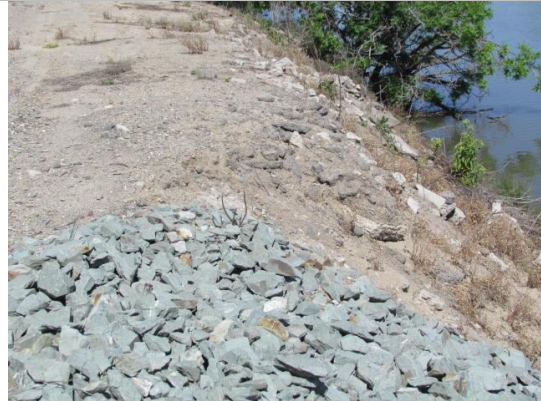
Photo 3 of 3 : FA_2015_RD0524_107_17_20150914_00025.jpg

Looking north at erosion site next to repaired site. (Spring 2012)

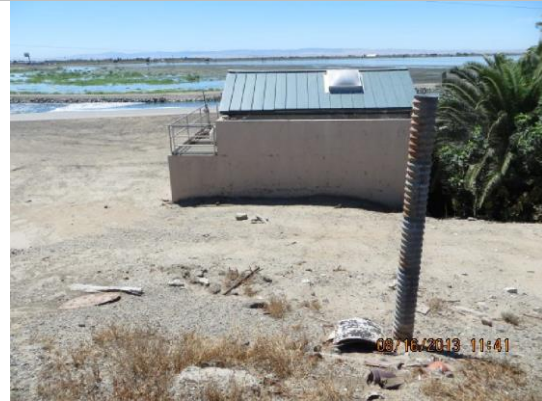
Photo 2 of 2 : UCIP_FA_2015_1461.jpg

LM Start	1.06	Rating **	M	Issue No.	938 (cont)	
LM End	1.06	Issue Type +	En	Location *	WS	
Category	Supplemental			GPS Latitude/Longitude		
				Start	End	
Item	DWR UCIP Field Study			37.934778 °	37.934778 °	
				-121.330460 °	-121.330460 °	
DWR ID						
Action/Comments						
Inspector Comments: FS_ID:18703 DS_ID:20600 EP_NO: 2725B FS_HLM: 1.075 Repair Type: Non-Urgent Crossing Status: Found UCIP Comments: Given amount of rust on adjacent CMP riser, it may be appropriate to do a video inspection of this pipe. FIELD_STRUCT_DESC: 36-inch concrete encased pipe through levee 11.5 feet below crown. Pump in pump house on the landward side. Flap gate on the waterward end. Two concrete cutoff walls. Siphon breaker in 8-inch CMP riser unit on the landward slope (Permit No. 2725B, 1959). Included in the 1964 O&M manual. FS Date: 08/16/2013

8-inch CMP standpipe on LS slope with pumphouse in background.

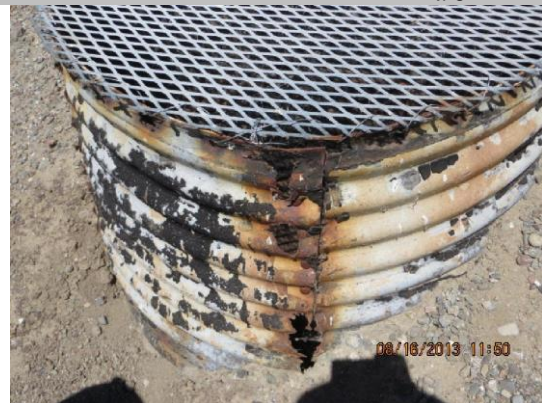
Photo 1 of 3 : UCIP_FA_2015_1538.jpg

36-inch CMP riser on LS slope severely corroded with various holes along seams.

Inspector Comments: FS_ID:17589
 DS_ID:20601
 EP_NO: 2725B
 FS_HLM: 1.078
 Repair Type: Non-Urgent
 Crossing Status: Found
 UCIP Comments: CMP riser severely corroded. Good indicator of potential condition of 48-inch pipe. Recommend Video Inspection.
 FIELD_STRUCT_DESC: 48-inch CMP sewer line through the levee 16.0 feet below crown. Runs underneath the river and through levee with 36-inch CMP riser/inspection chamber on landward shoulder.
 Distribution/pumphouse on LS toe (Permit No. 2725B, 1959). Included in the 1964 O&M manual.
 FS Date: 08/16/2013

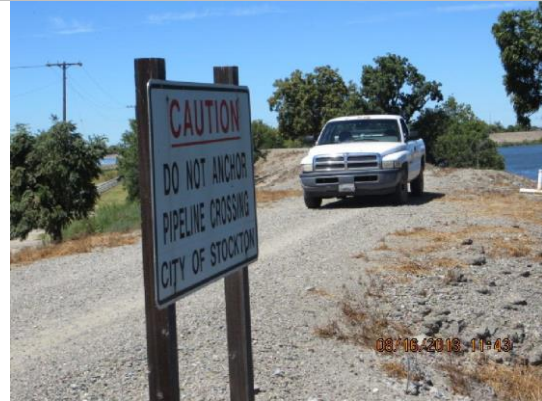
Photo 2 of 3 : UCIP_FA_2015_1539.jpg

Caution sign on WS shoulder.

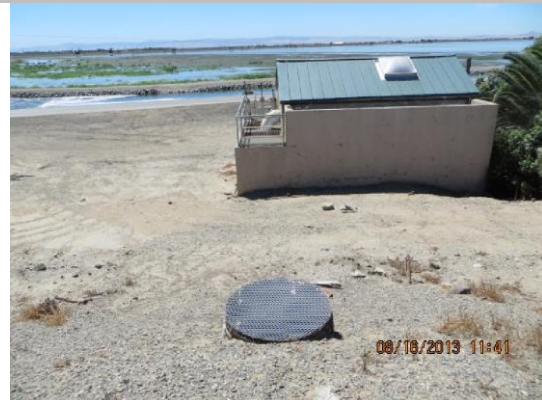
Photo 3 of 3 : UCIP_FA_2015_1540.jpg

CMP riser for access/inspection on LS slope with distribution/pumphouse on LS toe.

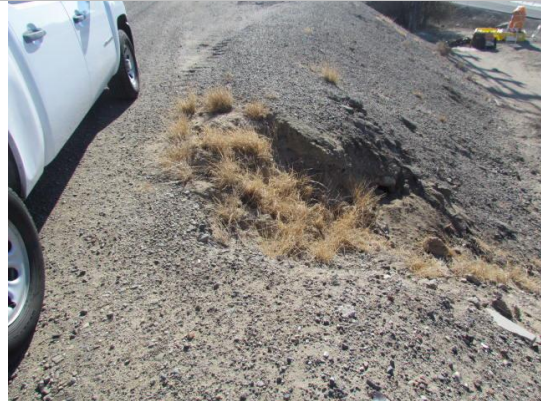
Photo 1 of 7 : FA_2015_RD0524_107_18_20151023_00246.jpg

LM Start	1.08	Rating **	U	Issue No.	18
LM End	1.08	Issue Type +	Ma	Location *	LS
Category	Earthen Levee			GPS Latitude/Longitude	
				Start	End
Item	Slope Stability			37.934645 °	37.934645 °
				-121.330310 °	-121.330310 °
DWR ID	DWR_RD0524_01_s _ 2012_18				
Action/Comments					
Repair slope instability. Inspector Comments: Slope damage extend from shoulder to middle of slope.

Looking south at caving on landward shoulder. (Fall 2015)

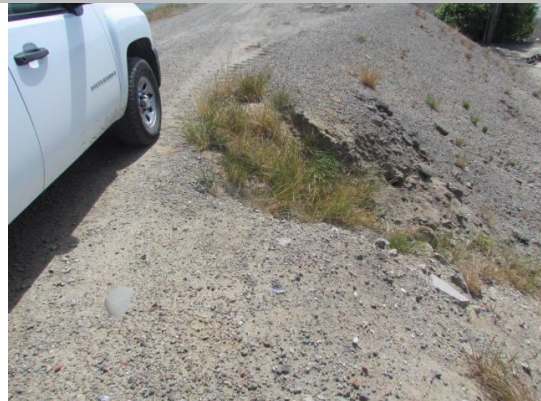
Photo 2 of 7 : FA_2015_RD0524_107_18_20150914_00026.jpg

Looking south at caving on landward shoulder. (Spring 2015)

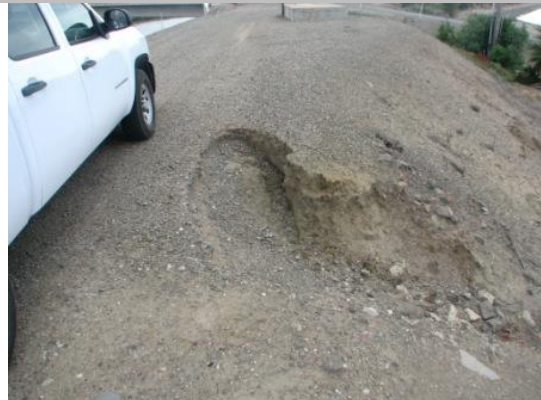
Photo 3 of 7 : FA_2015_RD0524_107_18_20150914_00027.jpg

Landward slope damage. Spring 2014

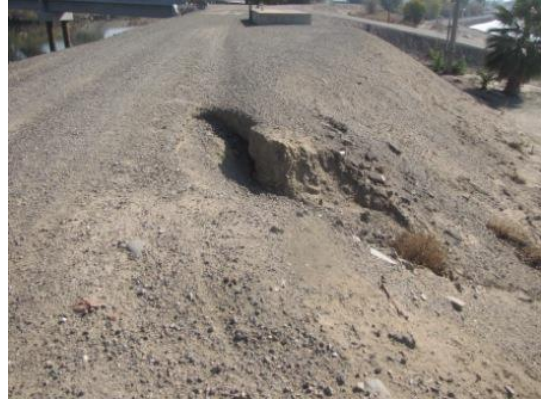
Photo 4 of 7 : FA_2015_RD0524_107_18_20150914_00028.jpg

Updated picture of the erosion site on the landside shoulder. Fall 2014

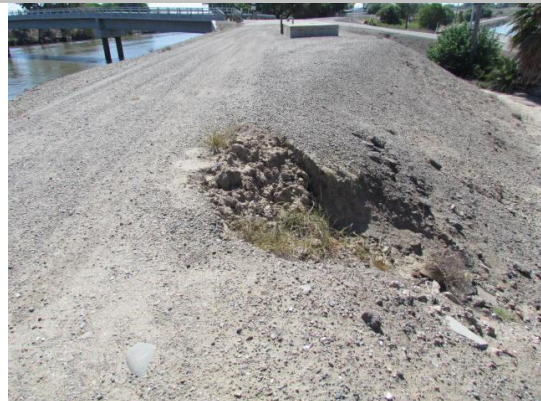
Photo 5 of 7 : FA_2015_RD0524_107_18_20150914_00029.jpg

Looking south at caving on landside shoulder. (Spring 2013)

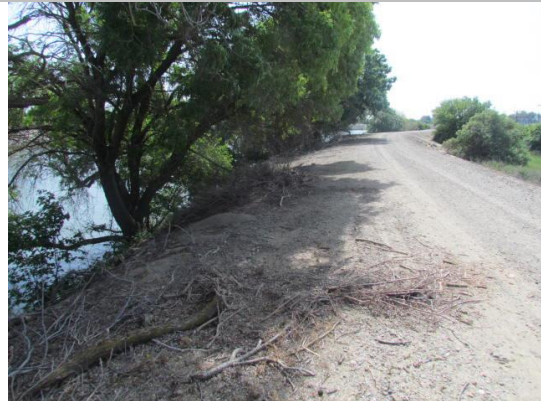
Photo 1 of 1 : FA_2015_RD0524_107_171_20150914_00160.jpg

LM Start	1.12	Rating **	M	Issue No.	171
LM End	1.16	Issue Type +	Ma	Location *	WS
Category	Earthen Levee			GPS Latitude/Longitude	
				Start	End
Item	Encroachments			37.934225 °	37.933815 °
				-121.329693 °	-121.329242 °
DWR ID	DWR_RD0524_01_s_2015_171				
Action/Comments					
Prunings					
Inspector Comments: Prunings left on waterward shoulder and slope.

Looking south at prunings on waterward shoulders.

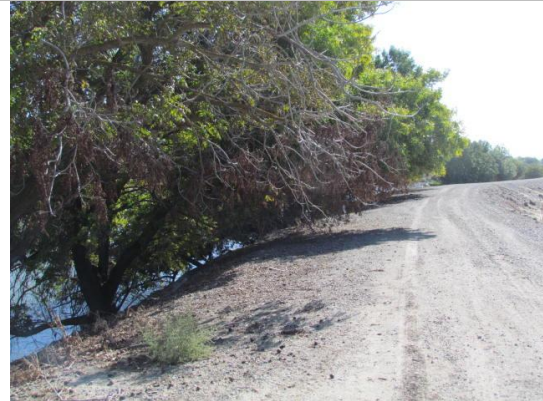
Photo 1 of 1 : FA_2015_RD0524_107_19_20150914_00032.jpg

Looking northwest at low hanging tree branches at waterside toe.

LM Start	1.13	Rating **	M	Issue No.	19
LM End	1.16	Issue Type +	Ma	Location *	WS
Category	Earthen Levee			GPS Latitude/Longitude	
				Start	End
Item	Trim / Thin Trees			37.934118 °	37.933775 °
				-121.329657 °	-121.329305 °
DWR ID	DWR_RD0524_01_s _ 2012_19				
Action/Comments					
Trim trees to at least five feet above ground level.

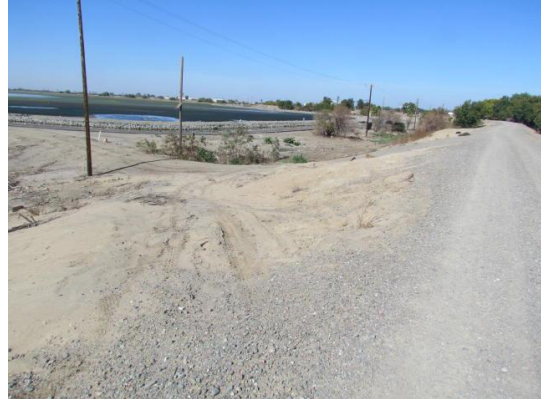
Photo 1 of 2 : FA_2015_RD0524_107_263_20150914_00189.jpg

LM Start	1.25	Rating **	U	Issue No.	263
LM End	1.25	Issue Type +	En	Location *	LS
Category	Earthen Levee			GPS Latitude/Longitude	
				Start	End
Item	Encroachments			37.932533 °	37.932533 °
				-121.328650 °	-121.328650 °
DWR ID	DWR_RD0524_01_s _ 2012_263				
Action/Comments					
Ramp					
Inspector Comments: Unauthorized ramps on landside slope. Ramps were caused by vehicle traffic.

Looking northwest at unauthorized ramp on landside slope.

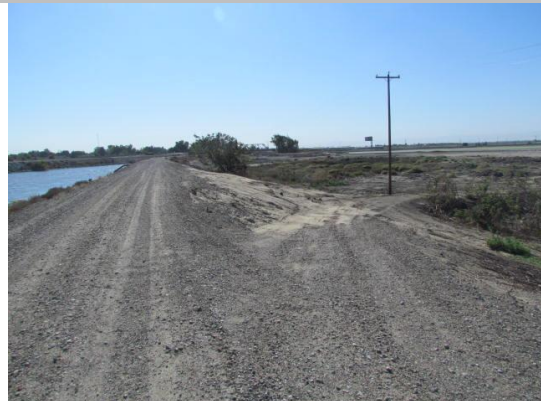
Photo 2 of 2 : FA_2015_RD0524_107_263_20150914_00190.jpg

Looking south at unauthorized ramp on landside slope.

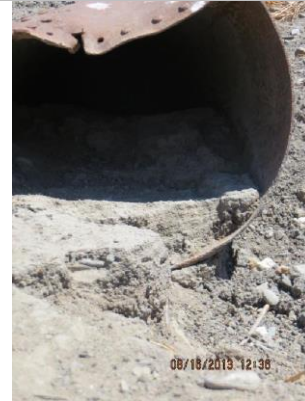
Photo 1 of 3 : UCIP_FA_2015_1585.jpg

Action/Comments					
Inspector Comments: FS_ID:41271 DS_ID:20602 EP_NO: N/A FS_HLM: 1.306 Repair Type: Urgent Crossing Status: Found UCIP Comments: Pipe appears to be open on both ends. Abandoned and should be done so properly. FIELD_STRUCT_DESC: *Abandoned* 12-inch pipe through levee 3.5 feet below crown. Open on both ends. Originally included in the 1964 O&M manual. FS Date: 08/16/2013

Pipe appears open on both ends. View from LS slope.

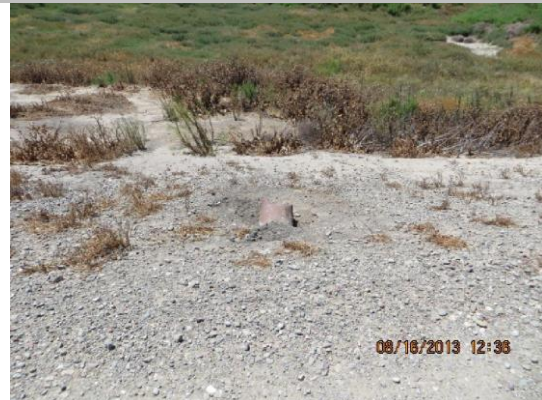
Photo 2 of 3 : UCIP_FA_2015_1586.jpg

Pipe open and visible on LS slope.

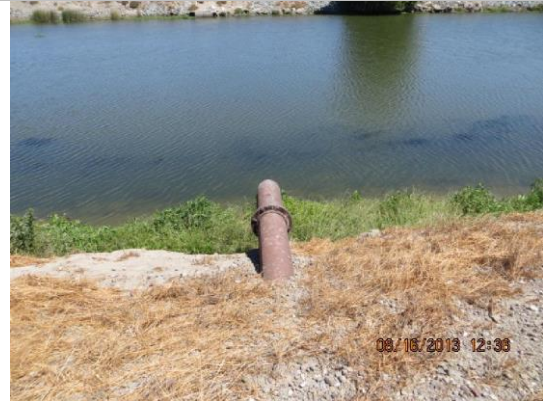
Photo 3 of 3 : UCIP_FA_2015_1600.jpg

Pipe visible and open on WS slope.

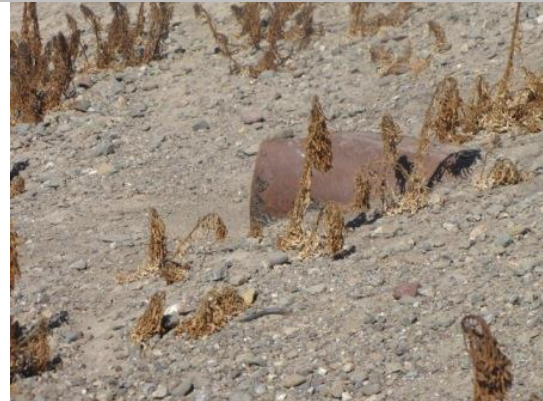
Photo 1 of 2 : FA_2015_RD0524_107_33_20150914_00051.jpg

LM Start	1.30	Rating **	U	Issue No.	33
LM End	1.30	Issue Type +	Ma	Location *	WS
Category	Earthen Levee			GPS Latitude/Longitude	
				Start	End
Item	Encroachments			37.931948 °	37.931948 °
				-121.328387 °	-121.328387 °
DWR ID	DWR_RD0524_01_s_2012_33				
Action/Comments					
Pipe Inspector Comments: Pipe is not in use and should be properly abandoned.

Looking west at pipe on landside slope.

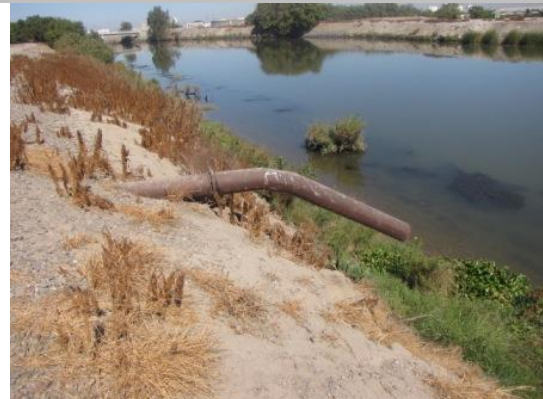
Photo 2 of 2 : FA_2015_RD0524_107_33_20150914_00052.jpg

Looking north at broken pipe.

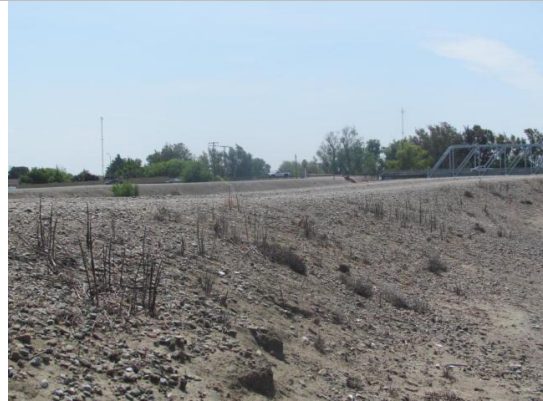
Photo 1 of 2 : FA_2015_RD0524_107_172_20150914_00161.jpg

LM Start	1.36	Rating **	U	Issue No.	172
LM End	1.40	Issue Type +	Ma	Location *	CR
Category	Earthen Levee			GPS Latitude/Longitude	
				Start	End
Item	Crown Surface / Depressions / Rutting			37.931085 °	37.930517 °
				-121.328112 °	-121.328072 °
DWR ID	DWR_RD0524_01_s_2015_172				
Action/Comments					
Repair depressions or ruts in the crown or slope. Inspector Comments: Levee crown depression several inches below original crown elevation. Section should be survey to determine proper elevation.

Looking east at depression on levee crown.

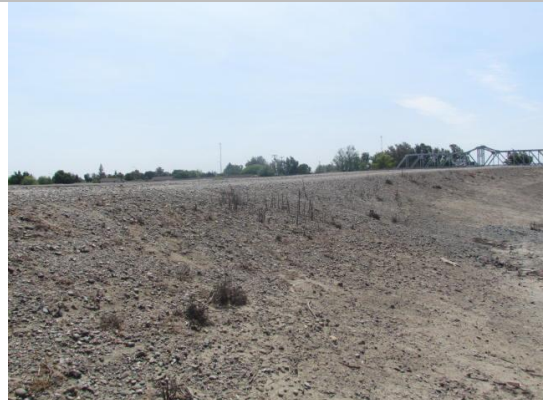
Photo 2 of 2 : FA_2015_RD0524_107_172_20150914_00162.jpg

Looking southeast at depression on levee crown.
