**Flood Control Project Maintenance
Levee Inspections**

Fall 2015 Levee Maintenance Deficiency Summary Report

San Joaquin River Basin

Reclamation District No. 0524 Middle Roberts Island

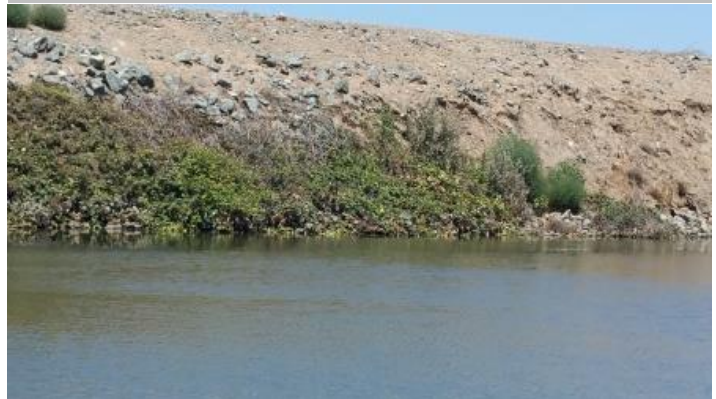
Photo 3 of 3 : SJR2015_RD0524U01RM42.09_4.JPG

Close view of the erosion. Note the vegetation at the site.

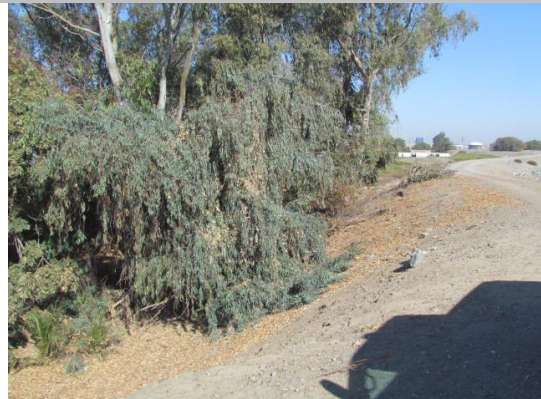
Photo 1 of 4 : FA_2015_RD0524_107_916_20151023_00247.jpg

LM Start	1.49	Rating **	U	Issue No.	916
LM End	1.49	Issue Type +	Ma	Location *	LS
Category	Earthen Levee			GPS Latitude/Longitude	
				Start	End
Item	Trim / Thin Trees			37.929118 °	37.929118 °
				-121.328368 °	-121.328368 °
DWR ID	DWR_RD0524_01_s_2012_916				
Action/Comments					
Trim and thin trees to allow visibility of the ground and room to flood fight.					
Inspector Comments: Untrimmed trees and dense vegetation on landward toe.

Looking southwest at dense trees on landward slope and toe fall 2015

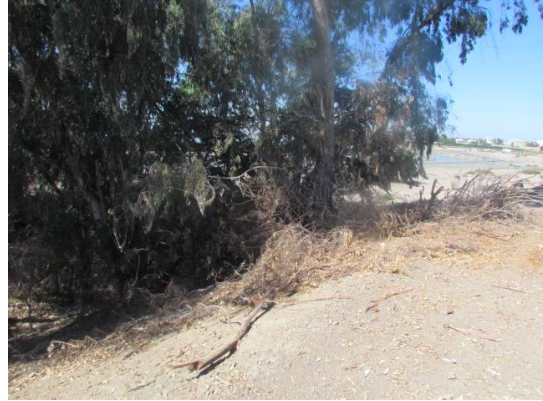
Photo 2 of 4 : FA_2015_RD0524_107_916_20150914_00199.jpg

Looking south at trees on landside slope. (Fall 2012)

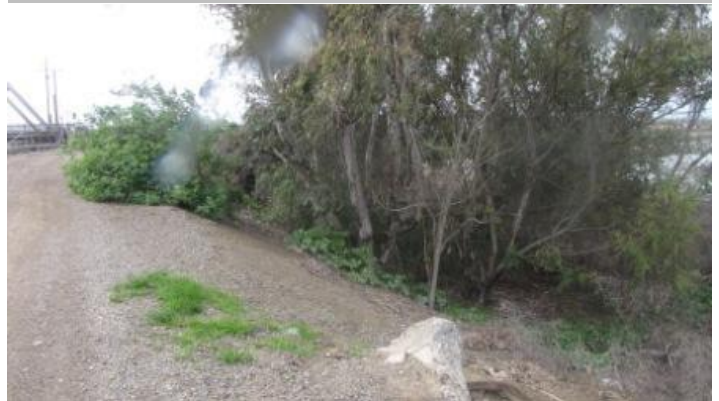
Photo 3 of 4 : FA_2015_RD0524_107_916_20150914_00200.jpg

Looking south at dense veg. on landside slope and toe.

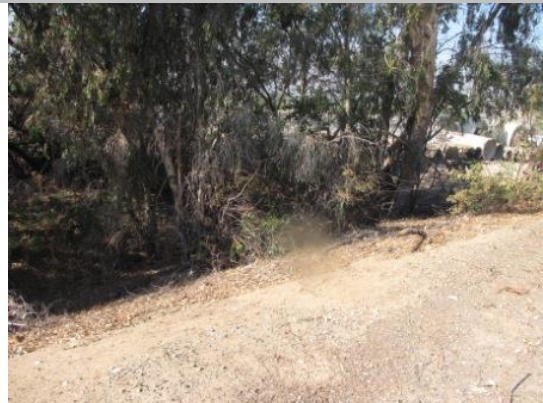
Photo 4 of 4 : FA_2015_RD0524_107_916_20150914_00198.jpg

Dense vegetation on landside toe.

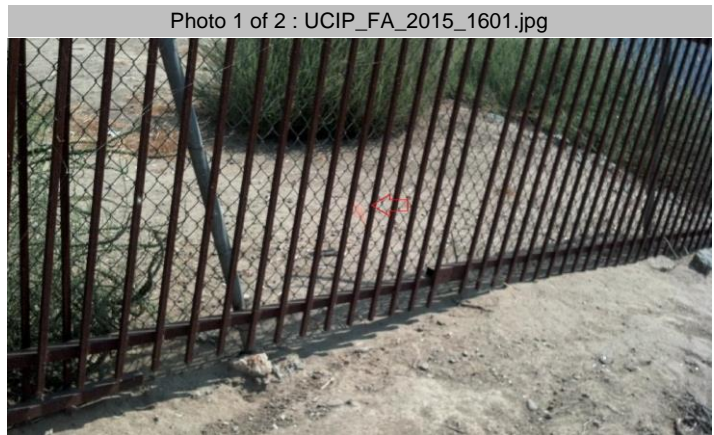
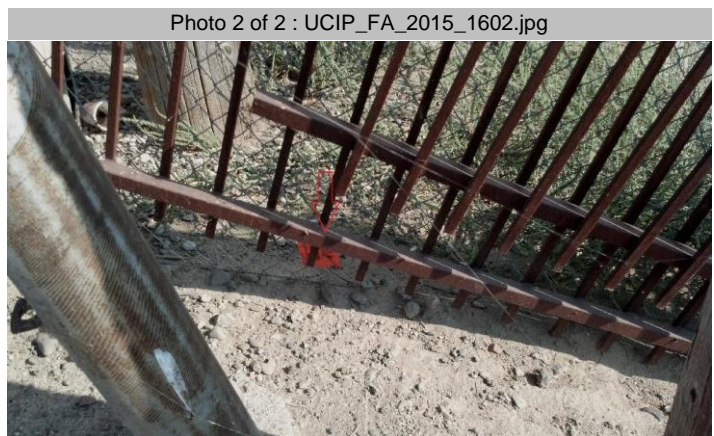
LM Start	1.54	Rating **	M	Issue No.	941
LM End	1.54	Issue Type +	En	Location *	LS
Category	Supplemental			GPS Latitude/Longitude	
				Start	End
Item	DWR UCIP Field Study			37.928429 °	37.928429 °
				-121.328297 °	-121.328297 °
DWR ID					
Action/Comments					
Inspector Comments: FS_ID:17798					
DS_ID:20605					
EP_NO: N/A					
FS_HLM: 1.558					
Repair Type: Non-Urgent					
Crossing Status: Indicator Found

USAA markers along alignment at gate.

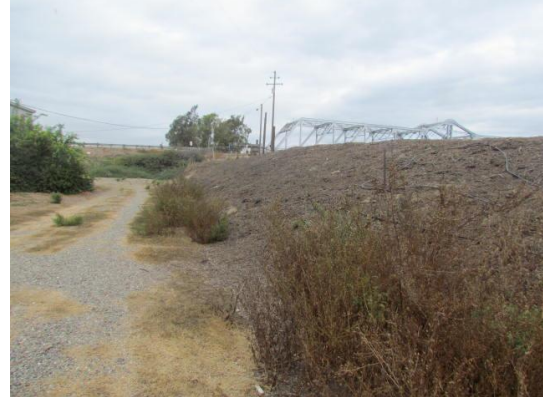
Photo 2 of 5 : FA_2015_RD0524_107_23_20150914_00036.jpg

Looking north from landward berm at corrected site.

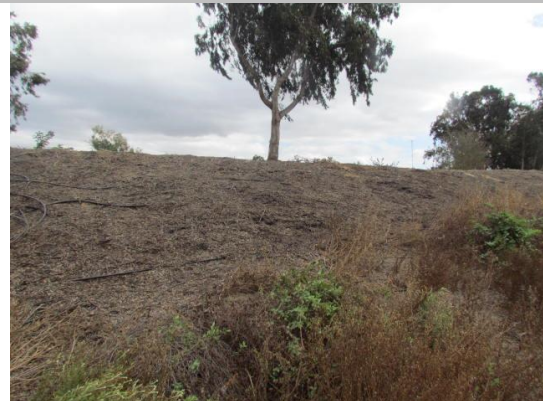
Photo 3 of 5 : FA_2015_RD0524_107_23_20150914_00037.jpg

Looking east from landward berm at corrected site.

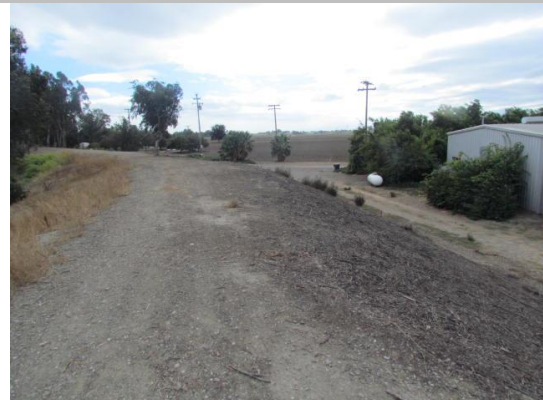
Photo 4 of 5 : FA_2015_RD0524_107_23_20150914_00038.jpg

Looking south from levee crown at corrected site.

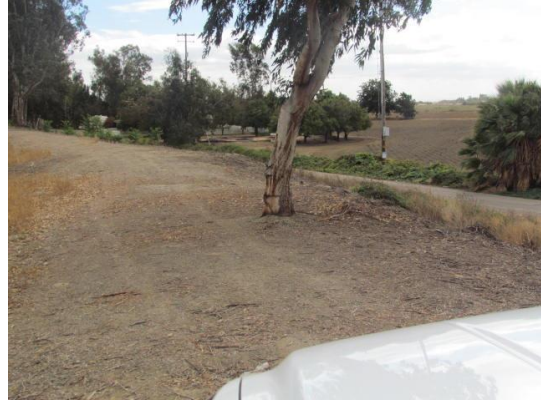
Photo 5 of 5 : FA_2015_RD0524_107_23_20150914_00039.jpg

Looking south from levee crown at upstream end of corrected site.

LM Start	1.55	Rating **	A/W	Issue No.	23 (cont)
LM End	1.59	Issue Type +	Ma	Location *	LS
Category	Earthen Levee			GPS Latitude/Longitude	
				Start	End
Item	Vegetation			37.928388 °	37.927797 °
				-121.328280 °	-121.327854 °
DWR ID	DWR_RD0524_01_s _ 2012_23				
Action/Comments					
Remove the wild growth other than native grasses from the levee slopes.

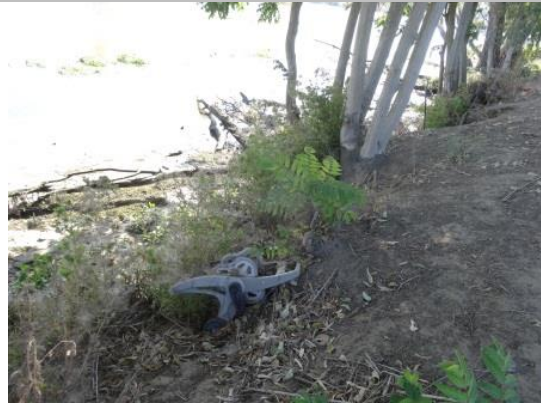
Photo 1 of 2 : SJR2015_RD0524U01RM42.20_1.jpg

LM Start	1.56	Rating **	U	Issue No.	90
LM End	1.62	Issue Type +	Ma	Location *	WS
Category	Supplemental			GPS Latitude/Longitude	
				Start	End
Item	DWR Erosion Survey			37.927770 °	37.927770 °
				-121.327870 °	-121.327870 °
DWR ID					
Action/Comments					
Inspector Comments: 06/24/2015: No significant change observed. 6/19/2014: No significant change observed. 08/13/2013: No significant change observed. 08/07/2012: : The site has been visited by boat survey. No significant change observed 08/23/2011: No significant change observed on site. Trees concerned still in place. 09/07/2010: No significant change observed on site. The concern here is the undermining of the levee toe where most of trees are. There are erosion pockets lined along the lower slope and at the base of the trees, exposing tree roots. There is minimal slope protection. 09/29/2009: The lower slope is lined with minor erosion pockets; some tree roots are exposed; there is visible undermining of the levee toe; site is immediately upstream of the Highway 4 Bridge; the bridge is possibly causing a scour to occur, eroding the bank. [2015 Site ID:RD0524U01RM42.2]

Front view of the site where undermining has occurred.

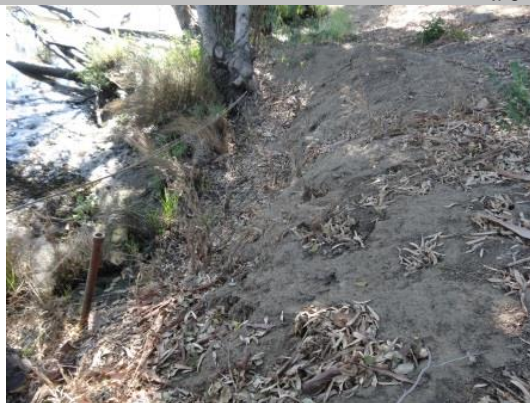
Photo 2 of 2 : SJR2015_RD0524U01RM42.20_5.jpg

Inspector Comments: 06/24/2015: No significant change observed.
6/19/2014: No significant change observed.
08/13/2013: No significant change observed.
08/07/2012: : The site has been visited by boat survey. No significant change observed
08/23/2011: No significant change observed on site. Trees concerned still in place.
09/07/2010: No significant change observed on site. The concern here is the undermining of the levee toe where most of trees are. There are erosion pockets lined along the lower slope and at the base of the trees, exposing tree roots. There is minimal slope protection.
09/29/2009: The lower slope is lined with minor erosion pockets; some tree roots are exposed; there is visible undermining of the levee toe; site is immediately upstream of the Highway 4 Bridge; the bridge is possibly causing a scour to occur, eroding the bank. [2015 Site ID:RD0524U01RM42.2]

Close view of the erosion at the levee toe.

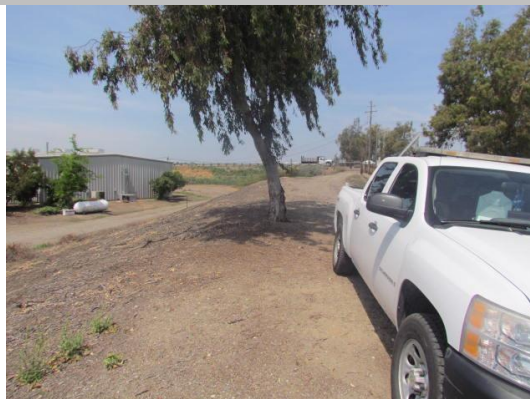
Photo 1 of 1 : FA_2015_RD0524_107_173_20150914_00163.jpg

LM Start	1.58	Rating **	U	Issue No.	173
LM End	1.58	Issue Type +	Ma	Location *	LS
Category	Earthen Levee			GPS Latitude/Longitude	
				Start	End
Item	Trim / Thin Trees			37.927975 °	37.927975 °
				-121.328088 °	-121.328088 °
DWR ID	DWR_RD0524_01_s_2015_173

Looking northwest at tree on within levee crown.

Trim trees to at least five feet above ground level.
Inspector Comments: Tree is located on landward shoulder and crown should be removed.

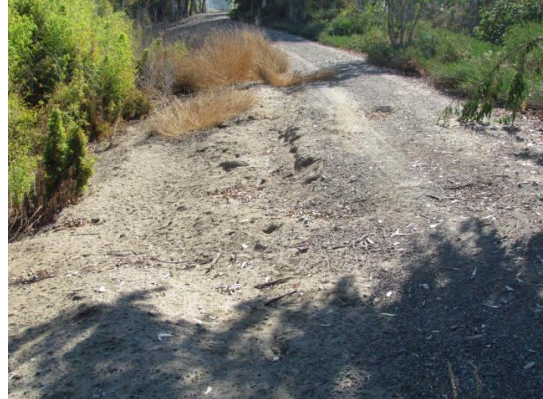
Photo 1 of 1 : FA_2015_RD0524_107_136_20150914_00149.jpg

LM Start	1.59	Rating **	M	Issue No.	136
LM End	1.59	Issue Type +	Ma	Location *	CR
Category	Earthen Levee			GPS Latitude/Longitude	
				Start	End
Item	Slope Stability			37.927775 °	37.927775 °
				-121.327860 °	-121.327860 °
DWR ID	DWR_RD0524_01_s_2013_136				
Action/Comments					
Repair the levee slope damaged by foot traffic and prevent access where possible.					
Inspector Comments: Waterward shoulder caving.

Looking south at depression on levee crown near waterward shoulder.

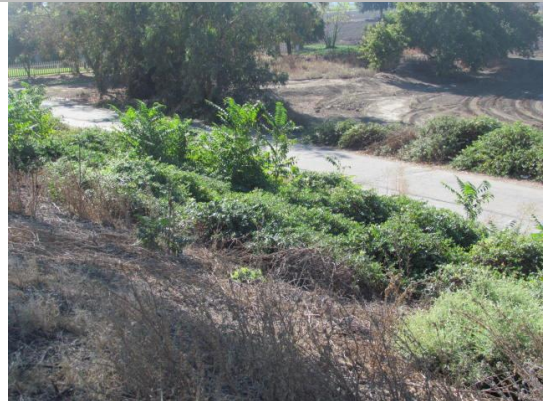
Photo 1 of 3 : FA_2015_RD0524_107_24_20151023_00248.jpg

LM Start	1.60	Rating **	U	Issue No.	24
LM End	1.61	Issue Type +	Ma	Location *	LS
Category	Earthen Levee			GPS Latitude/Longitude	
				Start	End
Item	Vegetation			37.927635 °	37.927540 °
				-121.327812 °	-121.327648 °
DWR ID	DWR_RD0524_01_s_2012_24				
Action/Comments					
Remove the wild growth other than native grasses from the levee slopes.					
Inspector Comments: Vegetation blocking landward toe.

Looking southwest at dense vegetation on landward slope fall 2015

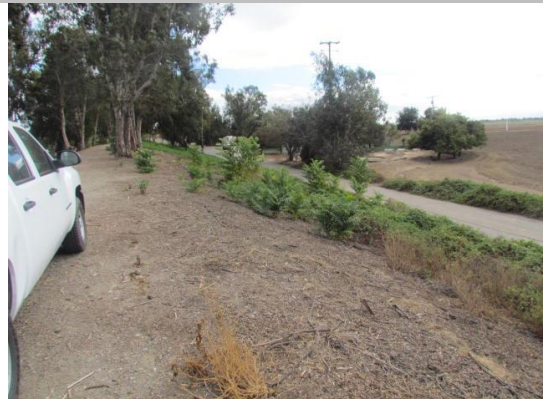
Photo 2 of 3 : FA_2015_RD0524_107_24_20150914_00040.jpg

Looking south at vegetation blocking view of landward toe.

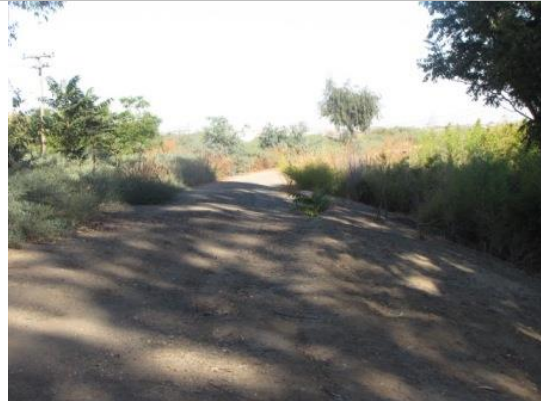
Photo 3 of 3 : FA_2015_RD0524_107_24_20150914_00041.jpg

LM Start	1.60	Rating **	U	Issue No.	24 (cont)	
LM End	1.61	Issue Type +	Ma	Location *	LS	
Category	Earthen Levee			GPS Latitude/Longitude		
				Start		End
Item	Vegetation			37.927635 °		37.927540 °
				-121.327812 °		-121.327648 °
DWR ID	DWR_RD0524_01_s _ 2012_24					
Action/Comments						
Remove the wild growth other than native grasses from the levee slopes.						
Inspector Comments: Vegetation blocking landward toe.

Looking north at dense vegetation on the landside and waterside slopes.

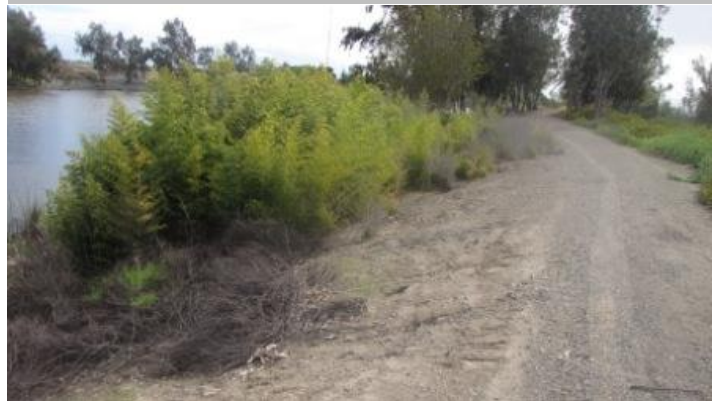
Photo 1 of 1 : FA_2015_RD0524_107_25_20150914_00042.jpg

LM Start	1.60	Rating **	A/W	Issue No.	25
LM End	1.61	Issue Type +	Ma	Location *	WS
Category	Earthen Levee			GPS Latitude/Longitude	
				Start	End
Item	Vegetation			37.927635 °	37.927540 °
				-121.327812 °	-121.327648 °
DWR ID	DWR_RD0524_01_s _ 2012_25				
Action/Comments					
Remove the wild growth other than native grasses from the levee slopes.

Looking southeast at dense vegetation on the waterside slope.

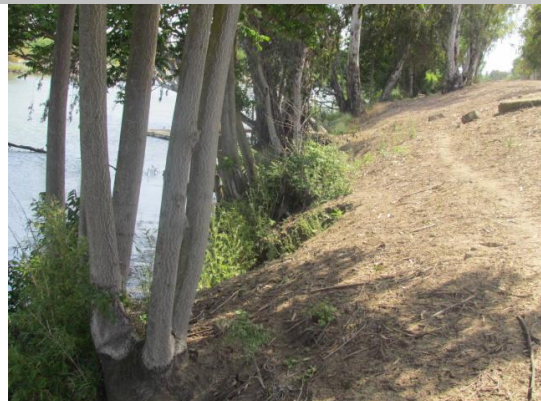
Photo 1 of 3 : FA_2015_RD0524_107_26_20150914_00043.jpg

LM Start	1.62	Rating **	M	Issue No.	26
LM End	1.64	Issue Type +	Ma	Location *	WS
Category	Earthen Levee			GPS Latitude/Longitude	
				Start	End
Item	Erosion / Bank Caving			37.927507 °	37.927295 °
				-121.327593 °	-121.327298 °
DWR ID	DWR_RD0524_01_s _ 2012_26				
Action/Comments					
Note and monitor erosion site.					
Inspector Comments: Several erosions along this reach.

Looking south at waterward erosion.

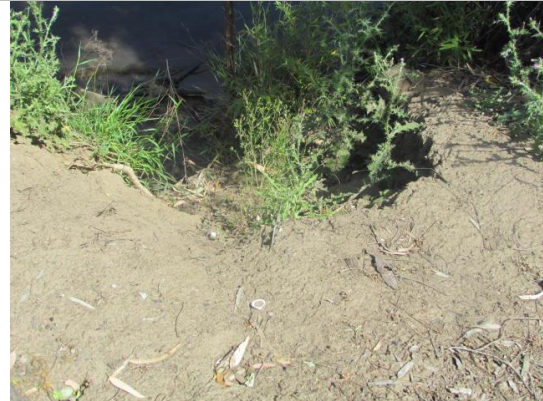
Photo 2 of 3 : FA_2015_RD0524_107_26_20150914_00044.jpg

LM Start	1.62	Rating **	M	Issue No.	26 (cont)
LM End	1.64	Issue Type +	Ma	Location *	WS
Category	Earthen Levee			GPS Latitude/Longitude	
				Start	End
Item	Erosion / Bank Caving			37.927507 °	37.927295 °
				-121.327593 °	-121.327298 °
DWR ID	DWR_RD0524_01_s _ 2012_26				
Action/Comments					
Note and monitor erosion site.					
Inspector Comments: Several erosions along this reach.

Looking east at waterward erosion.

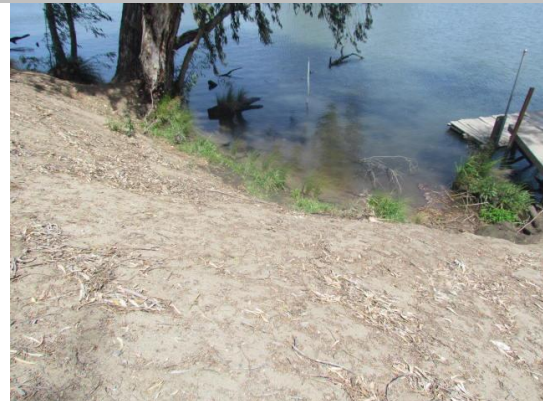
Photo 3 of 3 : FA_2015_RD0524_107_26_20150914_00045.jpg

Looking east at waterward erosion and depression.

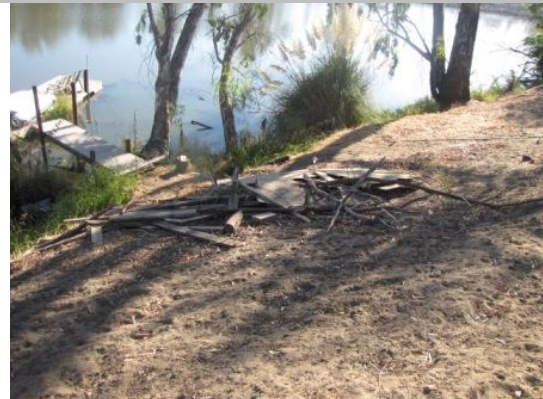
Photo 1 of 2 : FA_2015_RD0524_107_39_20150914_00062.jpg

LM Start	1.64	Rating **	U	Issue No.	39
LM End	1.64	Issue Type +	En	Location *	WS
Category	Earthen Levee			GPS Latitude/Longitude	
				Start	End
Item	Encroachments			37.927372 °	37.927372 °
				-121.327278 °	-121.327278 °
DWR ID	DWR_RD0524_01_s _ 2012_39				
Action/Comments					
Pole					
Inspector Comments: Landowner constructed boat dock without permission from the CVFPB.

Looking at garbage on waterside slope.

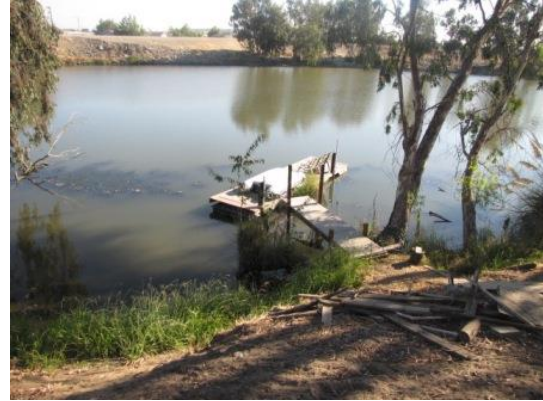
Photo 2 of 2 : FA_2015_RD0524_107_39_20150914_00063.jpg

LM Start	1.64	Rating **	U	Issue No.	39 (cont)
LM End	1.64	Issue Type +	En	Location *	WS
Category	Earthen Levee			GPS Latitude/Longitude	
				Start	End
Item	Encroachments			37.927372 °	37.927372 °
				-121.327278 °	-121.327278 °
DWR ID	DWR_RD0524_01_s _ 2012_39				
Action/Comments					
Pole					
Inspector Comments: Landowner constructed boat dock without permission from the CVFPB.

Looking east at non-permitted boat dock.

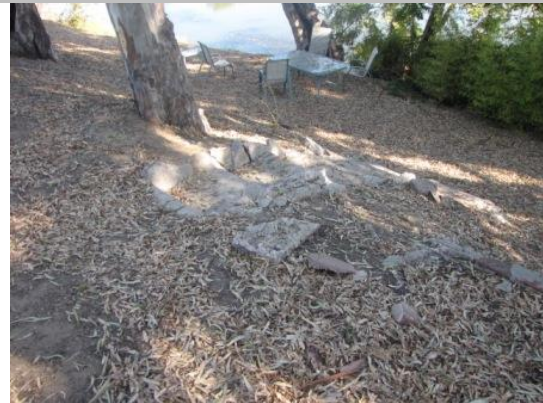
Photo 1 of 3 : FA_2015_RD0524_107_45_20150914_00067.jpg

LM Start	1.67	Rating **	U	Issue No.	45
LM End	1.67	Issue Type +	Ma	Location *	WS
Category	Earthen Levee			GPS Latitude/Longitude	
				Start	End
Item	Encroachments			37.927018 °	37.927018 °
				-121.326872 °	-121.326872 °
DWR ID	DWR_RD0524_01_s _ 2012_45				
Action/Comments					
Stairway					
Inspector Comments: Stairs and retaining wall

Looking northeast at non-permitted concrete stairs on waterside slope.

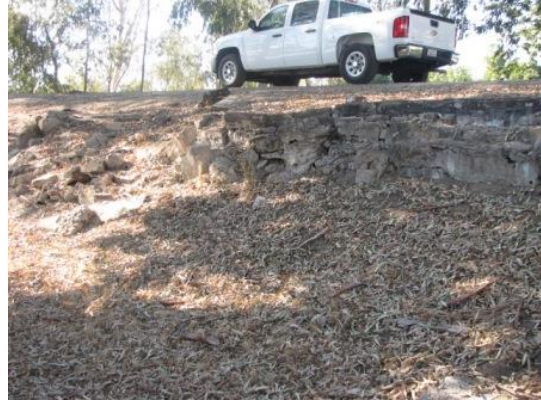
Photo 2 of 3 : FA_2015_RD0524_107_45_20150914_00068.jpg

Looking southwest at retaining wall connected to concrete stairs.

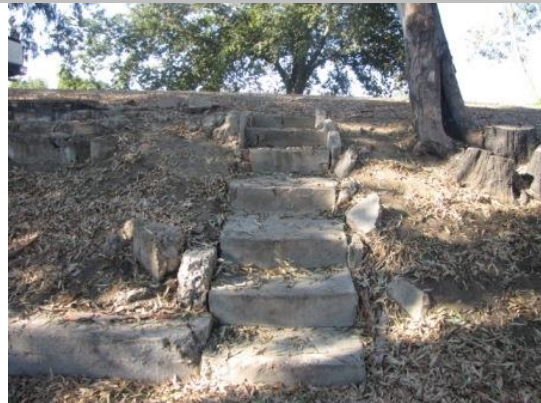
Photo 3 of 3 : FA_2015_RD0524_107_45_20150914_00069.jpg

Looking west at concrete stairs on waterside slope.

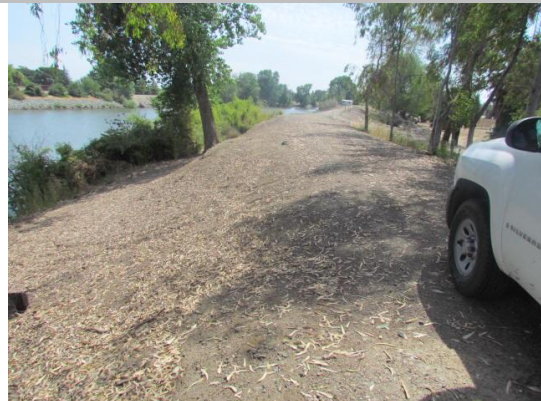
Photo 1 of 1 : FA_2015_RD0524_107_27_20150914_00046.jpg

LM Start	1.69	Rating **	M	Issue No.	27
LM End	1.70	Issue Type +	Ma	Location *	WS
Category	Earthen Levee			GPS Latitude/Longitude	
				Start	End
Item	Slope Stability			37.926728 °	37.926730 °
				-121.326597 °	-121.326508 °
DWR ID	DWR_RD0524_01_s _ 2012_27				
Action/Comments					
Repair slope instability. Inspector Comments: Slope damage several feet long and greater than one inch deep.

Looking south at landward slope depression.

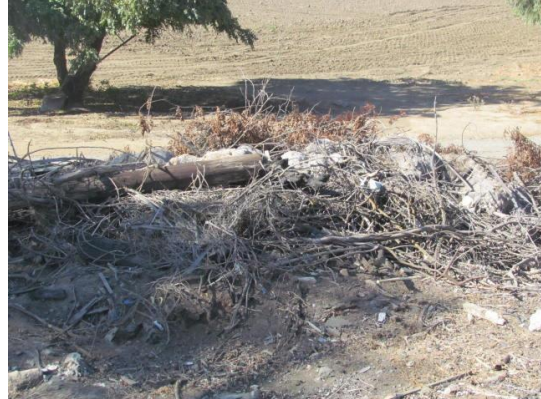
Photo 1 of 1 : FA_2015_RD0524_107_28_20151023_00249.jpg

LM Start	1.73	Rating **	M	Issue No.	28
LM End	1.73	Issue Type +	Ma	Location *	LS
Category	Earthen Levee			GPS Latitude/Longitude	
				Start	End
Item	Encroachments			37.926322 °	37.926322 °
				-121.326115 °	-121.326115 °
DWR ID	DWR_RD0524_01_s _ 2012_28				
Action/Comments					
Garbage					
Inspector Comments: Large pruning piles on landside slope.

Looking west at pruning pile at landward toe fall 2015.

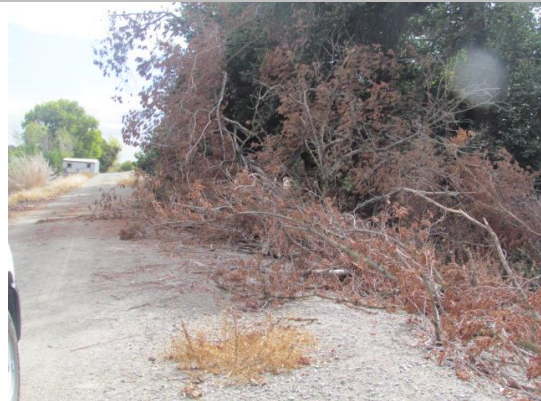
Photo 1 of 4 : FA_2015_RD0524_107_46_20150914_00070.jpg

LM Start	1.75	Rating **	U	Issue No.	46
LM End	1.76	Issue Type +	Ma	Location *	LS
Category	Earthen Levee			GPS Latitude/Longitude	
				Start	End
Item	Encroachments			37.926152 °	37.925993 °
				-121.325927 °	-121.325777 °
DWR ID	DWR_RD0524_01_s _ 2012_46				
Action/Comments					
Tree or limb					
Inspector Comments: Downed tree limbs on landward slope.

Looking south at tree limbs on landward slope.

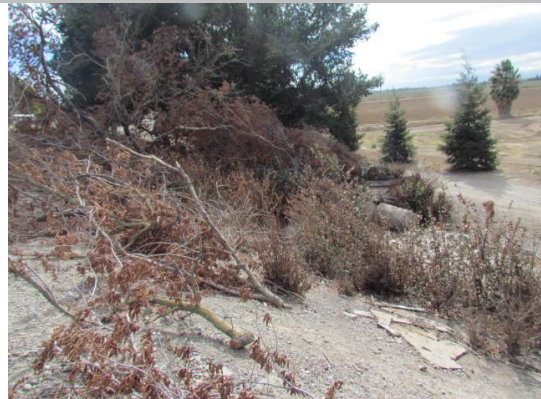
Photo 2 of 4 : FA_2015_RD0524_107_46_20150914_00071.jpg

Looking southwest at tree limbs on landward slope.

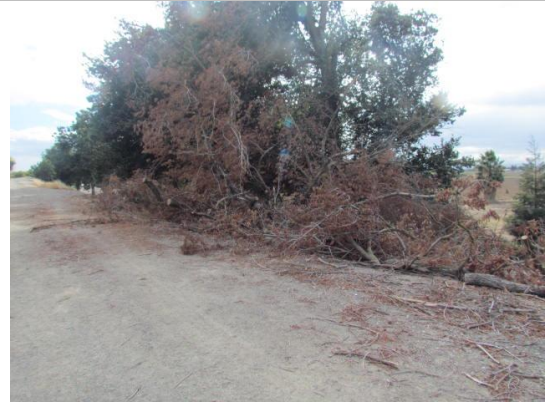
Photo 3 of 4 : FA_2015_RD0524_107_46_20150914_00072.jpg

LM Start	1.75	Rating **	U	Issue No.	46 (cont)	
LM End	1.76	Issue Type +	Ma	Location *	LS	
Category	Earthen Levee			GPS Latitude/Longitude		
				Start	End	
Item	Encroachments			37.926152 °	37.925993 °	
				-121.325927 °	-121.325777 °	
DWR ID	DWR_RD0524_01_s _ 2012_46					
Action/Comments						
Tree or limb						
Inspector Comments: Downed tree limbs on landward slope.

Looking south at tree limbs on landward slope.

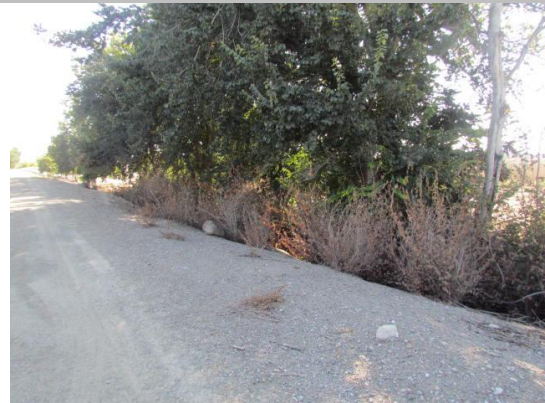
Photo 4 of 4 : FA_2015_RD0524_107_46_20150914_00073.jpg

Looking southwest at dense vegetation and low hanging tree branches on landside slope and toe.

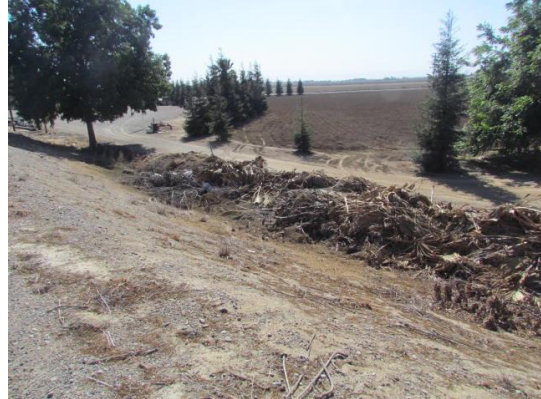
Photo 1 of 1 : FA_2015_RD0524_107_100_20150914_00119.jpg

LM Start	1.78	Rating **	A/W	Issue No.	100
LM End	1.78	Issue Type +	Ma	Location *	LS
Category	Earthen Levee			GPS Latitude/Longitude	
				Start	End
Item	Encroachments			37.925752 °	37.925752 °
				-121.325592 °	-121.325592 °
DWR ID	DWR_RD0524_01_s_2012_100				
Action/Comments					
Prunings

Looking southwest at prunings on landside toe.

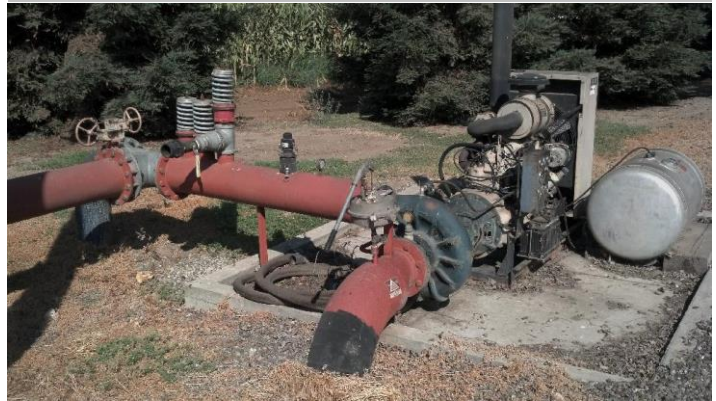
Photo 1 of 3 : UCIP_FA_2015_1981.jpg

LM Start	1.80	Rating **	M	Issue No.	942
LM End	1.80	Issue Type +	En	Location *	LS
Category	Supplemental			GPS Latitude/Longitude	
				Start	End
Item	DWR UCIP Field Study			37.925480 °	37.925480 °
				-121.325358 °	-121.325358 °
DWR ID					
Action/Comments					
Inspector Comments: FS_ID:21866 DS_ID:24032 EP_NO: N/A FS_HLM: 1.823 Repair Type: Non-Urgent Crossing Status: Found UCIP Comments: No permit identified for crossing. FIELD_STRUCT_DESC: 12-inch wrapped steel irrigation pipe through the levee at an unknown depth below the crown. Pump, butterfly valves, vent, and siphon breaker at concrete pad 50-feet off LS toe. Siphon breaker in 14-inch concrete standpipe on LS shoulder. FS Date: 08/20/2013

Pumping plant with siphon breaker, vents, and butterfly valves.

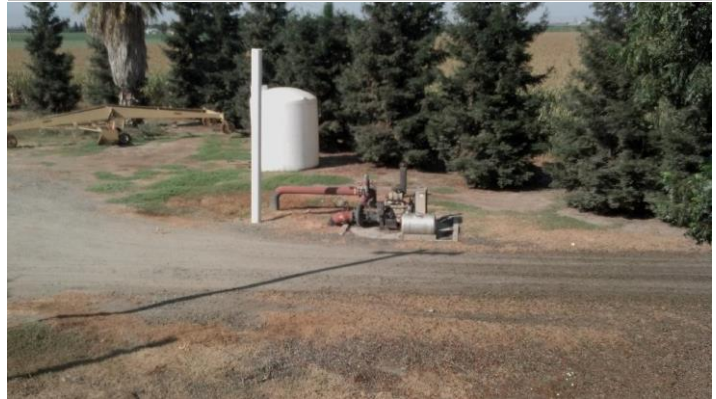
Photo 2 of 3 : UCIP_FA_2015_1982.jpg

Inspector Comments: FS_ID:21866
 DS_ID:24032
 EP_NO: N/A
 FS_HLM: 1.823
 Repair Type: Non-Urgent
 Crossing Status: Found
 UCIP Comments: No permit identified for crossing.
 FIELD_STRUCT_DESC: 12-inch wrapped steel irrigation pipe through the levee at an unknown depth below the crown. Pump, butterfly valves, vent, and siphon breaker at concrete pad 50-feet off LS toe.
 Siphon breaker in 14-inch concrete standpipe on LS shoulder.
 FS Date: 08/20/2013

Pumping plant off LS toe.

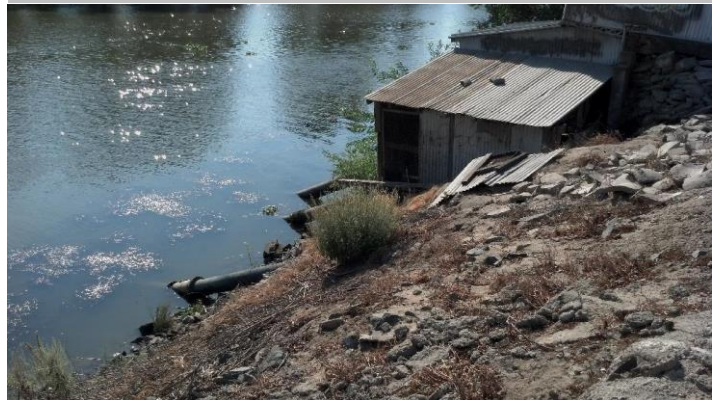
Photo 3 of 3 : UCIP_FA_2015_1983.jpg

Pipe visible at lower left.

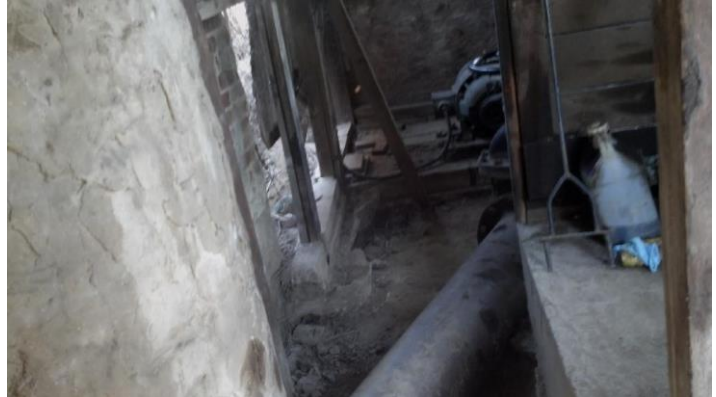
Photo 1 of 3 : UCIP_FA_2015_1603.jpg

LM Start	1.81	Rating **	M	Issue No.	943
LM End	1.81	Issue Type +	En	Location *	LS
Category	Supplemental			GPS Latitude/Longitude	
				Start	End
Item	DWR UCIP Field Study			37.925429 °	37.925429
				-121.325323 °	-121.325323
DWR ID					
Action/Comments					
Inspector Comments: FS_ID:17847					
DS_ID:20609					
EP_NO: N/A					
FS_HLM: 1.827					
Repair Type: Non-Urgent					
Crossing Status: Found

Pipes at connection to concrete surge box on WS inside pumphouse.

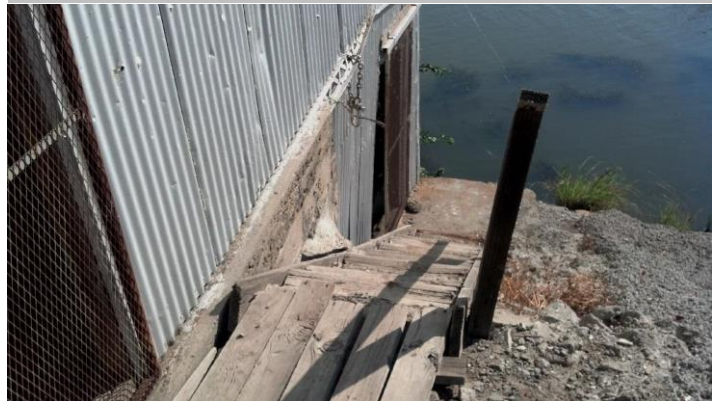
Photo 2 of 3 : UCIP_FA_2015_1604.jpg

Steps to pump on WS slope.

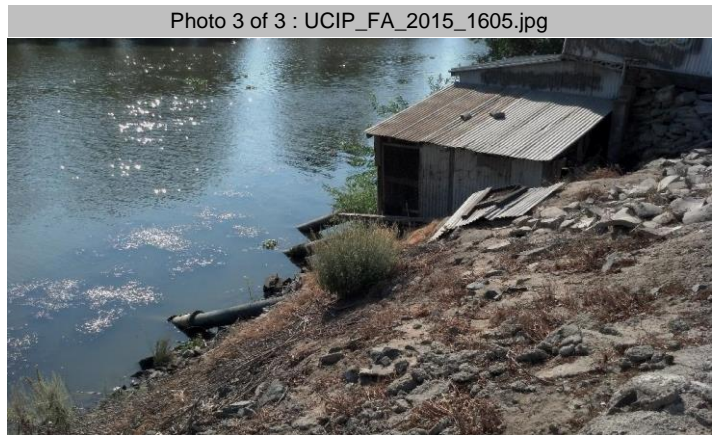
LM Start	1.81	Rating **	M	Issue No.	943 (cont)
LM End	1.81	Issue Type +	En	Location *	LS
Category	Supplemental			GPS Latitude/Longitude	
				Start	End
Item	DWR UCIP Field Study			37.925429 °	37.925429 °
				-121.325323 °	-121.325323 °
DWR ID					
Action/Comments					
Inspector Comments: FS_ID:17847					
DS_ID:20609					
EP_NO: N/A					
FS_HLM: 1.827					
Repair Type: Non-Urgent					
Crossing Status: Found

Pipes and pumphouse on WS slope.

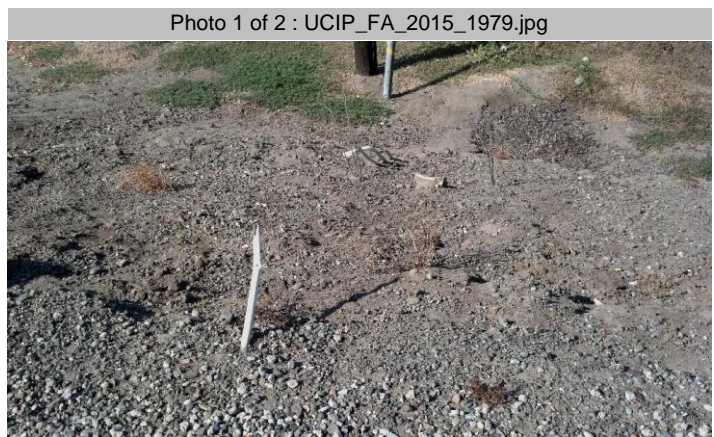
LM Start	1.81	Rating **	M	Issue No.	944
LM End	1.81	Issue Type +	En	Location *	LS
Category	Supplemental			GPS Latitude/Longitude	
				Start	End
Item	DWR UCIP Field Study			37.925431 °	37.925431 °
				-121.325310 °	-121.325310 °
DWR ID					
Action/Comments					
Inspector Comments: FS_ID:21865 DS_ID:24033 EP_NO: N/A FS_HLM: 1.827 Repair Type: Non-Urgent Crossing Status: Found UCIP Comments: Pipes appear abandoned and should be removed from levee. FIELD_STRUCT_DESC: One 1-inch and two 3/4-inch PVC conduits through the levee 6-inches below the crown. FS Date: 08/20/2013

Pipes visible on LS slope.

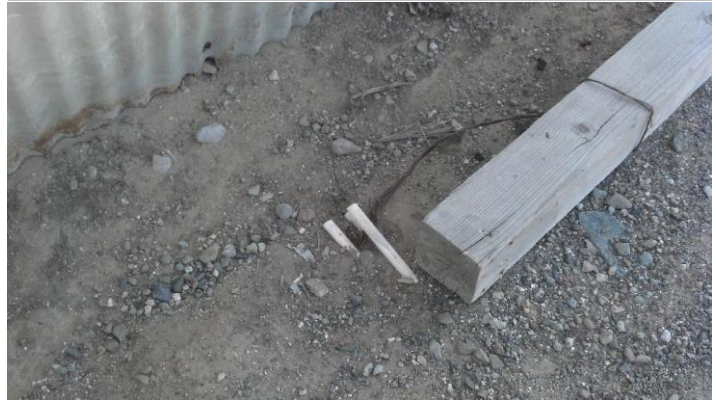
Photo 2 of 2 : UCIP_FA_2015_1980.jpg

LM Start	1.81	Rating **	M	Issue No.	944 (cont)
LM End	1.81	Issue Type +	En	Location *	LS
Category	Supplemental			GPS Latitude/Longitude	
				Start	End
Item	DWR UCIP Field Study			37.925431 °	37.925431 °
				-121.325310 °	-121.325310 °
DWR ID					
Action/Comments					
Inspector Comments: FS_ID:21865					
DS_ID:24033					
EP_NO: N/A					
FS_HLM: 1.827					
Repair Type: Non-Urgent					
Crossing Status: Found					
UCIP Comments: Pipes appear abandoned and should be removed from levee.					
FIELD_STRUCT_DESC: One 1-inch and two 3/4-inch PVC conduits through the levee 6-inches below the crown.					
FS Date: 08/20/2013

Pipes visible on WS shoulder directly in front of pumphouse.

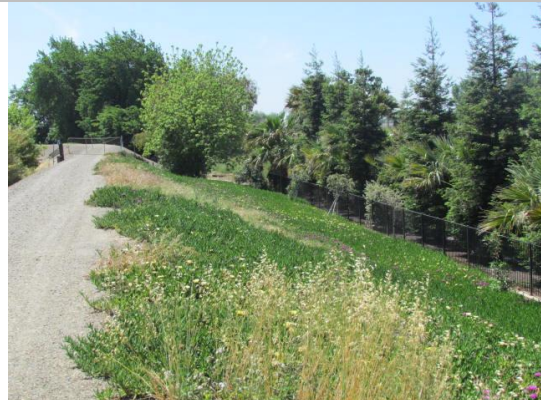
Photo 1 of 1 : FA_2015_RD0524_107_78_20150914_00101.jpg

LM Start	1.90	Rating **	M	Issue No.	78
LM End	1.94	Issue Type +	En	Location *	LS
Category	Earthen Levee			GPS Latitude/Longitude	
				Start	End
Item	Vegetation			37.924364 °	37.923805 °
				-121.324473 °	-121.324238 °
DWR ID	DWR_RD0524_01_s_2012_78				
Action/Comments					
Landscaping

Looking southwest at landscaping on landside slope. (Spring 2012)

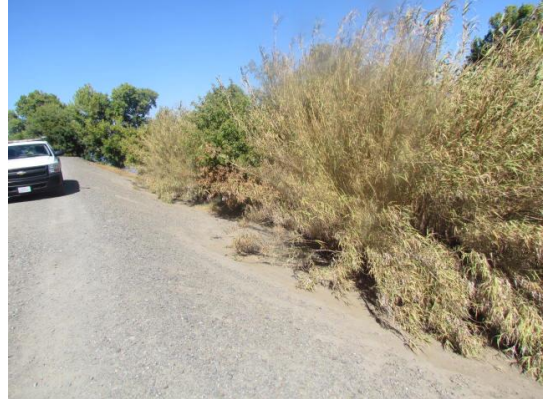
Photo 1 of 2 : FA_2015_RD0524_107_104_20150914_00122.jpg

LM Start	1.94	Rating **	A/W	Issue No.	104
LM End	1.94	Issue Type +	En	Location *	WS
Category	Earthen Levee			GPS Latitude/Longitude	
				Start	End
Item	Vegetation			37.923808 °	37.923808 °
				-121.324260 °	-121.324260 °
DWR ID	DWR_RD0524_01_s _ 2012_104				
Action/Comments					
Remove the wild growth other than native grasses from the levee slopes. Inspector Comments: Bamboo outside of the twenty foot vegetation zone.

Looking northeast at sprayed bamboo on waterside slope. (Fall 2012)

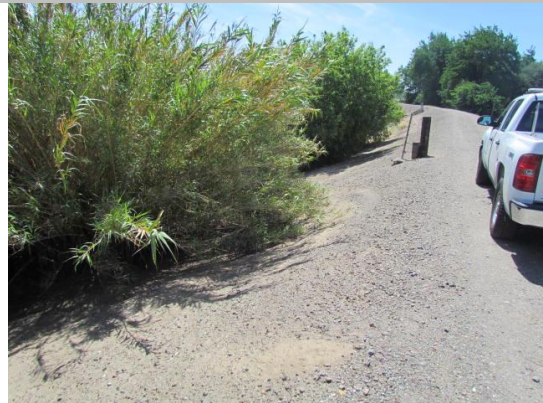
Photo 2 of 2 : FA_2015_RD0524_107_104_20150914_00123.jpg

Looking southeast at bamboo on waterside slope.

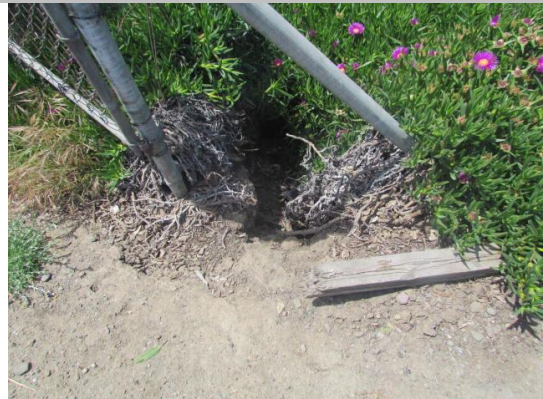
Photo 1 of 2 : FA_2015_RD0524_107_176_20150914_00166.jpg

LM Start	1.94	Rating **	U	Issue No.	176
LM End	1.94	Issue Type +	Ma	Location *	LS
Category	Earthen Levee			GPS Latitude/Longitude	
				Start	End
Item	Erosion / Bank Caving			37.923688 °	37.923688
				-121.324223 °	-121.324223
DWR ID	DWR_RD0524_01_s _ 2015_176				
Action/Comments					
Schedule repair of erosion site prior to the next inspection. Inspector Comments: Landward caving (3 x 18" x 5) caused by broken sprinklers.

Looking west at erosion within landscaping on landward shoulder and slope.

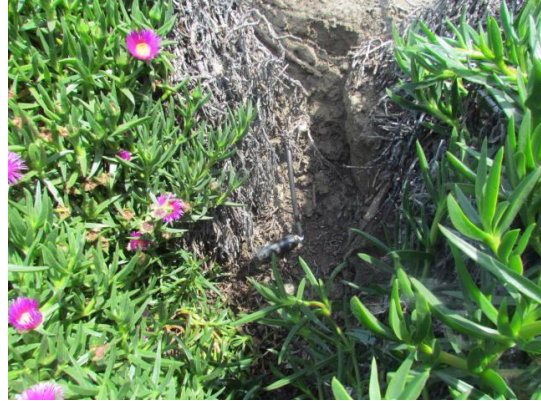
Photo 2 of 2 : FA_2015_RD0524_107_176_20150914_00167.jpg

LM Start	1.94	Rating **	U	Issue No.	176 (cont)
LM End	1.94	Issue Type +	Ma	Location *	LS
Category	Earthen Levee			GPS Latitude/Longitude	
				Start	End
Item	Erosion / Bank Caving			37.923688 °	37.923688 °
				-121.324223 °	-121.324223 °
DWR ID	DWR_RD0524_01_s _ 2015_176				
Action/Comments					
Schedule repair of erosion site prior to the next inspection. Inspector Comments: Landward caving (3 x 18" x 5) caused by broken sprinklers.

Looking east at erosion within landscaping on landward slope and shoulder.

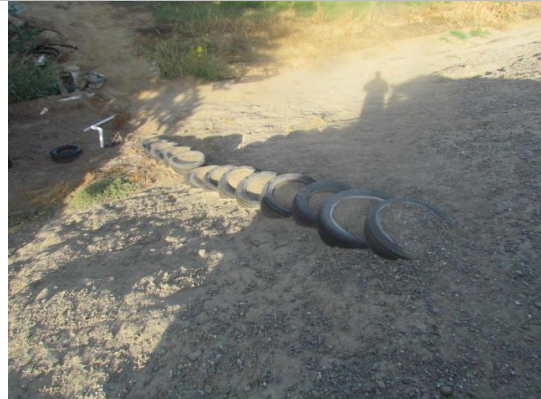
Photo 1 of 1 : FA_2015_RD0524_107_4_20150914_00009.jpg

LM Start	1.99	Rating **	M	Issue No.	4
LM End	1.99	Issue Type +	En	Location *	LS
Category	Earthen Levee			GPS Latitude/Longitude	
				Start	End
Item	Encroachments			37.923068 °	37.923068 °
				-121.323990 °	-121.323990 °
DWR ID	DWR_RD0524_01_f _ 2012_4				
Action/Comments					
Stairway Inspector Comments: Landowner installed rubber tires for a stairway on landside slope.

Looking west at rubber tires being used as stairs on landside slope.

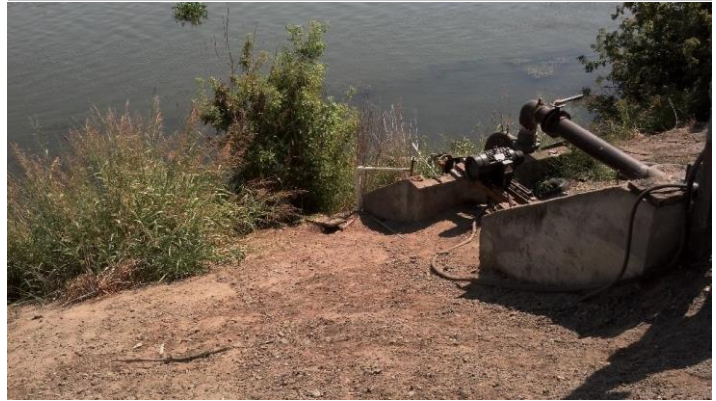
Photo 1 of 3 : UCIP_FA_2015_1984.jpg

LM Start	1.99	Rating **	M	Issue No.	945
LM End	1.99	Issue Type +	En	Location *	LS
Category	Supplemental			GPS Latitude/Longitude	
				Start	End
Item	DWR UCIP Field Study			37.923022 °	37.923022 °
				-121.323953 °	-121.323953 °
DWR ID					
Action/Comments					
Inspector Comments: FS_ID:21872 DS_ID:24035 EP_NO: N/A FS_HLM: 2.013 Repair Type: Non-Urgent Crossing Status: Found UCIP Comments: No permit identified for this crossing. FIELD_STRUCT_DESC: 3-inch PVC domestic non-potable water line through the levee at unknowd depth below the crown. Pump on concrete pad at WS toe. FS Date: 08/20/2013

Pump and pipe visible on WS slope.

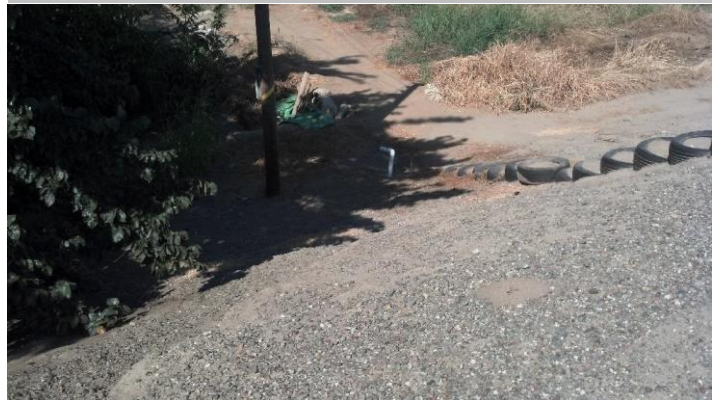
Photo 2 of 3 : UCIP_FA_2015_1985.jpg

PVC pipe visible on LS toe.

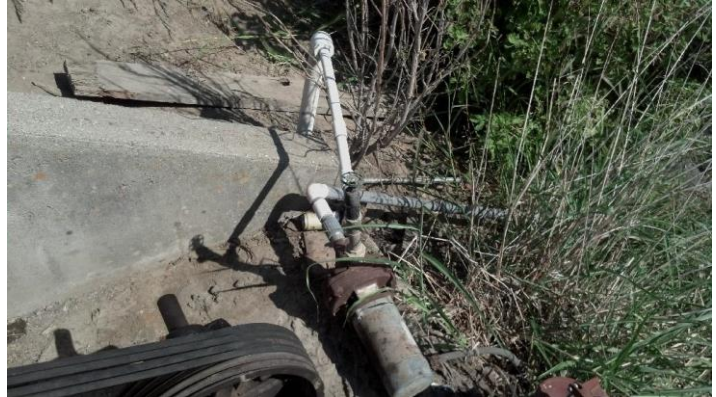
Photo 3 of 3 : UCIP_FA_2015_1986.jpg

LM Start	1.99	Rating **	M	Issue No.	945 (cont)
LM End	1.99	Issue Type +	En	Location *	LS
Category	Supplemental			GPS Latitude/Longitude	
				Start	End
Item	DWR UCIP Field Study			37.923022 °	37.923022 °
				-121.323953 °	-121.323953 °
DWR ID					
Action/Comments					
Inspector Comments: FS_ID:21872 DS_ID:24035 EP_NO: N/A FS_HLM: 2.013 Repair Type: Non-Urgent Crossing Status: Found

Pump on concrete pad at WS slope.

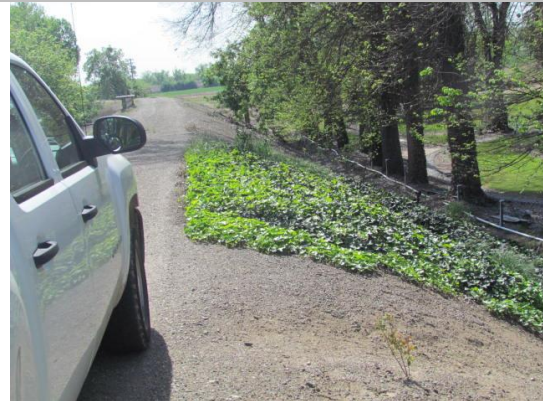
Photo 1 of 1 : FA_2015_RD0524_107_106_20150914_00124.jpg

LM Start	2.00	Rating **	U	Issue No.	106
LM End	2.00	Issue Type +	En	Location *	LS
Category	Earthen Levee			GPS Latitude/Longitude	
				Start	End
Item	Vegetation			37.922923 °	37.922923 °
				-121.323837 °	-121.323837 °
DWR ID	DWR_RD0524_01_s_2012_106				
Action/Comments					
Landscaping

Looking southwest at ground cover on landward slope.

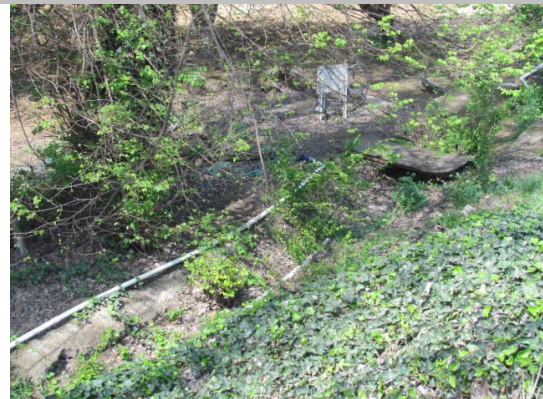
Photo 1 of 2 : FA_2015_RD0524_107_182_20150914_00174.jpg

LM Start	2.01	Rating **	M	Issue No.	182
LM End	2.04	Issue Type +	En	Location *	LS
Category	Earthen Levee			GPS Latitude/Longitude	
				Start	End
Item	Encroachments			37.922837 °	37.922514 °
				-121.323785 °	-121.323504 °
DWR ID	DWR_RD0524_01_s_2014_182				
Action/Comments					
Ditch Inspector Comments: Old irrigation ditch at the landward toe should be removed.

Looking northwest at an old irrigation ditch at landward toe.

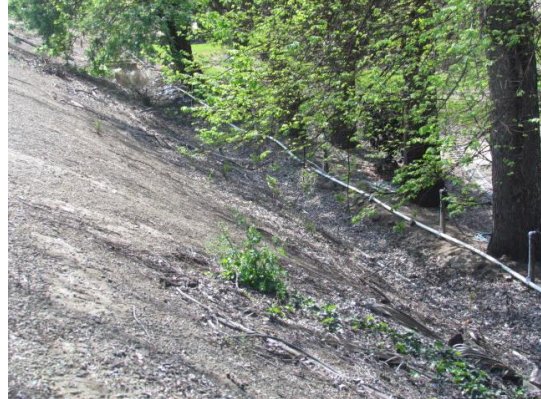
Photo 2 of 2 : FA_2015_RD0524_107_182_20150914_00175.jpg

LM Start	2.01	Rating **	M	Issue No.	182 (cont)
LM End	2.04	Issue Type +	En	Location *	LS
Category	Earthen Levee			GPS Latitude/Longitude	
				Start	End
Item	Encroachments			37.922837 °	37.922514 °
				-121.323785 °	-121.323504 °
DWR ID	DWR_RD0524_01_s_2014_182				
Action/Comments					
Ditch Inspector Comments: Old irrigation ditch at the landward toe should be removed.

Looking southwest at an old irrigation ditch at landward toe.

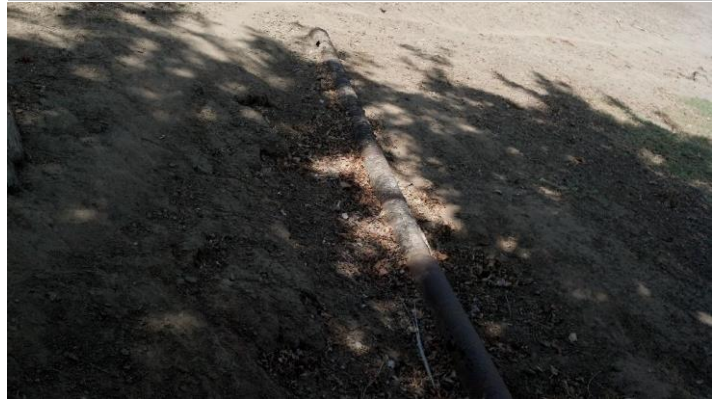
Photo 2 of 2 : UCIP_FA_2015_2015.jpg

LM Start	2.03	Rating **	M	Issue No.	946 (cont)	
LM End	2.03	Issue Type +	En	Location *	LS	
Category	Supplemental			GPS Latitude/Longitude		
				Start	End	
Item	DWR UCIP Field Study			37.922535 °	37.922535 °	
				-121.323568 °	-121.323568 °	
DWR ID						
Action/Comments						
Inspector Comments: FS_ID:21883						
DS_ID:24036						
EP_NO: N/A						
FS_HLM: 2.053						
Repair Type: Non-Urgent						
Crossing Status: Found						
UCIP Comments: Pipe abandoned and should be done so properly.						
Holes visible throughout exposed pipe.						
FIELD_STRUCT_DESC: 5-inch wrapped steel irrigation pipe through the levee 6-feet below the crown. No pump or other appurtances found.						
FS Date: 08/20/2013

Pipe visible on WS slope.

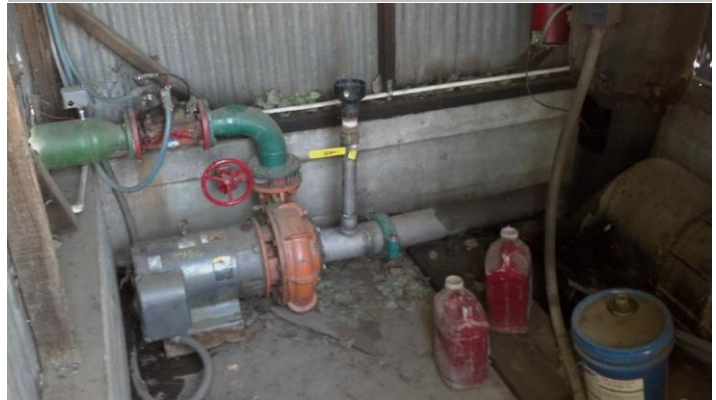
Photo 1 of 3 : UCIP_FA_2015_2016.jpg

LM Start	2.07	Rating **	M	Issue No.	947
LM End	2.07	Issue Type +	En	Location *	LS
Category	Supplemental			GPS Latitude/Longitude	
				Start	End
Item	DWR UCIP Field Study			37.922080 °	37.922080 °
				-121.323118 °	-121.323118 °
DWR ID					
Action/Comments					
Inspector Comments: FS_ID:21895 DS_ID:24038 EP_NO: N/A FS_HLM: 2.093 Repair Type: Non-Urgent Crossing Status: Found UCIP Comments: No permit identified for this crossing. FIELD_STRUCT_DESC: 6-inch steel irrigation pipe through the levee at an unknown depth. Vent, meter, butterfly valve, and pump at pumphouse on WS slope. FS Date: 08/20/2013

Pump and butterfly valve inside pumphouse on WS berm.

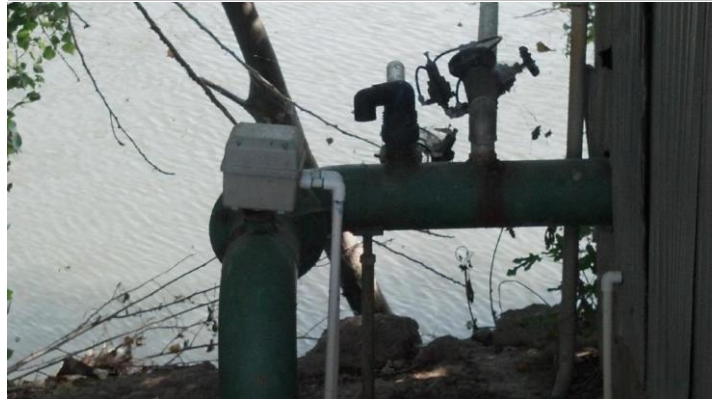
Photo 2 of 3 : UCIP_FA_2015_2017.jpg

LM Start	2.07	Rating **	M	Issue No.	947 (cont)	
LM End	2.07	Issue Type +	En	Location *	LS	
Category	Supplemental			GPS Latitude/Longitude		
				Start	End	
Item	DWR UCIP Field Study			37.922080 °	37.922080 °	
				-121.323118 °	-121.323118 °	
DWR ID						
Action/Comments						
Inspector Comments: FS_ID:21895						
DS_ID:24038						
EP_NO: N/A						
FS_HLM: 2.093						
Repair Type: Non-Urgent						
Crossing Status: Found						
UCIP Comments: No permit identified for this crossing.						
FIELD_STRUCT_DESC: 6-inch steel irrigation pipe through the levee at an unknown depth. Vent, meter, butterfly valve, and pump at pumphouse on WS slope.						
FS Date: 08/20/2013

Irrigation line visible on side of pumphouse.

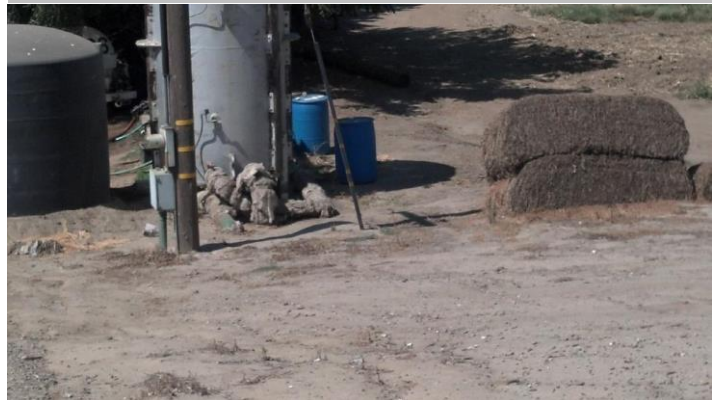
Photo 3 of 3 : UCIP_FA_2015_2018.jpg

Steel irrigation line visible in front of tank to right of powerpole off LS toe.

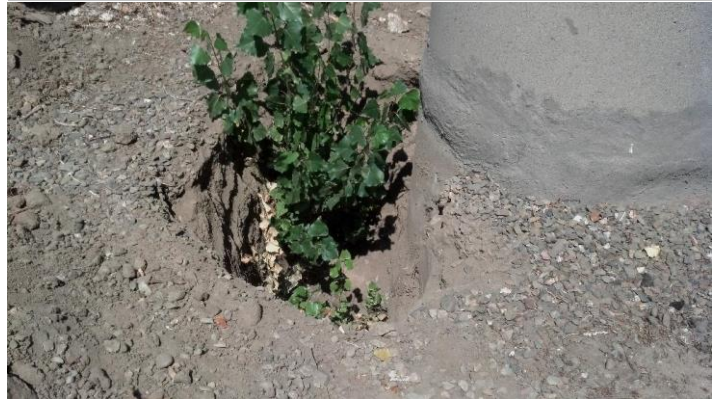
Photo 1 of 3 : UCIP_FA_2015_1650.jpg

LM Start	2.07	Rating **	M	Issue No.	948
LM End	2.07	Issue Type +	En	Location *	LS
Category	Supplemental			GPS Latitude/Longitude	
				Start	End
Item	DWR UCIP Field Study			37.922064 °	37.922064
				-121.323084 °	-121.323084
DWR ID					
Action/Comments					
Inspector Comments: FS_ID:17944					
DS_ID:20612					
EP_NO: N/A					
FS_HLM: 2.095					
Repair Type: Non-Urgent					
Crossing Status: Found

Hole over pipe next to 4-foot diameter concrete standpipe on WS slope.

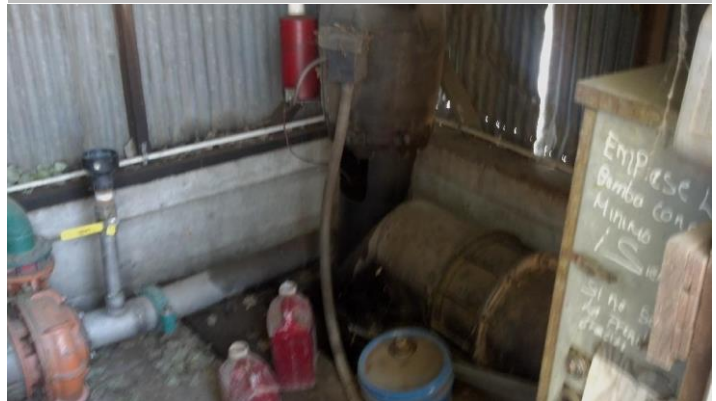
Photo 2 of 3 : UCIP_FA_2015_1651.jpg

Pump and pipe inside pumphouse.

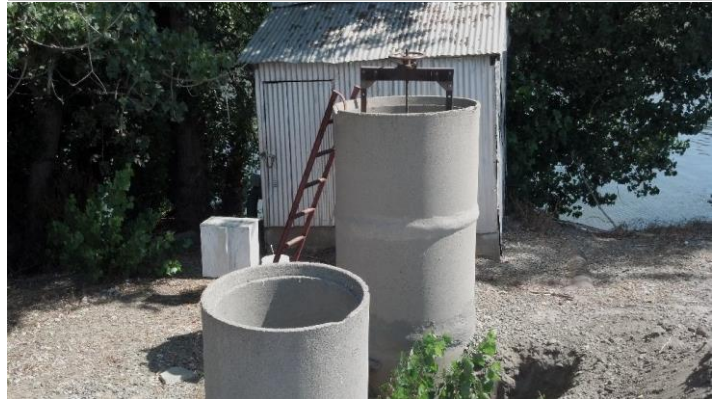
Photo 3 of 3 : UCIP_FA_2015_1652.jpg

LM Start	2.07	Rating **	M	Issue No.	948 (cont)
LM End	2.07	Issue Type +	En	Location *	LS
Category	Supplemental			GPS Latitude/Longitude	
				Start	End
Item	DWR UCIP Field Study			37.922064 °	37.922064 °
				-121.323084 °	-121.323084 °
DWR ID					
Action/Comments					
Inspector Comments: FS_ID:17944					
DS_ID:20612					
EP_NO: N/A					
FS_HLM: 2.095					
Repair Type: Non-Urgent					
Crossing Status: Found

Slide gate in concrete riser with secondary concrete riser in foreground.
Pumphouse in background.

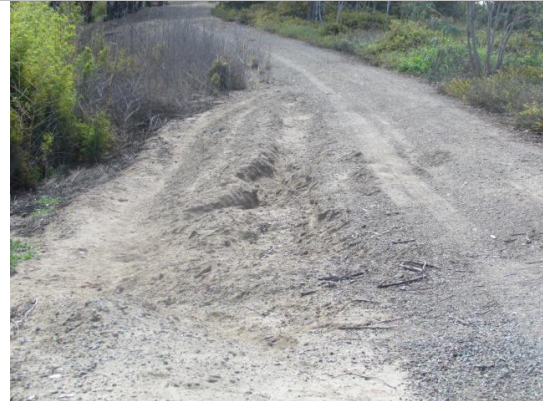
Photo 1 of 1 : FA_2015_RD0524_107_31_20150914_00049.jpg

LM Start	2.19	Rating **	M	Issue No.	31
LM End	2.25	Issue Type +	Ma	Location *	WS
Category	Earthen Levee			GPS Latitude/Longitude	
				Start	End
Item	Slope Stability			37.920992 °	37.920505
				-121.321373 °	-121.320485
DWR ID	DWR_RD0524_01_s_2012_31				
Action/Comments					
Repair slope instability.

Looking south slope damage on waterward shoulder and slope.
