**Flood Control Project Maintenance
Levee Inspections**

Fall 2015 Levee Maintenance Deficiency Summary Report

San Joaquin River Basin

Reclamation District No. 0524 Middle Roberts Island

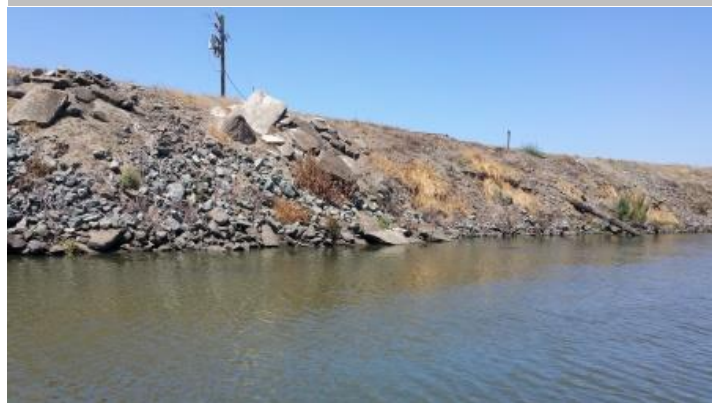
Photo 1 of 3 : SJR2015_RD0524U01RM42.84_1.JPG

LM Start	2.24	Rating **	U	Issue No.	103
LM End	2.27	Issue Type +	Ma	Location *	WS
Category	Supplemental			GPS Latitude/Longitude	
				Start	End
Item	DWR Erosion Survey			37.920650 °	37.920650 °
				-121.320370 °	-121.320370 °
DWR ID					
Action/Comments					
Inspector Comments: 06/24/2015: No significant change observed. 6/19/2014: No significant change observed. 08/13/2013: An irrigation pipe is on site. [2015 Site ID:RD0524U01RM42.84]

View from upstream.

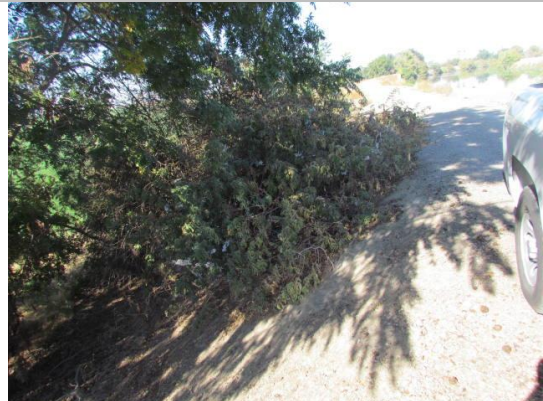
Photo 1 of 2 : FA_2015_RD0524_107_32_20151023_00250.jpg

LM Start	2.27	Rating **	U	Issue No.	32
LM End	2.29	Issue Type +	Ma	Location *	LS
Category	Earthen Levee			GPS Latitude/Longitude	
				Start	End
Item	Vegetation			37.920372 °	37.920167 °
				-121.320230 °	-121.319890 °
DWR ID	DWR_RD0524_01_s_2012_32				
Action/Comments					
Elderberries are blocking visibility and flood fight capability. Inspector Comments: Dense elderberry bushes on landward slope and toe.

Looking northwest at dense veg on landward slope and toe fall 2015.

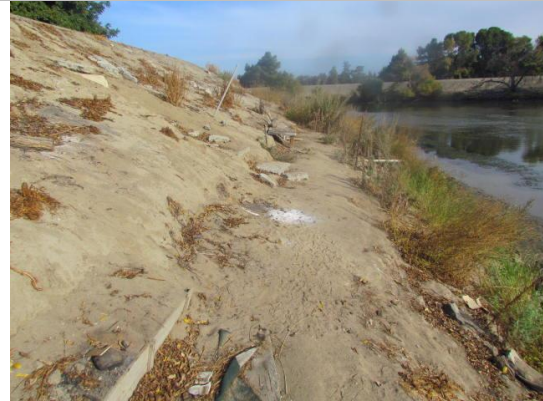
Photo 1 of 1 : FA_2015_RD0524_107_34_20150914_00053.jpg

LM Start	2.32	Rating **	M	Issue No.	34
LM End	2.33	Issue Type +	Ma	Location *	WS
Category	Earthen Levee			GPS Latitude/Longitude	
				Start	End
Item	Slope Stability			37.919885 °	37.919703 °
				-121.319713 °	-121.319702 °
DWR ID	DWR_RD0524_01_s_2012_34				
Action/Comments					
Repair the levee slope damaged by foot traffic and prevent access where possible.					
Inspector Comments: Slope damage caused by walking traffic and using bank as a fishing platform.

Looking northeast at damage to the slope possibly caused by human activity.

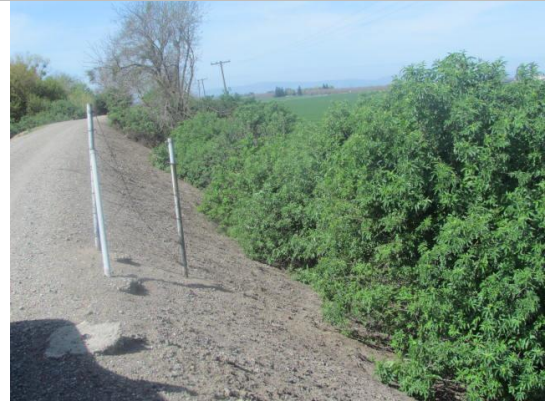
Photo 1 of 1 : FA_2015_RD0524_107_35_20150914_00054.jpg

LM Start	2.41	Rating **	U	Issue No.	35
LM End	2.45	Issue Type +	Ma	Location *	LS
Category	Earthen Levee			GPS Latitude/Longitude	
				Start	End
Item	Vegetation			37.918785 °	37.918515 °
				-121.320417 °	-121.321110 °
DWR ID	DWR_RD0524_01_s _ 2012_35				
Action/Comments					
Elderberries are blocking visibility and flood fight capability.

Looking southwest at dense vegetation on landward toe.

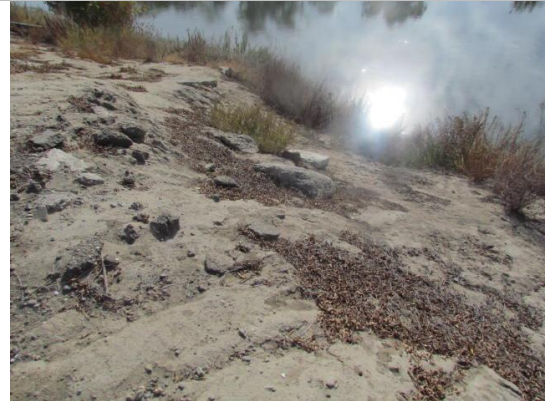
Photo 1 of 1 : FA_2015_RD0524_107_36_20150914_00055.jpg

LM Start	2.44	Rating **	M	Issue No.	36
LM End	2.47	Issue Type +	Ma	Location *	WS
Category	Earthen Levee			GPS Latitude/Longitude	
				Start	End
Item	Erosion / Bank Caving			37.918628 °	37.918438 °
				-121.320817 °	-121.321452 °
DWR ID	DWR_RD0524_01_s _ 2012_36				
Action/Comments					
Note and monitor erosion site.

Looking east at erosion on waterside slope.

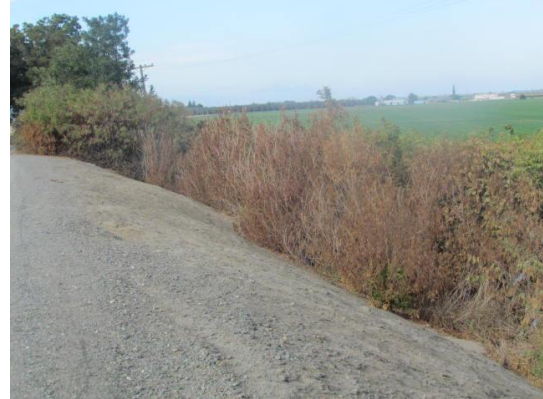
Photo 1 of 2 : FA_2015_RD0524_107_80_20150914_00103.jpg

LM Start	2.45	Rating **	M	Issue No.	80
LM End	2.45	Issue Type +	Ma	Location *	LS
Category	Earthen Levee			GPS Latitude/Longitude	
				Start	End
Item	Trim / Thin Trees			37.918480 °	37.918480 °
				-121.321114 °	-121.321114 °
DWR ID	DWR_RD0524_01_s _ 2012_80				
Action/Comments					
Trim trees to at least five feet above ground level.

Looking southwest at dense vegetation and trees on landside slope.
(Fall 2012)

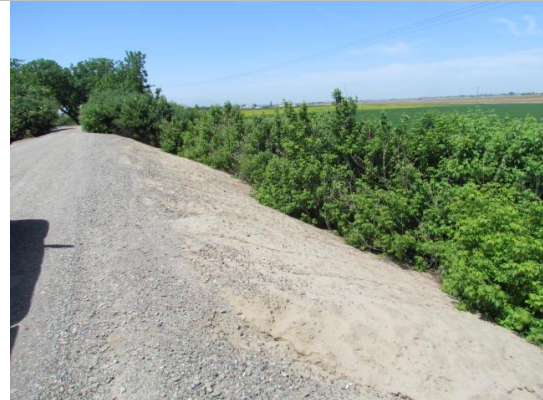
Photo 2 of 2 : FA_2015_RD0524_107_80_20150914_00104.jpg

Looking southwest at dense vegetation on landside toe.

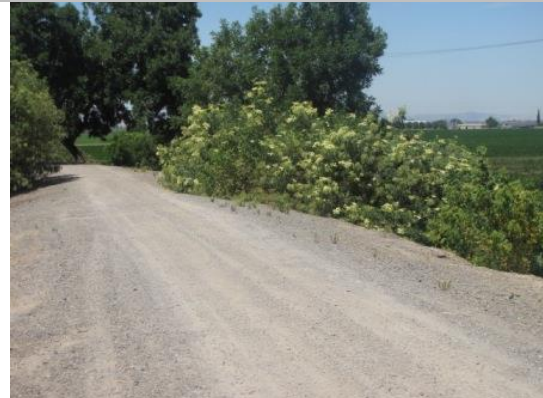
Photo 1 of 4 : FA_2015_RD0524_107_37_20150914_00056.jpg

LM Start	2.49	Rating **	U	Issue No.	37
LM End	2.50	Issue Type +	Ma	Location *	LS
Category	Earthen Levee			GPS Latitude/Longitude	
				Start	End
Item	Vegetation			37.918345 °	37.918302 °
				-121.321765 °	-121.321923 °
DWR ID	DWR_RD0524_01_s _ 2012_37				
Action/Comments					
Elderberries are blocking visibility and flood fight capability.

Looking south at elderberry on landside slope.

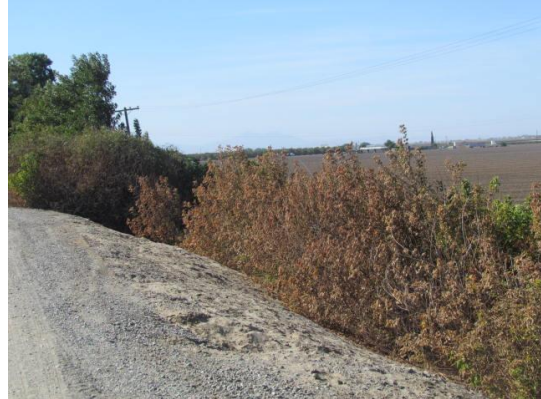
Photo 2 of 4 : FA_2015_RD0524_107_37_20150914_00057.jpg

Looking southwest at dense vegetation on landside toe.

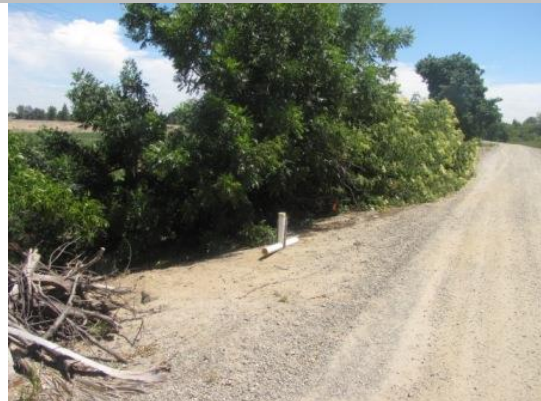
Photo 3 of 4 : FA_2015_RD0524_107_37_20150914_00058.jpg

Looking north at elderberry and trees on landside slope.

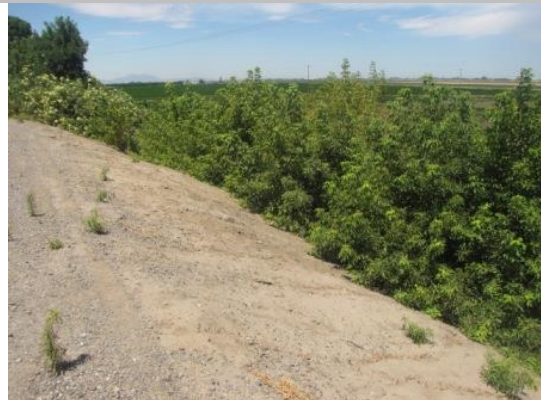
Photo 4 of 4 : FA_2015_RD0524_107_37_20150914_00059.jpg

Looking southwest at trees along levee landside toe.

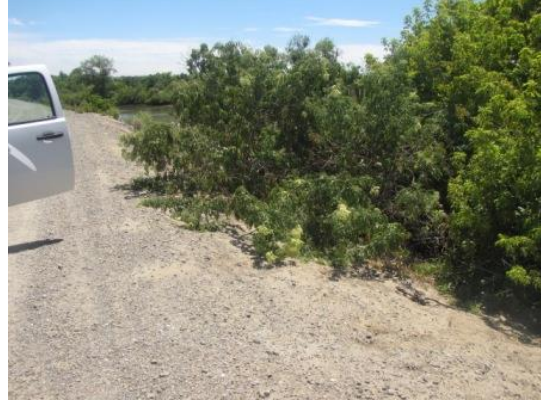
Photo 1 of 2 : FA_2015_RD0524_107_38_20150914_00060.jpg

LM Start	2.50	Rating **	U	Issue No.	38
LM End	2.50	Issue Type +	Ma	Location *	WS
Category	Earthen Levee			GPS Latitude/Longitude	
				Start	End
Item	Vegetation			37.918287 °	37.918287 °
				-121.321980 °	-121.321980 °
DWR ID	DWR_RD0524_01_s _ 2012_38				
Action/Comments					
Elderberries are blocking visibility and flood fight capability.

Looking north at elderberry on waterside slope.

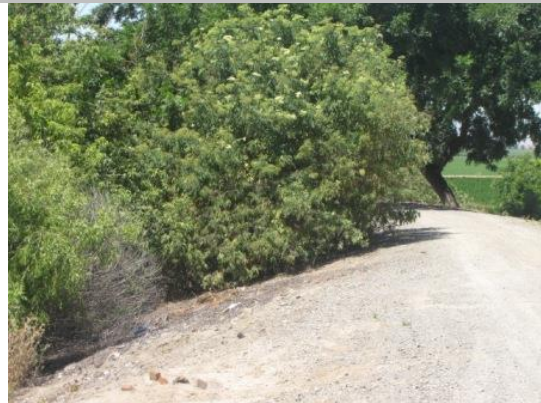
Photo 2 of 2 : FA_2015_RD0524_107_38_20150914_00061.jpg

Looking south at elderberry on waterside slope.

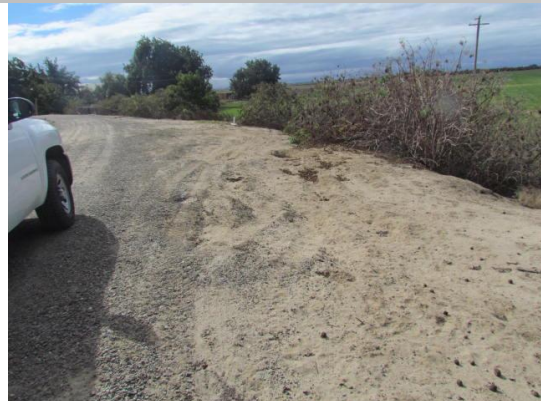
Photo 1 of 1 : FA_2015_RD0524_107_82_20150914_00107.jpg

LM Start	2.53	Rating **	M	Issue No.	82
LM End	2.56	Issue Type +	Ma	Location *	LS
Category	Earthen Levee			GPS Latitude/Longitude	
				Start	End
Item	Slope Stability			37.918060 °	37.917667 °
				-121.322384 °	-121.322713 °
DWR ID	DWR_RD0524_01_s _ 2012_82				
Action/Comments					
Repair slope instability.

Looking southwest at damaged landward slope.

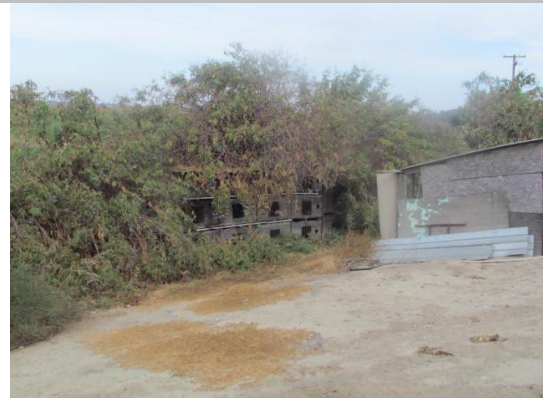
Photo 1 of 2 : FA_2015_RD0524_107_42_20150914_00064.jpg

LM Start	2.56	Rating **	U	Issue No.	42
LM End	2.56	Issue Type +	En	Location *	WS
Category	Earthen Levee			GPS Latitude/Longitude	
				Start	End
Item	Encroachments			37.917673 °	37.917673 °
				-121.322718 °	-121.322718 °
DWR ID	DWR_RD0524_01_s _ 2012_42				
Action/Comments					
Building					
Inspector Comments: Animal pens on landward slope and toe.

Looking west at animal pens on landside toe. (Fall 2012)

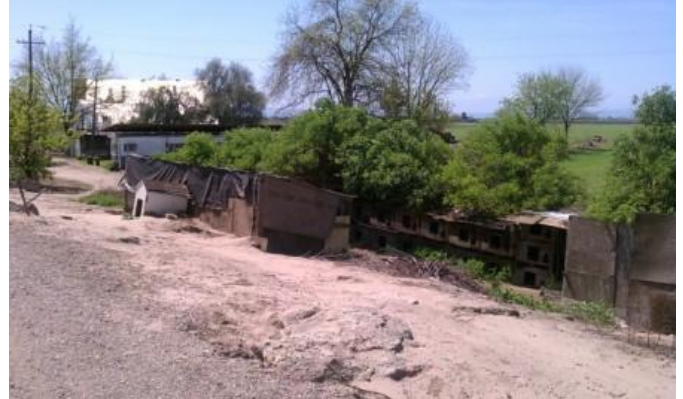
Photo 2 of 2 : FA_2015_RD0524_107_42_20150914_00065.jpg

LM Start	2.56	Rating **	U	Issue No.	42 (cont)
LM End	2.56	Issue Type +	En	Location *	WS
Category	Earthen Levee			GPS Latitude/Longitude	
				Start	End
Item	Encroachments			37.917673 °	37.917673 °
				-121.322718 °	-121.322718 °
DWR ID	DWR_RD0524_01_s_2012_42				
Action/Comments					
Building					
Inspector Comments: Animal pens on landward slope and toe.

Looking at animal pens on landside slope and toe.

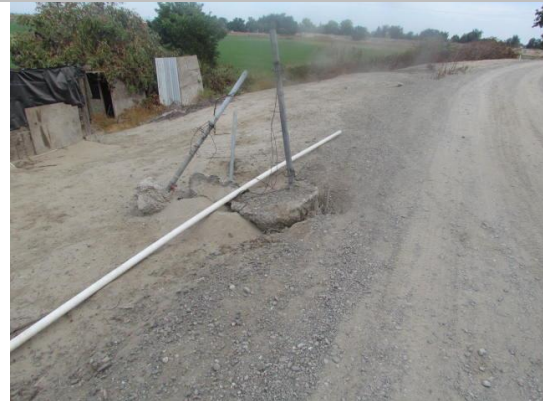
Photo 1 of 1 : FA_2015_RD0524_107_12_20150914_00016.jpg

LM Start	2.57	Rating **	M	Issue No.	12
LM End	2.57	Issue Type +	En	Location *	LS
Category	Earthen Levee			GPS Latitude/Longitude	
				Start	End
Item	Encroachments			37.917538 °	37.917538 °
				-121.322757 °	-121.322757 °
DWR ID	DWR_RD0524_01_f_2012_12				
Action/Comments					
Pole					
Inspector Comments: Old fence poles on landside shoulder and slope should be removed.

Looking northwest at fence poles on landside shoulder.

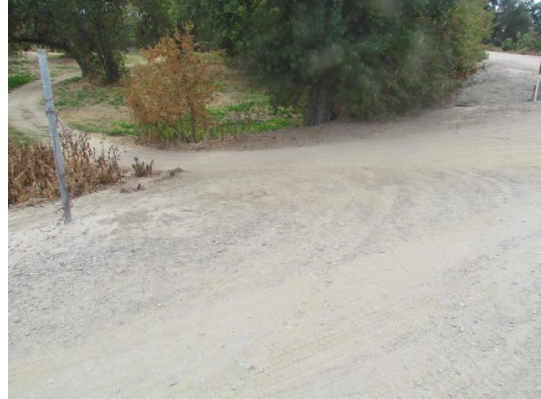
Photo 1 of 1 : FA_2015_RD0524_107_7_20150914_00011.jpg

LM Start	2.58	Rating **	M	Issue No.	7
LM End	2.58	Issue Type +	En	Location *	WS
Category	Earthen Levee			GPS Latitude/Longitude	
				Start	End
Item	Encroachments			37.917431 °	37.917431 °
				-121.322780 °	-121.322780 °
DWR ID	DWR_RD0524_01_f_2012_7				
Action/Comments					
Ramp

Looking southeast at unauthorized ramp on waterside slope.

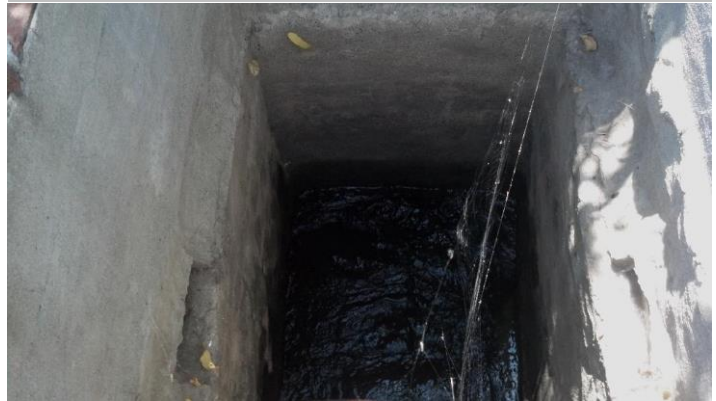
Photo 1 of 3 : UCIP_FA_2015_2019.jpg

LM Start	2.58	Rating **	M	Issue No.	949
LM End	2.58	Issue Type +	En	Location *	WS
Category	Supplemental			GPS Latitude/Longitude	
				Start	End
Item	DWR UCIP Field Study			37.917365 °	37.917365 °
				-121.322779 °	-121.322779 °
DWR ID					
Action/Comments					
Inspector Comments: FS_ID:21935 DS_ID:24040 EP_NO: N/A FS_HLM: 2.61 Repair Type: Non-Urgent Crossing Status: Found UCIP Comments: Need to determine type of abandonment for pipe at this location. FIELD_STRUCT_DESC: *Abandoned* Pump pad on LS shoulder with 4'X9' brick distribution box on WS slope. No pipe visible. 4'X9' brick distribution box on LS toe. FS Date: 08/20/2013

Distribution box on LS toe.

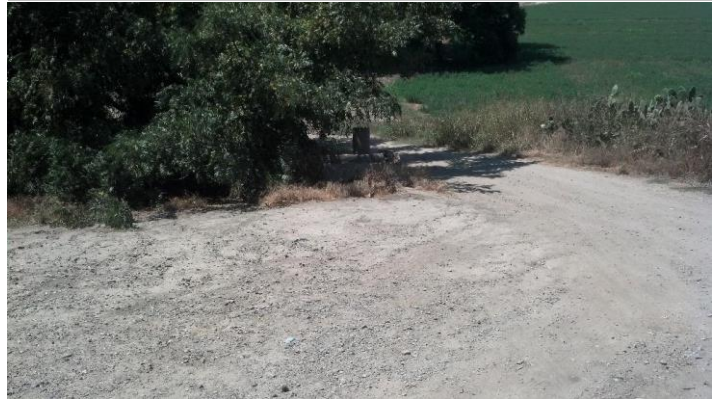
Photo 2 of 3 : UCIP_FA_2015_2020.jpg

Inspector Comments: FS_ID:21935
 DS_ID:24040
 EP_NO: N/A
 FS_HLM: 2.61
 Repair Type: Non-Urgent
 Crossing Status: Found
 UCIP Comments: Need to determine type of abandonment for pipe at this location.
 FIELD_STRUCT_DESC: *Abandoned* Pump pad on LS shoulder with 4'X9' brick distribution box on WS slope. No pipe visible. 4'X9' brick distribution box on LS toe.
 FS Date: 08/20/2013

Distribution box on LS toe.

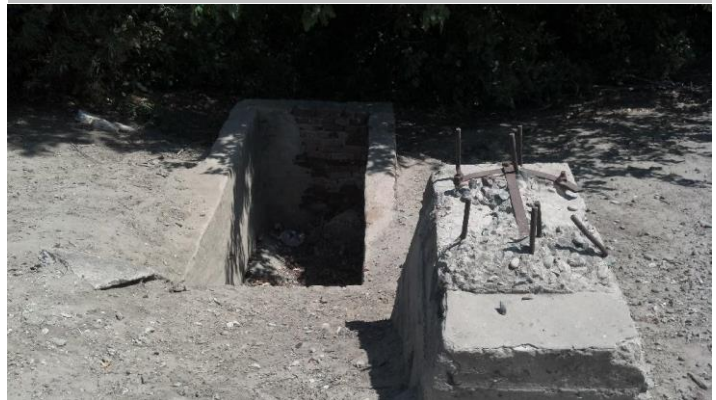
Photo 3 of 3 : UCIP_FA_2015_2021.jpg

Foundation for pump with distribution box on WS shoulder.

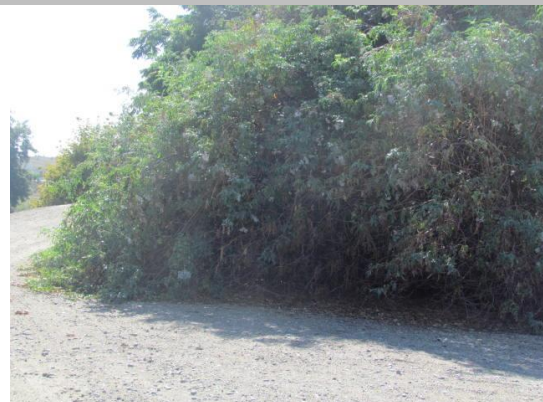
Photo 1 of 1 : FA_2015_RD0524_107_43_20151023_00251.jpg

LM Start	2.64	Rating **	U	Issue No.	43
LM End	2.64	Issue Type +	Ma	Location *	LS
Category	Earthen Levee			GPS Latitude/Longitude	
				Start	End
Item	Vegetation			37.916780 °	37.916780 °
				-121.322095 °	-121.322095 °
DWR ID	DWR_RD0524_01_s _ 2012_43				
Action/Comments					
Elderberries are blocking visibility and flood fight capability. Inspector Comments: Dense elderberry on landward shoulder, slope, and toe.

Looking southeast at dense veg on landward slope and toe fall 2015.

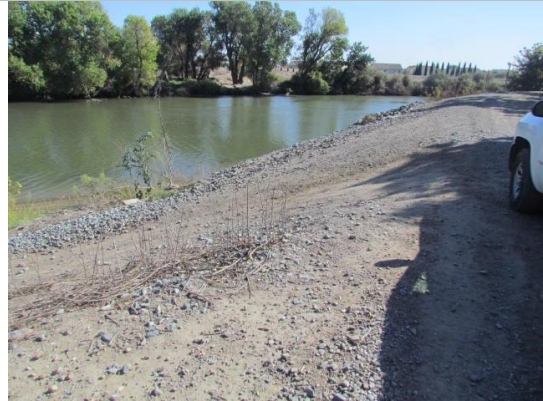
Photo 1 of 1 : FA_2015_RD0524_107_920_20150914_00201.jpg

LM Start	2.65	Rating **	U	Issue No.	920
LM End	2.65	Issue Type +	En	Location *	WS
Category	Earthen Levee			GPS Latitude/Longitude	
				Start	End
Item	Encroachments			37.916698 °	37.916698 °
				-121.322007 °	-121.322007 °
DWR ID	DWR_RD0524_01_s_2012_920				
Action/Comments					
Ramp

Looking southeast at unauthorized ramp on waterside slope.

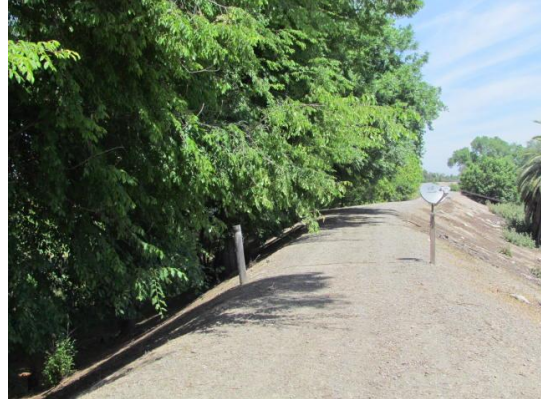
Photo 1 of 1 : FA_2015_RD0524_107_44_20150914_00066.jpg

LM Start	2.67	Rating **	A/W	Issue No.	44
LM End	2.77	Issue Type +	Ma	Location *	LS
Category	Earthen Levee			GPS Latitude/Longitude	
				Start	End
Item	Trim / Thin Trees			37.916418 °	37.915142 °
				-121.321963 °	-121.323018 °
DWR ID	DWR_RD0524_01_s_2012_44				
Action/Comments					
Trim trees over roadway to at least 12 feet above ground level. Inspector Comments: Trim over hanging trees at least 12 feet above ground level.

Looking north at dense trees overhanging levee crown.

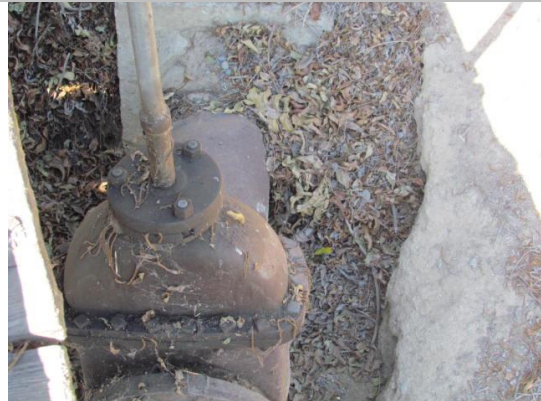
Photo 1 of 2 : FA_2015_RD0524_107_21_20150914_00033.jpg

LM Start	2.68	Rating **	M	Issue No.	21
LM End	2.68	Issue Type +	Ma	Location *	WS
Category	Earthen Levee			GPS Latitude/Longitude	
				Start	End
Item	Erosion / Bank Caving			37.916224 °	37.916224 °
				-121.322115 °	-121.322115 °
DWR ID	DWR_RD0524_01_f_2013_21				
Action/Comments					
Schedule repair of erosion site prior to the next inspection. Inspector Comments: Large erosion around irrigation pipe.

Looking at erosion around irrigation pipe on waterward slope.

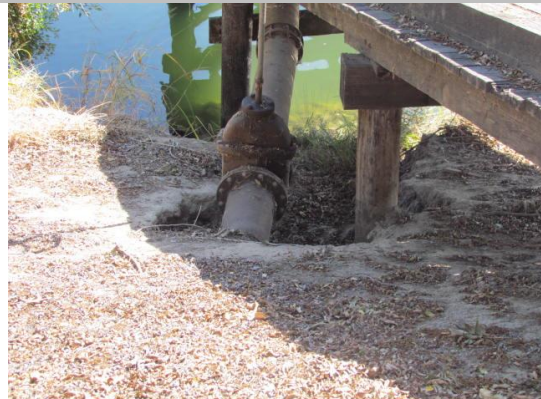
Photo 2 of 2 : FA_2015_RD0524_107_21_20150914_00034.jpg

Looking east at erosion around irrigation pipe on waterward slope.

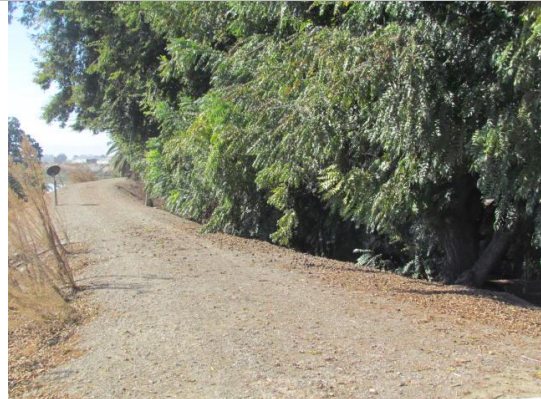
Photo 1 of 1 : FA_2015_RD0524_107_60_20151023_00252.jpg

LM Start	2.72	Rating **	U	Issue No.	60
LM End	2.74	Issue Type +	Ma	Location *	LS
Category	Earthen Levee			GPS Latitude/Longitude	
				Start	End
Item	Trim / Thin Trees			37.915747 °	37.915492 °
				-121.322470 °	-121.322639 °
DWR ID	DWR_RD0524_01_s _ 2012_60				
Action/Comments					
Trim trees to at least five feet above ground level.					
Inspector Comments: Untrimmed trees on landward slope.

Looking southwest at dense untrimmed trees on landward slope and toe fall 2015.

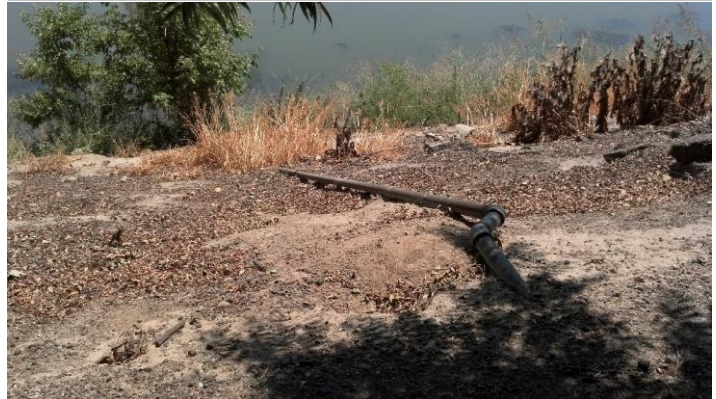
Photo 1 of 2 : UCIP_FA_2015_1653.jpg

LM Start	2.72	Rating **	M	Issue No.	950
LM End	2.72	Issue Type +	En	Location *	LS
Category	Supplemental			GPS Latitude/Longitude	
				Start	End
Item	DWR UCIP Field Study			37.915698 °	37.915698 °
				-121.322501 °	-121.322501 °
DWR ID					
Action/Comments					
Inspector Comments: FS_ID:18085 DS_ID:20616 EP_NO: N/A FS_HLM: 2.75 Repair Type: Non-Urgent Crossing Status: Found UCIP Comments: No permit identified for crossing. Unknown use. Pipe should be removed. FIELD_STRUCT_DESC: 3-inch galvanized iron pipe through the levee 0.3 feet below the crown. Valve on the landward shoulder. FS Date: 08/20/2013

Pipe visible on WS slope.

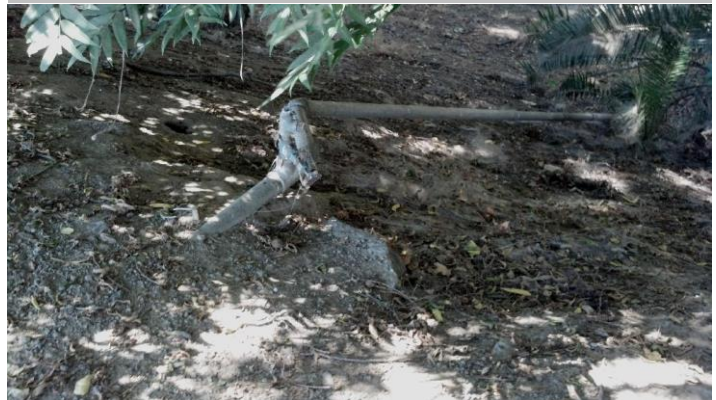
Photo 2 of 2 : UCIP_FA_2015_1654.jpg

Pipe and vent visible on LS slope.

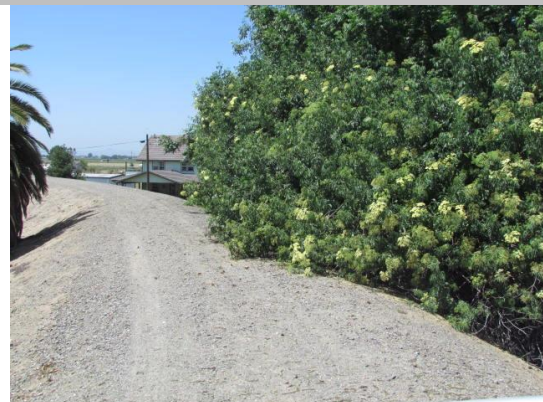
Photo 1 of 2 : FA_2015_RD0524_107_48_20150914_00074.jpg

LM Start	2.80	Rating **	U	Issue No.	48
LM End	2.80	Issue Type +	Ma	Location *	LS
Category	Earthen Levee			GPS Latitude/Longitude	
				Start	End
Item	Vegetation			37.915022 °	37.915022 °
				-121.323443 °	-121.323443 °
DWR ID	DWR_RD0524_01_s _ 2012_48				
Action/Comments					
Elderberries are blocking visibility and flood fight capability.

Looking south at dense elderberry on landside slope.(Spring 2012)

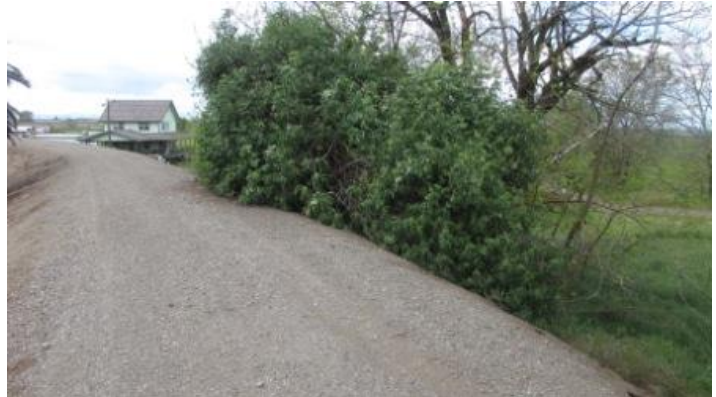
Photo 2 of 2 : FA_2015_RD0524_107_48_20150914_00075.jpg

LM Start	2.80	Rating **	U	Issue No.	48 (cont)
LM End	2.80	Issue Type +	Ma	Location *	LS
Category	Earthen Levee			GPS Latitude/Longitude	
				Start	End
Item	Vegetation			37.915022 °	37.915022 °
				-121.323443 °	-121.323443 °
DWR ID	DWR_RD0524_01_s _ 2012_48				
Action/Comments					
Elderberries are blocking visibility and flood fight capability.

Looking south at elderberry on landside slope.(Spring 2011)

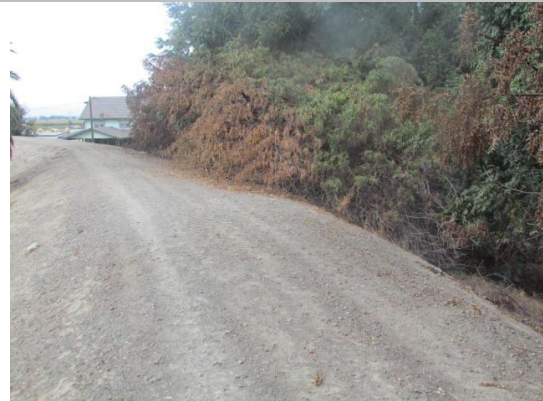
Photo 1 of 1 : FA_2015_RD0524_107_91_20150914_00111.jpg

LM Start	2.80	Rating **	U	Issue No.	91
LM End	2.80	Issue Type +	Ma	Location *	LS
Category	Earthen Levee			GPS Latitude/Longitude	
				Start	End
Item	Trim / Thin Trees			37.915063 °	37.915063 °
				-121.323585 °	-121.323585 °
DWR ID	DWR_RD0524_01_s _ 2012_91				
Action/Comments					
Thin trees to allow visibility of the ground and room to flood fight.

Looking southwest at dense vegetation on landside slope.

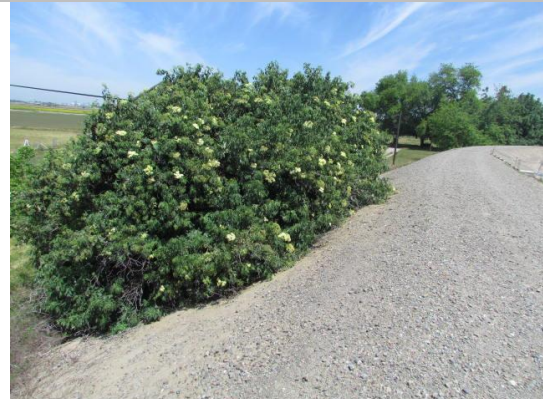
Photo 1 of 1 : FA_2015_RD0524_107_49_20150914_00076.jpg

LM Start	2.86	Rating **	U	Issue No.	49
LM End	2.86	Issue Type +	Ma	Location *	LS
Category	Earthen Levee			GPS Latitude/Longitude	
				Start	End
Item	Vegetation			37.914427 °	37.914427 °
				-121.324198 °	-121.324198 °
DWR ID	DWR_RD0524_01_s _ 2012_49				
Action/Comments					
Elderberries are blocking visibility and flood fight capability.

Looking northwest at elderberry on landside slope.

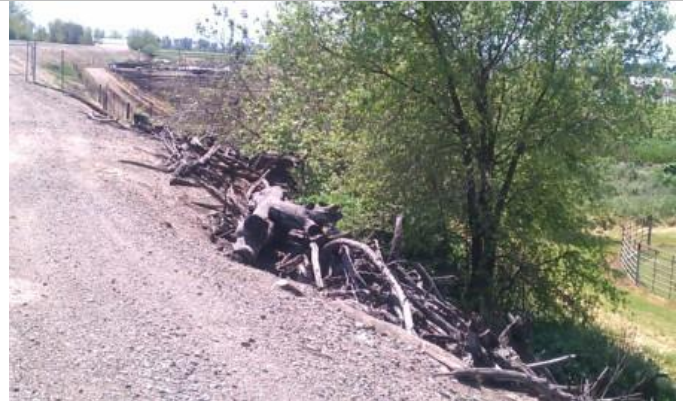
Photo 1 of 1 : FA_2015_RD0524_107_50_20150914_00077.jpg

LM Start	2.90	Rating **	U	Issue No.	50
LM End	2.92	Issue Type +	Ma	Location *	LS
Category	Earthen Levee			GPS Latitude/Longitude	
				Start	End
Item	Encroachments			37.913767 °	37.913503 °
				-121.324427 °	-121.324488 °
DWR ID	DWR_RD0524_01_s _ 2012_50				
Action/Comments					
Prunings

Looking southwest at prunings on landside slope.

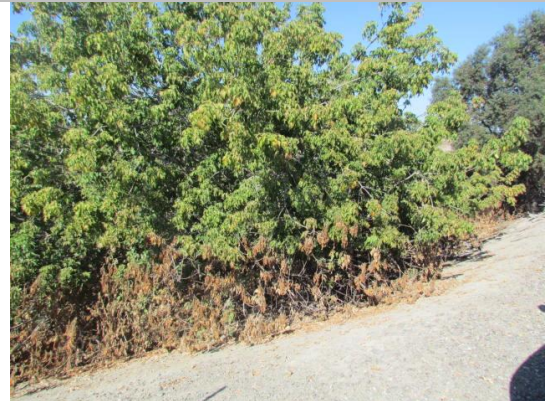
Photo 1 of 2 : FA_2015_RD0524_107_51_20151023_00253.jpg

LM Start	2.93	Rating **	U	Issue No.	51
LM End	2.93	Issue Type +	Ma	Location *	LS
Category	Earthen Levee			GPS Latitude/Longitude	
				Start	End
Item	Trim / Thin Trees			37.913415 °	37.913415
				-121.324503 °	-121.324503
DWR ID	DWR_RD0524_01_s _ 2012_51				
Action/Comments					
Trim trees to at least five feet above ground level.					
Inspector Comments: Untrimmed trees on landward slope and toe.

Looking south at dense trees on landward slope fall 2015

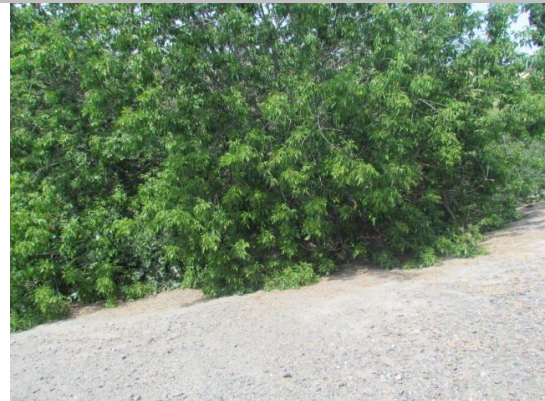
Photo 2 of 2 : FA_2015_RD0524_107_51_20150914_00078.jpg

Looking south at dense trees on landward slope spring 2015

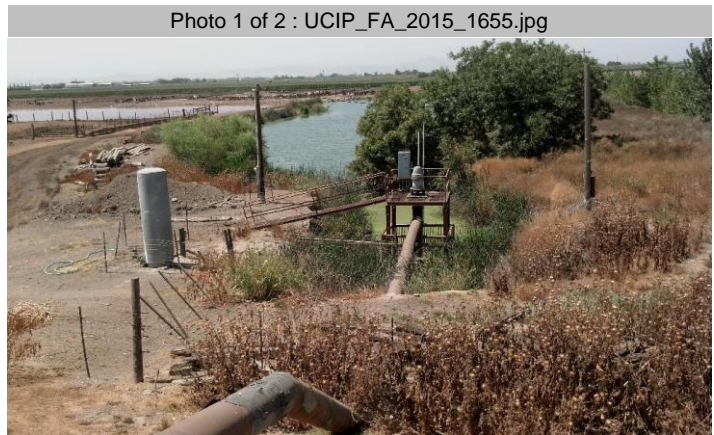
LM Start	2.95	Rating **	M	Issue No.	951
LM End	2.95	Issue Type +	En	Location *	LS
Category	Supplemental			GPS Latitude/Longitude	
				Start	End
Item	DWR UCIP Field Study			37.913101 °	37.913101 °
				-121.324500 °	-121.324500 °
DWR ID					
Action/Comments					
Inspector Comments: FS_ID:18089					
DS_ID:20617					
EP_NO: N/A					
FS_HLM: 2.98					
Repair Type: Non-Urgent					
Crossing Status: Indicator Found

Pipe, pump, power pole, and meter visible off LS toe.

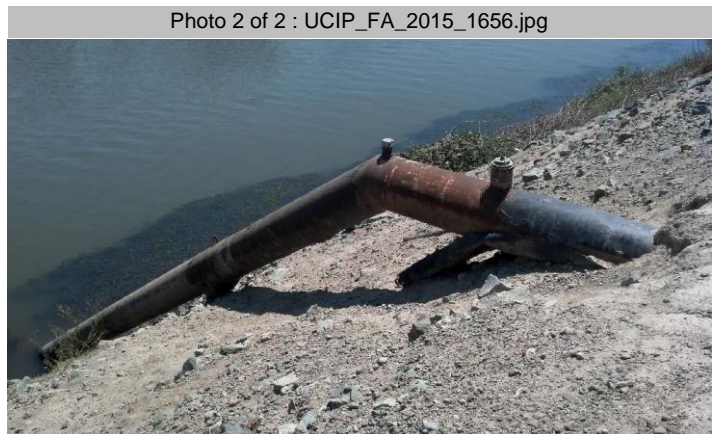
PVC wrapped pipe and siphon breaker visible on WS slope.

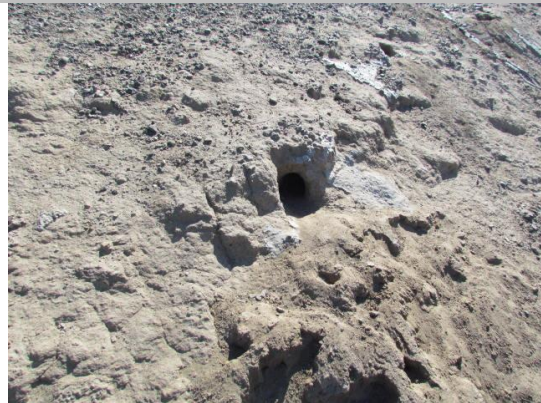
Photo 1 of 2 : FA_2015_RD0524_107_925_20151023_00254.jpg

LM Start	3.07	Rating **	M	Issue No.	925
LM End	3.27	Issue Type +	Ma	Location *	LS
Category	Earthen Levee			GPS Latitude/Longitude	
				Start	End
Item	Animal Control			37.911382 °	37.908602 °
				-121.324928 °	-121.325395 °
DWR ID	DWR_RD0524_01_s _ 2012_925				
Action/Comments					
Exterminate rodents and backfill and compact or grout burrows. Inspector Comments: Several rodent holes on levee slopes.

Looking at typical view of rodent hole with this section fall 2015.

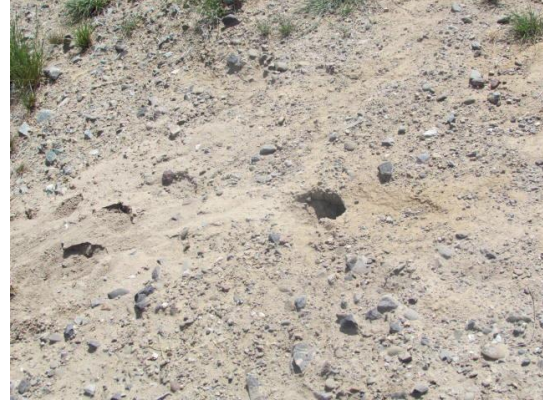
Photo 2 of 2 : FA_2015_RD0524_107_925_20150914_00202.jpg

LM Start	3.07	Rating **	M	Issue No.	925 (cont)
LM End	3.27	Issue Type +	Ma	Location *	LS
Category	Earthen Levee			GPS Latitude/Longitude	
				Start	End
Item	Animal Control			37.911382 °	37.908602 °
				-121.324928 °	-121.325395 °
DWR ID	DWR_RD0524_01_s_2012_925				
Action/Comments					
Exterminate rodents and backfill and compact or grout burrows. Inspector Comments: Several rodent holes on levee slopes.

Looking at typical rodent holes on landward slope along this reach.

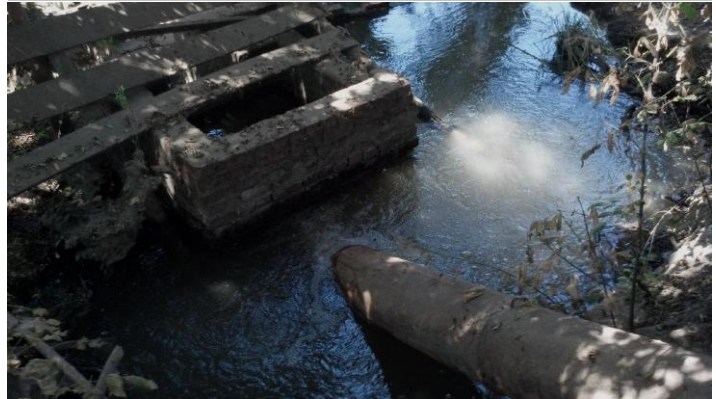
Photo 1 of 3 : UCIP_FA_2015_1524.jpg

Inspector Comments: FS_ID:42932
 DS_ID:20618
 EP_NO: N/A
 FS_HLM: 3.38
 Repair Type: Urgent
 Crossing Status: Found
 UCIP Comments: Extensive erosion on LS toe at distribution box due to failure of box/pipe connection. Erosion on LS slope do to recently repaired leak at gate valve.
 FIELD_STRUCT_DESC: 14-inch steel irrigation pipe through the levee 7-feet below the crown, pump house on the waterward slope. Gate valve on the LS slope and a 4'X4' brick distribution box at the LS toe.
 Originally included in the 1964 O&M manual.
 FS Date: 08/20/2013

Extensive erosion around distribution box at LS toe.

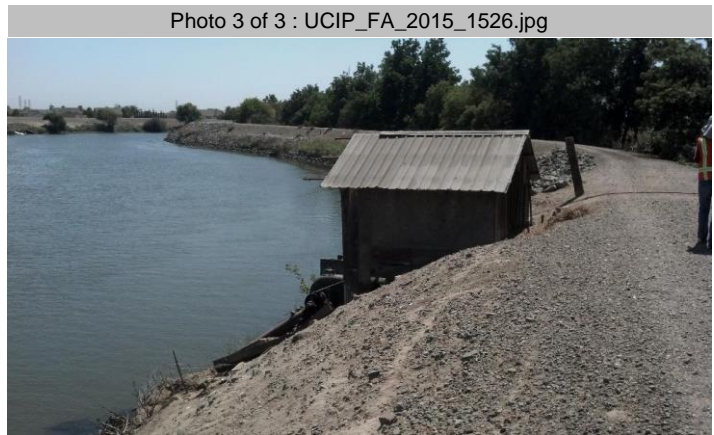
LM Start	3.35	Rating **	U	Issue No.	952 (cont)
LM End	3.35	Issue Type +	En	Location *	LS
Category	Supplemental			GPS Latitude/Longitude	
				Start	End
Item	DWR UCIP Field Study			37.907504 °	37.907504 °
				-121.325420 °	-121.325420 °
DWR ID					
Action/Comments					
Inspector Comments: FS_ID:42932					
DS_ID:20618					
EP_NO: N/A					
FS_HLM: 3.38					
Repair Type: Urgent					
Crossing Status: Found

Pipe and pumphouse on WS slope.

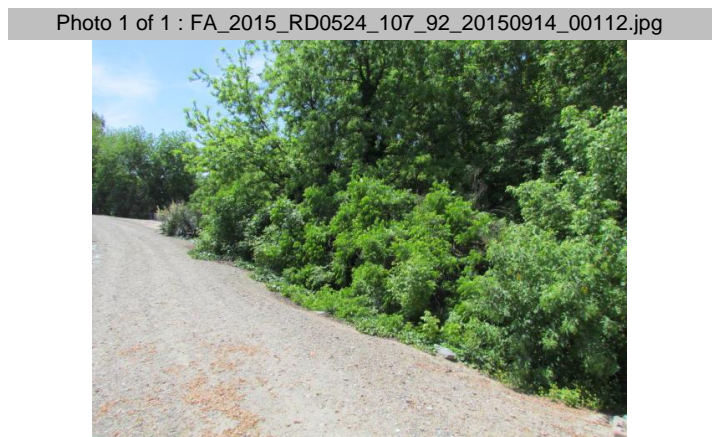
LM Start	3.35	Rating **	U	Issue No.	92
LM End	3.37	Issue Type +	En	Location *	LS
Category	Earthen Levee			GPS Latitude/Longitude	
				Start	End
Item	Vegetation			37.907407 °	37.907177 °
				-121.325435 °	-121.325392 °
DWR ID	DWR_RD0524_01_s_2012_92				
Action/Comments					
Landscaping

Looking southwest at dense landscaping on landside slope.

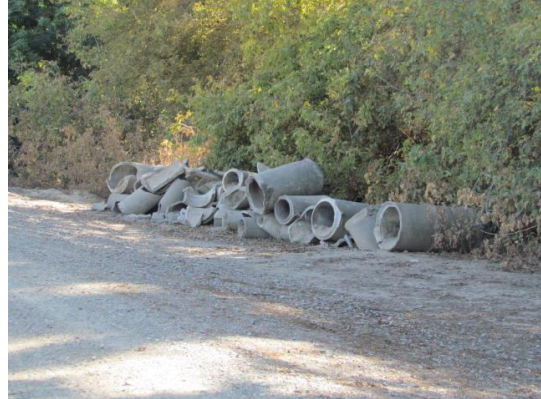
Photo 1 of 1 : FA_2015_RD0524_107_56_20150914_00081.jpg

LM Start	3.42	Rating **	M	Issue No.	56
LM End	3.42	Issue Type +	Ma	Location *	LS
Category	Earthen Levee			GPS Latitude/Longitude	
				Start	End
Item	Encroachments			37.906540 °	37.906540 °
				-121.325015 °	-121.325015 °
DWR ID	DWR_RD0524_01_s_2012_56				
Action/Comments					
Material					
Inspector Comments: Broken concrete pipes

Looking southwest at concrete pipes on landside toe.

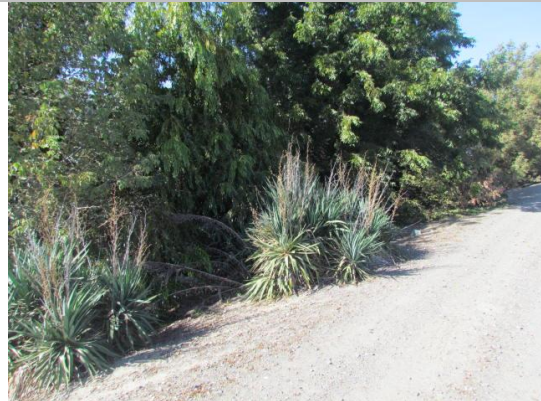
Photo 1 of 1 : FA_2015_RD0524_107_54_20150914_00079.jpg

LM Start	3.45	Rating **	U	Issue No.	54
LM End	3.45	Issue Type +	Ma	Location *	LS
Category	Earthen Levee			GPS Latitude/Longitude	
				Start	End
Item	Trim / Thin Trees			37.906227 °	37.906227 °
				-121.324683 °	-121.324683 °
DWR ID	DWR_RD0524_01_s_2012_54				
Action/Comments					
Trim and thin trees to allow visibility of the ground and room to flood fight.					
Inspector Comments: Dense untrimmed trees on landward slope.

Looking northwest at dense vegetation on landside slope.

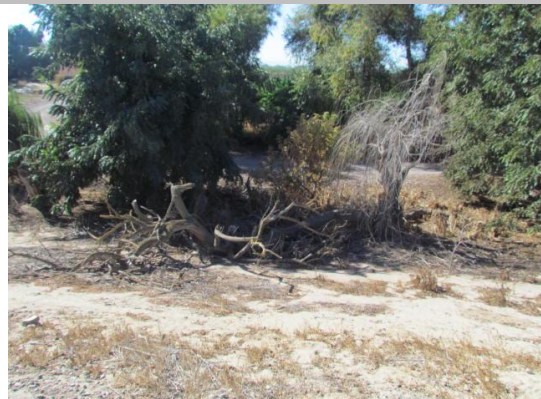
Photo 1 of 1 : FA_2015_RD0524_107_177_20151023_00255.jpg

LM Start	3.48	Rating **	M	Issue No.	177
LM End	3.48	Issue Type +	Ma	Location *	LS
Category	Earthen Levee			GPS Latitude/Longitude	
				Start	End
Item	Encroachments			37.905994 °	37.905994 °
				-121.324194 °	-121.324194 °
DWR ID	DWR_RD0524_01_f_2014_177				
Action/Comments					
Tree or limb					
Inspector Comments: Dead tree on landward toe.

Looking at dead tree limb at landward toe fall 2015.

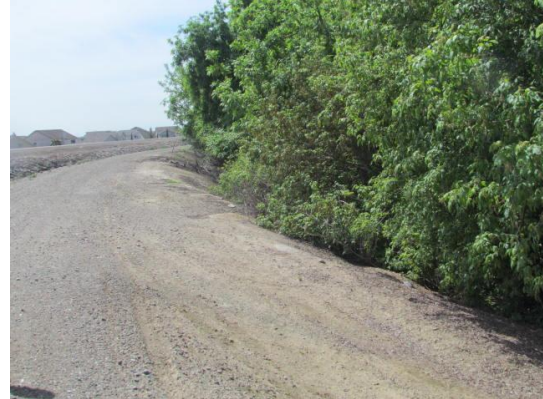
Photo 1 of 1 : FA_2015_RD0524_107_57_20150914_00082.jpg

LM Start	3.51	Rating **	U	Issue No.	57
LM End	3.61	Issue Type +	Ma	Location *	LS
Category	Earthen Levee			GPS Latitude/Longitude	
				Start	End
Item	Trim / Thin Trees			37.905638 °	37.904430 °
				-121.323892 °	-121.324570 °
DWR ID	DWR_RD0524_01_s_2012_57				
Action/Comments					
Trim and thin trees to allow visibility of the ground and room to flood fight.

Looking south at dense trees on landward slope.

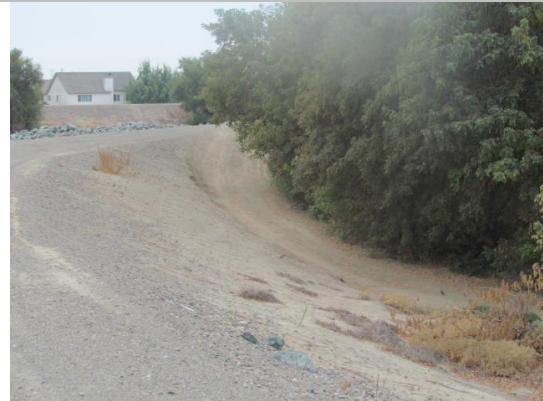
Photo 1 of 1 : FA_2015_RD0524_107_265_20150914_00191.jpg

LM Start	3.51	Rating **	M	Issue No.	265
LM End	3.51	Issue Type +	En	Location *	LS
Category	Earthen Levee			GPS Latitude/Longitude	
				Start	End
Item	Encroachments			37.905552 °	37.905552 °
				-121.323847 °	-121.323847 °
DWR ID	DWR_RD0524_01_s_2012_265				
Action/Comments					
Ramp					
Inspector Comments: Unauthorized ramp on landside slope.

Looking southeast at unauthorized ramp on landside slope and toe.

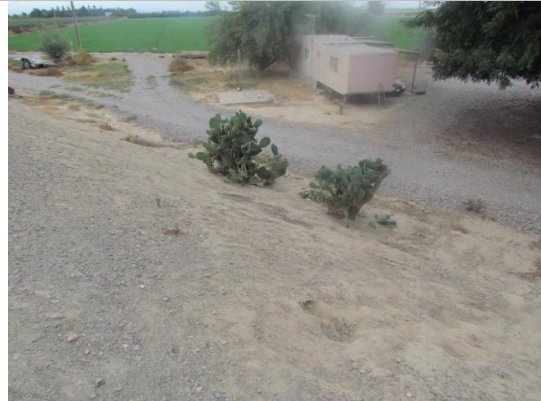
Photo 1 of 1 : FA_2015_RD0524_107_124_20150914_00138.jpg

LM Start	3.61	Rating **	M	Issue No.	124
LM End	3.61	Issue Type +	En	Location *	LS
Category	Earthen Levee			GPS Latitude/Longitude	
				Start	End
Item	Vegetation			37.904375 °	37.904375
				-121.324615 °	-121.324615
DWR ID	DWR_RD0524_01_f_2012_124				
Action/Comments					
Landscaping					
Inspector Comments: Landowner planted cactus on landside toe.

Looking west at cactus on landside toe.

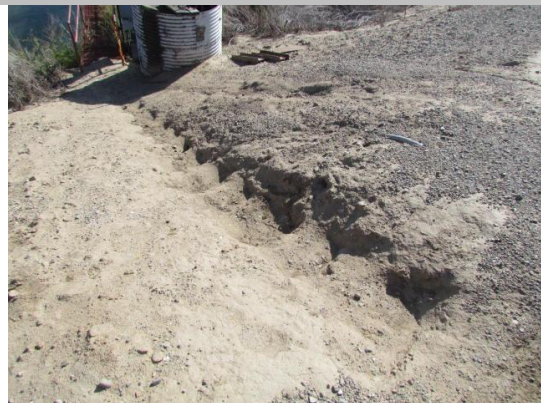
Photo 1 of 1 : FA_2015_RD0524_107_58_20150914_00083.jpg

LM Start	3.64	Rating **	M	Issue No.	58
LM End	3.64	Issue Type +	Ma	Location *	WS
Category	Earthen Levee			GPS Latitude/Longitude	
				Start	End
Item	Slope Stability			37.904113 °	37.904113 °
				-121.325080 °	-121.325080 °
DWR ID	DWR_RD0524_01_s_2012_58				
Action/Comments					
Repair the levee slope damaged by foot traffic and prevent access where possible.					
Inspector Comments: Landowner cut steps into waterside slope.

Looking southeast steps cut into waterside slope.

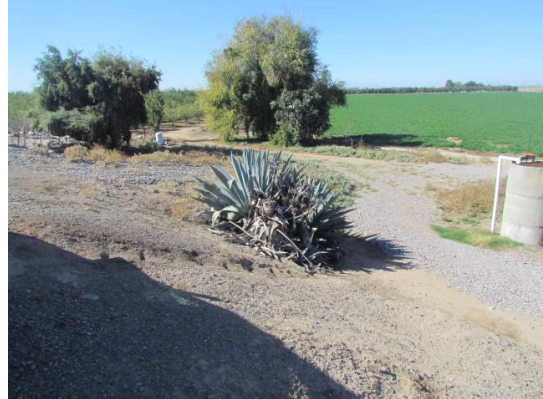
Photo 1 of 1 : FA_2015_RD0524_107_190_20151023_00256.jpg

LM Start	3.65	Rating **	U	Issue No.	190
LM End	3.65	Issue Type +	Ma	Location *	LS
Category	Earthen Levee			GPS Latitude/Longitude	
				Start	End
Item	Vegetation			37.904070 °	37.904070 °
				-121.325118 °	-121.325118 °
DWR ID	DWR_RD0524_01_f_2015_190				
Action/Comments					
Remove the wild growth other than native grasses from the levee slopes.					
Inspector Comments: Large century plant at landward toe.

Looking southwest at century plant at landward toe fall 2015.

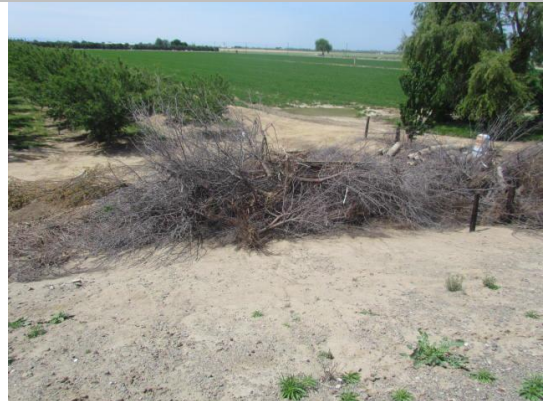
Photo 1 of 1 : FA_2015_RD0524_107_192_20150914_00177.jpg

LM Start	3.67	Rating **	U	Issue No.	192
LM End	3.67	Issue Type +	Ma	Location *	LS
Category	Earthen Levee			GPS Latitude/Longitude	
				Start	End
Item	Encroachments			37.903782 °	37.903782 °
				-121.325363 °	-121.325363 °
DWR ID	DWR_RD0524_01_s_2015_192				
Action/Comments					
Prunings					
Inspector Comments: Large pruning piles at landward toe.

Looking east at pruning pile at landward toe.

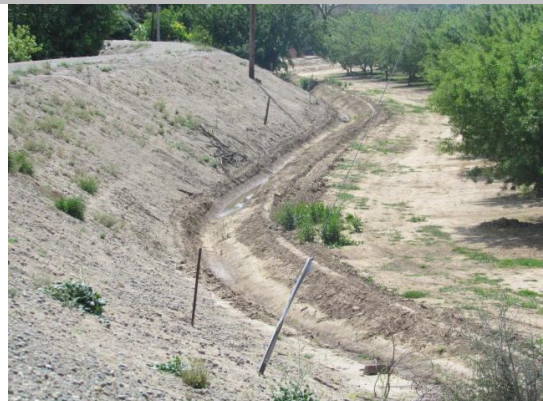
Photo 1 of 2 : FA_2015_RD0524_107_194_20150914_00179.jpg

LM Start	3.69	Rating **	M	Issue No.	194
LM End	3.78	Issue Type +	En	Location *	LS
Category	Earthen Levee			GPS Latitude/Longitude	
				Start	End
Item	Encroachments			37.903553 °	37.902505 °
				-121.325468 °	-121.326425 °
DWR ID	DWR_RD0524_01_s_2015_194				
Action/Comments					
Ditch					
Inspector Comments: Irrigation ditch at landward toe.

Looking south at irrigation ditch at landward toe.

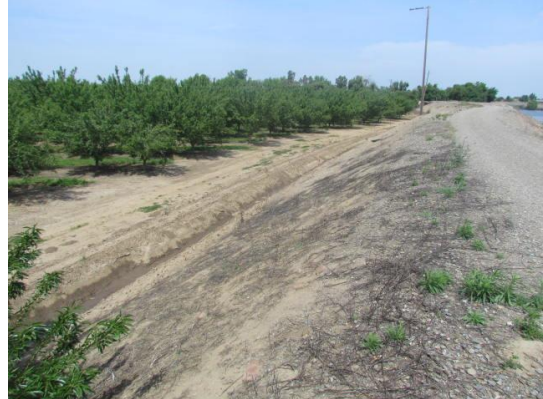
Photo 2 of 2 : FA_2015_RD0524_107_194_20150914_00180.jpg

LM Start	3.69	Rating **	M	Issue No.	194 (cont)
LM End	3.78	Issue Type +	En	Location *	LS
Category	Earthen Levee			GPS Latitude/Longitude	
				Start	End
Item	Encroachments			37.903553 °	37.902505 °
				-121.325468 °	-121.326425 °
DWR ID	DWR_RD0524_01_s_2015_194				
Action/Comments					
Ditch					
Inspector Comments: Irrigation ditch at landward toe.

Looking east at south end of irrigation ditch at landward toe.

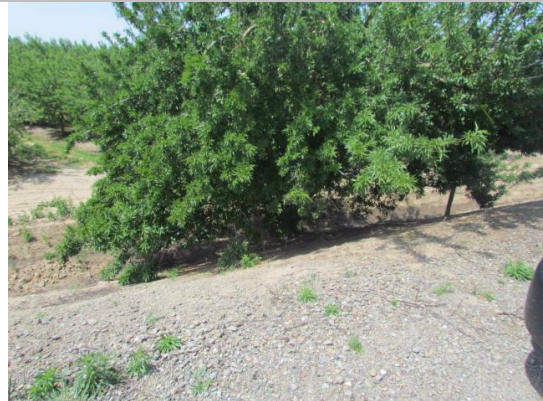
Photo 1 of 1 : FA_2015_RD0524_107_927_20150914_00203.jpg

LM Start	3.77	Rating **	M	Issue No.	927
LM End	3.77	Issue Type +	Ma	Location *	LS
Category	Earthen Levee			GPS Latitude/Longitude	
				Start	End
Item	Trim / Thin Trees			37.902645 °	37.902645 °
				-121.326340 °	-121.326340 °
DWR ID	DWR_RD0524_01_s_2012_927				
Action/Comments					
Trim trees to at least five feet above ground level.

Looking east at untrimmed tree on landward slope.

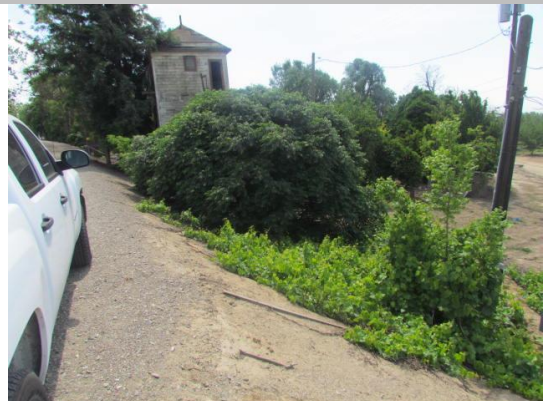
Photo 1 of 1 : FA_2015_RD0524_107_59_20150914_00084.jpg

LM Start	3.78	Rating **	M	Issue No.	59
LM End	3.78	Issue Type +	Ma	Location *	LS
Category	Earthen Levee			GPS Latitude/Longitude	
				Start	End
Item	Trim / Thin Trees			37.902417 °	37.902417 °
				-121.326482 °	-121.326482 °
DWR ID	DWR_RD0524_01_s_2012_59				
Action/Comments					
Trim trees to at least five feet above ground level.

Looking south at untrimmed trees on landward slope.

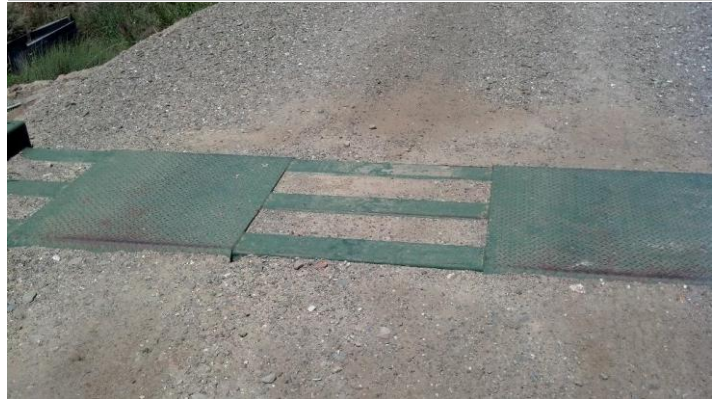
Photo 1 of 3 : UCIP_FA_2015_2490.jpg

Inspector Comments: FS_ID:22725
 DS_ID:24044
 EP_NO: N/A
 FS_HLM: 3.821
 Repair Type: Non-Urgent
 Crossing Status: Found
 UCIP Comments: No permit identified for this crossing.
 FIELD_STRUCT_DESC: 8-inch steel irrigation pipe through the levee 0-feet below the crown. Pipe integrated into steel cattleguard style crossing. Slant pump and butterfly valve at concrete foundation on WS slope. Filter plant, vents, and butterfly valves on LS toe.
 FS Date: 08/20/2013

Steel, integrated cattleguard style pipe crossing at crown elevation.

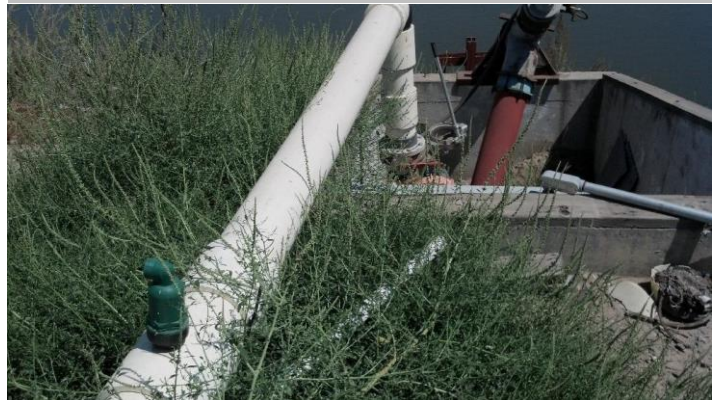
Photo 2 of 3 : UCIP_FA_2015_2491.jpg

Vent on PVC pipe at WS shoulder.

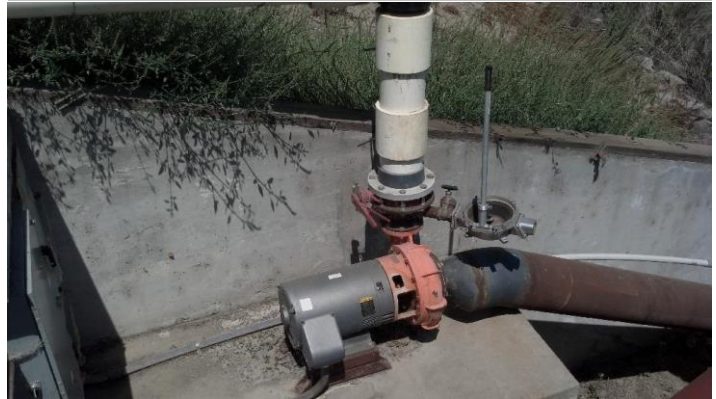
Photo 3 of 3 : UCIP_FA_2015_2492.jpg

LM Start	3.79	Rating **	M	Issue No.	953 (cont)
LM End	3.79	Issue Type +	En	Location *	LS
Category	Supplemental			GPS Latitude/Longitude	
				Start	End
Item	DWR UCIP Field Study			37.902371 °	37.902371 °
				-121.326440 °	-121.326440 °
DWR ID					
Action/Comments					
Inspector Comments: FS_ID:22725					
DS_ID:24044					
EP_NO: N/A					
FS_HLM: 3.821					
Repair Type: Non-Urgent					
Crossing Status: Found

Pump and butterfly valve on concrete pad on WS shoulder.

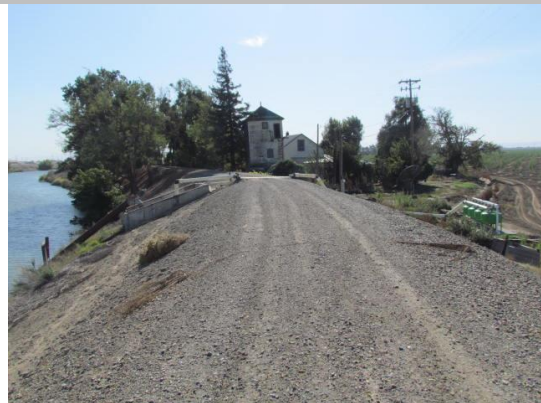
Photo 1 of 3 : FA_2015_RD0524_107_266_20150914_00192.jpg

LM Start	3.79	Rating **	M	Issue No.	266
LM End	3.79	Issue Type +	En	Location *	LS
Category	Earthen Levee			GPS Latitude/Longitude	
				Start	End
Item	Encroachments			37.902365 °	37.902365 °
				-121.326453 °	-121.326453 °
DWR ID	DWR_RD0524_01_s_2012_266				
Action/Comments					
Equipment					
Inspector Comments: Landowner installed water filter piping system without permit.

Looking south at unauthorized irrigation pipe across levee and water filtration system at landside toe.

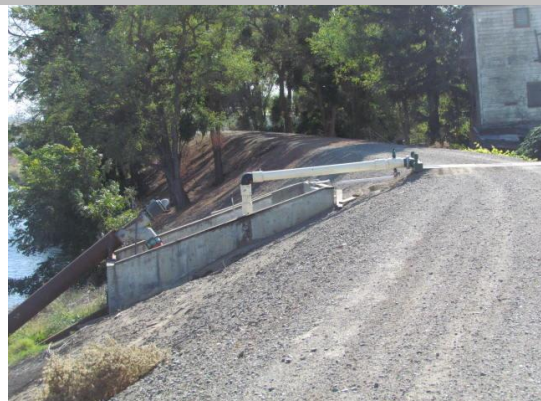
Photo 2 of 3 : FA_2015_RD0524_107_266_20150914_00193.jpg

Looking south unauthorized PVC irrigation pipe across the levee crown.

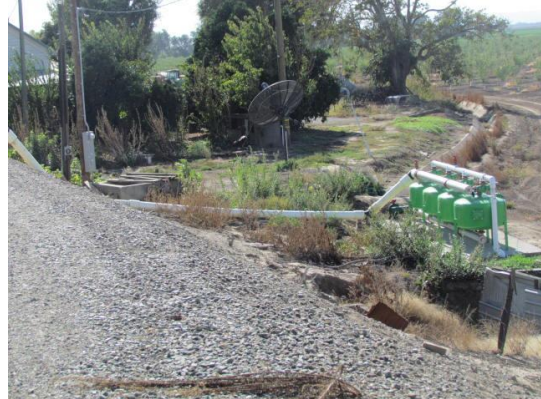
Photo 3 of 3 : FA_2015_RD0524_107_266_20150914_00194.jpg

LM Start	3.79	Rating **	M	Issue No.	266 (cont)
LM End	3.79	Issue Type +	En	Location *	LS
Category	Earthen Levee			GPS Latitude/Longitude	
				Start	End
Item	Encroachments			37.902365 °	37.902365 °
				-121.326453 °	-121.326453 °
DWR ID	DWR_RD0524_01_s _ 2012_266				
Action/Comments					
Equipment					
Inspector Comments: Landowner installed water filter piping system without permit.

Looking west at water filtration system on landside toe.

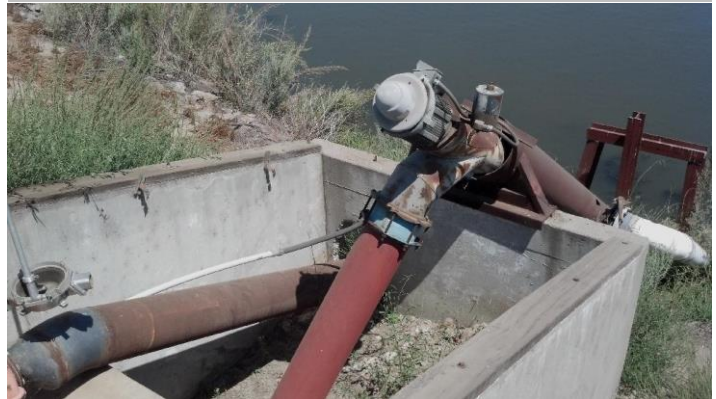
Photo 1 of 3 : UCIP_FA_2015_1542.jpg

LM Start	3.79	Rating **	M	Issue No.	954
LM End	3.79	Issue Type +	En	Location *	LS
Category	Supplemental			GPS Latitude/Longitude	
				Start	End
Item	DWR UCIP Field Study			37.902361 °	37.902361 °
				-121.326443 °	-121.326443 °
DWR ID					
Action/Comments					
Inspector Comments: FS_ID:18307					
DS_ID:20620					
EP_NO: N/A					
FS_HLM: 3.822					
Repair Type: Non-Urgent					
Crossing Status: Found					
UCIP Comments: Appears abandoned and if so should be done so properly. Evidence of severe internal corrosion in concrete distribution box at LS toe.					
FIELD_STRUCT_DESC: 12-inch concrete encased pipe through the levee 10.5 feet below the crown, pump and gate valve in pump house on the waterward slope. 6'X6' Concrete distribution box on the landward toe. Two concrete cutoff walls. Service pole at the landward toe. Originally included in the 1964 O&M manual.					
FS Date: 08/20/2013

Slant pump and pipe on WS slope.
