**Flood Control Project Maintenance
Levee Inspections**

Fall 2015 Levee Maintenance Deficiency Summary Report

San Joaquin River Basin

Reclamation District No. 0524 Middle Roberts Island

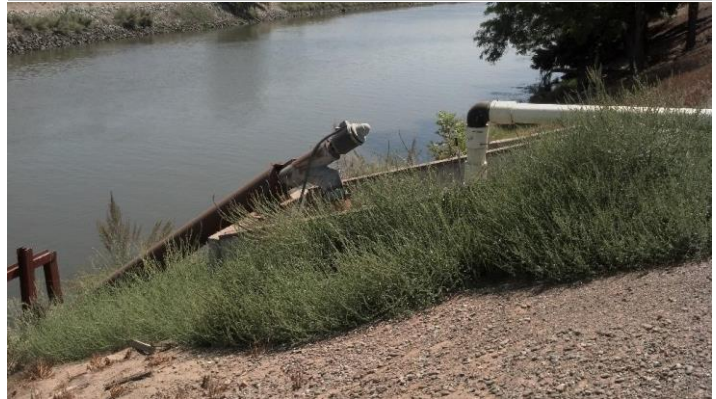
Photo 2 of 3 : UCIP_FA_2015_1543.jpg

Inspector Comments: FS_ID:18307
 DS_ID:20620
 EP_NO: N/A
 FS_HLM: 3.822
 Repair Type: Non-Urgent
 Crossing Status: Found
 UCIP Comments: Appears abandoned and if so should be done so properly. Evidence of severe internal corrosion in concrete distribution box at LS toe.
 FIELD_STRUCT_DESC: 12-inch concrete encased pipe through the levee 10.5 feet below the crown, pump and gate valve in pump house on the waterward slope. 6'X6' Concrete distribution box on the landward toe. Two concrete cutoff walls. Service pole at the landward toe. Originally included in the 1964 O&M manual.
 FS Date: 08/20/2013

Slant pump visible at concrete foundation on WS slope. Pumphouse removed.

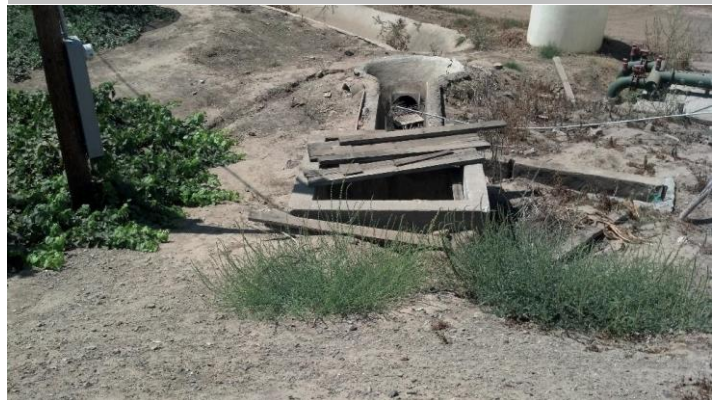
Photo 3 of 3 : UCIP_FA_2015_1657.jpg

6'X6' concrete distribution box and power pole on LS toe.

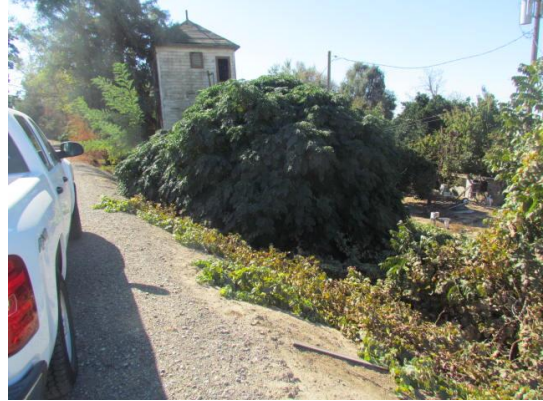
Photo 1 of 1 : FA_2015_RD0524_107_928_20151023_00257.jpg

LM Start	3.80	Rating **	U	Issue No.	928
LM End	3.81	Issue Type +	Ma	Location *	LS
Category	Earthen Levee			GPS Latitude/Longitude	
				Start	End
Item	Trim / Thin Trees			37.902155 °	37.902002 °
				-121.326523 °	-121.326550 °
DWR ID	DWR_RD0524_01_s_2012_928				
Action/Comments					
Trim trees to at least five feet above ground level.					
Inspector Comments: Several trees on landward slope.

Looking south at dense vegetation on landward slope and toe.

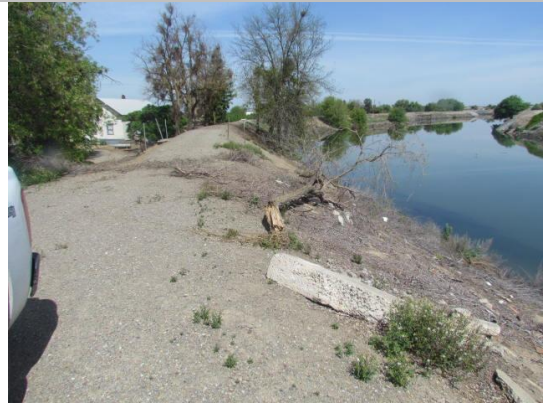
Photo 1 of 1 : FA_2015_RD0524_107_187_20150914_00176.jpg

LM Start	3.85	Rating **	M	Issue No.	187
LM End	3.85	Issue Type +	Ma	Location *	WS
Category	Earthen Levee			GPS Latitude/Longitude	
				Start	End
Item	Encroachments			37.901447 °	37.901447 °
				-121.326500 °	-121.326500 °
DWR ID	DWR_RD0524_01_s_2014_187				
Action/Comments					
Tree or limb					
Inspector Comments: Tree limb on waterward shoulder.

Looking northeast at tree limb on waterward slope.

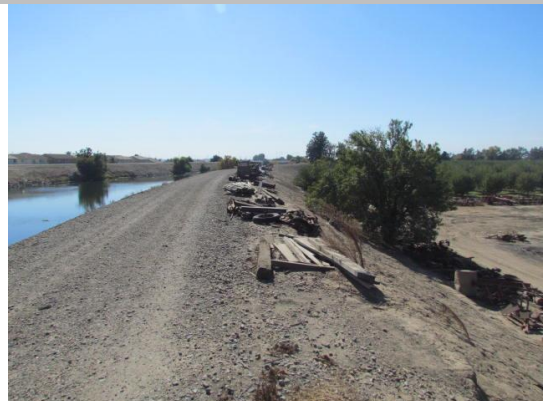
Photo 1 of 3 : FA_2015_RD0524_107_95_20150914_00115.jpg

LM Start	3.87	Rating **	U	Issue No.	95
LM End	3.90	Issue Type +	En	Location *	LS
Category	Earthen Levee			GPS Latitude/Longitude	
				Start	End
Item	Encroachments			37.901147 °	37.900735 °
				-121.326453 °	-121.326425 °
DWR ID	DWR_RD0524_01_f_2013_95				
Action/Comments					
Equipment					
Inspector Comments: Landowner is storing equipment on landward shoulder and landward toe.

Looking south at farm equipment stored on landward shoulder and toe.

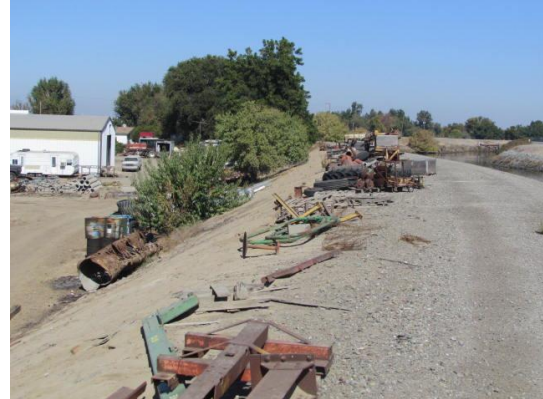
Photo 2 of 3 : FA_2015_RD0524_107_95_20150914_00116.jpg

Looking north at farm equipment stored on landward shoulder.

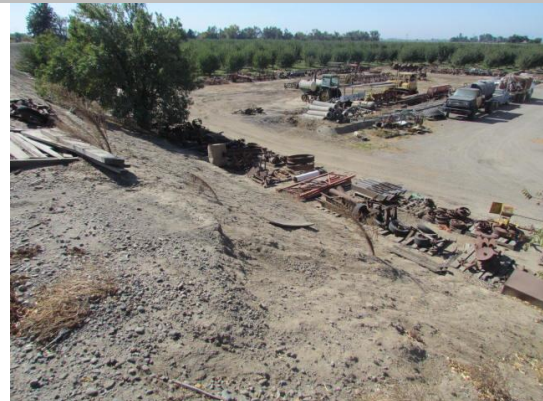
Photo 3 of 3 : FA_2015_RD0524_107_95_20150914_00117.jpg

Looking west at farm equipment stored at landward toe.

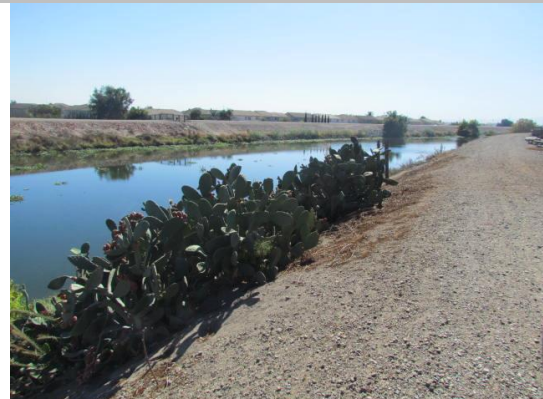
Photo 1 of 2 : FA_2015_RD0524_107_94_20151023_00258.jpg

LM Start	3.88	Rating **	U	Issue No.	94
LM End	3.88	Issue Type +	Ma	Location *	WS
Category	Earthen Levee			GPS Latitude/Longitude	
				Start	End
Item	Vegetation			37.900952 °	37.900952
				-121.326443 °	-121.326443
DWR ID	DWR_RD0524_01_s_2012_94				
Action/Comments					
Remove the wild growth other than native grasses from the levee slopes.					
Inspector Comments: Remove cactus from waterward slope.

Looking southeast at cactus on waterward slope fall 2015

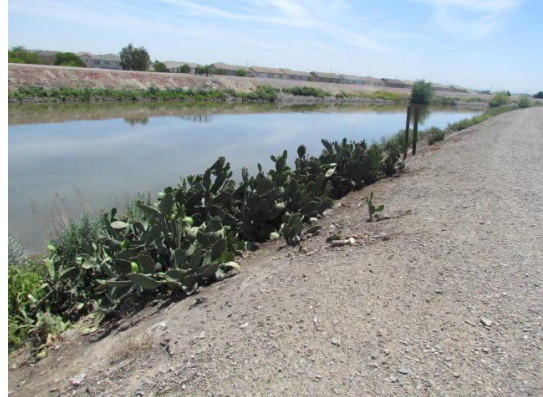
Photo 2 of 2 : FA_2015_RD0524_107_94_20150914_00114.jpg

LM Start	3.88	Rating **	U	Issue No.	94 (cont)	
LM End	3.88	Issue Type +	Ma	Location *	WS	
Category	Earthen Levee			GPS Latitude/Longitude		
				Start	End	
Item	Vegetation			37.900952 °	37.900952 °	
				-121.326443 °	-121.326443 °	
DWR ID	DWR_RD0524_01_s _ 2012_94					
Action/Comments						
Remove the wild growth other than native grasses from the levee slopes.						
Inspector Comments: Remove cactus from waterward slope.

Looking southeast at cactus on waterside slope. Fall 2013

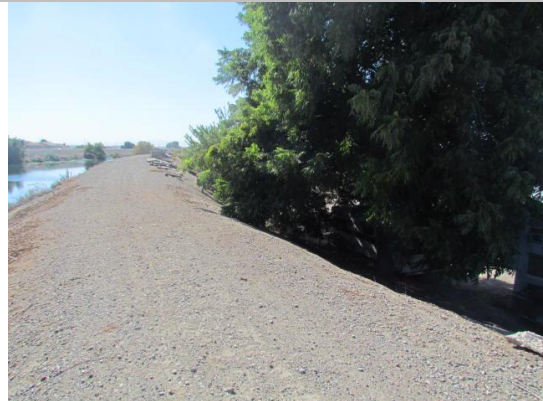
Photo 1 of 1 : FA_2015_RD0524_107_83_20151023_00259.jpg

LM Start	3.89	Rating **	U	Issue No.	83
LM End	3.89	Issue Type +	Ma	Location *	LS
Category	Earthen Levee			GPS Latitude/Longitude	
				Start	End
Item	Trim / Thin Trees			37.900854 °	37.900854 °
				-121.326438 °	-121.326438 °
DWR ID	DWR_RD0524_01_s _ 2012_83				
Action/Comments					
Trim trees to at least five feet above ground level.					
Inspector Comments: Untrimmed tree on landward slope.

Looking south at untrimmed trees on landward slope and toe.

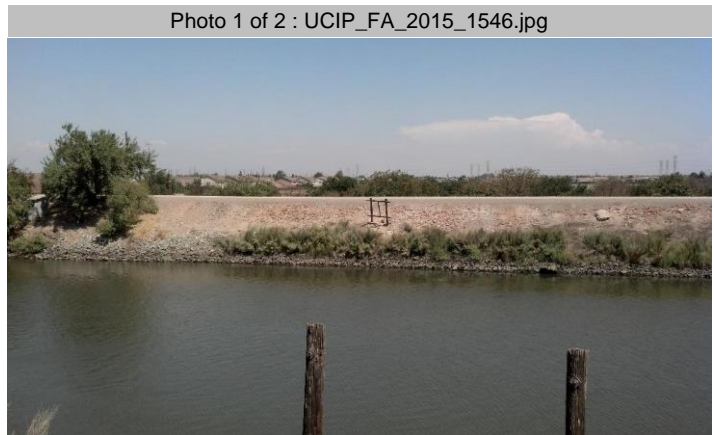
LM Start	3.90	Rating **	M	Issue No.	955
LM End	3.90	Issue Type +	En	Location *	LS
Category	Supplemental			GPS Latitude/Longitude	
				Start	End
Item	DWR UCIP Field Study			37.900778 °	37.900778 °
				-121.326420 °	-121.326420 °
DWR ID					
Action/Comments					
Inspector Comments: FS_ID:41464 DS_ID:20621 EP_NO: N/A FS_HLM: 3.932 Repair Type: Non-Urgent Crossing Status: Found UCIP Comments: Appears to be abandoned as signage has been removed. FIELD_STRUCT_DESC: 2.5-inch submarine telephone conduit through levee and across channel 2.0 feet below crown. Sign posts remain on both sides of river on the waterward slope. FS Date: 08/20/2013

Sign posts visible on opposite river bank in same condition.

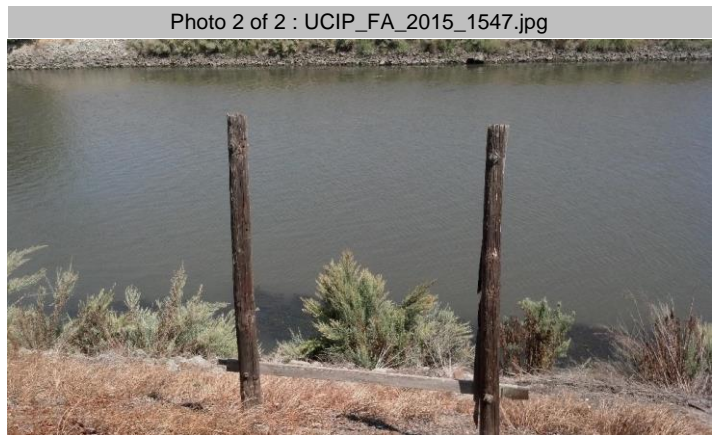
LM Start	3.90	Rating **	M	Issue No.	955 (cont)
LM End	3.90	Issue Type +	En	Location *	LS

Sign posts with sign removed on WS slope.

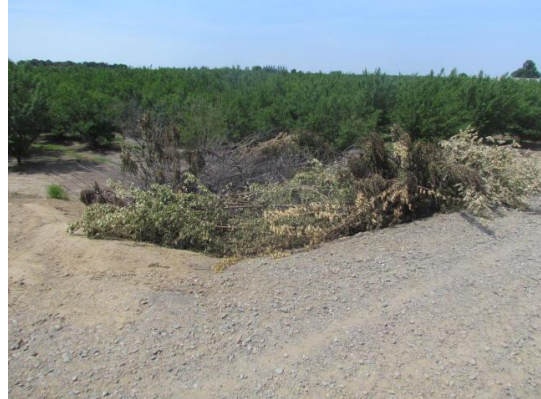
Photo 1 of 1 : FA_2015_RD0524_107_195_20150914_00181.jpg

LM Start	4.02	Rating **	U	Issue No.	195
LM End	4.02	Issue Type +	Ma	Location *	LS
Category	Earthen Levee			GPS Latitude/Longitude	
				Start	End
Item	Encroachments			37.899093 °	37.899093 °
				-121.326933 °	-121.326933 °
DWR ID	DWR_RD0524_01_s _ 2015_195				
Action/Comments					
Prunings					
Inspector Comments: Pruning pile blocking view of landward slope.

Looking east at pruning pile at landward toe.

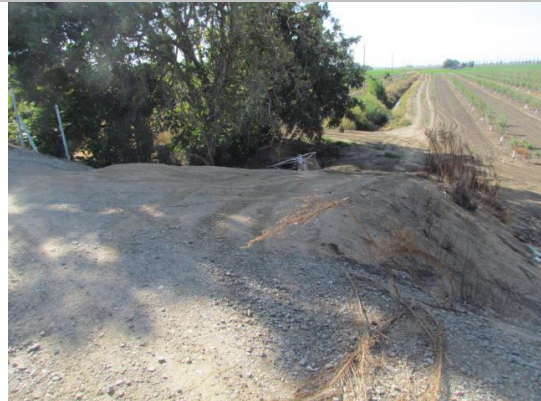
Photo 1 of 1 : FA_2015_RD0524_107_101_20150914_00120.jpg

LM Start	4.02	Rating **	U	Issue No.	101
LM End	4.02	Issue Type +	En	Location *	LS
Category	Earthen Levee			GPS Latitude/Longitude	
				Start	End
Item	Encroachments			37.899027 °	37.899027 °
				-121.326982 °	-121.326982 °
DWR ID	DWR_RD0524_01_s _ 2012_101				
Action/Comments					
Ramp					
Inspector Comments: Unauthorized ramp. Ramp does not meet Title 23 standard.

Looking west at unauthorized ramp on landside slope.

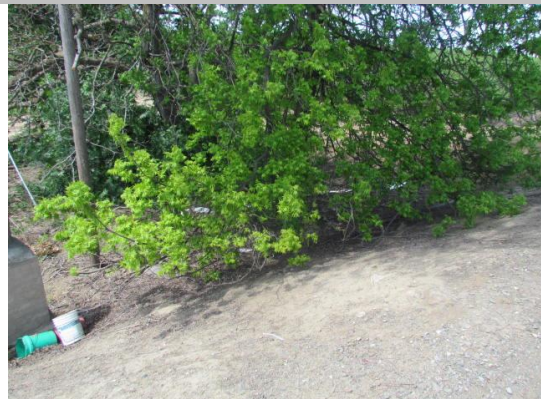
Photo 1 of 1 : FA_2015_RD0524_107_61_20150914_00085.jpg

Looking east at untrimmed tree at landward toe.

LM Start	4.03	Rating **	M	Issue No.	61
LM End	4.03	Issue Type +	Ma	Location *	LS
Category	Earthen Levee			GPS Latitude/Longitude	
				Start	End
Item	Trim / Thin Trees			37.898925 °	37.898925 °
				-121.327015 °	-121.327015 °
DWR ID	DWR_RD0524_01_s _ 2012_61				
Action/Comments					
Trim trees to at least five feet above ground level.

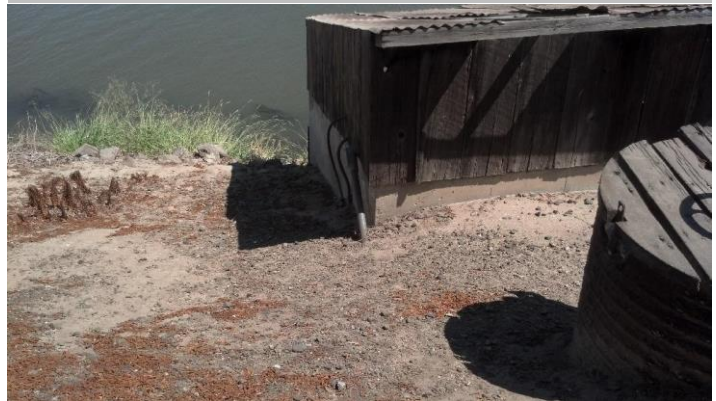
Photo 1 of 3 : UCIP_FA_2015_1556.jpg

LM Start	4.04	Rating **	M	Issue No.	956
LM End	4.04	Issue Type +	En	Location *	LS
Category	Supplemental			GPS Latitude/Longitude	
				Start	End
Item	DWR UCIP Field Study			37.898853 °	37.898853 °
				-121.327049 °	-121.327049 °
DWR ID					
Action/Comments					
Inspector Comments: FS_ID:18314 DS_ID:20623 EP_NO: N/A FS_HLM: 4.072 Repair Type: Non-Urgent Crossing Status: Found UCIP Comments: Appears abandoned and if so should be done so properly. FIELD_STRUCT_DESC: 8-inch concrete encased pipe through the levee 9.5-feet below crown, pump and gate valve in pump house on the waterward slope. Slide gate in 42-inch corrugated metal pipe riser on the waterward slope. Brick standpipe at the toe of the landward slope. 1.5-inch galvanized iron electrical conduit through the levee 3-feet below the crown at the same location. Originally included in the 1964 O&M manual. FS Date: 08/20/2013

Electrical conduit visible on WS slope at pumphouse.

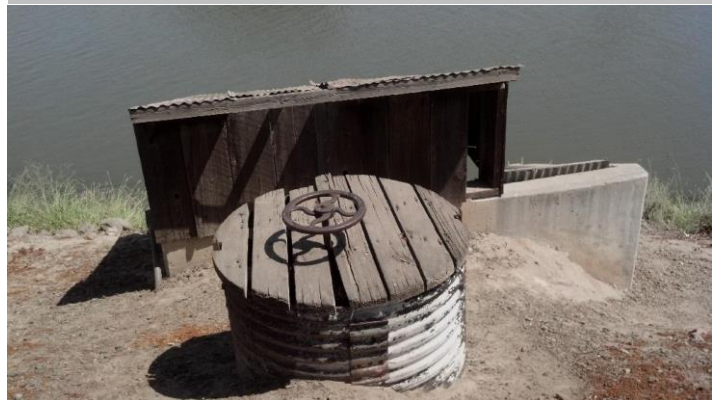
Photo 2 of 3 : UCIP_FA_2015_1557.jpg

Pumphouse and gate valve in CMP riser on WS slope.

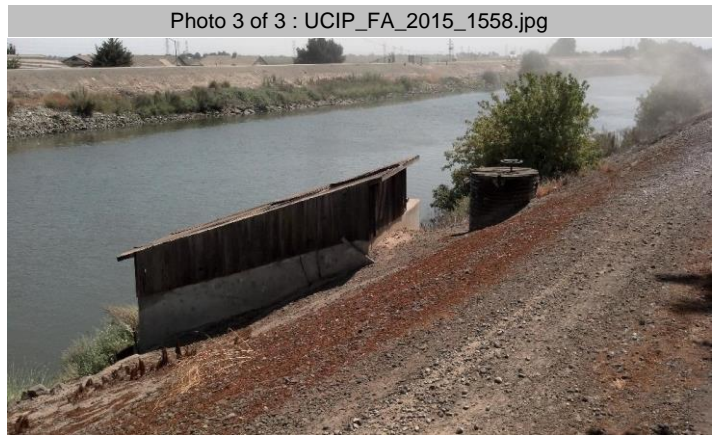
LM Start	4.04	Rating **	M	Issue No.	956 (cont)
LM End	4.04	Issue Type +	En	Location *	LS
Category	Supplemental			GPS Latitude/Longitude	
				Start	End
Item	DWR UCIP Field Study			37.898853 °	37.898853 °
				-121.327049 °	-121.327049 °
DWR ID					
Action/Comments					
Inspector Comments: FS_ID:18314 DS_ID:20623 EP_NO: N/A FS_HLM: 4.072 Repair Type: Non-Urgent Crossing Status: Found

Pumphouse and gate valve in CMP riser on WS slope.

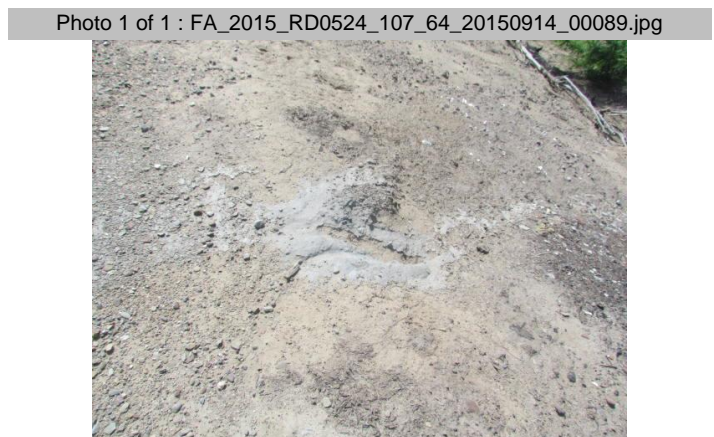
Looking at typical view of grouted rodent holes on landward slope.

LM Start	4.04	Rating **	M	Issue No.	64
LM End	4.09	Issue Type +	Ma	Location *	LS
Category	Earthen Levee			GPS Latitude/Longitude	
				Start	End
Item	Animal Control			37.898832 °	37.898090 °
				-121.327092 °	-121.327457 °
DWR ID	DWR_RD0524_01_s_2012_64				
Action/Comments					
No rodents visible, but rodent burrows visible; need to backfill and compact or grout burrows.

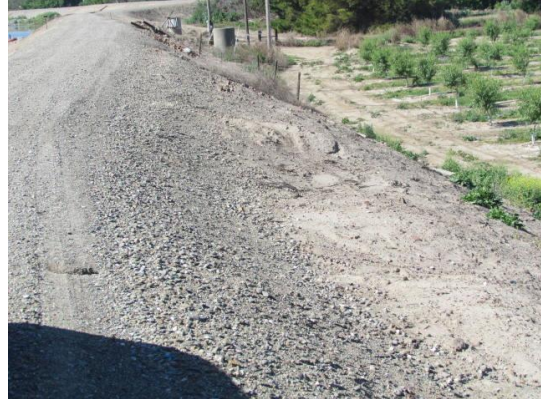
Photo 1 of 1 : FA_2015_RD0524_107_108_20150914_00125.jpg

Looking southwest at caving slope on landside of levee.

LM Start	4.10	Rating **	M	Issue No.	108
LM End	4.10	Issue Type +	Ma	Location *	LS
Category	Earthen Levee			GPS Latitude/Longitude	
				Start	End
Item	Slope Stability			37.898035 °	37.898035 °
				-121.327447 °	-121.327447 °
DWR ID	DWR_RD0524_01_s_2012_108				
Action/Comments					
Repair slope instability.

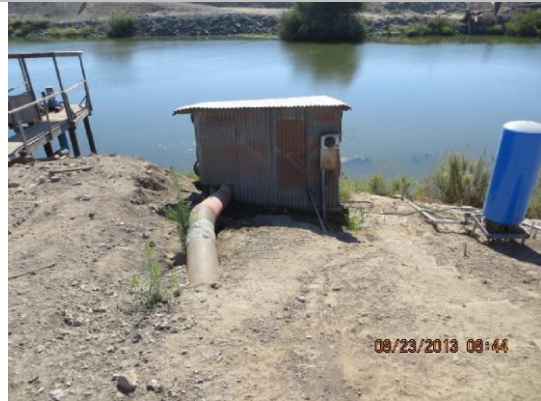
Photo 1 of 3 : UCIP_FA_2015_1419.jpg

LM Start	4.16	Rating **	M	Issue No.	957
LM End	4.16	Issue Type +	En	Location *	LS
Category	Supplemental			GPS Latitude/Longitude	
				Start	End
Item	DWR UCIP Field Study			37.897118 °	37.897118 °
				-121.327910 °	-121.327910 °
DWR ID					
Action/Comments					
Inspector Comments: FS_ID:18318					
DS_ID:20625					
EP_NO: N/A					
FS_HLM: 4.202					
Repair Type: Non-Urgent					
Crossing Status: Found					
UCIP Comments: Small leak on WS slope causing minor erosion on WS slope.					
FIELD_STRUCT_DESC: 12-inch steel irrigation pipe through the levee 4.5 feet below the crown, pumphouse and gate valve on the waterward slope. 36-inch concrete standpipe, power pole, and meter on LS toe. Originally included in the 1964 O&M manual.					
FS Date: 08/23/2013

Pumphouse and pipe on WS slope.

Inspector Comments: FS_ID:18318
 DS_ID:20625
 EP_NO: N/A
 FS_HLM: 4.202
 Repair Type: Non-Urgent
 Crossing Status: Found
 UCIP Comments: Small leak on WS slope causing minor erosion on WS slope.
 FIELD_STRUCT_DESC: 12-inch steel irrigation pipe through the levee 4.5 feet below the crown, pumphouse and gate valve on the waterward slope. 36-inch concrete standpipe, power pole, and meter on LS toe.
 Originally included in the 1964 O&M manual.
 FS Date: 08/23/2013

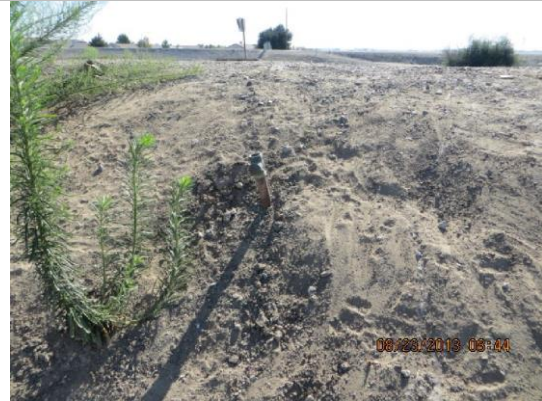
Photo 2 of 3 : UCIP_FA_2015_1420.jpg

Vent or siphon breaker just off LS shoulder.

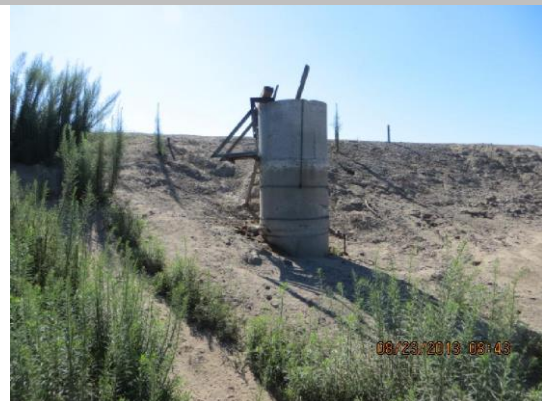
Photo 3 of 3 : UCIP_FA_2015_1421.jpg

Concrete standpipe on LS slope.

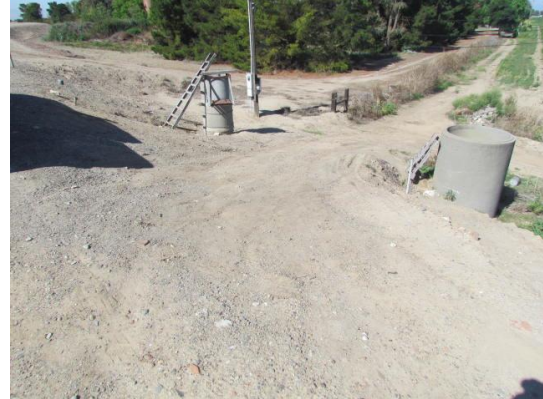
Photo 1 of 1 : FA_2015_RD0524_107_110_20150914_00126.jpg

LM Start	4.16	Rating **	M	Issue No.	110
LM End	4.16	Issue Type +	En	Location *	LS
Category	Earthen Levee			GPS Latitude/Longitude	
				Start	End
Item	Encroachments			37.897103 °	37.897103
				-121.327895 °	-121.327895
DWR ID	DWR_RD0524_01_s_2012_110				
Action/Comments					
Ramp					
Inspector Comments: Two unauthorized ramps on landward slope.

Looking southwest at an unauthorized ramp on landside slope.

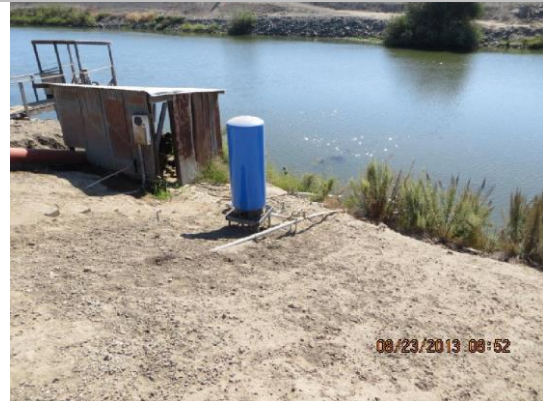
Photo 1 of 2 : UCIP_FA_2015_2376.jpg

LM Start	4.17	Rating **	M	Issue No.	958
LM End	4.17	Issue Type +	En	Location *	LS
Category	Supplemental			GPS Latitude/Longitude	
				Start	End
Item	DWR UCIP Field Study			37.897074 °	37.897074 °
				-121.327926 °	-121.327926 °
DWR ID					
Action/Comments					
Inspector Comments: FS_ID:22069 DS_ID:24049 EP_NO: N/A FS_HLM: 4.205 Repair Type: Non-Urgent Crossing Status: Found UCIP Comments: No permit identified for this crossing. FIELD_STRUCT_DESC: 2.25-inch PVC domestic water service through the levee 5-feet below the crown. Pump and tank on WS slope with a vent on the LS slope. FS Date: 08/23/2013

Pipe, pump, and tank visible on WS slope.

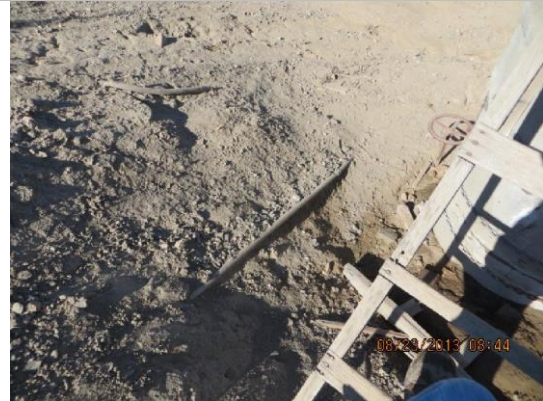
Photo 2 of 2 : UCIP_FA_2015_2377.jpg

LM Start	4.17	Rating **	M	Issue No.	958 (cont)	
LM End	4.17	Issue Type +	En	Location *	LS	
Category	Supplemental			GPS Latitude/Longitude		
				Start	End	
Item	DWR UCIP Field Study			37.897074 °	37.897074 °	
				-121.327926 °	-121.327926 °	
DWR ID						
Action/Comments						
Inspector Comments: FS_ID:22069 DS_ID:24049 EP_NO: N/A FS_HLM: 4.205 Repair Type: Non-Urgent Crossing Status: Found UCIP Comments: No permit identified for this crossing. FIELD_STRUCT_DESC: 2.25-inch PVC domestic water service through the levee 5-feet below the crown. Pump and tank on WS slope with a vent on the LS slope. FS Date: 08/23/2013

Pipe visible on LS slope.

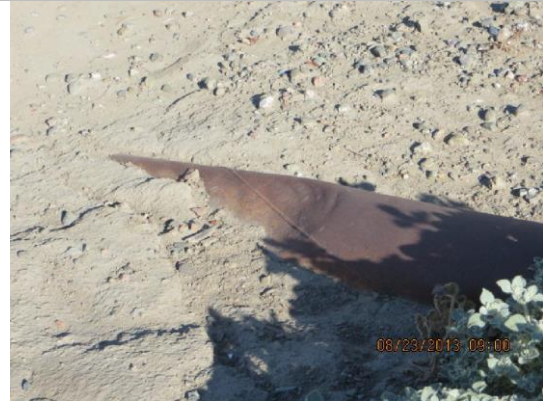
Photo 1 of 3 : UCIP_FA_2015_1422.jpg

Action/Comments					
Inspector Comments: FS_ID:18320					
DS_ID:20626					
EP_NO: N/A					
FS_HLM: 4.405					
Repair Type: Non-Urgent					
Crossing Status: Found					
UCIP Comments: Small leak in pipe on LS slope and pipe slightly crushed on LS toe.					
FIELD_STRUCT_DESC: 9-inch steel stormdrain pipe through the levee					
3.0 feet below the crown, pump in drain ditch on the landward side.					
Siphon breaker on the waterward slope. Originally included in the 1964 O&M manual.					
FS Date: 08/23/2013

Pipe partially crushed at LS toe.

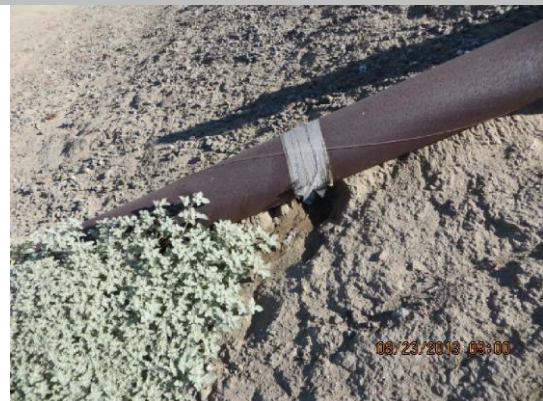
Photo 2 of 3 : UCIP_FA_2015_1423.jpg

Small leak in pipe on LS slope.

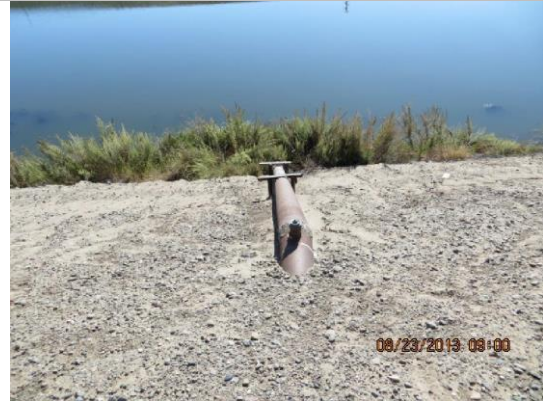
Photo 3 of 3 : UCIP_FA_2015_1424.jpg

LM Start	4.36	Rating **	M	Issue No.	959 (cont)
LM End	4.36	Issue Type +	En	Location *	LS
Category	Supplemental			GPS Latitude/Longitude	
				Start	End
Item	DWR UCIP Field Study			37.894453 °	37.894453 °
				-121.329232 °	-121.329232 °
DWR ID					
Action/Comments					
Inspector Comments: FS_ID:18320					
DS_ID:20626					
EP_NO: N/A					
FS_HLM: 4.405					
Repair Type: Non-Urgent					
Crossing Status: Found

Pipe and siphon breaker on WS slope.

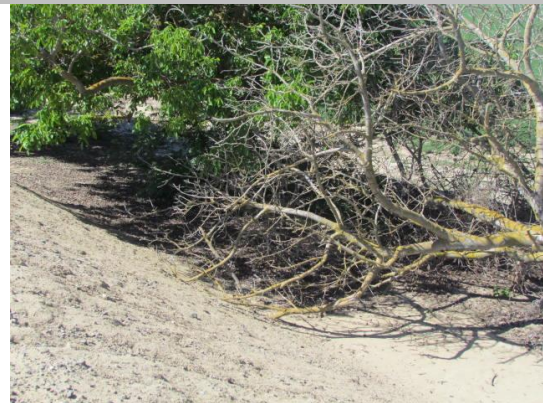
Photo 1 of 1 : FA_2015_RD0524_107_111_20150914_00127.jpg

LM Start	4.38	Rating **	M	Issue No.	111
LM End	4.38	Issue Type +	En	Location *	LS
Category	Earthen Levee			GPS Latitude/Longitude	
				Start	End
Item	Encroachments			37.894258 °	37.894258 °
				-121.329247 °	-121.329247 °
DWR ID	DWR_RD0524_01_s_2012_111				
Action/Comments					
Tree or limb					
Inspector Comments: Dead tree at landside toe should be removed from levee toe.

Looking west at dead tree at landside toe.

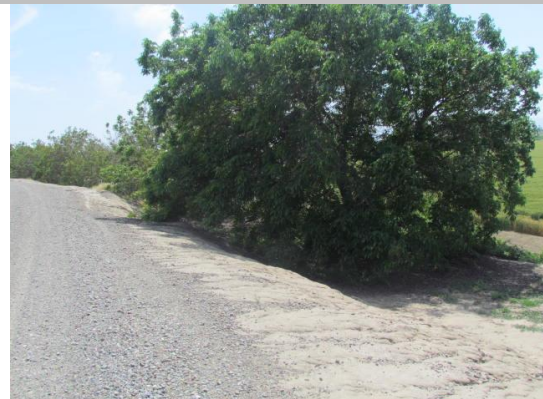
Photo 1 of 2 : FA_2015_RD0524_107_112_20150914_00128.jpg

LM Start	4.40	Rating **	U	Issue No.	112
LM End	4.53	Issue Type +	Ma	Location *	LS
Category	Earthen Levee			GPS Latitude/Longitude	
				Start	End
Item	Trim / Thin Trees			37.893928 °	37.892230 °
				-121.329203 °	-121.328187 °
DWR ID	DWR_RD0524_01_s_2012_112				
Action/Comments					
Trim trees to at least five feet above ground level.					
Inspector Comments: Untrimmed trees along landward slope and toe.

Looking southeast at untrimmed tree at landward toe.

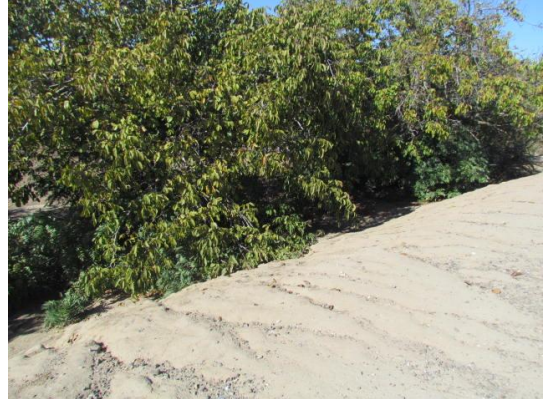
Photo 2 of 2 : FA_2015_RD0524_107_112_20151023_00260.jpg

LM Start	4.40	Rating **	U	Issue No.	112 (cont)
LM End	4.53	Issue Type +	Ma	Location *	LS
Category	Earthen Levee			GPS Latitude/Longitude	
				Start	End
Item	Trim / Thin Trees			37.893928 °	37.892230 °
				-121.329203 °	-121.328187 °
DWR ID	DWR_RD0524_01_s_2012_112				
Action/Comments					
Trim trees to at least five feet above ground level.					
Inspector Comments: Untrimmed trees along landward slope and toe.

Looking northeast at untrimmed tree on landward slope and toe fall 2015.

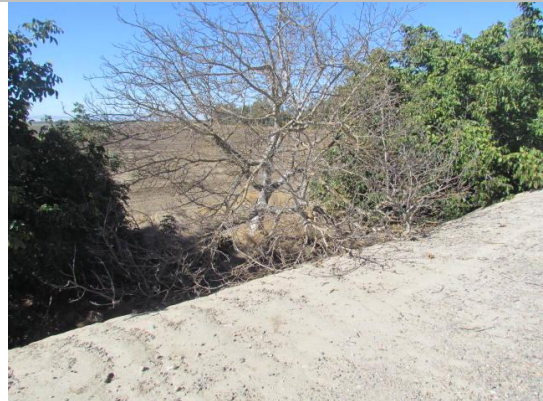
Photo 1 of 1 : FA_2015_RD0524_107_199_20151023_00261.jpg

LM Start	4.43	Rating **	U	Issue No.	199
LM End	4.43	Issue Type +	Ma	Location *	LS
Category	Earthen Levee			GPS Latitude/Longitude	
				Start	End
Item	Encroachments			37.893582 °	37.893582 °
				-121.329108 °	-121.329108 °
DWR ID	DWR_RD0524_01_f_2015_199				
Action/Comments					
Tree or limb					
Inspector Comments: Remove dead tree from landward toe.

Looking west at dead tree on landward slope and toe fall 2015.

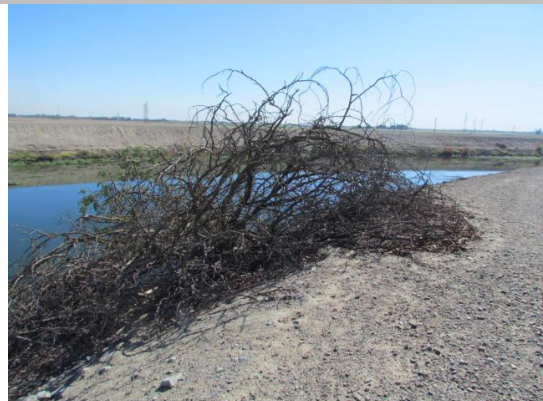
Photo 1 of 2 : FA_2015_RD0524_107_102_20151023_00262.jpg

LM Start	4.52	Rating **	U	Issue No.	102
LM End	4.52	Issue Type +	Ma	Location *	WS
Category	Earthen Levee			GPS Latitude/Longitude	
				Start	End
Item	Encroachments			37.892368 °	37.892368 °
				-121.328200 °	-121.328200 °
DWR ID	DWR_RD0524_01_s_2012_102				
Action/Comments					
Prunings					
Inspector Comments: Dead tree on waterward slope.

Looking southeast at dead tree on waterside slope fall 2015

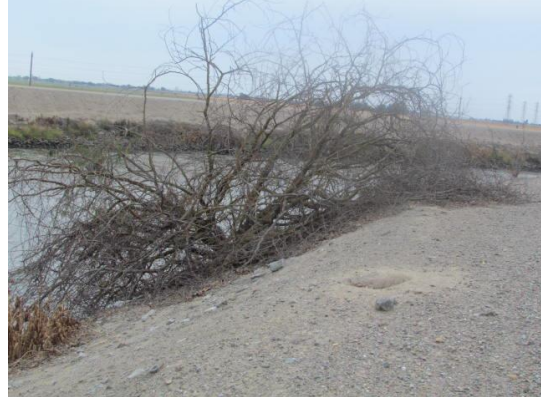
Photo 2 of 2 : FA_2015_RD0524_107_102_20150914_00121.jpg

LM Start	4.52	Rating **	U	Issue No.	102 (cont)
LM End	4.52	Issue Type +	Ma	Location *	WS
Category	Earthen Levee			GPS Latitude/Longitude	
				Start	End
Item	Encroachments			37.892368 °	37.892368 °
				-121.328200 °	-121.328200 °
DWR ID	DWR_RD0524_01_s_2012_102				
Action/Comments					
Prunings					
Inspector Comments: Dead tree on waterward slope.

Looking southeast at dead tree on waterside slope.

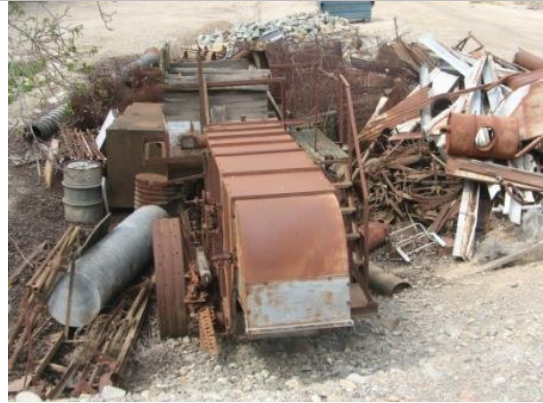
Photo 1 of 1 : FA_2015_RD0524_107_66_20150914_00090.jpg

LM Start	4.60	Rating **	M	Issue No.	66
LM End	4.60	Issue Type +	Ma	Location *	LS
Category	Earthen Levee			GPS Latitude/Longitude	
				Start	End
Item	Encroachments			37.891365 °	37.891365 °
				-121.328633 °	-121.328633 °
DWR ID	DWR_RD0524_01_s_2012_66				
Action/Comments					
Garbage

Garbage at landward toe next to ramp at LM 4.64

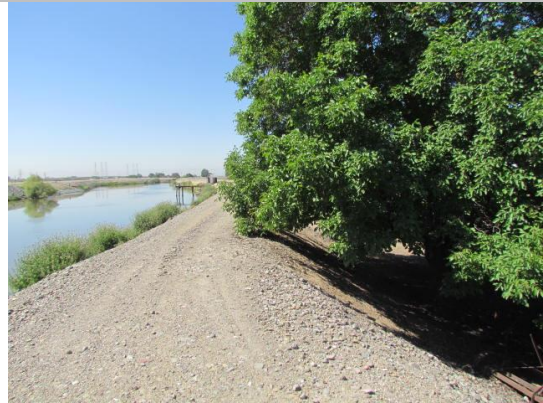
Photo 1 of 1 : FA_2015_RD0524_107_63_20150914_00088.jpg

LM Start	4.61	Rating **	U	Issue No.	63
LM End	4.61	Issue Type +	Ma	Location *	LS
Category	Earthen Levee			GPS Latitude/Longitude	
				Start	End
Item	Trim / Thin Trees			37.891285 °	37.891285 °
				-121.328728 °	-121.328728 °
DWR ID	DWR_RD0524_01_s_2012_63				
Action/Comments					
Trim trees to at least five feet above ground level.

Looking south at dense trees on landside slope.

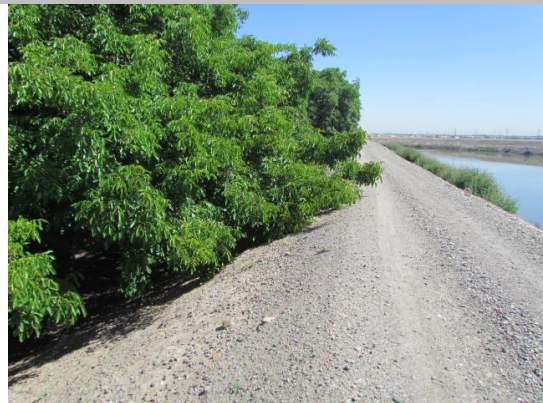
Photo 1 of 1 : FA_2015_RD0524_107_113_20150914_00129.jpg

LM Start	4.63	Rating **	M	Issue No.	113
LM End	4.63	Issue Type +	Ma	Location *	LS
Category	Earthen Levee			GPS Latitude/Longitude	
				Start	End
Item	Trim / Thin Trees			37.890973 °	37.890973 °
				-121.328970 °	-121.328970 °
DWR ID	DWR_RD0524_01_s_2012_113				
Action/Comments					
Trim trees to at least five feet above ground level.

Looking north at dense trees on landside slope.

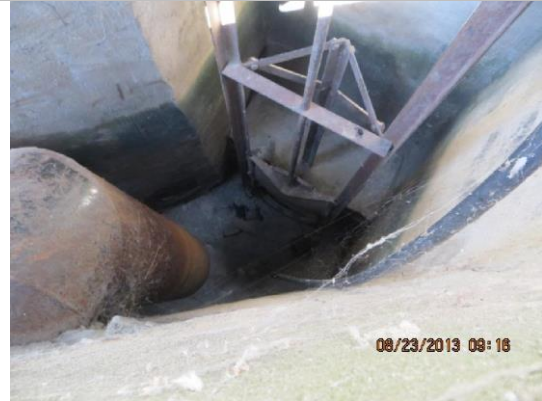
Photo 1 of 3 : UCIP_FA_2015_1429.jpg

Inspector Comments: FS_ID:18323
 DS_ID:20646
 EP_NO: 0
 FS_HLM: 4.726
 Repair Type: Non-Urgent
 Crossing Status: Found
 UCIP Comments: Good candidate for video inspection as brick and mortar deteriorating inside tunnel.
 FIELD_STRUCT_DESC: 22-inch concrete pipe through the levee 12.0 feet below the crown. Pump on pier at WS toe. 16-inch pipe from pump discharges into a concrete riser inside the pumphouse on the WS shoulder. Brick and mortar channel on LS toe. Originally included in the 1964 O&M manual.
 FS Date: 08/23/2013

Slide gate inside concrete riser within shed on WS shoulder.

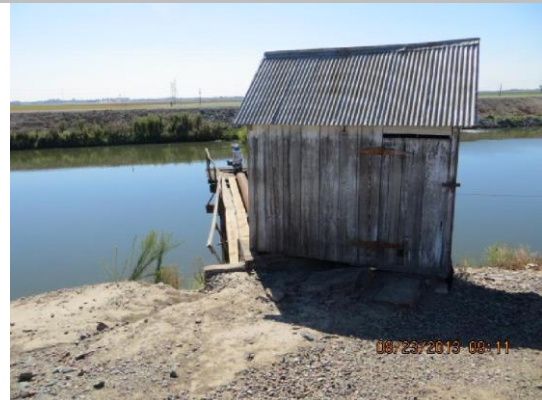
Photo 2 of 3 : UCIP_FA_2015_1430.jpg

Pump on pier and slide gate house on WS shoulder.

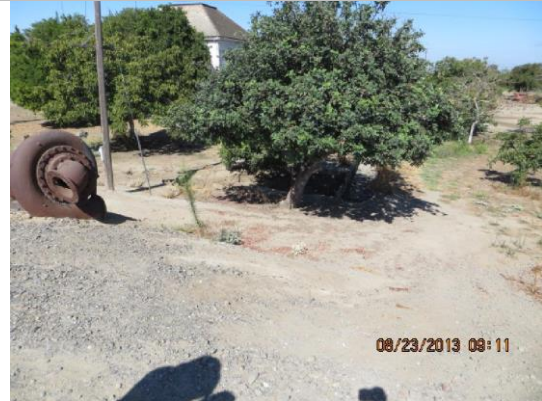
Photo 3 of 3 : UCIP_FA_2015_1431.jpg

Brick and mortar channel on LS toe.

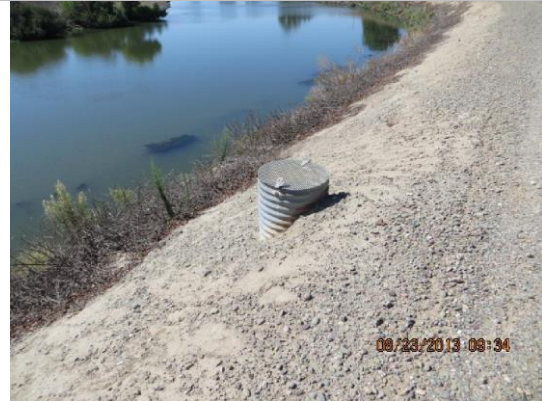
Photo 1 of 3 : UCIP_FA_2015_2251.jpg

Inspector Comments: FS_ID:22728
 DS_ID:20628
 EP_NO: 3817
 FS_HLM: 4.935
 Repair Type: Non-Urgent
 Crossing Status: Found
 UCIP Comments: Appears abandoned and if so should be done so properly.
 FIELD_STRUCT_DESC: 6-inch steel pipe through the levee 3.0 feet below the crown, pump 120-feet off the LS toe. Siphon breaker in 24-inch CMP on the waterward shoulder (Permit No. 3817) Originally included in the 1964 O&M manual.
 FS Date: 08/23/2013

Siphon breaker in 24-inch CMP riser on WS shoulder.

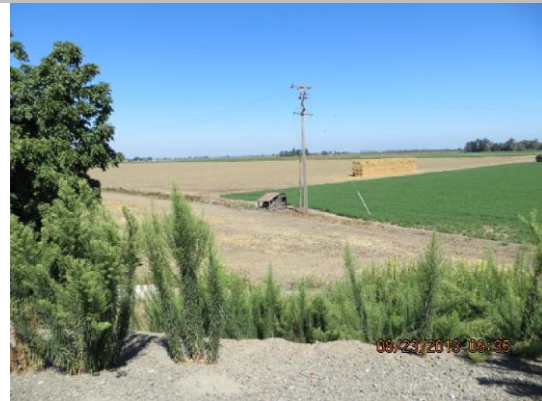
Photo 2 of 3 : UCIP_FA_2015_2493.jpg

Pump in pumphouse 120-feet off LS toe.

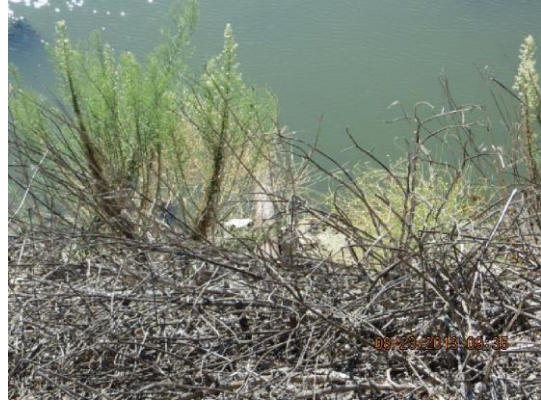
Photo 3 of 3 : UCIP_FA_2015_2494.jpg

Pipe visible on WS toe.

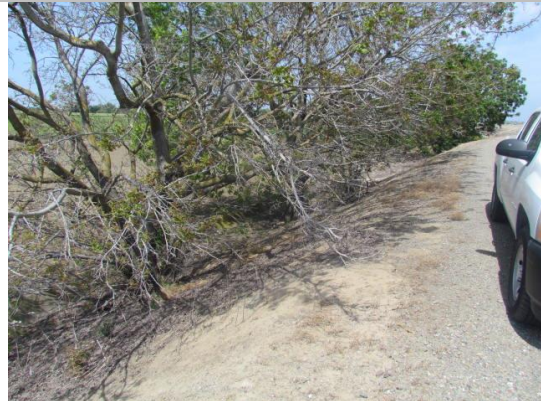
Photo 1 of 1 : FA_2015_RD0524_107_84_20150914_00108.jpg

LM Start	4.90	Rating **	U	Issue No.	84
LM End	4.93	Issue Type +	Ma	Location *	LS
Category	Earthen Levee			GPS Latitude/Longitude	
				Start	End
Item	Trim / Thin Trees			37.887655 °	37.887277 °
				-121.331202 °	-121.331609 °
DWR ID	DWR_RD0524_01_s_2012_84				
Action/Comments					
Trim trees to at least five feet above ground level.

Looking northeast at untrimmed trees on landward slope.

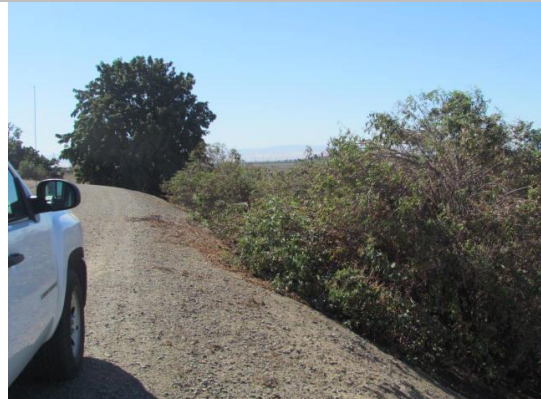
Photo 1 of 1 : FA_2015_RD0524_107_114_20151023_00263.jpg

LM Start	4.96	Rating **	U	Issue No.	114
LM End	4.98	Issue Type +	Ma	Location *	LS
Category	Earthen Levee			GPS Latitude/Longitude	
				Start	End
Item	Vegetation			37.886907 °	37.886673 °
				-121.331862 °	-121.331965 °
DWR ID	DWR_RD0524_01_s_2012_114				
Action/Comments					
Elderberries are blocking visibility and flood fight capability. Inspector Comments: Dense elderberry on landward slope.

Looking southwest at dense elderberry bush on landward slope and toe fall 2015.

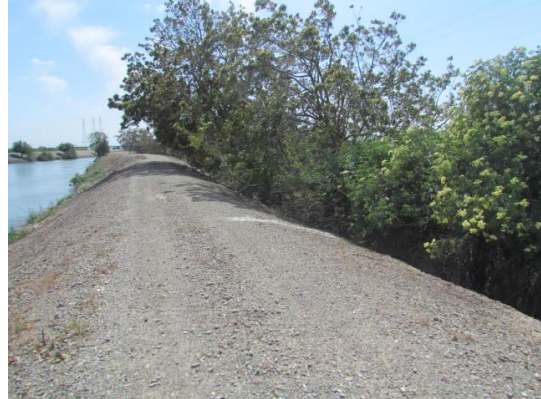
Photo 1 of 1 : FA_2015_RD0524_107_71_20150914_00092.jpg

LM Start	5.00	Rating **	U	Issue No.	71
LM End	5.07	Issue Type +	Ma	Location *	LS
Category	Earthen Levee			GPS Latitude/Longitude	
				Start	End
Item	Trim / Thin Trees			37.886410 °	37.885286 °
				-121.332092 °	-121.332167 °
DWR ID	DWR_RD0524_01_s _ 2012_71				
Action/Comments					
Trim trees to at least five feet above ground level.

Looking south at untrimmed trees on landward slope.

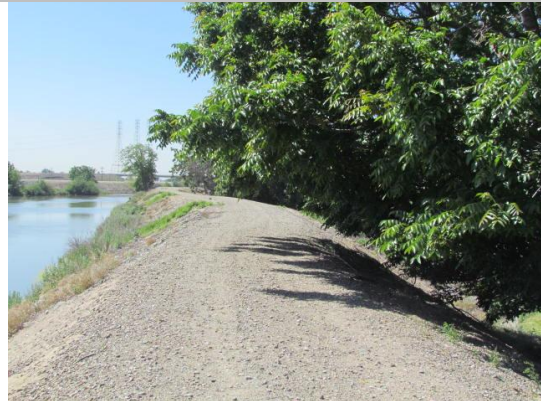
Photo 1 of 1 : FA_2015_RD0524_107_68_20150914_00091.jpg

LM Start	5.07	Rating **	U	Issue No.	68
LM End	5.07	Issue Type +	Ma	Location *	LS
Category	Earthen Levee			GPS Latitude/Longitude	
				Start	End
Item	Trim / Thin Trees			37.885400 °	37.885400 °
				-121.332153 °	-121.332153 °
DWR ID	DWR_RD0524_01_s _ 2012_68				
Action/Comments					
Trim trees over roadway to at least 12 feet above ground level.

Looking south at overhanging trees.

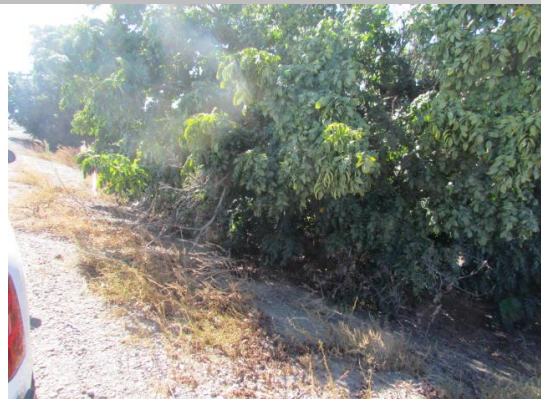
Photo 1 of 1 : FA_2015_RD0524_107_188_20151023_00264.jpg

LM Start	5.12	Rating **	U	Issue No.	188
LM End	5.17	Issue Type +	Ma	Location *	LS
Category	Earthen Levee			GPS Latitude/Longitude	
				Start	End
Item	Trim / Thin Trees			37.884627 °	37.883965 °
				-121.332172 °	-121.332152 °
DWR ID	DWR_RD0524_01_s _ 2014_188				
Action/Comments					
Trim trees to at least five feet above ground level.					
Inspector Comments: Untrimmed trees on landward slope and toe.

Looking southwest at untrimmed trees on landward slope and toe.

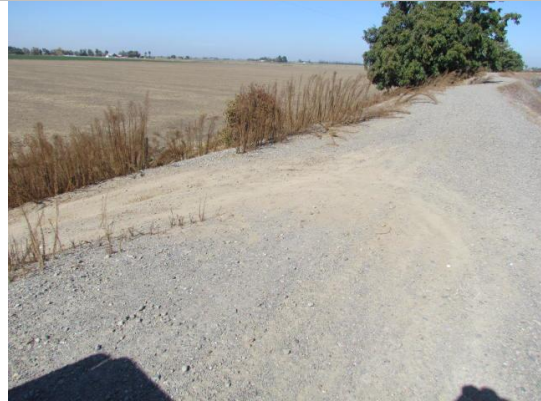
Photo 1 of 1 : FA_2015_RD0524_107_115_20150914_00130.jpg

LM Start	5.19	Rating **	M	Issue No.	115
LM End	5.19	Issue Type +	Ma	Location *	LS
Category	Earthen Levee			GPS Latitude/Longitude	
				Start	End
Item	Slope Stability			37.883587 °	37.883587 °
				-121.332100 °	-121.332100 °
DWR ID	DWR_RD0524_01_s_2012_115				
Action/Comments					
Repair the levee slope damaged by vehicle traffic and prevent access where possible.					
Inspector Comments: Vehicle traffic created a ramp on landward slope.

Looking northwest at slope damage on landward slope.

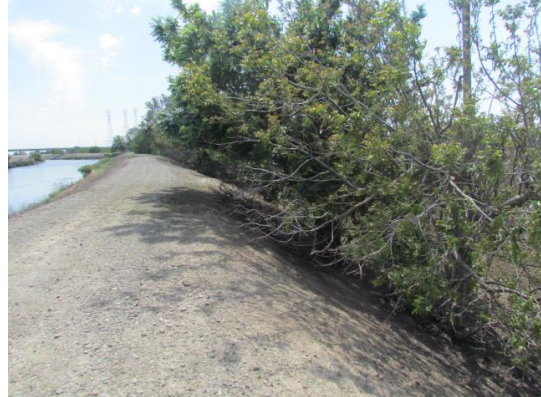
Photo 1 of 1 : FA_2015_RD0524_107_85_20150914_00109.jpg

LM Start	5.28	Rating **	U	Issue No.	85
LM End	5.34	Issue Type +	Ma	Location *	LS
Category	Earthen Levee			GPS Latitude/Longitude	
				Start	End
Item	Trim / Thin Trees			37.882377 °	37.881498 °
				-121.332598 °	-121.332800 °
DWR ID	DWR_RD0524_01_s _ 2012_85				
Action/Comments					
Trim trees to at least five feet above ground level.

Looking south at untrimmed trees on landward slope.

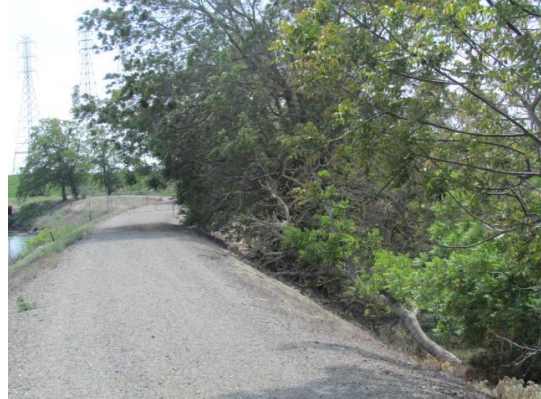
Photo 1 of 1 : FA_2015_RD0524_107_932_20150914_00206.jpg

LM Start	5.38	Rating **	U	Issue No.	932
LM End	5.41	Issue Type +	Ma	Location *	LS
Category	Earthen Levee			GPS Latitude/Longitude	
				Start	End
Item	Trim / Thin Trees			37.880945 °	37.880522 °
				-121.332837 °	-121.332918 °
DWR ID	DWR_RD0524_01_s _ 2012_932				
Action/Comments					
Trim trees to at least five feet above ground level.

Looking south at untrimmed trees on landward slope and toe.

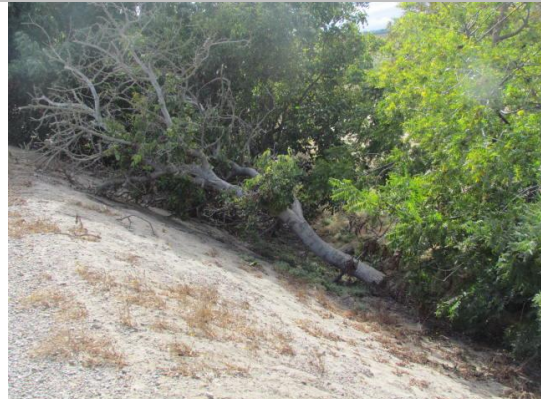
Photo 1 of 1 : FA_2015_RD0524_107_178_20150914_00168.jpg

LM Start	5.39	Rating **	M	Issue No.	178
LM End	5.39	Issue Type +	Ma	Location *	LS
Category	Earthen Levee			GPS Latitude/Longitude	
				Start	End
Item	Encroachments			37.880806 °	37.880806 °
				-121.332833 °	-121.332833 °
DWR ID	DWR_RD0524_01_f _ 2014_178				
Action/Comments					
Tree or limb					
Inspector Comments: Downed tree on landward toe.

Looking south at downed tree on landward slope.

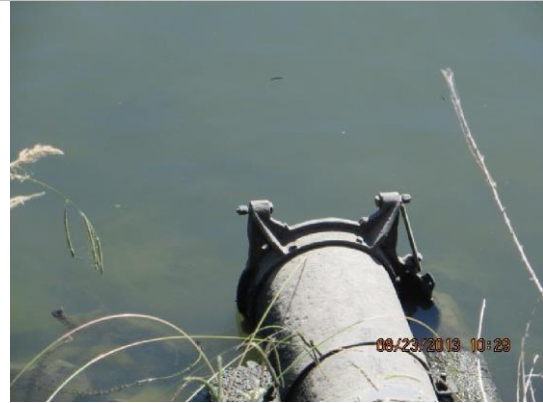
Photo 1 of 3 : UCIP_FA_2015_1488.jpg

Action/Comments					
Inspector Comments: FS_ID:18345 DS_ID:20630 EP_NO: N/A FS_HLM: 5.456 Repair Type: Urgent Crossing Status: Found UCIP Comments: flap gate damage and does not work at WS toe. Large hole in pipe at WS toe. Pipe appears abandoned and should be done so properly. FIELD_STRUCT_DESC: 1 of 2: 12-inch pipe through the levee 6.0-feet below the crown, pump missing from the landward side. Flap gate on the waterward end. Originally included in the 1964 O&M manual. FS Date: 08/23/2013

Broken flap gate at WS toe.

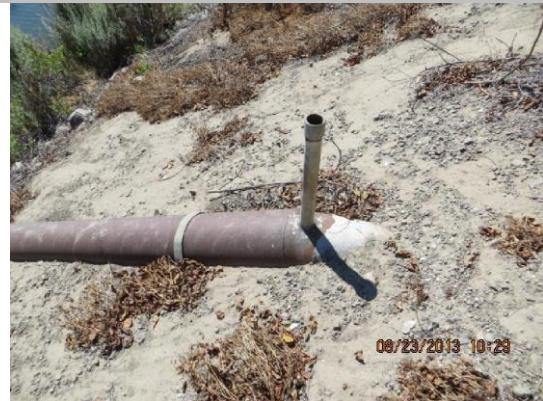
Photo 2 of 3 : UCIP_FA_2015_1489.jpg

Vent on pipe on WS slope. Possible slurry standpipe that has not yet been used.

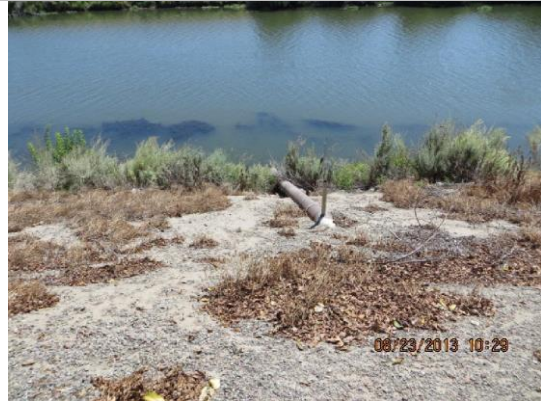
Photo 3 of 3 : UCIP_FA_2015_1490.jpg

Pipe visible on WS slope.

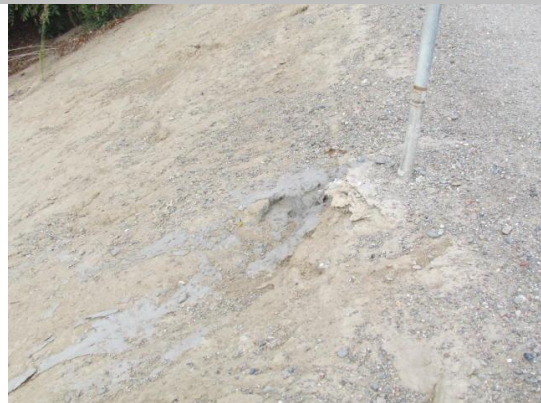
Photo 1 of 2 : FA_2015_RD0524_107_931_20150914_00204.jpg

LM Start	5.41	Rating **	A/W	Issue No.	931
LM End	5.41	Issue Type +	Ma	Location *	LS
Category	Earthen Levee			GPS Latitude/Longitude	
				Start	End
Item	Animal Control			37.880575 °	37.880575 °
				-121.332890 °	-121.332890 °
DWR ID	DWR_RD0524_01_s_2012_931				
Action/Comments					
Exterminate rodents and backfill and compact or grout burrows. Inspector Comments: LMA grouted rodent holes.

Looking north at typical view of grouted rodent holes on landward shoulder and slope.

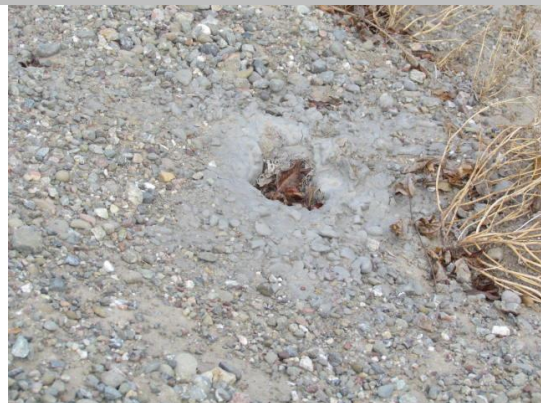
Photo 2 of 2 : FA_2015_RD0524_107_931_20150914_00205.jpg

Looking north at typical view of grouted rodent holes on waterward slope.

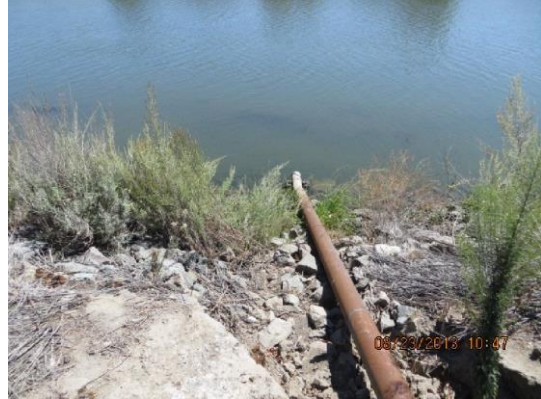
Photo 1 of 3 : UCIP_FA_2015_1364.jpg

LM Start	5.42	Rating **	M	Issue No.	963
LM End	5.42	Issue Type +	En	Location *	LS
Category	Supplemental			GPS Latitude/Longitude	
				Start	End
Item	DWR UCIP Field Study			37.880358 °	37.880358 °
				-121.332972 °	-121.332972 °
DWR ID					
Action/Comments					
Inspector Comments: FS_ID:18348					
DS_ID:20631					
EP_NO: N/A					
FS_HLM: 5.473					
Repair Type: Non-Urgent					
Crossing Status: Found

No flap gate on end of pipe at WS toe.

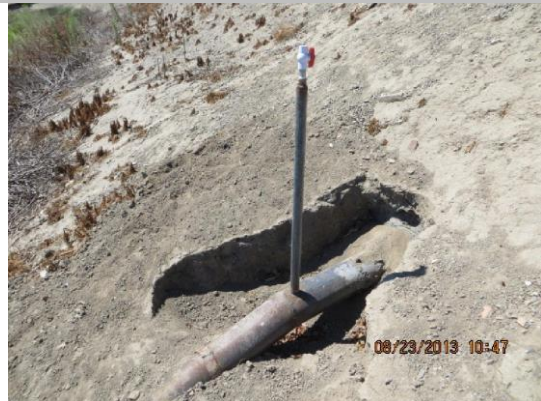
Photo 2 of 3 : UCIP_FA_2015_1365.jpg

8-inch pipe sleeved through 10-inch pipe with vent on WS slope.

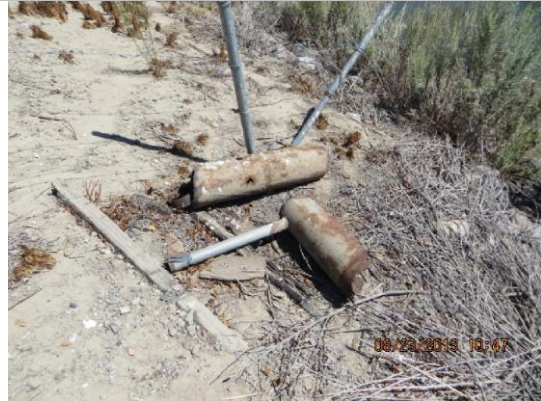
Photo 3 of 3 : UCIP_FA_2015_1366.jpg

10-inch pipe debris on the WS slope.

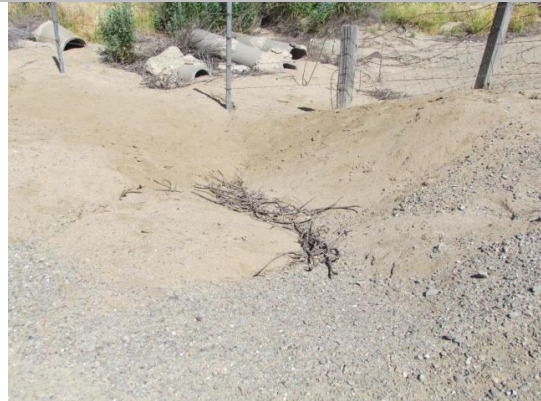
Photo 1 of 3 : FA_2015_RD0524_107_118_20150914_00131.jpg

LM Start	5.42	Rating **	M	Issue No.	118
LM End	5.42	Issue Type +	Ma	Location *	LS
Category	Earthen Levee			GPS Latitude/Longitude	
				Start	End
Item	Slope Stability			37.880323 °	37.880323
				-121.332968 °	-121.332968
DWR ID	DWR_RD0524_01_s_2012_118				
Action/Comments					
Repair slope instability.					
Inspector Comments: Slope damage caused by human activity.

Looking west at slope damage on landside slope.

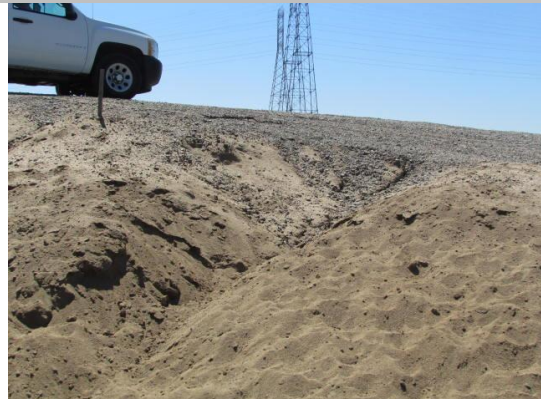
Photo 2 of 3 : FA_2015_RD0524_107_118_20150914_00132.jpg

Looking southeast at damaged slope.

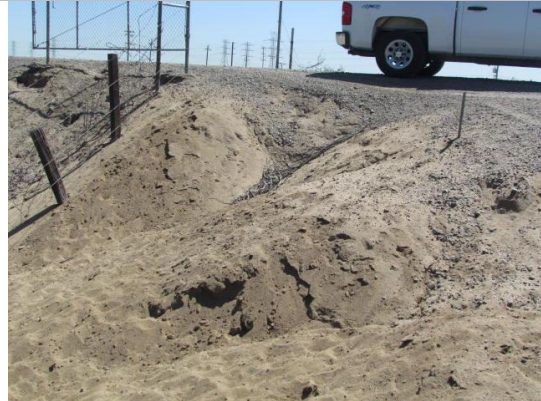
Photo 3 of 3 : FA_2015_RD0524_107_118_20150914_00133.jpg

LM Start	5.42	Rating **	M	Issue No.	118 (cont)
LM End	5.42	Issue Type +	Ma	Location *	LS
Category	Earthen Levee			GPS Latitude/Longitude	
				Start	End
Item	Slope Stability			37.880323 °	37.880323
				-121.332968 °	-121.332968
DWR ID	DWR_RD0524_01_s _ 2012_118				
Action/Comments					
Repair slope instability.					
Inspector Comments: Slope damage caused by human activity.

Looking east at slope caving on landside slope.

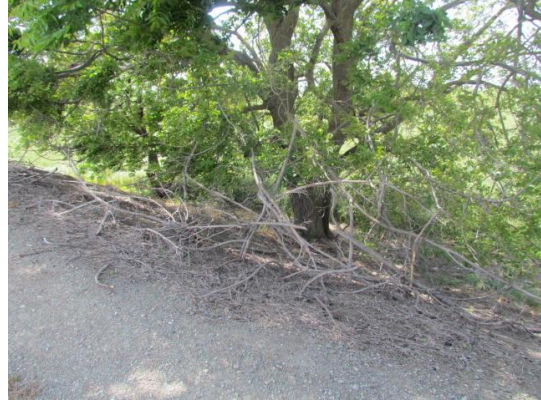
Photo 1 of 1 : FA_2015_RD0524_107_73_20150914_00093.jpg

LM Start	5.44	Rating **	U	Issue No.	73
LM End	5.44	Issue Type +	Ma	Location *	LS
Category	Earthen Levee			GPS Latitude/Longitude	
				Start	End
Item	Trim / Thin Trees			37.880085 °	37.880085
				-121.333045 °	-121.333045
DWR ID	DWR_RD0524_01_s _ 2012_73				
Action/Comments					
Trim trees to at least five feet above ground level.

Looking east at untrimmed trees on landward slope.
