**Flood Control Project Maintenance
Levee Inspections**

Fall 2015 Levee Maintenance Deficiency Summary Report

San Joaquin River Basin

Reclamation District No. 0524 Middle Roberts Island

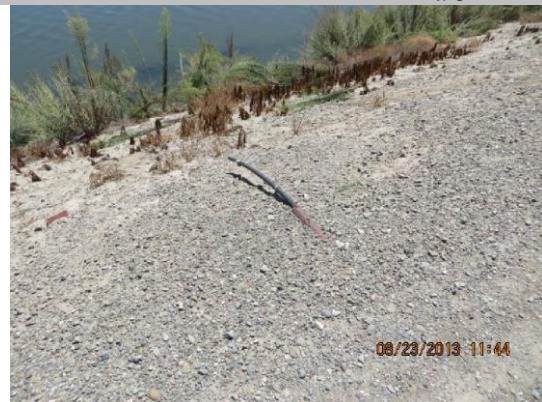
Photo 1 of 2 : UCIP_FA_2015_1570.jpg

LM Start	5.74	Rating **	M	Issue No.	964
LM End	5.74	Issue Type +	En	Location *	LS
Category	Supplemental			GPS Latitude/Longitude	
				Start	End
Item	DWR UCIP Field Study			37.876001 °	37.876001 °
				-121.332725 °	-121.332725 °
DWR ID					
Action/Comments					
Inspector Comments: FS_ID:18364 DS_ID:20649 EP_NO: N/A FS_HLM: 5.791 Repair Type: Non-Urgent Crossing Status: Found UCIP Comments: Abandoned and should be done so properly. FIELD_STRUCT_DESC: 2.25-inch steel conduit for a 1-inch plastic electrical conduit through the levee 0.25-feet below the crown. Lines exposed on both slopes. FS Date: 08/23/2013

Steel conduit and electrical conduit visible on the WS shoulder.

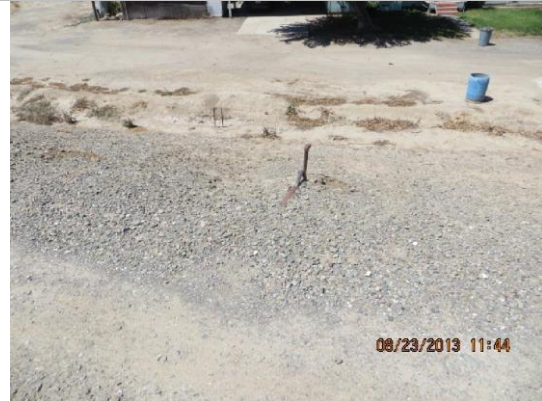
Photo 2 of 2 : UCIP_FA_2015_1571.jpg

LM Start	5.74	Rating **	M	Issue No.	964 (cont)	
LM End	5.74	Issue Type +	En	Location *	LS	
Category	Supplemental			GPS Latitude/Longitude		
				Start	End	
Item	DWR UCIP Field Study			37.876001 °	37.876001 °	
				-121.332725 °	-121.332725 °	
DWR ID						
Action/Comments						
Inspector Comments: FS_ID:18364						
DS_ID:20649						
EP_NO: N/A						
FS_HLM: 5.791						
Repair Type: Non-Urgent						
Crossing Status: Found						
UCIP Comments: Abandoned and should be done so properly.						
FIELD_STRUCT_DESC: 2.25-inch steel conduit for a 1-inch plastic electrical conduit through the levee 0.25-feet below the crown. Lines exposed on both slopes.						
FS Date: 08/23/2013

Steel conduit and electrical conduit visible on the LS shoulder.

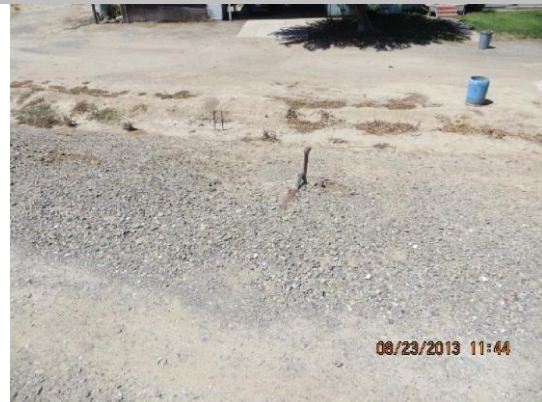
Photo 1 of 1 : UCIP_FA_2015_1572.jpg

LM Start	5.74	Rating **	M	Issue No.	965
LM End	5.74	Issue Type +	En	Location *	LS
Category	Supplemental			GPS Latitude/Longitude	
				Start	End
Item	DWR UCIP Field Study			37.876001 °	37.876001 °
				-121.332725 °	-121.332725 °
DWR ID					
Action/Comments					
Inspector Comments: FS_ID:40793 DS_ID:20635 EP_NO: N/A FS_HLM: 5.791 Repair Type: Non-Urgent Crossing Status: Indicator Found UCIP Comments: Appears abandoned and if so should be done so properly. No permit identified for this crossing. FIELD_STRUCT_DESC: 1-inch steel waterline through the levee 1.0-foot below the crown. Pipe visible only on LS shoulder. FS Date: 08/23/2013

Steel waterline visible on LS shoulder.

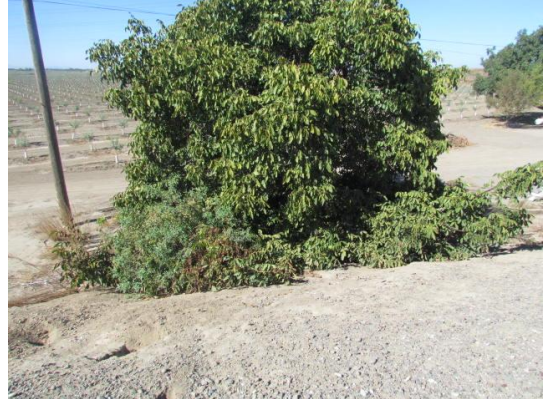
Photo 1 of 1 : FA_2015_RD0524_107_196_20151023_00265.jpg

LM Start	5.77	Rating **	U	Issue No.	196
LM End	5.77	Issue Type +	Ma	Location *	LS
Category	Earthen Levee			GPS Latitude/Longitude	
				Start	End
Item	Trim / Thin Trees			37.875510 °	37.875510 °
				-121.332953 °	-121.332953 °
DWR ID	DWR_RD0524_01_s_2015_196				
Action/Comments					
Trim trees to at least five feet above ground level.					
Inspector Comments: Untrimmed tree on landward slope and toe.

Looking west at untrimmed tree at landward toe fall 2015.

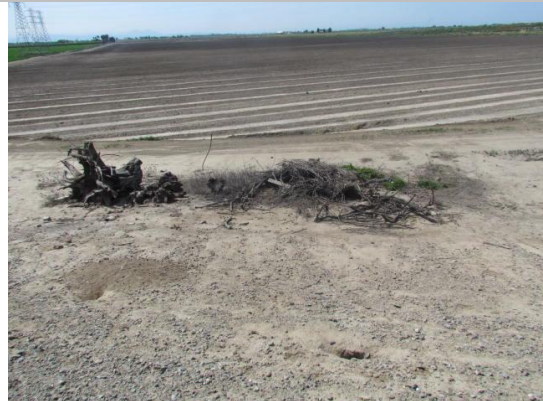
Photo 1 of 1 : FA_2015_RD0524_107_267_20150914_00195.jpg

LM Start	5.79	Rating **	M	Issue No.	267
LM End	5.79	Issue Type +	Ma	Location *	LS
Category	Earthen Levee			GPS Latitude/Longitude	
				Start	End
Item	Encroachments			37.875328 °	37.875328 °
				-121.333050 °	-121.333050 °
DWR ID	DWR_RD0524_01_s_2012_267				
Action/Comments					
Prunings Inspector Comments: Prunings at landside toe should be burned or removed.

Looking east at pruning piles at landward toe and berm.

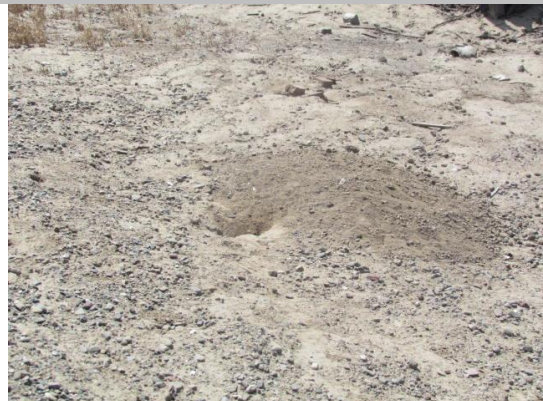
Photo 1 of 2 : FA_2015_RD0524_107_197_20150914_00182.jpg

LM Start	5.79	Rating **	M	Issue No.	197
LM End	5.79	Issue Type +	Ma	Location *	LS
Category	Earthen Levee			GPS Latitude/Longitude	
				Start	End
Item	Animal Control			37.875310 °	37.875310 °
				-121.333065 °	-121.333065 °
DWR ID	DWR_RD0524_01_s_2015_197				
Action/Comments					
Exterminate rodents and backfill and compact or grout burrows. Inspector Comments: Several rodent holes on landward slope and levee crown.

Looking north at typical view of rodent holes on landward slope.

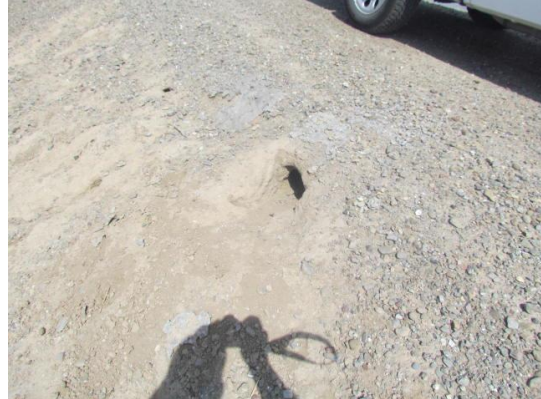
Photo 2 of 2 : FA_2015_RD0524_107_197_20150914_00183.jpg

LM Start	5.79	Rating **	M	Issue No.	197 (cont)
LM End	5.79	Issue Type +	Ma	Location *	LS
Category	Earthen Levee			GPS Latitude/Longitude	
				Start	End
Item	Animal Control			37.875310 °	37.875310 °
				-121.333065 °	-121.333065 °
DWR ID	DWR_RD0524_01_s_2015_197				
Action/Comments					
Exterminate rodents and backfill and compact or grout burrows. Inspector Comments: Several rodent holes on landward slope and levee crown.

Looking southwest at typical view of rodent hole at landward shoulder.

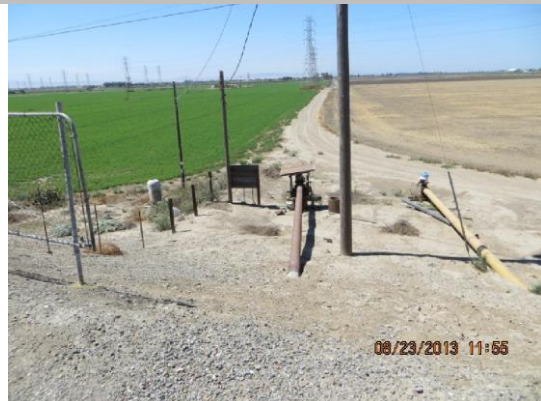
Photo 1 of 2 : UCIP_FA_2015_1573.jpg

LM Start	5.81	Rating **	M	Issue No.	966
LM End	5.81	Issue Type +	En	Location *	LS
Category	Supplemental			GPS Latitude/Longitude	
				Start	End
Item	DWR UCIP Field Study			37.874972 °	37.874972
				-121.333246 °	-121.333246
DWR ID					
Action/Comments					
Inspector Comments: FS_ID:18369					
DS_ID:20636					
EP_NO: N/A					
FS_HLM: 5.868					
Repair Type: Non-Urgent					
Crossing Status: Found					
UCIP Comments: Apparent leak on WS shoulder at concrete riser.					
Erosion under pipe. This may have been fixed when the pipe was sleeved with a PVC liner.					
FIELD_STRUCT_DESC: 10-inch steel storm drain pipe through the levee 5.0 feet below the crown. Pump on the landward side. Siphon breaker in a 36-inch concrete riser on the waterward shoulder. Power pole at the landward toe. PVC liner sleeved inside steel pipe.					
Originally included in the 1964 O&M manual.					
FS Date: 08/23/2013

Pipe, pump, power pole, and meter off LS toe.

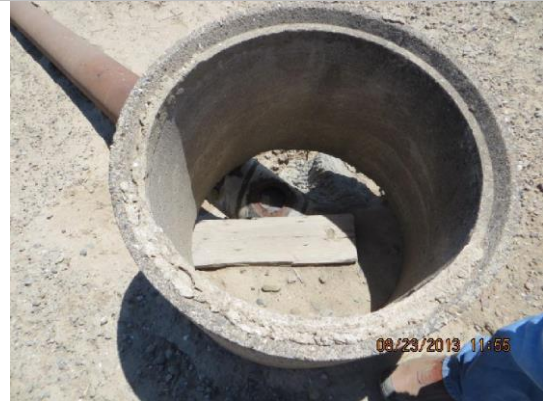
Photo 2 of 2 : UCIP_FA_2015_1574.jpg

Inspector Comments: FS_ID:18369
DS_ID:20636
EP_NO: N/A
FS_HLM: 5.868
Repair Type: Non-Urgent
Crossing Status: Found
UCIP Comments: Apparent leak on WS shoulder at concrete riser. Erosion under pipe. This may have been fixed when the pipe was sleeved with a PVC liner.
FIELD_STRUCT_DESC: 10-inch steel storm drain pipe through the levee 5.0 feet below the crown. Pump on the landward side. Siphon breaker in a 36-inch concrete riser on the waterward shoulder. Power pole at the landward toe. PVC liner sleeved inside steel pipe. Originally included in the 1964 O&M manual.
FS Date: 08/23/2013

Concrete standpipe over pipe on WS shoulder.

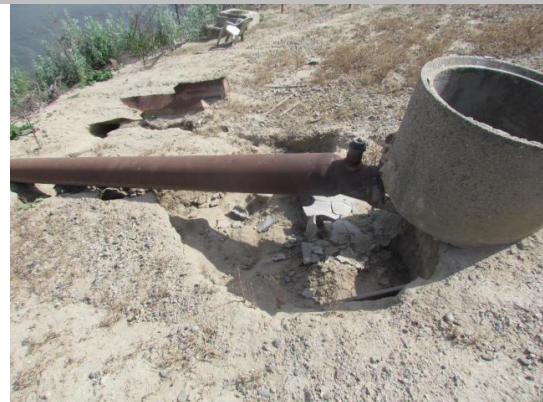
Photo 1 of 3 : FA_2015_RD0524_107_198_20150914_00184.jpg

LM Start	5.81	Rating **	U	Issue No.	198
LM End	5.81	Issue Type +	Ma	Location *	WS
Category	Interior Drainage & Piping Systems			GPS Latitude/Longitude	
				Start	End
Item	Erosion Areas			37.874950 °	37.874950 °
				-121.333273 °	-121.333273 °
DWR ID	DWR_RD0524_01_s_2015_198

Inspector Comments: Large erosion around irrigation pipe on waterward slope.

Looking south at erosion around irrigation pipe on waterward slope.

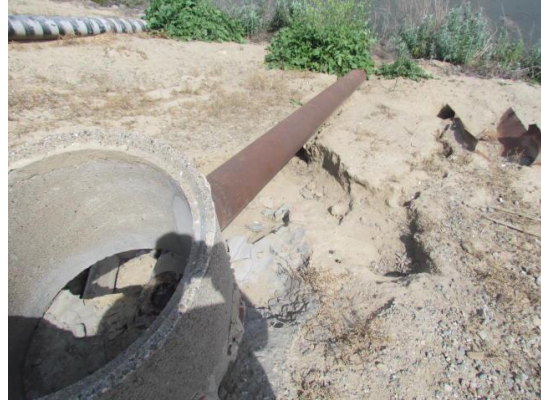
Photo 2 of 3 : FA_2015_RD0524_107_198_20150914_00185.jpg

LM Start	5.81	Rating **	U	Issue No.	198 (cont)
LM End	5.81	Issue Type +	Ma	Location *	WS
Category	Interior Drainage & Piping Systems			GPS Latitude/Longitude	
				Start	End
Item	Erosion Areas			37.874950 °	37.874950 °
				-121.333273 °	-121.333273 °
DWR ID	DWR_RD0524_01_s_2015_198				
Action/Comments					
Inspector Comments: Large erosion around irrigation pipe on waterward slope.

Looking east at erosion around irrigation pipe.

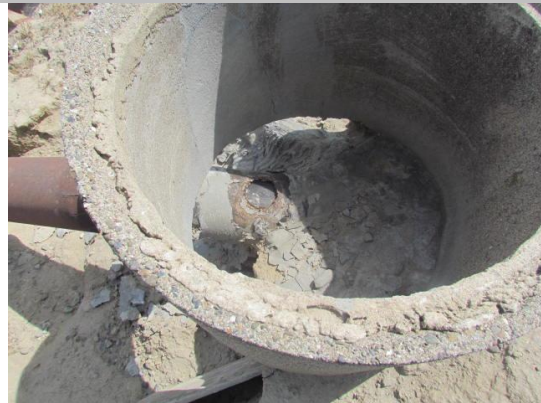
Photo 3 of 3 : FA_2015_RD0524_107_198_20150914_00186.jpg

Looking at erosion around pipe inside concrete collar.

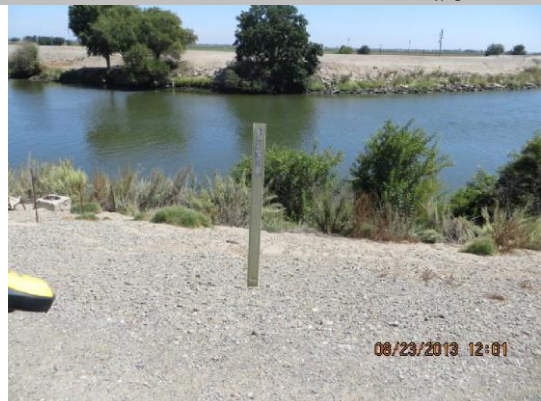
Photo 1 of 1 : UCIP_FA_2015_1462.jpg

LM Start	5.82	Rating **	M	Issue No.	967
LM End	5.82	Issue Type +	En	Location *	WS
Category	Supplemental			GPS Latitude/Longitude	
				Start	End
Item	DWR UCIP Field Study			37.874829 °	37.874829 °
				-121.333265 °	-121.333265 °
DWR ID					
Action/Comments					
Inspector Comments: FS_ID:18705 DS_ID:20656 EP_NO: N/A FS_HLM: 5.878 Repair Type: Non-Urgent Crossing Status: Indicator Found

Gasline marker on WS shoulder.

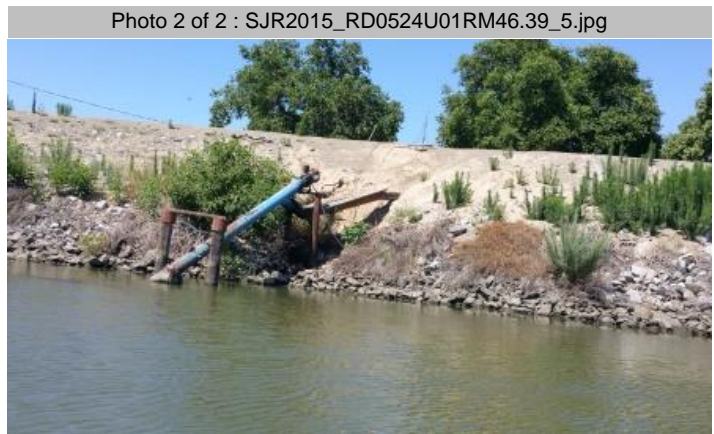
LM Start	5.86	Rating **	U	Issue No.	47
LM End	5.86	Issue Type +	Ma	Location *	WS
Category	Supplemental			GPS Latitude/Longitude	
				Start	End
Item	DWR Erosion Survey			37.874370 °	37.874370 °
				-121.332850 °	-121.332850 °
DWR ID					
Action/Comments					
Inspector Comments: 06/24/2015: No significant change observed. 06/19/2014: No significant change observed. 08/13/2013: No significant change observed. 08/07/2012: The erosion is near a water-intake structure. Pipe leakage likely caused the erosion. [2015 Site ID:RD0524U01RM46.39]

Front view of the site.

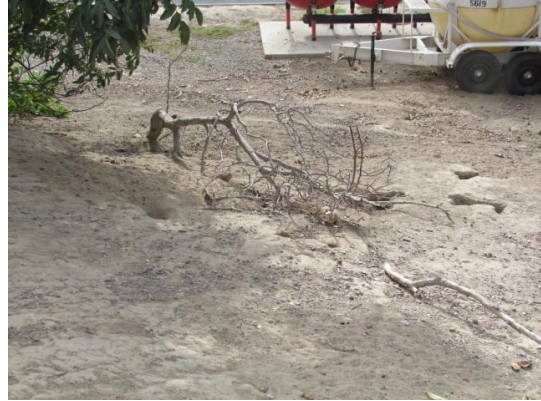
Photo 2 of 2 : FA_2015_RD0524_107_75_20150914_00098.jpg

LM Start	5.86	Rating **	M	Issue No.	75 (cont)
LM End	5.88	Issue Type +	Ma	Location *	WS
Category	Earthen Levee			GPS Latitude/Longitude	
				Start	End
Item	Animal Control			37.874240 °	37.874002 °
				-121.333187 °	-121.333027 °
DWR ID	DWR_RD0524_01_s_2012_75				
Action/Comments					
No rodents visible, but rodent burrows visible; need to backfill and compact or grout burrows. Inspector Comments: District has grouted rodent holes, but other rodent holes have appeared.

Looking typical view of several rodent holes on landward slope and toe.

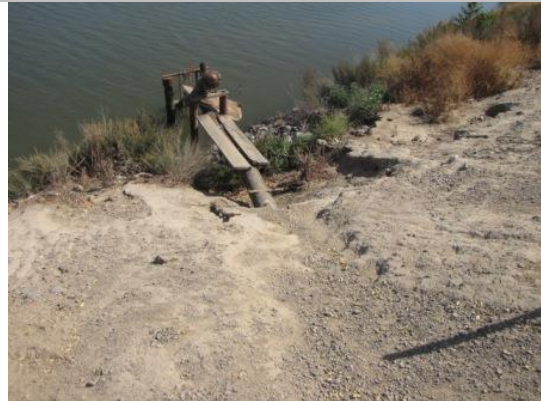
Photo 1 of 3 : FA_2015_RD0524_107_74_20150914_00094.jpg

LM Start	5.86	Rating **	M	Issue No.	74
LM End	5.87	Issue Type +	Ma	Location *	WS
Category	Earthen Levee			GPS Latitude/Longitude	
				Start	End
Item	Erosion / Bank Caving			37.874240 °	37.874165 °
				-121.333185 °	-121.333155 °
DWR ID	DWR_RD0524_01_s_2012_74				
Action/Comments					
Note and monitor erosion site.					
Inspector Comments: Erosion on landward slope around intake pipe.

Looking southeast at erosion around pipe.

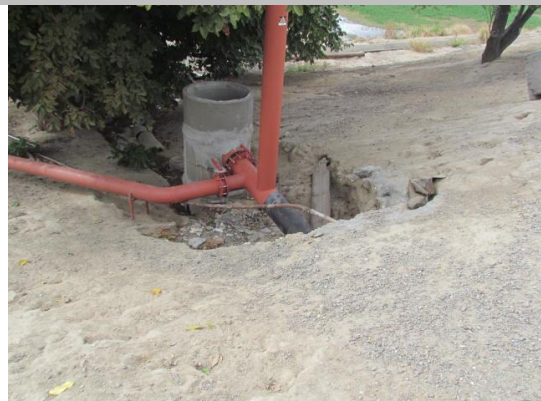
Photo 2 of 3 : FA_2015_RD0524_107_74_20150914_00095.jpg

Looking west at erosion around intake pipe on landward slope.

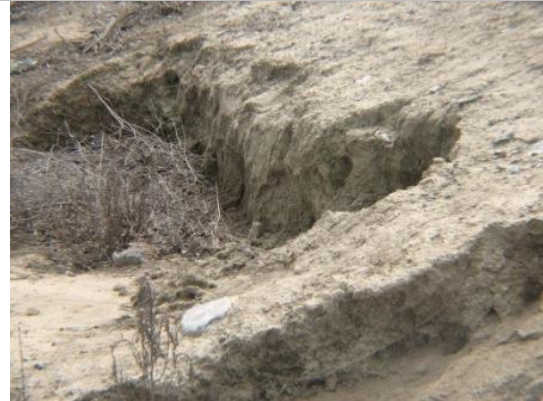
Photo 3 of 3 : FA_2015_RD0524_107_74_20150914_00096.jpg

LM Start	5.86	Rating **	M	Issue No.	74 (cont)
LM End	5.87	Issue Type +	Ma	Location *	WS
Category	Earthen Levee			GPS Latitude/Longitude	
				Start	End
Item	Erosion / Bank Caving			37.874240 °	37.874165 °
				-121.333185 °	-121.333155 °
DWR ID	DWR_RD0524_01_s_2012_74				
Action/Comments					
Note and monitor erosion site.					
Inspector Comments: Erosion on landward slope around intake pipe.

Erosion at waterward toe and around irrigation pipe at LM 5.92

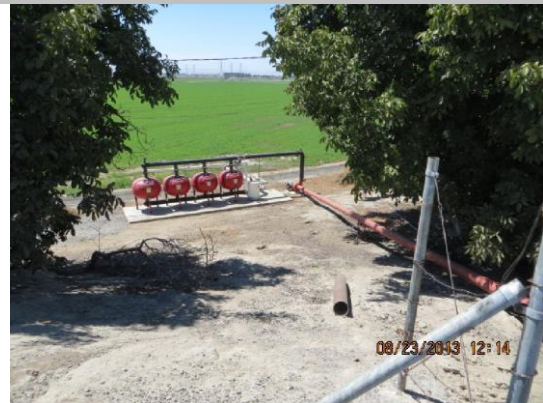
Photo 1 of 3 : UCIP_FA_2015_1172.jpg

LM Start	5.87	Rating **	M	Issue No.	968
LM End	5.87	Issue Type +	En	Location *	WS
Category	Supplemental			GPS Latitude/Longitude	
				Start	End
Item	DWR UCIP Field Study			37.874194 °	37.874194 °
				-121.333182 °	-121.333182 °
DWR ID					
Action/Comments					
Inspector Comments: FS_ID:18379 DS_ID:20638 EP_NO: N/A FS_HLM: 5.923 Repair Type: Non-Urgent Crossing Status: Found UCIP Comments: Heavy erosion around pipe upstream of standpipe on LS slope. Verify pipe is not leaking and repair erosion on LS slope. FIELD_STRUCT_DESC: 12-inch steel irrigation pipe through the levee 10.0 feet below the crown. Slant pump on pier at WS toe. 10-inch steel standpipe on LS slope. 42-inch concrete standpipe on LS slope. Filter plant, and power pole on LS toe. 1.5-inch galvanized iron electrical conduit at same location. Originally included in the 1964 O&M manual. FS Date: 08/23/2013

Filter pump on LS toe.

Inspector Comments: FS_ID:18379
 DS_ID:20638
 EP_NO: N/A
 FS_HLM: 5.923
 Repair Type: Non-Urgent
 Crossing Status: Found
 UCIP Comments: Heavy erosion around pipe upstream of standpipe on LS slope. Verify pipe is not leaking and repair erosion on LS slope.
 FIELD_STRUCT_DESC: 12-inch steel irrigation pipe through the levee 10.0 feet below the crown. Slant pump on pier at WS toe. 10-inch steel standpipe on LS slope. 42-inch concrete standpipe on LS slope. Filter plant, and power pole on LS toe. 1.5-inch galvanized iron electrical conduit at same location. Originally included in the 1964 O&M manual.
 FS Date: 08/23/2013

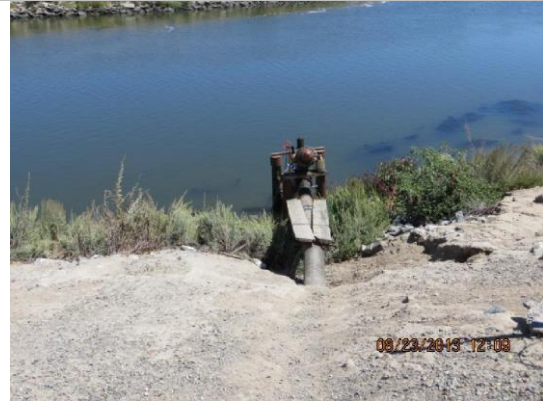
Photo 2 of 3 : UCIP_FA_2015_1173.jpg

LM Start	5.87	Rating **	M	Issue No.	968 (cont)
LM End	5.87	Issue Type +	En	Location *	WS

Slant pump on WS toe.

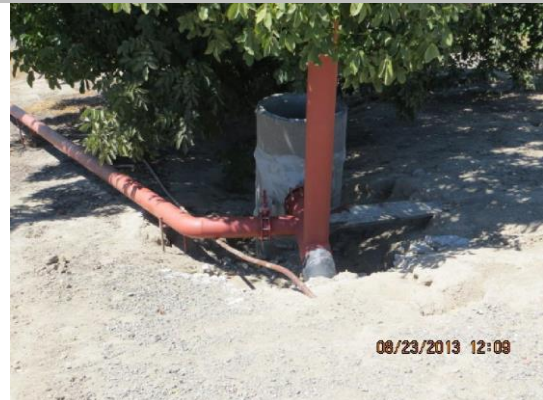
Photo 3 of 3 : UCIP_FA_2015_1174.jpg

Butterfly valves and standpipes on LS slope along with electrical conduit.

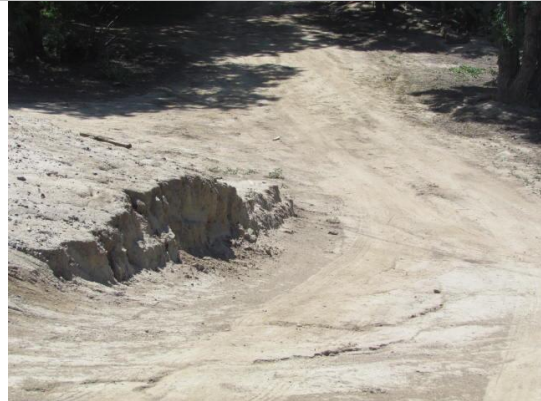
Photo 1 of 2 : FA_2015_RD0524_107_119_20150914_00134.jpg

LM Start	5.89	Rating **	U	Issue No.	119
LM End	5.89	Issue Type +	Ma	Location *	LS
Category	Earthen Levee			GPS Latitude/Longitude	
				Start	End
Item	Slope Stability			37.873893 °	37.873893
				-121.332978 °	-121.332978
DWR ID	DWR_RD0524_01_s _ 2012_119				
Action/Comments					
Repair the levee slope damaged by vehicle traffic and prevent access where possible.					
Inspector Comments: Landowner is using damaged area as a ramp.

Looking west at unauthorized ramp and landside slope damage.

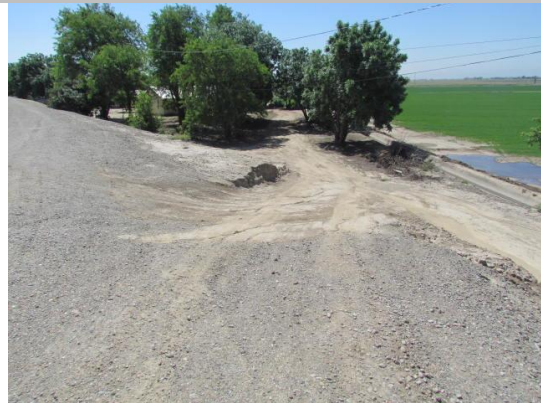
Photo 2 of 2 : FA_2015_RD0524_107_119_20150914_00135.jpg

LM Start	5.89	Rating **	U	Issue No.	119 (cont)
LM End	5.89	Issue Type +	Ma	Location *	LS

Looking southwest at damaged slope and ramp on landside slope.

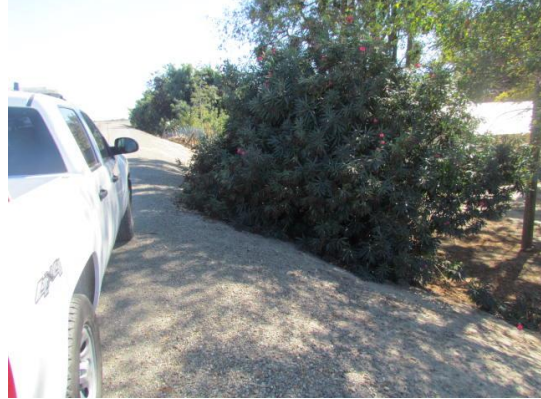
Photo 1 of 1 : FA_2015_RD0524_107_200_20151023_00266.jpg

LM Start	5.92	Rating **	U	Issue No.	200
LM End	5.92	Issue Type +	Ma	Location *	LS
Category	Earthen Levee			GPS Latitude/Longitude	
				Start	End
Item	Vegetation			37.873623 °	37.873623
				-121.332585 °	-121.332585
DWR ID	DWR_RD0524_01_f_2015_200				
Action/Comments					
Remove the wild growth other than native grasses from the levee slopes.					
Inspector Comments: Oleander bush on landward slope.

Looking south at oleander on landward slope fall 2015.

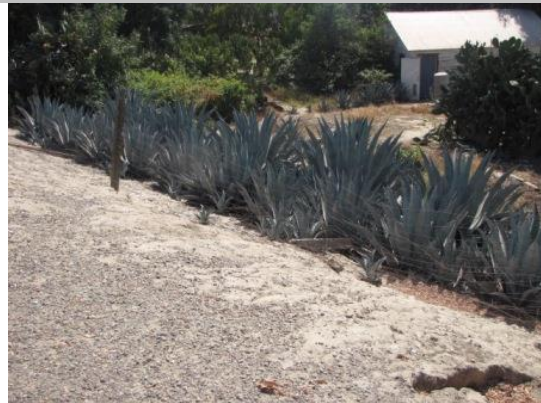
Photo 1 of 1 : FA_2015_RD0524_107_88_20150914_00110.jpg

LM Start	5.94	Rating **	U	Issue No.	88
LM End	5.95	Issue Type +	En	Location *	LS
Category	Earthen Levee			GPS Latitude/Longitude	
				Start	End
Item	Vegetation			37.873543 °	37.873445 °
				-121.332308 °	-121.332127 °
DWR ID	DWR_RD0524_01_s_2012_88				
Action/Comments					
Landscaping Inspector Comments: Cactus and Century plants on landward slope and toe.

Looking southeast at fence and cactus on landside slope and toe.

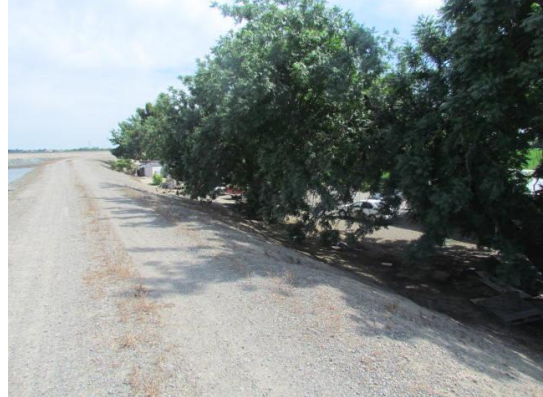
Photo 1 of 1 : FA_2015_RD0524_107_120_20150914_00136.jpg

LM Start	5.96	Rating **	U	Issue No.	120
LM End	5.96	Issue Type +	Ma	Location *	LS
Category	Earthen Levee			GPS Latitude/Longitude	
				Start	End
Item	Trim / Thin Trees			37.873347 °	37.873347 °
				-121.332028 °	-121.332028 °
DWR ID	DWR_RD0524_01_s_2012_120				
Action/Comments					
Trim trees to at least five feet above ground level.

Looking south at untrimmed trees on landward slope and toe.

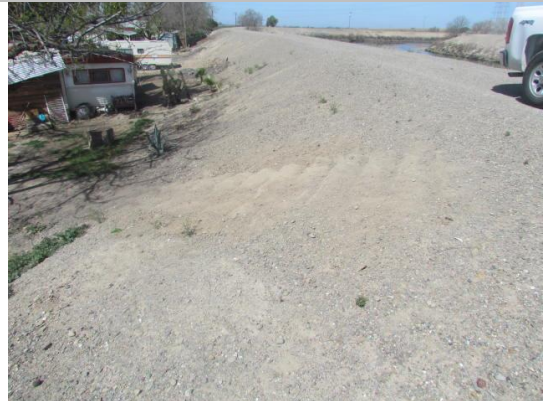
Photo 1 of 1 : FA_2015_RD0524_107_933_20150914_00207.jpg

LM Start	6.00	Rating **	M	Issue No.	933
LM End	6.00	Issue Type +	Ma	Location *	LS
Category	Earthen Levee			GPS Latitude/Longitude	
				Start	End
Item	Slope Stability			37.873047 °	37.873047 °
				-121.331408 °	-121.331408 °
DWR ID	DWR_RD0524_01_s_2012_933				
Action/Comments					
Repair the levee slope damaged by foot traffic and prevent access where possible.					
Inspector Comments: Landowner cut steps into landside slope.

Looking north at steps cut into landward slope.

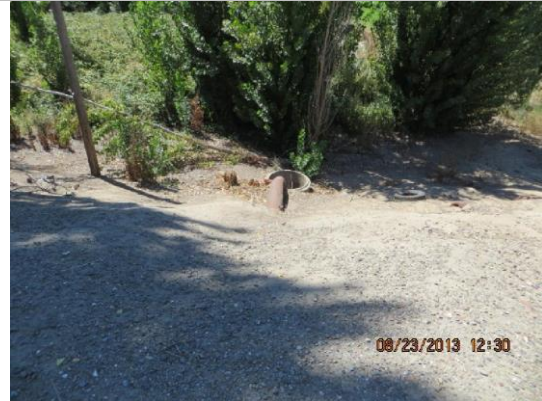
Photo 1 of 2 : UCIP_FA_2015_1658.jpg

Inspector Comments: FS_ID:18392
 DS_ID:20641
 EP_NO: N/A
 FS_HLM: 6.206
 Repair Type: Non-Urgent
 Crossing Status: Found
 UCIP Comments: Pipe and pump abandoned and should be done so properly.
 FIELD_STRUCT_DESC: *ABANDONED*10-inch pipe through levee 12.0 feet below crown, pump on the waterward slope. Originally included in the 1964 O&M manual.
 FS Date: 08/23/2013

LM Start	6.15	Rating **	M	Issue No.	969 (cont)
LM End	6.15	Issue Type +	En	Location *	LS

Pipe and concrete standpipe visible on LS toe.

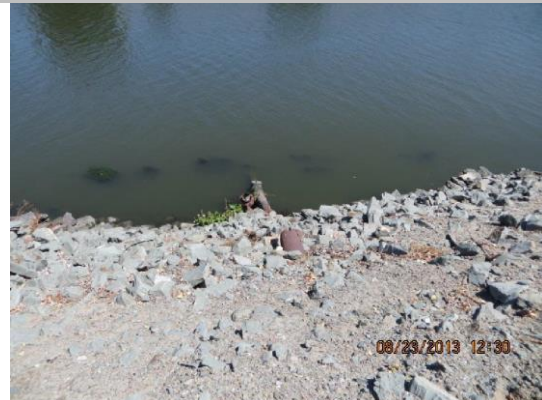
Photo 2 of 2 : UCIP_FA_2015_1659.jpg

Pump and open pipe visible on WS slope.

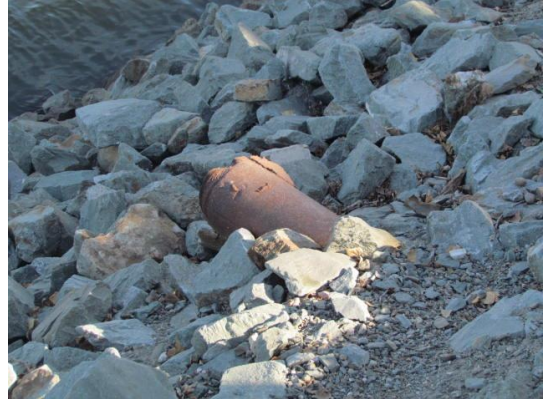
Photo 1 of 1 : FA_2015_RD0524_107_268_20150914_00196.jpg

LM Start	6.15	Rating **	M	Issue No.	268
LM End	6.15	Issue Type +	Ma	Location *	WS
Category	Earthen Levee			GPS Latitude/Longitude	
				Start	End
Item	Encroachments			37.871137 °	37.871137 °
				-121.330138 °	-121.330138 °
DWR ID	DWR_RD0524_01_s_2012_268				
Action/Comments					
Pipe					
Inspector Comments: Open abandoned 10" pipe on waterside slope below flood elevation. Pipe should be removed or properly abandoned.

Looking southeast at abandoned pipe on waterside slope.

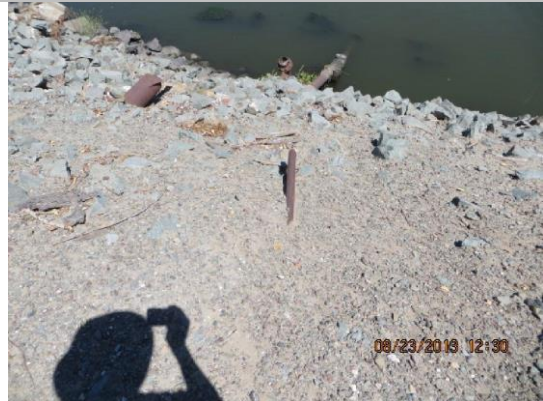
Photo 1 of 2 : UCIP_FA_2015_2378.jpg

LM Start	6.15	Rating **	M	Issue No.	970
LM End	6.15	Issue Type +	En	Location *	WS
Category	Supplemental			GPS Latitude/Longitude	
				Start	End
Item	DWR UCIP Field Study			37.871118 °	37.871118 °
				-121.330137 °	-121.330137 °
DWR ID					
Action/Comments					
Inspector Comments: FS_ID:22073 DS_ID:24052 EP_NO: N/A FS_HLM: 6.207 Repair Type: Non-Urgent Crossing Status: Found UCIP Comments: Abandoned and should be done so properly. FIELD_STRUCT_DESC: *ABANDONED* 1.75-inch galvanized iron electrical conduit through the levee 1-foot below the crown. Power pole on LS toe. FS Date: 08/23/2013

Pipe visible on WS slope.

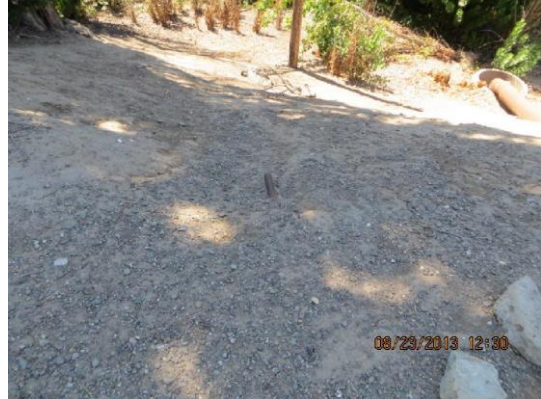
Photo 2 of 2 : UCIP_FA_2015_2379.jpg

LM Start	6.15	Rating **	M	Issue No.	970 (cont)	
LM End	6.15	Issue Type +	En	Location *	WS	
Category	Supplemental			GPS Latitude/Longitude		
				Start	End	
Item	DWR UCIP Field Study			37.871118 °	37.871118 °	
				-121.330137 °	-121.330137 °	
DWR ID						
Action/Comments						
Inspector Comments: FS_ID:22073						
DS_ID:24052						
EP_NO: N/A						
FS_HLM: 6.207						
Repair Type: Non-Urgent						
Crossing Status: Found						
UCIP Comments: Abandoned and should be done so properly.						
FIELD_STRUCT_DESC: *ABANDONED* 1.75-inch galvanized iron						
electrical conduit through the levee 1-foot below the crown. Power pole						
on LS toe.						
FS Date: 08/23/2013

Pipe visible on LS slope.

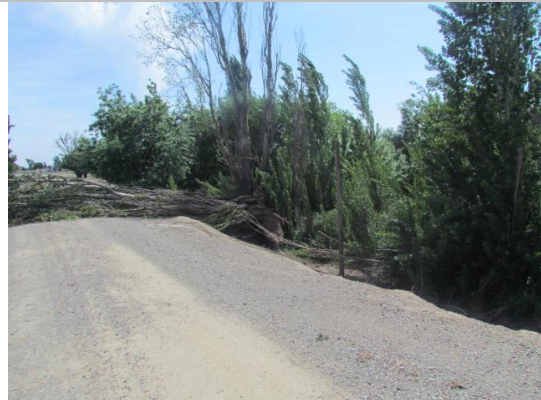
Photo 1 of 2 : FA_2015_RD0524_107_81_20150914_00105.jpg

LM Start	6.15	Rating **	U	Issue No.	81
LM End	6.15	Issue Type +	Ma	Location *	LS
Category	Earthen Levee			GPS Latitude/Longitude	
				Start	End
Item	Encroachments			37.871097 °	37.871097 °
				-121.330100 °	-121.330100 °
DWR ID	DWR_RD0524_01_s_2015_81				
Action/Comments					
Tree or limb Inspector Comments: Large tree fallen across levee crown blocking access.

Looking southwest at large tree across levee crown.

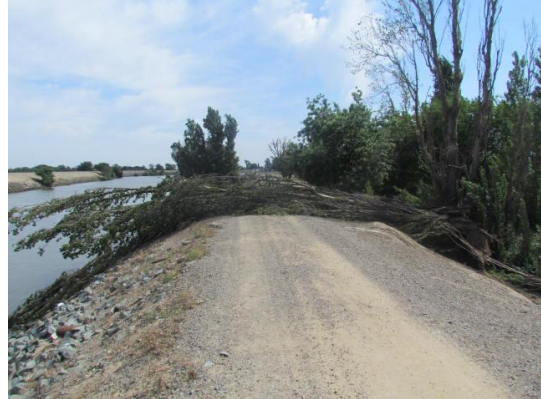
Photo 2 of 2 : FA_2015_RD0524_107_81_20150914_00106.jpg

LM Start	6.15	Rating **	U	Issue No.	81 (cont)
LM End	6.15	Issue Type +	Ma	Location *	LS
Category	Earthen Levee			GPS Latitude/Longitude	
				Start	End
Item	Encroachments			37.871097 °	37.871097 °
				-121.330100 °	-121.330100 °
DWR ID	DWR_RD0524_01_s _ 2015_81				
Action/Comments					
Tree or limb Inspector Comments: Large tree fallen across levee crown blocking access.

Looking south at large tree across levee crown.

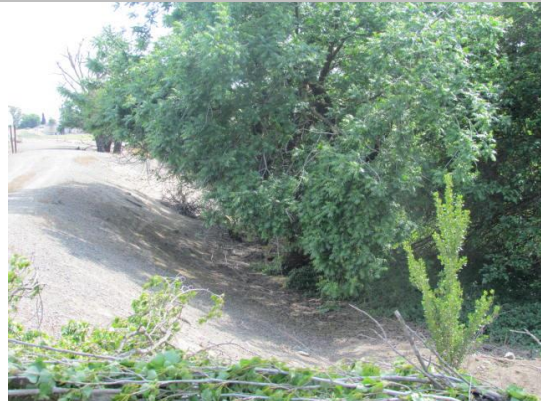
Photo 1 of 1 : FA_2015_RD0524_107_98_20150914_00118.jpg

LM Start	6.17	Rating **	U	Issue No.	98
LM End	6.17	Issue Type +	Ma	Location *	LS
Category	Earthen Levee			GPS Latitude/Longitude	
				Start	End
Item	Trim / Thin Trees			37.870842 °	37.870842 °
				-121.330000 °	-121.330000 °
DWR ID	DWR_RD0524_01_s _ 2012_98				
Action/Comments					
Trim trees to at least five feet above ground level.

Looking southeast at untrimmed trees at landward toe.
