**Flood Control Project Maintenance  
Levee Inspections**

**Fall 2016 Levee Maintenance Deficiency Summary Report**

**Reclamation District No. 0524 Middle Roberts Island**

Waterway			Bank	Unit Miles
Unit No. 01 San Joaquin River			Left	6.20
	Spring (March - May)	Summer (June - August)	(September - November) Fall	Winter (December - February)
Unit Maintenance Rating (Fall Only)			<b>U</b>	
Date of Inspection	4/12/2016 - 4/13/2016		10/10/2016 - 10/11/2016	
DWR Inspector	Richard Willoughby		Richard Willoughby	
Accompanied By	Mario Jaques RD 524		Mario Jaques RD 524

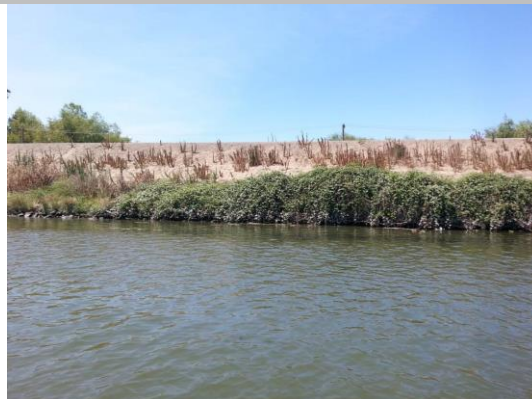
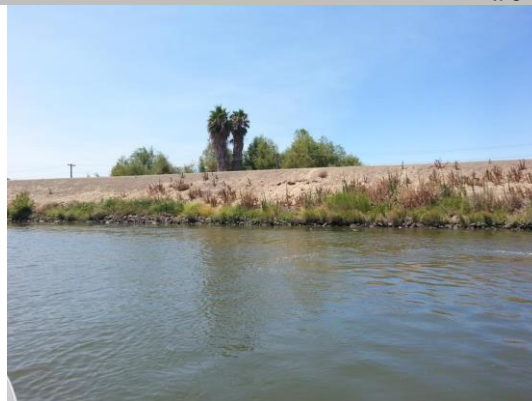
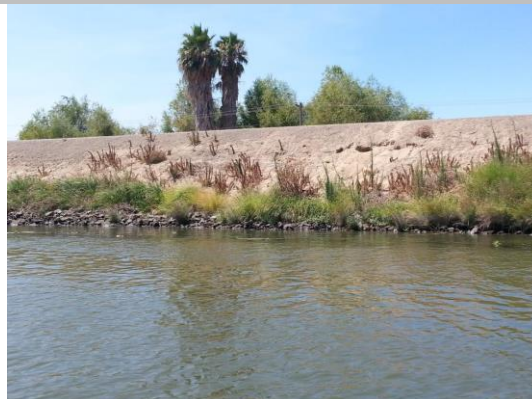
LM Start	0.19	Rating **	U	Issue No.	5
LM End	0.19	Issue Type +	Ma	Location *	WS
Category	Supplemental			GPS Latitude/Longitude	
				Start	End
Item	DWR Erosion Survey			37.939085 °	37.939085 °
				-121.343917 °	-121.343917 °
DWR ID					
Comment Code					
Inspector Comment					
07/25/2016: No significant change observed.					
06/24/2015: No significant change observed.					
06/19/2014: No significant change observed.					
08/13/2013: The erosion was discovered during 2013 spring levee inspection. Inspector comment: Erosion is located along the lower level of water-ward slope. [2016 Site ID:RD0524U01RM40.85]

Close view of the erosion.

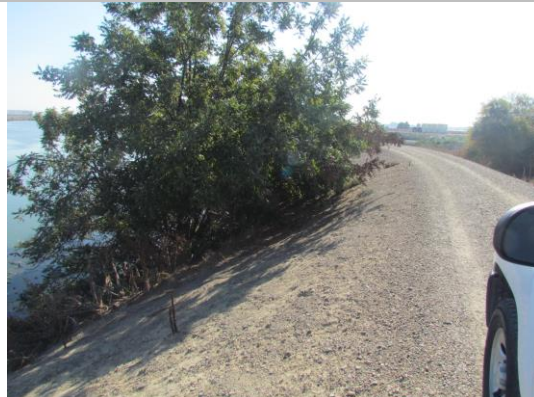
Photo 1 of 1 : FA\_2016\_RD0524\_107\_201\_20161013\_00384.jpg

LM Start	0.23	Rating **	U	Issue No.	201
LM End	0.23	Issue Type +	Ma	Location *	WS
Category	Earthen Levee			GPS Latitude/Longitude	
				Start	End
Item	Trim / Thin Trees			37.938648 °	37.938648 °
				-121.343480 °	-121.343480 °
DWR ID	DWR_RD0524_01_f_2016_201				
Comment Code					
T2 : Thin trees to allow visibility of the ground and room to flood fight.					
Inspector Comment					
Untrimmed trees on waterward slope.

Looking east at untrimmed tree on landward slope.

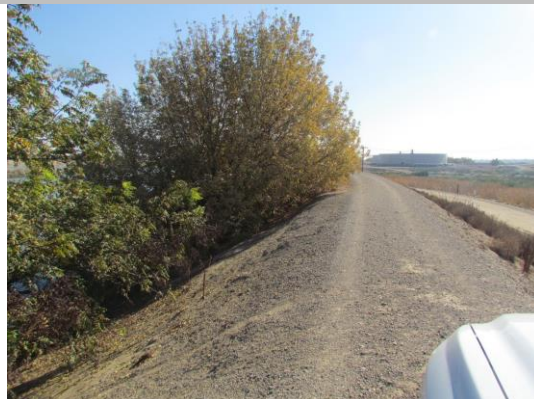
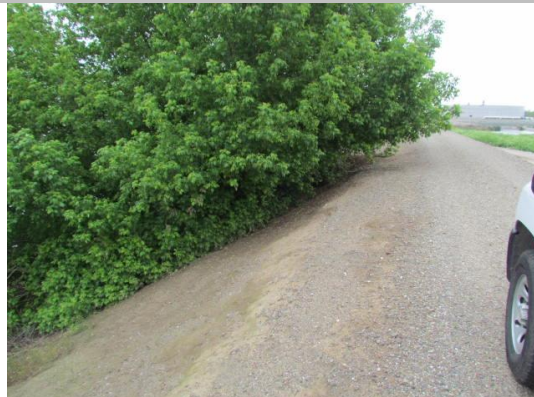
LM Start	0.27	Rating **	U	Issue No.	179
LM End	0.27	Issue Type +	Ma	Location *	WS
Category	Earthen Levee			GPS Latitude/Longitude	
				Start	End
Item	Trim / Thin Trees			37.938438 °	37.938438 °
				-121.342883 °	-121.342883 °
DWR ID	DWR_RD0524_01_s_2014_179				
Comment Code					
T2 : Thin trees to allow visibility of the ground and room to flood fight.					
Inspector Comment					
Tree blocking view of waterward slope.

Looking east at untrimmed tree on waterward slope. (Fall 2016)

Looking east at untrimmed tree on waterward slope (Spring 2016)

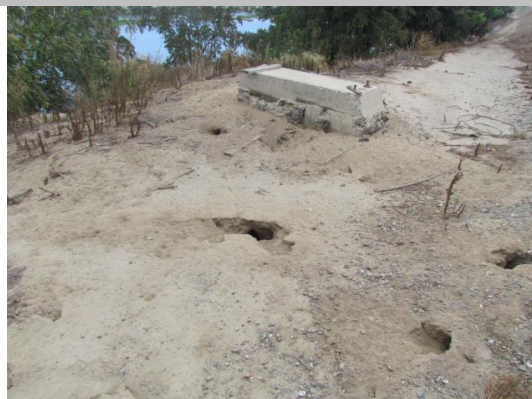
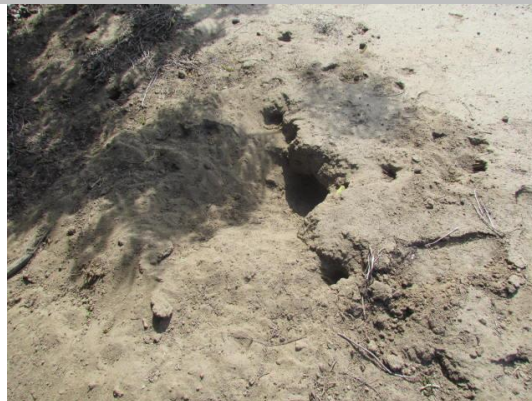
Looking southeast at several rodent holes on waterward slope. (Spring 2016)

Looking west at several rodent holes on waterward shoulder. (Spring 2015)

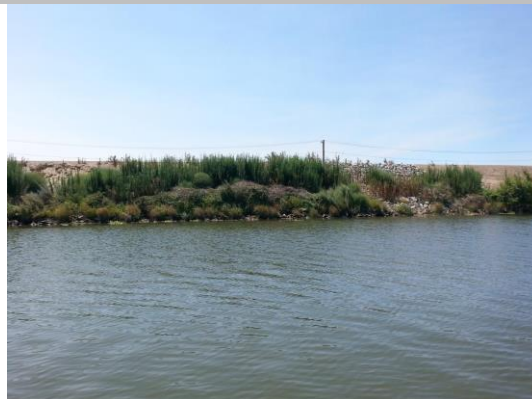
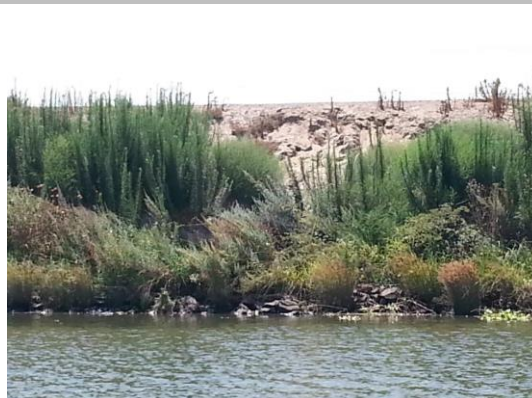
LM Start	0.40	Rating **	U	Issue No.	16
LM End	0.40	Issue Type +	Ma	Location *	WS
Category	Supplemental			GPS Latitude/Longitude	
				Start	End
Item	DWR Erosion Survey			37.938870 °	37.938870 °
				-121.340460 °	-121.340460 °
DWR ID					
Comment Code					
Inspector Comment					
07/25/2016: More vegetation observed at the site.					
06/24/2015: No significant change observed.					
06/19/2014: No significant change observed.					
08/13/2013: No significant change at this site.					
08/07/2012: The erosion is at the upper levee slope, and likely caused by slope slip. The lower levee slope is covered with dense vegetation.					
[2016 Site ID:RD0524U01RM40.99]

Front view of the site.

Close view of the erosion.

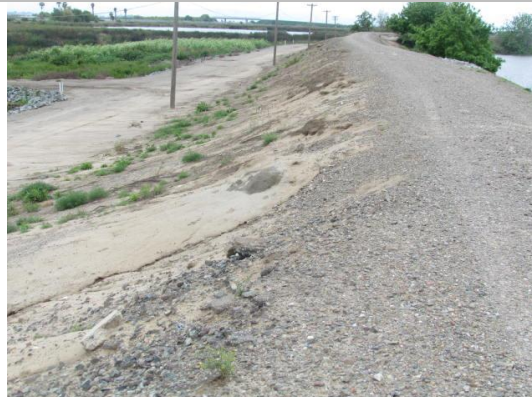
Photo 1 of 2 : FA\_2016\_RD0524\_107\_205\_20160929\_00246.jpg

LM Start	0.40	Rating **	U	Issue No.	205
LM End	0.46	Issue Type +	Ma	Location *	LS
Category	Earthen Levee			GPS Latitude/Longitude	
				Start	End
Item	Slope Stability			37.938625 °	37.938695 °
				-121.340479 °	-121.339420 °
DWR ID	DWR_RD0524_01_s_2016_205				
Comment Code					
S1 : Repair slope instability.					
Inspector Comment					
Several damage site within this reach.

Looking at slope damage on landward slope.

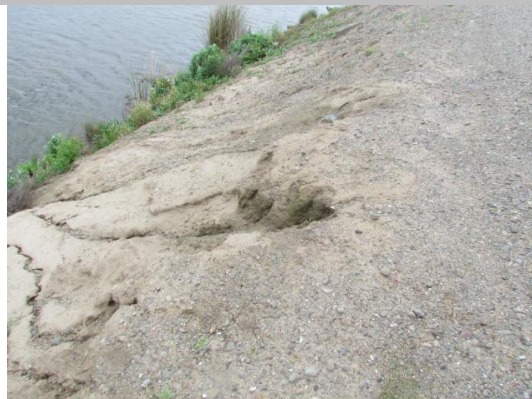
Photo 1 of 3 : FA\_2016\_RD0524\_107\_170\_20160929\_00210.jpg

LM Start	0.41	Rating **	U	Issue No.	170
LM End	0.45	Issue Type +	Ma	Location *	WS
Category	Earthen Levee			GPS Latitude/Longitude	
				Start	End
Item	Slope Stability			37.938628 °	37.938688 °
				-121.340385 °	-121.339627 °
DWR ID	DWR_RD0524_01_s_2015_170				
Comment Code					
S1 : Repair slope instability.					
Inspector Comment					
Several slope instabilities within this reach.

Looking at slope damage on waterward shoulder (Spring 2016)

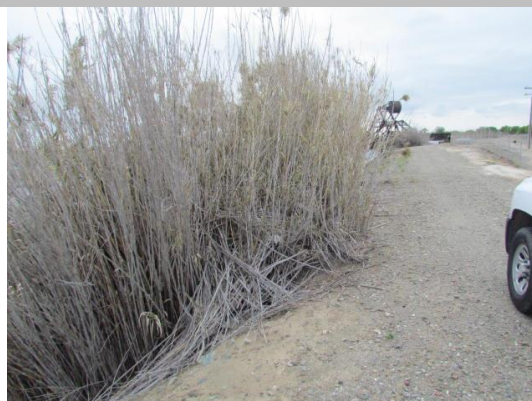
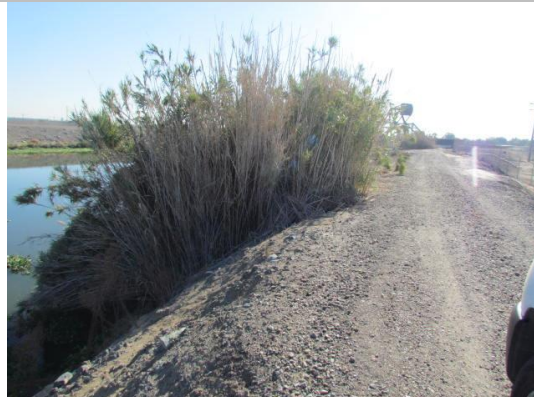
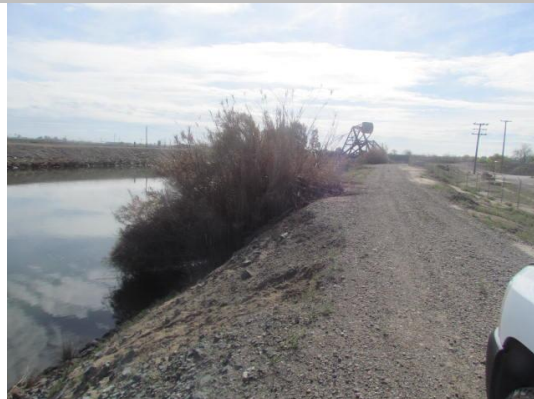
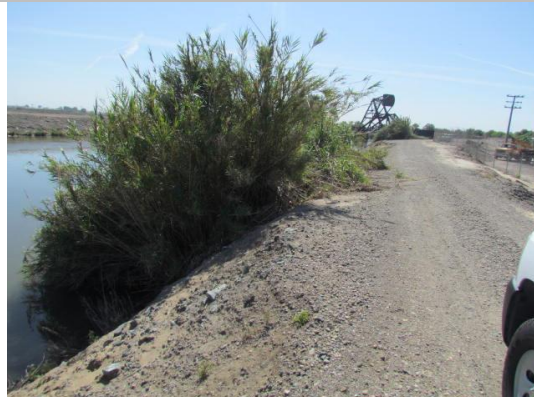
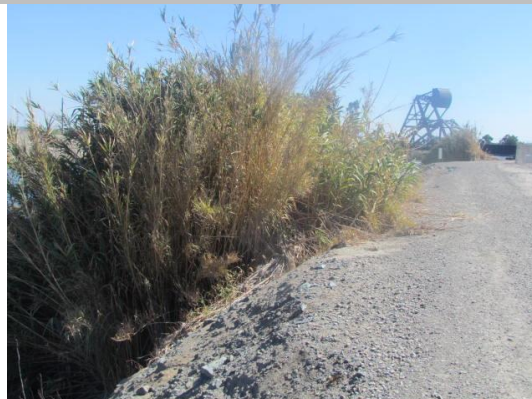
LM Start	0.62	Rating **	U	Issue No.	11
LM End	0.63	Issue Type +	Ma	Location *	WS
Category	Earthen Levee			GPS Latitude/Longitude	
				Start	End
Item	Vegetation			37.938278 °	37.938247 °
				-121.336524 °	-121.336503 °
DWR ID	DWR_RD0524_01_s_2012_11				
Comment Code					
V2 : Remove the wild growth other than native grasses from the levee slopes.					
Inspector Comment					
Bamboo on waterward slope. Bamboo has been killed but still blocking view of waterward slope.

Looking at bamboo on waterward slope. (Spring 2016)

Looking at bamboo on waterside slope. (Fall 2015)

Looking at dying bamboo on waterward slope. (Spring 2013)

Looking at bamboo on waterside slope. (Spring 2012)

Looking at bamboo on waterside slope. (Fall Inspection 2012)

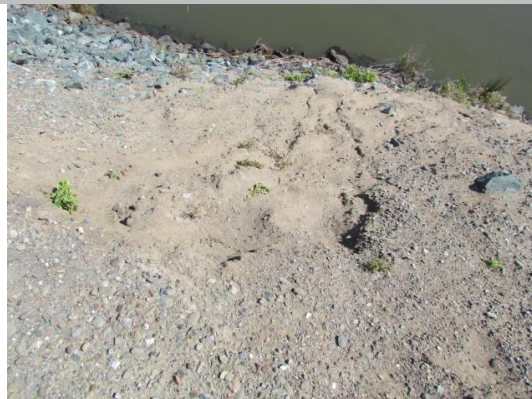
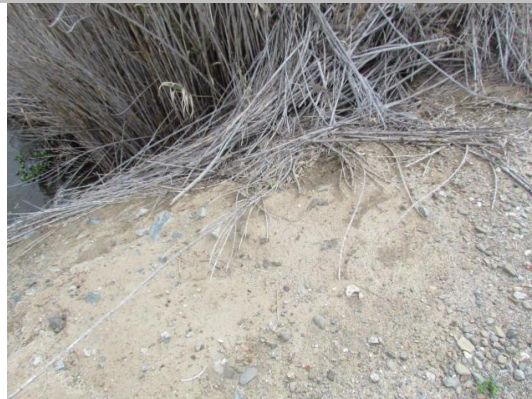
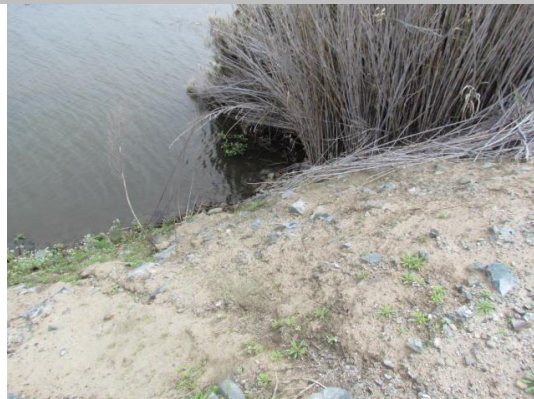
LM Start	0.63	Rating **	U	Issue No.	10
LM End	0.63	Issue Type +	Ma	Location *	WS
Category	Earthen Levee			GPS Latitude/Longitude	
				Start	End
Item	Erosion / Bank Caving			37.938247 °	37.938247 °
				-121.336503 °	-121.336503 °
DWR ID	DWR_RD0524_01_f_2015_10				
Comment Code					
E2 : Schedule repair of erosion site prior to the next inspection.					
Inspector Comment					
Erosion located next to and under bamboo.

Looking east at waterside erosion appears to be caused by runoff.

Looking east at erosion under bamboo on waterward slope.

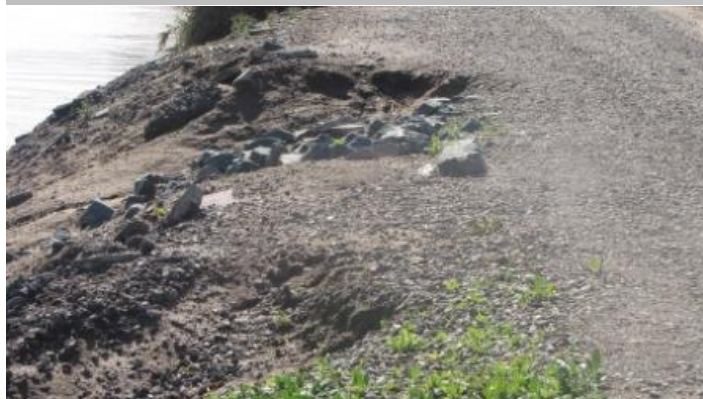
Photo 2 of 4 : FA\_2016\_RD0524\_107\_13\_20160929\_00025.jpg

LM Start	0.64	Rating **	M	Issue No.	13
LM End	0.65	Issue Type +	Ma	Location *	WS
Category	Earthen Levee			GPS Latitude/Longitude	
				Start	End
Item	Slope Stability			37.938105 °	37.938023 °
				-121.336288 °	-121.336173 °
DWR ID	DWR_RD0524_01_s_2012_13				
Comment Code					
S1 : Repair slope instability.					
Inspector Comment					
Depression extend from shoulder to mid levee slope two site with this section.

Looking south at erosion on waterside shoulder.

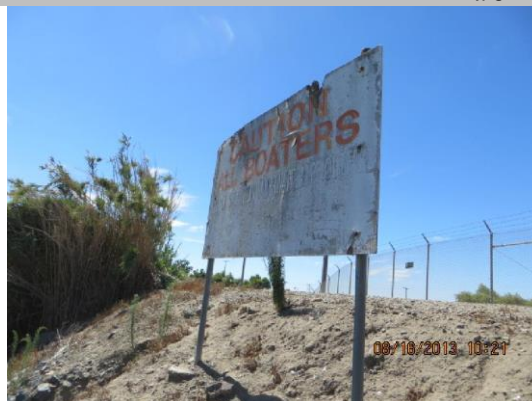
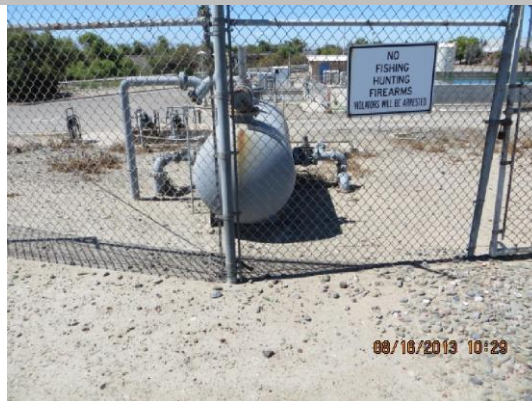
FS\_ID:17563  
DS\_ID:20592  
EP\_NO: 6035  
Repair Type: Non-Urgent  
Crossing Status: Found  
UCIP Comments: Flows from primer tank causing erosion on LS slope.  
FIELD\_STRUCT\_DESC: 48-inch pipe through levee 7.3 feet below crown. Siphon pumps and primer tank enclosed by cyclone fence on the landward shoulder. Gate valve at inlet sump 100-feet off LS toe. One concrete cutoff wall. (Permit No. 6035, 1968).  
FS Date: 8/16/2013

Signage for effluent pipe on WS shoulder.

Siphon Priming tank and associated pipes on LS shoulder.

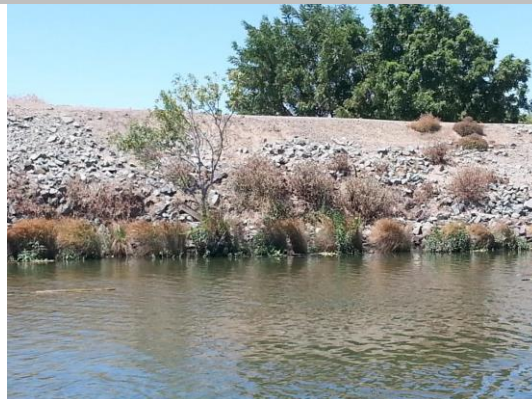
Photo 1 of 1 : SJR2016\_RD0524U01RM41.36\_3.jpg

LM Start	0.71	Rating **	M	Issue No.	17
LM End	0.73	Issue Type +	Ma	Location *	WS
Category	Supplemental			GPS Latitude/Longitude	
				Start	End
Item	DWR Erosion Survey			37.937222 °	37.937222 °
				-121.335277 °	-121.335277 °
DWR ID					
Comment Code					
Inspector Comment					
07/25/2016: No significant change observed.					
06/24/2015: The erosion site is immediately downstream of the RR bridge. [2016 Site ID:RD0524U01RM41.36]

Close view of the erosion.

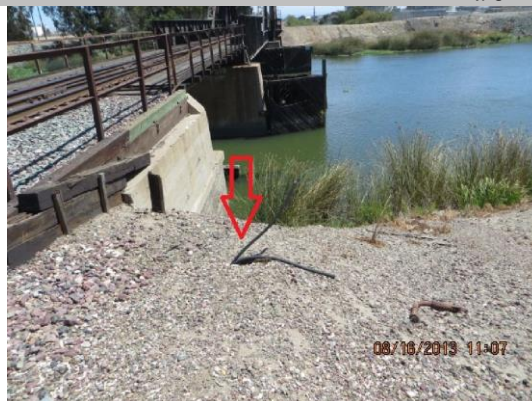
Photo 1 of 1 : UCIP\_FA\_2016\_41463\_29717.jpg

LM Start	0.74	Rating **	M	Issue No.	965
LM End	0.74	Issue Type +	En	Location *	WS
Category	Supplemental			GPS Latitude/Longitude	
				Start	End
Item	DWR UCIP Field Study			37.936951 °	37.936951 °
				-121.335132 °	-121.335132 °
DWR ID					
Comment Code					
Inspector Comment					
FS_ID:41463					
DS_ID:20595					
EP_NO: N/A					
Repair Type: Non-Urgent					
Crossing Status: Indicator Found					
UCIP Comments: Appears abandoned and should be done so properly.					
FIELD_STRUCT_DESC: 2.5-inch telephone conduit through levee 2.0 feet below crown and under the channel. Conduit visible on WS shoulder.					
FS Date: 8/16/2013

Conduit visible on WS shoulder next to bridge abutment. Cable appears to be abandoned.

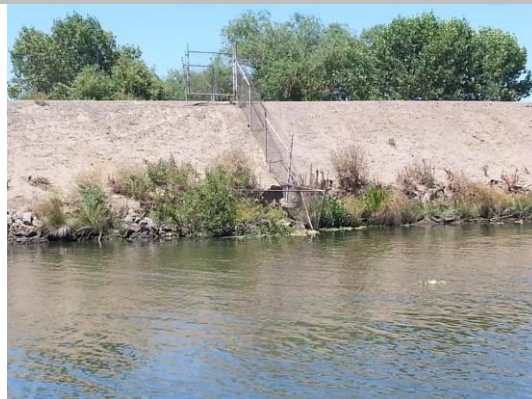
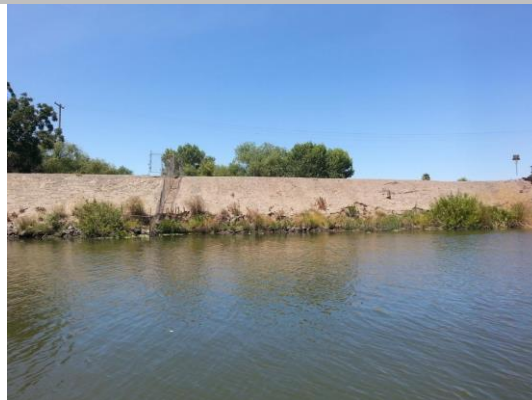
07/25/2016: No significant change observed.  
 06/24/2015: No significant change observed.  
 06/19/2014: No significant change observed.  
 08/13/2013: No significant change at this site.  
 08/07/2012: The site has been visited by boat survey. No significant change observed.  
 08/23/2011: The site is located immediately upstream of a Railroad bridge. Dense vegetation at the water line blocks the view of erosion.  
 [2016 Site ID:RD0524U01RM41.39]

Front view of the erosion site.

Front view of the erosion.

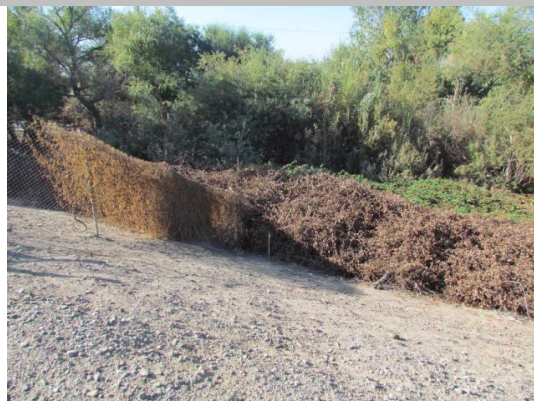
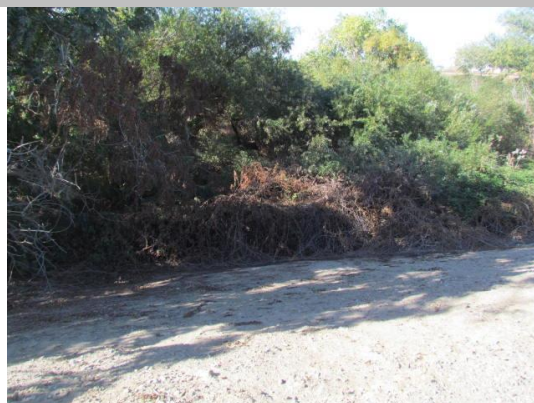
LM Start	0.77	Rating **	U	Issue No.	262
LM End	0.77	Issue Type +	Ma	Location *	LS
Category	Earthen Levee			GPS Latitude/Longitude	
				Start	End
Item	Vegetation			37.936555 °	37.936555 °
				-121.334847 °	-121.334847 °
DWR ID	DWR_RD0524_01_s_2012_262				
Comment Code					
V2 : Remove the wild growth other than native grasses from the levee slopes.					
Inspector Comment					
Dense vegetation at landside toe along fence line.

Looking west at dense vegetation at landward slope and toe fall 2015.

Looking west at dense vegetation on landside toe. Spring 2014

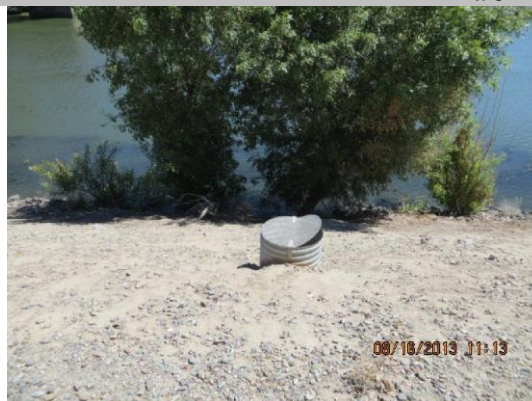
Photo 1 of 2 : UCIP\_FA\_2016\_17571\_29719.jpg

LM Start	0.78	Rating **	M	Issue No.	950
LM End	0.78	Issue Type +	En	Location *	LS
Category	Supplemental			GPS Latitude/Longitude	
				Start	End
Item	DWR UCIP Field Study			37.936474 °	37.936474 °
				-121.334830 °	-121.334830 °
DWR ID					
Comment Code					
Inspector Comment					
FS_ID:17571					
DS_ID:20596					
EP_NO: N/A					
Repair Type: Non-Urgent					
Crossing Status: Found					
UCIP Comments: Large hole in pipe at WS toe. Appears abandoned and should be done so properly.					
FIELD_STRUCT_DESC: 8-inch steel drain pipe through the levee 4.0 feet below the crown. Pump at the toe of the landward slope (not found 8/16/13). Siphon breaker in 24-inch cmp Riser on the waterward slope. Originally included in the 1964 O&M manual.					
FS Date: 8/16/2013

Siphon breaker in 24-inch cmp riser on WS slope.

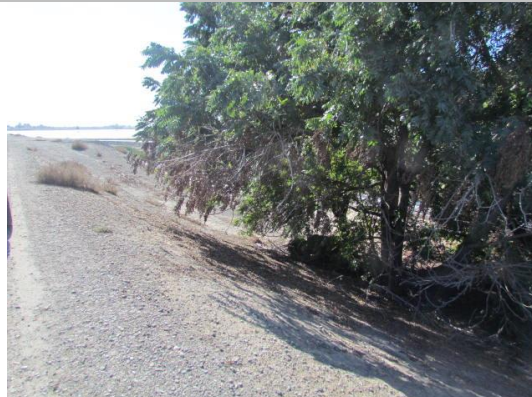
Photo 1 of 1 : FA\_2016\_RD0524\_107\_76\_20160929\_00126.jpg

LM Start	0.78	Rating **	U	Issue No.	76
LM End	0.78	Issue Type +	Ma	Location *	LS
Category	Earthen Levee			GPS Latitude/Longitude	
				Start	End
Item	Trim / Thin Trees			37.936444 °	37.936444 °
				-121.334797 °	-121.334797 °
DWR ID	DWR_RD0524_01_s_2012_76				
Comment Code					
T1 : Trim trees to at least five feet above ground level.					
Inspector Comment

Looking southwest at low hanging tree branches at landside toe.

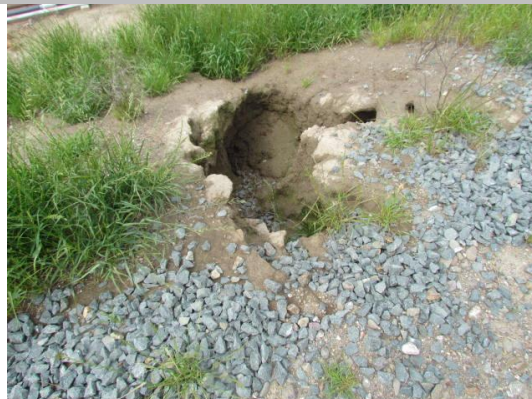
Photo 1 of 6 : FA\_2016\_RD0524\_107\_2\_20160929\_00001.jpg

LM Start	0.81	Rating **	U	Issue No.	2
LM End	0.81	Issue Type +	Ma	Location *	LS
Category	Earthen Levee			GPS Latitude/Longitude	
				Start	End
Item	Erosion / Bank Caving			37.936093 °	37.936004 °
				-121.334648 °	-121.334615 °
DWR ID	DWR_RD0524_01_f_2013_2				
Comment Code					
E2 : Schedule repair of erosion site prior to the next inspection.					
Inspector Comment					
One large hole. Hole is over 12" deep and 12" wide and several holes and finger erosions on landward slope.

Looking west at large hole on landward shoulder (Spring 2016)

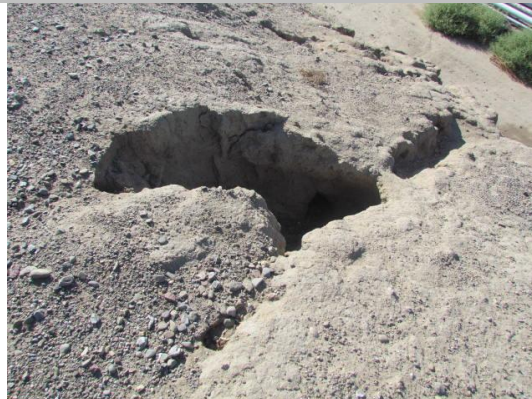
Photo 2 of 6 : FA\_2016\_RD0524\_107\_2\_20160929\_00002.jpg

Looking southwest at hole on landward shoulder.

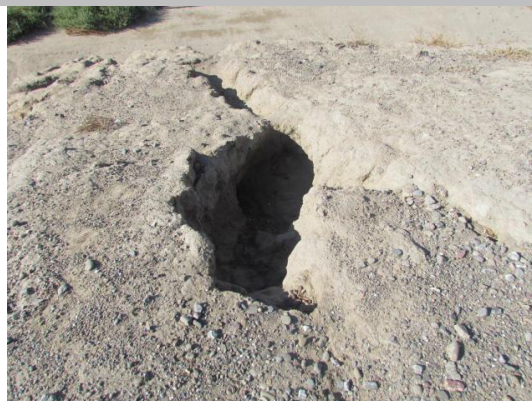
Photo 3 of 6 : FA\_2016\_RD0524\_107\_2\_20160929\_00003.jpg

LM Start	0.81	Rating **	U	Issue No.	2 (cont)	
LM End	0.81	Issue Type +	Ma	Location *	LS	
Category	Earthen Levee			GPS Latitude/Longitude		
				Start	End	
Item	Erosion / Bank Caving			37.936093 °	37.936004 °	
				-121.334648 °	-121.334615 °	
DWR ID	DWR_RD0524_01_f_2013_2					
Comment Code						
E2 : Schedule repair of erosion site prior to the next inspection.						
Inspector Comment						
One large hole. Hole is over 12" deep and 12" wide and several holes and finger erosions on landward slope.

Looking west at hole on landward shoulder.

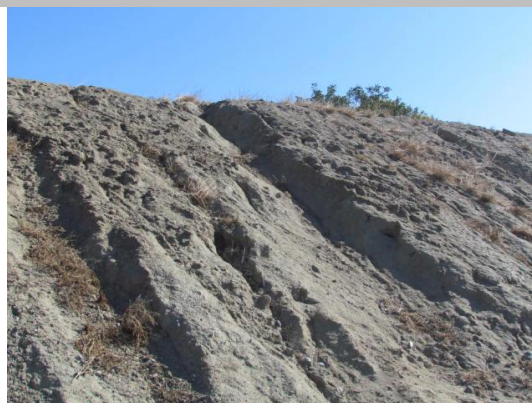
Photo 4 of 6 : FA\_2016\_RD0524\_107\_2\_20160929\_00004.jpg

Looking southeast at finger erosion on landward slope.

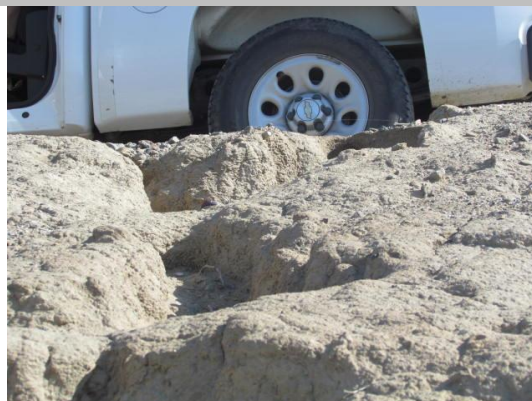
Photo 5 of 6 : FA\_2016\_RD0524\_107\_2\_20160929\_00005.jpg

Looking east at erosion on landward slope.

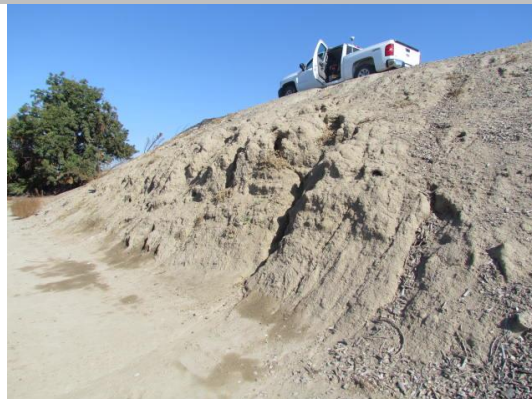
Photo 6 of 6 : FA\_2016\_RD0524\_107\_2\_20160929\_00006.jpg

LM Start	0.81	Rating **	U	Issue No.	2 (cont)	
LM End	0.81	Issue Type +	Ma	Location *	LS	
Category	Earthen Levee			GPS Latitude/Longitude		
				Start	End	
Item	Erosion / Bank Caving			37.936093 °	37.936004 °	
				-121.334648 °	-121.334615 °	
DWR ID	DWR_RD0524_01_f_2013_2					
Comment Code						
E2 : Schedule repair of erosion site prior to the next inspection.						
Inspector Comment						
One large hole. Hole is over 12" deep and 12" wide and several holes and finger erosions on landward slope.

Looking northeast at several finger erosion on landward slope.

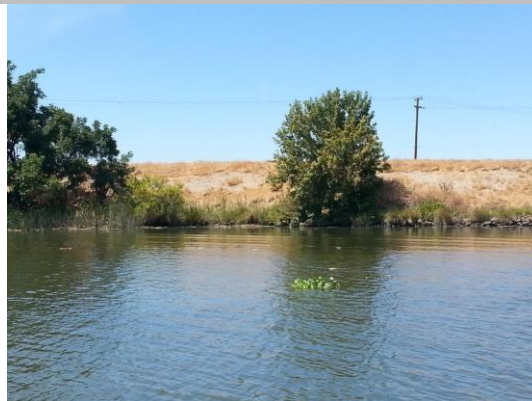
Photo 1 of 2 : SJR2016\_RD0524U01RM41.44\_2.jpg

LM Start	0.83	Rating **	U	Issue No.	22
LM End	0.84	Issue Type +	Ma	Location *	WS
Category	Supplemental			GPS Latitude/Longitude	
				Start	End
Item	DWR Erosion Survey			37.935930 °	37.935930 °
				-121.334133 °	-121.334133 °
DWR ID					
Comment Code					
Inspector Comment					
07/25/2016: No significant change observed.					
06/24/2015: No significant change observed.					
06/19/2014: No significant change observed.					
08/13/2013: Site was discovered during boat survey. The dense vegetation blocks a clear view of the erosion. Size of erosion site was very roughly estimated. [2016 Site ID:RD0524U01RM41.44]

Close view of the erosion site.

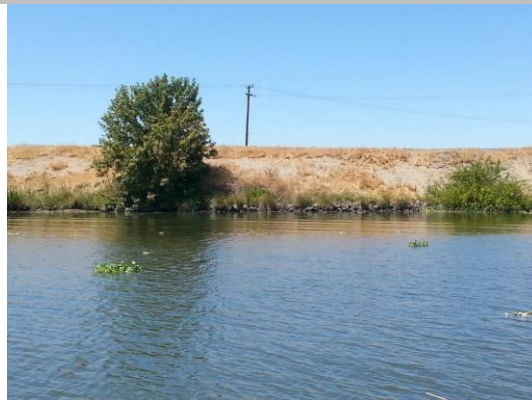
Photo 2 of 2 : SJR2016\_RD0524U01RM41.44\_3.jpg

Front view of the erosion.

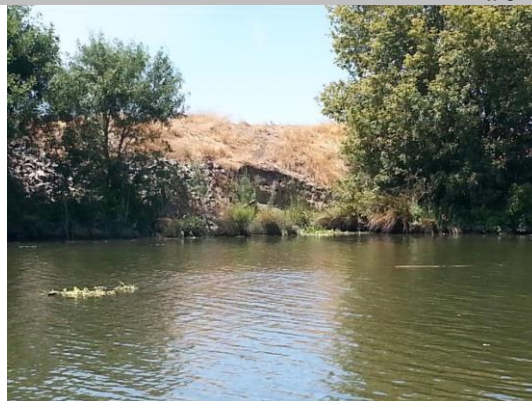
Photo 1 of 2 : SJR2016\_RD0524U01RM41.5\_1.jpg

LM Start	0.91	Rating **	U	Issue No.	33
LM End	0.91	Issue Type +	Ma	Location *	WS
Category	Supplemental			GPS Latitude/Longitude	
				Start	End
Item	DWR Erosion Survey			37.935576 °	37.935576 °
				-121.333202 °	-121.333202 °
DWR ID					
Comment Code					
Inspector Comment					
07/25/2016: No significant change observed.					
06/24/2015: No significant change observed.					
06/19/2014: No significant change observed.					
08/13/2013: No significant change at this site.					
08/07/2012: The site has been visited by boat survey. No significant change observed					
08/23/2011: The erosion site is immediately downstream of the riprap protection. [2016 Site ID:RD0524U01RM41.5]

Front view of the erosion. Note the riprap protection near the site.

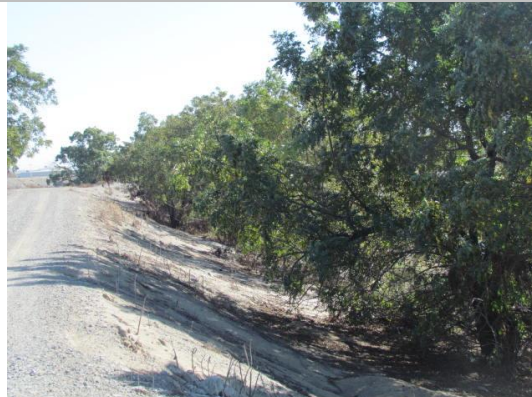
Photo 1 of 1 : FA\_2016\_RD0524\_107\_77\_20160929\_00127.jpg

LM Start	0.93	Rating **	U	Issue No.	77
LM End	1.01	Issue Type +	Ma	Location *	LS
Category	Earthen Levee			GPS Latitude/Longitude	
				Start	End
Item	Trim / Thin Trees			37.935259 °	37.935049 °
				-121.332864 °	-121.331334 °
DWR ID	DWR_RD0524_01_s_2012_77				
Comment Code					
T1 : Trim trees to at least five feet above ground level.					
Inspector Comment

Looking south at low hanging tree branches at landside toe.

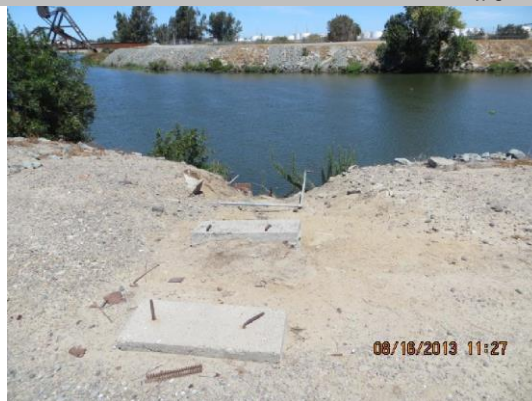
Photo 1 of 2 : UCIP\_FA\_2016\_22724\_38442.jpg

FS\_ID:22724  
DS\_ID:20597  
EP\_NO: N/A  
Repair Type: Non-Urgent  
Crossing Status: Found  
UCIP Comments: 11/16/2016 - Location may be at LM 0.92 (37.935267, -121.332985) rather than LM 0.974. Need to field verify (DWR UCIP - thatch)  
8/16/2013 - Pipe abandoned and should be done so properly. (DWR UCIP -wwylie)  
FIELD\_STRUCT\_DESC: \*Abandoned\* 14-inch pipe through the levee 6.0 feet below the crown. Concrete pad for pump on WS shoulder. No pump or other appurtances remain. Originally included in the 1964 O&M manual.  
FS Date: 8/16/2013

Concrete pad for pump mount on WS shoulder.

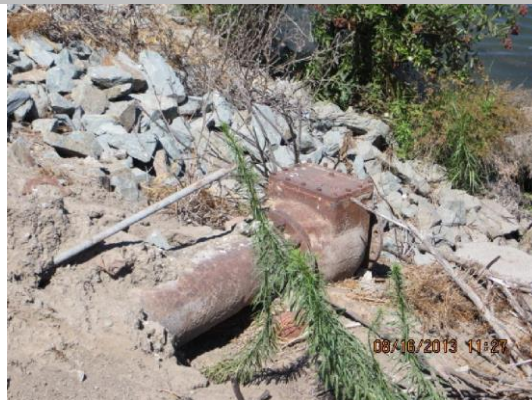
Photo 2 of 2 : UCIP\_FA\_2016\_22724\_38441.jpg

Pipe visible on WS slope.

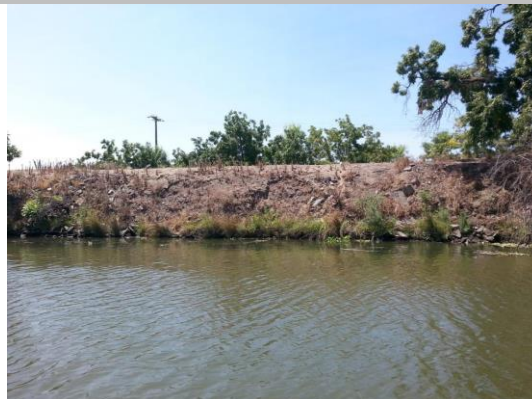
Photo 1 of 2 : SJR2016\_RD0524U01RM41.58\_1.jpg

LM Start	1.00	Rating **	U	Issue No.	47
LM End	1.00	Issue Type +	Ma	Location *	WS
Category	Supplemental			GPS Latitude/Longitude	
				Start	End
Item	DWR Erosion Survey			37.935410 °	37.935410 °
				-121.331560 °	-121.331560 °
DWR ID					
Comment Code					
Inspector Comment					
07/25/2016: No significant change observed.					
06/24/2015: No significant change observed.					
06/19/2014: No significant change observed.					
08/13/2013: No significant change at this site.					
08/07/2012: The erosion was discovered during the boat survey. [2016					
Site ID:RD0524U01RM41.58]

Front view of the erosion.

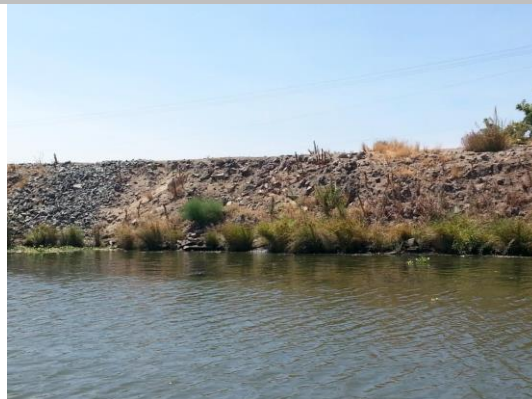
Photo 3 of 3 : SJR2016\_RD0524U01RM41.59\_4.jpg

LM Start	1.02	Rating **	U	Issue No.	55 (cont)
LM End	1.02	Issue Type +	Ma	Location *	WS
Category	Supplemental			GPS Latitude/Longitude	
				Start	End
Item	DWR Erosion Survey			37.935078 °	37.935078 °
				-121.331134 °	-121.331134 °
DWR ID					
Comment Code					
Inspector Comment					
07/25/2016: No significant change observed.					
06/24/2015: No significant change observed.					
06/19/2014: No significant change observed.					
08/13/2013: No significant change at this site.					
08/07/2012: The site has been visited by boat survey. Site has been repaired, but new erosion occurred at the levee slope and immediately upstream of the repaired site.					
08/23/2011: The site is about 500 ft downstream of bridge. The levee toe seems to be protected, but the protection is being washed away.					
[2016 Site ID:RD0524U01RM41.59]

Front view of the erosion.

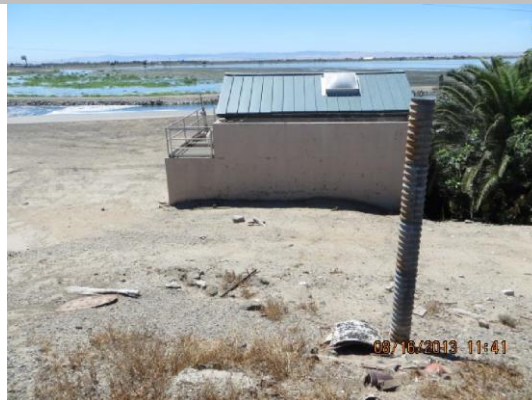
Photo 1 of 2 : UCIP\_FA\_2016\_18703\_31243.jpg

LM Start	1.06	Rating **	M	Issue No.	942
LM End	1.06	Issue Type +	En	Location *	WS
Category	Supplemental			GPS Latitude/Longitude	
				Start	End
Item	DWR UCIP Field Study			37.934778 °	37.934778 °
				-121.330460 °	-121.330460 °
DWR ID					
Comment Code					
Inspector Comment					
FS_ID:18703 DS_ID:20600 EP_NO: 2725B Repair Type: Non-Urgent Crossing Status: Found UCIP Comments: Given amount of rust on adjacent CMP riser, it may be appropriate to do a video inspection of this pipe. FIELD_STRUCT_DESC: 36-inch concrete encased pipe through levee 11.5 feet below crown. Pump in pump house on the landward side. Flap gate on the waterward end. Two concrete cutoff walls. Siphon breaker in 8-inch CMP riser unit on the landward slope (Permit No. 2725B, 1959). Included in the 1964 O&M manual. FS Date: 8/16/2013

8-inch CMP standpipe on LS slope with pumphouse in background.

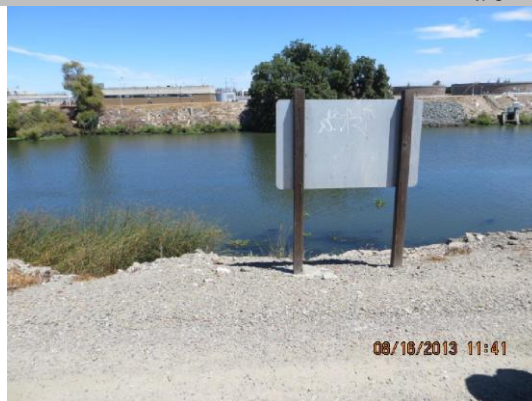
Photo 2 of 2 : UCIP\_FA\_2016\_18703\_31242.jpg

Caution sign on WS shoulder for pipe crossings.

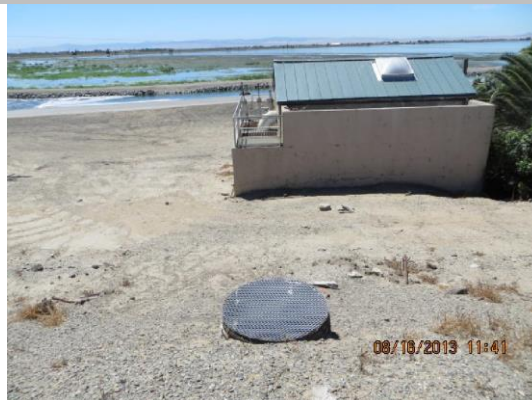
Photo 1 of 2 : UCIP\_FA\_2016\_17589\_29748.jpg

LM Start	1.07	Rating **	M	Issue No.	954
LM End	1.07	Issue Type +	En	Location *	WS
Category	Supplemental			GPS Latitude/Longitude	
				Start	End
Item	DWR UCIP Field Study			37.934750 °	37.934750 °
				-121.330405 °	-121.330405 °
DWR ID					
Comment Code					
Inspector Comment					
FS_ID:17589 DS_ID:20601 EP_NO: 2725B Repair Type: Non-Urgent Crossing Status: Found UCIP Comments: CMP riser severely corroded. Good indicator of potential condition of 48-inch pipe. Recommend Video Inspection. FIELD_STRUCT_DESC: 48-inch CMP sewer line through the levee 16.0 feet below crown. Runs underneath the river and through levee with 36-inch CMP riser/inspection chamber on landward shoulder. Distribution/pumphouse on LS toe (Permit No. 2725B, 1959). Included in the 1964 O&M manual. FS Date: 8/16/2013

CMP riser for access/inspection on LS slope with distribution/pumphouse on LS toe.

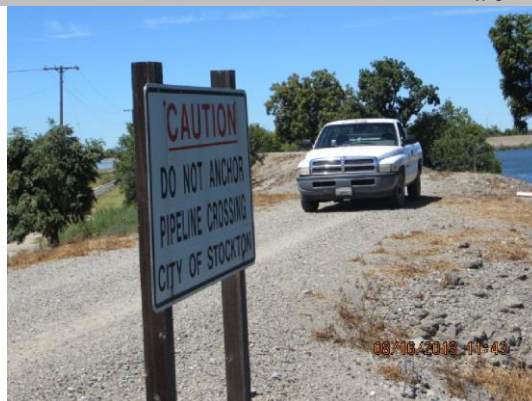
Photo 2 of 2 : UCIP\_FA\_2016\_17589\_29747.jpg

Caution sign on WS shoulder.

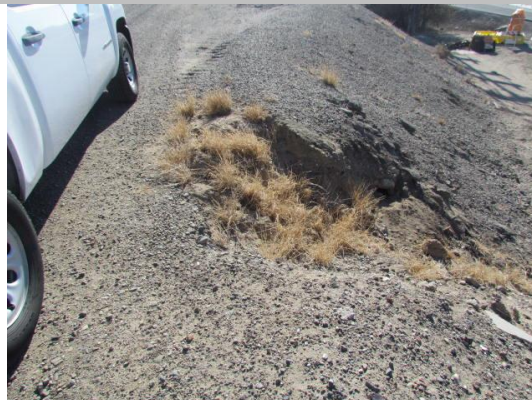
Photo 1 of 7 : FA\_2016\_RD0524\_107\_18\_20160929\_00037.jpg

LM Start	1.08	Rating **	U	Issue No.	18
LM End	1.08	Issue Type +	Ma	Location *	LS
Category	Earthen Levee			GPS Latitude/Longitude	
				Start	End
Item	Slope Stability			37.934645 °	37.934645 °
				-121.330310 °	-121.330310 °
DWR ID	DWR_RD0524_01_s_2012_18				
Comment Code					
S1 : Repair slope instability.					
Inspector Comment					
Slope damage extend from shoulder to middle of slope.

Looking south at caving on landward shoulder. (Fall 2015)

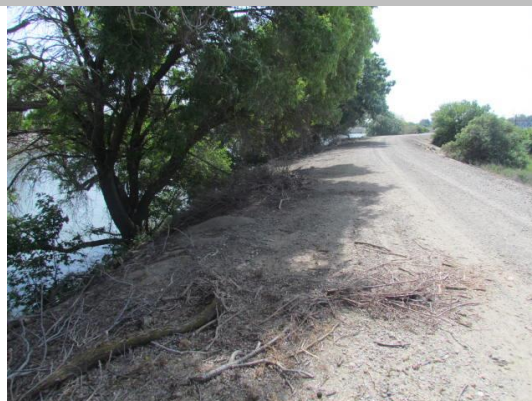
Photo 1 of 1 : FA\_2016\_RD0524\_107\_171\_20160929\_00213.jpg

LM Start	1.12	Rating **	M	Issue No.	171
LM End	1.16	Issue Type +	Ma	Location *	WS
Category	Earthen Levee			GPS Latitude/Longitude	
				Start	End
Item	Encroachments			37.934225 °	37.933815 °
				-121.329693 °	-121.329242 °
DWR ID	DWR_RD0524_01_s_2015_171				
Comment Code					
PR : Prunings					
Inspector Comment					
Prunings left on waterward shoulder and slope.

Looking south at prunings on waterward shoulders.

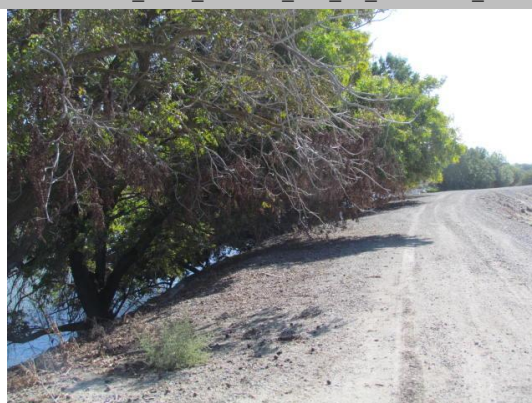
Photo 1 of 1 : FA\_2016\_RD0524\_107\_19\_20160929\_00044.jpg

LM Start	1.13	Rating **	M	Issue No.	19
LM End	1.16	Issue Type +	Ma	Location *	WS
Category	Earthen Levee			GPS Latitude/Longitude	
				Start	End
Item	Trim / Thin Trees			37.934118 °	37.933775 °
				-121.329657 °	-121.329305 °
DWR ID	DWR_RD0524_01_s_2012_19				
Comment Code					
T1 : Trim trees to at least five feet above ground level.					
Inspector Comment

Looking southeast at low hanging tree branches at waterside toe.

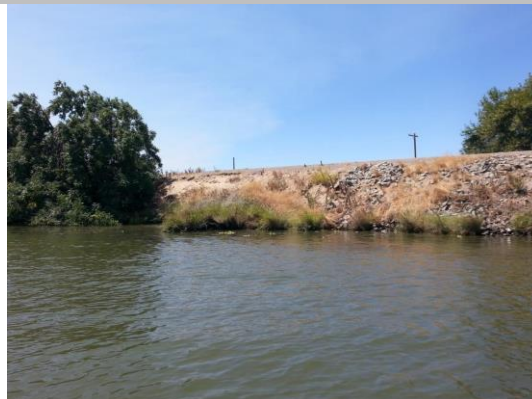
Photo 1 of 3 : SJR2016\_RD0524U01RM41.79\_2.jpg

07/25/2016: No significant change observed.  
 06/24/2015: No significant change observed.  
 06/19/2014: No significant change observed.  
 08/13/2013: No significant change at this site.  
 08/07/2012: The site has been visited by boat survey. No significant change observed  
 08/23/2011: No significant change observed on site.  
 09/07/2010: No significant change observed on site. Vegetation is visible at the water line. There is an exposed pipe discharge partially hanging at the mid-slope, possibly still used for discharging irrigation/runoff water. There is minimal rip rap protection along the bank, and what's left of it is no longer adequately protecting the bank.  
 9/29/2009: Site consists of a 400-foot long eroding bank with minimal vegetation and protection; the existing rip rap has sloughed, rendering it useless; note that there is an exposed section of a pipe.  
 10/18/2006: There is extensive loss of rip rap on some sections; sewage disposal pond is on the landside of the levee; there is an exposed pipe outlet "hanging" from the upper slope. [2016 Site ID:RD0524U01RM41.79]

Direct view of the site.

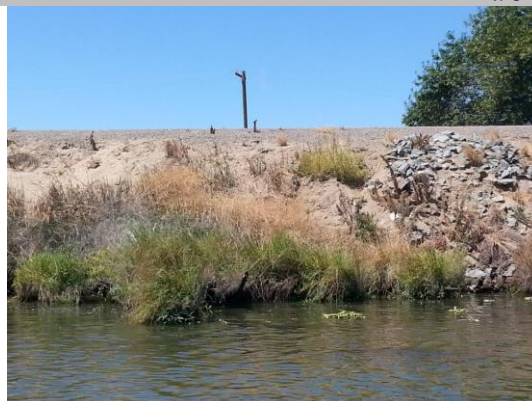
Photo 2 of 3 : SJR2016\_RD0524U01RM41.79\_3.jpg

Close view of the erosion.

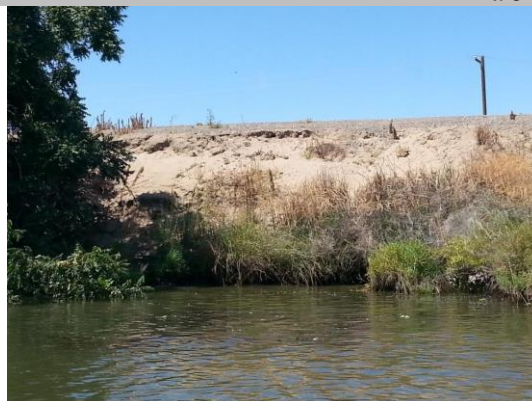
Photo 3 of 3 : SJR2016\_RD0524U01RM41.79\_4.jpg

Comment Code						
Inspector Comment						
07/25/2016: No significant change observed.						
06/24/2015: No significant change observed.						
06/19/2014: No significant change observed.						
08/13/2013: No significant change at this site.						
08/07/2012: The site has been visited by boat survey. No significant change observed						
08/23/2011: No significant change observed on site.						
09/07/2010: No significant change observed on site. Vegetation is visible at the water line. There is an exposed pipe discharge partially hanging at the mid-slope, possibly still used for discharging irrigation/runoff water. There is minimal rip rap protection along the bank, and what's left of it is no longer adequately protecting the bank.						
9/29/2009: Site consists of a 400-foot long eroding bank with minimal vegetation and protection; the existing rip rap has sloughed, rendering it useless; note that there is an exposed section of a pipe.

10/18/2006: There is extensive loss of rip rap on some sections; sewage disposal pond is on the landside of the levee; there is an exposed pipe outlet "hanging" from the upper slope. [2016 Site ID:RD0524U01RM41.79]

Close view of the site. Note the tree near the erosion site.

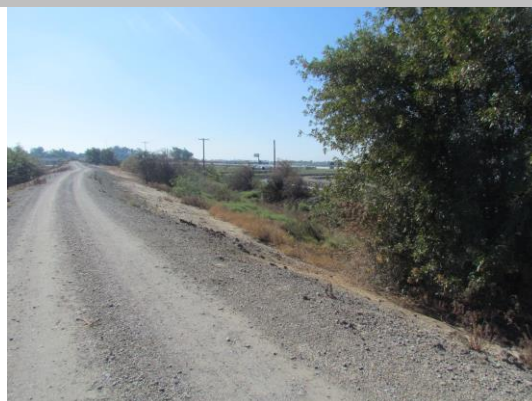
Photo 1 of 4 : FA\_2016\_RD0524\_107\_915\_20161013\_00387.jpg

LM Start	1.16	Rating **	U	Issue No.	915
LM End	1.23	Issue Type +	Ma	Location *	LS
Category	Earthen Levee			GPS Latitude/Longitude	
				Start	End
Item	Vegetation			37.933775 °	37.932784 °
				-121.329250 °	-121.328765 °
DWR ID	DWR_RD0524_01_s_2012_915				
Comment Code					
V2 : Remove the wild growth other than native grasses from the levee slopes.					
Inspector Comment					
Control veg at landward toe and berm.

Looking southwest at dense veg at landward toe and berm. (Fall 2016)

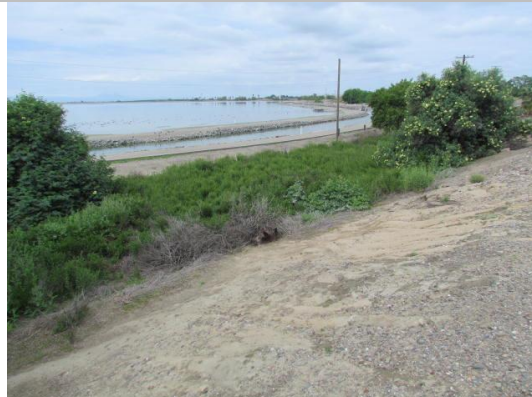
Looking northwest at dense veg at landward toe and berm. (Spirng 2016)

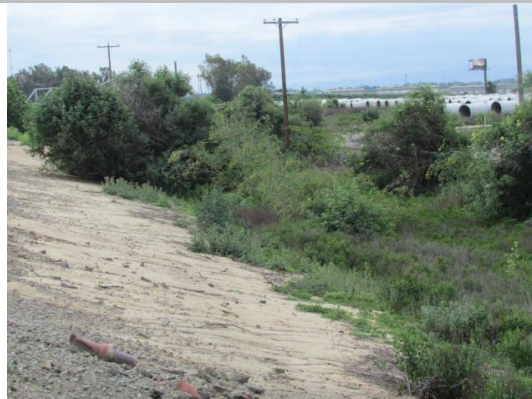
Looking southwest at dense veg at landward toe and berm. (Spring 2015)

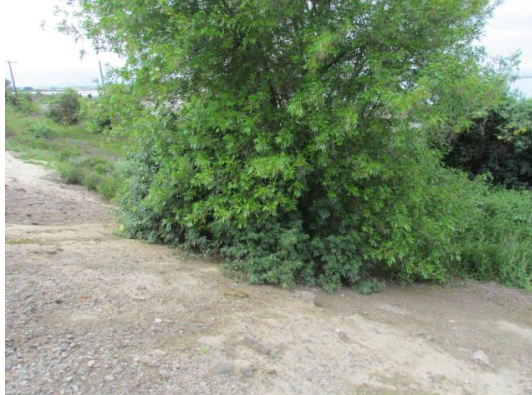
Photo 1 of 1 : FA\_2016\_RD0524\_107\_206\_20160929\_00248.jpg

LM Start	1.17	Rating **	U	Issue No.	206
LM End	1.17	Issue Type +	Ma	Location *	LS
Category	Earthen Levee			GPS Latitude/Longitude	
				Start	End
Item	Trim / Thin Trees			37.933591 °	37.933591 °
				-121.329154 °	-121.329154 °
DWR ID	DWR_RD0524_01_s_2016_206				
Comment Code					
T1 : Trim trees to at least five feet above ground level.					
Inspector Comment

Looking southwest a untrimmed tree at landward toe. (Spring 2016)

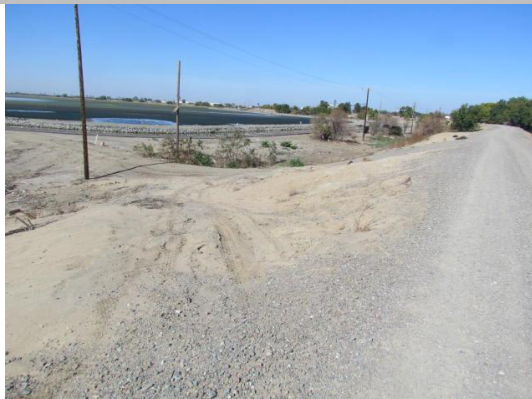
Photo 1 of 2 : FA\_2016\_RD0524\_107\_263\_20160929\_00267.jpg

LM Start	1.25	Rating **	U	Issue No.	263
LM End	1.25	Issue Type +	En	Location *	LS
Category	Earthen Levee			GPS Latitude/Longitude	
				Start	End
Item	Encroachments			37.932533 °	37.932533 °
				-121.328650 °	-121.328650 °
DWR ID	DWR_RD0524_01_s_2012_263				
Comment Code					
RA : Ramp					
Inspector Comment					
Unauthorized ramps on landside slope. Ramps were caused by vehicle traffic.

Looking northwest at unauthorized ramp on landside slope.

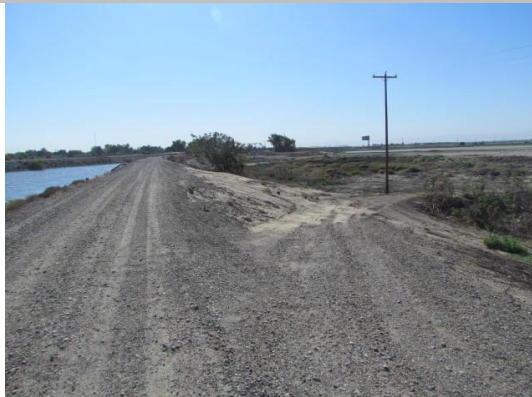
Photo 2 of 2 : FA\_2016\_RD0524\_107\_263\_20160929\_00268.jpg

Looking south at unauthorized ramp on landside slope.

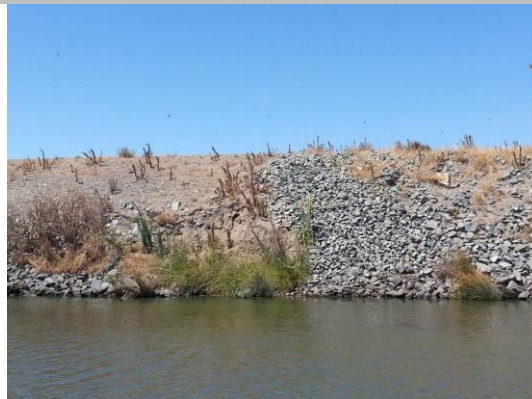
Photo 1 of 3 : SJR2016\_RD0524U01RM41.92\_2.jpg

LM Start	1.29	Rating **	U	Issue No.	71
LM End	1.32	Issue Type +	Ma	Location *	WS
Category	Supplemental			GPS Latitude/Longitude	
				Start	End
Item	DWR Erosion Survey			37.931858 °	37.931858 °
				-121.328300 °	-121.328300 °
DWR ID					
Comment Code					
Inspector Comment					
07/25/2016: No significant change observed.					
06/24/2015: No significant change observed.					
06/19/2014: No significant change observed.					
08/13/2013: New signs of animal activity were found.					
08/07/2012: The site was first reported in 2012 spring levee inspection report. [2016 Site ID:RD0524U01RM41.92]

Front view of the erosion.

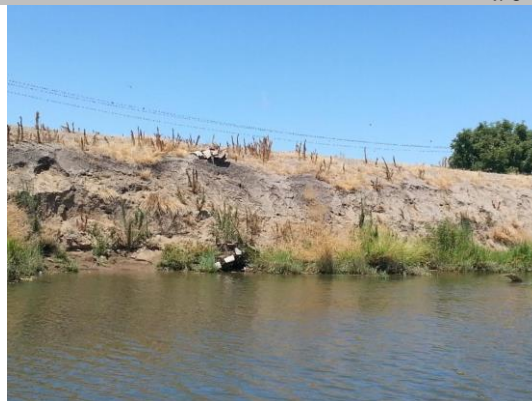
Photo 2 of 3 : SJR2016\_RD0524U01RM41.92\_3.jpg

Front view of the erosion.

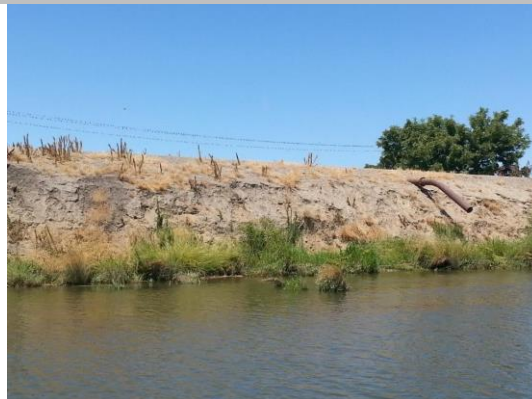
Photo 3 of 3 : SJR2016\_RD0524U01RM41.92\_4.jpg

Front view of the erosion. Note the drainage pipe on the site.

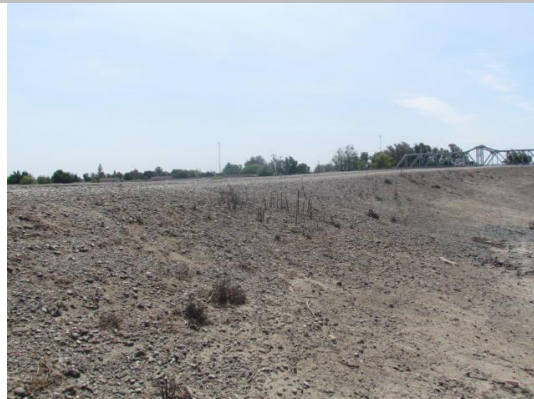
Photo 2 of 2 : FA\_2016\_RD0524\_107\_172\_20160929\_00215.jpg

LM Start	1.36	Rating **	U	Issue No.	172
LM End	1.40	Issue Type +	Ma	Location *	CR
Category	Earthen Levee			GPS Latitude/Longitude	
				Start	End
Item	Crown Surface / Depressions / Rutting			37.931085 °	37.930517 °
				-121.328112 °	-121.328072 °
DWR ID	DWR_RD0524_01_s_2015_172				
Comment Code					
C2 : Repair depressions or ruts in the crown or slope.					
Inspector Comment					
Levee crown depression several inches below original crown elevation. Section should be survey to determine proper elevation.

Looking southeast at depression on levee crown.

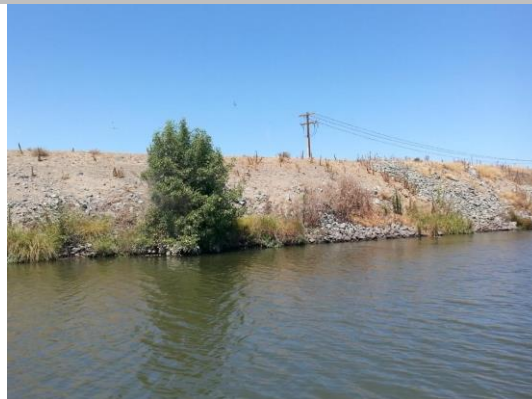
Photo 1 of 3 : SJR2016\_RD0524U01RM42.03\_2.jpg

LM Start	1.39	Rating **	U	Issue No.	79
LM End	1.39	Issue Type +	Ma	Location *	WS
Category	Supplemental			GPS Latitude/Longitude	
				Start	End
Item	DWR Erosion Survey			37.930575 °	37.930575 °
				-121.328090 °	-121.328090 °
DWR ID					
Comment Code					
Inspector Comment					
07/25/2016: No significant change observed					
06/24/2015: No significant change observed.					
06/19/2014: No significant change observed.					
08/13/2013: No significant change observed.					
08/07/2012: The site was first reported in 2012 spring levee inspection report. The site is located about 750 ft downstream of SR 4 Bridge.					
[2016 Site ID:RD0524U01RM42.03]

Front view of the erosion.

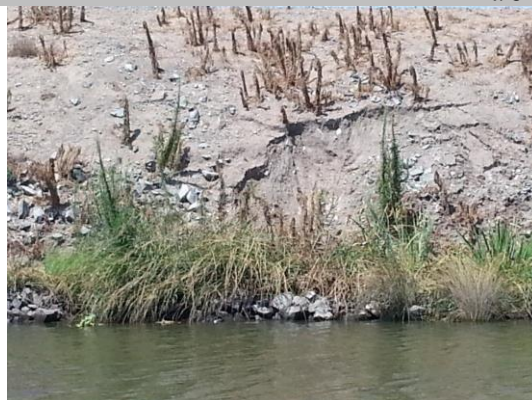
Photo 2 of 3 : SJR2016\_RD0524U01RM42.03\_3.jpg

Close view of the erosion.

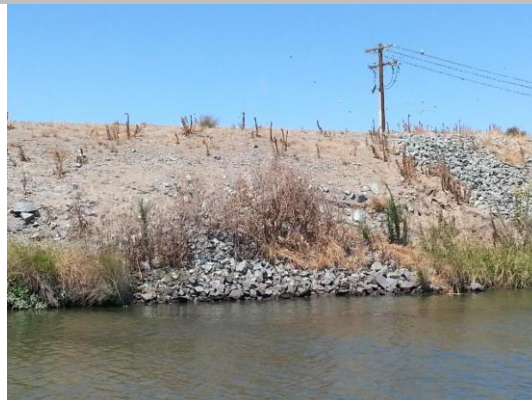
Photo 3 of 3 : SJR2016\_RD0524U01RM42.03\_4.jpg

Close view of the erosion.

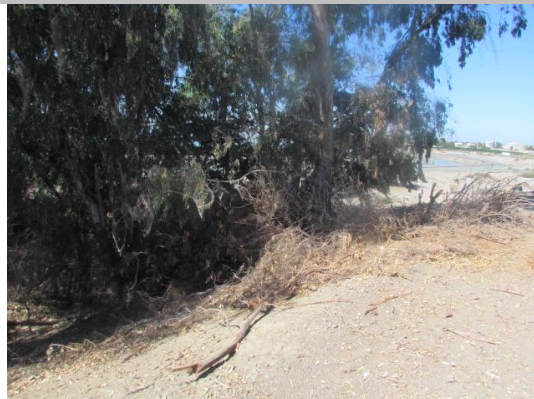
Photo 2 of 4 : FA\_2016\_RD0524\_107\_916\_20160929\_00278.jpg

Looking at trees on landside slope. (Fall 2012)
