**Flood Control Project Maintenance  
Levee Inspections**

**Fall 2016 Levee Maintenance Deficiency Summary Report**

**Reclamation District No. 0524 Middle Roberts Island**

Waterway			Bank	Unit Miles
Unit No. 01 San Joaquin River			Left	6.20
	Spring (March - May)	Summer (June - August)	(September - November) Fall	Winter (December - February)
Unit Maintenance Rating (Fall Only)			<b>U</b>	
Date of Inspection	4/12/2016 - 4/13/2016		10/10/2016 - 10/11/2016	
DWR Inspector	Richard Willoughby		Richard Willoughby	
Accompanied By	Mario Jaques RD 524		Mario Jaques RD 524

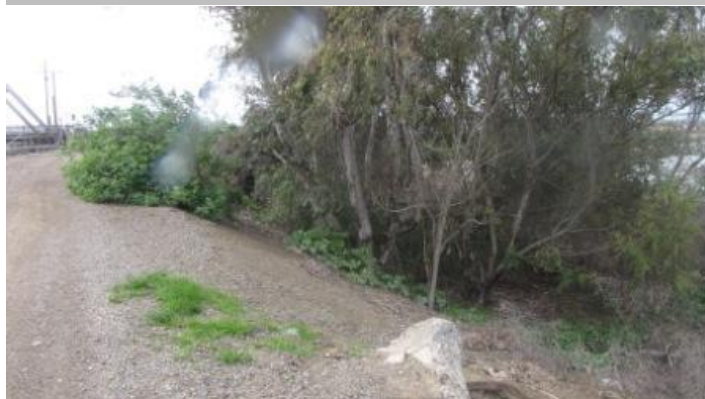
Photo 3 of 4 : FA\_2016\_RD0524\_107\_916\_20160929\_00279.jpg

Looking at dense veg. on landside slope and toe.

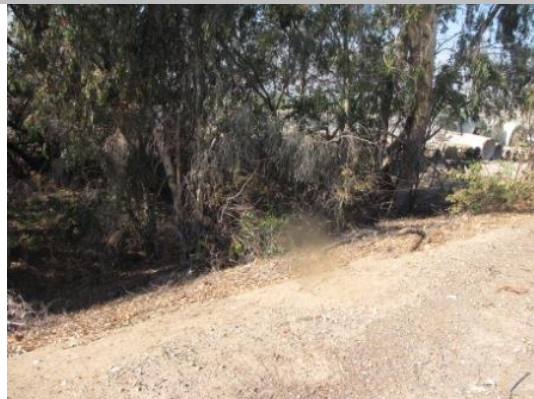
Photo 4 of 4 : FA\_2016\_RD0524\_107\_916\_20160929\_00280.jpg

Dense vegetation on landside toe.

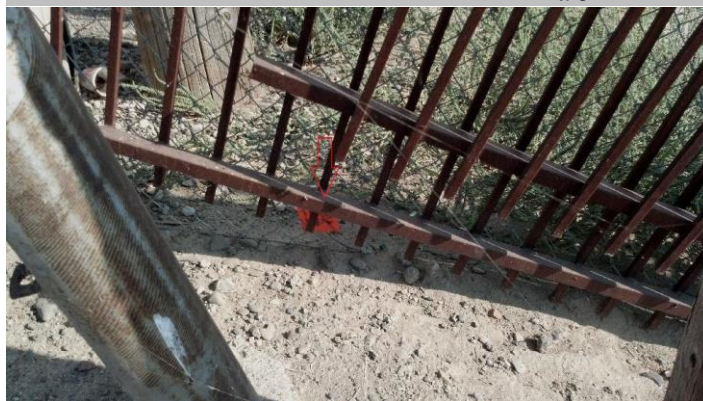
Photo 1 of 2 : UCIP\_FA\_2016\_17798\_29935.jpg

LM Start	1.54	Rating **	M	Issue No.	952
LM End	1.54	Issue Type +	En	Location *	LS
Category	Supplemental			GPS Latitude/Longitude	
				Start	End
Item	DWR UCIP Field Study			37.928429 °	37.928429 °
				-121.328297 °	-121.328297 °
DWR ID					
Comment Code					
Inspector Comment					
FS_ID:17798					
DS_ID:20605					
EP_NO: N/A					
Repair Type: Non-Urgent					
Crossing Status: Indicator Found					
UCIP Comments: No permit identified for this crossing.					
FIELD_STRUCT_DESC: Fiber optics cable crossing. USAA marker flags over crown along alignment of gate.					
FS Date: 8/20/2013

USAA markers along alignment at gate.

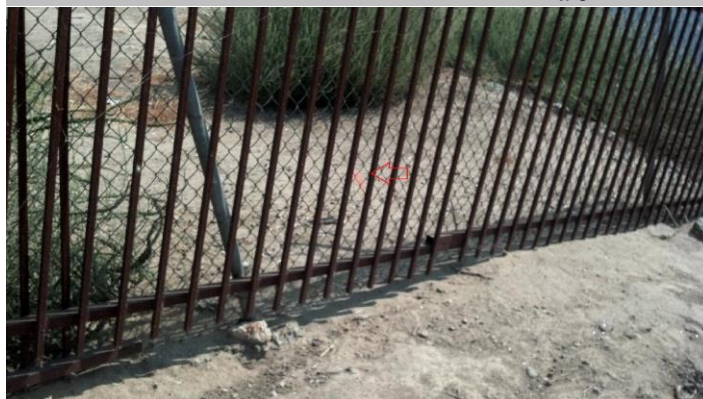
Photo 2 of 2 : UCIP\_FA\_2016\_17798\_29934.jpg

USAA markers along alignment at gate.

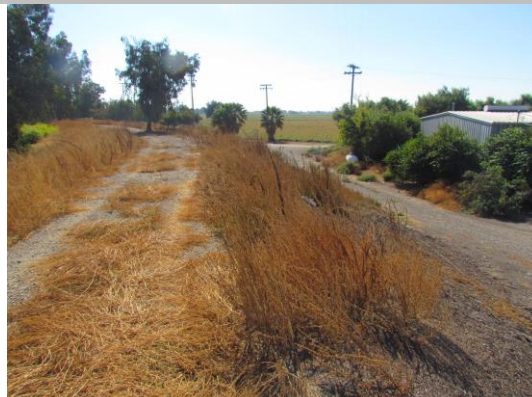
Photo 1 of 1 : FA\_2016\_RD0524\_107\_23\_20161013\_00388.jpg

LM Start	1.55	Rating **	U	Issue No.	23
LM End	1.59	Issue Type +	Ma	Location *	LS
Category	Earthen Levee			GPS Latitude/Longitude	
				Start	End
Item	Vegetation			37.928388 °	37.927797 °
				-121.328280 °	-121.327854 °
DWR ID	DWR_RD0524_01_s_2012_23				
Comment Code					
V2 : Remove the wild growth other than native grasses from the levee slopes.					
Inspector Comment					
Dense vegetation on landward slope.

Looking southwest at dense veg on landward slope. (Fall 2016)

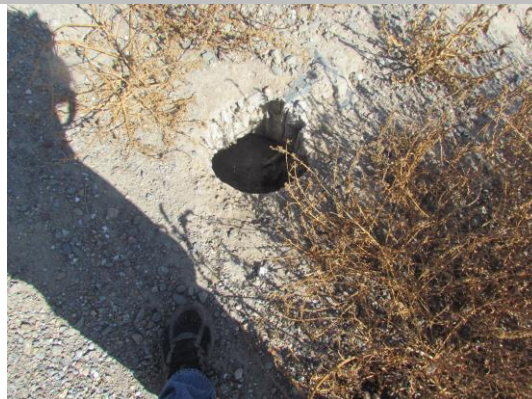
Photo 1 of 2 : FA\_2016\_RD0524\_107\_202\_20161013\_00389.jpg

LM Start	1.55	Rating **	U	Issue No.	202
LM End	1.55	Issue Type +	Ma	Location *	WS
Category	Earthen Levee			GPS Latitude/Longitude	
				Start	End
Item	Erosion / Bank Caving			37.928372 °	37.928372 °
				-121.328283 °	-121.328283 °
DWR ID	DWR_RD0524_01_f_2016_202				
Comment Code					
E2 : Schedule repair of erosion site prior to the next inspection.					
Inspector Comment					
Large hole (looks like fences post or telephone pole) on waterward shoulder.

Looking at large hole (Fence/telephone post hole) on waterward shoulder.

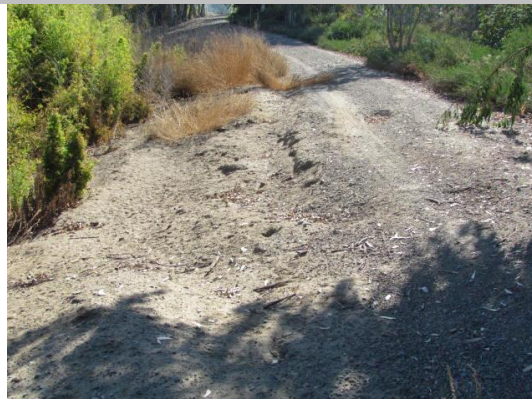
Photo 1 of 1 : FA\_2016\_RD0524\_107\_136\_20160929\_00203.jpg

LM Start	1.59	Rating **	M	Issue No.	136
LM End	1.59	Issue Type +	Ma	Location *	CR
Category	Earthen Levee			GPS Latitude/Longitude	
				Start	End
Item	Slope Stability			37.927775 °	37.927775 °
				-121.327860 °	-121.327860 °
DWR ID	DWR_RD0524_01_s_2013_136				
Comment Code					
S2 : Repair the levee slope damaged by foot traffic and prevent access where possible.					
Inspector Comment					
Waterward shoulder caving.

Looking south at depression on levee crown near waterward shoulder.

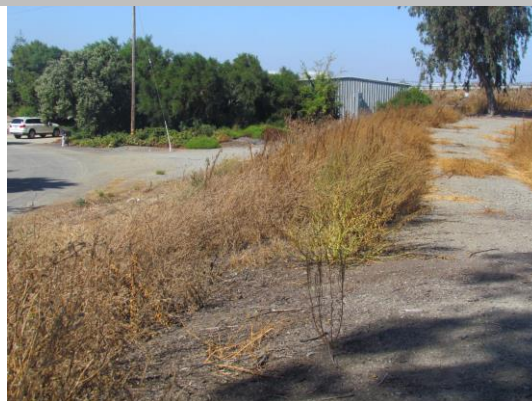
Photo 1 of 1 : FA\_2016\_RD0524\_107\_24\_20161013\_00394.jpg

LM Start	1.60	Rating **	U	Issue No.	24
LM End	1.61	Issue Type +	Ma	Location *	LS
Category	Earthen Levee			GPS Latitude/Longitude	
				Start	End
Item	Vegetation			37.927635 °	37.927540 °
				-121.327812 °	-121.327648 °
DWR ID	DWR_RD0524_01_s_2012_24				
Comment Code					
V2 : Remove the wild growth other than native grasses from the levee slopes.					
Inspector Comment					
Vegetation blocking landward toe.

Looking northwest at dense veg on waterward slope.

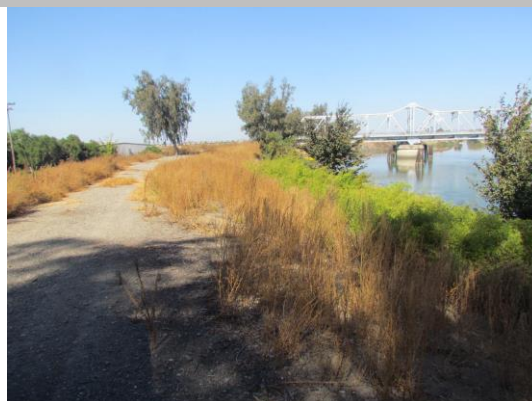
Photo 1 of 3 : FA\_2016\_RD0524\_107\_25\_20161013\_00392.jpg

LM Start	1.60	Rating **	U	Issue No.	25
LM End	1.61	Issue Type +	Ma	Location *	WS
Category	Earthen Levee			GPS Latitude/Longitude	
				Start	End
Item	Vegetation			37.927635 °	37.927540 °
				-121.327812 °	-121.327648 °
DWR ID	DWR_RD0524_01_s_2012_25				
Comment Code					
V2 : Remove the wild growth other than native grasses from the levee slopes.					
Inspector Comment

Looking northwest at dense veg on waterward slope.

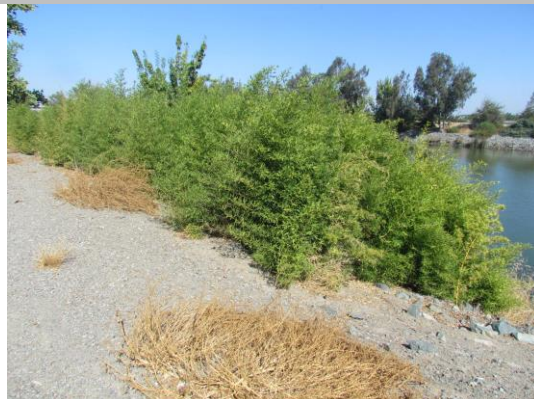
Photo 2 of 3 : FA\_2016\_RD0524\_107\_25\_20161013\_00393.jpg

LM Start	1.60	Rating **	U	Issue No.	25 (cont)
LM End	1.61	Issue Type +	Ma	Location *	WS
Category	Earthen Levee			GPS Latitude/Longitude	
				Start	End
Item	Vegetation			37.927635 °	37.927540 °
				-121.327812 °	-121.327648 °
DWR ID	DWR_RD0524_01_s_2012_25				
Comment Code					
V2 : Remove the wild growth other than native grasses from the levee slopes.					
Inspector Comment

Looking northwest at end of dense veg on waterward slope.

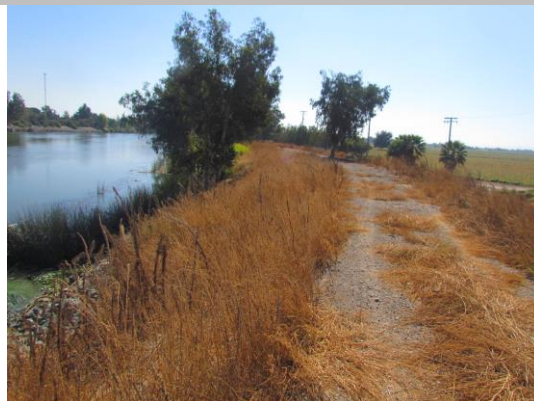
Photo 3 of 3 : FA\_2016\_RD0524\_107\_25\_20161013\_00391.jpg

Looking southwest at dense veg on waterward slope.

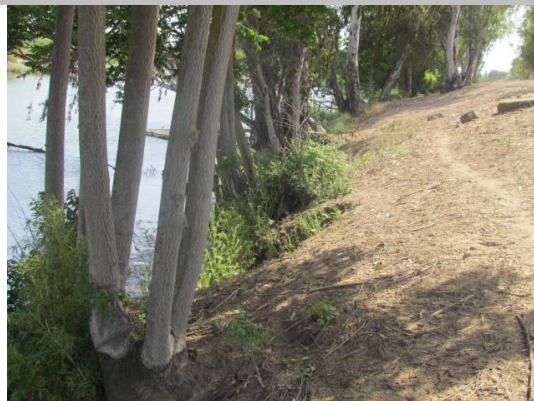
Photo 1 of 3 : FA\_2016\_RD0524\_107\_26\_20160929\_00059.jpg

LM Start	1.62	Rating **	M	Issue No.	26
LM End	1.64	Issue Type +	Ma	Location *	WS
Category	Earthen Levee			GPS Latitude/Longitude	
				Start	End
Item	Erosion / Bank Caving			37.927507 °	37.927295 °
				-121.327593 °	-121.327298 °
DWR ID	DWR_RD0524_01_s_2012_26				
Comment Code					
E1 : Note and monitor erosion site.					
Inspector Comment					
Several erosions along this reach.

Looking south at waterward erosion.

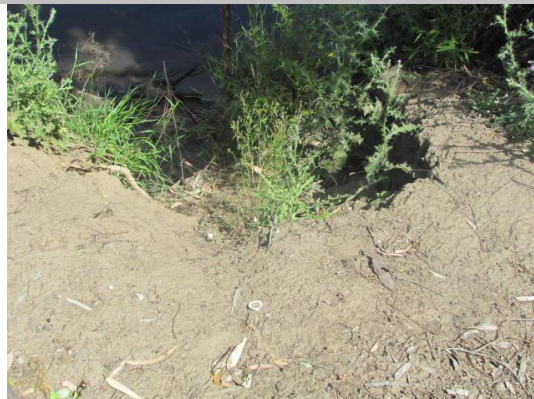
Photo 2 of 3 : FA\_2016\_RD0524\_107\_26\_20160929\_00060.jpg

LM Start	1.62	Rating **	M	Issue No.	26 (cont)	
LM End	1.64	Issue Type +	Ma	Location *	WS	
Category	Earthen Levee			GPS Latitude/Longitude		
				Start		End
Item	Erosion / Bank Caving			37.927507 °		37.927295 °
				-121.327593 °		-121.327298 °
DWR ID	DWR_RD0524_01_s_2012_26					
Comment Code						
E1 : Note and monitor erosion site.						
Inspector Comment						
Several erosions along this reach.

Looking east at waterward erosion.

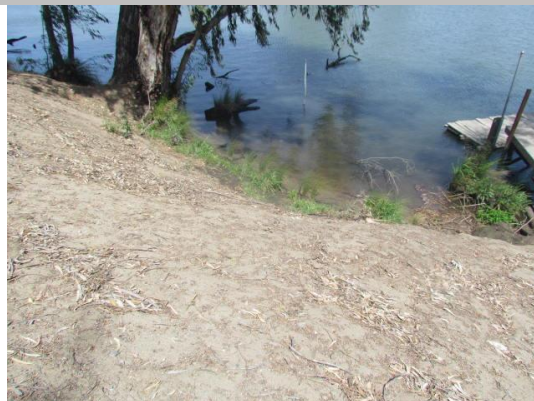
Photo 3 of 3 : FA\_2016\_RD0524\_107\_26\_20160929\_00061.jpg

Looking east at waterward erosion and depression.

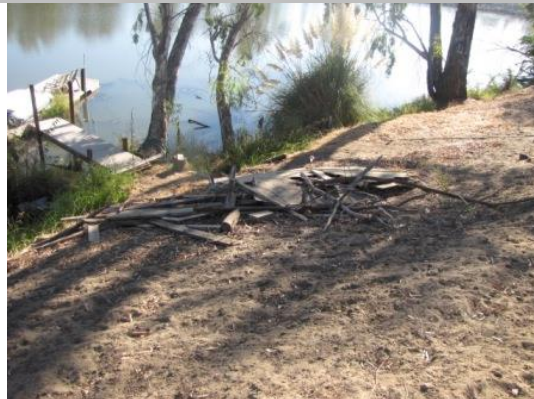
Photo 1 of 2 : FA\_2016\_RD0524\_107\_39\_20160929\_00081.jpg

LM Start	1.64	Rating **	U	Issue No.	39
LM End	1.64	Issue Type +	En	Location *	WS
Category	Earthen Levee			GPS Latitude/Longitude	
				Start	End
Item	Encroachments			37.927372 °	37.927372 °
				-121.327278 °	-121.327278 °
DWR ID	DWR_RD0524_01_s_2012_39				
Comment Code					
PO : Pole					
Inspector Comment					
Landowner constructed boat dock without permit.

Looking at garbage on waterside slope.

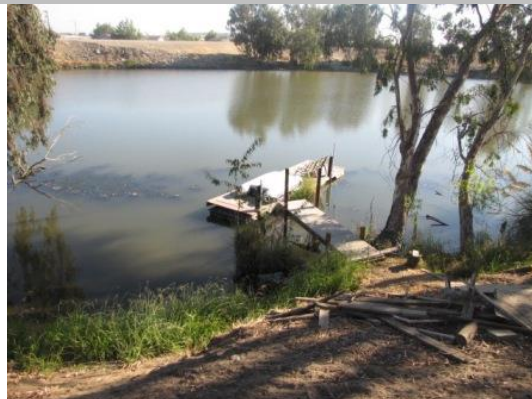
Photo 2 of 2 : FA\_2016\_RD0524\_107\_39\_20160929\_00082.jpg

LM Start	1.64	Rating **	U	Issue No.	39 (cont)	
LM End	1.64	Issue Type +	En	Location *	WS	
Category	Earthen Levee			GPS Latitude/Longitude		
				Start		End
Item	Encroachments			37.927372 °		37.927372 °
				-121.327278 °		-121.327278 °
DWR ID	DWR_RD0524_01_s_2012_39					
Comment Code						
PO : Pole						
Inspector Comment						
Landowner constructed boat dock without permit.

Looking east at non-permitted boat dock.

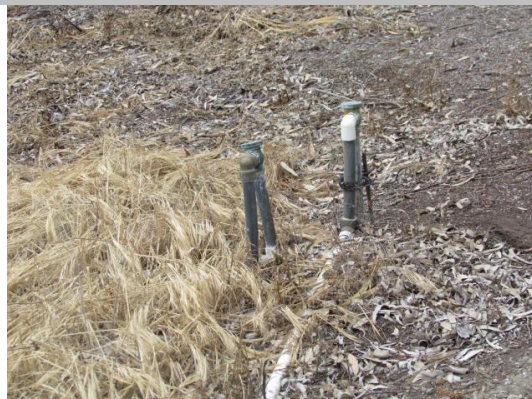
Photo 2 of 2 : FA\_2016\_RD0524\_107\_207\_20160929\_00250.jpg

LM Start	1.65	Rating **	M	Issue No.	207
LM End	1.71	Issue Type +	En	Location *	LS
Category	Earthen Levee			GPS Latitude/Longitude	
				Start	End
Item	Encroachments			37.927237 °	37.926621 °
				-121.327183 °	-121.326400 °
DWR ID	DWR_RD0524_01_s_2016_207				
Comment Code					
LI : Landscape Irrigation					
Inspector Comment					
Sprinklers on landward shoulder

Looking south at sprinkler line and sprinklers on landward shoulder.

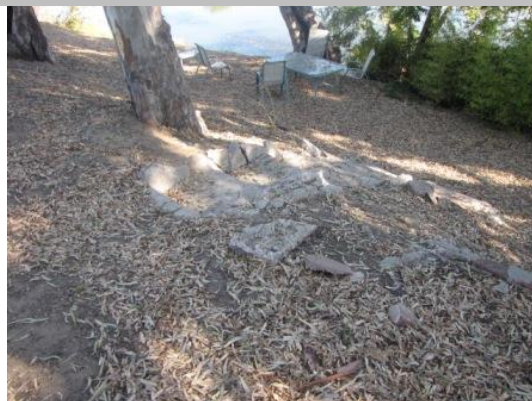
Photo 1 of 3 : FA\_2016\_RD0524\_107\_45\_20160929\_00089.jpg

LM Start	1.67	Rating **	U	Issue No.	45
LM End	1.67	Issue Type +	Ma	Location *	WS
Category	Earthen Levee			GPS Latitude/Longitude	
				Start	End
Item	Encroachments			37.927018 °	37.927018 °
				-121.326872 °	-121.326872 °
DWR ID	DWR_RD0524_01_s_2012_45				
Comment Code					
ST : Stairway					
Inspector Comment					
Stairs and retaining wall

Looking northeast at non-permitted concrete stairs on waterside slope.

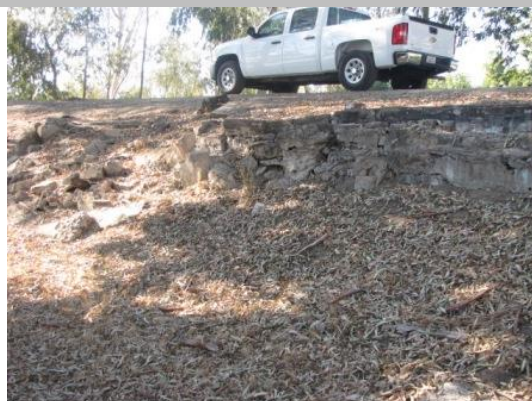
Photo 2 of 3 : FA\_2016\_RD0524\_107\_45\_20160929\_00090.jpg

Looking southwest at retaining wall connected to concrete stairs.

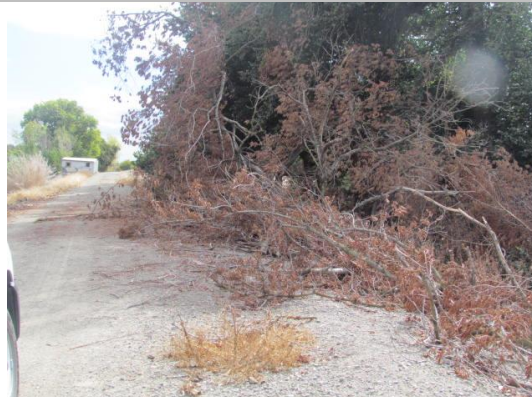
Photo 1 of 4 : FA\_2016\_RD0524\_107\_46\_20160929\_00092.jpg

LM Start	1.75	Rating **	U	Issue No.	46
LM End	1.76	Issue Type +	Ma	Location *	LS
Category	Earthen Levee			GPS Latitude/Longitude	
				Start	End
Item	Encroachments			37.926152 °	37.925993 °
				-121.325927 °	-121.325777 °
DWR ID	DWR_RD0524_01_s_2012_46				
Comment Code					
TR : Tree or limb					
Inspector Comment					
Downed tree limbs on landward slope.

Looking south at tree limbs on landward slope.

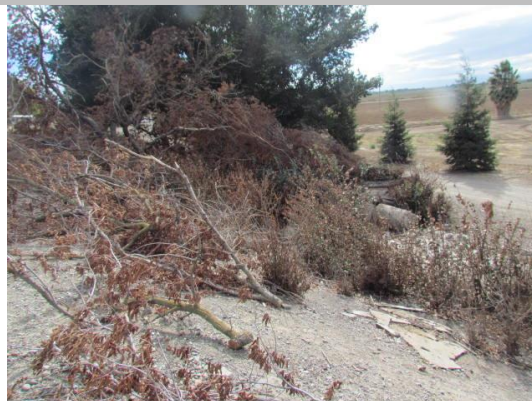
Photo 2 of 4 : FA\_2016\_RD0524\_107\_46\_20160929\_00093.jpg

Looking southwest at tree limbs on landward slope.

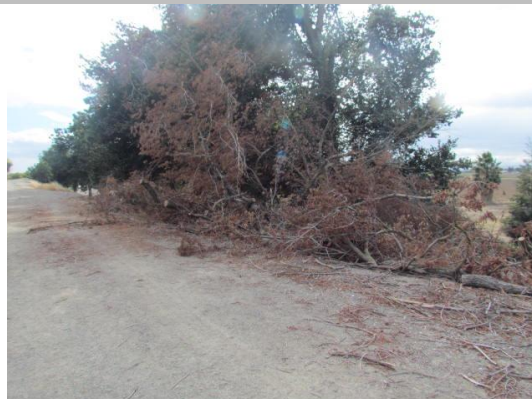
Photo 3 of 4 : FA\_2016\_RD0524\_107\_46\_20160929\_00094.jpg

Looking south at tree limbs on landward slope.

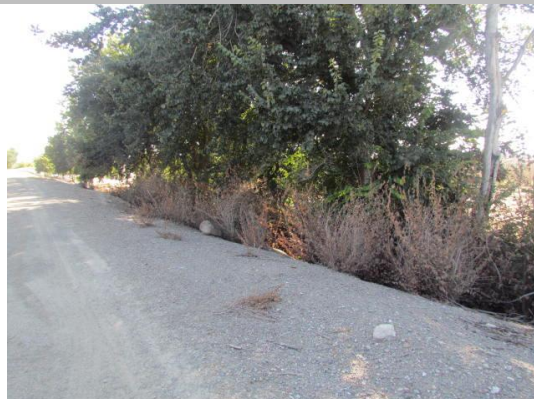
Photo 4 of 4 : FA\_2016\_RD0524\_107\_46\_20160929\_00095.jpg

LM Start	1.75	Rating **	U	Issue No.	46 (cont)	
LM End	1.76	Issue Type +	Ma	Location *	LS	
Category	Earthen Levee			GPS Latitude/Longitude		
				Start		End
Item	Encroachments			37.926152 °		37.925993 °
				-121.325927 °		-121.325777 °
DWR ID	DWR_RD0524_01_s_2012_46					
Comment Code						
TR : Tree or limb						
Inspector Comment						
Downed tree limbs on landward slope.

Looking southwest at dense vegetation and low hanging tree branches on landside slope and toe.

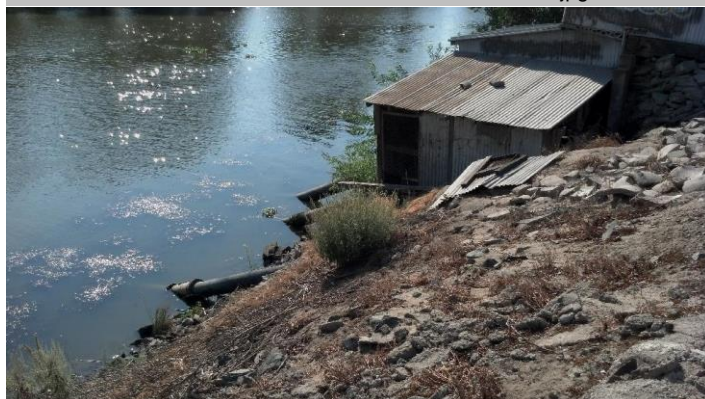
Photo 1 of 2 : UCIP\_FA\_2016\_21866\_37124.jpg

LM Start	1.80	Rating **	M	Issue No.	957
LM End	1.80	Issue Type +	En	Location *	LS
Category	Supplemental			GPS Latitude/Longitude	
				Start	End
Item	DWR UCIP Field Study			37.925480 °	37.925480 °
				-121.325358 °	-121.325358 °
DWR ID					
Comment Code					
Inspector Comment					
FS_ID:21866					
DS_ID:24032					
EP_NO: N/A					
Repair Type: Non-Urgent					
Crossing Status: Found					
UCIP Comments: No permit identified for crossing.					
FIELD_STRUCT_DESC: 12-inch wrapped steel irrigation pipe through the levee at an unknown depth below the crown. Pump, butterfly valves, vent, and siphon breaker at concrete pad 50-feet off LS toe.					
Siphon breaker in 14-inch concrete standpipe on LS shoulder.					
FS Date: 8/20/2013

Pipe visible at lower left.

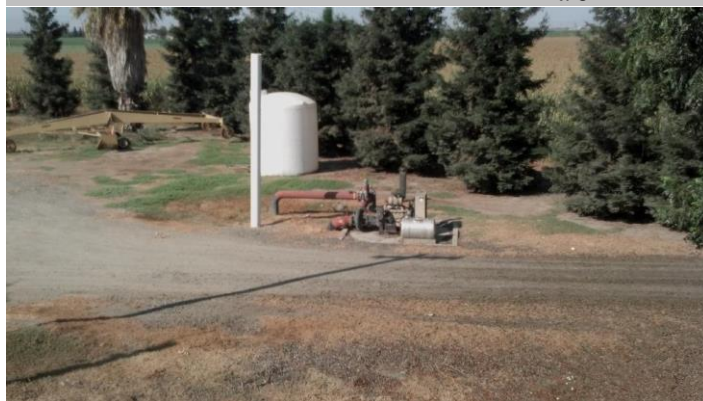
Photo 2 of 2 : UCIP\_FA\_2016\_21866\_37123.jpg

Pumping plant off LS toe.

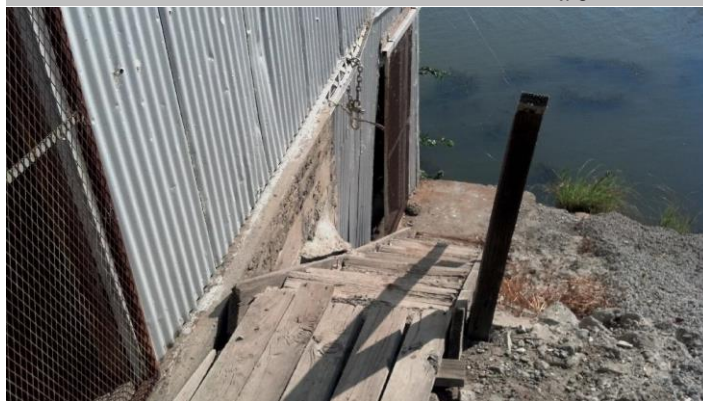
Photo 2 of 2 : UCIP\_FA\_2016\_17847\_29961.jpg

Steps to pump on WS slope.

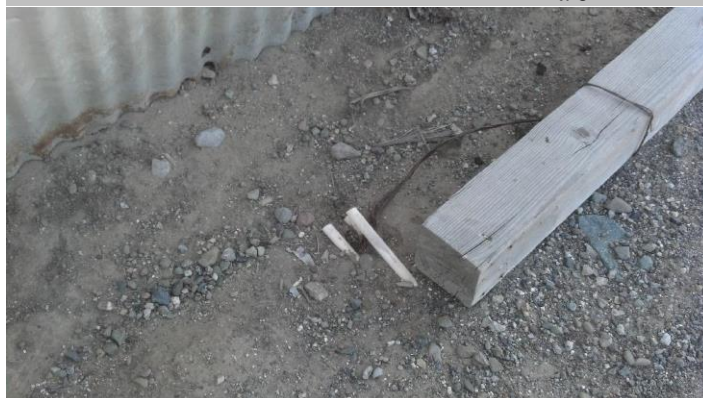
Photo 1 of 2 : UCIP\_FA\_2016\_21865\_37121.jpg

LM Start	1.81	Rating **	M	Issue No.	956
LM End	1.81	Issue Type +	En	Location *	LS
Category	Supplemental			GPS Latitude/Longitude	
				Start	End
Item	DWR UCIP Field Study			37.925431 °	37.925431 °
				-121.325310 °	-121.325310 °
DWR ID					
Comment Code					
Inspector Comment					
FS_ID:21865 DS_ID:24033 EP_NO: N/A Repair Type: Non-Urgent Crossing Status: Found UCIP Comments: Pipes appear abandoned and should be removed from levee. FIELD_STRUCT_DESC: *ABANDONED* One 1-inch and two 3/4-inch PVC conduits through the levee 6-inches below the crown. FS Date: 8/20/2013

Pipes visible on WS shoulder directly in front of pumphouse.

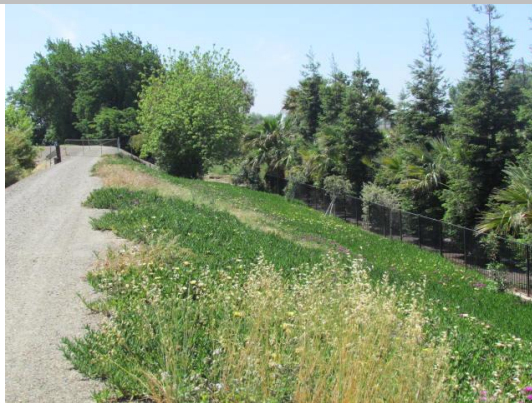
Photo 1 of 1 : FA\_2016\_RD0524\_107\_78\_20160929\_00128.jpg

LM Start	1.90	Rating **	U	Issue No.	78
LM End	1.94	Issue Type +	En	Location *	LS
Category	Earthen Levee			GPS Latitude/Longitude	
				Start	End
Item	Vegetation			37.924364 °	37.923805 °
				-121.324473 °	-121.324238 °
DWR ID	DWR_RD0524_01_s_2012_78				
Comment Code					
V6 : Landscaping					
Inspector Comment

Looking southwest at landscaping on landside slope. (Spring 2012)

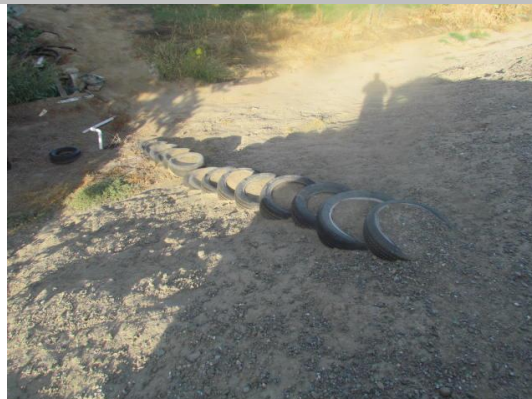
Photo 1 of 1 : FA\_2016\_RD0524\_107\_4\_20160929\_00010.jpg

LM Start	1.99	Rating **	M	Issue No.	4
LM End	1.99	Issue Type +	En	Location *	LS
Category	Earthen Levee			GPS Latitude/Longitude	
				Start	End
Item	Encroachments			37.923068 °	37.923068 °
				-121.323990 °	-121.323990 °
DWR ID	DWR_RD0524_01_f_2012_4				
Comment Code					
ST : Stairway					
Inspector Comment					
Landowner installed rubber tires for a stairway on landside slope.

Looking west at rubber tires being used as stairs on landside slope.

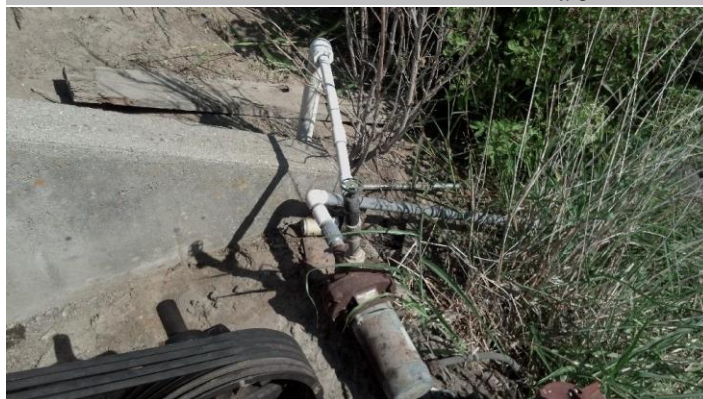
Photo 1 of 2 : UCIP\_FA\_2016\_21872\_37128.jpg

LM Start	1.99	Rating **	M	Issue No.	958
LM End	1.99	Issue Type +	En	Location *	LS
Category	Supplemental			GPS Latitude/Longitude	
				Start	End
Item	DWR UCIP Field Study			37.923022 °	37.923022 °
				-121.323953 °	-121.323953 °
DWR ID					
Comment Code					
Inspector Comment					
FS_ID:21872 DS_ID:24035 EP_NO: N/A Repair Type: Non-Urgent Crossing Status: Found UCIP Comments: No permit identified for this crossing. FIELD_STRUCT_DESC: 3-inch PVC domestic non-potable water line through the levee at unknowd depth below the crown. Pump on concrete pad at WS toe. FS Date: 8/20/2013

Pump on concrete pad at WS slope.

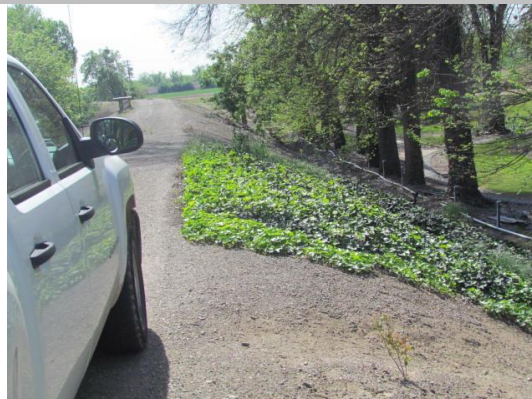
Photo 1 of 1 : FA\_2016\_RD0524\_107\_106\_20160929\_00167.jpg

LM Start	2.00	Rating **	U	Issue No.	106
LM End	2.00	Issue Type +	En	Location *	LS
Category	Earthen Levee			GPS Latitude/Longitude	
				Start	End
Item	Vegetation			37.922923 °	37.922923 °
				-121.323837 °	-121.323837 °
DWR ID	DWR_RD0524_01_s_2012_106				
Comment Code					
V6 : Landscaping					
Inspector Comment

Looking southwest at ground cover on landward slope.

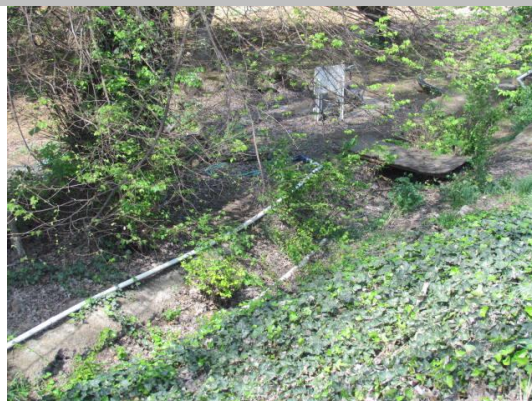
Photo 1 of 2 : FA\_2016\_RD0524\_107\_182\_20160929\_00229.jpg

LM Start	2.01	Rating **	M	Issue No.	182
LM End	2.04	Issue Type +	En	Location *	LS
Category	Earthen Levee			GPS Latitude/Longitude	
				Start	End
Item	Encroachments			37.922837 °	37.922514 °
				-121.323785 °	-121.323504 °
DWR ID	DWR_RD0524_01_s_2014_182				
Comment Code					
DT : Ditch					
Inspector Comment					
Old irrigation ditch at the landward toe should be removed.

Looking northwest at an old irrigation ditch at landward toe.

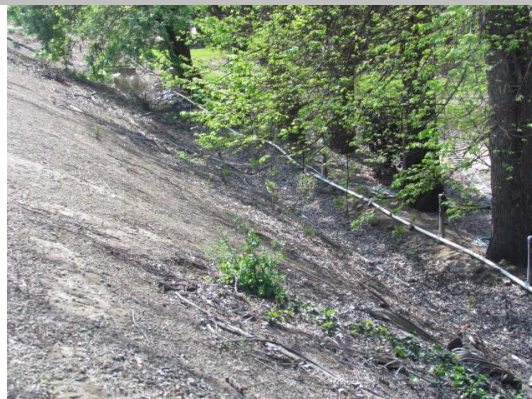
Photo 2 of 2 : FA\_2016\_RD0524\_107\_182\_20160929\_00230.jpg

Looking southwest at an old irrigation ditch at landward toe.

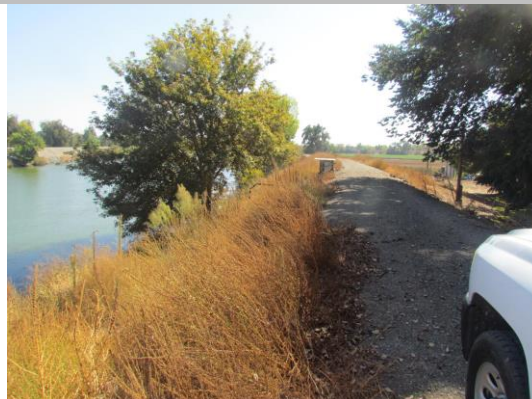
Photo 1 of 1 : FA\_2016\_RD0524\_107\_6\_20161013\_00396.jpg

LM Start	2.02	Rating **	U	Issue No.	6
LM End	2.07	Issue Type +	Ma	Location *	WS
Category	Earthen Levee			GPS Latitude/Longitude	
				Start	End
Item	Vegetation			37.922625 °	37.922062 °
				-121.323640 °	-121.323117 °
DWR ID	DWR_RD0524_01_f_2012_6				
Comment Code					
V2 : Remove the wild growth other than native grasses from the levee slopes.					
Inspector Comment					
Dense vegetation on waterward slope.

Looking southeast at dense veg on waterward slope.

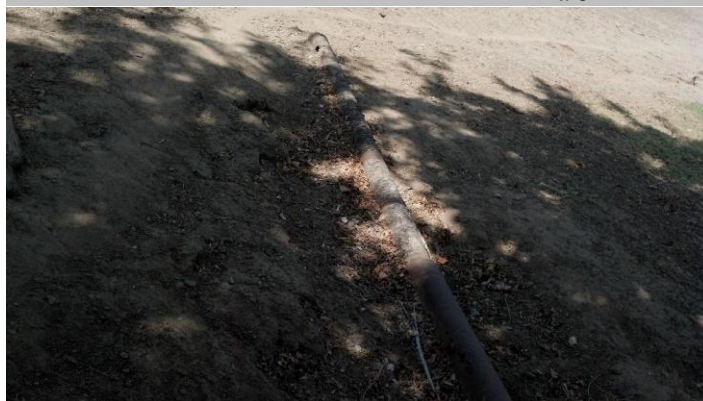
Photo 1 of 2 : UCIP\_FA\_2016\_21883\_37134.jpg

LM Start	2.03	Rating **	M	Issue No.	959
LM End	2.03	Issue Type +	En	Location *	WS
Category	Supplemental			GPS Latitude/Longitude	
				Start	End
Item	DWR UCIP Field Study			37.922535 °	37.922535 °
				-121.323568 °	-121.323568 °
DWR ID					
Comment Code					
Inspector Comment					
FS_ID:21883 DS_ID:24036 EP_NO: N/A Repair Type: Non-Urgent Crossing Status: Found UCIP Comments: Pipe abandoned and should be done so properly. Holes visible throughout exposed pipe. FIELD_STRUCT_DESC: 5-inch wrapped steel irrigation pipe through the levee 6-feet below the crown. No pump or other appurtances found. FS Date: 8/20/2013

Pipe visible on WS slope.

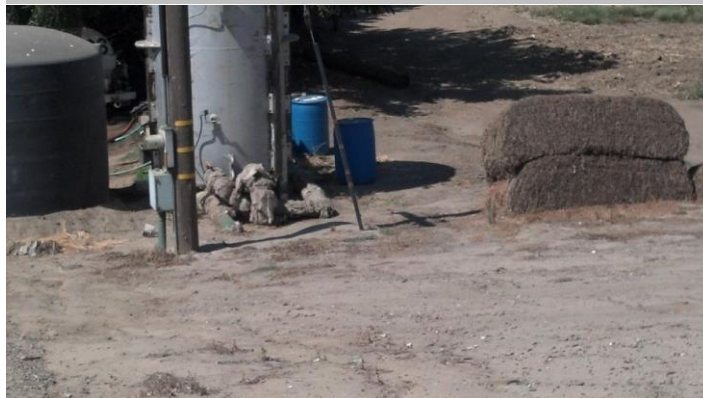
Photo 1 of 2 : UCIP\_FA\_2016\_21895\_37142.jpg

LM Start	2.07	Rating **	M	Issue No.	960
LM End	2.07	Issue Type +	En	Location *	WS
Category	Supplemental			GPS Latitude/Longitude	
				Start	End
Item	DWR UCIP Field Study			37.922080 °	37.922080 °
				-121.323118 °	-121.323118 °
DWR ID					
Comment Code					
Inspector Comment					
FS_ID:21895 DS_ID:24038 EP_NO: N/A Repair Type: Non-Urgent Crossing Status: Found UCIP Comments: No permit identified for this crossing. FIELD_STRUCT_DESC: 6-inch steel irrigation pipe through the levee at an unknown depth. Vent, meter, butterfly valve, and pump at pumphouse on WS slope. FS Date: 8/20/2013

Steel irrigation line visible in front of tank to right of powerpole off LS toe.

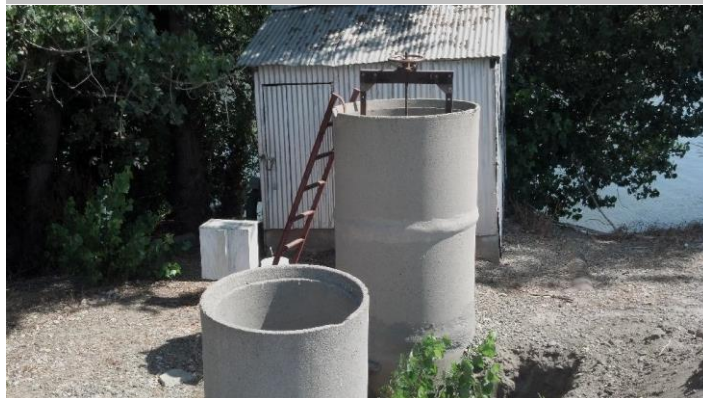
Photo 1 of 2 : UCIP\_FA\_2016\_17944\_30045.jpg

LM Start	2.07	Rating **	M	Issue No.	939
LM End	2.07	Issue Type +	En	Location *	WS
Category	Supplemental			GPS Latitude/Longitude	
				Start	End
Item	DWR UCIP Field Study			37.922064 °	37.922064 °
				-121.323084 °	-121.323084 °
DWR ID					
Comment Code					
Inspector Comment					
FS_ID:17944 DS_ID:20612 EP_NO: N/A Repair Type: Non-Urgent Crossing Status: Found UCIP Comments: Soil excavated from cover over pipe on WS next to concrete riser. May indicate a leak or other problem. FIELD_STRUCT_DESC: 20-inch steel pipe through the levee 15.0 feet below the crown. Pump in pump house on the waterward slope. Slide gate in 4-foot diameter concrete standpipe on WS slope with secondary concrete standpipe. PVC standpipe visible 350-feet off LS toe. Originally included in the 1964 O&M manual. FS Date: 8/20/2013

Slide gate in concrete riser with secondary concrete riser in foreground. Pumphouse in background.

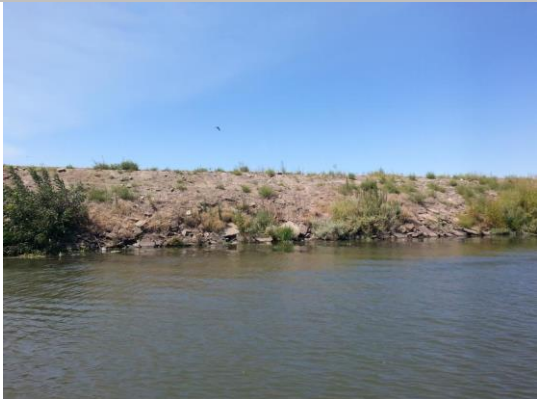
Photo 2 of 2 : SJR2016\_RD0524U01RM42.79\_4.jpg

Front view of the erosion.

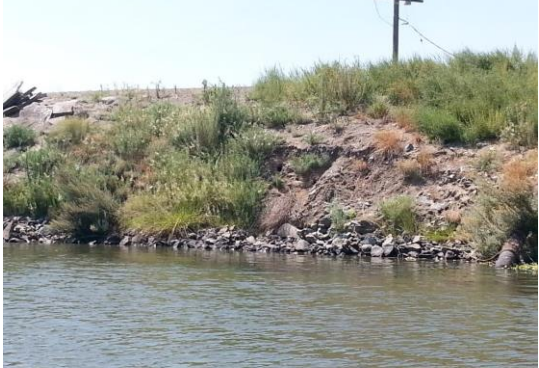
Photo 3 of 3 : SJR2016\_RD0524U01RM42.84\_4.jpg

Close view of the erosion. Note the irrigation pipe next to the erosion.

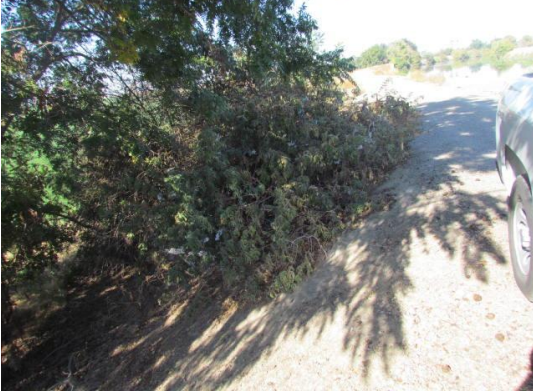
Photo 1 of 2 : FA\_2016\_RD0524\_107\_32\_20160929\_00068.jpg

Looking northwest at dense veg on landward slope and toe fall 2015.

LM Start	2.27	Rating **	U	Issue No.	32 (cont)
LM End	2.29	Issue Type +	Ma	Location *	LS
Category	Earthen Levee			GPS Latitude/Longitude	
				Start	End
Item	Vegetation			37.920372 °	37.920167 °
				-121.320230 °	-121.319890 °
DWR ID	DWR_RD0524_01_s_2012_32				
Comment Code					
V4 : Elderberries are blocking visibility and flood fight capability.					
Inspector Comment					
Dense elderberry bushes on landward slope and toe.

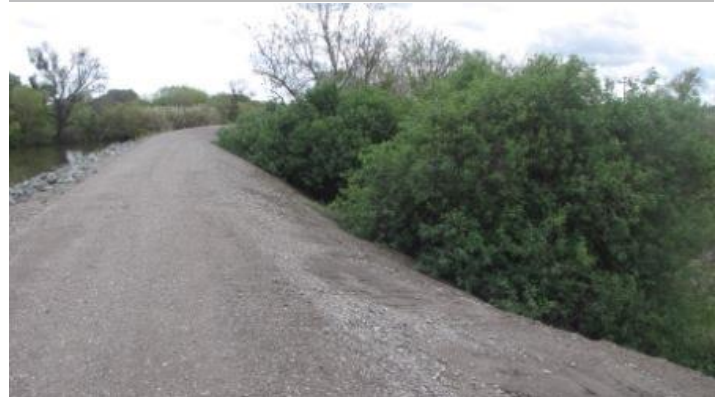
Photo 2 of 2 : FA\_2016\_RD0524\_107\_32\_20160929\_00069.jpg

Looking south at dense veg on landside slope and toe.

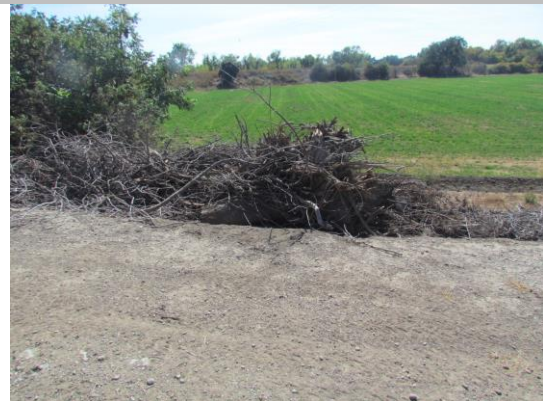
Photo 1 of 1 : FA\_2016\_RD0524\_107\_203\_20161013\_00397.jpg

LM Start	2.27	Rating **	U	Issue No.	203
LM End	2.27	Issue Type +	Ma	Location *	LS
Category	Earthen Levee			GPS Latitude/Longitude	
				Start	End
Item	Encroachments			37.920327 °	37.920327 °
				-121.320175 °	-121.320175 °
DWR ID	DWR_RD0524_01_f_2016_203				
Comment Code					
PR : Prunings					
Inspector Comment					
Large pruning pile on landward slope and toe.

Looking west at pruning pile on waterward slope.

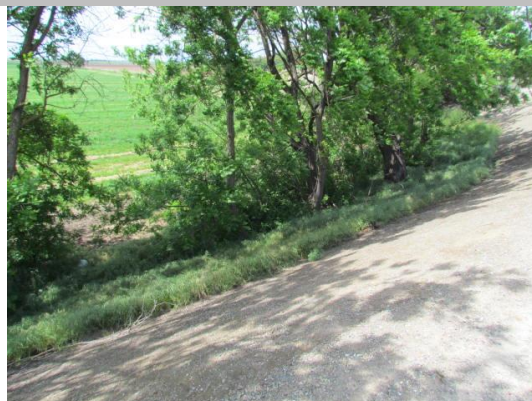
Photo 1 of 1 : FA\_2016\_RD0524\_107\_107\_20160929\_00168.jpg

LM Start	2.33	Rating **	U	Issue No.	107
LM End	2.33	Issue Type +	Ma	Location *	LS
Category	Earthen Levee			GPS Latitude/Longitude	
				Start	End
Item	Trim / Thin Trees			37.919742 °	37.919742 °
				-121.319623 °	-121.319623 °
DWR ID	DWR_RD0524_01_s_2012_107				
Comment Code					
T1 : Trim trees to at least five feet above ground level.					
Inspector Comment

Looking northwest at untrimmed trees at landward toe.

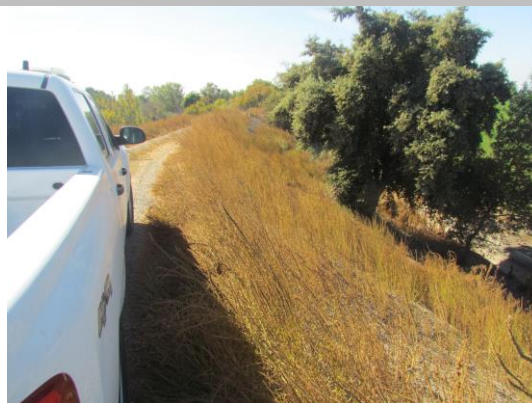
Photo 1 of 1 : FA\_2016\_RD0524\_107\_204\_20161013\_00398.jpg

LM Start	2.38	Rating **	U	Issue No.	204
LM End	2.42	Issue Type +	Ma	Location *	LS
Category	Earthen Levee			GPS Latitude/Longitude	
				Start	End
Item	Vegetation			37.919067 °	37.918713 °
				-121.319935 °	-121.320595 °
DWR ID	DWR_RD0524_01_f_2016_204				
Comment Code					
V2 : Remove the wild growth other than native grasses from the levee slopes.					
Inspector Comment					
Dense vegetation on landward slope and waterward slope.

Looking south at dense veg on landward slope.

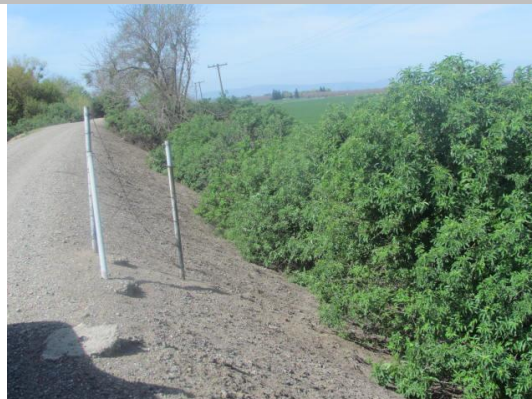
Photo 1 of 1 : FA\_2016\_RD0524\_107\_35\_20160929\_00073.jpg

LM Start	2.41	Rating **	U	Issue No.	35
LM End	2.45	Issue Type +	Ma	Location *	LS
Category	Earthen Levee			GPS Latitude/Longitude	
				Start	End
Item	Vegetation			37.918785 °	37.918515 °
				-121.320417 °	-121.321110 °
DWR ID	DWR_RD0524_01_s_2012_35				
Comment Code					
V4 : Elderberries are blocking visibility and flood fight capability.					
Inspector Comment

Looking southwest at dense vegetation on landward toe.

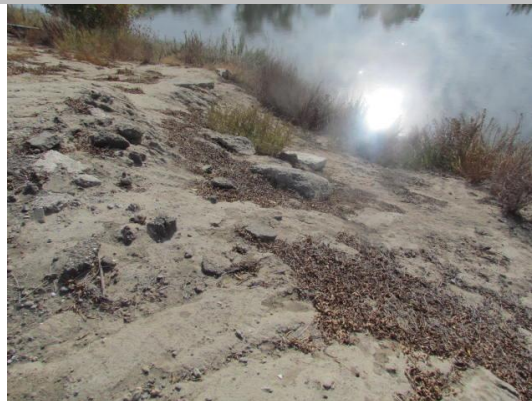
Photo 1 of 1 : FA\_2016\_RD0524\_107\_36\_20160929\_00074.jpg

LM Start	2.44	Rating **	M	Issue No.	36
LM End	2.47	Issue Type +	Ma	Location *	WS
Category	Earthen Levee			GPS Latitude/Longitude	
				Start	End
Item	Erosion / Bank Caving			37.918628 °	37.918438 °
				-121.320817 °	-121.321452 °
DWR ID	DWR_RD0524_01_s_2012_36				
Comment Code					
E1 : Note and monitor erosion site.					
Inspector Comment

Looking east at erosion on waterside slope.

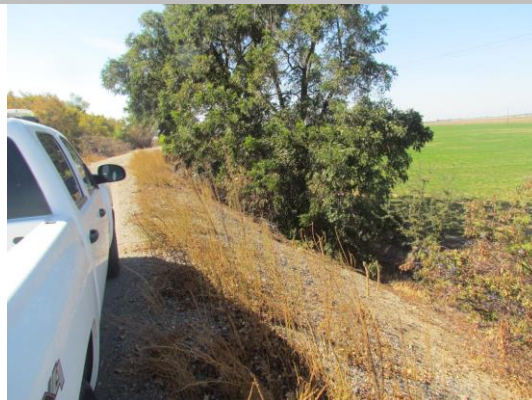
Photo 1 of 1 : FA\_2016\_RD0524\_107\_80\_20161013\_00399.jpg

LM Start	2.45	Rating **	U	Issue No.	80
LM End	2.45	Issue Type +	Ma	Location *	LS
Category	Earthen Levee			GPS Latitude/Longitude	
				Start	End
Item	Trim / Thin Trees			37.918480 °	37.918480 °
				-121.321114 °	-121.321114 °
DWR ID	DWR_RD0524_01_s_2012_80				
Comment Code					
T1 : Trim trees to at least five feet above ground level.					
Inspector Comment					
Untrimmed tree on landward slope.

Looking south at untrimmed tree on landward slope.

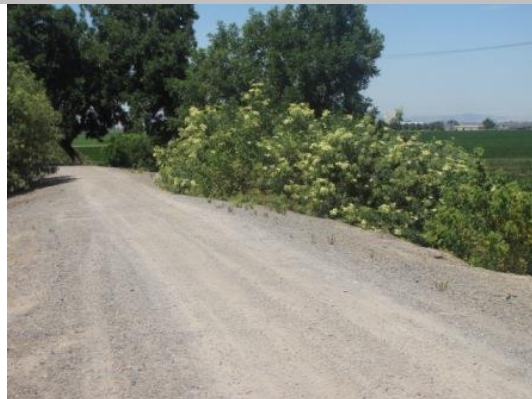
Photo 1 of 4 : FA\_2016\_RD0524\_107\_37\_20160929\_00075.jpg

LM Start	2.49	Rating **	U	Issue No.	37
LM End	2.50	Issue Type +	Ma	Location *	LS
Category	Earthen Levee			GPS Latitude/Longitude	
				Start	End
Item	Vegetation			37.918345 °	37.918302 °
				-121.321765 °	-121.321923 °
DWR ID	DWR_RD0524_01_s _ 2012_37				
Comment Code					
V4 : Elderberries are blocking visibility and flood fight capability.					
Inspector Comment

Looking south at elderberry on landside slope.

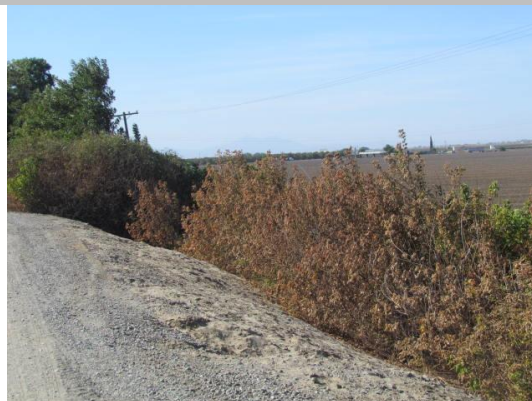
Photo 2 of 4 : FA\_2016\_RD0524\_107\_37\_20160929\_00076.jpg

Looking southwest at dense vegetation on landside toe.

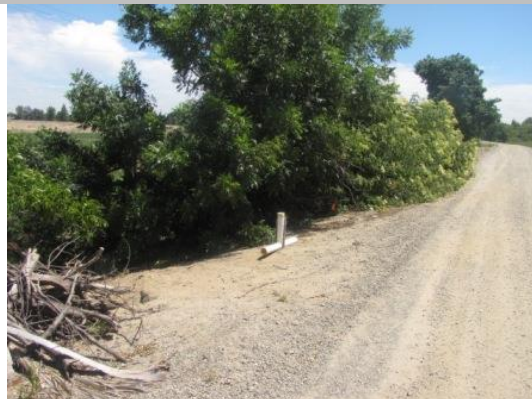
Photo 3 of 4 : FA\_2016\_RD0524\_107\_37\_20160929\_00077.jpg

Looking north at elderberry and trees on landside slope.

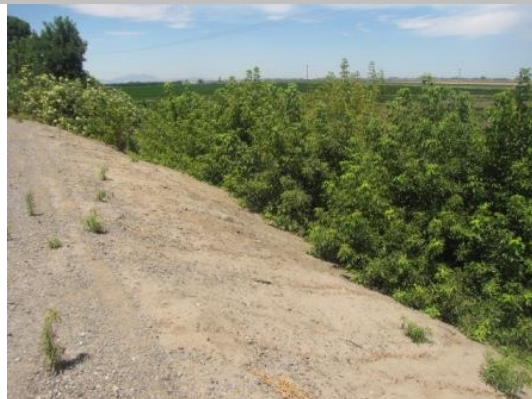
Photo 4 of 4 : FA\_2016\_RD0524\_107\_37\_20160929\_00078.jpg

LM Start	2.49	Rating **	U	Issue No.	37 (cont)
LM End	2.50	Issue Type +	Ma	Location *	LS
Category	Earthen Levee			GPS Latitude/Longitude	
				Start	End
Item	Vegetation			37.918345 °	37.918302 °
				-121.321765 °	-121.321923 °
DWR ID	DWR_RD0524_01_s_2012_37				
Comment Code					
V4 : Elderberries are blocking visibility and flood fight capability.					
Inspector Comment

Looking southwest at trees along levee landside toe.

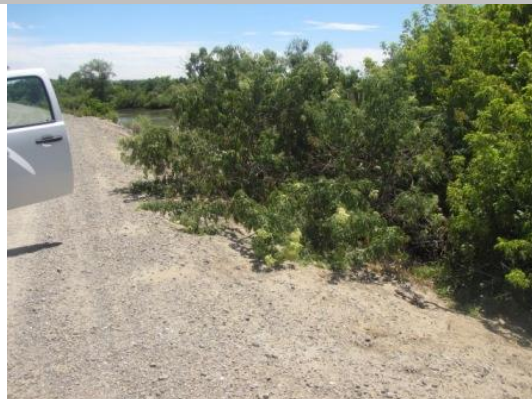
Photo 1 of 2 : FA\_2016\_RD0524\_107\_38\_20160929\_00079.jpg

LM Start	2.50	Rating **	U	Issue No.	38
LM End	2.50	Issue Type +	Ma	Location *	WS
Category	Earthen Levee			GPS Latitude/Longitude	
				Start	End
Item	Vegetation			37.918287 °	37.918287 °
				-121.321980 °	-121.321980 °
DWR ID	DWR_RD0524_01_s_2012_38				
Comment Code					
V4 : Elderberries are blocking visibility and flood fight capability.					
Inspector Comment

Looking north at elderberry on waterside slope.

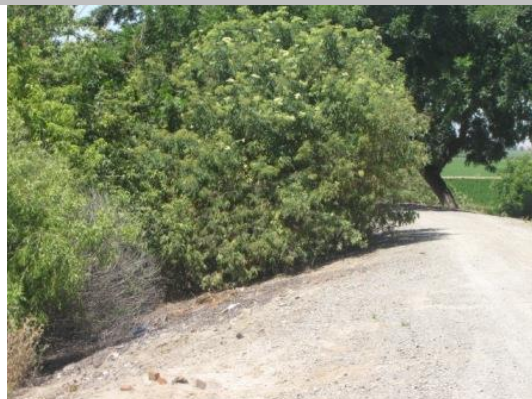
Photo 2 of 2 : FA\_2016\_RD0524\_107\_38\_20160929\_00080.jpg

Looking south at elderberry on waterside slope.

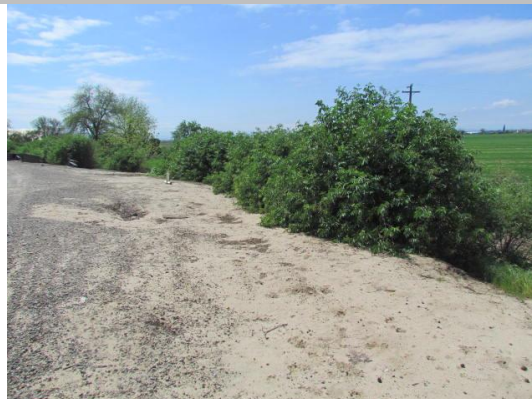
Photo 1 of 1 : FA\_2016\_RD0524\_107\_40\_20160929\_00083.jpg

LM Start	2.53	Rating **	U	Issue No.	40
LM End	2.57	Issue Type +	Ma	Location *	LS
Category	Earthen Levee			GPS Latitude/Longitude	
				Start	End
Item	Vegetation			37.918047 °	37.917498 °
				-121.322415 °	-121.322797 °
DWR ID	DWR_RD0524_01_s_2012_40				
Comment Code					
V4 : Elderberries are blocking visibility and flood fight capability.					
Inspector Comment

Looking southwest at dense veg on landward slope.

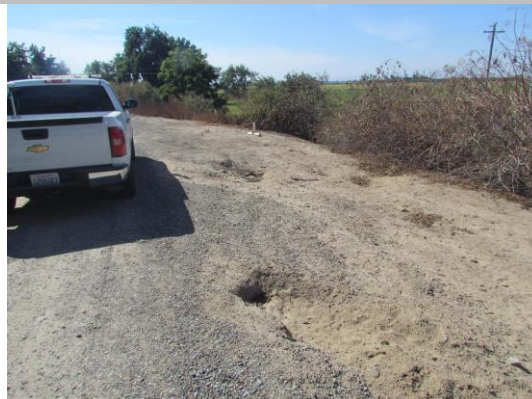
Photo 1 of 2 : FA\_2016\_RD0524\_107\_82\_20161013\_00400.jpg

LM Start	2.54	Rating **	U	Issue No.	82
LM End	2.54	Issue Type +	Ma	Location *	LS
Category	Earthen Levee			GPS Latitude/Longitude	
				Start	End
Item	Slope Stability			37.917978 °	37.917978 °
				-121.322483 °	-121.322483 °
DWR ID	DWR_RD0524_01_s_2012_82				
Comment Code					
S1 : Repair slope instability.					
Inspector Comment					
Landward slope damage from animal digging into levee.

Looking southwest at large holes on landward slope. (Fall 2016)

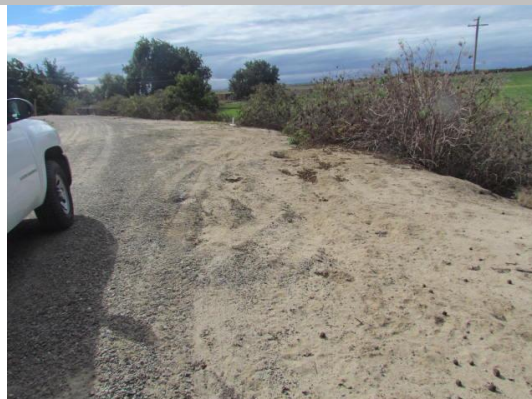
Photo 2 of 2 : FA\_2016\_RD0524\_107\_82\_20160929\_00136.jpg

Looking southwest at damaged landward slope. (Spring 2016)

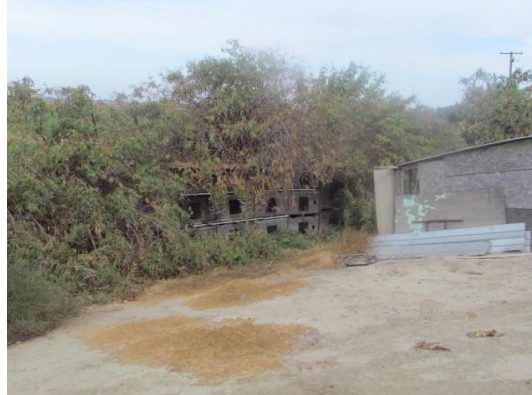
Photo 1 of 2 : FA\_2016\_RD0524\_107\_42\_20160929\_00085.jpg

Looking west at animal pens on landside toe. (Fall 2012)

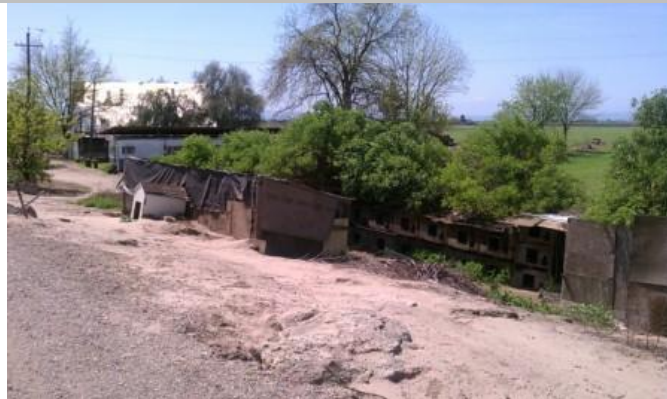
Photo 2 of 2 : FA\_2016\_RD0524\_107\_42\_20160929\_00086.jpg

Looking at animal pens on landside slope and toe.

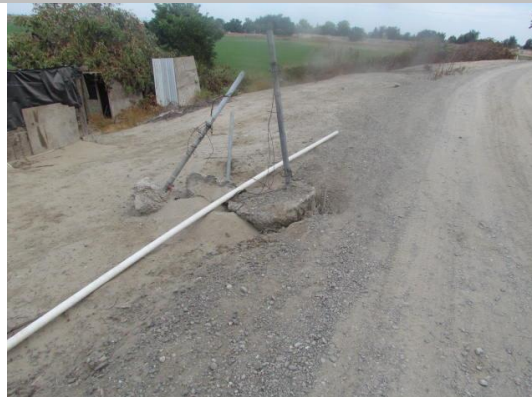
Photo 1 of 1 : FA\_2016\_RD0524\_107\_12\_20160929\_00023.jpg

LM Start	2.57	Rating **	M	Issue No.	12
LM End	2.57	Issue Type +	En	Location *	LS
Category	Earthen Levee			GPS Latitude/Longitude	
				Start	End
Item	Encroachments			37.917538 °	37.917538 °
				-121.322757 °	-121.322757 °
DWR ID	DWR_RD0524_01_f_2012_12				
Comment Code					
PO : Pole					
Inspector Comment					
Old fence poles on landside shoulder and slope should be removed.

Looking northwest at fence poles on landside shoulder.

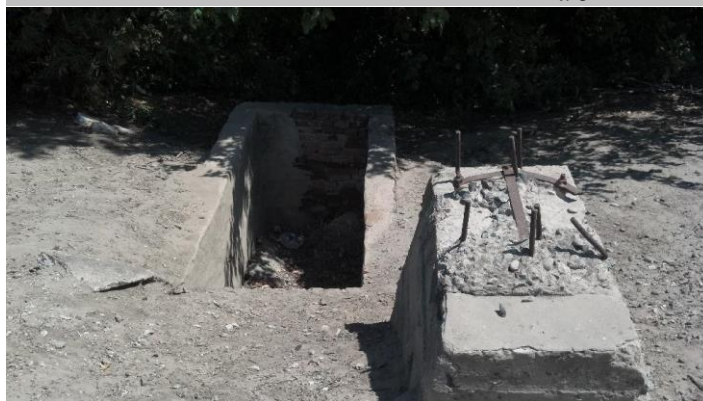
Photo 1 of 2 : UCIP\_FA\_2016\_21935\_37162.jpg

FS\_ID:21935  
DS\_ID:24040  
EP\_NO: N/A  
Repair Type: Non-Urgent  
Crossing Status: Found  
UCIP Comments: Need to determine type of abandonment for pipe at this location.  
FIELD\_STRUCT\_DESC: \*ABANDONED\* Pump pad on LS shoulder with 4'X9' brick distribution box on WS slope. No pipe visible. 4'X9' brick distribution box on LS toe.  
FS Date: 8/20/2013

Foundation for pump with distribution box on WS shoulder.

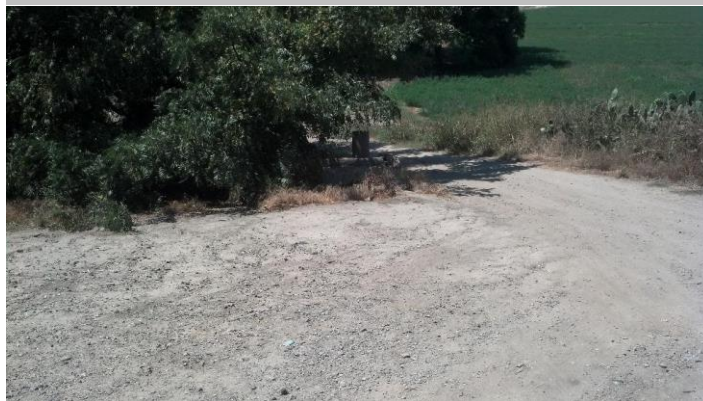
Photo 2 of 2 : UCIP\_FA\_2016\_21935\_37161.jpg

Distribution box on LS toe.

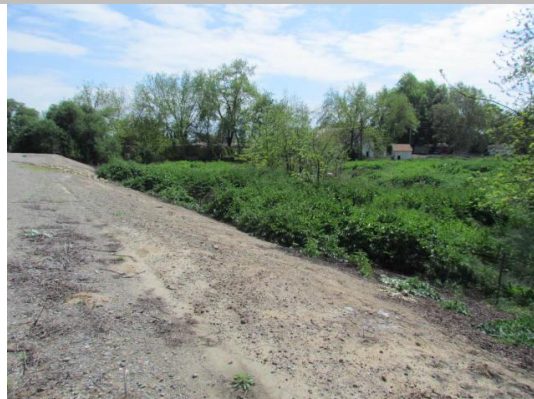
Photo 1 of 1 : FA\_2016\_RD0524\_107\_9\_20160929\_00014.jpg

Looking southwest at dense veg at landward toe.

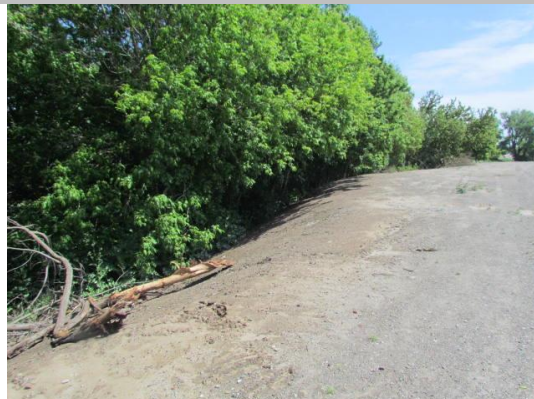
Photo 1 of 1 : FA\_2016\_RD0524\_107\_185\_20160929\_00231.jpg

Looking northwest at untrimmed trees on landward slope and toe.

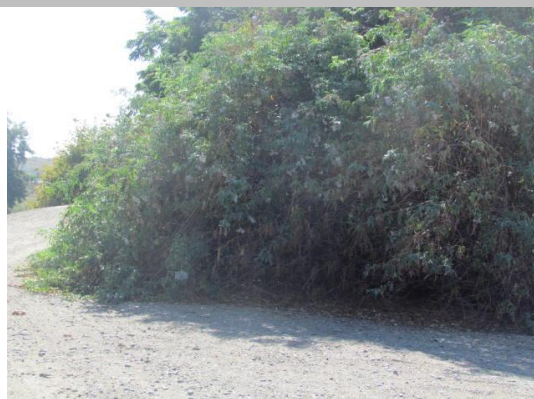
Photo 1 of 1 : FA\_2016\_RD0524\_107\_43\_20160929\_00087.jpg

Looking southeast at dense veg on landward slope and toe fall 2015.

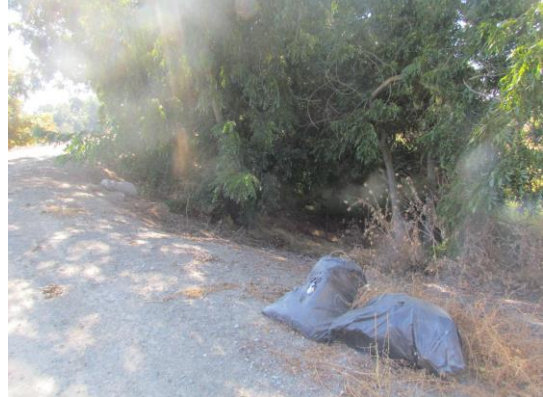
Photo 1 of 1 : FA\_2016\_RD0524\_107\_918\_20161013\_00404.jpg

LM Start	2.65	Rating **	U	Issue No.	918
LM End	2.66	Issue Type +	Ma	Location *	LS
Category	Earthen Levee			GPS Latitude/Longitude	
				Start	End
Item	Trim / Thin Trees			37.916718 °	37.916502 °
				-121.322020 °	-121.321980 °
DWR ID	DWR_RD0524_01_s_2012_918				
Comment Code					
T1 : Trim trees to at least five feet above ground level.					
Inspector Comment					
Untrimmed trees on landward slope and toe.

Looking south at untrimmed trees on landward slope.

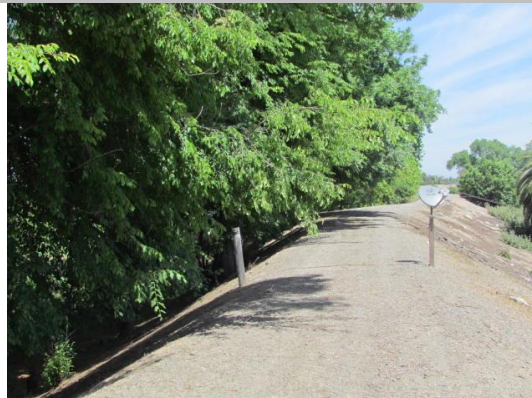
Photo 1 of 1 : FA\_2016\_RD0524\_107\_44\_20160929\_00088.jpg

LM Start	2.67	Rating **	M	Issue No.	44
LM End	2.77	Issue Type +	Ma	Location *	LS
Category	Earthen Levee			GPS Latitude/Longitude	
				Start	End
Item	Trim / Thin Trees			37.916418 °	37.915142 °
				-121.321963 °	-121.323018 °
DWR ID	DWR_RD0524_01_s_2012_44				
Comment Code					
T4 : Trim trees over roadway to at least 12 feet above ground level.					
Inspector Comment					
Trim over hanging trees at least 12 feet above ground level.

Looking north at dense trees overhanging levee crown.
