**Flood Control Project Maintenance  
Levee Inspections**

**Fall 2016 Levee Maintenance Deficiency Summary Report**

**Reclamation District No. 0524 Middle Roberts Island**

Waterway			Bank	Unit Miles
Unit No. 01 San Joaquin River			Left	6.20
	Spring (March - May)	Summer (June - August)	(September - November) Fall	Winter (December - February)
Unit Maintenance Rating (Fall Only)			<b>U</b>	
Date of Inspection	4/12/2016 - 4/13/2016		10/10/2016 - 10/11/2016	
DWR Inspector	Richard Willoughby		Richard Willoughby	
Accompanied By	Mario Jaques RD 524		Mario Jaques RD 524

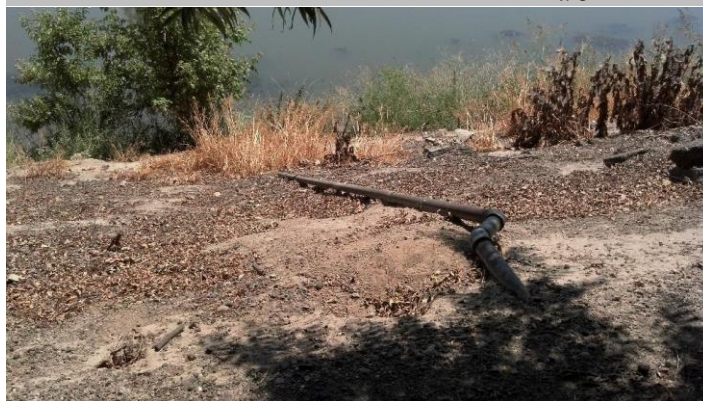
Photo 2 of 2 : UCIP\_FA\_2016\_18085\_30190.jpg

LM Start	2.73	Rating **	M	Issue No.	940 (cont)
LM End	2.73	Issue Type +	En	Location *	LS
Category	Supplemental			GPS Latitude/Longitude	
				Start	End
Item	DWR UCIP Field Study			37.915698 °	37.915698 °
				-121.322501 °	-121.322501 °
DWR ID					
Comment Code					
Inspector Comment					
FS_ID:18085 DS_ID:20616 EP_NO: N/A Repair Type: Non-Urgent Crossing Status: Found UCIP Comments: No permit identified for crossing. Unknoww use. Pipe should be removed. FIELD_STRUCT_DESC: 3-inch galvanized iron pipe through the levee 0.3 feet below the crown. Valve on the landward shoulder. FS Date: 8/20/2013 3:28:19 PM

Pipe visible on WS slope.

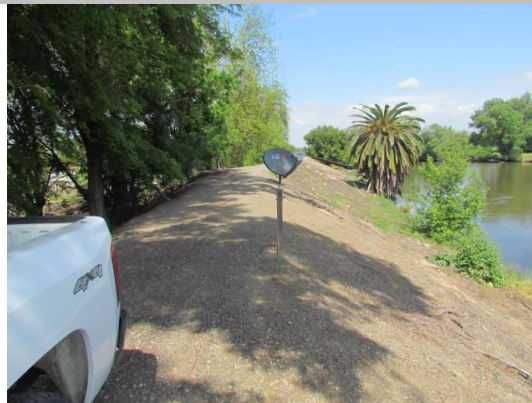
Photo 1 of 1 : FA\_2016\_RD0524\_107\_41\_20160929\_00084.jpg

LM Start	2.74	Rating **	M	Issue No.	41
LM End	2.74	Issue Type +	En	Location *	WS
Category	Earthen Levee			GPS Latitude/Longitude	
				Start	End
Item	Encroachments			37.915556 °	37.915556 °
				-121.322616 °	-121.322616 °
DWR ID	DWR_RD0524_01_s_2016_41				
Comment Code					
EQ : Equipment					
Inspector Comment					
Landowner installed satellite dish on waterward shoulder.

Looking north at satellite dish on waterward shoulder.

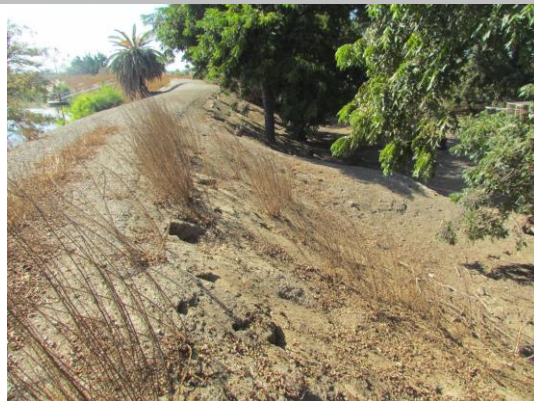
Photo 1 of 2 : FA\_2016\_RD0524\_107\_219\_20161013\_00406.jpg

LM Start	2.77	Rating **	U	Issue No.	219
LM End	2.80	Issue Type +	Ma	Location *	LS
Category	Earthen Levee			GPS Latitude/Longitude	
				Start	End
Item	Animal Control			37.915195 °	37.915052 °
				-121.322930 °	-121.323430 °
DWR ID	DWR_RD0524_01_f_2016_219				
Comment Code					
A1 : Exterminate rodents and backfill and compact or grout burrows.					
Inspector Comment					
Several large rodent holes on landward slope.

Looking south at several rodent holes on landward slope.

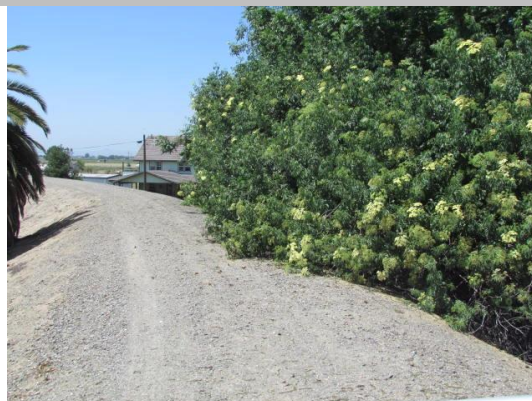
Photo 1 of 2 : FA\_2016\_RD0524\_107\_48\_20160929\_00098.jpg

LM Start	2.80	Rating **	U	Issue No.	48
LM End	2.80	Issue Type +	Ma	Location *	LS
Category	Earthen Levee			GPS Latitude/Longitude	
				Start	End
Item	Vegetation			37.915022 °	37.915022 °
				-121.323443 °	-121.323443 °
DWR ID	DWR_RD0524_01_s_2012_48				
Comment Code					
V4 : Elderberries are blocking visibility and flood fight capability.					
Inspector Comment

Looking south at dense elderberry on landside slope.(Spring 2012)

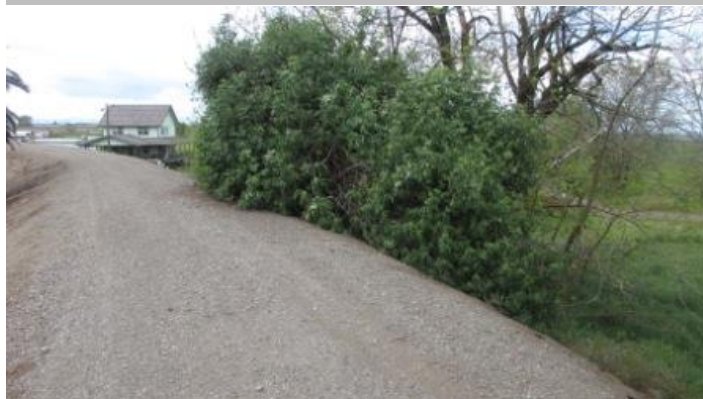
Photo 2 of 2 : FA\_2016\_RD0524\_107\_48\_20160929\_00099.jpg

Looking south at elderberry on landside slope.(Spring 2011)

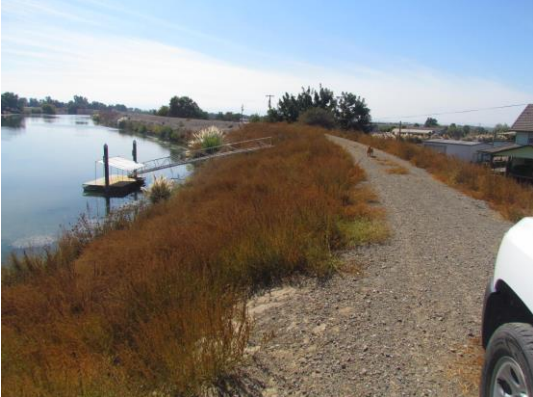
Photo 1 of 1 : FA\_2016\_RD0524\_107\_220\_20161013\_00408.jpg

Looking at dense veg on waterward slope.

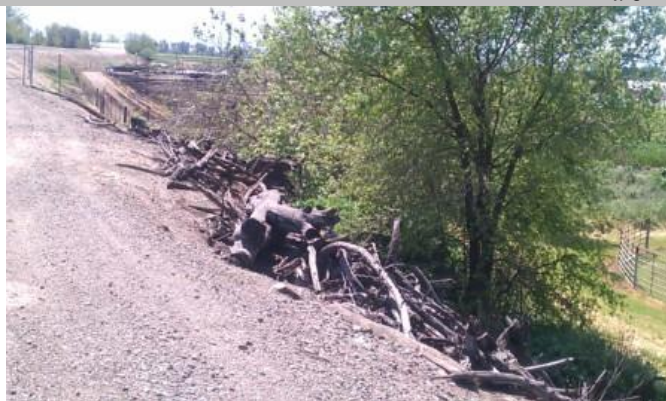
Photo 1 of 1 : FA\_2016\_RD0524\_107\_50\_20160929\_00101.jpg

LM Start	2.90	Rating **	U	Issue No.	50
LM End	2.92	Issue Type +	Ma	Location *	LS
Category	Earthen Levee			GPS Latitude/Longitude	
				Start	End
Item	Encroachments			37.913767 °	37.913503 °
				-121.324427 °	-121.324488 °
DWR ID	DWR_RD0524_01_s_2012_50				
Comment Code					
PR : Prunings					
Inspector Comment

Looking southwest at prunings on landside slope.

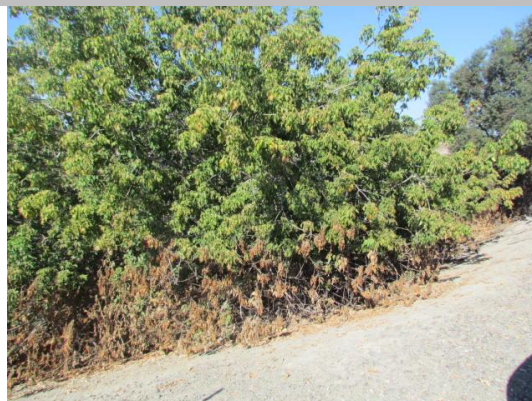
Photo 1 of 2 : FA\_2016\_RD0524\_107\_51\_20160929\_00102.jpg

LM Start	2.93	Rating **	U	Issue No.	51
LM End	2.93	Issue Type +	Ma	Location *	LS
Category	Earthen Levee			GPS Latitude/Longitude	
				Start	End
Item	Trim / Thin Trees			37.913415 °	37.913415 °
				-121.324503 °	-121.324503 °
DWR ID	DWR_RD0524_01_s_2012_51				
Comment Code					
T1 : Trim trees to at least five feet above ground level.					
Inspector Comment					
Untrimmed trees on landward slope and toe.

Looking south at dense trees on landward slope fall 2015

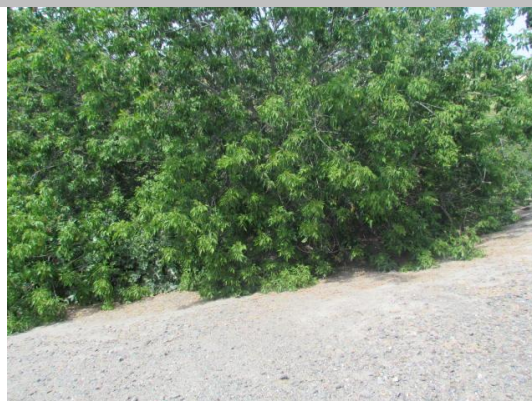
Photo 2 of 2 : FA\_2016\_RD0524\_107\_51\_20160929\_00103.jpg

Looking south at dense trees on landward slope spring 2015

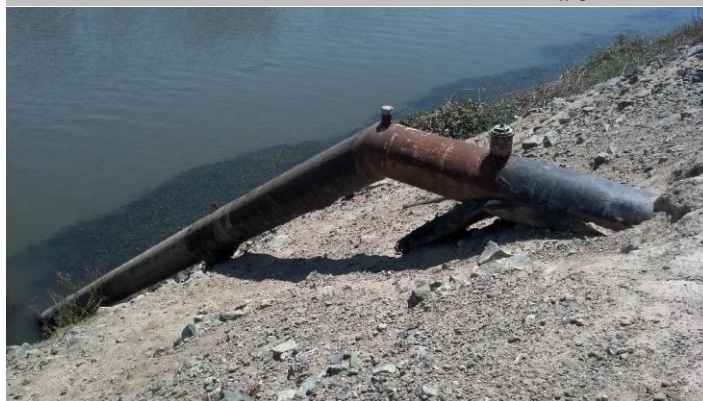
Photo 1 of 2 : UCIP\_FA\_2016\_18089\_30198.jpg

LM Start	2.95	Rating **	M	Issue No.	941
LM End	2.95	Issue Type +	En	Location *	LS
Category	Supplemental			GPS Latitude/Longitude	
				Start	End
Item	DWR UCIP Field Study			37.913101 °	37.913101 °
				-121.324500 °	-121.324500 °
DWR ID					
Comment Code					
Inspector Comment					
FS_ID:18089 DS_ID:20617 EP_NO: N/A Repair Type: Non-Urgent Crossing Status: Indicator Found UCIP Comments: Review crossing with inspector as records indicate that this should be an 8-inch pipe through levee 3.0 feet below crown, pump on landward side. Siphon breaker on the waterward slope. Originally included in the 1964 O&M manual. FIELD_STRUCT_DESC: 16-inch wrapped steel storm discharge pipe through the levee 1.5-feet below the crown. Pump on steel pile structure at drainage canal off LS toe. FS Date: 8/20/2013

PVC wrapped pipe and siphon breaker visible on WS slope.

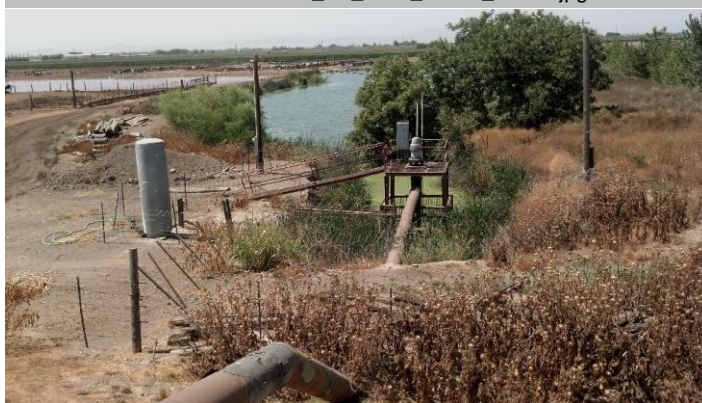
Photo 2 of 2 : UCIP\_FA\_2016\_18089\_30197.jpg

LM Start	2.95	Rating **	M	Issue No.	941 (cont)
LM End	2.95	Issue Type +	En	Location *	LS
Category	Supplemental			GPS Latitude/Longitude	
				Start	End
Item	DWR UCIP Field Study			37.913101°	37.913101°
				-121.324500°	-121.324500°
DWR ID					
Comment Code					
Inspector Comment					
FS_ID:18089 DS_ID:20617 EP_NO: N/A Repair Type: Non-Urgent Crossing Status: Indicator Found UCIP Comments: Review crossing with inspector as records indicate that this should be an 8-inch pipe through levee 3.0 feet below crown, pump on landward side. Siphon breaker on the waterward slope. Originally included in the 1964 O&M manual. FIELD_STRUCT_DESC: 16-inch wrapped steel storm discharge pipe through the levee 1.5-feet below the crown. Pump on steel pile structure at drainage canal off LS toe. FS Date: 8/20/2013

Pipe, pump, power pole, and meter visible off LS toe.

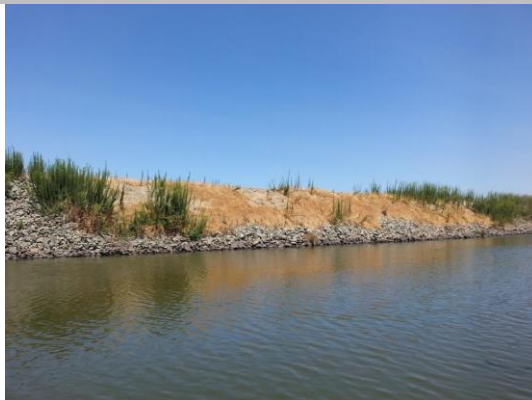
Photo 1 of 2 : SJR2016\_RD0524U01RM43.52\_1.jpg

LM Start	2.96	Rating **	U	Issue No.	126
LM End	2.96	Issue Type +	Ma	Location *	WS
Category	Supplemental			GPS Latitude/Longitude	
				Start	End
Item	DWR Erosion Survey			37.913010 °	37.913010 °
				-121.324490 °	-121.324490 °
DWR ID					
Comment Code					
Inspector Comment					
07/25/2016: No significant change observed.					
06/24/2015: No significant change observed.					
06/19/2014: No significant change observed.					
08/13/2013: No significant change observed.					
08/07/2012: The site was first reported in 2012 spring levee inspection report. [2016 Site ID:RD0524U01RM43.52]

Upstream view of the erosion.

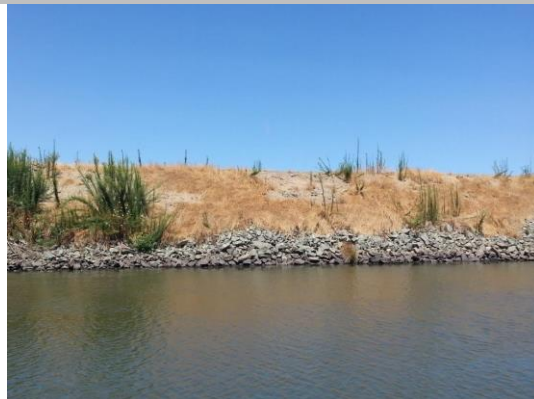
Photo 2 of 2 : SJR2016\_RD0524U01RM43.52\_4.jpg

LM Start	2.96	Rating **	U	Issue No.	126 (cont)
LM End	2.96	Issue Type +	Ma	Location *	WS
Category	Supplemental			GPS Latitude/Longitude	
				Start	End
Item	DWR Erosion Survey			37.913010 °	37.913010 °
				-121.324490 °	-121.324490 °
DWR ID					
Comment Code					
Inspector Comment					
07/25/2016: No significant change observed.					
06/24/2015: No significant change observed.					
06/19/2014: No significant change observed.					
08/13/2013: No significant change observed.					
08/07/2012: The site was first reported in 2012 spring levee inspection report. [2016 Site ID:RD0524U01RM43.52]

Close view of the erosion. Note the vegetation at the site.

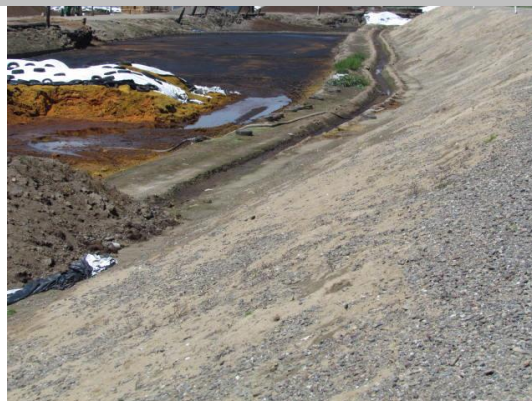
Photo 1 of 2 : FA\_2016\_RD0524\_107\_212\_20160929\_00255.jpg

LM Start	<b>3.11</b>	Rating **	M	Issue No.	<b>212 (cont)</b>
LM End	<b>3.27</b>	Issue Type +	En	Location *	LS

Looking northwest at southend of ditch at landward toe.

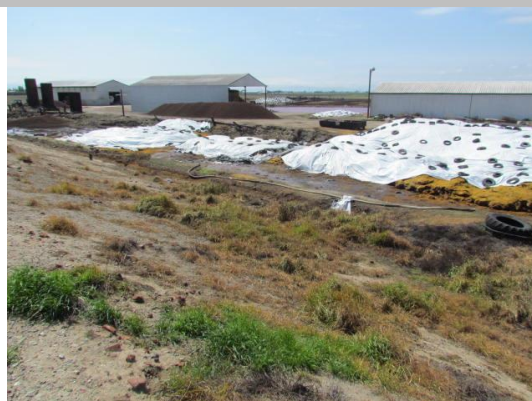
Photo 2 of 2 : FA\_2016\_RD0524\_107\_212\_20160929\_00256.jpg

Looking southwest at northend of ditch at landward toe.

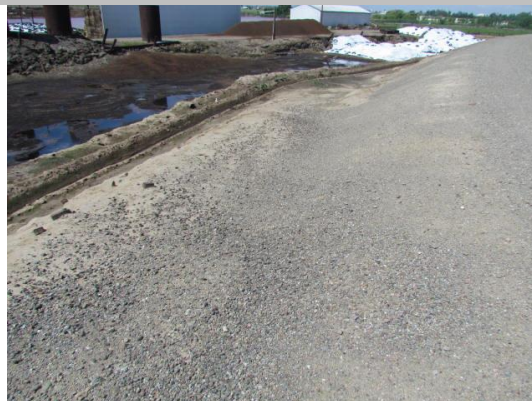
Photo 1 of 1 : FA\_2016\_RD0524\_107\_211\_20160929\_00254.jpg

LM Start	3.18	Rating **	U	Issue No.	211
LM End	3.18	Issue Type +	En	Location *	LS
Category	Earthen Levee			GPS Latitude/Longitude	
				Start	End
Item	Encroachments			37.909945 °	37.909945 °
				-121.325543 °	-121.325543 °
DWR ID	DWR_RD0524_01_s_2016_211				
Comment Code					
RA : Ramp					
Inspector Comment					
Unauthorized ramp on landward slope.

Looking northwest at unauthorized ramp on landward slope.

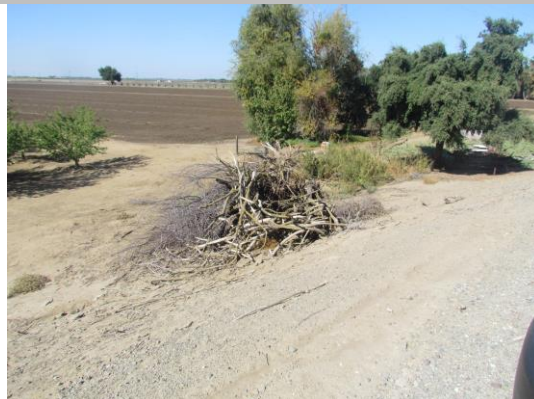
Photo 1 of 1 : FA\_2016\_RD0524\_107\_192\_20161013\_00417.jpg

LM Start	3.67	Rating **	U	Issue No.	192
LM End	3.67	Issue Type +	En	Location *	LS
Category	Earthen Levee			GPS Latitude/Longitude	
				Start	End
Item	Encroachments			37.903782 °	37.903782 °
				-121.325363 °	-121.325363 °
DWR ID	DWR_RD0524_01_s_2015_192				
Comment Code					
PR : Prunings					
Inspector Comment					
Large pruning piles at landward toe.

Looking west at pruning pile at landward toe.

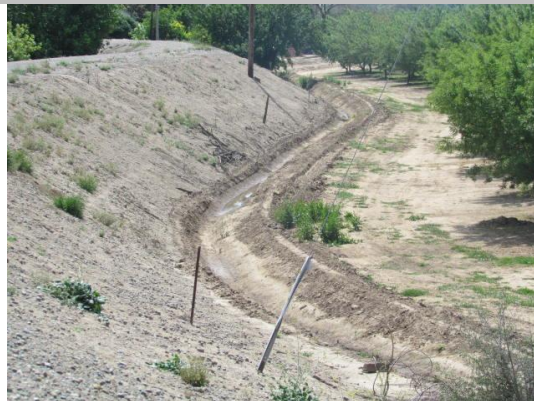
Photo 1 of 2 : FA\_2016\_RD0524\_107\_194\_20160929\_00236.jpg

LM Start	3.69	Rating **	U	Issue No.	194
LM End	3.78	Issue Type +	En	Location *	LS
Category	Earthen Levee			GPS Latitude/Longitude	
				Start	End
Item	Encroachments			37.903553 °	37.902505 °
				-121.325468 °	-121.326425 °
DWR ID	DWR_RD0524_01_s_2015_194				
Comment Code					
DT : Ditch					
Inspector Comment					
Shallow Irrigation ditch at landward toe.

Looking south at irrigation ditch at landward toe.

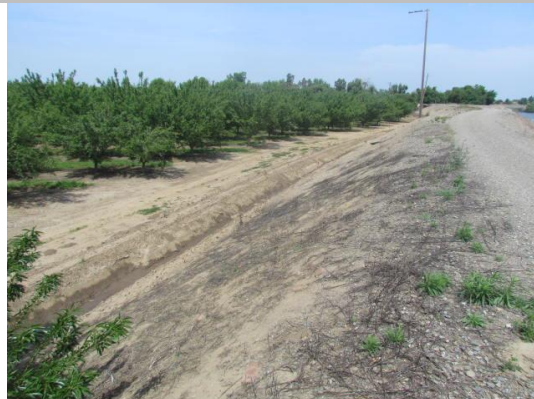
Photo 2 of 2 : FA\_2016\_RD0524\_107\_194\_20160929\_00237.jpg

Looking east at south end of irrigation ditch at landward toe.

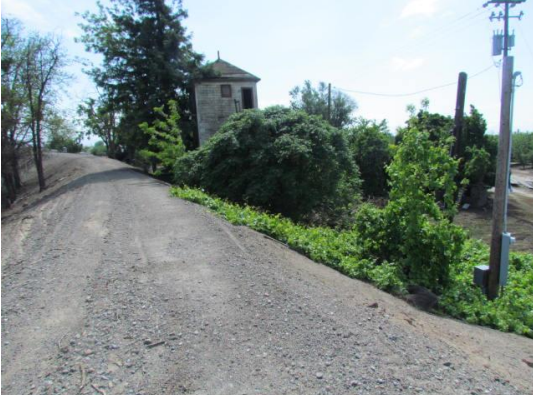
Photo 1 of 1 : FA\_2016\_RD0524\_107\_59\_20160929\_001110.jpg

Looking south at dense veg on landward slope and toe.

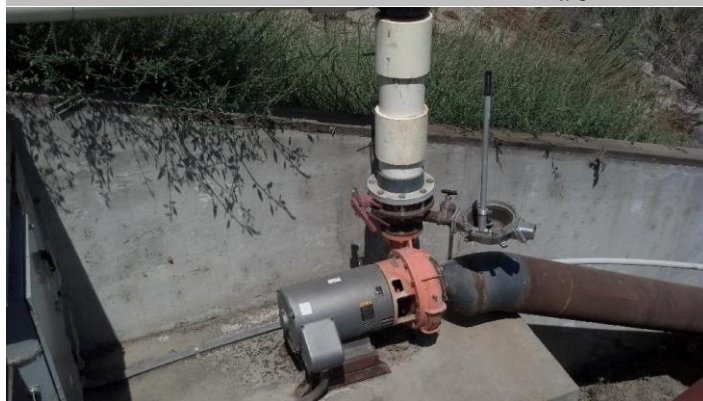
Photo 1 of 2 : UCIP\_FA\_2016\_22725\_38445.jpg

FS\_ID:22725  
DS\_ID:24044  
EP\_NO: N/A  
Repair Type: Non-Urgent  
Crossing Status: Found  
UCIP Comments: No permit identified for this crossing.  
FIELD\_STRUCT\_DESC: 8-inch steel irrigation pipe through the levee 0-feet below the crown. Pipe integrated into steel cattelguard style crossing. Slant pump and butterfly valve at concrete foundation on WS slope. Filter plant, vents, and butterfly valves on LS toe.  
FS Date: 8/20/2013

Pump and butterfly valve on concrete pad on WS shoulder.

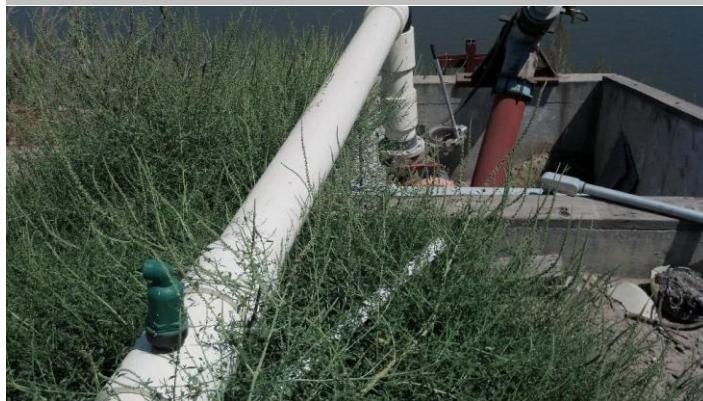
Photo 2 of 2 : UCIP\_FA\_2016\_22725\_38444.jpg

Vent on PVC pipe at WS shoulder.

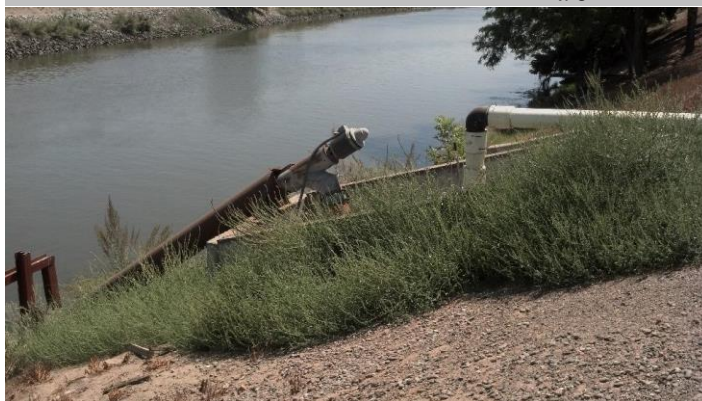
Photo 1 of 2 : UCIP\_FA\_2016\_18307\_30528.jpg

LM Start	3.79	Rating **	M	Issue No.	936
LM End	3.79	Issue Type +	En	Location *	LS
Category	Supplemental			GPS Latitude/Longitude	
				Start	End
Item	DWR UCIP Field Study			37.902361 °	37.902361 °
				-121.326443 °	-121.326443 °
DWR ID					
Comment Code					
Inspector Comment					
FS_ID:18307					
DS_ID:20620					
EP_NO: N/A					
Repair Type: Non-Urgent					
Crossing Status: Found					
UCIP Comments: Appears abandoned and if so should be done so properly. Evidence of severe internal corrosion in concrete distribution box at LS toe.					
FIELD_STRUCT_DESC: 12-inch concrete encased pipe through the levee 10.5 feet below the crown, pump and gate valve in pump house on the waterward slope. 6'X6' Concrete distribution box on the landward toe. Two concrete cutoff walls. Service pole at the landward toe. Originally included in the 1964 O&M manual.					
FS Date: 8/20/2013

Slant pump visible at concrete foundation on WS slope. Pumphouse removed.

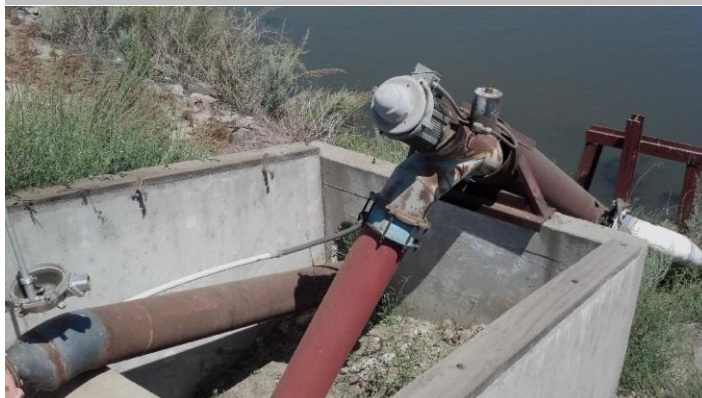
Photo 2 of 2 : UCIP\_FA\_2016\_18307\_30527.jpg

Slant pump and pipe on WS slope.

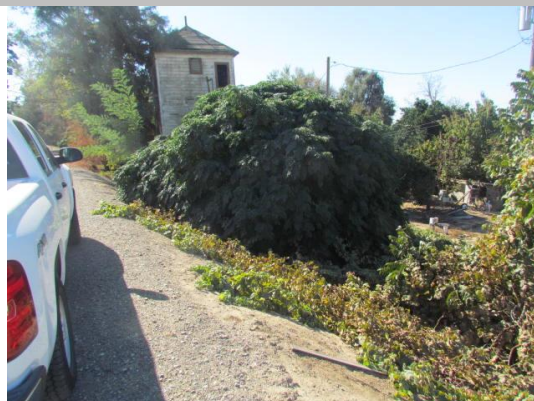
Photo 1 of 1 : FA\_2016\_RD0524\_107\_928\_20160929\_00287.jpg

LM Start	3.80	Rating **	U	Issue No.	928
LM End	3.81	Issue Type +	Ma	Location *	LS
Category	Earthen Levee			GPS Latitude/Longitude	
				Start	End
Item	Trim / Thin Trees			37.902155 °	37.902002 °
				-121.326523 °	-121.326550 °
DWR ID	DWR_RD0524_01_s_2012_928				
Comment Code					
T1 : Trim trees to at least five feet above ground level.					
Inspector Comment					
Several trees on landward slope.

Looking south at dense vegetation on landward slope and toe.

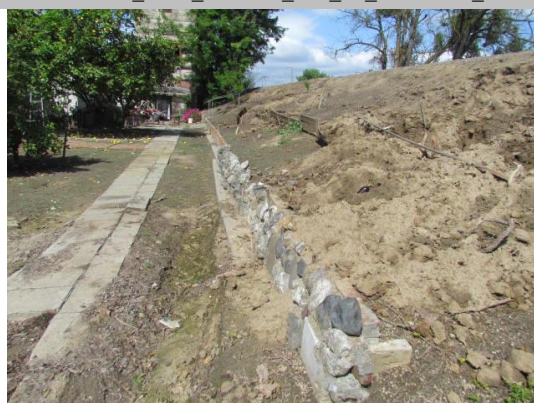
Photo 1 of 3 : FA\_2016\_RD0524\_107\_92\_20160929\_00148.jpg

LM Start	3.82	Rating **	U	Issue No.	92
LM End	3.82	Issue Type +	En	Location *	LS
Category	Earthen Levee			GPS Latitude/Longitude	
				Start	End
Item	Encroachments			37.901912 °	37.901912 °
				-121.326533 °	-121.326533 °
DWR ID	DWR_RD0524_01_s_2016_92				
Comment Code					
RW : Retaining Wall					
Inspector Comment					
Unauthorized retaining wall, sprinklers, and steps on landward slope.

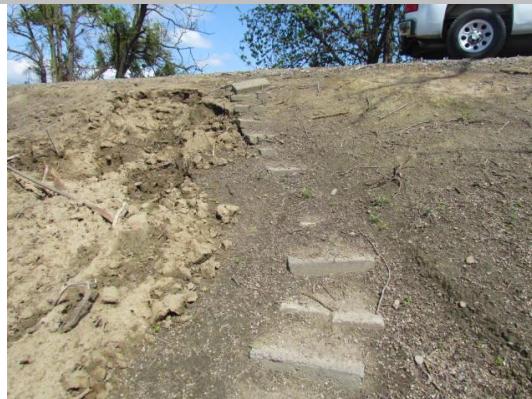
Photo 2 of 3 : FA\_2016\_RD0524\_107\_92\_20160929\_00149.jpg

LM Start	3.82	Rating **	U	Issue No.	92 (cont)	
LM End	3.82	Issue Type +	En	Location *	LS	
Category	Earthen Levee			GPS Latitude/Longitude		
				Start		End
Item	Encroachments			37.901912 °		37.901912 °
				-121.326533 °		-121.326533 °
DWR ID	DWR_RD0524_01_s_2016_92					
Comment Code						
RW : Retaining Wall						
Inspector Comment						
Unauthorized retaining wall, sprinklers, and steps on landward slope.

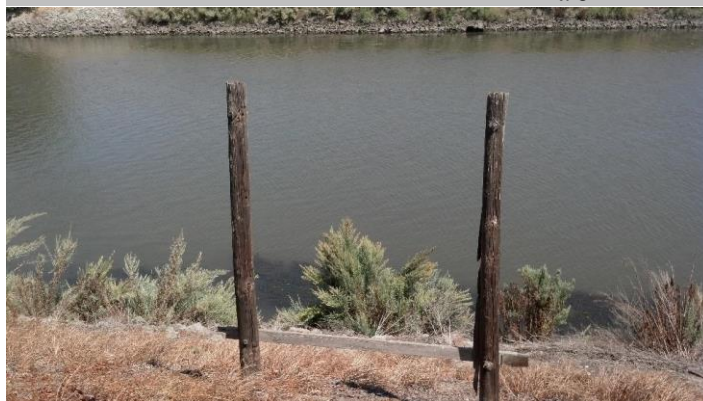
Photo 1 of 2 : UCIP\_FA\_2016\_41464\_30543.jpg

FS\_ID:41464  
DS\_ID:20621  
EP\_NO: N/A  
Repair Type: Non-Urgent  
Crossing Status: Found  
UCIP Comments: Appears to be abandoned as signage has been removed.  
FIELD\_STRUCT\_DESC: 2.5-inch submarine telephone conduit through levee and across channel 2.0 feet below crown. Sign posts remain on both sides of river on the waterward slope.  
FS Date: 8/20/2013

Sign posts with sign removed on WS slope.

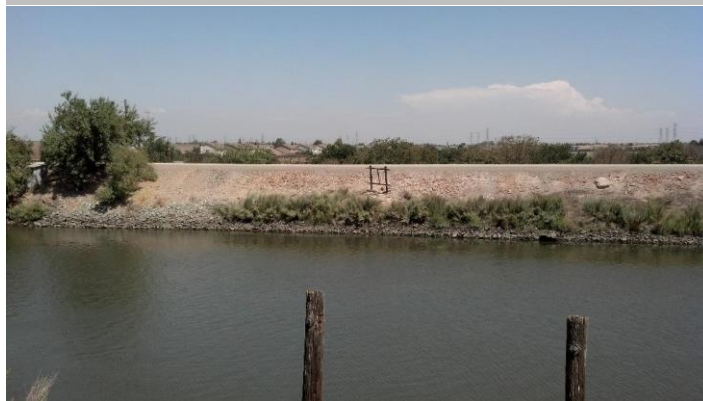
Photo 2 of 2 : UCIP\_FA\_2016\_41464\_30542.jpg

Sign posts visible on opposite river bank in same condition.

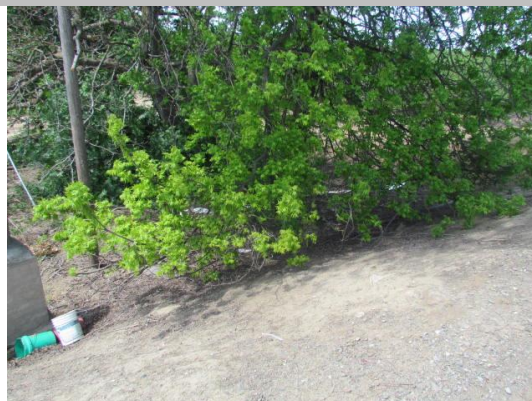
Photo 1 of 1 : FA\_2016\_RD0524\_107\_61\_20160929\_00112.jpg

LM Start	4.03	Rating **	M	Issue No.	61
LM End	4.03	Issue Type +	Ma	Location *	LS
Category	Earthen Levee			GPS Latitude/Longitude	
				Start	End
Item	Trim / Thin Trees			37.898925 °	37.898925 °
				-121.327015 °	-121.327015 °
DWR ID	DWR_RD0524_01_s_2012_61				
Comment Code					
T1 : Trim trees to at least five feet above ground level.					
Inspector Comment

Looking east at untrimmed tree at landward toe.

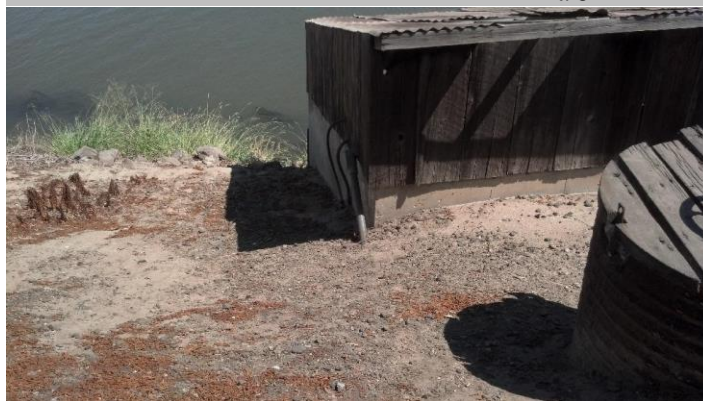
Photo 1 of 2 : UCIP\_FA\_2016\_18314\_30559.jpg

LM Start	4.04	Rating **	M	Issue No.	937
LM End	4.04	Issue Type +	En	Location *	LS
Category	Supplemental			GPS Latitude/Longitude	
				Start	End
Item	DWR UCIP Field Study			37.898853 °	37.898853 °
				-121.327049 °	-121.327049 °
DWR ID					
Comment Code					
Inspector Comment					
FS_ID:18314 DS_ID:20623 EP_NO: N/A Repair Type: Non-Urgent Crossing Status: Found UCIP Comments: Appears abandoned and if so should be done so properly. FIELD_STRUCT_DESC: 8-inch concrete encased pipe through the levee 9.5-feet below crown, pump and gate valve in pump house on the waterward slope. Slide gate in 42-inch corrugated metal pipe riser on the waterward slope. Brick standpipe at the toe of the landward slope. 1.5-inch galvanized iron electrical conduit through the levee 3-feet below the crown at the same location. Originally included in the 1964 O&M manual. FS Date: 8/20/2013

Electrical conduit visible on WS slope at pumphouse.

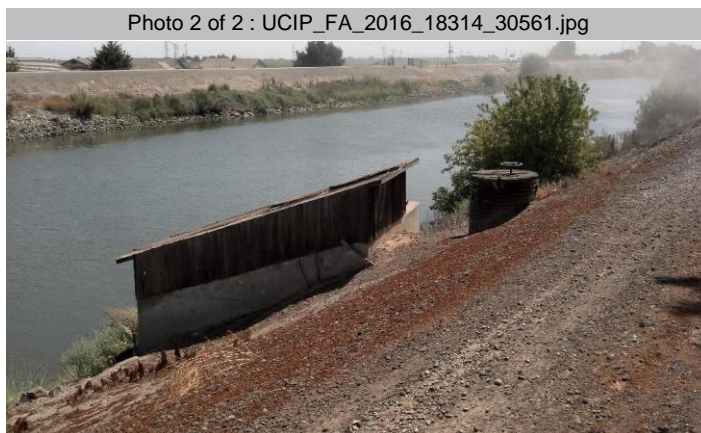
LM Start	4.04	Rating **	M	Issue No.	937 (cont)	
LM End	4.04	Issue Type +	En	Location *	LS	
Category	Supplemental			GPS Latitude/Longitude		
				Start		End
Item	DWR UCIP Field Study			37.898853 °	37.898853 °	
				-121.327049 °	-121.327049 °	
DWR ID						
Comment Code						
Inspector Comment						
FS_ID:18314 DS_ID:20623 EP_NO: N/A Repair Type: Non-Urgent Crossing Status: Found UCIP Comments: Appears abandoned and if so should be done so properly. FIELD_STRUCT_DESC: 8-inch concrete encased pipe through the levee 9.5-feet below crown, pump and gate valve in pump house on the waterward slope. Slide gate in 42-inch corrugated metal pipe riser on the waterward slope. Brick standpipe at the toe of the landward slope. 1.5-inch galvanized iron electrical conduit through the levee 3-feet below the crown at the same location. Originally included in the 1964 O&M manual. FS Date: 8/20/2013

Pumphouse and gate valve in CMP riser on WS slope.

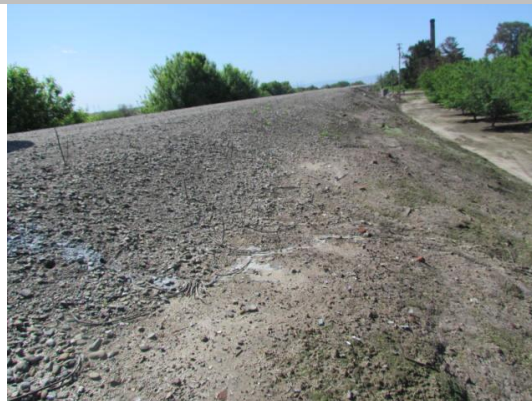
Photo 1 of 3 : FA\_2016\_RD0524\_107\_108\_20160929\_00169.jpg

LM Start	4.10	Rating **	U	Issue No.	108
LM End	4.15	Issue Type +	Ma	Location *	LS
Category	Earthen Levee			GPS Latitude/Longitude	
				Start	End
Item	Slope Stability			37.898035 °	°
				-121.327447 °	-121.327806 °
DWR ID	DWR_RD0524_01_s_2012_108				
Comment Code					
S1 : Repair slope instability.					
Inspector Comment					
Slope depression is greater than 1" and longer than 200'.

Looking north at caving slope on landside of levee.

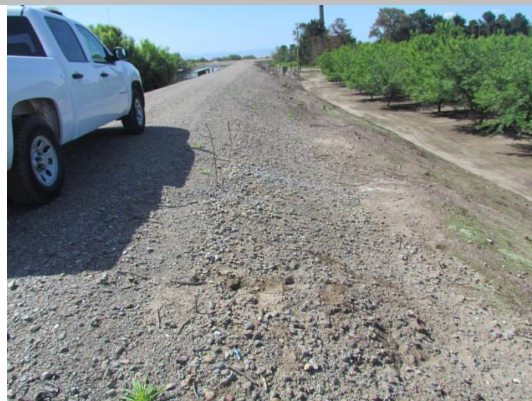
Photo 2 of 3 : FA\_2016\_RD0524\_107\_108\_20160929\_00170.jpg

LM Start	<b>4.10</b>	Rating **	U	Issue No.	<b>108 (cont)</b>
LM End	<b>4.15</b>	Issue Type +	Ma	Location *	LS

Looking south at damage slope on landside of levee.

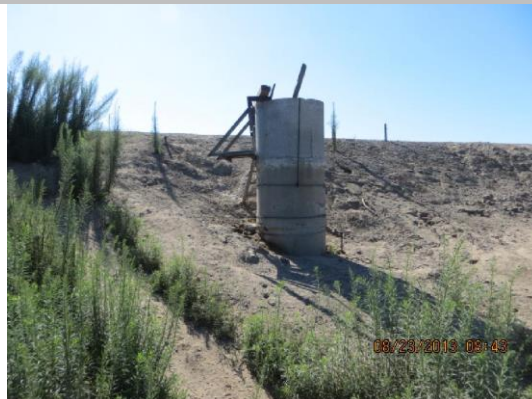
Photo 1 of 2 : UCIP\_FA\_2016\_18318\_30589.jpg

LM Start	4.16	Rating **	M	Issue No.	938
LM End	4.16	Issue Type +	En	Location *	LS
Category	Supplemental			GPS Latitude/Longitude	
				Start	End
Item	DWR UCIP Field Study			37.897118 °	37.897118 °
				-121.327910 °	-121.327910 °
DWR ID					
Comment Code					
Inspector Comment					
FS_ID:18318					
DS_ID:20625					
EP_NO: N/A					
Repair Type: Non-Urgent					
Crossing Status: Found					
UCIP Comments: Small leak on WS slope causing minor erosion on WS slope.					
FIELD_STRUCT_DESC: 12-inch steel irrigation pipe through the levee 4.5 feet below the crown, pumphouse and gate valve on the waterward slope. 36-inch concrete standpipe, power pole, and meter on LS toe.					
Originally included in the 1964 O&M manual.					
FS Date: 8/23/2013

Concrete standpipe on LS slope.

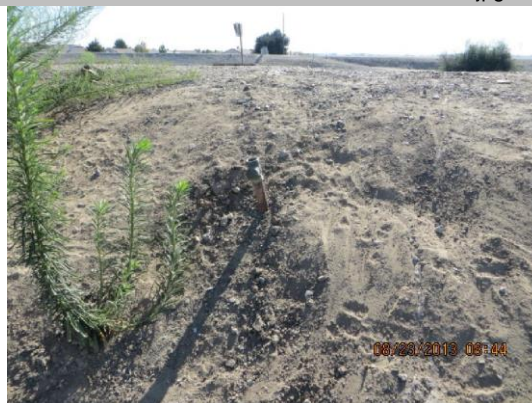
Photo 2 of 2 : UCIP\_FA\_2016\_18318\_30588.jpg

LM Start	<b>4.16</b>	Rating **	M	Issue No.	<b>938 (cont)</b>
LM End	<b>4.16</b>	Issue Type +	En	Location *	LS

Vent or siphon breaker just off LS shoulder.

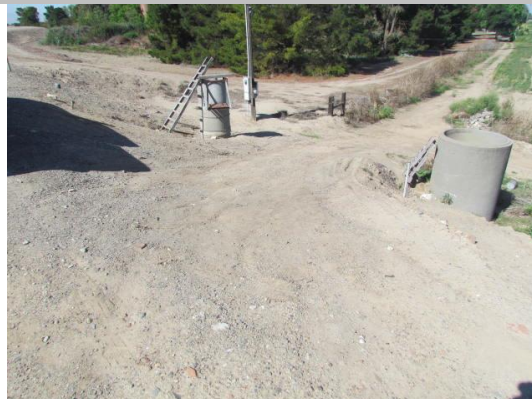
Photo 1 of 1 : FA\_2016\_RD0524\_107\_110\_20160929\_00172.jpg

LM Start	4.16	Rating **	M	Issue No.	110
LM End	4.16	Issue Type +	En	Location *	LS
Category	Earthen Levee			GPS Latitude/Longitude	
				Start	End
Item	Encroachments			37.897103 °	37.897103 °
				-121.327895 °	-121.327895 °
DWR ID	DWR_RD0524_01_s_2012_110				
Comment Code					
RA : Ramp					
Inspector Comment					
Two unauthorized ramps on landward slope.

Looking southwest at an unauthorized ramp on landside slope.

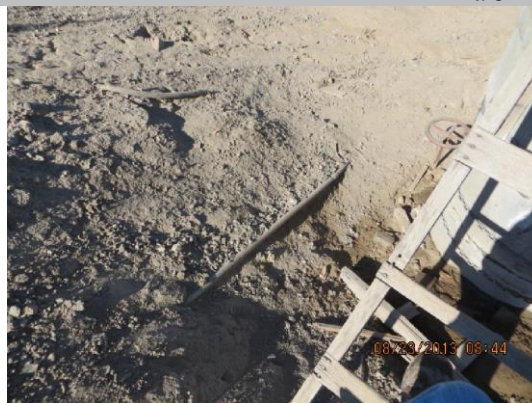
Photo 1 of 2 : UCIP\_FA\_2016\_22069\_37660.jpg

LM Start	4.17	Rating **	M	Issue No.	947
LM End	4.17	Issue Type +	En	Location *	LS
Category	Supplemental			GPS Latitude/Longitude	
				Start	End
Item	DWR UCIP Field Study			37.897074 °	37.897074 °
				-121.327926 °	-121.327926 °
DWR ID					
Comment Code					
Inspector Comment					
FS_ID:22069 DS_ID:24049 EP_NO: N/A Repair Type: Non-Urgent Crossing Status: Found UCIP Comments: No permit identified for this crossing. FIELD_STRUCT_DESC: 2.25-inch PVC domestic water service through the levee 5-feet below the crown. Pump and tank on WS slope with a vent on the LS slope. FS Date: 8/23/2013

Pipe visible on LS slope.

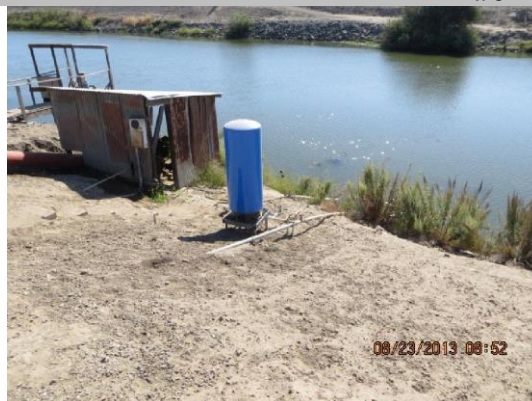
Photo 2 of 2 : UCIP\_FA\_2016\_22069\_37659.jpg

LM Start	4.17	Rating **	M	Issue No.	947 (cont)
LM End	4.17	Issue Type +	En	Location *	LS
Category	Supplemental			GPS Latitude/Longitude	
				Start	End
Item	DWR UCIP Field Study			37.897074 °	37.897074 °
				-121.327926 °	-121.327926 °
DWR ID					
Comment Code					
Inspector Comment					
FS_ID:22069 DS_ID:24049 EP_NO: N/A Repair Type: Non-Urgent Crossing Status: Found UCIP Comments: No permit identified for this crossing. FIELD_STRUCT_DESC: 2.25-inch PVC domestic water service through the levee 5-feet below the crown. Pump and tank on WS slope with a vent on the LS slope. FS Date: 8/23/2013

Pipe, pump, and tank visible on WS slope.

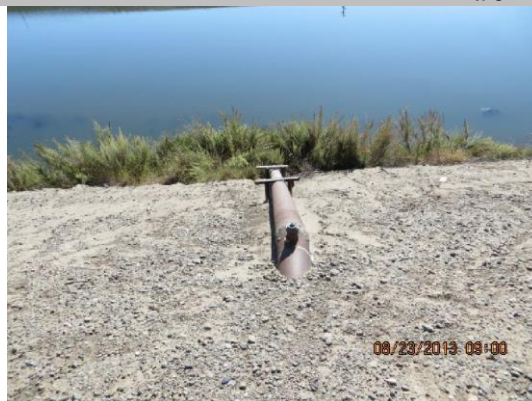
Photo 1 of 2 : UCIP\_FA\_2016\_18320\_30594.jpg

LM Start	4.37	Rating **	M	Issue No.	934
LM End	4.37	Issue Type +	En	Location *	LS
Category	Supplemental			GPS Latitude/Longitude	
				Start	End
Item	DWR UCIP Field Study			37.894453 °	37.894453 °
				-121.329232 °	-121.329232 °
DWR ID					
Comment Code					
Inspector Comment					
FS_ID:18320					
DS_ID:20626					
EP_NO: N/A					
Repair Type: Non-Urgent					
Crossing Status: Found					
UCIP Comments: Small leak in pipe on LS slope and pipe slightly crushed on LS toe.					
FIELD_STRUCT_DESC: 9-inch steel stormdrain pipe through the levee 3.0 feet below the crown, pump in drain ditch on the landward side.					
Siphon breaker on the waterward slope. Originally included in the 1964 O&M manual.					
FS Date: 8/23/2013

Pipe and siphon breaker on WS slope.

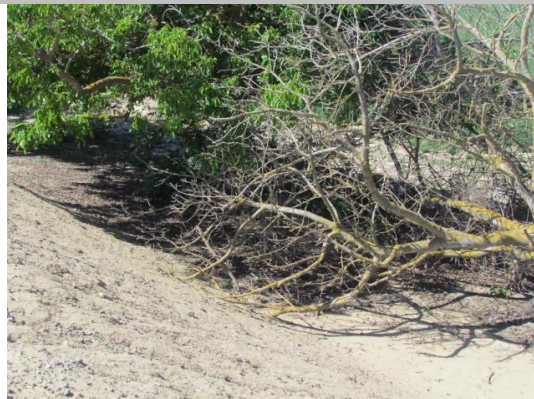
Photo 1 of 1 : FA\_2016\_RD0524\_107\_111\_20160929\_00173.jpg

LM Start	4.38	Rating **	M	Issue No.	111
LM End	4.38	Issue Type +	En	Location *	LS
Category	Earthen Levee			GPS Latitude/Longitude	
				Start	End
Item	Encroachments			37.894258 °	37.894258 °
				-121.329247 °	-121.329247 °
DWR ID	DWR_RD0524_01_s_2012_111				
Comment Code					
TR : Tree or limb					
Inspector Comment					
Dead tree at landside toe should be removed from levee toe.

Looking west at dead tree at landside toe.

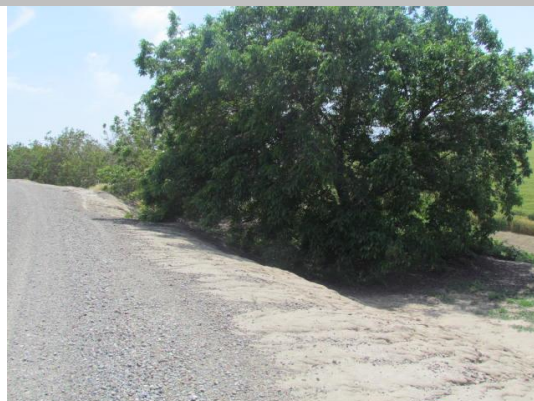
Photo 1 of 2 : FA\_2016\_RD0524\_107\_112\_20160929\_00174.jpg

LM Start	4.40	Rating **	U	Issue No.	112
LM End	4.53	Issue Type +	Ma	Location *	LS
Category	Earthen Levee			GPS Latitude/Longitude	
				Start	End
Item	Trim / Thin Trees			37.893928 °	37.892230 °
				-121.329203 °	-121.328187 °
DWR ID	DWR_RD0524_01_s_2012_112				
Comment Code					
T1 : Trim trees to at least five feet above ground level.					
Inspector Comment					
Untrimmed trees along landward slope and toe.

Looking southeast at untrimmed tree at landward toe.

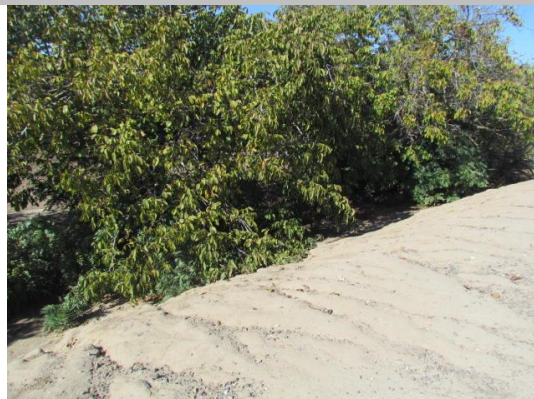
Photo 2 of 2 : FA\_2016\_RD0524\_107\_112\_20160929\_00175.jpg

LM Start	<b>4.40</b>	Rating **	U	Issue No.	<b>112 (cont)</b>
LM End	<b>4.53</b>	Issue Type +	Ma	Location *	LS

Looking northeast at untrimmed tree on landward slope and toe fall 2015.

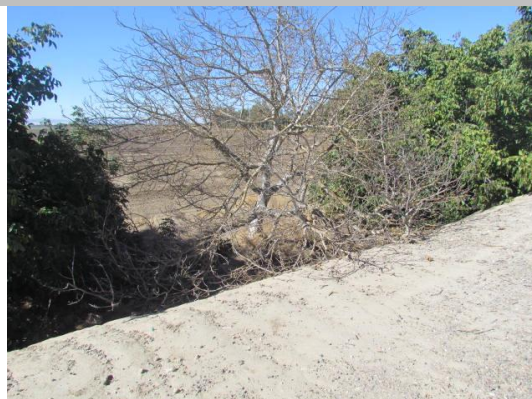
Photo 1 of 1 : FA\_2016\_RD0524\_107\_199\_20160929\_00244.jpg

LM Start	4.43	Rating **	U	Issue No.	199
LM End	4.43	Issue Type +	Ma	Location *	LS
Category	Earthen Levee			GPS Latitude/Longitude	
				Start	End
Item	Encroachments			37.893582 °	37.893582 °
				-121.329108 °	-121.329108 °
DWR ID	DWR_RD0524_01_f_2015_199				
Comment Code					
TR : Tree or limb					
Inspector Comment					
Remove dead tree from landward toe.

Looking west at dead tree on landward slope and toe fall 2015.

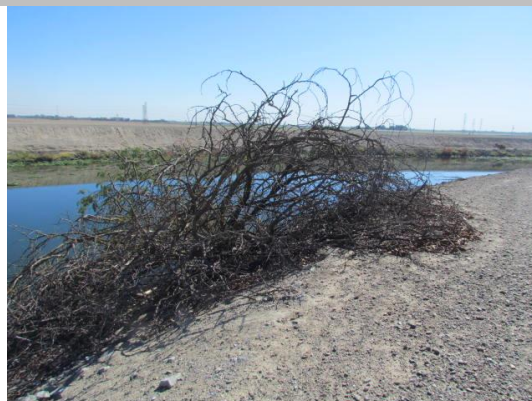
Photo 1 of 2 : FA\_2016\_RD0524\_107\_102\_20160929\_00160.jpg

LM Start	4.52	Rating **	U	Issue No.	102
LM End	4.52	Issue Type +	En	Location *	WS
Category	Earthen Levee			GPS Latitude/Longitude	
				Start	End
Item	Encroachments			37.892368 °	37.892368 °
				-121.328200 °	-121.328200 °
DWR ID	DWR_RD0524_01_f_2016_102				
Comment Code					
TR : Tree or limb					
Inspector Comment					
Dead tree on waterward slope.

Looking southeast at dead tree on waterside slope fall 2015

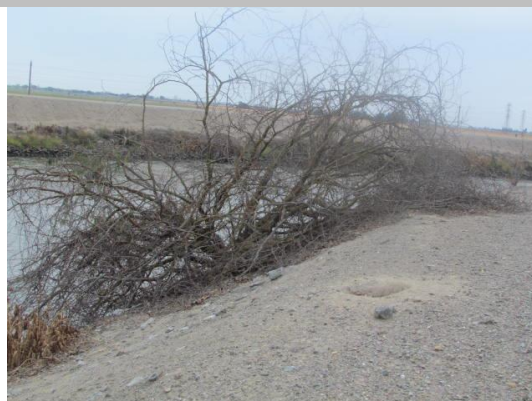
Photo 2 of 2 : FA\_2016\_RD0524\_107\_102\_20160929\_00161.jpg

LM Start	<b>4.52</b>	Rating **	U	Issue No.	<b>102 (cont)</b>
LM End	<b>4.52</b>	Issue Type +	En	Location *	WS

Looking southeast at dead tree on waterside slope.

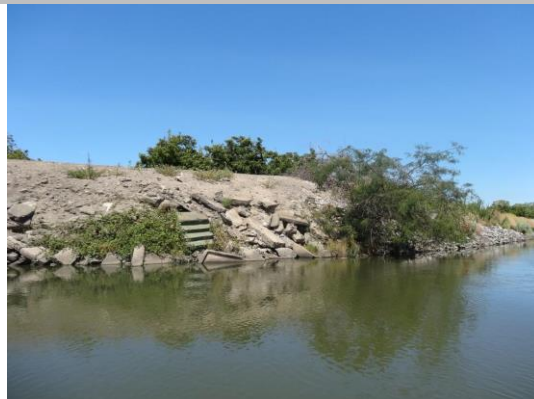
Photo 1 of 2 : SJR2016\_RD0524U01RM45.07\_3.jpg

LM Start	4.53	Rating **	U	Issue No.	132
LM End	4.54	Issue Type +	Ma	Location *	WS
Category	Supplemental			GPS Latitude/Longitude	
				Start	End
Item	DWR Erosion Survey			37.892230 °	37.892230 °
				-121.327930 °	-121.327930 °
DWR ID					
Comment Code					
Inspector Comment					
07/25/2016: No significant change observed.					
06/24/2015: No significant change observed.					
06/19/2014: No significant change observed.					
08/13/2013: No significant change observed.					
08/07/2012: The erosion is located at the inside of a river bend. Site is covered with broken concrete blocks and other debris. [2016 Site ID:RD0524U01RM45.07]

Front view of the site. Note the loosely placed concrete blocks at the site.

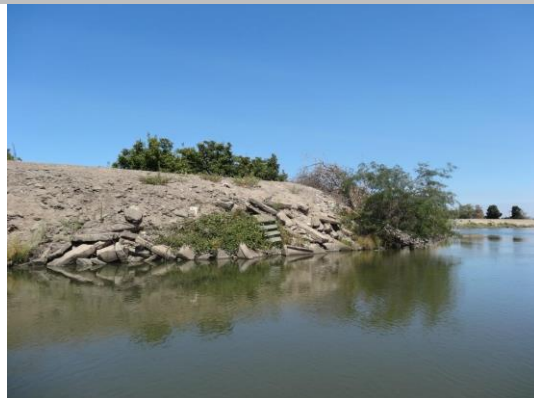
Photo 2 of 2 : SJR2016\_RD0524U01RM45.07\_4.jpg

Upstream view of the erosion.

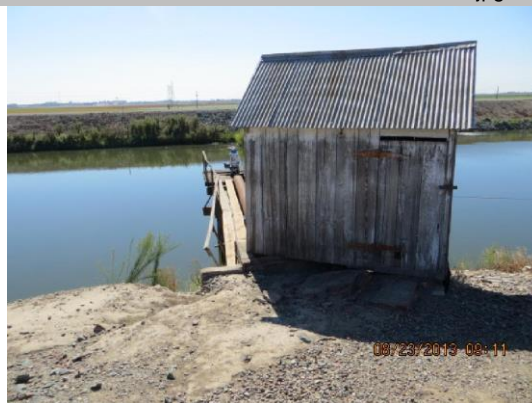
Photo 2 of 2 : UCIP\_FA\_2016\_18323\_30602.jpg

Pump on pier and slide gate house on WS shoulder.

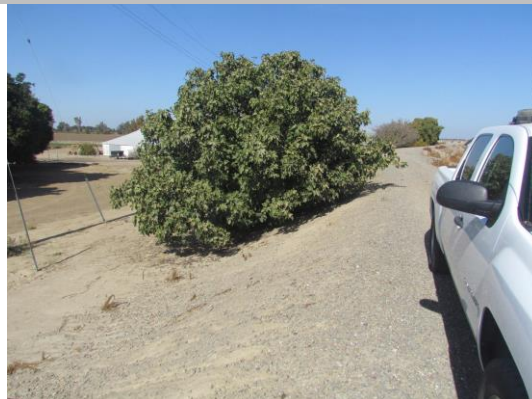
Photo 1 of 1 : FA\_2016\_RD0524\_107\_67\_20161013\_00415.jpg

LM Start	4.70	Rating **	U	Issue No.	67
LM End	4.70	Issue Type +	Ma	Location *	LS
Category	Earthen Levee			GPS Latitude/Longitude	
				Start	End
Item	Trim / Thin Trees			37.890108 °	37.890108 °
				-121.329523 °	-121.329523 °
DWR ID	DWR_RD0524_01_s_2012_67				
Comment Code					
T1 : Trim trees to at least five feet above ground level.					
Inspector Comment					
Fig tree at landside toe.

Looking northwest at untrimmed tree on landward slope.

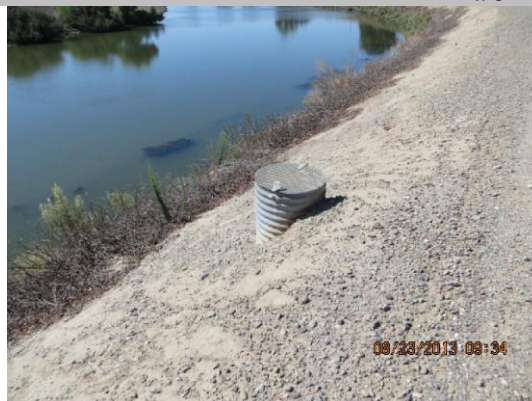
Photo 1 of 2 : UCIP\_FA\_2016\_22728\_38453.jpg

LM Start	4.89	Rating **	M	Issue No.	964
LM End	4.89	Issue Type +	En	Location *	WS
Category	Supplemental			GPS Latitude/Longitude	
				Start	End
Item	DWR UCIP Field Study			37.887694 °	37.887694 °
				-121.331019 °	-121.331019 °
DWR ID					
Comment Code					
Inspector Comment					
FS_ID:22728					
DS_ID:20628					
EP_NO: 3817					
Repair Type: Non-Urgent					
Crossing Status: Found					
UCIP Comments: Appears abandoned and if so should be done so properly.					
FIELD_STRUCT_DESC: *ABANDONED* 6-inch steel pipe through the levee 3.0 feet below the crown, pump 120-feet off the LS toe. Siphon breaker in 24-inch CMP on the waterward shoulder (Permit No. 3817)					
Originally included in the 1964 O&M manual.					
FS Date: 8/23/2013

Siphon breaker in 24-inch CMP riser on WS shoulder.

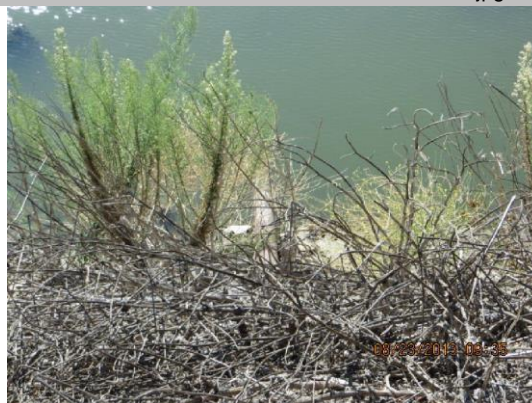
Photo 2 of 2 : UCIP\_FA\_2016\_22728\_38452.jpg

LM Start	<b>4.89</b>	Rating **	M	Issue No.	<b>964 (cont)</b>
LM End	<b>4.89</b>	Issue Type +	En	Location *	WS

Pipe visible on WS toe.

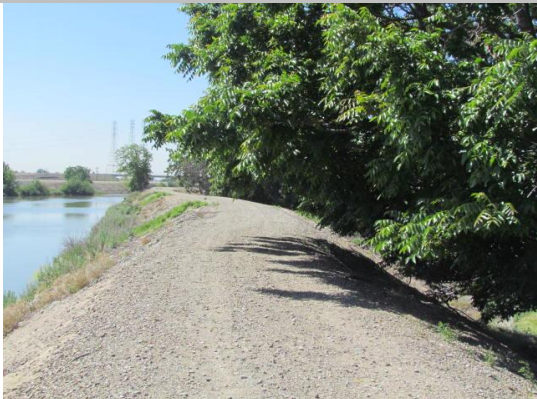
Photo 1 of 1 : FA\_2016\_RD0524\_107\_68\_20160929\_001116.jpg

Looking south at overhanging trees.

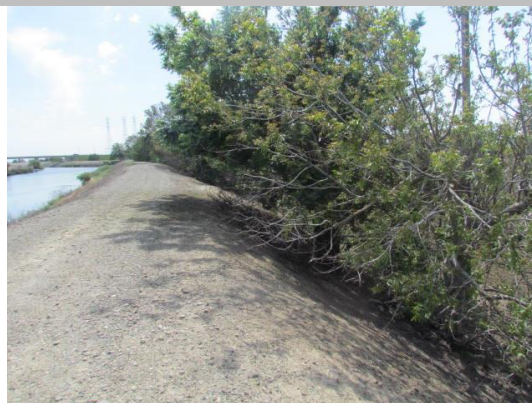
Photo 1 of 1 : FA\_2016\_RD0524\_107\_85\_20160929\_00139.jpg

Looking south at untrimmed trees on landward slope.

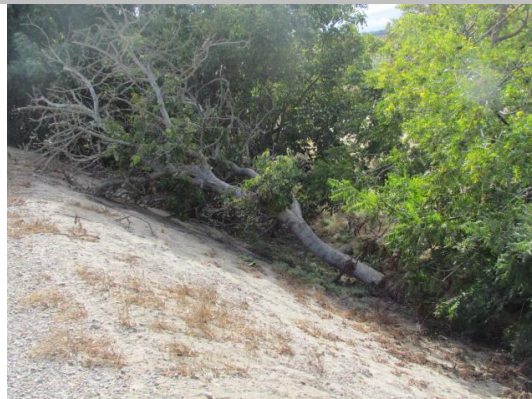
Photo 1 of 1 : FA\_2016\_RD0524\_107\_178\_20160929\_00223.jpg

LM Start	5.39	Rating **	M	Issue No.	178
LM End	5.39	Issue Type +	Ma	Location *	LS
Category	Earthen Levee			GPS Latitude/Longitude	
				Start	End
Item	Encroachments			37.880806 °	37.880806 °
				-121.332833 °	-121.332833 °
DWR ID	DWR_RD0524_01_f_2014_178				
Comment Code					
TR : Tree or limb					
Inspector Comment					
Downed tree on landward toe.

Looking south at downed tree on landward slope.

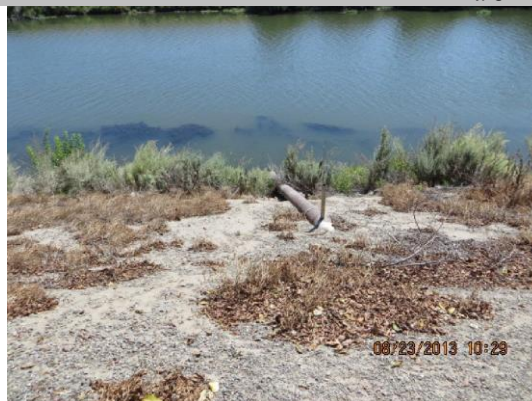
Photo 1 of 2 : UCIP\_FA\_2016\_50749\_30689.jpg

Comment Code					
Inspector Comment					
FS_ID:50749 DS_ID:20630 EP_NO: N/A Repair Type: Urgent Crossing Status: Found UCIP Comments: 11/16/2016 same as previous inspection hole in pipe is still present on WS near toe. This pipe does not appear to be in use. Need to contact owner to determine status of crossing. If the crossing is abandoned or still in use, owner will need to coordinate with the CVFPB to comply with Title 23 requirements. (O. Magana - DWR UCIP)08/23/2013 flap gate damage and does not work at WS toe. Large hole in pipe at WS toe. Pipe appears abandoned and should be done so properly. (W. Wylie - DWR UCIP) FIELD_STRUCT_DESC: *ABANDONED* 1 of 2: 12-inch steel irrigation pipe (O&M references 10-inch pipe) through the levee, 6 feet below the crown. Pump located on waterside (WS), no pump found in 2013. Flap gate located on the WS end. [Additional Reference(s): DWR Levee Log, 2004. USACE San Joaquin River O&M Unit No. 7, April 1964, (HLM 5.48), Drawing No. 07-04-1490, sheet 1490/4, station 8+01.3] FS Date: 11/16/2016

Pipe visible on WS slope.

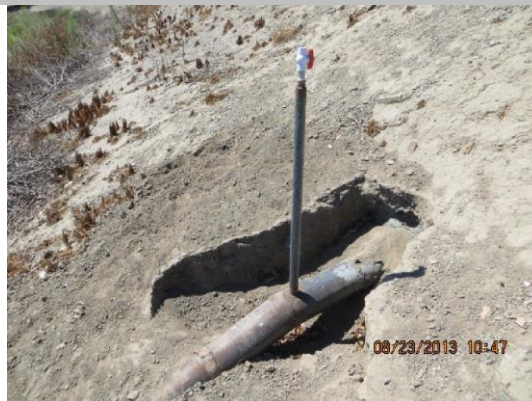
Photo 2 of 2 : UCIP\_FA\_2016\_18348\_30705.jpg

LM Start	<b>5.42</b>	Rating **	M	Issue No.	<b>944 (cont)</b>
LM End	<b>5.42</b>	Issue Type +	En	Location *	LS

8-inch pipe sleeved through 10-inch pipe with vent on WS slope.

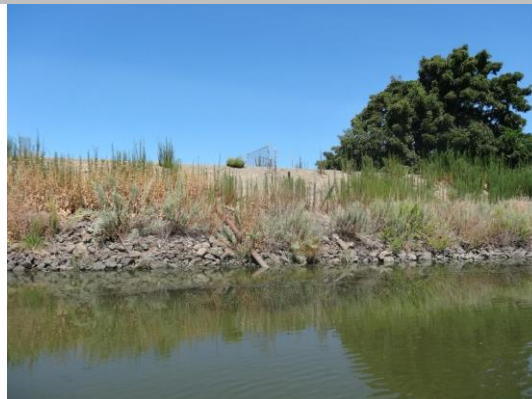
Photo 1 of 2 : SJR2016\_RD0524U01RM45.97\_1.jpg

LM Start	5.43	Rating **	U	Issue No.	134
LM End	5.43	Issue Type +	Ma	Location *	WS
Category	Supplemental			GPS Latitude/Longitude	
				Start	End
Item	DWR Erosion Survey			37.880320 °	37.880320 °
				-121.333266 °	-121.333266 °
DWR ID					
Comment Code					
Inspector Comment					
07/25/2016: No significant change observed.					
06/24/2015: No significant change observed.					
06/19/2014: No significant change observed.					
08/13/2013: The erosion seems to be getting worse. More material sloughing visible.					
08/07/2012: The erosion is underneath an irrigation pipe. The likely cause of the erosion is the pipe leakage. [2016 Site ID:RD0524U01RM45.97]

Close view of the erosion and the pipe on the site.

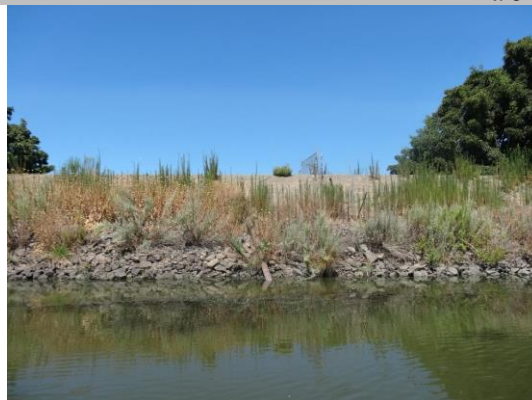
Photo 2 of 2 : SJR2016\_RD0524U01RM45.97\_4.jpg

Front view of the site.

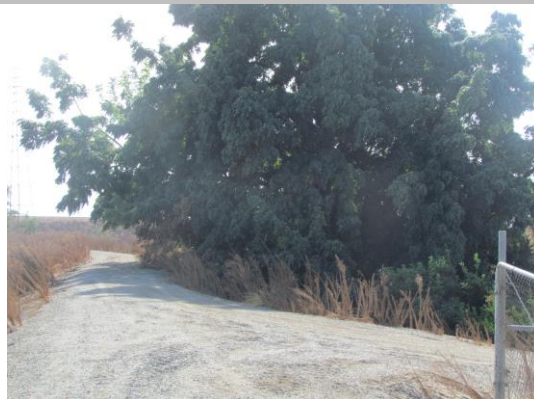
Photo 1 of 1 : FA\_2016\_RD0524\_107\_73\_20161013\_00414.jpg

LM Start	5.44	Rating **	U	Issue No.	73
LM End	5.44	Issue Type +	Ma	Location *	LS
Category	Earthen Levee			GPS Latitude/Longitude	
				Start	End
Item	Trim / Thin Trees			37.880085 °	37.880085 °
				-121.333045 °	-121.333045 °
DWR ID	DWR_RD0524_01_s _ 2012_73				
Comment Code					
T1 : Trim trees to at least five feet above ground level.					
Inspector Comment					
Untrimmed trees on landward slope.

Looking southwest at large untrimmed tree on landward slope.

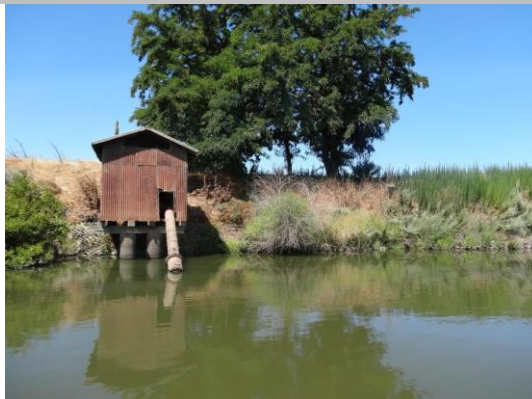
Photo 1 of 2 : SJR2016\_RD0524U01RM46.06\_3.jpg

LM Start	5.53	Rating **	M	Issue No.	135
LM End	5.53	Issue Type +	Ma	Location *	WS
Category	Supplemental			GPS Latitude/Longitude	
				Start	End
Item	DWR Erosion Survey			37.878920 °	37.878920 °
				-121.332670 °	-121.332670 °
DWR ID					
Comment Code					
Inspector Comment					
07/25/2016: No significant change observed.					
06/24/2015: No significant change observed.					
6/19/2014: No significant change observed.					
08/13/2013: Larger trees are at the levee shoulder, and an irrigation pump station is next to the erosion site. [2016 Site ID:RD0524U01RM46.06]

Close view of the site. Note large trees at the levee shoulder.

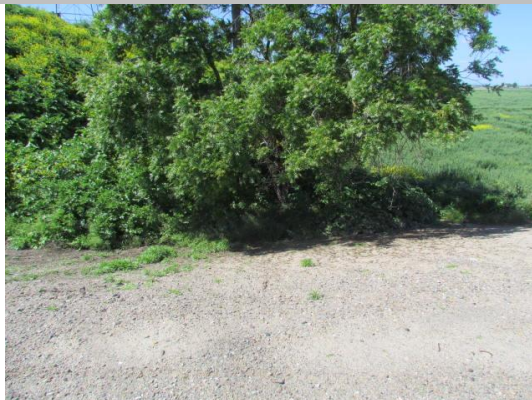
Photo 1 of 2 : FA\_2016\_RD0524\_107\_214\_20160929\_00258.jpg

LM Start	5.58	Rating **	U	Issue No.	214
LM End	5.58	Issue Type +	Ma	Location *	LS
Category	Earthen Levee			GPS Latitude/Longitude	
				Start	End
Item	Vegetation			37.878083 °	37.878083 °
				-121.332717 °	-121.332717 °
DWR ID	DWR_RD0524_01_s_2016_214				
Comment Code					
V2 : Remove the wild growth other than native grasses from the levee slopes.					
Inspector Comment					
Tall weeds, grasses and trees blocking view of landward toe.
