**Flood Control Project Maintenance  
Levee Inspections**

**Fall 2016 Levee Maintenance Deficiency Summary Report**

**Reclamation District No. 0524 Middle Roberts Island**

Waterway			Bank	Unit Miles
Unit No. 01 San Joaquin River			Left	6.20
	Spring (March - May)	Summer (June - August)	(September - November) Fall	Winter (December - February)
Unit Maintenance Rating (Fall Only)			<b>U</b>	
Date of Inspection	4/12/2016 - 4/13/2016		10/10/2016 - 10/11/2016	
DWR Inspector	Richard Willoughby		Richard Willoughby	
Accompanied By	Mario Jaques RD 524		Mario Jaques RD 524

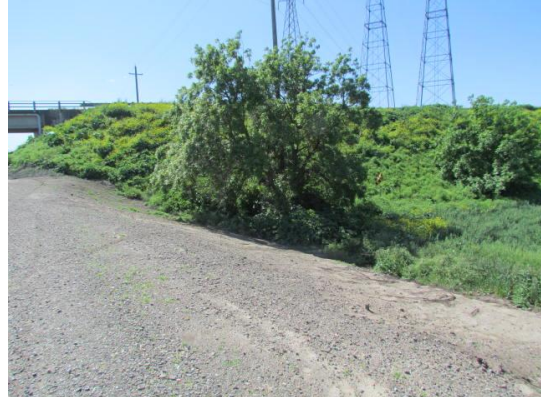
Photo 2 of 2 : FA\_2016\_RD0524\_107\_214\_20160929\_00259.jpg

LM Start	5.58	Rating **	U	Issue No.	214 (cont)	
LM End	5.58	Issue Type +	Ma	Location *	LS	
Category	Earthen Levee			GPS Latitude/Longitude		
				Start		End
Item	Vegetation			37.878083 °		37.878083 °
				-121.332717 °		-121.332717 °
DWR ID	DWR_RD0524_01_s_2016_214					
Comment Code						
V2 : Remove the wild growth other than native grasses from the levee slopes.						
Inspector Comment						
Tall weeds, grasses and trees blocking view of landward toe.

Looking west at dense veg at landward toe.

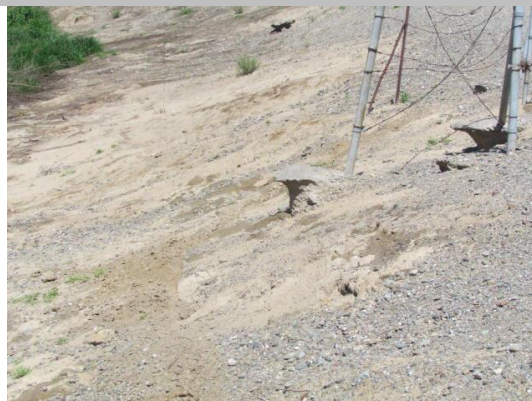
Photo 1 of 3 : FA\_2016\_RD0524\_107\_215\_20160929\_00260.jpg

LM Start	5.64	Rating **	U	Issue No.	215
LM End	5.64	Issue Type +	Ma	Location *	LS
Category	Earthen Levee			GPS Latitude/Longitude	
				Start	End
Item	Slope Stability			37.877378 °	37.877378 °
				-121.332343 °	-121.332343 °
DWR ID	DWR_RD0524_01_s_2016_215				
Comment Code					
S1 : Repair slope instability.					
Inspector Comment					
Levee slope damage is due vehicle traffic and foot traffic. Vehicle traffic created a ramp on landward slope.

Looking north at damage slope on landward slope.

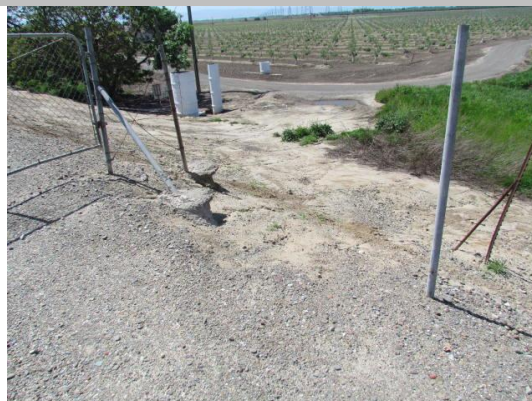
Photo 3 of 3 : FA\_2016\_RD0524\_107\_215\_20160929\_00262.jpg

Looking west at damage slope on landward slope.

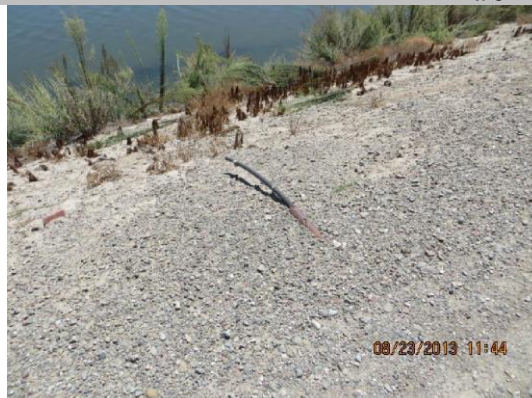
Photo 2 of 2 : UCIP\_FA\_2016\_18364\_30760.jpg

Steel conduit and electrical conduit visible on the WS shoulder.

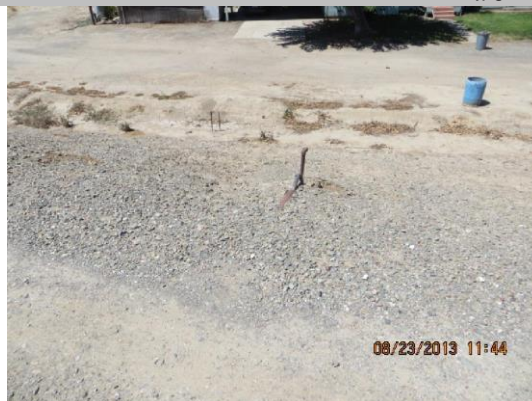
Photo 1 of 1 : UCIP\_FA\_2016\_40793\_30781.jpg

LM Start	5.74	Rating **	M	Issue No.	967
LM End	5.74	Issue Type +	En	Location *	LS
Category	Supplemental			GPS Latitude/Longitude	
				Start	End
Item	DWR UCIP Field Study			37.876001 °	37.876001 °
				-121.332725 °	-121.332725 °
DWR ID					
Comment Code					
Inspector Comment					
FS_ID:40793 DS_ID:20635 EP_NO: N/A Repair Type: Non-Urgent Crossing Status: Indicator Found UCIP Comments: Appears abandoned and if so should be done so properly. No permit identified for this crossing. FIELD_STRUCT_DESC: *ABANDONED* 1-inch steel waterline through the levee 1.0-foot below the crown. Pipe visible only on LS shoulder. FS Date: 8/23/2013

Steel waterline visible on LS shoulder.

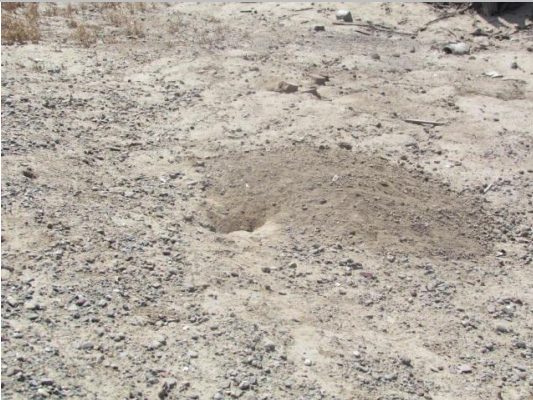
Photo 1 of 2 : FA\_2016\_RD0524\_107\_197\_20160929\_00239.jpg

Looking north at typical view of rodent holes on landward slope.

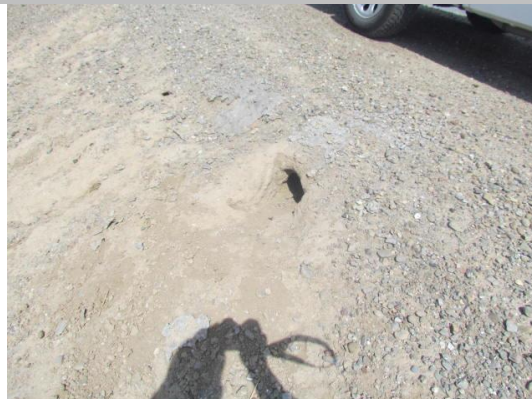
Photo 2 of 2 : FA\_2016\_RD0524\_107\_197\_20160929\_00240.jpg

LM Start	5.79	Rating **	M	Issue No.	197 (cont)	
LM End	5.79	Issue Type +	Ma	Location *	LS	
Category	Earthen Levee			GPS Latitude/Longitude		
				Start		End
Item	Animal Control			37.875310 °		37.875310 °
				-121.333065 °		-121.333065 °
DWR ID	DWR_RD0524_01_s_2015_197					
Comment Code						
A1 : Exterminate rodents and backfill and compact or grout burrows.						
Inspector Comment						
Several rodent holes on landward slope and levee crown.

Looking southwest at typical view of rodent hole at landward shoulder.

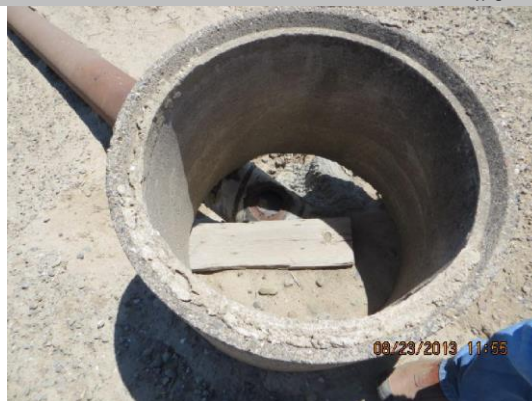
Photo 1 of 2 : UCIP\_FA\_2016\_18369\_30785.jpg

LM Start	5.81	Rating **	M	Issue No.	946
LM End	5.81	Issue Type +	En	Location *	LS
Category	Supplemental			GPS Latitude/Longitude	
				Start	End
Item	DWR UCIP Field Study			37.874972 °	37.874972 °
				-121.333246 °	-121.333246 °
DWR ID					
Comment Code					
Inspector Comment					
FS_ID:18369 DS_ID:20636 EP_NO: N/A Repair Type: Non-Urgent Crossing Status: Found UCIP Comments: Apparent leak on WS shoulder at concrete riser. Erosion under pipe. This may have been fixed when the pipe was sleeved with a PVC liner. FIELD_STRUCT_DESC: 10-inch steel storm drain pipe through the levee 5.0 feet below the crown. Pump on the landward side. Siphon breaker in a 36-inch concrete riser on the waterward shoulder. Power pole at the landward toe. PVC liner sleeved inside steel pipe. Originally included in the 1964 O&M manual. FS Date: 8/23/2013

Concrete standpipe over pipe on WS shoulder.

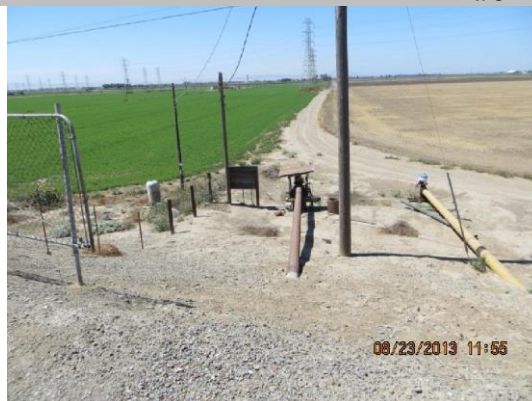
Photo 2 of 2 : UCIP\_FA\_2016\_18369\_30784.jpg

Item	DWR UCIP Field Study			37.874972 °	37.874972 °	
				-121.333246 °	-121.333246 °	
DWR ID						
Comment Code						
Inspector Comment						
FS_ID:18369						
DS_ID:20636						
EP_NO: N/A						
Repair Type: Non-Urgent						
Crossing Status: Found						
UCIP Comments: Apparent leak on WS shoulder at concrete riser.						
Erosion under pipe. This may have been fixed when the pipe was sleeved with a PVC liner.						
FIELD_STRUCT_DESC: 10-inch steel storm drain pipe through the levee 5.0 feet below the crown. Pump on the landward side. Siphon breaker in a 36-inch concrete riser on the waterward shoulder. Power pole at the landward toe. PVC liner sleeved inside steel pipe.						
Originally included in the 1964 O&M manual.						
FS Date: 8/23/2013

Pipe, pump, power pole, and meter off LS toe.

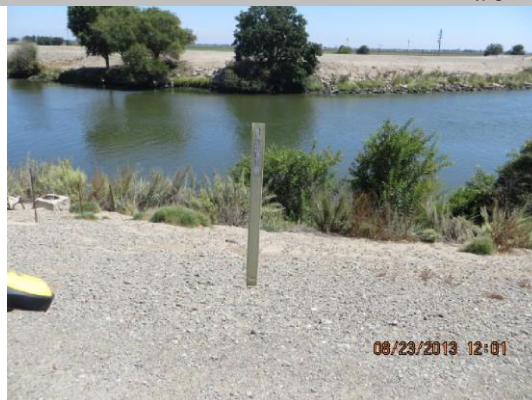
Photo 1 of 1 : UCIP\_FA\_2016\_18705\_31249.jpg

LM Start	5.82	Rating **	M	Issue No.	943
LM End	5.82	Issue Type +	En	Location *	LS
Category	Supplemental			GPS Latitude/Longitude	
				Start	End
Item	DWR UCIP Field Study			37.874829 °	37.874829 °
				-121.333265 °	-121.333265 °
DWR ID					
Comment Code					
Inspector Comment					
FS_ID:18705 DS_ID:20656 EP_NO: N/A Repair Type: Non-Urgent Crossing Status: Indicator Found UCIP Comments: Need to verify gasline exists and if so improve signage. FIELD_STRUCT_DESC: Gasline marker sign on WS shoulder. FS Date: 8/23/2013

Gasline marker on WS shoulder.

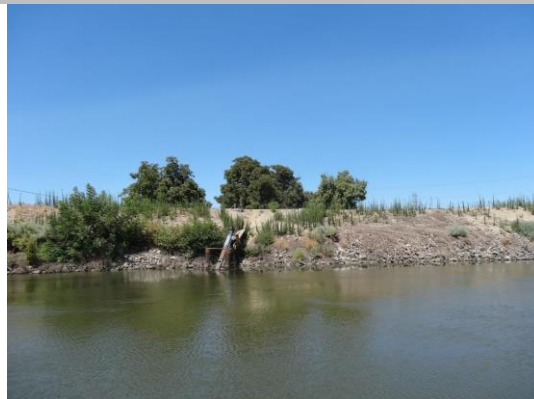
Photo 1 of 2 : SJR2016\_RD0524U01RM46.39\_2.jpg

LM Start	5.86	Rating **	U	Issue No.	139
LM End	5.86	Issue Type +	Ma	Location *	WS
Category	Supplemental			GPS Latitude/Longitude	
				Start	End
Item	DWR Erosion Survey			37.874370 °	37.874370 °
				-121.332850 °	-121.332850 °
DWR ID					
Comment Code					
Inspector Comment					
07/25/2016: No significant change observed.					
06/24/2015: No significant change observed.					
06/19/2014: No significant change observed.					
08/13/2013: No significant change observed.					
08/07/2012: The erosion is near a water-intake structure. Pipe leakage likely caused the erosion. [2016 Site ID:RD0524U01RM46.39]

Close view of the erosion and the pipe on the site.

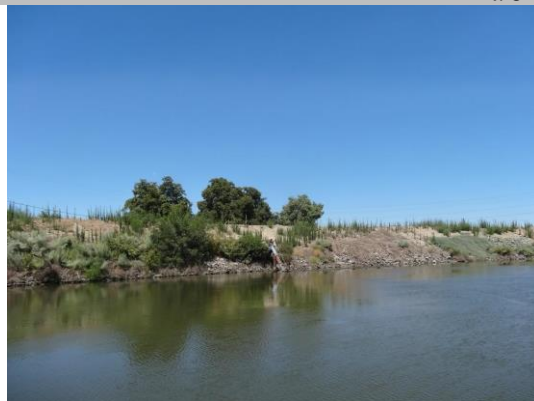
Photo 2 of 2 : SJR2016\_RD0524U01RM46.39\_4.jpg

Upstream view of the erosion and vegetation at the site.

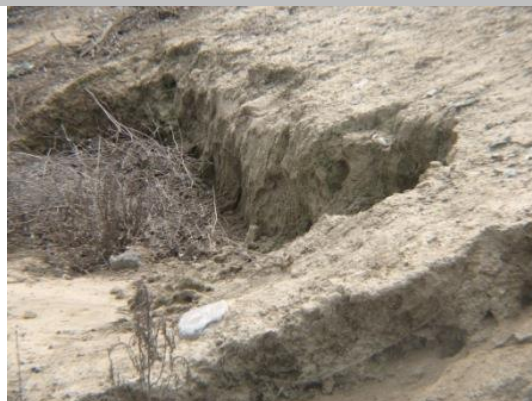
Photo 3 of 3 : FA\_2016\_RD0524\_107\_74\_20160929\_00123.jpg

LM Start	5.86	Rating **	U	Issue No.	74 (cont)	
LM End	5.87	Issue Type +	Ma	Location *	WS	
Category	Earthen Levee			GPS Latitude/Longitude		
				Start		End
Item	Erosion / Bank Caving			37.874240 °		37.874165 °
				-121.333185 °		-121.333155 °
DWR ID	DWR_RD0524_01_s_2012_74					
Comment Code						
E1 : Note and monitor erosion site.						
Inspector Comment						
Erosion on landward slope around intake pipe.

Erosion at waterward toe and around irrigation pipe at LM 5.92

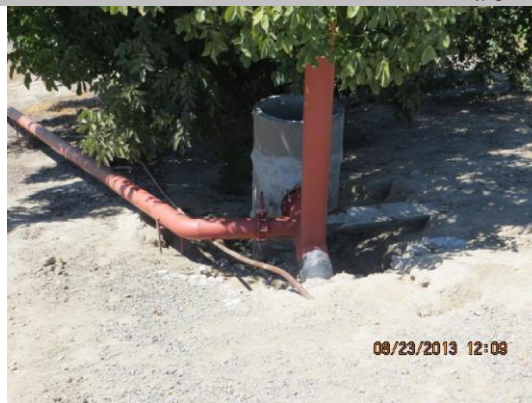
Photo 1 of 2 : UCIP\_FA\_2016\_18379\_30829.jpg

Comment Code					
Inspector Comment					
FS_ID:18379					
DS_ID:20638					
EP_NO: N/A					
Repair Type: Non-Urgent					
Crossing Status: Found					
UCIP Comments: Heavy erosion around pipe upstream of standpipe on LS slope. Verify pipe is not leaking and repair erosion on LS slope.					
FIELD_STRUCT_DESC: 12-inch steel irrigation pipe through the levee 10.0 feet below the crown. Slant pump on pier at WS toe. 10-inch steel standpipe on LS slope. 42-inch concrete standpipe on LS slope. Filter plant, and power pole on LS toe. 1.5-inch galvanized iron electrical conduit at same location. Originally included in the 1964 O&M manual.					
FS Date: 8/23/2013

Butterfly valves and standpipes on LS slope along with electrical conduit.

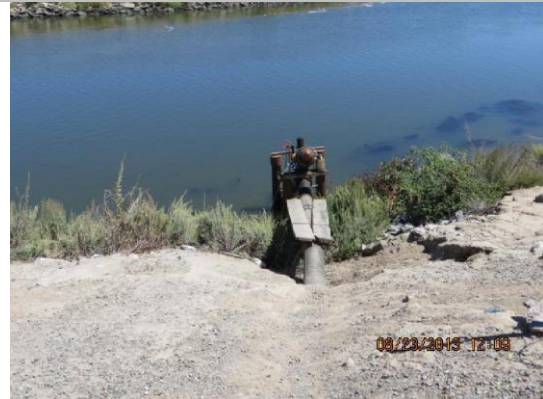
Photo 2 of 2 : UCIP\_FA\_2016\_18379\_30828.jpg

Comment Code					
Inspector Comment					
FS_ID:18379					
DS_ID:20638					
EP_NO: N/A					
Repair Type: Non-Urgent					
Crossing Status: Found					
UCIP Comments: Heavy erosion around pipe upstream of standpipe on LS slope. Verify pipe is not leaking and repair erosion on LS slope.					
FIELD_STRUCT_DESC: 12-inch steel irrigation pipe through the levee 10.0 feet below the crown. Slant pump on pier at WS toe. 10-inch steel standpipe on LS slope. 42-inch concrete standpipe on LS slope. Filter plant, and power pole on LS toe. 1.5-inch galvanized iron electrical conduit at same location. Originally included in the 1964 O&M manual.					
FS Date: 8/23/2013

Slant pump on WS toe.

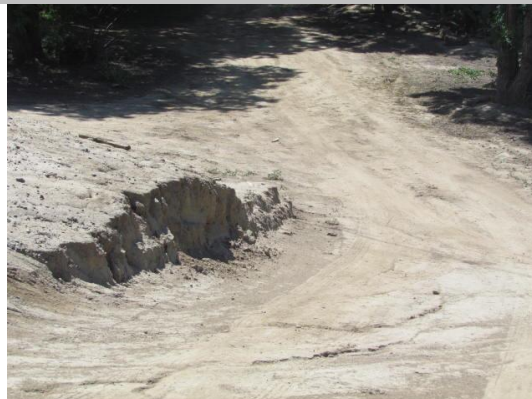
Photo 1 of 2 : FA\_2016\_RD0524\_107\_119\_20160929\_00183.jpg

LM Start	5.89	Rating **	U	Issue No.	119
LM End	5.89	Issue Type +	Ma	Location *	LS
Category	Earthen Levee			GPS Latitude/Longitude	
				Start	End
Item	Slope Stability			37.873893 °	37.873893 °
				-121.332978 °	-121.332978 °
DWR ID	DWR_RD0524_01_s_2012_119				
Comment Code					
S3 : Repair the levee slope damaged by vehicle traffic and prevent access where possible.					
Inspector Comment					
Landowner is using damaged area as a ramp.

Looking west at unauthorized ramp and landside slope damage.

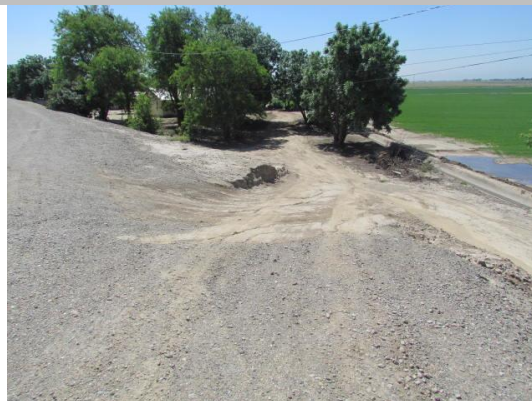
Photo 2 of 2 : FA\_2016\_RD0524\_107\_119\_20160929\_00184.jpg

Looking southwest at damaged slope and ramp on landside slope.

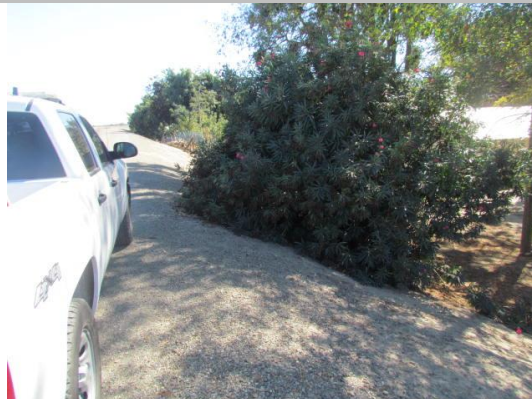
Photo 1 of 1 : FA\_2016\_RD0524\_107\_200\_20160929\_00245.jpg

LM Start	5.92	Rating **	U	Issue No.	200
LM End	5.92	Issue Type +	Ma	Location *	LS
Category	Earthen Levee			GPS Latitude/Longitude	
				Start	End
Item	Vegetation			37.873623 °	37.873623 °
				-121.332585 °	-121.332585 °
DWR ID	DWR_RD0524_01_f_2015_200				
Comment Code					
V2 : Remove the wild growth other than native grasses from the levee slopes.					
Inspector Comment					
Oleander bush on landward slope.

Looking south at oleander on landward slope fall 2015.

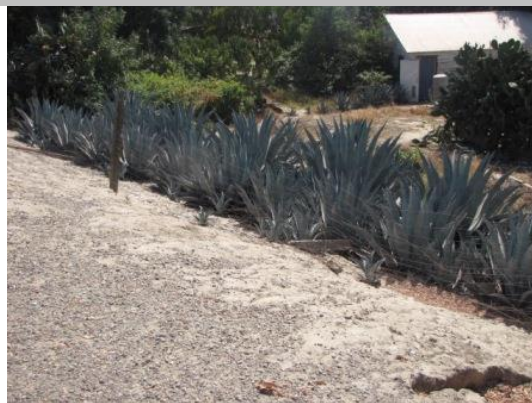
Photo 1 of 1 : FA\_2016\_RD0524\_107\_88\_20160929\_00141.jpg

LM Start	5.94	Rating **	U	Issue No.	88
LM End	5.95	Issue Type +	En	Location *	LS
Category	Earthen Levee			GPS Latitude/Longitude	
				Start	End
Item	Vegetation			37.873543 °	37.873445 °
				-121.332308 °	-121.332127 °
DWR ID	DWR_RD0524_01_s_2012_88				
Comment Code					
V6 : Landscaping					
Inspector Comment					
Cactus and Century plants on landward slope and toe.

Looking southeast at fence and cactus on landside slope and toe.

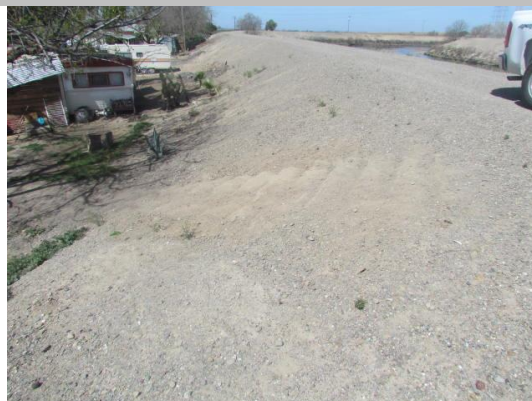
Photo 1 of 1 : FA\_2016\_RD0524\_107\_933\_20160929\_00291.jpg

LM Start	6.00	Rating **	M	Issue No.	933
LM End	6.00	Issue Type +	Ma	Location *	LS
Category	Earthen Levee			GPS Latitude/Longitude	
				Start	End
Item	Slope Stability			37.873047 °	37.873047 °
				-121.331408 °	-121.331408 °
DWR ID	DWR_RD0524_01_s_2012_933				
Comment Code					
S2 : Repair the levee slope damaged by foot traffic and prevent access where possible.					
Inspector Comment					
Landowner cut steps into landside slope.

Looking north at steps cut into landward slope.

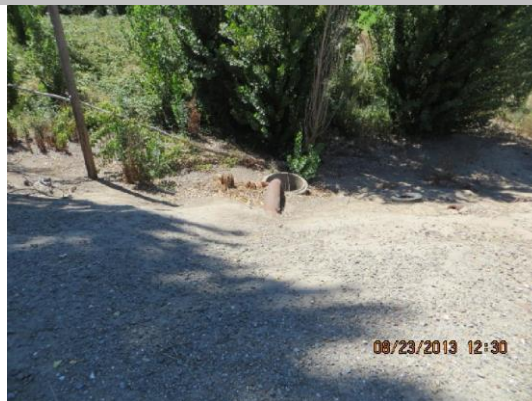
Photo 2 of 2 : UCIP\_FA\_2016\_18392\_30909.jpg

FS\_ID:18392  
DS\_ID:20641  
EP\_NO: N/A  
Repair Type: Non-Urgent  
Crossing Status: Found  
UCIP Comments: Pipe and pump abandoned and should be done so properly.  
FIELD\_STRUCT\_DESC: \*ABANDONED\*10-inch pipe through levee 12.0 feet below crown, pump on the waterward slope. Originally included in the 1964 O&M manual.  
FS Date: 8/23/2013

Pipe and concrete standpipe visible on LS toe.

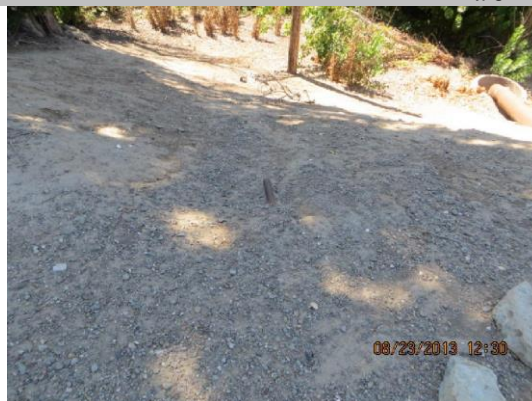
Photo 1 of 2 : UCIP\_FA\_2016\_22073\_37670.jpg

FS\_ID:22073  
DS\_ID:24052  
EP\_NO: N/A  
Repair Type: Non-Urgent  
Crossing Status: Found  
UCIP Comments: Abandoned and should be done so properly.  
FIELD\_STRUCT\_DESC: \*ABANDONED\* 1.75-inch galvanized iron electrical conduit through the levee 1-foot below the crown. Power pole on LS toe.  
FS Date: 8/23/2013

Pipe visible on LS slope.

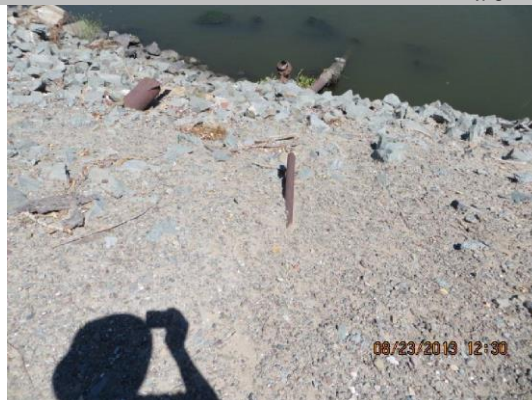
Photo 2 of 2 : UCIP\_FA\_2016\_22073\_37669.jpg

Pipe visible on WS slope.

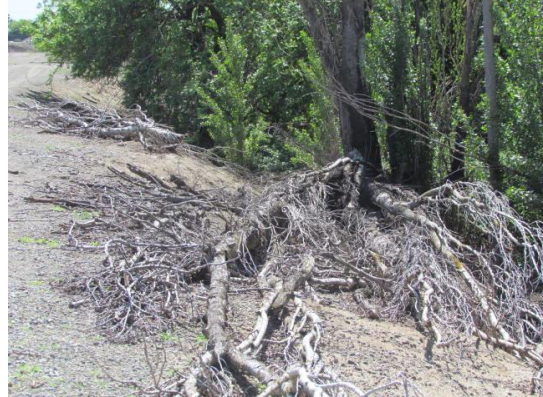
Photo 1 of 4 : FA\_2016\_RD0524\_107\_81\_20160929\_00132.jpg

Looking west at tree branches and limbs left on landward shoulder and slope. (Spring 2016)

LM Start	6.15	Rating **	U	Issue No.	81 (cont)	
LM End	6.15	Issue Type +	Ma	Location *	LS	
Category	Earthen Levee			GPS Latitude/Longitude		
				Start	End	
Item	Encroachments			37.871097 °	37.871097 °	
				-121.330100 °	-121.330100 °	
DWR ID	DWR_RD0524_01_s_2015_81					
Comment Code						
TR : Tree or limb						
Inspector Comment						
Large tree fallen across levee crown blocking access. Fallen tree branches and limbs left on landward slope.

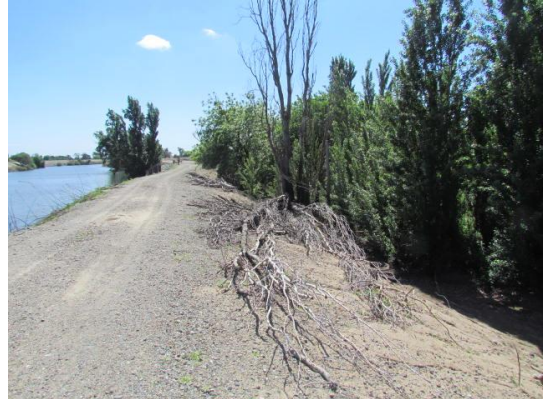
Photo 2 of 4 : FA\_2016\_RD0524\_107\_81\_20160929\_00133.jpg

Looking south at tree branches and limbs left on landward shoulder and slope. (Spring 2016)

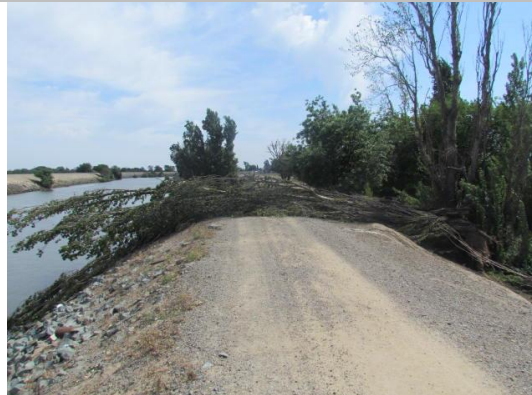
Photo 4 of 4 : FA\_2016\_RD0524\_107\_81\_20160929\_00135.jpg

Looking south at large tree across levee crown. (Fall 2015)

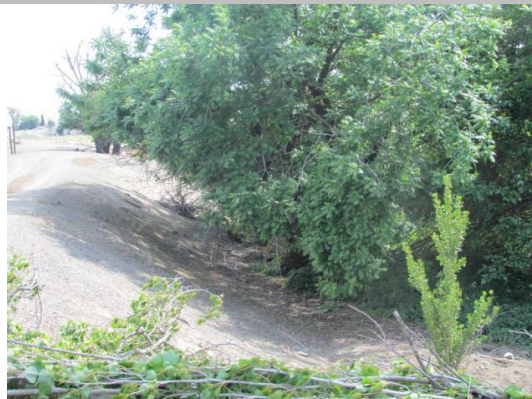
Photo 1 of 1 : FA\_2016\_RD0524\_107\_98\_20160929\_00156.jpg

LM Start	6.17	Rating **	U	Issue No.	98
LM End	6.17	Issue Type +	Ma	Location *	LS
Category	Earthen Levee			GPS Latitude/Longitude	
				Start	End
Item	Trim / Thin Trees			37.870842 °	37.870842 °
				-121.330000 °	-121.330000 °
DWR ID	DWR_RD0524_01_s_2012_98				
Comment Code					
T1 : Trim trees to at least five feet above ground level.					
Inspector Comment

Looking southeast at untrimmed trees at landward toe.

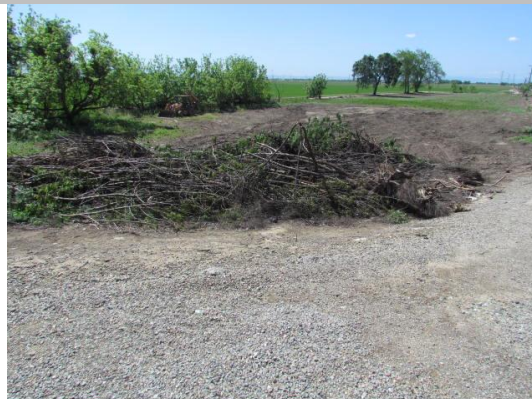
Photo 1 of 1 : FA\_2016\_RD0524\_107\_86\_20160929\_00140.jpg

LM Start	6.20	Rating **	U	Issue No.	86
LM End	6.20	Issue Type +	En	Location *	LS
Category	Earthen Levee			GPS Latitude/Longitude	
				Start	End
Item	Encroachments			37.870388 °	37.870388 °
				-121.329840 °	-121.329840 °
DWR ID	DWR_RD0524_01_s_ 2016_86				
Comment Code					
PR : Prunings					
Inspector Comment					
Large pruning pile left at landward toe. After farmer cleared field.

Looking west at prunings at landward toe and berm.
