**Flood Control Project Maintenance  
Levee Inspections**

**Fall 2017 Levee Maintenance Deficiency Summary Report**

***San Joaquin River Basin***

**Reclamation District No. 0524 Middle Roberts Island**

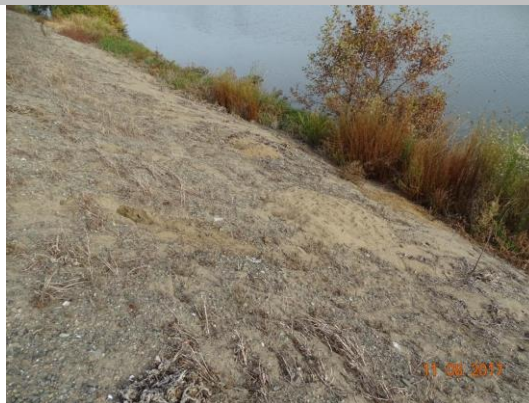
Photo 1 of 1 : FA\_2017\_RD0524\_107\_237\_20171116\_00465.jpg

LM Start	0.14	Rating **	M	Issue No.	237
LM End	0.14	Issue Type +	Ma	Location *	WS
Category	Earthen Levee			GPS Latitude/Longitude	
				Start	End
Item	Animal Control			37.939774 °	37.939774 °
				-121.344490 °	-121.344490 °
DWR ID	DWR_RD0524_01_f_2017_237				
Comment Code					
A3 : No rodents visible, but rodent burrows visible; need to backfill and compact or grout burrows.					
Inspector Comment

Looking northwest at the waterside slope.

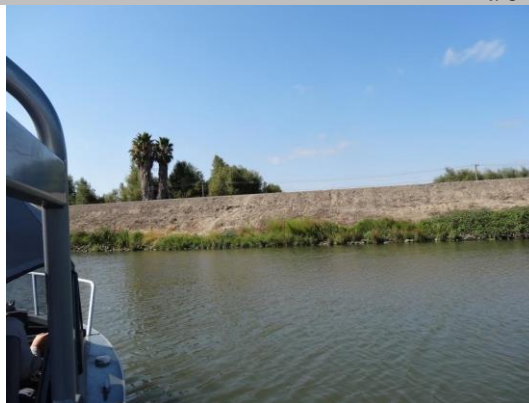
LM Start	0.19	Rating **	U	Issue No.	1 (cont)	
LM End	0.19	Issue Type +	Ma	Location *	WS	
Category	Supplemental			GPS Latitude/Longitude		
				Start		End
Item	DWR Erosion Survey			37.939085 °		37.939085 °
				-121.343917 °		-121.343917 °
DWR ID	RD0524U01RM40.85					
Comment Code						
Inspector Comment						
09/13/2017: No significant change observed.						
07/25/2016: No significant change observed.						
06/24/2015: No significant change observed.						
06/19/2014: No significant change observed.						
08/13/2013: The erosion was discovered during 2013 spring levee inspection. Inspector comment: Erosion is located along the lower level of water-ward slope. [2017 Site ID:RD0524U01RM40.85]

Front view of the erosion.

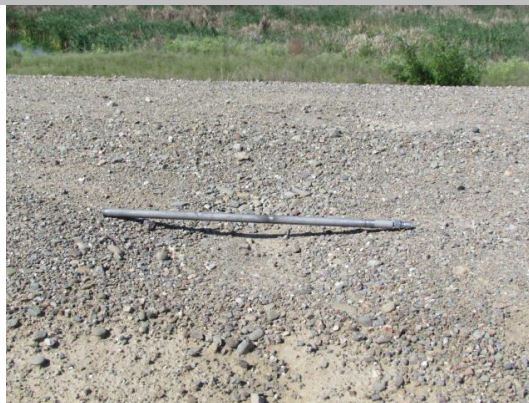
Photo 1 of 3 : FA\_2017\_RD0524\_107\_3\_20170919\_00001.jpg

LM Start	0.21	Rating **	M	Issue No.	3
LM End	0.21	Issue Type +	Ma	Location *	CR
Category	Earthen Levee			GPS Latitude/Longitude	
				Start	End
Item	Crown Surface / Depressions / Rutting			37.938890 °	37.938890 °
				-121.343657 °	-121.343657 °
DWR ID	DWR_RD0524_01_s_2016_3				
Comment Code					
C2 : Repair depressions or ruts in the crown or slope.					
Inspector Comment					
No change in status.

Looking west at 3" depression on levee crown. (Spring 2012)

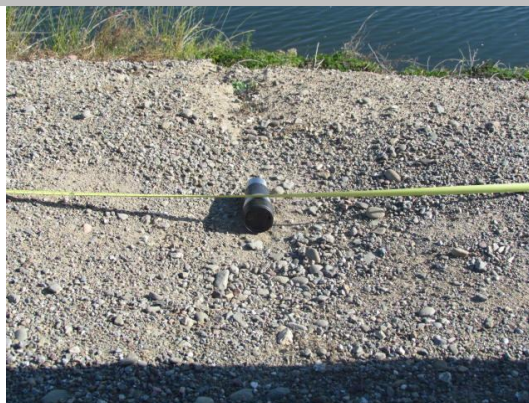
Photo 2 of 3 : FA\_2017\_RD0524\_107\_3\_20170919\_00002.jpg

Looking west at depression on levee crown near waterward shoulder.

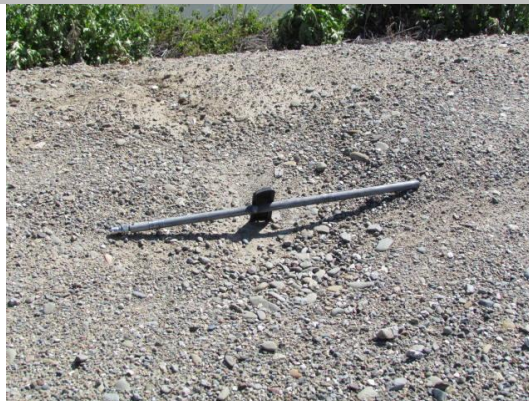
Photo 3 of 3 : FA\_2017\_RD0524\_107\_3\_20170919\_00003.jpg

Looking east at 3" depression on levee crown. (Spring 2012)

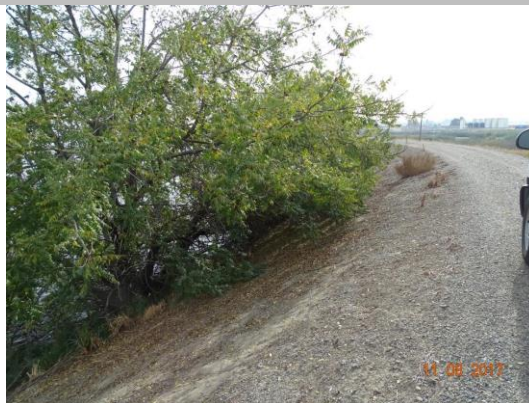
Photo 1 of 1 : FA\_2017\_RD0524\_107\_201\_20171116\_00466.jpg

LM Start	0.23	Rating **	U	Issue No.	201
LM End	0.23	Issue Type +	Ma	Location *	WS
Category	Earthen Levee			GPS Latitude/Longitude	
				Start	End
Item	Trim / Thin Trees			37.938648 °	37.938648 °
				-121.343480 °	-121.343480 °
DWR ID	DWR_RD0524_01_f_2016_201				
Comment Code					
T2 : Thin trees to allow visibility of the ground and room to flood fight.					
Inspector Comment					
Untrimmed trees on waterside slope.

Looking southeast at the waterside slope.

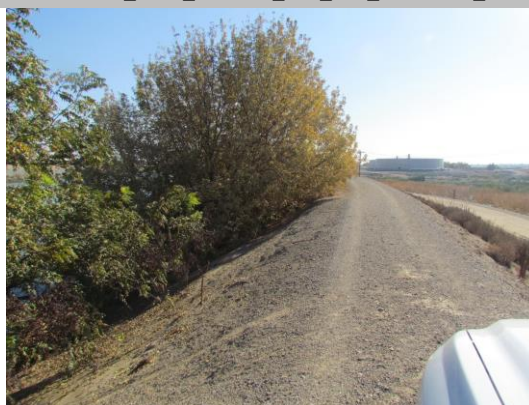
Photo 1 of 4 : FA\_2017\_RD0524\_107\_179\_20170919\_00217.jpg

LM Start	0.27	Rating **	U	Issue No.	179
LM End	0.27	Issue Type +	Ma	Location *	WS
Category	Earthen Levee			GPS Latitude/Longitude	
				Start	End
Item	Trim / Thin Trees			37.938438 °	37.938438 °
				-121.342883 °	-121.342883 °
DWR ID	DWR_RD0524_01_s_2014_179				
Comment Code					
T2 : Thin trees to allow visibility of the ground and room to flood fight.					
Inspector Comment					
Tree blocking view of waterside slope.

Looking east at untrimmed tree on waterward slope. (Fall 2016)

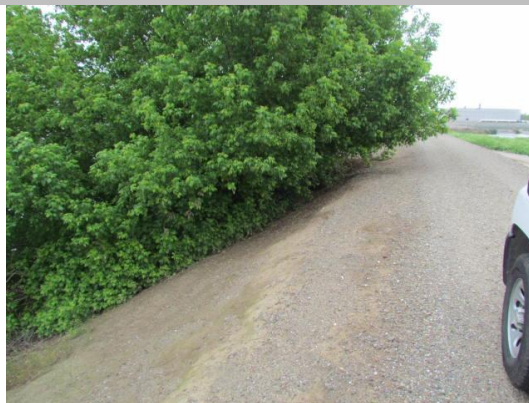
Photo 2 of 4 : FA\_2017\_RD0524\_107\_179\_20170919\_00218.jpg

Looking east at untrimmed tree on waterward slope (Spring 2016)

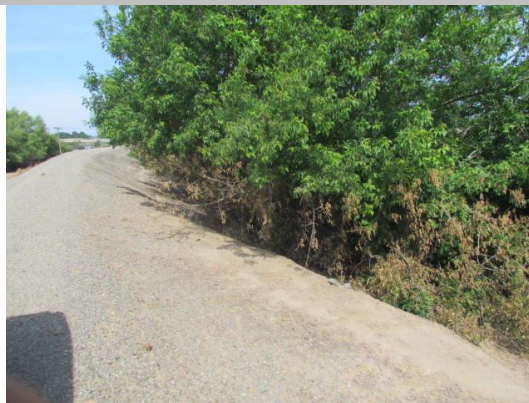
Photo 3 of 4 : FA\_2017\_RD0524\_107\_179\_20170919\_00219.jpg

LM Start	0.27	Rating **	U	Issue No.	179 (cont)	
LM End	0.27	Issue Type +	Ma	Location *	WS	
Category	Earthen Levee			GPS Latitude/Longitude		
				Start		End
Item	Trim / Thin Trees			37.938438 °		37.938438 °
				-121.342883 °		-121.342883 °
DWR ID	DWR_RD0524_01_s_2014_179					
Comment Code						
T2 : Thin trees to allow visibility of the ground and room to flood fight.						
Inspector Comment						
Tree blocking view of waterside slope.

Looking west at untrimmed tree on waterward slope. (Spring 2015)

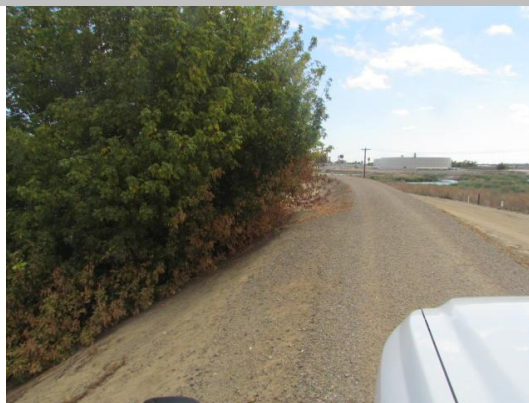
Photo 4 of 4 : FA\_2017\_RD0524\_107\_179\_20170919\_00220.jpg

Looking east at untrimmed tree on waterward slope. (Fall 2015)

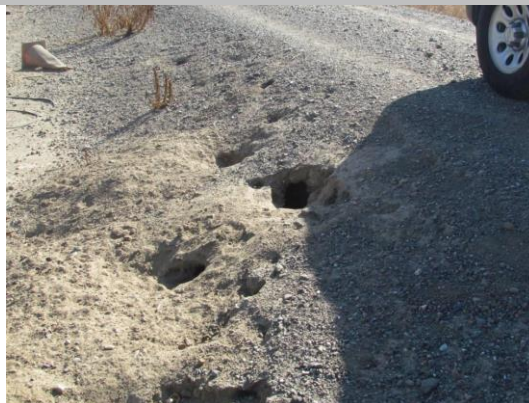
Photo 1 of 4 : FA\_2017\_RD0524\_107\_174\_20170919\_00208.jpg

LM Start	0.30	Rating **	U	Issue No.	174
LM End	0.30	Issue Type +	Ma	Location *	WS
Category	Earthen Levee			GPS Latitude/Longitude	
				Start	End
Item	Animal Control			37.938382 °	37.938382 °
				-121.342352 °	-121.342352 °
DWR ID	DWR_RD0524_01_f_2014_174				
Comment Code					
A1 : Exterminate rodents and backfill and compact or grout burrows.					
Inspector Comment					
Several rodent holes present at this site. No change at site during fall 2017 inspection.					
Active rodent activity during spring 2017 inspection. No change at site.

Looking southwest at several rodent holes on waterward slope. (Fall 2016)

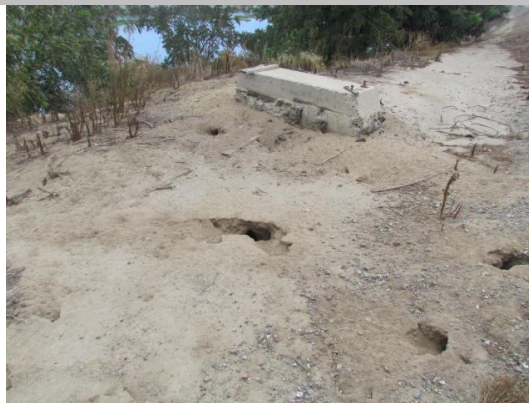
Photo 2 of 4 : FA\_2017\_RD0524\_107\_174\_20170919\_00209.jpg

LM Start	0.30	Rating **	U	Issue No.	174 (cont)	
LM End	0.30	Issue Type +	Ma	Location *	WS	
Category	Earthen Levee			GPS Latitude/Longitude		
				Start		End
Item	Animal Control			37.938382 °		37.938382 °
				-121.342352 °		-121.342352 °
DWR ID	DWR_RD0524_01_f_2014_174					
Comment Code						
A1 : Exterminate rodents and backfill and compact or grout burrows.						
Inspector Comment						
Several rodent holes present at this site. No change at site during fall 2017 inspection.						
Active rodent activity during spring 2017 inspection. No change at site.

Looking southeast at several rodent holes on waterward slope. (Spring 2016)

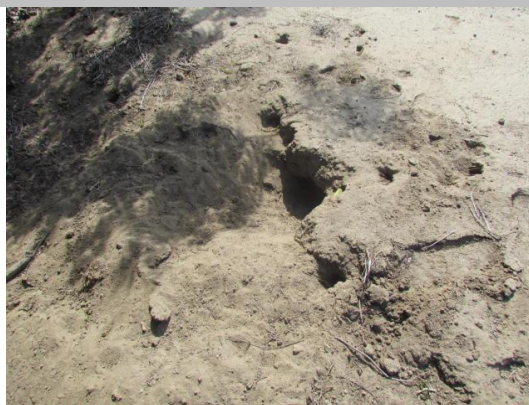
Photo 3 of 4 : FA\_2017\_RD0524\_107\_174\_20170919\_00210.jpg

Looking west at several rodent holes on waterward shoulder. (Spring 2015)

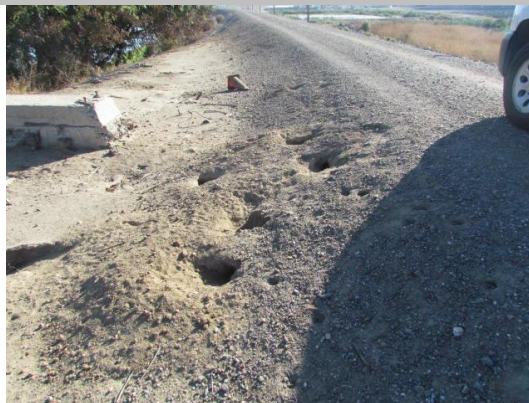
Photo 4 of 4 : FA\_2017\_RD0524\_107\_174\_20170919\_00211.jpg

Looking southeast at several rodent holes on waterward slope. (Fall 2015).

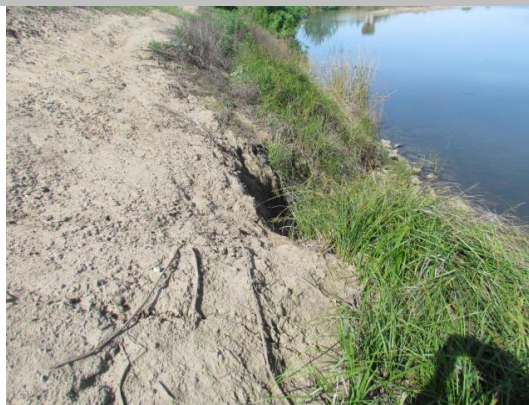
Photo 2 of 2 : FA\_2017\_RD0524\_107\_180\_20170919\_00222.jpg

LM Start	0.34	Rating **	M	Issue No.	180
LM End	0.34	Issue Type +	Ma	Location *	WS
Category	Earthen Levee			GPS Latitude/Longitude	
				Start	End
Item	Erosion / Bank Caving			37.938461 °	37.938461 °
				-121.341626 °	-121.341626 °
DWR ID	DWR_RD0524_01_s_2014_180				
Comment Code					
E2 : Schedule repair of erosion site prior to the next inspection.					
Inspector Comment					
Erosion is located along the lower level of waterside slope.

Looking northeast at erosion on waterward toe.

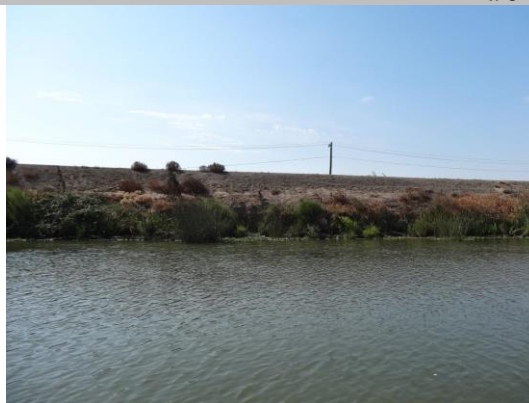
Photo 1 of 4 : SJR2017\_RD0524U01RM40.93\_1.jpg

LM Start	0.34	Rating **	M	Issue No.	2
LM End	0.34	Issue Type +	Ma	Location *	WS
Category	Supplemental			GPS Latitude/Longitude	
				Start	End
Item	DWR Erosion Survey			37.938461 °	37.938461 °
				-121.341526 °	-121.341526 °
DWR ID	RD0524U01RM40.93				
Comment Code					
Inspector Comment					
09/13/2017: There are two pocket erosions at the site; both erosions are around 10 ft long and 6 ft high. [2017 Site ID:RD0524U01RM40.93]

Front view of the erosion site.

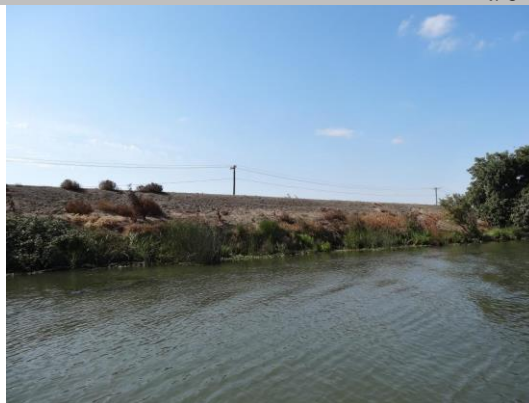
Photo 2 of 4 : SJR2017\_RD0524U01RM40.93\_2.jpg

Looking downstream of the erosion.

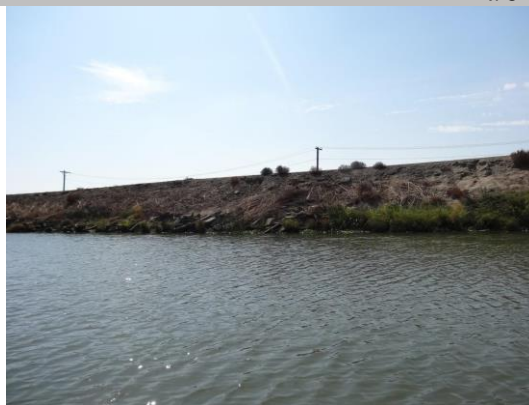
Photo 3 of 4 : SJR2017\_RD0524U01RM40.93\_3.jpg

Close view of the erosion site.

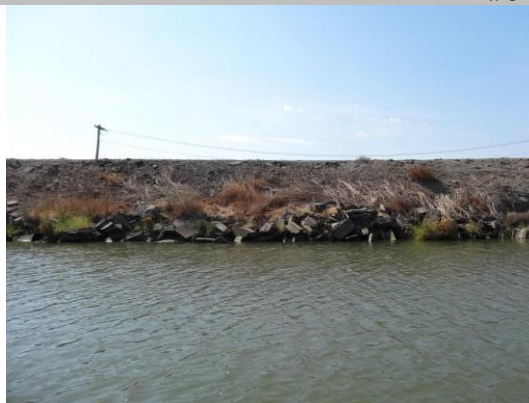
Photo 1 of 4 : SJR2017\_RD0524U01RM40.99\_1.jpg

LM Start	0.40	Rating **	A/W	Issue No.	5	
LM End	0.40	Issue Type +	Ma	Location *	WS	
Category	Supplemental			GPS Latitude/Longitude		
				Start	End	
Item	DWR Erosion Survey			37.938870 °	37.938870 °	
				-121.340460 °	-121.340460 °	
DWR ID	RD0524U01RM40.99					
Comment Code						
Inspector Comment						
09/13/2017: No significant change observed.						
07/25/2016: More vegetation observed at the site.						
06/24/2015: No significant change observed.						
06/19/2014: No significant change observed.						
08/13/2013: No significant change at this site.						
08/07/2012: The erosion is at the upper levee slope, and likely caused by slope slip. The lower levee slope is covered with dense vegetation.						
[2017 Site ID:RD0524U01RM40.99]

Front view of the erosion site.

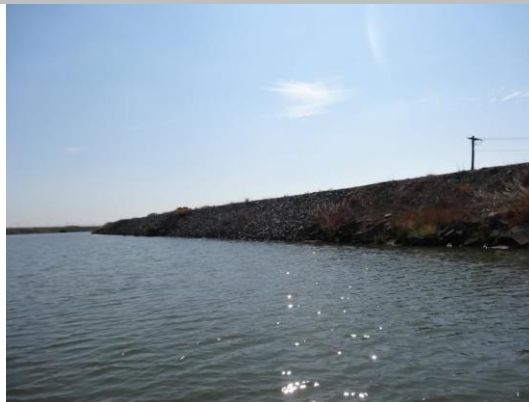
Photo 2 of 4 : SJR2017\_RD0524U01RM40.99\_2.jpg

Downstream view of the site.

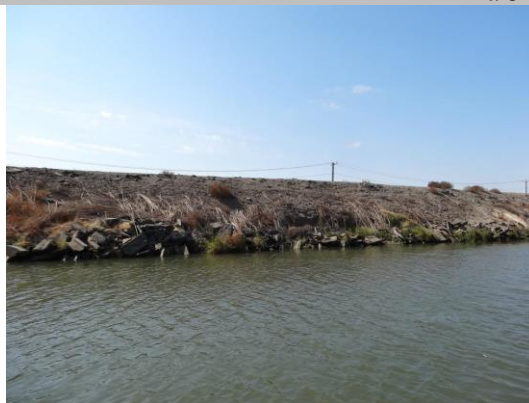
Photo 3 of 4 : SJR2017\_RD0524U01RM40.99\_3.jpg

LM Start	0.40	Rating **	A/W	Issue No.	5 (cont)	
LM End	0.40	Issue Type +	Ma	Location *	WS	
Category	Supplemental			GPS Latitude/Longitude		
				Start	End	
Item	DWR Erosion Survey			37.938870 °	37.938870 °	
				-121.340460 °	-121.340460 °	
DWR ID	RD0524U01RM40.99					
Comment Code						
Inspector Comment						
09/13/2017: No significant change observed.						
07/25/2016: More vegetation observed at the site.						
06/24/2015: No significant change observed.						
06/19/2014: No significant change observed.						
08/13/2013: No significant change at this site.						
08/07/2012: The erosion is at the upper levee slope, and likely caused by slope slip. The lower levee slope is covered with dense vegetation.						
[2017 Site ID:RD0524U01RM40.99]

Close view of the erosion.

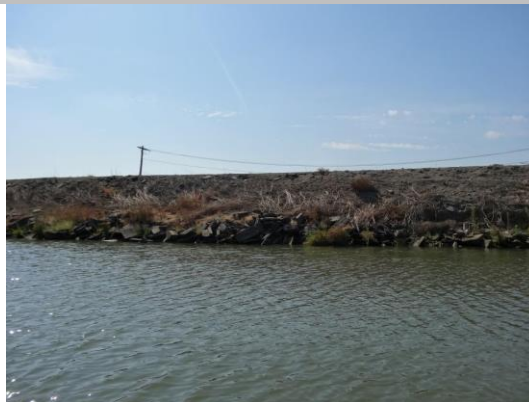
Photo 4 of 4 : SJR2017\_RD0524U01RM40.99\_4.jpg

Close view of the erosion.

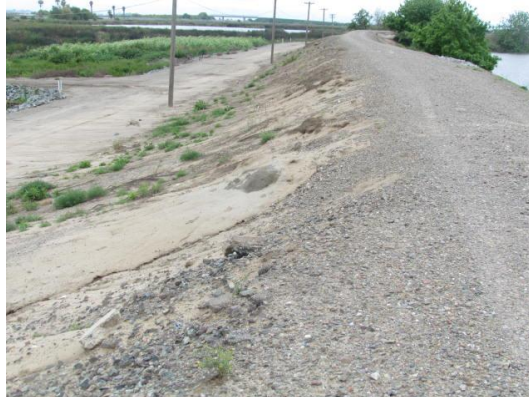
Photo 1 of 2 : FA\_2017\_RD0524\_107\_205\_20170919\_00246.jpg

LM Start	0.40	Rating **	U	Issue No.	205
LM End	0.46	Issue Type +	Ma	Location *	LS
Category	Earthen Levee			GPS Latitude/Longitude	
				Start	End
Item	Erosion / Bank Caving			37.938625 °	37.938695 °
				-121.340479 °	-121.339420 °
DWR ID	DWR_RD0524_01_s_2016_205				
Comment Code					
E2 : Schedule repair of erosion site prior to the next inspection.					
Inspector Comment					
Several damaged sites within this reach.

Looking at slope damage on landward slope.

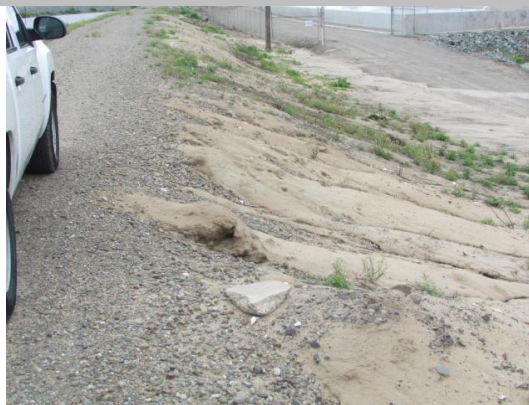
Photo 2 of 2 : FA\_2017\_RD0524\_107\_205\_20170919\_00247.jpg

Looking at slope damage on landward slope.

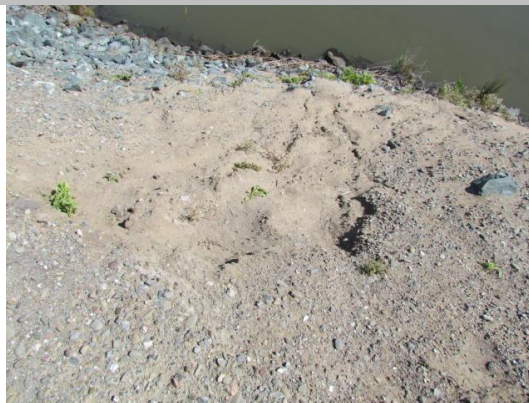
Photo 1 of 3 : FA\_2017\_RD0524\_107\_10\_20170919\_00011.jpg

LM Start	0.63	Rating **	U	Issue No.	10
LM End	0.63	Issue Type +	Ma	Location *	WS
Category	Earthen Levee			GPS Latitude/Longitude	
				Start	End
Item	Erosion / Bank Caving			37.938247 °	37.938247 °
				-121.336503 °	-121.336503 °
DWR ID	DWR_RD0524_01_f_2015_10				
Comment Code					
E2 : Schedule repair of erosion site prior to the next inspection.					
Inspector Comment					
Erosion located next to and under bamboo.

Looking east at waterside erosion appears to be caused by runoff.

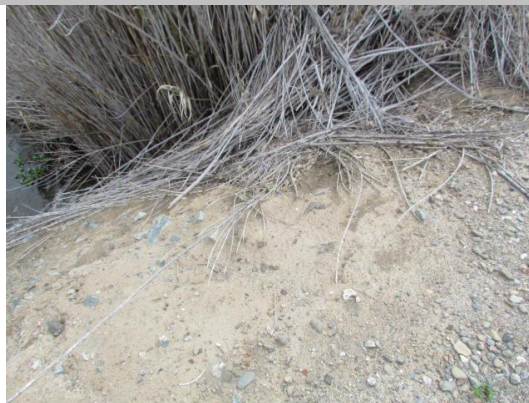
Photo 2 of 3 : FA\_2017\_RD0524\_107\_10\_20170919\_00012.jpg

LM Start	0.63	Rating **	U	Issue No.	10 (cont)	
LM End	0.63	Issue Type +	Ma	Location *	WS	
Category	Earthen Levee			GPS Latitude/Longitude		
				Start		End
Item	Erosion / Bank Caving			37.938247 °		37.938247 °
				-121.336503 °		-121.336503 °
DWR ID	DWR_RD0524_01_f_2015_10					
Comment Code						
E2 : Schedule repair of erosion site prior to the next inspection.						
Inspector Comment						
Erosion located next to and under bamboo.

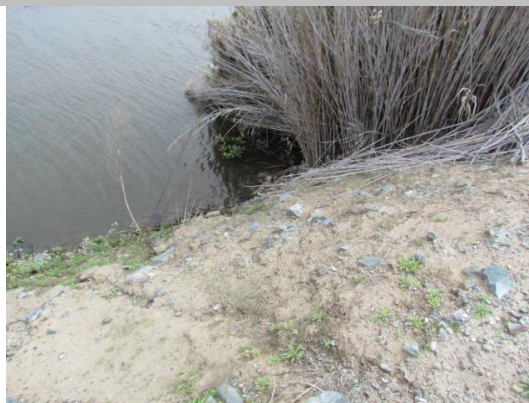
Photo 3 of 3 : FA\_2017\_RD0524\_107\_10\_20170919\_00013.jpg

Looking east at erosion under bamboo on waterward slope.

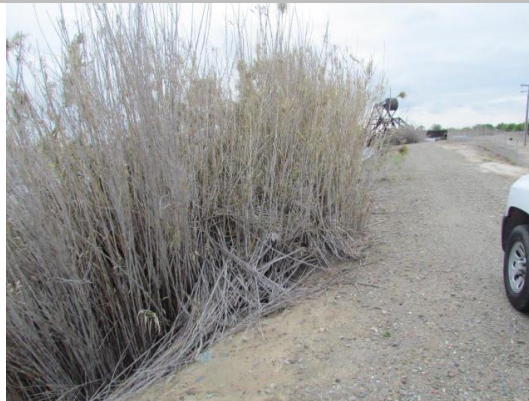
Photo 2 of 4 : FA\_2017\_RD0524\_107\_11\_20170919\_00014.jpg

Looking at bamboo on waterward slope. (Spring 2016)

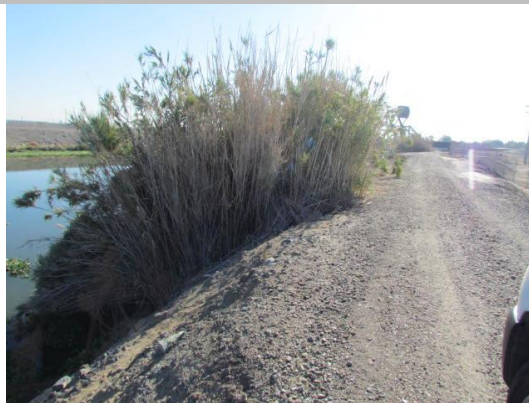
Photo 3 of 4 : FA\_2017\_RD0524\_107\_11\_20170919\_00015.jpg

Looking at bamboo on waterside slope. (Fall 2015)

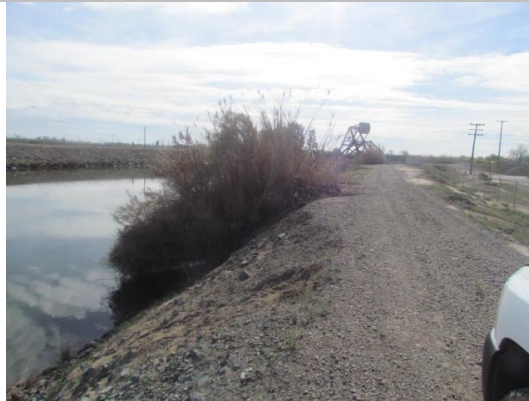
Photo 4 of 4 : FA\_2017\_RD0524\_107\_11\_20170919\_00016.jpg

Looking at dying bamboo on waterward slope. (Spring 2013)

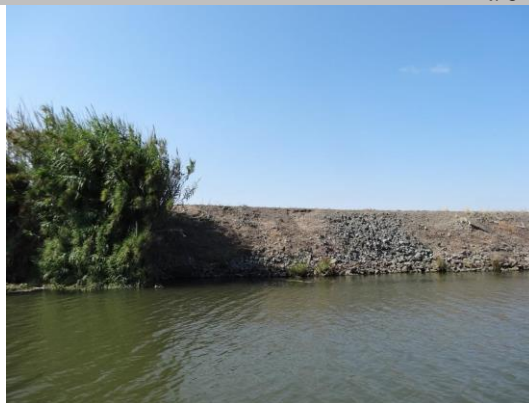
Photo 1 of 2 : SJR2017\_RD0524U01RM41.26\_1.jpg

LM Start	0.63	Rating **	U	Issue No.	15
LM End	0.63	Issue Type +	Ma	Location *	WS
Category	Supplemental			GPS Latitude/Longitude	
				Start	End
Item	DWR Erosion Survey			37.938247 °	37.938247 °
				-121.336503 °	-121.336503 °
DWR ID	RD0524U01RM41.26				
Comment Code					
Inspector Comment					
09/13/2017: The erosion was discovered by levee inspection. The erosion site is immediately downstream of tall vegetations. [2017 Site ID:RD0524U01RM41.26]

Front view of the erosion. The erosion is located at the shadow of the vegetation.

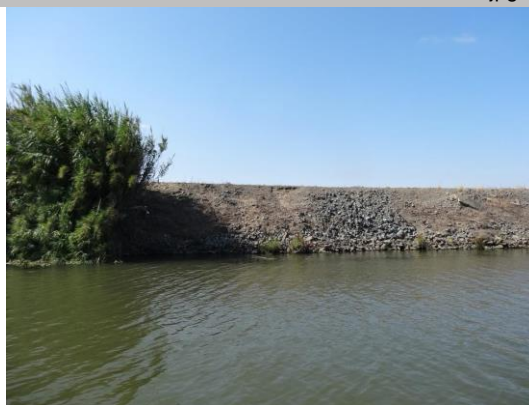
Photo 2 of 2 : SJR2017\_RD0524U01RM41.26\_2.jpg

Front view of the erosion.

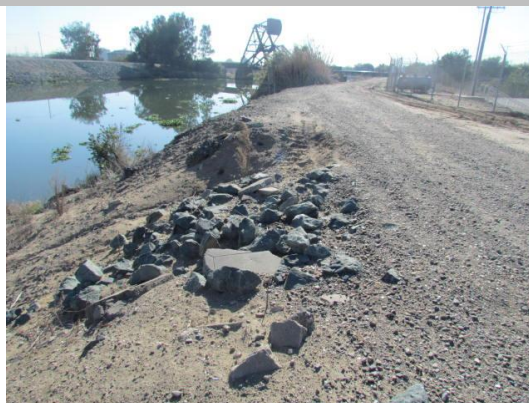
Photo 1 of 4 : FA\_2017\_RD0524\_107\_13\_20170919\_00020.jpg

LM Start	0.64	Rating **	M	Issue No.	13
LM End	0.65	Issue Type +	Ma	Location *	WS
Category	Earthen Levee			GPS Latitude/Longitude	
				Start	End
Item	Slope Stability			37.938105 °	37.938023 °
				-121.336288 °	-121.336173 °
DWR ID	DWR_RD0524_01_s_2012_13				
Comment Code					
S1 : Repair slope instability.					
Inspector Comment					
Depression extends from shoulder to mid levee slope two site with this section.

Looking southeast at depression on waterward shoulder fall 2015

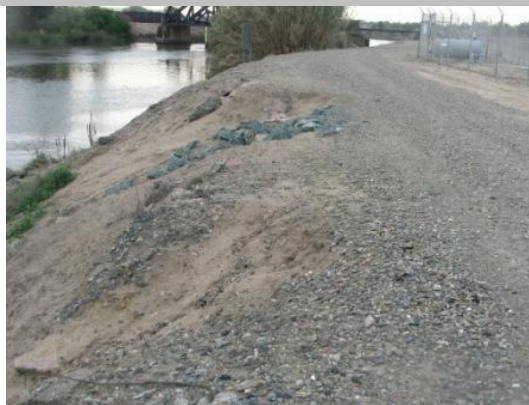
Photo 3 of 4 : FA\_2017\_RD0524\_107\_13\_20170919\_00022.jpg

View of the erosion.

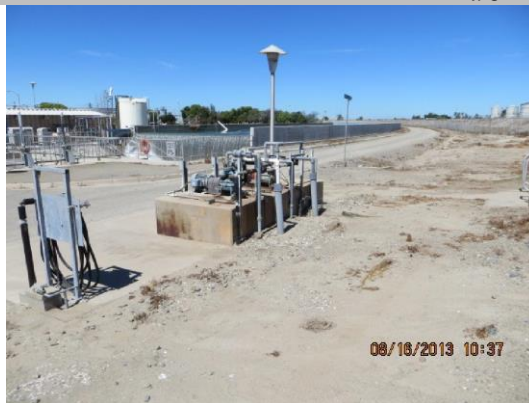
Photo 3 of 3 : UCIP\_FA\_2017\_17563\_29700.jpg

Vacuum pumps off LS toe.

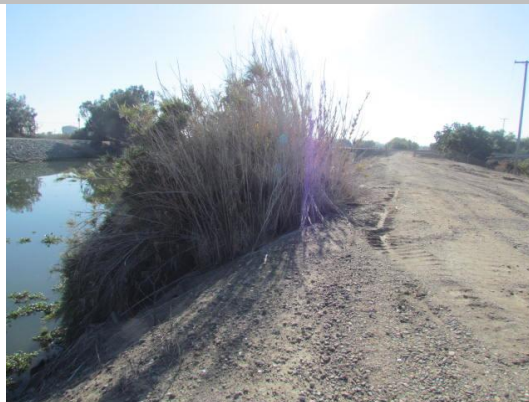
Photo 1 of 3 : FA\_2017\_RD0524\_107\_14\_20170919\_00024.jpg

LM Start	0.67	Rating **	U	Issue No.	14
LM End	0.67	Issue Type +	Ma	Location *	WS
Category	Earthen Levee			GPS Latitude/Longitude	
				Start	End
Item	Vegetation			37.937808 °	37.937808 °
				-121.335913 °	-121.335913 °
DWR ID	DWR_RD0524_01_s_2012_14				
Comment Code					
V2 : Remove the wild growth other than native grasses from the levee slopes.					
Inspector Comment					
Bamboo on waterside slope.

Looking south at dying bamboo on waterward slope. Fall 2015

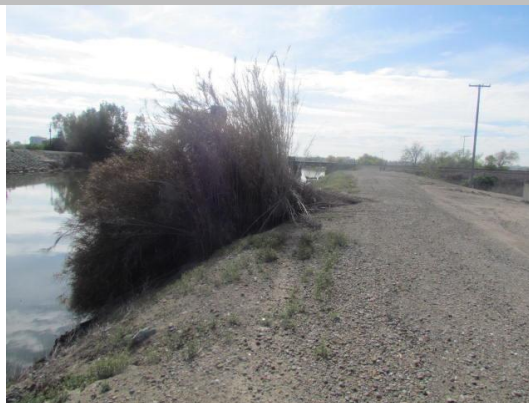
Photo 2 of 3 : FA\_2017\_RD0524\_107\_14\_20170919\_00025.jpg

Looking south at dying bamboo on waterward slope. (Spring 2013)

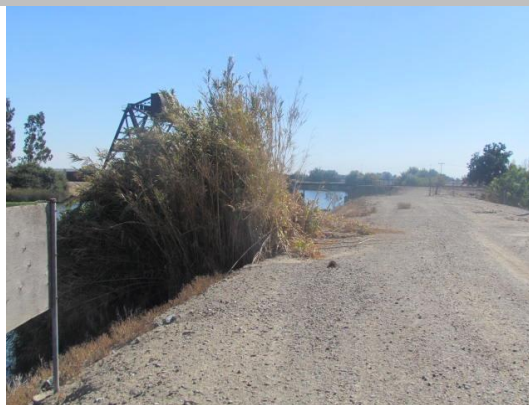
Photo 3 of 3 : FA\_2017\_RD0524\_107\_14\_20170919\_00026.jpg

Looking south at bamboo on waterside slope. (Fall 2012)

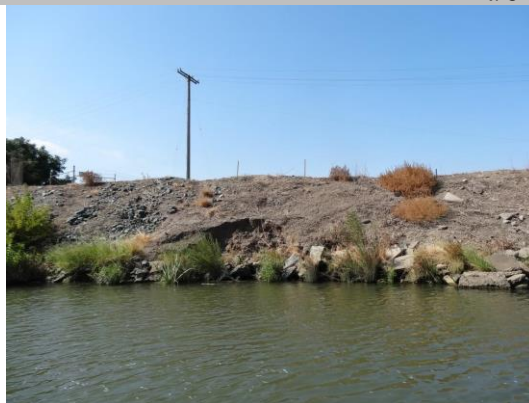
Photo 1 of 4 : SJR2017\_RD0524U01RM41.34\_1.jpg

LM Start	0.70	Rating **	M	Issue No.	16
LM End	0.70	Issue Type +	Ma	Location *	WS
Category	Supplemental			GPS Latitude/Longitude	
				Start	End
Item	DWR Erosion Survey			37.937577 °	37.937577 °
				-121.335491 °	-121.335491 °
DWR ID	RD0524U01RM41.34				
Comment Code					
Inspector Comment					
09/13/2017: Pocket erosion above the protected levee toe. [2017 Site ID:RD0524U01RM41.34]

Front view of the erosion.

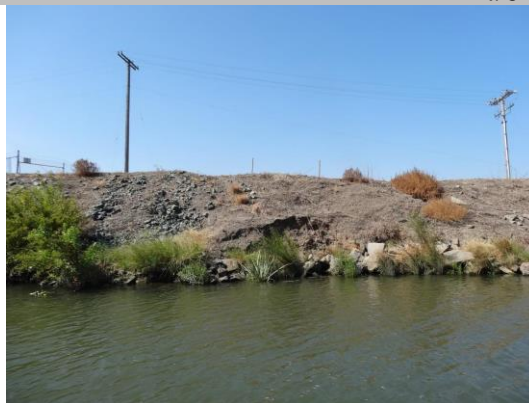
Photo 2 of 4 : SJR2017\_RD0524U01RM41.34\_2.jpg

Close view of the erosion.

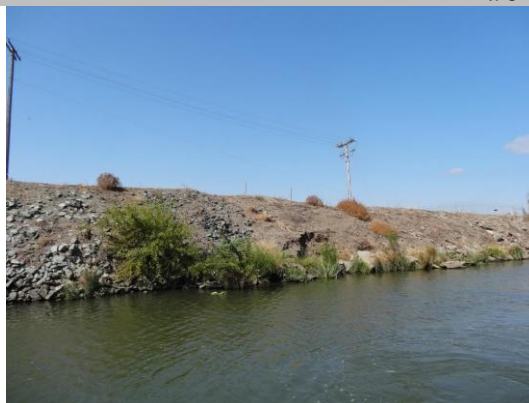
Photo 3 of 4 : SJR2017\_RD0524U01RM41.34\_3.jpg

Looking downstream of the erosion site.

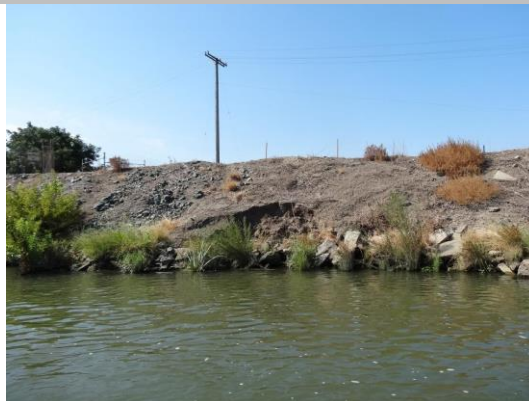
Photo 4 of 4 : SJR2017\_RD0524U01RM41.34\_4.jpg

Close view of the erosion.

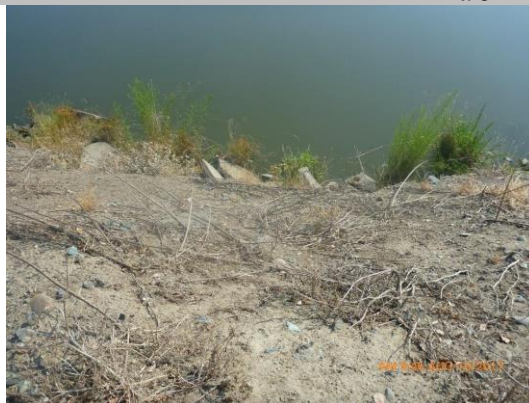
Photo 1 of 3 : LEVAL\_FA\_2017\_541\_4079.jpg

LM Start	0.70	Rating **	A/W	Issue No.	153
LM End	0.70	Issue Type +	Ma	Location *	
Category	Supplemental			GPS Latitude/Longitude	
				Start	End
Item	2017 Storm Damage			37.937500 °	37.937500 °
				-121.335500 °	-121.335500 °
DWR ID	DWR_RD0524_01_f_2017_153				
Comment Code					
Inspector Comment					
Levee Evaluation Comments					
Description:Slope protection repairs are needed along the waterside slope due to erosion and riprap displacement from high water. Based upon levee inspections, it was determined the waterside levee slope is eroding, deteriorating, and degrading. The eroded levee sections need to be restored back to design standards to prevent further deterioration and damage.					
Site ID No:541					
Site Designation:LMA-447					
Repair Type: Erosion					
Rating:Area of Concern					
Field Date:8/10/2017					
Notes:

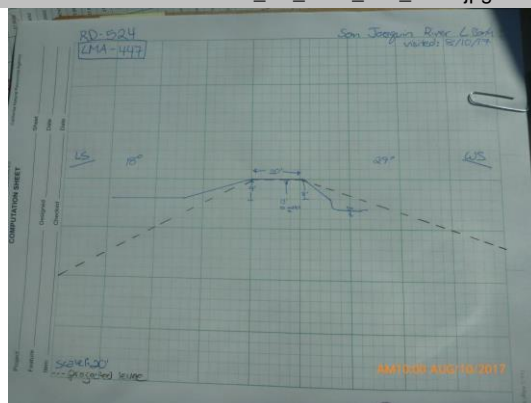
Photo 3 of 3 : LEVAL\_FA\_2017\_541\_4083.jpg

LM Start	0.70	Rating **	A/W	Issue No.	153 (cont)
LM End	0.70	Issue Type +	Ma	Location *	
Category	Supplemental			GPS Latitude/Longitude	
				Start	End
Item	2017 Storm Damage			37.937500 °	37.937500 °
				-121.335500 °	-121.335500 °
DWR ID	DWR_RD0524_01_f_2017_153				
Comment Code					
Inspector Comment					
Levee Evaluation Comments					
Description:Slope protection repairs are needed along the waterside slope due to erosion and riprap displacement from high water. Based upon levee inspections, it was determined the waterside levee slope is eroding, deteriorating, and degrading. The eroded levee sections need to be restored back to design standards to prevent further deterioration and damage.					
Site ID No:541					
Site Designation:LMA-447					
Repair Type: Erosion					
Rating:Area of Concern					
Field Date:8/10/2017					
Notes:

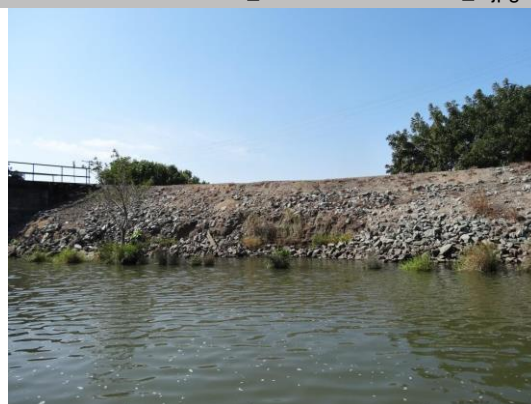
Photo 1 of 3 : SJR2017\_RD0524U01RM41.36\_1.jpg

LM Start	0.71	Rating **	M	Issue No.	17
LM End	0.73	Issue Type +	Ma	Location *	WS
Category	Supplemental			GPS Latitude/Longitude	
				Start	End
Item	DWR Erosion Survey			37.937222 °	37.937222 °
				-121.335277 °	-121.335277 °
DWR ID	RD0524U01RM41.36				
Comment Code					
Inspector Comment					
09/13/2017: No significant change observed.					
07/25/2016: No significant change observed.					
06/24/2015: The erosion site is immediately downstream of the RR bridge. [2017 Site ID:RD0524U01RM41.36]

Front view of the erosion.

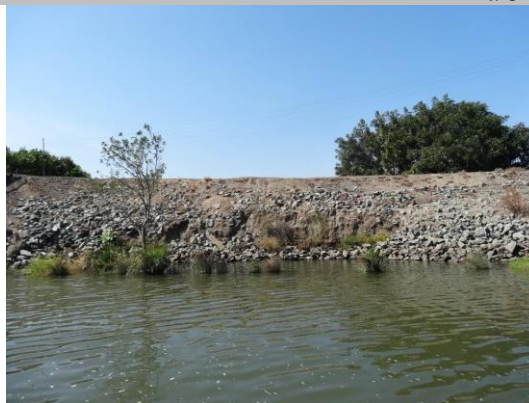
Photo 2 of 3 : SJR2017\_RD0524U01RM41.36\_2.jpg

Close view of the erosion.

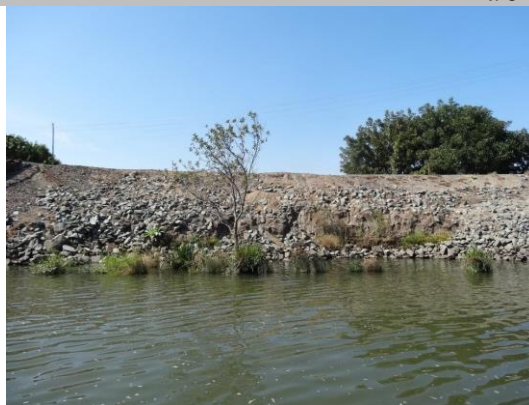
Photo 3 of 3 : SJR2017\_RD0524U01RM41.36\_3.jpg

Close view of the erosion.

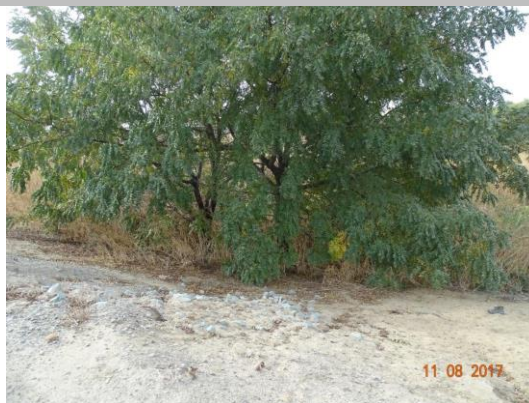
Photo 1 of 2 : FA\_2017\_RD0524\_107\_156\_20171116\_00468.jpg

LM Start	0.72	Rating **	M	Issue No.	156
LM End	0.72	Issue Type +	Ma	Location *	LS
Category	Earthen Levee			GPS Latitude/Longitude	
				Start	End
Item	Trim / Thin Trees			37.937258 °	37.937258 °
				-121.335373 °	-121.335373 °
DWR ID	DWR_RD0524_01_s_2017_156				
Comment Code					
T1 : Trim trees to at least five feet above ground level.					
Inspector Comment					
Dense vegetation on landside slope.

Looking southwest at the landside slope.

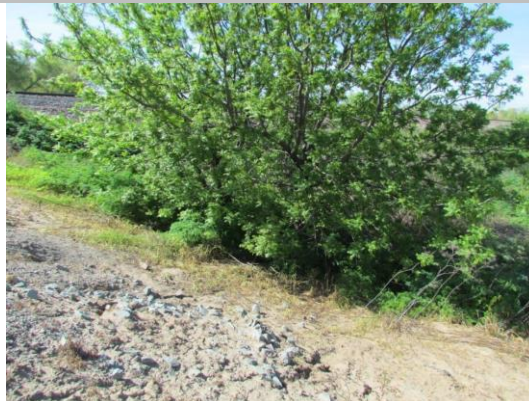
Photo 2 of 2 : FA\_2017\_RD0524\_107\_156\_20170919\_00189.jpg

Looking west at dense untrimmed tree on landward slope.

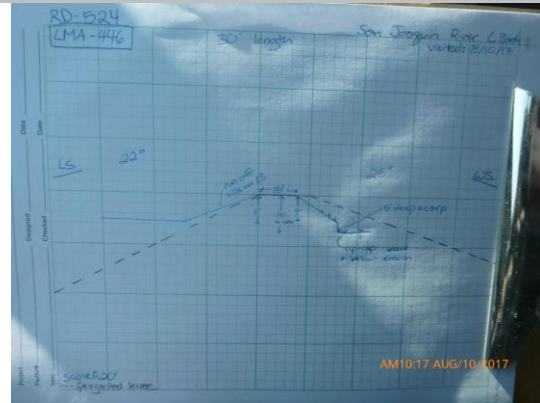
Photo 3 of 3 : LEVAL\_FA\_2017\_540\_4089.jpg

LM Start	0.72	Rating **	A/W	Issue No.	154 (cont)
LM End	0.73	Issue Type +	Ma	Location *	
Category	Supplemental			GPS Latitude/Longitude	
				Start	End
Item	2017 Storm Damage			37.937200 °	37.937100 °
				-121.335300 °	-121.335300 °
DWR ID	DWR_RD0524_01_f_2017_154				
Comment Code					
Inspector Comment					
Levee Evaluation Comments					
Description:Slope protection repairs are needed along the waterside slope due to erosion and riprap displacement from high water. Based upon levee inspections, it was determined the waterside levee slope is eroding, deteriorating, and degrading. The eroded levee sections need to be restored back to design standards to prevent further deterioration and damage.					
Site ID No:540					
Site Designation:LMA-446					
Repair Type: Erosion					
Rating:Area of Concern					
Field Date:8/10/2017					
Notes:

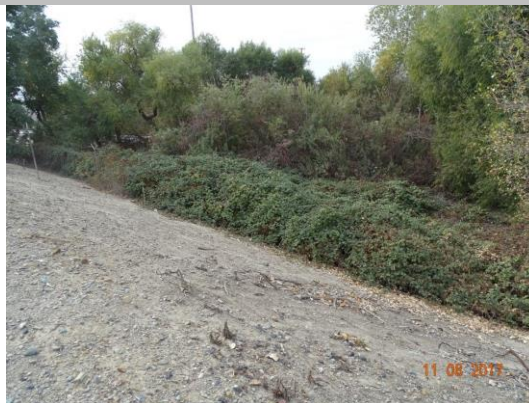
Photo 1 of 3 : FA\_2017\_RD0524\_107\_262\_20171116\_00470.jpg

Looking northeast at the landside slope.

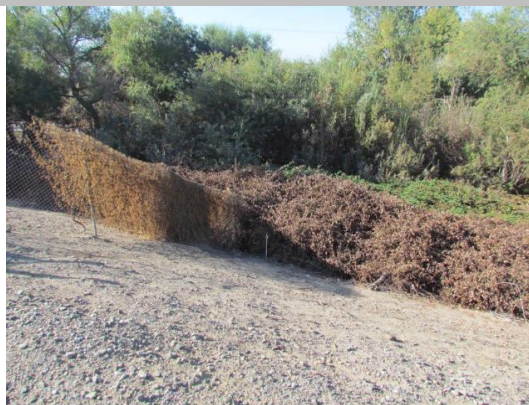
Photo 2 of 3 : FA\_2017\_RD0524\_107\_262\_20170919\_00269.jpg

Looking west at dense vegetation at landward slope and toe fall 2015.

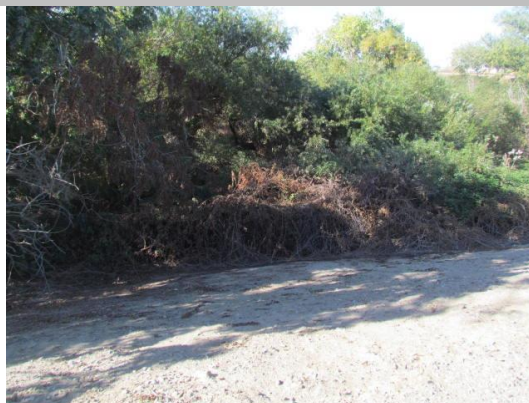
Photo 3 of 3 : FA\_2017\_RD0524\_107\_262\_20170919\_00270.jpg

Looking west at dense vegetation on landside toe. Spring 2014

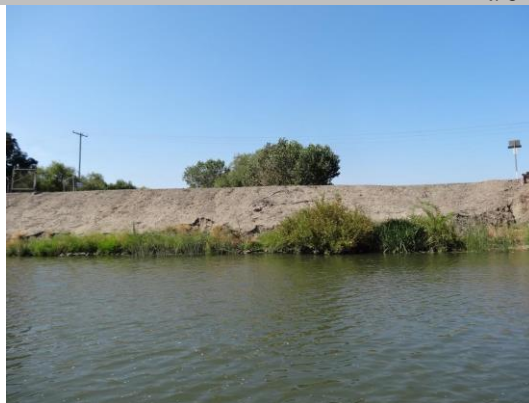
Photo 1 of 4 : SJR2017\_RD0524U01RM41.39\_1.jpg

LM Start	0.76	Rating **	U	Issue No.	21
LM End	0.77	Issue Type +	Ma	Location *	WS
Category	Supplemental			GPS Latitude/Longitude	
				Start	End
Item	DWR Erosion Survey			37.936821 °	37.936821 °
				-121.334582 °	-121.334582 °
DWR ID	RD0524U01RM41.39				
Comment Code					
Inspector Comment					
09/13/2017: No significant change observed.					
07/25/2016: No significant change observed.					
06/24/2015: No significant change observed.					
06/19/2014: No significant change observed.					
08/13/2013: No significant change at this site.					
08/07/2012: The site has been visited by boat survey. No significant change observed.					
08/23/2011: The site is located immediately upstream of a Railroad bridge. Dense vegetation at the water line blocks the view of erosion.					
[2017 Site ID:RD0524U01RM41.39]

Front view of the erosion site.

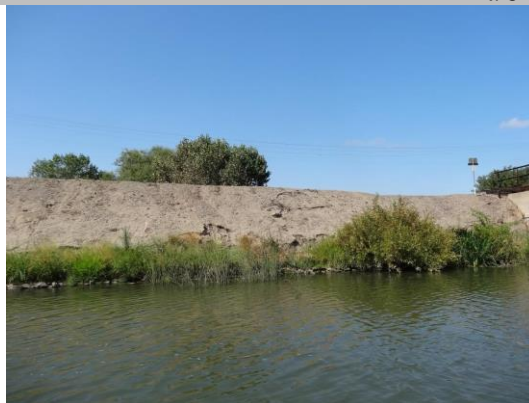
Photo 3 of 4 : SJR2017\_RD0524U01RM41.39\_3.jpg

Front view of the erosion.

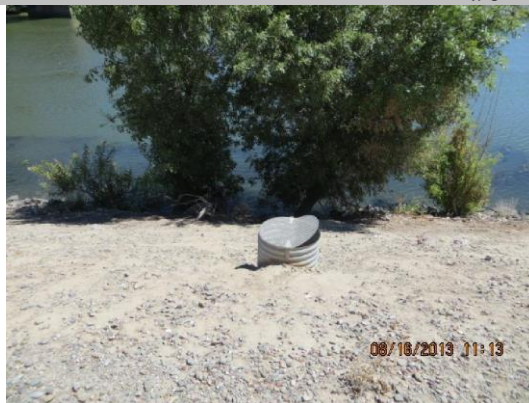
Photo 1 of 2 : UCIP\_FA\_2017\_17571\_29719.jpg

LM Start	0.78	Rating **	M	Issue No.	935
LM End	0.78	Issue Type +	Ma	Location *	
Category	Supplemental			GPS Latitude/Longitude	
				Start	End
Item	DWR UCIP LMA Responsibility			37.936474 °	37.936474 °
				-121.334830 °	-121.334830 °
DWR ID					
Comment Code					
Inspector Comment					
FS_ID:17571 DS_ID:20596 EP_NO: N/A Repair Type: Non-Urgent Crossing Status: Found UCIP Comments: Large hole in pipe at WS toe. Appears abandoned and should be done so properly. FIELD_STRUCT_DESC: 8-inch steel pipe of unknown purpose through the levee, 4 feet below the crown. Pump at the toe of the landside (LS) slope, not found 8/16/13. Siphon breaker in 24-inch corrugated metal riser unit on the waterside (WS) slope. [Additional Reference(s): USACE San Joaquin O&M Manual 7, April 1964, (HLM 0.79)]. FS Date: 8/16/2013

Siphon breaker in 24-inch cmp riser on WS slope.

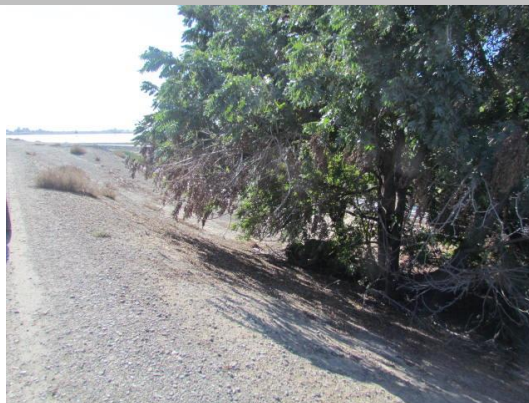
Photo 1 of 1 : FA\_2017\_RD0524\_107\_76\_20170919\_00120.jpg

Looking southwest at low hanging tree branches at landside toe.

LM Start	0.78	Rating **	U	Issue No.	76
LM End	0.78	Issue Type +	Ma	Location *	LS
Category	Earthen Levee			GPS Latitude/Longitude	
				Start	End
Item	Trim / Thin Trees			37.936444 °	37.936444 °
				-121.334797 °	-121.334797 °
DWR ID	DWR_RD0524_01_s_2012_76				
Comment Code					
T1 : Trim trees to at least five feet above ground level.					
Inspector Comment

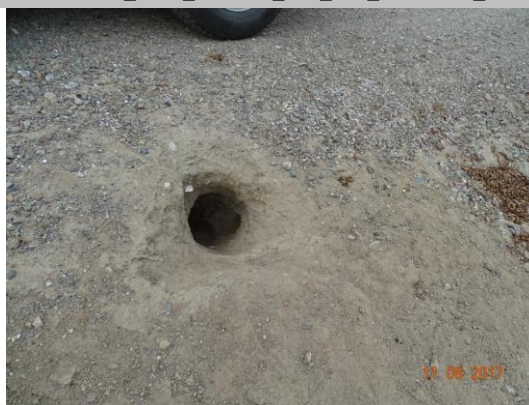
Photo 1 of 1 : FA\_2017\_RD0524\_107\_239\_20171116\_00471.jpg

Looking west at the waterside shoulder.

LM Start	0.79	Rating **	U	Issue No.	239
LM End	0.79	Issue Type +	Ma	Location *	WS
Category	Earthen Levee			GPS Latitude/Longitude	
				Start	End
Item	Animal Control			37.936413 °	37.936413 °
				-121.334779 °	-121.334779 °
DWR ID	DWR_RD0524_01_f_2017_239				
Comment Code					
A3 : No rodents visible, but rodent burrows visible; need to backfill and compact or grout burrows.					
Inspector Comment

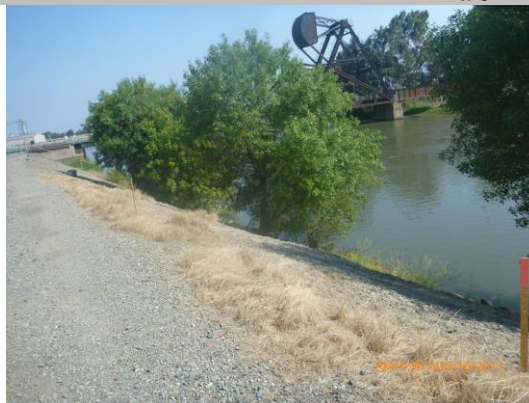
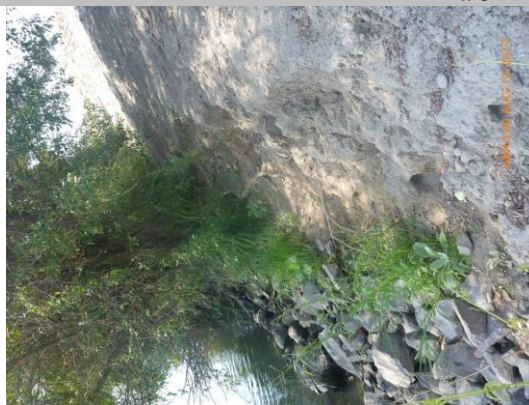
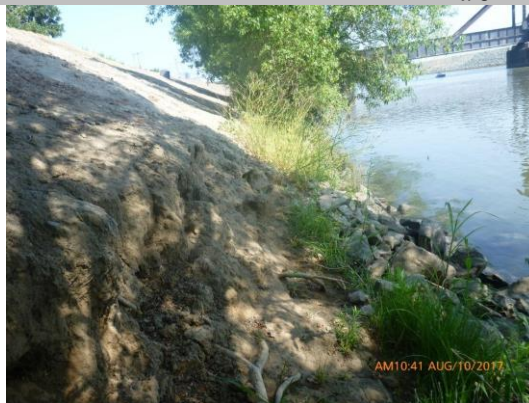
LM Start	0.79	Rating **	A/W	Issue No.	155
LM End	0.80	Issue Type +	Ma	Location *	
Category	Supplemental			GPS Latitude/Longitude	
				Start	End
Item	2017 Storm Damage			37.936300 °	37.936200 °
				-121.334700 °	-121.334600 °
DWR ID	DWR_RD0524_01_f_2017_155				
Comment Code					
Inspector Comment					
Levee Evaluation Comments					
Description:Slope protection repairs are needed along the waterside slope due to erosion and riprap displacement from high water. Based upon levee inspections, it was determined the waterside levee slope is eroding, deteriorating, and degrading. The eroded levee sections need to be restored back to design standards to prevent further deterioration and damage.					
Site ID No:538					
Site Designation:LMA-444					
Repair Type: Erosion					
Rating:Area of Concern					
Field Date:8/10/2017					
Notes:

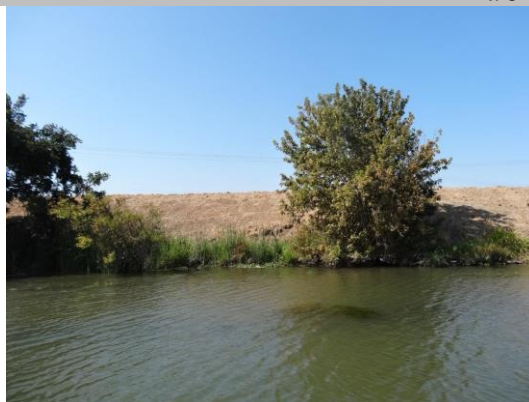
Photo 1 of 2 : SJR2017\_RD0524U01RM41.44\_1.jpg

LM Start	0.83	Rating **	U	Issue No.	22
LM End	0.84	Issue Type +	Ma	Location *	WS
Category	Supplemental			GPS Latitude/Longitude	
				Start	End
Item	DWR Erosion Survey			37.935930 °	37.935930 °
				-121.334133 °	-121.334133 °
DWR ID	RD0524U01RM41.44				
Comment Code					
Inspector Comment					
09/13/2017: No significant change observed.					
07/25/2016: No significant change observed.					
06/24/2015: No significant change observed.					
06/19/2014: No significant change observed.					
08/13/2013: Site was discovered during boat survey. The dense vegetation blocks a clear view of the erosion. Size of erosion site was very roughly estimated. [2017 Site ID:RD0524U01RM41.44]

Front view of the erosion. The tree and vegetation block the view of the site.

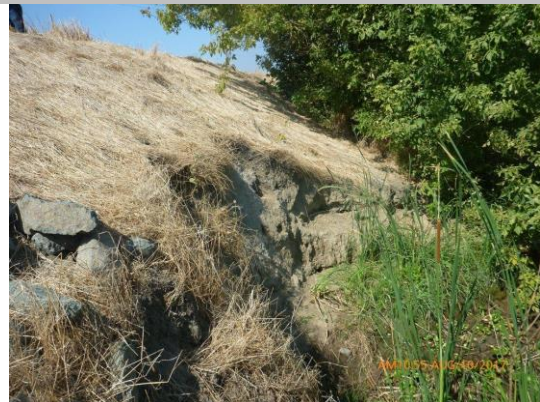
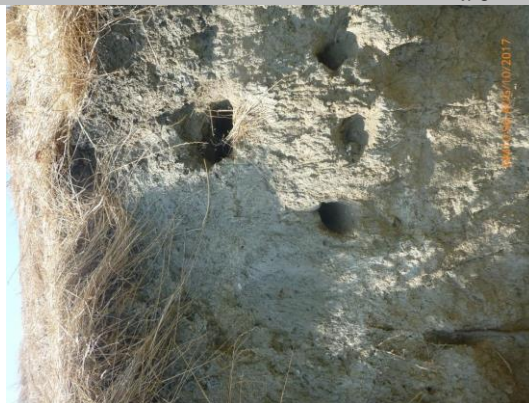
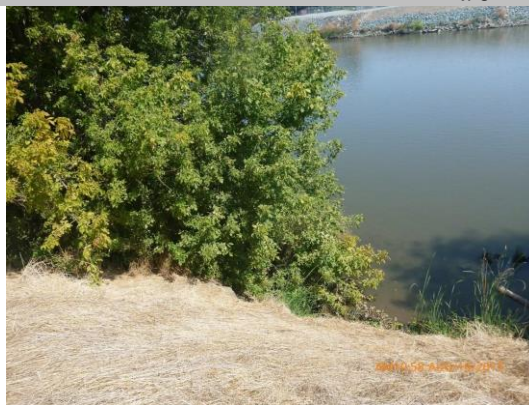
LM Start	0.90	Rating **	A/W	Issue No.	193
LM End	0.91	Issue Type +	Ma	Location *	
Category	Supplemental			GPS Latitude/Longitude	
				Start	End
Item	2017 Storm Damage			37.935400 °	37.935300 °
				-121.333300 °	-121.333200 °
DWR ID	DWR_RD0524_01_f_2017_193				
Comment Code					
Inspector Comment					
Levee Evaluation Comments					
Description:Slope protection repairs are needed along the waterside slope due to erosion and riprap displacement from high water. Based upon levee inspections, it was determined the waterside levee slope is eroding, deteriorating, and degrading. The eroded levee sections need to be restored back to design standards to prevent further deterioration and damage.					
Site ID No:537					
Site Designation:LMA-443					
Repair Type: Erosion					
Rating:Serious					
Field Date:8/10/2017					
Notes:

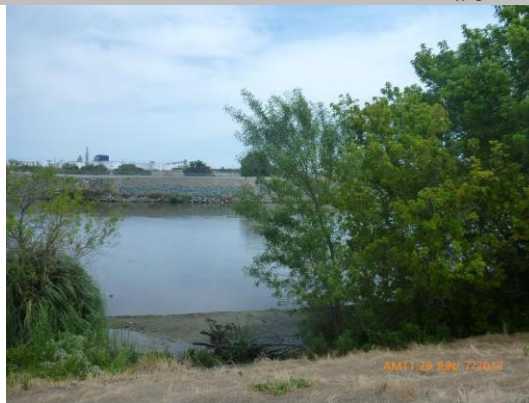
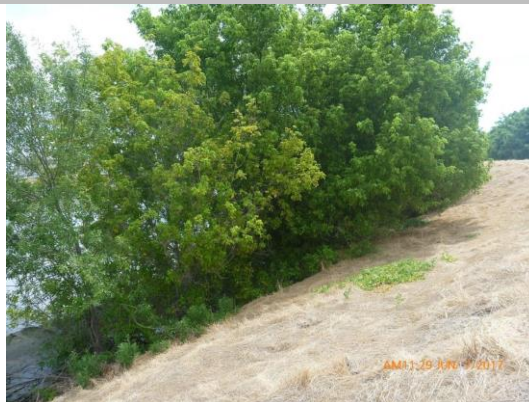
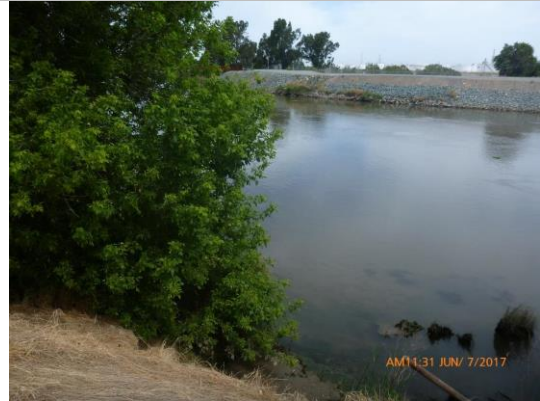
LM Start	0.91	Rating **	A/W	Issue No.	187	
LM End		Issue Type +	Ma	Location *		
Category	Supplemental			GPS Latitude/Longitude		
				Start	End	
Item	2017 Storm Damage			37.935580 °		°
				-121.333200 °		°
DWR ID	DWR_RD0524_01_f_2017_187					
Comment Code						
Inspector Comment						
Levee Evaluation Comments						
Description:						
Site ID No:87						
Site Designation:DWR_RD0524_01_s_2012_99						
Repair Type: Erosion						
Rating:Area of Concern						
Field Date:6/7/2017						
Notes: no observable defects to levee, vegetation blocks ws toe

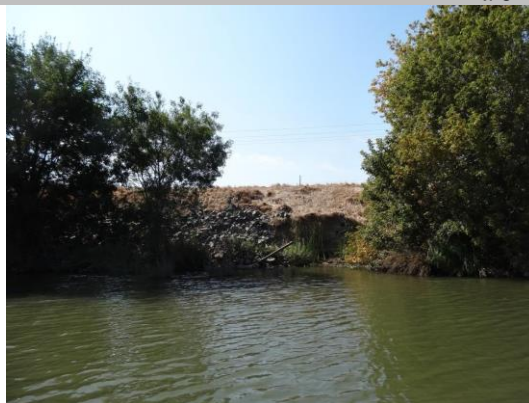
Photo 2 of 3 : SJR2017\_RD0524U01RM41.5\_2.jpg

LM Start	0.91	Rating **	U	Issue No.	29
LM End	0.91	Issue Type +	Ma	Location *	WS
Category	Supplemental			GPS Latitude/Longitude	
				Start	End
Item	DWR Erosion Survey			37.935576 °	37.935576 °
				-121.333202 °	-121.333202 °
DWR ID	RD0524U01RM41.5				
Comment Code					
Inspector Comment					
09/13/2017: No significant change observed.					
07/25/2016: No significant change observed.					
06/24/2015: No significant change observed.					
06/19/2014: No significant change observed.					
08/13/2013: No significant change at this site.					
08/07/2012: The site has been visited by boat survey. No significant change observed					
08/23/2011: The erosion site is immediately downstream of the riprap protection. [2017 Site ID:RD0524U01RM41.5]

Close view of the erosion.

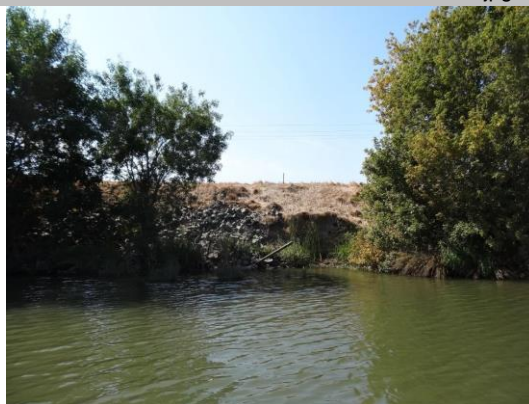
Photo 3 of 3 : SJR2017\_RD0524U01RM41.5\_3.jpg

Close view of the erosion.

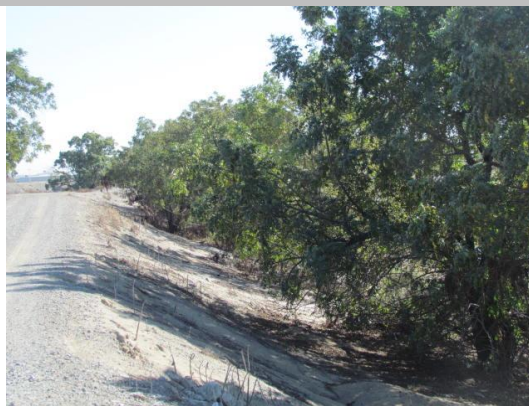
Photo 1 of 1 : FA\_2017\_RD0524\_107\_77\_20170919\_00121.jpg

Looking south at low hanging tree branches at landside toe.

LM Start	0.93	Rating **	M	Issue No.	77
LM End	1.01	Issue Type +	Ma	Location *	LS
Category	Earthen Levee			GPS Latitude/Longitude	
				Start	End
Item	Trim / Thin Trees			37.935259 °	37.935049 °
				-121.332864 °	-121.331334 °
DWR ID	DWR_RD0524_01_s_2012_77				
Comment Code					
T1 : Trim trees to at least five feet above ground level.					
Inspector Comment
