**Flood Control Project Maintenance  
Levee Inspections**

**Fall 2017 Levee Maintenance Deficiency Summary Report**

***San Joaquin River Basin***

**Reclamation District No. 0524 Middle Roberts Island**

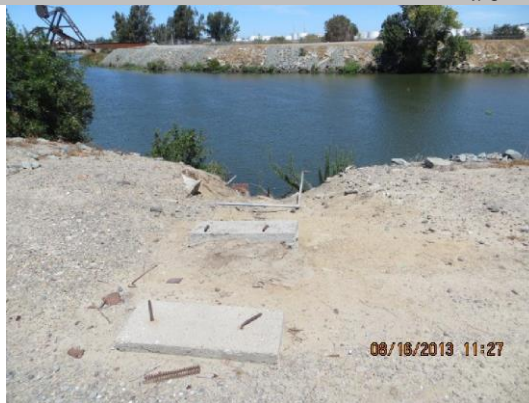
Photo 1 of 3 : UCIP\_FA\_2017\_22724\_38442.jpg

Comment Code					
Inspector Comment					
FS_ID:22724					
DS_ID:20597					
EP_NO: N/A					
Repair Type: Non-Urgent					
Crossing Status: Found					
UCIP Comments: 11/16/2016 - Location may be at LM 0.92 (37.935267, -121.332985) rather than LM 0.974. Need to field verify (DWR UCIP - thatch)					
8/16/2013 - Pipe abandoned and should be done so properly. (DWR UCIP -wwylie)					
FIELD_STRUCT_DESC: *ABANDONED* 14-inch irrigation pipe of an unknown material through the levee, 6 feet below the crown. Concrete pad for pump on the waterside (WS) shoulder. No pump or other appurtenances remain. [Additional Reference(s): DWR Levee Log, 2004. USACE San Joaquin O&M Manual 7, April 1964, (HLM 0.93)].					
FS Date: 8/16/2013

Concrete pad for pump mount on WS shoulder.

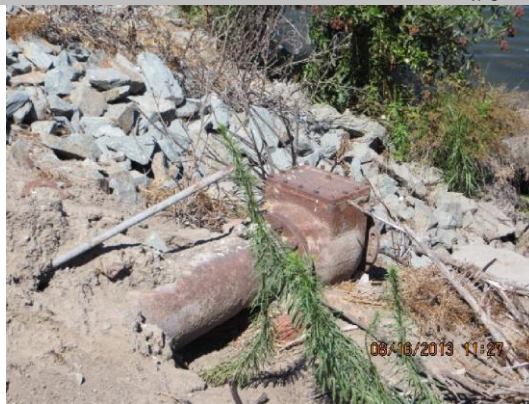
Photo 2 of 3 : UCIP\_FA\_2017\_22724\_38441.jpg

Pipe visible on WS slope.

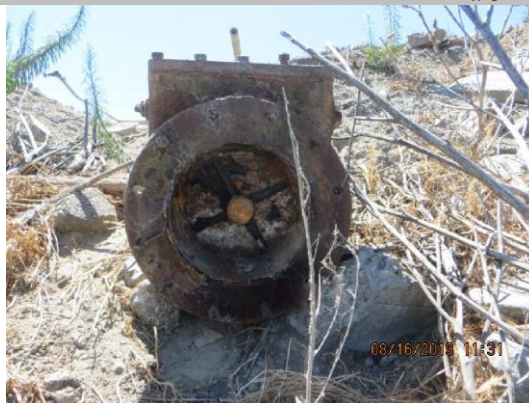
Photo 3 of 3 : UCIP\_FA\_2017\_22724\_38440.jpg

(37.935267, -121.332985) rather than LM 0.974. Need to field verify						
(DWR UCIP - thatch)						
8/16/2013 - Pipe abandoned and should be done so properly. (DWR						
UCIP -wwylie)						
FIELD_STRUCT_DESC: *ABANDONED* 14-inch irrigation pipe of an						
unknown material through the levee, 6 feet below the crown. Concrete						
pad for pump on the waterside (WS) shoulder. No pump or other						
appurtenances remain. [Additional Reference(s): DWR Levee Log,						
2004. USACE San Joaquin O&M Manual 7, April 1964, (HLM 0.93)].						
FS Date: 8/16/2013

One way check valve closed on WS slope.

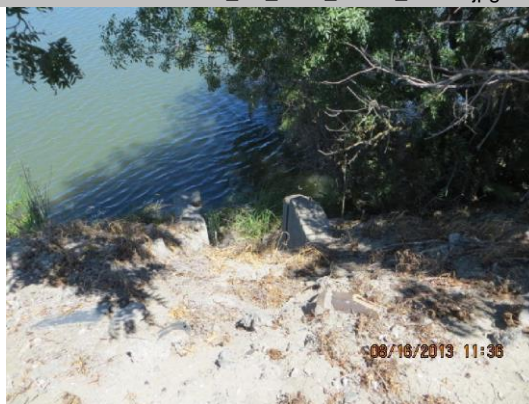
Photo 1 of 2 : UCIP\_FA\_2017\_17575\_29736.jpg

LM Start	0.98	Rating **	A/W	Issue No.	937
LM End	0.98	Issue Type +	Ma	Location *	
Category	Supplemental			GPS Latitude/Longitude	
				Start	End
Item	DWR UCIP LMA Responsibility			37.935163 °	37.935163 °
				-121.331887 °	-121.331887 °
DWR ID					
Comment Code					
Inspector Comment					
FS_ID:17575 DS_ID:20598 EP_NO: N/A Repair Type: No Action Needed Crossing Status: Found UCIP Comments: FIELD_STRUCT_DESC: *ABANDONED* 36-inch drainage pipe of an unknown material through the levee, 15 feet below the crown. Landside (LS) end is not visible. Concrete headwall at outlet on the waterside (WS) slope is visible. Pipe appears to be abandoned in place. Slide gate on the WS removed. [Additional Reference(s): DWR Levee Log, 2004. USACE San Joaquin O&M Manual 7, April 1964, (HLM 0.99)]. FS Date: 8/16/2013

Concrete headwall visible on WS slope.

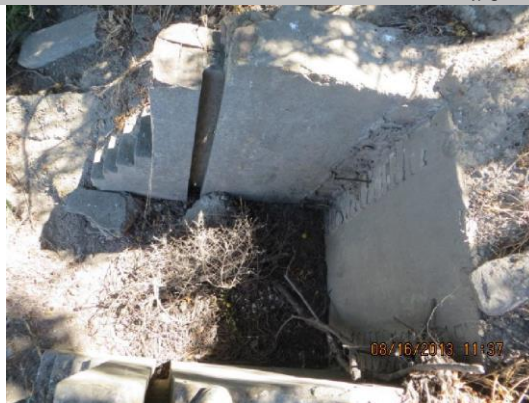
Photo 2 of 2 : UCIP\_FA\_2017\_17575\_29735.jpg

LM Start	0.98	Rating **	A/W	Issue No.	937 (cont)	
LM End	0.98	Issue Type +	Ma	Location *		
Category	Supplemental			GPS Latitude/Longitude		
				Start		End
Item	DWR UCIP LMA Responsibility			37.935163 °		37.935163 °
				-121.331887 °		-121.331887 °
DWR ID						
Comment Code						
Inspector Comment						
FS_ID:17575 DS_ID:20598 EP_NO: N/A Repair Type: No Action Needed Crossing Status: Found UCIP Comments: FIELD_STRUCT_DESC: *ABANDONED* 36-inch drainage pipe of an unknown material through the levee, 15 feet below the crown. Landside (LS) end is not visible. Concrete headwall at outlet on the waterside (WS) slope is visible. Pipe appears to be abandoned in place. Slide gate on the WS removed. [Additional Reference(s): DWR Levee Log, 2004. USACE San Joaquin O&M Manual 7, April 1964, (HLM 0.99)]. FS Date: 8/16/2013

Slide gate removed from headwall on WS slope.

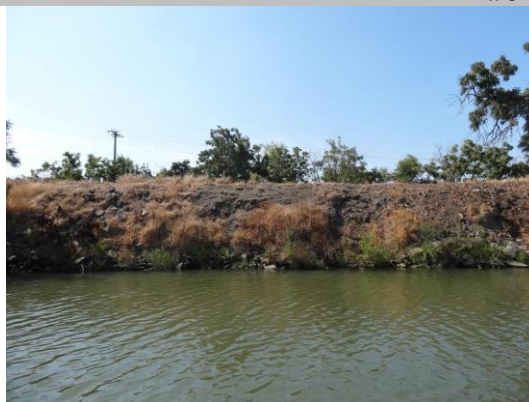
Photo 1 of 4 : SJR2017\_RD0524U01RM41.58\_1.jpg

LM Start	1.00	Rating **	U	Issue No.	30
LM End	1.00	Issue Type +	Ma	Location *	WS
Category	Supplemental			GPS Latitude/Longitude	
				Start	End
Item	DWR Erosion Survey			37.935410 °	37.935410 °
				-121.331560 °	-121.331560 °
DWR ID	RD0524U01RM41.58				
Comment Code					
Inspector Comment					
09/13/2017: No significant change observed.					
07/25/2016: No significant change observed.					
06/24/2015: No significant change observed.					
06/19/2014: No significant change observed.					
08/13/2013: No significant change at this site.					
08/07/2012: The erosion was discovered during the boat survey. [2017					
Site ID:RD0524U01RM41.58]

Front view of the erosion.

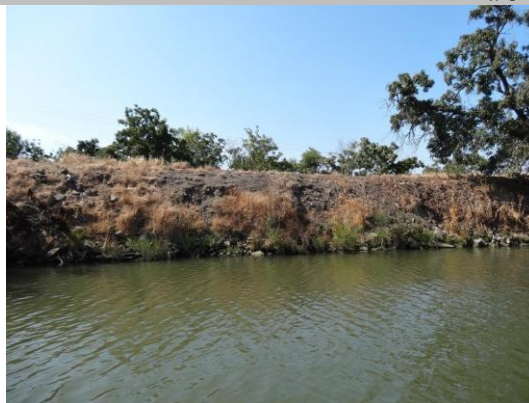
Photo 2 of 4 : SJR2017\_RD0524U01RM41.58\_2.jpg

LM Start	1.00	Rating **	U	Issue No.	30 (cont)	
LM End	1.00	Issue Type +	Ma	Location *	WS	
Category	Supplemental			GPS Latitude/Longitude		
				Start	End	
Item	DWR Erosion Survey			37.935410 °	37.935410 °	
				-121.331560 °	-121.331560 °	
DWR ID	RD0524U01RM41.58					
Comment Code						
Inspector Comment						
09/13/2017: No significant change observed.						
07/25/2016: No significant change observed.						
06/24/2015: No significant change observed.						
06/19/2014: No significant change observed.						
08/13/2013: No significant change at this site.						
08/07/2012: The erosion was discovered during the boat survey. [2017						
Site ID:RD0524U01RM41.58]

Close view of the erosion.

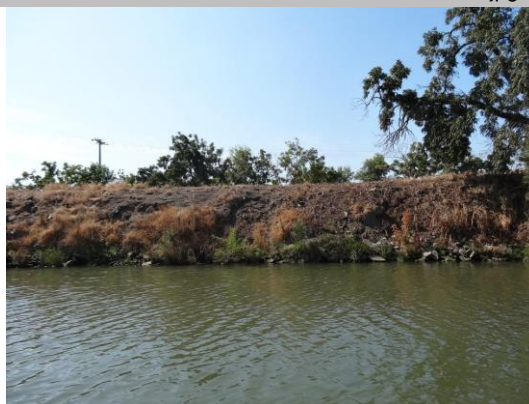
Photo 3 of 4 : SJR2017\_RD0524U01RM41.58\_3.jpg

Front view of the erosion.

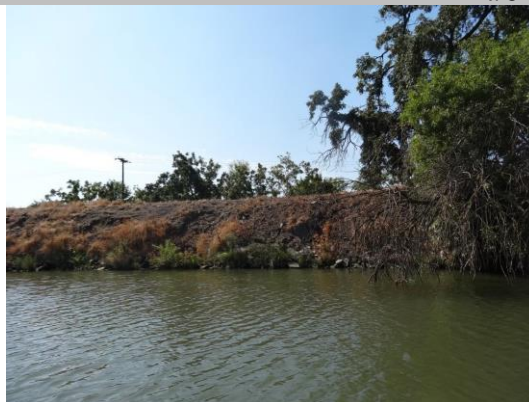
Photo 4 of 4 : SJR2017\_RD0524U01RM41.58\_4.jpg

Downstream view of the erosion.

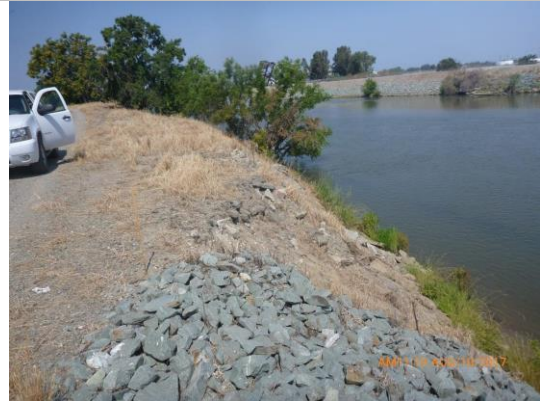
Photo 3 of 3 : LEVAL\_FA\_2017\_536\_4111.jpg

Item	2017 Storm Damage			37.935100 °	37.935100 °	
				-121.331500 °	-121.331300 °	
DWR ID	DWR_RD0524_01_f_2017_198					
Comment Code						
Inspector Comment						
Levee Evaluation Comments						
Description:Slope protection repairs are needed along the waterside slope due to erosion and riprap displacement from high water. Based upon levee inspections, it was determined the waterside levee slope is eroding, deteriorating, and degrading. The eroded levee sections need to be restored back to design standards to prevent further deterioration and damage.						
Site ID No:536						
Site Designation:LMA-442						
Repair Type: Erosion						
Rating:Area of Concern						
Field Date:8/10/2017						
Notes: Appears to be previous repair site adjacent to LMA-442. Large fox den on land side

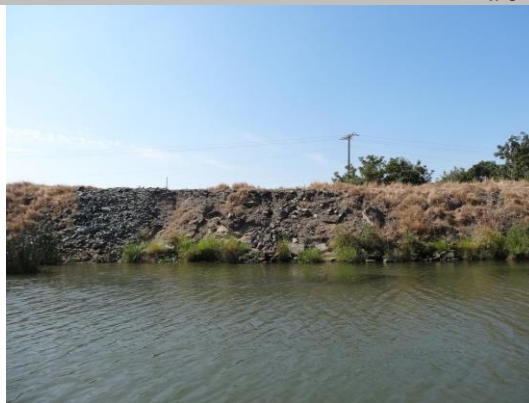
Photo 2 of 3 : SJR2017\_RD0524U01RM41.59\_2.jpg

Comment Code						
Inspector Comment						
09/13/2017: No significant change observed.						
07/25/2016: No significant change observed.						
06/24/2015: No significant change observed.						
06/19/2014: No significant change observed.						
08/13/2013: No significant change at this site.						
08/07/2012: The site has been visited by boat survey. Site has been repaired, but new erosion occurred at the levee slope and immediately upstream of the repaired site.						
08/23/2011: The site is about 500 ft downstream of bridge. The levee toe seems to be protected, but the protection is being washed away.						
[2017 Site ID:RD0524U01RM41.59]

Close view of the erosion.

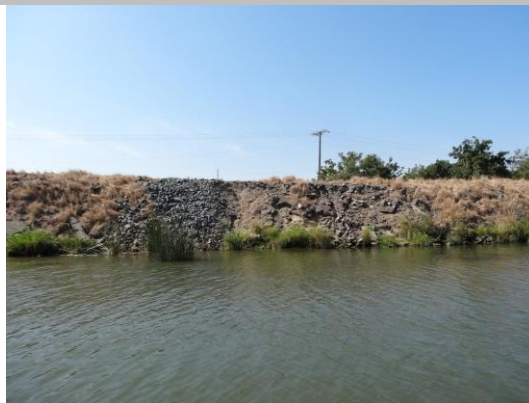
Photo 3 of 3 : SJR2017\_RD0524U01RM41.59\_3.jpg

Front view of the site.

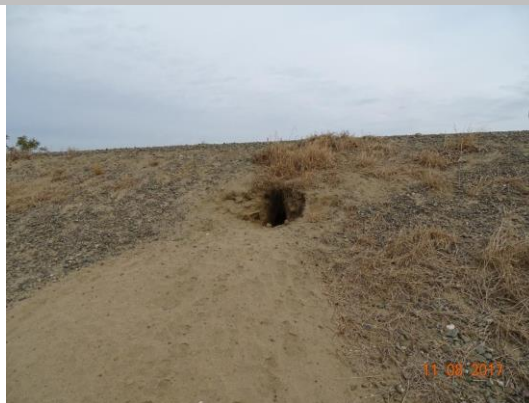
Photo 1 of 1 : FA\_2017\_RD0524\_107\_238\_20171116\_00469.jpg

LM Start	1.02	Rating **	U	Issue No.	238
LM End	1.02	Issue Type +	Ma	Location *	LS
Category	Earthen Levee			GPS Latitude/Longitude	
				Start	End
Item	Animal Control			37.934991 °	37.934991 °
				-121.331160 °	-121.331160 °
DWR ID	DWR_RD0524_01_f_2017_238				
Comment Code					
A3 : No rodents visible, but rodent burrows visible; need to backfill and compact or grout burrows.					
Inspector Comment

Looking northeast at the landside slope.

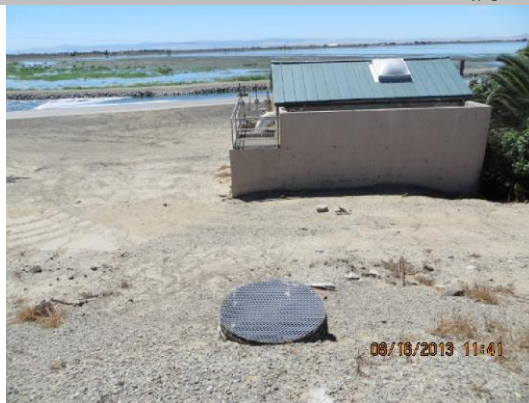
Photo 1 of 3 : UCIP\_FA\_2017\_17589\_29748.jpg

Comment Code						
Inspector Comment						
FS_ID:17589 DS_ID:20601 EP_NO: 2725B Repair Type: Non-Urgent Crossing Status: Found UCIP Comments: CMP riser severely corroded. Good indicator of potential condition of 48-inch pipe. Recommend Video Inspection. FIELD_STRUCT_DESC: 48-inch corrugated metal sewer line through the levee, 16 feet below the crown. Runs underneath the river and through the levee with 36-inch corrugated metal riser unit/inspection chamber on the landside (LS) shoulder. Distribution/pump house on the LS toe. (Permit No. 2725-B, 1959 - City of Stockton). [Additional Reference(s): DWR Levee Log, 2004. USACE San Joaquin O&M Manual 7, April 1964, (HLM 1.08)]. FS Date: 8/16/2013

CMP riser for access/inspection on LS slope with distribution/pumphouse on LS toe.

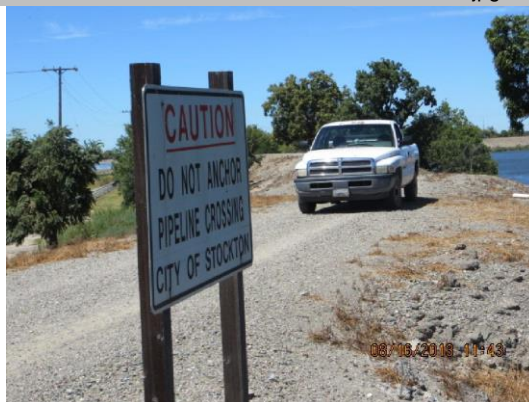
Photo 2 of 3 : UCIP\_FA\_2017\_17589\_29747.jpg

Caution sign on WS shoulder.

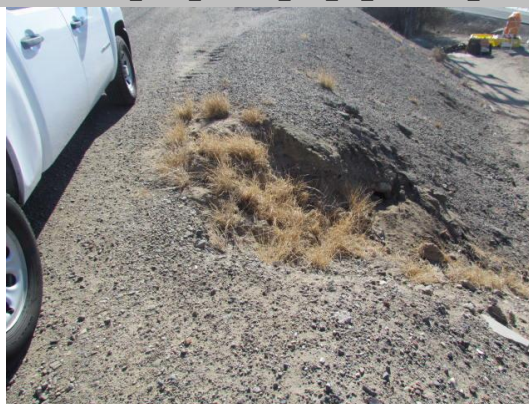
Photo 1 of 7 : FA\_2017\_RD0524\_107\_18\_20170919\_00031.jpg

LM Start	1.07	Rating **	U	Issue No.	18
LM End	1.07	Issue Type +	Ma	Location *	LS
Category	Earthen Levee			GPS Latitude/Longitude	
				Start	End
Item	Slope Stability			37.934715 °	37.934715 °
				-121.330343 °	-121.330343 °
DWR ID	DWR_RD0524_01_s_2012_18				
Comment Code					
S1 : Repair slope instability.					
Inspector Comment					
Slope damage extends from shoulder to middle of slope.

Looking south at caving on landward shoulder. (Fall 2015)

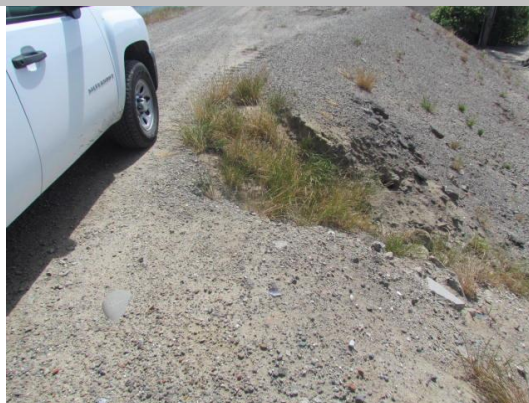
Photo 3 of 7 : FA\_2017\_RD0524\_107\_18\_20170919\_00033.jpg

Looking south at caving on landward shoulder. (Spring 2015)

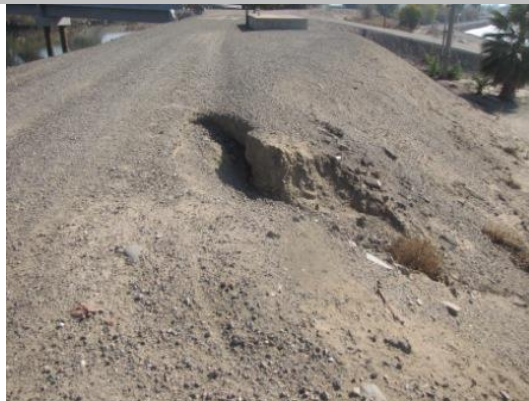
Photo 4 of 7 : FA\_2017\_RD0524\_107\_18\_20170919\_00034.jpg

Updated picture of the erosion site on the landside shoulder. Fall 2014

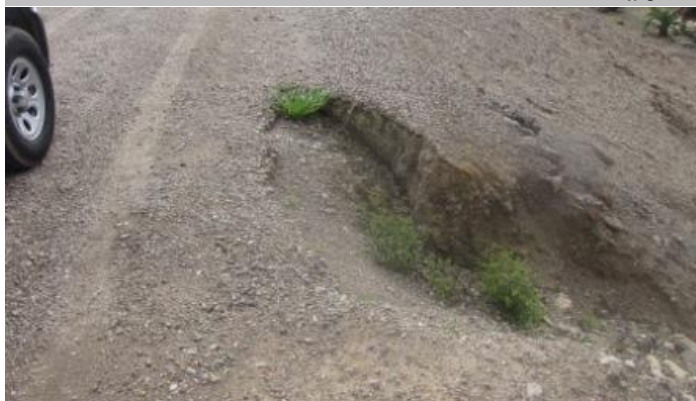
Photo 6 of 7 : FA\_2017\_RD0524\_107\_18\_20170919\_00036.jpg

LM Start	1.07	Rating **	U	Issue No.	18 (cont)	
LM End	1.07	Issue Type +	Ma	Location *	LS	
Category	Earthen Levee			GPS Latitude/Longitude		
				Start		End
Item	Slope Stability			37.934715 °		37.934715 °
				-121.330343 °		-121.330343 °
DWR ID	DWR_RD0524_01_s_2012_18					
Comment Code						
S1 : Repair slope instability.						
Inspector Comment						
Slope damage extends from shoulder to middle of slope.

Looking at updated slope stability as of Fall 2013.

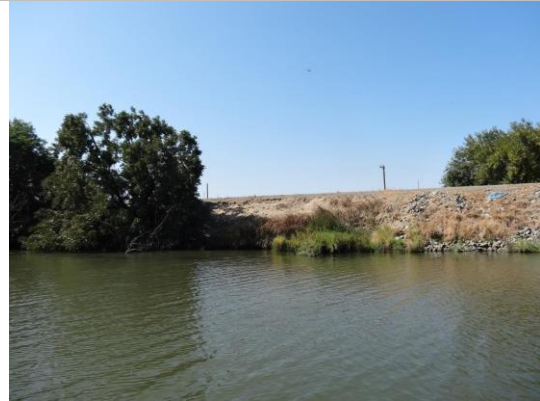
Photo 1 of 4 : SJR2017\_RD0524U01RM41.79\_1.jpg

Comment Code					
Inspector Comment					
09/13/2017: No significant change observed.					
07/25/2016: No significant change observed.					
06/24/2015: No significant change observed.					
06/19/2014: No significant change observed.					
08/13/2013: No significant change at this site.					
08/07/2012: The site has been visited by boat survey. No significant change observed					
08/23/2011: No significant change observed on site.					
09/07/2010: No significant change observed on site. Vegetation is visible at the water line. There is an exposed pipe discharge partially hanging at the mid-slope, possibly still used for discharging irrigation/runoff water. There is minimal rip rap protection along the bank, and what's left of it is no longer adequately protecting the bank.					
9/29/2009: Site consists of a 400-foot long eroding bank with minimal vegetation and protection; the existing rip rap has sloughed, rendering it useless; note that there is an exposed section of a pipe.

Direct view of the site.

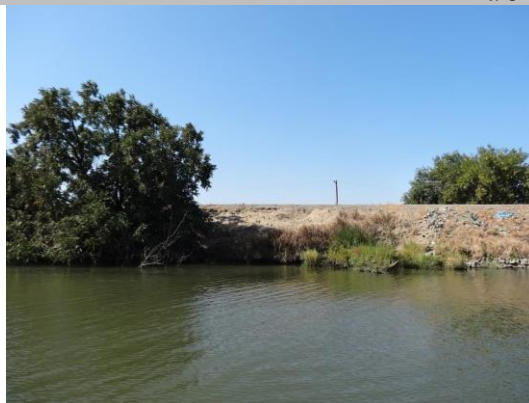
Photo 3 of 4 : SJR2017\_RD0524U01RM41.79\_3.jpg

Comment Code						
Inspector Comment						
09/13/2017: No significant change observed.						
07/25/2016: No significant change observed.						
06/24/2015: No significant change observed.						
06/19/2014: No significant change observed.						
08/13/2013: No significant change at this site.						
08/07/2012: The site has been visited by boat survey. No significant change observed						
08/23/2011: No significant change observed on site.						
09/07/2010: No significant change observed on site. Vegetation is visible at the water line. There is an exposed pipe discharge partially hanging at the mid-slope, possibly still used for discharging irrigation/runoff water. There is minimal rip rap protection along the bank, and what's left of it is no longer adequately protecting the bank.						
9/29/2009: Site consists of a 400-foot long eroding bank with minimal vegetation and protection; the existing rip rap has sloughed, rendering it useless; note that there is an exposed section of a pipe.

View of the erosion.

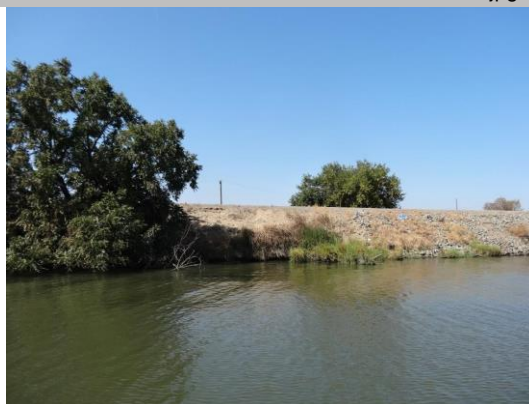
Photo 4 of 4 : SJR2017\_RD0524U01RM41.79\_4.jpg

View of the site. Note the tree near the erosion site.

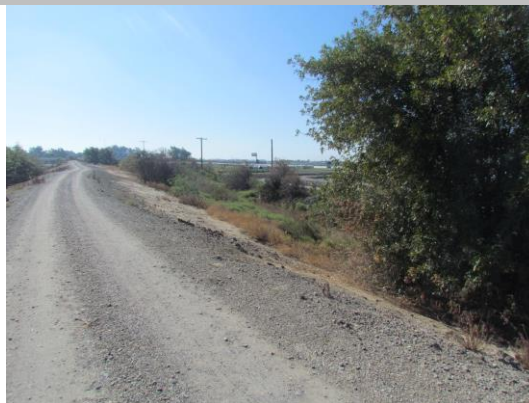
Photo 1 of 4 : FA\_2017\_RD0524\_107\_915\_20170919\_00277.jpg

Looking southwest at dense veg at landward toe and berm. (Fall 2016)

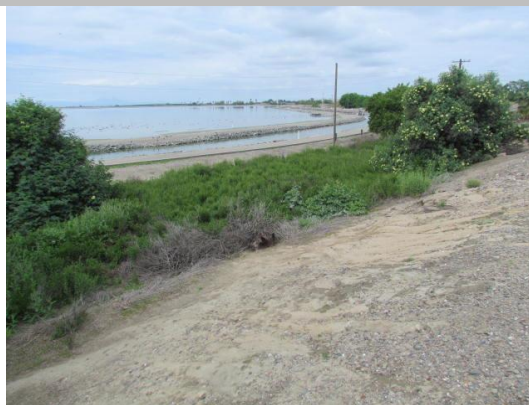
Photo 2 of 4 : FA\_2017\_RD0524\_107\_915\_20170919\_00278.jpg

Looking northwest at dense veg at landward toe and berm. (Spring 2016)

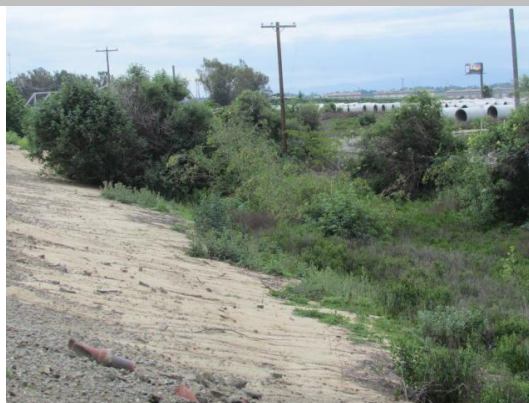
Photo 3 of 4 : FA\_2017\_RD0524\_107\_915\_20170919\_00279.jpg

Looking southwest at dense veg at landward toe and berm. (Spring 2015)

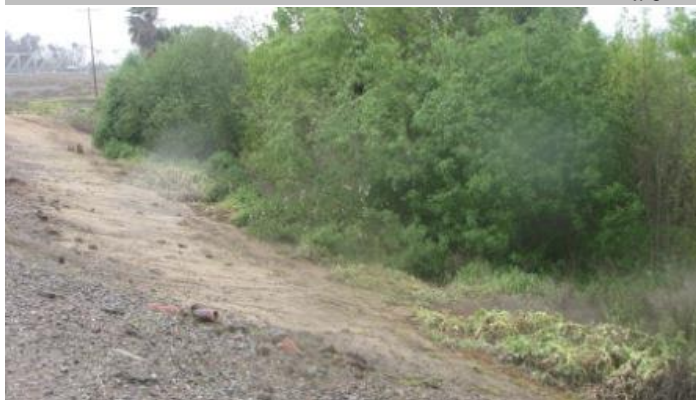
Photo 4 of 4 : FA\_2017\_RD0524\_107\_915\_20170919\_00280.jpg

LM Start	1.16	Rating **	U	Issue No.	915 (cont)	
LM End	1.23	Issue Type +	Ma	Location *	LS	
Category	Earthen Levee			GPS Latitude/Longitude		
				Start		End
Item	Vegetation			37.933775 °		37.932784 °
				-121.329250 °		-121.328765 °
DWR ID	DWR_RD0524_01_s_2012_915					
Comment Code						
V2 : Remove the wild growth other than native grasses from the levee slopes.						
Inspector Comment						
Control veg at landside toe and berm.

Looking southwest at dense veg. on landside toe. (Fall 2015)

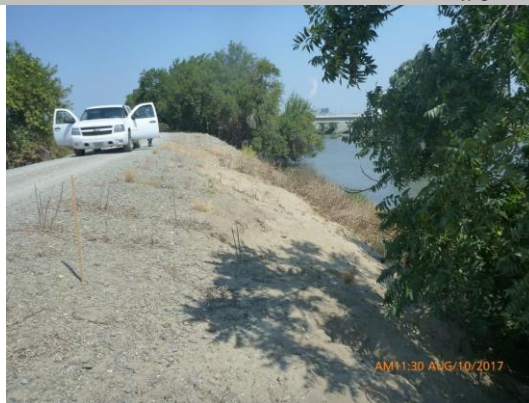
Photo 3 of 3 : LEVAL\_FA\_2017\_535\_4117.jpg

LM Start	<b>1.18</b>	Rating **	A/W	Issue No.	<b>221 (cont)</b>
LM End	<b>1.20</b>	Issue Type +	Ma	Location *	
Category	Supplemental			GPS Latitude/Longitude	
				Start	End
Item	2017 Storm Damage			37.933500 °	37.933200 °
				-121.329100 °	-121.328900 °
DWR ID	DWR_RD0524_01_f_2017_221				
Comment Code					
Inspector Comment					
<b>Levee Evaluation Comments</b> Description: Slope protection repairs are needed along the waterside slope due to erosion and riprap displacement from high water. Based upon levee inspections, it was determined the waterside levee slope is eroding, deteriorating, and degrading. The eroded levee sections need to be restored back to design standards to prevent further deterioration and damage. Site ID No: 535 Site Designation: LMA-441 Repair Type: Erosion Rating: Area of Concern Field Date: 8/10/2017 Notes:

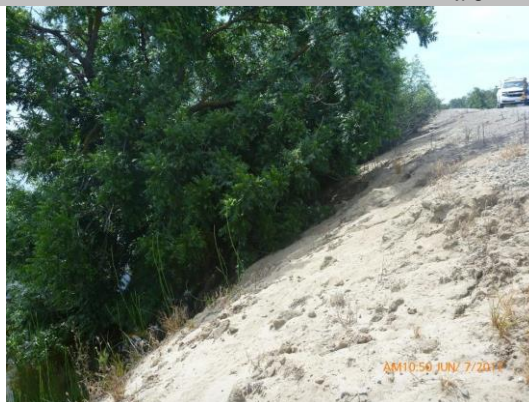
Photo 1 of 3 : LEVAL\_FA\_2017\_84\_1225.jpg

LM Start	<b>1.19</b>	Rating **	A/W	Issue No.	<b>220</b>
LM End		Issue Type +	Ma	Location *	
Category	Supplemental			GPS Latitude/Longitude	
				Start	End
Item	2017 Storm Damage			37.933347 °	°
				-121.329110 °	°
DWR ID	DWR_RD0524_01_f_2017_220				
Comment Code					
Inspector Comment					
<b>Levee Evaluation Comments</b> Description: Site ID No: 84 Site Designation: FSRP-13-42 Repair Type: Erosion Rating: Area of Concern Field Date: 6/7/2017 Notes:

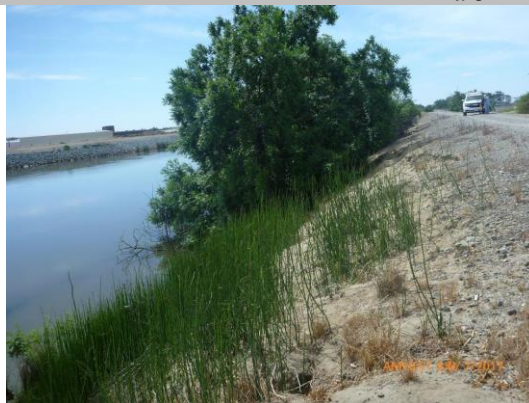
Photo 2 of 3 : LEVAL\_FA\_2017\_84\_1278.jpg

LM Start	1.19	Rating **	A/W	Issue No.	220 (cont)	
LM End		Issue Type +	Ma	Location *		
Category	Supplemental			GPS Latitude/Longitude		
				Start	End	
Item	2017 Storm Damage			37.933347 °		°
				-121.329110 °		°
DWR ID	DWR_RD0524_01_f_2017_220					
Comment Code						
Inspector Comment						
Levee Evaluation Comments						
Description:						
Site ID No:84						
Site Designation:FSRP-13-42						
Repair Type: Erosion						
Rating:Area of Concern						
Field Date:6/7/2017						
Notes:

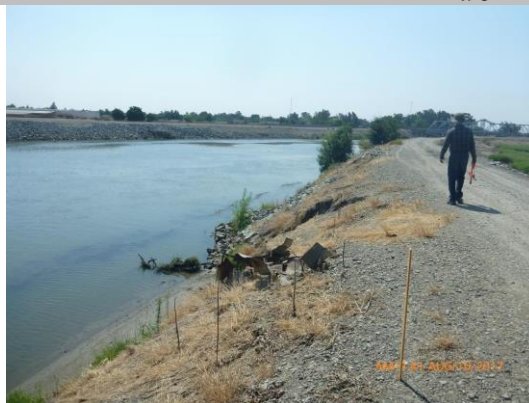
Photo 1 of 3 : LEVAL\_FA\_2017\_534\_4121.jpg

LM Start	1.25	Rating **	A/W	Issue No.	222
LM End	1.30	Issue Type +	Ma	Location *	
Category	Supplemental			GPS Latitude/Longitude	
				Start	End
Item	2017 Storm Damage			37.932600 °	37.931900 °
				-121.328700 °	-121.328400 °
DWR ID	DWR_RD0524_01_f _ 2017_222				
Comment Code					
Inspector Comment					
Levee Evaluation Comments					
Description:Slope protection repairs are needed along the waterside slope due to erosion and riprap displacement from high water. Based upon levee inspections, it was determined the waterside levee slope is eroding, deteriorating, and degrading. The eroded levee sections need to be restored back to design standards to prevent further deterioration and damage.					
Site ID No:534					
Site Designation:LMA-440					
Repair Type: Erosion					
Rating:Serious					
Field Date:8/10/2017					
Notes: site is related to, but not combined with, LMA-439

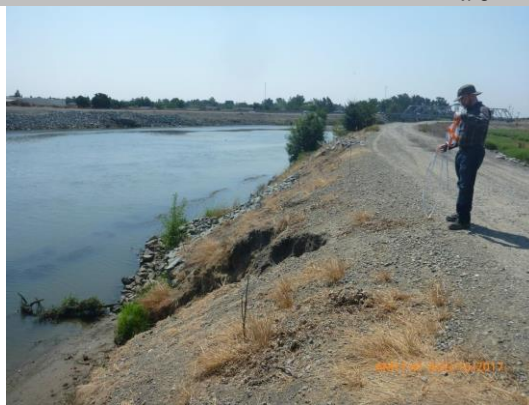
Photo 2 of 3 : LEVAL\_FA\_2017\_534\_4122.jpg

LM Start	<b>1.25</b>	Rating **	A/W	Issue No.	<b>222 (cont)</b>
LM End	<b>1.30</b>	Issue Type +	Ma	Location *

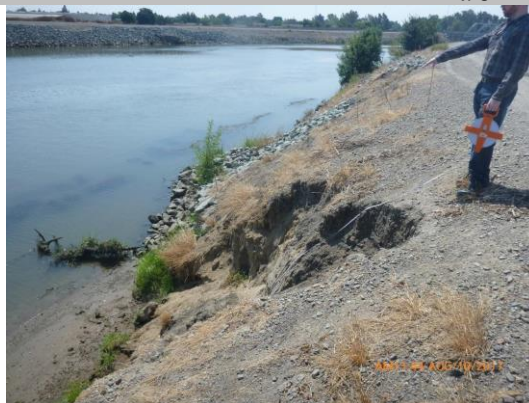
Photo 3 of 3 : LEVAL\_FA\_2017\_534\_4126.jpg

LM Start	1.25	Rating **	A/W	Issue No.	222 (cont)
LM End	1.30	Issue Type +	Ma	Location *	
Category	Supplemental			GPS Latitude/Longitude	
				Start	End
Item	2017 Storm Damage			37.932600 °	37.931900 °
				-121.328700 °	-121.328400 °
DWR ID	DWR_RD0524_01_f_2017_222				
Comment Code					
Inspector Comment					
Levee Evaluation Comments					
Description:Slope protection repairs are needed along the waterside slope due to erosion and riprap displacement from high water. Based upon levee inspections, it was determined the waterside levee slope is eroding, deteriorating, and degrading. The eroded levee sections need to be restored back to design standards to prevent further deterioration and damage.					
Site ID No:534					
Site Designation:LMA-440					
Repair Type: Erosion					
Rating:Serious					
Field Date:8/10/2017					
Notes: site is related to, but not combined with, LMA-439

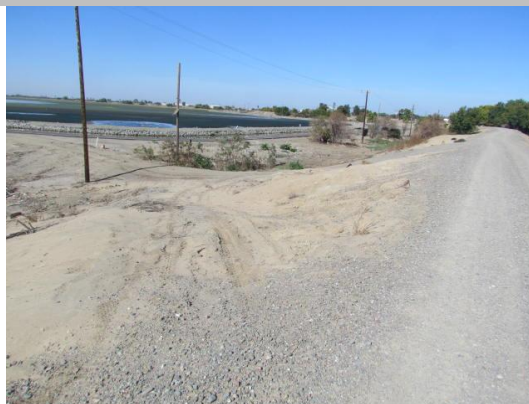
Photo 1 of 2 : FA\_2017\_RD0524\_107\_263\_20170919\_00272.jpg

LM Start	1.25	Rating **	U	Issue No.	263
LM End	1.25	Issue Type +	En	Location *	LS
Category	Earthen Levee			GPS Latitude/Longitude	
				Start	End
Item	Encroachments			37.932533 °	37.932533 °
				-121.328650 °	-121.328650 °
DWR ID	DWR_RD0524_01_s_2012_263				
Comment Code					
RA : Ramp					
Inspector Comment					
Unauthorized ramps on landside slope. Ramps were caused by vehicle traffic.

Looking northwest at unauthorized ramp on landside slope.

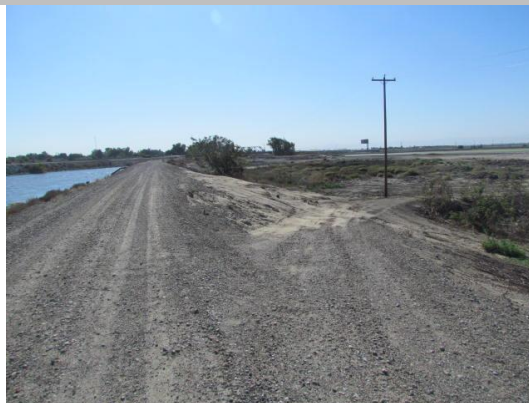
Photo 2 of 2 : FA\_2017\_RD0524\_107\_263\_20170919\_00273.jpg

LM Start	1.25	Rating **	U	Issue No.	263 (cont)	
LM End	1.25	Issue Type +	En	Location *	LS	
Category	Earthen Levee			GPS Latitude/Longitude		
				Start		End
Item	Encroachments			37.932533 °		37.932533 °
				-121.328650 °		-121.328650 °
DWR ID	DWR_RD0524_01_s_2012_263					
Comment Code						
RA : Ramp						
Inspector Comment						
Unauthorized ramps on landside slope. Ramps were caused by vehicle traffic.

Looking south at unauthorized ramp on landside slope.

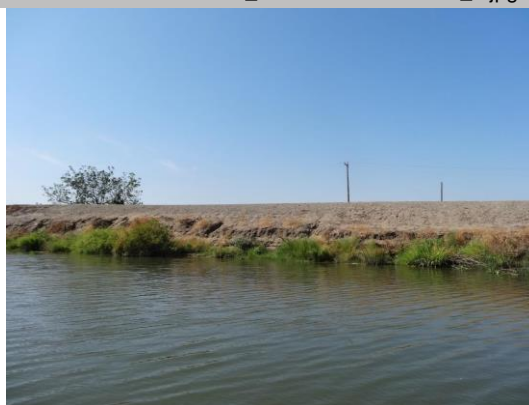
Photo 1 of 4 : SJR2017\_RD0524U01RM41.92\_1.jpg

LM Start	1.27	Rating **	U	Issue No.	47
LM End	1.33	Issue Type +	Ma	Location *	WS
Category	Supplemental			GPS Latitude/Longitude	
				Start	End
Item	DWR Erosion Survey			37.931858 °	37.931858 °
				-121.328300 °	-121.328300 °
DWR ID	RD0524U01RM41.92				
Comment Code					
Inspector Comment					
09/13/2017. The erosion has developed along the levee slope. The length of the erosion is nearly doubled comparing to the prior survey.					
07/25/2016: No significant change observed.					
06/24/2015: No significant change observed.					
06/19/2014: No significant change observed.					
08/13/2013: New signs of animal activity were found.					
08/07/2012: The site was first reported in 2012 spring levee inspection report. [2017 Site ID:RD0524U01RM41.92]

Front view of the erosion.

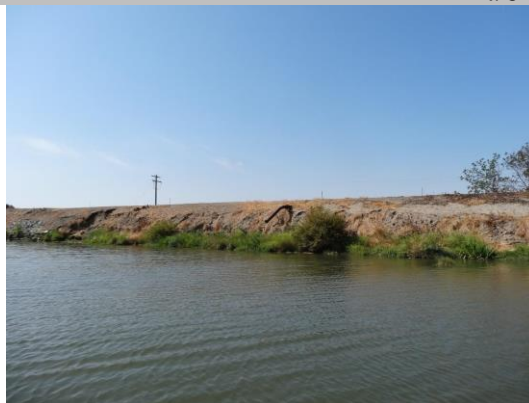
Photo 2 of 4 : SJR2017\_RD0524U01RM41.92\_2.jpg

LM Start	1.27	Rating **	U	Issue No.	47 (cont)	
LM End	1.33	Issue Type +	Ma	Location *	WS	
Category	Supplemental			GPS Latitude/Longitude		
				Start	End	
Item	DWR Erosion Survey			37.931858 °	37.931858 °	
				-121.328300 °	-121.328300 °	
DWR ID	RD0524U01RM41.92					
Comment Code						
Inspector Comment						
09/13/2017. The erosion has developed along the levee slope. The length of the erosion is nearly doubled comparing to the prior survey.						
07/25/2016: No significant change observed.						
06/24/2015: No significant change observed.						
06/19/2014: No significant change observed.						
08/13/2013: New signs of animal activity were found.						
08/07/2012: The site was first reported in 2012 spring levee inspection report. [2017 Site ID:RD0524U01RM41.92]

Front view of the erosion.

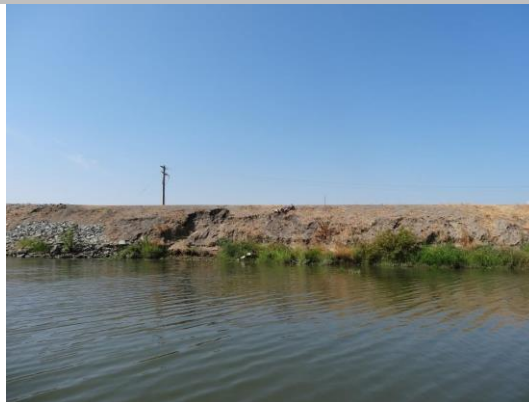
Photo 3 of 4 : SJR2017\_RD0524U01RM41.92\_3.jpg

Close view of the erosion.

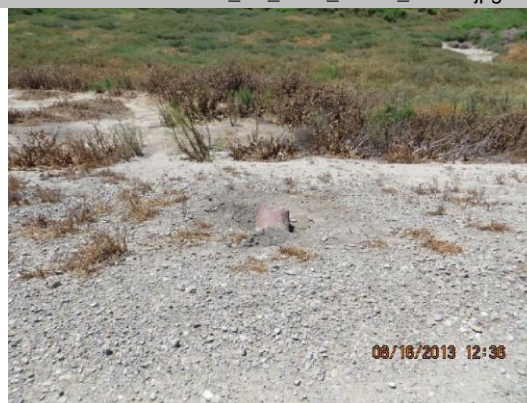
Photo 2 of 3 : UCIP\_FA\_2017\_51319\_29861.jpg

Comment Code						
Inspector Comment						
FS_ID:51319 DS_ID:20602 EP_NO: N/A Repair Type: Urgent Crossing Status: Found UCIP Comments: 11/16/2016 same as previous inspection both ends are open. This pipe does not appear in use. Need to contact owner to determine status of crossing. If the crossing is abandoned or in use, owner will need to coordinate with the CVFPB to comply with Title 23 requirements. (O. Magana - DWR UCIP)08/16/2013 Pipe appears to be open on both ends. Abandoned and should be done so properly. (W. Wylie - DWR UCIP) FIELD_STRUCT_DESC: *ABANDONED* 12-inch steel drainage pipe through the levee, 3.5 feet below the crown. Pipe is opened on the waterside (WS) and landside (LS) ends. The pump house referenced in O&M manual is missing from the LS (2013). [Additional Reference(s): DWR Levee Log, 2004. USACE San Joaquin O&M Manual 7, April 1964, (HLM 1.31)]. FS Date: 11/16/2016

Pipe open and visible on LS slope.

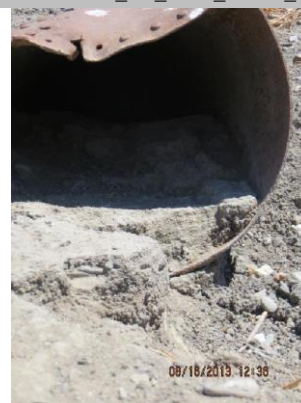
Photo 3 of 3 : UCIP\_FA\_2017\_51319\_29860.jpg

Pipe appears open on both ends. View from LS slope.

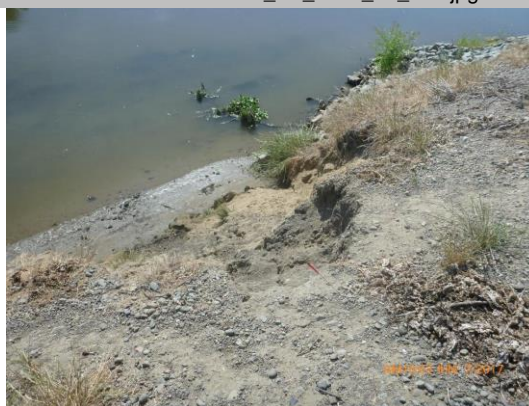
Photo 1 of 3 : LEVAL\_FA\_2017\_85\_398.jpg

LM Start	1.30	Rating **	A/W	Issue No.	223
LM End	1.31	Issue Type +	Ma	Location *	
Category	Supplemental			GPS Latitude/Longitude	
				Start	End
Item	2017 Storm Damage			37.931860 °	37.931690 °
				-121.328310 °	-121.328280 °
DWR ID	DWR_RD0524_01_f_2017_223				
Comment Code					
Inspector Comment					
Levee Evaluation Comments					
Description:					
Site ID No:85					
Site Designation:DWR_RD0524_01_s_2012_21					
Repair Type: Erosion					
Rating:Critical					
Field Date:6/7/2017					
Notes: fox den inside erosion site

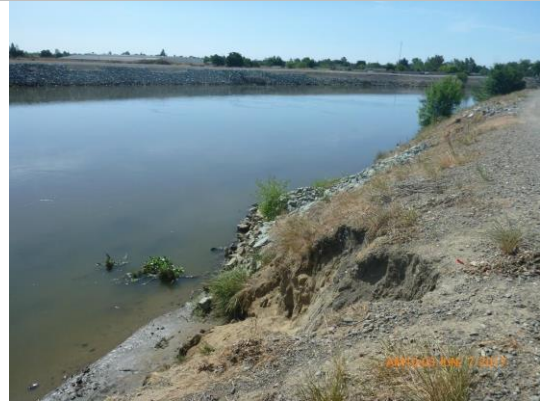
Photo 3 of 3 : LEVAL\_FA\_2017\_85\_1211.jpg

LM Start	1.30	Rating **	A/W	Issue No.	223 (cont)	
LM End	1.31	Issue Type +	Ma	Location *		
Category	Supplemental			GPS Latitude/Longitude		
				Start		End
Item	2017 Storm Damage			37.931860 °		37.931690 °
				-121.328310 °		-121.328280 °
DWR ID	DWR_RD0524_01_f_2017_223					
Comment Code						
Inspector Comment						
Levee Evaluation Comments						
Description:						
Site ID No:85						
Site Designation:DWR_RD0524_01_s_2012_21						
Repair Type: Erosion						
Rating:Critical						
Field Date:6/7/2017						
Notes: fox den inside erosion site

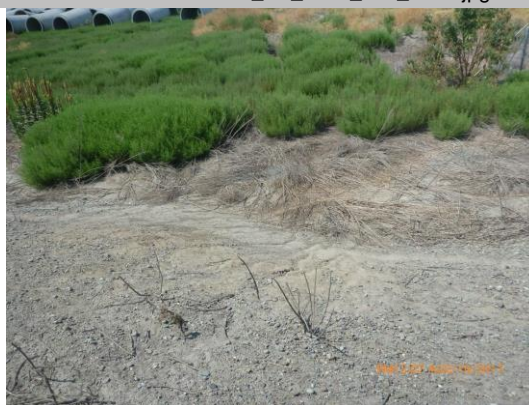
Photo 1 of 3 : LEVAL\_FA\_2017\_532\_4171.jpg

LM Start	1.33	Rating **	A/W	Issue No.	225
LM End	1.33	Issue Type +	Ma	Location *	
Category	Supplemental			GPS Latitude/Longitude	
				Start	End
Item	2017 Storm Damage			37.931500 °	37.931500 °
				-121.328200 °	-121.328200 °
DWR ID	DWR_RD0524_01_f _ 2017_225				
Comment Code					
Inspector Comment					
Levee Evaluation Comments					
Description:Slope protection repairs are needed along the waterside slope due to erosion and riprap displacement from high water. Based upon levee inspections, it was determined the waterside levee slope is eroding, deteriorating, and degrading. The eroded levee sections need to be restored back to design standards to prevent further deterioration and damage.					
Site ID No:532					
Site Designation:LMA-438					
Repair Type: Erosion					
Rating:Area of Concern					
Field Date:8/10/2017					
Notes:

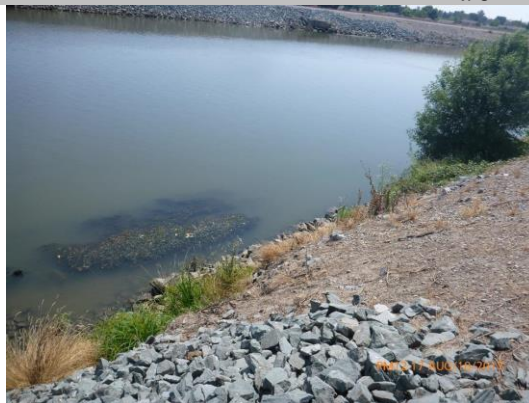
Photo 2 of 3 : LEVAL\_FA\_2017\_532\_4173.jpg

LM Start	1.33	Rating **	A/W	Issue No.	225 (cont)
LM End	1.33	Issue Type +	Ma	Location *	
Category	Supplemental			GPS Latitude/Longitude	
				Start	End
Item	2017 Storm Damage			37.931500 °	37.931500 °
				-121.328200 °	-121.328200 °
DWR ID	DWR_RD0524_01_f_2017_225				
Comment Code					
Inspector Comment					
Levee Evaluation Comments					
Description:Slope protection repairs are needed along the waterside slope due to erosion and riprap displacement from high water. Based upon levee inspections, it was determined the waterside levee slope is eroding, deteriorating, and degrading. The eroded levee sections need to be restored back to design standards to prevent further deterioration and damage.					
Site ID No:532					
Site Designation:LMA-438					
Repair Type: Erosion					
Rating:Area of Concern					
Field Date:8/10/2017					
Notes:

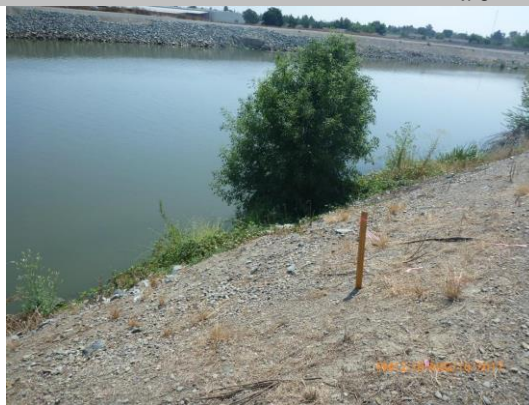
Photo 3 of 3 : LEVAL\_FA\_2017\_532\_4174.jpg

LM Start	<b>1.33</b>	Rating **	A/W	Issue No.	<b>225 (cont)</b>
LM End	<b>1.33</b>	Issue Type +	Ma	Location *

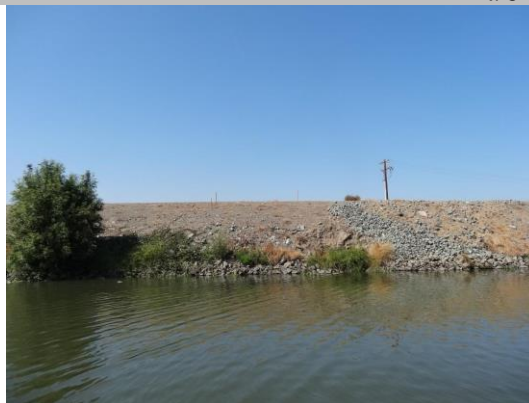
Photo 1 of 2 : SJR2017\_RD0524U01RM41.95\_1.jpg

LM Start	1.33	Rating **	M	Issue No.	55
LM End	1.33	Issue Type +	Ma	Location *	WS
Category	Supplemental			GPS Latitude/Longitude	
				Start	End
Item	DWR Erosion Survey			37.931510 °	37.931510 °
				-121.328120 °	-121.328120 °
DWR ID	RD0524U01RM41.95				
Comment Code					
Inspector Comment					
09/13/2017: The erosion is located immediately upstream of a protected levee section. [2017 Site ID:RD0524U01RM41.95]

Front view of the erosion.

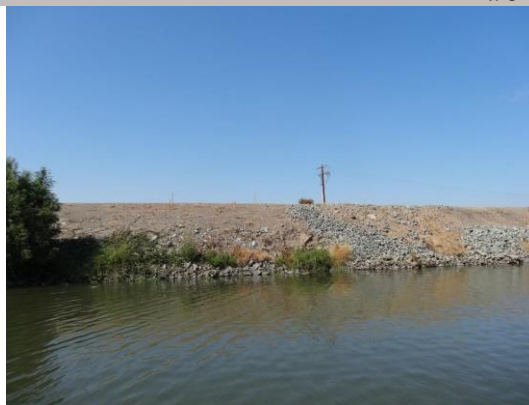
Photo 2 of 2 : SJR2017\_RD0524U01RM41.95\_2.jpg

LM Start	<b>1.33</b>	Rating **	M	Issue No.	<b>55 (cont)</b>
LM End	<b>1.33</b>	Issue Type +	Ma	Location *	WS

Front view of the erosion.

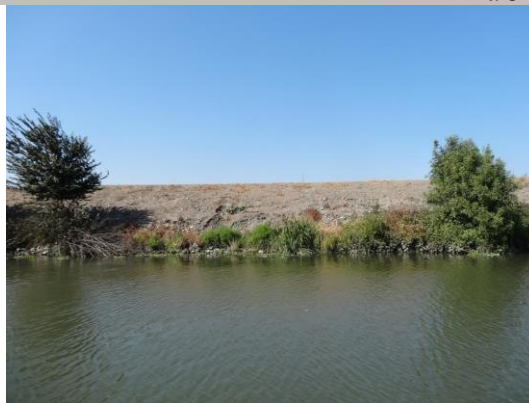
Photo 1 of 3 : SJR2017\_RD0524U01RM42.03\_1.jpg

LM Start	1.39	Rating **	U	Issue No.	56
LM End	1.39	Issue Type +	Ma	Location *	WS
Category	Supplemental			GPS Latitude/Longitude	
				Start	End
Item	DWR Erosion Survey			37.930575 °	37.930575 °
				-121.328090 °	-121.328090 °
DWR ID	RD0524U01RM42.03				
Comment Code					
Inspector Comment					
09/13/2017: No significant change observed 07/25/2016: No significant change observed 06/24/2015: No significant change observed. 06/19/2014: No significant change observed. 08/13/2013: No significant change observed. 08/07/2012: The site was first reported in 2012 spring levee inspection report. The site is located about 750 ft downstream of SR 4 Bridge. [2017 Site ID:RD0524U01RM42.03]

Front view of the erosion.

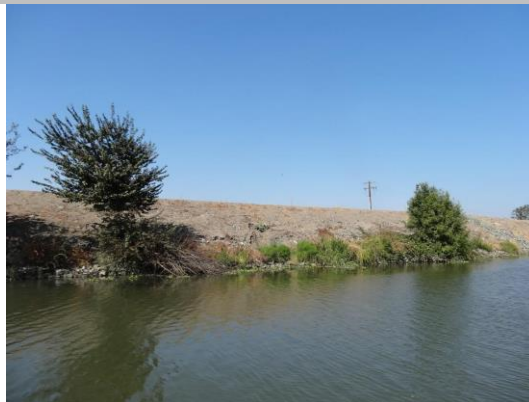
Photo 2 of 3 : SJR2017\_RD0524U01RM42.03\_2.jpg

Front view of the erosion.

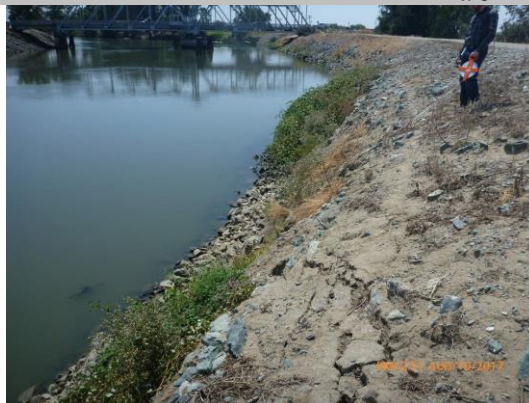
Photo 2 of 3 : LEVAL\_FA\_2017\_530\_4184.jpg

LM Start	1.43	Rating **	A/W	Issue No.	226 (cont)	
LM End	1.44	Issue Type +	Ma	Location *		
Category	Supplemental			GPS Latitude/Longitude		
				Start	End	
Item	2017 Storm Damage			37.930100 °	37.929900 °	
				-121.328300 °	-121.328300 °	
DWR ID	DWR_RD0524_01_f_2017_226					
Comment Code						
Inspector Comment						
Levee Evaluation Comments						
Description:Slope protection repairs are needed along the waterside slope due to erosion and riprap displacement from high water. Based upon levee inspections, it was determined the waterside levee slope is eroding, deteriorating, and degrading. The eroded levee sections need to be restored back to design standards to prevent further deterioration and damage.						
Site ID No:530						
Site Designation:LMA-436						
Repair Type: Erosion						
Rating:Area of Concern						
Field Date:8/10/2017						
Notes:

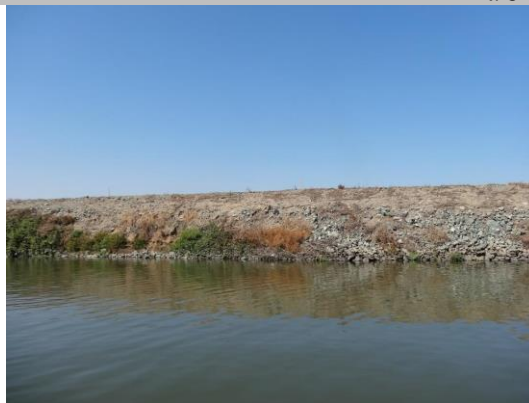
Photo 1 of 4 : SJR2017\_RD0524U01RM42.09\_1.jpg

LM Start	1.45	Rating **	U	Issue No.	60
LM End	1.47	Issue Type +	Ma	Location *	WS
Category	Supplemental			GPS Latitude/Longitude	
				Start	End
Item	DWR Erosion Survey			37.929650 °	37.929650 °
				-121.328110 °	-121.328110 °
DWR ID	RD0524U01RM42.09				
Comment Code					
Inspector Comment					
09/13/2017: No significant change observed.					
07/25/2016: No significant change observed.					
06/24/2015: No significant change observed.					
06/19/2014: No significant change observed.					
08/13/2013: The site is located approximately 400 ft. downstream SR 4 Bridge. Dense vegetation is visible at the toe. [2017 Site ID:RD0524U01RM42.09]

Front view of the erosion site.

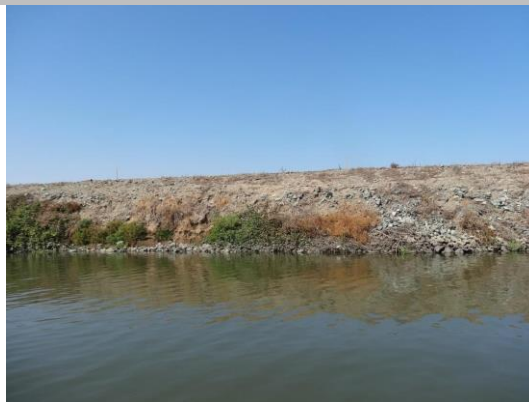
Photo 2 of 4 : SJR2017\_RD0524U01RM42.09\_2.jpg

Front view of the erosion.

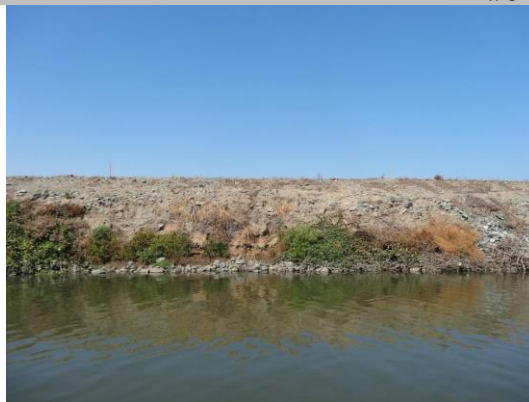
Photo 3 of 4 : SJR2017\_RD0524U01RM42.09\_3.jpg

Close view of the erosion. Note the vegetation at the site.

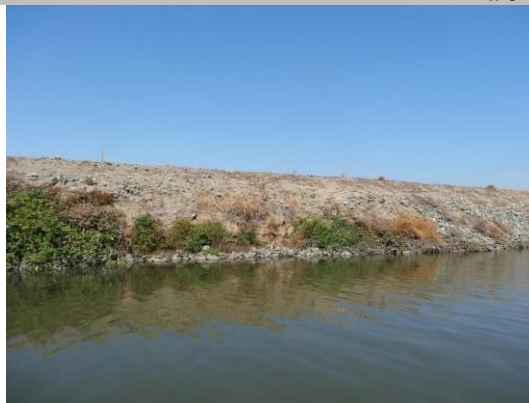
Photo 4 of 4 : SJR2017\_RD0524U01RM42.09\_4.jpg

LM Start	1.45	Rating **	U	Issue No.	60 (cont)
LM End	1.47	Issue Type +	Ma	Location *	WS
Category	Supplemental			GPS Latitude/Longitude	
				Start	End
Item	DWR Erosion Survey			37.929650 °	37.929650 °
				-121.328110 °	-121.328110 °
DWR ID	RD0524U01RM42.09				
Comment Code					
Inspector Comment					
09/13/2017: No significant change observed.					
07/25/2016: No significant change observed.					
06/24/2015: No significant change observed.					
06/19/2014: No significant change observed.					
08/13/2013: The site is located approximately 400 ft. downstream SR 4 Bridge. Dense vegetation is visible at the toe. [2017 Site ID:RD0524U01RM42.09]

Close view of the erosion.

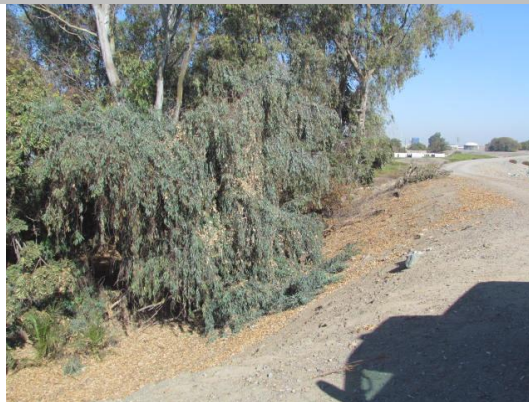
Photo 1 of 4 : FA\_2017\_RD0524\_107\_916\_20170919\_00281.jpg

LM Start	1.49	Rating **	U	Issue No.	916
LM End	1.49	Issue Type +	Ma	Location *	LS
Category	Earthen Levee			GPS Latitude/Longitude	
				Start	End
Item	Trim / Thin Trees			37.929118 °	37.929118 °
				-121.328368 °	-121.328368 °
DWR ID	DWR_RD0524_01_s_2012_916				
Comment Code					
T3 : Trim and thin trees to allow visibility of the ground and room to flood fight.					
Inspector Comment					
Untrimmed trees and dense vegetation on landside toe.

Looking at dense trees on landward slope and toe fall 2015

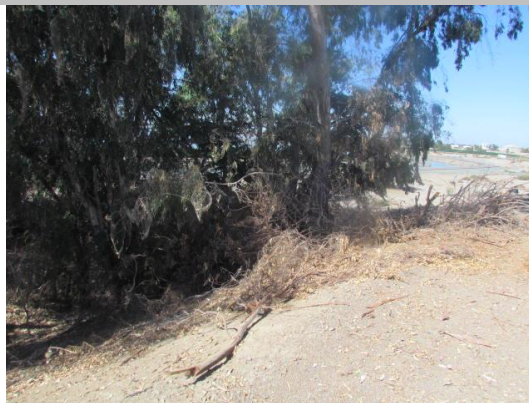
Photo 2 of 4 : FA\_2017\_RD0524\_107\_916\_20170919\_00282.jpg

LM Start	1.49	Rating **	U	Issue No.	916 (cont)	
LM End	1.49	Issue Type +	Ma	Location *	LS	
Category	Earthen Levee			GPS Latitude/Longitude		
				Start		End
Item	Trim / Thin Trees			37.929118 °		37.929118 °
				-121.328368 °		-121.328368 °
DWR ID	DWR_RD0524_01_s_2012_916					
Comment Code						
T3 : Trim and thin trees to allow visibility of the ground and room to flood fight.						
Inspector Comment						
Untrimmed trees and dense vegetation on landside toe.

Looking at trees on landside slope. (Fall 2012)

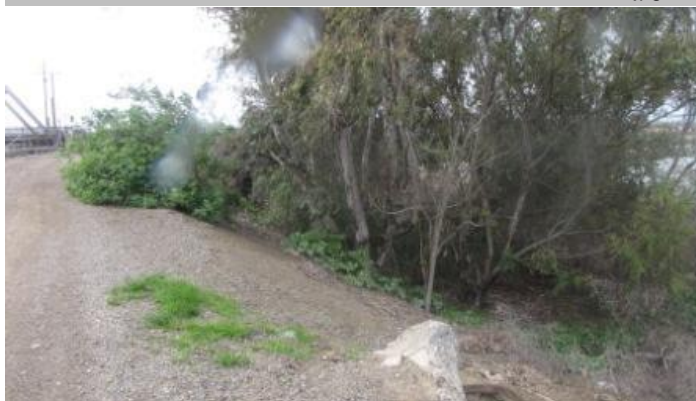
Photo 3 of 4 : FA\_2017\_RD0524\_107\_916\_20170919\_00283.jpg

Looking at dense veg. on landside slope and toe.

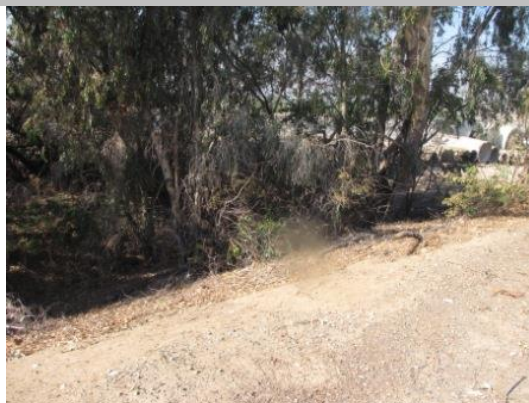
Photo 4 of 4 : FA\_2017\_RD0524\_107\_916\_20170919\_00284.jpg

Dense vegetation on landside toe.

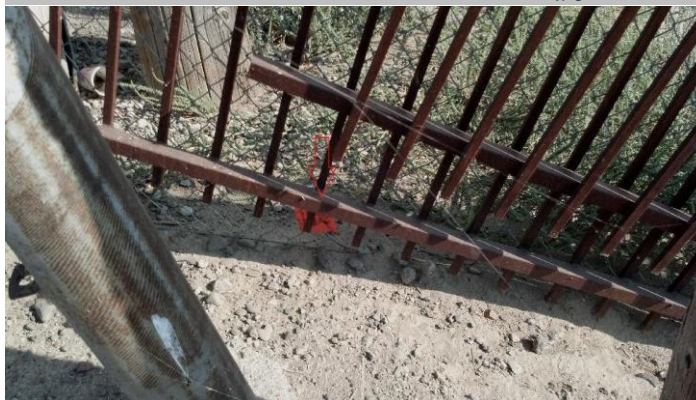
Photo 1 of 2 : UCIP\_FA\_2017\_17798\_29935.jpg

FS\_ID:17798  
DS\_ID:20605  
EP\_NO: N/A  
Repair Type: Non-Urgent  
Crossing Status: Indicator Found  
UCIP Comments: No permit identified for this crossing.  
FIELD\_STRUCT\_DESC: Fiber optics cable crossing of an unknown material. USA marker flags over crown along alignment of gate.  
FS Date: 8/20/2013

USAA markers along alignment at gate.

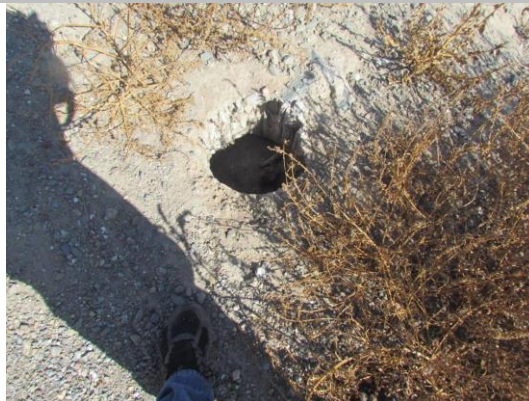
Photo 1 of 2 : FA\_2017\_RD0524\_107\_202\_20170919\_00242.jpg

LM Start	1.55	Rating **	U	Issue No.	202
LM End	1.55	Issue Type +	Ma	Location *	WS
Category	Earthen Levee			GPS Latitude/Longitude	
				Start	End
Item	Erosion / Bank Caving			37.928391 °	37.928391 °
				-121.328273 °	-121.328273 °
DWR ID	DWR_RD0524_01_f_2016_202				
Comment Code					
E2 : Schedule repair of erosion site prior to the next inspection.					
Inspector Comment					
Large hole (looks like fences post or telephone pole) on waterside shoulder.

Looking at large hole (Fence/telephone post hole) on waterward shoulder.

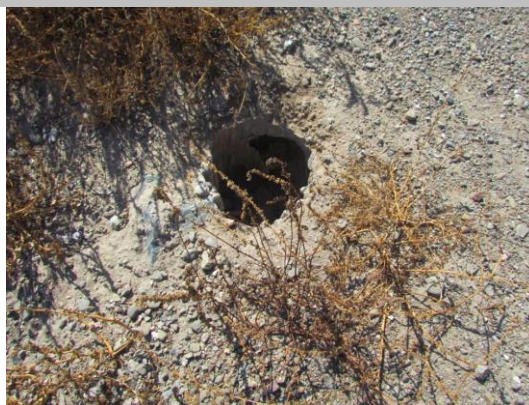
Photo 2 of 2 : FA\_2017\_RD0524\_107\_202\_20170919\_00243.jpg

Looking at hole on waterward shoulder.

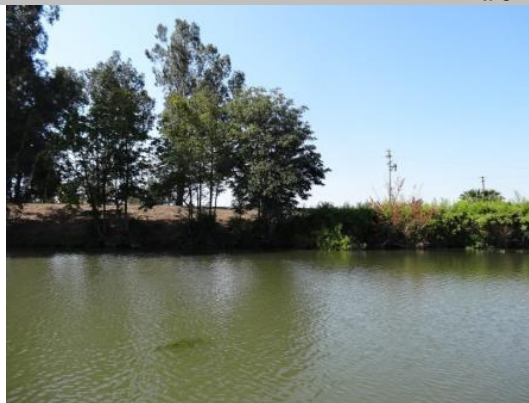
Photo 1 of 3 : SJR2017\_RD0524U01RM42.2\_1.jpg

Comment Code					
Inspector Comment					
09/13/2017: No significant change observed. 07/25/2016: No significant change observed. 06/24/2015: No significant change observed. 06/19/2014: No significant change observed. 08/13/2013: No significant change observed. 08/07/2012: The site has been visited by boat survey. No significant change observed 08/23/2011: No significant change observed on site. Trees concerned still in place. 09/07/2010: No significant change observed on site. The concern here is the undermining of the levee toe where most of trees are. There are erosion pockets lined along the lower slope and at the base of the trees, exposing tree roots. There is minimal slope protection. 09/29/2009: The lower slope is lined with minor erosion pockets; some tree roots are exposed; there is visible undermining of the levee toe; site is immediately upstream of the Highway 4 Bridge; the bridge is possibly causing a scour to occur, eroding the bank. [2017 Site ID:RD0524U01RM42.2]

Front view of the site where undermining has occurred.

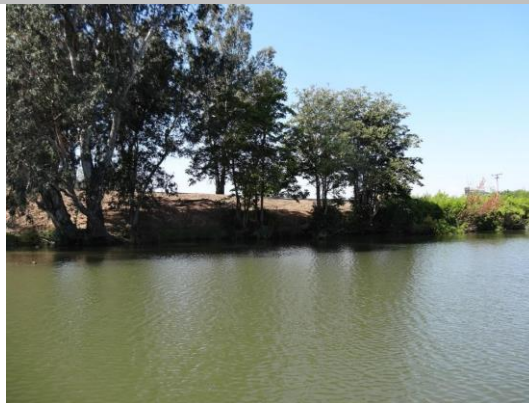
Photo 2 of 3 : SJR2017\_RD0524U01RM42.2\_2.jpg

Close view of the erosion.
