**Flood Control Project Maintenance  
Levee Inspections**

**Fall 2017 Levee Maintenance Deficiency Summary Report**

***San Joaquin River Basin***

**Reclamation District No. 0524 Middle Roberts Island**

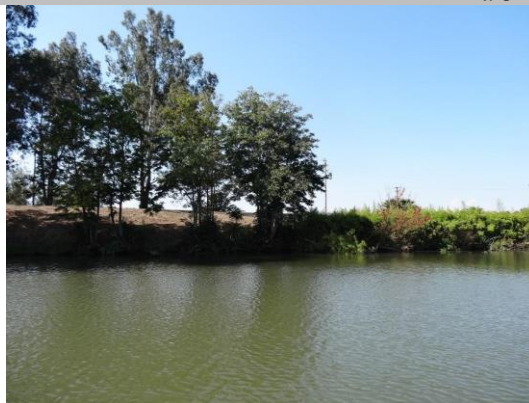
Photo 3 of 3 : SJR2017\_RD0524U01RM42.2\_3.jpg

Comment Code						
Inspector Comment						
09/13/2017: No significant change observed. 07/25/2016: No significant change observed. 06/24/2015: No significant change observed. 06/19/2014: No significant change observed. 08/13/2013: No significant change observed. 08/07/2012: The site has been visited by boat survey. No significant change observed 08/23/2011: No significant change observed on site. Trees concerned still in place. 09/07/2010: No significant change observed on site. The concern here is the undermining of the levee toe where most of trees are. There are erosion pockets lined along the lower slope and at the base of the trees, exposing tree roots. There is minimal slope protection. 09/29/2009: The lower slope is lined with minor erosion pockets; some tree roots are exposed; there is visible undermining of the levee toe; site is immediately upstream of the Highway 4 Bridge; the bridge is possibly causing a scour to occur, eroding the bank. [2017 Site ID:RD0524U01RM42.2]

Front view of the erosion. Dense vegetation is visible.

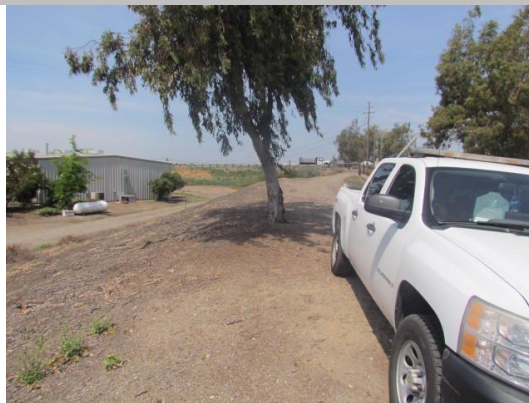
Photo 1 of 1 : FA\_2017\_RD0524\_107\_173\_20170919\_00207.jpg

LM Start	1.58	Rating **	U	Issue No.	173
LM End	1.58	Issue Type +	Ma	Location *	LS
Category	Earthen Levee			GPS Latitude/Longitude	
				Start	End
Item	Trim / Thin Trees			37.927975 °	37.927975 °
				-121.328088 °	-121.328088 °
DWR ID	DWR_RD0524_01_s_2015_173				
Comment Code					
T1 : Trim trees to at least five feet above ground level.					
Inspector Comment					
Tree is located on landside shoulder and crown should be removed.

Looking northwest at tree on within levee crown.

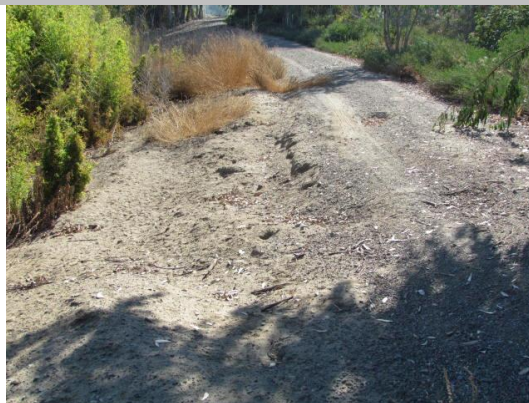
Photo 1 of 1 : FA\_2017\_RD0524\_107\_136\_20170919\_00186.jpg

LM Start	1.59	Rating **	M	Issue No.	136
LM End	1.59	Issue Type +	Ma	Location *	CR
Category	Earthen Levee			GPS Latitude/Longitude	
				Start	End
Item	Slope Stability			37.927775 °	37.927775 °
				-121.327860 °	-121.327860 °
DWR ID	DWR_RD0524_01_s_2013_136				
Comment Code					
S2 : Repair the levee slope damaged by foot traffic and prevent access where possible.					
Inspector Comment					
Waterside shoulder caving.

Looking south at depression on levee crown near waterward shoulder.

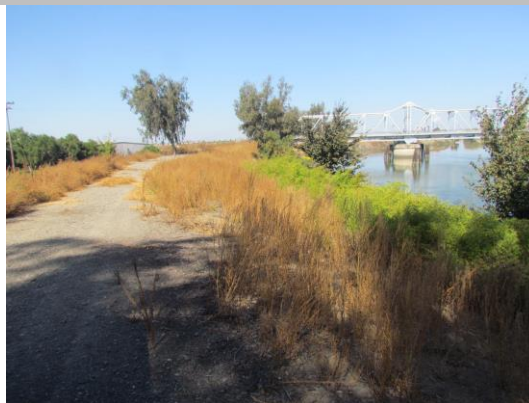
Photo 1 of 3 : FA\_2017\_RD0524\_107\_25\_20170919\_00045.jpg

LM Start	1.60	Rating **	U	Issue No.	25
LM End	1.61	Issue Type +	Ma	Location *	WS
Category	Earthen Levee			GPS Latitude/Longitude	
				Start	End
Item	Vegetation			37.927635 °	37.927540 °
				-121.327812 °	-121.327648 °
DWR ID	DWR_RD0524_01_s_2012_25				
Comment Code					
V2 : Remove the wild growth other than native grasses from the levee slopes.					
Inspector Comment

Looking northwest at dense veg on waterward slope.

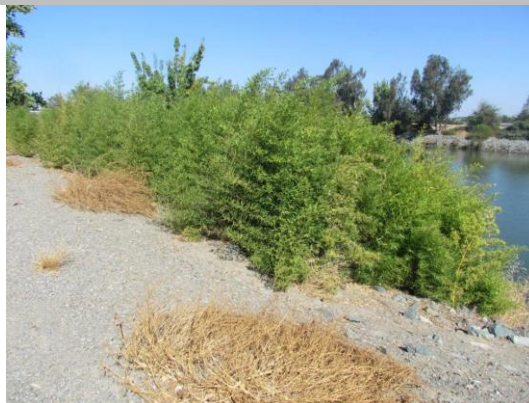
Photo 2 of 3 : FA\_2017\_RD0524\_107\_25\_20170919\_00046.jpg

Looking northwest at end of dense veg on waterward slope.

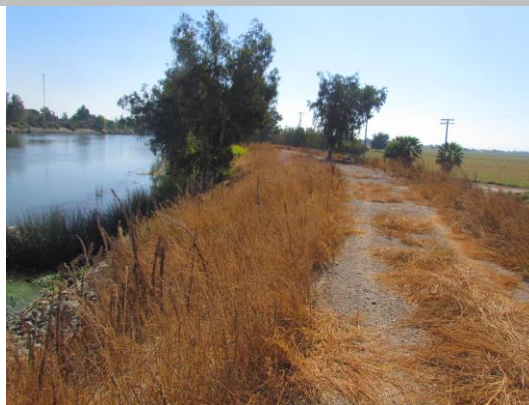
Photo 3 of 3 : FA\_2017\_RD0524\_107\_25\_20170919\_00047.jpg

Looking southwest at dense veg on waterward slope.

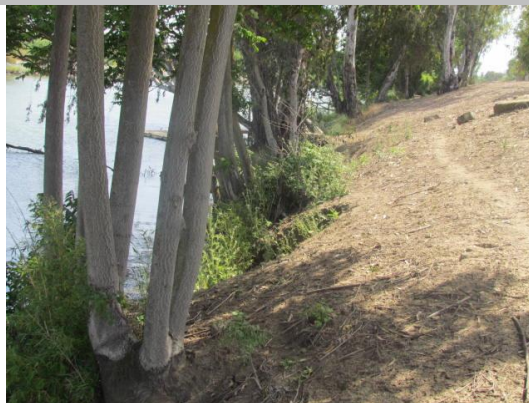
Photo 1 of 3 : FA\_2017\_RD0524\_107\_26\_20170919\_00048.jpg

LM Start	1.62	Rating **	M	Issue No.	26
LM End	1.64	Issue Type +	Ma	Location *	WS
Category	Earthen Levee			GPS Latitude/Longitude	
				Start	End
Item	Erosion / Bank Caving			37.927507 °	37.927295 °
				-121.327593 °	-121.327298 °
DWR ID	DWR_RD0524_01_s_2012_26				
Comment Code					
E1 : Note and monitor erosion site.					
Inspector Comment					
Several erosions along this reach.

Looking south at waterward erosion.

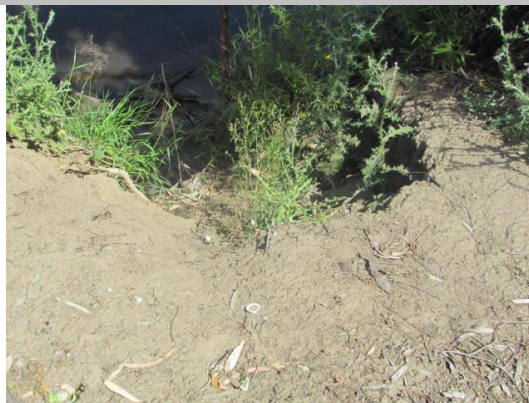
Photo 2 of 3 : FA\_2017\_RD0524\_107\_26\_20170919\_00049.jpg

Looking east at waterward erosion.

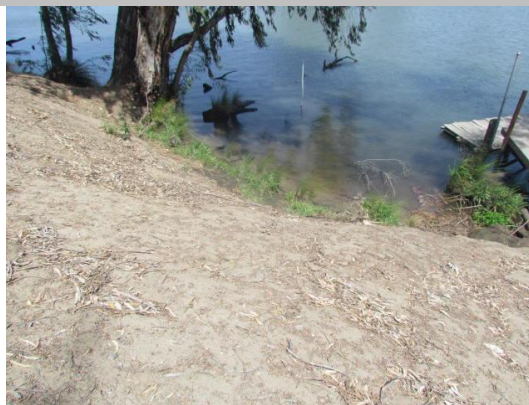
Photo 3 of 3 : FA\_2017\_RD0524\_107\_26\_20170919\_00050.jpg

Looking east at waterward erosion and depression.

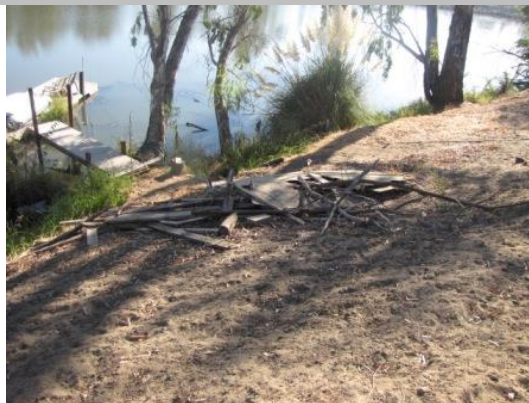
Photo 1 of 2 : FA\_2017\_RD0524\_107\_39\_20170919\_00069.jpg

LM Start	1.64	Rating **	U	Issue No.	39
LM End	1.64	Issue Type +	En	Location *	WS
Category	Earthen Levee			GPS Latitude/Longitude	
				Start	End
Item	Encroachments			37.927372 °	37.927372 °
				-121.327278 °	-121.327278 °
DWR ID	DWR_RD0524_01_s_2012_39				
Comment Code					
PO : Pole					
Inspector Comment					
Landowner constructed boat dock without permit.

Looking at garbage on waterside slope.

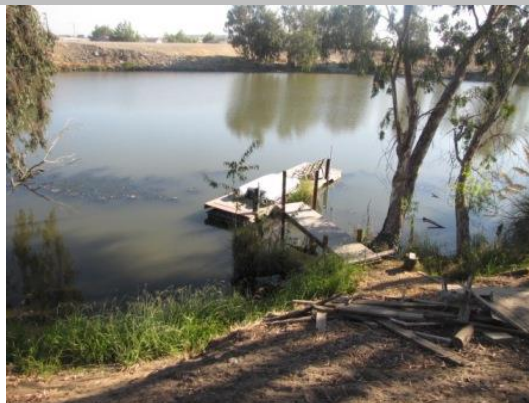
Photo 2 of 2 : FA\_2017\_RD0524\_107\_39\_20170919\_00070.jpg

LM Start	1.64	Rating **	U	Issue No.	39 (cont)	
LM End	1.64	Issue Type +	En	Location *	WS	
Category	Earthen Levee			GPS Latitude/Longitude		
				Start		End
Item	Encroachments			37.927372 °		37.927372 °
				-121.327278 °		-121.327278 °
DWR ID	DWR_RD0524_01_s_2012_39					
Comment Code						
PO : Pole						
Inspector Comment						
Landowner constructed boat dock without permit.

Looking east at non-permitted boat dock.

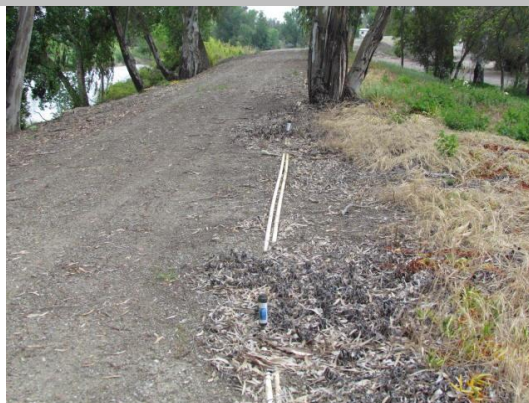
Photo 1 of 2 : FA\_2017\_RD0524\_107\_207\_20170919\_00249.jpg

LM Start	1.65	Rating **	M	Issue No.	207
LM End	1.71	Issue Type +	En	Location *	LS
Category	Earthen Levee			GPS Latitude/Longitude	
				Start	End
Item	Encroachments			37.927237 °	37.926621 °
				-121.327183 °	-121.326400 °
DWR ID	DWR_RD0524_01_s_2016_207				
Comment Code					
LI : Landscape Irrigation					
Inspector Comment					
Sprinklers on landside shoulder

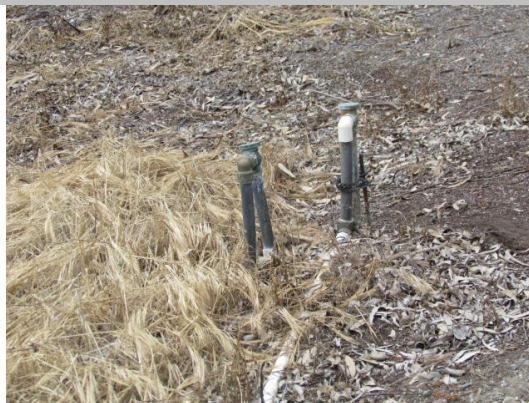
Photo 2 of 2 : FA\_2017\_RD0524\_107\_207\_20170919\_00250.jpg

Looking south at sprinkler line and sprinklers on landward shoulder.

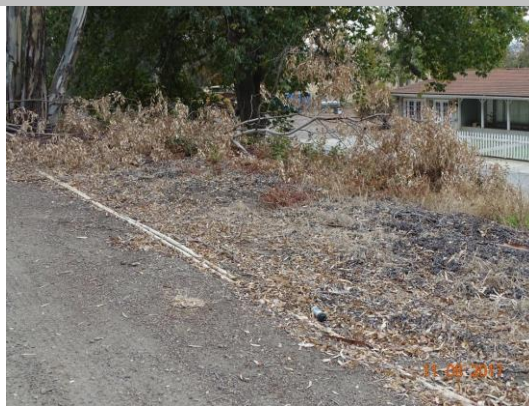
Photo 1 of 1 : FA\_2017\_RD0524\_107\_240\_20171116\_00473.jpg

LM Start	1.66	Rating **	M	Issue No.	240
LM End	1.66	Issue Type +	Ma	Location *	LS
Category	Earthen Levee			GPS Latitude/Longitude	
				Start	End
Item	Encroachments			37.927159 °	37.927159 °
				-121.327022 °	-121.327022 °
DWR ID	DWR_RD0524_01_f_2017_240				
Comment Code					
TR : Tree or limb					
Inspector Comment

Looking southeast at the landside slope.

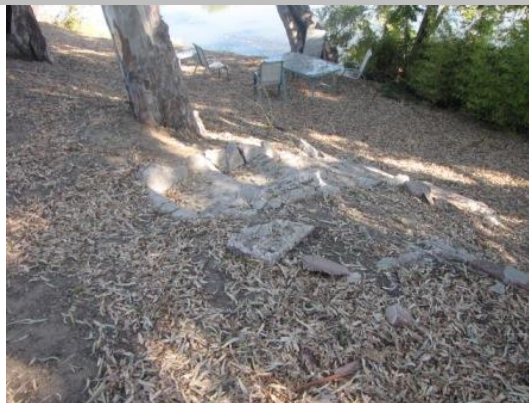
Photo 1 of 3 : FA\_2017\_RD0524\_107\_45\_20170919\_00077.jpg

LM Start	1.67	Rating **	U	Issue No.	45
LM End	1.67	Issue Type +	Ma	Location *	WS
Category	Earthen Levee			GPS Latitude/Longitude	
				Start	End
Item	Encroachments			37.927018 °	37.927018 °
				-121.326872 °	-121.326872 °
DWR ID	DWR_RD0524_01_s_2012_45				
Comment Code					
ST : Stairway					
Inspector Comment					
Stairs and retaining wall.

Looking northeast at non-permitted concrete stairs on waterside slope.

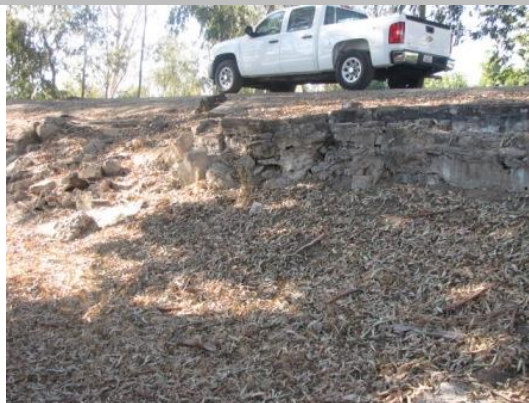
Photo 2 of 3 : FA\_2017\_RD0524\_107\_45\_20170919\_00078.jpg

LM Start	1.67	Rating **	U	Issue No.	45 (cont)	
LM End	1.67	Issue Type +	Ma	Location *	WS	
Category	Earthen Levee			GPS Latitude/Longitude		
				Start		End
Item	Encroachments			37.927018 °		37.927018 °
				-121.326872 °		-121.326872 °
DWR ID	DWR_RD0524_01_s_2012_45					
Comment Code						
ST : Stairway						
Inspector Comment						
Stairs and retaining wall.

Looking southwest at retaning wall connected to concrete stairs.

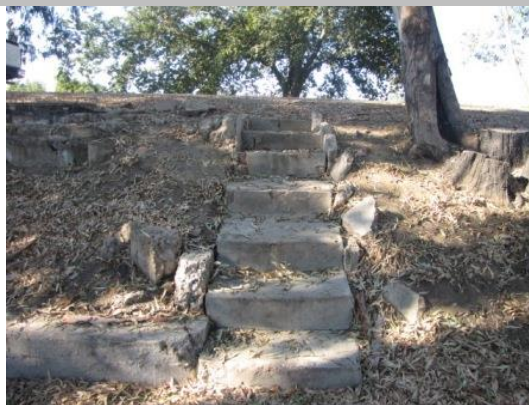
Photo 3 of 3 : FA\_2017\_RD0524\_107\_45\_20170919\_00079.jpg

Looking west at concrete stairs on waterside slope.

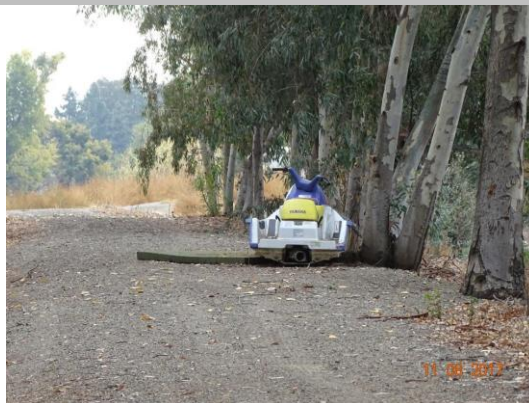
Photo 1 of 1 : FA\_2017\_RD0524\_107\_241\_20171116\_00474.jpg

LM Start	1.67	Rating **	M	Issue No.	241
LM End	1.67	Issue Type +	En	Location *	CR
Category	Earthen Levee			GPS Latitude/Longitude	
				Start	End
Item	Encroachments			37.926990 °	37.926990 °
				-121.326811 °	-121.326811 °
DWR ID	DWR_RD0524_01_f_2017_241				
Comment Code					
EQ : Equipment					
Inspector Comment					
Landowner has stored a jetski on the crown.

Looking southeast at the levee crown.

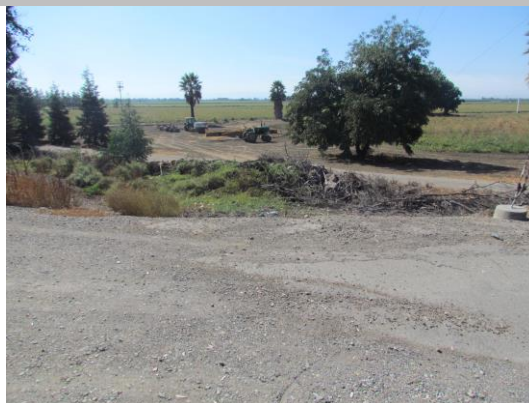
Photo 1 of 1 : FA\_2017\_RD0524\_107\_28\_20170919\_00052.jpg

LM Start	1.73	Rating **	U	Issue No.	28
LM End	1.73	Issue Type +	En	Location *	LS
Category	Earthen Levee			GPS Latitude/Longitude	
				Start	End
Item	Encroachments			37.926322 °	37.926322 °
				-121.326115 °	-121.326115 °
DWR ID	DWR_RD0524_01_s_2012_28				
Comment Code					
GA : Garbage					
Inspector Comment					
Large pruning piles on landside slope.

Looking west at pruning and garbage piles at landward berm.

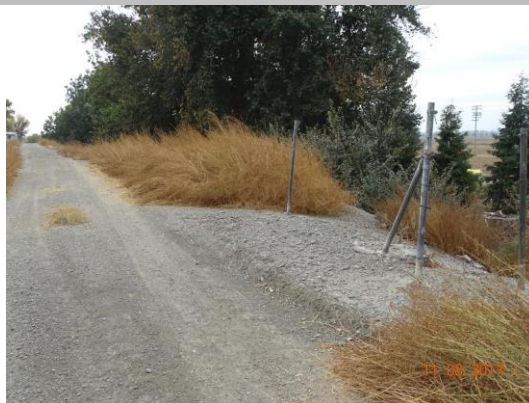
Photo 1 of 1 : FA\_2017\_RD0524\_107\_245\_20171116\_00477.jpg

LM Start	1.73	Rating **	U	Issue No.	245
LM End	1.75	Issue Type +	Ma	Location *	LS
Category	Earthen Levee			GPS Latitude/Longitude	
				Start	End
Item	Vegetation			37.926312 °	37.926093 °
				-121.326065 °	-121.325864 °
DWR ID	DWR_RD0524_01_f_2017_245				
Comment Code					
V2 : Remove the wild growth other than native grasses from the levee slopes.					
Inspector Comment

Looking southeast at the landside slope.

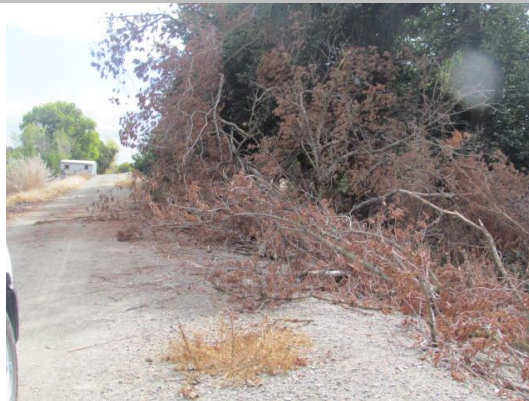
Photo 1 of 4 : FA\_2017\_RD0524\_107\_46\_20170919\_00080.jpg

LM Start	1.75	Rating **	U	Issue No.	46
LM End	1.76	Issue Type +	Ma	Location *	LS
Category	Earthen Levee			GPS Latitude/Longitude	
				Start	End
Item	Encroachments			37.926152 °	37.925993 °
				-121.325927 °	-121.325777 °
DWR ID	DWR_RD0524_01_s_2012_46				
Comment Code					
TR : Tree or limb					
Inspector Comment					
Downed tree limbs on landside slope.

Looking south at tree limbs on landward slope.

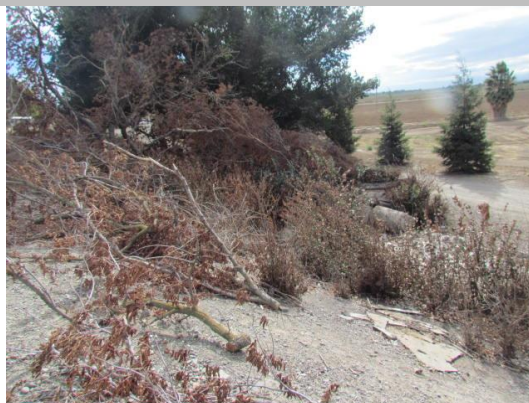
Photo 2 of 4 : FA\_2017\_RD0524\_107\_46\_20170919\_00081.jpg

Looking southwest at tree limbs on landward slope.

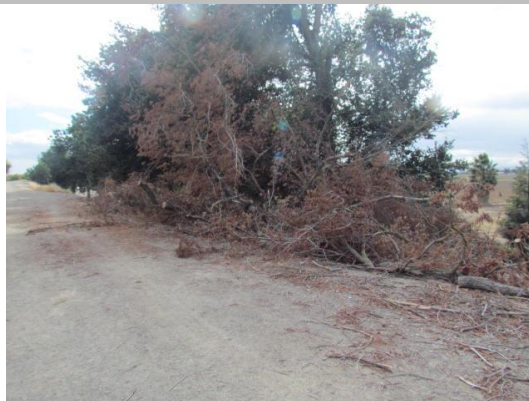
Photo 3 of 4 : FA\_2017\_RD0524\_107\_46\_20170919\_00082.jpg

Looking south at tree limbs on landward slope.

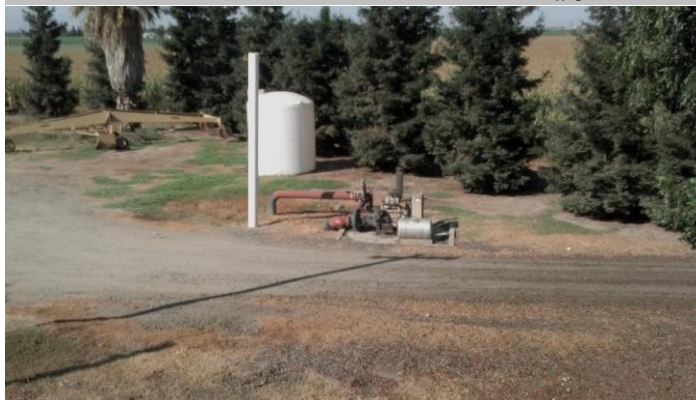
Photo 2 of 3 : UCIP\_FA\_2017\_21866\_37123.jpg

FS\_ID:21866  
DS\_ID:24032  
EP\_NO: N/A  
Repair Type: Non-Urgent  
Crossing Status: Found  
UCIP Comments: No permit identified for crossing.  
FIELD\_STRUCT\_DESC: 12-inch wrapped steel irrigation pipe through the levee, at an unknown depth. Pump, butterfly valves, vent, and siphon breaker at concrete pad 50 feet off the landside (LS) toe. Siphon breaker in 14-inch concrete standpipe on the LS shoulder.  
FS Date: 8/20/2013

Pumping plant off LS toe.

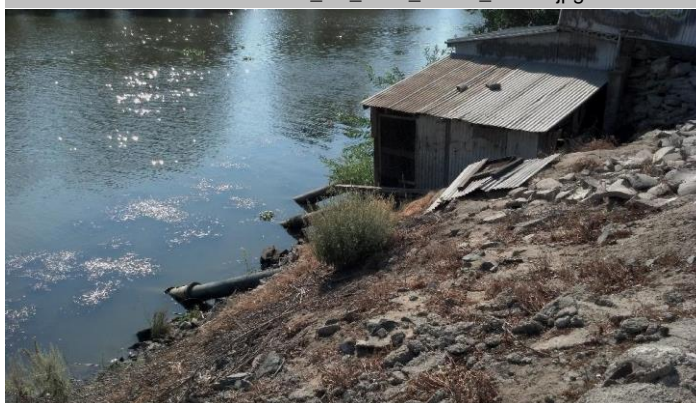
Photo 1 of 3 : UCIP\_FA\_2017\_17847\_29962.jpg

Comment Code						
Inspector Comment						
FS_ID:17847						
DS_ID:20609						
EP_NO: N/A						
Repair Type: Non-Urgent						
Crossing Status: Found						
UCIP Comments: Pipe appears abandoned and if so should be done so properly.						
FIELD_STRUCT_DESC: 14-inch irrigation pipe of an unknown material through the levee, 20 feet below the crown. 2 pumps and gate valves discharge into surge tank in pump house on the waterside (WS) slope. Concrete distribution box removed from the WS slope. Abandoned 36-inch diameter concrete standpipe on the landside (LS) toe next to service pole. [Additional Reference(s): DWR Levee Log, 2004. USACE San Joaquin O&M Manual 7, April 1964, (HLM 1.83)].						
FS Date: 8/20/2013

Pipes and pumphouse on WS slope.

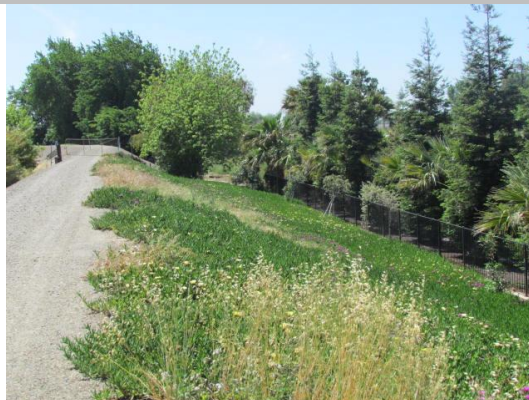
Photo 1 of 1 : FA\_2017\_RD0524\_107\_78\_20170919\_00122.jpg

LM Start	1.90	Rating **	U	Issue No.	78
LM End	1.94	Issue Type +	En	Location *	LS
Category	Earthen Levee			GPS Latitude/Longitude	
				Start	End
Item	Vegetation			37.924364 °	37.923805 °
				-121.324473 °	-121.324238 °
DWR ID	DWR_RD0524_01_s_2012_78				
Comment Code					
V6 : Landscaping					
Inspector Comment

Looking southwest at landscaping on landside slope. (Spring 2012)

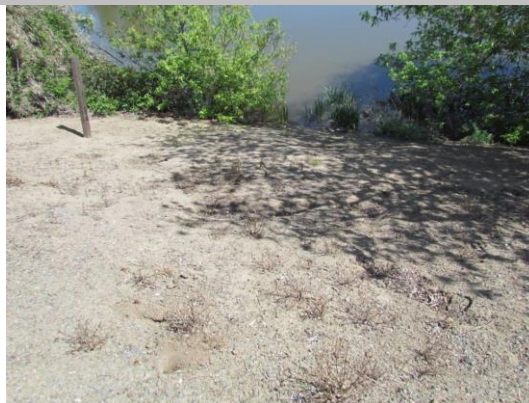
Photo 1 of 1 : FA\_2017\_RD0524\_107\_159\_20170919\_00192.jpg

LM Start	1.94	Rating **	M	Issue No.	159
LM End	1.95	Issue Type +	Ma	Location *	WS
Category	Earthen Levee			GPS Latitude/Longitude	
				Start	End
Item	Slope Stability			37.923703 °	37.923645 °
				-121.324238 °	-121.324233 °
DWR ID	DWR_RD0524_01_s_2017_159				
Comment Code					
S1 : Repair slope instability.					
Inspector Comment					
Minor sloughing and cracking.

Looking at minor cracking and sloughing on waterward slope.

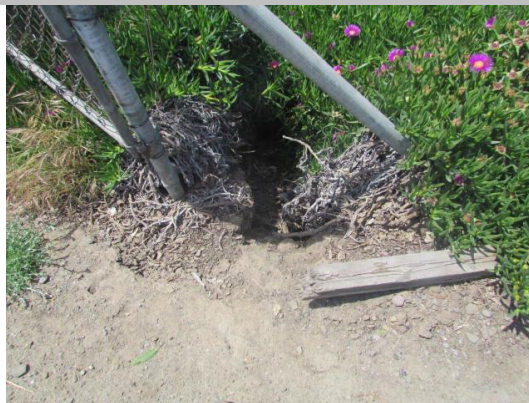
Photo 1 of 2 : FA\_2017\_RD0524\_107\_176\_20170919\_00213.jpg

LM Start	1.94	Rating **	U	Issue No.	176
LM End	1.94	Issue Type +	Ma	Location *	LS
Category	Earthen Levee			GPS Latitude/Longitude	
				Start	End
Item	Erosion / Bank Caving			37.923688 °	37.923688 °
				-121.324223 °	-121.324223 °
DWR ID	DWR_RD0524_01_s_2015_176				
Comment Code					
E2 : Schedule repair of erosion site prior to the next inspection.					
Inspector Comment					
Landside caving (3 x 18" x 5 ) caused by broken sprinklers.

Looking west at erosion within landscaping on landward shoulder and slope.

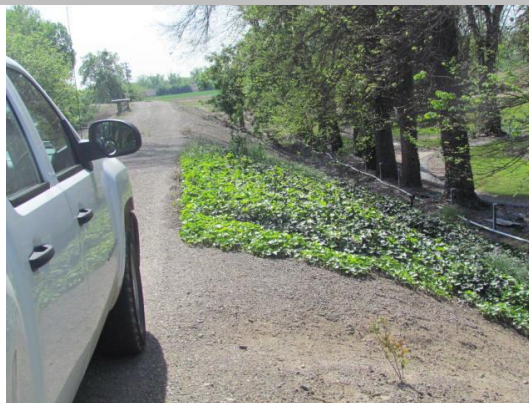
Photo 1 of 1 : FA\_2017\_RD0524\_107\_106\_20170919\_00157.jpg

LM Start	2.00	Rating **	U	Issue No.	106
LM End	2.00	Issue Type +	En	Location *	LS
Category	Earthen Levee			GPS Latitude/Longitude	
				Start	End
Item	Vegetation			37.922923 °	37.922923 °
				-121.323837 °	-121.323837 °
DWR ID	DWR_RD0524_01_s_2012_106				
Comment Code					
V6 : Landscaping					
Inspector Comment

Looking southwest at ground cover on landward slope.

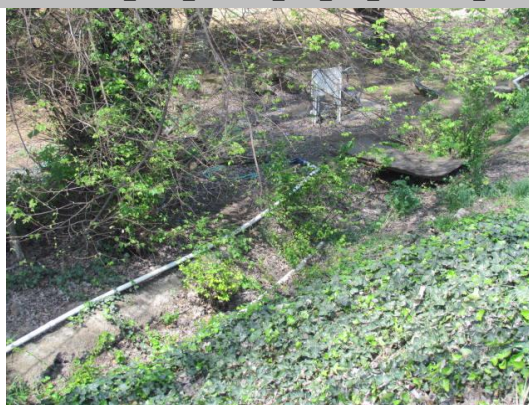
Photo 1 of 2 : FA\_2017\_RD0524\_107\_182\_20170919\_00224.jpg

LM Start	2.01	Rating **	M	Issue No.	182
LM End	2.04	Issue Type +	En	Location *	LS
Category	Earthen Levee			GPS Latitude/Longitude	
				Start	End
Item	Encroachments			37.922837 °	37.922514 °
				-121.323785 °	-121.323504 °
DWR ID	DWR_RD0524_01_s_2014_182				
Comment Code					
DT : Ditch					
Inspector Comment					
Old irrigation ditch at the landside toe should be removed.

Looking northwest at an old irrigation ditch at landward toe.

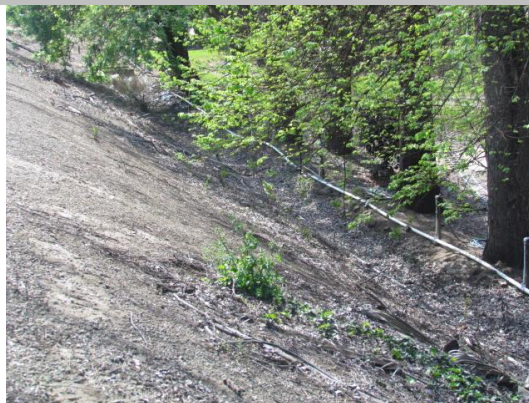
Photo 2 of 2 : FA\_2017\_RD0524\_107\_182\_20170919\_00225.jpg

Looking southwest at an old irrigation ditch at landward toe.

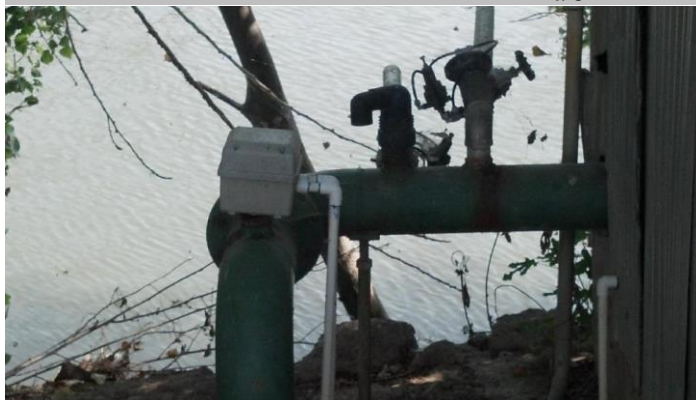
Photo 2 of 3 : UCIP\_FA\_2017\_21895\_37141.jpg

LM Start	2.07	Rating **	M	Issue No.	947 (cont)
LM End	2.07	Issue Type +	En	Location *	
Category	Supplemental			GPS Latitude/Longitude	
				Start	End
Item	DWR UCIP Field Study			37.922080 °	37.922080 °
				-121.323118 °	-121.323118 °
DWR ID					
Comment Code					
Inspector Comment					
FS_ID:21895 DS_ID:24038 EP_NO: N/A Repair Type: Non-Urgent Crossing Status: Found UCIP Comments: No permit identified for this crossing. FIELD_STRUCT_DESC: 6-inch steel irrigation pipe through the levee, at an unknown depth. Vent, meter, butterfly valve, and pump at pump house on the waterside (WS) slope. FS Date: 8/20/2013

Irrigation line visible on side of pumphouse.

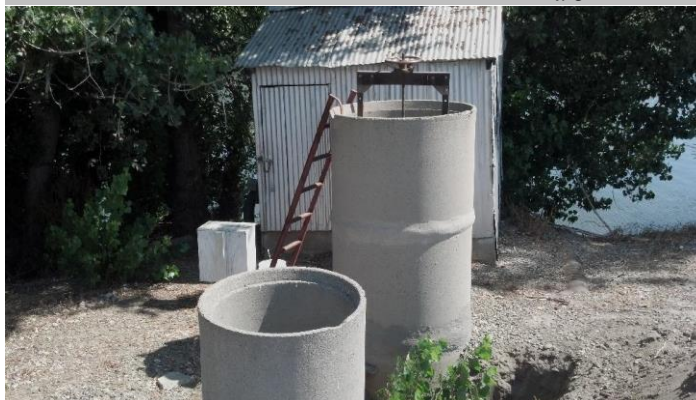
Photo 1 of 3 : UCIP\_FA\_2017\_17944\_30045.jpg

FS\_ID:17944  
DS\_ID:20612  
EP\_NO: N/A  
Repair Type: Non-Urgent  
Crossing Status: Found  
UCIP Comments: Soil excavated from cover over pipe on WS next to concrete riser. May indicate a leak or other problem.  
FIELD\_STRUCT\_DESC: 20-inch steel irrigation pipe through the levee, 15 feet below the crown. Pump in pump house on the waterside (WS) slope. Slide gate in 4-foot diameter concrete standpipe on the WS slope with secondary concrete standpipe. Polyvinyl chloride standpipe visible 350 feet off the landside (LS) toe. [Additional Reference(s): DWR Levee Log, 2004. USACE San Joaquin O&M Manual 7, April 1964, (HLM 2.10)].  
FS Date: 8/20/2013

Slide gate in concrete riser with secondary concrete riser in foreground.  
Pumphouse in background.

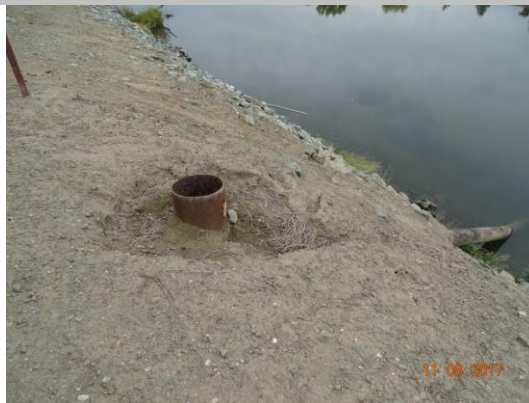
Photo 1 of 4 : FA\_2017\_RD0524\_107\_31\_20171116\_00478.jpg

LM Start	2.25	Rating **	U	Issue No.	31
LM End	2.25	Issue Type +	Ma	Location *	WS
Category	Earthen Levee			GPS Latitude/Longitude	
				Start	End
Item	Slope Stability			37.920493 °	37.920493 °
				-121.320565 °	-121.320565 °
DWR ID	DWR_RD0524_01_s_2012_31				
Comment Code					
S1 : Repair slope instability.					
Inspector Comment					
Slope instability probably cause by leak in irrigation pipe. Pipe should be inspected internally.

Looking northwest at waterside slope.

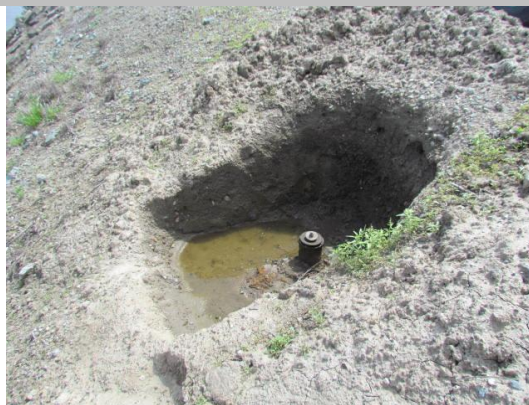
Photo 2 of 4 : FA\_2017\_RD0524\_107\_31\_20170919\_00053.jpg

Looking south at siphon on waterward slope.

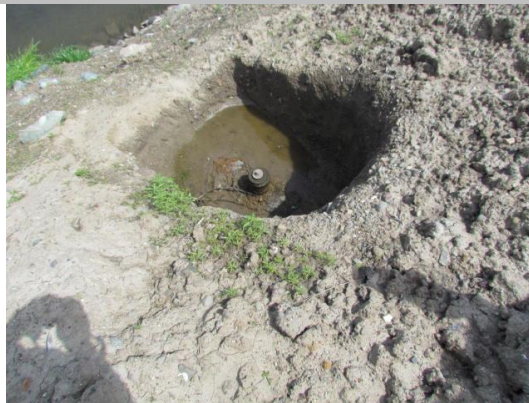
Photo 3 of 4 : FA\_2017\_RD0524\_107\_31\_20170919\_00054.jpg

Looking east at siphon on waterward slope.

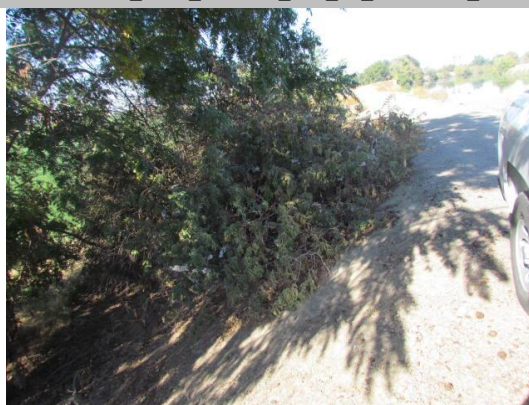
Photo 1 of 2 : FA\_2017\_RD0524\_107\_32\_20170919\_00056.jpg

LM Start	2.27	Rating **	U	Issue No.	32
LM End	2.29	Issue Type +	Ma	Location *	LS
Category	Earthen Levee			GPS Latitude/Longitude	
				Start	End
Item	Vegetation			37.920372 °	37.920167 °
				-121.320230 °	-121.319890 °
DWR ID	DWR_RD0524_01_s_2012_32				
Comment Code					
V4 : Elderberries are blocking visibility and flood fight capability.					
Inspector Comment					
Dense elderberry bushes on landside slope and toe.

Looking northwest at dense veg on landward slope and toe fall 2015.

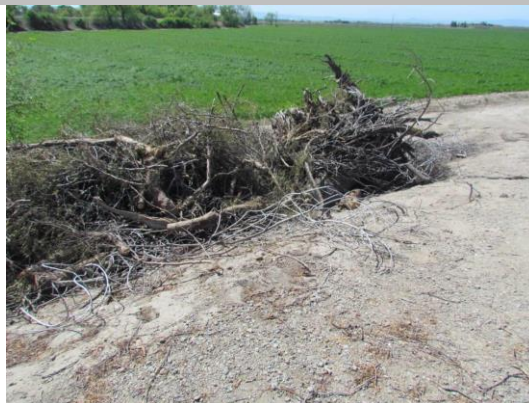
Photo 1 of 1 : FA\_2017\_RD0524\_107\_203\_20170919\_00244.jpg

LM Start	2.27	Rating **	U	Issue No.	203
LM End	2.27	Issue Type +	Ma	Location *	LS
Category	Earthen Levee			GPS Latitude/Longitude	
				Start	End
Item	Encroachments			37.920327 °	37.920327 °
				-121.320175 °	-121.320175 °
DWR ID	DWR_RD0524_01_f_2016_203				
Comment Code					
PR : Prunings					
Inspector Comment					
Large pruning pile on landside slope and toe.

Looking west at pruning pile on waterward slope.

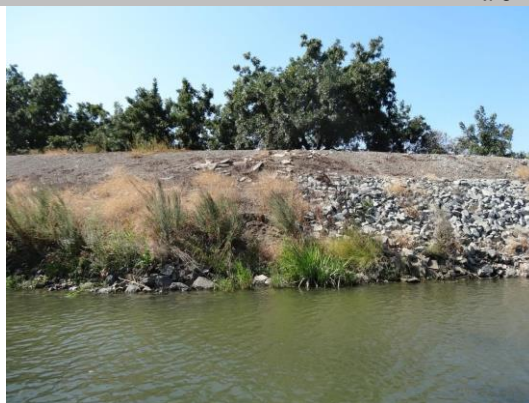
Photo 1 of 3 : SJR2017\_RD0524U01RM42.9\_1.jpg

LM Start	2.30	Rating **	M	Issue No.	70
LM End	2.30	Issue Type +	Ma	Location *	WS
Category	Supplemental			GPS Latitude/Longitude	
				Start	End
Item	DWR Erosion Survey			37.920150 °	37.920150 °
				-121.319700 °	-121.319700 °
DWR ID	RD0524U01RM42.9				
Comment Code					
Inspector Comment					
09/13/2017: The erosion is located immediately upstream of a repaired levee section. [2017 Site ID:RD0524U01RM42.9]

Front view of the pocket erosion.

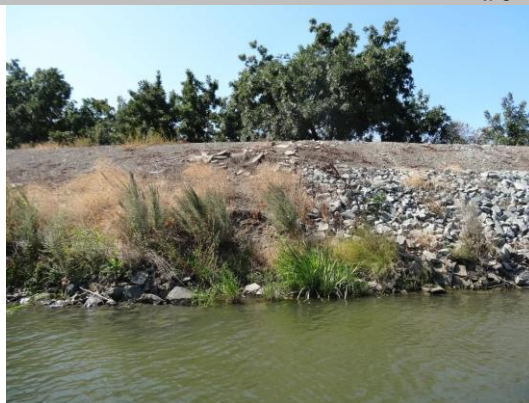
Photo 2 of 3 : SJR2017\_RD0524U01RM42.9\_2.jpg

Close view of the erosion.

LM Start	2.30	Rating **	M	Issue No.	70 (cont)	
LM End	2.30	Issue Type +	Ma	Location *	WS	
Category	Supplemental			GPS Latitude/Longitude		
				Start		End
Item	DWR Erosion Survey			37.920150 °		37.920150 °
				-121.319700 °		-121.319700 °
DWR ID	RD0524U01RM42.9					
Comment Code						
Inspector Comment						
09/13/2017: The erosion is located immediately upstream of a repaired levee section. [2017 Site ID:RD0524U01RM42.9]

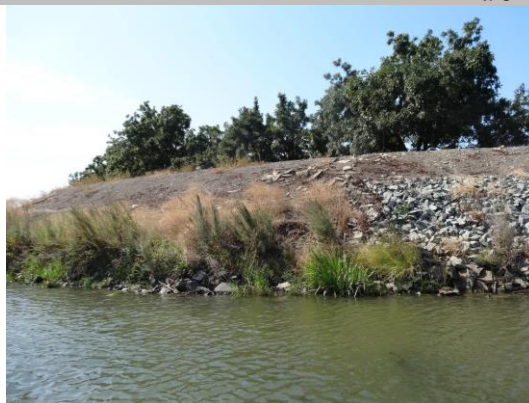
Photo 3 of 3 : SJR2017\_RD0524U01RM42.9\_3.jpg

Front view of the erosion.

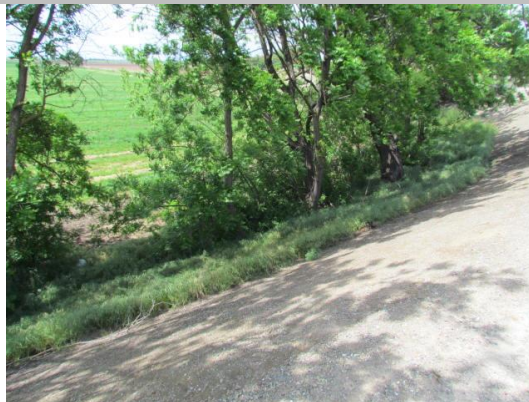
Photo 1 of 1 : FA\_2017\_RD0524\_107\_107\_20170919\_00158.jpg

LM Start	2.33	Rating **	M	Issue No.	107
LM End	2.33	Issue Type +	Ma	Location *	LS
Category	Earthen Levee			GPS Latitude/Longitude	
				Start	End
Item	Trim / Thin Trees			37.919742 °	37.919742 °
				-121.319623 °	-121.319623 °
DWR ID	DWR_RD0524_01_s_2012_107				
Comment Code					
T1 : Trim trees to at least five feet above ground level.					
Inspector Comment

Looking northwest at untrimmed trees at landward toe.

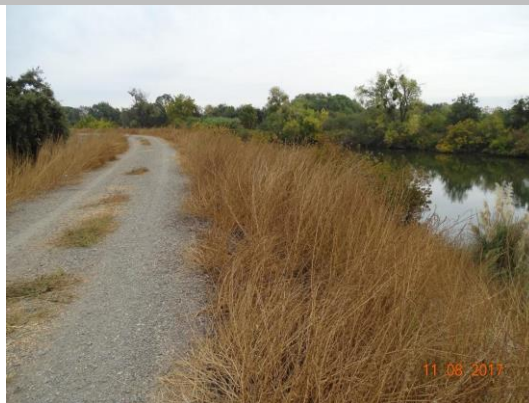
Photo 1 of 1 : FA\_2017\_RD0524\_107\_248\_20171116\_00479.jpg

LM Start	2.34	Rating **	U	Issue No.	248
LM End	2.44	Issue Type +	Ma	Location *	WS
Category	Earthen Levee			GPS Latitude/Longitude	
				Start	End
Item	Vegetation			37.919505 °	37.918574 °
				-121.319654 °	-121.320876 °
DWR ID	DWR_RD0524_01_f_2017_248				
Comment Code					
V2 : Remove the wild growth other than native grasses from the levee slopes.					
Inspector Comment

Looking northeast at the waterside slope.

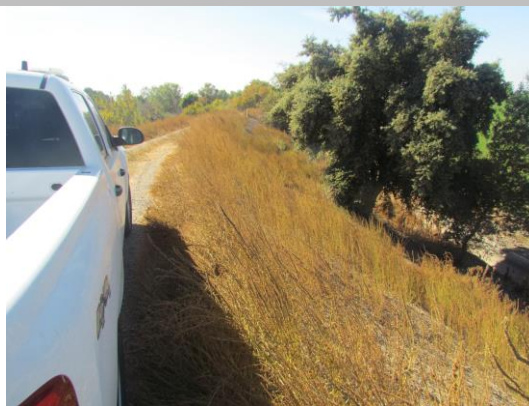
Photo 1 of 1 : FA\_2017\_RD0524\_107\_204\_20170919\_00245.jpg

LM Start	2.38	Rating **	M	Issue No.	204
LM End	2.42	Issue Type +	Ma	Location *	LS
Category	Earthen Levee			GPS Latitude/Longitude	
				Start	End
Item	Vegetation			37.919067 °	37.918713 °
				-121.319935 °	-121.320595 °
DWR ID	DWR_RD0524_01_f_2016_204				
Comment Code					
V2 : Remove the wild growth other than native grasses from the levee slopes.					
Inspector Comment					
Dense vegetation on landside slope and waterside slope.

Looking south at dense veg on landward slope.

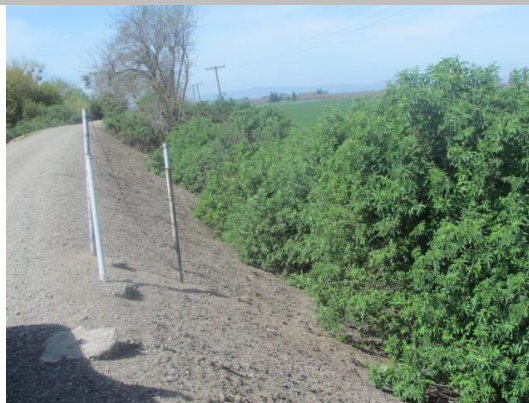
Photo 1 of 1 : FA\_2017\_RD0524\_107\_35\_20170919\_00061.jpg

LM Start	2.41	Rating **	U	Issue No.	35
LM End	2.45	Issue Type +	Ma	Location *	LS
Category	Earthen Levee			GPS Latitude/Longitude	
				Start	End
Item	Vegetation			37.918785 °	37.918515 °
				-121.320417 °	-121.321110 °
DWR ID	DWR_RD0524_01_s_2012_35				
Comment Code					
V4 : Elderberries are blocking visibility and flood fight capability.					
Inspector Comment

Looking southwest at dense vegetation on landward toe.

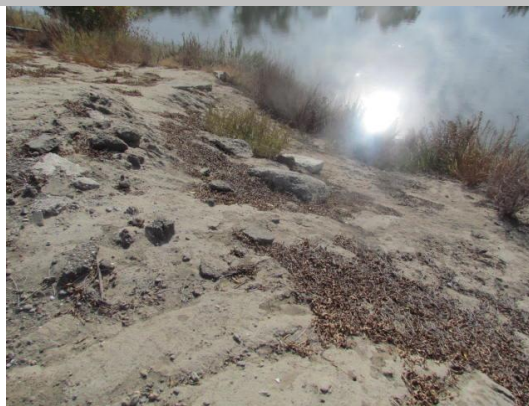
Photo 1 of 1 : FA\_2017\_RD0524\_107\_36\_20170919\_00062.jpg

LM Start	2.44	Rating **	M	Issue No.	36
LM End	2.47	Issue Type +	Ma	Location *	WS
Category	Earthen Levee			GPS Latitude/Longitude	
				Start	End
Item	Erosion / Bank Caving			37.918628 °	37.918438 °
				-121.320817 °	-121.321452 °
DWR ID	DWR_RD0524_01_s_2012_36				
Comment Code					
E1 : Note and monitor erosion site.					
Inspector Comment

Looking east at erosion on waterside slope.

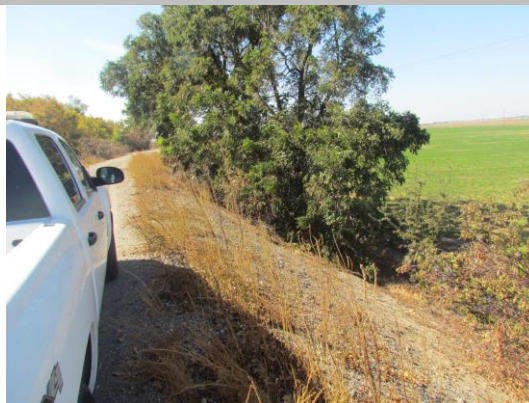
Photo 1 of 1 : FA\_2017\_RD0524\_107\_80\_20170919\_00126.jpg

LM Start	2.45	Rating **	U	Issue No.	80
LM End	2.45	Issue Type +	Ma	Location *	LS
Category	Earthen Levee			GPS Latitude/Longitude	
				Start	End
Item	Trim / Thin Trees			37.918480 °	37.918480 °
				-121.321114 °	-121.321114 °
DWR ID	DWR_RD0524_01_s_2012_80				
Comment Code					
T1 : Trim trees to at least five feet above ground level.					
Inspector Comment					
Untrimmed tree on landside slope.

Looking south at untrimmed tree on landward slope.

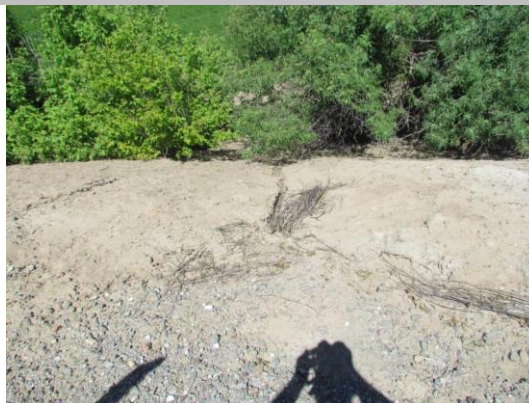
Photo 1 of 1 : FA\_2017\_RD0524\_107\_160\_20170919\_00193.jpg

LM Start	2.47	Rating **	M	Issue No.	160
LM End	2.48	Issue Type +	Ma	Location *	WS
Category	Earthen Levee			GPS Latitude/Longitude	
				Start	End
Item	Erosion / Bank Caving			37.918403 °	37.918383 °
				-121.321442 °	-121.321497 °
DWR ID	DWR_RD0524_01_s_2017_160				
Comment Code					
E1 : Note and monitor erosion site.					
Inspector Comment					
Runoff erosion on landside slope

Looking east at erosion caused by rain runoff on waterward slope.

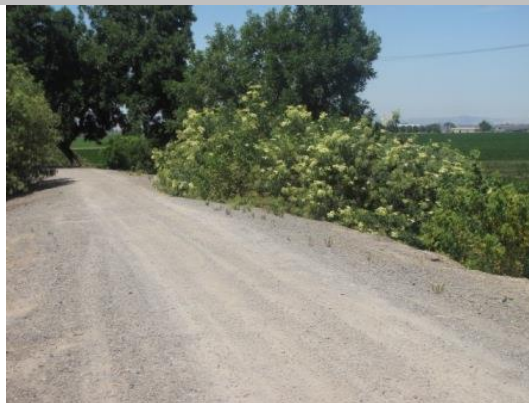
Photo 1 of 4 : FA\_2017\_RD0524\_107\_37\_20170919\_00063.jpg

LM Start	2.49	Rating **	U	Issue No.	37
LM End	2.50	Issue Type +	Ma	Location *	LS
Category	Earthen Levee			GPS Latitude/Longitude	
				Start	End
Item	Vegetation			37.918345 °	37.918302 °
				-121.321765 °	-121.321923 °
DWR ID	DWR_RD0524_01_s_2012_37				
Comment Code					
V4 : Elderberries are blocking visibility and flood fight capability.					
Inspector Comment

Looking south at elderberry on landside slope.

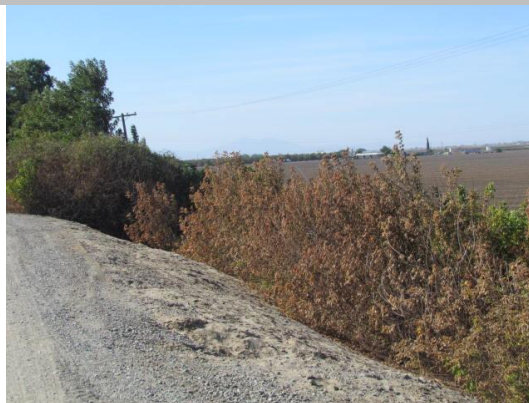
Photo 2 of 4 : FA\_2017\_RD0524\_107\_37\_20170919\_00064.jpg

LM Start	2.49	Rating **	U	Issue No.	37 (cont)
LM End	2.50	Issue Type +	Ma	Location *	LS
Category	Earthen Levee			GPS Latitude/Longitude	
				Start	End
Item	Vegetation			37.918345 °	37.918302 °
				-121.321765 °	-121.321923 °
DWR ID	DWR_RD0524_01_s_2012_37				
Comment Code					
V4 : Elderberries are blocking visibility and flood fight capability.					
Inspector Comment

Looking southwest at dense vegetation on landside toe.

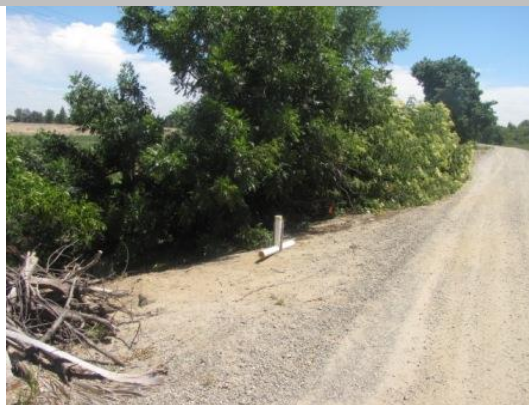
Photo 3 of 4 : FA\_2017\_RD0524\_107\_37\_20170919\_00065.jpg

Looking north at elderberry and trees on landside slope.

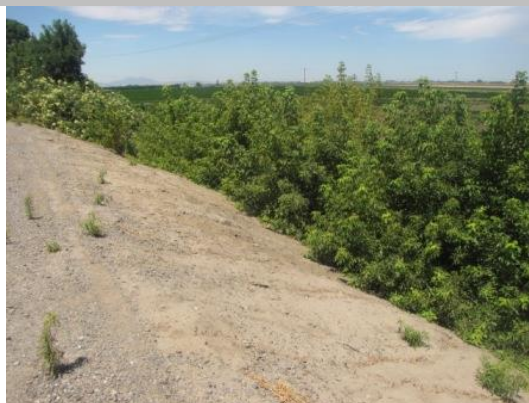
Photo 4 of 4 : FA\_2017\_RD0524\_107\_37\_20170919\_00066.jpg

Looking southwest at trees along levee landside toe.

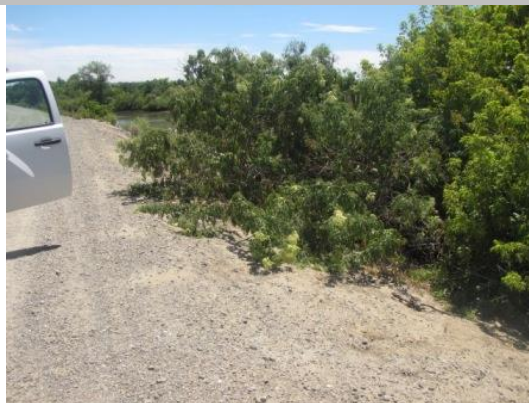
Photo 1 of 2 : FA\_2017\_RD0524\_107\_38\_20170919\_00067.jpg

LM Start	2.50	Rating **	U	Issue No.	38
LM End	2.50	Issue Type +	Ma	Location *	WS
Category	Earthen Levee			GPS Latitude/Longitude	
				Start	End
Item	Vegetation			37.918287 °	37.918287 °
				-121.321980 °	-121.321980 °
DWR ID	DWR_RD0524_01_s_2012_38				
Comment Code					
V4 : Elderberries are blocking visibility and flood fight capability.					
Inspector Comment

Looking north at elderberry on waterside slope.

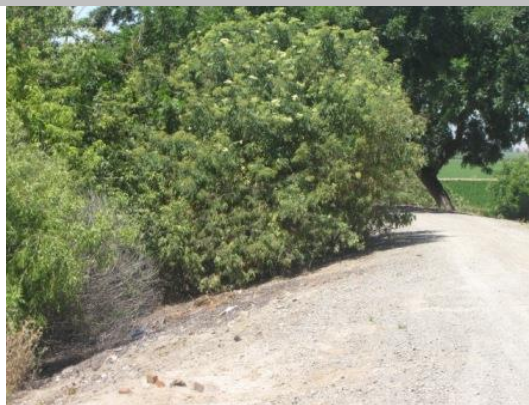
Photo 2 of 2 : FA\_2017\_RD0524\_107\_38\_20170919\_00068.jpg

Looking south at elderberry on waterside slope.

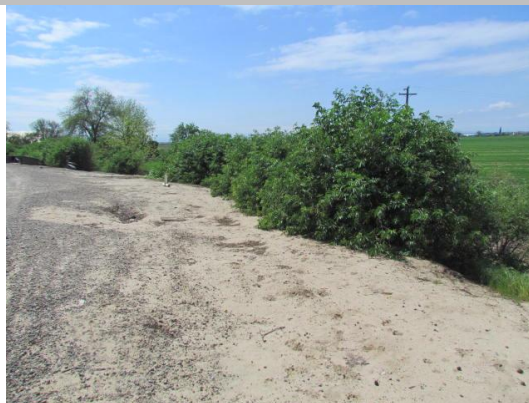
Photo 1 of 1 : FA\_2017\_RD0524\_107\_40\_20170919\_00071.jpg

LM Start	2.53	Rating **	U	Issue No.	40
LM End	2.57	Issue Type +	Ma	Location *	LS
Category	Earthen Levee			GPS Latitude/Longitude	
				Start	End
Item	Vegetation			37.918047 °	37.917498 °
				-121.322415 °	-121.322797 °
DWR ID	DWR_RD0524_01_s_2012_40				
Comment Code					
V4 : Elderberries are blocking visibility and flood fight capability.					
Inspector Comment

Looking southwest at dense veg on landward slope.

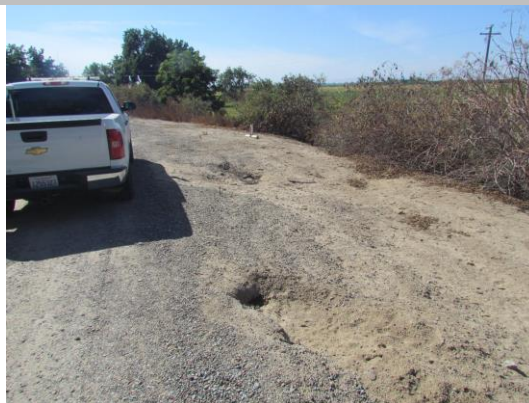
Photo 1 of 2 : FA\_2017\_RD0524\_107\_82\_20170919\_00131.jpg

LM Start	2.54	Rating **	M	Issue No.	82
LM End	2.54	Issue Type +	Ma	Location *	LS
Category	Earthen Levee			GPS Latitude/Longitude	
				Start	End
Item	Animal Control			37.917978 °	37.917978 °
				-121.322483 °	-121.322483 °
DWR ID	DWR_RD0524_01_s_2012_82				
Comment Code					
A3 : No rodents visible, but rodent burrows visible; need to backfill and compact or grout burrows.					
Inspector Comment					
Landside slope damage from animal digging into levee.

Looking southwest at large holes on landward slope. (Fall 2016)

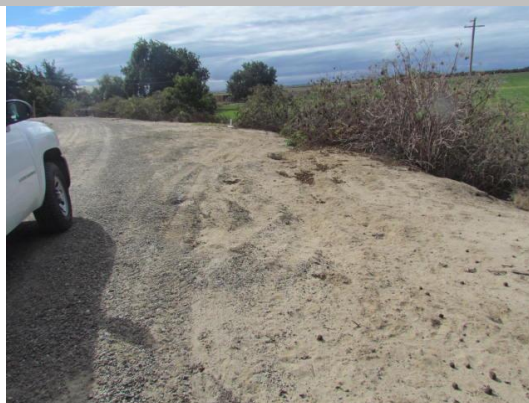
Photo 2 of 2 : FA\_2017\_RD0524\_107\_82\_20170919\_00132.jpg

Looking southwest at damaged landward slope. (Spring 2016)

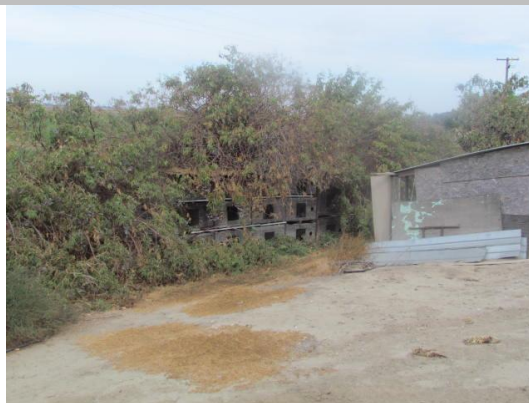
Photo 1 of 2 : FA\_2017\_RD0524\_107\_42\_20170919\_00073.jpg

LM Start	2.56	Rating **	U	Issue No.	42
LM End	2.56	Issue Type +	En	Location *	LS
Category	Earthen Levee			GPS Latitude/Longitude	
				Start	End
Item	Encroachments			37.917673 °	37.917673 °
				-121.322718 °	-121.322718 °
DWR ID	DWR_RD0524_01_s_2012_42				
Comment Code					
BU : Building					
Inspector Comment					
Animal pens on landside slope and toe.

Looking west at animal pens on landside toe. (Fall 2012)

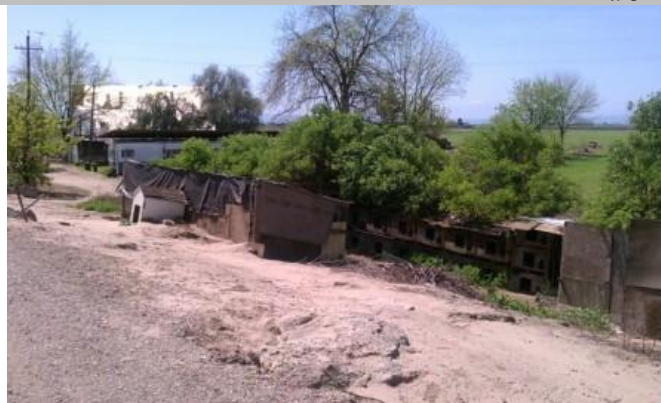
Photo 2 of 2 : FA\_2017\_RD0524\_107\_42\_20170919\_00074.jpg

LM Start	2.56	Rating **	U	Issue No.	42 (cont)	
LM End	2.56	Issue Type +	En	Location *	LS	
Category	Earthen Levee			GPS Latitude/Longitude		
				Start		End
Item	Encroachments			37.917673 °	37.917673 °	
				-121.322718 °	-121.322718 °	
DWR ID	DWR_RD0524_01_s_2012_42					
Comment Code						
BU : Building						
Inspector Comment						
Animal pens on landside slope and toe.

Looking at animal pens on landside slope and toe.

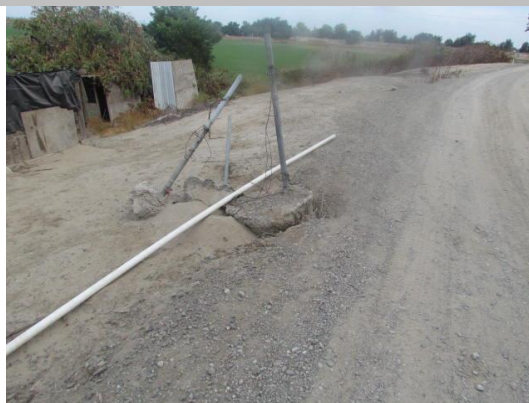
Photo 1 of 1 : FA\_2017\_RD0524\_107\_12\_20170919\_00019.jpg

LM Start	2.57	Rating **	M	Issue No.	12
LM End	2.57	Issue Type +	En	Location *	LS
Category	Earthen Levee			GPS Latitude/Longitude	
				Start	End
Item	Encroachments			37.917538 °	37.917538 °
				-121.322757 °	-121.322757 °
DWR ID	DWR_RD0524_01_f_2012_12				
Comment Code					
PO : Pole					
Inspector Comment					
Old fence poles on landside shoulder and slope should be removed. 4/3/17: Old post removed, a new larger post replacing the old post

Looking northwest at fence poles on landside shoulder.

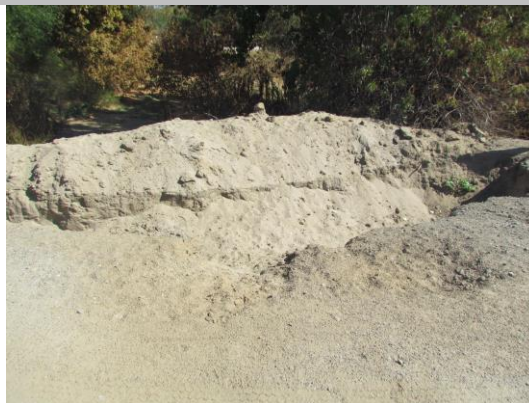
Photo 1 of 3 : FA\_2017\_RD0524\_107\_218\_20170919\_00264.jpg

LM Start	2.57	Rating **	U	Issue No.	218
LM End	2.57	Issue Type +	Ma	Location *	WS
Category	Earthen Levee			GPS Latitude/Longitude	
				Start	End
Item	Erosion / Bank Caving			37.917492 °	37.917492 °
				-121.322795 °	-121.322795 °
DWR ID	DWR_RD0524_01_f_2016_218				
Comment Code					
E2 : Schedule repair of erosion site prior to the next inspection.					
Inspector Comment					
Large trench on waterside shoulder and slope. Trench is 45 x 15 x 5.

Looking east at trench on waterward shoulder.

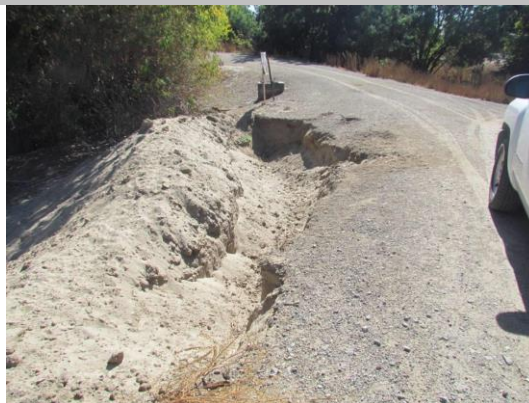
Photo 2 of 3 : FA\_2017\_RD0524\_107\_218\_20170919\_00265.jpg

LM Start	2.57	Rating **	U	Issue No.	218 (cont)	
LM End	2.57	Issue Type +	Ma	Location *	WS	
Category	Earthen Levee			GPS Latitude/Longitude		
				Start		End
Item	Erosion / Bank Caving			37.917492 °		37.917492 °
				-121.322795 °		-121.322795 °
DWR ID	DWR_RD0524_01_f_2016_218					
Comment Code						
E2 : Schedule repair of erosion site prior to the next inspection.						
Inspector Comment						
Large trench on waterside shoulder and slope. Trench is 45 x 15 x 5.

Looking south at trench on waterward shoulder.

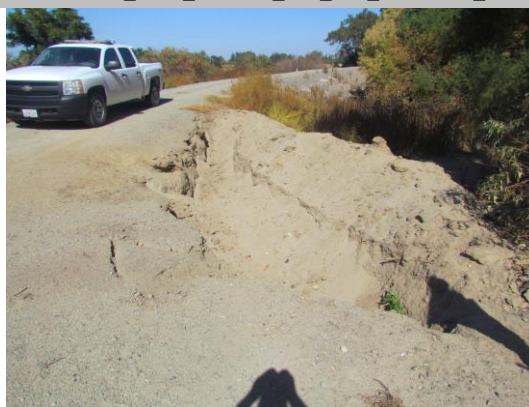
Photo 3 of 3 : FA\_2017\_RD0524\_107\_218\_20170919\_00266.jpg

Looking northwest at trench on waterward shoulder.

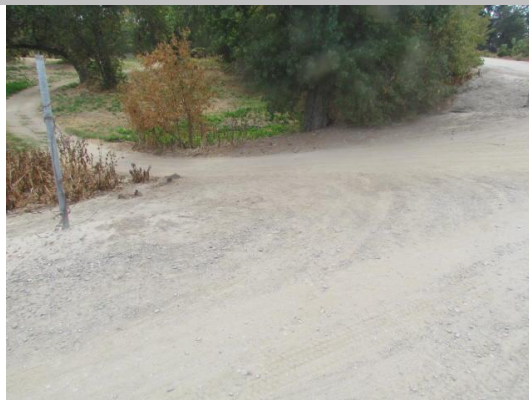
Photo 1 of 1 : FA\_2017\_RD0524\_107\_7\_20170919\_00009.jpg

LM Start	2.58	Rating **	M	Issue No.	7
LM End	2.58	Issue Type +	En	Location *	LS
Category	Earthen Levee			GPS Latitude/Longitude	
				Start	End
Item	Encroachments			37.917431 °	37.917431 °
				-121.322780 °	-121.322780 °
DWR ID	DWR_RD0524_01_f_2012_7				
Comment Code					
RA : Ramp					
Inspector Comment					
Ramp due to land owner traffic.

Looking southeast at unauthorized ramp on waterside slope.

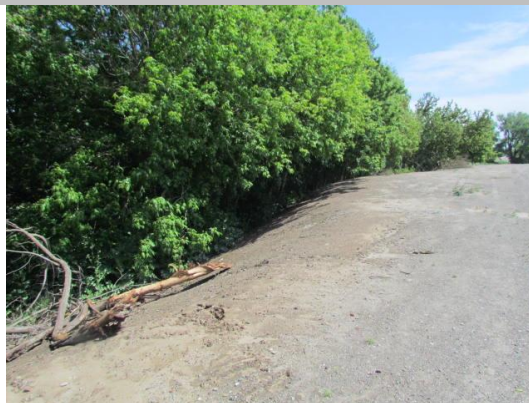
Photo 1 of 1 : FA\_2017\_RD0524\_107\_185\_20170919\_00229.jpg

LM Start	2.60	Rating **	U	Issue No.	185
LM End	2.64	Issue Type +	Ma	Location *	WS
Category	Earthen Levee			GPS Latitude/Longitude	
				Start	End
Item	Trim / Thin Trees			37.917152 °	37.916807 °
				-121.322582 °	-121.322069 °
DWR ID	DWR_RD0524_01_s_2014_185				
Comment Code					
T2 : Thin trees to allow visibility of the ground and room to flood fight.					
Inspector Comment

Looking northwest at untrimmed trees on landward slope and toe.

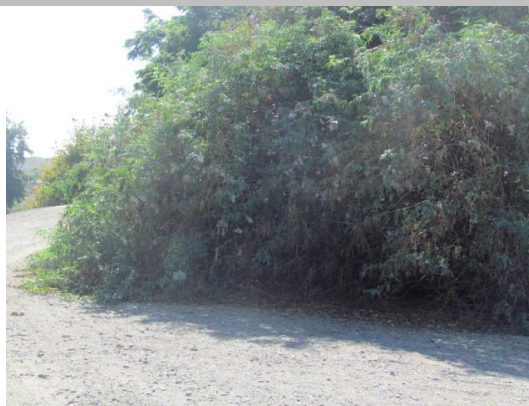
Photo 1 of 1 : FA\_2017\_RD0524\_107\_43\_20170919\_00075.jpg

LM Start	2.64	Rating **	U	Issue No.	43
LM End	2.64	Issue Type +	Ma	Location *	LS
Category	Earthen Levee			GPS Latitude/Longitude	
				Start	End
Item	Vegetation			37.916780 °	37.916780 °
				-121.322095 °	-121.322095 °
DWR ID	DWR_RD0524_01_s_2012_43				
Comment Code					
V4 : Elderberries are blocking visibility and flood fight capability.					
Inspector Comment					
Dense elderberry on landside shoulder, slope, and toe.

Looking southeast at dense veg on landward slope and toe fall 2015.

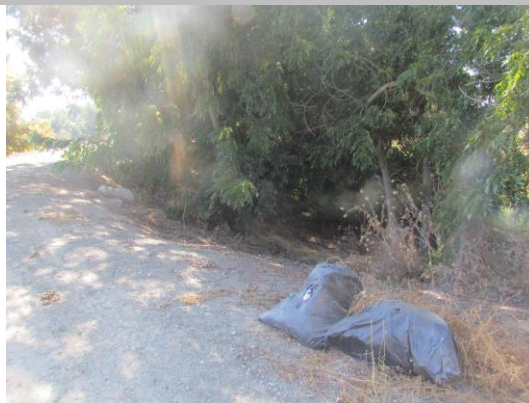
Photo 1 of 1 : FA\_2017\_RD0524\_107\_918\_20170919\_00285.jpg

LM Start	2.65	Rating **	U	Issue No.	918
LM End	2.66	Issue Type +	Ma	Location *	LS
Category	Earthen Levee			GPS Latitude/Longitude	
				Start	End
Item	Trim / Thin Trees			37.916718 °	37.916502 °
				-121.322020 °	-121.321980 °
DWR ID	DWR_RD0524_01_s_2012_918				
Comment Code					
T1 : Trim trees to at least five feet above ground level.					
Inspector Comment					
Untrimmed trees on landside slope and toe.

Looking south at untrimmed trees on landward slope.
