**Flood Control Project Maintenance  
Levee Inspections**

**Fall 2017 Levee Maintenance Deficiency Summary Report**

***San Joaquin River Basin***

**Reclamation District No. 0524 Middle Roberts Island**

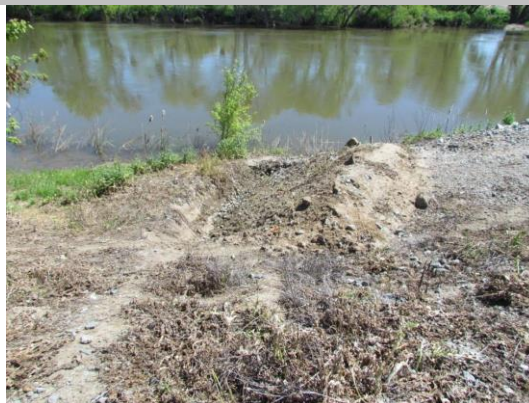
Photo 1 of 2 : FA\_2017\_RD0524\_107\_920\_20170919\_00286.jpg

LM Start	2.65	Rating **	U	Issue No.	920
LM End	2.65	Issue Type +	En	Location *	WS
Category	Earthen Levee			GPS Latitude/Longitude	
				Start	End
Item	Encroachments			37.916698 °	37.916698 °
				-121.322007 °	-121.322007 °
DWR ID	DWR_RD0524_01_s_2012_920				
Comment Code					
RA : Ramp					
Inspector Comment					
Hole dug at base of ramp on river side.

Looking east at hole at the end of ramp on waterward slope.

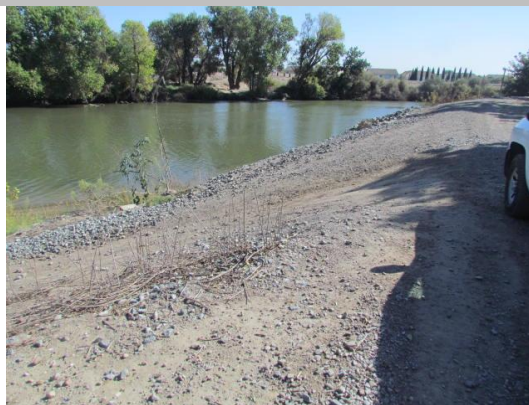
Photo 2 of 2 : FA\_2017\_RD0524\_107\_920\_20170919\_00287.jpg

Looking southeast at unauthorized ramp on waterside slope. (Spring 2016)

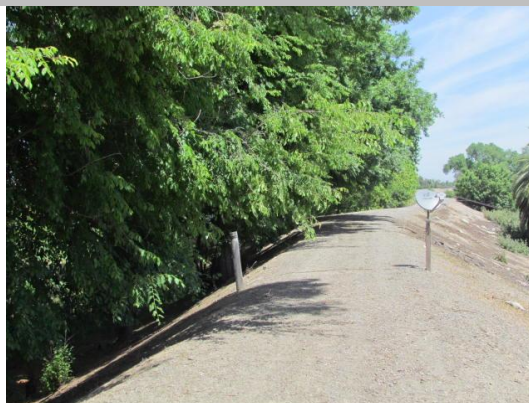
Photo 2 of 2 : FA\_2017\_RD0524\_107\_264\_20171120\_00494.jpg

Looking north at dense trees overhanging levee crown.

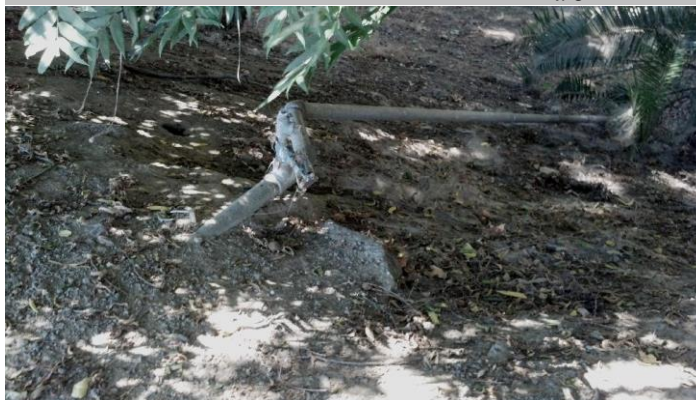
Photo 1 of 2 : UCIP\_FA\_2017\_18085\_30191.jpg

LM Start	2.73	Rating **	M	Issue No.	950
LM End	2.73	Issue Type +	En	Location *	
Category	Supplemental			GPS Latitude/Longitude	
				Start	End
Item	DWR UCIP Field Study			37.915698 °	37.915698 °
				-121.322501 °	-121.322501 °
DWR ID					
Comment Code					
Inspector Comment					
FS_ID:18085 DS_ID:20616 EP_NO: N/A Repair Type: Non-Urgent Crossing Status: Found UCIP Comments: No permit identified for crossing.  Unknoww use. Pipe should be removed. FIELD_STRUCT_DESC: 3-inch galvanized iron pipe of an unknown purpose through the levee, 0.3 feet below the crown. Valve on the landside (LS) shoulder. [Additional Reference(s): DWR Levee Log, 2004]. FS Date: 8/20/2013 3:28:19 PM

Pipe and vent visible on LS slope.

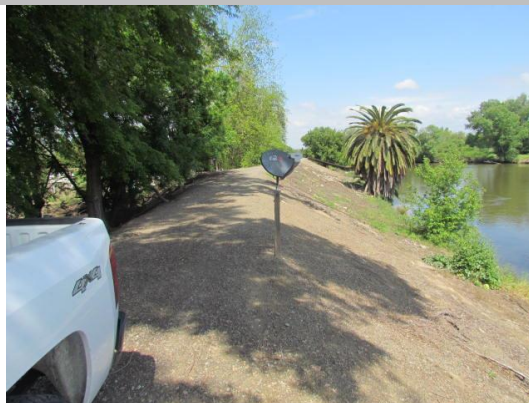
Photo 1 of 1 : FA\_2017\_RD0524\_107\_41\_20170919\_00072.jpg

LM Start	2.74	Rating **	M	Issue No.	41
LM End	2.74	Issue Type +	En	Location *	WS
Category	Earthen Levee			GPS Latitude/Longitude	
				Start	End
Item	Encroachments			37.915556 °	37.915556 °
				-121.322616 °	-121.322616 °
DWR ID	DWR_RD0524_01_s_2016_41				
Comment Code					
EQ : Equipment					
Inspector Comment					
Landowner installed satellite dish on waterside shoulder.

Looking north at satellite dish on waterward shoulder.

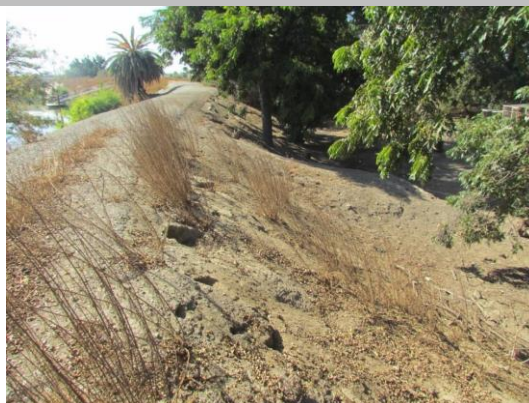
Photo 1 of 2 : FA\_2017\_RD0524\_107\_219\_20170919\_00267.jpg

LM Start	2.77	Rating **	U	Issue No.	219
LM End	2.80	Issue Type +	Ma	Location *	LS
Category	Earthen Levee			GPS Latitude/Longitude	
				Start	End
Item	Animal Control			37.915195 °	37.915052 °
				-121.322930 °	-121.323430 °
DWR ID	DWR_RD0524_01_f_2016_219				
Comment Code					
A1 : Exterminate rodents and backfill and compact or grout burrows.					
Inspector Comment					
Several large rodent holes on landside slope.

Looking south at several rodent holes on landward slope.

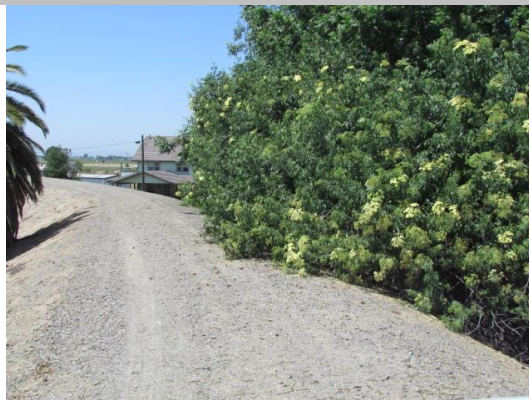
Photo 1 of 2 : FA\_2017\_RD0524\_107\_48\_20170919\_00086.jpg

LM Start	2.80	Rating **	U	Issue No.	48
LM End	2.80	Issue Type +	Ma	Location *	LS
Category	Earthen Levee			GPS Latitude/Longitude	
				Start	End
Item	Vegetation			37.915022 °	37.915022 °
				-121.323443 °	-121.323443 °
DWR ID	DWR_RD0524_01_s_2012_48				
Comment Code					
V4 : Elderberries are blocking visibility and flood fight capability.					
Inspector Comment

Looking south at dense elderberry on landside slope.(Spring 2012)

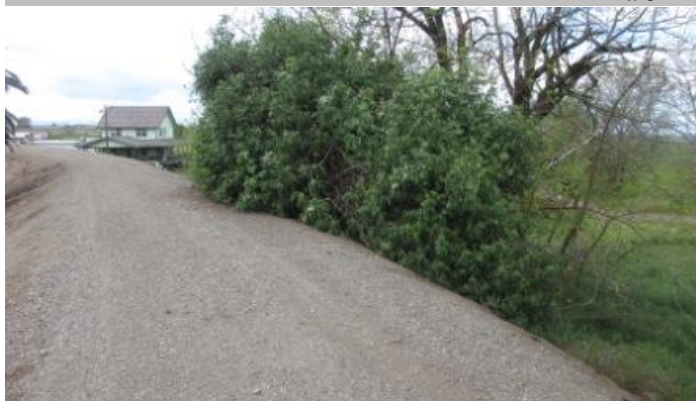
Photo 2 of 2 : FA\_2017\_RD0524\_107\_48\_20170919\_00087.jpg

Looking south at elderberry on landside slope.(Spring 2011)

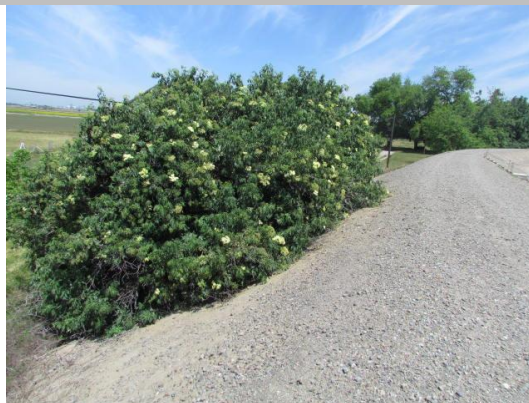
Photo 1 of 1 : FA\_2017\_RD0524\_107\_49\_20170919\_00088.jpg

LM Start	2.86	Rating **	U	Issue No.	49
LM End	2.86	Issue Type +	Ma	Location *	LS
Category	Earthen Levee			GPS Latitude/Longitude	
				Start	End
Item	Vegetation			37.914427 °	37.914427 °
				-121.324198 °	-121.324198 °
DWR ID	DWR_RD0524_01_s_2012_49				
Comment Code					
V4 : Elderberries are blocking visibility and flood fight capability.					
Inspector Comment

Looking northwest at elderberry on landside slope.

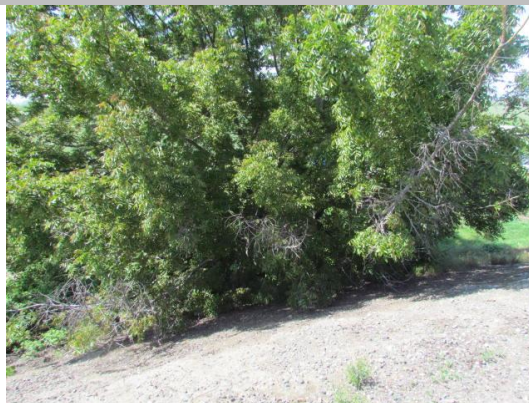
Photo 1 of 1 : FA\_2017\_RD0524\_107\_209\_20170919\_00251.jpg

LM Start	2.87	Rating **	U	Issue No.	209
LM End	2.87	Issue Type +	Ma	Location *	LS
Category	Earthen Levee			GPS Latitude/Longitude	
				Start	End
Item	Trim / Thin Trees			37.914257 °	37.914257 °
				-121.324317 °	-121.324317 °
DWR ID	DWR_RD0524_01_s_2016_209				
Comment Code					
T1 : Trim trees to at least five feet above ground level.					
Inspector Comment					
Untrimmed walnut tree on landside slope and toe.

Looking northwest at untrimmed tree at landward toe.

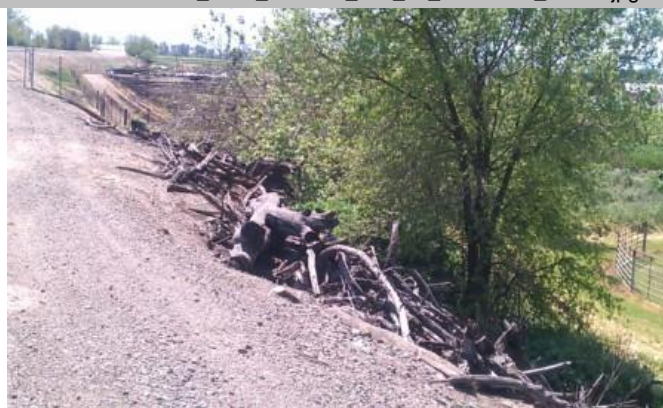
Photo 1 of 1 : FA\_2017\_RD0524\_107\_50\_20170919\_00089.jpg

LM Start	2.90	Rating **	U	Issue No.	50
LM End	2.92	Issue Type +	Ma	Location *	LS
Category	Earthen Levee			GPS Latitude/Longitude	
				Start	End
Item	Encroachments			37.913767 °	37.913486 °
				-121.324427 °	-121.324428 °
DWR ID	DWR_RD0524_01_s_2012_50				
Comment Code					
PR : Prunings					
Inspector Comment

Looking southwest at prunings on landside slope.

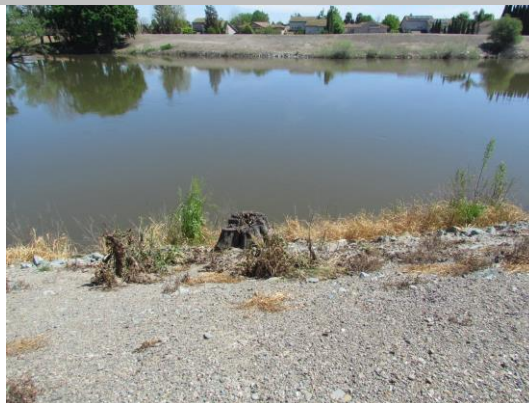
Photo 1 of 1 : FA\_2017\_RD0524\_107\_161\_20170919\_00194.jpg

LM Start	2.91	Rating **	U	Issue No.	161
LM End	2.91	Issue Type +	Ma	Location *	WS
Category	Earthen Levee			GPS Latitude/Longitude	
				Start	End
Item	Trim / Thin Trees			37.913733 °	37.913733 °
				-121.324398 °	-121.324398 °
DWR ID	DWR_RD0524_01_s_2017_161				
Comment Code					
T5 : Tree stumps.					
Inspector Comment

Looking east at large tree stump on waterward shoulder.

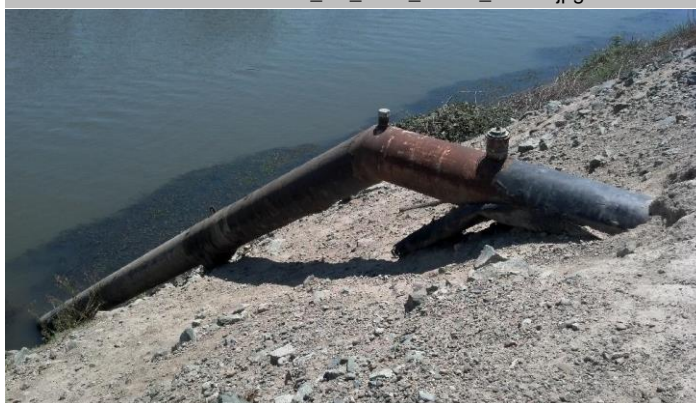
Photo 1 of 2 : UCIP\_FA\_2017\_18089\_30198.jpg

FS\_ID:18089  
DS\_ID:20617  
EP\_NO: N/A  
Repair Type: Non-Urgent  
Crossing Status: Indicator Found  
UCIP Comments: Review crossing with inspector as records indicate that this should be an 8-inch pipe through levee 3.0 feet below crown, pump on landward side. Siphon breaker on the waterward slope. Originally included in the 1964 O&M manual.  
FIELD\_STRUCT\_DESC: 16-inch wrapped steel storm discharge pipe through the levee, 1.5 feet below the crown. Pump on steel pile structure at drainage canal off landside (LS) toe. [Additional Reference(s): USACE San Joaquin O&M Manual 7, April 1964, (HLM 2.99) 9-inch pipe listed].  
FS Date: 8/20/2013

PVC wrapped pipe and siphon breaker visible on WS slope.

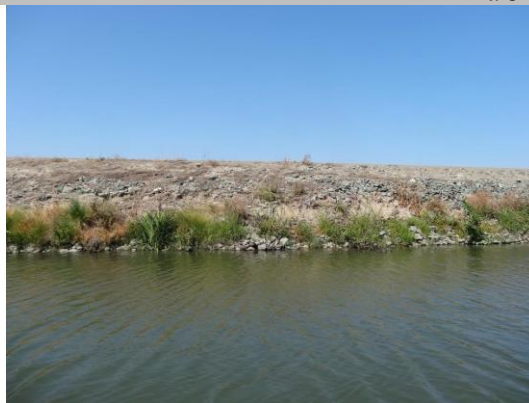
Photo 1 of 4 : SJR2017\_RD0524U01RM43.52\_1.jpg

LM Start	2.96	Rating **	U	Issue No.	71
LM End	2.96	Issue Type +	Ma	Location *	WS
Category	Supplemental			GPS Latitude/Longitude	
				Start	End
Item	DWR Erosion Survey			37.913010 °	37.913010 °
				-121.324490 °	-121.324490 °
DWR ID	RD0524U01RM43.52				
Comment Code					
Inspector Comment					
09/13/2017: A new pocket erosion observed at the eroison site, next to an irrigation pipe.					
07/25/2016: No significant change observed.					
06/24/2015: No significant change observed.					
06/19/2014: No significant change observed.					
08/13/2013: No significant change observed.					
08/07/2012: The site was first reported in 2012 spring levee inspection report. [2017 Site ID:RD0524U01RM43.52]

Front view of the erosion.

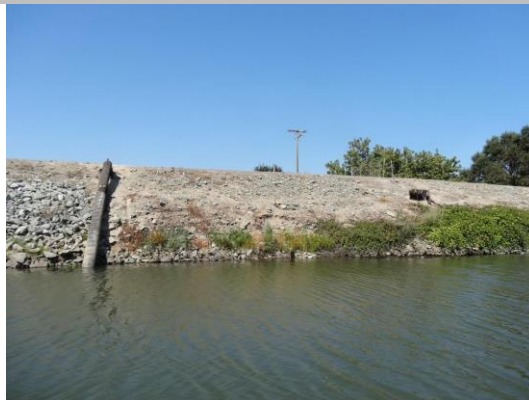
Photo 2 of 4 : SJR2017\_RD0524U01RM43.52\_2.jpg

View of the newly developed pocket erosion next to an irrigation pipe.

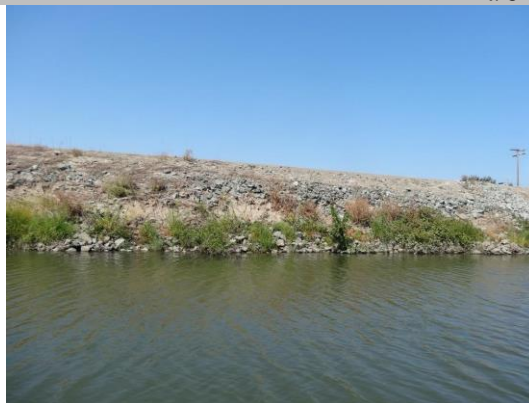
Photo 3 of 4 : SJR2017\_RD0524U01RM43.52\_3.jpg

Close view of the erosion.

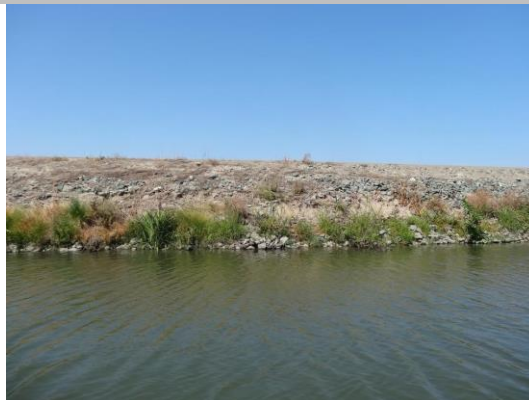
Photo 4 of 4 : SJR2017\_RD0524U01RM43.52\_4.jpg

Close view of the erosion. Note the new pocket erosion next to the irrigation pipe on the site.

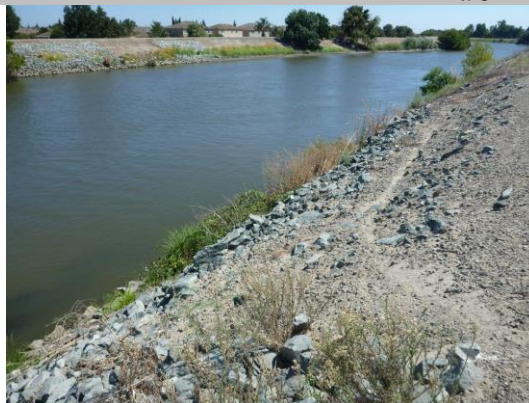
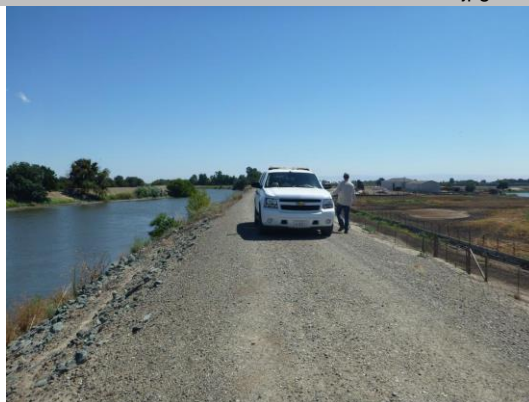
Comment Code					
Inspector Comment					
Levee Evaluation Comments					
Description:Slope protection repairs are needed along the waterside slope due to erosion. Based upon levee inspections, it was determined the waterside levee slopes were eroding, deteriorating and degrading in concave pocket sections at various locations along this levee reach. The eroded levee sections need to be restored back to design standards to prevent further deterioration of the damaged levee sections.					
Site ID No:465					
Site Designation:LMA-292					
Repair Type: Erosion					
Rating:Area of Concern					
Field Date:7/26/2017					
Notes: Lower priority because erosion is within rip rap, is only present on lower slope and is not too deep. Levee is narrow here.

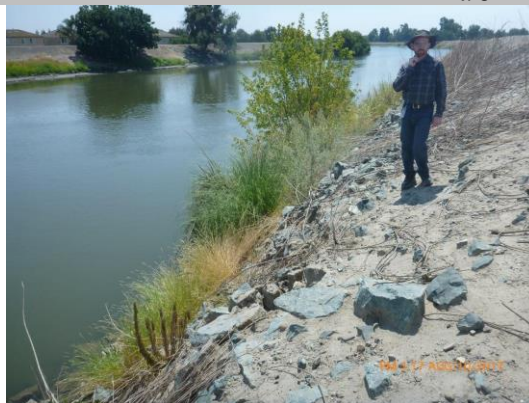
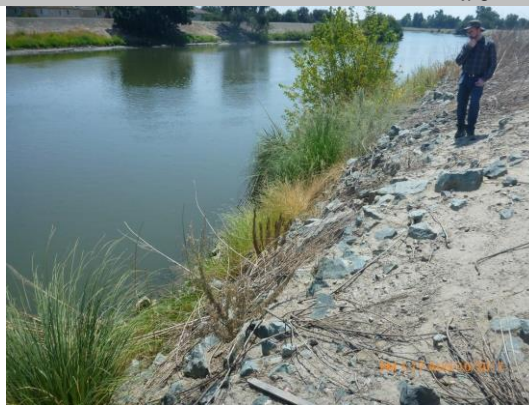
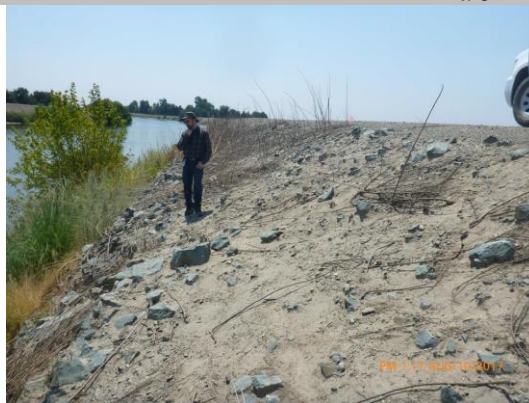
LM Start	2.99	Rating **	A/W	Issue No.	228
LM End	3.01	Issue Type +	Ma	Location *	
Category	Supplemental			GPS Latitude/Longitude	
				Start	End
Item	2017 Storm Damage			37.912500 °	37.912300 °
				-121.324700 °	-121.324700 °
DWR ID	DWR_RD0524_01_f_2017_228				
Comment Code					
Inspector Comment					
Levee Evaluation Comments					
Description:Slope protection repairs are needed along the waterside slope due to erosion and riprap displacement from high water. Based upon levee inspections, it was determined the waterside levee slope is eroding, deteriorating, and degrading. The eroded levee sections need to be restored back to design standards to prevent further deterioration and damage.					
Site ID No:529					
Site Designation:LMA-435					
Repair Type: Erosion					
Rating:Area of Concern					
Field Date:8/10/2017					
Notes:

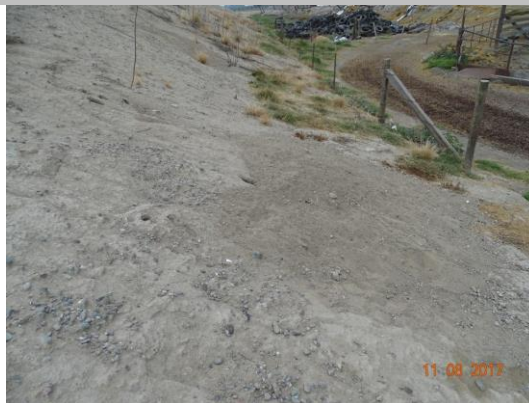
Photo 1 of 3 : FA\_2017\_RD0524\_107\_925\_20171116\_00480.jpg

LM Start	3.07	Rating **	M	Issue No.	925
LM End	3.27	Issue Type +	Ma	Location *	LS
Category	Earthen Levee			GPS Latitude/Longitude	
				Start	End
Item	Animal Control			37.911382 °	37.908602 °
				-121.324928 °	-121.325395 °
DWR ID	DWR_RD0524_01_s_2012_925				
Comment Code					
A1 : Exterminate rodents and backfill and compact or grout burrows.					
Inspector Comment					
Several rodent holes on levee slopes.

Looking southwest at the landside slope.

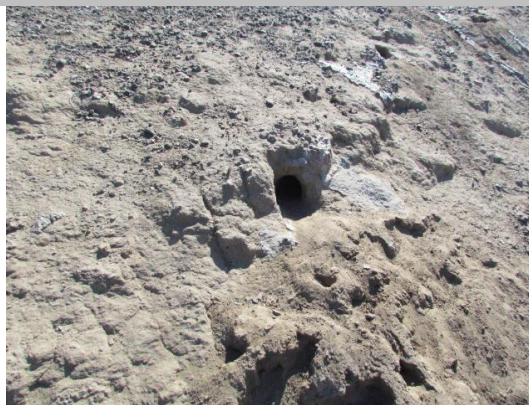
Photo 2 of 3 : FA\_2017\_RD0524\_107\_925\_20170919\_00288.jpg

Looking at typical view of rodent hole with this section fall 2015.

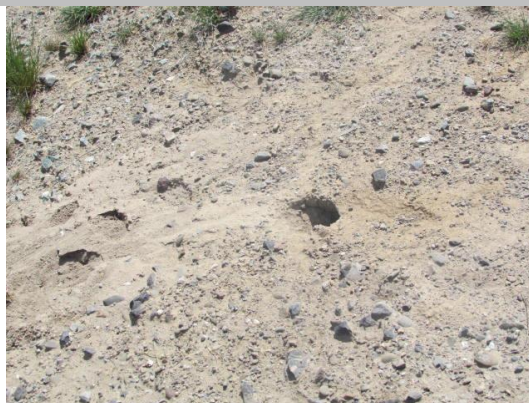
Photo 3 of 3 : FA\_2017\_RD0524\_107\_925\_20170919\_00289.jpg

Looking at typical rodent holes on landward slope along this reach.

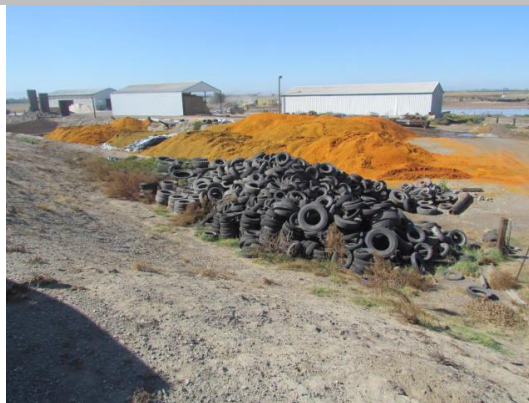
Photo 1 of 1 : FA\_2017\_RD0524\_107\_169\_20170919\_00200.jpg

LM Start	3.10	Rating **	U	Issue No.	169
LM End	3.10	Issue Type +	En	Location *	LS
Category	Earthen Levee			GPS Latitude/Longitude	
				Start	End
Item	Encroachments			37.911070 °	37.911070 °
				-121.325090 °	-121.325090 °
DWR ID	DWR_RD0524_01_f_2015_169				
Comment Code					
GA : Garbage					
Inspector Comment					
Rubber tire stockpile at landside toe.

Looking west at rubber tires at landward toe.

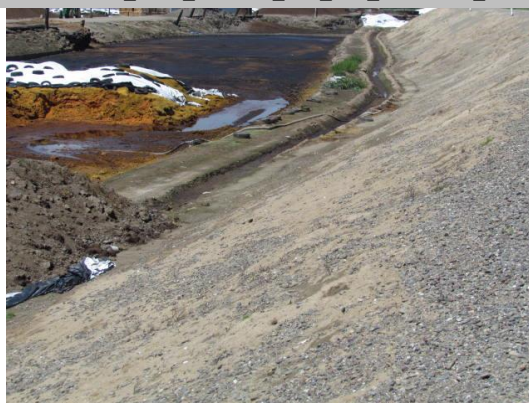
Photo 1 of 2 : FA\_2017\_RD0524\_107\_212\_20170919\_00254.jpg

LM Start	3.11	Rating **	M	Issue No.	212
LM End	3.27	Issue Type +	En	Location *	LS
Category	Earthen Levee			GPS Latitude/Longitude	
				Start	End
Item	Encroachments			37.910876 °	37.908558 °
				-121.325181 °	-121.325394 °
DWR ID	DWR_RD0524_01_s_2016_212				
Comment Code					
DT : Ditch					
Inspector Comment					
Shallow drainage ditch at landside toe.

Looking northwest at southend of ditch at landward toe.

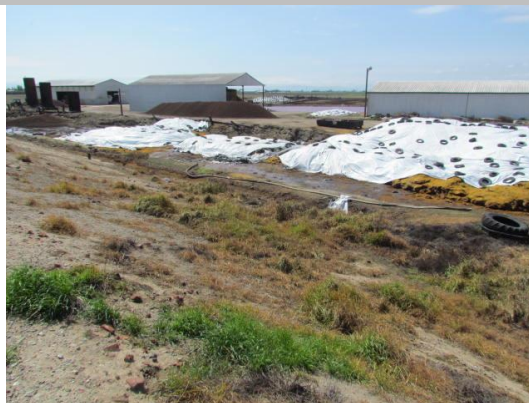
Photo 2 of 2 : FA\_2017\_RD0524\_107\_212\_20170919\_00255.jpg

Looking southwest at northend of ditch at landward toe.

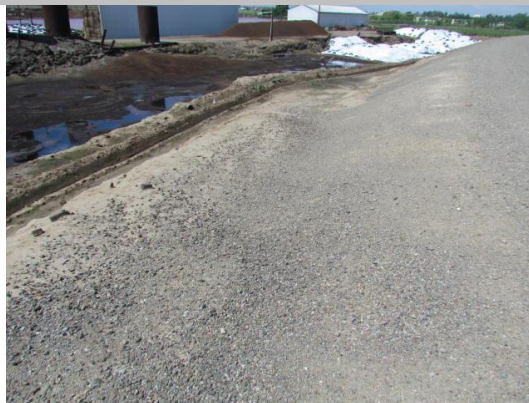
Photo 1 of 1 : FA\_2017\_RD0524\_107\_211\_20170919\_00253.jpg

LM Start	3.18	Rating **	U	Issue No.	211
LM End	3.18	Issue Type +	En	Location *	LS
Category	Earthen Levee			GPS Latitude/Longitude	
				Start	End
Item	Encroachments			37.909945 °	37.909945 °
				-121.325543 °	-121.325543 °
DWR ID	DWR_RD0524_01_s_2016_211				
Comment Code					
RA : Ramp					
Inspector Comment					
Unauthorized ramp on landside slope.

Looking northwest at unauthorized ramp on landward slope.

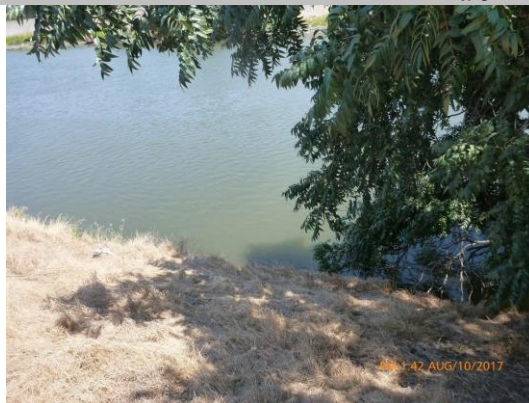
Photo 3 of 3 : LEVAL\_FA\_2017\_528\_4198.jpg

LM Start	3.26	Rating **	A/W	Issue No.	230 (cont)	
LM End	3.26	Issue Type +	Ma	Location *		
Category	Supplemental			GPS Latitude/Longitude		
				Start		End
Item	2017 Storm Damage			37.908800 °		37.908700 °
				-121.325400 °		-121.325300 °
DWR ID	DWR_RD0524_01_f_2017_230					
Comment Code						
Inspector Comment						
Levee Evaluation Comments						
Description:Slope protection repairs are needed along the waterside slope due to erosion and riprap displacement from high water. Based upon levee inspections, it was determined the waterside levee slope is eroding, deteriorating, and degrading. The eroded levee sections need to be restored back to design standards to prevent further deterioration and damage.						
Site ID No:528						
Site Designation:LMA-434						
Repair Type: Erosion						
Rating:Area of Concern						
Field Date:8/10/2017						
Notes: combined with LMA-433

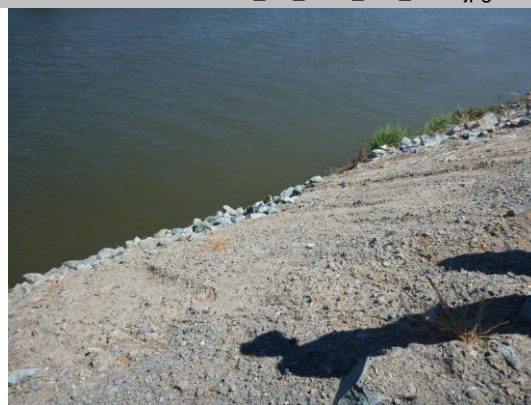
Photo 1 of 3 : LEVAL\_FA\_2017\_467\_2223.jpg

Comment Code					
Inspector Comment					
Levee Evaluation Comments					
Description:Slope protection repairs are needed along the waterside slope due to erosion. Based upon levee inspections, it was determined the waterside levee slopes were eroding, deteriorating and degrading in concave pocket sections at various locations along this levee reach. The eroded levee sections need to be restored back to design standards to prevent further deterioration of the damaged levee sections.					
Site ID No:467					
Site Designation:LMA-294					
Repair Type: Erosion					
Rating:Area of Concern					
Field Date:7/26/2017					
Notes: It looks like new rip rap was placed on the lower 1/4 of the slope. There is a 2-3 ft scarp above the rip rap.

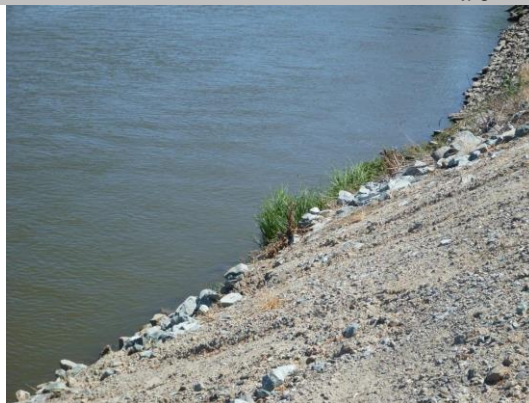
Photo 2 of 3 : LEVAL\_FA\_2017\_467\_2224.jpg

Comment Code						
Inspector Comment						
Levee Evaluation Comments						
Description:Slope protection repairs are needed along the waterside slope due to erosion. Based upon levee inspections, it was determined the waterside levee slopes were eroding, deteriorating and degrading in concave pocket sections at various locations along this levee reach. The eroded levee sections need to be restored back to design standards to prevent further deterioration of the damaged levee sections.						
Site ID No:467						
Site Designation:LMA-294						
Repair Type: Erosion						
Rating:Area of Concern						
Field Date:7/26/2017						
Notes: It looks like new rip rap was played on the lower 1/4 of the slope. There is a 2-3 ft scarp above the rip rap.

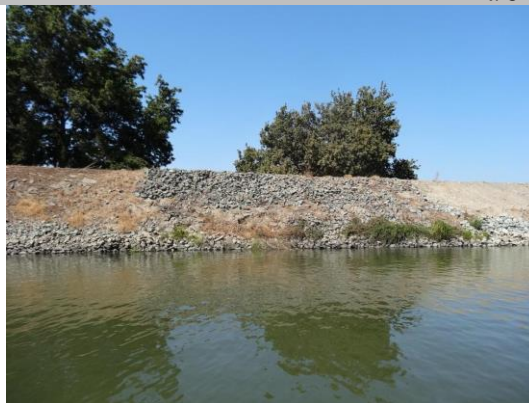
Photo 1 of 4 : SJR2017\_RD0524U01RM43.86\_1.jpg

LM Start	3.30	Rating **	U	Issue No.	79
LM End	3.32	Issue Type +	Ma	Location *	WS
Category	Supplemental			GPS Latitude/Longitude	
				Start	End
Item	DWR Erosion Survey			37.908090 °	37.908090 °
				-121.325090 °	-121.325090 °
DWR ID	RD0524U01RM43.86				
Comment Code					
Inspector Comment					
09/13/2017: No significant change observed.					
07/25/2016: No significant change observed.					
06/24/2015: No significant change observed.					
06/19/2014: No significant change observed.					
08/13/2013: The levee toe seems to have been protected by river rocks and vegetation on site. [2017 Site ID:RD0524U01RM43.86]

Front View of the erosion.

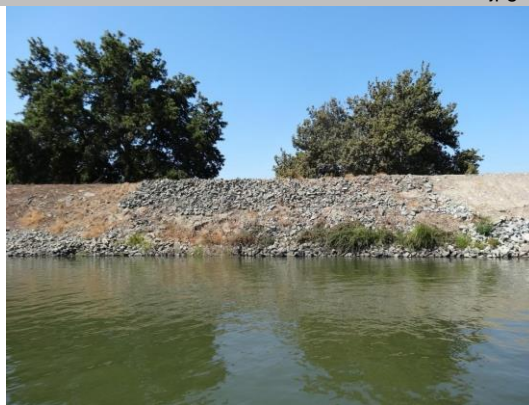
Photo 2 of 4 : SJR2017\_RD0524U01RM43.86\_2.jpg

Front view of the erosion.

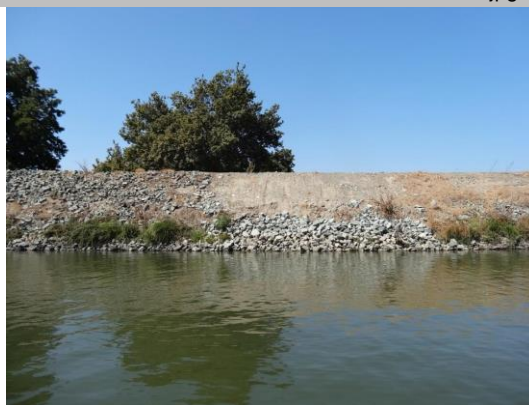
Photo 3 of 4 : SJR2017\_RD0524U01RM43.86\_3.jpg

Close view of the erosion. Note the river rocks and vegetation at the levee toe.

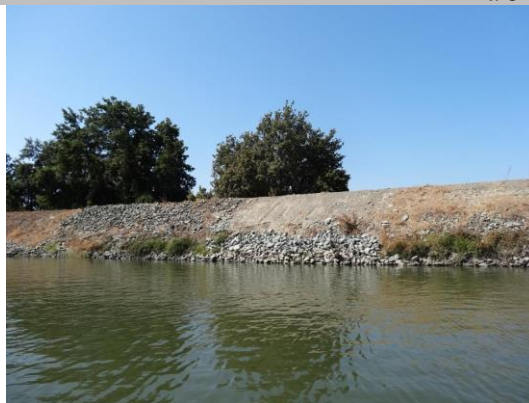
Photo 4 of 4 : SJR2017\_RD0524U01RM43.86\_4.jpg

LM Start	3.30	Rating **	U	Issue No.	79 (cont)
LM End	3.32	Issue Type +	Ma	Location *	WS
Category	Supplemental			GPS Latitude/Longitude	
				Start	End
Item	DWR Erosion Survey			37.908090 °	37.908090 °
				-121.325090 °	-121.325090 °
DWR ID	RD0524U01RM43.86				
Comment Code					
Inspector Comment					
09/13/2017: No significant change observed.					
07/25/2016: No significant change observed.					
06/24/2015: No significant change observed.					
06/19/2014: No significant change observed.					
08/13/2013: The levee toe seems to have been protected by river rocks and vegetation on site. [2017 Site ID:RD0524U01RM43.86]

Front View of the erosion.

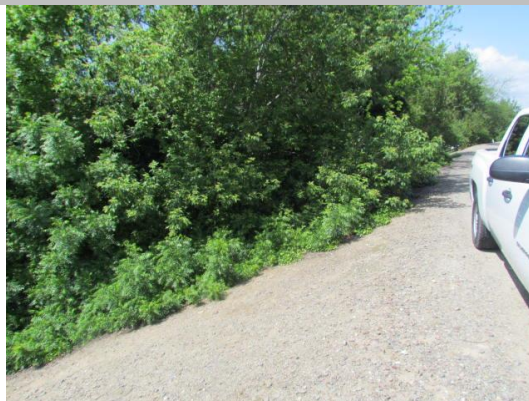
Photo 1 of 2 : FA\_2017\_RD0524\_107\_926\_20170919\_00290.jpg

LM Start	3.30	Rating **	U	Issue No.	926
LM End	3.37	Issue Type +	Ma	Location *	LS
Category	Earthen Levee			GPS Latitude/Longitude	
				Start	End
Item	Trim / Thin Trees			37.908158 °	37.907112 °
				-121.325418 °	-121.325350 °
DWR ID	DWR_RD0524_01_s_2012_926				
Comment Code					
T1 : Trim trees to at least five feet above ground level.					
Inspector Comment

Looking southwest at dense veg on landward slope.

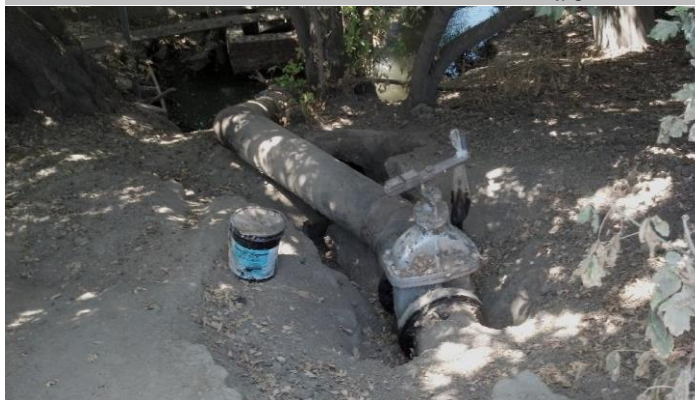
Photo 2 of 3 : UCIP\_FA\_2017\_51320\_30205.jpg

FS\_ID:51320  
DS\_ID:20618  
EP\_NO: N/A  
Repair Type: Urgent  
Crossing Status: Found  
UCIP Comments: 11/16/2016 same as previous inspection erosion is still present on LS toe and slope. Owner will need to coordinate with CVFPB to address erosion issue on LS toe. (O. Magana - DWR UCIP)08/20/2013 Extensive erosion on LS toe at distribution box due to failure of box/pipe connection. Erosion on LS slope do to recently repaired leak at gate valve. (W. Wylie - DWR UCIP)  
FIELD\_STRUCT\_DESC: 14-inch steel irrigation pipe through the levee, 7 feet below the crown. Pump house located on the waterside (WS) slope. Gate valve located on the landside (LS) slope. 4-foot by 4-foot brick distribution box, built in 1918, located on the LS toe. This site was used to manufacture brick back in 1918, and some of the appurtenances that remain are still in use (distribution box and ditch).  
[Additional Reference(s): DWR Levee Log, 2004. USACE San Joaquin O&M Manual 7, April 1964, (HLM 3.38) 12-inch pipe listed, (conversation with owner, 2016)].

Pipe, gatevalve, and erosion on LS slope.

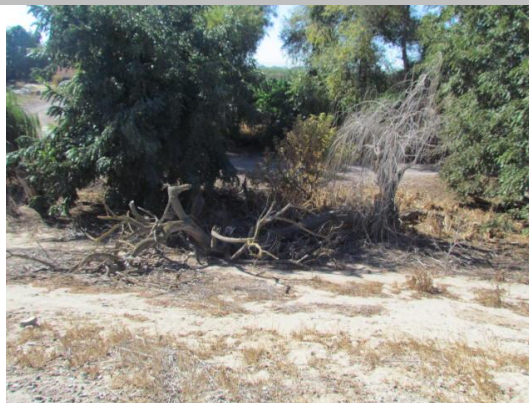
Photo 1 of 1 : FA\_2017\_RD0524\_107\_177\_20170919\_00215.jpg

LM Start	3.48	Rating **	M	Issue No.	177
LM End	3.48	Issue Type +	Ma	Location *	LS
Category	Earthen Levee			GPS Latitude/Longitude	
				Start	End
Item	Encroachments			37.905994 °	37.905994 °
				-121.324194 °	-121.324194 °
DWR ID	DWR_RD0524_01_f_2014_177				
Comment Code					
TR : Tree or limb					
Inspector Comment					
Dead tree on landside toe.

Looking at dead tree limb at landward toe fall 2015.

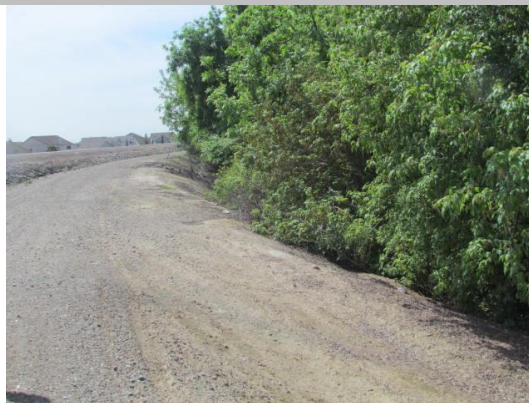
Photo 1 of 1 : FA\_2017\_RD0524\_107\_57\_20170919\_00097.jpg

LM Start	3.51	Rating **	U	Issue No.	57
LM End	3.59	Issue Type +	Ma	Location *	LS
Category	Earthen Levee			GPS Latitude/Longitude	
				Start	End
Item	Trim / Thin Trees			37.905638 °	37.904570 °
				-121.323892 °	-121.324215 °
DWR ID	DWR_RD0524_01_s_2012_57				
Comment Code					
T3 : Trim and thin trees to allow visibility of the ground and room to flood fight.					
Inspector Comment

Looking south at dense trees on landward slope.

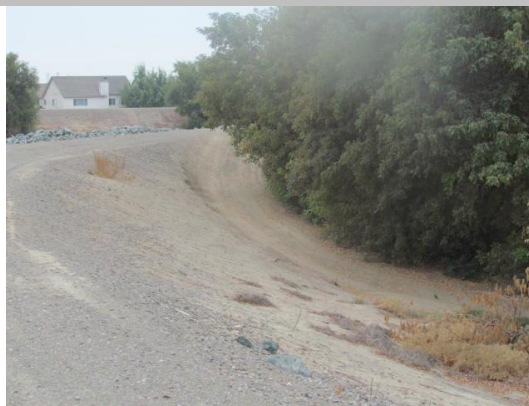
Photo 1 of 1 : FA\_2017\_RD0524\_107\_265\_20170919\_00275.jpg

LM Start	3.51	Rating **	M	Issue No.	265
LM End	3.51	Issue Type +	En	Location *	LS
Category	Earthen Levee			GPS Latitude/Longitude	
				Start	End
Item	Encroachments			37.905552 °	37.905552 °
				-121.323847 °	-121.323847 °
DWR ID	DWR_RD0524_01_s_2012_265				
Comment Code					
RA : Ramp					
Inspector Comment					
Unauthorized ramp on landside slope.

Looking southeast at unauthorized ramp on landside slope and toe.

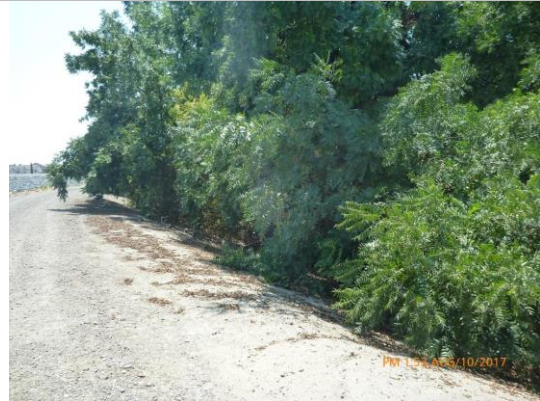
Photo 3 of 3 : LEVAL\_FA\_2017\_526\_4203.jpg

LM Start	3.53	Rating **	A/W	Issue No.	233 (cont)
LM End	3.54	Issue Type +	Ma	Location *	
Category	Supplemental			GPS Latitude/Longitude	
				Start	End
Item	2017 Storm Damage			37.905300 °	37.905200 °
				-121.323800 °	-121.323900 °
DWR ID	DWR_RD0524_01_f_2017_233				
Comment Code					
Inspector Comment					
Levee Evaluation Comments					
Description:Slope protection repairs are needed along the waterside slope due to erosion and riprap displacement from high water. Based upon levee inspections, it was determined the waterside levee slope is eroding, deteriorating, and degrading. The eroded levee sections need to be restored back to design standards to prevent further deterioration and damage.					
Site ID No:526					
Site Designation:LMA-432					
Repair Type: Erosion					
Rating:Area of Concern					
Field Date:8/10/2017					
Notes:

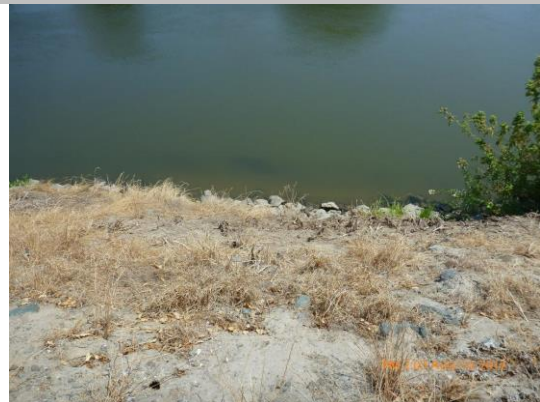
Photo 1 of 3 : LEVAL\_FA\_2017\_525\_4205.jpg

LM Start	3.56	Rating **	A/W	Issue No.	234
LM End	3.57	Issue Type +	Ma	Location *	
Category	Supplemental			GPS Latitude/Longitude	
				Start	End
Item	2017 Storm Damage			37.904900 °	37.904800 °
				-121.323900 °	-121.324100 °
DWR ID	DWR_RD0524_01_f_2017_234				
Comment Code					
Inspector Comment					
Levee Evaluation Comments					
Description:Slope protection repairs are needed along the waterside slope due to erosion and riprap displacement from high water. Based upon levee inspections, it was determined the waterside levee slope is eroding, deteriorating, and degrading. The eroded levee sections need to be restored back to design standards to prevent further deterioration and damage.					
Site ID No:525					
Site Designation:LMA-431					
Repair Type: Erosion					
Rating:Area of Concern					
Field Date:8/10/2017					
Notes:

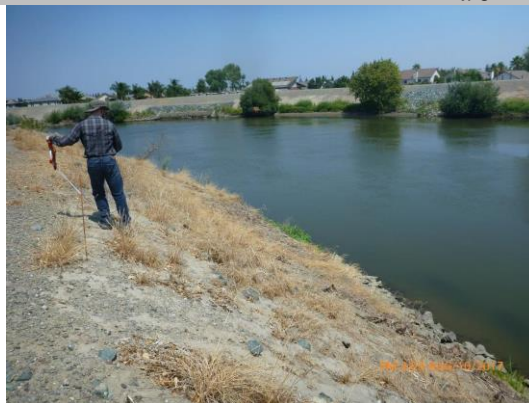
Photo 2 of 3 : LEVAL\_FA\_2017\_525\_4206.jpg

LM Start	3.56	Rating **	A/W	Issue No.	234 (cont)
LM End	3.57	Issue Type +	Ma	Location *	
Category	Supplemental			GPS Latitude/Longitude	
				Start	End
Item	2017 Storm Damage			37.904900 °	37.904800 °
				-121.323900 °	-121.324100 °
DWR ID	DWR_RD0524_01_f_2017_234				
Comment Code					
Inspector Comment					
Levee Evaluation Comments					
Description:Slope protection repairs are needed along the waterside slope due to erosion and riprap displacement from high water. Based upon levee inspections, it was determined the waterside levee slope is eroding, deteriorating, and degrading. The eroded levee sections need to be restored back to design standards to prevent further deterioration and damage.					
Site ID No:525					
Site Designation:LMA-431					
Repair Type: Erosion					
Rating:Area of Concern					
Field Date:8/10/2017					
Notes:

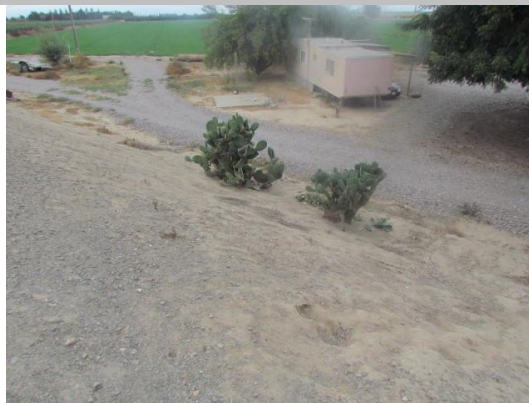
Photo 1 of 1 : FA\_2017\_RD0524\_107\_124\_20170919\_00176.jpg

LM Start	3.61	Rating **	M	Issue No.	124
LM End	3.61	Issue Type +	En	Location *	LS
Category	Earthen Levee			GPS Latitude/Longitude	
				Start	End
Item	Vegetation			37.904375 °	37.904375 °
				-121.324615 °	-121.324615 °
DWR ID	DWR_RD0524_01_f_2012_124				
Comment Code					
V6 : Landscaping					
Inspector Comment					
Landowner planted cactus on landside toe.

Looking west at cactus on landside toe.

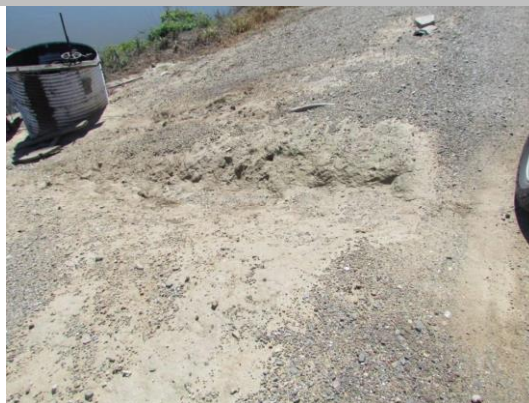
Photo 1 of 2 : FA\_2017\_RD0524\_107\_58\_20170919\_00098.jpg

LM Start	3.64	Rating **	M	Issue No.	58
LM End	3.64	Issue Type +	Ma	Location *	WS
Category	Earthen Levee			GPS Latitude/Longitude	
				Start	End
Item	Slope Stability			37.904113 °	37.904113 °
				-121.325080 °	-121.325080 °
DWR ID	DWR_RD0524_01_s_2012_58				
Comment Code					
S2 : Repair the levee slope damaged by foot traffic and prevent access where possible.					
Inspector Comment					
Landowner cut steps into waterside slope.					
4/3/17: Steps washed away slope damage remains.

Looking south at step cut into waterward slope. (Spring 2017)

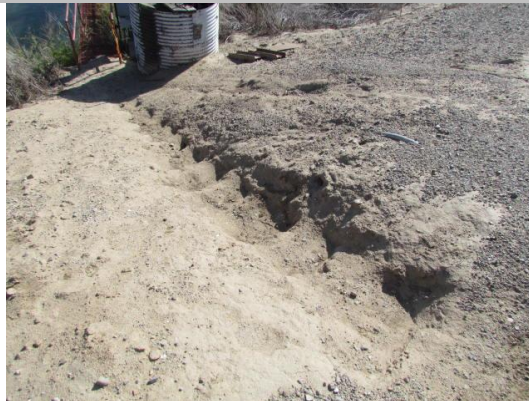
Photo 2 of 2 : FA\_2017\_RD0524\_107\_58\_20170919\_00099.jpg

Looking southeast steps cut into waterside slope.

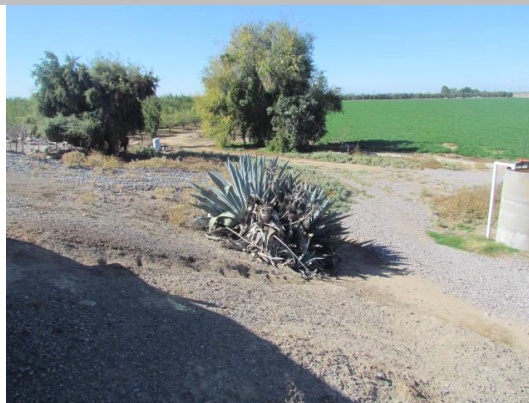
Photo 1 of 1 : FA\_2017\_RD0524\_107\_190\_20170919\_00231.jpg

LM Start	3.65	Rating **	U	Issue No.	190
LM End	3.65	Issue Type +	Ma	Location *	LS
Category	Earthen Levee			GPS Latitude/Longitude	
				Start	End
Item	Vegetation			37.904070 °	37.904070 °
				-121.325118 °	-121.325118 °
DWR ID	DWR_RD0524_01_f_2015_190				
Comment Code					
V2 : Remove the wild growth other than native grasses from the levee slopes.					
Inspector Comment					
Large century plant at landside toe.

Looking southwest at century plant at landward toe fall 2015.

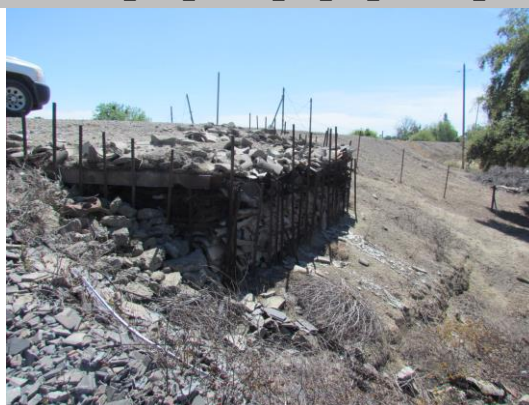
Photo 1 of 1 : FA\_2017\_RD0524\_107\_164\_20170919\_00195.jpg

LM Start	3.66	Rating **	U	Issue No.	164
LM End	3.66	Issue Type +	En	Location *	LS
Category	Earthen Levee			GPS Latitude/Longitude	
				Start	End
Item	Encroachments			37.903983 °	37.903983 °
				-121.325198 °	-121.325198 °
DWR ID	DWR_RD0524_01_s_2017_164				
Comment Code					
BU : Building					
Inspector Comment					
Abandoned deck on landside shoulder.

Looking south at abandoned deck on landward shoulder and slope.

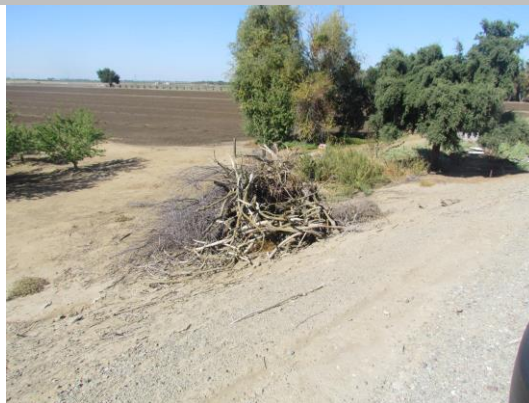
Photo 1 of 1 : FA\_2017\_RD0524\_107\_192\_20170919\_00232.jpg

LM Start	3.67	Rating **	U	Issue No.	192
LM End	3.67	Issue Type +	En	Location *	LS
Category	Earthen Levee			GPS Latitude/Longitude	
				Start	End
Item	Encroachments			37.903782 °	37.903782 °
				-121.325363 °	-121.325363 °
DWR ID	DWR_RD0524_01_s_2015_192				
Comment Code					
PR : Prunings					
Inspector Comment					
Large pruning piles at landside toe.

Looking west at pruning pile at landward toe.

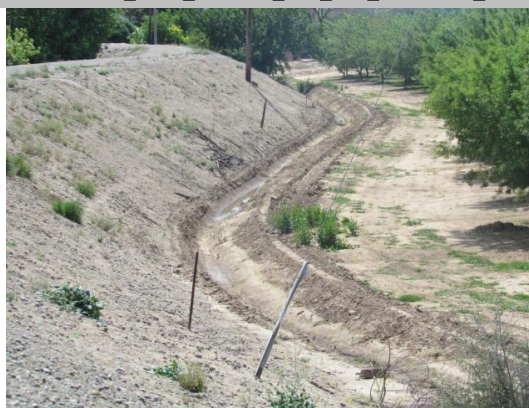
Photo 1 of 2 : FA\_2017\_RD0524\_107\_194\_20170919\_00233.jpg

LM Start	3.69	Rating **	U	Issue No.	194
LM End	3.78	Issue Type +	En	Location *	LS
Category	Earthen Levee			GPS Latitude/Longitude	
				Start	End
Item	Encroachments			37.903553 °	37.902505 °
				-121.325468 °	-121.326425 °
DWR ID	DWR_RD0524_01_s_2015_194				
Comment Code					
DT : Ditch					
Inspector Comment					
Shallow Irrigation ditch at landside toe.

Looking south at irrigation ditch at landward toe.

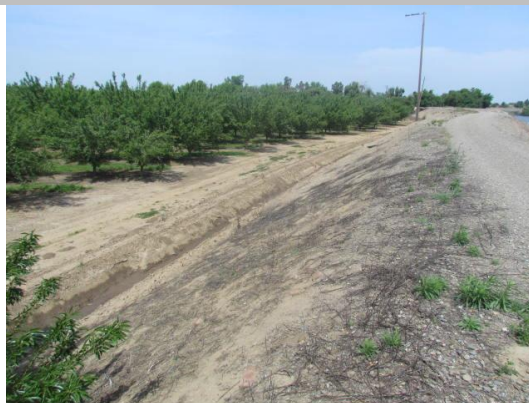
Photo 2 of 2 : FA\_2017\_RD0524\_107\_194\_20170919\_00234.jpg

Looking east at south end of irrigation ditch at landward toe.

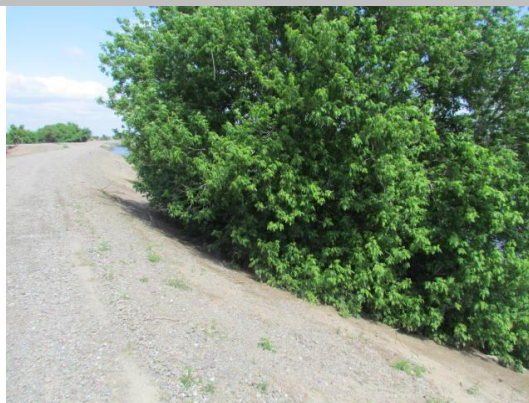
Photo 1 of 1 : FA\_2017\_RD0524\_107\_52\_20170919\_00092.jpg

LM Start	3.75	Rating **	U	Issue No.	52
LM End	3.75	Issue Type +	Ma	Location *	WS
Category	Earthen Levee			GPS Latitude/Longitude	
				Start	End
Item	Trim / Thin Trees			37.902828 °	37.902828 °
				-121.326170 °	-121.326170 °
DWR ID	DWR_RD0524_01_s_2016_52				
Comment Code					
T1 : Trim trees to at least five feet above ground level.					
Inspector Comment

Looking south at untrimmed tree on landward slope and toe.

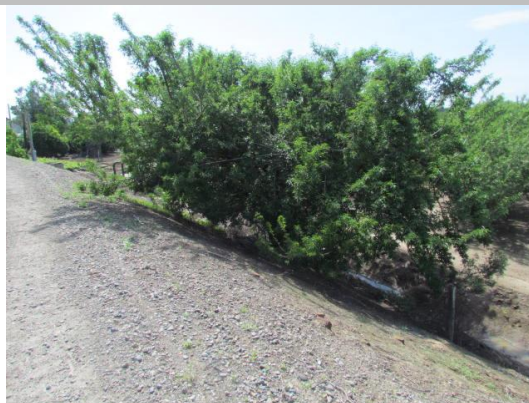
Photo 1 of 1 : FA\_2017\_RD0524\_107\_927\_20170919\_00292.jpg

LM Start	3.77	Rating **	U	Issue No.	927
LM End	3.77	Issue Type +	Ma	Location *	LS
Category	Earthen Levee			GPS Latitude/Longitude	
				Start	End
Item	Trim / Thin Trees			37.902645 °	37.902645 °
				-121.326340 °	-121.326340 °
DWR ID	DWR_RD0524_01_s_2012_927				
Comment Code					
T1 : Trim trees to at least five feet above ground level.					
Inspector Comment					
Untrimmed almond tree on landside slope.

Looking southwest at untrimmed tree at landward toe.

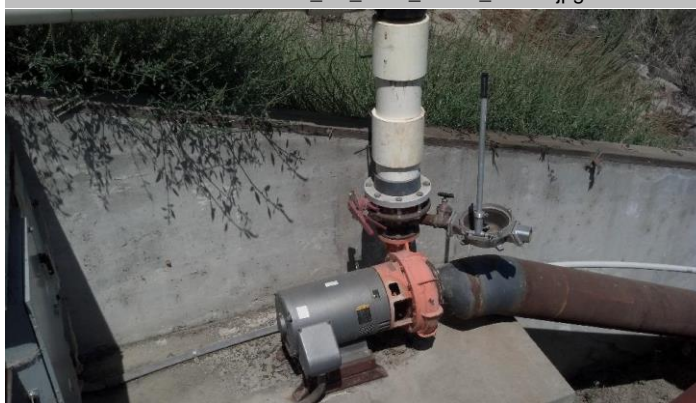
Photo 1 of 3 : UCIP\_FA\_2017\_22725\_38445.jpg

LM Start	3.79	Rating **	M	Issue No.	953
LM End	3.79	Issue Type +	En	Location *	
Category	Supplemental			GPS Latitude/Longitude	
				Start	End
Item	DWR UCIP Field Study			37.902371 °	37.902371 °
				-121.326440 °	-121.326440 °
DWR ID					
Comment Code					
Inspector Comment					
FS_ID:22725					
DS_ID:24044					
EP_NO: N/A					
Repair Type: Non-Urgent					
Crossing Status: Found					
UCIP Comments: No permit identified for this crossing.					
FIELD_STRUCT_DESC: 8-inch steel irrigation pipe through the levee, 0 feet below the crown. Pipe integrated into steel cattle guard style crossing. Slant pump and butterfly valve at concrete foundation on the waterside (WS) slope. Filter plant, vents, and butterfly valves on the landside (LS) toe.					
FS Date: 8/20/2013

Pump and butterfly valve on concrete pad on WS shoulder.

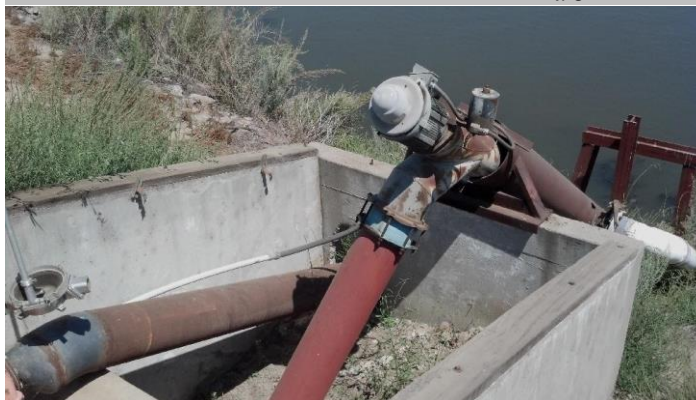
Photo 2 of 3 : UCIP\_FA\_2017\_18307\_30527.jpg

FS\_ID:18307  
DS\_ID:20620  
EP\_NO: N/A  
Repair Type: Non-Urgent  
Crossing Status: Found  
UCIP Comments: Appears abandoned and if so should be done so properly. Evidence of severe internal corrosion in concrete distribution box at LS toe.  
FIELD\_STRUCT\_DESC: 12-inch concrete encased steel irrigation pipe through the levee, 10.5 feet below the crown. Pump and gate valve in pump house on the waterside (WS) slope. 6-foot by 6-foot Concrete distribution box on the landside (LS) toe. Two concrete cutoff walls. Service pole at the LS toe. [Additional Reference(s): DWR Levee Log, 2004. USACE San Joaquin O&M Manual 7, April 1964, (HLM 3.83)].  
FS Date: 8/20/2013

Slant pump and pipe on WS slope.

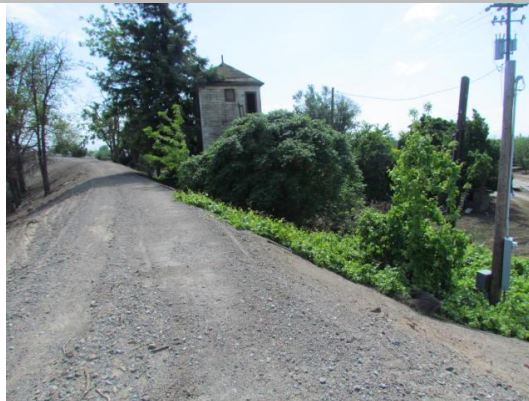
Photo 1 of 1 : FA\_2017\_RD0524\_107\_59\_20170919\_00100.jpg

LM Start	3.79	Rating **	U	Issue No.	59
LM End	3.80	Issue Type +	Ma	Location *	LS
Category	Earthen Levee			GPS Latitude/Longitude	
				Start	End
Item	Trim / Thin Trees			37.902287 °	37.902163 °
				-121.326462 °	-121.326476 °
DWR ID	DWR_RD0524_01_s_2012_59				
Comment Code					
T1 : Trim trees to at least five feet above ground level.					
Inspector Comment

Looking south at dense veg on landward slope and toe.

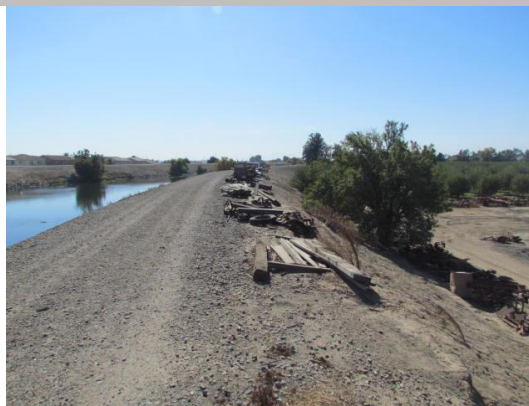
Photo 1 of 3 : FA\_2017\_RD0524\_107\_95\_20170919\_00147.jpg

LM Start	3.87	Rating **	U	Issue No.	95
LM End	3.97	Issue Type +	En	Location *	LS
Category	Earthen Levee			GPS Latitude/Longitude	
				Start	End
Item	Encroachments			37.901147 °	37.899764 °
				-121.326453 °	-121.326589 °
DWR ID	DWR_RD0524_01_f_2013_95				
Comment Code					
EQ : Equipment					
Inspector Comment					
Landowner is storing equipment on landside shoulder and landside toe.

Looking south at farm equipment stored on landward shoulder and toe.

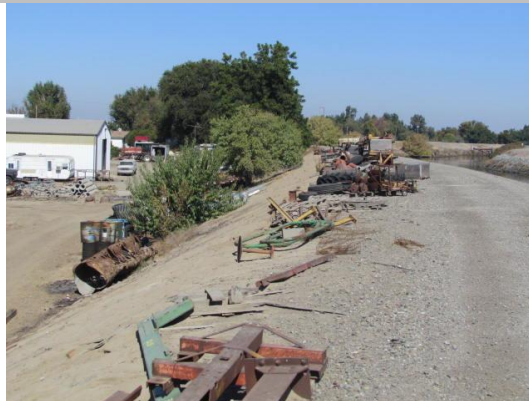
Photo 2 of 3 : FA\_2017\_RD0524\_107\_95\_20170919\_00148.jpg

Looking north at farm equipment stored on landward shoulder.

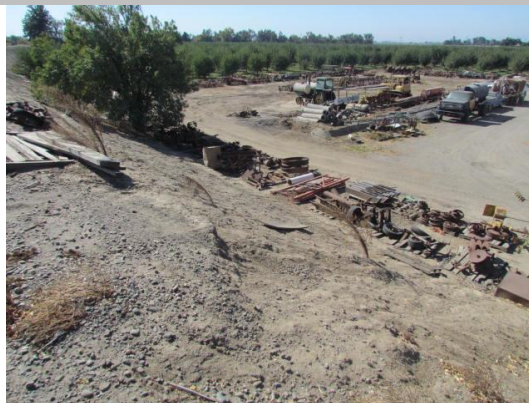
Photo 3 of 3 : FA\_2017\_RD0524\_107\_95\_20170919\_00149.jpg

LM Start	3.87	Rating **	U	Issue No.	95 (cont)	
LM End	3.97	Issue Type +	En	Location *	LS	
Category	Earthen Levee			GPS Latitude/Longitude		
				Start		End
Item	Encroachments			37.901147 °		37.899764 °
				-121.326453 °		-121.326589 °
DWR ID	DWR_RD0524_01_f_2013_95					
Comment Code						
EQ : Equipment						
Inspector Comment						
Landowner is storing equipment on landside shoulder and landside toe.

Looking west at farm equipment stored at landward toe.

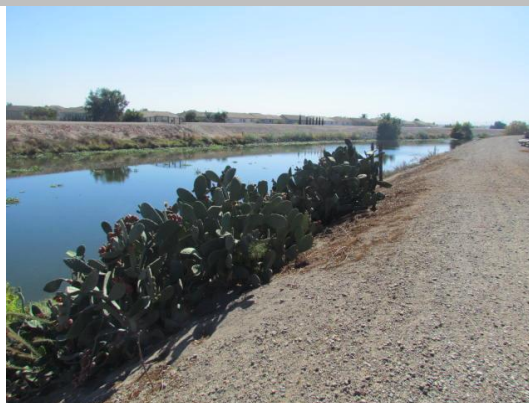
Photo 1 of 2 : FA\_2017\_RD0524\_107\_94\_20170919\_00145.jpg

LM Start	3.89	Rating **	U	Issue No.	94
LM End	3.89	Issue Type +	Ma	Location *	WS
Category	Earthen Levee			GPS Latitude/Longitude	
				Start	End
Item	Vegetation			37.900940 °	37.900940 °
				-121.326414 °	-121.326414 °
DWR ID	DWR_RD0524_01_s_2012_94				
Comment Code					
V2 : Remove the wild growth other than native grasses from the levee slopes.					
Inspector Comment					
Remove cactus from waterside slope.

Looking southeast at cactus on waterward slope fall 2015

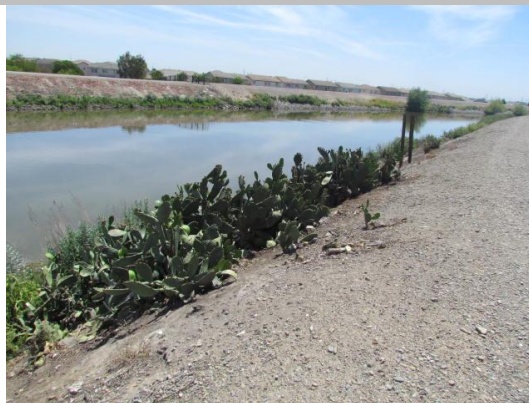
Photo 2 of 2 : FA\_2017\_RD0524\_107\_94\_20170919\_00146.jpg

Looking southeast at cactus on waterside slope. Fall 2013

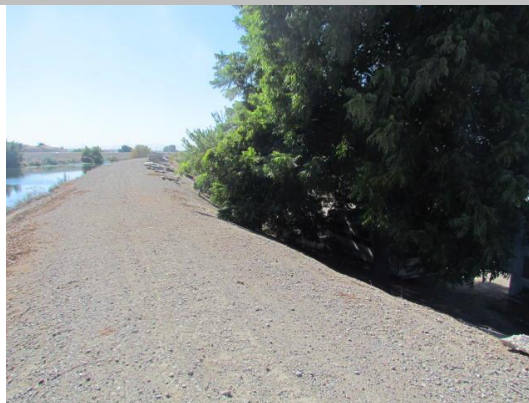
Photo 1 of 1 : FA\_2017\_RD0524\_107\_83\_20170919\_00133.jpg

LM Start	3.89	Rating **	U	Issue No.	83
LM End	3.90	Issue Type +	Ma	Location *	LS
Category	Earthen Levee			GPS Latitude/Longitude	
				Start	End
Item	Trim / Thin Trees			37.900915 °	37.900760 °
				-121.326414 °	-121.326414 °
DWR ID	DWR_RD0524_01_f_2017_83				
Comment Code					
T1 : Trim trees to at least five feet above ground level.					
Inspector Comment					
Untrimmed tree on landside slope.

Looking south at untrimmed trees on landward slope and toe.

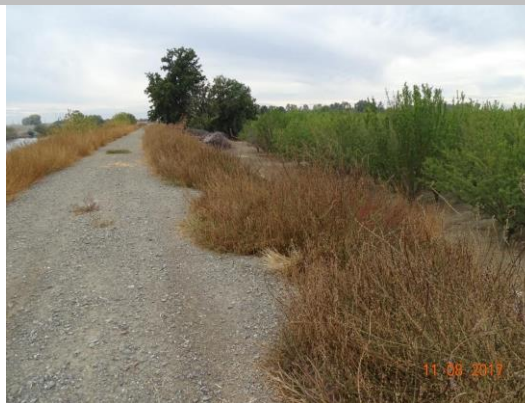
Photo 1 of 1 : FA\_2017\_RD0524\_107\_253\_20171116\_00482.jpg

LM Start	3.97	Rating **	U	Issue No.	253
LM End	4.02	Issue Type +	Ma	Location *	LS
Category	Earthen Levee			GPS Latitude/Longitude	
				Start	End
Item	Vegetation			37.899748 °	37.899116 °
				-121.326596 °	-121.326905 °
DWR ID	DWR_RD0524_01_f_2017_253				
Comment Code					
V2 : Remove the wild growth other than native grasses from the levee slopes.					
Inspector Comment

Looking southwest at the landside slope.
