**Flood Control Project Maintenance  
Levee Inspections**

**Fall 2017 Levee Maintenance Deficiency Summary Report**

***San Joaquin River Basin***

**Reclamation District No. 0524 Middle Roberts Island**

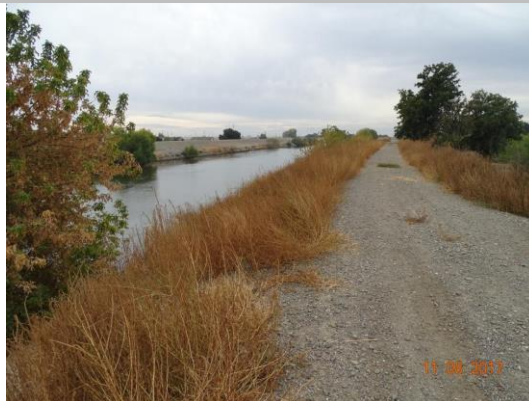
Photo 1 of 1 : FA\_2017\_RD0524\_107\_254\_20171116\_00483.jpg

LM Start	3.97	Rating **	U	Issue No.	254
LM End	4.03	Issue Type +	Ma	Location *	WS
Category	Earthen Levee			GPS Latitude/Longitude	
				Start	End
Item	Vegetation			37.899718 °	37.898945 °
				-121.326605 °	-121.327003 °
DWR ID	DWR_RD0524_01_f_2017_254				
Comment Code					
V2 : Remove the wild growth other than native grasses from the levee slopes.					
Inspector Comment

Looking southwest at the waterside slope.

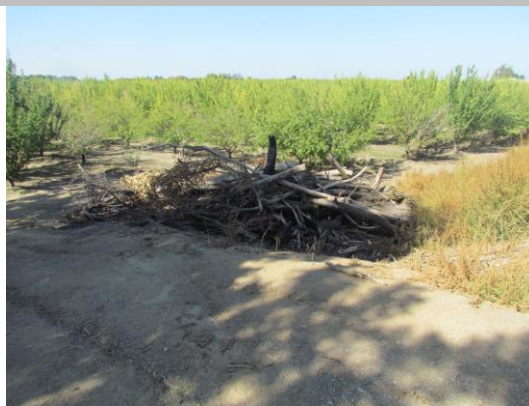
Photo 1 of 2 : FA\_2017\_RD0524\_107\_195\_20170919\_00235.jpg

LM Start	4.02	Rating **	U	Issue No.	195
LM End	4.02	Issue Type +	En	Location *	LS
Category	Earthen Levee			GPS Latitude/Longitude	
				Start	End
Item	Encroachments			37.899093 °	37.899093 °
				-121.326933 °	-121.326933 °
DWR ID	DWR_RD0524_01_s_2015_195				
Comment Code					
PR : Prunings					
Inspector Comment					
Pruning pile blocking view of landside slope.

Looking southwest at large pruning pile at landward toe. (Fall 2016)

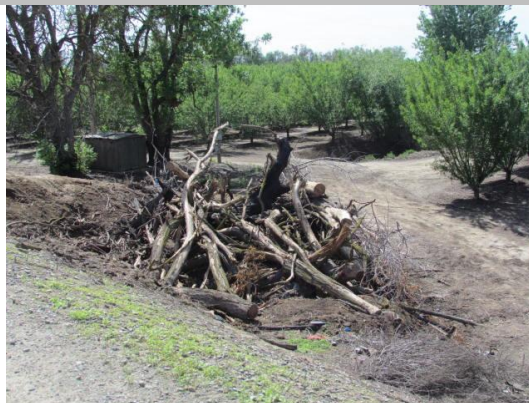
Photo 2 of 2 : FA\_2017\_RD0524\_107\_195\_20170919\_00236.jpg

Looking at pruning pile at landward toe. (Spring 2016)

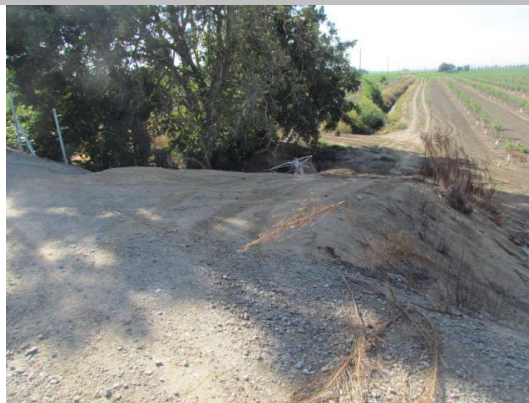
Photo 1 of 1 : FA\_2017\_RD0524\_107\_101\_20170919\_00154.jpg

LM Start	4.02	Rating **	U	Issue No.	101
LM End	4.02	Issue Type +	En	Location *	LS
Category	Earthen Levee			GPS Latitude/Longitude	
				Start	End
Item	Encroachments			37.899027 °	37.899027 °
				-121.326982 °	-121.326982 °
DWR ID	DWR_RD0524_01_s_2012_101				
Comment Code					
RA : Ramp					
Inspector Comment					
Unauthorized ramp. Ramp does not meet Title 23 standard.

Looking west at unauthorized ramp on landside slope.

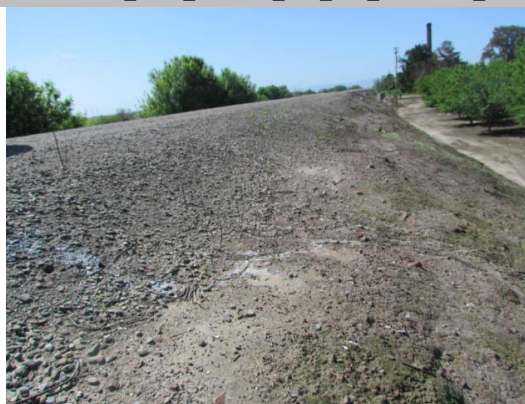
Photo 1 of 3 : FA\_2017\_RD0524\_107\_108\_20170919\_00159.jpg

LM Start	4.10	Rating **	U	Issue No.	108
LM End	4.15	Issue Type +	Ma	Location *	LS
Category	Earthen Levee			GPS Latitude/Longitude	
				Start	End
Item	Slope Stability			37.898035 °	°
				-121.327447 °	-121.327806 °
DWR ID	DWR_RD0524_01_s_2012_108				
Comment Code					
S1 : Repair slope instability.					
Inspector Comment					
Slope depression is greater than 1" and longer than 200'.

Looking north at caving slope on landside of levee.

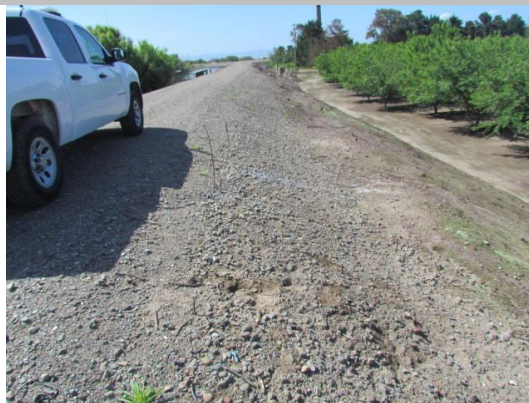
Photo 2 of 3 : FA\_2017\_RD0524\_107\_108\_20170919\_00160.jpg

LM Start	4.10	Rating **	U	Issue No.	108 (cont)	
LM End	4.15	Issue Type +	Ma	Location *	LS	
Category	Earthen Levee			GPS Latitude/Longitude		
				Start		End
Item	Slope Stability			37.898035 °	°	
				-121.327447 °	-121.327806 °	
DWR ID	DWR_RD0524_01_s_2012_108					
Comment Code						
S1 : Repair slope instability.						
Inspector Comment						
Slope depression is greater than 1" and longer than 200'.

Looking south at damage slope on landside of levee.

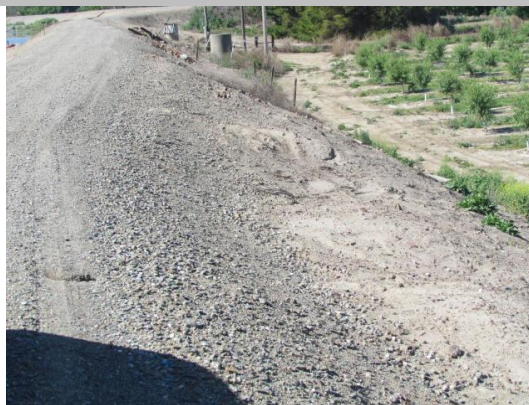
Photo 3 of 3 : FA\_2017\_RD0524\_107\_108\_20170919\_00161.jpg

Looking southwest at caving slope on landside of levee. (Spring 2014)

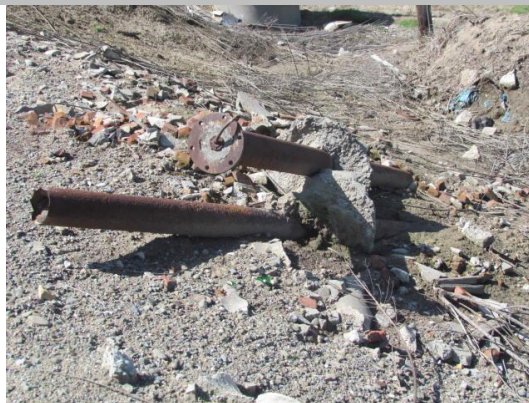
Photo 1 of 1 : FA\_2017\_RD0524\_107\_213\_20170919\_00256.jpg

LM Start	4.16	Rating **	M	Issue No.	213	
LM End	4.16	Issue Type +	Ma	Location *	LS	
Category	Earthen Levee			GPS Latitude/Longitude		
				Start		End
Item	Encroachments			37.897235 °		37.897235 °
				-121.327865 °		-121.327865 °
DWR ID	DWR_RD0524_01_s_2016_213					
Comment Code						
GA : Garbage						
Inspector Comment						
Old fence post and concrete and brick rubble on landside slope.

Looking west at old fence post and concrete rubble on landward slope.

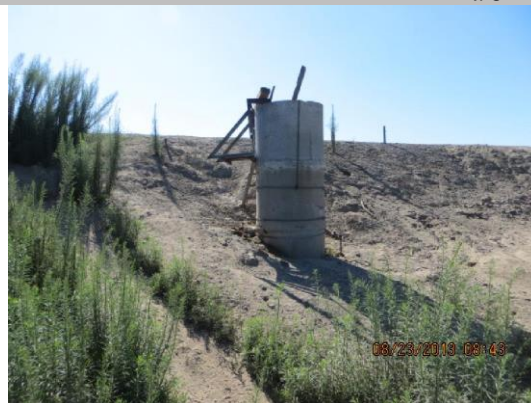
Photo 1 of 3 : UCIP\_FA\_2017\_18318\_30589.jpg

LM Start	4.16	Rating **	M	Issue No.	957	
LM End	4.16	Issue Type +	En	Location *		
Category	Supplemental			GPS Latitude/Longitude		
				Start	End	
Item	DWR UCIP Field Study			37.897118 °	37.897118 °	
				-121.327910 °	-121.327910 °	
DWR ID						
Comment Code						
Inspector Comment						
FS_ID:18318						
DS_ID:20625						
EP_NO: N/A						
Repair Type: Non-Urgent						
Crossing Status: Found						
UCIP Comments: Small leak on WS slope causing minor erosion on WS slope.						
FIELD_STRUCT_DESC: 12-inch steel irrigation pipe through the levee, 4.5 feet below the crown. Pump house and gate valve on the waterside (WS) slope. 36-inch concrete standpipe, power pole, and meter on the landside (LS) toe. [Additional Reference(s): DWR Levee Log, 2004. USACE San Joaquin O&M Manual 7, April 1964, (HLM 4.21)].						
FS Date: 8/23/2013

Concrete standpipe on LS slope.

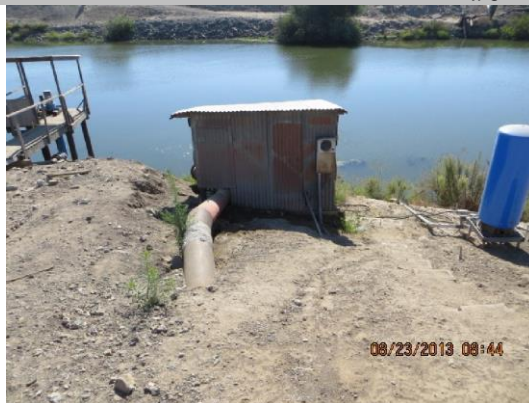
Photo 3 of 3 : UCIP\_FA\_2017\_18318\_30587.jpg

LM Start	4.16	Rating **	M	Issue No.	957 (cont)	
LM End	4.16	Issue Type +	En	Location *		
Category	Supplemental			GPS Latitude/Longitude		
				Start		End
Item	DWR UCIP Field Study			37.897118 °		37.897118 °
				-121.327910 °		-121.327910 °
DWR ID						
Comment Code						
Inspector Comment						
FS_ID:18318 DS_ID:20625 EP_NO: N/A Repair Type: Non-Urgent Crossing Status: Found UCIP Comments: Small leak on WS slope causing minor erosion on WS slope. FIELD_STRUCT_DESC: 12-inch steel irrigation pipe through the levee, 4.5 feet below the crown. Pump house and gate valve on the waterside (WS) slope. 36-inch concrete standpipe, power pole, and meter on the landside (LS) toe. [Additional Reference(s): DWR Levee Log, 2004. USACE San Joaquin O&M Manual 7, April 1964, (HLM 4.21)]. FS Date: 8/23/2013

Pumphouse and pipe on WS slope.

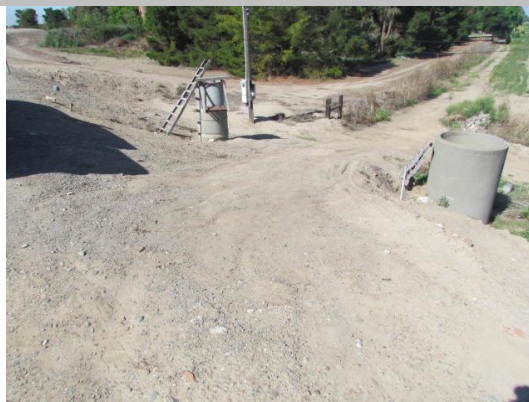
Photo 1 of 1 : FA\_2017\_RD0524\_107\_110\_20170919\_00162.jpg

LM Start	4.16	Rating **	M	Issue No.	110
LM End	4.16	Issue Type +	En	Location *	LS
Category	Earthen Levee			GPS Latitude/Longitude	
				Start	End
Item	Encroachments			37.897103 °	37.897103 °
				-121.327895 °	-121.327895 °
DWR ID	DWR_RD0524_01_s_2012_110				
Comment Code					
RA : Ramp					
Inspector Comment					
Two unauthorized ramps on landside slope.

Looking southwest at an unauthorized ramp on landside slope.

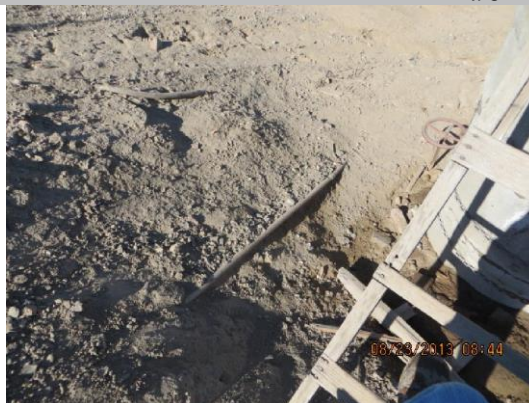
Photo 1 of 2 : UCIP\_FA\_2017\_22069\_37660.jpg

LM Start	4.17	Rating **	M	Issue No.	958
LM End	4.17	Issue Type +	En	Location *	
Category	Supplemental			GPS Latitude/Longitude	
				Start	End
Item	DWR UCIP Field Study			37.897074 °	37.897074 °
				-121.327926 °	-121.327926 °
DWR ID					
Comment Code					
Inspector Comment					
FS_ID:22069 DS_ID:24049 EP_NO: N/A Repair Type: Non-Urgent Crossing Status: Found UCIP Comments: No permit identified for this crossing. FIELD_STRUCT_DESC: 2.25-inch polyvinyl chloride domestic water service line through the levee, 5 feet below the crown. Pump and tank on the waterside (WS) slope with a vent on the landside (LS) slope. FS Date: 8/23/2013

Pipe visible on LS slope.

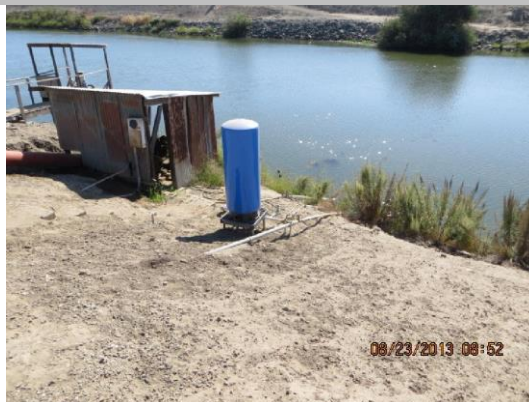
Photo 2 of 2 : UCIP\_FA\_2017\_22069\_37659.jpg

Pipe, pump, and tank visible on WS slope.

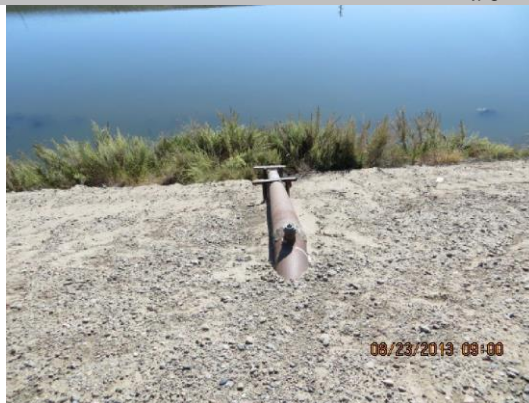
Photo 1 of 3 : UCIP\_FA\_2017\_18320\_30594.jpg

LM Start	4.37	Rating **	M	Issue No.	959
LM End	4.37	Issue Type +	Ma	Location *	
Category	Supplemental			GPS Latitude/Longitude	
				Start	End
Item	DWR UCIP LMA Responsibility			37.894453 °	37.894453 °
				-121.329232 °	-121.329232 °
DWR ID					
Comment Code					
Inspector Comment					
FS_ID:18320 DS_ID:20626 EP_NO: N/A Repair Type: Non-Urgent Crossing Status: Found UCIP Comments: Small leak in pipe on LS slope and pipe slightly crushed on LS toe. FIELD_STRUCT_DESC: 9-inch steel pipe of unknown purpose through the levee, 3 feet below the crown. Pump in drainage ditch on the landside (LS). Siphon breaker on the waterside (WS) slope. [Additional Reference(s): DWR Levee Log, 2004. USACE San Joaquin O&M Manual 7, April 1964, (HLM 4.42) 8-inch pipe listed]. FS Date: 8/23/2013

Pipe and siphon breaker on WS slope.

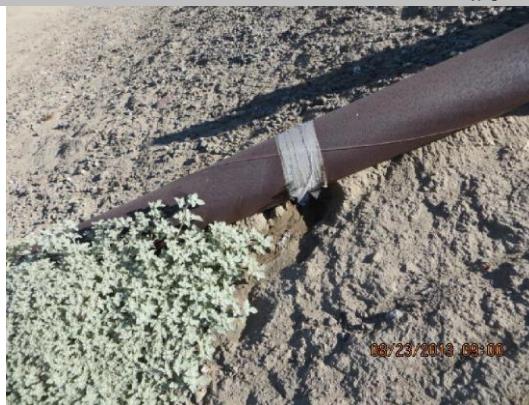
Photo 2 of 3 : UCIP\_FA\_2017\_18320\_30593.jpg

Small leak in pipe on LS slope.

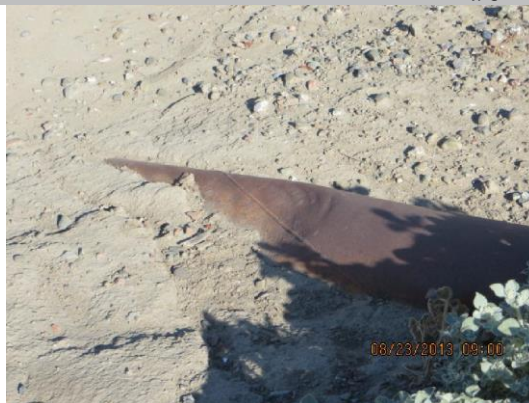
Photo 3 of 3 : UCIP\_FA\_2017\_18320\_30592.jpg

LM Start	4.37	Rating **	M	Issue No.	959 (cont)	
LM End	4.37	Issue Type +	Ma	Location *		
Category	Supplemental			GPS Latitude/Longitude		
				Start	End	
Item	DWR UCIP LMA Responsibility			37.894453 °	37.894453 °	
				-121.329232 °	-121.329232 °	
DWR ID						
Comment Code						
Inspector Comment						
FS_ID:18320 DS_ID:20626 EP_NO: N/A Repair Type: Non-Urgent Crossing Status: Found UCIP Comments: Small leak in pipe on LS slope and pipe slightly crushed on LS toe. FIELD_STRUCT_DESC: 9-inch steel pipe of unknown purpose through the levee, 3 feet below the crown. Pump in drainage ditch on the landside (LS). Siphon breaker on the waterside (WS) slope. [Additional Reference(s): DWR Levee Log, 2004. USACE San Joaquin O&M Manual 7, April 1964, (HLM 4.42) 8-inch pipe listed]. FS Date: 8/23/2013

Pipe partially crushed at LS toe.

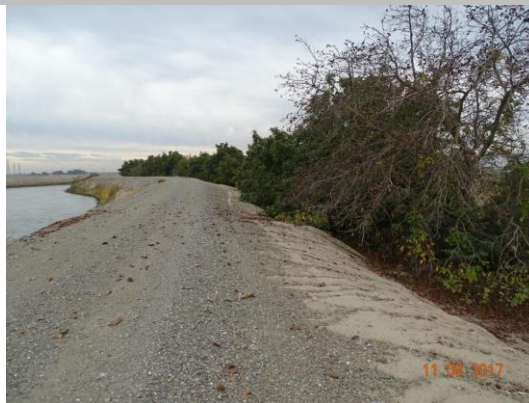
Photo 1 of 3 : FA\_2017\_RD0524\_107\_112\_20171116\_00484.jpg

LM Start	4.40	Rating **	U	Issue No.	112
LM End	4.52	Issue Type +	Ma	Location *	LS
Category	Earthen Levee			GPS Latitude/Longitude	
				Start	End
Item	Trim / Thin Trees			37.893933 °	37.892347 °
				-121.329181 °	-121.328192 °
DWR ID	DWR_RD0524_01_s_2012_112				
Comment Code					
T1 : Trim trees to at least five feet above ground level.					
Inspector Comment					
Untrimmed trees along landside slope and toe.

Looking southeast at the landside slope.

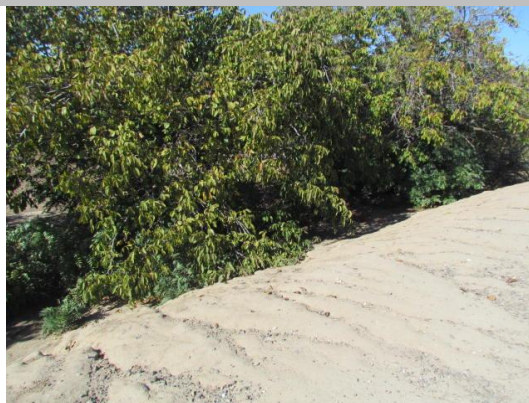
Photo 3 of 3 : FA\_2017\_RD0524\_107\_112\_20170919\_00165.jpg

Looking northeast at untrimmed tree on landward slope and toe fall 2015.

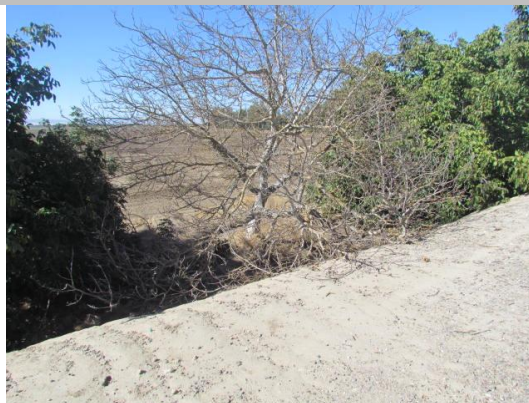
Photo 1 of 1 : FA\_2017\_RD0524\_107\_199\_20170919\_00239.jpg

LM Start	4.42	Rating **	U	Issue No.	199
LM End	4.42	Issue Type +	Ma	Location *	LS
Category	Earthen Levee			GPS Latitude/Longitude	
				Start	End
Item	Encroachments			37.893659 °	37.893659 °
				-121.329092 °	-121.329092 °
DWR ID	DWR_RD0524_01_f_2015_199				
Comment Code					
TR : Tree or limb					
Inspector Comment					
Remove dead tree from landside toe.

Looking west at dead tree on landward slope and toe fall 2015.

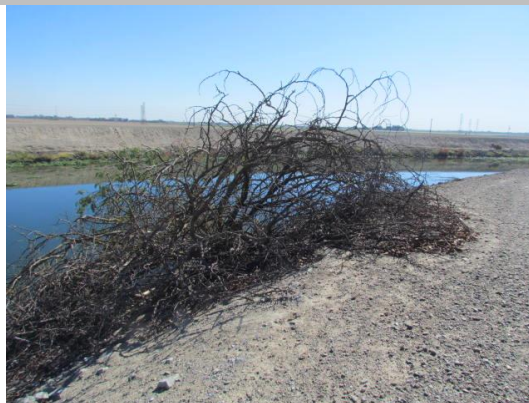
Photo 1 of 2 : FA\_2017\_RD0524\_107\_102\_20170919\_00155.jpg

LM Start	4.52	Rating **	U	Issue No.	102
LM End	4.52	Issue Type +	Ma	Location *	WS
Category	Earthen Levee			GPS Latitude/Longitude	
				Start	End
Item	Encroachments			37.892383 °	37.892383 °
				-121.328194 °	-121.328194 °
DWR ID	DWR_RD0524_01_f_2016_102				
Comment Code					
TR : Tree or limb					
Inspector Comment					
Dead tree on waterside slope.

Looking southeast at dead tree on waterside slope fall 2015

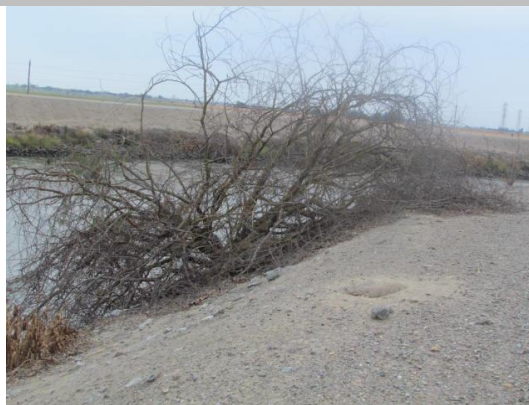
Photo 2 of 2 : FA\_2017\_RD0524\_107\_102\_20170919\_00156.jpg

Looking southeast at dead tree on waterside slope.

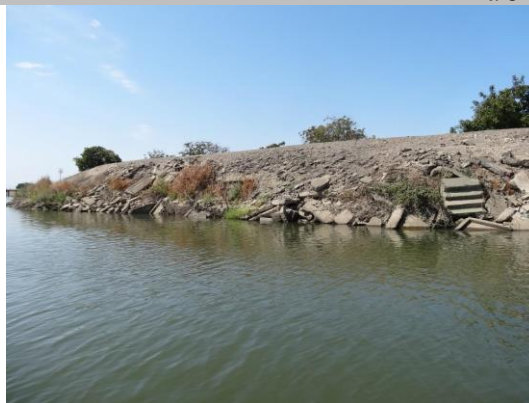
Photo 1 of 3 : SJR2017\_RD0524U01RM45.07\_1.jpg

LM Start	4.53	Rating **	A/W	Issue No.	90	
LM End	4.54	Issue Type +	Ma	Location *	WS	
Category	Supplemental			GPS Latitude/Longitude		
				Start	End	
Item	DWR Erosion Survey			37.892230 °	37.892230 °	
				-121.327930 °	-121.327930 °	
DWR ID	RD0524U01RM45.07					
Comment Code						
Inspector Comment						
09/13/2017: No significant change observed. 07/25/2016: No significant change observed. 06/24/2015: No significant change observed. 06/19/2014: No significant change observed. 08/13/2013: No significant change observed. 08/07/2012: The erosion is located at the inside of a river bend. Site is covered with broken concrete blocks and other debris. [2017 Site ID:RD0524U01RM45.07]

Front view of the erosion site.

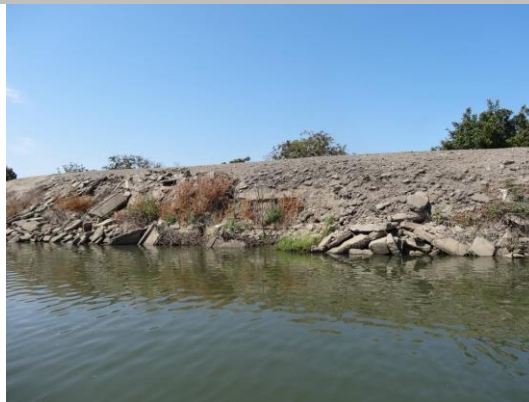
Photo 2 of 3 : SJR2017\_RD0524U01RM45.07\_2.jpg

Close view of the site.

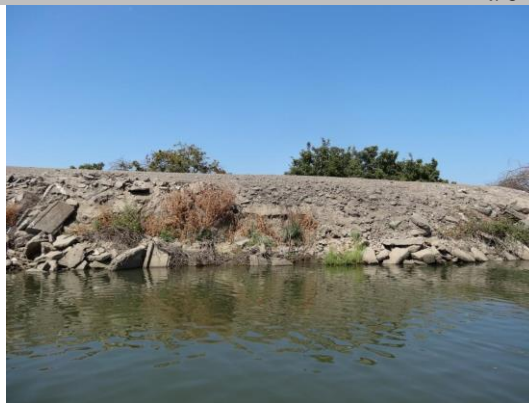
Photo 3 of 3 : SJR2017\_RD0524U01RM45.07\_3.jpg

LM Start	4.53	Rating **	A/W	Issue No.	90 (cont)	
LM End	4.54	Issue Type +	Ma	Location *	WS	
Category	Supplemental			GPS Latitude/Longitude		
				Start	End	
Item	DWR Erosion Survey			37.892230 °	37.892230 °	
				-121.327930 °	-121.327930 °	
DWR ID	RD0524U01RM45.07					
Comment Code						
Inspector Comment						
09/13/2017: No significant change observed. 07/25/2016: No significant change observed. 06/24/2015: No significant change observed. 06/19/2014: No significant change observed. 08/13/2013: No significant change observed. 08/07/2012: The erosion is located at the inside of a river bend. Site is covered with broken concrete blocks and other debris. [2017 Site ID:RD0524U01RM45.07]

Front view of the site. Note the loosely placed concrete blocks at the site.

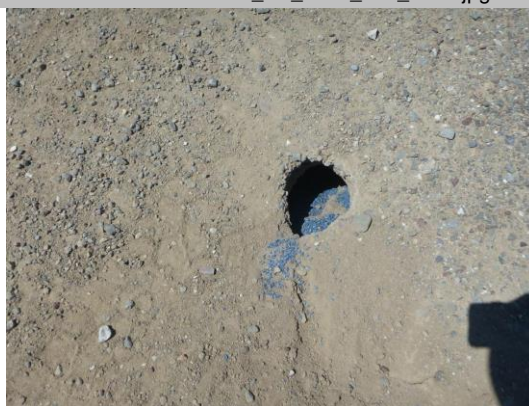
Photo 3 of 3 : LEVAL\_FA\_2017\_468\_2221.jpg

Item	2017 Storm Damage		37.892200 °	°								
			-121.328000 °	°								
DWR ID	DWR_RD0524_01_f_2017_235											
Comment Code												
Inspector Comment												
<p>Levee Evaluation Comments</p> <p>Description: Slope protection repairs are needed along the waterside slope due to erosion. Based upon levee inspections, it was determined the waterside levee slopes were eroding, deteriorating and degrading in concave pocket sections at various locations along this levee reach. The eroded levee sections need to be restored back to design standards to prevent further deterioration of the damaged levee sections.</p> <p>Site ID No: 468</p> <p>Site Designation: LMA-295</p> <p>Repair Type: Erosion</p> <p>Rating: Serious</p> <p>Field Date: 7/26/2017</p> <p>Notes: Serious because erosion is impacting the levee, but there is some slope protection here. Slope is armored with asphalt and concrete rubble. The surrounding slopes are pretty barren, but there is a small bush within the site so it may be older.</p>

Description: Slope protection repairs are needed along the waterside slope due to erosion. Based upon levee inspections, it was determined the waterside levee slopes were eroding, deteriorating and degrading in concave pocket sections at various locations along this levee reach. The eroded levee sections need to be restored back to design standards to prevent further deterioration of the damaged levee sections.

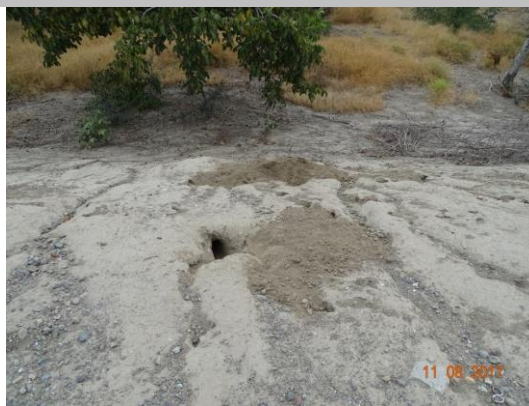
Photo 1 of 1 : FA\_2017\_RD0524\_107\_257\_20171116\_00486.jpg

LM Start	<b>4.56</b>	Rating **	M	Issue No.	<b>257</b>							
LM End	<b>4.56</b>	Issue Type +	Ma	Location *	LS							
Category	Earthen Levee		GPS Latitude/Longitude									
			Start	End								
Item	Animal Control		37.891903 °	37.891903 °								
			-121.328264 °	-121.328264 °								
DWR ID	DWR_RD0524_01_f_2017_257											
Comment Code												
<p>A3 : No rodents visible, but rodent burrows visible; need to backfill and compact or grout burrows.</p>												
Inspector Comment

Looking west at the landside slope.

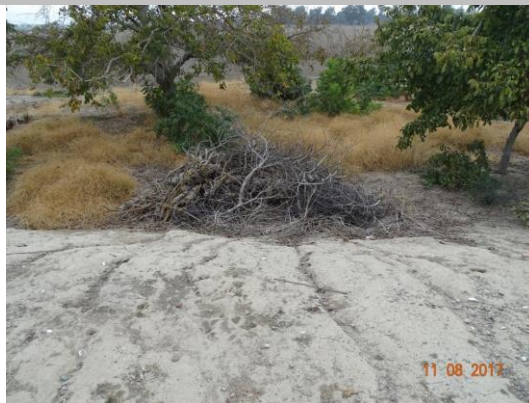
Photo 1 of 1 : FA\_2017\_RD0524\_107\_258\_20171116\_00485.jpg

LM Start	4.57	Rating **	M	Issue No.	258
LM End	4.57	Issue Type +	En	Location *	LS
Category	Earthen Levee			GPS Latitude/Longitude	
				Start	End
Item	Encroachments			37.891778 °	37.891778 °
				-121.328342 °	-121.328342 °
DWR ID	DWR_RD0524_01_f_2017_258				
Comment Code					
PR : Prunings					
Inspector Comment

Looking west at the landside slope.

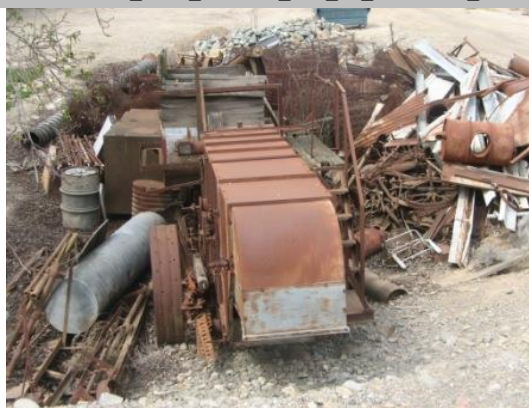
Photo 1 of 1 : FA\_2017\_RD0524\_107\_66\_20170919\_00106.jpg

LM Start	4.60	Rating **	M	Issue No.	66
LM End	4.60	Issue Type +	En	Location *	LS
Category	Earthen Levee			GPS Latitude/Longitude	
				Start	End
Item	Encroachments			37.891365 °	37.891365 °
				-121.328633 °	-121.328633 °
DWR ID	DWR_RD0524_01_s_2012_66				
Comment Code					
GA : Garbage					
Inspector Comment					
Old farm equipment at landside toe.

Garbage at landward toe next to ramp at LM 4.64

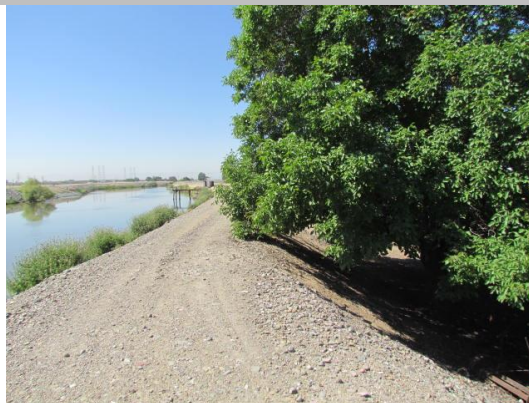
Photo 1 of 1 : FA\_2017\_RD0524\_107\_63\_20170919\_00105.jpg

LM Start	4.61	Rating **	U	Issue No.	63
LM End	4.61	Issue Type +	Ma	Location *	LS
Category	Earthen Levee			GPS Latitude/Longitude	
				Start	End
Item	Trim / Thin Trees			37.891285 °	37.891285 °
				-121.328728 °	-121.328728 °
DWR ID	DWR_RD0524_01_s_2012_63				
Comment Code					
T1 : Trim trees to at least five feet above ground level.					
Inspector Comment

Looking south at dense trees on landside slope.

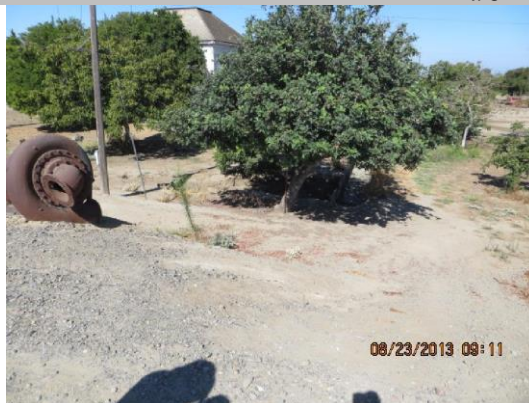
Photo 1 of 3 : UCIP\_FA\_2017\_18323\_30603.jpg

Comment Code					
Inspector Comment					
FS_ID:18323					
DS_ID:20646					
EP_NO: 0					
Repair Type: Non-Urgent					
Crossing Status: Found					
UCIP Comments: Good candidate for video inspection as brick and mortar deteriorating inside tunnel.					
FIELD_STRUCT_DESC: 22-inch concrete irrigation pipe through the levee, 12 feet below the crown. Pump on pier at the waterside (WS) toe. 16-inch pipe from pump discharges into a concrete riser unit inside the pump house on the WS shoulder. Brick and mortar channel on the landside (LS) toe. [Additional Reference(s): USACE San Joaquin O&M Manual 7, April 1964, (HLM 4.73) 14-inch pipe listed].					
FS Date: 8/23/2013

Brick and mortar channel on LS toe.

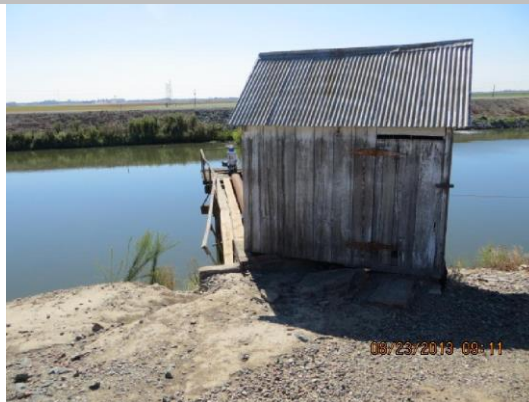
Photo 2 of 3 : UCIP\_FA\_2017\_18323\_30602.jpg

Pump on pier and slide gate house on WS shoulder.

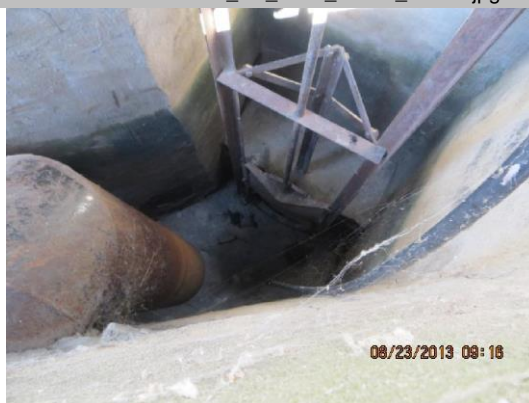
Photo 3 of 3 : UCIP\_FA\_2017\_18323\_30601.jpg

Comment Code						
Inspector Comment						
FS_ID:18323						
DS_ID:20646						
EP_NO: 0						
Repair Type: Non-Urgent						
Crossing Status: Found						
UCIP Comments: Good candidate for video inspection as brick and mortar deteriorating inside tunnel.						
FIELD_STRUCT_DESC: 22-inch concrete irrigation pipe through the levee, 12 feet below the crown. Pump on pier at the waterside (WS) toe. 16-inch pipe from pump discharges into a concrete riser unit inside the pump house on the WS shoulder. Brick and mortar channel on the landside (LS) toe. [Additional Reference(s): USACE San Joaquin O&M Manual 7, April 1964, (HLM 4.73) 14-inch pipe listed].						
FS Date: 8/23/2013

Slide gate inside concrete riser within shed on WS shoulder.

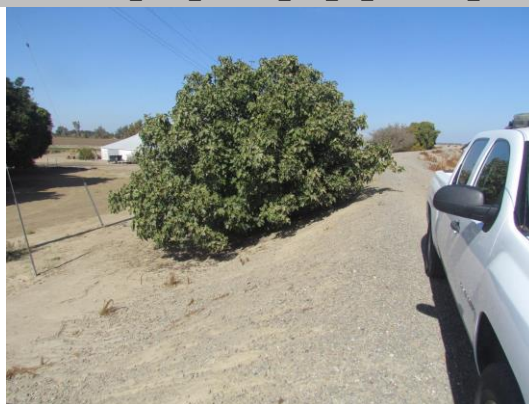
Photo 1 of 1 : FA\_2017\_RD0524\_107\_67\_20170919\_00107.jpg

LM Start	4.70	Rating **	U	Issue No.	67
LM End	4.70	Issue Type +	Ma	Location *	LS
Category	Earthen Levee			GPS Latitude/Longitude	
				Start	End
Item	Trim / Thin Trees			37.890108 °	37.890108 °
				-121.329523 °	-121.329523 °
DWR ID	DWR_RD0524_01_s_2012_67				
Comment Code					
T1 : Trim trees to at least five feet above ground level.					
Inspector Comment					
Fig tree at landside toe.

Looking northwest at untrimmed tree on landward slope.

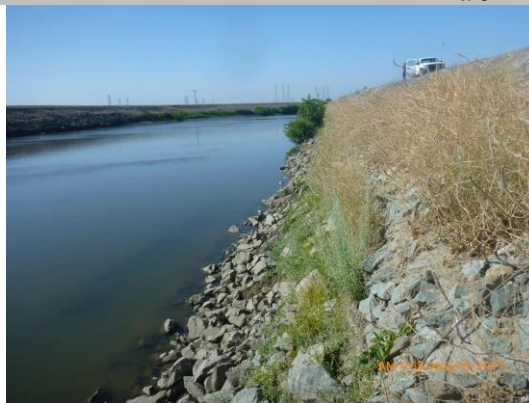
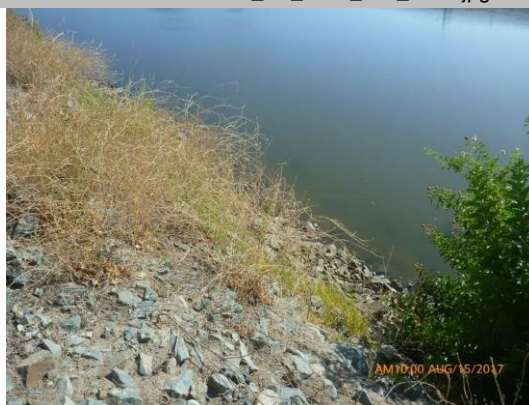
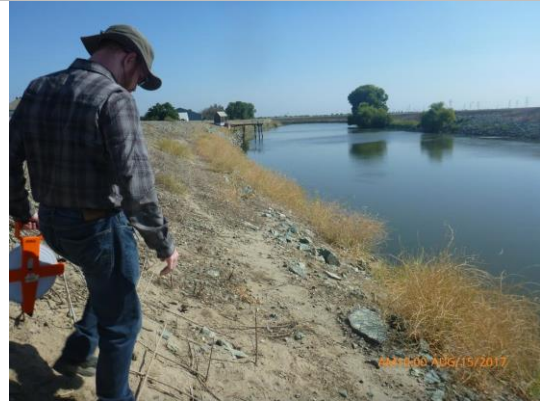
LM Start	4.76	Rating **	A/W	Issue No.	236
LM End	4.76	Issue Type +	Ma	Location *	
Category	Supplemental			GPS Latitude/Longitude	
				Start	End
Item	2017 Storm Damage			37.889300 °	37.889300 °
				-121.329800 °	-121.329800 °
DWR ID	DWR_RD0524_01_f_2017_236				
Comment Code					
Inspector Comment					
Levee Evaluation Comments					
Description:Slope protection repairs are needed along the waterside slope due to erosion and riprap displacement from high water. Based upon levee inspections, it was determined the waterside levee slope is eroding, deteriorating, and degrading. The eroded levee sections need to be restored back to design standards to prevent further deterioration and damage.					
Site ID No:523					
Site Designation:LMA-429					
Repair Type: Erosion					
Rating:Area of Concern					
Field Date:8/15/2017					
Notes:

LM Start	4.76	Rating **	A/W	Issue No.	236 (cont)	
LM End	4.76	Issue Type +	Ma	Location *		
Category	Supplemental			GPS Latitude/Longitude		
				Start	End	
Item	2017 Storm Damage			37.889300 °	37.889300 °	
				-121.329800 °	-121.329800 °	
DWR ID	DWR_RD0524_01_f_2017_236					
Comment Code						
Inspector Comment						
Levee Evaluation Comments						
Description:Slope protection repairs are needed along the waterside slope due to erosion and riprap displacement from high water. Based upon levee inspections, it was determined the waterside levee slope is eroding, deteriorating, and degrading. The eroded levee sections need to be restored back to design standards to prevent further deterioration and damage.						
Site ID No:523						
Site Designation:LMA-429						
Repair Type: Erosion						
Rating:Area of Concern						
Field Date:8/15/2017						
Notes:

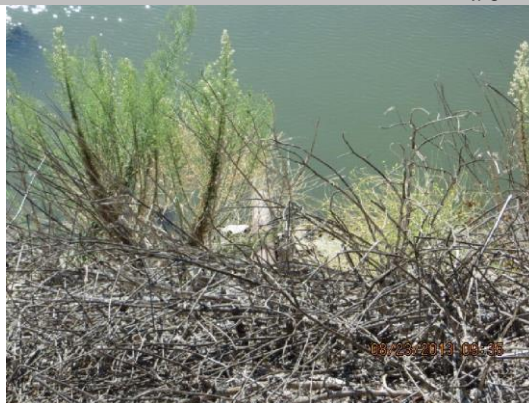
Photo 2 of 3 : UCIP\_FA\_2017\_22728\_38452.jpg

LM Start	4.89	Rating **	M	Issue No.	961 (cont)	
LM End	4.89	Issue Type +	En	Location *		
Category	Supplemental			GPS Latitude/Longitude		
				Start		End
Item	DWR UCIP Field Study			37.887694 °	37.887694 °	
				-121.331019 °	-121.331019 °	
DWR ID						
Comment Code						
Inspector Comment						
FS_ID:22728 DS_ID:20628 EP_NO: 3817 Repair Type: Non-Urgent Crossing Status: Found UCIP Comments: Appears abandoned and if so should be done so properly. FIELD_STRUCT_DESC: *ABANDONED* 6-inch steel drainage pipe through the levee, 3 feet below the crown. Pump 120 feet off the landside (LS) toe. Siphon breaker in 24-inch corrugated metal riser unit on the waterside (WS) shoulder. (Permit No. 3817, 1961 - Ohm and Saunders). [Additional Reference(s): DWR Levee Log, 2004. USACE San Joaquin O&M Manual 7, April 1964, (HLM 4.95)]. FS Date: 8/23/2013

Pipe visible on WS toe.

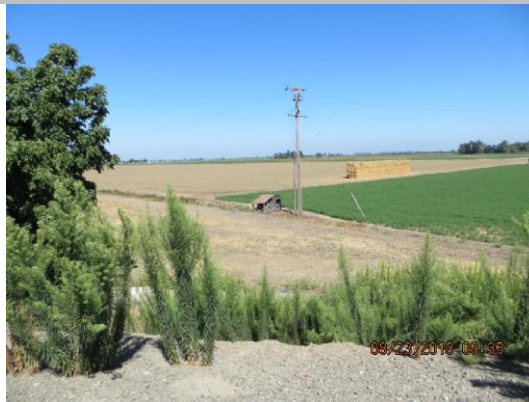
Photo 3 of 3 : UCIP\_FA\_2017\_22728\_38451.jpg

Pump in pumphouse 120-feet off LS toe.

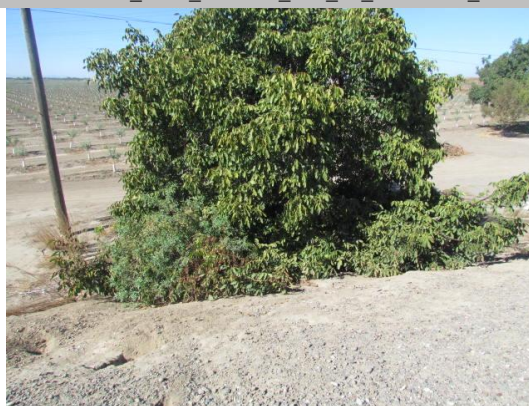
Photo 1 of 1 : FA\_2017\_RD0524\_107\_84\_20170919\_00134.jpg

LM Start	4.90	Rating **	U	Issue No.	84
LM End	4.93	Issue Type +	Ma	Location *	LS
Category	Earthen Levee			GPS Latitude/Longitude	
				Start	End
Item	Trim / Thin Trees			37.887613 °	37.887258 °
				-121.331161 °	-121.331596 °
DWR ID	DWR_RD0524_01_s_2012_84				
Comment Code					
T1 : Trim trees to at least five feet above ground level.					
Inspector Comment					
Untrimmed trees on landside slope.

Looking west at untrimmed tree on landward slope.

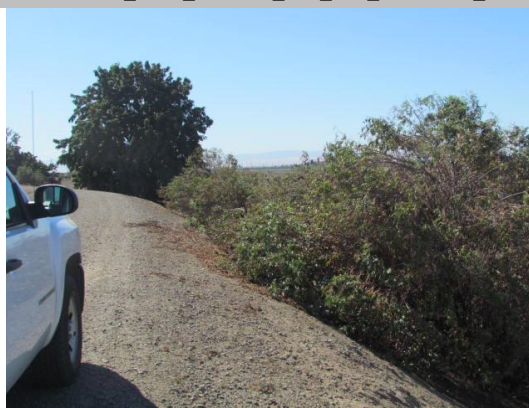
Photo 1 of 1 : FA\_2017\_RD0524\_107\_114\_20170919\_00167.jpg

LM Start	4.96	Rating **	U	Issue No.	114
LM End	4.98	Issue Type +	Ma	Location *	LS
Category	Earthen Levee			GPS Latitude/Longitude	
				Start	End
Item	Vegetation			37.886948 °	37.886672 °
				-121.331834 °	-121.331962 °
DWR ID	DWR_RD0524_01_s_2012_114				
Comment Code					
V4 : Elderberries are blocking visibility and flood fight capability.					
Inspector Comment					
Dense elderberry on landside slope.

Looking southwest at dense elderberry bush on landward slope and toe fall 2015.

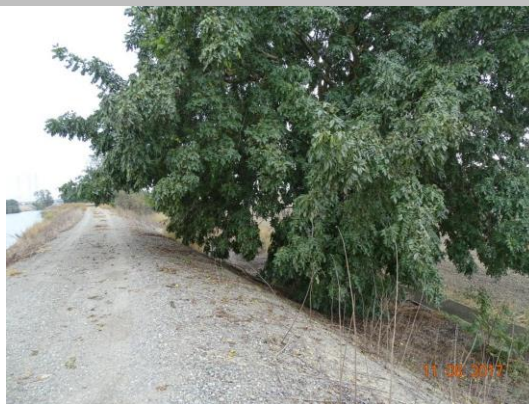
Photo 1 of 1 : FA\_2017\_RD0524\_107\_260\_20171116\_00487.jpg

LM Start	5.00	Rating **	M	Issue No.	260
LM End	5.00	Issue Type +	Ma	Location *	LS
Category	Earthen Levee			GPS Latitude/Longitude	
				Start	End
Item	Trim / Thin Trees			37.886367 °	37.886367 °
				-121.332047 °	-121.332047 °
DWR ID	DWR_RD0524_01_f_2017_260				
Comment Code					
T4 : Trim trees over roadway to at least 12 feet above ground level.					
Inspector Comment

Looking southwest at the landside slope.

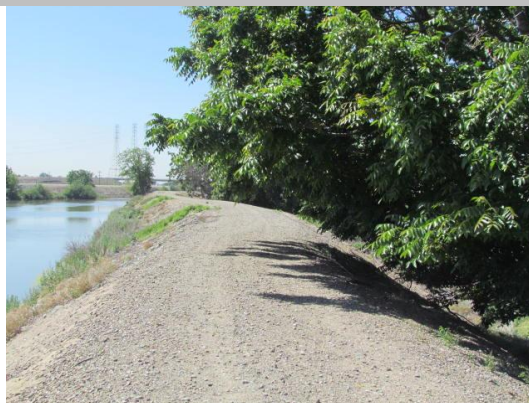
Photo 1 of 1 : FA\_2017\_RD0524\_107\_68\_20170919\_00108.jpg

LM Start	5.07	Rating **	U	Issue No.	68
LM End	5.07	Issue Type +	Ma	Location *	LS
Category	Earthen Levee			GPS Latitude/Longitude	
				Start	End
Item	Trim / Thin Trees			37.885400 °	37.885400 °
				-121.332153 °	-121.332153 °
DWR ID	DWR_RD0524_01_s_2012_68				
Comment Code					
T4 : Trim trees over roadway to at least 12 feet above ground level.					
Inspector Comment

Looking south at overhanging trees.

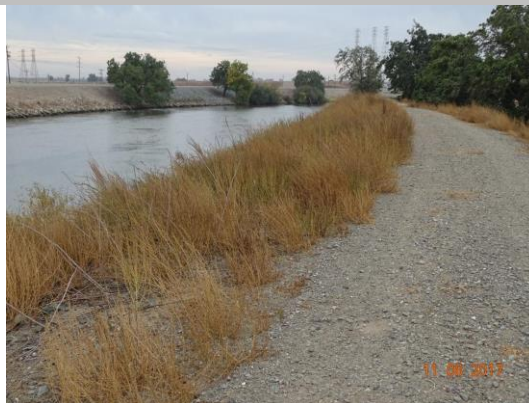
Photo 1 of 1 : FA\_2017\_RD0524\_107\_261\_20171116\_00488.jpg

LM Start	5.08	Rating **	U	Issue No.	261
LM End	5.13	Issue Type +	Ma	Location *	WS
Category	Earthen Levee			GPS Latitude/Longitude	
				Start	End
Item	Vegetation			37.885206 °	37.884465 °
				-121.332159 °	-121.332134 °
DWR ID	DWR_RD0524_01_f_2017_261				
Comment Code					
V2 : Remove the wild growth other than native grasses from the levee slopes.					
Inspector Comment

Looking south at the waterside slope.

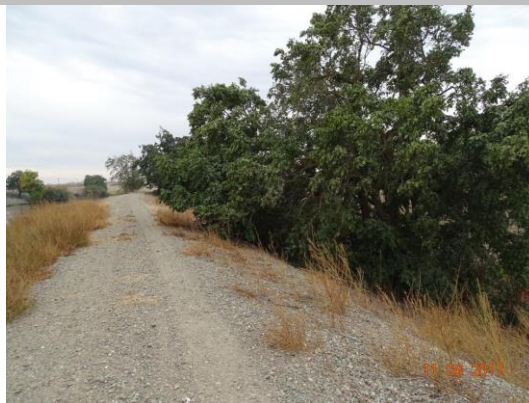
Photo 1 of 1 : FA\_2017\_RD0524\_107\_266\_20171116\_00489.jpg

LM Start	5.12	Rating **	U	Issue No.	266
LM End	5.16	Issue Type +	Ma	Location *	LS
Category	Earthen Levee			GPS Latitude/Longitude	
				Start	End
Item	Trim / Thin Trees			37.884608 °	37.884023 °
				-121.332153 °	-121.332100 °
DWR ID	DWR_RD0524_01_f_2017_266				
Comment Code					
T1 : Trim trees to at least five feet above ground level.					
Inspector Comment

Looking south at the landside slope.

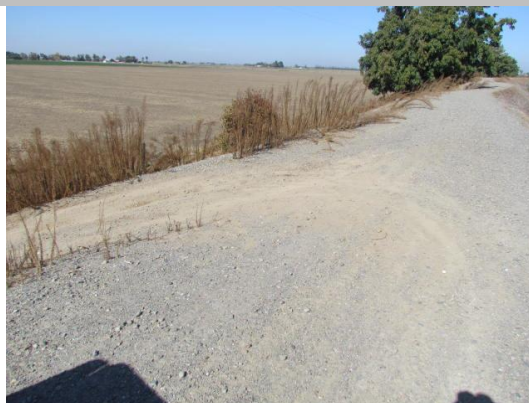
Photo 1 of 1 : FA\_2017\_RD0524\_107\_115\_20170919\_00168.jpg

LM Start	5.19	Rating **	M	Issue No.	115
LM End	5.19	Issue Type +	Ma	Location *	LS
Category	Earthen Levee			GPS Latitude/Longitude	
				Start	End
Item	Slope Stability			37.883587 °	37.883587 °
				-121.332100 °	-121.332100 °
DWR ID	DWR_RD0524_01_s_2012_115				
Comment Code					
S3 : Repair the levee slope damaged by vehicle traffic and prevent access where possible.					
Inspector Comment					
Vehicle traffic created a ramp on landside slope.

Looking northwest at slope damage on landward slope.

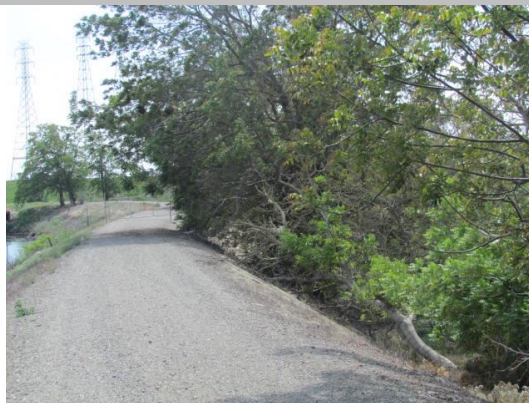
Photo 1 of 1 : FA\_2017\_RD0524\_107\_932\_20170919\_00293.jpg

LM Start	5.38	Rating **	U	Issue No.	932
LM End	5.41	Issue Type +	Ma	Location *	LS
Category	Earthen Levee			GPS Latitude/Longitude	
				Start	End
Item	Trim / Thin Trees			37.880945 °	37.880522 °
				-121.332837 °	-121.332918 °
DWR ID	DWR_RD0524_01_s_2012_932				
Comment Code					
T1 : Trim trees to at least five feet above ground level.					
Inspector Comment

Looking south at untrimmed trees on landward slope and toe.

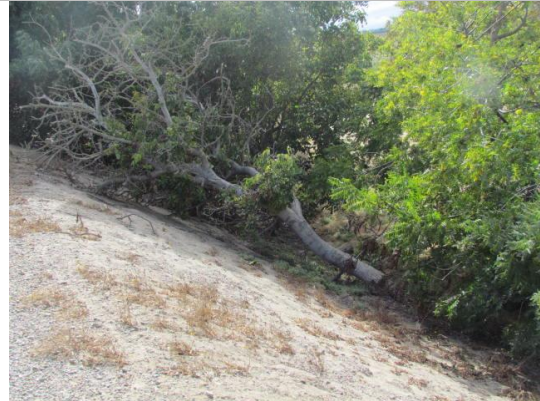
Photo 1 of 1 : FA\_2017\_RD0524\_107\_178\_20170919\_00216.jpg

LM Start	5.39	Rating **	M	Issue No.	178
LM End	5.39	Issue Type +	Ma	Location *	LS
Category	Earthen Levee			GPS Latitude/Longitude	
				Start	End
Item	Encroachments			37.880806 °	37.880806 °
				-121.332833 °	-121.332833 °
DWR ID	DWR_RD0524_01_f_2014_178				
Comment Code					
TR : Tree or limb					
Inspector Comment					
Downed tree on landside toe.

Looking south at downed tree on landward slope.

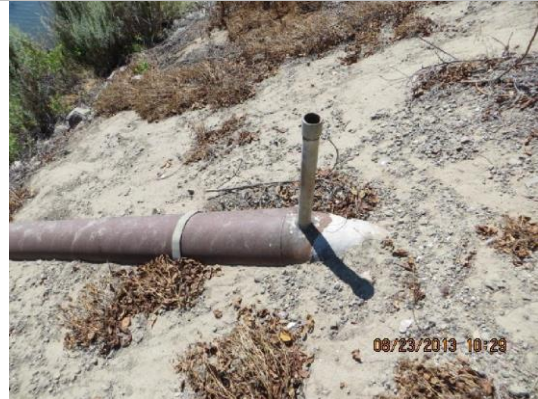
Photo 2 of 3 : UCIP\_FA\_2017\_51633\_30688.jpg

Comment Code						
Inspector Comment						
FS_ID:51633 DS_ID:20630 EP_NO: N/A Repair Type: Urgent Crossing Status: Found UCIP Comments: 11/16/2016 same as previous inspection hole in pipe is still pressent on WS near toe. This pipe does not appear to be in use. Need to contact owner to determine status of crossing. If the crossing is abandoned or still in use, owner will need to coordinate with the CVFPB to comply with Title 23 requirements. (O. Magana - DWR UCIP)08/23/2013 flap gate damage and does not work at WS toe. Large hole in pipe at WS toe. Pipe appears abandoned and should be done so properly. (W. Wylie - DWR UCIP) FIELD_STRUCT_DESC: *ABANDONED* 1 of 2: 12-inch steel irrigation pipe through the levee, 6 feet below the crown. Pump located on the waterside (WS), no pump found in 2013. Flap gate located on the WS end. [Additional Reference(s): DWR Levee Log, 2004. USACE San Joaquin O&M Manual 7, April 1964, (HLM 5.48) 10-inch pipe listed, Drawing No. 07-04-1490, Sheet 1490/4, (Station 8+01.3)]. FS Date: 11/16/2016

Vent on pipe on WS slope. Possible slurry standpipe that has not yet been used.

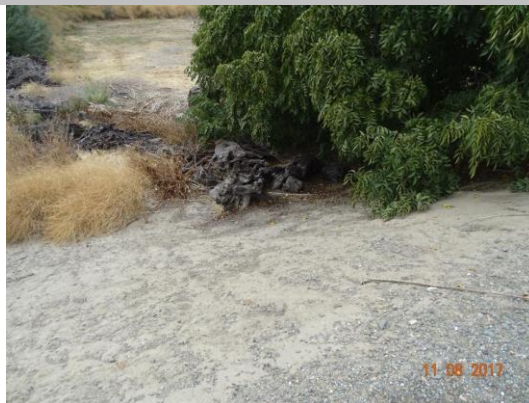
Photo 1 of 1 : FA\_2017\_RD0524\_107\_269\_20171116\_00490.jpg

LM Start	5.41	Rating **	U	Issue No.	269
LM End	5.41	Issue Type +	En	Location *	LS
Category	Earthen Levee			GPS Latitude/Longitude	
				Start	End
Item	Encroachments			37.880468 °	37.880468 °
				-121.332909 °	-121.332909 °
DWR ID	DWR_RD0524_01_f_2017_269				
Comment Code					
TR : Tree or limb					
Inspector Comment

Looking west at the landside slope.

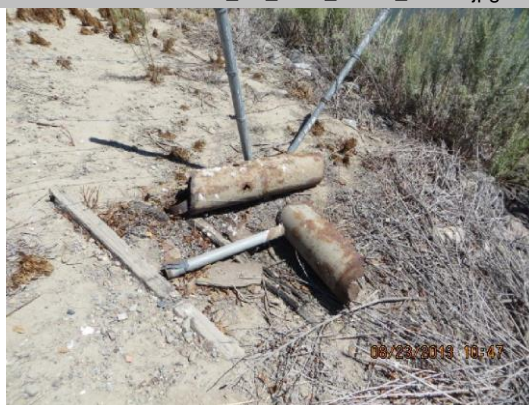
Photo 1 of 3 : UCIP\_FA\_2017\_18348\_30706.jpg

LM Start	5.42	Rating **	M	Issue No.	963
LM End	5.42	Issue Type +	Ma	Location *	
Category	Supplemental			GPS Latitude/Longitude	
				Start	End
Item	DWR UCIP LMA Responsibility			37.880358 °	37.880358 °
				-121.332972 °	-121.332972 °
DWR ID					
Comment Code					
Inspector Comment					
FS_ID:18348					
DS_ID:20631					
EP_NO: N/A					
Repair Type: Non-Urgent					
Crossing Status: Found					
UCIP Comments: Recent work being done on WS slope. Pipe may still be in use.					
FIELD_STRUCT_DESC: 10-inch steel drainage pipe through the levee, 6 feet below the crown. Pump not found on the landside (LS).					
[Additional Reference(s): DWR Levee Log, 2004. USACE San Joaquin O&M Manual 7, April 1964, (HLM 5.50)].					
FS Date: 8/23/2013

10-inch pipe debris on the WS slope.

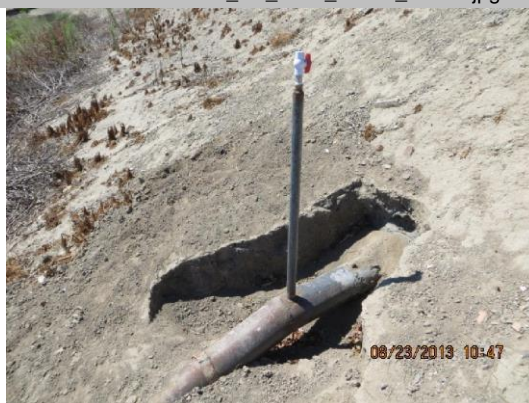
Photo 2 of 3 : UCIP\_FA\_2017\_18348\_30705.jpg

8-inch pipe sleeved through 10-inch pipe with vent on WS slope.

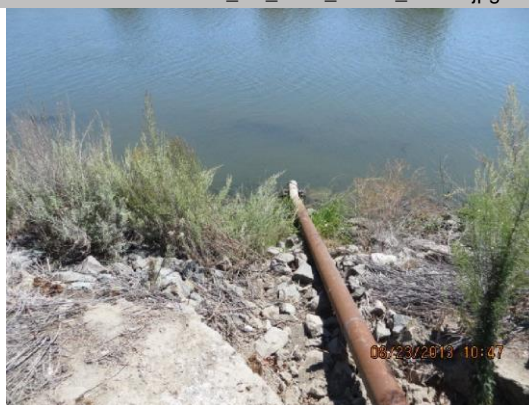
Photo 3 of 3 : UCIP\_FA\_2017\_18348\_30704.jpg

No flap gate on end of pipe at WS toe.

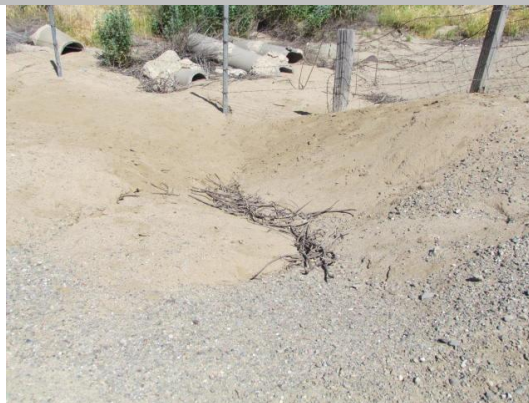
Photo 1 of 3 : FA\_2017\_RD0524\_107\_118\_20170919\_00170.jpg

LM Start	5.42	Rating **	M	Issue No.	118
LM End	5.42	Issue Type +	Ma	Location *	LS
Category	Earthen Levee			GPS Latitude/Longitude	
				Start	End
Item	Slope Stability			37.880323 °	37.880323 °
				-121.332968 °	-121.332968 °
DWR ID	DWR_RD0524_01_s_2012_118				
Comment Code					
S1 : Repair slope instability.					
Inspector Comment					
Slope damage caused by human activity.

Looking west at slope damage on landside slope.

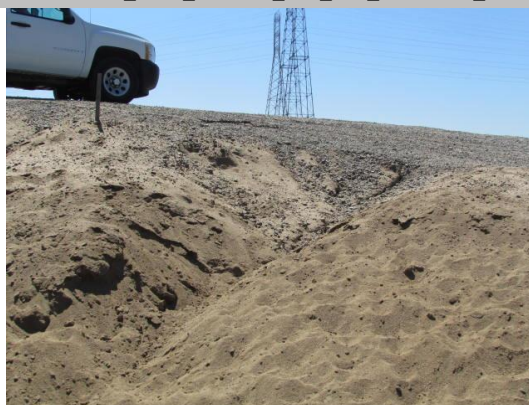
Photo 2 of 3 : FA\_2017\_RD0524\_107\_118\_20170919\_00171.jpg

Looking southeast at damaged slope.

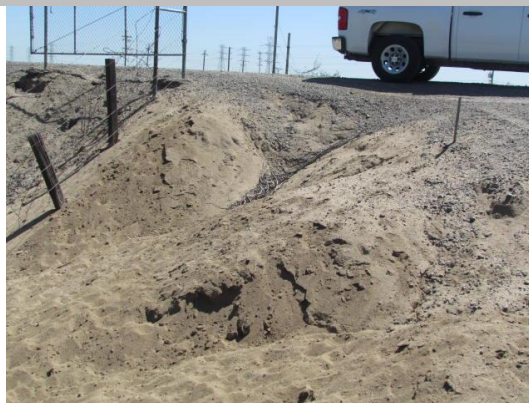
Photo 3 of 3 : FA\_2017\_RD0524\_107\_118\_20170919\_00172.jpg

Looking east at slope caving on landside slope.

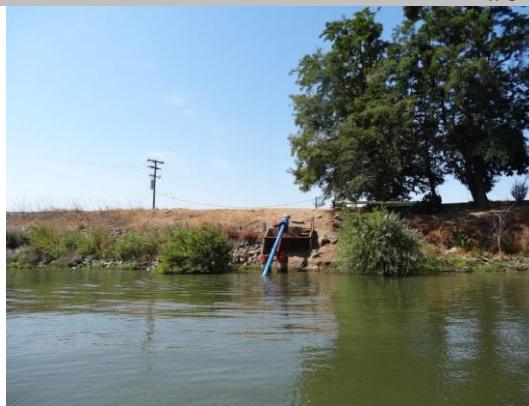
Photo 1 of 2 : SJR2017\_RD0524U01RM46.06\_1.jpg

LM Start	5.53	Rating **	M	Issue No.	92
LM End	5.53	Issue Type +	Ma	Location *	WS
Category	Supplemental			GPS Latitude/Longitude	
				Start	End
Item	DWR Erosion Survey			37.878920 °	37.878920 °
				-121.332670 °	-121.332670 °
DWR ID	RD0524U01RM46.06				
Comment Code					
Inspector Comment					
09/13/2017: No significant change observed.					
07/25/2016: No significant change observed.					
06/24/2015: No significant change observed.					
06/19/2014: No significant change observed.					
08/13/2013: Larger trees are at the levee shoulder, and an irrigation pump station is next to the erosion site. [2017 Site ID:RD0524U01RM46.06]

Front view of the erosion.

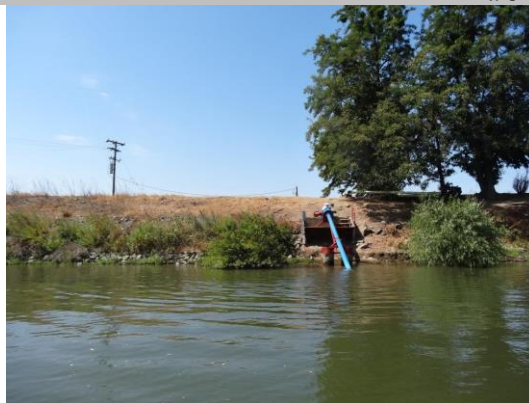
Photo 2 of 2 : SJR2017\_RD0524U01RM46.06\_2.jpg

Close view of the site.

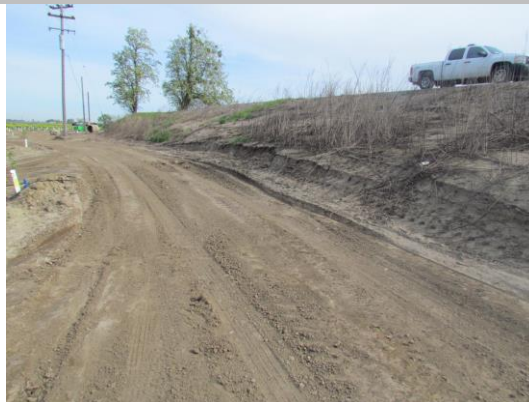
Photo 1 of 2 : FA\_2017\_RD0524\_107\_166\_20170919\_00196.jpg

LM Start	5.56	Rating **	U	Issue No.	166
LM End	5.56	Issue Type +	En	Location *	LS
Category	Earthen Levee			GPS Latitude/Longitude	
				Start	End
Item	Encroachments			37.878333 °	37.878333 °
				-121.332875 °	-121.332875 °
DWR ID	DWR_RD0524_01_s_2017_166				
Comment Code					
AT : Agricultural tilling					
Inspector Comment					
Damaged landside toe appears to be caused by farming activity.

Looking northeast at cut into landward toe.

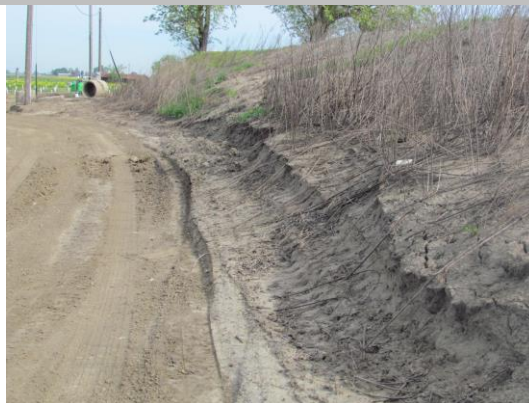
Photo 2 of 2 : FA\_2017\_RD0524\_107\_166\_20170919\_00197.jpg

Looking at north at damage to landward toe.

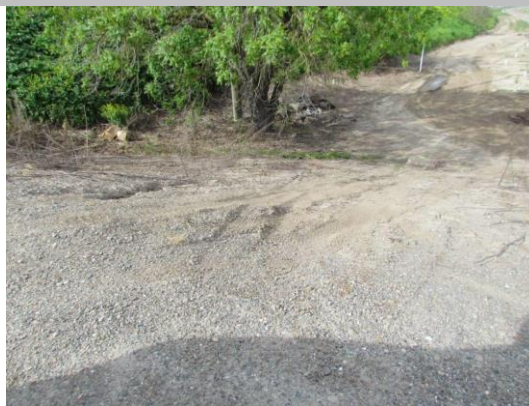
Photo 1 of 1 : FA\_2017\_RD0524\_107\_167\_20170919\_00198.jpg

LM Start	5.58	Rating **	M	Issue No.	167
LM End	5.58	Issue Type +	Ma	Location *	LS
Category	Earthen Levee			GPS Latitude/Longitude	
				Start	End
Item	Slope Stability			37.878115 °	37.878115 °
				-121.332763 °	-121.332763 °
DWR ID	DWR_RD0524_01_s_2017_167				
Comment Code					
S3 : Repair the levee slope damaged by vehicle traffic and prevent access where possible.					
Inspector Comment					
Slope damage caused by vehicle traffic.

Looking west at slope damage caused by vehicle traffic on landward slope.

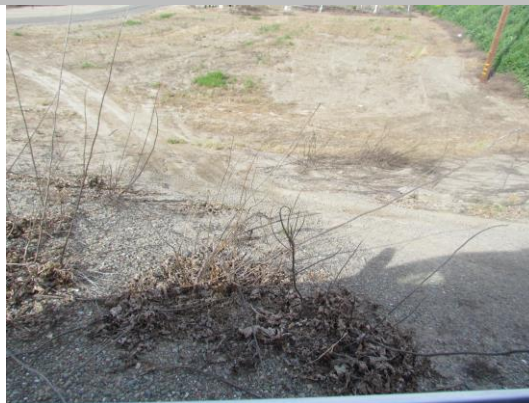
Photo 1 of 1 : FA\_2017\_RD0524\_107\_168\_20170919\_00199.jpg

LM Start	5.63	Rating **	M	Issue No.	168
LM End	5.63	Issue Type +	Ma	Location *	LS
Category	Earthen Levee			GPS Latitude/Longitude	
				Start	End
Item	Slope Stability			37.877527 °	37.877527 °
				-121.332385 °	-121.332385 °
DWR ID	DWR_RD0524_01_s_2017_168				
Comment Code					
S3 : Repair the levee slope damaged by vehicle traffic and prevent access where possible.					
Inspector Comment					
Slope damage on landside slope.

Looking northwest at slope damage caused by vehicle traffic on landward slope.

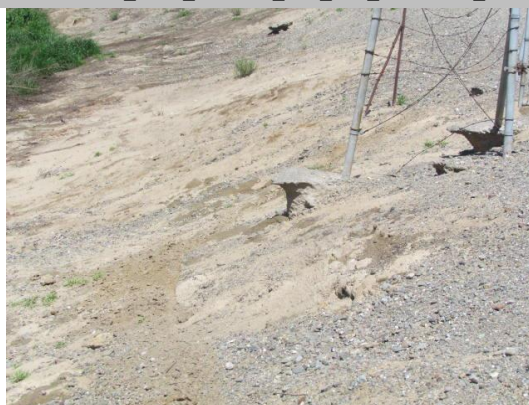
Photo 1 of 3 : FA\_2017\_RD0524\_107\_215\_20170919\_00259.jpg

LM Start	5.64	Rating **	U	Issue No.	215
LM End	5.64	Issue Type +	Ma	Location *	LS
Category	Earthen Levee			GPS Latitude/Longitude	
				Start	End
Item	Slope Stability			37.877378 °	37.877378 °
				-121.332343 °	-121.332343 °
DWR ID	DWR_RD0524_01_s_2016_215				
Comment Code					
S1 : Repair slope instability.					
Inspector Comment					
Levee slope damage is due vehicle traffic and foot traffic. Vehicle traffic created a ramp on landside slope.

Looking north at damage slope on landward slope.

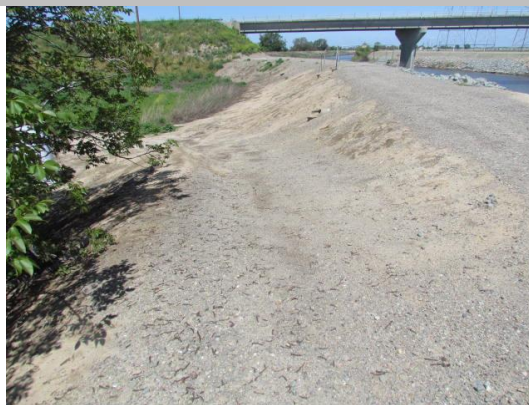
Photo 2 of 3 : FA\_2017\_RD0524\_107\_215\_20170919\_00260.jpg

Looking north at slope damage (ramp) on landward slope.
