**Flood Control Project Maintenance  
Levee Inspections**

**Fall 2017 Levee Maintenance Deficiency Summary Report**

***San Joaquin River Basin***

**Reclamation District No. 0524 Middle Roberts Island**

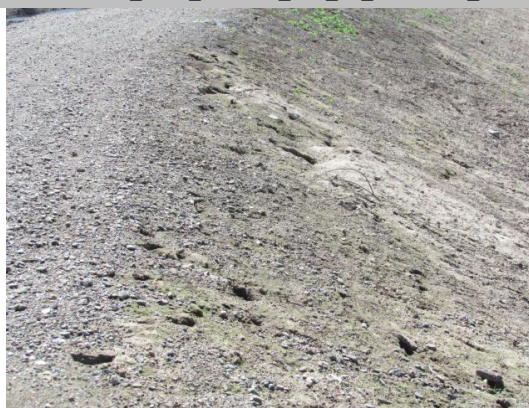
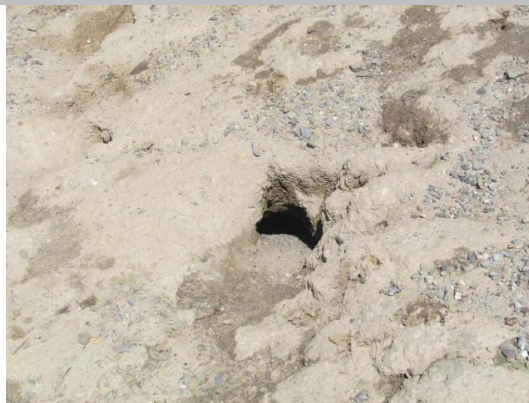
LM Start	5.64	Rating **	M	Issue No.	69
LM End	5.80	Issue Type +	Ma	Location *	LS
Category	Earthen Levee			GPS Latitude/Longitude	
				Start	End
Item	Animal Control			37.877298 °	37.875073 °
				-121.332343 °	-121.333168 °
DWR ID	DWR_RD0524_01_s_2012_69				
Comment Code					
A3 : No rodents visible, but rodent burrows visible; need to backfill and compact or grout burrows.					
Inspector Comment					
District has grouted rodent holes, but rodents are still present.

Looking south at rodent holes on landward slope.

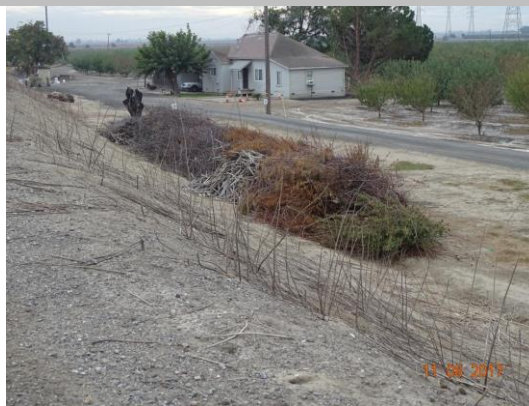
Photo 1 of 2 : FA\_2017\_RD0524\_107\_175\_20171116\_00491.jpg

LM Start	5.70	Rating **	U	Issue No.	175
LM End	5.70	Issue Type +	En	Location *	LS
Category	Earthen Levee			GPS Latitude/Longitude	
				Start	End
Item	Encroachments			37.876417 °	37.876417 °
				-121.332505 °	-121.332505 °
DWR ID	DWR_RD0524_01_s_2017_175				
Comment Code					
PR : Prunings					
Inspector Comment

Looking southwest at the landside slope.

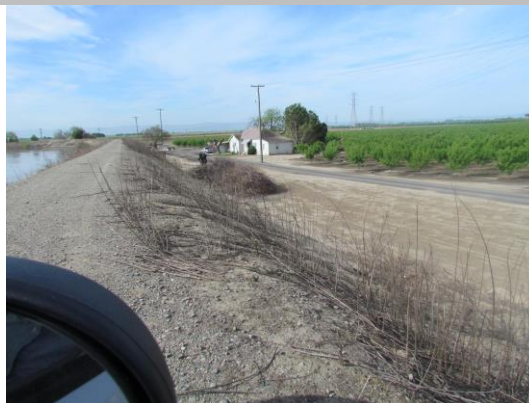
Photo 2 of 2 : FA\_2017\_RD0524\_107\_175\_20170919\_00212.jpg

Looking south at large pruning pile at landward toe.

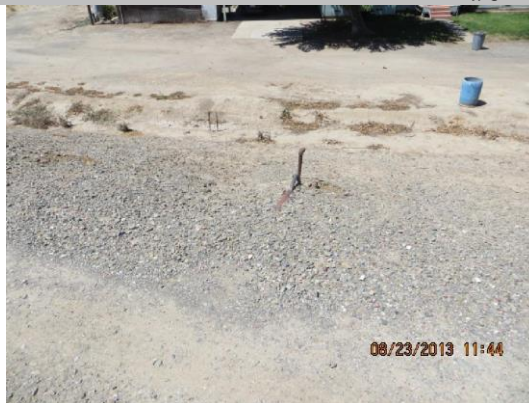
Photo 1 of 2 : UCIP\_FA\_2017\_18364\_30761.jpg

LM Start	5.74	Rating **	M	Issue No.	964	
LM End	5.74	Issue Type +	En	Location *		
Category	Supplemental			GPS Latitude/Longitude		
				Start	End	
Item	DWR UCIP Field Study			37.876001 °	37.876001 °	
				-121.332725 °	-121.332725 °	
DWR ID						
Comment Code						
Inspector Comment						
FS_ID:18364 DS_ID:20649 EP_NO: N/A Repair Type: Non-Urgent Crossing Status: Found UCIP Comments: Abandoned and should be done so properly. FIELD_STRUCT_DESC: 2.25-inch steel conduit for a 1-inch plastic electrical conduit through the levee, 0.25 feet below the crown. Lines exposed on both slopes. [Additional Reference(s): DWR Levee Log, 2004]. FS Date: 8/23/2013

Steel conduit and electrical conduit visible on the LS shoulder.

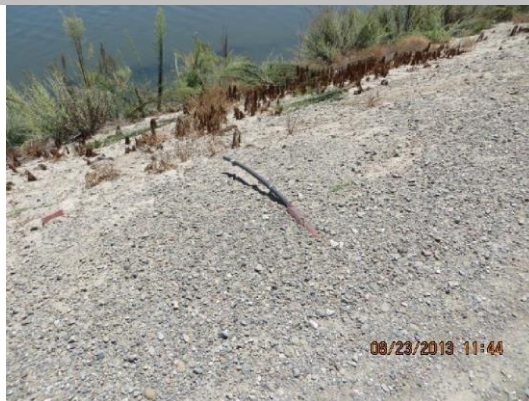
Photo 2 of 2 : UCIP\_FA\_2017\_18364\_30760.jpg

LM Start	<b>5.74</b>	Rating **	M	Issue No.	<b>964 (cont)</b>
LM End	<b>5.74</b>	Issue Type +	En	Location *

Steel conduit and electrical conduit visible on the WS shoulder.

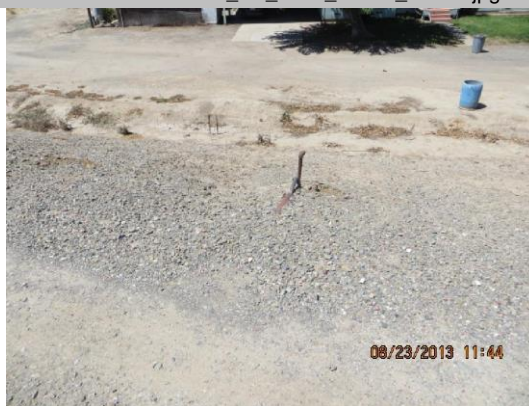
Photo 1 of 1 : UCIP\_FA\_2017\_40793\_30781.jpg

LM Start	5.74	Rating **	M	Issue No.	965	
LM End	5.74	Issue Type +	En	Location *		
Category	Supplemental			GPS Latitude/Longitude		
				Start	End	
Item	DWR UCIP Field Study			37.876001 °	37.876001 °	
				-121.332725 °	-121.332725 °	
DWR ID						
Comment Code						
Inspector Comment						
FS_ID:40793						
DS_ID:20635						
EP_NO: N/A						
Repair Type: Non-Urgent						
Crossing Status: Indicator Found						
UCIP Comments: Appears abandoned and if so should be done so properly. No permit identified for this crossing.						
FIELD_STRUCT_DESC: *ABANDONED* 1-inch steel water line through the levee, 1 foot below the crown. Pipe visible only on the landside (LS) shoulder.						
FS Date: 8/23/2013

Steel waterline visible on LS shoulder.

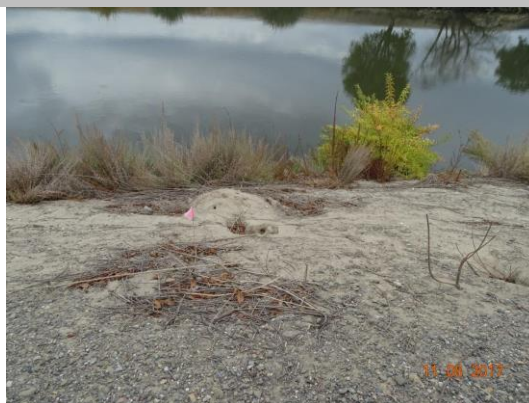
Photo 1 of 1 : FA\_2017\_RD0524\_107\_271\_20171116\_00492.jpg

LM Start	5.76	Rating **	U	Issue No.	271
LM End	5.76	Issue Type +	Ma	Location *	WS
Category	Earthen Levee			GPS Latitude/Longitude	
				Start	End
Item	Animal Control			37.875631 °	37.875631 °
				-121.332907 °	-121.332907 °
DWR ID	DWR_RD0524_01_f_2017_271				
Comment Code					
A3 : No rodents visible, but rodent burrows visible; need to backfill and compact or grout burrows.					
Inspector Comment

Looking east at the waterside slope.

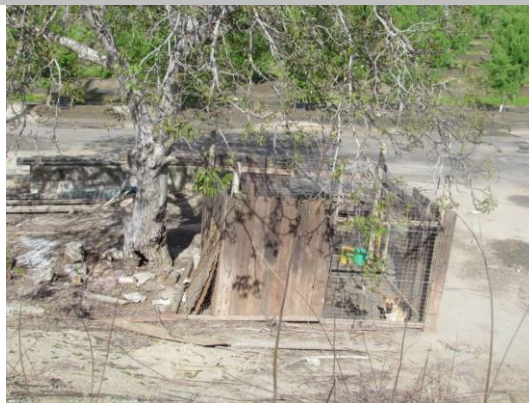
Photo 1 of 1 : FA\_2017\_RD0524\_107\_181\_20170919\_00223.jpg

LM Start	5.77	Rating **	U	Issue No.	181
LM End	5.77	Issue Type +	En	Location *	LS
Category	Earthen Levee			GPS Latitude/Longitude	
				Start	End
Item	Encroachments			37.875545 °	37.875545 °
				-121.332952 °	-121.332952 °
DWR ID	DWR_RD0524_01_s_2017_181				
Comment Code					
BU : Building					
Inspector Comment					
Animal kennels at landside toe.

Looking west at animal pen at landward toe.

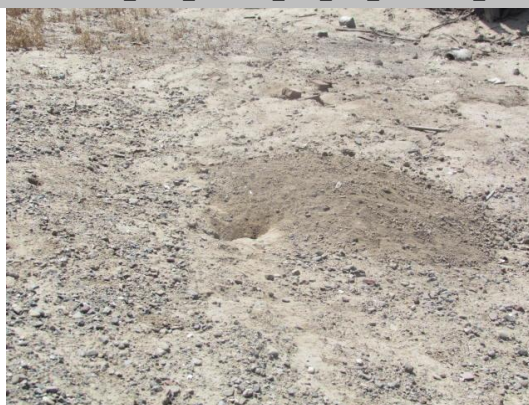
Photo 1 of 2 : FA\_2017\_RD0524\_107\_197\_20170919\_00237.jpg

LM Start	5.77	Rating **	M	Issue No.	197
LM End	5.79	Issue Type +	Ma	Location *	LS
Category	Earthen Levee			GPS Latitude/Longitude	
				Start	End
Item	Animal Control			37.875545 °	37.875310 °
				-121.332952 °	-121.333065 °
DWR ID	DWR_RD0524_01_s_2015_197				
Comment Code					
A1 : Exterminate rodents and backfill and compact or grout burrows.					
Inspector Comment					
Several rodent holes on landside slope and levee crown.

Looking north at typical view of rodent holes on landward slope.

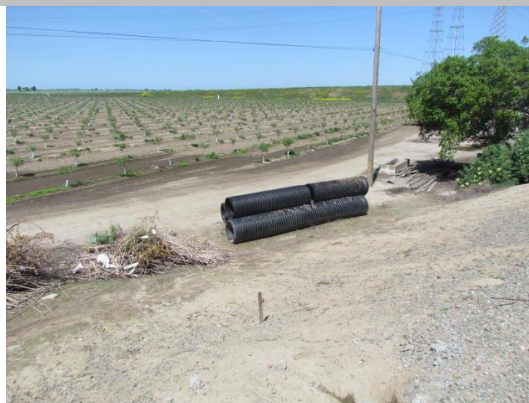
Photo 1 of 1 : FA\_2017\_RD0524\_107\_216\_20170919\_00262.jpg

LM Start	5.78	Rating **	U	Issue No.	216
LM End	5.78	Issue Type +	En	Location *	LS
Category	Earthen Levee			GPS Latitude/Longitude	
				Start	End
Item	Encroachments			37.875426 °	37.875426 °
				-121.333011 °	-121.333011 °
DWR ID	DWR_RD0524_01_s_2016_216				
Comment Code					
EQ : Equipment					
Inspector Comment					
Farmer storing irrigation pipes at landside toe.

Looking west at irrigation pipes stored at landward toe.

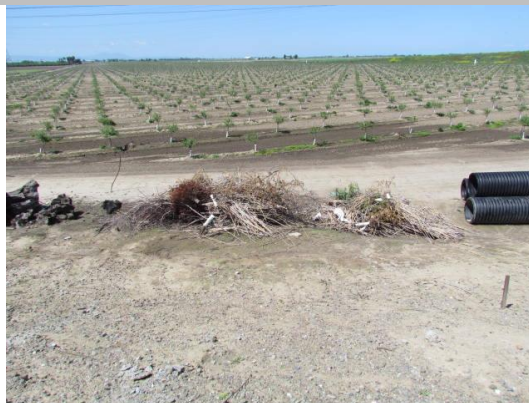
Photo 1 of 1 : FA\_2017\_RD0524\_107\_267\_20170919\_00276.jpg

LM Start	5.79	Rating **	U	Issue No.	267
LM End	5.79	Issue Type +	En	Location *	LS
Category	Earthen Levee			GPS Latitude/Longitude	
				Start	End
Item	Encroachments			37.875328 °	37.875328 °
				-121.333050 °	-121.333050 °
DWR ID	DWR_RD0524_01_s_2012_267				
Comment Code					
PR : Prunings					
Inspector Comment					
Prunings at landside toe should be burned or removed.

Looking west at prunings at landward toe.

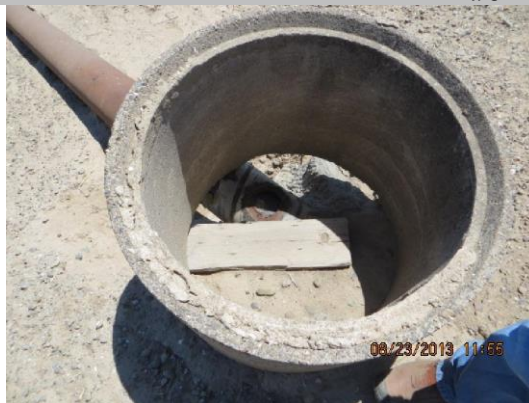
Photo 1 of 2 : UCIP\_FA\_2017\_18369\_30785.jpg

Comment Code					
Inspector Comment					
FS_ID:18369 DS_ID:20636 EP_NO: N/A Repair Type: Non-Urgent Crossing Status: Found UCIP Comments: Apparent leak on WS shoulder at concrete riser. Erosion under pipe. This may have been fixed when the pipe was sleeved with a PVC liner. FIELD_STRUCT_DESC: 10-inch steel drainage pipe through the levee, 5 feet below the crown. Pump on the landside (LS). Siphon breaker in a 36-inch concrete riser unit on the waterside (WS) shoulder. Power pole at the LS toe. Polyvinyl chloride liner sleeved inside steel pipe. [Additional Reference(s): DWR Levee Log, 2004. USACE San Joaquin O&M Manual 7, April 1964, (HLM 5.88)]. FS Date: 8/23/2013

Concrete standpipe over pipe on WS shoulder.

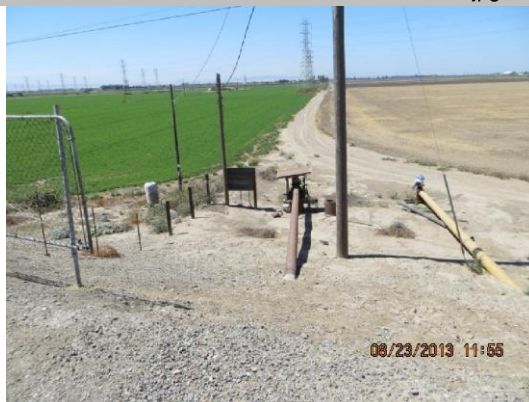
Photo 2 of 2 : UCIP\_FA\_2017\_18369\_30784.jpg

Pipe, pump, power pole, and meter off LS toe.

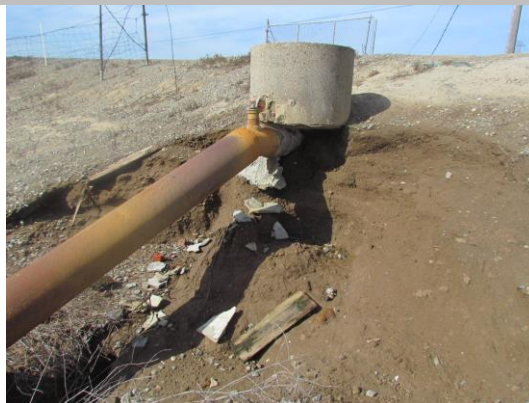
Photo 1 of 3 : FA\_2017\_RD0524\_107\_183\_20170919\_00226.jpg

LM Start	5.81	Rating **	U	Issue No.	183
LM End	5.81	Issue Type +	Ma	Location *	WS
Category	Earthen Levee			GPS Latitude/Longitude	
				Start	End
Item	Erosion / Bank Caving			37.874973 °	37.874973 °
				-121.333227 °	-121.333227 °
DWR ID	DWR_RD0524_01_s_2017_183				
Comment Code					
E2 : Schedule repair of erosion site prior to the next inspection.					
Inspector Comment					
Bank caving on waterside around pipe structure.

Looking west at erosion around pipe and on waterward slope.

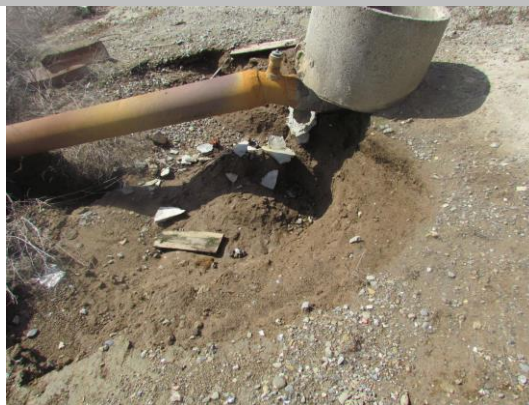
Photo 2 of 3 : FA\_2017\_RD0524\_107\_183\_20170919\_00227.jpg

Looking south at erosion around pipe and on waterward slope.

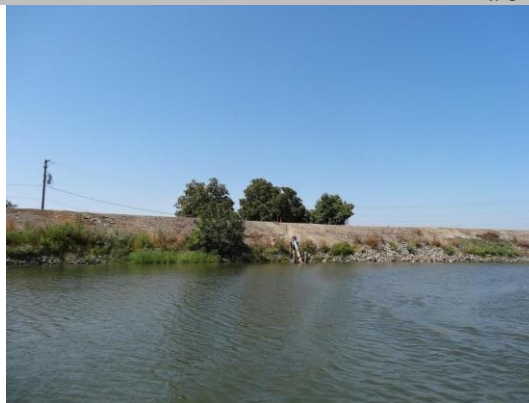
Photo 2 of 2 : SJR2017\_RD0524U01RM46.39\_2.jpg

LM Start	5.86	Rating **	U	Issue No.	93 (cont)	
LM End	5.86	Issue Type +	Ma	Location *	WS	
Category	Supplemental			GPS Latitude/Longitude		
				Start	End	
Item	DWR Erosion Survey			37.874370 °	37.874370 °	
				-121.332850 °	-121.332850 °	
DWR ID	RD0524U01RM46.39					
Comment Code						
Inspector Comment						
09/13/2017: No significant change observed.						
07/25/2016: No significant change observed.						
06/24/2015: No significant change observed.						
06/19/2014: No significant change observed.						
08/13/2013: No significant change observed.						
08/07/2012: The erosion is near a water-intake structure. Pipe leakage likely caused the erosion. [2017 Site ID:RD0524U01RM46.39]

View of the erosion.

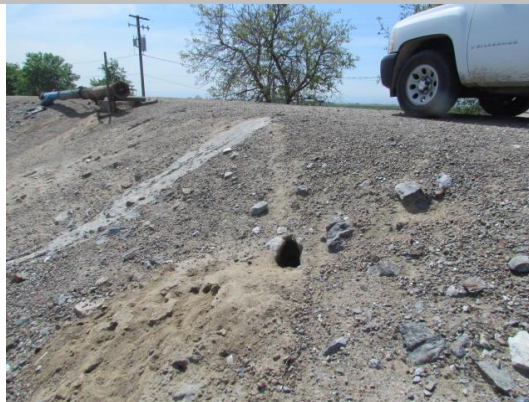
Photo 1 of 2 : FA\_2017\_RD0524\_107\_75\_20170919\_00118.jpg

LM Start	5.86	Rating **	M	Issue No.	75
LM End	5.88	Issue Type +	Ma	Location *	WS
Category	Earthen Levee			GPS Latitude/Longitude	
				Start	End
Item	Animal Control			37.874240 °	37.874002 °
				-121.333187 °	-121.333027 °
DWR ID	DWR_RD0524_01_s_2012_75				
Comment Code					
A1 : Exterminate rodents and backfill and compact or grout burrows.					
Inspector Comment					
District has grouted rodent holes, but other rodent holes have appeared. Active rodents in area.

Looking southwest at typical rodent holes on waterward slope.

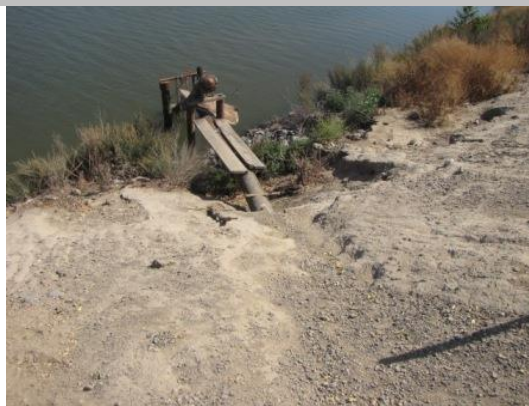
Photo 1 of 3 : FA\_2017\_RD0524\_107\_74\_20170919\_00115.jpg

LM Start	5.87	Rating **	U	Issue No.	74
LM End	5.87	Issue Type +	Ma	Location *	WS
Category	Earthen Levee			GPS Latitude/Longitude	
				Start	End
Item	Erosion / Bank Caving			37.874202 °	37.874086 °
				-121.333197 °	-121.333153 °
DWR ID	DWR_RD0524_01_s_2012_74				
Comment Code					
E1 : Note and monitor erosion site.					
Inspector Comment					
Erosion on landside slope around intake pipe.

Looking southeast at erosion around pipe.

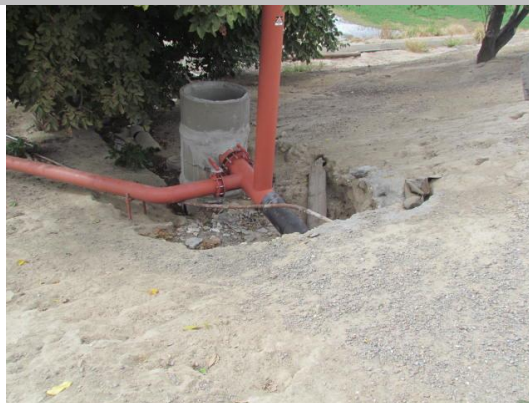
Photo 2 of 3 : FA\_2017\_RD0524\_107\_74\_20170919\_00116.jpg

Looking west at erosion around intake pipe on landward slope.

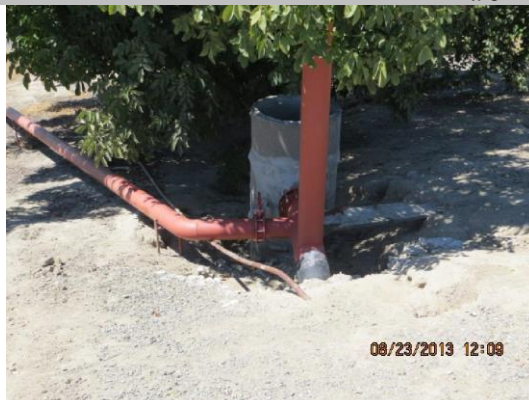
Photo 1 of 3 : UCIP\_FA\_2017\_18379\_30829.jpg

Comment Code						
Inspector Comment						
FS_ID:18379						
DS_ID:20638						
EP_NO: N/A						
Repair Type: Non-Urgent						
Crossing Status: Found						
UCIP Comments: Heavy erosion around pipe upstream of standpipe on LS slope. Verify pipe is not leaking and repair erosion on LS slope.						
FIELD_STRUCT_DESC: 12-inch steel irrigation pipe through the levee, 10 feet below the crown. Slant pump on pier at the waterside (WS) toe.						
10-inch steel standpipe on the landside (LS) slope. 42-inch concrete standpipe on the LS slope. Filter plant and power pole on the LS toe.

Butterfly valves and standpipes on LS slope along with electrical conduit.

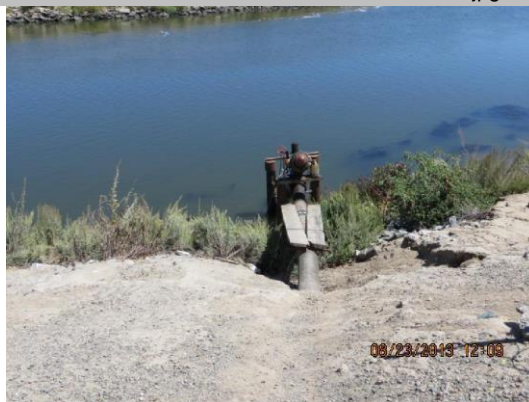
Photo 2 of 3 : UCIP\_FA\_2017\_18379\_30828.jpg

Slant pump on WS toe.

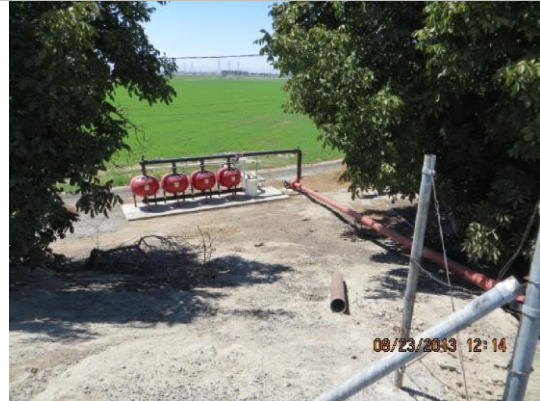
Photo 3 of 3 : UCIP\_FA\_2017\_18379\_30827.jpg

Comment Code						
Inspector Comment						
FS_ID:18379						
DS_ID:20638						
EP_NO: N/A						
Repair Type: Non-Urgent						
Crossing Status: Found						
UCIP Comments: Heavy erosion around pipe upstream of standpipe on LS slope. Verify pipe is not leaking and repair erosion on LS slope.						
FIELD_STRUCT_DESC: 12-inch steel irrigation pipe through the levee, 10 feet below the crown. Slant pump on pier at the waterside (WS) toe.						
10-inch steel standpipe on the landside (LS) slope. 42-inch concrete standpipe on the LS slope. Filter plant and power pole on the LS toe.

Filter pump on LS toe.

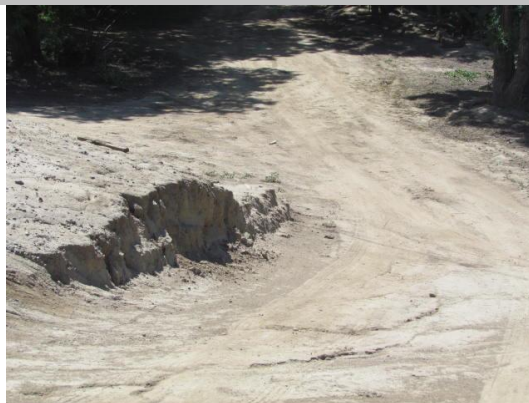
Photo 1 of 2 : FA\_2017\_RD0524\_107\_119\_20170919\_00173.jpg

LM Start	5.89	Rating **	U	Issue No.	119
LM End	5.89	Issue Type +	Ma	Location *	LS
Category	Earthen Levee			GPS Latitude/Longitude	
				Start	End
Item	Slope Stability			37.873893 °	37.873893 °
				-121.332978 °	-121.332978 °
DWR ID	DWR_RD0524_01_s_2012_119				
Comment Code					
S3 : Repair the levee slope damaged by vehicle traffic and prevent access where possible.					
Inspector Comment					
Landowner is using damaged area as a ramp.

Looking west at unauthorized ramp and landside slope damage.

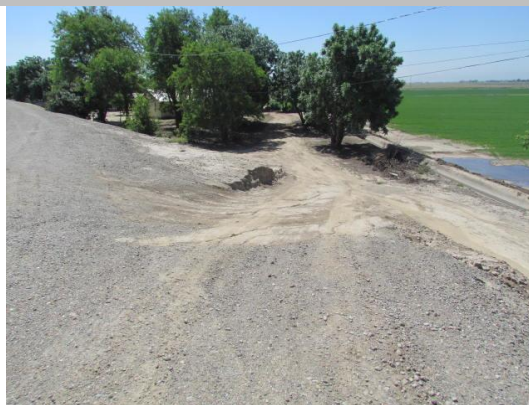
Photo 2 of 2 : FA\_2017\_RD0524\_107\_119\_20170919\_00174.jpg

Looking southwest at damaged slope and ramp on landside slope.

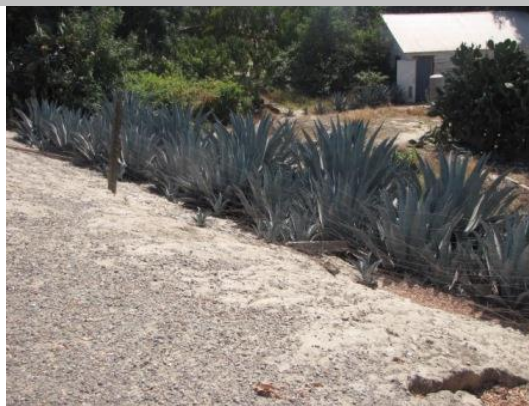
Photo 1 of 1 : FA\_2017\_RD0524\_107\_88\_20170919\_00137.jpg

LM Start	5.94	Rating **	U	Issue No.	88
LM End	5.95	Issue Type +	En	Location *	LS
Category	Earthen Levee			GPS Latitude/Longitude	
				Start	End
Item	Vegetation			37.873543 °	37.873445 °
				-121.332308 °	-121.332127 °
DWR ID	DWR_RD0524_01_s_2012_88				
Comment Code					
V6 : Landscaping					
Inspector Comment					
Cactus and Century plants on landside slope and toe.

Looking southeast at fence and cactus on landside slope and toe.

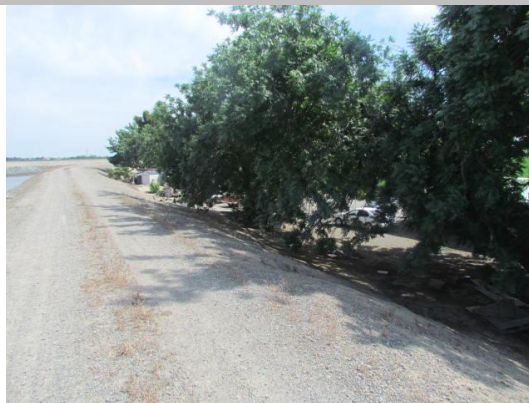
Photo 1 of 1 : FA\_2017\_RD0524\_107\_120\_20170919\_00175.jpg

LM Start	5.96	Rating **	U	Issue No.	120
LM End	5.96	Issue Type +	Ma	Location *	LS
Category	Earthen Levee			GPS Latitude/Longitude	
				Start	End
Item	Trim / Thin Trees			37.873347 °	37.873347 °
				-121.332028 °	-121.332028 °
DWR ID	DWR_RD0524_01_s_2012_120				
Comment Code					
T1 : Trim trees to at least five feet above ground level.					
Inspector Comment

Looking south at untrimmed trees on landward slope and toe.

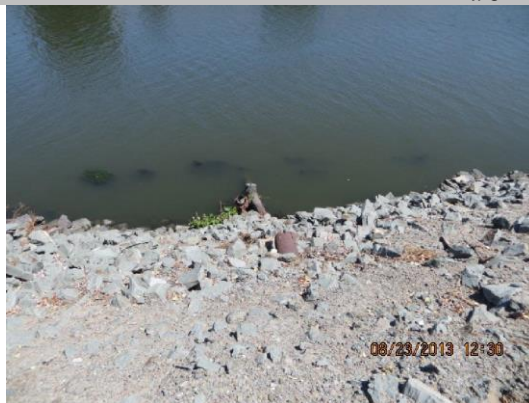
Photo 1 of 2 : UCIP\_FA\_2017\_18392\_30910.jpg

LM Start	6.15	Rating **	M	Issue No.	969	
LM End	6.15	Issue Type +	En	Location *		
Category	Supplemental			GPS Latitude/Longitude		
				Start	End	
Item	DWR UCIP Field Study			37.871138 °	37.871138 °	
				-121.330146 °	-121.330146 °	
DWR ID						
Comment Code						
Inspector Comment						
FS_ID:18392						
DS_ID:20641						
EP_NO: N/A						
Repair Type: Non-Urgent						
Crossing Status: Found						
UCIP Comments: Pipe and pump abandoned and should be done so properly.						
FIELD_STRUCT_DESC: *ABANDONED* 10-inch irrigation pipe of an unknown material through the levee, 12 feet below the crown. Pump on the waterside (WS) slope. [Additional Reference(s): DWR Levee Log, 2004. USACE San Joaquin O&M Manual 7, April 1964, (HLM 6.22)].						
FS Date: 8/23/2013

Pump and open pipe visible on WS slope.

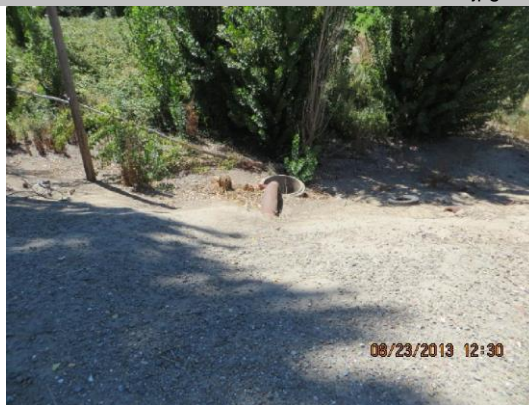
Photo 2 of 2 : UCIP\_FA\_2017\_18392\_30909.jpg

Pipe and concrete standpipe visible on LS toe.

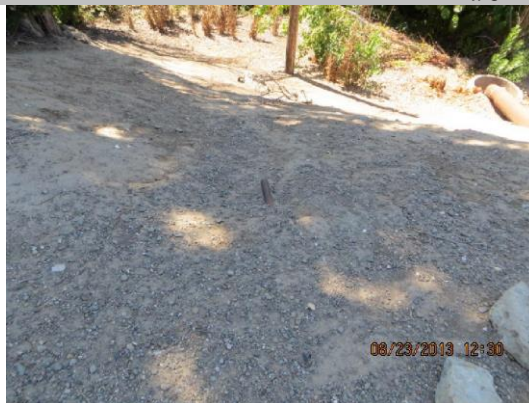
Photo 1 of 2 : UCIP\_FA\_2017\_22073\_37670.jpg

LM Start	6.15	Rating **	M	Issue No.	970
LM End	6.15	Issue Type +	En	Location *	
Category	Supplemental			GPS Latitude/Longitude	
				Start	End
Item	DWR UCIP Field Study			37.871118 °	37.871118 °
				-121.330137 °	-121.330137 °
DWR ID					
Comment Code					
Inspector Comment					
FS_ID:22073 DS_ID:24052 EP_NO: N/A Repair Type: Non-Urgent Crossing Status: Found UCIP Comments: Abandoned and should be done so properly. FIELD_STRUCT_DESC: *ABANDONED* 1.75-inch galvanized iron electrical conduit through the levee, 1 foot below the crown. Power pole on the landside (LS) toe. FS Date: 8/23/2013

Pipe visible on LS slope.

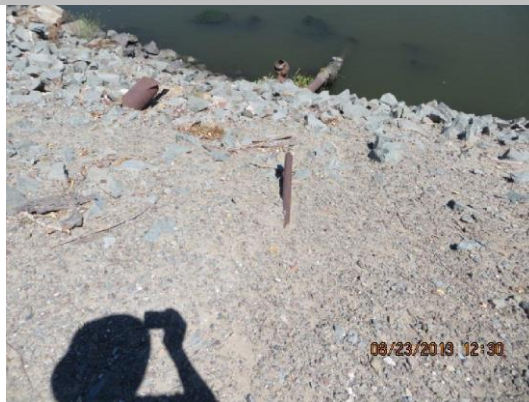
Photo 2 of 2 : UCIP\_FA\_2017\_22073\_37669.jpg

Pipe visible on WS slope.

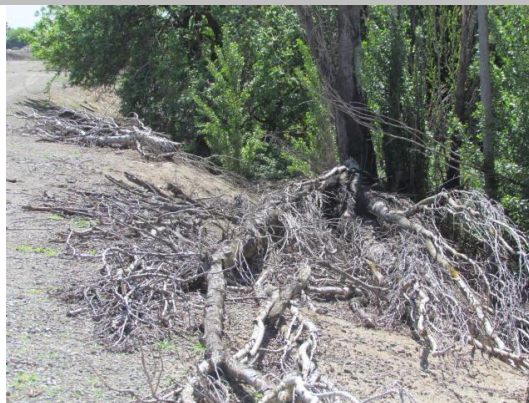
Photo 1 of 4 : FA\_2017\_RD0524\_107\_81\_20170919\_00127.jpg

LM Start	6.15	Rating **	M	Issue No.	81
LM End	6.15	Issue Type +	Ma	Location *	LS
Category	Earthen Levee			GPS Latitude/Longitude	
				Start	End
Item	Encroachments			37.871097 °	37.871097 °
				-121.330100 °	-121.330100 °
DWR ID	DWR_RD0524_01_s_2015_81				
Comment Code					
TR : Tree or limb					
Inspector Comment					
Fallen tree branches and limbs on landside slope.

Looking west at tree branches and limbs left on landward shoulder and slope. (Spring 2016)

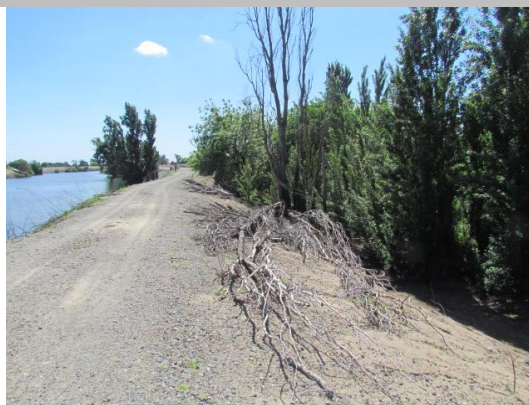
Photo 2 of 4 : FA\_2017\_RD0524\_107\_81\_20170919\_00128.jpg

Looking south at tree branches and limbs left on landward shoulder and slope. (Spring 2016)

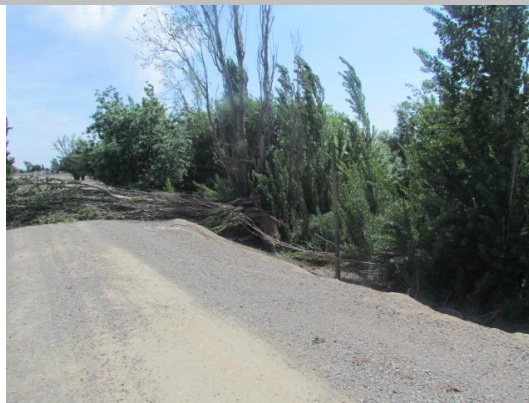
Photo 3 of 4 : FA\_2017\_RD0524\_107\_81\_20170919\_00129.jpg

Looking southwest at large tree across levee crown. (Fall 2015)

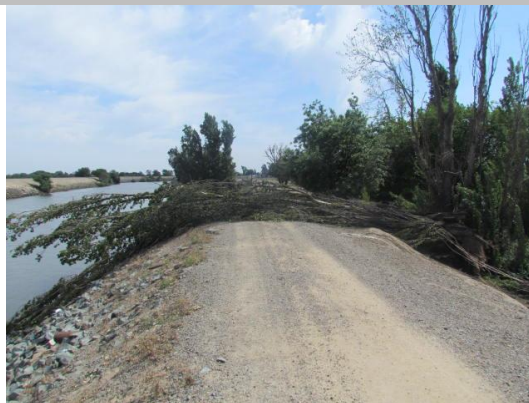
Photo 4 of 4 : FA\_2017\_RD0524\_107\_81\_20170919\_00130.jpg

LM Start	6.15	Rating **	M	Issue No.	81 (cont)	
LM End	6.15	Issue Type +	Ma	Location *	LS	
Category	Earthen Levee			GPS Latitude/Longitude		
				Start		End
Item	Encroachments			37.871097 °		37.871097 °
				-121.330100 °		-121.330100 °
DWR ID	DWR_RD0524_01_s_2015_81					
Comment Code						
TR : Tree or limb						
Inspector Comment						
Fallen tree branches and limbs on landside slope.

Looking south at large tree across levee crown. (Fall 2015)

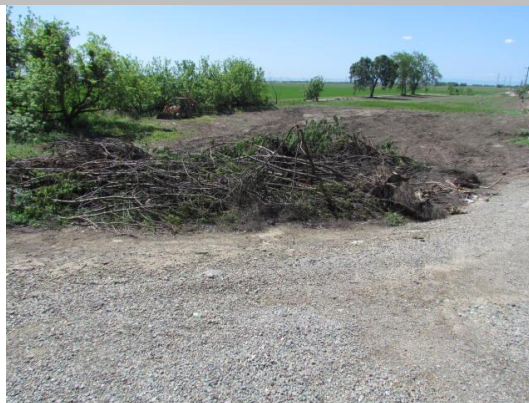
Photo 1 of 1 : FA\_2017\_RD0524\_107\_86\_20170919\_00136.jpg

LM Start	6.20	Rating **	U	Issue No.	86
LM End	6.20	Issue Type +	En	Location *	LS
Category	Earthen Levee			GPS Latitude/Longitude	
				Start	End
Item	Encroachments			37.870388 °	37.870388 °
				-121.329840 °	-121.329840 °
DWR ID	DWR_RD0524_01_s_2016_86				
Comment Code					
PR : Prunings					
Inspector Comment					
Large pruning pile left at landside toe.

Looking west at prunings at landward toe and berm.
