**Flood Control Project Maintenance  
Levee Inspections**

**Fall 2019 Levee Maintenance Deficiency Summary Report**

**Flood Control Project Maintenance  
Levee Inspections****LMA District Cover Sheet****Fall 2019 Levee Inspection Results****Reclamation District No. 0524 Middle Roberts Island**

**Reclamation District No. 0524 Middle Roberts Island**

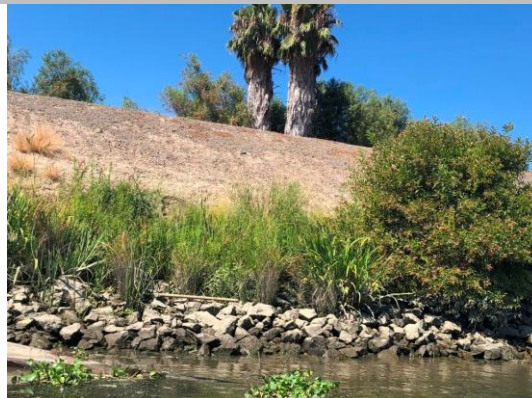
Photo 1 of 3 : SJR2019\_RD0524U01RM40.85\_4.JPG

Site ID: RD0524U01RM40.85  
 08/13/2019: No significant change observed.  
 09/13/2017: No significant change observed.  
 07/25/2016: No significant change observed.  
 06/24/2015: No significant change observed.  
 06/19/2014: No significant change observed.  
 08/13/2013: The erosion was discovered during 2013 spring levee inspection. Inspector comment: Erosion is located along the lower level of water-ward slope.

Close-up view of the erosion.

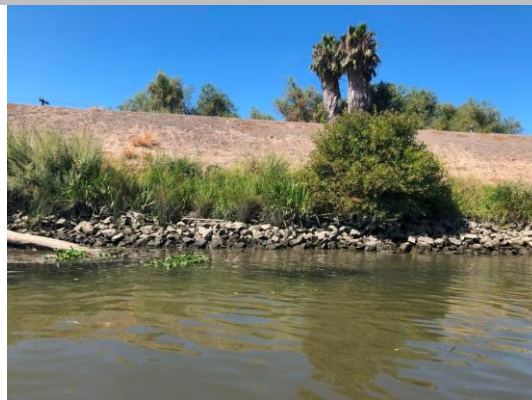
Photo 2 of 3 : SJR2019\_RD0524U01RM40.85\_1.JPG

Front view of the erosion.

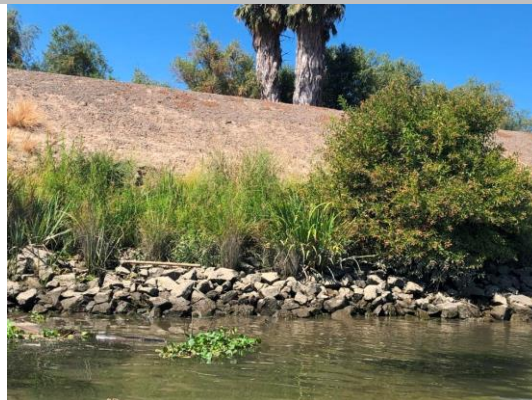
Photo 3 of 3 : SJR2019\_RD0524U01RM40.85\_2.JPG

LM Start	0.18	Rating **	U	Issue No.	1 (cont)	
LM End	0.18	Issue Type +	Ma	Location *		
Category	Supplemental			GPS Latitude/Longitude		
				Start	End	
Item	DWR Erosion Survey			37.939085 °	37.939085 °	
				-121.343917 °	-121.343917 °	
DWR ID	RD0524U01RM40.85					
Comment Code						
Inspector Comment						
Site ID: RD0524U01RM40.85 08/13/2019: No significant change observed. 09/13/2017: No significant change observed. 07/25/2016: No significant change observed. 06/24/2015: No significant change observed. 06/19/2014: No significant change observed. 08/13/2013: The erosion was discovered during 2013 spring levee inspection. Inspector comment: Erosion is located along the lower level of water-ward slope.

Front view of the erosion.

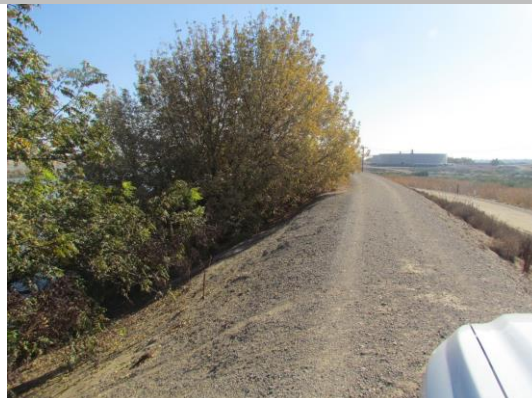
Photo 2 of 2 : FA\_2019\_RD0524\_107\_179\_20190830\_00160.jpg

LM Start	0.27	Rating **	U	Issue No.	179 (cont)	
LM End	0.27	Issue Type +	Ma	Location *	WS	
Category	Earthen Levee			GPS Latitude/Longitude		
				Start		End
Item	Trim / Thin Trees			37.938438 °		37.938438 °
				-121.342883 °		-121.342883 °
DWR ID	DWR_RD0524_01_s_2014_179					
Comment Code						
T3 : Trim and thin trees to allow visibility of the ground and room to flood fight.						
Inspector Comment						
Tree blocking view of waterside slope.

Looking east at untrimmed tree on waterward slope. (Fall 2016)

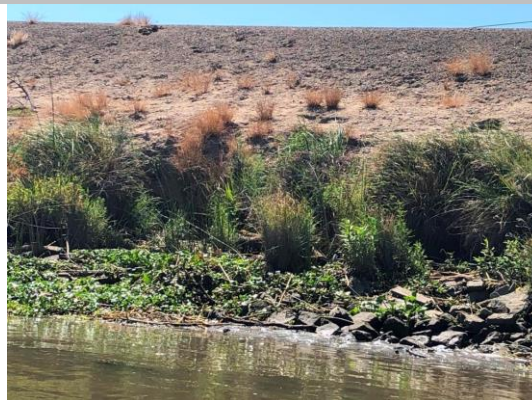
Photo 3 of 3 : SJR2019\_RD0524U01RM40.93\_3.JPG

LM Start	0.34	Rating **	M	Issue No.	2 (cont)	
LM End	0.34	Issue Type +	Ma	Location *		
Category	Supplemental			GPS Latitude/Longitude		
				Start	End	
Item	DWR Erosion Survey			37.938461 °	37.938461 °	
				-121.341526 °	-121.341526 °	
DWR ID	RD0524U01RM40.93					
Comment Code						
Inspector Comment						
Site ID: RD0524U01RM40.93						
08/13/2019: No significant change observed.						
09/13/2017: There are two pocket erosions at the site; both erosions are around 10 ft long and 6 ft high.

Close-up view of the erosion site.

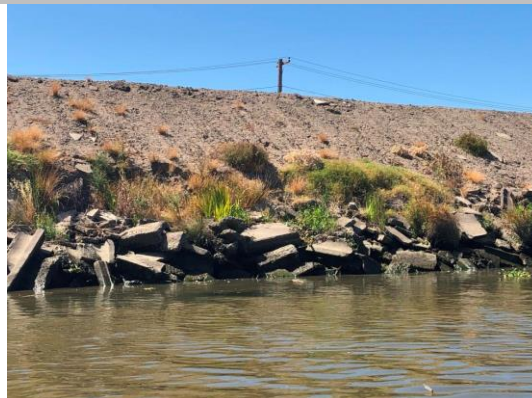
Photo 2 of 3 : SJR2019\_RD0524U01RM40.99\_2.jpg

Site ID: RD0524U01RM40.99  
 08/13/2019: No significant change observed.  
 09/13/2017: No significant change observed.  
 07/25/2016: More vegetation observed at the site.  
 06/24/2015: No significant change observed.  
 06/19/2014: No significant change observed.  
 08/13/2013: No significant change at this site.  
 08/07/2012: The erosion is at the upper levee slope, and likely caused by slope slip. The lower levee slope is covered with dense vegetation.

Front view of the site.

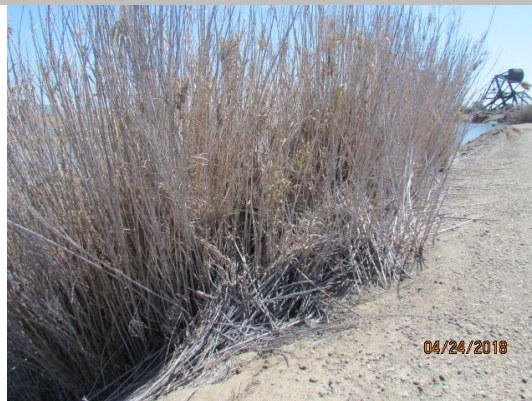
Photo 1 of 2 : FA\_2019\_RD0524\_107\_11\_20190830\_00013.jpg

LM Start	0.63	Rating **	U	Issue No.	11
LM End	0.64	Issue Type +	Ma	Location *	WS
Category	Earthen Levee			GPS Latitude/Longitude	
				Start	End
Item	Vegetation			37.938232 °	37.938160 °
				-121.336484 °	-121.336357 °
DWR ID	DWR_RD0524_01_s_2012_11				
Comment Code					
V2 : Remove the wild growth other than native grasses from the levee slopes.					
Inspector Comment					
Arrundo on waterside slope

Looking at bamboo on waterward slope. (Spring 2018)

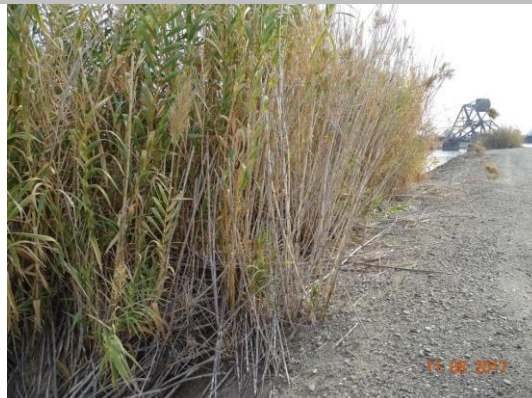
Photo 2 of 2 : FA\_2019\_RD0524\_107\_11\_20190830\_00014.jpg

LM Start	0.63	Rating **	U	Issue No.	11 (cont)	
LM End	0.64	Issue Type +	Ma	Location *	WS	
Category	Earthen Levee			GPS Latitude/Longitude		
				Start		End
Item	Vegetation			37.938232°		37.938160°
				-121.336484°		-121.336357°
DWR ID	DWR_RD0524_01_s_2012_11					
Comment Code						
V2 : Remove the wild growth other than native grasses from the levee slopes.						
Inspector Comment						
Arrundo on waterside slope

Looking southeast at the waterside slope.

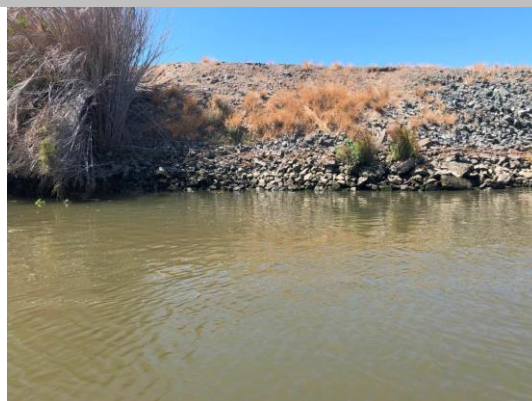
Photo 1 of 3 : SJR2019\_RD0524U01RM41.26\_1.JPG

LM Start	0.63	Rating **	U	Issue No.	15	
LM End	0.63	Issue Type +	Ma	Location *		
Category	Supplemental			GPS Latitude/Longitude		
				Start	End	
Item	DWR Erosion Survey			37.938247 °	37.938247 °	
				-121.336503 °	-121.336503 °	
DWR ID	RD0524U01RM41.26					
Comment Code						
Inspector Comment						
Site ID: RD0524U01RM41.26						
08/13/2019: No significant change observed.						
09/13/2017: The erosion was discovered by levee inspection. The erosion site is immediately downstream of tall vegetation.

Front view of the erosion. The erosion is located at the shadow of the vegetation.

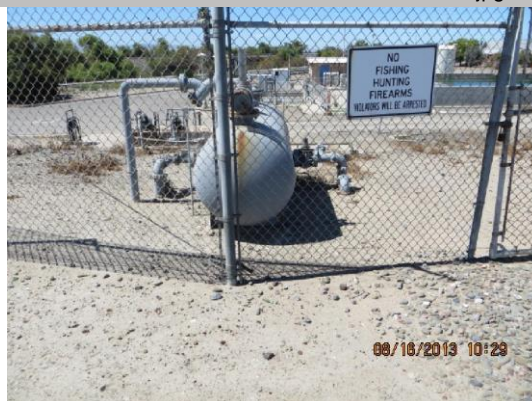
Photo 2 of 3 : UCIP\_FA\_2019\_17563\_29701.jpg

LM Start	0.67	Rating **	M	Issue No.	933 (cont)	
LM End	0.67	Issue Type +	En	Location *		
Category	Supplemental			GPS Latitude/Longitude		
				Start		End
Item	DRAFT DWR UCIP Field Study			37.937891 °		37.937891 °
				-121.335939 °		-121.335939 °
DWR ID	20592					
Comment Code						
Inspector Comment						
DS_ID:20592 FS_ID:17563 EP_NO: 6035 Repair Type: Non-Urgent Crossing Status: Found UCIP Comments: Flows from primer tank causing erosion on LS slope. FIELD_STRUCT_DESC: 48-inch coated steel sewer pipe through the levee, 7.3 feet below the crown. Siphon pumps and primer tank enclosed by cyclone fence on the landside (LS) shoulder. Gate valve at inlet sump 100 feet off the LS toe. One concrete cutoff wall. (Permit No. 6035, 1968 - City of Stockton). [Additional Reference(s): DWR Levee Log, 2004]. FS Date: 8/16/2013

Siphon Priming tank and associated pipes on LS shoulder.

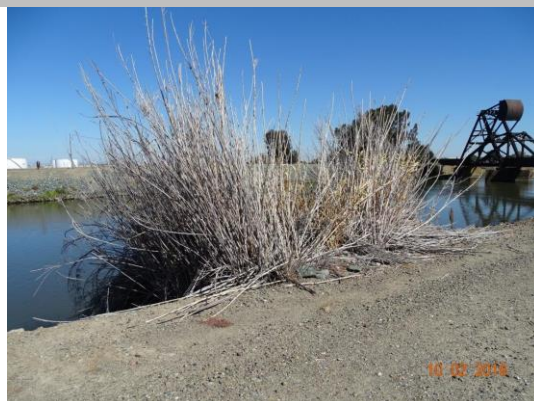
Photo 1 of 2 : FA\_2019\_RD0524\_107\_14\_20191117\_00363.jpg

LM Start	0.67	Rating **	U	Issue No.	14
LM End	0.67	Issue Type +	Ma	Location *	WS
Category	Earthen Levee			GPS Latitude/Longitude	
				Start	End
Item	Vegetation			37.937808 °	37.937808 °
				-121.335913 °	-121.335913 °
DWR ID	DWR_RD0524_01_s_2012_14				
Comment Code					
V2 : Remove the wild growth other than native grasses from the levee slopes.					
Inspector Comment					
Arundo on waterside slope

View of bamboo on waterside slope. Fall 2019

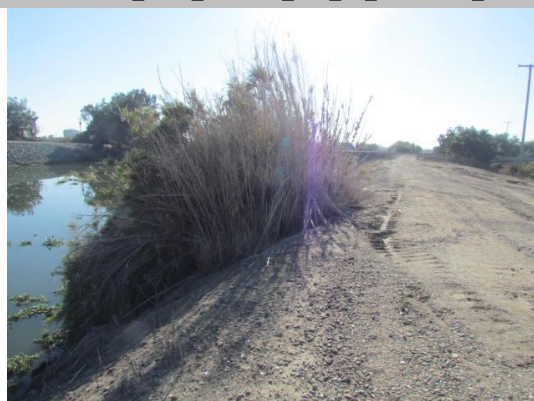
Photo 2 of 2 : FA\_2019\_RD0524\_107\_14\_20190830\_00015.jpg

Looking south at dying bamboo on waterward slope. Fall 2015

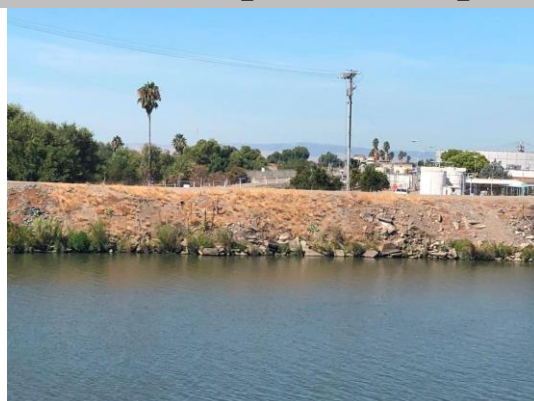
Photo 1 of 2 : SJR2019\_RD0524U01RM41.34\_1.JPG

LM Start	0.70	Rating **	M	Issue No.	16
LM End	0.70	Issue Type +	Ma	Location *	
Category	Supplemental			GPS Latitude/Longitude	
				Start	End
Item	DWR Erosion Survey			37.937577 °	37.937577 °
				-121.335491 °	-121.335491 °
DWR ID	RD0524U01RM41.34				
Comment Code					
Inspector Comment					
Site ID: RD0524U01RM41.34					
08/22/2019: No significant change observed.					
09/13/2017: Pocket erosion above the protected levee toe.

Front view of the erosion.

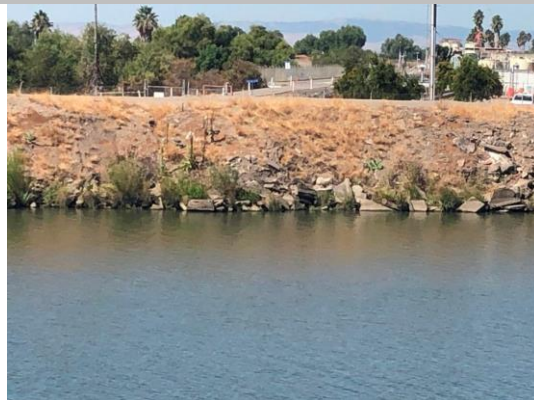
Photo 2 of 2 : SJR2019\_RD0524U01RM41.34\_2.JPG

LM Start	0.70	Rating **	M	Issue No.	16 (cont)	
LM End	0.70	Issue Type +	Ma	Location *		
Category	Supplemental			GPS Latitude/Longitude		
				Start	End	
Item	DWR Erosion Survey			37.937577°	37.937577°	
				-121.335491°	-121.335491°	
DWR ID	RD0524U01RM41.34					
Comment Code						
Inspector Comment						
Site ID: RD0524U01RM41.34						
08/22/2019: No significant change observed.						
09/13/2017: Pocket erosion above the protected levee toe.

Close-up view of the erosion.

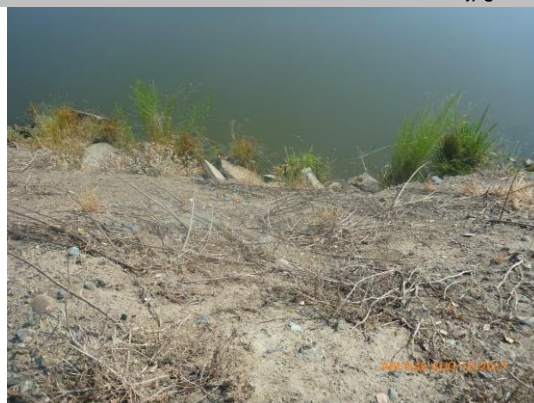
Photo 1 of 3 : LEVAL\_FA\_2019\_541\_4079.jpg

LM Start	0.70	Rating **	A/W	Issue No.	153
LM End	0.70	Issue Type +	Ma	Location *	
Category	Supplemental			GPS Latitude/Longitude	
				Start	End
Item	2017 Storm Damage			37.937500 °	37.937500 °
				-121.335500 °	-121.335500 °
DWR ID	LMA-447				
Comment Code					
Inspector Comment					
Levee Evaluation Comments					
Description:Slope protection repairs are needed along the waterside slope due to erosion and riprap displacement from high water. Based upon levee inspections, it was determined the waterside levee slope is eroding, deteriorating, and degrading. The eroded levee sections need to be restored back to design standards to prevent further deterioration and damage.					
Site ID No:541					
Site Designation:LMA-447					
Repair Type: Erosion					
Rating:Area of Concern					
Field Date:8/10/2017					
Notes:

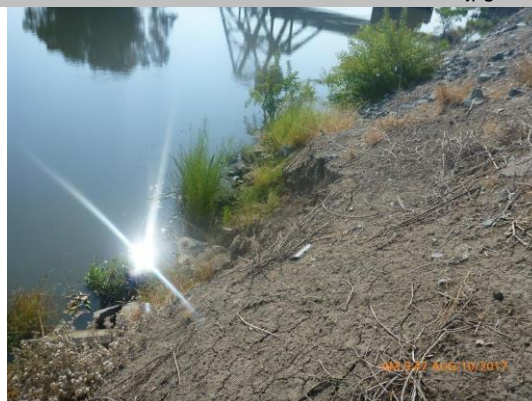
Photo 2 of 3 : LEVAL\_FA\_2019\_541\_4080.jpg

LM Start	<b>0.70</b>	Rating **	A/W	Issue No.	<b>153 (cont)</b>
LM End	<b>0.70</b>	Issue Type +	Ma	Location *	
Category	Supplemental			GPS Latitude/Longitude	
				Start	End
Item	2017 Storm Damage			37.937500°	37.937500°
				-121.335500°	-121.335500°
DWR ID	LMA-447				
Comment Code					
Inspector Comment					
<p>Levee Evaluation Comments</p> <p>Description: Slope protection repairs are needed along the waterside slope due to erosion and riprap displacement from high water. Based upon levee inspections, it was determined the waterside levee slope is eroding, deteriorating, and degrading. The eroded levee sections need to be restored back to design standards to prevent further deterioration and damage.</p> <p>Site ID No: 541</p> <p>Site Designation: LMA-447</p> <p>Repair Type: Erosion</p> <p>Rating: Area of Concern</p> <p>Field Date: 8/10/2017</p> <p>Notes:</p>

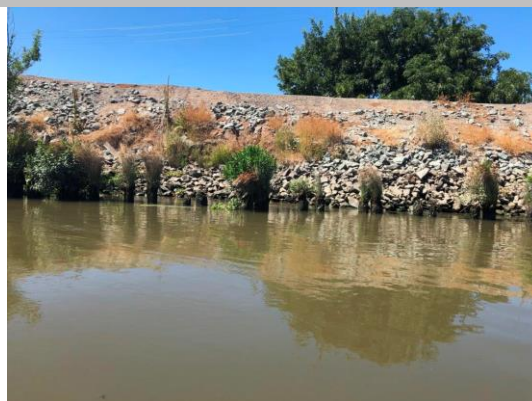
Photo 1 of 3 : SJR2019\_RD0524U01RM41.36\_1.JPG

LM Start	0.71	Rating **	M	Issue No.	17
LM End	0.73	Issue Type +	Ma	Location *	
Category	Supplemental			GPS Latitude/Longitude	
				Start	End
Item	DWR Erosion Survey			37.937222 °	37.937222 °
				-121.335277 °	-121.335277 °
DWR ID	RD0524U01RM41.36				
Comment Code					
Inspector Comment					
Site ID: RD0524U01RM41.36					
08/13/2019: No significant change observed.					
09/13/2017: No significant change observed.					
07/25/2016: No significant change observed.					
06/24/2015: The erosion site is immediately downstream of the RR bridge.

Front view of the erosion.

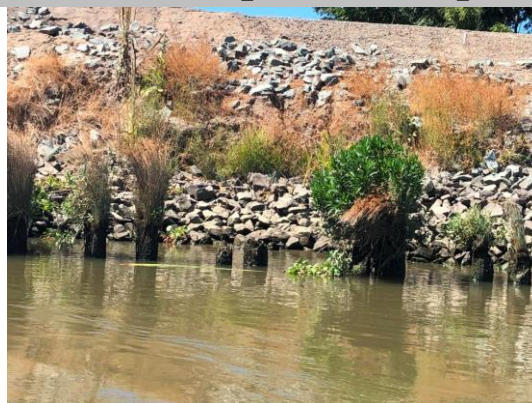
Photo 2 of 3 : SJR2019\_RD0524U01RM41.36\_2.JPG

Close-up view of the erosion.

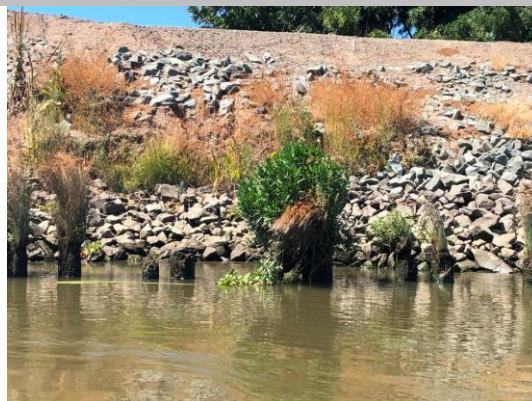
Photo 3 of 3 : SJR2019\_RD0524U01RM41.36\_3.JPG

Close-up view of the erosion.

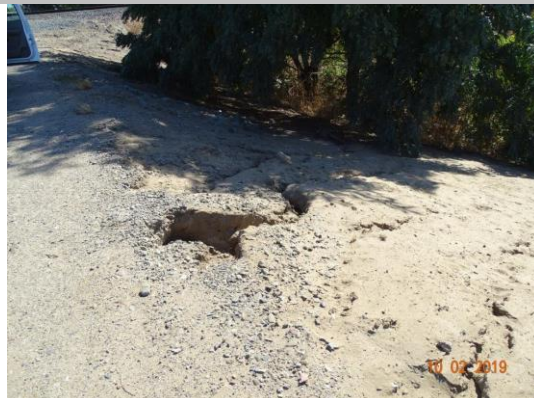
Photo 1 of 2 : FA\_2019\_RD0524\_107\_157\_20191117\_00364.jpg

LM Start	0.72	Rating **	M	Issue No.	157
LM End	0.72	Issue Type +	Ma	Location *	LS
Category	Earthen Levee			GPS Latitude/Longitude	
				Start	End
Item	Erosion / Bank Caving			37.937290 °	37.937290 °
				-121.335417 °	-121.335417 °
DWR ID	DWR_RD0524_01_s_2017_157				
Comment Code					
E2 : Schedule repair of erosion site prior to the next inspection.					
Inspector Comment					
Slope damage caused by rain runoff on landside slope.

View of erosion caused by surface runoff. Fall 2019

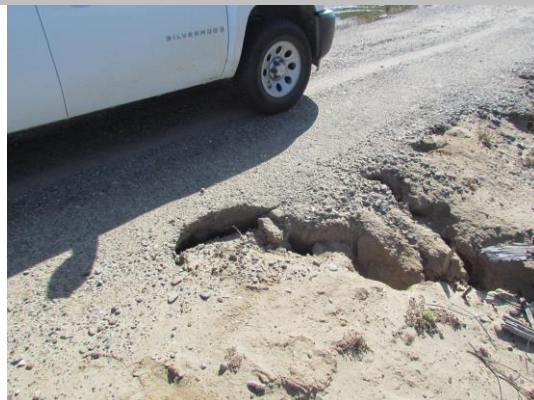
Photo 2 of 2 : FA\_2019\_RD0524\_107\_157\_20190830\_00148.jpg

Looking west at slope damage caused by rain runoff on landward slope.

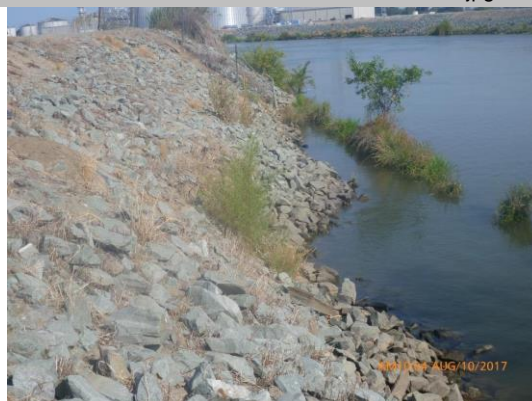
Photo 1 of 3 : LEVAL\_FA\_2019\_540\_4087.jpg

LM Start	0.72	Rating **	A/W	Issue No.	154
LM End	0.73	Issue Type +	Ma	Location *	
Category	Supplemental			GPS Latitude/Longitude	
				Start	End
Item	2017 Storm Damage			37.937200 °	37.937100 °
				-121.335300 °	-121.335300 °
DWR ID	LMA-446				
Comment Code					
Inspector Comment					
Levee Evaluation Comments					
Description:Slope protection repairs are needed along the waterside slope due to erosion and riprap displacement from high water. Based upon levee inspections, it was determined the waterside levee slope is eroding, deteriorating, and degrading. The eroded levee sections need to be restored back to design standards to prevent further deterioration and damage.					
Site ID No:540					
Site Designation:LMA-446					
Repair Type: Erosion					
Rating:Area of Concern					
Field Date:8/10/2017					
Notes:

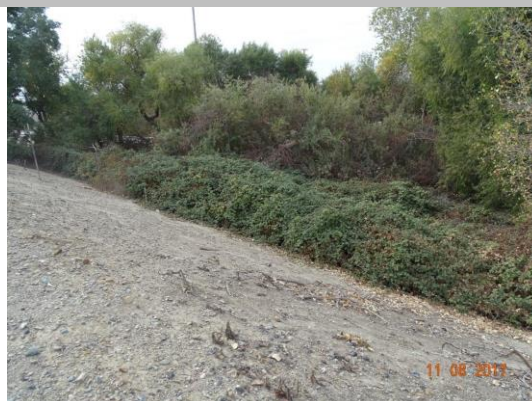
Photo 1 of 3 : FA\_2019\_RD0524\_107\_262\_20190830\_00244.jpg

LM Start	0.75	Rating **	U	Issue No.	262
LM End	0.78	Issue Type +	Ma	Location *	LS
Category	Earthen Levee			GPS Latitude/Longitude	
				Start	End
Item	Vegetation			37.936813 °	37.936539 °
				-121.335019 °	-121.334863 °
DWR ID	DWR_RD0524_01_s_2012_262				
Comment Code					
V2 : Remove the wild growth other than native grasses from the levee slopes.					
Inspector Comment					
Dense vegetation at landside toe along fence line.

Looking northeast at the landside slope.

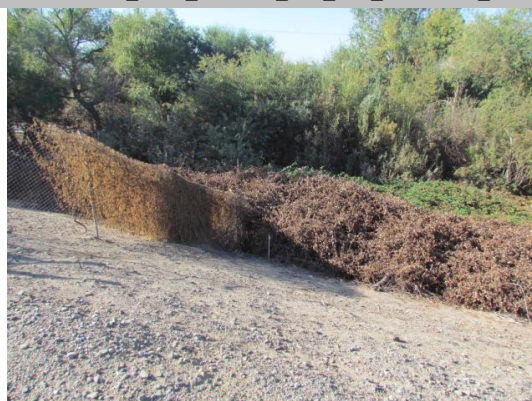
Photo 2 of 3 : FA\_2019\_RD0524\_107\_262\_20190830\_00245.jpg

Looking west at dense vegetation at landward slope and toe fall 2015.

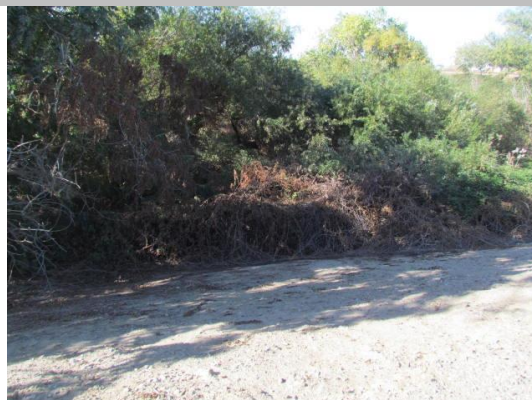
Photo 3 of 3 : FA\_2019\_RD0524\_107\_262\_20190830\_00246.jpg

Looking west at dense vegetation on landside toe. Spring 2014

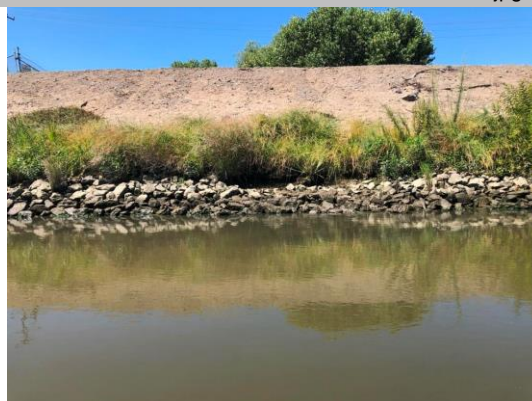
Photo 1 of 3 : SJR2019\_RD0524U01RM41.39\_1.jpg

Front view of the erosion site.

LM Start	0.76	Rating **	U	Issue No.	21 (cont)	
LM End	0.77	Issue Type +	Ma	Location *		
Category	Supplemental			GPS Latitude/Longitude		
				Start	End	
Item	DWR Erosion Survey			37.936821 °	37.936821 °	
				-121.334582 °	-121.334582 °	
DWR ID	RD0524U01RM41.39					
Comment Code						
Inspector Comment						
Site ID: RD0524U01RM41.39						
08/13/2019: No significant change observed.						
09/13/2017: No significant change observed.						
07/25/2016: No significant change observed.						
06/24/2015: No significant change observed.						
06/19/2014: No significant change observed.						
08/13/2013: No significant change at this site.						
08/07/2012: The site has been visited by boat survey. No significant change observed.						
08/23/2011: The site is located immediately upstream of a Railroad bridge. Dense vegetation at the water line blocks the view of erosion.

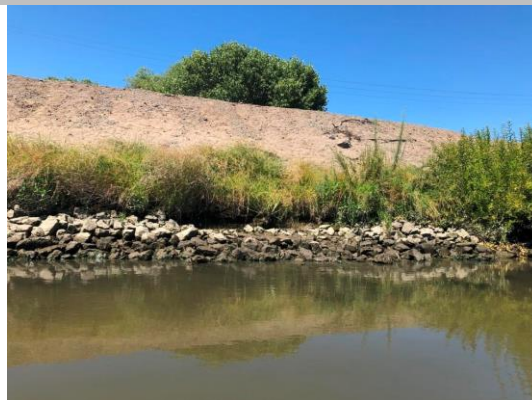
Photo 2 of 3 : SJR2019\_RD0524U01RM41.39\_2.jpg

Front view of the erosion site. Vegetation is visible.

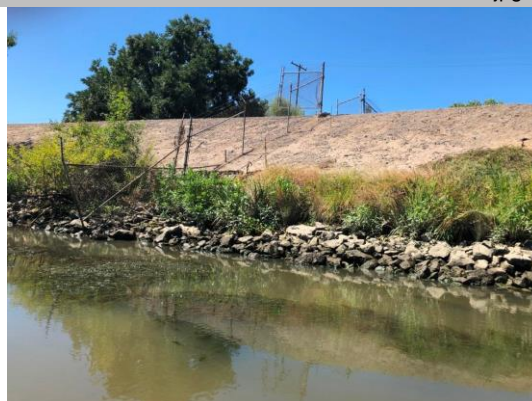
Photo 3 of 3 : SJR2019\_RD0524U01RM41.39\_3.jpg

Downstream view of the erosion.

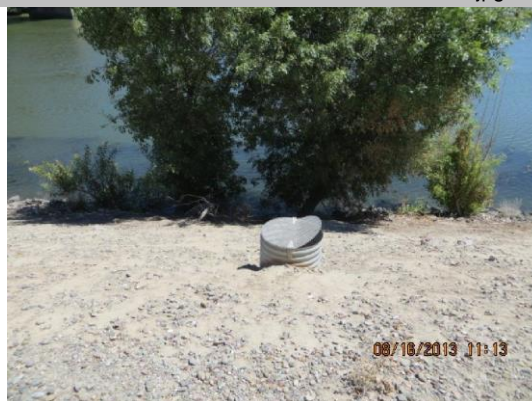
Photo 1 of 2 : UCIP\_FA\_2019\_17571\_29719.jpg

LM Start	0.78	Rating **	M	Issue No.	935	
LM End	0.78	Issue Type +	En	Location *		
Category	Supplemental			GPS Latitude/Longitude		
				Start		End
Item	DRAFT DWR UCIP Field Study			37.936474 °		37.936474 °
				-121.334830 °		-121.334830 °
DWR ID	20596					
Comment Code						
Inspector Comment						
DS_ID:20596 FS_ID:17571 EP_NO: N/A Repair Type: Non-Urgent Crossing Status: Found UCIP Comments: Large hole in pipe at WS toe. Appears abandoned and should be done so properly. FIELD_STRUCT_DESC: 8-inch steel pipe of unknown purpose through the levee, 4 feet below the crown. Pump at the toe of the landside (LS) slope, not found 8/16/13. Siphon breaker in 24-inch corrugated metal riser unit on the waterside (WS) slope. [Additional Reference(s): USACE San Joaquin O&M Manual 7, April 1964, (HLM 0.79)]. FS Date: 8/16/2013

Siphon breaker in 24-inch cmp riser on WS slope.

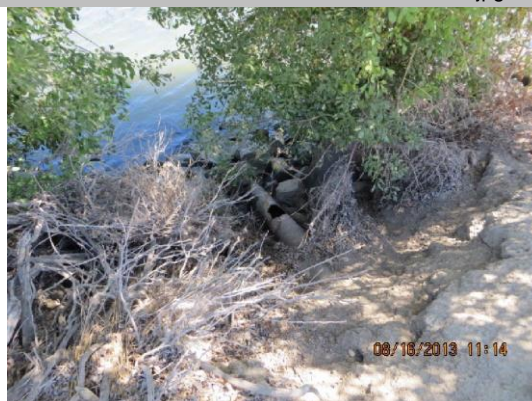
Photo 2 of 2 : UCIP\_FA\_2019\_17571\_29718.jpg

LM Start	0.78	Rating **	M	Issue No.	935 (cont)	
LM End	0.78	Issue Type +	En	Location *		
Category	Supplemental			GPS Latitude/Longitude		
				Start	End	
Item	DRAFT DWR UCIP Field Study			37.936474 °	37.936474 °	
				-121.334830 °	-121.334830 °	
DWR ID	20596					
Comment Code						
Inspector Comment						
DS_ID:20596 FS_ID:17571 EP_NO: N/A Repair Type: Non-Urgent Crossing Status: Found UCIP Comments: Large hole in pipe at WS toe. Appears abandoned and should be done so properly. FIELD_STRUCT_DESC: 8-inch steel pipe of unknown purpose through the levee, 4 feet below the crown. Pump at the toe of the landside (LS) slope, not found 8/16/13. Siphon breaker in 24-inch corrugated metal riser unit on the waterside (WS) slope. [Additional Reference(s): USACE San Joaquin O&M Manual 7, April 1964, (HLM 0.79)]. FS Date: 8/16/2013

Large hole in pipe at WS toe.

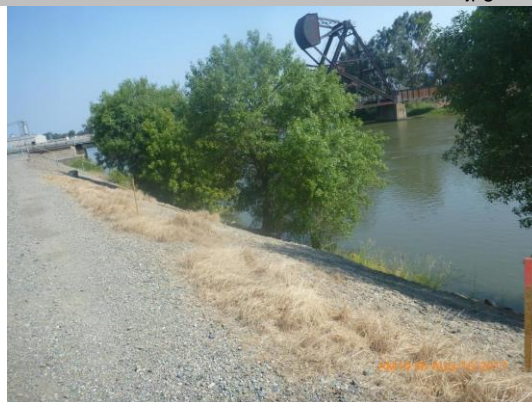
Photo 1 of 3 : LEVAL\_FA\_2019\_538\_4097.jpg

LM Start	0.79	Rating **	A/W	Issue No.	155
LM End	0.80	Issue Type +	Ma	Location *	WS
Category	Supplemental			GPS Latitude/Longitude	
				Start	End
Item	2017 Storm Damage			37.936300 °	37.936200 °
				-121.334700 °	-121.334600 °
DWR ID	LMA-444				
Comment Code					
Inspector Comment					
Levee Evaluation Comments					
Description:Slope protection repairs are needed along the waterside slope due to erosion and riprap displacement from high water. Based upon levee inspections, it was determined the waterside levee slope is eroding, deteriorating, and degrading. The eroded levee sections need to be restored back to design standards to prevent further deterioration and damage.					
Site ID No:538					
Site Designation:LMA-444					
Repair Type: Erosion					
Rating:Area of Concern					
Field Date:8/10/2017					
Notes:

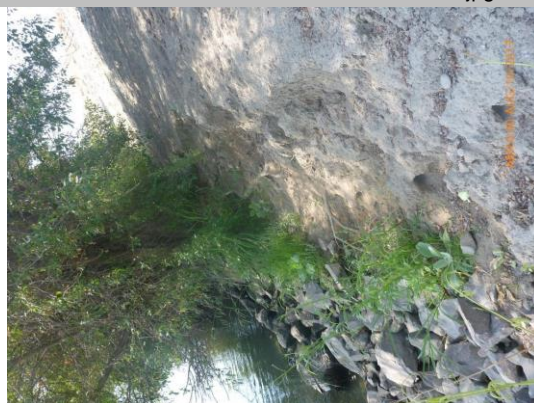
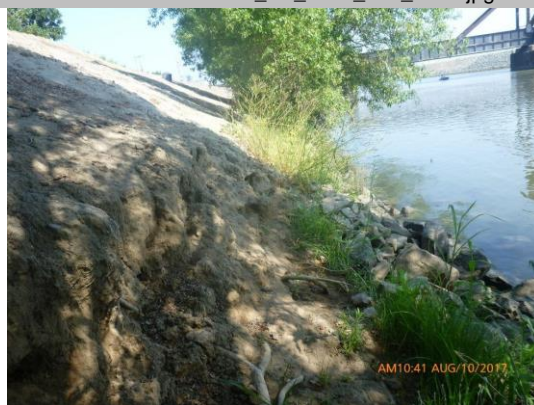
LM Start	0.79	Rating **	A/W	Issue No.	155 (cont)
LM End	0.80	Issue Type +	Ma	Location *	WS
Category	Supplemental			GPS Latitude/Longitude	
				Start	End
Item	2017 Storm Damage			37.936300 °	37.936200 °
				-121.334700 °	-121.334600 °
DWR ID	LMA-444				
Comment Code					
Inspector Comment					
Levee Evaluation Comments					
Description:Slope protection repairs are needed along the waterside slope due to erosion and riprap displacement from high water. Based upon levee inspections, it was determined the waterside levee slope is eroding, deteriorating, and degrading. The eroded levee sections need to be restored back to design standards to prevent further deterioration and damage.					
Site ID No:538					
Site Designation:LMA-444					
Repair Type: Erosion					
Rating:Area of Concern					
Field Date:8/10/2017					
Notes:

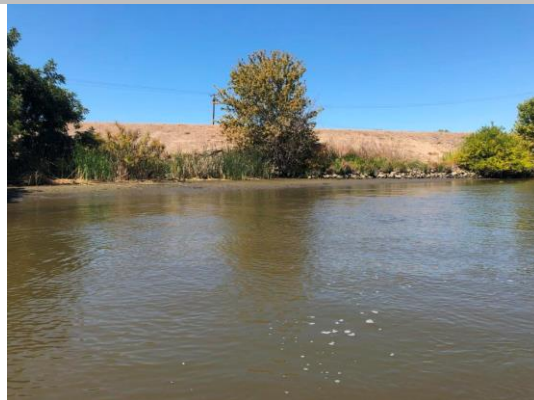
Photo 1 of 3 : SJR2019\_RD0524U01RM41.44\_1.JPG

Front view of the erosion. The tree and vegetation block the view of the site.

LM Start	0.83	Rating **	U	Issue No.	22 (cont)	
LM End	0.84	Issue Type +	Ma	Location *		
Category	Supplemental			GPS Latitude/Longitude		
				Start	End	
Item	DWR Erosion Survey			37.935930 °	37.935930 °	
				-121.334133 °	-121.334133 °	
DWR ID	RD0524U01RM41.44					
Comment Code						
Inspector Comment						
Site ID: RD0524U01RM41.44						
08/13/2019: No significant change observed.						
09/13/2017: No significant change observed.						
07/25/2016: No significant change observed.						
06/24/2015: No significant change observed.						
06/19/2014: No significant change observed.						
08/13/2013: Site was discovered during boat survey. The dense vegetation blocks a clear view of the erosion. Size of erosion site was very roughly estimated.

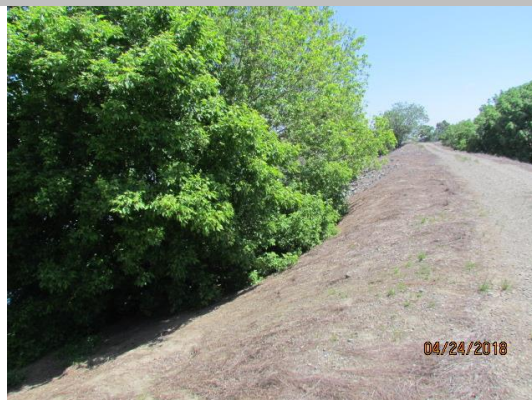
Photo 1 of 1 : FA\_2019\_RD0524\_107\_149\_20190830\_00135.jpg

Looking southeast at untrimmed trees on waterward slope. (Spring 2018)

LM Start	0.90	Rating **	M	Issue No.	149
LM End	0.90	Issue Type +	Ma	Location *	WS
Category	Earthen Levee			GPS Latitude/Longitude	
				Start	End
Item	Trim / Thin Trees			37.935319 °	37.935319 °
				-121.333406 °	-121.333406 °
DWR ID	DWR_RD0524_01_s_2018_149				
Comment Code					
T1 : Trim trees to at least five feet above ground level.					
Inspector Comment

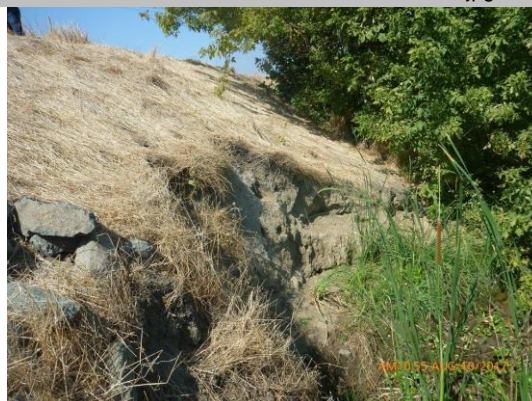
Photo 1 of 3 : LEVAL\_FA\_2019\_537\_4102.jpg

LM Start	0.90	Rating **	A/W	Issue No.	193
LM End	0.91	Issue Type +	Ma	Location *	
Category	Supplemental			GPS Latitude/Longitude	
				Start	End
Item	2017 Storm Damage			37.935400 °	37.935300 °
				-121.333300 °	-121.333200 °
DWR ID	LMA-443				
Comment Code					
Inspector Comment					
Levee Evaluation Comments					
Description:Slope protection repairs are needed along the waterside slope due to erosion and riprap displacement from high water. Based upon levee inspections, it was determined the waterside levee slope is eroding, deteriorating, and degrading. The eroded levee sections need to be restored back to design standards to prevent further deterioration and damage.					
Site ID No:537					
Site Designation:LMA-443					
Repair Type: Erosion					
Rating:Serious					
Field Date:8/10/2017					
Notes:

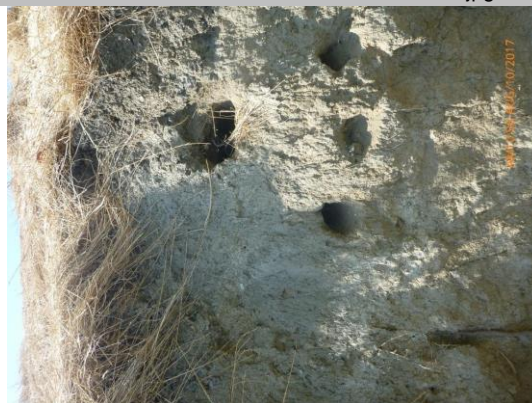
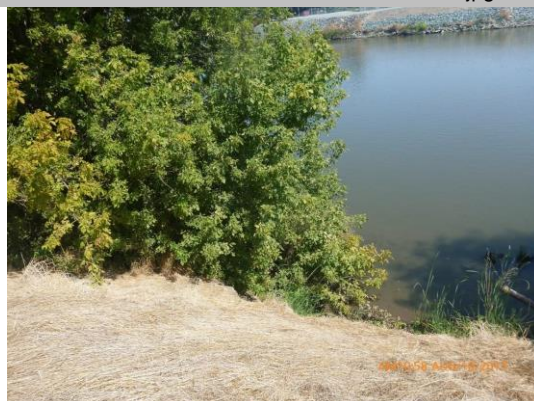
LM Start	0.90	Rating **	A/W	Issue No.	193 (cont)	
LM End	0.91	Issue Type +	Ma	Location *		
Category	Supplemental			GPS Latitude/Longitude		
				Start	End	
Item	2017 Storm Damage			37.935400 °	37.935300 °	
				-121.333300 °	-121.333200 °	
DWR ID	LMA-443					
Comment Code						
Inspector Comment						
Levee Evaluation Comments						
Description:Slope protection repairs are needed along the waterside slope due to erosion and riprap displacement from high water. Based upon levee inspections, it was determined the waterside levee slope is eroding, deteriorating, and degrading. The eroded levee sections need to be restored back to design standards to prevent further deterioration and damage.						
Site ID No:537						
Site Designation:LMA-443						
Repair Type: Erosion						
Rating:Serious						
Field Date:8/10/2017						
Notes:

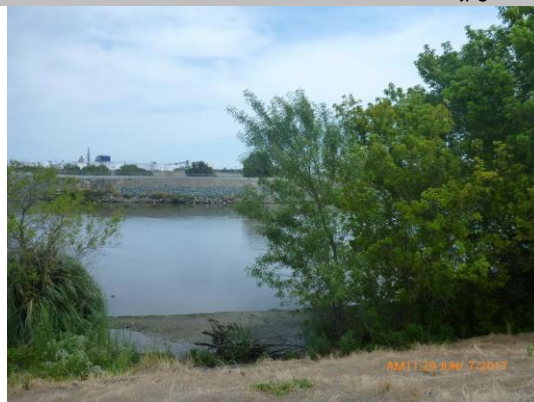
Photo 1 of 3 : LEVAL\_FA\_2019\_87\_1285.jpg

LM Start	0.91	Rating **	A/W	Issue No.	187	
LM End		Issue Type +	Ma	Location *		
Category	Supplemental			GPS Latitude/Longitude		
				Start	End	
Item	2017 Storm Damage			37.935580°		°
				-121.333200°		°
DWR ID	DWR_RD0524_01_s_2012_99					
Comment Code						
Inspector Comment						
Levee Evaluation Comments						
Description:						
Site ID No:87						
Site Designation:DWR_RD0524_01_s_2012_99						
Repair Type: Erosion						
Rating:Area of Concern						
Field Date:6/7/2017						
Notes: no observable defects to levee, vegetation blocks ws toe

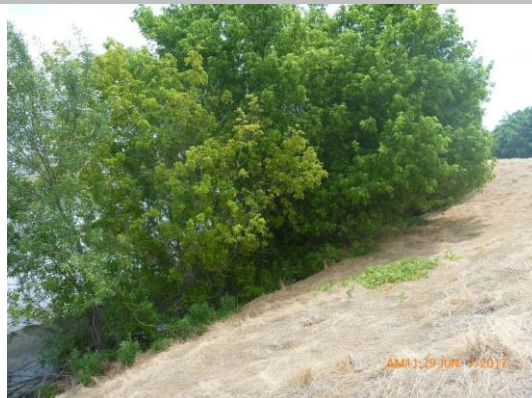
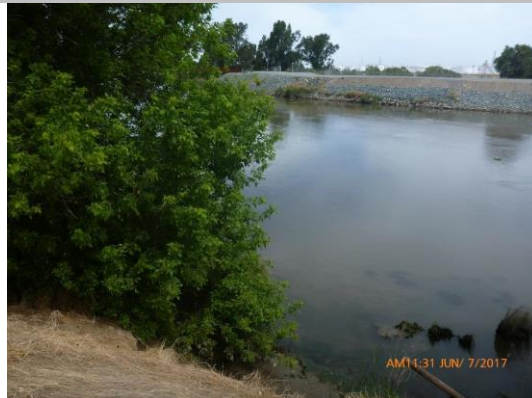
LM Start	0.91	Rating **	A/W	Issue No.	187 (cont)	
LM End		Issue Type +	Ma	Location *		
Category	Supplemental			GPS Latitude/Longitude		
				Start	End	
Item	2017 Storm Damage			37.935580 °	°	
				-121.333200 °	°	
DWR ID	DWR_RD0524_01_s_2012_99					
Comment Code						
Inspector Comment						
Levee Evaluation Comments						
Description:						
Site ID No:87						
Site Designation:DWR_RD0524_01_s_2012_99						
Repair Type: Erosion						
Rating:Area of Concern						
Field Date:6/7/2017						
Notes: no observable defects to levee, vegetation blocks ws toe

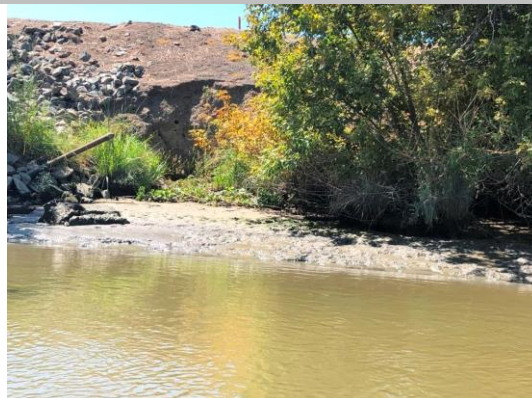
Photo 1 of 3 : SJR2019\_RD0524U01RM41.50\_2.jpg

Site ID: RD0524U01RM41.5  
 08/13/2019: No significant change observed. Signs of animal activities at the site.  
 09/13/2017: No significant change observed.  
 07/25/2016: No significant change observed.  
 06/24/2015: No significant change observed.  
 06/19/2014: No significant change observed.  
 08/13/2013: No significant change at this site.  
 08/07/2012: The site has been visited by boat survey. No significant change observed  
 08/23/2011: The erosion site is immediately downstream of the riprap protection.

Front view of the erosion.

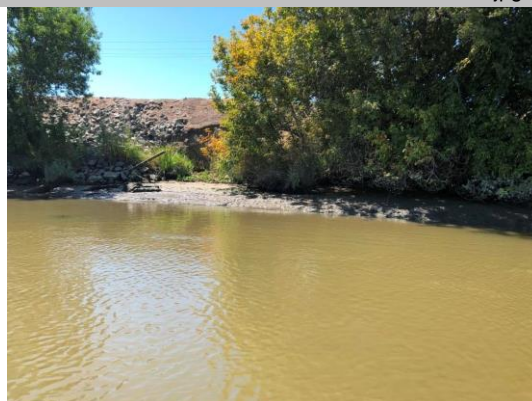
Photo 3 of 3 : SJR2019\_RD0524U01RM41.50\_3.jpg

LM Start	0.91	Rating **	U	Issue No.	29 (cont)	
LM End	0.91	Issue Type +	Ma	Location *		
Category	Supplemental			GPS Latitude/Longitude		
				Start	End	
Item	DWR Erosion Survey			37.935576 °	37.935576 °	
				-121.333202 °	-121.333202 °	
DWR ID	RD0524U01RM41.5					
Comment Code						
Inspector Comment						
Site ID: RD0524U01RM41.5						
08/13/2019: No significant change observed. Signs of animal activities at the site.						
09/13/2017: No significant change observed.						
07/25/2016: No significant change observed.						
06/24/2015: No significant change observed.						
06/19/2014: No significant change observed.						
08/13/2013: No significant change at this site.						
08/07/2012: The site has been visited by boat survey. No significant change observed						
08/23/2011: The erosion site is immediately downstream of the riprap protection.

Close-up view of the erosion.

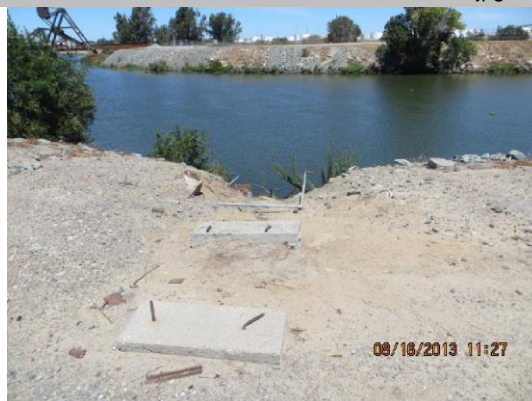
Photo 1 of 3 : UCIP\_FA\_2019\_22724\_38442.jpg

DS\_ID:20597  
FS\_ID:22724  
EP\_NO: N/A  
Repair Type: Non-Urgent  
Crossing Status: Found  
UCIP Comments: 11/16/2016 - Location may be at LM 0.92 (37.935267, -121.332985) rather than LM 0.974. Need to field verify (DWR UCIP - thatch)  
8/16/2013 - Pipe abandoned and should be done so properly. (DWR UCIP -wwylie)  
FIELD\_STRUCT\_DESC: \*ABANDONED\* 14-inch irrigation pipe of an unknown material through the levee, 6 feet below the crown. Concrete pad for pump on the waterside (WS) shoulder. No pump or other appurtenances remain. [Additional Reference(s): DWR Levee Log, 2004. USACE San Joaquin O&M Manual 7, April 1964, (HLM 0.93)].  
FS Date: 8/16/2013

Concrete pad for pump mount on WS shoulder.

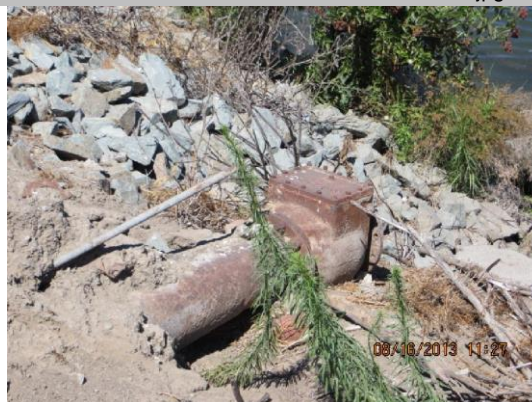
Photo 2 of 3 : UCIP\_FA\_2019\_22724\_38441.jpg

Pipe visible on WS slope.

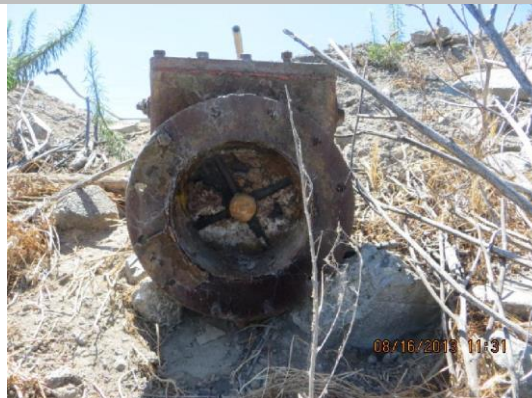
Photo 3 of 3 : UCIP\_FA\_2019\_22724\_38440.jpg

Comment Code						
Inspector Comment						
DS_ID:20597 FS_ID:22724 EP_NO: N/A Repair Type: Non-Urgent Crossing Status: Found UCIP Comments: 11/16/2016 - Location may be at LM 0.92 (37.935267, -121.332985) rather than LM 0.974. Need to field verify (DWR UCIP - thatch) 8/16/2013 - Pipe abandoned and should be done so properly. (DWR UCIP -wwylie) FIELD_STRUCT_DESC: *ABANDONED* 14-inch irrigation pipe of an unknown material through the levee, 6 feet below the crown. Concrete pad for pump on the waterside (WS) shoulder. No pump or other appurtenances remain. [Additional Reference(s): DWR Levee Log, 2004. USACE San Joaquin O&M Manual 7, April 1964, (HLM 0.93)]. FS Date: 8/16/2013

One way check valve closed on WS slope.

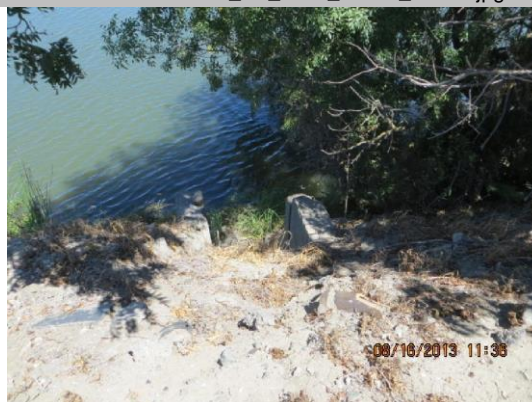
Photo 1 of 2 : UCIP\_FA\_2019\_17575\_29736.jpg

LM Start	0.98	Rating **	A/W	Issue No.	937
LM End	0.98	Issue Type +	Ma	Location *	
Category	Supplemental			GPS Latitude/Longitude	
				Start	End
Item	DRAFT DWR UCIP LMA Responsibility			37.935163°	37.935163°
				-121.331887°	-121.331887°
DWR ID	20598				
Comment Code					
Inspector Comment					
DS_ID:20598					
FS_ID:17575					
EP_NO: N/A					
Repair Type: No Action Needed					
Crossing Status: Found					
UCIP Comments:					
FIELD_STRUCT_DESC: *ABANDONED* 36-inch drainage pipe of an unknown material through the levee, 15 feet below the crown. Landside (LS) end is not visible. Concrete headwall at outlet on the waterside (WS) slope is visible. Pipe appears to be abandoned in place. Slide gate on the WS removed. [Additional Reference(s): DWR Levee Log, 2004. USACE San Joaquin O&M Manual 7, April 1964, (HLM 0.99)].					
FS Date: 8/16/2013

Concrete headwall visible on WS slope.

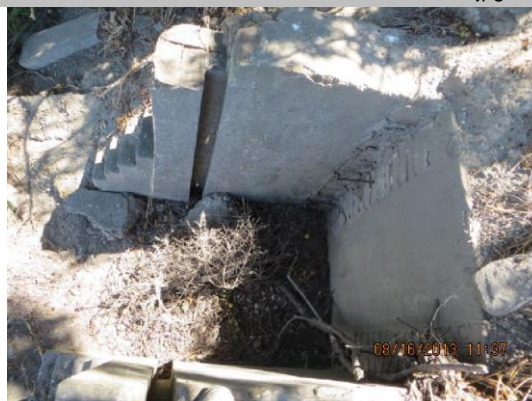
Photo 2 of 2 : UCIP\_FA\_2019\_17575\_29735.jpg

Slide gate removed from headwall on WS slope.

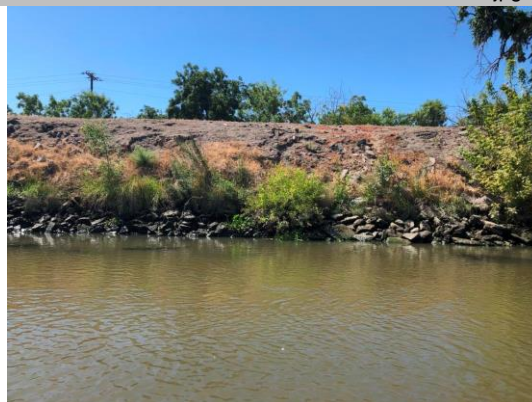
Photo 1 of 3 : SJR2019\_RD0524U01RM41.58\_1.jpg

LM Start	1.00	Rating **	U	Issue No.	30	
LM End	1.00	Issue Type +	Ma	Location *		
Category	Supplemental			GPS Latitude/Longitude		
				Start	End	
Item	DWR Erosion Survey			37.935410	°	
				-121.331560	°	
DWR ID	RD0524U01RM41.58					
Comment Code						
Inspector Comment						
Site ID: RD0524U01RM41.58						
08/13/2019: No significant change observed.						
09/13/2017: No significant change observed.						
07/25/2016: No significant change observed.						
06/24/2015: No significant change observed.						
06/19/2014: No significant change observed.						
08/13/2013: No significant change at this site.						
08/07/2012: The erosion was discovered during the boat survey.

Front view of the erosion.

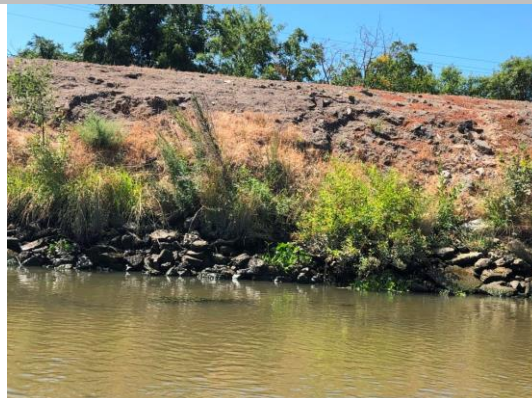
Photo 2 of 3 : SJR2019\_RD0524U01RM41.58\_3.jpg

LM Start	1.00	Rating **	U	Issue No.	30 (cont)	
LM End	1.00	Issue Type +	Ma	Location *		
Category	Supplemental			GPS Latitude/Longitude		
				Start	End	
Item	DWR Erosion Survey			37.935410°	37.935410°	
				-121.331560°	-121.331560°	
DWR ID	RD0524U01RM41.58					
Comment Code						
Inspector Comment						
Site ID: RD0524U01RM41.58						
08/13/2019: No significant change observed.						
09/13/2017: No significant change observed.						
07/25/2016: No significant change observed.						
06/24/2015: No significant change observed.						
06/19/2014: No significant change observed.						
08/13/2013: No significant change at this site.						
08/07/2012: The erosion was discovered during the boat survey.

Close-up view of the erosion.

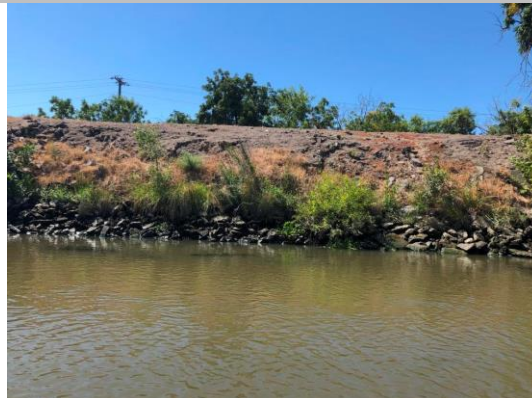
Photo 3 of 3 : SJR2019\_RD0524U01RM41.58\_2.jpg

Front view of the erosion.

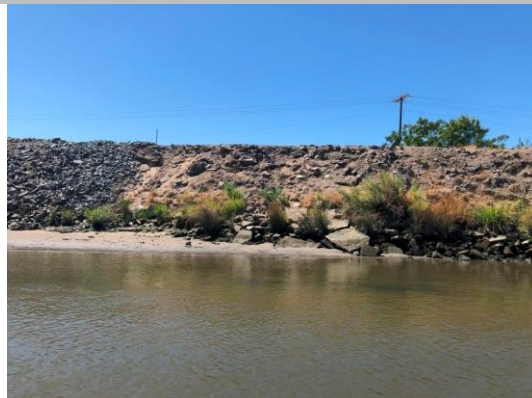
Photo 1 of 3 : SJR2019\_RD0524U01RM41.59\_1.jpg

Site ID: RD0524U01RM41.59  
 08/13/2019: No significant change observed.  
 09/13/2017: No significant change observed.  
 07/25/2016: No significant change observed.  
 06/24/2015: No significant change observed.  
 06/19/2014: No significant change observed.  
 08/13/2013: No significant change at this site.  
 08/07/2012: The site has been visited by boat survey. Site has been repaired, but new erosion occurred at the levee slope and immediately upstream of the repaired site.  
 08/23/2011: The site is about 500 ft downstream of bridge. The levee toe seems to be protected, but the protection is being washed away.

Front view of the site.

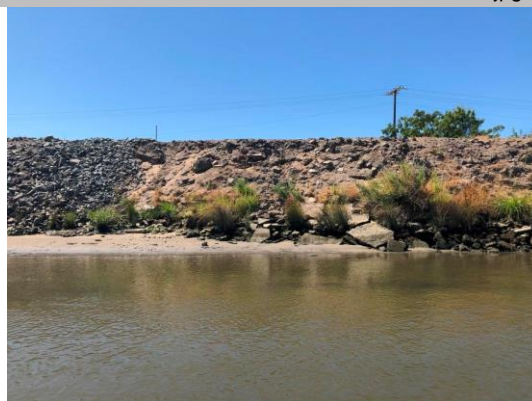
Photo 3 of 3 : SJR2019\_RD0524U01RM41.59\_2.jpg

Comment Code						
Inspector Comment						
Site ID: RD0524U01RM41.59 08/13/2019: No significant change observed. 09/13/2017: No significant change observed. 07/25/2016: No significant change observed. 06/24/2015: No significant change observed. 06/19/2014: No significant change observed. 08/13/2013: No significant change at this site. 08/07/2012: The site has been visited by boat survey. Site has been repaired, but new erosion occurred at the levee slope and immediately upstream of the repaired site. 08/23/2011: The site is about 500 ft downstream of bridge. The levee toe seems to be protected, but the protection is being washed away.

Front view of the site.

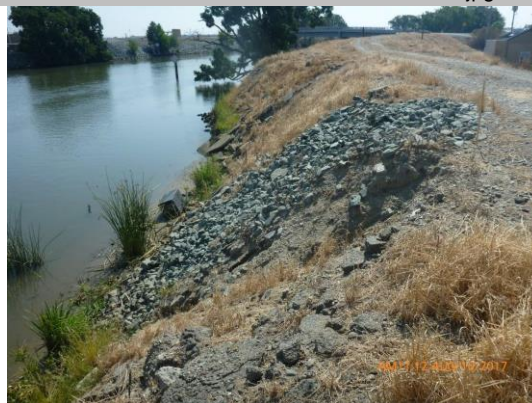
Photo 1 of 3 : LEVAL\_FA\_2019\_536\_4109.jpg

Comment Code					
Inspector Comment					
Levee Evaluation Comments					
Description:Slope protection repairs are needed along the waterside slope due to erosion and riprap displacement from high water. Based upon levee inspections, it was determined the waterside levee slope is eroding, deteriorating, and degrading. The eroded levee sections need to be restored back to design standards to prevent further deterioration and damage.					
Site ID No:536					
Site Designation:LMA-442					
Repair Type: Erosion					
Rating:Area of Concern					
Field Date:8/10/2017					
Notes: Appears to be previous repair site adjacent to LMA-442. Large fox den on land side

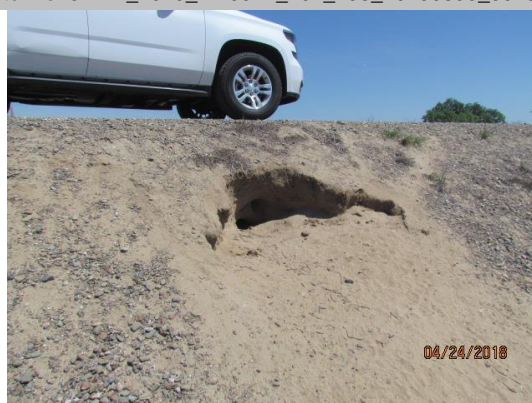
Photo 2 of 3 : FA\_2019\_RD0524\_107\_238\_20190830\_00234.jpg

Looking east at large rodent hole on landward slope. (Spring 2018)

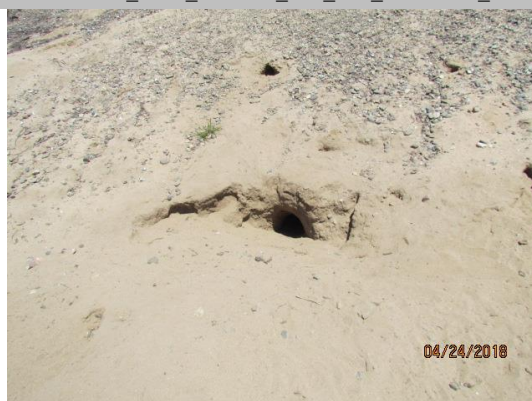
Photo 3 of 3 : FA\_2019\_RD0524\_107\_238\_20190830\_00235.jpg

Looking northeast at rodent hole on landward slope. (Spring 2018)

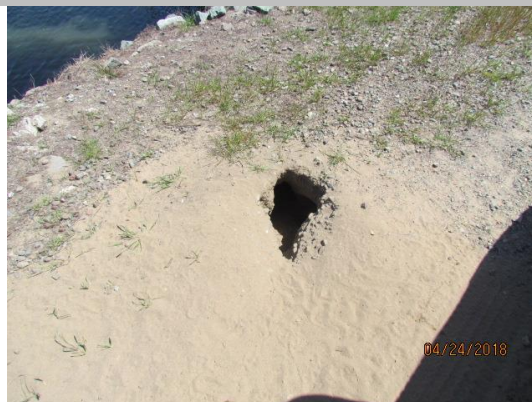
Photo 1 of 3 : FA\_2019\_RD0524\_107\_150\_20190830\_00136.jpg

LM Start	1.04	Rating **	U	Issue No.	150
LM End	1.04	Issue Type +	Ma	Location *	WS
Category	Earthen Levee			GPS Latitude/Longitude	
				Start	End
Item	Animal Control			37.934896 °	37.934896 °
				-121.330781 °	-121.330781 °
DWR ID	DWR_RD0524_01_s_2018_150				
Comment Code					
A3 : No rodents visible, but rodent burrows visible; need to backfill and compact or grout burrows.					
Inspector Comment					
Large rodent hole on waterward shoulder and crown of levee.

Looking at close-up view of rodent hole on waterward shoulder. (Spring 2018)

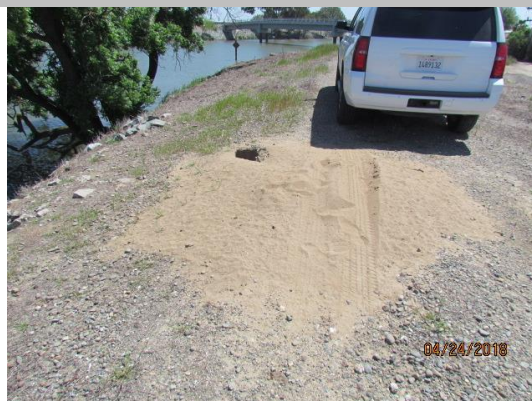
Photo 2 of 3 : FA\_2019\_RD0524\_107\_150\_20190830\_00137.jpg

LM Start	1.04	Rating **	U	Issue No.	150 (cont)	
LM End	1.04	Issue Type +	Ma	Location *	WS	
Category	Earthen Levee			GPS Latitude/Longitude		
				Start	End	
Item	Animal Control			37.934896 °	37.934896 °	
				-121.330781 °	-121.330781 °	
DWR ID	DWR_RD0524_01_s_2018_150					
Comment Code						
A3 : No rodents visible, but rodent burrows visible; need to backfill and compact or grout burrows.						
Inspector Comment						
Large rodent hole on waterward shoulder and crown of levee.

Looking south at large rodent hole on waterward shoulder. (Spring 2018)

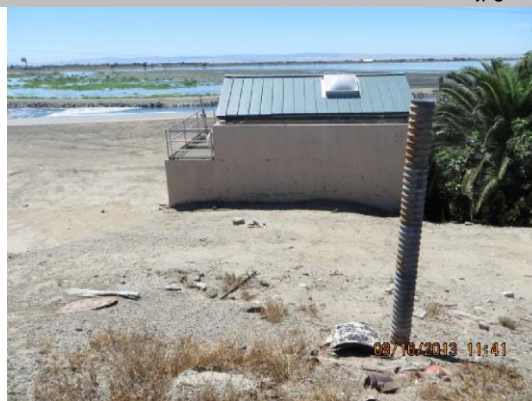
Photo 1 of 2 : UCIP\_FA\_2019\_18703\_31243.jpg

Comment Code						
Inspector Comment						
DS_ID:20600 FS_ID:18703 EP_NO: 2725B Repair Type: Non-Urgent Crossing Status: Found UCIP Comments: Given amount of rust on adjacent CMP riser, it may be appropriate to do a video inspection of this pipe. FIELD_STRUCT_DESC: 36-inch concrete encased sewer pipe through the levee, 11.5 feet below the crown. Pump in pump house on the landside (LS). Flap gate on the waterside (WS) end. Two concrete cutoff walls. Siphon breaker in 8-inch corrugated metal riser unit on the LS slope. (Permit No. 2725-B, 1959 - City of Stockton). [Additional Reference(s): DWR Levee Log, 2004. USACE San Joaquin O&M Manual 7, April 1964, (HLM 1.08)]. FS Date: 8/16/2013

8-inch CMP standpipe on LS slope with pumphouse in background.

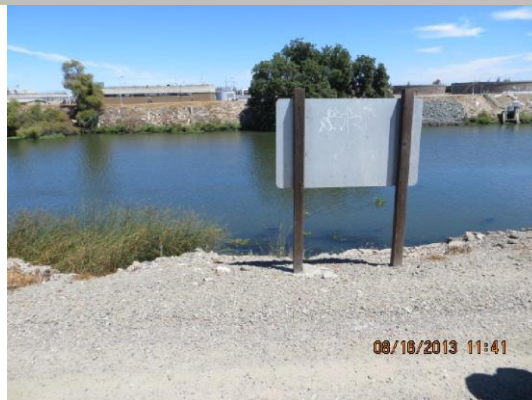
Photo 2 of 2 : UCIP\_FA\_2019\_18703\_31242.jpg

Caution sign on WS shoulder for pipe crossings.

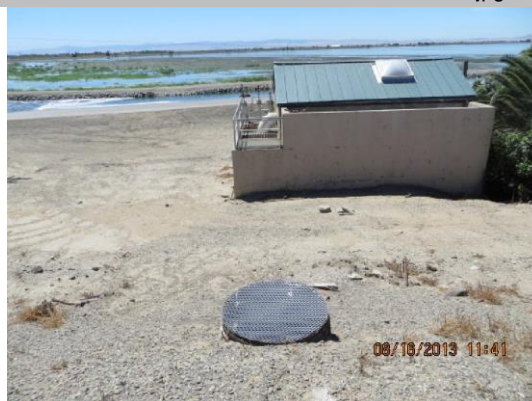
Photo 1 of 3 : UCIP\_FA\_2019\_17589\_29748.jpg

Comment Code					
Inspector Comment					
DS_ID:20601 FS_ID:17589 EP_NO: 2725B Repair Type: Non-Urgent Crossing Status: Found UCIP Comments: CMP riser severely corroded. Good indicator of potential condition of 48-inch pipe. Recommend Video Inspection. FIELD_STRUCT_DESC: 48-inch corrugated metal sewer line through the levee, 16 feet below the crown. Runs underneath the river and through the levee with 36-inch corrugated metal riser unit/inspection chamber on the landside (LS) shoulder. Distribution/pump house on the LS toe. (Permit No. 2725-B, 1959 - City of Stockton). [Additional Reference(s): DWR Levee Log, 2004. USACE San Joaquin O&M Manual 7, April 1964, (HLM 1.08)]. FS Date: 8/16/2013

CMP riser for access/inspection on LS slope with distribution/pumphouse on LS toe.

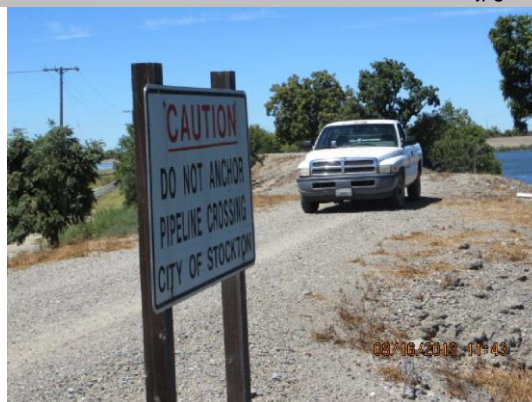
Photo 2 of 3 : UCIP\_FA\_2019\_17589\_29747.jpg

Caution sign on WS shoulder.
