**Flood Control Project Maintenance  
Levee Inspections**

**Fall 2019 Levee Maintenance Deficiency Summary Report**

**Flood Control Project Maintenance  
Levee Inspections****LMA District Cover Sheet****Fall 2019 Levee Inspection Results****Reclamation District No. 0524 Middle Roberts Island**

**Reclamation District No. 0524 Middle Roberts Island**

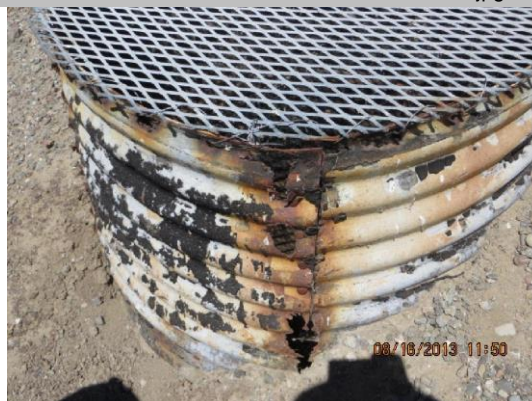
Photo 3 of 3 : UCIP\_FA\_2019\_17589\_29746.jpg

Comment Code						
Inspector Comment						
DS_ID:20601 FS_ID:17589 EP_NO: 2725B Repair Type: Non-Urgent Crossing Status: Found UCIP Comments: CMP riser severely corroded. Good indicator of potential condition of 48-inch pipe. Recommend Video Inspection. FIELD_STRUCT_DESC: 48-inch corrugated metal sewer line through the levee, 16 feet below the crown. Runs underneath the river and through the levee with 36-inch corrugated metal riser unit/inspection chamber on the landside (LS) shoulder. Distribution/pump house on the LS toe. (Permit No. 2725-B, 1959 - City of Stockton). [Additional Reference(s): DWR Levee Log, 2004. USACE San Joaquin O&M Manual 7, April 1964, (HLM 1.08)]. FS Date: 8/16/2013

36-inch CMP riser on LS slope severely corroded with various holes along seams.

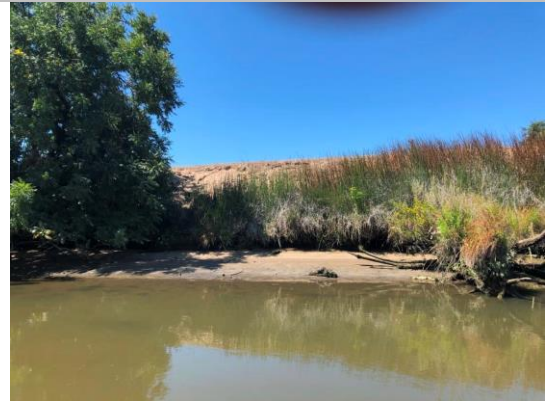
Photo 1 of 3 : SJR2019\_RD0524U01RM41.79\_1.jpg

Direct view of the site.

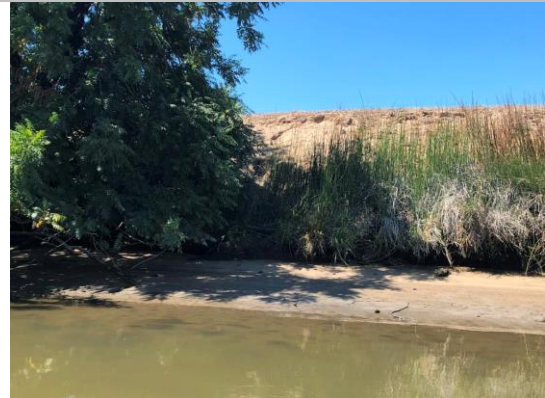
Photo 2 of 3 : SJR2019\_RD0524U01RM41.79\_2.jpg

Direct view of the site.

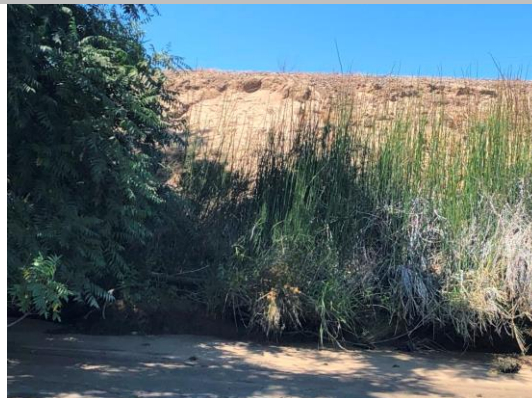
Photo 3 of 3 : SJR2019\_RD0524U01RM41.79\_4.jpg

Comment Code						
Inspector Comment						
Site ID: RD0524U01RM41.79 08/13/2019: No significant change observed. 09/13/2017: No significant change observed. 07/25/2016: No significant change observed. 06/24/2015: No significant change observed. 06/19/2014: No significant change observed. 08/13/2013: No significant change at this site. 08/07/2012: The site has been visited by boat survey. No significant change observed 08/23/2011: No significant change observed on site. 09/07/2010: No significant change observed on site. Vegetation is visible at the water line. There is an exposed pipe discharge partially hanging at the mid-slope, possibly still used for discharging irrigation/runoff water. There is minimal rip rap protection along the bank, and what's left of it is no longer adequately protecting the bank. 9/29/2009: Site consists of a 400-foot long eroding bank with minimal vegetation and protection; the existing rip rap has sloughed, rendering it useless; note that there is an exposed section of a pipe. 10/18/2006: There is extensive loss of rip rap on some sections; sewage disposal pond is on the landside of the levee; there is an exposed pipe outlet "hanging" from the upper slope.

Close-up view of the erosion.

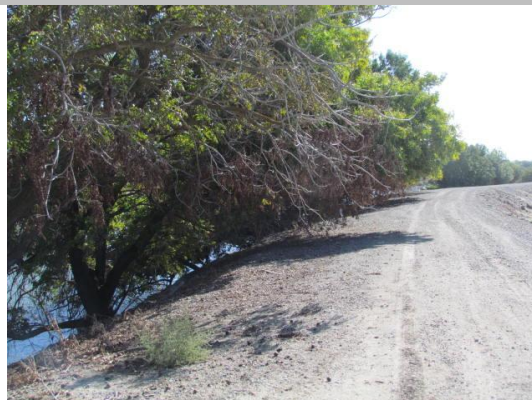
Photo 1 of 1 : FA\_2019\_RD0524\_107\_19\_20190830\_00027.jpg

LM Start	1.16	Rating **	M	Issue No.	19
LM End	1.16	Issue Type +	Ma	Location *	WS
Category	Earthen Levee			GPS Latitude/Longitude	
				Start	End
Item	Trim / Thin Trees			37.933810 °	37.933810 °
				-121.329317 °	-121.329317 °
DWR ID	DWR_RD0524_01_s_2012_19				
Comment Code					
T3 : Trim and thin trees to allow visibility of the ground and room to flood fight.					
Inspector Comment

Looking southeast at low hanging tree branches at waterside toe.

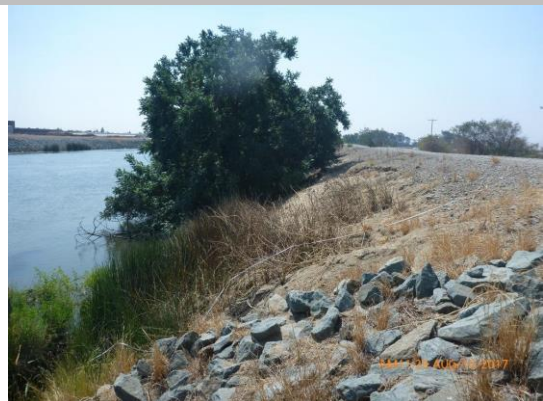
Photo 1 of 3 : LEVAL\_FA\_2019\_535\_4115.jpg

LM Start	1.18	Rating **	A/W	Issue No.	221
LM End	1.20	Issue Type +	Ma	Location *	
Category	Supplemental			GPS Latitude/Longitude	
				Start	End
Item	2017 Storm Damage			37.933500°	37.933200°
				-121.329100°	-121.328900°
DWR ID	LMA-441				
Comment Code					
Inspector Comment					
Levee Evaluation Comments					
Description:Slope protection repairs are needed along the waterside slope due to erosion and riprap displacement from high water. Based upon levee inspections, it was determined the waterside levee slope is eroding, deteriorating, and degrading. The eroded levee sections need to be restored back to design standards to prevent further deterioration and damage.					
Site ID No:535					
Site Designation:LMA-441					
Repair Type: Erosion					
Rating:Area of Concern					
Field Date:8/10/2017					
Notes:

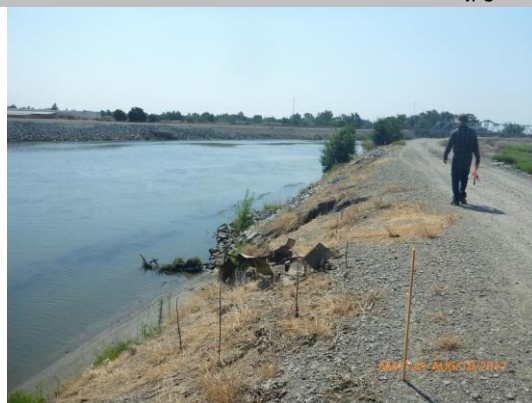
Photo 1 of 3 : LEVAL\_FA\_2019\_534\_4121.jpg

Comment Code					
Inspector Comment					
Levee Evaluation Comments					
Description:Slope protection repairs are needed along the waterside slope due to erosion and riprap displacement from high water. Based upon levee inspections, it was determined the waterside levee slope is eroding, deteriorating, and degrading. The eroded levee sections need to be restored back to design standards to prevent further deterioration and damage.					
Site ID No:534					
Site Designation:LMA-440					
Repair Type: Erosion					
Rating:Serious					
Field Date:8/10/2017					
Notes: site is related to, but not combined with, LMA-439 a portion of this site has been repaired.

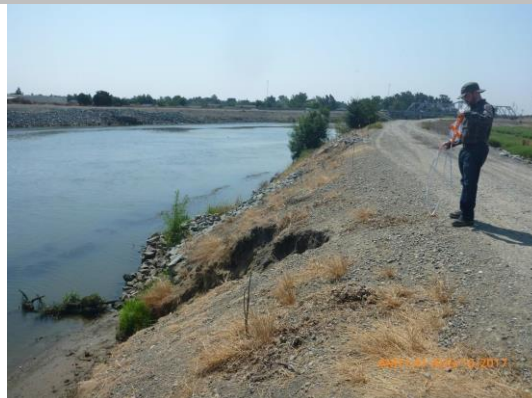
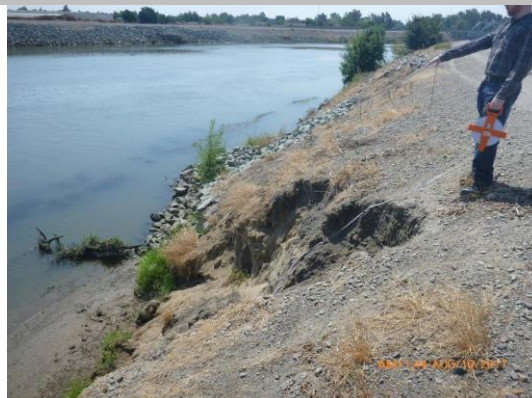
Item	2017 Storm Damage		37.932600 °	37.931900 °								
			-121.328700 °	-121.328400 °								
DWR ID	LMA-440											
Comment Code												
Inspector Comment												
<p>Levee Evaluation Comments</p> <p>Description: Slope protection repairs are needed along the waterside slope due to erosion and riprap displacement from high water. Based upon levee inspections, it was determined the waterside levee slope is eroding, deteriorating, and degrading. The eroded levee sections need to be restored back to design standards to prevent further deterioration and damage.</p> <p>Site ID No: 534</p> <p>Site Designation: LMA-440</p> <p>Repair Type: Erosion</p> <p>Rating: Serious</p> <p>Field Date: 8/10/2017</p> <p>Notes: site is related to, but not combined with, LMA-439 a portion of this site has been repaired.</p>

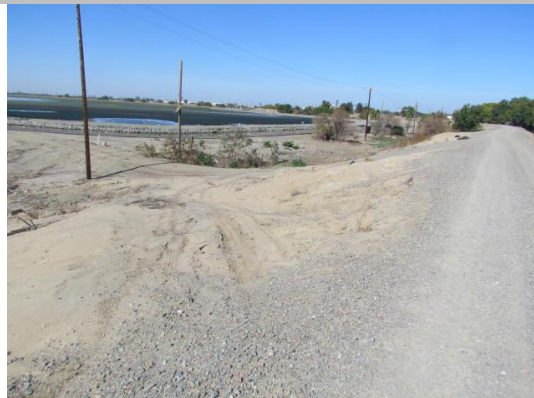
Photo 1 of 2 : FA\_2019\_RD0524\_107\_263\_20190830\_00247.jpg

LM Start	1.25	Rating **	M	Issue No.	263
LM End	1.25	Issue Type +	En	Location *	LS
Category	Earthen Levee			GPS Latitude/Longitude	
				Start	End
Item	Encroachments			37.932533 °	37.932533 °
				-121.328650 °	-121.328650 °
DWR ID	DWR_RD0524_01_s_2012_263				
Comment Code					
RA : Ramp					
Inspector Comment					
Unauthorized ramps on landside slope. Ramps were caused by vehicle traffic.

Looking northwest at unauthorized ramp on landside slope.

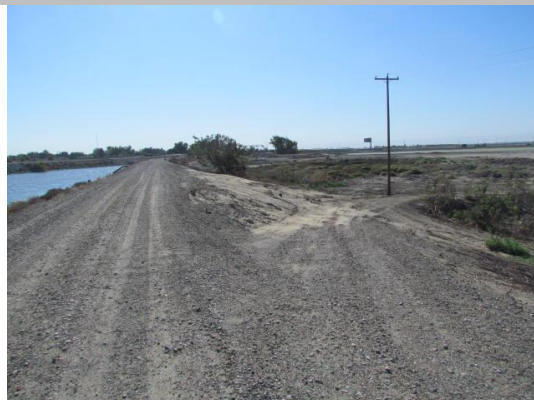
Photo 2 of 2 : FA\_2019\_RD0524\_107\_263\_20190830\_00248.jpg

Looking south at unauthorized ramp on landside slope.

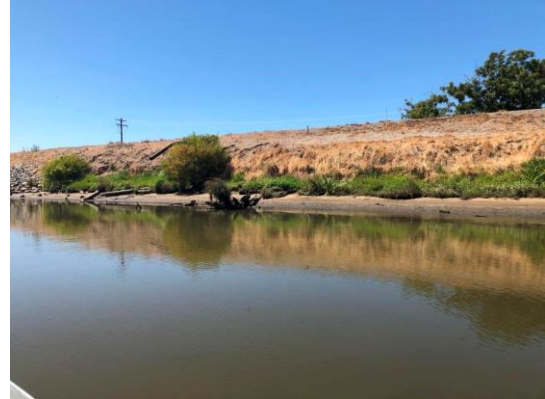
Photo 1 of 3 : SJR2019\_RD0524U01RM41.92\_2.jpg

LM Start	1.27	Rating **	A/W	Issue No.	47
LM End	1.33	Issue Type +	Ma	Location *	
Category	Supplemental			GPS Latitude/Longitude	
				Start	End
Item	DWR Erosion Survey			37.931858 °	37.931858 °
				-121.328300 °	-121.328300 °
DWR ID	RD0524U01RM41.92				
Comment Code					
Inspector Comment					
Site ID: RD0524U01RM41.92					
08/13/2019: No significant change observed.					
09/13/2017: The erosion has developed along the levee slope. The length of the erosion is nearly doubled comparing to the prior survey.					
07/25/2016: No significant change observed.					
06/24/2015: No significant change observed.					
06/19/2014: No significant change observed.					
08/13/2013: New signs of animal activity were found.					
08/07/2012: The site was first reported in 2012 spring levee inspection report.

Downstream view of the erosion.

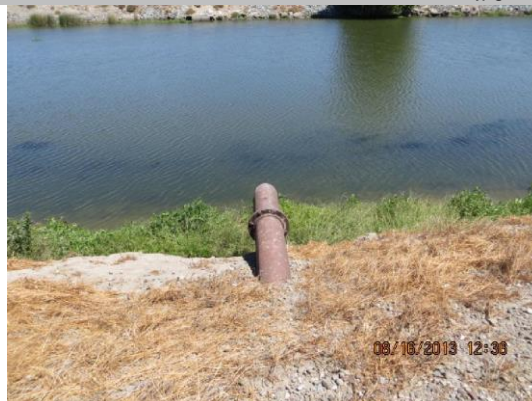
Photo 1 of 3 : UCIP\_FA\_2019\_53162\_29862.jpg

Comment Code					
Inspector Comment					
DS_ID:20602 FS_ID:53162 EP_NO: N/A Repair Type: Non-Urgent Crossing Status: Found UCIP Comments: 10/2/2018 Pipe appears abandoned, but both the pipe and levee appear in good condition; downgrading to Non-Urgent (D. Sanoski - DWR UCIP).11/16/2016 same as previous inspection both ends are open. This pipe does not appear in use. Need to contact owner to determine status of crossing. If the crossing is abandoned or in use, owner will need to coordinate with the CVFPB to comply with Title 23 requirements. (O. Magana - DWR UCIP)08/16/2013 Pipe appears to be open on both ends. Abandoned and should be done so properly. (W. Wylie - DWR UCIP) FIELD_STRUCT_DESC: *ABANDONED* 12-inch steel drainage pipe through the levee, 3.5 feet below the crown. Pipe is opened on the waterside (WS) and landside (LS) ends. The pump house referenced in O&M manual is missing from the LS (2013). [Additional Reference(s): DWR Levee Log, 2004. USACE San Joaquin O&M Manual 7, April 1964, (HLM 1.31)]. FS Date: 10/2/2018 1:10:16 PM

Pipe visible and open on WS slope.

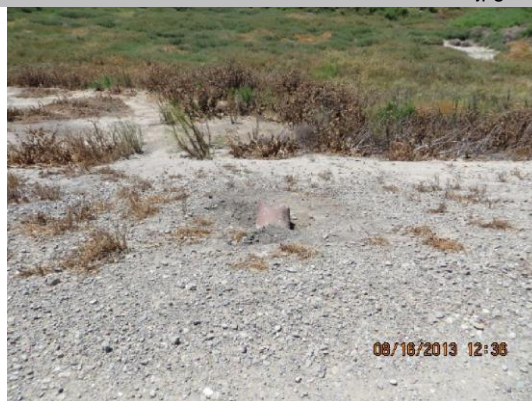
Photo 2 of 3 : UCIP\_FA\_2019\_53162\_29861.jpg

DS\_ID:20602  
FS\_ID:53162  
EP\_NO: N/A  
Repair Type: Non-Urgent  
Crossing Status: Found  
UCIP Comments: 10/2/2018 Pipe appears abandoned, but both the pipe and levee appear in good condition; downgrading to Non-Urgent (D. Sanoski - DWR UCIP). 11/16/2016 same as previous inspection both ends are open. This pipe does not appear in use. Need to contact owner to determine status of crossing. If the crossing is abandoned or in use, owner will need to coordinate with the CVFPB to comply with Title 23 requirements. (O. Magana - DWR UCIP) 08/16/2013 Pipe appears to be open on both ends. Abandoned and should be done so properly. (W. Wylie - DWR UCIP)  
FIELD\_STRUCT\_DESC: \*ABANDONED\* 12-inch steel drainage pipe through the levee, 3.5 feet below the crown. Pipe is opened on the waterside (WS) and landside (LS) ends. The pump house referenced in O&M manual is missing from the LS (2013). [Additional Reference(s): DWR Levee Log, 2004. USACE San Joaquin O&M Manual 7, April 1964, (HLM 1.31)].

Pipe open and visible on LS slope.

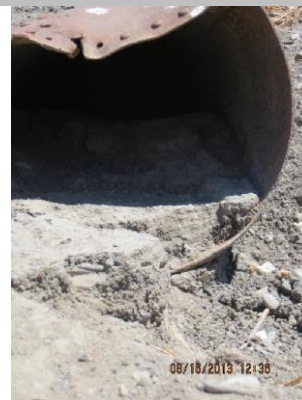
Photo 3 of 3 : UCIP\_FA\_2019\_53162\_29860.jpg

Pipe appears open on both ends. View from LS slope.

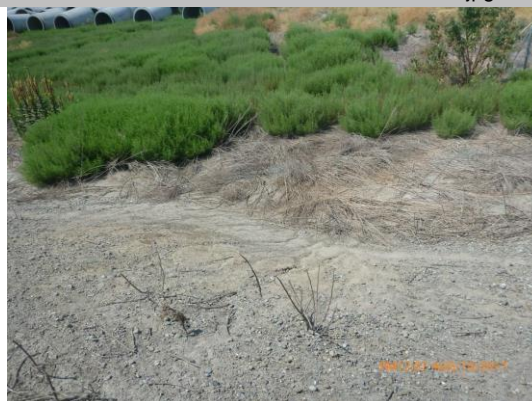
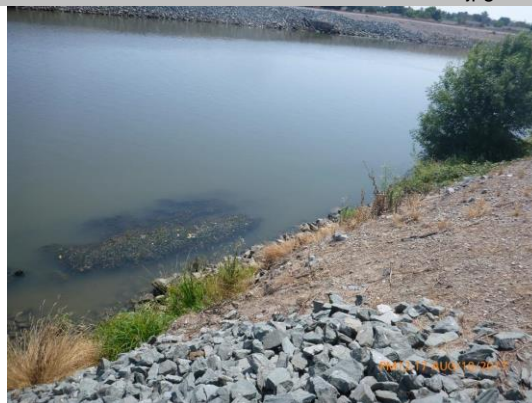
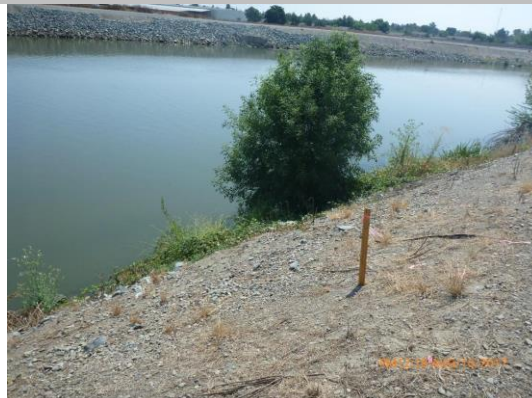
LM Start	1.33	Rating **	A/W	Issue No.	225
LM End	1.33	Issue Type +	Ma	Location *	
Category	Supplemental			GPS Latitude/Longitude	
				Start	End
Item	2017 Storm Damage			37.931500 °	37.931500 °
				-121.328200 °	-121.328200 °
DWR ID	LMA-438				
Comment Code					
Inspector Comment					
Levee Evaluation Comments					
Description:Slope protection repairs are needed along the waterside slope due to erosion and riprap displacement from high water. Based upon levee inspections, it was determined the waterside levee slope is eroding, deteriorating, and degrading. The eroded levee sections need to be restored back to design standards to prevent further deterioration and damage.					
Site ID No:532					
Site Designation:LMA-438					
Repair Type: Erosion					
Rating:Area of Concern					
Field Date:8/10/2017					
Notes:

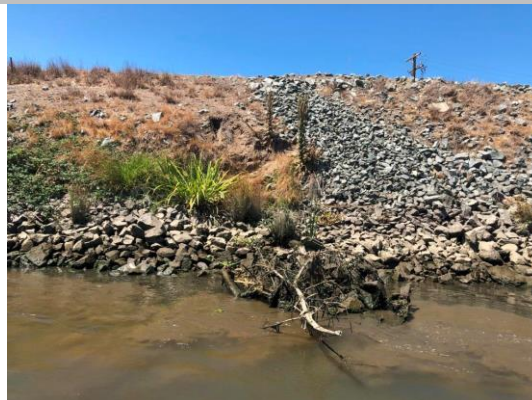
Photo 1 of 2 : SJR2019\_RD0524U01RM41.95\_4.JPG

LM Start	<b>1.33</b>	Rating **	M	Issue No.	<b>55</b>
LM End	<b>1.33</b>	Issue Type +	Ma	Location *	
Category	Supplemental			GPS Latitude/Longitude	
				Start	End
Item	DWR Erosion Survey			37.931510 °	37.931510 °
				-121.328120 °	-121.328120 °
DWR ID	RD0524U01RM41.95				
Comment Code					
Inspector Comment					
<p>Site ID: RD0524U01RM41.95</p> <p>08/13/2019: No significant change observed.</p> <p>09/13/2017: The erosion is located immediately upstream of a protected levee section.</p>

Front view of the erosion.

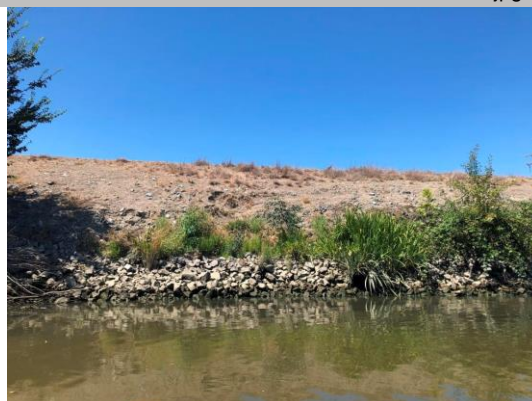
Photo 2 of 3 : SJR2019\_RD0524U01RM42.03\_4.jpg

LM Start	1.39	Rating **	U	Issue No.	56 (cont)	
LM End	1.39	Issue Type +	Ma	Location *		
Category	Supplemental			GPS Latitude/Longitude		
				Start	End	
Item	DWR Erosion Survey			37.930575 °	37.930575 °	
				-121.328090 °	-121.328090 °	
DWR ID	RD0524U01RM42.03					
Comment Code						
Inspector Comment						
Site ID: RD0524U01RM42.03 08/13/2019: No significant change observed. 09/13/2017: No significant change observed 07/25/2016: No significant change observed 06/24/2015: No significant change observed. 06/19/2014: No significant change observed. 08/13/2013: No significant change observed. 08/07/2012: The site was first reported in 2012 spring levee inspection report. The site is located about 750 ft downstream of SR 4 Bridge.

Front view of the erosion.

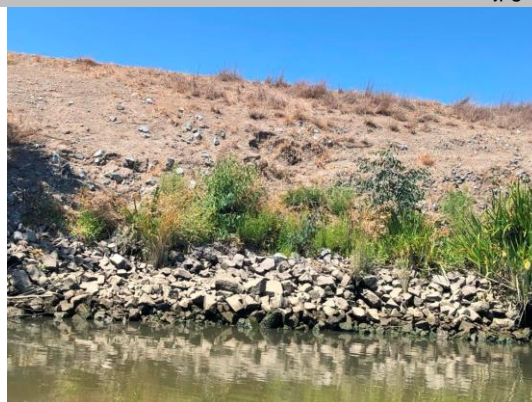
Photo 3 of 3 : SJR2019\_RD0524U01RM42.03\_2.jpg

Close-up view of the erosion.

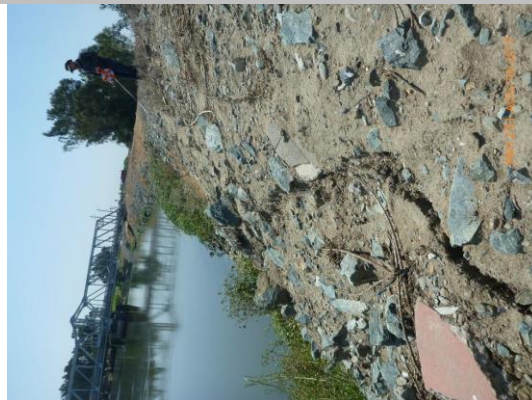
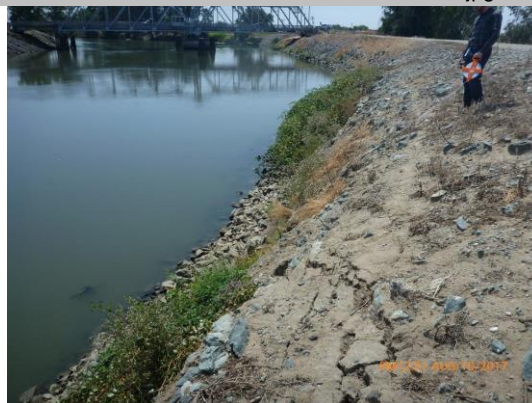
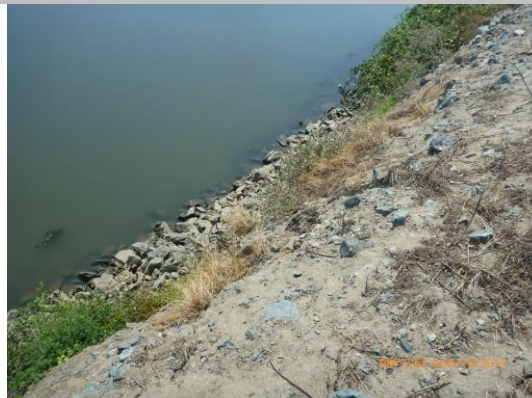
LM Start	1.43	Rating **	A/W	Issue No.	226
LM End	1.44	Issue Type +	Ma	Location *	
Category	Supplemental			GPS Latitude/Longitude	
				Start	End
Item	2017 Storm Damage			37.930100 °	37.929900 °
				-121.328300 °	-121.328300 °
DWR ID	LMA-436				
Comment Code					
Inspector Comment					
Levee Evaluation Comments					
Description:Slope protection repairs are needed along the waterside slope due to erosion and riprap displacement from high water. Based upon levee inspections, it was determined the waterside levee slope is eroding, deteriorating, and degrading. The eroded levee sections need to be restored back to design standards to prevent further deterioration and damage.					
Site ID No:530					
Site Designation:LMA-436					
Repair Type: Erosion					
Rating:Area of Concern					
Field Date:8/10/2017					
Notes:

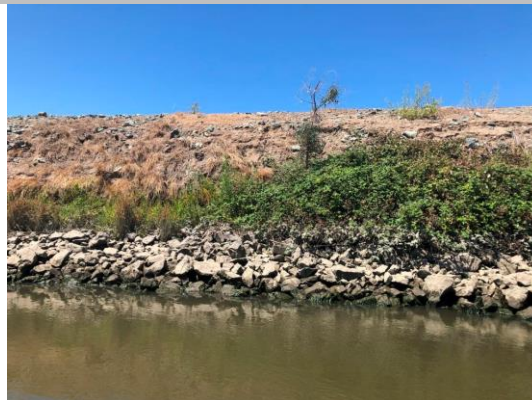
Photo 1 of 3 : SJR2019\_RD0524U01RM42.09\_1.JPG

LM Start	1.45	Rating **	U	Issue No.	60	
LM End	1.47	Issue Type +	Ma	Location *		
Category	Supplemental			GPS Latitude/Longitude		
				Start	End	
Item	DWR Erosion Survey			37.929650 °	37.929650 °	
				-121.328110 °	-121.328110 °	
DWR ID	RD0524U01RM42.09					
Comment Code						
Inspector Comment						
Site ID: RD0524U01RM42.09 08/13/2019: No significant change observed. 09/13/2017: No significant change observed. 07/25/2016: No significant change observed. 06/24/2015: No significant change observed. 06/19/2014: No significant change observed. 08/13/2013: The site is located approximately 400 ft. downstream SR 4 Bridge. Dense vegetation is visible at the toe.

Front view of the erosion site.

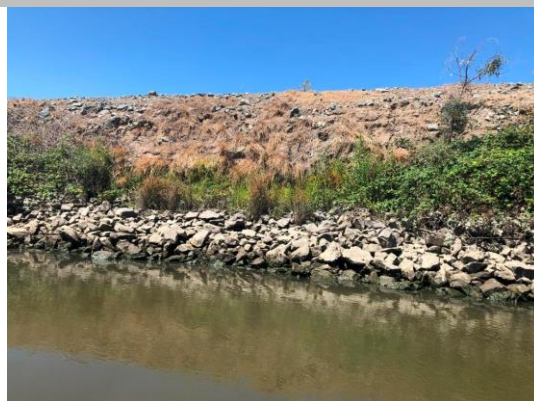
Photo 2 of 3 : SJR2019\_RD0524U01RM42.09\_2.JPG

LM Start	1.45	Rating **	U	Issue No.	60 (cont)	
LM End	1.47	Issue Type +	Ma	Location *		
Category	Supplemental			GPS Latitude/Longitude		
				Start	End	
Item	DWR Erosion Survey			37.929650 °	37.929650 °	
				-121.328110 °	-121.328110 °	
DWR ID	RD0524U01RM42.09					
Comment Code						
Inspector Comment						
Site ID: RD0524U01RM42.09 08/13/2019: No significant change observed. 09/13/2017: No significant change observed. 07/25/2016: No significant change observed. 06/24/2015: No significant change observed. 06/19/2014: No significant change observed. 08/13/2013: The site is located approximately 400 ft. downstream SR 4 Bridge. Dense vegetation is visible at the toe.

Front view of the erosion.

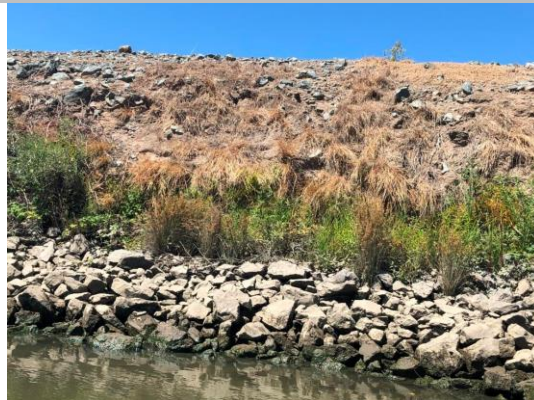
Photo 3 of 3 : SJR2019\_RD0524U01RM42.09\_3.JPG

Close-up view of the erosion. Note the vegetation at the site.

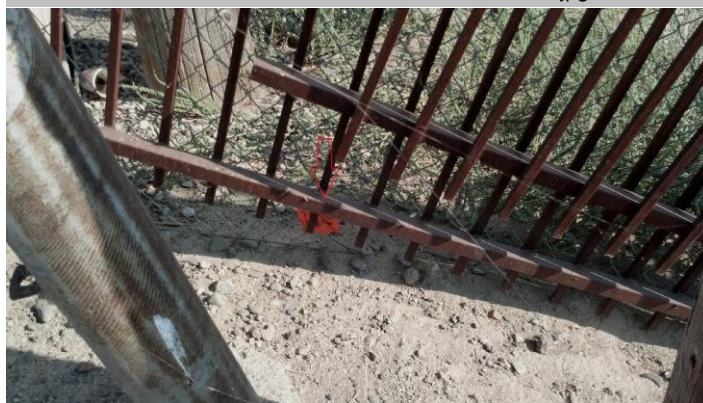
Photo 1 of 2 : UCIP\_FA\_2019\_17798\_29935.jpg

LM Start	1.54	Rating **	M	Issue No.	941
LM End	1.54	Issue Type +	En	Location *	
Category	Supplemental			GPS Latitude/Longitude	
				Start	End
Item	DRAFT DWR UCIP Field Study			37.928429 °	37.928429 °
				-121.328297 °	-121.328297 °
DWR ID	20605				
Comment Code					
Inspector Comment					
DS_ID:20605					
FS_ID:17798					
EP_NO: N/A					
Repair Type: Non-Urgent					
Crossing Status: Indicator Found					
UCIP Comments: No permit identified for this crossing.					
FIELD_STRUCT_DESC: Fiber optics cable crossing of an unknown material. USA marker flags over crown along alignment of gate.					
FS Date: 8/20/2013

USAA markers along alignment at gate.

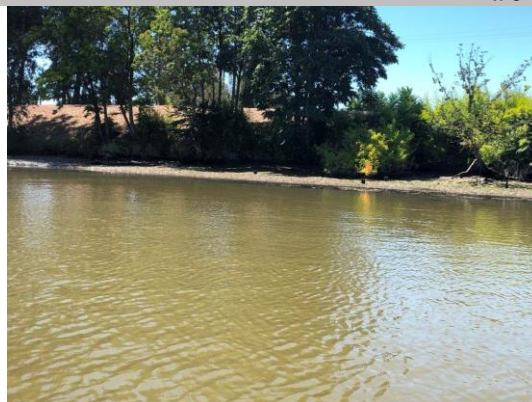
Photo 1 of 3 : SJR2019\_RD0524U01RM42.20\_2.jpg

Comment Code						
Inspector Comment						
Site ID: RD0524U01RM42.2						
08/13/2019: No significant change observed.						
09/13/2017: No significant change observed.						
07/25/2016: No significant change observed.						
06/24/2015: No significant change observed.						
06/19/2014: No significant change observed.						
08/13/2013: No significant change observed.						
08/07/2012: The site has been visited by boat survey. No significant change observed						
08/23/2011: No significant change observed on site. Trees concerned still in place.						
09/07/2010: No significant change observed on site. The concern here is the undermining of the levee toe where most of trees are. There are erosion pockets lined along the lower slope and at the base of the trees, exposing tree roots. There is minimal slope protection.						
09/29/2009: The lower slope is lined with minor erosion pockets; some tree roots are exposed; there is visible undermining of the levee toe; site is immediately upstream of the Highway 4 Bridge; the bridge is possibly causing a scour to occur, eroding the bank.

Front view of the site where undermining has occurred.

09/07/2010: No significant change observed on site. The concern here is the undermining of the levee toe where most of trees are. There are erosion pockets lined along the lower slope and at the base of the trees, exposing tree roots. There is minimal slope protection.

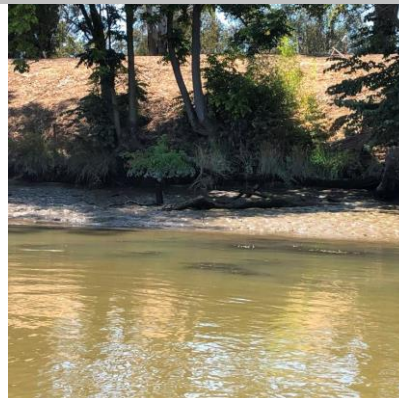
Photo 2 of 3 : SJR2019\_RD0524U01RM42.20\_4.jpg

Close-up view of the erosion.

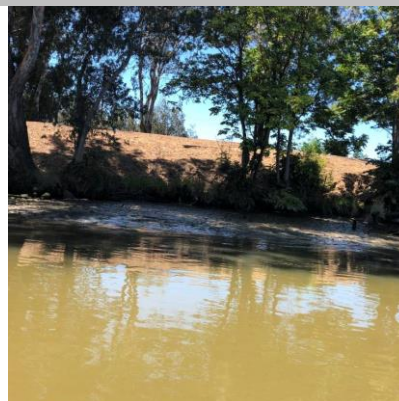
Photo 3 of 3 : SJR2019\_RD0524U01RM42.20\_5.jpg

Front view of the erosion.

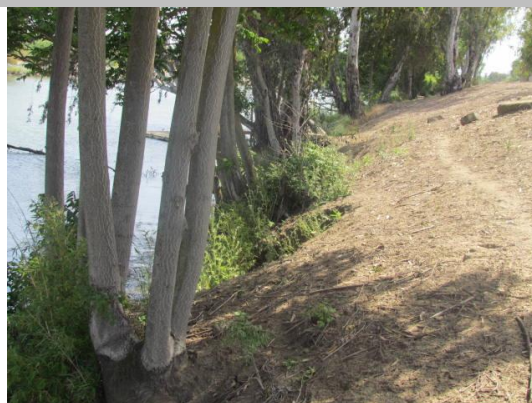
Photo 1 of 3 : FA\_2019\_RD0524\_107\_26\_20190830\_00035.jpg

Looking south at waterward erosion.

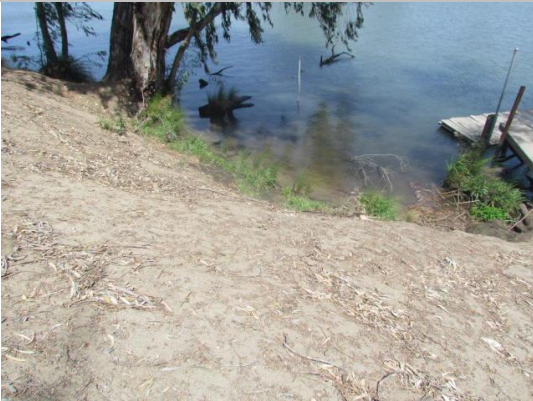
Photo 3 of 3 : FA\_2019\_RD0524\_107\_26\_20190830\_00037.jpg

Looking east at waterward erosion and depression.

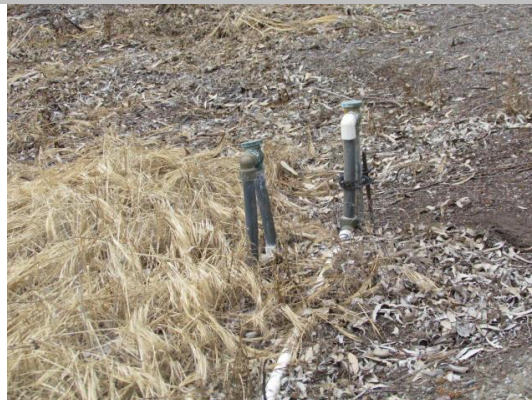
Photo 2 of 2 : FA\_2019\_RD0524\_107\_207\_20190830\_00188.jpg

LM Start	1.65	Rating **	M	Issue No.	207 (cont)	
LM End	1.71	Issue Type +	En	Location *	LS	
Category	Earthen Levee			GPS Latitude/Longitude		
				Start		End
Item	Encroachments			37.927237 °		37.926621 °
				-121.327183 °		-121.326400 °
DWR ID	DWR_RD0524_01_s_2016_207					
Comment Code						
LI : Landscape Irrigation						
Inspector Comment						
Sprinklers on landside shoulder

Looking south at sprinkler line and sprinklers on landward shoulder.

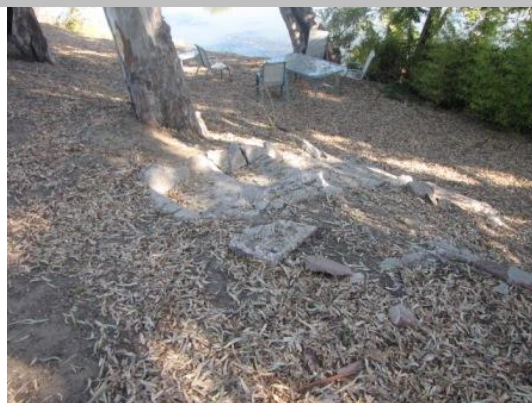
Photo 1 of 3 : FA\_2019\_RD0524\_107\_45\_20190830\_00058.jpg

LM Start	1.67	Rating **	U	Issue No.	45
LM End	1.67	Issue Type +	En	Location *	WS
Category	Earthen Levee			GPS Latitude/Longitude	
				Start	End
Item	Encroachments			37.927018 °	37.927018 °
				-121.326872 °	-121.326872 °
DWR ID	DWR_RD0524_01_s_2012_45				
Comment Code					
ST : Stairway					
Inspector Comment					
Stairs and retaining wall.

Looking northeast at non-permitted concrete stairs on waterside slope.

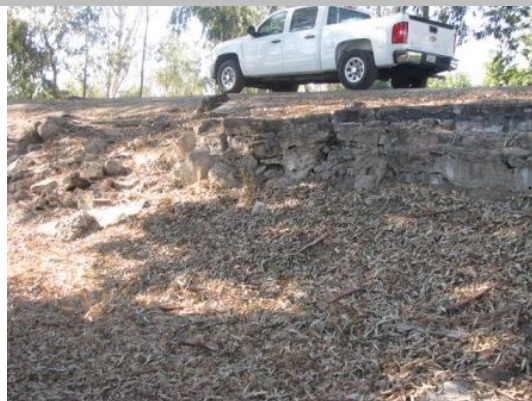
Photo 2 of 3 : FA\_2019\_RD0524\_107\_45\_20190830\_00059.jpg

Looking southwest at retaining wall connected to concrete stairs.

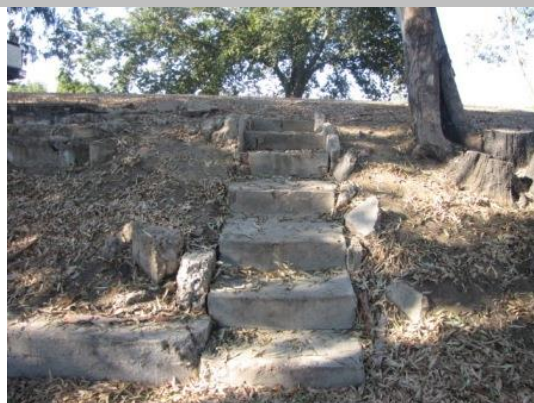
Photo 3 of 3 : FA\_2019\_RD0524\_107\_45\_20190830\_00060.jpg

Looking west at concrete stairs on waterside slope.

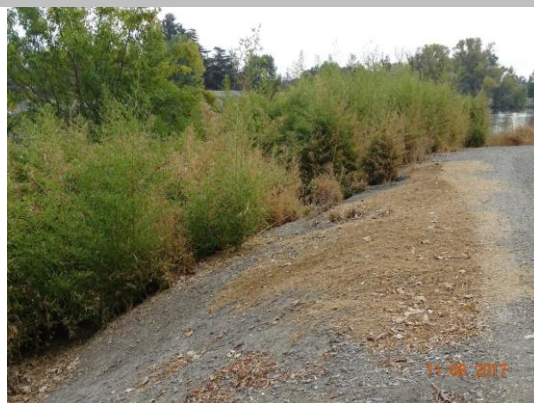
Photo 1 of 1 : FA\_2019\_RD0524\_107\_243\_20190830\_00236.jpg

Looking southeast at the waterside slope.

LM Start	1.71	Rating **	U	Issue No.	243
LM End	1.72	Issue Type +	Ma	Location *	WS
Category	Earthen Levee			GPS Latitude/Longitude	
				Start	End
Item	Vegetation			37.926638 °	37.926471 °
				-121.326374 °	-121.326175 °
DWR ID	DWR_RD0524_01_f_2017_243				
Comment Code					
V2 : Remove the wild growth other than native grasses from the levee slopes.					
Inspector Comment

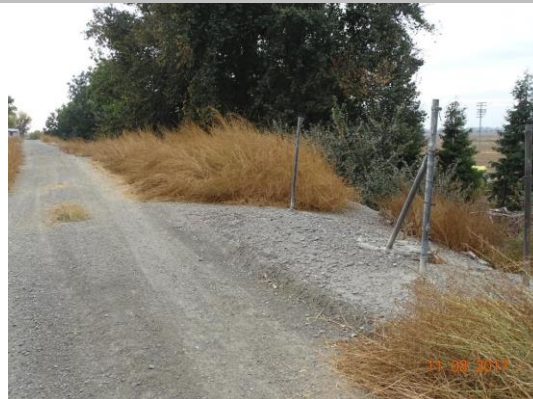
Photo 1 of 1 : FA\_2019\_RD0524\_107\_245\_20190830\_00238.jpg

Looking southeast at the landside slope.

LM Start	1.73	Rating **	U	Issue No.	245
LM End	1.75	Issue Type +	Ma	Location *	LS
Category	Earthen Levee			GPS Latitude/Longitude	
				Start	End
Item	Vegetation			37.926312 °	37.926093 °
				-121.326065 °	-121.325864 °
DWR ID	DWR_RD0524_01_f_2017_245				
Comment Code					
V2 : Remove the wild growth other than native grasses from the levee slopes.					
Inspector Comment

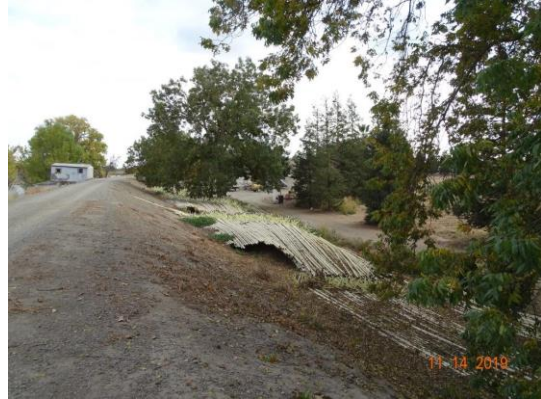
Photo 1 of 2 : FA\_2019\_RD0524\_107\_46\_20191117\_00368.jpg

LM Start	1.76	Rating **	U	Issue No.	46
LM End	1.86	Issue Type +	En	Location *	LS
Category	Earthen Levee			GPS Latitude/Longitude	
				Start	End
Item	Encroachments			37.925993 °	37.924875 °
				-121.325777 °	-121.324788 °
DWR ID	DWR_RD0524_01_s_2012_46				
Comment Code					
EQ : Equipment					
Inspector Comment					
Irrigation pipes stored at landward toe.

View of irrigation pipes being stored on landside slope and easement.  
Fall 2019

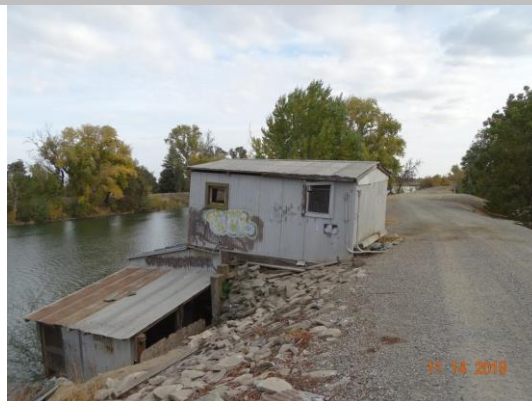
Photo 1 of 1 : FA\_2019\_RD0524\_107\_148\_20191117\_00369.jpg

LM Start	1.81	Rating **	U	Issue No.	148
LM End	1.81	Issue Type +	En	Location *	WS
Category	Earthen Levee			GPS Latitude/Longitude	
				Start	End
Item	Encroachments			37.925457 °	37.925457 °
				-121.325332 °	-121.325332 °
DWR ID	DWR_RD0524_01_f_2019_148				
Comment Code					
BU : Building					
Inspector Comment					
Pump house on waterside shoulder. Fall 2019

View of pump house on waterside shoulder. Fall 2019

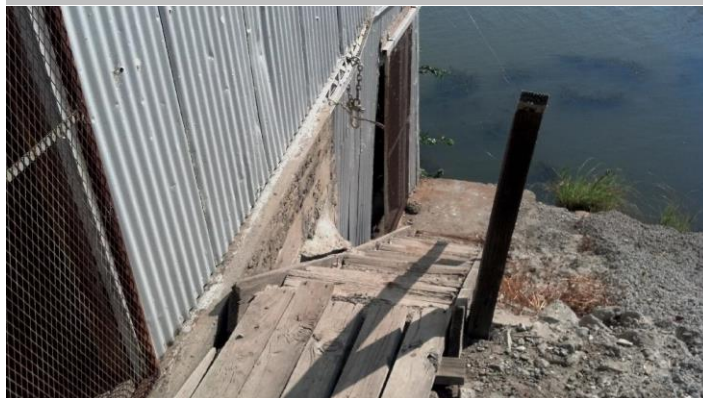
Photo 2 of 3 : UCIP\_FA\_2019\_17847\_29961.jpg

Comment Code						
Inspector Comment						
DS_ID:20609						
FS_ID:17847						
EP_NO: N/A						
Repair Type: Non-Urgent						
Crossing Status: Found						
UCIP Comments: Pipe appears abandoned and if so should be done so properly.						
FIELD_STRUCT_DESC: 14-inch irrigation pipe of an unknown material through the levee, 20 feet below the crown. 2 pumps and gate valves discharge into surge tank in pump house on the waterside (WS) slope. Concrete distribution box removed from the WS slope. Abandoned 36-inch diameter concrete standpipe on the landside (LS) toe next to service pole. [Additional Reference(s): DWR Levee Log, 2004. USACE San Joaquin O&M Manual 7, April 1964, (HLM 1.83)].						
FS Date: 8/20/2013

Steps to pump on WS slope.

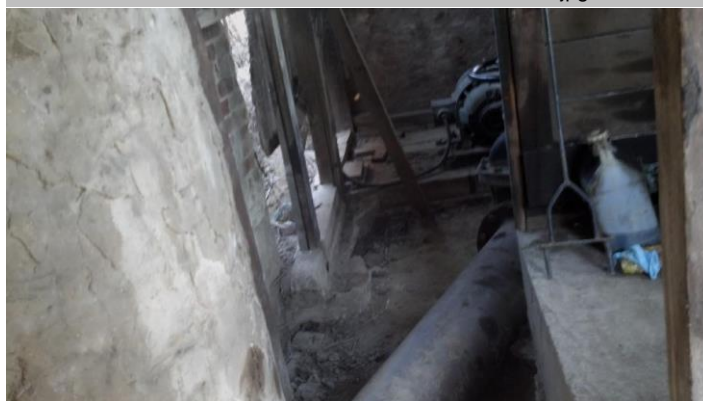
Photo 3 of 3 : UCIP\_FA\_2019\_17847\_29960.jpg

Comment Code						
Inspector Comment						
DS_ID:20609						
FS_ID:17847						
EP_NO: N/A						
Repair Type: Non-Urgent						
Crossing Status: Found						
UCIP Comments: Pipe appears abandoned and if so should be done so properly.						
FIELD_STRUCT_DESC: 14-inch irrigation pipe of an unknown material through the levee, 20 feet below the crown. 2 pumps and gate valves discharge into surge tank in pump house on the waterside (WS) slope. Concrete distribution box removed from the WS slope. Abandoned 36-inch diameter concrete standpipe on the landside (LS) toe next to service pole. [Additional Reference(s): DWR Levee Log, 2004. USACE San Joaquin O&M Manual 7, April 1964, (HLM 1.83)].						
FS Date: 8/20/2013

Pipes at connection to concrete surge box on WS inside pumphouse.

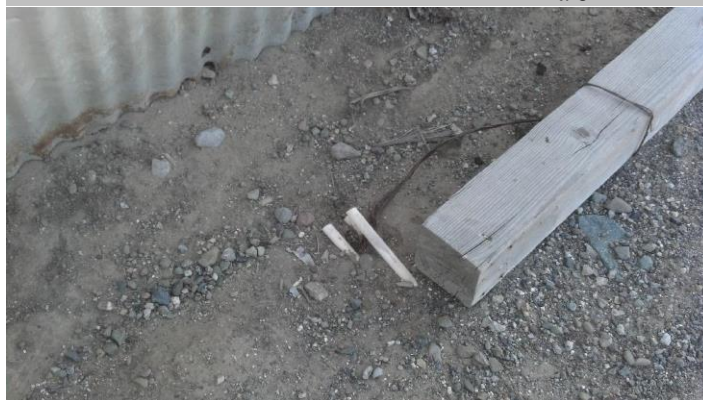
Photo 1 of 2 : UCIP\_FA\_2019\_21865\_37121.jpg

LM Start	1.81	Rating **	M	Issue No.	944	
LM End	1.81	Issue Type +	En	Location *		
Category	Supplemental			GPS Latitude/Longitude		
				Start	End	
Item	DRAFT DWR UCIP Field Study			37.925431 °	37.925431 °	
				-121.325310 °	-121.325310 °	
DWR ID	24033					
Comment Code						
Inspector Comment						
DS_ID:24033 FS_ID:21865 EP_NO: N/A Repair Type: Non-Urgent Crossing Status: Found UCIP Comments: Pipes appear abandoned and should be removed from levee. FIELD_STRUCT_DESC: *ABANDONED* One 1-inch and two 0.75-inch polyvinyl chloride conduits of an unknown purpose through the levee, 6 inches below the crown. FS Date: 8/20/2013

Pipes visible on WS shoulder directly in front of pumphouse.

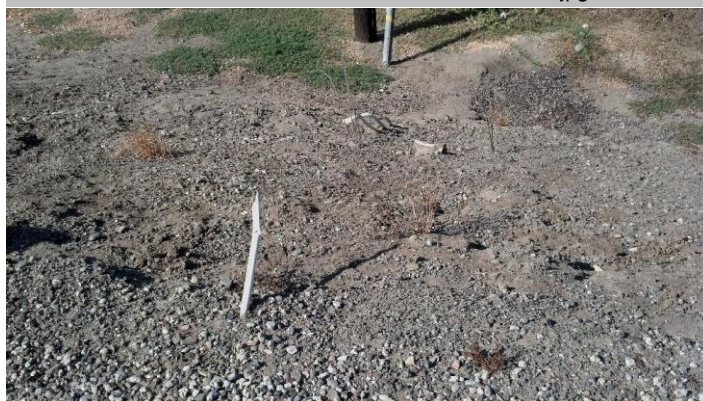
Photo 2 of 2 : UCIP\_FA\_2019\_21865\_37120.jpg

LM Start	1.81	Rating **	M	Issue No.	944 (cont)	
LM End	1.81	Issue Type +	En	Location *		
Category	Supplemental			GPS Latitude/Longitude		
				Start	End	
Item	DRAFT DWR UCIP Field Study			37.925431 °	37.925431 °	
				-121.325310 °	-121.325310 °	
DWR ID	24033					
Comment Code						
Inspector Comment						
DS_ID:24033						
FS_ID:21865						
EP_NO: N/A						
Repair Type: Non-Urgent						
Crossing Status: Found						
UCIP Comments: Pipes appear abandoned and should be removed from levee.						
FIELD_STRUCT_DESC: *ABANDONED* One 1-inch and two 0.75-inch polyvinyl chloride conduits of an unknown purpose through the levee, 6 inches below the crown.						
FS Date: 8/20/2013

Pipes visible on LS slope.

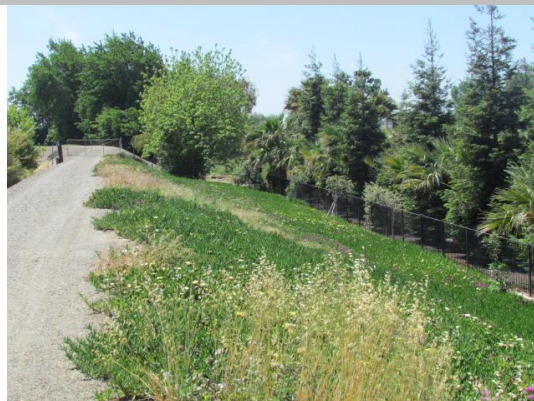
Photo 1 of 1 : FA\_2019\_RD0524\_107\_78\_20190830\_00099.jpg

LM Start	1.90	Rating **	U	Issue No.	78
LM End	1.94	Issue Type +	En	Location *	LS
Category	Earthen Levee			GPS Latitude/Longitude	
				Start	End
Item	Vegetation			37.924364 °	37.923805 °
				-121.324473 °	-121.324238 °
DWR ID	DWR_RD0524_01_s_2012_78				
Comment Code					
V6 : Landscaping					
Inspector Comment					
Unauthorized ice-plant on LS slope hinders ability to inspect landside slope.

Looking southwest at landscaping on landside slope. (Spring 2012)

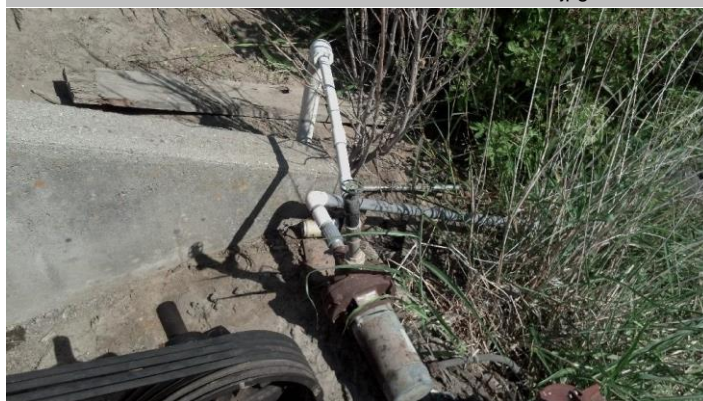
Photo 1 of 3 : UCIP\_FA\_2019\_21872\_37128.jpg

LM Start	1.99	Rating **	M	Issue No.	945
LM End	1.99	Issue Type +	En	Location *	
Category	Supplemental			GPS Latitude/Longitude	
				Start	End
Item	DRAFT DWR UCIP Field Study			37.923022 °	37.923022 °
				-121.323953 °	-121.323953 °
DWR ID	24035				
Comment Code					
Inspector Comment					
DS_ID:24035 FS_ID:21872 EP_NO: N/A Repair Type: Non-Urgent Crossing Status: Found UCIP Comments: No permit identified for this crossing. FIELD_STRUCT_DESC: 3-inch polyvinyl chloride domestic non-potable water line through the levee, at an unknown depth. Pump on concrete pad at the waterside (WS) toe. FS Date: 8/20/2013

Pump on concrete pad at WS slope.

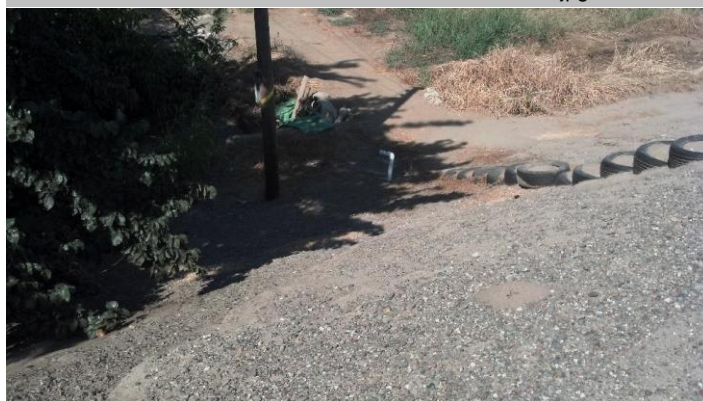
Photo 2 of 3 : UCIP\_FA\_2019\_21872\_37127.jpg

LM Start	1.99	Rating **	M	Issue No.	945 (cont)	
LM End	1.99	Issue Type +	En	Location *		
Category	Supplemental			GPS Latitude/Longitude		
				Start	End	
Item	DRAFT DWR UCIP Field Study			37.923022 °	37.923022 °	
				-121.323953 °	-121.323953 °	
DWR ID	24035					
Comment Code						
Inspector Comment						
DS_ID:24035						
FS_ID:21872						
EP_NO: N/A						
Repair Type: Non-Urgent						
Crossing Status: Found						
UCIP Comments: No permit identified for this crossing.						
FIELD_STRUCT_DESC: 3-inch polyvinyl chloride domestic non-potable water line through the levee, at an unknown depth. Pump on concrete pad at the waterside (WS) toe.						
FS Date: 8/20/2013

PVC pipe visible on LS toe.

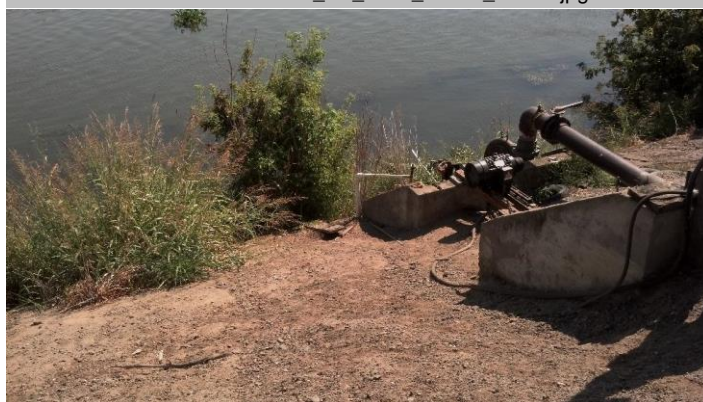
Photo 3 of 3 : UCIP\_FA\_2019\_21872\_37126.jpg

Pump and pipe visible on WS slope.

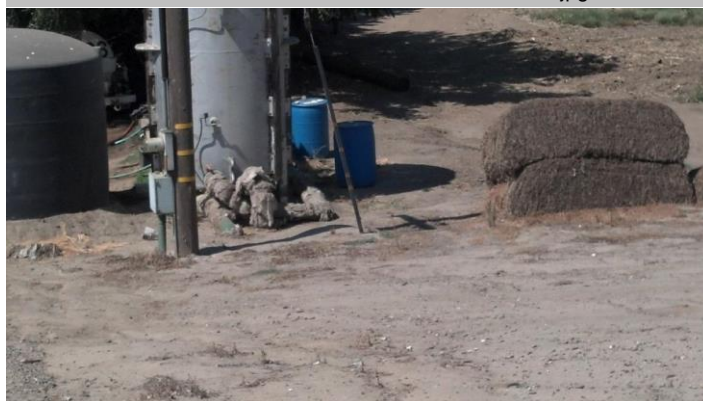
Photo 1 of 3 : UCIP\_FA\_2019\_21895\_37142.jpg

LM Start	2.07	Rating **	M	Issue No.	947
LM End	2.07	Issue Type +	En	Location *	
Category	Supplemental			GPS Latitude/Longitude	
				Start	End
Item	DRAFT DWR UCIP Field Study			37.922080°	37.922080°
				-121.323118°	-121.323118°
DWR ID	24038				
Comment Code					
Inspector Comment					
DS_ID:24038 FS_ID:21895 EP_NO: N/A Repair Type: Non-Urgent Crossing Status: Found UCIP Comments: No permit identified for this crossing. FIELD_STRUCT_DESC: 6-inch steel irrigation pipe through the levee, at an unknown depth. Vent, meter, butterfly valve, and pump at pump house on the waterside (WS) slope. FS Date: 8/20/2013

Steel irrigation line visible in front of tank to right of powerpole off LS toe.

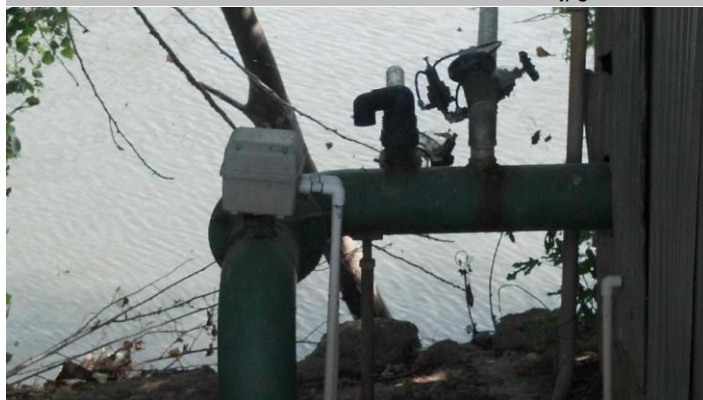
Photo 2 of 3 : UCIP\_FA\_2019\_21895\_37141.jpg

Irrigation line visible on side of pumphouse.

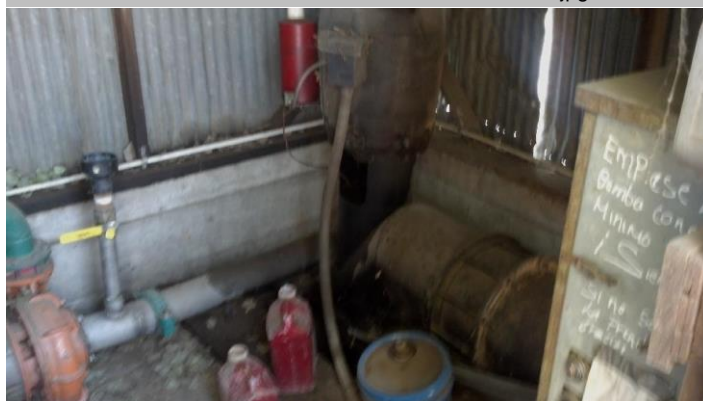
Photo 2 of 3 : UCIP\_FA\_2019\_17944\_30044.jpg

Comment Code						
Inspector Comment						
DS_ID:20612 FS_ID:17944 EP_NO: N/A Repair Type: Non-Urgent Crossing Status: Found UCIP Comments: Soil excavated from cover over pipe on WS next to concrete riser. May indicate a leak or other problem. FIELD_STRUCT_DESC: 20-inch steel irrigation pipe through the levee, 15 feet below the crown. Pump in pump house on the waterside (WS) slope. Slide gate in 4-foot diameter concrete standpipe on the WS slope with secondary concrete standpipe. Polyvinyl chloride standpipe visible 350 feet off the landside (LS) toe. [Additional Reference(s): DWR Levee Log, 2004. USACE San Joaquin O&M Manual 7, April 1964, (HLM 2.10)]. FS Date: 8/20/2013

Pump and pipe inside pumphouse.

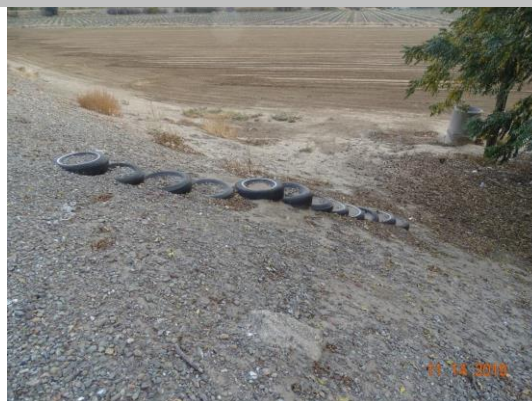
Photo 1 of 1 : FA\_2019\_RD0524\_107\_247\_20191117\_00370.jpg

LM Start	2.12	Rating **	M	Issue No.	247
LM End	2.12	Issue Type +	En	Location *	LS
Category	Earthen Levee			GPS Latitude/Longitude	
				Start	End
Item	Encroachments			37.921664 °	37.921664 °
				-121.322499 °	-121.322499 °
DWR ID	DWR_RD0524_01_f_2017_247				
Comment Code					
ST : Stairway					
Inspector Comment					
Landowner installed rubber tires for a stairway on landside slope.

View of rubber tires being used as stairs on landside slope. Fall 2019

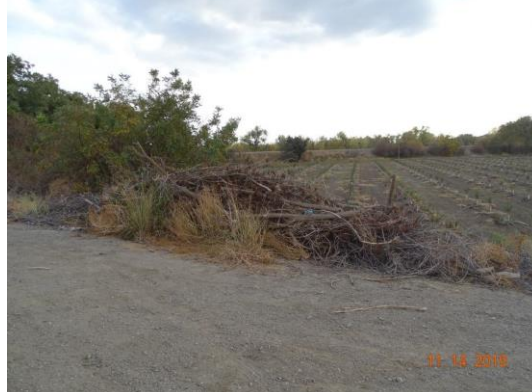
Photo 1 of 1 : FA\_2019\_RD0524\_107\_152\_20191117\_00371.jpg

LM Start	2.27	Rating **	U	Issue No.	152
LM End	2.27	Issue Type +	En	Location *	LS
Category	Earthen Levee			GPS Latitude/Longitude	
				Start	End
Item	Encroachments			37.920357°	37.920357°
				-121.320257°	-121.320257°
DWR ID	DWR_RD0524_01_f_2019_152				
Comment Code					
PR : Prunings					
Inspector Comment

View of prunings on landside slope. Fall 2019

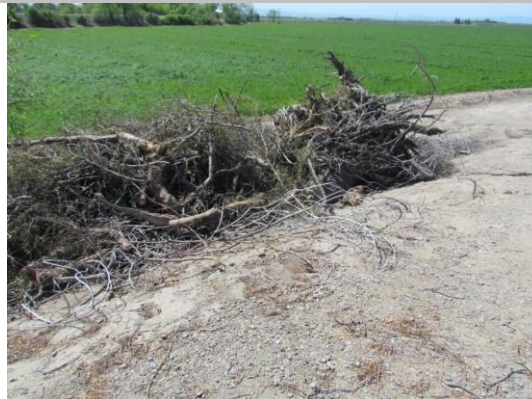
Photo 1 of 1 : FA\_2019\_RD0524\_107\_203\_20190830\_00186.jpg

LM Start	2.27	Rating **	U	Issue No.	203
LM End	2.27	Issue Type +	En	Location *	LS
Category	Earthen Levee			GPS Latitude/Longitude	
				Start	End
Item	Encroachments			37.920327°	37.920327°
				-121.320175°	-121.320175°
DWR ID	DWR_RD0524_01_f_2016_203				
Comment Code					
PR : Prunings					
Inspector Comment					
Large pruning pile on landside slope and toe.

Looking west at pruning pile on landside slope.

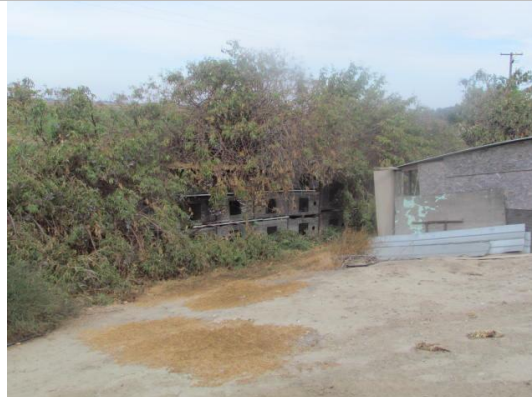
Photo 1 of 2 : FA\_2019\_RD0524\_107\_42\_20190830\_00052.jpg

LM Start	2.56	Rating **	U	Issue No.	42
LM End	2.56	Issue Type +	En	Location *	LS
Category	Earthen Levee			GPS Latitude/Longitude	
				Start	End
Item	Encroachments			37.917673 °	37.917673 °
				-121.322718 °	-121.322718 °
DWR ID	DWR_RD0524_01_s_2012_42				
Comment Code					
BU : Building					
Inspector Comment					
Animal pens on landside slope and toe.

Looking west at animal pens on landside toe. (Fall 2012)

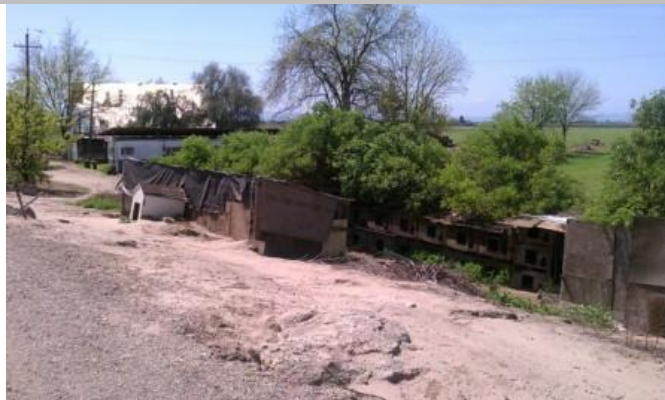
Photo 2 of 2 : FA\_2019\_RD0524\_107\_42\_20190830\_00053.jpg

LM Start	2.56	Rating **	U	Issue No.	42 (cont)	
LM End	2.56	Issue Type +	En	Location *	LS	
Category	Earthen Levee			GPS Latitude/Longitude		
				Start		End
Item	Encroachments			37.917673 °	37.917673 °	
				-121.322718 °	-121.322718 °	
DWR ID	DWR_RD0524_01_s_2012_42					
Comment Code						
BU : Building						
Inspector Comment						
Animal pens on landside slope and toe.

Looking at animal pens on landside slope and toe.

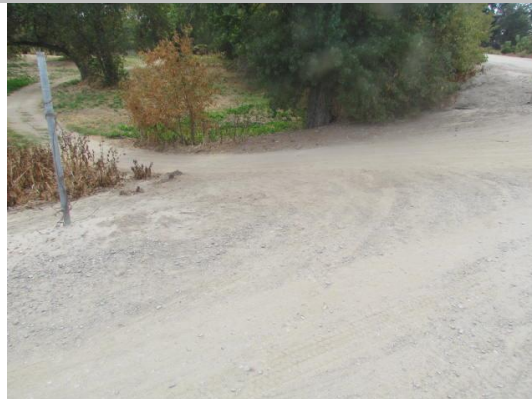
Photo 1 of 1 : FA\_2019\_RD0524\_107\_7\_20190830\_00012.jpg

LM Start	2.58	Rating **	M	Issue No.	7
LM End	2.58	Issue Type +	En	Location *	LS
Category	Earthen Levee			GPS Latitude/Longitude	
				Start	End
Item	Encroachments			37.917431 °	37.917431 °
				-121.322780 °	-121.322780 °
DWR ID	DWR_RD0524_01_f_2012_7				
Comment Code					
RA : Ramp					
Inspector Comment					
Ramp on landside providing access to land owner.

Looking southeast at unauthorized ramp on waterside slope.

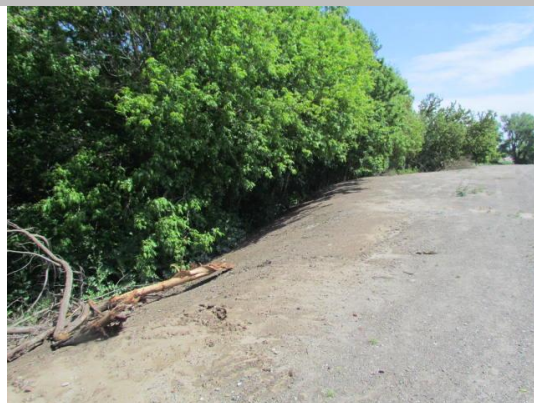
Photo 1 of 1 : FA\_2019\_RD0524\_107\_185\_20190830\_00164.jpg

LM Start	2.60	Rating **	M	Issue No.	185
LM End	2.64	Issue Type +	Ma	Location *	WS
Category	Earthen Levee			GPS Latitude/Longitude	
				Start	End
Item	Trim / Thin Trees			37.917152°	37.916807°
				-121.322582°	-121.322069°
DWR ID	DWR_RD0524_01_s_2014_185				
Comment Code					
T2 : Thin trees to allow visibility of the ground and room to flood fight.					
Inspector Comment

Looking northwest at untrimmed trees on landward slope and toe.

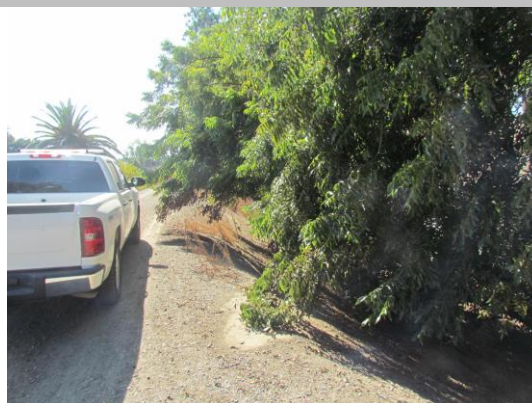
Photo 1 of 2 : FA\_2019\_RD0524\_107\_264\_20190830\_00249.jpg

LM Start	2.72	Rating **	M	Issue No.	264
LM End	2.76	Issue Type +	Ma	Location *	LS
Category	Earthen Levee			GPS Latitude/Longitude	
				Start	End
Item	Trim / Thin Trees			37.915698 °	37.915304 °
				-121.322498 °	-121.322763 °
DWR ID	DWR_RD0524_01_s_2012_264				
Comment Code					
T2 : Thin trees to allow visibility of the ground and room to flood fight.					
Inspector Comment					
Untrimmed trees along landside slope and toe. Additionally, trim limbs overhanging crown road 12 feet above ground level.

Looking south at untrimmed trees on landward slope.

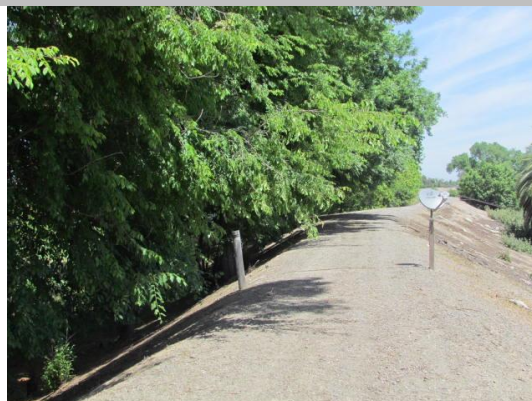
Photo 2 of 2 : FA\_2019\_RD0524\_107\_264\_20190830\_00250.jpg

Looking north at dense trees overhanging levee crown.
