**Flood Control Project Maintenance  
Levee Inspections**

**Fall 2019 Levee Maintenance Deficiency Summary Report**

**Flood Control Project Maintenance  
Levee Inspections****LMA District Cover Sheet****Fall 2019 Levee Inspection Results****Reclamation District No. 0524 Middle Roberts Island**

**Reclamation District No. 0524 Middle Roberts Island**

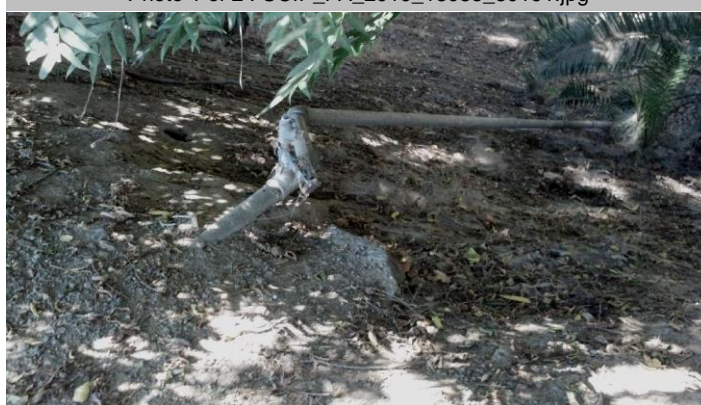
Photo 1 of 2 : UCIP\_FA\_2019\_18085\_30191.jpg

DS_ID:20616
FS_ID:18085
EP_NO: N/A
Repair Type: Non-Urgent
Crossing Status: Found
UCIP Comments: No permit identified for crossing. Unknown use.
Pipe should be removed.
FIELD_STRUCT_DESC: 3-inch galvanized iron pipe of an unknown purpose through the levee, 0.3 feet below the crown. Valve on the landside (LS) shoulder. [Additional Reference(s): DWR Levee Log, 2004].
FS Date: 8/20/2013 3:28:19 PM

Pipe and vent visible on LS slope.

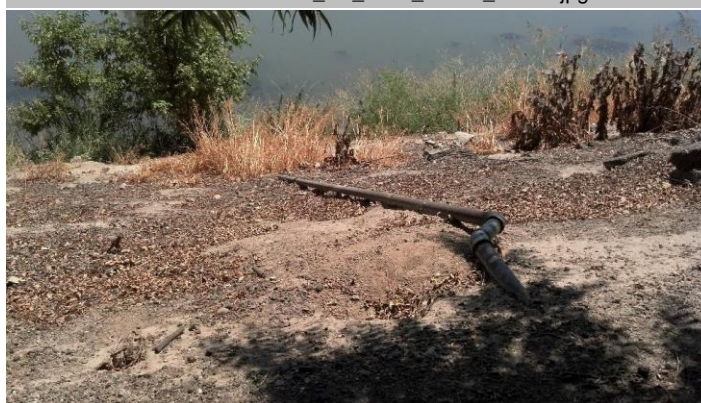
Photo 2 of 2 : UCIP\_FA\_2019\_18085\_30190.jpg

Pipe visible on WS slope.

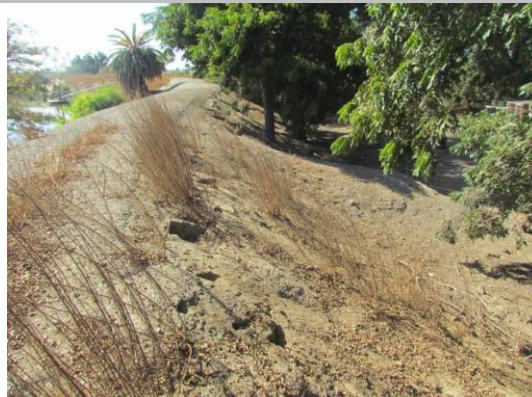
Photo 1 of 2 : FA\_2019\_RD0524\_107\_219\_20190830\_00194.jpg

LM Start	2.77	Rating **	U	Issue No.	219
LM End	2.80	Issue Type +	Ma	Location *	LS
Category	Earthen Levee			GPS Latitude/Longitude	
				Start	End
Item	Animal Control			37.915195 °	37.915052 °
				-121.322930 °	-121.323430 °
DWR ID	DWR_RD0524_01_f_2016_219				
Comment Code					
A1 : Exterminate rodents and backfill and compact or grout burrows.					
Inspector Comment					
Several large rodent holes on landside slope.

Looking south at several rodent holes on landward slope.

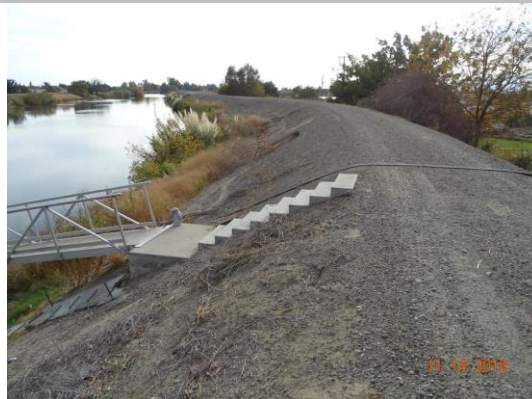
Photo 1 of 1 : FA\_2019\_RD0524\_107\_135\_20191117\_00372.jpg

LM Start	2.84	Rating **	U	Issue No.	135
LM End	2.84	Issue Type +	En	Location *	LS
Category	Earthen Levee			GPS Latitude/Longitude	
				Start	End
Item	Encroachments			37.914612 °	37.914612 °
				-121.324073 °	-121.324073 °
DWR ID	DWR_RD0524_01_s_2019_135				
Comment Code					
ST : Stairway					
Inspector Comment					
Stairway on landside and waterside slope

View of stairs on waterside slope. Fall 2019

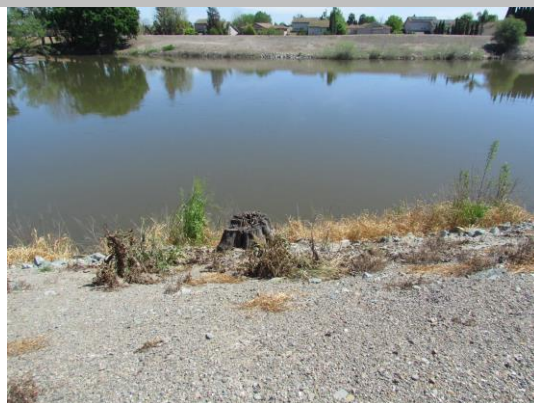
Photo 1 of 1 : FA\_2019\_RD0524\_107\_161\_20190830\_00150.jpg

LM Start	2.91	Rating **	U	Issue No.	161
LM End	2.91	Issue Type +	Ma	Location *	WS
Category	Earthen Levee			GPS Latitude/Longitude	
				Start	End
Item	Trim / Thin Trees			37.913733°	37.913733°
				-121.324398°	-121.324398°
DWR ID	DWR_RD0524_01_s_2017_161				
Comment Code					
T5 : Tree stumps.					
Inspector Comment

Looking east at large tree stump on waterward shoulder.

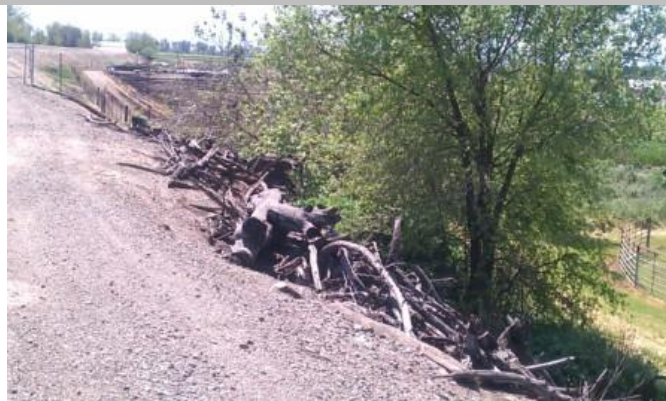
Photo 1 of 1 : FA\_2019\_RD0524\_107\_50\_20190830\_00066.jpg

LM Start	2.92	Rating **	M	Issue No.	50
LM End	2.92	Issue Type +	En	Location *	LS
Category	Earthen Levee			GPS Latitude/Longitude	
				Start	End
Item	Encroachments			37.913528 °	37.913528 °
				-121.324434 °	-121.324434 °
DWR ID	DWR_RD0524_01_s_2012_50				
Comment Code					
TR : Tree or limb					
Inspector Comment

Looking southwest at prunings on landside slope.

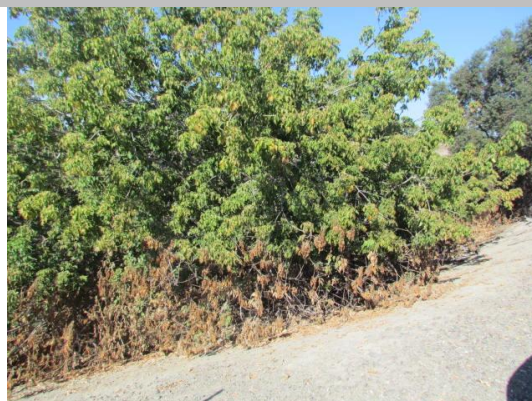
Photo 1 of 2 : FA\_2019\_RD0524\_107\_51\_20190830\_00067.jpg

LM Start	2.93	Rating **	U	Issue No.	51
LM End	2.93	Issue Type +	Ma	Location *	LS
Category	Earthen Levee			GPS Latitude/Longitude	
				Start	End
Item	Trim / Thin Trees			37.913415 °	37.913389 °
				-121.324503 °	-121.324440 °
DWR ID	DWR_RD0524_01_s_2012_51				
Comment Code					
T1 : Trim trees to at least five feet above ground level.					
Inspector Comment					
Untrimmed trees on landside slope and toe.

Looking south at dense trees on landward slope fall 2015

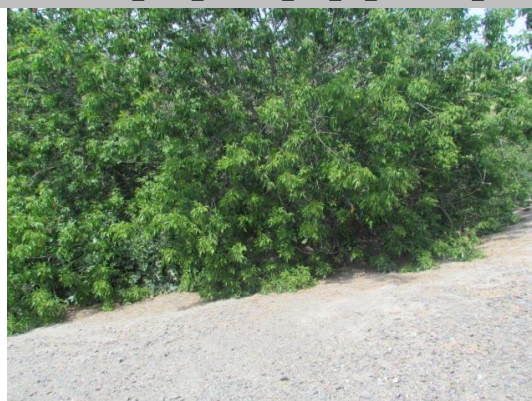
Photo 2 of 2 : FA\_2019\_RD0524\_107\_51\_20190830\_00068.jpg

LM Start	<b>2.93</b>	Rating **	U	Issue No.	<b>51 (cont)</b>
LM End	<b>2.93</b>	Issue Type +	Ma	Location *	LS

Looking south at dense trees on landward slope spring 2015

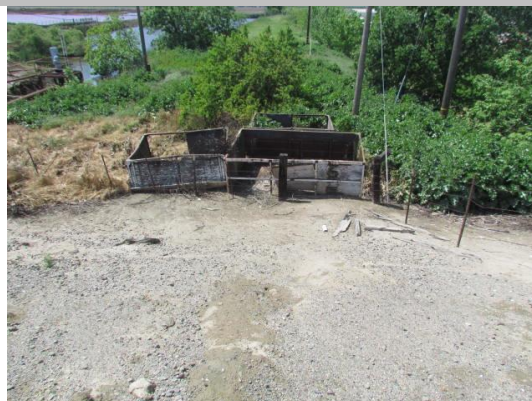
Photo 1 of 1 : FA\_2019\_RD0524\_107\_210\_20190830\_00189.jpg

LM Start	2.94	Rating **	M	Issue No.	210
LM End	2.94	Issue Type +	En	Location *	LS
Category	Earthen Levee			GPS Latitude/Longitude	
				Start	End
Item	Encroachments			37.913198 °	37.913198 °
				-121.324490 °	-121.324490 °
DWR ID	DWR_RD0524_01_s_2016_210				
Comment Code					
GA : Garbage					
Inspector Comment					
Old containers at landside toe.

Looking west at abandoned containers at landward toe.

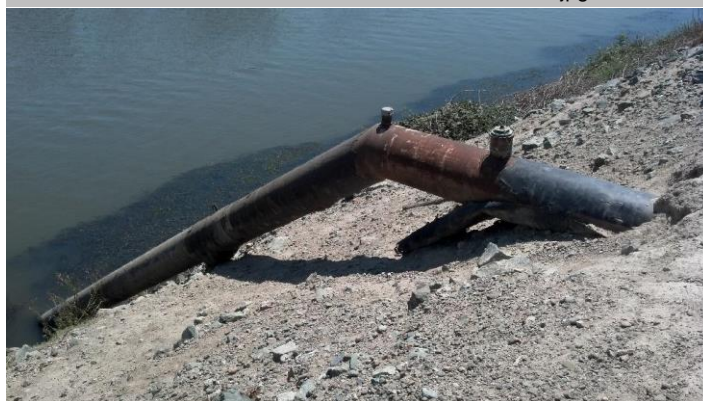
Photo 1 of 2 : UCIP\_FA\_2019\_18089\_30198.jpg

Comment Code						
Inspector Comment						
DS_ID:20617 FS_ID:18089 EP_NO: N/A Repair Type: Non-Urgent Crossing Status: Indicator Found UCIP Comments: Review crossing with inspector as records indicate that this should be an 8-inch pipe through levee 3.0 feet below crown, pump on landward side. Siphon breaker on the waterward slope. Originally included in the 1964 O&M manual. FIELD_STRUCT_DESC: 16-inch wrapped steel storm discharge pipe through the levee, 1.5 feet below the crown. Pump on steel pile structure at drainage canal off landside (LS) toe. [Additional Reference(s): USACE San Joaquin O&M Manual 7, April 1964, (HLM 2.99) 9-inch pipe listed]. FS Date: 8/20/2013

PVC wrapped pipe and siphon breaker visible on WS slope.

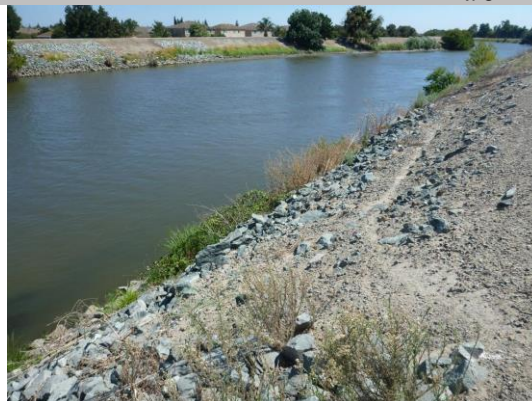
Photo 1 of 2 : LEVAL\_FA\_2019\_465\_2231.jpg

LM Start	2.96	Rating **	A/W	Issue No.	227
LM End		Issue Type +	Ma	Location *	
Category	Supplemental			GPS Latitude/Longitude	
				Start	End
Item	2017 Storm Damage			37.912900 °	°
				-121.324400 °	°
DWR ID	LMA-292

Comment Code					
Inspector Comment					
Levee Evaluation Comments					
Description:Slope protection repairs are needed along the waterside slope due to erosion. Based upon levee inspections, it was determined the waterside levee slopes were eroding, deteriorating and degrading in concave pocket sections at various locations along this levee reach. The eroded levee sections need to be restored back to design standards to prevent further deterioration of the damaged levee sections.					
Site ID No:465					
Site Designation:LMA-292					
Repair Type: Erosion					
Rating:Area of Concern					
Field Date:7/26/2017					
Notes: Lower priority because erosion is within rip rap, is only present on lower slope and is not too deep. Levee is narrow here.

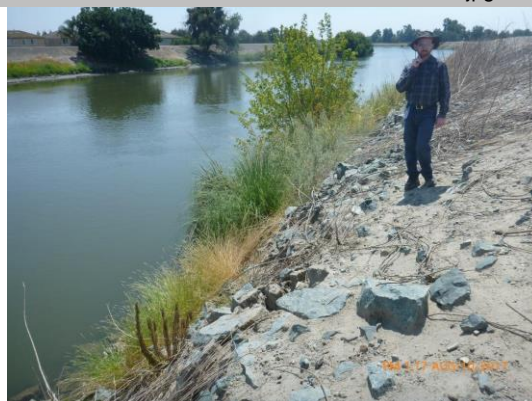
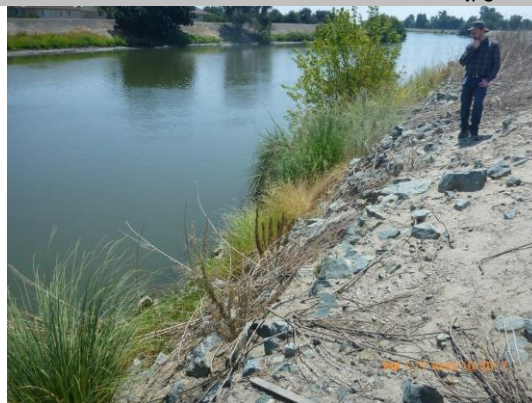
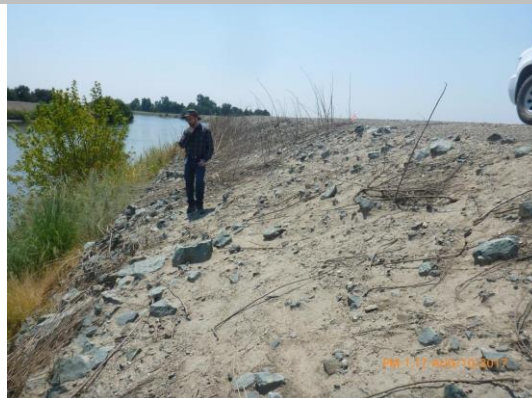
LM Start	2.99	Rating **	A/W	Issue No.	228
LM End	3.01	Issue Type +	Ma	Location *	
Category	Supplemental			GPS Latitude/Longitude	
				Start	End
Item	2017 Storm Damage			37.912500 °	37.912300 °
				-121.324700 °	-121.324700 °
DWR ID	LMA-435				
Comment Code					
Inspector Comment					
Levee Evaluation Comments					
Description:Slope protection repairs are needed along the waterside slope due to erosion and riprap displacement from high water. Based upon levee inspections, it was determined the waterside levee slope is eroding, deteriorating, and degrading. The eroded levee sections need to be restored back to design standards to prevent further deterioration and damage.					
Site ID No:529					
Site Designation:LMA-435					
Repair Type: Erosion					
Rating:Area of Concern					
Field Date:8/10/2017					
Notes:

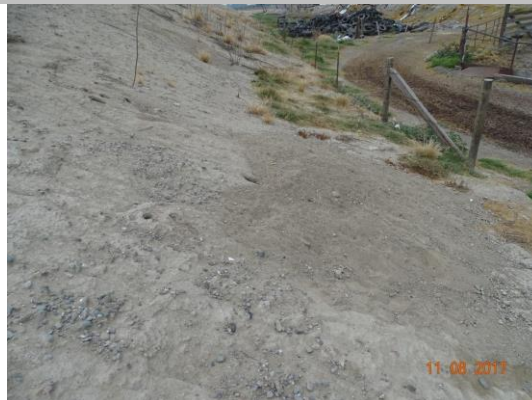
Photo 1 of 3 : FA\_2019\_RD0524\_107\_925\_20190830\_00256.jpg

LM Start	3.07	Rating **	M	Issue No.	925
LM End	3.27	Issue Type +	Ma	Location *	LS
Category	Earthen Levee			GPS Latitude/Longitude	
				Start	End
Item	Animal Control			37.911382 °	37.908602 °
				-121.324928 °	-121.325395 °
DWR ID	DWR_RD0524_01_s_2012_925				
Comment Code					
A1 : Exterminate rodents and backfill and compact or grout burrows.					
Inspector Comment					
Several rodent holes on levee slopes.

Looking southwest at the landside slope.

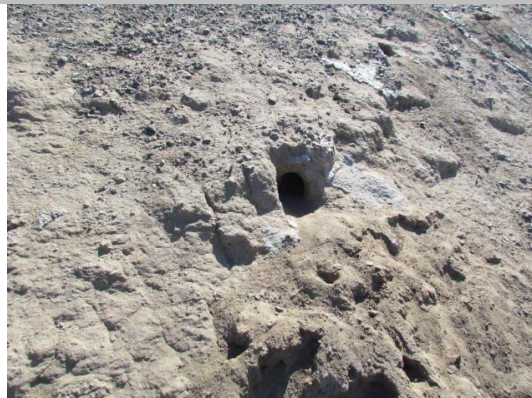
Photo 2 of 3 : FA\_2019\_RD0524\_107\_925\_20190830\_00257.jpg

LM Start	3.07	Rating **	M	Issue No.	925 (cont)	
LM End	3.27	Issue Type +	Ma	Location *	LS	
Category	Earthen Levee			GPS Latitude/Longitude		
				Start		End
Item	Animal Control			37.911382 °		37.908602 °
				-121.324928 °		-121.325395 °
DWR ID	DWR_RD0524_01_s_2012_925					
Comment Code						
A1 : Exterminate rodents and backfill and compact or grout burrows.						
Inspector Comment						
Several rodent holes on levee slopes.

Looking at typical view of rodent hole with this section fall 2015.

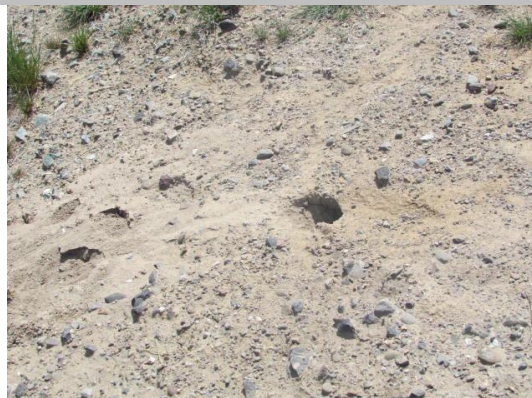
Photo 3 of 3 : FA\_2019\_RD0524\_107\_925\_20190830\_00258.jpg

LM Start	<b>3.07</b>	Rating **	M	Issue No.	<b>925 (cont)</b>
LM End	<b>3.27</b>	Issue Type +	Ma	Location *	LS

Looking at typical rodent holes on landward slope along this reach.

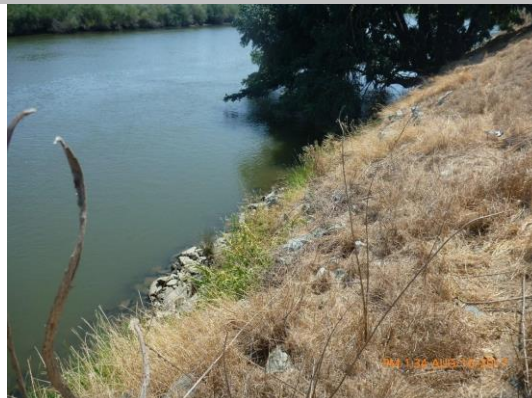
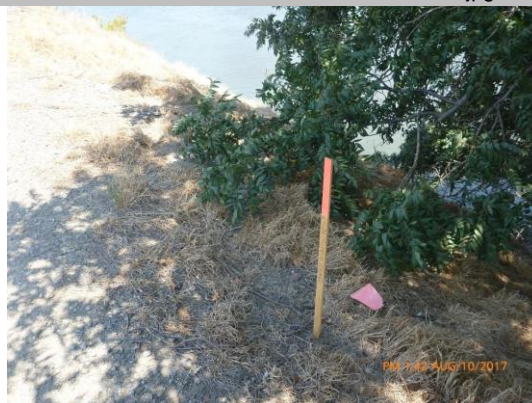
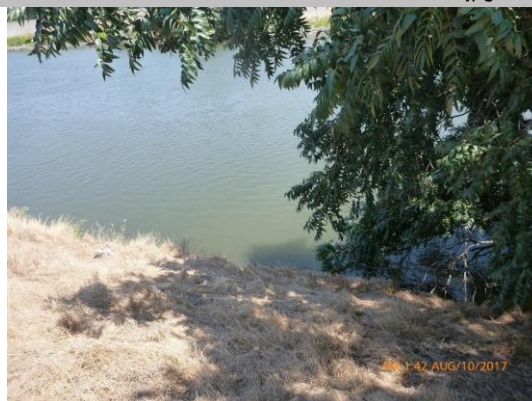
LM Start	3.26	Rating **	A/W	Issue No.	230
LM End	3.26	Issue Type +	Ma	Location *	
Category	Supplemental			GPS Latitude/Longitude	
				Start	End
Item	2017 Storm Damage			37.908800 °	37.908700 °
				-121.325400 °	-121.325300 °
DWR ID	LMA-434				
Comment Code					
Inspector Comment					
Levee Evaluation Comments					
Description:Slope protection repairs are needed along the waterside slope due to erosion and riprap displacement from high water. Based upon levee inspections, it was determined the waterside levee slope is eroding, deteriorating, and degrading. The eroded levee sections need to be restored back to design standards to prevent further deterioration and damage.					
Site ID No:528					
Site Designation:LMA-434					
Repair Type: Erosion					
Rating:Area of Concern					
Field Date:8/10/2017					
Notes: combined with LMA-433

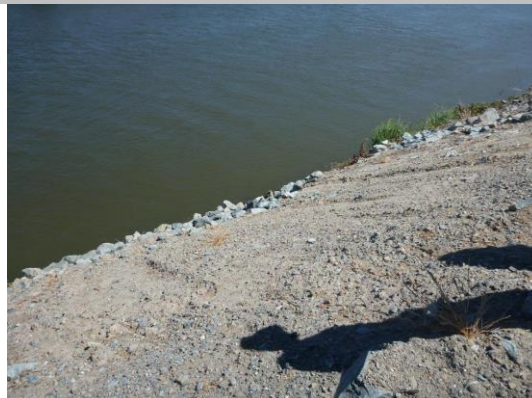
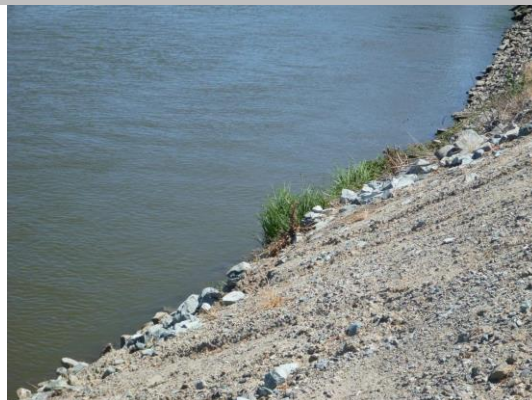
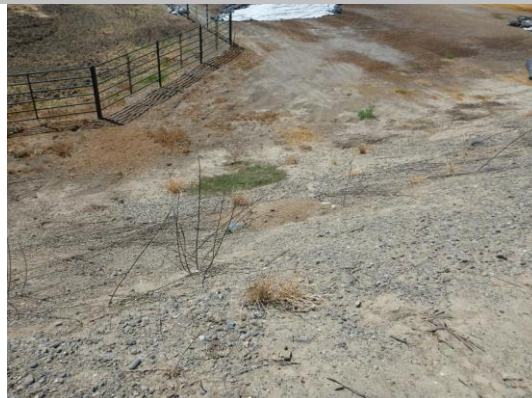
LM Start	3.30	Rating **	A/W	Issue No.	232
LM End		Issue Type +	Ma	Location *	
Category	Supplemental			GPS Latitude/Longitude	
				Start	End
Item	2017 Storm Damage			37.908200 °	°
				-121.325300 °	°
DWR ID	LMA-294

Comment Code					
Inspector Comment					
Levee Evaluation Comments					
Description:Slope protection repairs are needed along the waterside slope due to erosion. Based upon levee inspections, it was determined the waterside levee slopes were eroding, deteriorating and degrading in concave pocket sections at various locations along this levee reach. The eroded levee sections need to be restored back to design standards to prevent further deterioration of the damaged levee sections.					
Site ID No:467					
Site Designation:LMA-294					
Repair Type: Erosion					
Rating:Area of Concern					
Field Date:7/26/2017					
Notes: It looks like new rip rap was played on the lower 1/4 of the slope. There is a 2-3 ft scarp above the rip rap.

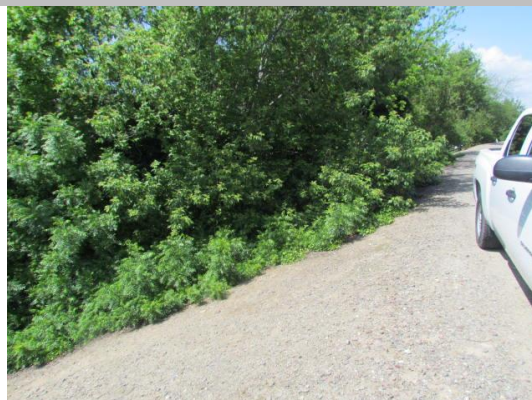
Photo 1 of 2 : FA\_2019\_RD0524\_107\_926\_20190830\_00259.jpg

LM Start	3.30	Rating **	M	Issue No.	926
LM End	3.37	Issue Type +	Ma	Location *	LS
Category	Earthen Levee			GPS Latitude/Longitude	
				Start	End
Item	Trim / Thin Trees			37.908158 °	37.907112 °
				-121.325418 °	-121.325350 °
DWR ID	DWR_RD0524_01_s_2012_926				
Comment Code					
T1 : Trim trees to at least five feet above ground level.					
Inspector Comment

Looking southwest at dense veg on landward slope.

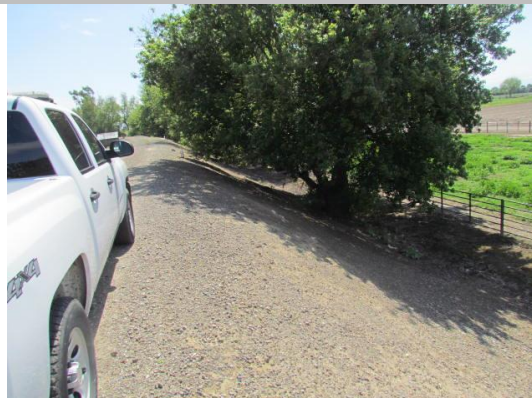
Photo 2 of 2 : FA\_2019\_RD0524\_107\_926\_20190830\_00260.jpg

LM Start	3.30	Rating **	M	Issue No.	926 (cont)
LM End	3.37	Issue Type +	Ma	Location *	LS
Category	Earthen Levee			GPS Latitude/Longitude	
				Start	End
Item	Trim / Thin Trees			37.908158 °	37.907112 °
				-121.325418 °	-121.325350 °
DWR ID	DWR_RD0524_01_s_2012_926				
Comment Code					
T1 : Trim trees to at least five feet above ground level.					
Inspector Comment

Looking at untrimmed trees on landward slope and toe.

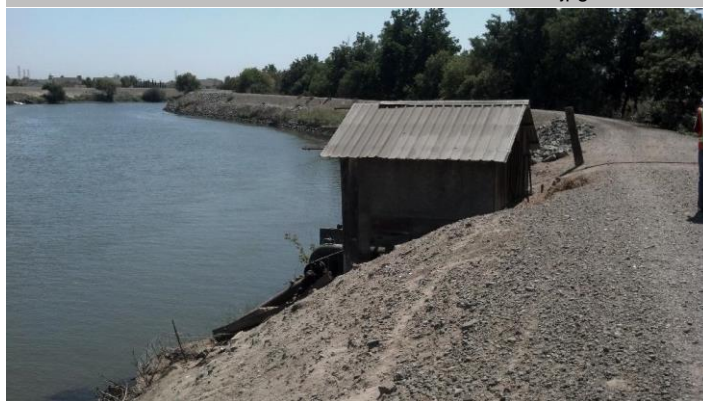
Photo 1 of 3 : UCIP\_FA\_2019\_53357\_30206.jpg

UCIP Comments: 10/2/2018 Same as previous inspection with severe LS slope integrity issues (D. Sanoski - DWR UCIP). 11/16/2016 same as previous inspection erosion is still present on LS toe and slope. Owner will need to coordinate with CVFPB to address erosion issue on LS toe. (O. Magana - DWR UCIP) 08/20/2013 Extensive erosion on LS toe at distribution box due to failure of box/pipe connection. Erosion on LS slope do to recently repaired leak at gate valve. (W. Wylie - DWR UCIP)

Pipe and pumphouse on WS slope.

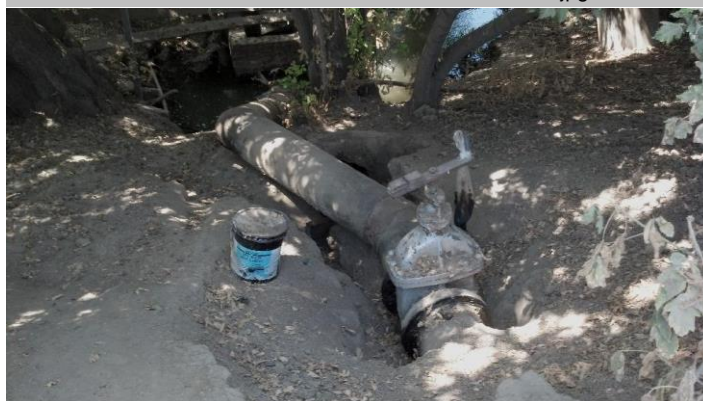
Photo 2 of 3 : UCIP\_FA\_2019\_53357\_30205.jpg

DS\_ID:20618  
FS\_ID:53357  
EP\_NO: N/A  
Repair Type: Urgent  
Crossing Status: Found  
UCIP Comments: 10/2/2018 Same as previous inspection with severe LS slope integrity issues (D. Sanoski - DWR UCIP). 11/16/2016 same as previous inspection erosion is still present on LS toe and slope. Owner will need to coordinate with CVFPB to address erosion issue on LS toe. (O. Magana - DWR UCIP) 08/20/2013 Extensive erosion on LS toe at distribution box due to failure of box/pipe connection. Erosion on LS slope do to recently repaired leak at gate valve. (W. Wylie - DWR UCIP)  
FIELD\_STRUCT\_DESC: 14-inch steel irrigation pipe through the levee, 7 feet below the crown. Pump house located on the waterside (WS) slope. Gate valve located on the landside (LS) slope. 4-foot by 4-foot brick distribution box, built in 1918, located on the LS toe. This site was used to manufacture brick back in 1918, and some of the appurtenances that remain are still in use (distribution box and ditch).

Pipe, gatevalve, and erosion on LS slope.

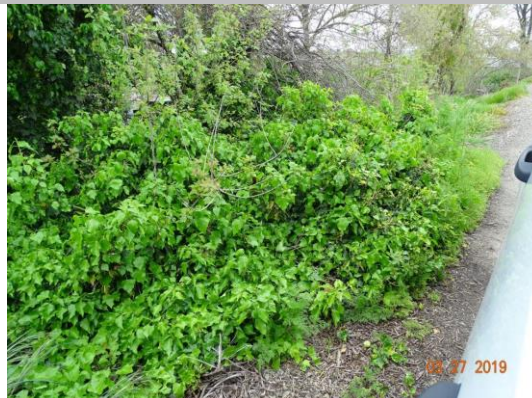
Photo 1 of 1 : FA\_2019\_RD0524\_107\_136\_20190830\_00132.jpg

LM Start	3.37	Rating **	U	Issue No.	136
LM End	3.37	Issue Type +	En	Location *	LS
Category	Earthen Levee			GPS Latitude/Longitude	
				Start	End
Item	Vegetation			37.907230 °	37.907230 °
				-121.325395 °	-121.325395 °
DWR ID	DWR_RD0524_01_s_2019_136				
Comment Code					
V6 : Landscaping					
Inspector Comment

Dense landscape vegetation on landside slope. Spring 2019.

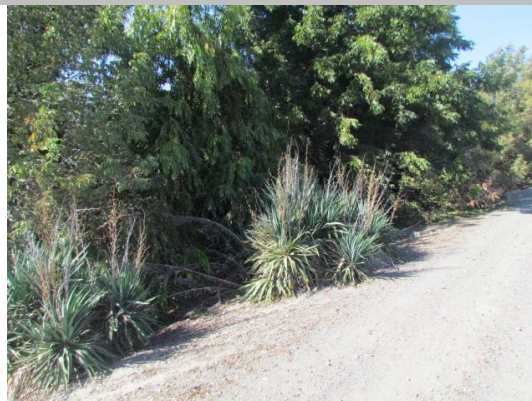
Photo 1 of 1 : FA\_2019\_RD0524\_107\_54\_20190830\_00069.jpg

LM Start	3.44	Rating **	U	Issue No.	54
LM End	3.47	Issue Type +	Ma	Location *	LS
Category	Earthen Levee			GPS Latitude/Longitude	
				Start	End
Item	Trim / Thin Trees			37.906291 °	37.906018 °
				-121.324748 °	-121.324300 °
DWR ID	DWR_RD0524_01_s_2012_54				
Comment Code					
T3 : Trim and thin trees to allow visibility of the ground and room to flood fight.					
Inspector Comment					
Dense untrimmed trees on landside slope.

Looking northwest at dense vegetation on landside slope.

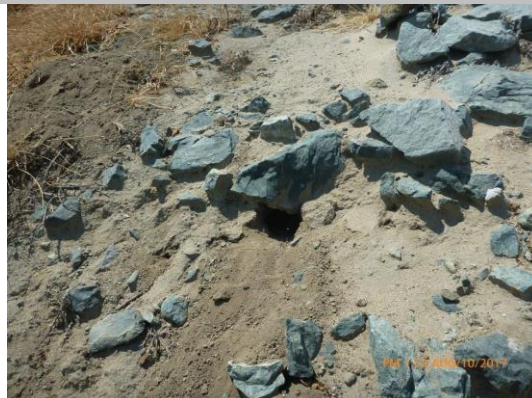
Photo 2 of 3 : LEVAL\_FA\_2019\_526\_4202.jpg

Item	2017 Storm Damage		37.905300 °	37.905200 °								
			-121.323800 °	-121.323900 °								
DWR ID	LMA-432											
Comment Code												
Inspector Comment												
<p>Levee Evaluation Comments</p> <p>Description: Slope protection repairs are needed along the waterside slope due to erosion and riprap displacement from high water. Based upon levee inspections, it was determined the waterside levee slope is eroding, deteriorating, and degrading. The eroded levee sections need to be restored back to design standards to prevent further deterioration and damage.</p> <p>Site ID No: 526</p> <p>Site Designation: LMA-432</p> <p>Repair Type: Erosion</p> <p>Rating: Area of Concern</p> <p>Field Date: 8/10/2017</p> <p>Notes:</p>

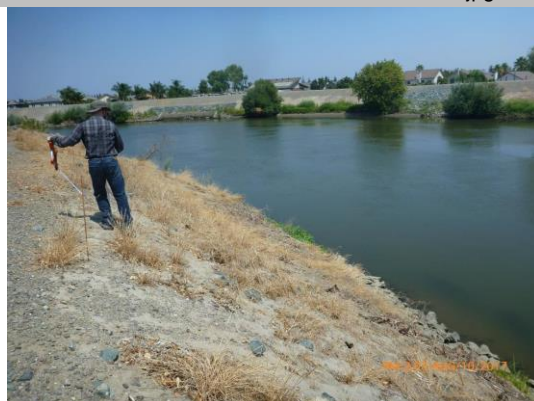
Photo 2 of 3 : LEVAL\_FA\_2019\_525\_4206.jpg

LM Start	3.56	Rating **	A/W	Issue No.	234 (cont)	
LM End	3.57	Issue Type +	Ma	Location *		
Category	Supplemental			GPS Latitude/Longitude		
				Start	End	
Item	2017 Storm Damage			37.904900 °	37.904800 °	
				-121.323900 °	-121.324100 °	
DWR ID	LMA-431					
Comment Code						
Inspector Comment						
Levee Evaluation Comments						
Description:Slope protection repairs are needed along the waterside slope due to erosion and riprap displacement from high water. Based upon levee inspections, it was determined the waterside levee slope is eroding, deteriorating, and degrading. The eroded levee sections need to be restored back to design standards to prevent further deterioration and damage.						
Site ID No:525						
Site Designation:LMA-431						
Repair Type: Erosion						
Rating:Area of Concern						
Field Date:8/10/2017						
Notes: No appearance of erosion, continue to monitor

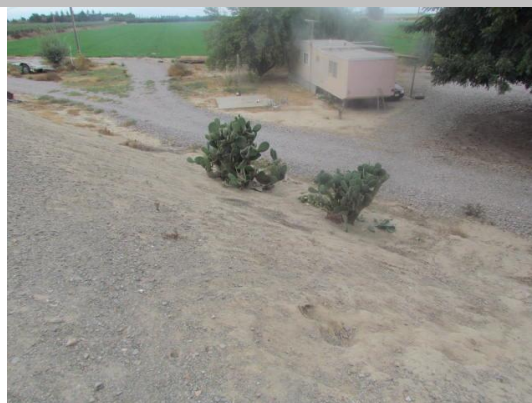
Photo 1 of 1 : FA\_2019\_RD0524\_107\_124\_20190830\_00131.jpg

LM Start	3.61	Rating **	M	Issue No.	124
LM End	3.61	Issue Type +	En	Location *	LS
Category	Earthen Levee			GPS Latitude/Longitude	
				Start	End
Item	Vegetation			37.904375 °	37.904375 °
				-121.324615 °	-121.324615 °
DWR ID	DWR_RD0524_01_f_2012_124				
Comment Code					
V6 : Landscaping					
Inspector Comment					
Landowner planted cactus on landside toe.

Looking west at cactus on landside toe.

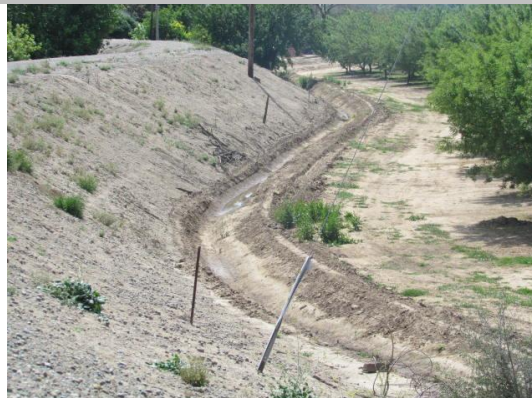
Photo 1 of 2 : FA\_2019\_RD0524\_107\_194\_20190830\_00173.jpg

LM Start	3.69	Rating **	U	Issue No.	194
LM End	3.78	Issue Type +	En	Location *	LS
Category	Earthen Levee			GPS Latitude/Longitude	
				Start	End
Item	Encroachments			37.903553 °	37.902505 °
				-121.325468 °	-121.326425 °
DWR ID	DWR_RD0524_01_s_2015_194				
Comment Code					
DT : Ditch					
Inspector Comment					
Shallow Irrigation ditch at landside toe.

Looking south at irrigation ditch at landward toe.

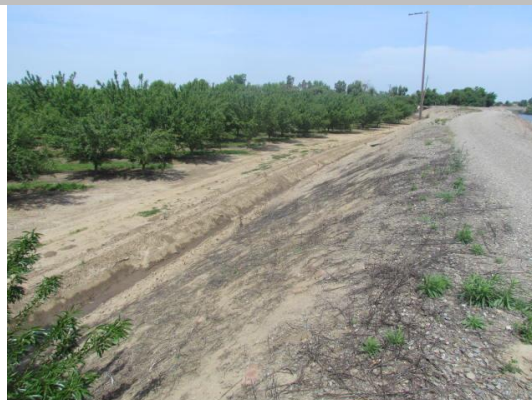
Photo 2 of 2 : FA\_2019\_RD0524\_107\_194\_20190830\_00174.jpg

Looking east at south end of irrigation ditch at landward toe.

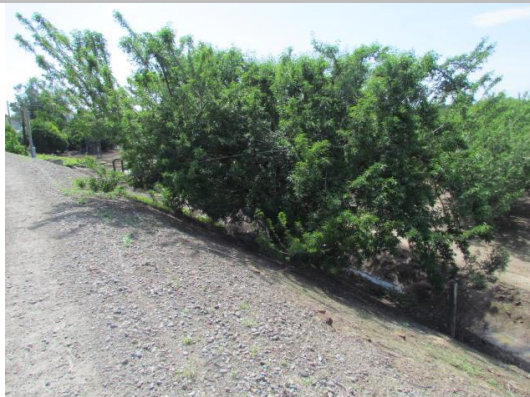
Photo 1 of 1 : FA\_2019\_RD0524\_107\_927\_20190830\_00261.jpg

LM Start	3.77	Rating **	M	Issue No.	927
LM End	3.77	Issue Type +	Ma	Location *	LS
Category	Earthen Levee			GPS Latitude/Longitude	
				Start	End
Item	Trim / Thin Trees			37.902645 °	37.902645 °
				-121.326340 °	-121.326340 °
DWR ID	DWR_RD0524_01_s_2012_927				
Comment Code					
T1 : Trim trees to at least five feet above ground level.					
Inspector Comment					
Trim trees to at least five feet above ground level.

Looking southwest at untrimmed tree at landward toe.

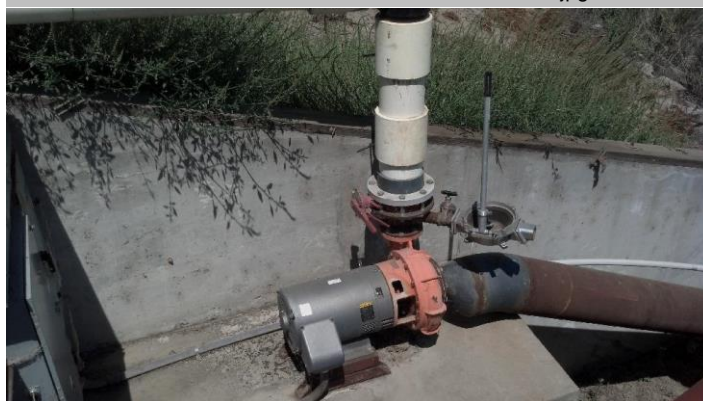
Photo 1 of 3 : UCIP\_FA\_2019\_22725\_38445.jpg

DS\_ID:24044  
FS\_ID:22725  
EP\_NO: N/A  
Repair Type: Non-Urgent  
Crossing Status: Found  
UCIP Comments: No permit identified for this crossing.  
FIELD\_STRUCT\_DESC: 8-inch steel irrigation pipe through the levee, 0 feet below the crown. Pipe integrated into steel cattle guard style crossing. Slant pump and butterfly valve at concrete foundation on the waterside (WS) slope. Filter plant, vents, and butterfly valves on the landside (LS) toe.  
FS Date: 8/20/2013

Pump and butterfly valve on concrete pad on WS shoulder.

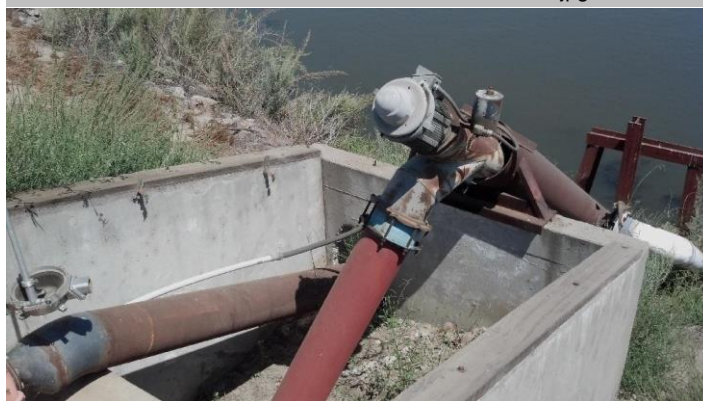
Photo 2 of 3 : UCIP\_FA\_2019\_18307\_30527.jpg

Comment Code						
Inspector Comment						
DS_ID:20620						
FS_ID:18307						
EP_NO: N/A						
Repair Type: Non-Urgent						
Crossing Status: Found						
UCIP Comments: Appears abandoned and if so should be done so properly. Evidence of severe internal corrosion in concrete distribution box at LS toe.						
FIELD_STRUCT_DESC: 12-inch concrete encased steel irrigation pipe through the levee, 10.5 feet below the crown. Pump and gate valve in pump house on the waterside (WS) slope. 6-foot by 6-foot Concrete distribution box on the landside (LS) toe. Two concrete cutoff walls. Service pole at the LS toe. [Additional Reference(s): DWR Levee Log, 2004. USACE San Joaquin O&M Manual 7, April 1964, (HLM 3.83)].						
FS Date: 8/20/2013

Slant pump and pipe on WS slope.

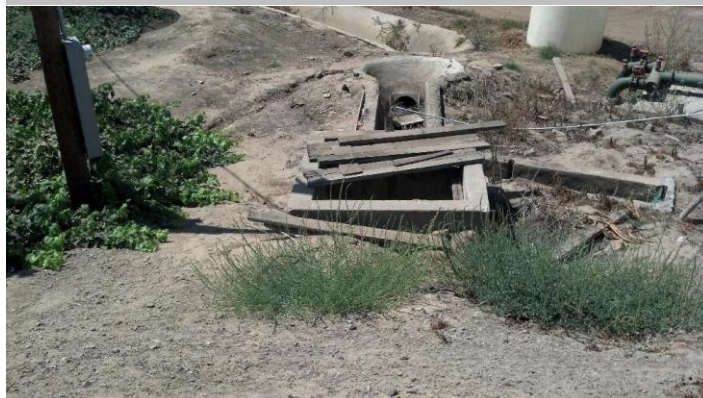
Photo 3 of 3 : UCIP\_FA\_2019\_18307\_30526.jpg

6'X6' concrete distribution box and power pole on LS toe.

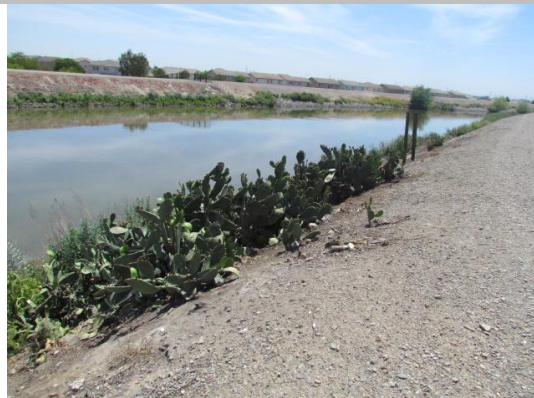
Photo 2 of 2 : FA\_2019\_RD0524\_107\_94\_20190830\_00118.jpg

LM Start	3.89	Rating **	U	Issue No.	94 (cont)	
LM End	3.89	Issue Type +	Ma	Location *	WS	
Category	Earthen Levee			GPS Latitude/Longitude		
				Start		End
Item	Vegetation			37.900940 °		37.900940 °
				-121.326414 °		-121.326414 °
DWR ID	DWR_RD0524_01_s_2012_94					
Comment Code						
V2 : Remove the wild growth other than native grasses from the levee slopes.						
Inspector Comment						
Remove cactus from waterside slope.

Looking southeast at cactus on waterside slope. Fall 2013

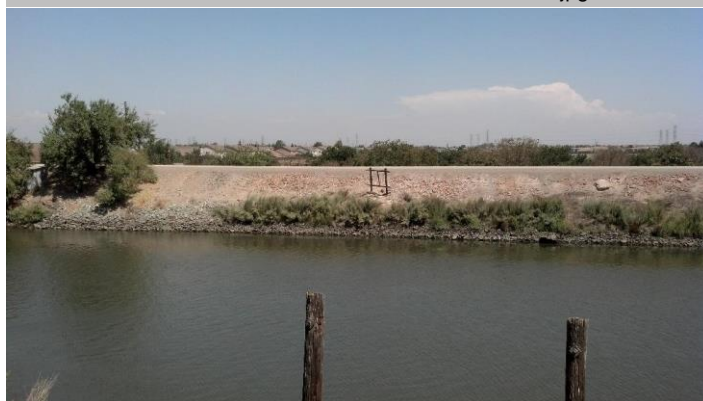
Photo 2 of 2 : UCIP\_FA\_2019\_41464\_30542.jpg

LM Start	3.90	Rating **	M	Issue No.	955 (cont)	
LM End	3.90	Issue Type +	En	Location *		
Category	Supplemental			GPS Latitude/Longitude		
				Start	End	
Item	DRAFT DWR UCIP Field Study			37.900778 °	37.900778 °	
				-121.326420 °	-121.326420 °	
DWR ID	20621					
Comment Code						
Inspector Comment						
DS_ID:20621						
FS_ID:41464						
EP_NO: N/A						
Repair Type: Non-Urgent						
Crossing Status: Found						
UCIP Comments: Appears to be abandoned as signage has been removed.						
FIELD_STRUCT_DESC: 2.5-inch submarine telephone conduit of an unknown material through the levee and across the channel, 2 feet below the crown. Sign posts remain on both sides of the river on the waterside (WS) slope. [Additional Reference(s): DWR Levee Log, 2004].						
FS Date: 8/20/2013

Sign posts visible on opposite river bank in same condition.

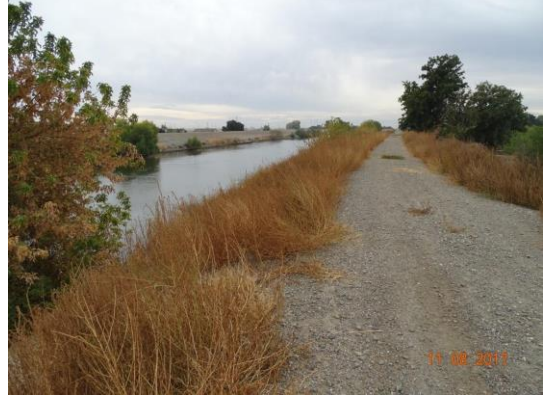
Photo 1 of 1 : FA\_2019\_RD0524\_107\_254\_20190830\_00241.jpg

LM Start	3.97	Rating **	M	Issue No.	254
LM End	4.03	Issue Type +	Ma	Location *	WS
Category	Earthen Levee			GPS Latitude/Longitude	
				Start	End
Item	Vegetation			37.899718 °	37.898945 °
				-121.326605 °	-121.327003 °
DWR ID	DWR_RD0524_01_f_2017_254				
Comment Code					
V2 : Remove the wild growth other than native grasses from the levee slopes.					
Inspector Comment

Looking southwest at the waterside slope.

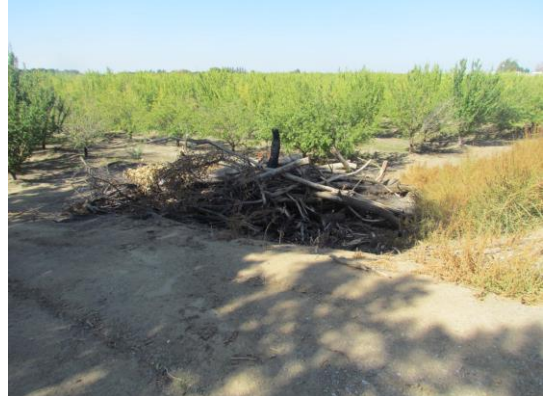
Photo 1 of 2 : FA\_2019\_RD0524\_107\_195\_20190830\_00175.jpg

LM Start	4.02	Rating **	M	Issue No.	195
LM End	4.02	Issue Type +	En	Location *	LS
Category	Earthen Levee			GPS Latitude/Longitude	
				Start	End
Item	Encroachments			37.899093 °	37.899093 °
				-121.326933 °	-121.326933 °
DWR ID	DWR_RD0524_01_s_2015_195				
Comment Code					
PR : Prunings					
Inspector Comment					
Pruning pile blocking view of landside slope.

Looking southwes at large pruning pile at landward toe. (Fall 2016)

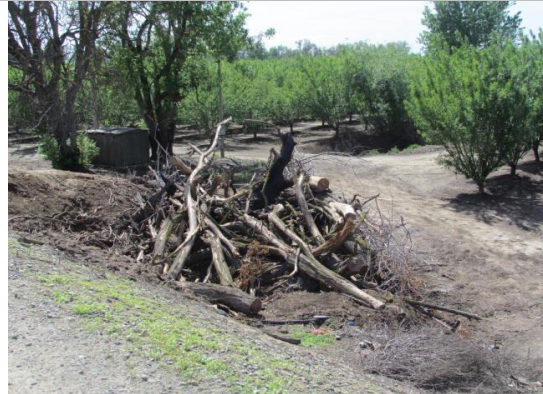
Photo 2 of 2 : FA\_2019\_RD0524\_107\_195\_20190830\_00176.jpg

Looking at pruning pile at landward toe. (Spring 2016)

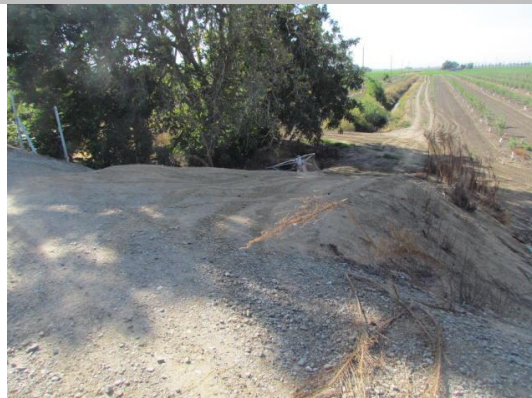
Photo 1 of 1 : FA\_2019\_RD0524\_107\_101\_20190830\_00123.jpg

LM Start	4.02	Rating **	U	Issue No.	101
LM End	4.02	Issue Type +	En	Location *	LS
Category	Earthen Levee			GPS Latitude/Longitude	
				Start	End
Item	Encroachments			37.899027°	37.899027°
				-121.326982°	-121.326982°
DWR ID	DWR_RD0524_01_s_2012_101				
Comment Code					
RA : Ramp					
Inspector Comment					
Unauthorized ramp. Ramp does not meet Title 23 standard.

Looking west at unauthorized ramp on landside slope.

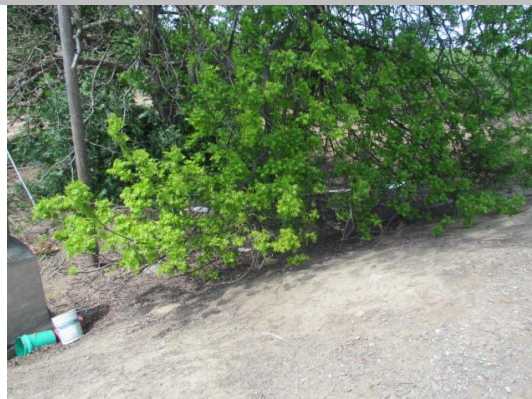
Photo 1 of 1 : FA\_2019\_RD0524\_107\_61\_20190830\_00082.jpg

LM Start	4.03	Rating **	M	Issue No.	61
LM End	4.03	Issue Type +	Ma	Location *	LS
Category	Earthen Levee			GPS Latitude/Longitude	
				Start	End
Item	Trim / Thin Trees			37.898925 °	37.898925 °
				-121.327015 °	-121.327015 °
DWR ID	DWR_RD0524_01_s_2012_61				
Comment Code					
T1 : Trim trees to at least five feet above ground level.					
Inspector Comment

Looking east at untrimmed tree at landward toe.

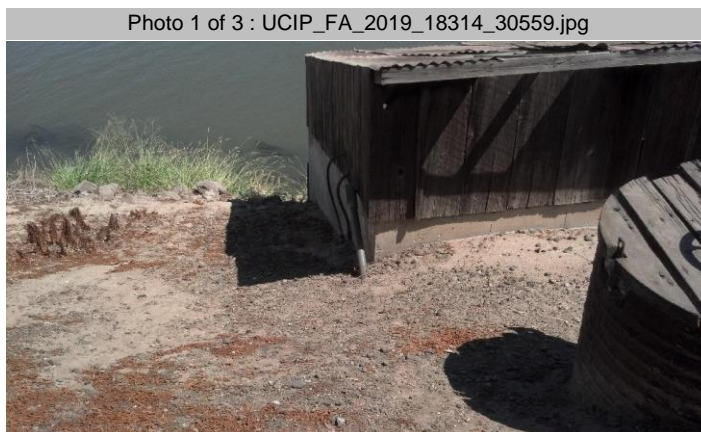
Comment Code					
Inspector Comment					
DS_ID:20623					
FS_ID:18314					
EP_NO: N/A					
Repair Type: Non-Urgent					
Crossing Status: Found					
UCIP Comments: Appears abandoned and if so should be done so properly.					
FIELD_STRUCT_DESC: 8-inch concrete encased steel irrigation pipe through the levee, 9.5 feet below the crown. Pump and gate valve in pump house on the waterside (WS) slope. Slide gate in 42-inch corrugated metal pipe riser unit on the WS slope. Brick standpipe at the toe of the landside (LS) slope. 1.5-inch galvanized iron electrical conduit through the levee, 3 feet below the crown at the same location.					
[Additional Reference(s): DWR Levee Log, 2004. USACE San Joaquin O&M Manual 7, April 1964, (HLM 4.08)].					
FS Date: 8/20/2013

Electrical conduit visible on WS slope at pumphouse.

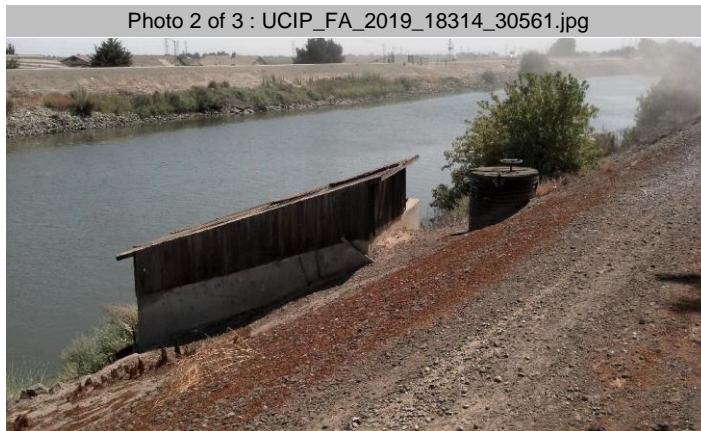
Pumphouse and gate valve in CMP riser on WS slope.

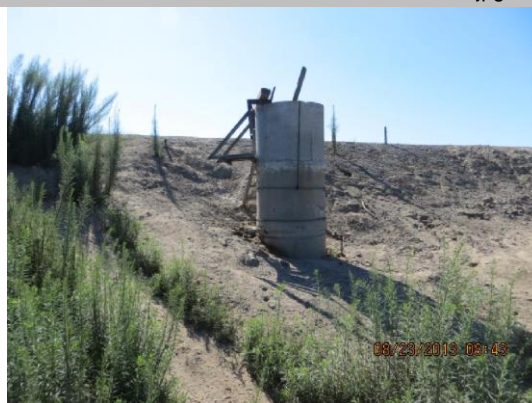
Photo 1 of 3 : UCIP\_FA\_2019\_18318\_30589.jpg

LM Start	4.16	Rating **	M	Issue No.	957
LM End	4.16	Issue Type +	En	Location *	
Category	Supplemental			GPS Latitude/Longitude	
				Start	End
Item	DRAFT DWR UCIP Field Study			37.897118 °	37.897118 °
				-121.327910 °	-121.327910 °
DWR ID	20625				
Comment Code					
Inspector Comment					
DS_ID:20625					
FS_ID:18318					
EP_NO: N/A					
Repair Type: Non-Urgent					
Crossing Status: Found					
UCIP Comments: Small leak on WS slope causing minor erosion on WS slope.					
FIELD_STRUCT_DESC: 12-inch steel irrigation pipe through the levee, 4.5 feet below the crown. Pump house and gate valve on the waterside (WS) slope. 36-inch concrete standpipe, power pole, and meter on the landside (LS) toe. [Additional Reference(s): DWR Levee Log, 2004. USACE San Joaquin O&M Manual 7, April 1964, (HLM 4.21)].					
FS Date: 8/23/2013

Concrete standpipe on LS slope.

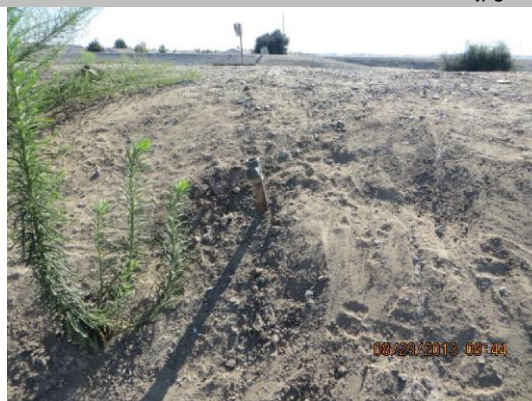
Photo 2 of 3 : UCIP\_FA\_2019\_18318\_30588.jpg

LM Start	4.16	Rating **	M	Issue No.	957 (cont)
LM End	4.16	Issue Type +	En	Location *	
Category	Supplemental			GPS Latitude/Longitude	
				Start	End
Item	DRAFT DWR UCIP Field Study			37.897118 °	37.897118 °
				-121.327910 °	-121.327910 °
DWR ID	20625				
Comment Code					
Inspector Comment					
DS_ID:20625 FS_ID:18318 EP_NO: N/A Repair Type: Non-Urgent Crossing Status: Found UCIP Comments: Small leak on WS slope causing minor erosion on WS slope. FIELD_STRUCT_DESC: 12-inch steel irrigation pipe through the levee, 4.5 feet below the crown. Pump house and gate valve on the waterside (WS) slope. 36-inch concrete standpipe, power pole, and meter on the landside (LS) toe. [Additional Reference(s): DWR Levee Log, 2004. USACE San Joaquin O&M Manual 7, April 1964, (HLM 4.21)]. FS Date: 8/23/2013

Vent or siphon breaker just off LS shoulder.

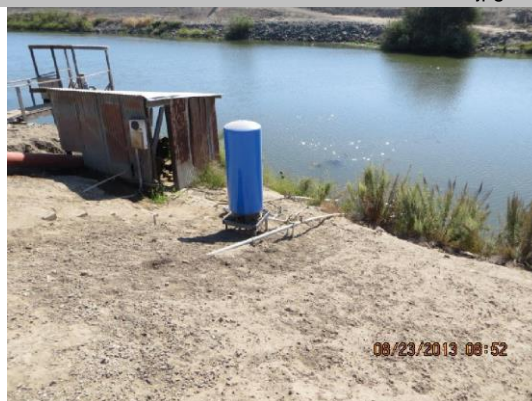
Photo 2 of 2 : UCIP\_FA\_2019\_22069\_37659.jpg

LM Start	4.17	Rating **	M	Issue No.	958 (cont)	
LM End	4.17	Issue Type +	En	Location *		
Category	Supplemental			GPS Latitude/Longitude		
				Start	End	
Item	DRAFT DWR UCIP Field Study			37.897074 °	37.897074 °	
				-121.327926 °	-121.327926 °	
DWR ID	24049					
Comment Code						
Inspector Comment						
DS_ID:24049						
FS_ID:22069						
EP_NO: N/A						
Repair Type: Non-Urgent						
Crossing Status: Found						
UCIP Comments: No permit identified for this crossing.						
FIELD_STRUCT_DESC: 2.25-inch polyvinyl chloride domestic water service line through the levee, 5 feet below the crown. Pump and tank on the waterside (WS) slope with a vent on the landside (LS) slope.						
FS Date: 8/23/2013

Pipe, pump, and tank visible on WS slope.

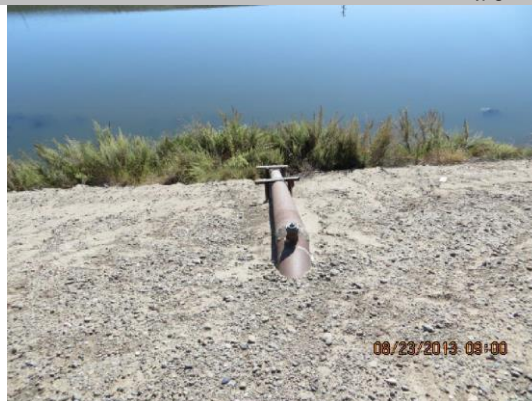
Photo 1 of 3 : UCIP\_FA\_2019\_18320\_30594.jpg

LM Start	4.37	Rating **	M	Issue No.	959	
LM End	4.37	Issue Type +	En	Location *		
Category	Supplemental			GPS Latitude/Longitude		
				Start	End	
Item	DRAFT DWR UCIP Field Study			37.894453 °	37.894453 °	
				-121.329232 °	-121.329232 °	
DWR ID	20626					
Comment Code						
Inspector Comment						
DS_ID:20626						
FS_ID:18320						
EP_NO: N/A						
Repair Type: Non-Urgent						
Crossing Status: Found						
UCIP Comments: Small leak in pipe on LS slope and pipe slightly crushed on LS toe.						
FIELD_STRUCT_DESC: 9-inch steel pipe of unknown purpose through the levee, 3 feet below the crown. Pump in drainage ditch on the landside (LS). Siphon breaker on the waterside (WS) slope. [Additional Reference(s): DWR Levee Log, 2004. USACE San Joaquin O&M Manual 7, April 1964, (HLM 4.42) 8-inch pipe listed].						
FS Date: 8/23/2013

Pipe and siphon breaker on WS slope.

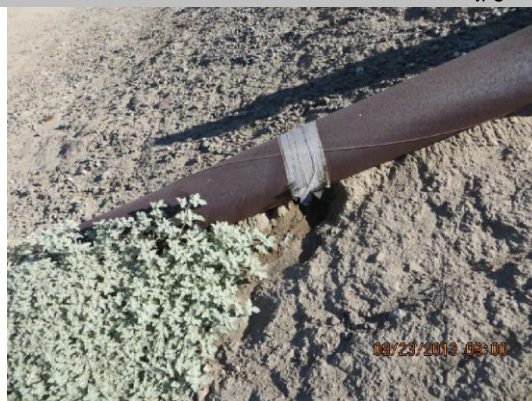
Photo 2 of 3 : UCIP\_FA\_2019\_18320\_30593.jpg

LM Start	4.37	Rating **	M	Issue No.	959 (cont)	
LM End	4.37	Issue Type +	En	Location *		
Category	Supplemental			GPS Latitude/Longitude		
				Start	End	
Item	DRAFT DWR UCIP Field Study			37.894453 °	37.894453 °	
				-121.329232 °	-121.329232 °	
DWR ID	20626					
Comment Code						
Inspector Comment						
DS_ID:20626 FS_ID:18320 EP_NO: N/A Repair Type: Non-Urgent Crossing Status: Found UCIP Comments: Small leak in pipe on LS slope and pipe slightly crushed on LS toe. FIELD_STRUCT_DESC: 9-inch steel pipe of unknown purpose through the levee, 3 feet below the crown. Pump in drainage ditch on the landside (LS). Siphon breaker on the waterside (WS) slope. [Additional Reference(s): DWR Levee Log, 2004. USACE San Joaquin O&M Manual 7, April 1964, (HLM 4.42) 8-inch pipe listed]. FS Date: 8/23/2013

Small leak in pipe on LS slope.

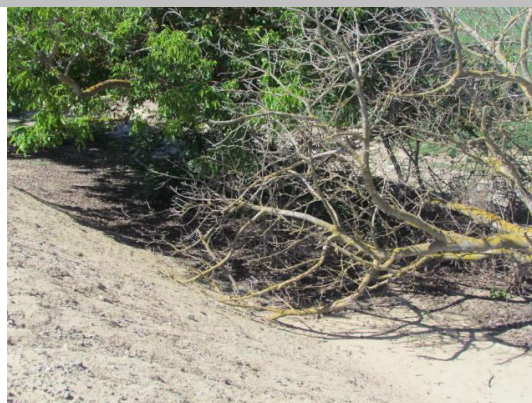
Photo 1 of 1 : FA\_2019\_RD0524\_107\_111\_20190830\_00128.jpg

LM Start	4.38	Rating **	M	Issue No.	111
LM End	4.38	Issue Type +	Ma	Location *	LS
Category	Earthen Levee			GPS Latitude/Longitude	
				Start	End
Item	Encroachments			37.894258 °	37.894258 °
				-121.329247 °	-121.329247 °
DWR ID	DWR_RD0524_01_s_2012_111				
Comment Code					
TR : Tree or limb					
Inspector Comment					
Dead tree at landside toe should be removed from levee toe.

Looking west at dead tree at landside toe.

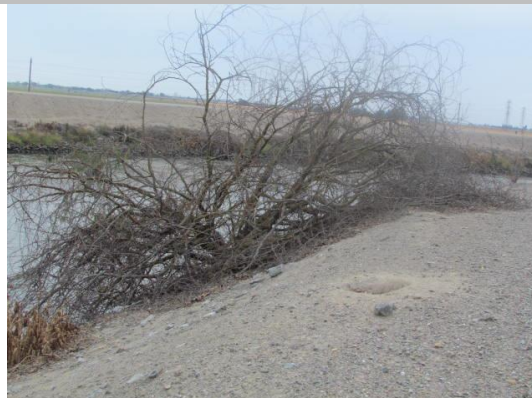
Photo 2 of 2 : FA\_2019\_RD0524\_107\_102\_20190830\_00125.jpg

LM Start	4.52	Rating **	U	Issue No.	102 (cont)	
LM End	4.52	Issue Type +	Ma	Location *	WS	
Category	Earthen Levee			GPS Latitude/Longitude		
				Start	End	
Item	Encroachments			37.892383 °	37.892383 °	
				-121.328194 °	-121.328194 °	
DWR ID	DWR_RD0524_01_f_2016_102					
Comment Code						
TR : Tree or limb						
Inspector Comment						
Dead tree on waterside slope should be removed

Looking southeast at dead tree on waterside slope.

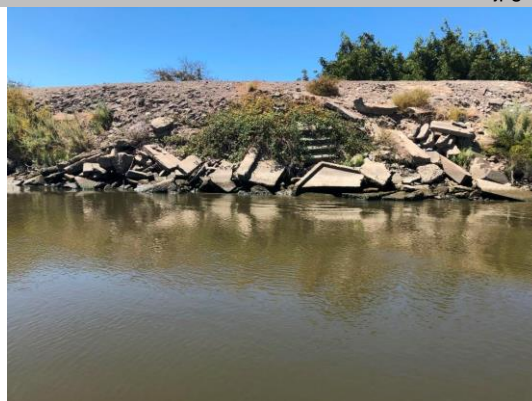
Photo 1 of 3 : SJR2019\_RD0524U01RM45.07\_1.jpg

LM Start	4.53	Rating **	A/W	Issue No.	70
LM End	4.54	Issue Type +	Ma	Location *	
Category	Supplemental			GPS Latitude/Longitude	
				Start	End
Item	DWR Erosion Survey			37.892230 °	37.892230 °
				-121.327930 °	-121.327930 °
DWR ID	RD0524U01RM45.07				
Comment Code					
Inspector Comment					
Site ID: RD0524U01RM45.07					
08/13/2019: No significant change observed.					
09/13/2017: No significant change observed.					
07/25/2016: No significant change observed.					
06/24/2015: No significant change observed.					
06/19/2014: No significant change observed.					
08/13/2013: No significant change observed.					
08/07/2012: The erosion is located at the inside of a river bend. Site is covered with broken concrete blocks and other debris.

Front view of the erosion site.

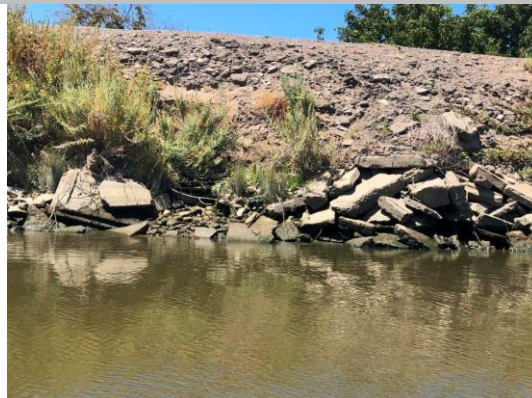
Photo 2 of 3 : SJR2019\_RD0524U01RM45.07\_3.jpg

Site ID: RD0524U01RM45.07  
 08/13/2019: No significant change observed.  
 09/13/2017: No significant change observed.  
 07/25/2016: No significant change observed.  
 06/24/2015: No significant change observed.  
 06/19/2014: No significant change observed.  
 08/13/2013: No significant change observed.  
 08/07/2012: The erosion is located at the inside of a river bend. Site is covered with broken concrete blocks and other debris.

Close-up view of the site.

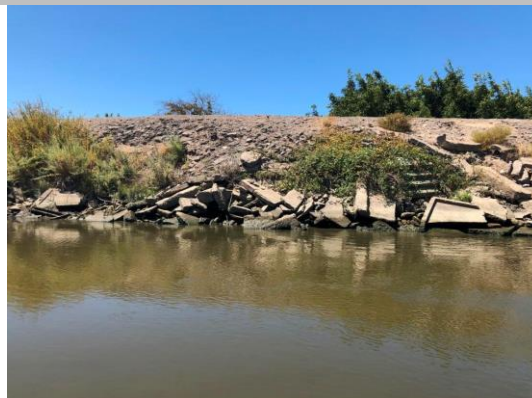
Photo 3 of 3 : SJR2019\_RD0524U01RM45.07\_2.jpg

Front view of the site. Note the loosely placed concrete blocks at the site.

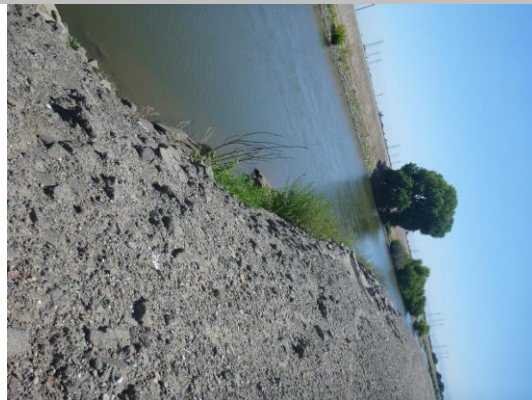
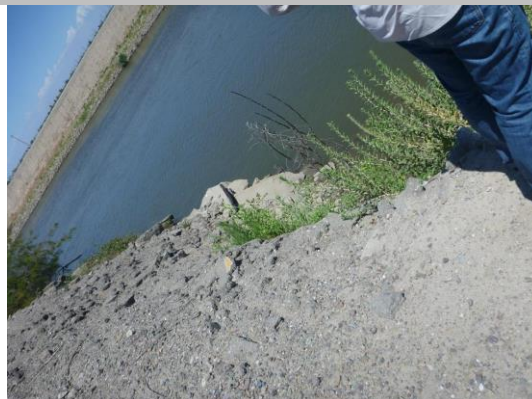
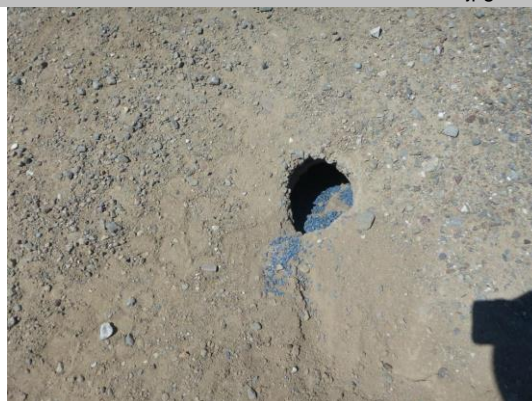
Description: Slope protection repairs are needed along the waterside slope due to erosion. Based upon levee inspections, it was determined the waterside levee slopes were eroding, deteriorating and degrading in concave pocket sections at various locations along this levee reach. The eroded levee sections need to be restored back to design standards to prevent further deterioration of the damaged levee sections.

Item	2017 Storm Damage		37.892200 °	°								
			-121.328000 °	°								
DWR ID	LMA-295											
Comment Code												
Inspector Comment												
<p>Levee Evaluation Comments</p> <p>Description: Slope protection repairs are needed along the waterside slope due to erosion. Based upon levee inspections, it was determined the waterside levee slopes were eroding, deteriorating and degrading in concave pocket sections at various locations along this levee reach. The eroded levee sections need to be restored back to design standards to prevent further deterioration of the damaged levee sections.</p> <p>Site ID No: 468</p> <p>Site Designation: LMA-295</p> <p>Repair Type: Erosion</p> <p>Rating: Serious</p> <p>Field Date: 7/26/2017</p> <p>Notes: Serious because erosion is impacting the levee, but there is some slope protection here. Slope is armored with asphalt and concrete rubble. The surrounding slopes are pretty barren, but there is a small bush within the site so it may be older.</p>
