**Flood Control Project Maintenance  
Levee Inspections**

**Fall 2019 Levee Maintenance Deficiency Summary Report**

**Flood Control Project Maintenance  
Levee Inspections****LMA District Cover Sheet****Fall 2019 Levee Inspection Results****Reclamation District No. 0524 Middle Roberts Island**

**Reclamation District No. 0524 Middle Roberts Island**

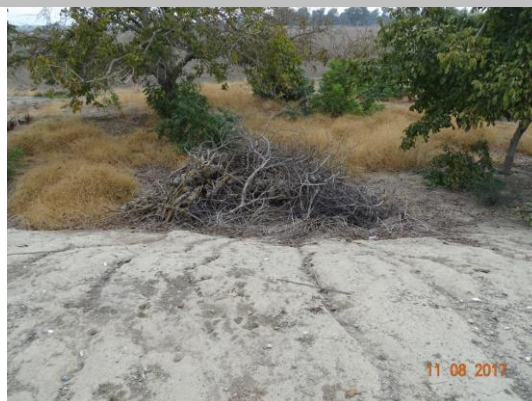
Photo 1 of 1 : FA\_2019\_RD0524\_107\_258\_20190830\_00242.jpg

LM Start	<b>4.57</b>	Rating **	M	Issue No.	<b>258</b>							
LM End	<b>4.57</b>	Issue Type +	En	Location *	LS							
Category	Earthen Levee		GPS Latitude/Longitude									
			Start	End								
Item	Encroachments		37.891778 °	37.891778 °								
			-121.328342 °	-121.328342 °								
DWR ID	DWR_RD0524_01_f_2017_258											
Comment Code												
PR : Prunings												
Inspector Comment

Looking west at the landside slope.

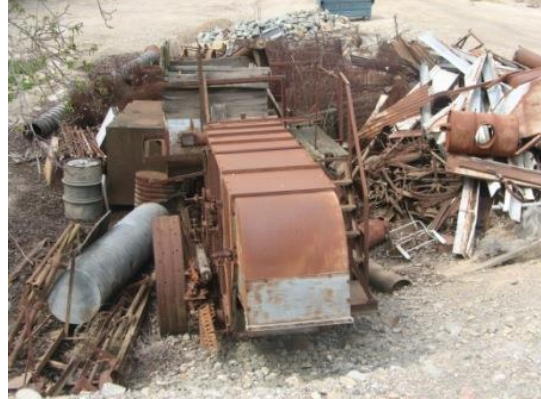
Photo 1 of 1 : FA\_2019\_RD0524\_107\_66\_20190830\_00086.jpg

LM Start	4.60	Rating **	M	Issue No.	66
LM End	4.60	Issue Type +	En	Location *	LS
Category	Earthen Levee			GPS Latitude/Longitude	
				Start	End
Item	Encroachments			37.891365 °	37.891365 °
				-121.328633 °	-121.328633 °
DWR ID	DWR_RD0524_01_s_2012_66				
Comment Code					
GA : Garbage					
Inspector Comment					
Old farm equipment at landside toe.

Garbage at landward toe next to ramp at LM 4.64

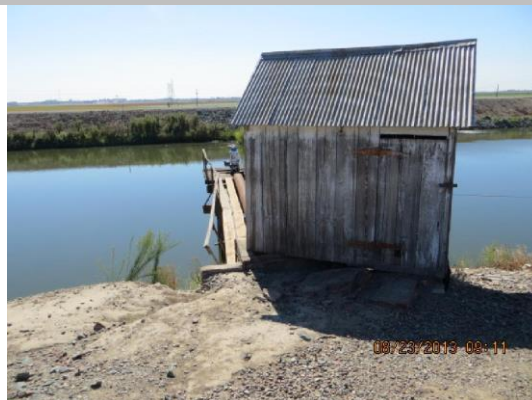
Photo 2 of 3 : UCIP\_FA\_2019\_18323\_30602.jpg

Pump on pier and slide gate house on WS shoulder.

Comment Code						
Inspector Comment						
DS_ID:20646						
FS_ID:18323						
EP_NO: 0						
Repair Type: Non-Urgent						
Crossing Status: Found						
UCIP Comments: Good candidate for video inspection as brick and mortar deteriorating inside tunnel.						
FIELD_STRUCT_DESC: 22-inch concrete irrigation pipe through the levee, 12 feet below the crown. Pump on pier at the waterside (WS) toe. 16-inch pipe from pump discharges into a concrete riser unit inside the pump house on the WS shoulder. Brick and mortar channel on the landside (LS) toe. [Additional Reference(s): USACE San Joaquin O&M Manual 7, April 1964, (HLM 4.73) 14-inch pipe listed].						
FS Date: 8/23/2013

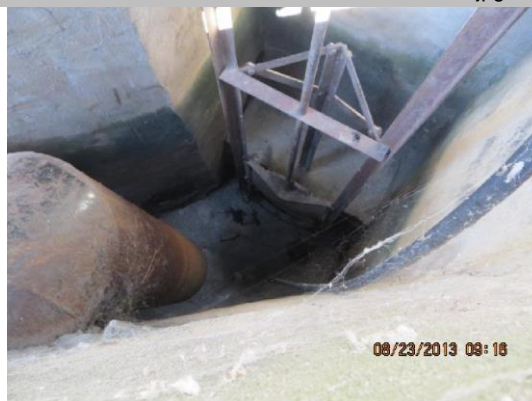
Photo 3 of 3 : UCIP\_FA\_2019\_18323\_30601.jpg

Slide gate inside concrete riser within shed on WS shoulder.

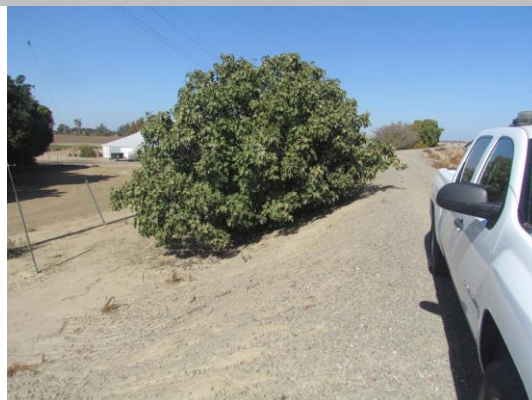
Photo 1 of 1 : FA\_2019\_RD0524\_107\_67\_20190830\_00087.jpg

LM Start	4.70	Rating **	M	Issue No.	67
LM End	4.70	Issue Type +	Ma	Location *	LS
Category	Earthen Levee			GPS Latitude/Longitude	
				Start	End
Item	Trim / Thin Trees			37.890108 °	37.890108 °
				-121.329523 °	-121.329523 °
DWR ID	DWR_RD0524_01_s_2012_67				
Comment Code					
T1 : Trim trees to at least five feet above ground level.					
Inspector Comment					
Fig tree at landside toe.

Looking northwest at untrimmed tree on landward slope.

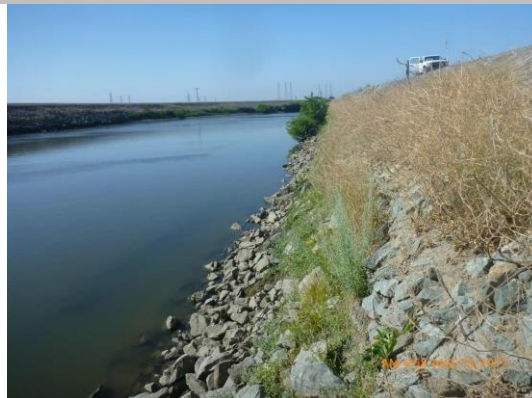
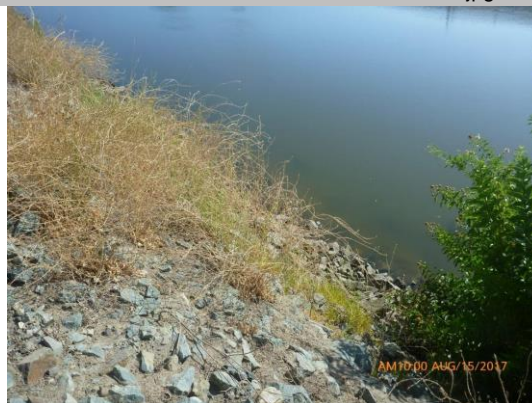
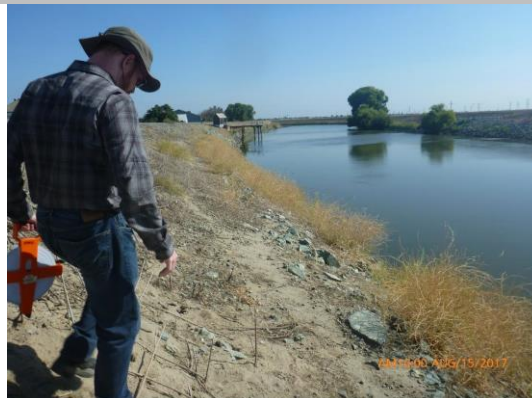
LM Start	4.76	Rating **	A/W	Issue No.	236
LM End	4.76	Issue Type +	Ma	Location *	
Category	Supplemental			GPS Latitude/Longitude	
				Start	End
Item	2017 Storm Damage			37.889300 °	37.889300 °
				-121.329800 °	-121.329800 °
DWR ID	LMA-429				
Comment Code					
Inspector Comment					
Levee Evaluation Comments					
Description:Slope protection repairs are needed along the waterside slope due to erosion and riprap displacement from high water. Based upon levee inspections, it was determined the waterside levee slope is eroding, deteriorating, and degrading. The eroded levee sections need to be restored back to design standards to prevent further deterioration and damage.					
Site ID No:523					
Site Designation:LMA-429					
Repair Type: Erosion					
Rating:Area of Concern					
Field Date:8/15/2017					
Notes:

LM Start	<b>4.76</b>	Rating **	A/W	Issue No.	<b>236 (cont)</b>
LM End	<b>4.76</b>	Issue Type +	Ma	Location *	
Category	Supplemental			GPS Latitude/Longitude	
				Start	End
Item	2017 Storm Damage			37.889300 °	37.889300 °
				-121.329800 °	-121.329800 °
DWR ID	LMA-429				
Comment Code					
Inspector Comment					
<p>Levee Evaluation Comments</p> <p>Description: Slope protection repairs are needed along the waterside slope due to erosion and riprap displacement from high water. Based upon levee inspections, it was determined the waterside levee slope is eroding, deteriorating, and degrading. The eroded levee sections need to be restored back to design standards to prevent further deterioration and damage.</p> <p>Site ID No: 523</p> <p>Site Designation: LMA-429</p> <p>Repair Type: Erosion</p> <p>Rating: Area of Concern</p> <p>Field Date: 8/15/2017</p> <p>Notes:</p>

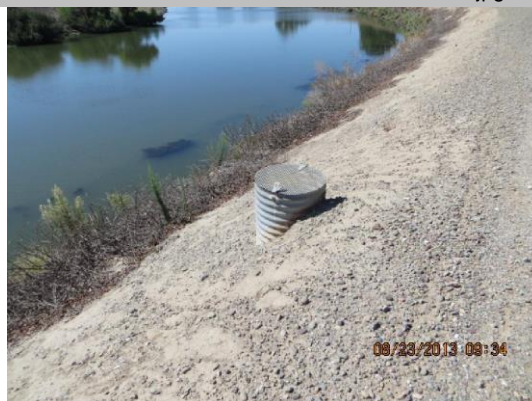
Photo 1 of 3 : UCIP\_FA\_2019\_22728\_38453.jpg

LM Start	4.89	Rating **	M	Issue No.	961	
LM End	4.89	Issue Type +	En	Location *		
Category	Supplemental			GPS Latitude/Longitude		
				Start	End	
Item	DRAFT DWR UCIP Field Study			37.887694 °	37.887694 °	
				-121.331019 °	-121.331019 °	
DWR ID	20628					
Comment Code						
Inspector Comment						
DS_ID:20628 FS_ID:22728 EP_NO: 3817 Repair Type: Non-Urgent Crossing Status: Found UCIP Comments: Appears abandoned and if so should be done so properly. FIELD_STRUCT_DESC: *ABANDONED* 6-inch steel drainage pipe through the levee, 3 feet below the crown. Pump 120 feet off the landside (LS) toe. Siphon breaker in 24-inch corrugated metal riser unit on the waterside (WS) shoulder. (Permit No. 3817, 1961 - Ohm and Saunders). [Additional Reference(s): DWR Levee Log, 2004. USACE San Joaquin O&M Manual 7, April 1964, (HLM 4.95)]. FS Date: 8/23/2013

Siphon breaker in 24-inch CMP riser on WS shoulder.

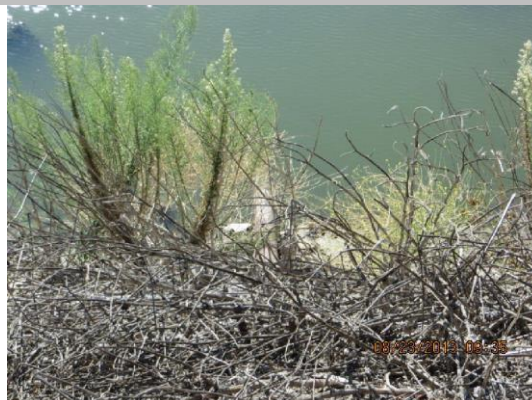
Photo 2 of 3 : UCIP\_FA\_2019\_22728\_38452.jpg

Pipe visible on WS toe.

LM Start	4.89	Rating **	M	Issue No.	961 (cont)	
LM End	4.89	Issue Type +	En	Location *		
Category	Supplemental			GPS Latitude/Longitude		
				Start	End	
Item	DRAFT DWR UCIP Field Study			37.887694 °	37.887694 °	
				-121.331019 °	-121.331019 °	
DWR ID	20628					
Comment Code						
Inspector Comment						
DS_ID:20628 FS_ID:22728 EP_NO: 3817 Repair Type: Non-Urgent Crossing Status: Found UCIP Comments: Appears abandoned and if so should be done so properly. FIELD_STRUCT_DESC: *ABANDONED* 6-inch steel drainage pipe through the levee, 3 feet below the crown. Pump 120 feet off the landside (LS) toe. Siphon breaker in 24-inch corrugated metal riser unit on the waterside (WS) shoulder. (Permit No. 3817, 1961 - Ohm and Saunders). [Additional Reference(s): DWR Levee Log, 2004. USACE San Joaquin O&M Manual 7, April 1964, (HLM 4.95)]. FS Date: 8/23/2013

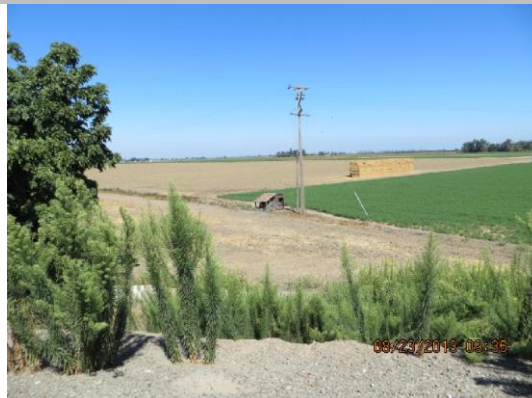
Photo 3 of 3 : UCIP\_FA\_2019\_22728\_38451.jpg

Pump in pumphouse 120-feet off LS toe.

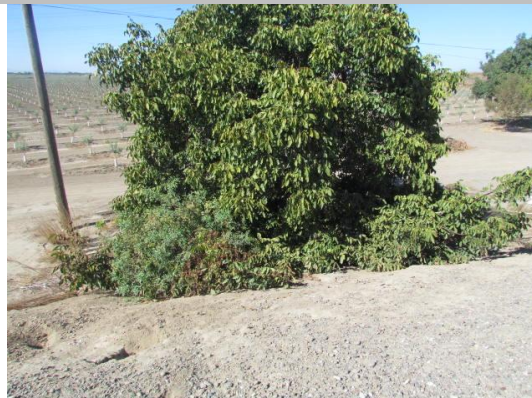
Photo 1 of 1 : FA\_2019\_RD0524\_107\_84\_20190830\_00106.jpg

LM Start	4.90	Rating **	M	Issue No.	84
LM End	4.93	Issue Type +	Ma	Location *	LS
Category	Earthen Levee			GPS Latitude/Longitude	
				Start	End
Item	Trim / Thin Trees			37.887613 °	37.887258 °
				-121.331161 °	-121.331596 °
DWR ID	DWR_RD0524_01_s_2012_84				
Comment Code					
T1 : Trim trees to at least five feet above ground level.					
Inspector Comment					
Untrimmed trees on landside slope.

Looking west at untrimmed tree on landward slope.

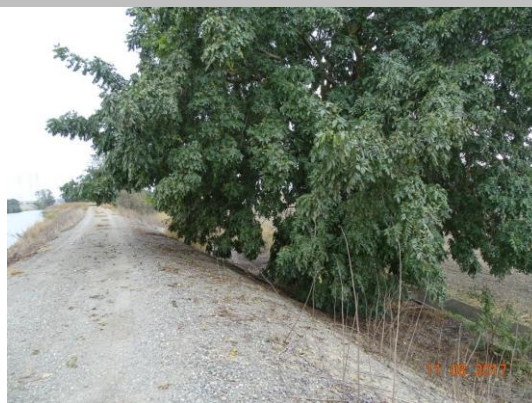
Photo 1 of 1 : FA\_2019\_RD0524\_107\_260\_20190830\_00243.jpg

LM Start	5.00	Rating **	M	Issue No.	260
LM End	5.00	Issue Type +	Ma	Location *	LS
Category	Earthen Levee			GPS Latitude/Longitude	
				Start	End
Item	Trim / Thin Trees			37.886367 °	37.886367 °
				-121.332047 °	-121.332047 °
DWR ID	DWR_RD0524_01_f_2017_260				
Comment Code					
T4 : Trim trees over roadway to at least 12 feet above ground level.					
Inspector Comment

Looking southwest at the landside slope.

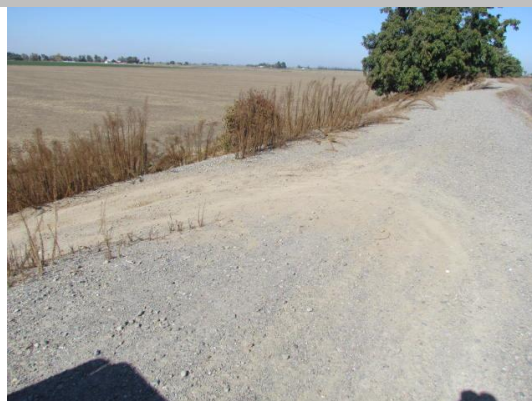
Photo 1 of 1 : FA\_2019\_RD0524\_107\_115\_20190830\_00129.jpg

LM Start	5.19	Rating **	M	Issue No.	115
LM End	5.19	Issue Type +	En	Location *	LS
Category	Earthen Levee			GPS Latitude/Longitude	
				Start	End
Item	Encroachments			37.883587°	37.883587°
				-121.332100°	-121.332100°
DWR ID	DWR_RD0524_01_s_2012_115				
Comment Code					
RA : Ramp					
Inspector Comment

Looking northwest at slope damage on landward slope.

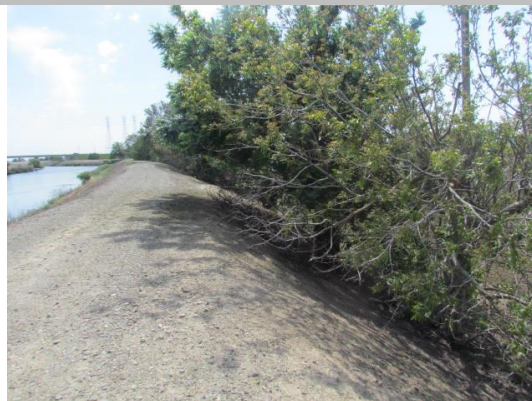
Photo 1 of 1 : FA\_2019\_RD0524\_107\_85\_20190830\_00107.jpg

LM Start	5.28	Rating **	M	Issue No.	85
LM End	5.34	Issue Type +	Ma	Location *	LS
Category	Earthen Levee			GPS Latitude/Longitude	
				Start	End
Item	Trim / Thin Trees			37.882363 °	37.881511 °
				-121.332577 °	-121.332777 °
DWR ID	DWR_RD0524_01_s_2012_85				
Comment Code					
T1 : Trim trees to at least five feet above ground level.					
Inspector Comment

Looking south at untrimmed trees on landward slope.

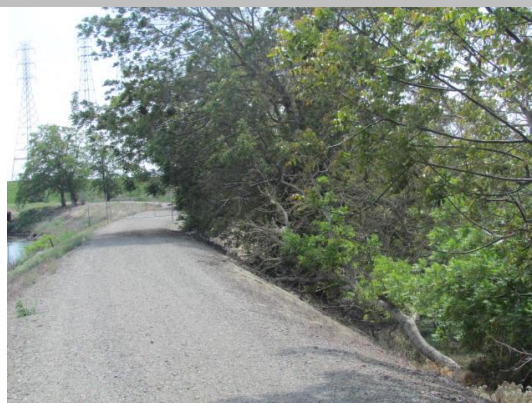
Photo 1 of 1 : FA\_2019\_RD0524\_107\_932\_20190830\_00262.jpg

LM Start	5.38	Rating **	M	Issue No.	932
LM End	5.41	Issue Type +	Ma	Location *	LS
Category	Earthen Levee			GPS Latitude/Longitude	
				Start	End
Item	Trim / Thin Trees			37.880945 °	37.880522 °
				-121.332837 °	-121.332918 °
DWR ID	DWR_RD0524_01_s_2012_932				
Comment Code					
T1 : Trim trees to at least five feet above ground level.					
Inspector Comment

Looking south at untrimmed trees on landward slope and toe.

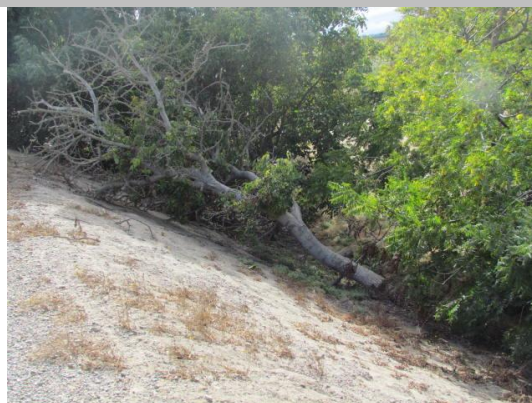
Photo 1 of 1 : FA\_2019\_RD0524\_107\_178\_20190830\_00159.jpg

LM Start	5.39	Rating **	M	Issue No.	178
LM End	5.39	Issue Type +	Ma	Location *	LS
Category	Earthen Levee			GPS Latitude/Longitude	
				Start	End
Item	Encroachments			37.880806 °	37.880806 °
				-121.332833 °	-121.332833 °
DWR ID	DWR_RD0524_01_f_2014_178				
Comment Code					
TR : Tree or limb					
Inspector Comment					
Tree limbs on landside toe.

Looking south at downed tree on landward slope.

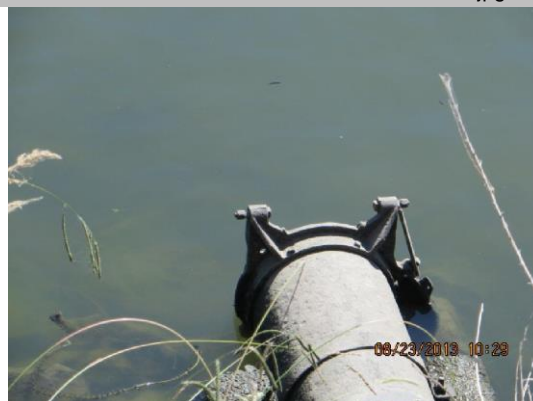
Photo 3 of 3 : UCIP\_FA\_2019\_53358\_30687.jpg

Comment Code						
Inspector Comment						
DS_ID:20630 FS_ID:53358 EP_NO: N/A Repair Type: Urgent Crossing Status: Found UCIP Comments: 10/2/2018 Same as last inspection. Holes present in pipe pose a potential threat to levee's internal integrity. Recommend video inspection (D. Sanoski - DWR UCIP).11/16/2016 same as previous inspection hole in pipe is still pressent on WS near toe. This pipe does not appear to be in use. Need to contact owner to determine status of crossing. If the crossing is abandoned or still in use, owner will need to coordinate with the CVFPB to comply with Title 23 requirements. (O. Magana - DWR UCIP)08/23/2013 flap gate damage and does not work at WS toe. Large hole in pipe at WS toe. Pipe appears abandoned and should be done so properly. (W. Wylie - DWR UCIP) FIELD_STRUCT_DESC: *ABANDONED* 1 of 2: 12-inch steel irrigation pipe through the levee, 6 feet below the crown. Pump located on the waterside (WS), no pump found in 2013. Flap gate located on the WS end. [Additional Reference(s): DWR Levee Log, 2004. USACE San Joaquin O&M Manual 7, April 1964, (HLM 5.48) 10-inch pipe listed, Drawing No. 07-04-1490, Sheet 1490/4, (Station 8+01.3)]. FS Date: 10/2/2018 1:34:00 PM

Broken flap gate at WS toe.

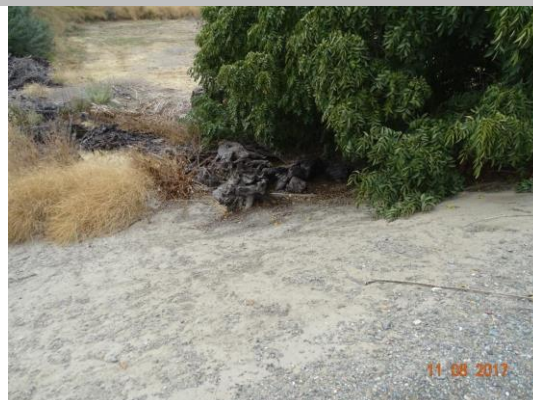
Photo 1 of 1 : FA\_2019\_RD0524\_107\_269\_20190830\_00252.jpg

LM Start	5.41	Rating **	M	Issue No.	269
LM End	5.41	Issue Type +	En	Location *	LS
Category	Earthen Levee			GPS Latitude/Longitude	
				Start	End
Item	Encroachments			37.880468 °	37.880468 °
				-121.332909 °	-121.332909 °
DWR ID	DWR_RD0524_01_f_2017_269				
Comment Code					
TR : Tree or limb					
Inspector Comment

Looking west at the landside slope.

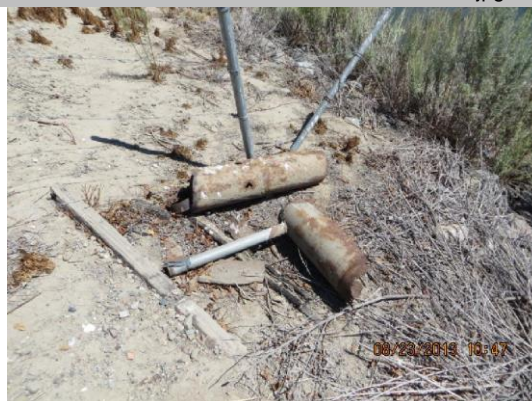
Photo 1 of 3 : UCIP\_FA\_2019\_18348\_30706.jpg

LM Start	5.42	Rating **	M	Issue No.	963	
LM End	5.42	Issue Type +	Ma	Location *		
Category	Supplemental			GPS Latitude/Longitude		
				Start	End	
Item	DRAFT DWR UCIP LMA Responsibility			37.880358 °	37.880358 °	
				-121.332972 °	-121.332972 °	
DWR ID	20631					
Comment Code						
Inspector Comment						
DS_ID:20631						
FS_ID:18348						
EP_NO: N/A						
Repair Type: Non-Urgent						
Crossing Status: Found						
UCIP Comments: Recent work being done on WS slope. Pipe may still be in use.						
FIELD_STRUCT_DESC: 10-inch steel drainage pipe through the levee, 6 feet below the crown. Pump not found on the landside (LS).						
[Additional Reference(s): DWR Levee Log, 2004. USACE San Joaquin O&M Manual 7, April 1964, (HLM 5.50)].						
FS Date: 8/23/2013

10-inch pipe debris on the WS slope.

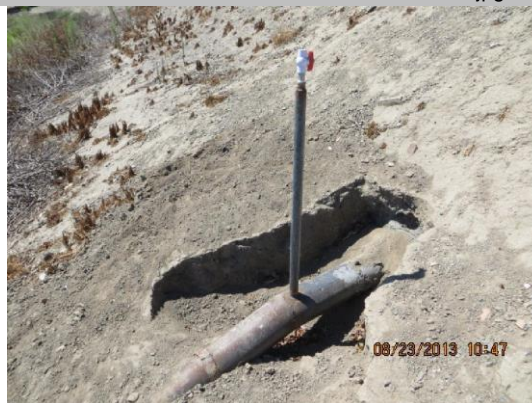
Photo 2 of 3 : UCIP\_FA\_2019\_18348\_30705.jpg

8-inch pipe sleeved through 10-inch pipe with vent on WS slope.

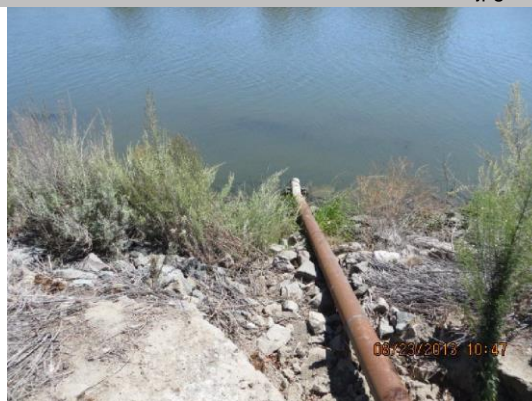
Photo 3 of 3 : UCIP\_FA\_2019\_18348\_30704.jpg

LM Start	5.42	Rating **	M	Issue No.	963 (cont)	
LM End	5.42	Issue Type +	Ma	Location *		
Category	Supplemental			GPS Latitude/Longitude		
				Start	End	
Item	DRAFT DWR UCIP LMA Responsibility			37.880358 °	37.880358 °	
				-121.332972 °	-121.332972 °	
DWR ID	20631					
Comment Code						
Inspector Comment						
DS_ID:20631						
FS_ID:18348						
EP_NO: N/A						
Repair Type: Non-Urgent						
Crossing Status: Found						
UCIP Comments: Recent work being done on WS slope. Pipe may still be in use.						
FIELD_STRUCT_DESC: 10-inch steel drainage pipe through the levee, 6 feet below the crown. Pump not found on the landside (LS).						
[Additional Reference(s): DWR Levee Log, 2004. USACE San Joaquin O&M Manual 7, April 1964, (HLM 5.50)].						
FS Date: 8/23/2013

No flap gate on end of pipe at WS toe.

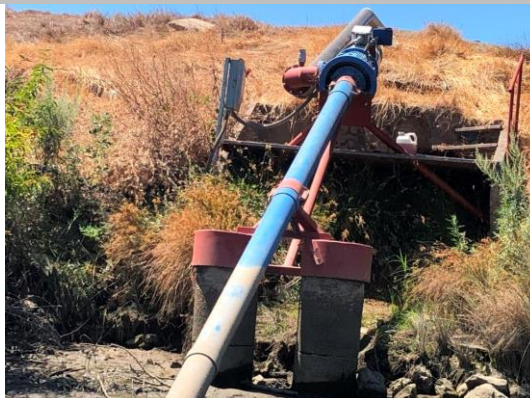
Photo 2 of 2 : SJR2019\_RD0524U01RM46.06\_4.JPG

LM Start	5.53	Rating **	M	Issue No.	71 (cont)	
LM End	5.53	Issue Type +	Ma	Location *		
Category	Supplemental			GPS Latitude/Longitude		
				Start	End	
Item	DWR Erosion Survey			37.878920 °	37.878920 °	
				-121.332670 °	-121.332670 °	
DWR ID	RD0524U01RM46.06					
Comment Code						
Inspector Comment						
Site ID: RD0524U01RM46.06						
08/13/2019: No significant change observed. More vegetation was observed at the site.						
09/13/2017: No significant change observed.						
07/25/2016: No significant change observed.						
06/24/2015: No significant change observed.						
06/19/2014: No significant change observed.						
08/13/2013: Larger trees are at the levee shoulder, and an irrigation pump station is next to the erosion site.

Close-up view of the site.

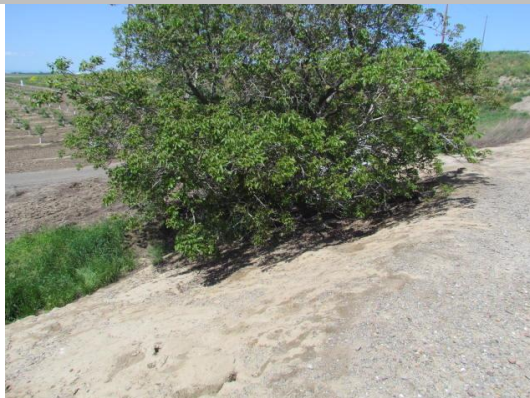
Photo 1 of 1 : FA\_2019\_RD0524\_107\_117\_20190830\_00130.jpg

LM Start	5.66	Rating **	M	Issue No.	117
LM End	5.66	Issue Type +	Ma	Location *	LS
Category	Earthen Levee			GPS Latitude/Longitude	
				Start	End
Item	Trim / Thin Trees			37.877100 °	37.877100 °
				-121.332323 °	-121.332323 °
DWR ID	DWR_RD0524_01_f_2013_117				
Comment Code					
T1 : Trim trees to at least five feet above ground level.					
Inspector Comment

Looking northwest at untrimmed tree on landward slope.

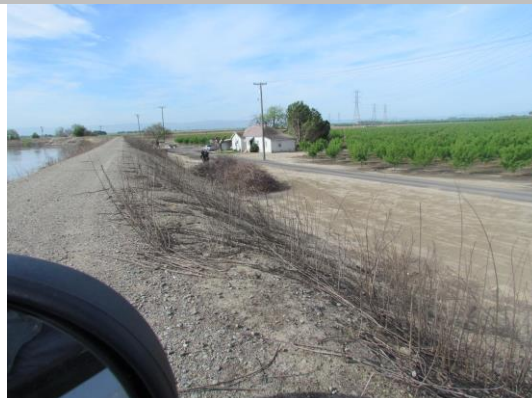
Photo 2 of 2 : FA\_2019\_RD0524\_107\_175\_20190830\_00158.jpg

LM Start	5.70	Rating **	U	Issue No.	175 (cont)	
LM End	5.70	Issue Type +	En	Location *	LS	
Category	Earthen Levee			GPS Latitude/Longitude		
				Start	End	
Item	Encroachments			37.876417°	37.876417°	
				-121.332505°	-121.332505°	
DWR ID	DWR_RD0524_01_s_2017_175					
Comment Code						
PR : Prunings						
Inspector Comment

Looking south at large pruning pile at landward toe.

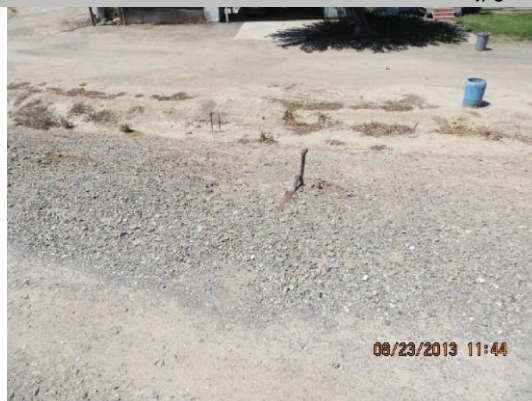
Photo 1 of 2 : UCIP\_FA\_2019\_18364\_30761.jpg

LM Start	5.74	Rating **	M	Issue No.	964	
LM End	5.74	Issue Type +	En	Location *		
Category	Supplemental			GPS Latitude/Longitude		
				Start	End	
Item	DRAFT DWR UCIP Field Study			37.876001 °	37.876001 °	
				-121.332725 °	-121.332725 °	
DWR ID	20649					
Comment Code						
Inspector Comment						
DS_ID:20649 FS_ID:18364 EP_NO: N/A Repair Type: Non-Urgent Crossing Status: Found UCIP Comments: Abandoned and should be done so properly. FIELD_STRUCT_DESC: 2.25-inch steel conduit for a 1-inch plastic electrical conduit through the levee, 0.25 feet below the crown. Lines exposed on both slopes. [Additional Reference(s): DWR Levee Log, 2004]. FS Date: 8/23/2013

Steel conduit and electrical conduit visible on the LS shoulder.

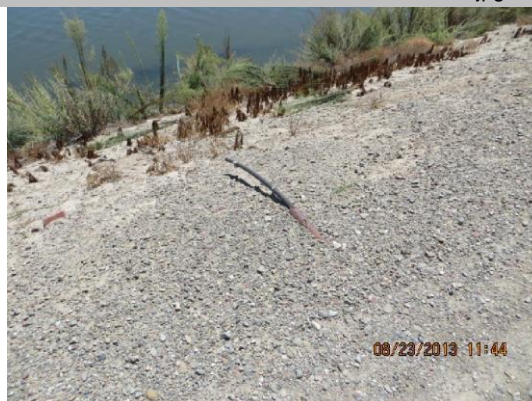
Photo 2 of 2 : UCIP\_FA\_2019\_18364\_30760.jpg

LM Start	5.74	Rating **	M	Issue No.	964 (cont)	
LM End	5.74	Issue Type +	En	Location *		
Category	Supplemental			GPS Latitude/Longitude		
				Start	End	
Item	DRAFT DWR UCIP Field Study			37.876001 °	37.876001 °	
				-121.332725 °	-121.332725 °	
DWR ID	20649					
Comment Code						
Inspector Comment						
DS_ID:20649 FS_ID:18364 EP_NO: N/A Repair Type: Non-Urgent Crossing Status: Found UCIP Comments: Abandoned and should be done so properly. FIELD_STRUCT_DESC: 2.25-inch steel conduit for a 1-inch plastic electrical conduit through the levee, 0.25 feet below the crown. Lines exposed on both slopes. [Additional Reference(s): DWR Levee Log, 2004]. FS Date: 8/23/2013

Steel conduit and electrical conduit visible on the WS shoulder.

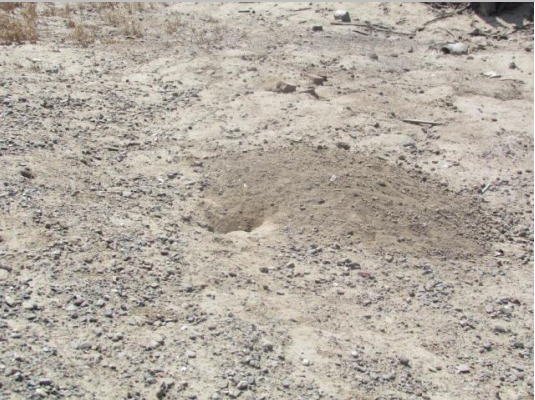
Photo 1 of 2 : FA\_2019\_RD0524\_107\_197\_20190830\_00177.jpg

Looking north at typical view of rodent holes on landward slope.

LM Start	5.77	Rating **	M	Issue No.	197 (cont)
LM End	5.79	Issue Type +	Ma	Location *	LS
Category	Earthen Levee			GPS Latitude/Longitude	
				Start	End
Item	Animal Control			37.875545°	37.875310°
				-121.332952°	-121.333065°
DWR ID	DWR_RD0524_01_f_2019_197				
Comment Code					
A3 : No rodents visible, but rodent burrows visible; need to backfill and compact or grout burrows.					
Inspector Comment					
Several rodent holes on landside slope and levee crown. LMA Backfilled hole but no rodent control measures are in place.

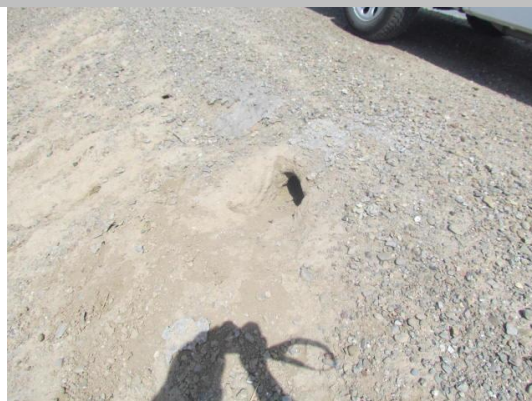
Photo 2 of 2 : FA\_2019\_RD0524\_107\_197\_20190830\_00178.jpg

Looking southwest at typical view of rodent hole at landward shoulder.

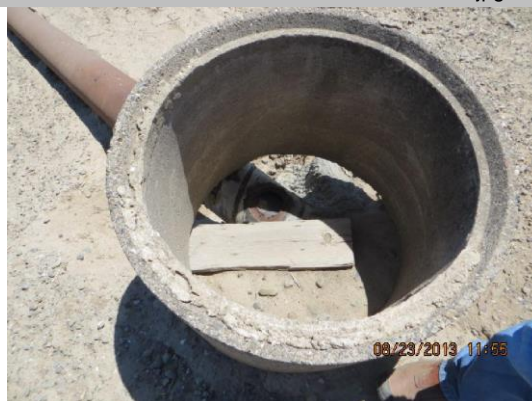
Photo 1 of 2 : UCIP\_FA\_2019\_18369\_30785.jpg

Comment Code						
Inspector Comment						
DS_ID:20636						
FS_ID:18369						
EP_NO: N/A						
Repair Type: Non-Urgent						
Crossing Status: Found						
UCIP Comments: Apparent leak on WS shoulder at concrete riser.						
Erosion under pipe. This may have been fixed when the pipe was sleeved with a PVC liner.						
FIELD_STRUCT_DESC: 10-inch steel drainage pipe through the levee, 5 feet below the crown. Pump on the landside (LS). Siphon breaker in a 36-inch concrete riser unit on the waterside (WS) shoulder. Power pole at the LS toe. Polyvinyl chloride liner sleeved inside steel pipe.						
[Additional Reference(s): DWR Levee Log, 2004. USACE San Joaquin O&M Manual 7, April 1964, (HLM 5.88)].						
FS Date: 8/23/2013

Concrete standpipe over pipe on WS shoulder.

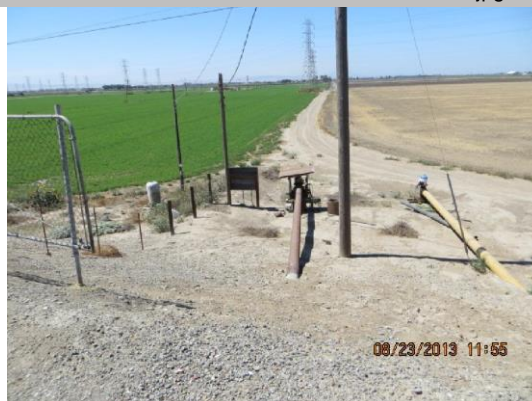
Photo 2 of 2 : UCIP\_FA\_2019\_18369\_30784.jpg

Comment Code						
Inspector Comment						
DS_ID:20636						
FS_ID:18369						
EP_NO: N/A						
Repair Type: Non-Urgent						
Crossing Status: Found						
UCIP Comments: Apparent leak on WS shoulder at concrete riser.						
Erosion under pipe. This may have been fixed when the pipe was sleeved with a PVC liner.						
FIELD_STRUCT_DESC: 10-inch steel drainage pipe through the levee, 5 feet below the crown. Pump on the landside (LS). Siphon breaker in a 36-inch concrete riser unit on the waterside (WS) shoulder. Power pole at the LS toe. Polyvinyl chloride liner sleeved inside steel pipe.						
[Additional Reference(s): DWR Levee Log, 2004. USACE San Joaquin O&M Manual 7, April 1964, (HLM 5.88)].						
FS Date: 8/23/2013

Pipe, pump, power pole, and meter off LS toe.

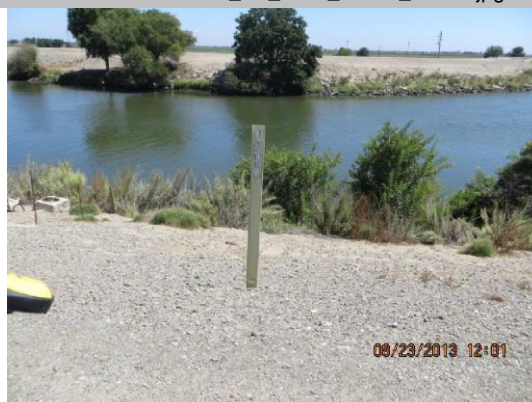
Photo 1 of 1 : UCIP\_FA\_2019\_18705\_31249.jpg

LM Start	5.82	Rating **	M	Issue No.	967
LM End	5.82	Issue Type +	En	Location *	
Category	Supplemental			GPS Latitude/Longitude	
				Start	End
Item	DRAFT DWR UCIP Field Study			37.874829°	37.874829°
				-121.333265°	-121.333265°
DWR ID	20656				
Comment Code					
Inspector Comment					
DS_ID:20656 FS_ID:18705 EP_NO: N/A Repair Type: Non-Urgent Crossing Status: Indicator Found UCIP Comments: Need to verify gasline exists and if so improve signage. FIELD_STRUCT_DESC: Gas line marker sign on the waterside (WS) shoulder. FS Date: 8/23/2013

Gasline marker on WS shoulder.

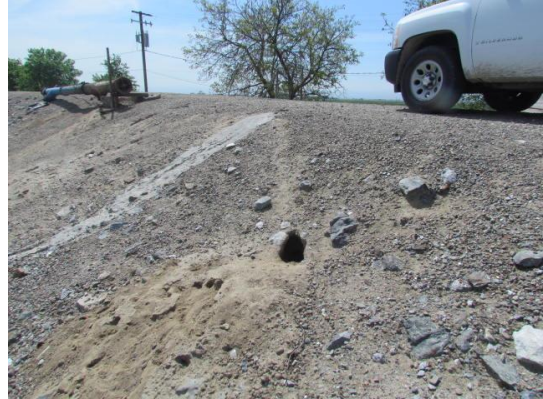
Photo 1 of 2 : FA\_2019\_RD0524\_107\_75\_20190830\_00096.jpg

LM Start	5.86	Rating **	M	Issue No.	75
LM End	5.88	Issue Type +	Ma	Location *	WS
Category	Earthen Levee			GPS Latitude/Longitude	
				Start	End
Item	Animal Control			37.874240 °	37.874002 °
				-121.333187 °	-121.333027 °
DWR ID	DWR_RD0524_01_s_2012_75				
Comment Code					
A1 : Exterminate rodents and backfill and compact or grout burrows.					
Inspector Comment					
District has grouted rodent holes, but other rodent holes have appeared. Active rodents in area.

Looking southwest at typical rodent holes on waterward slope.

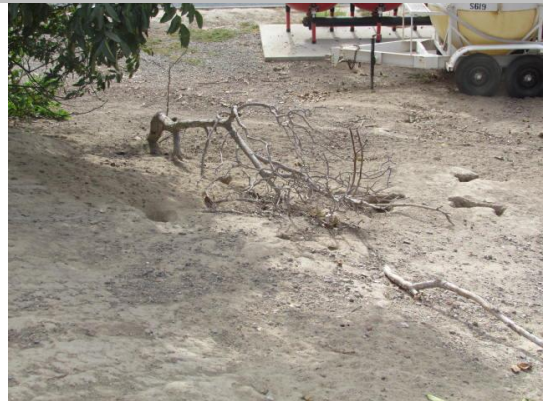
Photo 2 of 2 : FA\_2019\_RD0524\_107\_75\_20190830\_00097.jpg

Looking typical view of several rodent holes on landward slope and toe.

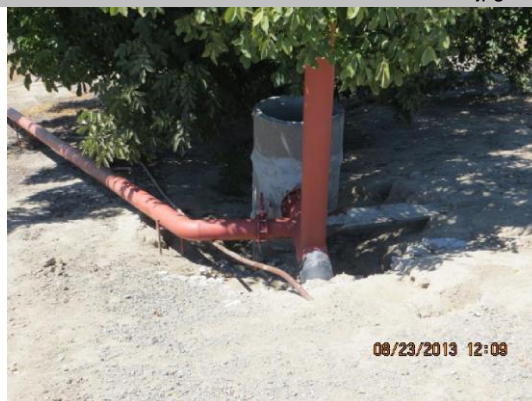
Photo 1 of 3 : UCIP\_FA\_2019\_18379\_30829.jpg

Comment Code						
Inspector Comment						
DS_ID:20638 FS_ID:18379 EP_NO: N/A Repair Type: Non-Urgent Crossing Status: Found UCIP Comments: Heavy erosion around pipe upstream of standpipe on LS slope. Verify pipe is not leaking and repair erosion on LS slope. FIELD_STRUCT_DESC: 12-inch steel irrigation pipe through the levee, 10 feet below the crown. Slant pump on pier at the waterside (WS) toe. 10-inch steel standpipe on the landside (LS) slope. 42-inch concrete standpipe on the LS slope. Filter plant and power pole on the LS toe. 1.5-inch galvanized iron electrical conduit at same location. [Additional Reference(s): DWR Levee Log, 2004. USACE San Joaquin O&M Manual 7, April 1964, (HLM 5.93)]. FS Date: 8/23/2013

Butterfly valves and standpipes on LS slope along with electrical conduit.

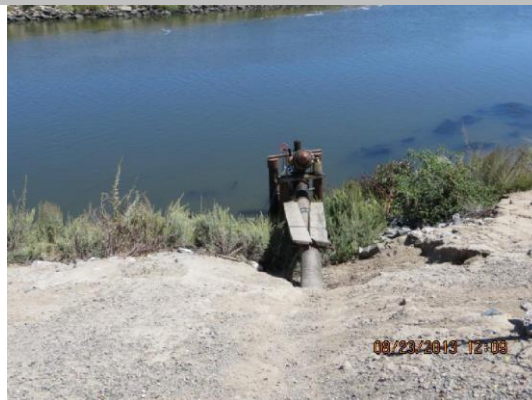
Photo 2 of 3 : UCIP\_FA\_2019\_18379\_30828.jpg

Slant pump on WS toe.

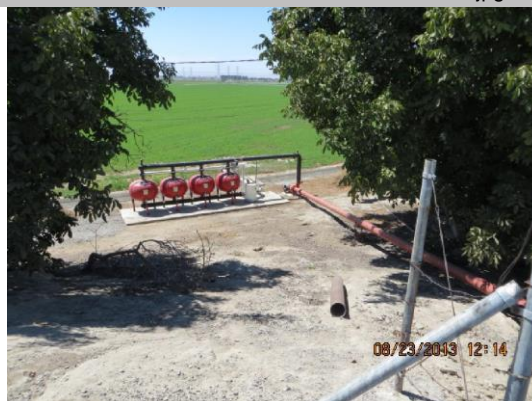
Photo 3 of 3 : UCIP\_FA\_2019\_18379\_30827.jpg

Comment Code						
Inspector Comment						
DS_ID:20638 FS_ID:18379 EP_NO: N/A Repair Type: Non-Urgent Crossing Status: Found UCIP Comments: Heavy erosion around pipe upstream of standpipe on LS slope. Verify pipe is not leaking and repair erosion on LS slope. FIELD_STRUCT_DESC: 12-inch steel irrigation pipe through the levee, 10 feet below the crown. Slant pump on pier at the waterside (WS) toe. 10-inch steel standpipe on the landside (LS) slope. 42-inch concrete standpipe on the LS slope. Filter plant and power pole on the LS toe. 1.5-inch galvanized iron electrical conduit at same location. [Additional Reference(s): DWR Levee Log, 2004. USACE San Joaquin O&M Manual 7, April 1964, (HLM 5.93)]. FS Date: 8/23/2013

Filter pump on LS toe.

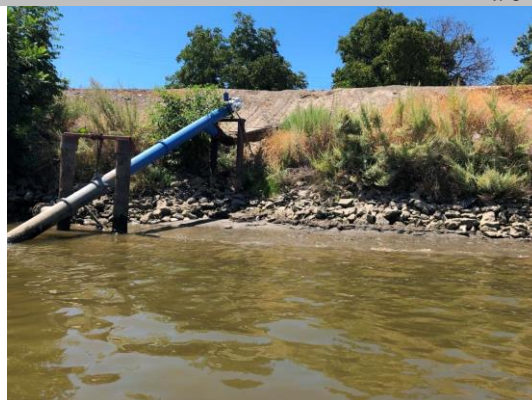
Photo 1 of 2 : SJR2019\_RD0524U01RM46.39\_1.jpg

LM Start	5.87	Rating **	U	Issue No.	79
LM End	5.87	Issue Type +	Ma	Location *	
Category	Supplemental			GPS Latitude/Longitude	
				Start	End
Item	DWR Erosion Survey			37.874185 °	37.874185 °
				-121.333110 °	-121.333110 °
DWR ID	RD0524U01RM46.39				
Comment Code					
Inspector Comment					
Site ID: RD0524U01RM46.39					
08/13/2019: No significant change observed.					
09/13/2017: No significant change observed.					
07/25/2016: No significant change observed.					
06/24/2015: No significant change observed.					
06/19/2014: No significant change observed.					
08/13/2013: No significant change observed.					
08/07/2012: The erosion is near a water-intake structure. Pipe leakage likely caused the erosion.

Front view of the site.

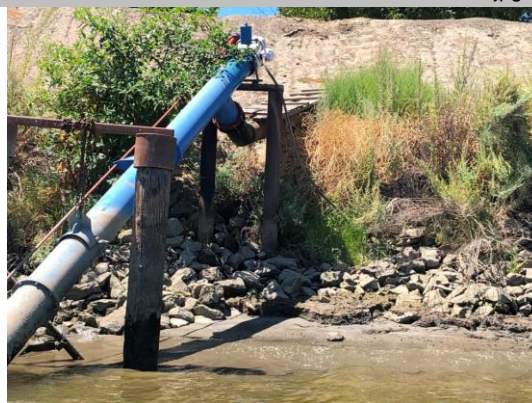
Photo 2 of 2 : SJR2019\_RD0524U01RM46.39\_3.jpg

LM Start	5.87	Rating **	U	Issue No.	79 (cont)	
LM End	5.87	Issue Type +	Ma	Location *		
Category	Supplemental			GPS Latitude/Longitude		
				Start	End	
Item	DWR Erosion Survey			37.874185 °	37.874185 °	
				-121.333110 °	-121.333110 °	
DWR ID	RD0524U01RM46.39					
Comment Code						
Inspector Comment						
Site ID: RD0524U01RM46.39						
08/13/2019: No significant change observed.						
09/13/2017: No significant change observed.						
07/25/2016: No significant change observed.						
06/24/2015: No significant change observed.						
06/19/2014: No significant change observed.						
08/13/2013: No significant change observed.						
08/07/2012: The erosion is near a water-intake structure. Pipe leakage likely caused the erosion.

Close-up view of the erosion.

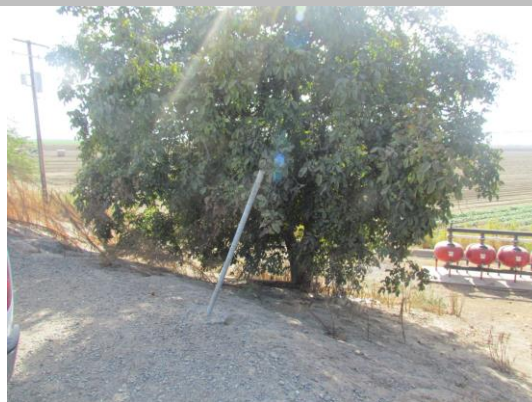
Photo 1 of 1 : FA\_2019\_RD0524\_107\_98\_20190830\_00122.jpg

LM Start	5.87	Rating **	M	Issue No.	98
LM End	5.87	Issue Type +	Ma	Location *	LS
Category	Earthen Levee			GPS Latitude/Longitude	
				Start	End
Item	Trim / Thin Trees			37.874085 °	37.874085 °
				-121.333154 °	-121.333154 °
DWR ID	DWR_RD0524_01_s_2012_98				
Comment Code					
T1 : Trim trees to at least five feet above ground level.					
Inspector Comment					
Untrimmed walnut tree on landside slope.

Looking west at walnut tree on landward slope.

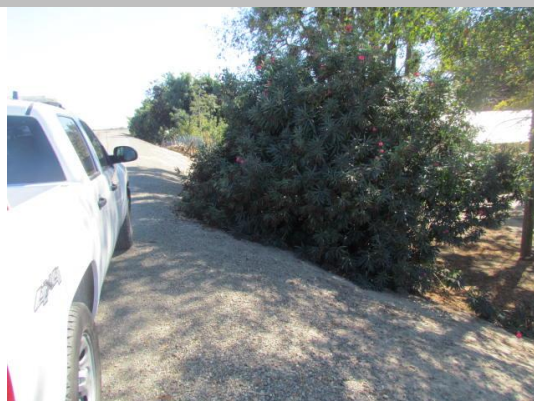
Photo 1 of 1 : FA\_2019\_RD0524\_107\_200\_20190830\_00183.jpg

Looking south at oleander on landward slope fall 2015.

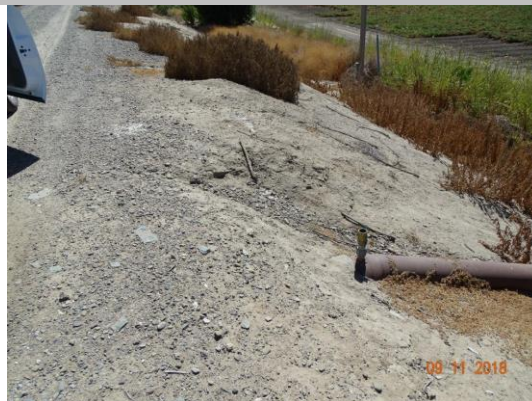
Photo 1 of 1 : FA\_2019\_RD0524\_107\_147\_20190830\_00134.jpg

LM Start	6.08	Rating **	M	Issue No.	147
LM End	6.08	Issue Type +	Ma	Location *	LS
Category	Earthen Levee			GPS Latitude/Longitude	
				Start	End
Item	Erosion / Bank Caving			37.872017 °	37.872017 °
				-121.330487 °	-121.330487 °
DWR ID	DWR_RD0524_01_f_2018_147				
Comment Code					
E1 : Note and monitor erosion site.					
Inspector Comment					
Erosion around and near pipe on landward slope.

Looking at landward erosion. (Fall 2018)

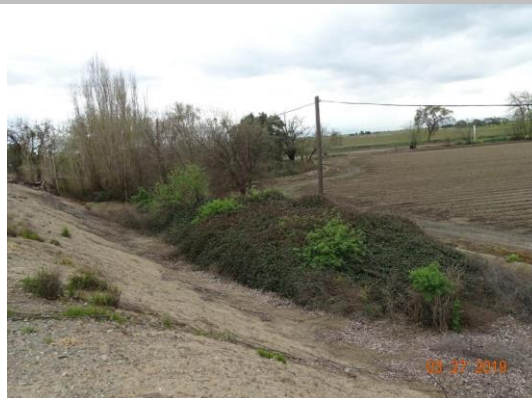
Photo 1 of 1 : FA\_2019\_RD0524\_107\_142\_20190830\_00133.jpg

LM Start	6.11	Rating **	U	Issue No.	142
LM End	6.11	Issue Type +	Ma	Location *	LS
Category	Earthen Levee			GPS Latitude/Longitude	
				Start	End
Item	Vegetation			37.871631 °	37.871631 °
				-121.330332 °	-121.330332 °
DWR ID	DWR_RD0524_01_s_2019_142				
Comment Code					
V2 : Remove the wild growth other than native grasses from the levee slopes.					
Inspector Comment					
Dense vegetation within landside easement blocking visibility.

Dense vegetation on landside toe. Spring 2019.

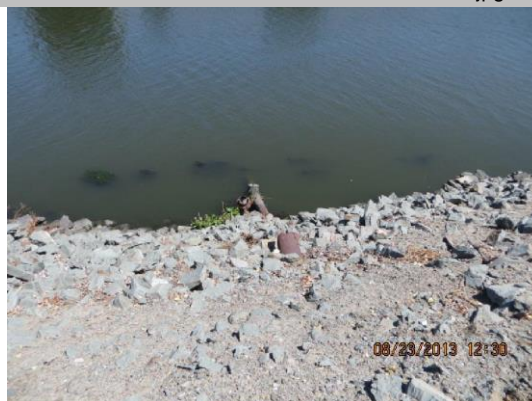
Photo 1 of 2 : UCIP\_FA\_2019\_18392\_30910.jpg

LM Start	6.15	Rating **	M	Issue No.	969
LM End	6.15	Issue Type +	En	Location *	
Category	Supplemental			GPS Latitude/Longitude	
				Start	End
Item	DRAFT DWR UCIP Field Study			37.871138 °	37.871138 °
				-121.330146 °	-121.330146 °
DWR ID	20641				
Comment Code					
Inspector Comment					
DS_ID:20641					
FS_ID:18392					
EP_NO: N/A					
Repair Type: Non-Urgent					
Crossing Status: Found					
UCIP Comments: Pipe and pump abandoned and should be done so properly.					
FIELD_STRUCT_DESC: *ABANDONED* 10-inch irrigation pipe of an unknown material through the levee, 12 feet below the crown. Pump on the waterside (WS) slope. [Additional Reference(s): DWR Levee Log, 2004. USACE San Joaquin O&M Manual 7, April 1964, (HLM 6.22)].					
FS Date: 8/23/2013

Pump and open pipe visible on WS slope.

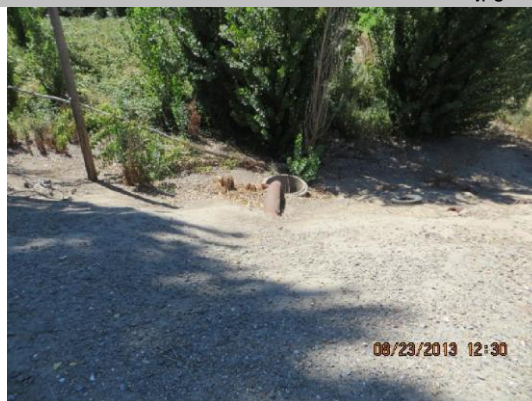
Photo 2 of 2 : UCIP\_FA\_2019\_18392\_30909.jpg

LM Start	6.15	Rating **	M	Issue No.	969 (cont)
LM End	6.15	Issue Type +	En	Location *	
Category	Supplemental			GPS Latitude/Longitude	
				Start	End
Item	DRAFT DWR UCIP Field Study			37.871138 °	37.871138 °
				-121.330146 °	-121.330146 °
DWR ID	20641				
Comment Code					
Inspector Comment					
DS_ID:20641 FS_ID:18392 EP_NO: N/A Repair Type: Non-Urgent Crossing Status: Found UCIP Comments: Pipe and pump abandoned and should be done so properly. FIELD_STRUCT_DESC: *ABANDONED* 10-inch irrigation pipe of an unknown material through the levee, 12 feet below the crown. Pump on the waterside (WS) slope. [Additional Reference(s): DWR Levee Log, 2004. USACE San Joaquin O&M Manual 7, April 1964, (HLM 6.22)]. FS Date: 8/23/2013

Pipe and concrete standpipe visible on LS toe.

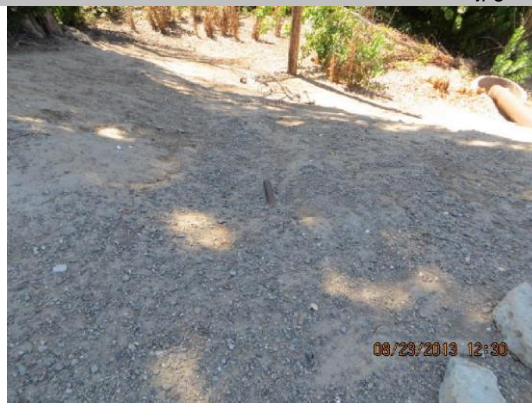
Photo 1 of 2 : UCIP\_FA\_2019\_22073\_37670.jpg

LM Start	6.15	Rating **	M	Issue No.	970
LM End	6.15	Issue Type +	En	Location *	
Category	Supplemental			GPS Latitude/Longitude	
				Start	End
Item	DRAFT DWR UCIP Field Study			37.871118°	37.871118°
				-121.330137°	-121.330137°
DWR ID	24052				
Comment Code					
Inspector Comment					
DS_ID:24052 FS_ID:22073 EP_NO: N/A Repair Type: Non-Urgent Crossing Status: Found UCIP Comments: Abandoned and should be done so properly. FIELD_STRUCT_DESC: *ABANDONED* 1.75-inch galvanized iron electrical conduit through the levee, 1 foot below the crown. Power pole on the landside (LS) toe. FS Date: 8/23/2013

Pipe visible on LS slope.

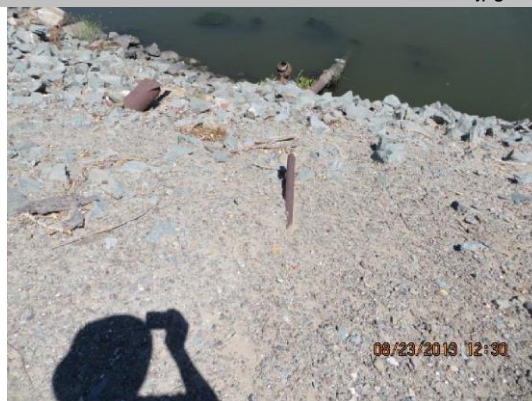
Photo 2 of 2 : UCIP\_FA\_2019\_22073\_37669.jpg

LM Start	6.15	Rating **	M	Issue No.	970 (cont)	
LM End	6.15	Issue Type +	En	Location *		
Category	Supplemental			GPS Latitude/Longitude		
				Start	End	
Item	DRAFT DWR UCIP Field Study			37.871118 °	37.871118 °	
				-121.330137 °	-121.330137 °	
DWR ID	24052					
Comment Code						
Inspector Comment						
DS_ID:24052						
FS_ID:22073						
EP_NO: N/A						
Repair Type: Non-Urgent						
Crossing Status: Found						
UCIP Comments: Abandoned and should be done so properly.						
FIELD_STRUCT_DESC: *ABANDONED* 1.75-inch galvanized iron						
electrical conduit through the levee, 1 foot below the crown. Power pole						
on the landside (LS) toe.						
FS Date: 8/23/2013

Pipe visible on WS slope.

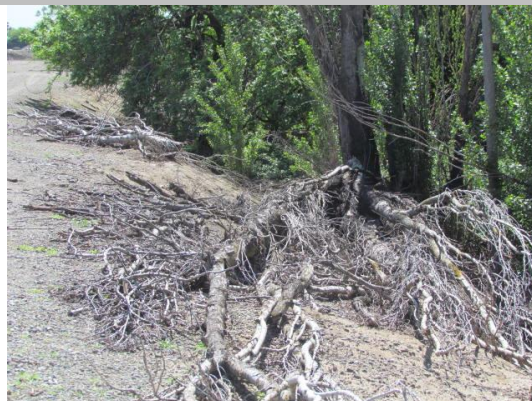
Photo 1 of 2 : FA\_2019\_RD0524\_107\_81\_20190830\_00104.jpg

LM Start	6.15	Rating **	M	Issue No.	81
LM End	6.15	Issue Type +	Ma	Location *	LS
Category	Earthen Levee			GPS Latitude/Longitude	
				Start	End
Item	Encroachments			37.871097°	37.871097°
				-121.330100°	-121.330100°
DWR ID	DWR_RD0524_01_s_2015_81				
Comment Code					
TR : Tree or limb					
Inspector Comment					
Fallen tree branches and limbs on landside slope.

Looking west at tree branches and limbs left on landward shoulder and slope. (Spring 2016)

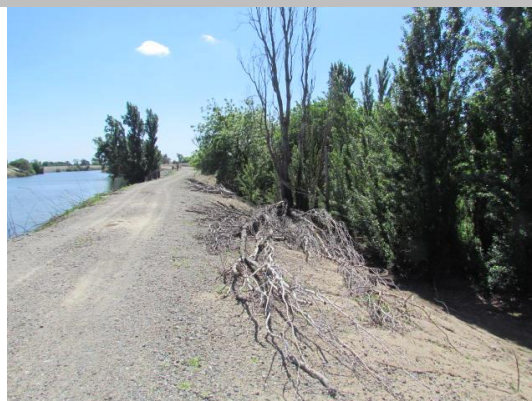
Photo 2 of 2 : FA\_2019\_RD0524\_107\_81\_20190830\_00105.jpg

LM Start	6.15	Rating **	M	Issue No.	81 (cont)	
LM End	6.15	Issue Type +	Ma	Location *	LS	
Category	Earthen Levee			GPS Latitude/Longitude		
				Start		End
Item	Encroachments			37.871097°	37.871097°	
				-121.330100°	-121.330100°	
DWR ID	DWR_RD0524_01_s_2015_81					
Comment Code						
TR : Tree or limb						
Inspector Comment						
Fallen tree branches and limbs on landside slope.

Looking south at tree branches and limbs left on landward shoulder and slope. (Spring 2016)

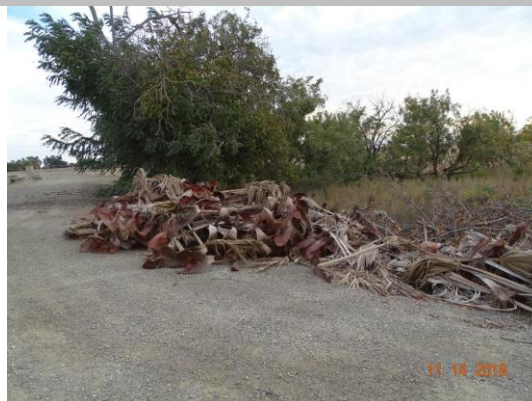
Photo 1 of 2 : FA\_2019\_RD0524\_107\_86\_20191117\_00377.jpg

LM Start	6.20	Rating **	U	Issue No.	86
LM End	6.20	Issue Type +	En	Location *	LS
Category	Earthen Levee			GPS Latitude/Longitude	
				Start	End
Item	Encroachments			37.870388 °	37.870388 °
				-121.329840 °	-121.329840 °
DWR ID	DWR_RD0524_01_s_2016_86				
Comment Code					
PR : Prunings					
Inspector Comment					
Large pruning pile on landside shoulder.

View of pruning pile on landside shoulder and slope. Fall 2019

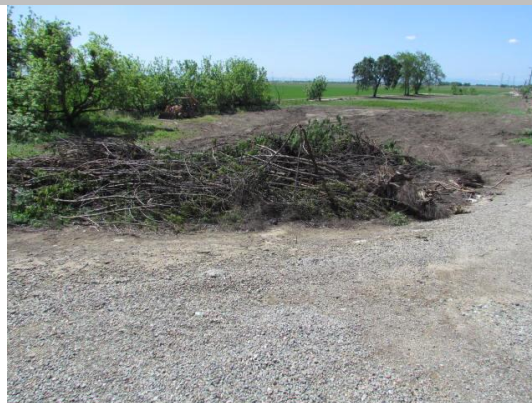
Photo 2 of 2 : FA\_2019\_RD0524\_107\_86\_20190830\_00108.jpg

Looking west at prunings at landward toe and berm.
