## Flood Control Project Maintenance Levee Inspections

### Fall 2020 Levee Maintenance Deficiency Summary Report

#### San Joaquin River Basin

**Reclamation District No. 0524 Middle Roberts Island**

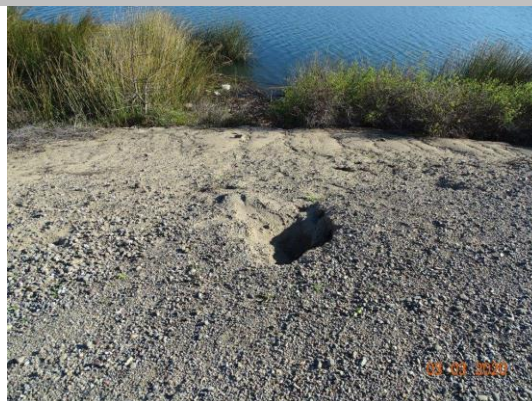
Photo 1 of 1 : FA\_2020\_RD0524\_107\_96\_20200901\_00044.jpg

LM Start	0.00	Rating **	U	Issue No.	96
LM End	0.00	Issue Type +	Ma	Location *	WS
Category	Earthen Levee			GPS Latitude/Longitude	
				Start	End
Item	Animal Control			37.941193 °	37.941193 °
				-121.346093 °	-121.346093 °
DWR ID	DWR_RD0524_01_s_2020_96				
Comment Code					
A1 : Exterminate rodents and backfill and compact or grout burrows.					
Inspector Comment

View of large animal burrow on waterside hinge. Spring 2020

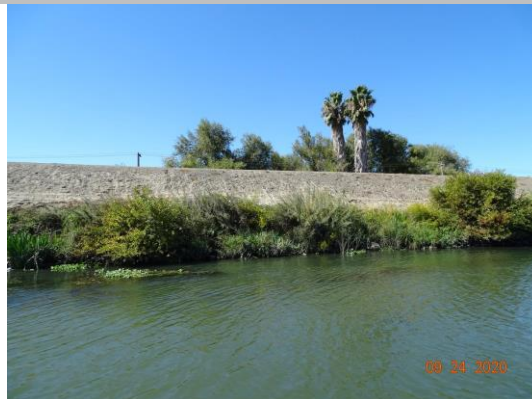
Photo 1 of 2 : SJR2019\_RD0524U01RM40.85\_02.JPG

LM Start	0.18	Rating **	U	Issue No.	5
LM End	0.18	Issue Type +	Ma	Location *	WS
Category	Supplemental			GPS Latitude/Longitude	
				Start	End
Item	DWR Erosion Survey			37.939085 °	37.939085 °
				-121.343917 °	-121.343917 °
DWR ID	RD0524U01RM40.85				
Comment Code					
Inspector Comment					
Site ID: RD0524U01RM40.85 09/24/2020: From 2014 to present, no significant changes were observed during the annual survey. 08/13/2013: The erosion was discovered during 2013 spring levee inspection. Inspector comment: Erosion is located along the lower level of water-ward slope.

9/24/2020: Front view of the erosion.

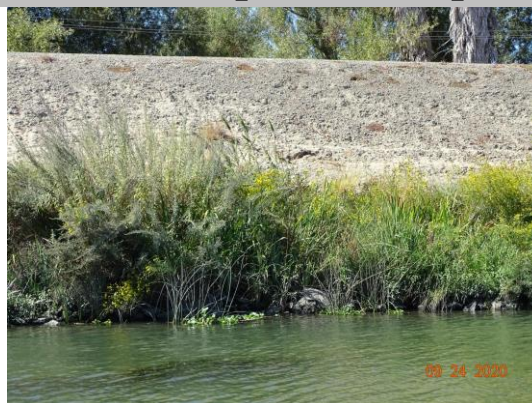
Photo 2 of 2 : SJR2019\_RD0524U01RM40.85\_05.JPG

9/24/2020: Close-up view of the erosion.

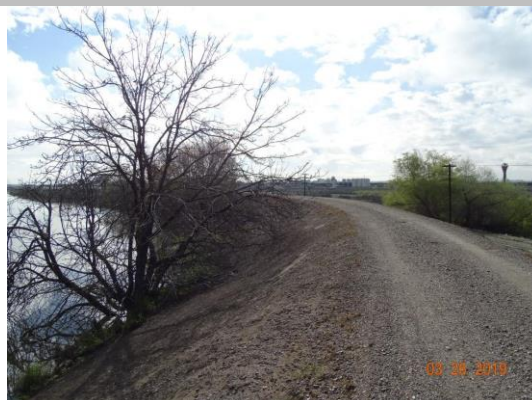
Photo 1 of 1 : FA\_2020\_RD0524\_107\_201\_20200901\_00083.jpg

LM Start	0.23	Rating **	M	Issue No.	201
LM End	0.23	Issue Type +	Ma	Location *	WS
Category	Earthen Levee			GPS Latitude/Longitude	
				Start	End
Item	Trim / Thin Trees			37.938648 °	37.938648 °
				-121.343480 °	-121.343480 °
DWR ID	DWR_RD0524_01_f_2016_201				
Comment Code					
T1 : Trim trees to at least five feet above ground level.					
Inspector Comment

View of tree on waterside slope looking upstream. Spring 2019.

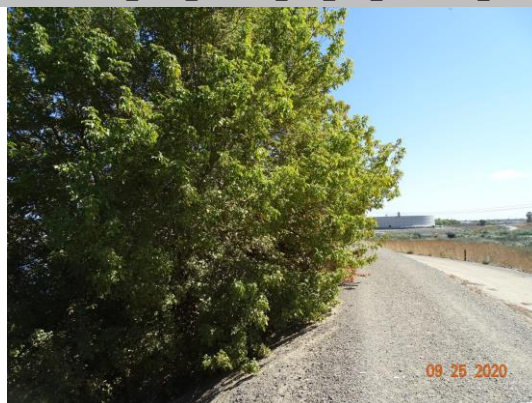
Photo 1 of 1 : FA\_2020\_RD0524\_107\_179\_20201005\_00225.jpg

LM Start	0.27	Rating **	U	Issue No.	179
LM End	0.27	Issue Type +	Ma	Location *	WS
Category	Earthen Levee			GPS Latitude/Longitude	
				Start	End
Item	Trim / Thin Trees			37.938438 °	37.938438 °
				-121.342883 °	-121.342883 °
DWR ID	DWR_RD0524_01_s_2014_179				
Comment Code					
T3 : Trim and thin trees to allow visibility of the ground and room to flood fight.					
Inspector Comment					
Tree blocking view of waterside slope.

View of large untrimmed walnut tree on landside slope. Fall 2020

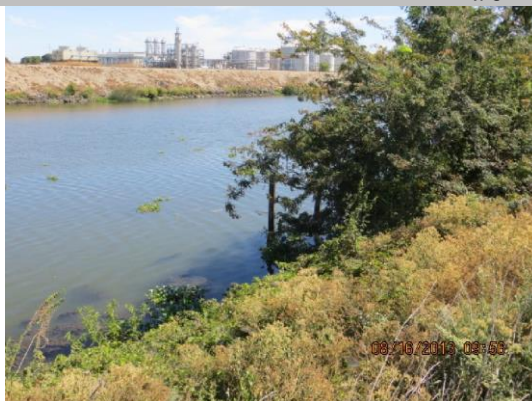
Photo 1 of 3 : UCIP\_FA\_2020\_61802\_29692.jpg

Comment Code						
Inspector Comment						
DS_ID:20590 FS_ID:61802 EP_NO: N/A Repair Type: Non-Urgent EVAL Issue: Abandoned encroachment Crossing Status: Indicator Found UCIP Comments: 06/23/2020 Record updated from No Action Needed to Non-Urgent. Crossing appears abandoned. (D.Sanoski - DWR UCIP)  FIELD_STRUCT_DESC: *ABANDONED* 14-inch irrigation pipe of an unknown material through the levee, 3 feet below the crown. Plugged with concrete. Concrete pad for pump still exists on the waterside (WS) shoulder. (Abandoned under Permit No. 6035, 1968 - City of Stockton). [Additional Reference(s): DWR Levee Log, 2004. USACE San Joaquin O&M Manual 7, April 1964, (HLM 0.27)]. FS Date: 6/23/2020 2:30:00 PM

Kasons in stream where 14-inch pipe would have been at WS toe.

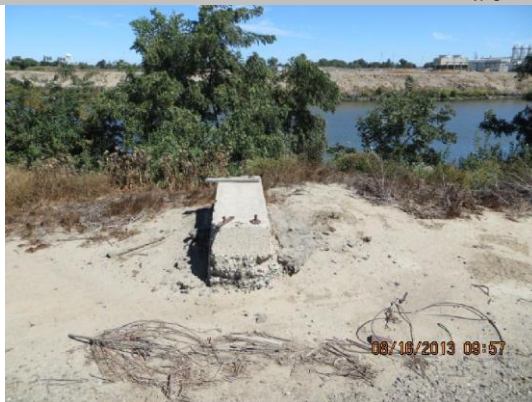
Photo 2 of 3 : UCIP\_FA\_2020\_61802\_29691.jpg

Concrete pad for pump remains on WS shoulder.

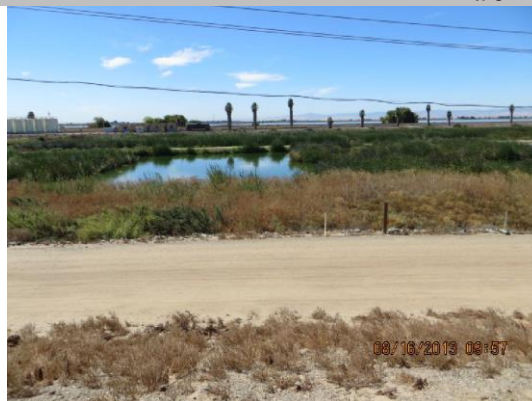
Photo 3 of 3 : UCIP\_FA\_2020\_61802\_29690.jpg

No evidence of crossing remains on LS slope or toe.

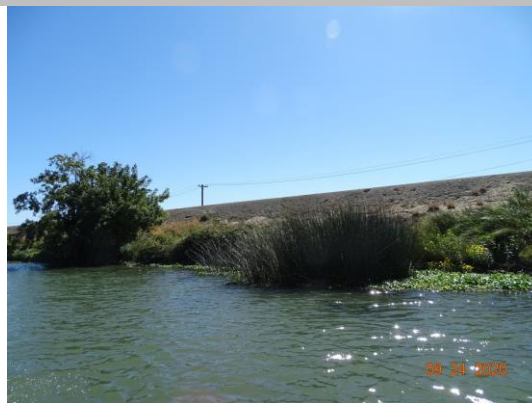
Photo 1 of 2 : SJR2019\_RD0524U01RM40.93\_02.JPG

LM Start	0.34	Rating **	M	Issue No.	24
LM End	0.34	Issue Type +	Ma	Location *	WS
Category	Supplemental			GPS Latitude/Longitude	
				Start	End
Item	DWR Erosion Survey			37.938461 °	37.938461 °
				-121.341526 °	-121.341526 °
DWR ID	RD0524U01RM40.93				
Comment Code					
Inspector Comment					
Site ID: RD0524U01RM40.93					
09/24/2020: From 2018 to present, no significant changes were observed during the annual survey.					
09/13/2017: There are two pocket erosions at the site; both erosions are around 10 ft long and 6 ft high.

9/24/2020: View of the erosion looking upstream.

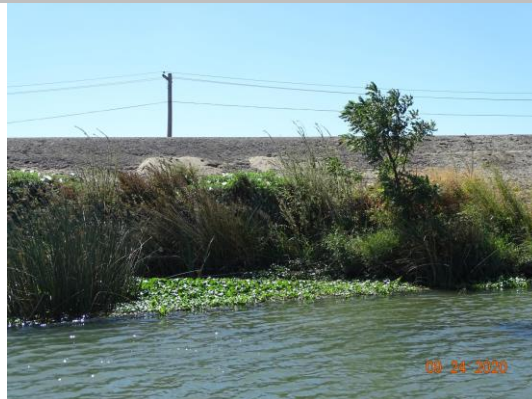
Photo 2 of 2 : SJR2019\_RD0524U01RM40.93\_03.JPG

9/24/2020: Front view of the one of the erosion pockets.

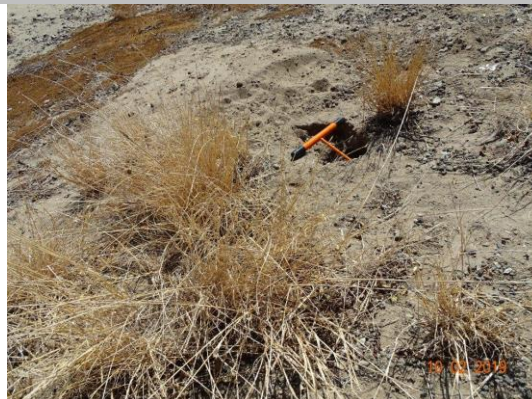
Photo 1 of 1 : FA\_2020\_RD0524\_107\_125\_20200901\_00056.jpg

LM Start	0.35	Rating **	U	Issue No.	125
LM End	0.36	Issue Type +	Ma	Location *	LS
Category	Earthen Levee			GPS Latitude/Longitude	
				Start	End
Item	Animal Control			37.938487 °	37.938509 °
				-121.341491 °	-121.341300 °
DWR ID	DWR_RD0524_01_f_2019_125				
Comment Code					
A3 : No rodents visible, but rodent burrows visible; need to backfill and compact or grout burrows.					
Inspector Comment

View of large rodent hole on landside slope. Fall 2019

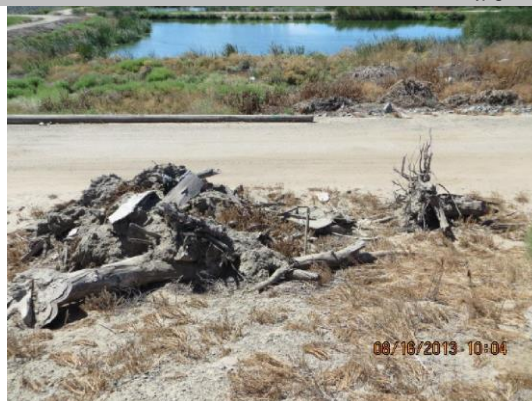
Photo 2 of 3 : UCIP\_FA\_2020\_61803\_29693.jpg

Comment Code						
Inspector Comment						
DS_ID:20591 FS_ID:61803 EP_NO: N/A Repair Type: Non-Urgent EVAL Issue: Pipe Not Found Crossing Status: Indicator Found UCIP Comments: 06/23/2020 Record updated from No Action Needed to Non-Urgent. Crossing not found. Crossing appears abandoned. (D.Sanoski - DWR UCIP)						
FIELD_STRUCT_DESC: *ABANDONED* 8-inch irrigation pipe of an unknown material through the levee, 5 feet below the crown. Plugged with concrete. Abandoned pump house and pump on the waterside (WS) slope. (Abandoned under Permit No. 6035, 1968 - City of Stockton). [Additional Reference(s): DWR Levee Log, 2004. USACE San Joaquin O&M Manual 7, April 1964, (HLM 0.33)]. FS Date: 6/23/2020 2:30:00 PM

Some evidence of pumphouse in debris pile on LS toe.

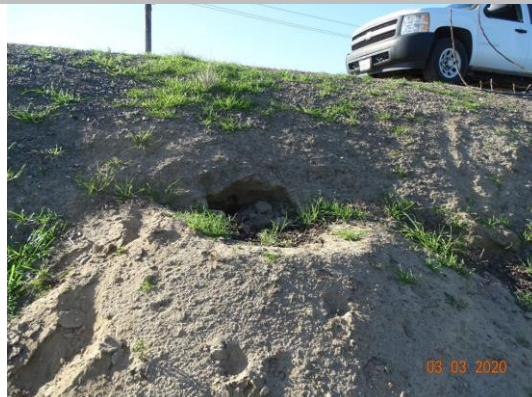
Photo 1 of 1 : FA\_2020\_RD0524\_107\_122\_20200901\_00055.jpg

LM Start	0.36	Rating **	U	Issue No.	122
LM End	0.36	Issue Type +	Ma	Location *	WS
Category	Earthen Levee			GPS Latitude/Longitude	
				Start	End
Item	Animal Control			37.938509 °	37.938509 °
				-121.341297 °	-121.341297 °
DWR ID	DWR_RD0524_01_f_2019_122				
Comment Code					
A3 : No rodents visible, but rodent burrows visible; need to backfill and compact or grout burrows.					
Inspector Comment

View of large animal burrow on waterside slope. Spring 2020

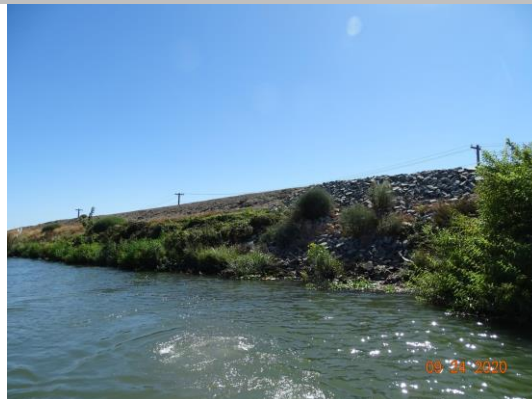
Photo 1 of 2 : SJR2019\_RD0524U01RM40.99\_01.JPG

LM Start	0.40	Rating **	U	Issue No.	16
LM End	0.40	Issue Type +	Ma	Location *	WS
Category	Supplemental			GPS Latitude/Longitude	
				Start	End
Item	DWR Erosion Survey			37.938608 °	37.938608 °
				-121.340498 °	-121.340498 °
DWR ID	RD0524U01RM40.99				
Comment Code					
Inspector Comment					
Site ID: RD0524U01RM40.99					
09/24/2020: From 2013 to present, no significant changes were observed during the annual survey. A small erosion repair site is located immediately downstream.					
08/07/2012: The erosion is at the upper levee slope, and likely caused by slope slip. The lower levee slope is covered with dense vegetation.

9/24/2020: Overview of the erosion which is just upstream of a small erosion repair.

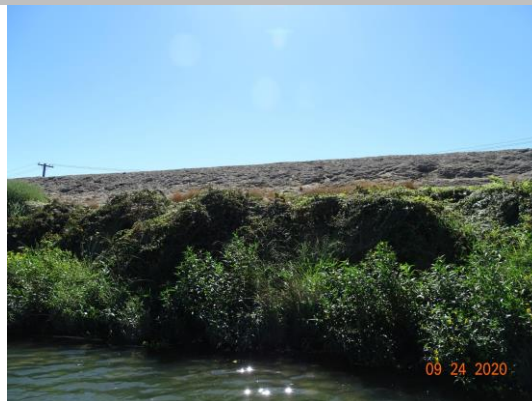
Photo 2 of 2 : SJR2019\_RD0524U01RM40.99\_03.JPG

9/24/2020: Close-up view of the erosion on the upper levee slope.

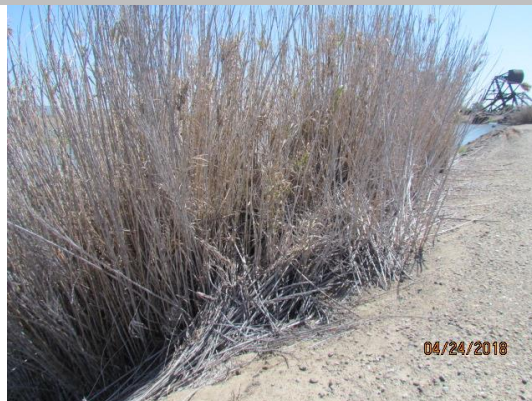
Photo 1 of 1 : FA\_2020\_RD0524\_107\_11\_20200901\_00005.jpg

LM Start	0.63	Rating **	U	Issue No.	11
LM End	0.64	Issue Type +	Ma	Location *	WS
Category	Earthen Levee			GPS Latitude/Longitude	
				Start	End
Item	Vegetation			37.938232 °	37.938160 °
				-121.336484 °	-121.336357 °
DWR ID	DWR_RD0524_01_s_2012_11				
Comment Code					
V2 : Remove the wild growth other than native grasses from the levee slopes.					
Inspector Comment					
Arrundo on waterside slope.

Looking at bamboo on waterward slope. (Spring 2018)

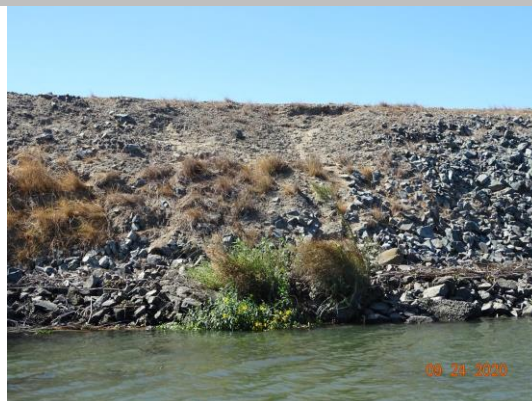
Photo 2 of 2 : SJR2019\_RD0524U01RM41.26\_02.JPG

LM Start	0.63	Rating **	M	Issue No.	25
LM End	0.63	Issue Type +	Ma	Location *	WS
Category	Supplemental			GPS Latitude/Longitude	
				Start	End
Item	DWR Erosion Survey			37.938247 °	37.938247 °
				-121.336503 °	-121.336503 °
DWR ID	RD0524U01RM41.26				
Comment Code					
Inspector Comment					
Site ID: RD0524U01RM41.26					
09/24/2020: From 2018 to present, no significant changes were observed during the annual survey.					
09/13/2017: The erosion was discovered by levee inspection. The erosion site is immediately downstream of tall vegetation.

9/24/2020: Close-up view of the erosion.

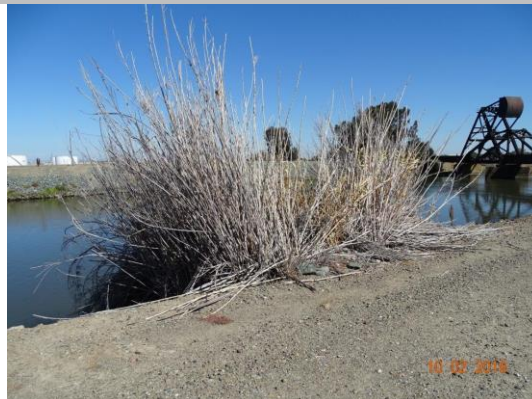
Photo 1 of 1 : FA\_2020\_RD0524\_107\_14\_20200901\_00006.jpg

LM Start	0.67	Rating **	U	Issue No.	14
LM End	0.67	Issue Type +	Ma	Location *	WS
Category	Earthen Levee			GPS Latitude/Longitude	
				Start	End
Item	Vegetation			37.937808 °	37.937808 °
				-121.335913 °	-121.335913 °
DWR ID	DWR_RD0524_01_s_2012_14				
Comment Code					
V2 : Remove the wild growth other than native grasses from the levee slopes.					
Inspector Comment					
Arundo on waterside slope.

View of bamboo on waterside slope. Fall 2019

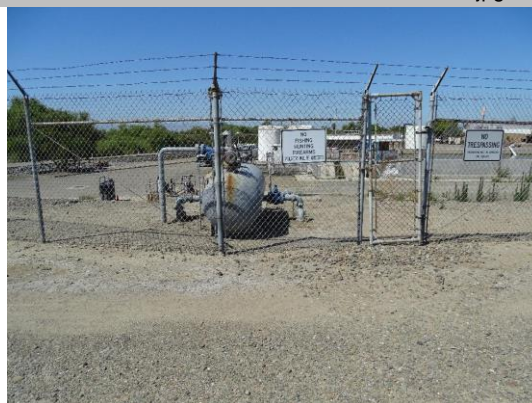
Photo 3 of 3 : UCIP\_FA\_2020\_61809\_89240.jpg

LM Start	0.67	Rating **	M	Issue No.	935	
LM End	0.67	Issue Type +	En	Location *		
Category	Supplemental			GPS Latitude/Longitude		
				Start		End
Item	DWR UCIP Field Study			37.937813 °		37.937813 °
				-121.335817 °		-121.335817 °
DWR ID	20653					
Comment Code						
Inspector Comment						
DS_ID:20653 FS_ID:61809 EP_NO: 9127A Repair Type: Non-Urgent EVAL Issue: Abandoned encroachment Crossing Status: Indicator Found UCIP Comments: 06/23/2020 Record updated from No Action Needed to Non-Urgent. Crossing appears abandoned. (D.Sanoski - DWR UCIP)						
FIELD_STRUCT_DESC: *REMOVED* 3 of 4: 6-inch polyvinyl chloride sewer pipe through the levee, 1 foot below the crown. Evidence of crossing remains in concrete debris on the waterside (WS) slope. (Permit No. 9127-A, 1975 - City of Stockton). FS Date: 6/23/2020 2:31:00 PM

Land-Side: view of LS and tank.

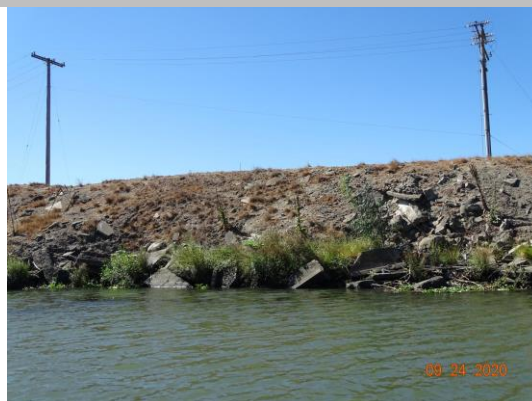
Photo 1 of 2 : SJR2019\_RD0524U01RM41.34\_03.JPG

LM Start	0.70	Rating **	M	Issue No.	26
LM End	0.70	Issue Type +	Ma	Location *	WS
Category	Supplemental			GPS Latitude/Longitude	
				Start	End
Item	DWR Erosion Survey			37.937577 °	37.937577 °
				-121.335491 °	-121.335491 °
DWR ID	RD0524U01RM41.34				
Comment Code					
Inspector Comment					
Site ID: RD0524U01RM41.34					
09/24/2020: From 2018 to present, no significant changes were observed during the annual survey.					
09/13/2017: Pocket erosion above the protected levee toe.

9/24/2020: Front view of the erosion.

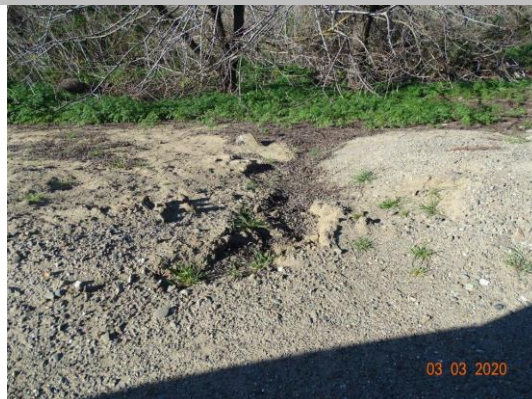
Photo 1 of 1 : FA\_2020\_RD0524\_107\_157\_20200901\_00064.jpg

LM Start	0.72	Rating **	M	Issue No.	157
LM End	0.72	Issue Type +	Ma	Location *	LS
Category	Earthen Levee			GPS Latitude/Longitude	
				Start	End
Item	Erosion / Bank Caving			37.937290 °	37.937290 °
				-121.335417 °	-121.335417 °
DWR ID	DWR_RD0524_01_s_2017_157				
Comment Code					
E2 : Schedule repair of erosion site prior to the next inspection.					
Inspector Comment					
Rills on landside slope appear to be caused by surface runoff.

View of erosion caused by surface runoff on landside slope. Spring 2020

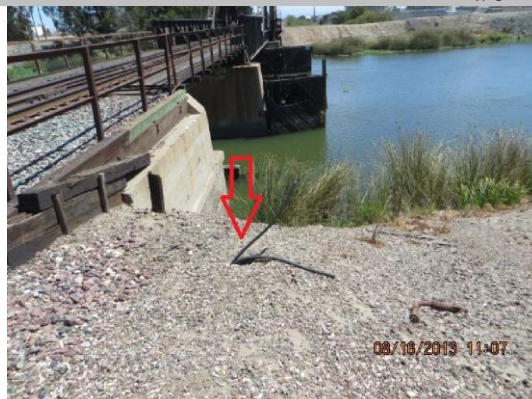
Photo 1 of 3 : UCIP\_FA\_2020\_61917\_29717.jpg

Comment Code						
Inspector Comment						
DS_ID:20595 FS_ID:61917 EP_NO: N/A Repair Type: Non-Urgent EVAL Issue: Unauthorized Encroachment, installed decades prior Crossing Status: Indicator Found UCIP Comments: 06/23/2020 Record remains Non-Urgent. Unauthorized encroachment recorded in Levee Log prior to 2011. Found a telephone utility box at the same location. (D.Sanoski - DWR UCIP) FIELD_STRUCT_DESC: 2.5-inch telephone conduit of an unknown material through the levee, 2 feet below the crown and under the channel. Conduit visible on the waterside (WS) shoulder. [Additional Reference(s): DWR Levee Log, 2004]. FS Date: 6/23/2020 2:32:00 PM

Conduit visible on WS shoulder next to bridge abutment. Cable appears to be abandoned.

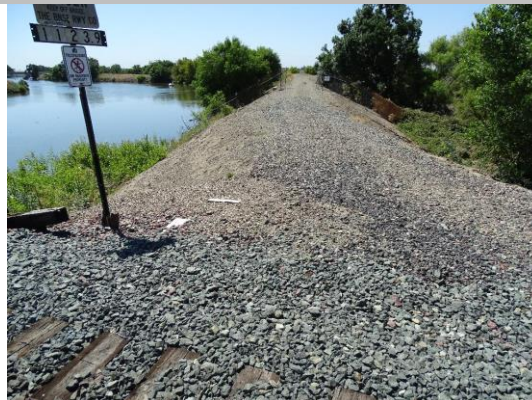
Photo 2 of 3 : UCIP\_FA\_2020\_61917\_89277.jpg

Top of Levee: view of crown.

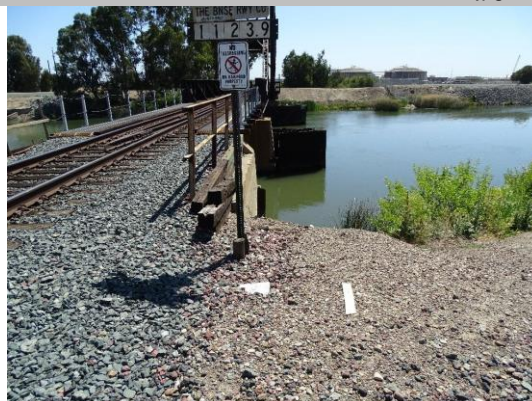
Photo 3 of 3 : UCIP\_FA\_2020\_61917\_89278.jpg

Water-Side: view of WS slope and telephone cable box.

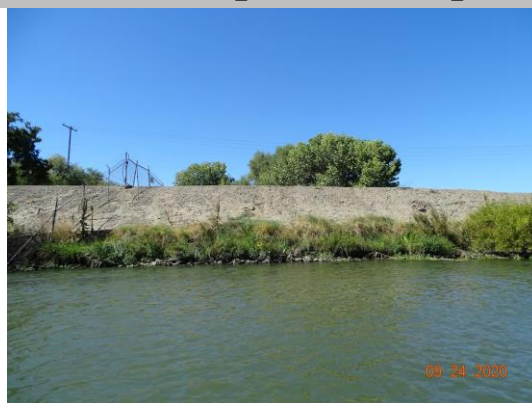
Photo 1 of 2 : SJR2019\_RD0524U01RM41.39\_01.JPG

LM Start	0.76	Rating **	U	Issue No.	4
LM End	0.77	Issue Type +	Ma	Location *	WS
Category	Supplemental			GPS Latitude/Longitude	
				Start	End
Item	DWR Erosion Survey			37.936749 °	37.936749 °
				-121.334971 °	-121.334971 °
DWR ID	RD0524U01RM41.39

09/24/2020: From 2013 to present, no significant changes were observed during the annual survey.

08/23/2011: The site is located immediately upstream of a Railroad bridge. Dense vegetation at the water line blocks the view of erosion.

9/24/2020: Front view of the erosion.

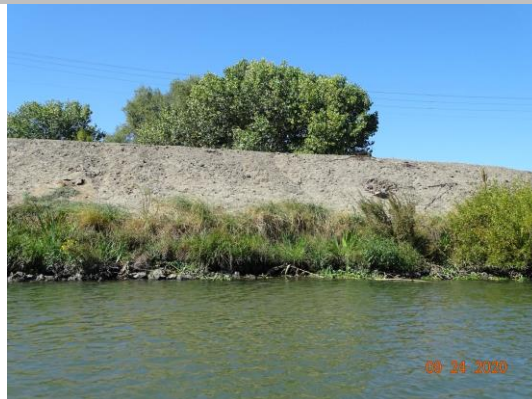
Photo 2 of 2 : SJR2019\_RD0524U01RM41.39\_02.JPG

LM Start	<b>0.76</b>	Rating **	U	Issue No.	<b>4 (cont)</b>
LM End	<b>0.77</b>	Issue Type +	Ma	Location *	WS
Category	Supplemental		GPS Latitude/Longitude		
			Start	End	
Item	DWR Erosion Survey		37.936749 °	37.936749 °	
			-121.334971 °	-121.334971 °	
DWR ID	RD0524U01RM41.39

9/24/2020: Close-up view of the erosion.

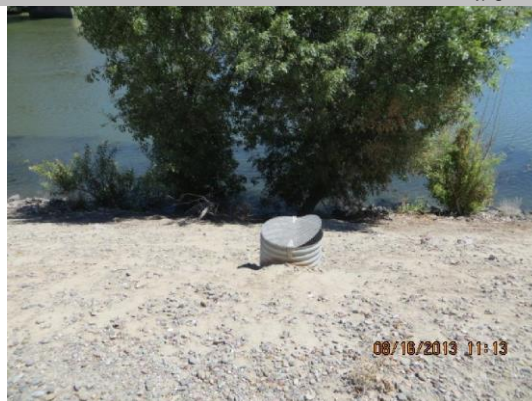
Photo 1 of 3 : UCIP\_FA\_2020\_61918\_29719.jpg

DS\_ID:20596  
FS\_ID:61918  
EP\_NO: N/A  
Repair Type: Non-Urgent  
EVAL Issue: Unauthorized Encroachment, installed decades prior  
Crossing Status: Found  
UCIP Comments: 06/23/2020 Record remains Non-Urgent.  
Unauthorized encroachment recorded in Levee Log prior to 2011. No permit has been identified authorizing pipe. Crossing appears abandoned. (D.Sanoski - DWR UCIP)

FIELD\_STRUCT\_DESC: \*ABANDONED\* 8-inch steel pipe of unknown purpose through the levee, 4 feet below the crown. Pump at the toe of the landside (LS) slope, not found 8/16/13. Siphon breaker in 24-inch corrugated metal riser unit on the waterside (WS) slope. [Additional Reference(s): USACE San Joaquin O&M Manual 7, April 1964, (HLM 0.79)].

Siphon breaker in 24-inch cmp riser on WS slope.

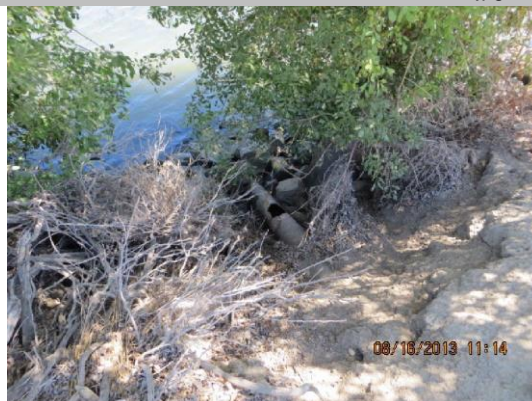
Photo 2 of 3 : UCIP\_FA\_2020\_61918\_29718.jpg

Large hole in pipe at WS toe.

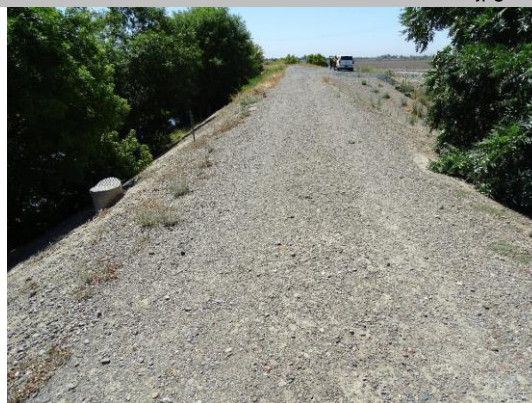
Photo 3 of 3 : UCIP\_FA\_2020\_61918\_89281.jpg

Top of Levee: view of crown.

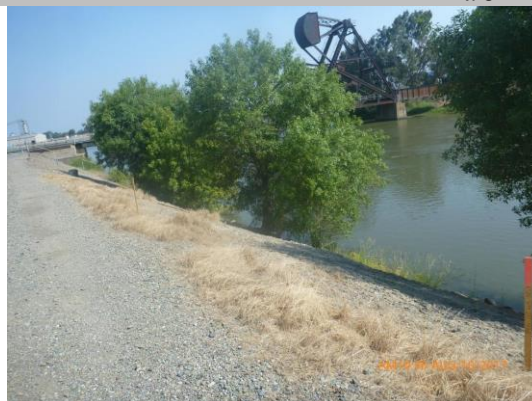
Photo 1 of 1 : LEVAL\_FA\_2020\_538\_4097.jpg

LM Start	0.79	Rating **	M	Issue No.	155	
LM End	0.80	Issue Type +	Ma	Location *	WS	
Category	Earthen Levee			GPS Latitude/Longitude		
				Start		End
Item	Erosion / Bank Caving			37.936300 °		37.936200 °
				-121.334700 °		-121.334600 °
DWR ID	LMA-444					
Comment Code						
E2 : Schedule repair of erosion site prior to the next inspection.						
Inspector Comment						
This was a 2017 Storm Damage Site. Slope protection repairs are needed along the waterside slope due to erosion and riprap displacement from high water. Based upon levee inspections, it was determined the waterside levee slope is eroding, deteriorating, and degrading. The eroded levee sections need to be restored back to design standards to prevent further deterioration and damage. Site ID No:538 Site Designation:LMA-444

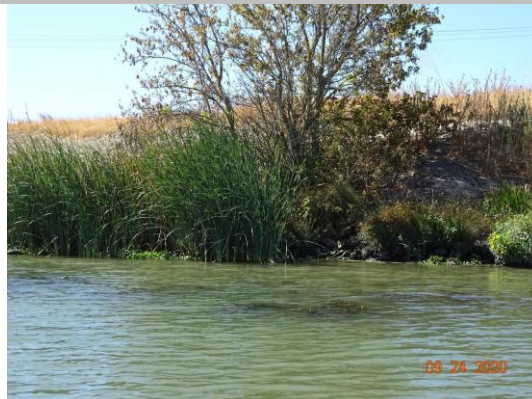
Photo 1 of 2 : SJR2019\_RD0524U01RM41.44\_02.JPG

09/24/2020: From 2014 to present, no significant changes were observed during the annual survey. The vegetation is tall and limiting the view of the erosion.

9/24/2020: Tall vegetation is blocking the view of the erosion.

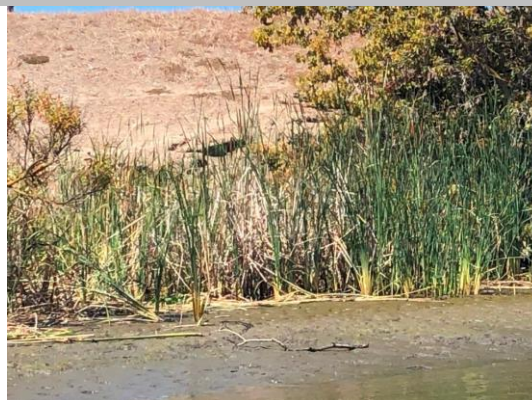
Photo 2 of 2 : SJR2019\_RD0524U01RM41.44\_3.JPG

8/13/2020: Close-up view of the site.

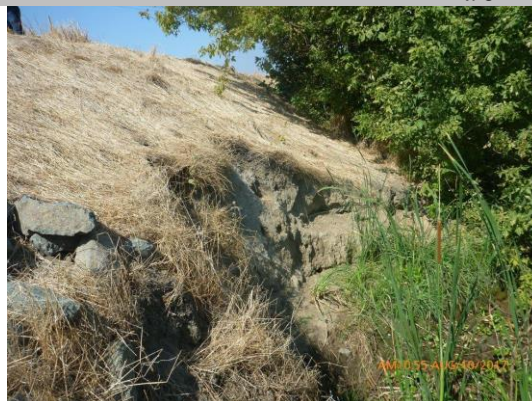
Photo 1 of 3 : LEVAL\_FA\_2020\_537\_4102.jpg

LM Start	0.90	Rating **	A/W	Issue No.	193
LM End	0.91	Issue Type +	Ma	Location *	WS
Category	Supplemental			GPS Latitude/Longitude	
				Start	End
Item	2017 Storm Damage			37.935400 °	37.935300 °
				-121.333300 °	-121.333200 °
DWR ID	LMA-443				
Comment Code					
Inspector Comment					
Planned For Repair.					
Levee Evaluation Comments					
Description:Slope protection repairs are needed along the waterside slope due to erosion and riprap displacement from high water. Based upon levee inspections, it was determined the waterside levee slope is eroding, deteriorating, and degrading. The eroded levee sections need to be restored back to design standards to prevent further deterioration and damage.					
Site ID No:537					
Site Designation:LMA-443					
Repair Type: Erosion					
Rating:Serious					
Field Date:8/10/2017					
Notes:

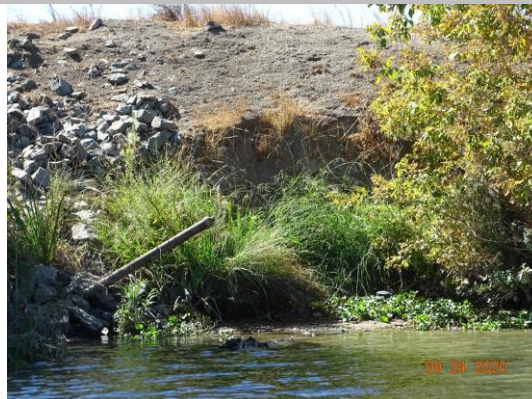
Photo 2 of 2 : SJR2019\_RD0524U01RM41.5\_02.JPG

LM Start	<b>0.91</b>	Rating **	U	Issue No.	<b>3 (cont)</b>
LM End	<b>0.91</b>	Issue Type +	Ma	Location *	WS
Category	Supplemental		GPS Latitude/Longitude		
			Start	End	
Item	DWR Erosion Survey		37.935297 °	37.935297 °	
			-121.333182 °	-121.333182 °	
DWR ID	RD0524U01RM41.5

9/24/2020: Close-up view of the erosion.

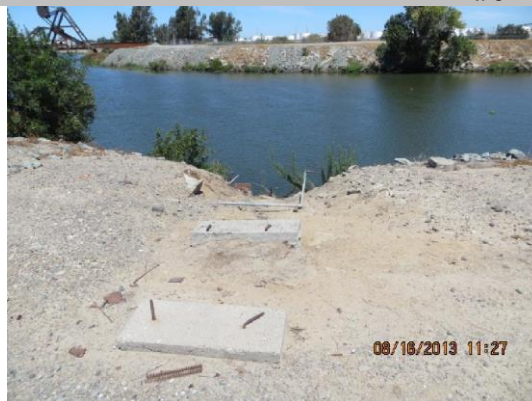
Photo 1 of 3 : UCIP\_FA\_2020\_61919\_38442.jpg

DS\_ID:20597  
FS\_ID:61919  
EP\_NO: N/A  
Repair Type: Non-Urgent  
EVAL Issue: Unauthorized Encroachment, installed decades prior  
Crossing Status: Found  
UCIP Comments: 06/23/2020 Record remains Non-Urgent.  
Unauthorized encroachment recorded in Levee Log prior to 2011. No permit has been identified authorizing pipe. Crossing appears abandoned. Location updated to be at LM 0.92. (D.Sanoski - DWR UCIP)  
11/16/2016 - Location may be at LM 0.92 (37.935267, -121.332985) rather than LM 0.974. Need to field verify (DWR UCIP - thatch)  
8/16/2013 - Pipe abandoned and should be done so properly. (DWR UCIP - wwylie)  
FIELD\_STRUCT\_DESC: \*ABANDONED\* 14-inch irrigation pipe of an unknown material through the levee, 6 feet below the crown. Concrete pad for pump on the waterside (WS) shoulder. No pump or other appurtenances remain. [Additional Reference(s): DWR Levee Log, 2004. USACE San Joaquin O&M Manual 7, April 1964, (HLM 0.93)].

Concrete pad for pump mount on WS shoulder.

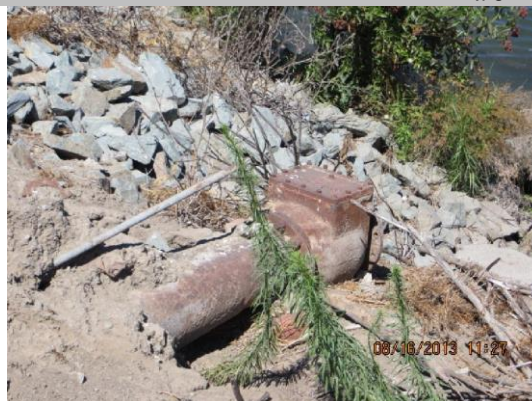
Photo 2 of 3 : UCIP\_FA\_2020\_61919\_38441.jpg

Pipe visible on WS slope.

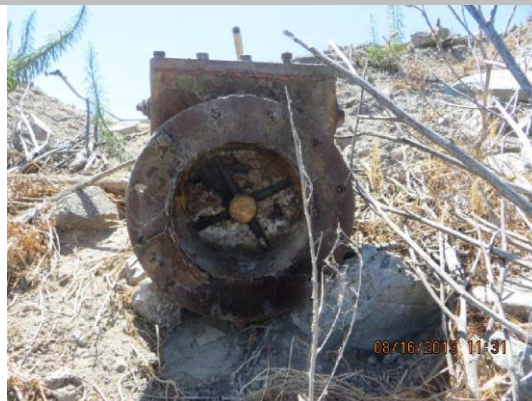
Photo 3 of 3 : UCIP\_FA\_2020\_61919\_38440.jpg

One way check valve closed on WS slope.

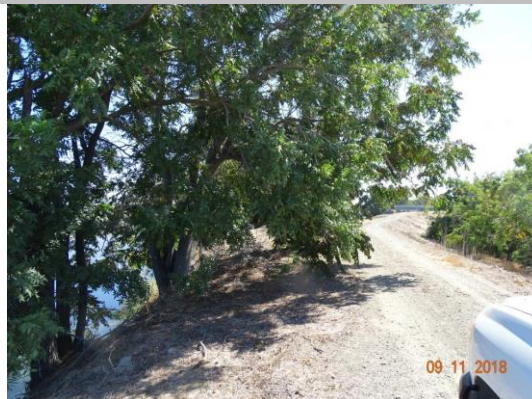
Photo 1 of 1 : FA\_2020\_RD0524\_107\_20\_20200901\_00013.jpg

LM Start	0.97	Rating **	M	Issue No.	20
LM End	0.97	Issue Type +	Ma	Location *	WS
Category	Earthen Levee			GPS Latitude/Longitude	
				Start	End
Item	Trim / Thin Trees			37.935181 °	37.935181 °
				-121.332125 °	-121.332125 °
DWR ID	DWR_RD0524_01_f_2017_20				
Comment Code					
T3 : Trim and thin trees to allow visibility of the ground and room to flood fight.					
Inspector Comment

Looking southeast at untrimmed tree on waterward slope.(Fall 2018)

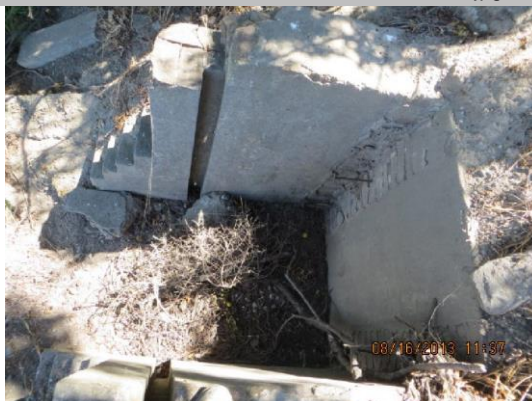
Photo 2 of 3 : UCIP\_FA\_2020\_61920\_29735.jpg

Comment Code					
Inspector Comment					
DS_ID:20598 FS_ID:61920 EP_NO: N/A Repair Type: Non-Urgent EVAL Issue: Unauthorized Encroachment, installed decades prior Crossing Status: Found UCIP Comments: 06/23/2020 Record updated from No Action Needed to Non-Urgent. Unauthorized encroachment recorded in Levee Log prior to 2011. No permit has been identified authorizing pipe. Crossing appears abandoned. (D.Sanoski - DWR UCIP)  FIELD_STRUCT_DESC: *ABANDONED* 36-inch drainage pipe of an unknown material through the levee, 15 feet below the crown. Landside (LS) end is not visible. Concrete headwall at outlet on the waterside (WS) slope is visible. Pipe appears to be abandoned in place. Slide gate on the WS removed. [Additional Reference(s): DWR Levee Log, 2004. USACE San Joaquin O&M Manual 7, April 1964, (HLM 0.99)]. FS Date: 6/23/2020 2:32:00 PM

Slide gate removed from headwall on WS slope.

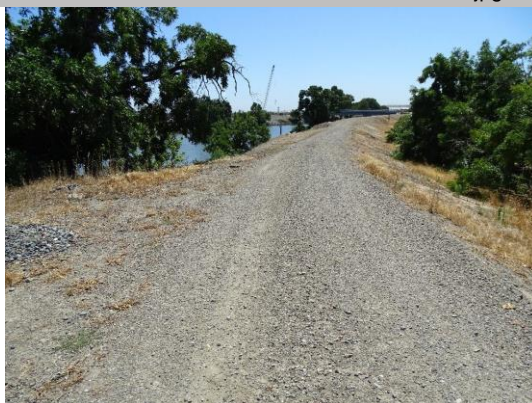
Photo 3 of 3 : UCIP\_FA\_2020\_61920\_89287.jpg

Top of Levee: view of crown.

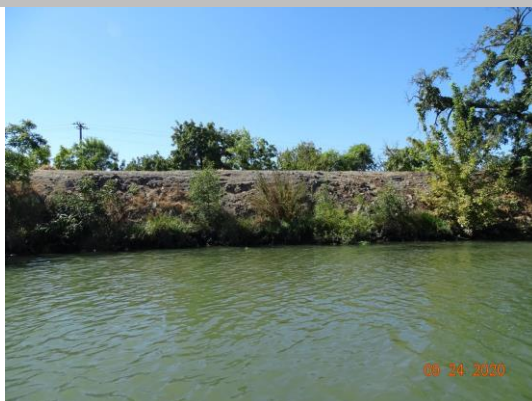
Photo 1 of 2 : SJR2019\_RD0524U01RM41.58\_03.JPG

LM Start	1.00	Rating **	U	Issue No.	15
LM End	1.01	Issue Type +	Ma	Location *	WS
Category	Supplemental			GPS Latitude/Longitude	
				Start	End
Item	DWR Erosion Survey			37.935106 °	37.935106 °
				-121.331554 °	-121.331554 °
DWR ID	RD0524U01RM41.58				
Comment Code					
Inspector Comment					
Site ID: RD0524U01RM41.58					
09/24/2020: From 2013 to present, no significant changes were observed during the annual survey.					
08/07/2012: The erosion was discovered during the boat survey.

9/24/2020: Front view of the erosion.

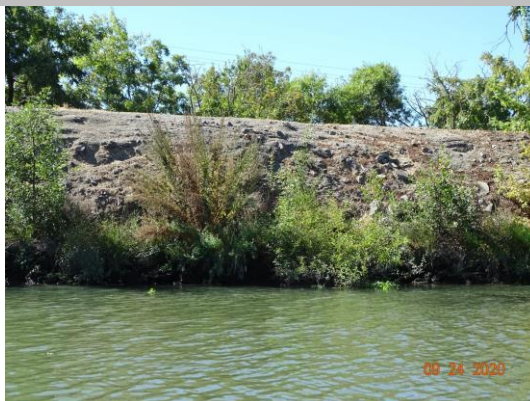
Photo 2 of 2 : SJR2019\_RD0524U01RM41.58\_02.JPG

9/24/2020: Close-up view of the erosion.

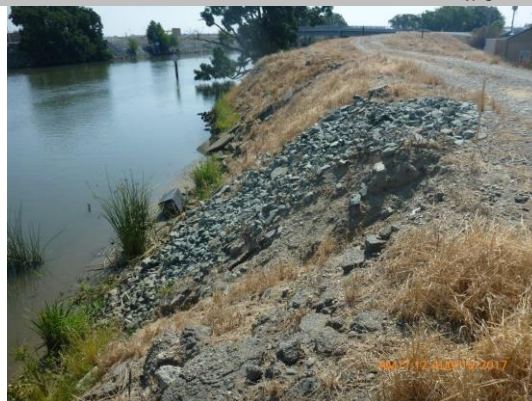
Photo 1 of 1 : LEVAL\_FA\_2020\_536\_4109.jpg

LM Start	1.00	Rating **	M	Issue No.	198
LM End	1.01	Issue Type +	Ma	Location *	WS
Category	Earthen Levee			GPS Latitude/Longitude	
				Start	End
Item	Erosion / Bank Caving			37.935100 °	37.935100 °
				-121.331500 °	-121.331300 °
DWR ID	LMA-442				
Comment Code					
E2 : Schedule repair of erosion site prior to the next inspection.					
Inspector Comment					
This was a 2017 Storm Damage Site. Slope protection repairs are needed along the waterside slope due to erosion and riprap displacement from high water. Based upon levee inspections, it was determined the waterside levee slope is eroding, deteriorating, and degrading. The eroded levee sections need to be restored back to design standards to prevent further deterioration and damage. Site ID No:536 Site Designation:LMA-442 There appears to be previous repair site adjacent to LMA-442. Large fox den on landside.

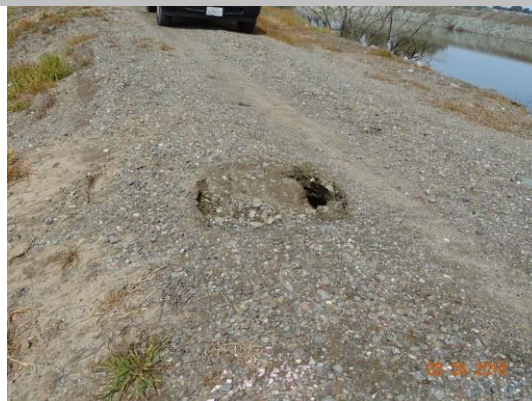
Photo 1 of 1 : FA\_2020\_RD0524\_107\_238\_20200901\_00106.jpg

LM Start	1.01	Rating **	U	Issue No.	238
LM End	1.01	Issue Type +	Ma	Location *	LS
Category	Earthen Levee			GPS Latitude/Longitude	
				Start	End
Item	Animal Control			37.935075 °	37.935075 °
				-121.331460 °	-121.331460 °
DWR ID	DWR_RD0524_01_f_2017_238				
Comment Code					
A3 : No rodents visible, but rodent burrows visible; need to backfill and compact or grout burrows.					
Inspector Comment					
Multiple large rodent holes on landward slope and toe. Large hole on crown near landside shoulder

Large rodent hole landside shoulder looking downstream. Spring 2019.

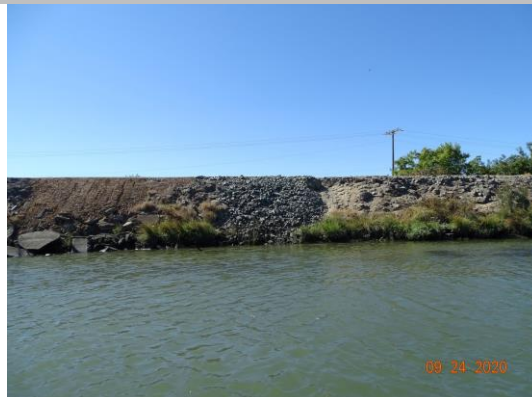
Photo 1 of 2 : SJR2019\_RD0524U01RM41.59\_04.JPG

09/24/2020: From 2013 to present, no significant changes were observed during the annual survey. The erosion is occurring immediately downstream of a repaired site.

08/07/2012: The site has been visited by boat survey. Site has been repaired, but new erosion occurred at the levee slope and immediately upstream of the repaired site.

9/24/2020: The erosion is occurring immediately downstream of a repaired site.

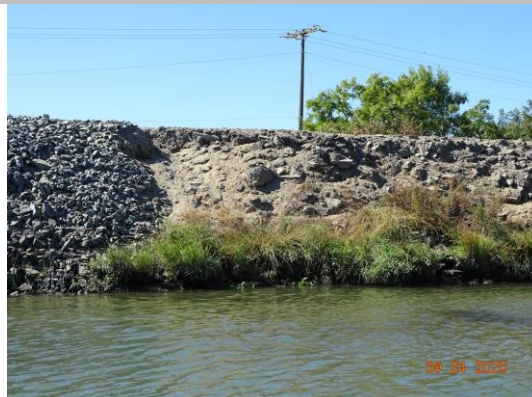
Photo 2 of 2 : SJR2019\_RD0524U01RM41.59\_03.JPG

9/24/2020: Close-up view of the erosion.

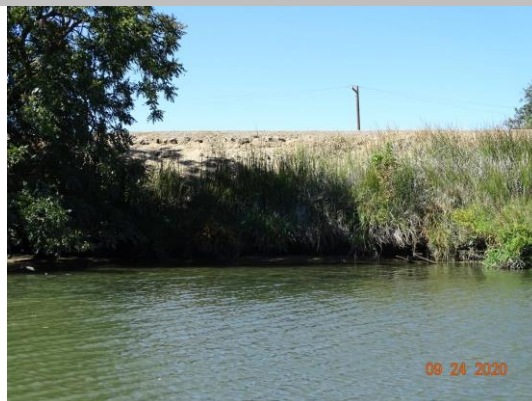
Photo 1 of 2 : SJR2019\_RD0524U01RM41.79\_04.JPG

09/24/2020: From 2011 to present, no significant changes were observed during the annual survey. Minimal vegetation covers the upper levee slope. The lower slope is covered with medium dense vegetation. Riprap is visible in some areas.

9/24/2020: Erosion visible on the upper levee slope.

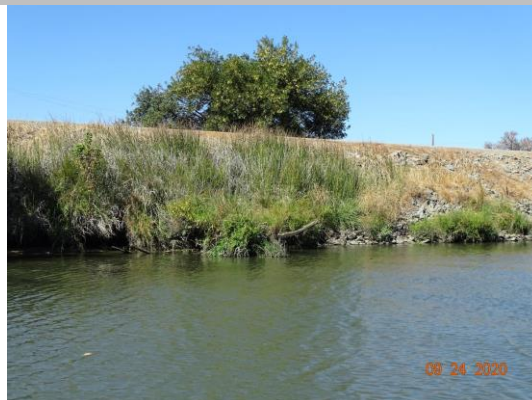
Photo 2 of 2 : SJR2019\_RD0524U01RM41.79\_02.JPG

9/24/2020: Front view of the erosion with riprap on the levee slope.

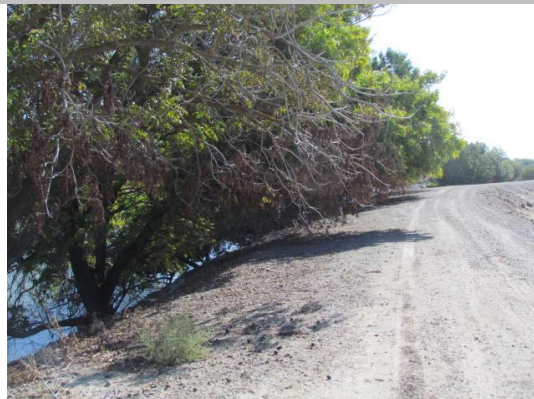
Photo 1 of 1 : FA\_2020\_RD0524\_107\_19\_20200901\_00012.jpg

LM Start	1.16	Rating **	M	Issue No.	19
LM End	1.16	Issue Type +	Ma	Location *	WS
Category	Earthen Levee			GPS Latitude/Longitude	
				Start	End
Item	Trim / Thin Trees			37.933810 °	37.933810 °
				-121.329317 °	-121.329317 °
DWR ID	DWR_RD0524_01_s _ 2012_19				
Comment Code					
T1 : Trim trees to at least five feet above ground level.					
Inspector Comment

Looking southeast at low hanging tree branches at waterside toe.

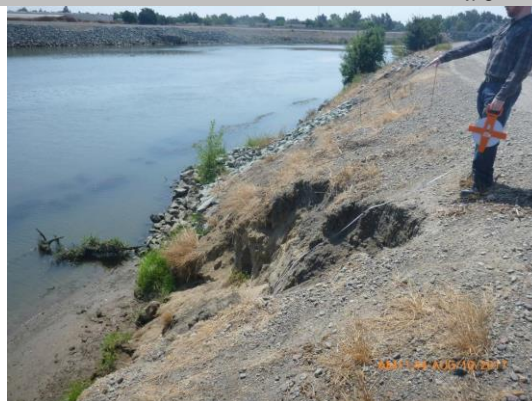
Photo 3 of 3 : LEVAL\_FA\_2020\_534\_4126.jpg

LM Start	1.25	Rating **	A/W	Issue No.	222 (cont)
LM End	1.30	Issue Type +	Ma	Location *	WS
Category	Supplemental			GPS Latitude/Longitude	
				Start	End
Item	2017 Storm Damage			37.932600 °	37.931900 °
				-121.328700 °	-121.328400 °
DWR ID	LMA-440

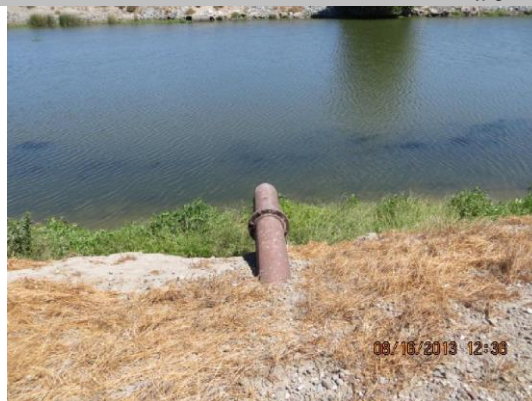
Photo 1 of 3 : UCIP\_FA\_2020\_61927\_29862.jpg

DS\_ID:20602  
FS\_ID:61927  
EP\_NO: N/A  
Repair Type: Non-Urgent  
EVAL Issue: Unauthorized Encroachment, installed decades prior  
Crossing Status: Found  
UCIP Comments: 06/23/2020 Record remains Non-Urgent.  
Unauthorized encroachment recorded in Levee Log prior to 2011. No permit has been identified authorizing pipe. Crossing appears abandoned. (D.Sanoski - DWR UCIP)  
10/2/2018 Pipe appears abandoned, but both the pipe and levee appear in good condition; downgrading to Non-Urgent (D. Sanoski - DWR UCIP).11/16/2016 same as previous inspection both ends are open. This pipe does not appear in use. Need to contact owner to determine status of crossing. If the crossing is abandoned or in use, owner will need to coordinate with the CVFPB to comply with Title 23 requirements. (O. Magana - DWR UCIP)08/16/2013 Pipe appears to be open on both ends. Abandoned and should be done so properly. (W. Wylie - DWR UCIP)

FIELD\_STRUCT\_DESC: \*ABANDONED\* 12-inch steel drainage pipe through the levee, 3.5 feet below the crown. Pipe is opened on the waterside (WS) and landside (LS) ends. The pump house referenced in O&M manual is missing from the LS (2013). [Additional Reference(s): DWR Levee Log, 2004. USACE San Joaquin O&M Manual 7, April 1964, (HLM 1.31)].  
FS Date: 6/23/2020 2:35:00 PM

Pipe visible and open on WS slope.

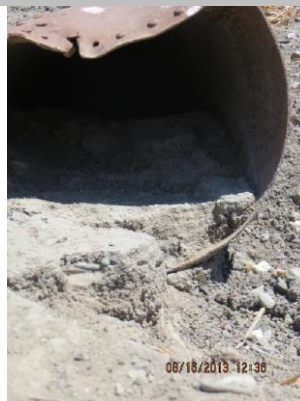
Photo 3 of 3 : UCIP\_FA\_2020\_61927\_29860.jpg

Pipe appears open on both ends. View from LS slope.

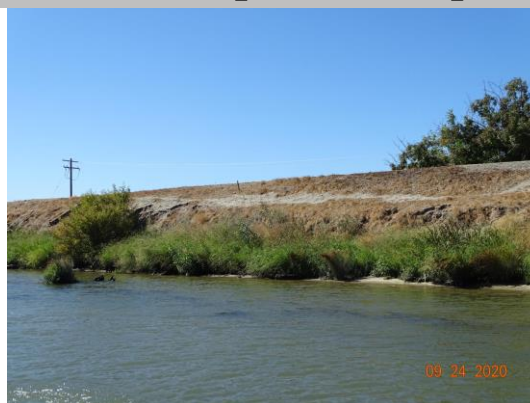
Photo 1 of 3 : SJR2019\_RD0524U01RM41.92\_04.JPG

9/24/2020: Overview of the erosion.

LM Start	1.30	Rating **	U	Issue No.	17 (cont)
LM End	1.33	Issue Type +	Ma	Location *	WS
Category	Supplemental			GPS Latitude/Longitude	
				Start	End
Item	DWR Erosion Survey			37.931858 °	37.931858 °
				-121.328300 °	-121.328300 °
DWR ID	RD0524U01RM41.92

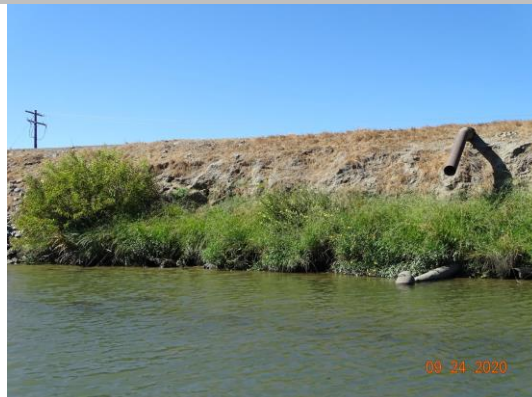
Photo 2 of 3 : SJR2019\_RD0524U01RM41.92\_01.JPG

9/24/2020: View of the erosion near the upstream end.

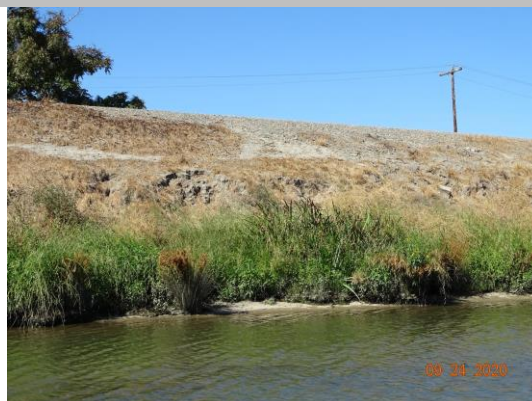
Photo 3 of 3 : SJR2019\_RD0524U01RM41.92\_03.JPG

LM Start	<b>1.30</b>	Rating **	U	Issue No.	<b>17 (cont)</b>
LM End	<b>1.33</b>	Issue Type +	Ma	Location *	WS

9/24/2020: Close-up view of the erosion.

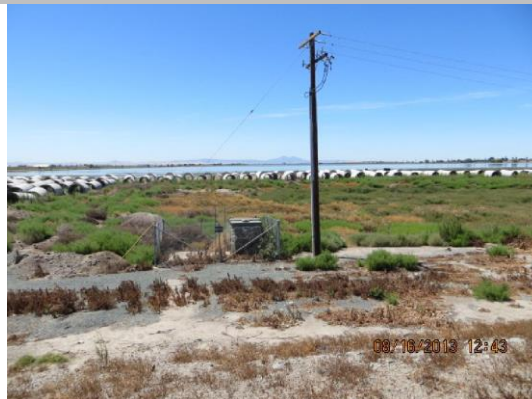
Photo 1 of 3 : UCIP\_FA\_2020\_61928\_29892.jpg

Comment Code						
Inspector Comment						
DS_ID:20603 FS_ID:61928 EP_NO: N/A Repair Type: Non-Urgent EVAL Issue: Pipe Not Found Crossing Status: Indicator Found UCIP Comments: 06/23/2020 Record updated from No Action Needed to Non-Urgent. Crossing not found. Unauthorized encroachment recorded in Levee Log prior to 2011. No permit has been identified authorizing pipe. Crossing appears abandoned. (D.Sanoski - DWR UCIP)  FIELD_STRUCT_DESC: 2-inch galvanized iron pipe of unknown purpose through the levee, 4 feet below the crown. Pump on the landside (LS). Concrete pad and electrical equipment off the LS toe may be indicator of correct location. Pipe not found, 8/2013. [Additional Reference(s): DWR Levee Log, 2004. USACE San Joaquin O&M Manual 7, April 1964, (HLM 1.38)]. FS Date: 6/23/2020 2:35:00 PM

Concrete pad and electrical panel off LS toe. Possible indicator of correct location.

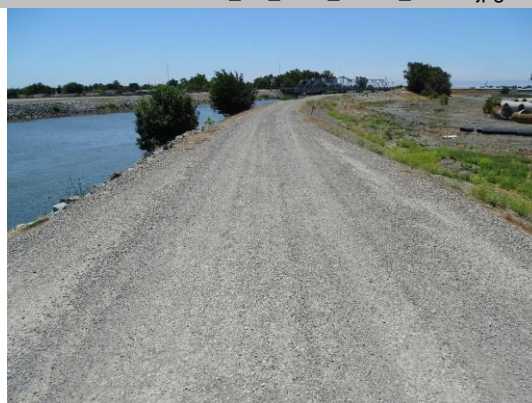
Photo 2 of 3 : UCIP\_FA\_2020\_61928\_89312.jpg

Top of Levee: view of crown.

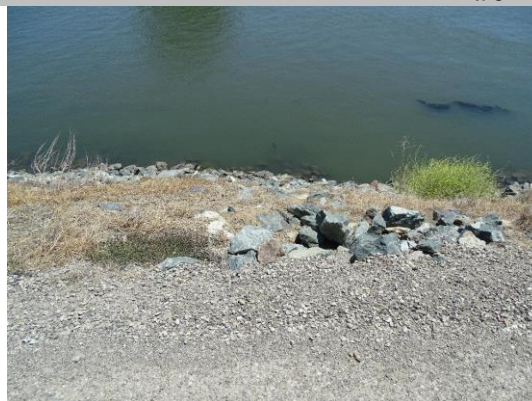
Photo 3 of 3 : UCIP\_FA\_2020\_61928\_89313.jpg

Water-Side: view of WS slope.

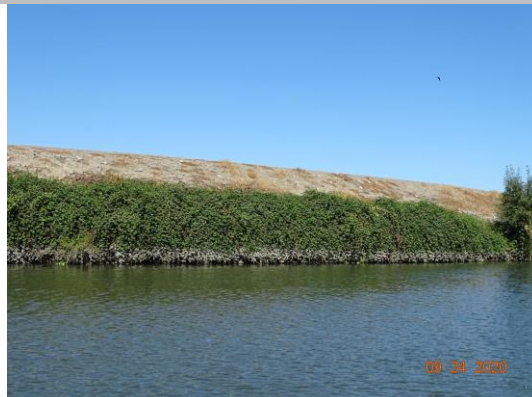
Photo 1 of 2 : SJR2019\_RD0524U01RM42.03\_02.JPG

LM Start	1.39	Rating **	M	Issue No.	18
LM End	1.39	Issue Type +	Ma	Location *	WS
Category	Supplemental			GPS Latitude/Longitude	
				Start	End
Item	DWR Erosion Survey			37.930575 °	37.930575 °
				-121.328090 °	-121.328090 °
DWR ID	RD0524U01RM42.03				
Comment Code					
Inspector Comment					
Site ID: RD0524U01RM42.03 09/24/2020: From 2013 to present, no significant changes were observed during the annual survey. Dense vegetation is limiting the view. 08/07/2012: The site was first reported in 2012 spring levee inspection report. The site is located about 750 ft downstream of SR 4 Bridge.

9/24/2020: Dense vegetation is limiting the view of the erosion.

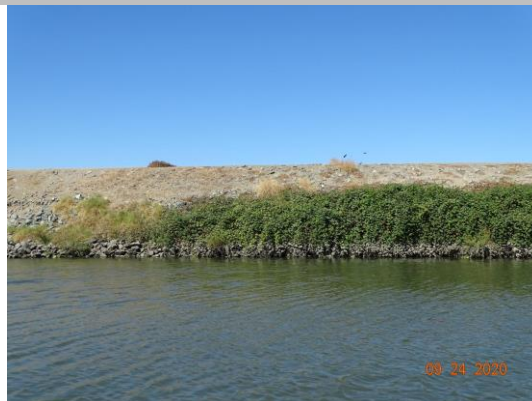
Photo 2 of 2 : SJR2019\_RD0524U01RM42.03\_01.JPG

9/24/2020: Another view of the erosion site.

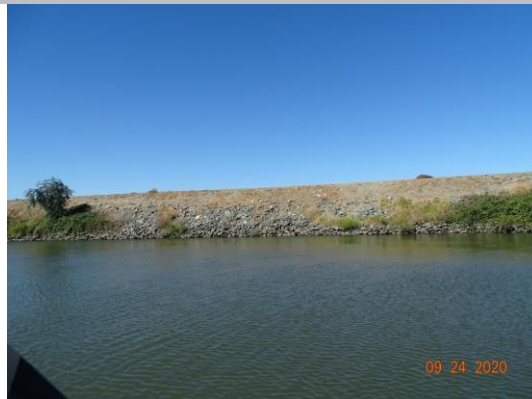
Photo 1 of 2 : SJR2019\_RD0524U01RM42.09\_03.JPG

LM Start	1.45	Rating **	U	Issue No.	9
LM End	1.47	Issue Type +	Ma	Location *	WS
Category	Supplemental			GPS Latitude/Longitude	
				Start	End
Item	DWR Erosion Survey			37.929623 °	37.929623 °
				-121.328366 °	-121.328366 °
DWR ID	RD0524U01RM42.09				
Comment Code					
Inspector Comment					
Site ID: RD0524U01RM42.09 09/24/2020: From 2014 to present, no significant changes were observed during the annual survey. The vegetation cover is only minimal. 08/13/2013: The site is located approximately 400 ft. downstream SR 4 Bridge. Dense vegetation is visible at the toe.

9/24/2020: Overview of the erosion.

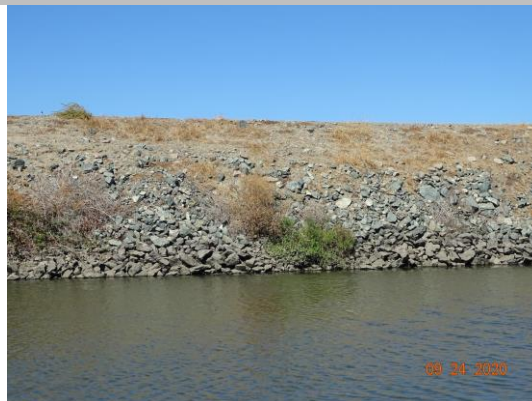
Photo 2 of 2 : SJR2019\_RD0524U01RM42.09\_02.JPG

9/24/2020: Close-up view of the erosion.

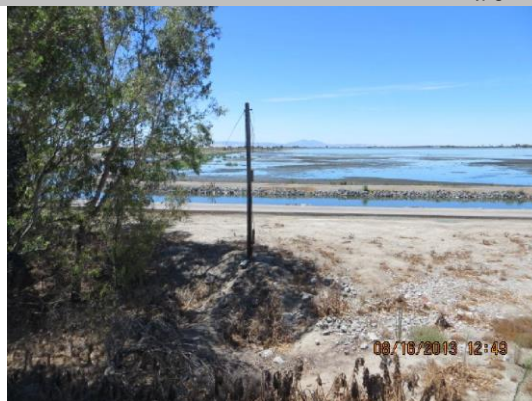
Photo 1 of 3 : UCIP\_FA\_2020\_61929\_37105.jpg

LM Start	1.48	Rating **	M	Issue No.	942
LM End	1.48	Issue Type +	En	Location *	
Category	Supplemental			GPS Latitude/Longitude	
				Start	End
Item	DWR UCIP Field Study			37.929277 °	37.929277 °
				-121.328394 °	-121.328394 °
DWR ID	24031				
Comment Code					
Inspector Comment					
DS_ID:24031 FS_ID:61929 EP_NO: 898 Repair Type: Non-Urgent EVAL Issue: Compliant Crossing Status: Indicator Found UCIP Comments: 06/23/2020 Record remains No Action Needed. No issues observed during inspection. (D.Sanoski - DWR UCIP)  FIELD_STRUCT_DESC: Steel communications conduit of an unknown diameter through the levee, 1.5 feet below the crown. Telephone pole with conduit visible off landside (LS) toe. (Permit No. 898, 1942 - PT&T). FS Date: 6/23/2020 2:36:00 PM

Telephone pole off LS toe.

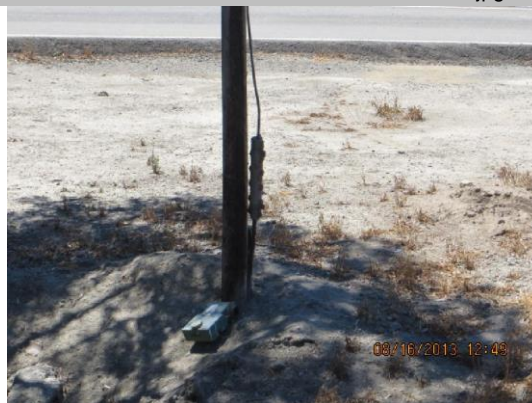
Photo 2 of 3 : UCIP\_FA\_2020\_61929\_37104.jpg

Telephone pole off LS toe.

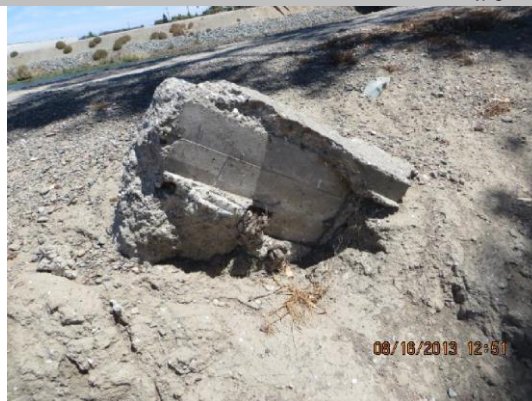
Photo 3 of 3 : UCIP\_FA\_2020\_61929\_37103.jpg

Possible headwall for conduit at LS shoulder.

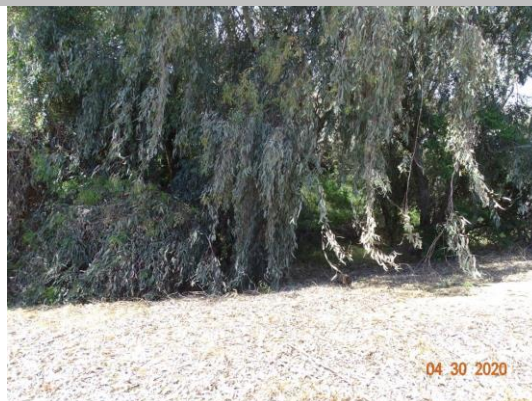
Photo 1 of 1 : FA\_2020\_RD0524\_107\_916\_20200901\_00118.jpg

LM Start	1.49	Rating **	M	Issue No.	916
LM End	1.50	Issue Type +	Ma	Location *	LS
Category	Earthen Levee			GPS Latitude/Longitude	
				Start	End
Item	Trim / Thin Trees			37.929118 °	37.929017 °
				-121.328368 °	-121.328367 °
DWR ID	DWR_RD0524_01_s_2012_916				
Comment Code					
T3 : Trim and thin trees to allow visibility of the ground and room to flood fight.					
Inspector Comment					
Untrimmed trees and dense vegetation on landside toe.

View of tree that need to be trimmed and thinned on landside slope.  
Spring 2020
