## Flood Control Project Maintenance Levee Inspections

### Fall 2020 Levee Maintenance Deficiency Summary Report

#### San Joaquin River Basin

**Reclamation District No. 0524 Middle Roberts Island**

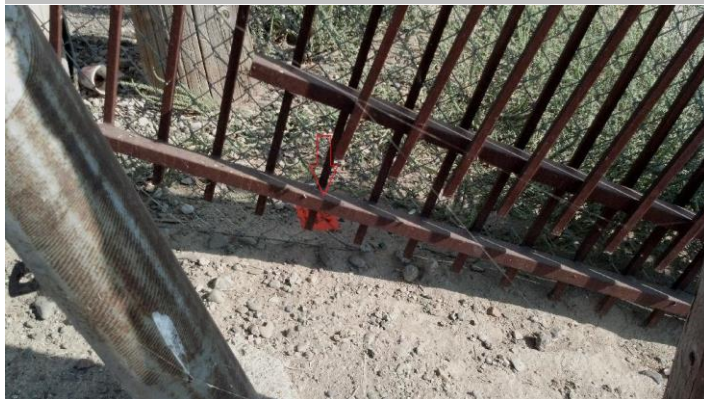
Photo 1 of 3 : UCIP\_FA\_2020\_61932\_29935.jpg

LM Start	1.54	Rating **	M	Issue No.	943	
LM End	1.54	Issue Type +	En	Location *		
Category	Supplemental			GPS Latitude/Longitude		
				Start		End
Item	DWR UCIP Field Study			37.928429 °		37.928429 °
				-121.328297 °		-121.328297 °
DWR ID	20605					
Comment Code						
Inspector Comment						
DS_ID:20605 FS_ID:61932 EP_NO: N/A Repair Type: Non-Urgent EVAL Issue: Pipe Not Found Crossing Status: Indicator Found UCIP Comments: 06/23/2020 Record remains Non-Urgent. Crossing not found. Unauthorized encroachment recorded in Levee Log prior to 2011. (D.Sanoski - DWR UCIP)  FIELD_STRUCT_DESC: Fiber optics cable crossing of an unknown material. USA marker flags over crown along alignment of gate. FS Date: 6/23/2020 2:37:00 PM

USAA markers along alignment at gate.

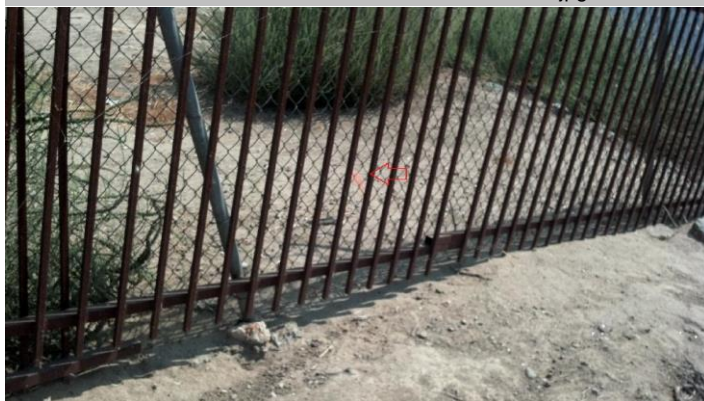
Photo 2 of 3 : UCIP\_FA\_2020\_61932\_29934.jpg

USAA markers along alignment at gate.

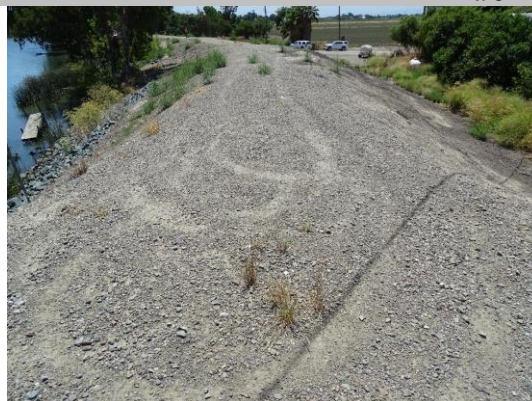
Photo 3 of 3 : UCIP\_FA\_2020\_61932\_89326.jpg

Top of Levee: view of crown.

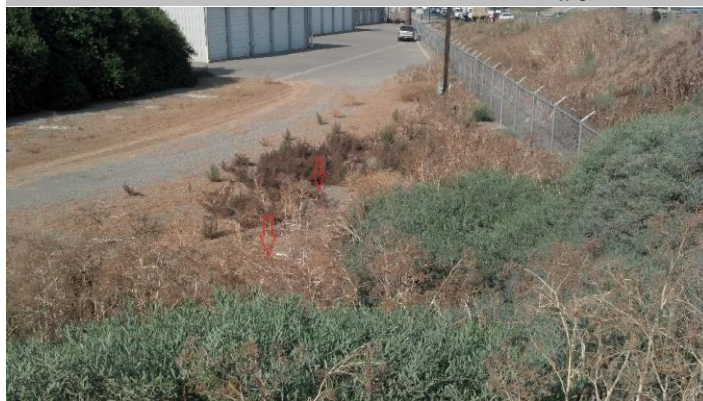
Photo 1 of 3 : UCIP\_FA\_2020\_61933\_29933.jpg

DS\_ID:20644  
 FS\_ID:61933  
 EP\_NO: 16937  
 Repair Type: Non-Urgent  
 EVAL Issue: Pipe Not Found  
 Crossing Status: Indicator Found  
 UCIP Comments: 06/23/2020 Record updated from No Action Needed to Non-Urgent. Crossing not found. (D.Sanoski - DWR UCIP)

FIELD\_STRUCT\_DESC: 16-inch high-density polyethylene communications conduit through the levee, 40 feet below the crown. Four 4.25-inch ducts sleeved through 16-inch conduit. Fiber optics flags found on alignment 2013. (Permit No. 16937, 1999 - Pacific Bell).  
 FS Date: 6/23/2020 2:37:00 PM

USAA flags mark alignment off LS toe and on crown.

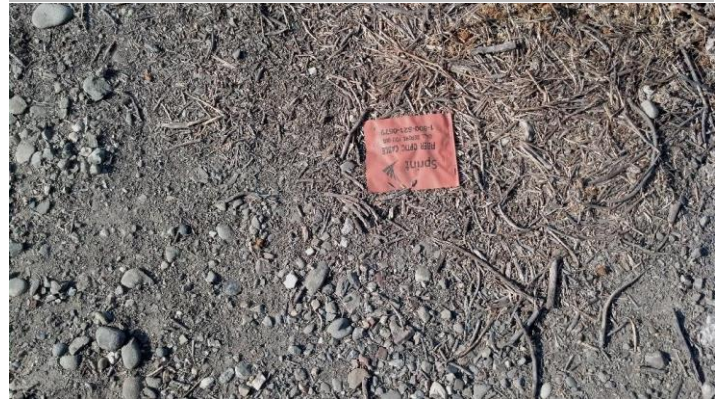
Photo 2 of 3 : UCIP\_FA\_2020\_61933\_29932.jpg

USAA marker on crown.

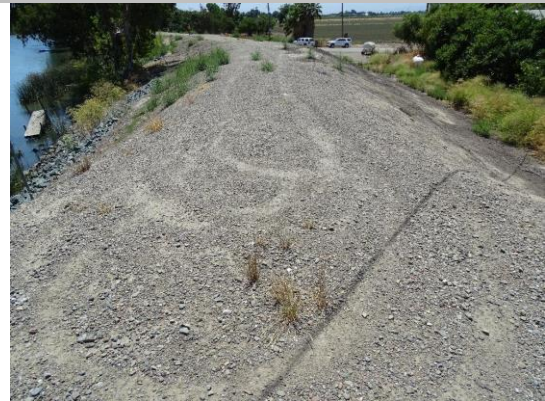
Photo 3 of 3 : UCIP\_FA\_2020\_61933\_89329.jpg

Top of Levee: view of crown.

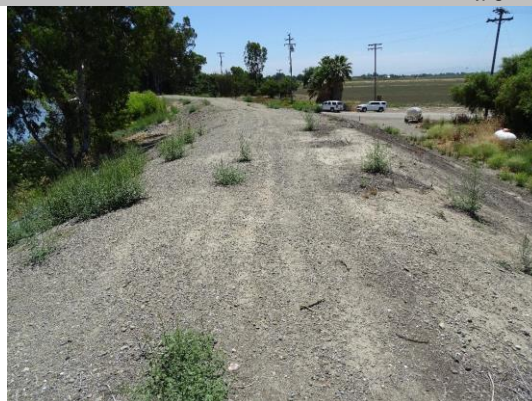
Photo 1 of 3 : UCIP\_FA\_2020\_61934\_89332.jpg

LM Start	1.55	Rating **	M	Issue No.	945	
LM End	1.55	Issue Type +	En	Location *		
Category	Supplemental			GPS Latitude/Longitude		
				Start		End
Item	DWR UCIP Field Study			37.928271 °	37.928271 °	
				-121.328208 °	-121.328208 °	
DWR ID	20606					
Comment Code						
Inspector Comment						
DS_ID:20606 FS_ID:61934 EP_NO: N/A Repair Type: Non-Urgent EVAL Issue: Pipe Not Found Crossing Status: Not Found UCIP Comments: 06/23/2020 Record updated from No Action Needed to Non-Urgent. Crossing not found. Unauthorized encroachment recorded in Levee Log prior to 2011. (D.Sanoski - DWR UCIP)  FIELD_STRUCT_DESC: 6-inch pipe of an unknown material or purpose sticking up on crown with locked inspection cover. Could not locate, 8/20/2013. [Additional Reference(s): DWR Levee Log, 2004]. FS Date: 6/23/2020 2:37:00 PM

Top of Levee: view of crown.

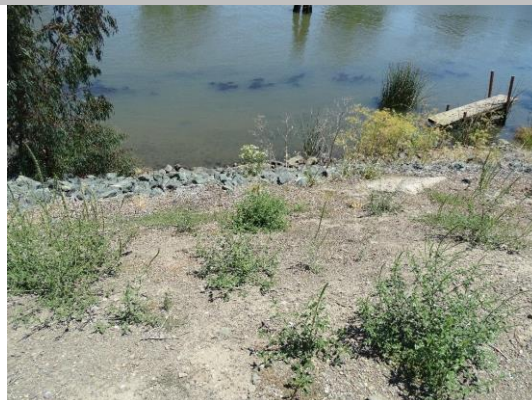
Photo 2 of 3 : UCIP\_FA\_2020\_61934\_89333.jpg

Water-Side: view of WS slope.

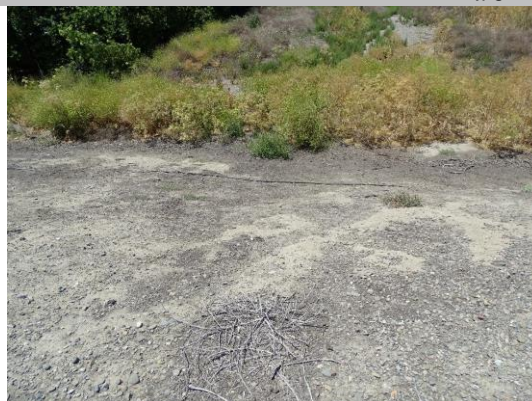
Photo 3 of 3 : UCIP\_FA\_2020\_61934\_89334.jpg

Land-Side: view of LS slope.

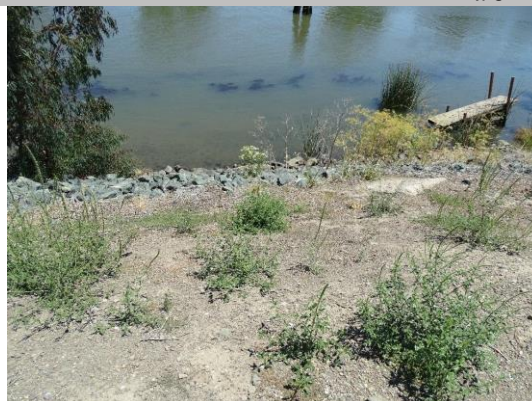
Photo 2 of 3 : UCIP\_FA\_2020\_61935\_89336.jpg

DS\_ID:20607  
 FS\_ID:61935  
 EP\_NO: N/A  
 Repair Type: Non-Urgent  
 EVAL Issue: Unauthorized Encroachment, installed decades prior  
 Crossing Status: Found  
 UCIP Comments: 06/23/2020 Record updated from No Action Needed to Non-Urgent. Unauthorized encroachment recorded in Levee Log prior to 2011. Crossing appears abandoned. (D.Sanoski - DWR UCIP)

Water-Side: view of WS slope.

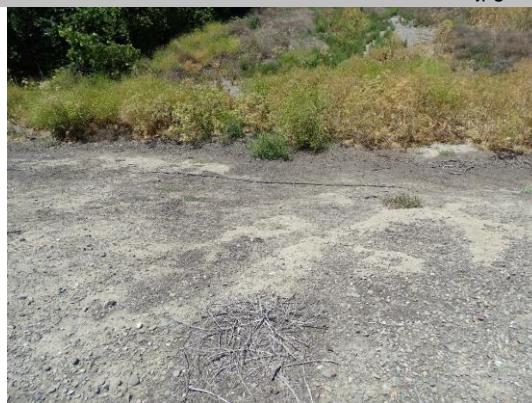
Photo 3 of 3 : UCIP\_FA\_2020\_61935\_89337.jpg

Land-Side: view of LS slope.

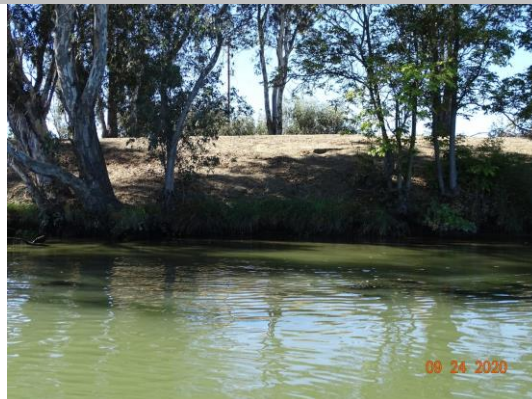
Photo 1 of 3 : SJR2019\_RD0524U01RM42.2\_02.JPG

09/24/2020: From 2013 to present, no significant changes were observed during the annual survey. Several erosion pockets and undermining of the levee toe visible.

09/07/2010: No significant change observed on site. The concern here is the undermining of the levee toe where most of trees are. There are erosion pockets lined along the lower slope and at the base of the trees, exposing tree roots. There is minimal slope protection.

9/24/2020: View of an erosion pocket between trees.

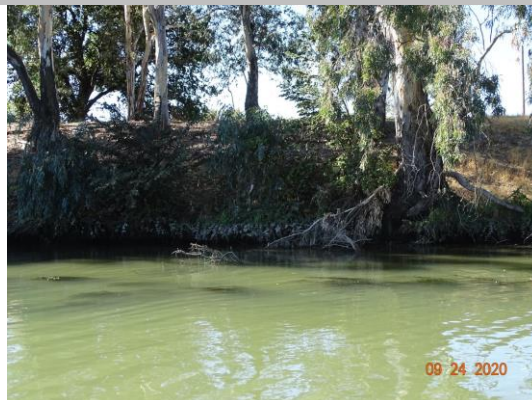
Photo 2 of 3 : SJR2019\_RD0524U01RM42.2\_05.JPG

9/24/2020: Visible undermining of the levee toe.

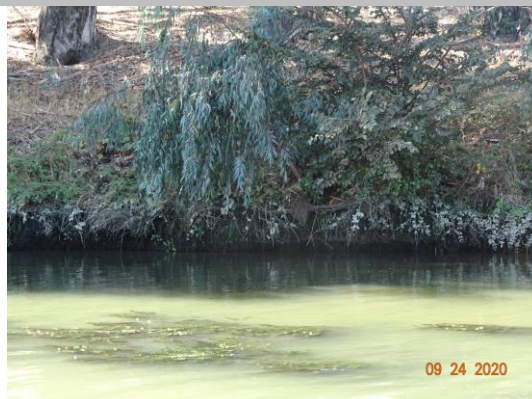
Photo 3 of 3 : SJR2019\_RD0524U01RM42.2\_06.JPG

LM Start	1.56	Rating **	U	Issue No.	1 (cont)
LM End	1.62	Issue Type +	Ma	Location *	WS
Category	Supplemental			GPS Latitude/Longitude	
				Start	End
Item	DWR Erosion Survey			37.927770 °	37.927770 °
				-121.327870 °	-121.327870 °
DWR ID	RD0524U01RM42.2

9/24/2020: Close-up view of the erosion.

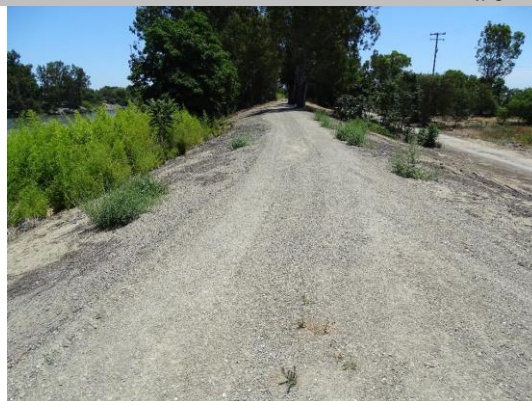
Photo 1 of 3 : UCIP\_FA\_2020\_61936\_89340.jpg

DS\_ID:20608  
 FS\_ID:61936  
 EP\_NO: N/A  
 Repair Type: Non-Urgent  
 EVAL Issue: Pipe Not Found  
 Crossing Status: Not Found  
 UCIP Comments: 06/23/2020 Record updated from No Action Needed to Non-Urgent. Crossing not found. Unauthorized encroachment recorded in Levee Log prior to 2011. No permit has been identified authorizing pipe. (D.Sanoski - DWR UCIP)

FIELD\_STRUCT\_DESC: 6-inch irrigation pipe of an unknown material through the levee, 3.5 feet below the crown. Pump on the waterside (WS). Open on the WS end. Rusting out on the landside (LS). Pipe exposed on the landside (LS) slope. Could not locate, 3/92. [Additional Reference(s): DWR Levee Log, 2004. USACE San Joaquin O&M Manual 7, April 1964, (HLM 1.61)].  
 FS Date: 6/23/2020 2:38:00 PM

Top of Levee: view of crown.

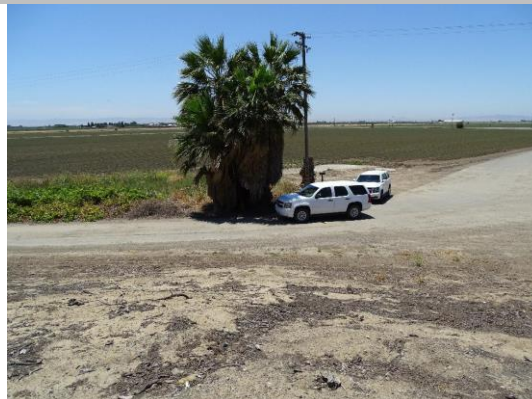
Photo 2 of 3 : UCIP\_FA\_2020\_61936\_89341.jpg

Land-Side: view of LS slope.

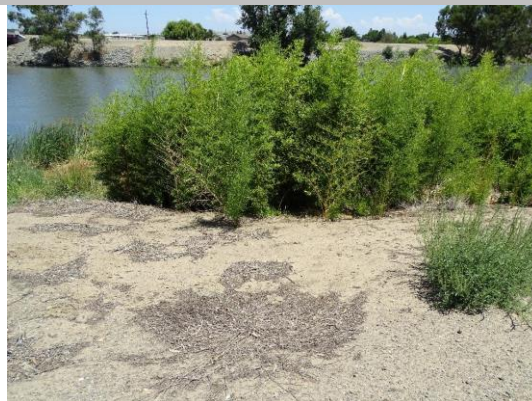
Photo 3 of 3 : UCIP\_FA\_2020\_61936\_89342.jpg

Water-Side: view of WS slope and no sign of pump.

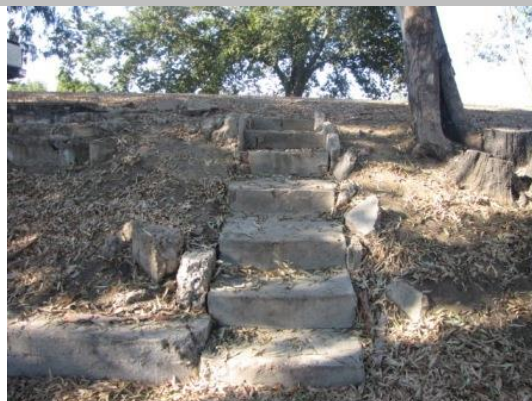
Photo 1 of 1 : FA\_2020\_RD0524\_107\_45\_20200901\_00022.jpg

LM Start	1.67	Rating **	M	Issue No.	45
LM End	1.67	Issue Type +	En	Location *	WS
Category	Earthen Levee			GPS Latitude/Longitude	
				Start	End
Item	Encroachments			37.927018 °	37.927018 °
				-121.326872 °	-121.326872 °
DWR ID	DWR_RD0524_01_s_2012_45				
Comment Code					
ST : Stairway					
Inspector Comment					
Stairs and retaining wall.

Looking west at concrete stairs on waterside slope.

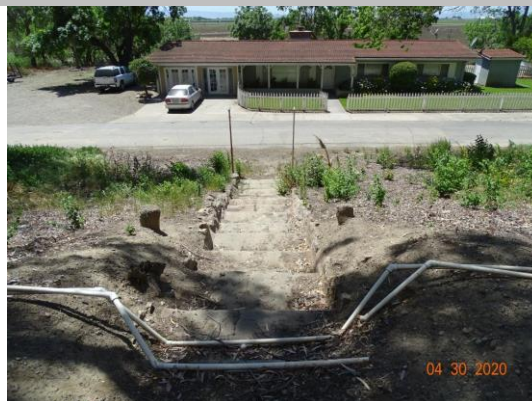
Photo 1 of 1 : FA\_2020\_RD0524\_107\_267\_20200901\_00115.jpg

LM Start	1.67	Rating **	M	Issue No.	267
LM End	1.67	Issue Type +	En	Location *	LS
Category	Earthen Levee			GPS Latitude/Longitude	
				Start	End
Item	Encroachments			37.927014 °	37.927014 °
				-121.326858 °	-121.326858 °
DWR ID	DWR_RD0524_01_s_2020_267				
Comment Code					
ST : Stairway					
Inspector Comment

View of concrete stairs on landside slope. Spring 2020

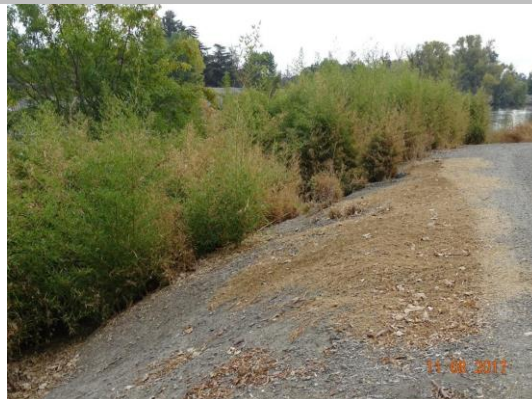
Photo 1 of 1 : FA\_2020\_RD0524\_107\_243\_20200901\_00108.jpg

Looking southeast at the waterside slope.

LM Start	1.70	Rating **	U	Issue No.	243
LM End	1.72	Issue Type +	Ma	Location *	WS
Category	Earthen Levee			GPS Latitude/Longitude	
				Start	End
Item	Vegetation			37.926704 °	37.926471 °
				-121.326462 °	-121.326175 °
DWR ID	DWR_RD0524_01_f_2017_243				
Comment Code					
V2 : Remove the wild growth other than native grasses from the levee slopes.					
Inspector Comment

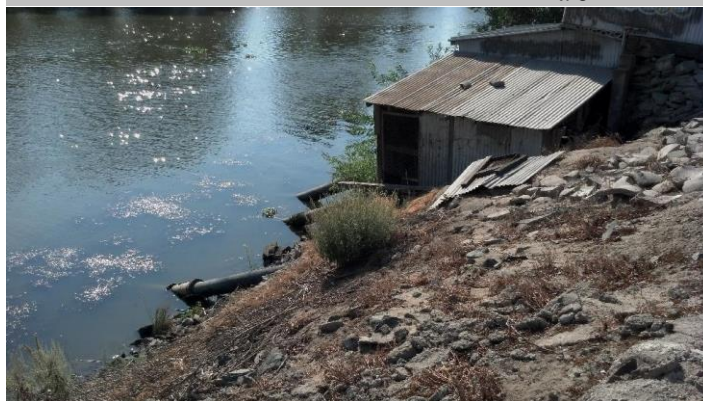
Photo 1 of 3 : UCIP\_FA\_2020\_61937\_37124.jpg

LM Start	1.80	Rating **	M	Issue No.	948	
LM End	1.80	Issue Type +	En	Location *		
Category	Supplemental			GPS Latitude/Longitude		
				Start		End
Item	DWR UCIP Field Study			37.925480 °		37.925480 °
				-121.325358 °		-121.325358 °
DWR ID	24032					
Comment Code						
Inspector Comment						
DS_ID:24032 FS_ID:61937 EP_NO: N/A Repair Type: Non-Urgent EVAL Issue: Unauthorized Encroachment Crossing Status: Found UCIP Comments: 06/23/2020 Record remains Non-Urgent. No permit has been found authorizing this pipe through the levee. (D.Sanoski - DWR UCIP)  FIELD_STRUCT_DESC: 12-inch wrapped steel irrigation pipe through the levee, at an unknown depth. Pump, butterfly valves, vent, and siphon breaker at concrete pad 50 feet off the landside (LS) toe. Siphon breaker in 14-inch concrete standpipe on the LS shoulder. FS Date: 6/23/2020 2:38:00 PM

Pipe visible at lower left.

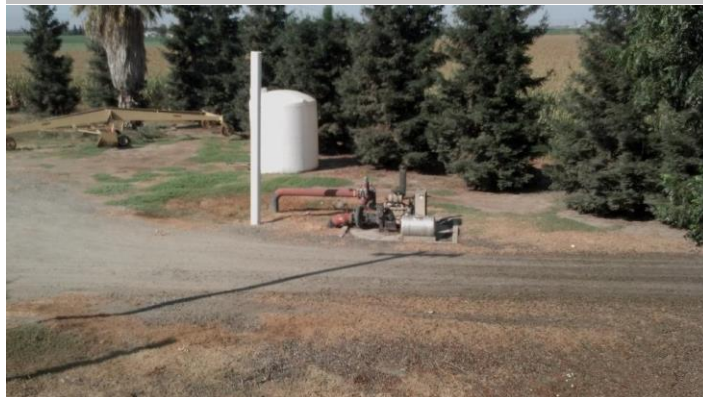
Photo 2 of 3 : UCIP\_FA\_2020\_61937\_37123.jpg

Pumping plant off LS toe.

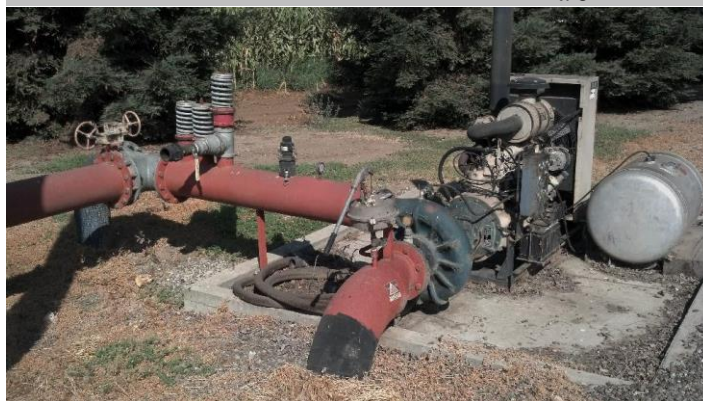
Photo 3 of 3 : UCIP\_FA\_2020\_61937\_37122.jpg

Pumping plant with siphon breaker, vents, and butterfly valves.

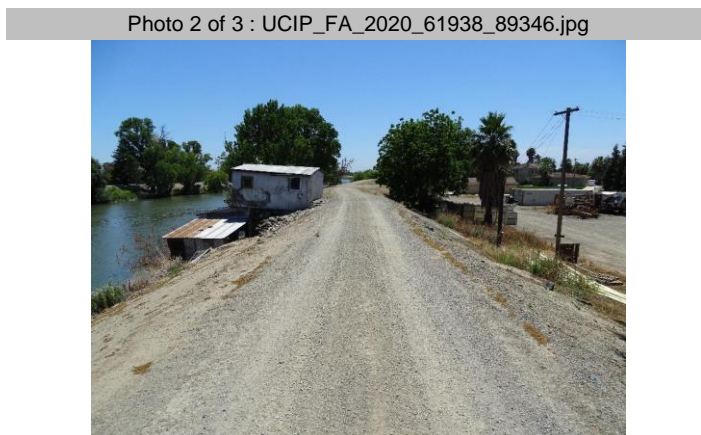
Overview of Levee: view of levee.

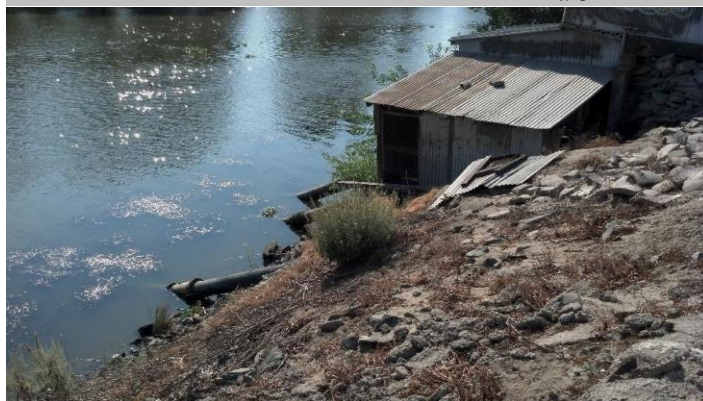
Photo 1 of 3 : UCIP\_FA\_2020\_61940\_29962.jpg

DS\_ID:20609  
 FS\_ID:61940  
 EP\_NO: N/A  
 Repair Type: Non-Urgent  
 EVAL Issue: Unauthorized Encroachment, installed decades prior  
 Crossing Status: Found  
 UCIP Comments: 06/23/2020 Record remains Non-Urgent.  
 Unauthorized encroachment recorded in Levee Log prior to 2011. No permit has been identified authorizing pipe. (D.Sanoski - DWR UCIP)  
 Pipe appears abandoned and if so should be done so properly.  
 FIELD\_STRUCT\_DESC: 14-inch irrigation pipe of an unknown material through the levee, 20 feet below the crown. 2 pumps and gate valves discharge into surge tank in pump house on the waterside (WS) slope. Concrete distribution box removed from the WS slope. Abandoned 36-inch diameter concrete standpipe on the landside (LS) toe next to service pole. [Additional Reference(s): DWR Levee Log, 2004. USACE San Joaquin O&M Manual 7, April 1964, (HLM 1.83)].  
 FS Date: 6/23/2020 2:39:00 PM

Pipes and pumphouse on WS slope.

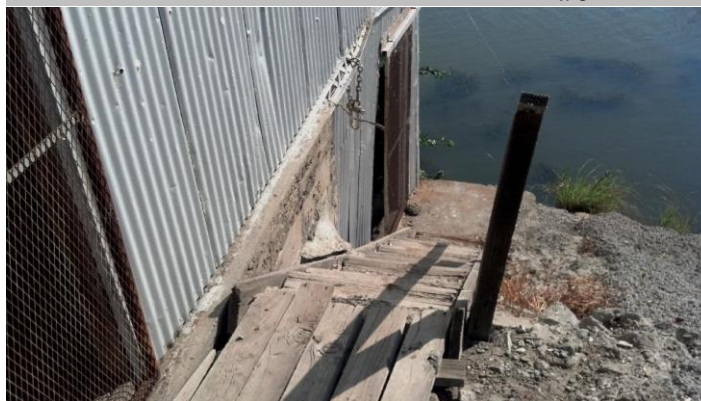
Photo 2 of 3 : UCIP\_FA\_2020\_61940\_29961.jpg

Steps to pump on WS slope.

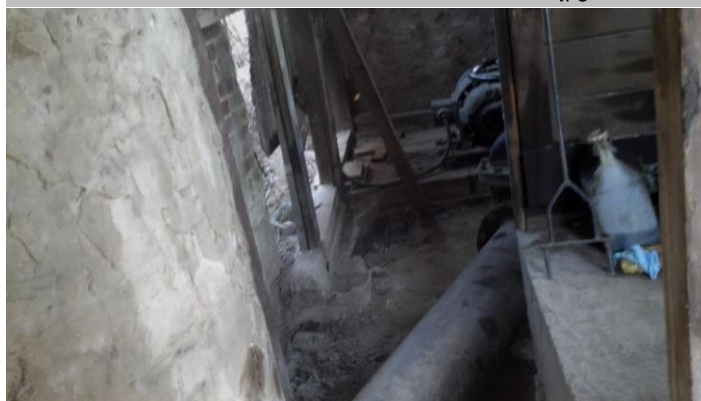
Photo 3 of 3 : UCIP\_FA\_2020\_61940\_29960.jpg

Pipes at connection to concrete surge box on WS inside pumphouse.

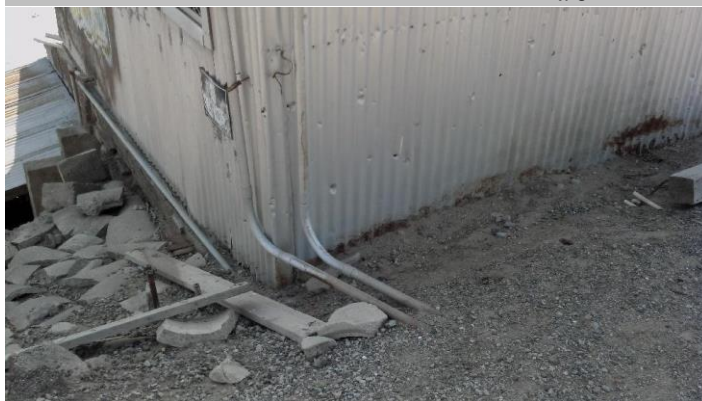
Photo 1 of 3 : UCIP\_FA\_2020\_61939\_29974.jpg

Comment Code						
Inspector Comment						
DS_ID:20661 FS_ID:61939 EP_NO: N/A Repair Type: Non-Urgent EVAL Issue: Unauthorized Encroachment, installed decades prior Crossing Status: Found UCIP Comments: 06/23/2020 Record updated from No Action Needed to Non-Urgent. Unauthorized encroachment recorded in Levee Log prior to 2011. No permit has been identified authorizing pipe. (D.Sanoski - DWR UCIP)  FIELD_STRUCT_DESC: 1.25-inch electrical conduit of an unknown material through the levee, 6 inches below the crown. Pole and meter at the landside (LS) toe. [Additional Reference(s): DWR Levee Log, 2004. USACE San Joaquin O&M Manual 7, April 1964, (HLM 1.83), listed as a 14-inch pipe, 20 feet below the crown]. FS Date: 6/23/2020 2:39:00 PM

Electrical conduit visible at corner of building on WS shoulder.

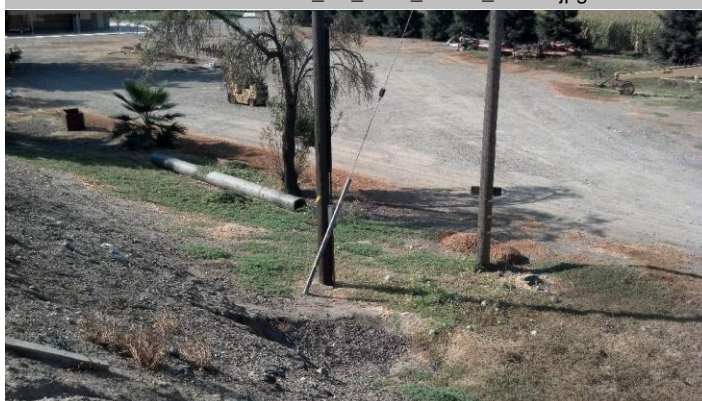
Photo 2 of 3 : UCIP\_FA\_2020\_61939\_29975.jpg

Conduit visible at power pole on LS toe.

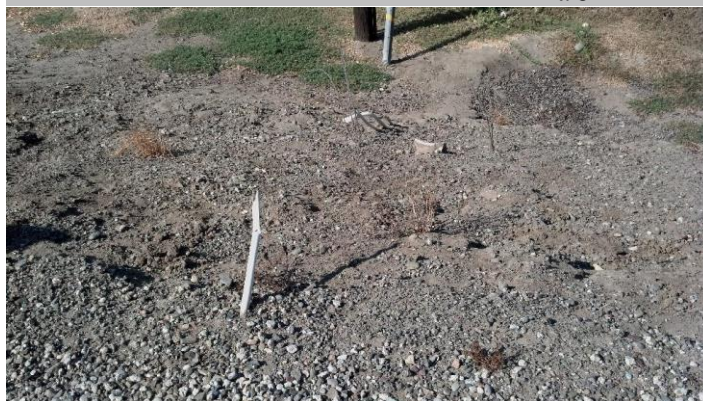
Photo 2 of 3 : UCIP\_FA\_2020\_62131\_37120.jpg

Pipes visible on LS slope.

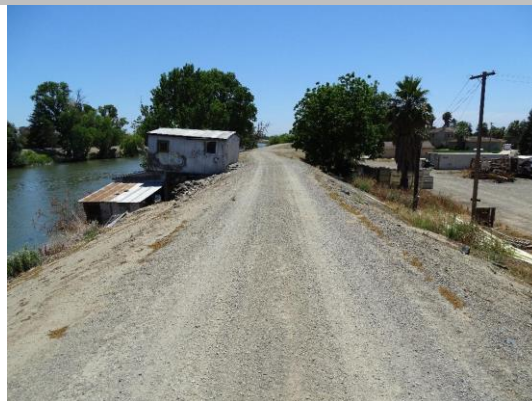
Photo 3 of 3 : UCIP\_FA\_2020\_62131\_89357.jpg

Overview of Levee: view of levee.

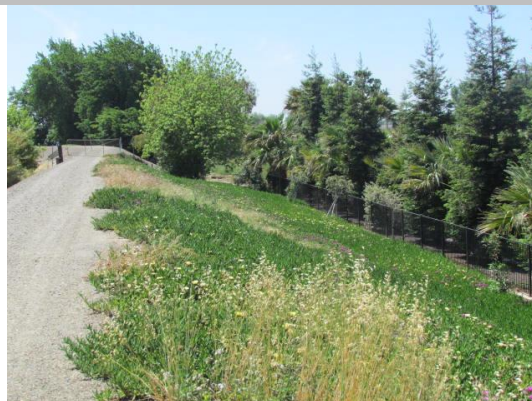
Photo 1 of 1 : FA\_2020\_RD0524\_107\_78\_20200901\_00037.jpg

LM Start	1.90	Rating **	U	Issue No.	78
LM End	1.94	Issue Type +	En	Location *	LS
Category	Earthen Levee			GPS Latitude/Longitude	
				Start	End
Item	Vegetation			37.924364 °	37.923805 °
				-121.324473 °	-121.324238 °
DWR ID	DWR_RD0524_01_s_2012_78				
Comment Code					
V6 : Landscaping					
Inspector Comment					
Unauthorized ice-plant on LS slope hinders ability to inspect landside slope.

Looking southwest at landscaping on landside slope. (Spring 2012)

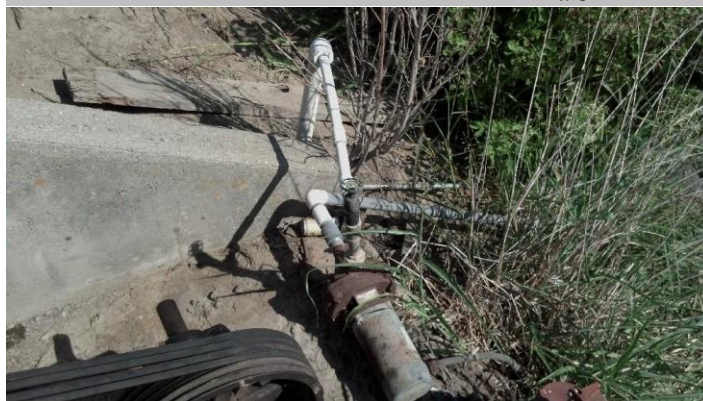
Photo 1 of 3 : UCIP\_FA\_2020\_61943\_37128.jpg

Comment Code						
Inspector Comment						
DS_ID:24035						
FS_ID:61943						
EP_NO: N/A						
Repair Type: Non-Urgent						
EVAL Issue: Unauthorized Encroachment, installed decades prior						
Crossing Status: Found						
UCIP Comments: 06/23/2020 Record remains Non-Urgent.						
Unauthorized encroachment recorded in Levee Log prior to 2011. No permit has been identified authorizing pipe. (D.Sanoski - DWR UCIP)						
No permit identified for this crossing.						
FIELD_STRUCT_DESC: 3-inch polyvinyl chloride domestic non-potable water line through the levee, at an unknown depth. Pump on concrete pad at the waterside (WS) toe.						
FS Date: 6/23/2020 2:40:00 PM

Pump on concrete pad at WS slope.

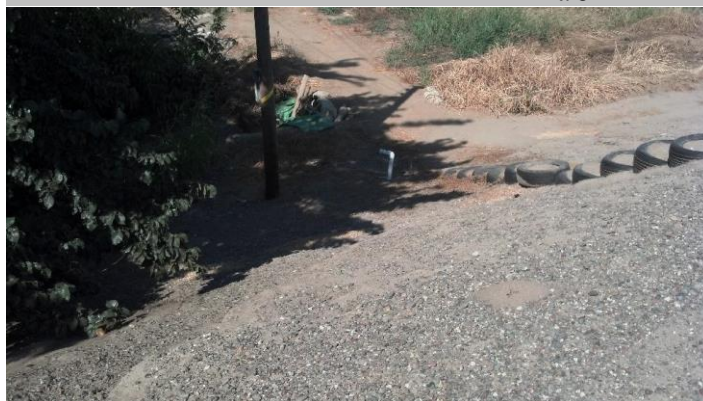
Photo 2 of 3 : UCIP\_FA\_2020\_61943\_37127.jpg

PVC pipe visible on LS toe.

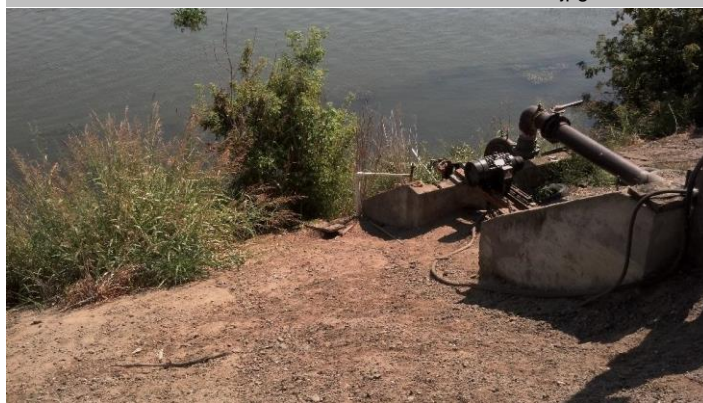
Photo 3 of 3 : UCIP\_FA\_2020\_61943\_37126.jpg

Pump and pipe visible on WS slope.

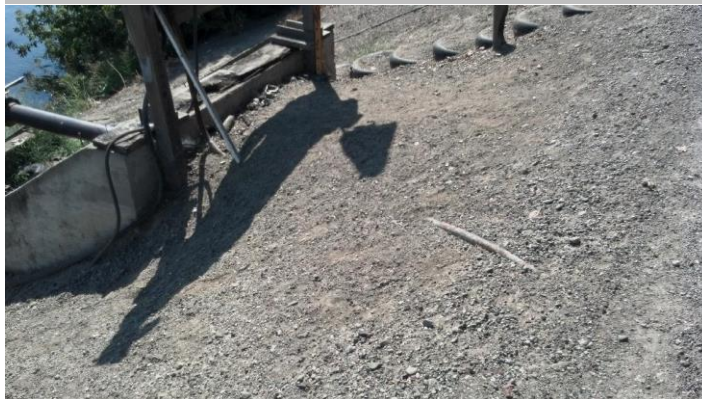
Photo 1 of 3 : UCIP\_FA\_2020\_61944\_37132.jpg

LM Start	1.99	Rating **	M	Issue No.	954	
LM End	1.99	Issue Type +	En	Location *		
Category	Supplemental			GPS Latitude/Longitude		
				Start		End
Item	DWR UCIP Field Study			37.923017 °		37.923017 °
				-121.323943 °		-121.323943 °
DWR ID	24034					
Comment Code						
Inspector Comment						
DS_ID:24034 FS_ID:61944 EP_NO: N/A Repair Type: Non-Urgent EVAL Issue: Unauthorized Encroachment, installed decades prior Crossing Status: Found UCIP Comments: 06/23/2020 Record updated from No Action Needed to Non-Urgent. Unauthorized encroachment recorded in Levee Log prior to 2011. No permit has been identified authorizing pipe. (D.Sanoski - DWR UCIP)  FIELD_STRUCT_DESC: 1.25-inch electrical conduit of an unknown material through the levee, 2 inches below the crown. Pump on the waterside (WS) slope. Power pole and meter at the landside (LS) toe. FS Date: 6/23/2020 2:40:00 PM

Galvanized iron electrical conduit visible on WS shoulder.

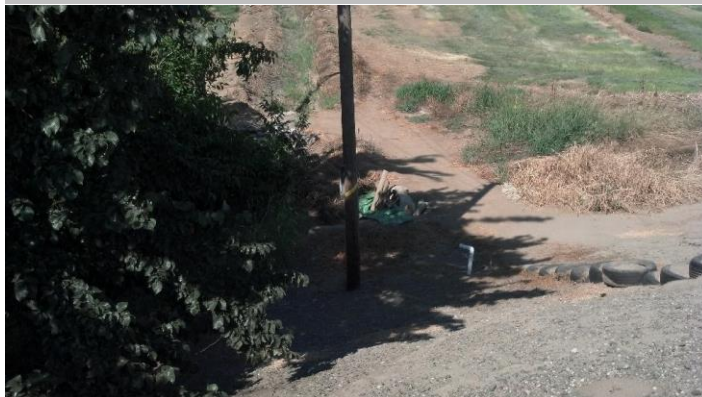
Photo 2 of 3 : UCIP\_FA\_2020\_61944\_37131.jpg

Conduit visible on pole at LS toe.

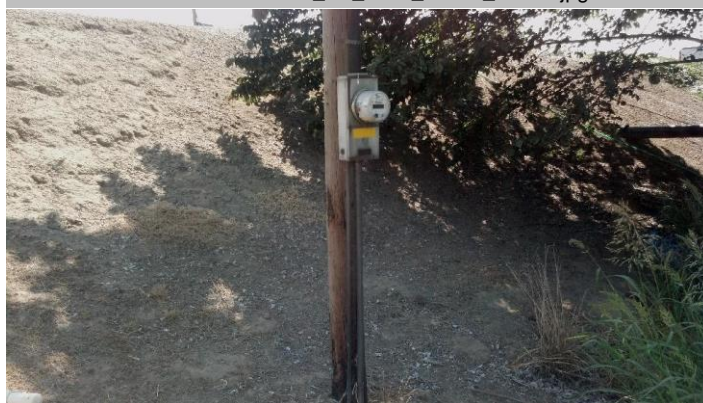
Photo 3 of 3 : UCIP\_FA\_2020\_61944\_37130.jpg

Conduit visible on pole at LS toe.

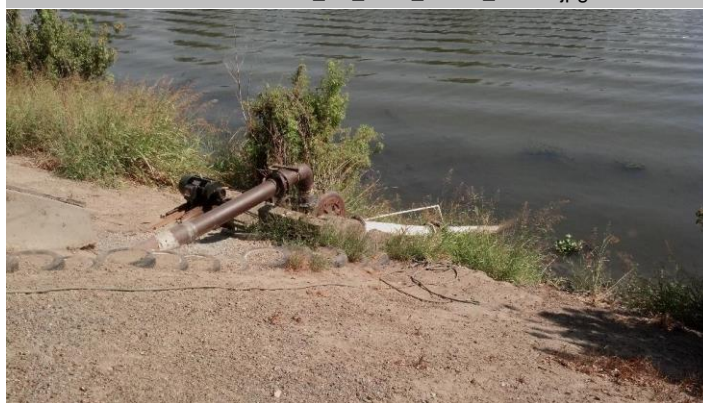
Photo 1 of 3 : UCIP\_FA\_2020\_61942\_29982.jpg

DS\_ID:20610  
FS\_ID:61942  
EP\_NO: N/A  
Repair Type: Non-Urgent  
EVAL Issue: Unauthorized Encroachment, installed decades prior  
Crossing Status: Found  
UCIP Comments: 06/23/2020 Record updated from No Action Needed to Non-Urgent. Unauthorized encroachment recorded in Levee Log prior to 2011. No permit has been identified authorizing pipe. (D.Sanoski - DWR UCIP)

FIELD\_STRUCT\_DESC: 10-inch steel irrigation pipe through the levee, 10 feet below the crown. 8-inch polyvinyl chloride pipe sleeved through 10-inch pipe. Two concrete platforms for pump and pump house on the waterside (WS) slope. 5-foot by 10-foot concrete distribution box and 36-inch concrete standpipe at the landside (LS) toe. Power pole at the LS toe. Concrete filled tire stairs on both slopes. [Additional Reference(s): DWR Levee Log, 2004. USACE San Joaquin O&M Manual 7, April 1964, (HLM 2.02)].  
FS Date: 6/23/2020 2:40:00 PM

Concrete pad, pump, pipe, and butterfly valve on WS slope.

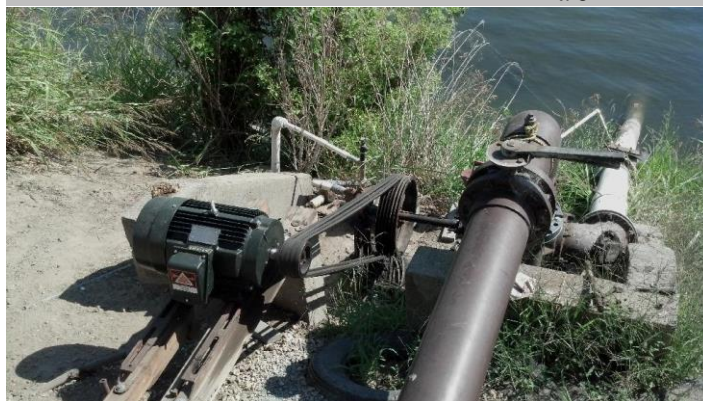
Photo 2 of 3 : UCIP\_FA\_2020\_61942\_29981.jpg

Concrete pad, pump, pipe, and butterfly valve on WS slope.

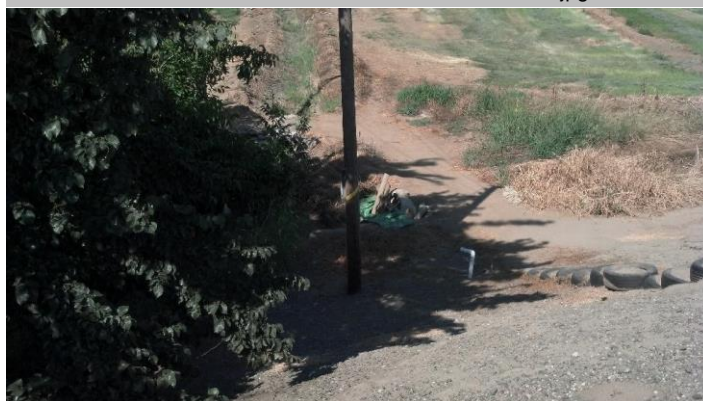
Photo 3 of 3 : UCIP\_FA\_2020\_61942\_29980.jpg

Power pole on LS toe. 5'X10' concrete distribution box and 36-inch concrete standpipe to left on LS toe.

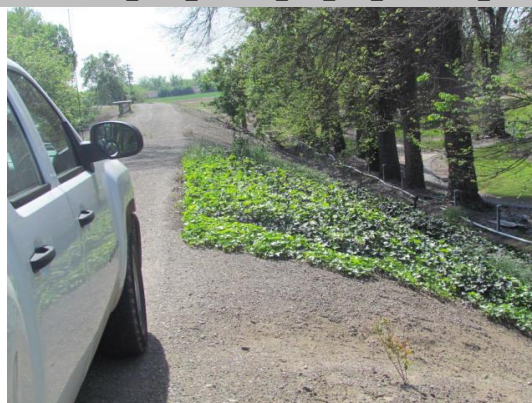
Photo 1 of 1 : FA\_2020\_RD0524\_107\_106\_20200901\_00050.jpg

LM Start	2.00	Rating **	U	Issue No.	106
LM End	2.03	Issue Type +	En	Location *	LS
Category	Earthen Levee			GPS Latitude/Longitude	
				Start	End
Item	Vegetation			37.922923 °	37.922519 °
				-121.323837 °	-121.323534 °
DWR ID	DWR_RD0524_01_s_2012_106				
Comment Code					
V6 : Landscaping					
Inspector Comment

Looking southwest at ground cover on landward slope.

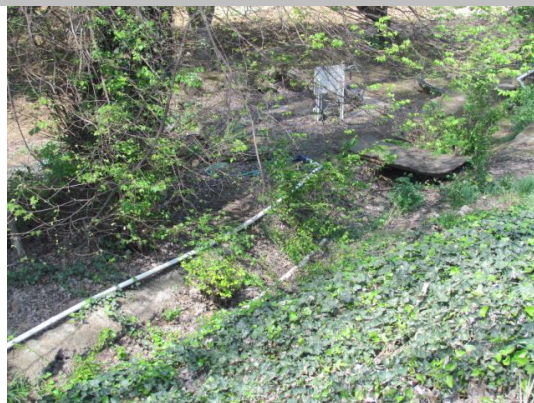
Photo 1 of 1 : FA\_2020\_RD0524\_107\_182\_20200901\_00072.jpg

LM Start	2.01	Rating **	M	Issue No.	182
LM End	2.04	Issue Type +	En	Location *	LS
Category	Earthen Levee			GPS Latitude/Longitude	
				Start	End
Item	Encroachments			37.922837 °	37.922514 °
				-121.323785 °	-121.323504 °
DWR ID	DWR_RD0524_01_s_2014_182				
Comment Code					
DT : Ditch					
Inspector Comment					
Old irrigation ditch at the landside toe should be removed.

Looking northwest at an old irrigation ditch at landward toe.

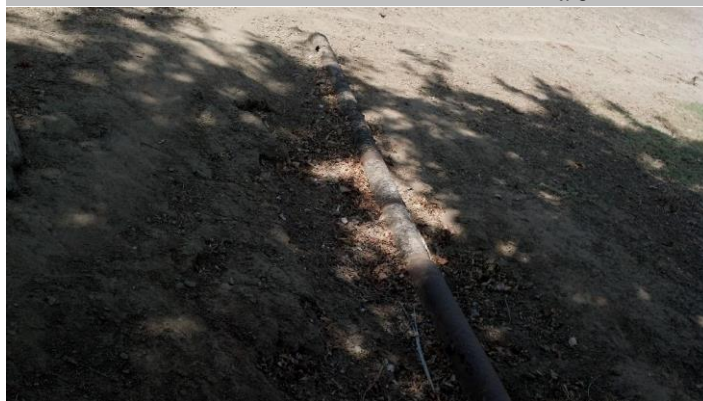
Photo 1 of 3 : UCIP\_FA\_2020\_61945\_37134.jpg

LM Start	2.03	Rating **	M	Issue No.	956	
LM End	2.03	Issue Type +	En	Location *		
Category	Supplemental			GPS Latitude/Longitude		
				Start		End
Item	DWR UCIP Field Study			37.922535 °	37.922535 °	
				-121.323568 °	-121.323568 °	
DWR ID	24036					
Comment Code						
Inspector Comment						
DS_ID:24036 FS_ID:61945 EP_NO: N/A Repair Type: Non-Urgent EVAL Issue: Unauthorized Encroachment Crossing Status: Found UCIP Comments: 06/23/2020 Record remains Non-Urgent. No permit has been found authorizing this pipe through the levee. Crossing appears abandoned. (D.Sanoski - DWR UCIP) Pipe abandoned and should be done so properly. Holes visible throughout exposed pipe. FIELD_STRUCT_DESC: 5-inch wrapped steel irrigation pipe through the levee, 6 feet below the crown. No pump or other appurtenances found. FS Date: 6/23/2020 2:41:00 PM

Pipe visible on WS slope.

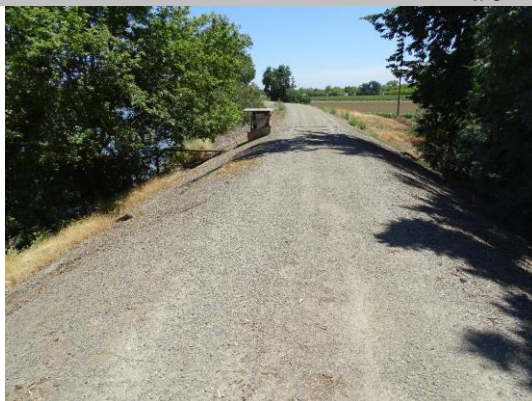
Photo 3 of 3 : UCIP\_FA\_2020\_61945\_89369.jpg

Top of Levee: view of crown with pipe pipe out of slope on WS.

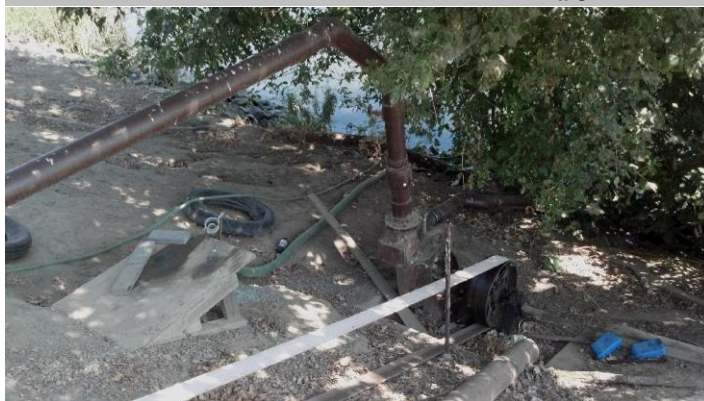
Photo 1 of 3 : UCIP\_FA\_2020\_61946\_30042.jpg

DS\_ID:20611  
FS\_ID:61946  
EP\_NO: N/A  
Repair Type: Non-Urgent  
EVAL Issue: Unauthorized Encroachment, installed decades prior  
Crossing Status: Found  
UCIP Comments: 06/23/2020 Record updated from No Action Needed to Non-Urgent. Unauthorized encroachment recorded in Levee Log prior to 2011. No permit has been identified authorizing pipe. (D.Sanoski - DWR UCIP)

Pump and PVC on WS slope. Pump motor in shed on WS shoulder.

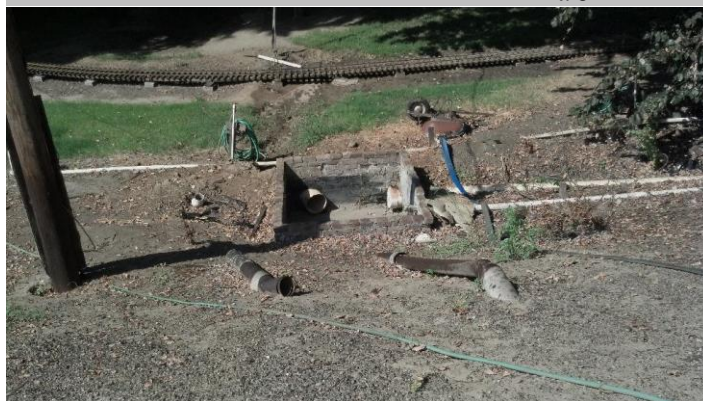
Photo 2 of 3 : UCIP\_FA\_2020\_61946\_30041.jpg

pipe, power pole, and 6'X6' brick distribution box on LS toe.

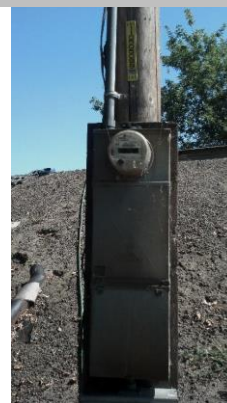
Photo 3 of 3 : UCIP\_FA\_2020\_61946\_30040.jpg

Power pole and meter on LS toe.

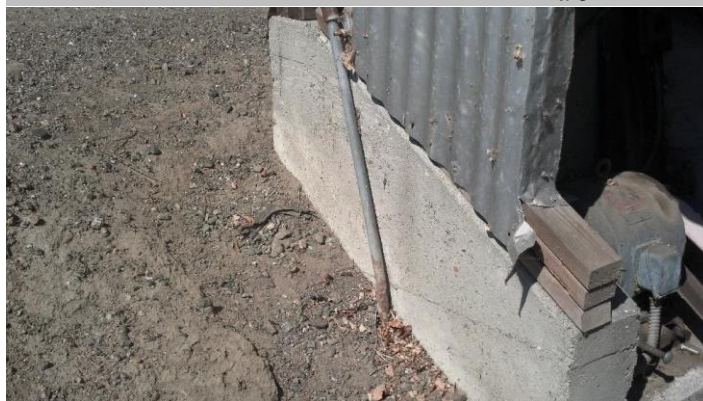
Photo 1 of 3 : UCIP\_FA\_2020\_61948\_37136.jpg

LM Start	2.04	Rating **	M	Issue No.	958	
LM End	2.04	Issue Type +	En	Location *		
Category	Supplemental			GPS Latitude/Longitude		
				Start	End	
Item	DWR UCIP Field Study			37.922433 °	37.922433 °	
				-121.323481 °	-121.323481 °	
DWR ID	24037					
Comment Code						
Inspector Comment						
DS_ID:24037 FS_ID:61948 EP_NO: N/A Repair Type: Non-Urgent EVAL Issue: Unauthorized Encroachment, installed decades prior Crossing Status: Found UCIP Comments: 06/23/2020 Record updated from No Action Needed to Non-Urgent. Unauthorized encroachment recorded in Levee Log prior to 2011. No permit has been identified authorizing pipe. (D.Sanoski - DWR UCIP)  FIELD_STRUCT_DESC: 1-inch galvanized iron electrical conduit through the levee, 3.5 feet below the crown. Pump motor on the waterside (WS) shoulder and a power pole and meter at the landside (LS) toe. FS Date: 6/23/2020 2:41:00 PM

Conduit visible on WS slope at pumphouse.

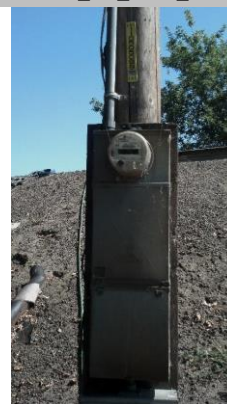
Photo 2 of 3 : UCIP\_FA\_2020\_61948\_37135.jpg

Conduit visible on LS toe at powerpole.

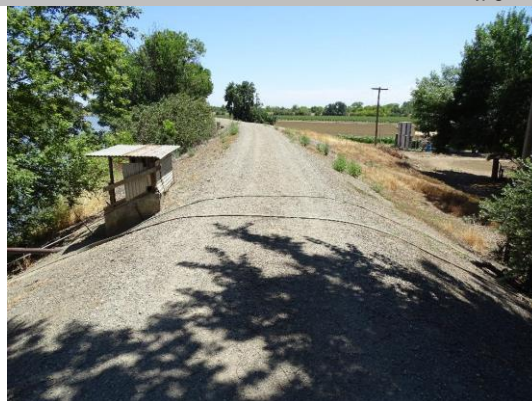
Photo 3 of 3 : UCIP\_FA\_2020\_61948\_89375.jpg

Top of Levee: view of crown.

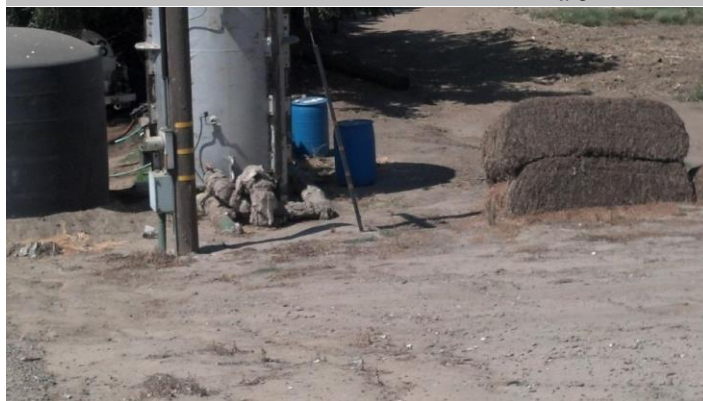
Photo 1 of 3 : UCIP\_FA\_2020\_61949\_37142.jpg

DS\_ID:24038  
 FS\_ID:61949  
 EP\_NO: N/A  
 Repair Type: Non-Urgent  
 EVAL Issue: Unauthorized Encroachment, installed decades prior  
 Crossing Status: Found  
 UCIP Comments: 06/23/2020 Record remains Non-Urgent.  
 Unauthorized encroachment recorded in Levee Log prior to 2011. No permit has been identified authorizing pipe. (D.Sanoski - DWR UCIP)  
 No permit identified for this crossing.  
 FIELD\_STRUCT\_DESC: 6-inch steel irrigation pipe through the levee, at an unknown depth. Vent, meter, butterfly valve, and pump at pump house on the waterside (WS) slope.  
 FS Date: 6/23/2020 2:42:00 PM

Steel irrigation line visible in front of tank to right of powerpole off LS toe.

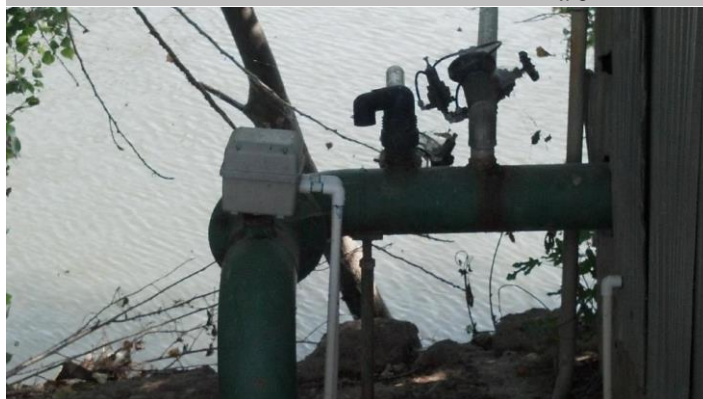
Photo 2 of 3 : UCIP\_FA\_2020\_61949\_37141.jpg

Irrigation line visible on side of pumphouse.

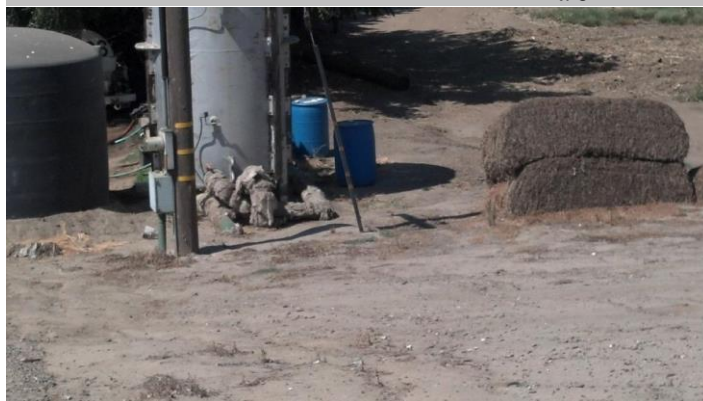
Photo 1 of 3 : UCIP\_FA\_2020\_61950\_37139.jpg

LM Start	2.07	Rating **	M	Issue No.	960	
LM End	2.07	Issue Type +	En	Location *		
Category	Supplemental			GPS Latitude/Longitude		
				Start	End	
Item	DWR UCIP Field Study			37.922080 °	37.922080 °	
				-121.323118 °	-121.323118 °	
DWR ID	24039					
Comment Code						
Inspector Comment						
DS_ID:24039 FS_ID:61950 EP_NO: N/A Repair Type: Non-Urgent EVAL Issue: Unauthorized Encroachment, installed decades prior Crossing Status: Found UCIP Comments: 06/23/2020 Record updated from No Action Needed to Non-Urgent. Unauthorized encroachment recorded in Levee Log prior to 2011. No permit has been identified authorizing pipe. (D.Sanoski - DWR UCIP)  FIELD_STRUCT_DESC: 3.5-inch polyvinyl chloride electrical conduit through the levee, at an unknown depth. Provides power for pump house on the waterside (WS) slope. Power pole on the landside (LS) toe. FS Date: 6/23/2020 2:42:00 PM

Conduit visible at base of power pole off LS toe.

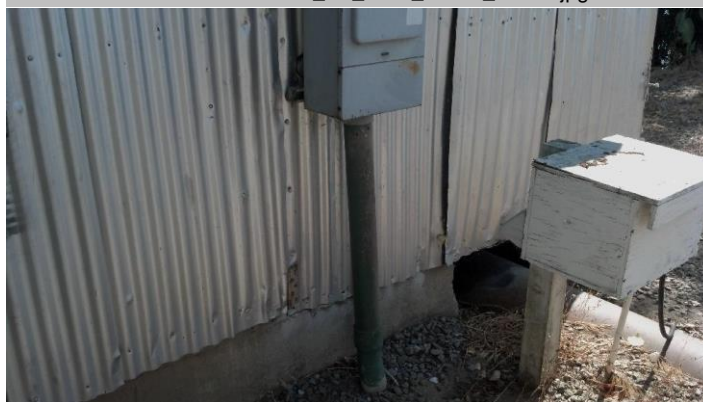
Photo 2 of 3 : UCIP\_FA\_2020\_61950\_37138.jpg

Conduit visible at pumphouse on WS toe.

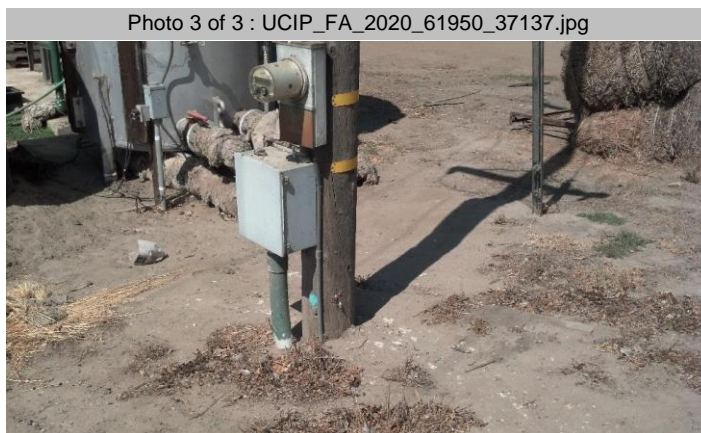
Conduit visible at base of power pole off LS toe.

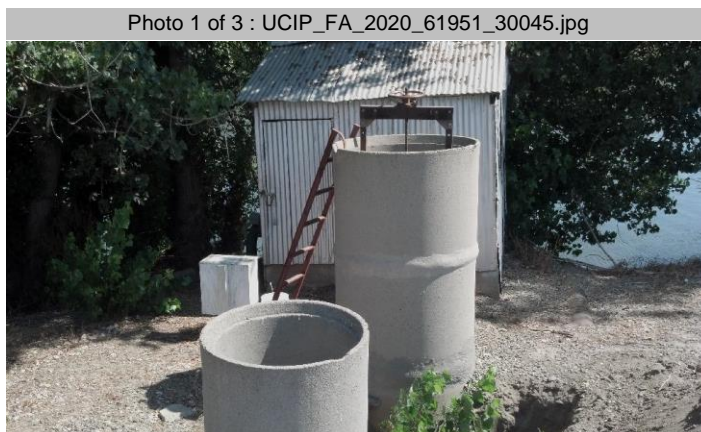
DS\_ID:20612  
FS\_ID:61951  
EP\_NO: N/A  
Repair Type: Non-Urgent  
EVAL Issue: Unauthorized Encroachment, installed decades prior  
Crossing Status: Found  
UCIP Comments: 06/23/2020 Record remains Non-Urgent.  
Unauthorized encroachment recorded in Levee Log prior to 2011. No permit has been identified authorizing pipe. There was no hole next to standpipe present at time of inspection. (D.Sanoski - DWR UCIP)  
Soil excavated from cover over pipe on WS next to concrete riser. May indicate a leak or other problem.  
FIELD\_STRUCT\_DESC: 20-inch steel irrigation pipe through the levee, 15 feet below the crown. Pump in pump house on the waterside (WS) slope. Slide gate in 4-foot diameter concrete standpipe on the WS slope with secondary concrete standpipe. Polyvinyl chloride standpipe visible 350 feet off the landside (LS) toe. [Additional Reference(s): DWR Levee Log, 2004. USACE San Joaquin O&M Manual 7, April 1964, (HLM 2.10)].

Slide gate in concrete riser with secondary concrete riser in foreground.  
Pumphouse in background.

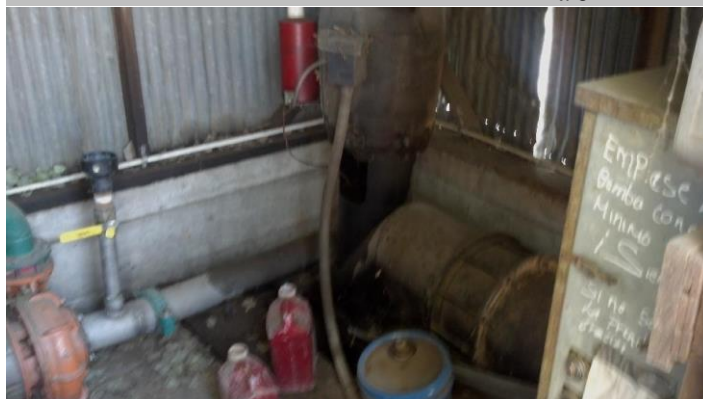
Photo 2 of 3 : UCIP\_FA\_2020\_61951\_30044.jpg

Pump and pipe inside pumphouse.

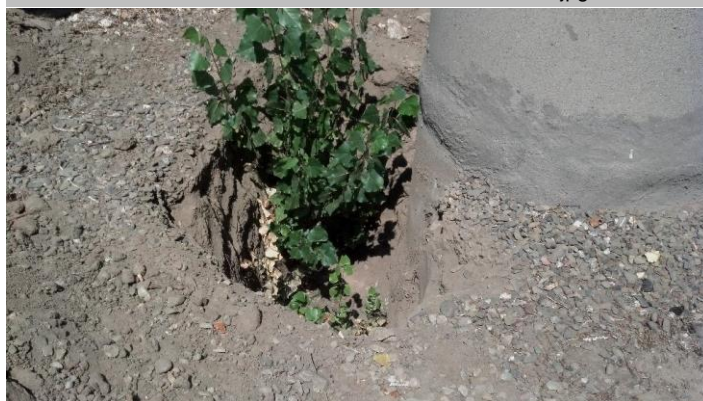
Photo 3 of 3 : UCIP\_FA\_2020\_61951\_30043.jpg

Hole over pipe next to 4-foot diameter concrete standpipe on WS slope.

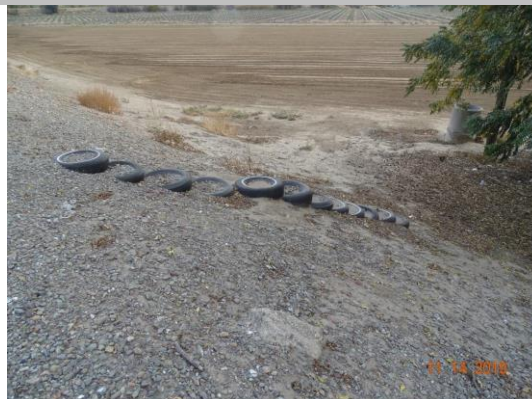
Photo 1 of 1 : FA\_2020\_RD0524\_107\_247\_20200901\_00109.jpg

LM Start	2.12	Rating **	M	Issue No.	247
LM End	2.12	Issue Type +	En	Location *	LS
Category	Earthen Levee			GPS Latitude/Longitude	
				Start	End
Item	Encroachments			37.921664 °	37.921664 °
				-121.322499 °	-121.322499 °
DWR ID	DWR_RD0524_01_f_2017_247				
Comment Code					
ST : Stairway					
Inspector Comment					
Landowner installed rubber tires for a stairway on landside slope.

View of rubber tires being used as stairs on landside slope. Fall 2019

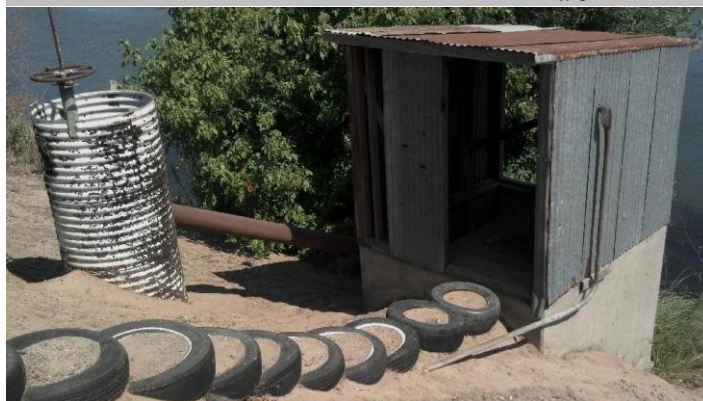
Photo 1 of 3 : UCIP\_FA\_2020\_61952\_37164.jpg

DS\_ID:20613  
FS\_ID:61952  
EP\_NO: N/A  
Repair Type: Non-Urgent  
EVAL Issue: Unauthorized Encroachment, installed decades prior  
Crossing Status: Found  
UCIP Comments: 06/24/2020 Record updated from No Action Needed to Non-Urgent. Unauthorized encroachment recorded in Levee Log prior to 2011. No permit has been identified authorizing pipe. (D.Sanoski - DWR UCIP)

Slide gate in 36-inch CMP riser and Pumphouse on WS slope.

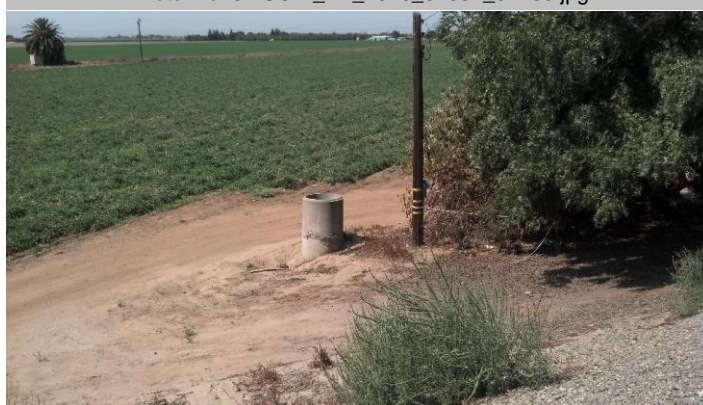
Photo 2 of 3 : UCIP\_FA\_2020\_61952\_37163.jpg

36-inch concrete riser off LS toe.

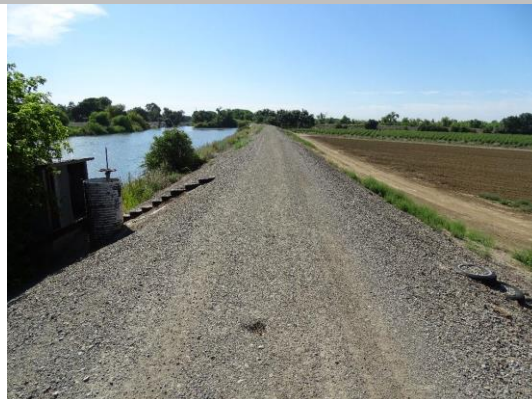
Photo 3 of 3 : UCIP\_FA\_2020\_61952\_89389.jpg

Top of Levee: view of crown.

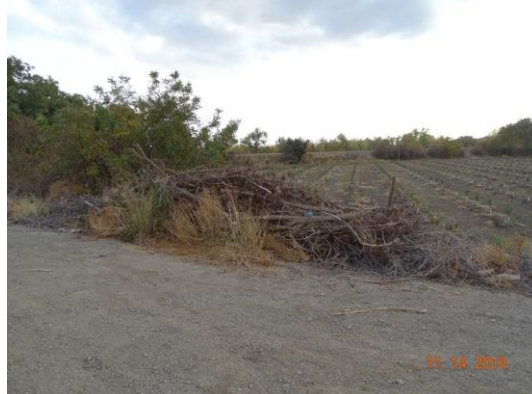
Photo 1 of 1 : FA\_2020\_RD0524\_107\_152\_20200901\_00062.jpg

LM Start	2.27	Rating **	U	Issue No.	152
LM End	2.27	Issue Type +	En	Location *	LS
Category	Earthen Levee			GPS Latitude/Longitude	
				Start	End
Item	Encroachments			37.920357 °	37.920357 °
				-121.320257 °	-121.320257 °
DWR ID	DWR_RD0524_01_f_2019_152				
Comment Code					
PR : Prunings					
Inspector Comment

View of prunings on landside slope. Fall 2019
