## Flood Control Project Maintenance Levee Inspections

### Fall 2020 Levee Maintenance Deficiency Summary Report

#### San Joaquin River Basin

**Reclamation District No. 0524 Middle Roberts Island**

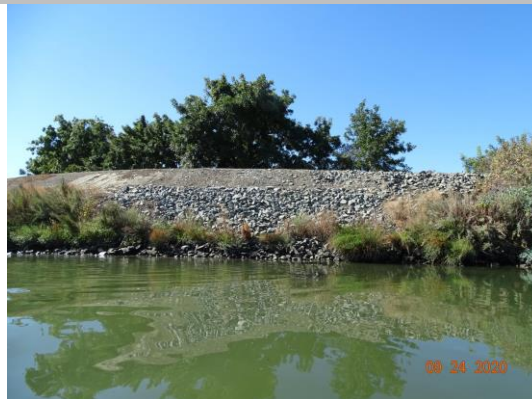
Photo 1 of 1 : SJR2019\_RD0524U01RM42.9\_02.JPG

LM Start	2.30	Rating **	A/W	Issue No.	29
LM End	2.30	Issue Type +	Ma	Location *	WS
Category	Supplemental			GPS Latitude/Longitude	
				Start	End
Item	DWR Erosion Survey			37.920150 °	37.920150 °
				-121.319700 °	-121.319700 °
DWR ID	RD0524U01RM42.9				
Comment Code					
Inspector Comment					
Site ID: RD0524U01RM42.9 09/24/2020: The repair is holding up well; no new erosion is visible. The repair is approximately 50 ft long and includes riprap covering the lower two thirds of the levee slope. The site will be removed from the erosion survey list in 2021. 08/13/2019: This erosion has been repaired. 09/13/2017: The erosion is located immediately upstream of a repaired levee section.

9/24/2020: View of the repaired erosion site.

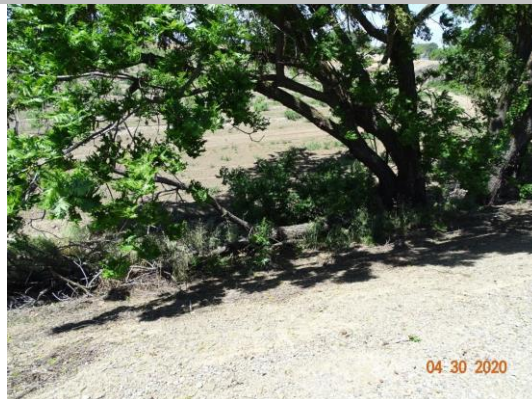
Photo 1 of 1 : FA\_2020\_RD0524\_107\_253\_20200901\_00111.jpg

LM Start	2.34	Rating **	M	Issue No.	253
LM End	2.34	Issue Type +	En	Location *	LS
Category	Earthen Levee			GPS Latitude/Longitude	
				Start	End
Item	Encroachments			37.919533 °	37.919533 °
				-121.319651 °	-121.319651 °
DWR ID	DWR_RD0524_01_s _ 2020_253				
Comment Code					
TR : Tree or limb					
Inspector Comment

View of downed tree on landside slope. Spring 2020

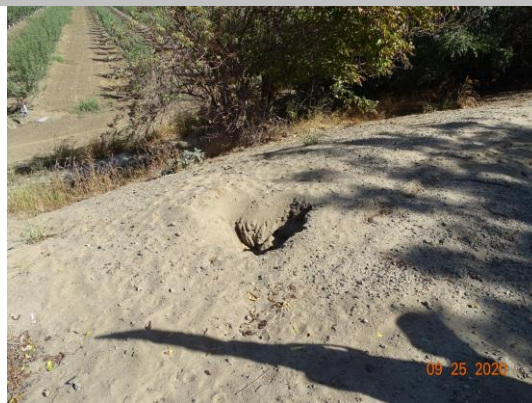
Photo 1 of 1 : FA\_2020\_RD0524\_107\_160\_20201005\_00224.jpg

LM Start	2.51	Rating **	U	Issue No.	160
LM End	2.51	Issue Type +	Ma	Location *	LS
Category	Earthen Levee			GPS Latitude/Longitude	
				Start	End
Item	Animal Control			37.918212 °	37.918212 °
				-121.322107 °	-121.322107 °
DWR ID	DWR_RD0524_01_f _ 2020_160				
Comment Code					
A3 : No rodents visible, but rodent burrows visible; need to backfill and compact or grout burrows.					
Inspector Comment

View of large rodent hole on landside slope. Fall 2020

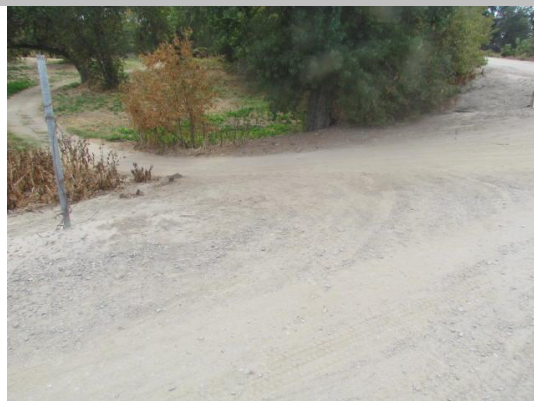
Photo 1 of 1 : FA\_2020\_RD0524\_107\_7\_20200901\_00004.jpg

LM Start	2.58	Rating **	M	Issue No.	7
LM End	2.58	Issue Type +	En	Location *	LS
Category	Earthen Levee			GPS Latitude/Longitude	
				Start	End
Item	Encroachments			37.917431 °	37.917431 °
				-121.322780 °	-121.322780 °
DWR ID	DWR_RD0524_01_f_2012_7				
Comment Code					
RA : Ramp					
Inspector Comment					
Ramp on landside providing access to land owner.

Looking southeast at unauthorized ramp on waterside slope.

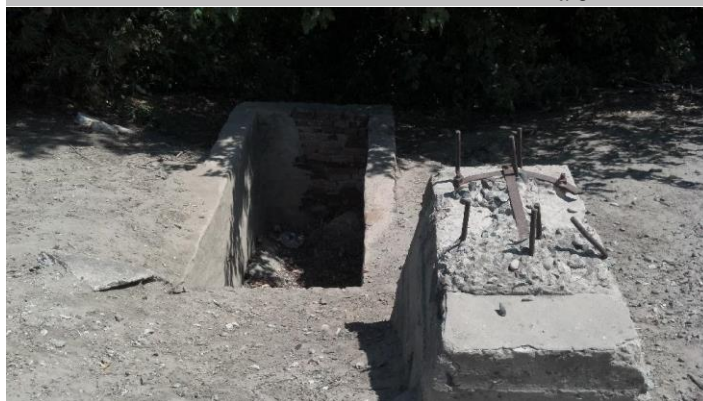
Photo 1 of 3 : UCIP\_FA\_2020\_61955\_37162.jpg

LM Start	2.58	Rating **	M	Issue No.	963	
LM End	2.58	Issue Type +	En	Location *		
Category	Supplemental			GPS Latitude/Longitude		
				Start		End
Item	DWR UCIP Field Study			37.917365 °	37.917365 °	
				-121.322779 °	-121.322779 °	
DWR ID	24040					
Comment Code						
Inspector Comment						
DS_ID:24040 FS_ID:61955 EP_NO: N/A Repair Type: Non-Urgent EVAL Issue: Unauthorized Encroachment Crossing Status: Found UCIP Comments: 06/24/2020 Record remains Non-Urgent. No permit has been found authorizing this pipe through the levee. Crossing appears abandoned. (D.Sanoski - DWR UCIP) Need to determine type of abandonment for pipe at this location. FIELD_STRUCT_DESC: *ABANDONED* Pump pad on the landside (LS) shoulder with 4-foot by 9-foot brick distribution box on the waterside (WS) slope. No pipe visible. 4-foot by 9-foot brick distribution box on the LS toe. FS Date: 6/24/2020 2:43:00 PM

Foundation for pump with distribution box on WS shoulder.

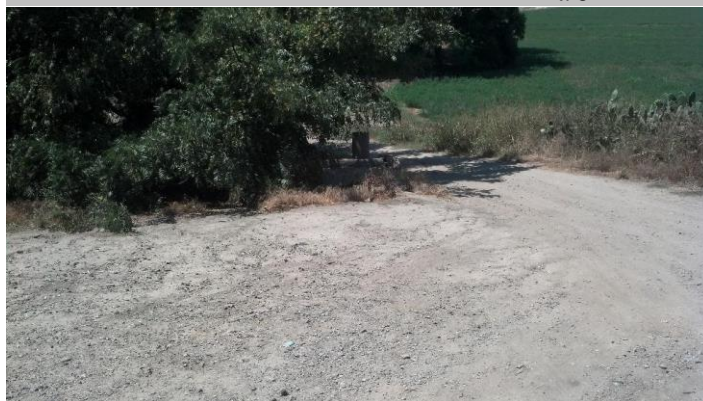
Photo 2 of 3 : UCIP\_FA\_2020\_61955\_37161.jpg

Distribution box on LS toe.

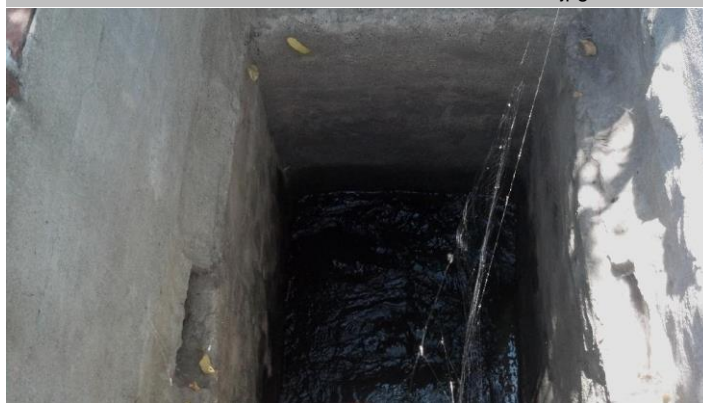
Photo 3 of 3 : UCIP\_FA\_2020\_61955\_37160.jpg

Distribution box on LS toe.

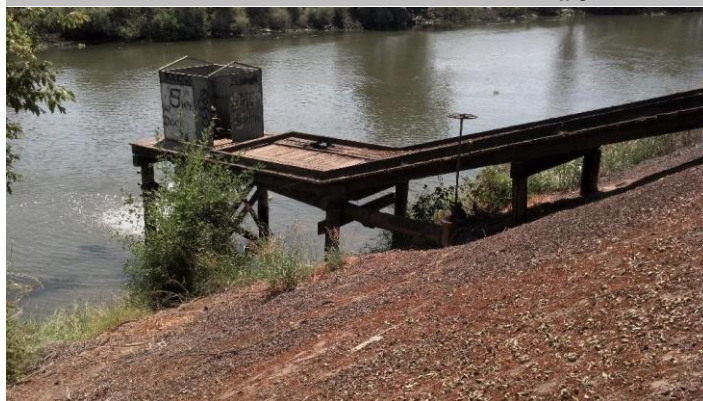
Photo 1 of 3 : UCIP\_FA\_2020\_61956\_30145.jpg

Comment Code						
Inspector Comment						
DS_ID:20615 FS_ID:61956 EP_NO: N/A Repair Type: Non-Urgent EVAL Issue: Unauthorized Encroachment, installed decades prior Crossing Status: Found UCIP Comments: 06/24/2020 Record updated from No Action Needed to Non-Urgent. Unauthorized encroachment recorded in Levee Log prior to 2011. No permit has been identified authorizing pipe. (D.Sanoski - DWR UCIP)  FIELD_STRUCT_DESC: 14-inch steel irrigation pipe through the levee, 12 feet below the crown. Pump in pump house on pile structure in stream. Timber drive ramp to the pump house. 48-inch diameter concrete standpipe on the landside (LS) toe. [Additional Reference(s): DWR Levee Log, 2004. USACE San Joaquin O&M Manual 7, April 1964, (HLM 2.71)]. FS Date: 6/24/2020 2:43:00 PM

Pump in pumphouse on wooden pier with wooden vehicle ramp.

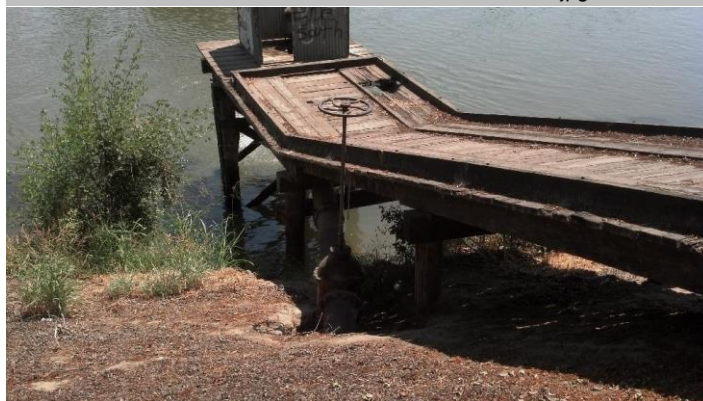
Photo 2 of 3 : UCIP\_FA\_2020\_61956\_30144.jpg

Gate valve on WS slope at wooden ramp.

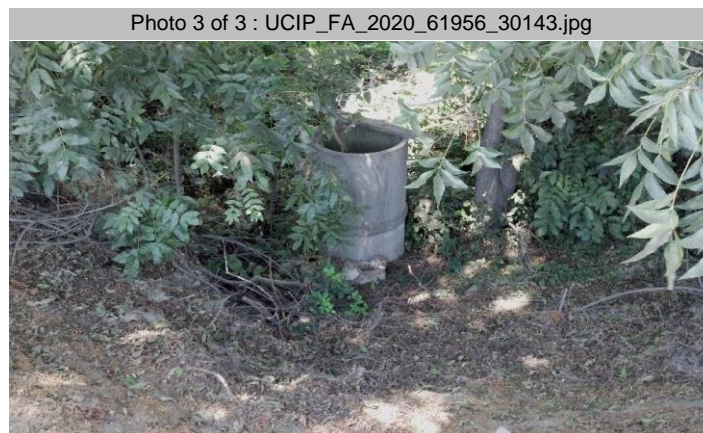
48-inch concrete riser on LS toe.

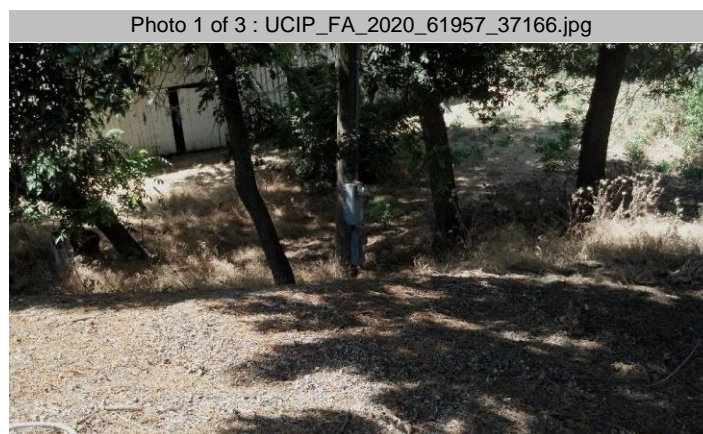
Conduit visible at base of power pole on LS slope.

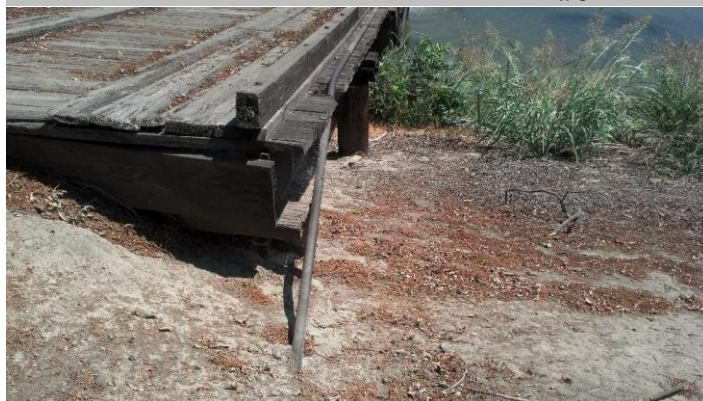
Photo 2 of 3 : UCIP\_FA\_2020\_61957\_37165.jpg

Conduit visible on WS shoulder.

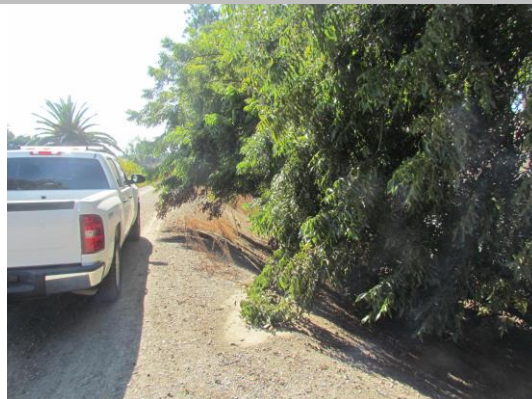
Photo 1 of 1 : FA\_2020\_RD0524\_107\_264\_20200901\_00113.jpg

LM Start	2.72	Rating **	M	Issue No.	264
LM End	2.76	Issue Type +	Ma	Location *	LS
Category	Earthen Levee			GPS Latitude/Longitude	
				Start	End
Item	Trim / Thin Trees			37.915698 °	37.915304 °
				-121.322498 °	-121.322763 °
DWR ID	DWR_RD0524_01_s_2012_264				
Comment Code					
T2 : Thin trees to allow visibility of the ground and room to flood fight.					
Inspector Comment					
Untrimmed trees along landside slope and toe. Additionally, trim limbs overhanging crown road 12 feet above ground level.

Looking south at untrimmed trees on landward slope.

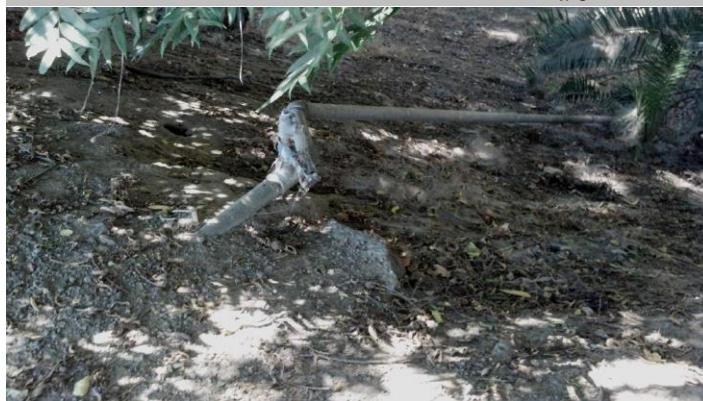
Photo 1 of 3 : UCIP\_FA\_2020\_61958\_30191.jpg

Comment Code						
Inspector Comment						
DS_ID:20616						
FS_ID:61958						
EP_NO: N/A						
Repair Type: Non-Urgent						
EVAL Issue: Unauthorized Encroachment, installed decades prior						
Crossing Status: Found						
UCIP Comments: 06/24/2020 Record remains Non-Urgent.						
Unauthorized encroachment recorded in Levee Log prior to 2011.						
Crossing appears abandoned. (D.Sanoski - DWR UCIP)						
FIELD_STRUCT_DESC: *ABANDONED* 3-inch galvanized iron pipe						
of an unknown purpose through the levee, 0.3 feet below the crown.						
Valve on the landside (LS) shoulder. [Additional Reference(s): DWR						
Levee Log, 2004].						
FS Date: 6/24/2020 2:44:00 PM

Pipe and vent visible on LS slope.

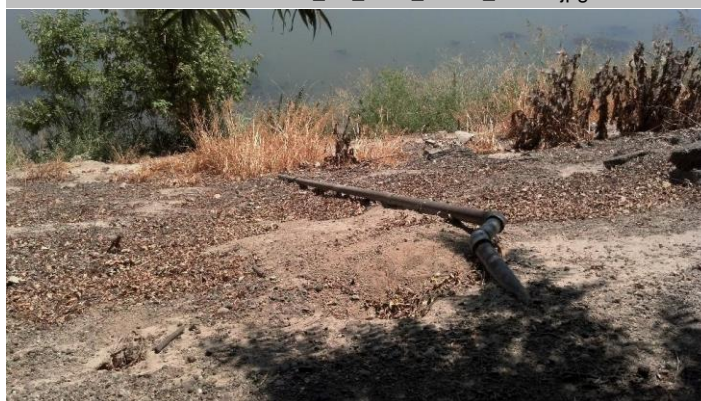
Photo 2 of 3 : UCIP\_FA\_2020\_61958\_30190.jpg

Pipe visible on WS slope.

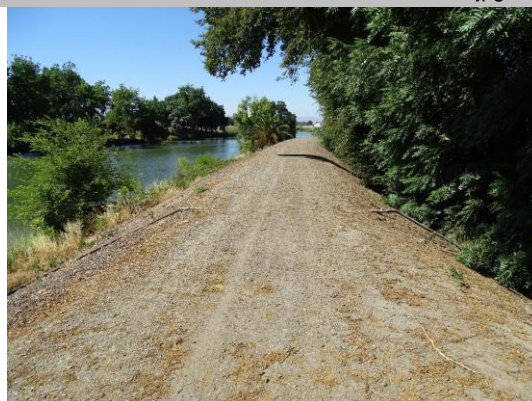
Photo 3 of 3 : UCIP\_FA\_2020\_61958\_89409.jpg

Top of Levee: view of crown with pipes into levee on both sides of crown.

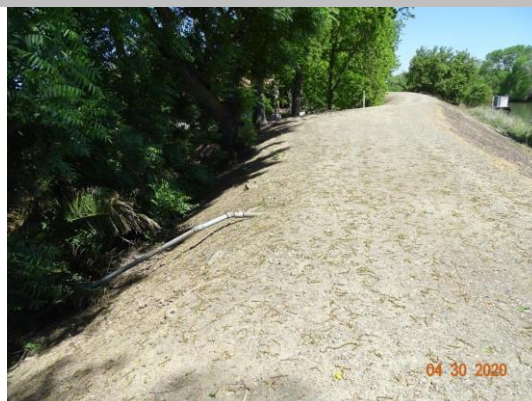
Photo 1 of 1 : FA\_2020\_RD0524\_107\_240\_20200901\_00107.jpg

LM Start	2.73	Rating **	M	Issue No.	240
LM End	2.73	Issue Type +	En	Location *	LS
Category	Earthen Levee			GPS Latitude/Longitude	
				Start	End
Item	Encroachments			37.915660 °	37.915660 °
				-121.322513 °	-121.322513 °
DWR ID	DWR_RD0524_01_s_2020_240				
Comment Code					
PI : Pipe					
Inspector Comment

View of 4 inch pipe going through levee from landside to waterside.  
Spring 2020

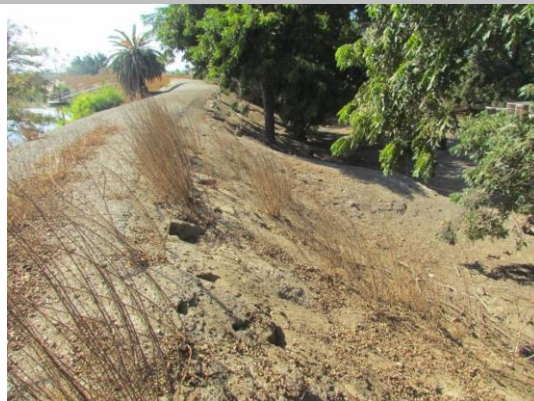
Photo 1 of 1 : FA\_2020\_RD0524\_107\_219\_20200901\_00091.jpg

LM Start	2.77	Rating **	U	Issue No.	219
LM End	2.80	Issue Type +	Ma	Location *	LS
Category	Earthen Levee			GPS Latitude/Longitude	
				Start	End
Item	Animal Control			37.915195 °	37.915052 °
				-121.322930 °	-121.323430 °
DWR ID	DWR_RD0524_01_f _ 2016_219				
Comment Code					
A1 : Exterminate rodents and backfill and compact or grout burrows.					
Inspector Comment					
Several large rodent holes on landside slope.

Looking south at several rodent holes on landward slope.

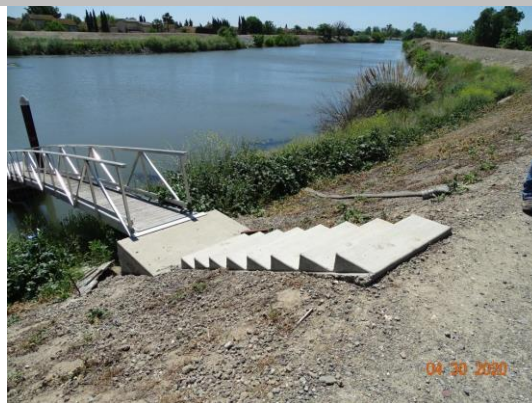
Photo 1 of 1 : FA\_2020\_RD0524\_107\_237\_20200901\_00105.jpg

View of concrete stairs on waterside slope. Spring 2020

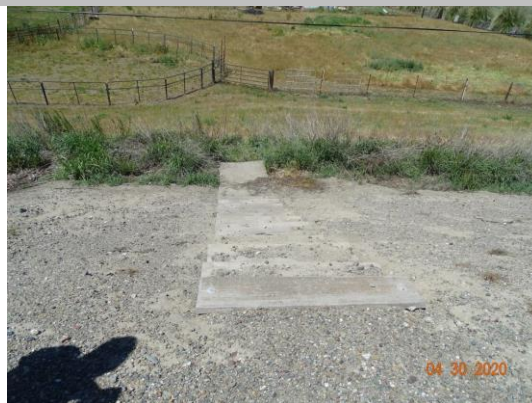
Photo 1 of 1 : FA\_2020\_RD0524\_107\_223\_20200901\_00096.jpg

LM Start	2.91	Rating **	M	Issue No.	223
LM End	2.91	Issue Type +	En	Location *	LS
Category	Earthen Levee			GPS Latitude/Longitude	
				Start	End
Item	Encroachments			37.913745 °	37.913745 °
				-121.324404 °	-121.324404 °
DWR ID	DWR_RD0524_01_s_2020_223				
Comment Code					
ST : Stairway					
Inspector Comment

View of stairs cut into levee landside slope. Spring 2020

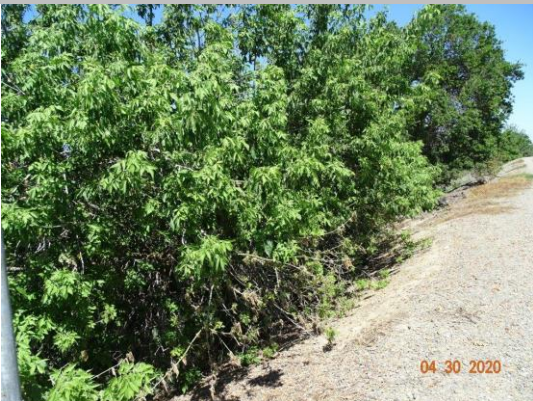
Photo 1 of 1 : FA\_2020\_RD0524\_107\_51\_20200901\_00025.jpg

View of trees that need to be trimmed and thinned on landside slope.  
Spring 2020

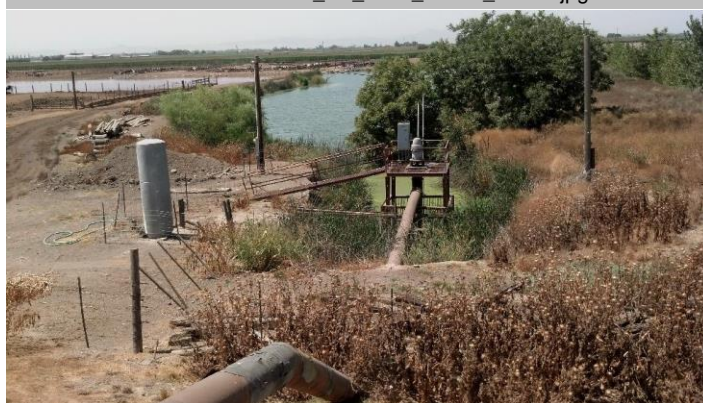
Photo 2 of 3 : UCIP\_FA\_2020\_61959\_30197.jpg

Pipe, pump, power pole, and meter visible off LS toe.

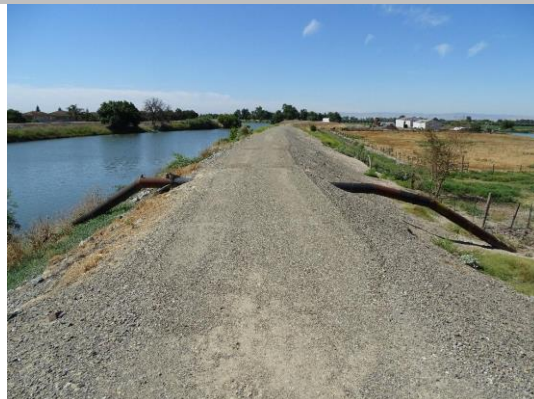
Photo 3 of 3 : UCIP\_FA\_2020\_61959\_89412.jpg

Overview of Levee: view of crown with pipe through crown.

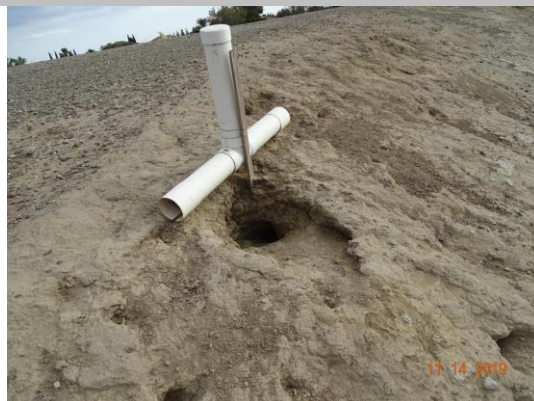
Photo 1 of 1 : FA\_2020\_RD0524\_107\_924\_20200901\_00119.jpg

LM Start	2.96	Rating **	U	Issue No.	924
LM End	3.07	Issue Type +	Ma	Location *	LS
Category	Earthen Levee			GPS Latitude/Longitude	
				Start	End
Item	Animal Control			37.913023 °	37.911366 °
				-121.324507 °	-121.324901 °
DWR ID	DWR_RD0524_01_s_2012_924				
Comment Code					
A1 : Exterminate rodents and backfill and compact or grout burrows.					
Inspector Comment

View of large rodent holes on landside slope. Fall 2019

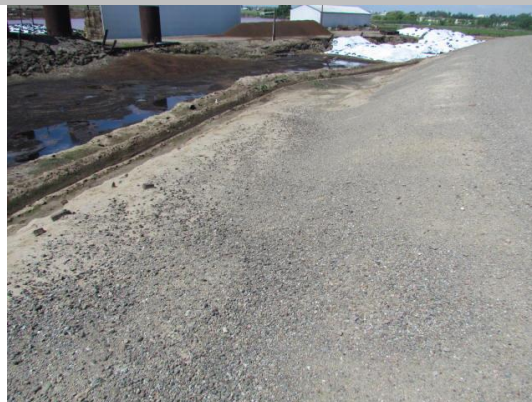
Photo 1 of 1 : FA\_2020\_RD0524\_107\_211\_20200901\_00087.jpg

LM Start	3.18	Rating **	M	Issue No.	211
LM End	3.18	Issue Type +	En	Location *	LS
Category	Earthen Levee			GPS Latitude/Longitude	
				Start	End
Item	Encroachments			37.909945 °	37.909945 °
				-121.325543 °	-121.325543 °
DWR ID	DWR_RD0524_01_f_2020_211				
Comment Code					
RA : Ramp					
Inspector Comment					
Unauthorized ramp on landside slope.

Looking northwest at unauthorized ramp on landward slope.

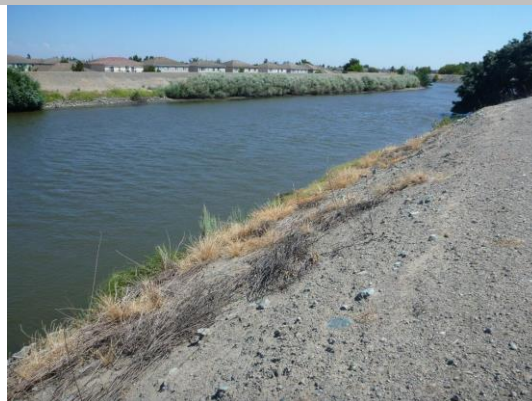
Photo 1 of 1 : LEVAL\_FA\_2020\_466\_2229.jpg

LM Start	3.23	Rating **	M	Issue No.	229
LM End	3.29	Issue Type +	Ma	Location *	WS
Category	Earthen Levee			GPS Latitude/Longitude	
				Start	End
Item	Erosion / Bank Caving			37.909200 °	37.908200 °
				-121.325300 °	-121.325300 °
DWR ID	LMA-293				
Comment Code					
E2 : Schedule repair of erosion site prior to the next inspection.					
Inspector Comment					
2017 Storm Damage Site ID 466, 528, 527, 467, Slope protection repairs are needed along the waterside slope due to erosion.					
Notes: Lower priority because damage is only on the lower 1/5 of slope.

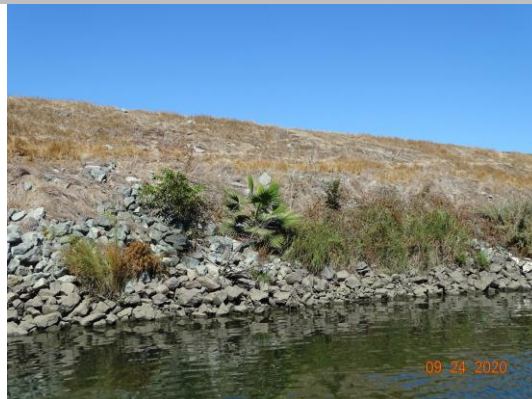
Photo 2 of 2 : SJR2019\_RD0524U01RM43.86\_03.JPG

LM Start	3.29	Rating **	A/W	Issue No.	8
LM End	3.31	Issue Type +	Ma	Location *	WS
Category	Supplemental			GPS Latitude/Longitude	
				Start	End
Item	DWR Erosion Survey			37.908036 °	37.908036 °
				-121.325397 °	-121.325397 °
DWR ID	RD0524U01RM43.86				
Comment Code					
Inspector Comment					
Site ID: RD0524U01RM43.86					
09/24/2020: No changes observed since the previous inspection. The site will be removed from the erosion survey list in 2021.					
08/13/2019: This erosion site has been repaired.					
09/13/2017: From 2014 to present, no significant changes were observed during the annual survey.					
08/13/2013: The levee toe seems to have been protected by river rocks and vegetation on site.

9/24/2020: Close-up view of the erosion.

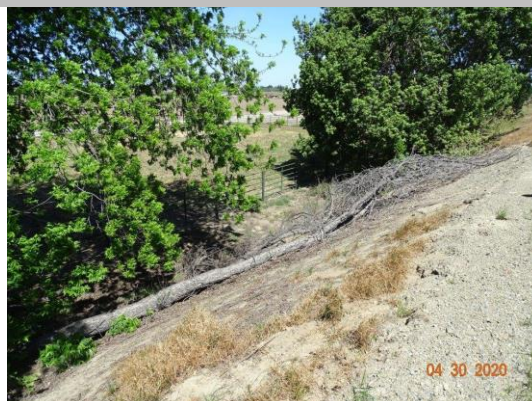
Photo 1 of 1 : FA\_2020\_RD0524\_107\_217\_20200901\_00090.jpg

LM Start	3.32	Rating **	M	Issue No.	217
LM End	3.32	Issue Type +	Ma	Location *	LS
Category	Earthen Levee			GPS Latitude/Longitude	
				Start	End
Item	Encroachments			37.907853 °	37.907853 °
				-121.325446 °	-121.325446 °
DWR ID	DWR_RD0524_01_s_2020_217				
Comment Code					
TR : Tree or limb					
Inspector Comment

View of downed tree on landside slope. Spring 2020

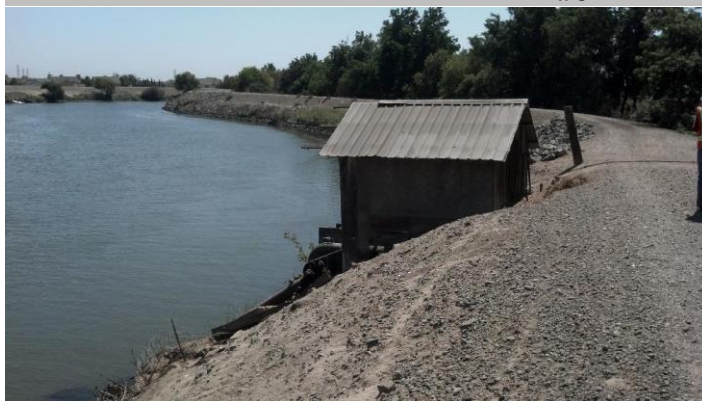
Photo 1 of 3 : UCIP\_FA\_2020\_61960\_30206.jpg

DS\_ID:20618  
FS\_ID:61960  
EP\_NO: N/A  
Repair Type: Non-Urgent  
EVAL Issue: Unauthorized Encroachment, installed decades prior  
Crossing Status: Found  
UCIP Comments: 06/24/2020 Record updated from Urgent to Non-Urgent. Unauthorized encroachment recorded in Levee Log prior to 2011. No permit has been identified authorizing pipe. (D.Sanoski - DWR UCIP)  
10/2/2018 Same as previous inspection with severe LS slope integrity issues (D. Sanoski - DWR UCIP).11/16/2016 same as previous inspection erosion is still present on LS toe and slope. Owner will need to coordinate with CVFPB to address erosion issue on LS toe. (O. Magana - DWR UCIP)08/20/2013 Extensive erosion on LS toe at distribution box due to failure of box/pipe connection. Erosion on LS slope do to recently repaired leak at gate valve. (W. Wylie - DWR UCIP)  
FIELD\_STRUCT\_DESC: 14-inch steel irrigation pipe through the levee, 7 feet below the crown. Pump house located on the waterside (WS) slope. Gate valve located on the landside (LS) slope. 4-foot by 4-foot brick distribution box, built in 1918, located on the LS toe. This site was used to manufacture brick back in 1918, and some of the appurtenances that remain are still in use (distribution box and ditch).

Pipe and pumphouse on WS slope.

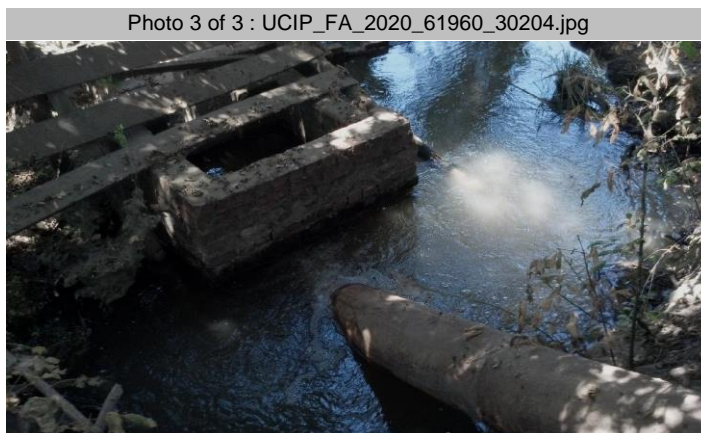
Extensive erosion around distribution box at LS toe.

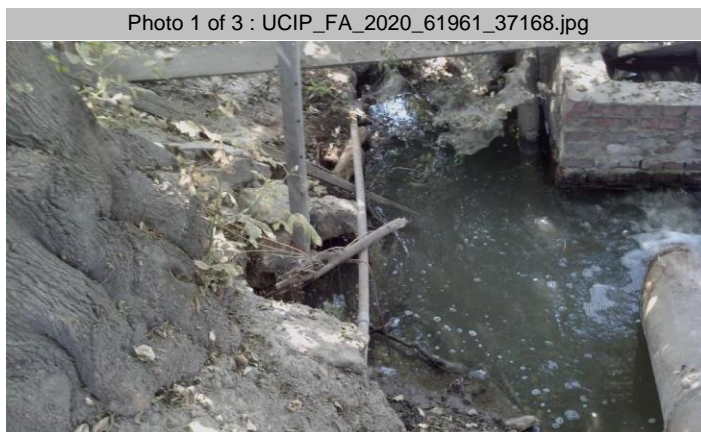
DS\_ID:24042  
FS\_ID:61961  
EP\_NO: N/A  
Repair Type: Non-Urgent  
EVAL Issue: Unauthorized Encroachment, installed decades prior  
Crossing Status: Found  
UCIP Comments: 06/24/2020 Record updated from No Action Needed to Non-Urgent. Unauthorized encroachment recorded in Levee Log prior to 2011. No permit has been identified authorizing pipe. (D.Sanoski - DWR UCIP)

FIELD\_STRUCT\_DESC: 1.5-inch galvanized iron electrical conduit through the levee, 3 feet below the crown. Power pole on the landside (LS) toe. Pump house on the waterside (WS) shoulder.  
FS Date: 6/24/2020 2:45:00 PM

Electrical conduit visible at LS toe to left of distribution box.

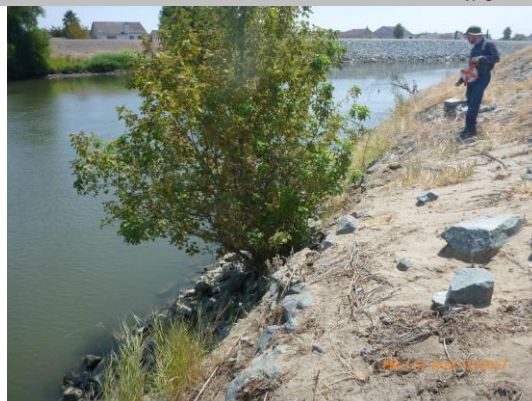
Photo 1 of 1 : LEVAL\_FA\_2020\_526\_4201.jpg

LM Start	3.53	Rating **	M	Issue No.	233
LM End	3.54	Issue Type +	Ma	Location *	WS
Category	Earthen Levee			GPS Latitude/Longitude	
				Start	End
Item	Erosion / Bank Caving			37.905300 °	37.905200 °
				-121.323800 °	-121.323900 °
DWR ID	LMA-432				
Comment Code					
E2 : Schedule repair of erosion site prior to the next inspection.					
Inspector Comment					
2017 Storm Damage Site, ID No. 526, LMA-432, Slope protection repairs are needed along the waterside slope due to erosion and riprap displacement from high water.

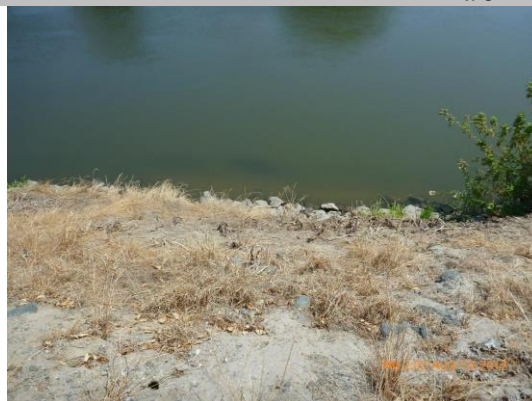
Photo 1 of 1 : LEVAL\_FA\_2020\_525\_4205.jpg

LM Start	3.56	Rating **	M	Issue No.	234
LM End	3.57	Issue Type +	Ma	Location *	WS
Category	Earthen Levee			GPS Latitude/Longitude	
				Start	End
Item	Erosion / Bank Caving			37.904900 °	37.904800 °
				-121.323900 °	-121.324100 °
DWR ID	LMA-431				
Comment Code					
E2 : Schedule repair of erosion site prior to the next inspection.					
Inspector Comment					
2017 Storm Damage Site, ID No. 525, LMA-431,Slope protection repairs are needed along the waterside slope due to erosion and riprap displacement from high water.

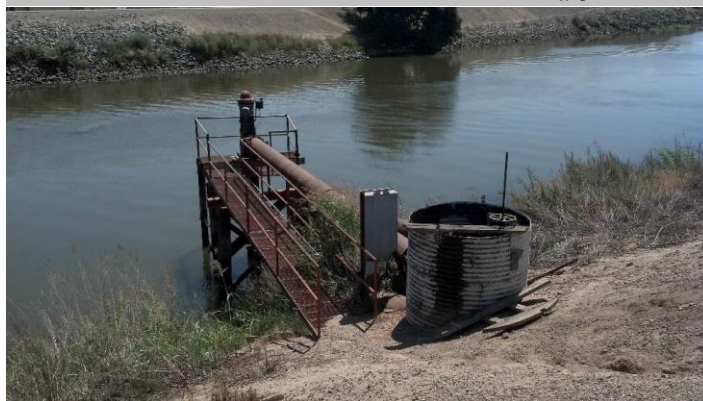
Photo 1 of 3 : UCIP\_FA\_2020\_61962\_30212.jpg

Comment Code						
Inspector Comment						
DS_ID:20619 FS_ID:61962 EP_NO: N/A Repair Type: Non-Urgent EVAL Issue: Unauthorized Encroachment, installed decades prior Crossing Status: Found UCIP Comments: 06/24/2020 Record updated from No Action Needed to Non-Urgent. Unauthorized encroachment recorded in Levee Log prior to 2011. No permit has been identified authorizing pipe. (D.Sanoski - DWR UCIP)  FIELD_STRUCT_DESC: 30-inch steel irrigation pipe through the levee, 26.5 feet below the crown. Pump on pile structure in the stream. Steel walkway to the pump on a pier. Slide gate in 66-inch corrugated metal riser unit on the waterside (WS) slope. 5-foot concrete standpipe on the landside (LS) toe. [Additional Reference(s): DWR Levee Log, 2004. USACE San Joaquin O&M Manual 7, April 1964, (HLM 3.69)]. FS Date: 6/24/2020 2:45:00 PM

Pump on steel pier with slide gate in CMP riser on WS slope.

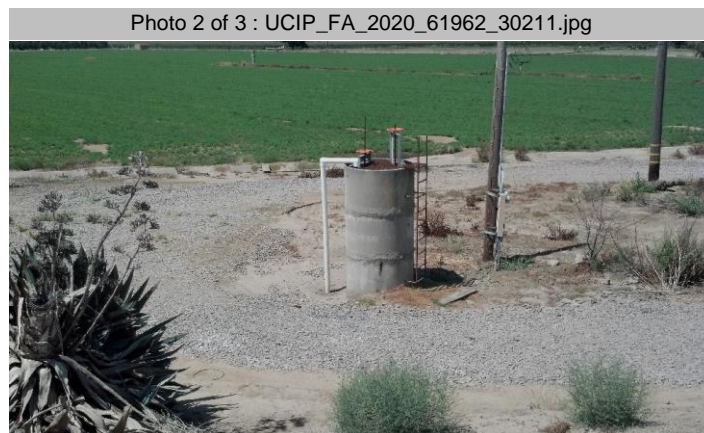
Concrete standpipe off LS toe.

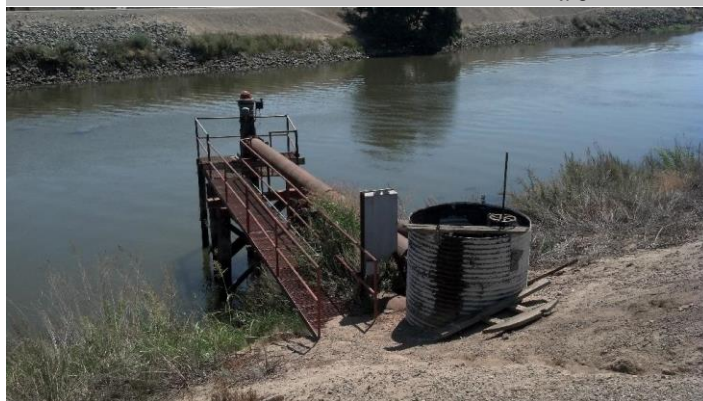
Photo 1 of 3 : UCIP\_FA\_2020\_61963\_37170.jpg

LM Start	3.65	Rating **	M	Issue No.	971	
LM End	3.65	Issue Type +	En	Location *		
Category	Supplemental			GPS Latitude/Longitude		
				Start		End
Item	DWR UCIP Field Study			37.904097 °		37.904097 °
				-121.325081 °		-121.325081 °
DWR ID	24043					
Comment Code						
Inspector Comment						
DS_ID:24043 FS_ID:61963 EP_NO: N/A Repair Type: Non-Urgent EVAL Issue: Unauthorized Encroachment, installed decades prior Crossing Status: Found UCIP Comments: 06/24/2020 Record updated from No Action Needed to Non-Urgent. Unauthorized encroachment recorded in Levee Log prior to 2011. No permit has been identified authorizing pipe. (D.Sanoski - DWR UCIP)  FIELD_STRUCT_DESC: 1.75-inch galvanized iron electrical conduit through the levee, 1 foot below the crown. Power pole on the landside (LS) toe and electrical box on the waterside (WS) slope. FS Date: 6/24/2020 2:46:00 PM

Electrical conduit visible next to walkway at panel.

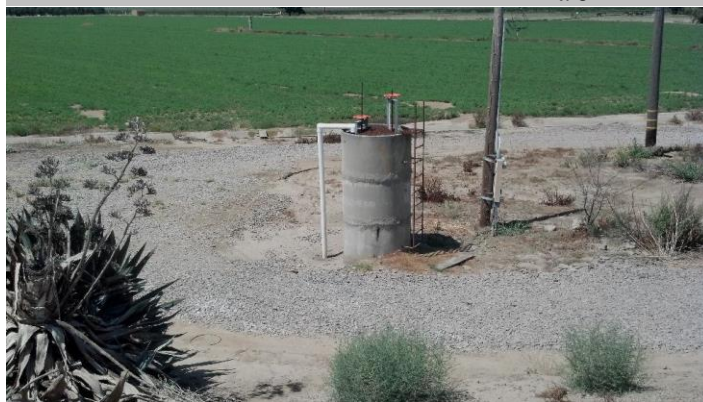
Photo 2 of 3 : UCIP\_FA\_2020\_61963\_37169.jpg

Electrical conduit visible off LS toe at power pole.

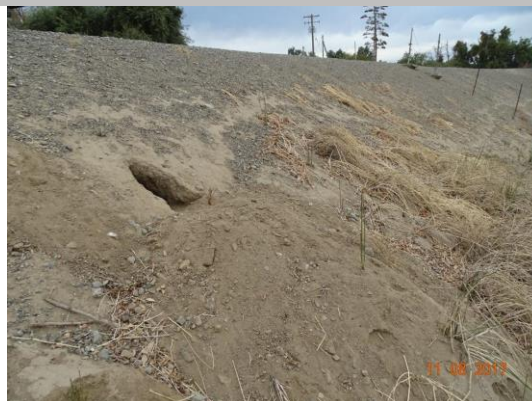
Photo 1 of 1 : FA\_2020\_RD0524\_107\_251\_20200901\_00110.jpg

LM Start	3.67	Rating **	U	Issue No.	251
LM End	3.69	Issue Type +	Ma	Location *	WS
Category	Earthen Levee			GPS Latitude/Longitude	
				Start	End
Item	Animal Control			37.903776 °	37.903513 °
				-121.325323 °	-121.325494 °
DWR ID	DWR_RD0524_01_f_2017_251				
Comment Code					
A3 : No rodents visible, but rodent burrows visible; need to backfill and compact or grout burrows.					
Inspector Comment					
Large rodent holes on waterside slope.

Looking northwest at the waterside slope.

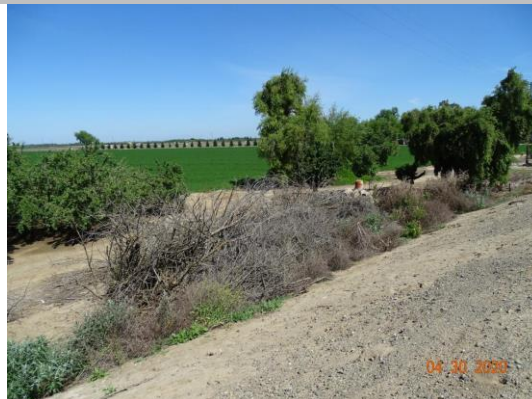
Photo 1 of 1 : FA\_2020\_RD0524\_107\_206\_20200901\_00085.jpg

LM Start	3.68	Rating **	U	Issue No.	206
LM End	3.68	Issue Type +	En	Location *	LS
Category	Earthen Levee			GPS Latitude/Longitude	
				Start	End
Item	Encroachments			37.903690 °	37.903690 °
				-121.325403 °	-121.325403 °
DWR ID	DWR_RD0524_01_s _ 2020_206				
Comment Code					
PR : Prunings					
Inspector Comment

View of large pruning pile on landside slope. Spring 2020

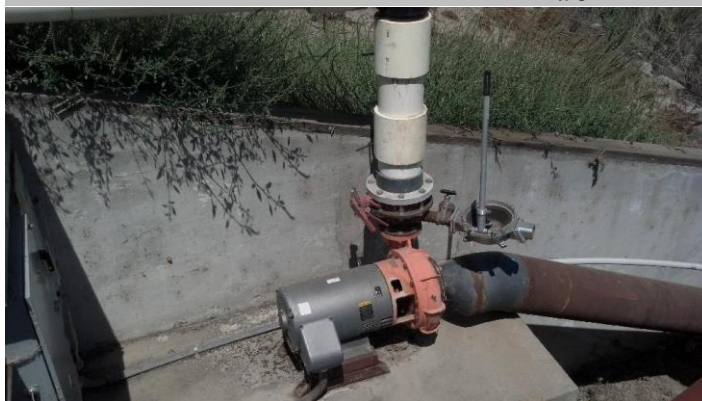
Photo 1 of 3 : UCIP\_FA\_2020\_61964\_38445.jpg

Comment Code						
Inspector Comment						
DS_ID:24044 FS_ID:61964 EP_NO: N/A Repair Type: Non-Urgent EVAL Issue: Unauthorized Encroachment, installed decades prior Crossing Status: Found UCIP Comments: 06/24/2020 Record remains Non-Urgent. Unauthorized encroachment recorded in Levee Log prior to 2011. No permit has been identified authorizing pipe. (D.Sanoski - DWR UCIP)  FIELD_STRUCT_DESC: 8-inch steel irrigation pipe through the levee, 0 feet below the crown. Pipe integrated into steel cattle guard style crossing. Slant pump and butterfly valve at concrete foundation on the waterside (WS) slope. Filter plant, vents, and butterfly valves on the landside (LS) toe. FS Date: 6/24/2020 2:46:00 PM

Pump and butterfly valve on concrete pad on WS shoulder.

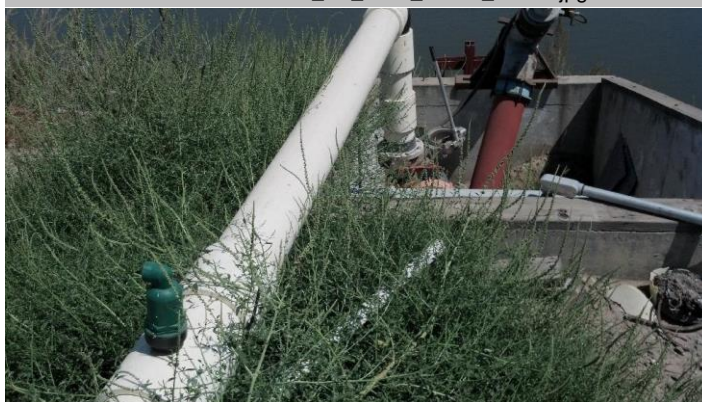
Photo 2 of 3 : UCIP\_FA\_2020\_61964\_38444.jpg

Vent on PVC pipe at WS shoulder.

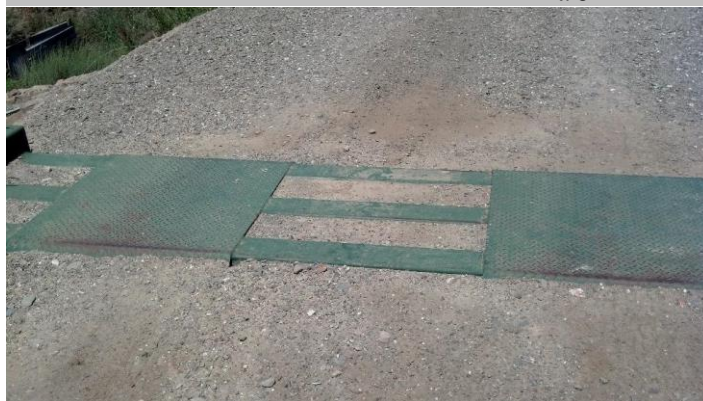
Photo 3 of 3 : UCIP\_FA\_2020\_61964\_38443.jpg

Steel, integrated cattleguard style pipe crossing at crown elevation.

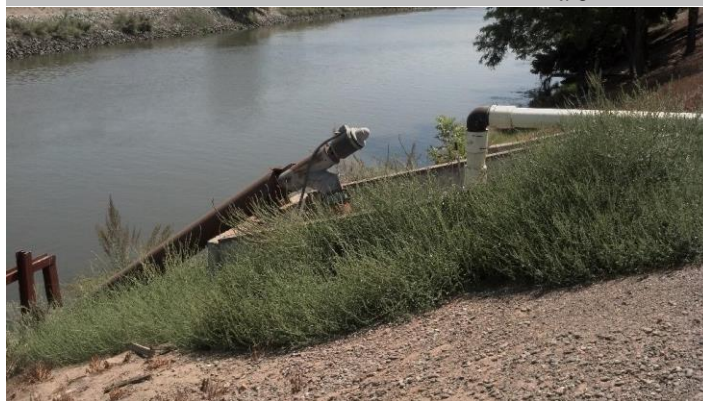
Photo 1 of 3 : UCIP\_FA\_2020\_61965\_30528.jpg

DS\_ID:20620  
FS\_ID:61965  
EP\_NO: N/A  
Repair Type: Non-Urgent  
EVAL Issue: Unauthorized Encroachment, installed decades prior  
Crossing Status: Found  
UCIP Comments: 06/24/2020 Record remains Non-Urgent.  
Unauthorized encroachment recorded in Levee Log prior to 2011. No permit has been identified authorizing pipe. Crossing appears abandoned. (D.Sanoski - DWR UCIP)  
Appears abandoned and if so should be done so properly. Evidence of severe internal corrosion in concrete distribution box at LS toe.  
FIELD\_STRUCT\_DESC: 12-inch concrete encased steel irrigation pipe through the levee, 10.5 feet below the crown. Pump and gate valve in pump house on the waterside (WS) slope. 6-foot by 6-foot Concrete distribution box on the landside (LS) toe. Two concrete cutoff walls.  
Service pole at the LS toe. [Additional Reference(s): DWR Levee Log, 2004. USACE San Joaquin O&M Manual 7, April 1964, (HLM 3.83)].

Slant pump visible at concrete foundation on WS slope. Pumphouse removed.

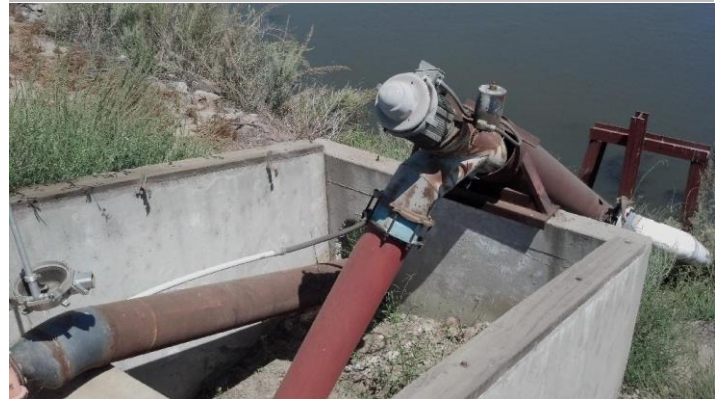
Photo 2 of 3 : UCIP\_FA\_2020\_61965\_30527.jpg

Slant pump and pipe on WS slope.

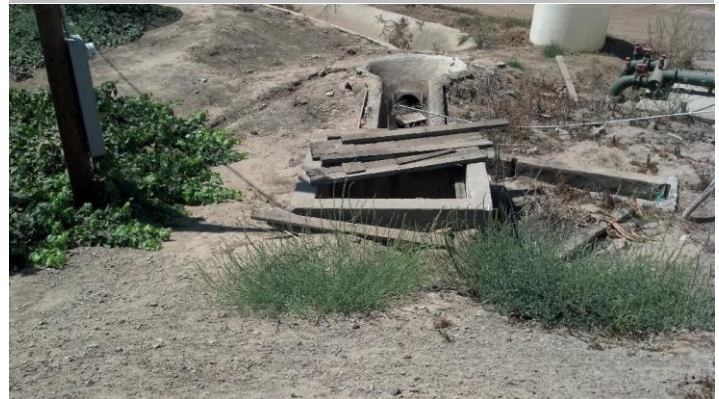
Photo 3 of 3 : UCIP\_FA\_2020\_61965\_30526.jpg

6'X6' concrete distribution box and power pole on LS toe.

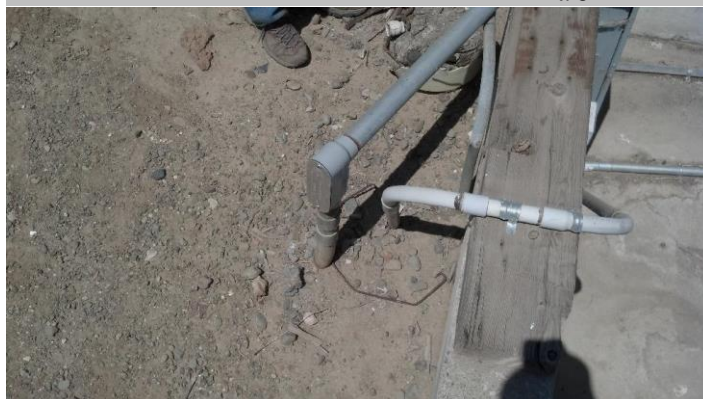
Photo 1 of 3 : UCIP\_FA\_2020\_61966\_38450.jpg

Comment Code						
Inspector Comment						
DS_ID:24045 FS_ID:61966 EP_NO: N/A Repair Type: Non-Urgent EVAL Issue: Unauthorized Encroachment, installed decades prior Crossing Status: Found UCIP Comments: 06/24/2020 Record updated from No Action Needed to Non-Urgent. Unauthorized encroachment recorded in Levee Log prior to 2011. No permit has been identified authorizing pipe. (D.Sanoski - DWR UCIP)  FIELD_STRUCT_DESC: 1.25-inch polyvinyl chloride electrical conduit through the levee, at an unknown depth. Power pole and meter box on the landside (LS) toe. Electrical box inside concrete foundation on the waterside (WS) slope. FS Date: 6/24/2020 2:47:00 PM

Electrical conduit visible at WS shoulder.

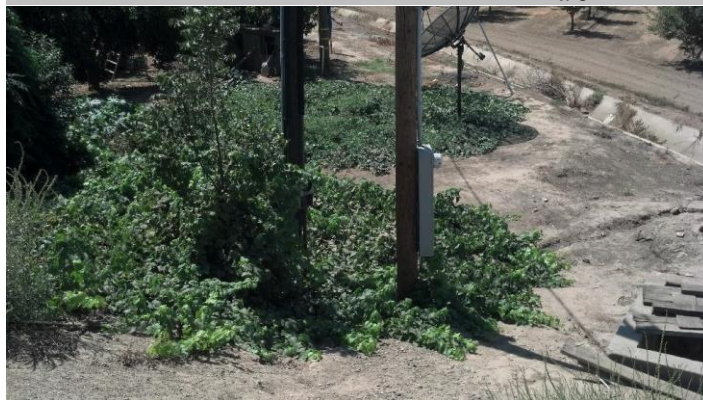
Photo 2 of 3 : UCIP\_FA\_2020\_61966\_38449.jpg

Electrical conduit visible at LS toe power pole.

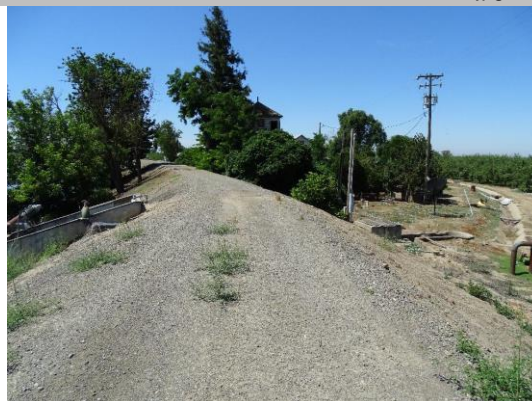
Photo 3 of 3 : UCIP\_FA\_2020\_61966\_89437.jpg

Top of Levee: view of crown.

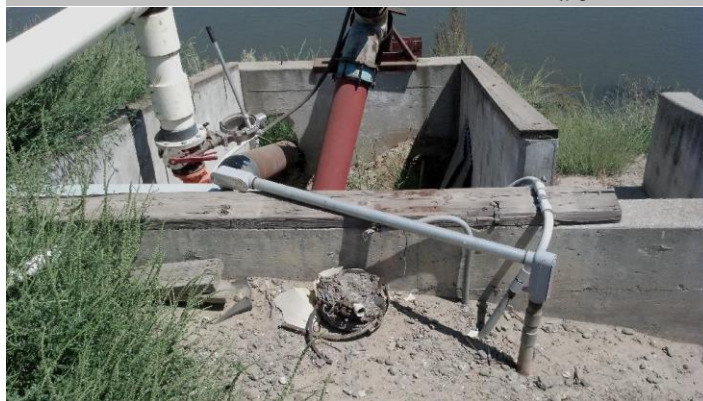
Photo 1 of 3 : UCIP\_FA\_2020\_61967\_38448.jpg

DS\_ID:24046  
FS\_ID:61967  
EP\_NO: N/A  
Repair Type: Non-Urgent  
EVAL Issue: Unauthorized Encroachment, installed decades prior  
Crossing Status: Found  
UCIP Comments: 06/24/2020 Record updated from No Action Needed to Non-Urgent. Unauthorized encroachment recorded in Levee Log prior to 2011. No permit has been identified authorizing pipe. (D.Sanoski - DWR UCIP)

FIELD\_STRUCT\_DESC: 2-inch galvanized iron electrical conduit through the levee, at an unknown depth below the crown. Power pole and meter box on the landside (LS) toe. Electrical box inside concrete foundation on the waterside (WS) slope.  
FS Date: 6/24/2020 2:47:00 PM

Electrical conduit visible on WS shoulder.

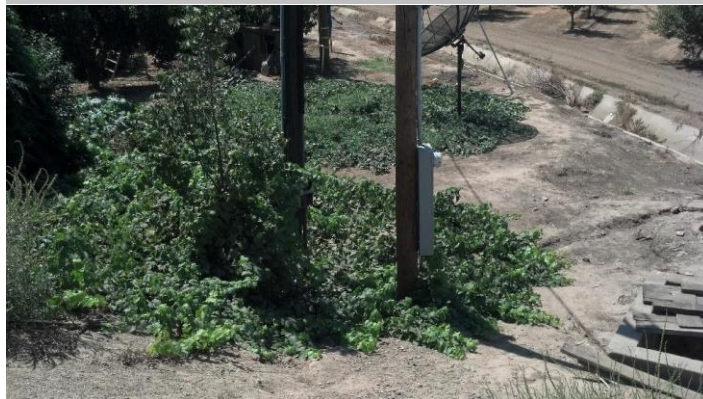
Photo 2 of 3 : UCIP\_FA\_2020\_61967\_38447.jpg

Electrical conduit visible on LS toe at power pole.

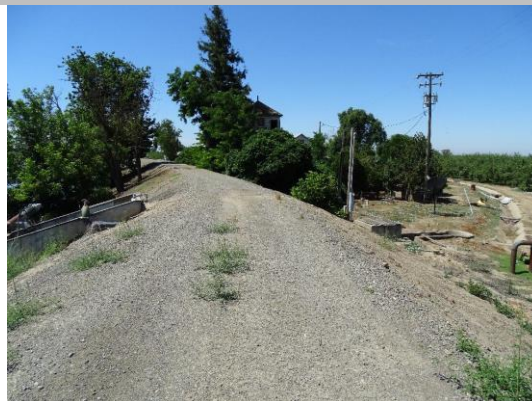
Photo 3 of 3 : UCIP\_FA\_2020\_61967\_89440.jpg

Top of Levee: view of crown.

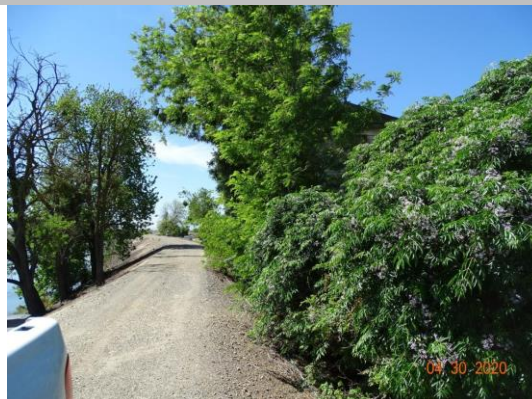
Photo 1 of 1 : FA\_2020\_RD0524\_107\_59\_20200901\_00028.jpg

LM Start	3.79	Rating **	U	Issue No.	59
LM End	3.81	Issue Type +	En	Location *	LS
Category	Earthen Levee			GPS Latitude/Longitude	
				Start	End
Item	Vegetation			37.902287 °	37.902039 °
				-121.326462 °	-121.326526 °
DWR ID	DWR_RD0524_01_s_2012_59				
Comment Code					
V6 : Landscaping					
Inspector Comment					
Landscaping on landward slope.

View of dense vegetation and landscaping that needs to be trimmed and thinned on landside slope. Spring 2020

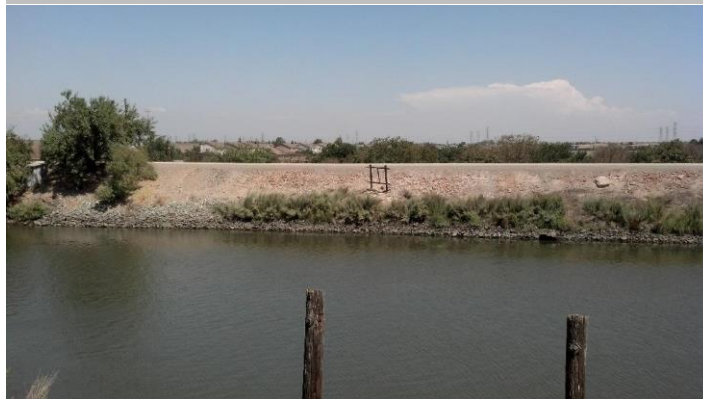
Photo 2 of 3 : UCIP\_FA\_2020\_61968\_30542.jpg

Comment Code						
Inspector Comment						
DS_ID:20621 FS_ID:61968 EP_NO: N/A Repair Type: Non-Urgent EVAL Issue: Unauthorized Encroachment, installed decades prior Crossing Status: Found UCIP Comments: 06/24/2020 Record remains Non-Urgent. Unauthorized encroachment recorded in Levee Log prior to 2011. Crossing appears abandoned. (D.Sanoski - DWR UCIP) Appears to be abandoned as signage has been removed. FIELD_STRUCT_DESC: 2.5-inch submarine telephone conduit of an unknown material through the levee and across the channel, 2 feet below the crown. Sign posts remain on both sides of the river on the waterside (WS) slope. [Additional Reference(s): DWR Levee Log, 2004]. FS Date: 6/24/2020 2:47:00 PM

Sign posts visible on opposite river bank in same condition.

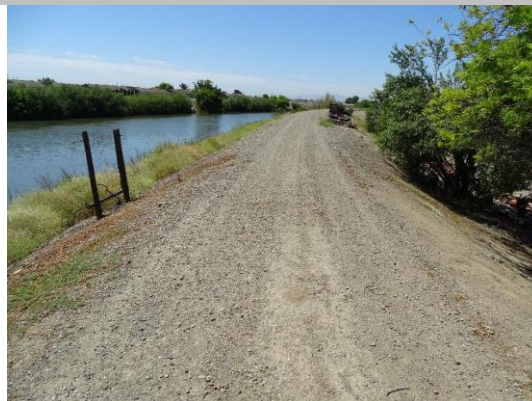
Photo 3 of 3 : UCIP\_FA\_2020\_61968\_89443.jpg

Top of Levee: view of crown.

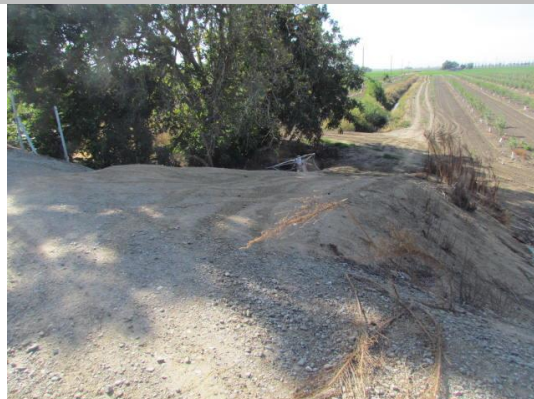
Photo 1 of 1 : FA\_2020\_RD0524\_107\_101\_20200901\_00046.jpg

LM Start	4.02	Rating **	U	Issue No.	101
LM End	4.02	Issue Type +	En	Location *	LS
Category	Earthen Levee			GPS Latitude/Longitude	
				Start	End
Item	Encroachments			37.899027 °	37.899027 °
				-121.326982 °	-121.326982 °
DWR ID	DWR_RD0524_01_s_2012_101				
Comment Code					
RA : Ramp					
Inspector Comment					
Unauthorized ramp. Ramp does not meet Title 23 standard.

Looking west at unauthorized ramp on landside slope.

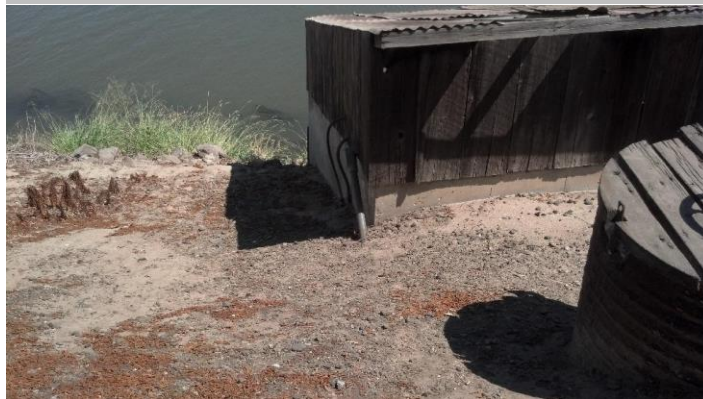
Photo 1 of 3 : UCIP\_FA\_2020\_61970\_30559.jpg

Comment Code						
Inspector Comment						
DS_ID:20623 FS_ID:61970 EP_NO: N/A Repair Type: Non-Urgent EVAL Issue: Unauthorized Encroachment, installed decades prior Crossing Status: Found UCIP Comments: 06/24/2020 Record remains Non-Urgent. Unauthorized encroachment recorded in Levee Log prior to 2011. No permit has been identified authorizing pipe. (D.Sanoski - DWR UCIP)  FIELD_STRUCT_DESC: 8-inch concrete encased steel irrigation pipe through the levee, 9.5 feet below the crown. Pump and gate valve in pump house on the waterside (WS) slope. Slide gate in 42-inch corrugated metal pipe riser unit on the WS slope. Brick standpipe at the toe of the landside (LS) slope. 1.5-inch galvanized iron electrical conduit through the levee, 3 feet below the crown at the same location. [Additional Reference(s): DWR Levee Log, 2004. USACE San Joaquin O&M Manual 7, April 1964, (HLM 4.08)]. FS Date: 6/24/2020 2:48:00 PM

Electrical conduit visible on WS slope at pumphouse.

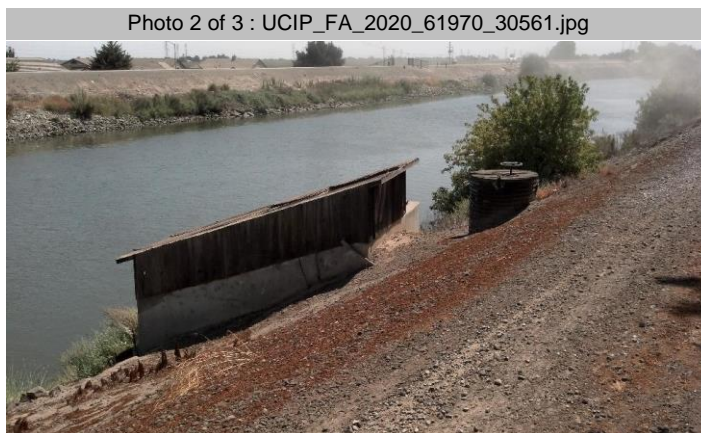
Pumphouse and gate valve in CMP riser on WS slope.

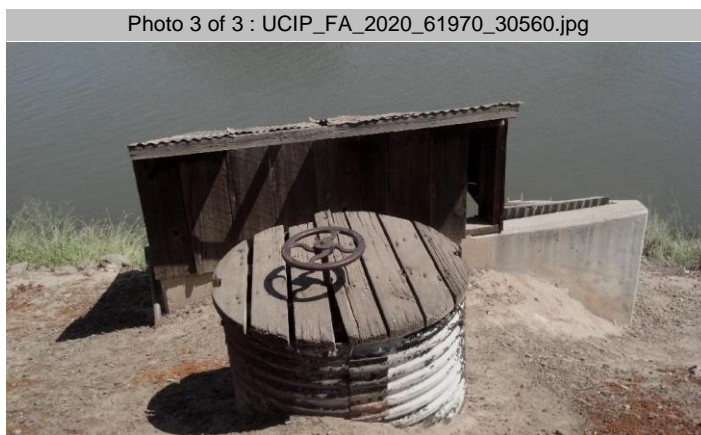
Pumphouse and gate valve in CMP riser on WS slope.

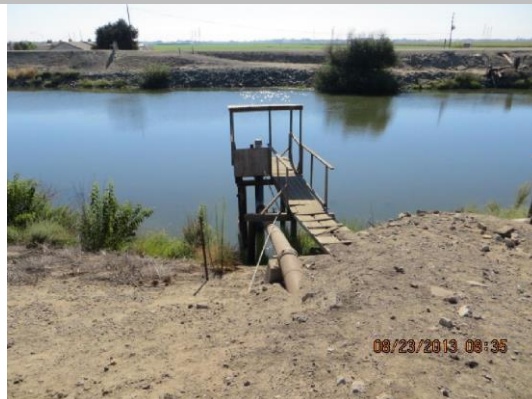
Photo 1 of 3 : UCIP\_FA\_2020\_61971\_30575.jpg

DS\_ID:20624  
FS\_ID:61971  
EP\_NO: N/A  
Repair Type: Non-Urgent  
EVAL Issue: Unauthorized Encroachment, installed decades prior  
Crossing Status: Found  
UCIP Comments: 06/24/2020 Record updated from No Action Needed to Non-Urgent. Unauthorized encroachment recorded in Levee Log prior to 2011. No permit has been identified authorizing pipe. (D.Sanoski - DWR UCIP)

Pump on pile structure on WS toe.

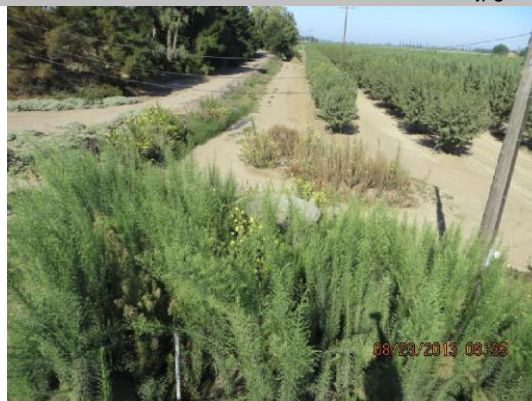
Photo 2 of 3 : UCIP\_FA\_2020\_61971\_30574.jpg

6-foot diameter concrete standpipe on LS toe with power pole.

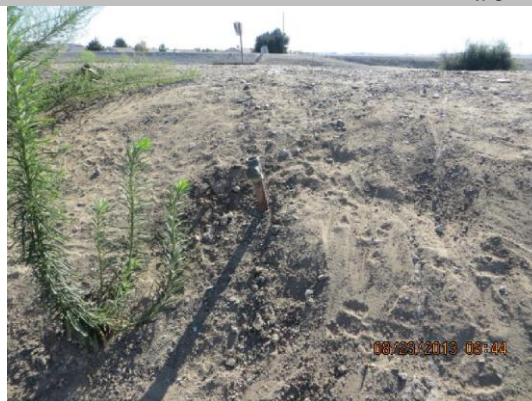
Photo 2 of 3 : UCIP\_FA\_2020\_61972\_30588.jpg

DS\_ID:20625  
FS\_ID:61972  
EP\_NO: N/A  
Repair Type: Non-Urgent  
EVAL Issue: Unauthorized Encroachment, installed decades prior  
Crossing Status: Found  
UCIP Comments: 06/24/2020 Record remains Non-Urgent.  
Unauthorized encroachment recorded in Levee Log prior to 2011. No permit has been identified authorizing pipe. (D.Sanoski - DWR UCIP)  
Small leak on WS slope causing minor erosion on WS slope.  
FIELD\_STRUCT\_DESC: 12-inch steel irrigation pipe through the levee, 4.5 feet below the crown. Pump house and gate valve on the waterside (WS) slope. 36-inch concrete standpipe, power pole, and meter on the landside (LS) toe. [Additional Reference(s): DWR Levee Log, 2004. USACE San Joaquin O&M Manual 7, April 1964, (HLM 4.21)].  
FS Date: 6/24/2020 2:49:00 PM

Vent or siphon breaker just off LS shoulder.
