## Flood Control Project Maintenance Levee Inspections

### Fall 2020 Levee Maintenance Deficiency Summary Report

#### San Joaquin River Basin

**Reclamation District No. 0524 Middle Roberts Island**

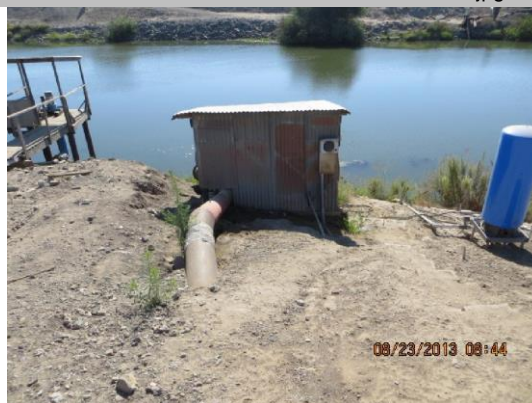
Photo 3 of 3 : UCIP\_FA\_2020\_61972\_30587.jpg

Pumphouse and pipe on WS slope.

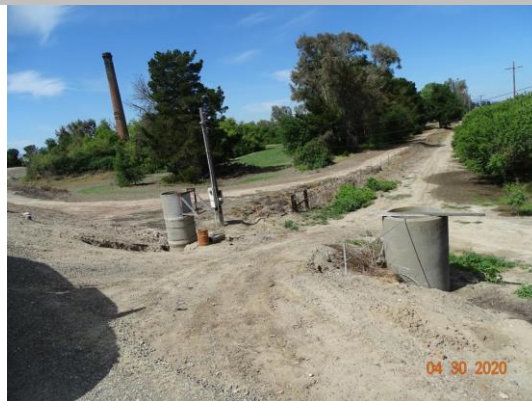
Photo 1 of 1 : FA\_2020\_RD0524\_107\_110\_20200901\_00051.jpg

LM Start	4.16	Rating **	M	Issue No.	110
LM End	4.16	Issue Type +	En	Location *	LS
Category	Earthen Levee			GPS Latitude/Longitude	
				Start	End
Item	Encroachments			37.897103 °	37.897103 °
				-121.327895 °	-121.327895 °
DWR ID	DWR_RD0524_01_s_2012_110				
Comment Code					
RA : Ramp					
Inspector Comment					
One unauthorized ramp on landside slope.

View of an unauthorized ramp on landside slope. Spring 2020

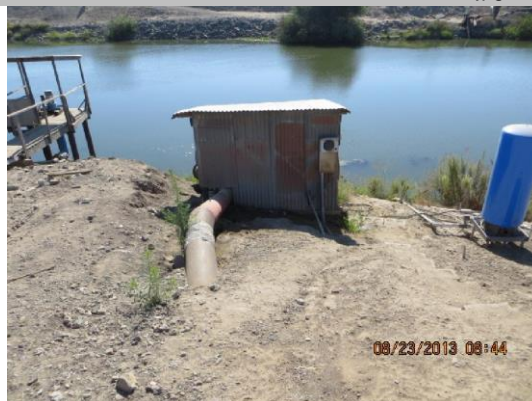
Photo 1 of 3 : UCIP\_FA\_2020\_61973\_38818.jpg

LM Start	4.17	Rating **	M	Issue No.	980	
LM End	4.17	Issue Type +	En	Location *		
Category	Supplemental			GPS Latitude/Longitude		
				Start	End	
Item	DWR UCIP Field Study			37.897097 °	37.897097 °	
				-121.327910 °	-121.327910 °	
DWR ID	24047					
Comment Code						
Inspector Comment						
DS_ID:24047 FS_ID:61973 EP_NO: N/A Repair Type: Non-Urgent EVAL Issue: Unauthorized Encroachment, installed decades prior Crossing Status: Found UCIP Comments: 06/24/2020 Record updated from No Action Needed to Non-Urgent. Unauthorized encroachment recorded in Levee Log prior to 2011. No permit has been identified authorizing pipe. (D.Sanoski - DWR UCIP)  FIELD_STRUCT_DESC: 1.25-inch galvanized iron electrical conduit through the levee, at an unknown depth. Power pole and meter box on the landside (LS) toe. Electrical box at pump house on the waterside (WS) slope. FS Date: 6/24/2020 2:49:00 PM

Electrical conduit at pumphouse on WS slope.

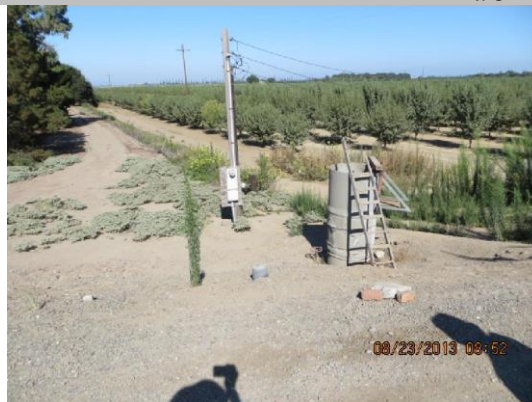
Photo 2 of 3 : UCIP\_FA\_2020\_61973\_38817.jpg

Power pole and meter on LS slope.

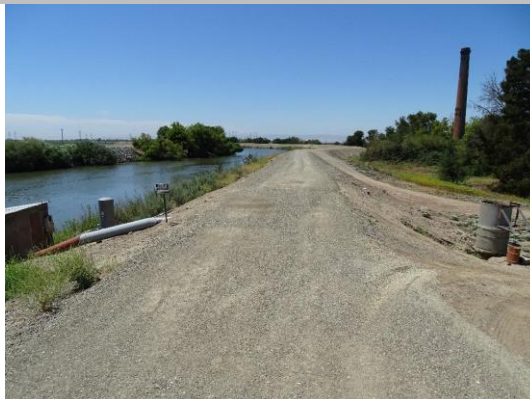
Photo 3 of 3 : UCIP\_FA\_2020\_61973\_89458.jpg

Overview of Levee: view of crown and assembly on both sides.

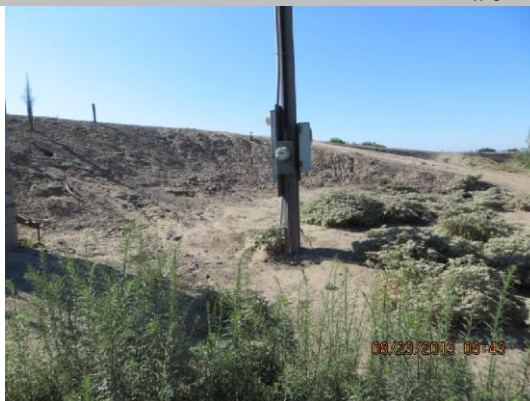
Photo 1 of 3 : UCIP\_FA\_2020\_61975\_37652.jpg

DS\_ID:24048  
FS\_ID:61975  
EP\_NO: N/A  
Repair Type: Non-Urgent  
EVAL Issue: Unauthorized Encroachment, installed decades prior  
Crossing Status: Found  
UCIP Comments: 06/24/2020 Record updated from No Action Needed to Non-Urgent. Unauthorized encroachment recorded in Levee Log prior to 2011. No permit has been identified authorizing pipe. (D.Sanoski - DWR UCIP)

FIELD\_STRUCT\_DESC: 2-inch polyvinyl chloride electrical conduit through the levee, at an unknown depth. Power pole and meter box on the landside (LS) toe. Pump on the waterside (WS) slope.  
FS Date: 6/24/2020 2:50:00 PM

PVC electrical conduit visible on power pole at LS toe.

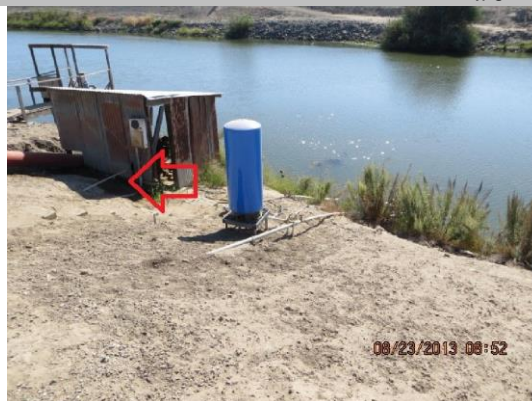
Photo 2 of 3 : UCIP\_FA\_2020\_61975\_37651.jpg

Electrical conduit visible at pumphouse on WS slope.

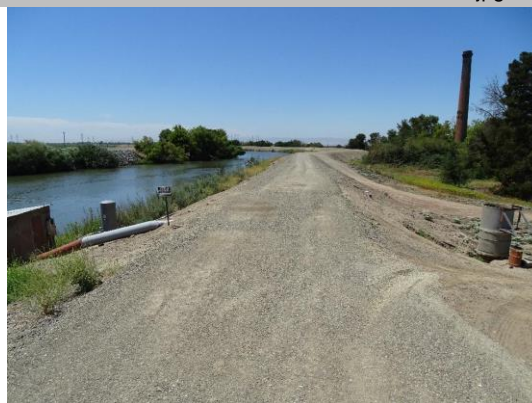
Photo 3 of 3 : UCIP\_FA\_2020\_61975\_89461.jpg

Overview of Levee: view of crown and assembly on both sides.

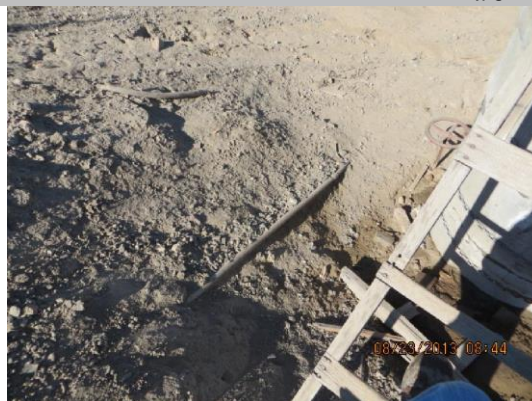
Photo 1 of 3 : UCIP\_FA\_2020\_61978\_37660.jpg

LM Start	4.17	Rating **	M	Issue No.	982	
LM End	4.17	Issue Type +	En	Location *		
Category	Supplemental			GPS Latitude/Longitude		
				Start		End
Item	DWR UCIP Field Study			37.897074 °		37.897074 °
				-121.327926 °		-121.327926 °
DWR ID	24049					
Comment Code						
Inspector Comment						
DS_ID:24049 FS_ID:61978 EP_NO: N/A Repair Type: Non-Urgent EVAL Issue: Unauthorized Encroachment, installed decades prior Crossing Status: Found UCIP Comments: 06/24/2020 Record remains Non-Urgent. Unauthorized encroachment recorded in Levee Log prior to 2011. No permit has been identified authorizing pipe. (D.Sanoski - DWR UCIP)  FIELD_STRUCT_DESC: 2.25-inch polyvinyl chloride domestic water service line through the levee, 5 feet below the crown. Pump and tank on the waterside (WS) slope with a vent on the landside (LS) slope. FS Date: 6/24/2020 2:50:00 PM

Pipe visible on LS slope.

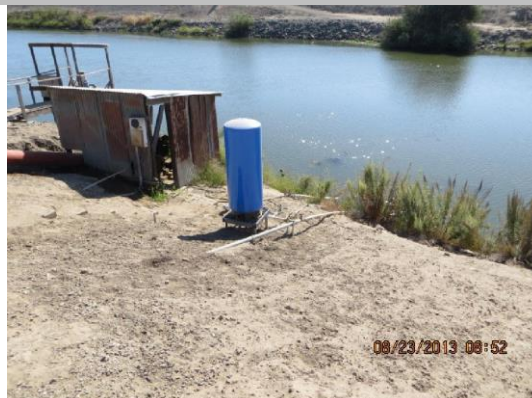
Photo 2 of 3 : UCIP\_FA\_2020\_61978\_37659.jpg

Pipe, pump, and tank visible on WS slope.

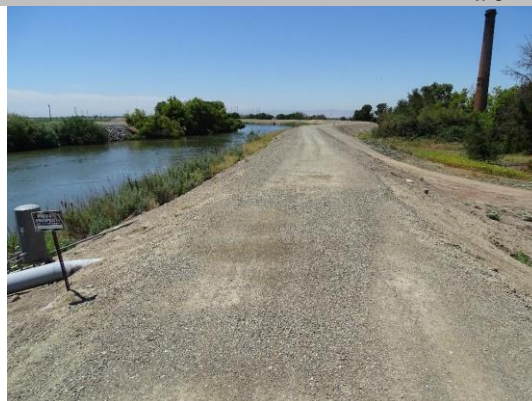
Photo 3 of 3 : UCIP\_FA\_2020\_61978\_89464.jpg

Top of Levee: view of crown.

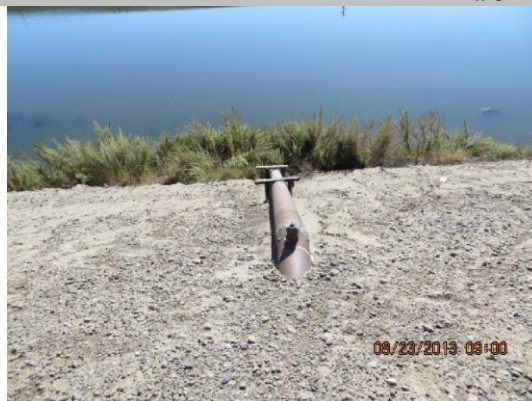
Photo 1 of 3 : UCIP\_FA\_2020\_61983\_30594.jpg

DS\_ID:20626  
 FS\_ID:61983  
 EP\_NO: N/A  
 Repair Type: Non-Urgent  
 EVAL Issue: Unauthorized Encroachment, installed decades prior  
 Crossing Status: Found  
 UCIP Comments: 06/24/2020 Record remains Non-Urgent.  
 Unauthorized encroachment recorded in Levee Log prior to 2011. No permit has been identified authorizing pipe. (D.Sanoski - DWR UCIP)  
 Small leak in pipe on LS slope and pipe slightly crushed on LS toe.  
 FIELD\_STRUCT\_DESC: 9-inch steel pipe of unknown purpose through the levee, 3 feet below the crown. Pump in drainage ditch on the landside (LS). Siphon breaker on the waterside (WS) slope. [Additional Reference(s): DWR Levee Log, 2004. USACE San Joaquin O&M Manual 7, April 1964, (HLM 4.42) 8-inch pipe listed].  
 FS Date: 6/24/2020 2:51:00 PM

Pipe and siphon breaker on WS slope.

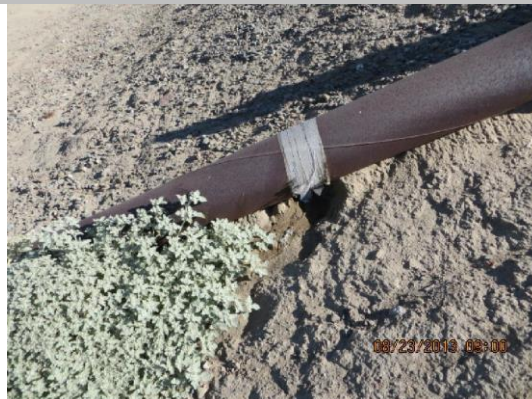
Photo 2 of 3 : UCIP\_FA\_2020\_61983\_30593.jpg

Small leak in pipe on LS slope.

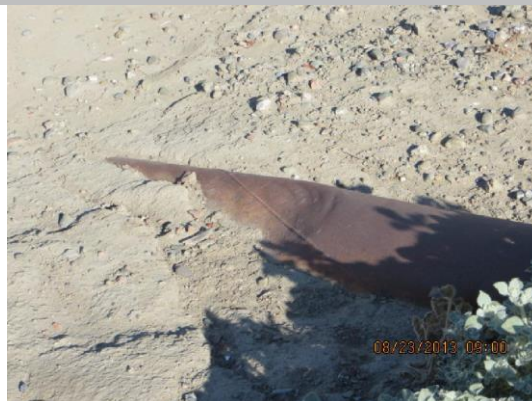
Photo 3 of 3 : UCIP\_FA\_2020\_61983\_30592.jpg

Pipe partially crushed at LS toe.

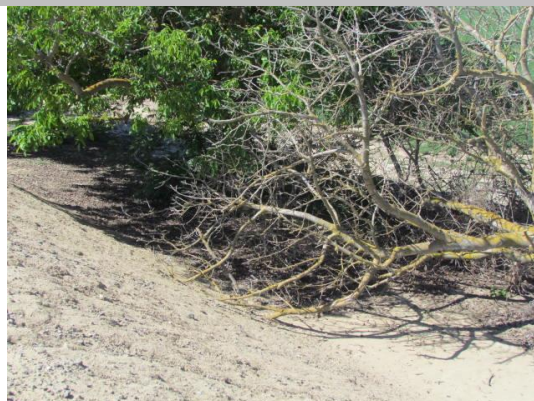
Photo 1 of 1 : FA\_2020\_RD0524\_107\_111\_20200901\_00052.jpg

LM Start	4.38	Rating **	M	Issue No.	111
LM End	4.38	Issue Type +	Ma	Location *	LS
Category	Earthen Levee			GPS Latitude/Longitude	
				Start	End
Item	Encroachments			37.894258 °	37.894258 °
				-121.329247 °	-121.329247 °
DWR ID	DWR_RD0524_01_s_2012_111				
Comment Code					
TR : Tree or limb					
Inspector Comment					
Dead tree at landside toe should be removed from levee toe.

Looking west at dead tree at landside toe.

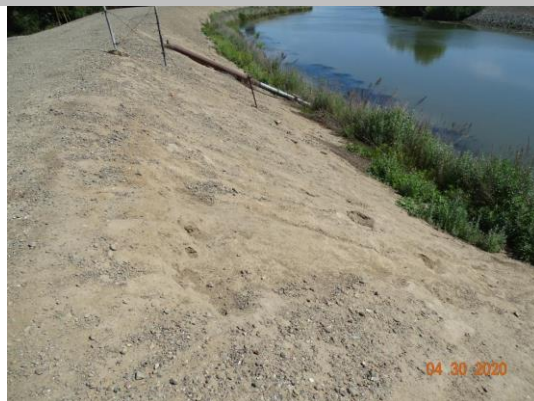
Photo 1 of 1 : FA\_2020\_RD0524\_107\_165\_20200901\_00066.jpg

LM Start	4.38	Rating **	U	Issue No.	165
LM End	4.38	Issue Type +	Ma	Location *	WS
Category	Earthen Levee			GPS Latitude/Longitude	
				Start	End
Item	Animal Control			37.894198 °	37.894198 °
				-121.329272 °	-121.329272 °
DWR ID	DWR_RD0524_01_s_2017_165				
Comment Code					
A3 : No rodents visible, but rodent burrows visible; need to backfill and compact or grout burrows.					
Inspector Comment

View of multiple animal burrows on waterside slope. Spring 2020

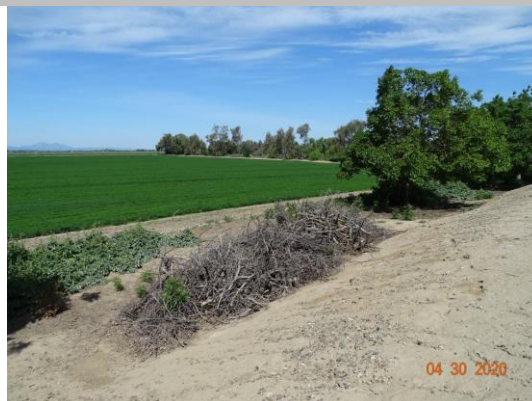
Photo 1 of 1 : FA\_2020\_RD0524\_107\_199\_20200901\_00081.jpg

LM Start	4.43	Rating **	M	Issue No.	199
LM End	4.43	Issue Type +	En	Location *	LS
Category	Earthen Levee			GPS Latitude/Longitude	
				Start	End
Item	Encroachments			37.893497 °	37.893497 °
				-121.329049 °	-121.329049 °
DWR ID	DWR_RD0524_01_f_2015_199				
Comment Code					
PR : Prunings					
Inspector Comment

View of prunings on landside slope. Spring 2020

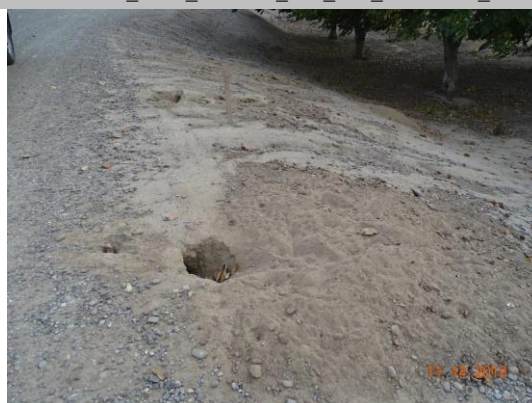
Photo 1 of 1 : FA\_2020\_RD0524\_107\_139\_20200901\_00058.jpg

LM Start	4.45	Rating **	U	Issue No.	139
LM End	4.51	Issue Type +	Ma	Location *	LS
Category	Earthen Levee			GPS Latitude/Longitude	
				Start	End
Item	Animal Control			37.893246 °	37.892579 °
				-121.328925 °	-121.328326 °
DWR ID	DWR_RD0524_01_s_2019_139				
Comment Code					
A1 : Exterminate rodents and backfill and compact or grout burrows.					
Inspector Comment

View of large rodent holes on landside slope. Fall 2019

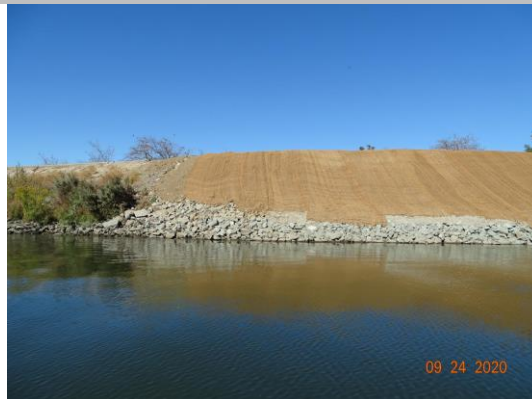
Photo 1 of 3 : SJR2019\_RD0524U01RM45.07\_01.JPG

LM Start	4.53	Rating **	A/W	Issue No.	13
LM End	4.54	Issue Type +	Ma	Location *	WS
Category	Supplemental			GPS Latitude/Longitude	
				Start	End
Item	DWR Erosion Survey			37.892274 °	37.892274 °
				-121.328168 °	-121.328168 °
DWR ID	RD0524U01RM45.07				
Comment Code					
Inspector Comment					
Site ID: RD0524U01RM45.07					
09/24/2020: The site is being repaired. The repair is approximately 150 ft long.					
08/13/2019: From 2013 to present, no significant changes were observed during the annual survey.					
08/07/2012: The erosion is located at the inside of a river bend. Site is covered with broken concrete blocks and other debris.

9/24/2020: Upstream end of the erosion repair.

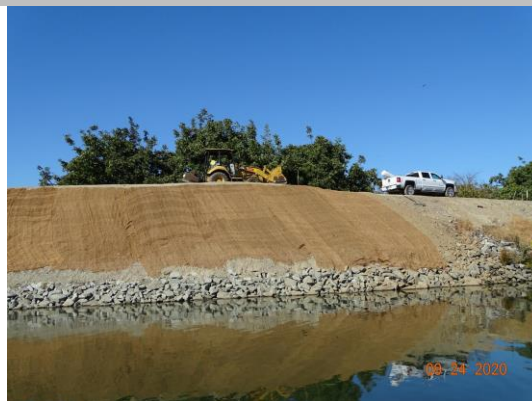
Photo 3 of 3 : SJR2019\_RD0524U01RM45.07\_04.JPG

9/24/2020: Downstream end of the erosion repair.

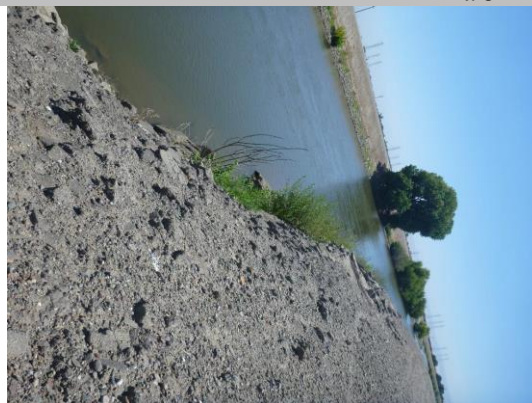
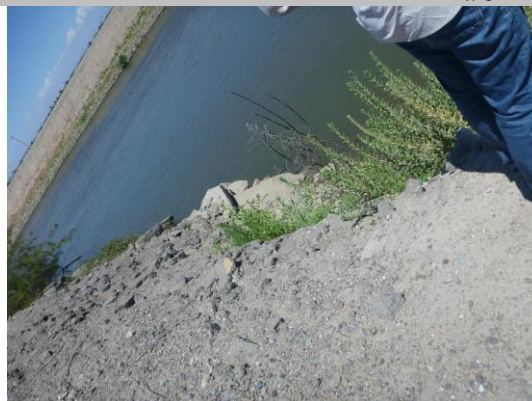
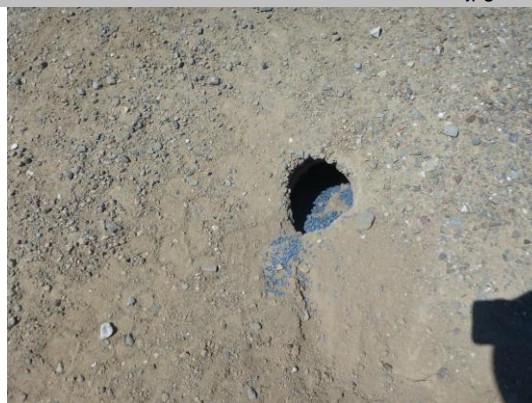
LM Start	<b>4.53</b>	Rating **	A/W	Issue No.	<b>30</b>
LM End	<b>4.53</b>	Issue Type +	Ma	Location *	WS
Category	Supplemental		GPS Latitude/Longitude		
			Start	End	
Item	2017 Storm Damage		37.892230 °	37.892200 °	
			-121.327930 °	-121.328000 °	
DWR ID	LMA-295

Description: Slope protection repairs are needed along the waterside slope due to erosion. Based upon levee inspections, it was determined the waterside levee slopes were eroding, deteriorating and degrading in concave pocket sections at various locations along this levee reach. The eroded levee sections need to be restored back to design standards to prevent further deterioration of the damaged levee sections.

Notes: Serious because erosion is impacting the levee, but there is some slope protection here. Slope is armored with asphalt and concrete rubble. The surrounding slopes are pretty barren, but there is a small bush within the site so it may be older.

Planned For Repair.

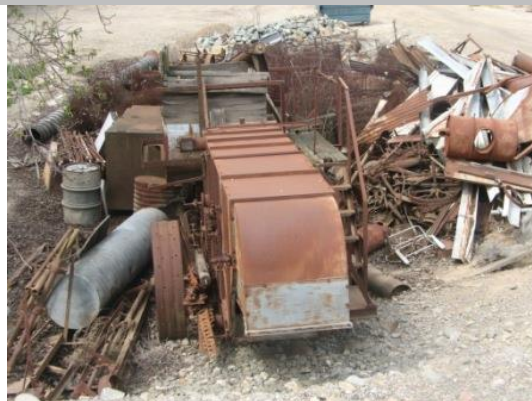
Photo 1 of 1 : FA\_2020\_RD0524\_107\_66\_20200901\_00032.jpg

LM Start	4.60	Rating **	M	Issue No.	66
LM End	4.60	Issue Type +	En	Location *	LS
Category	Earthen Levee			GPS Latitude/Longitude	
				Start	End
Item	Encroachments			37.891365 °	37.891365 °
				-121.328633 °	-121.328633 °
DWR ID	DWR_RD0524_01_s_2020_66				
Comment Code					
EQ : Equipment					
Inspector Comment					
Old farm equipment at landside toe.

Farm equipment being stored on landward toe.

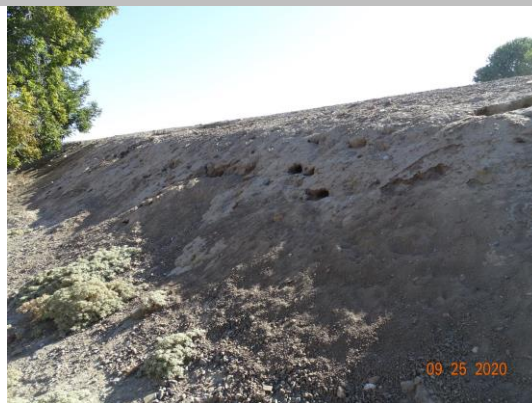
Photo 1 of 1 : FA\_2020\_RD0524\_107\_124\_20201005\_00222.jpg

LM Start	4.61	Rating **	U	Issue No.	124
LM End	4.63	Issue Type +	Ma	Location *	LS
Category	Earthen Levee			GPS Latitude/Longitude	
				Start	End
Item	Animal Control			37.891298 °	37.891061 °
				-121.328750 °	-121.328938 °
DWR ID	DWR_RD0524_01_f _ 2020_124				
Comment Code					
A3 : No rodents visible, but rodent burrows visible; need to backfill and compact or grout burrows.					
Inspector Comment

View of multiple large rodent holes on landside slope. Fall 2020

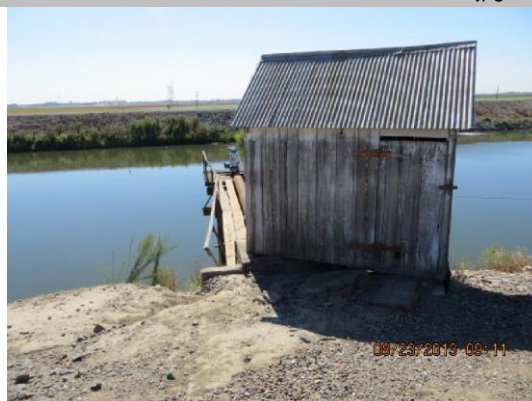
Photo 2 of 3 : UCIP\_FA\_2020\_61991\_30602.jpg

Pump on pier and slide gate house on WS shoulder.

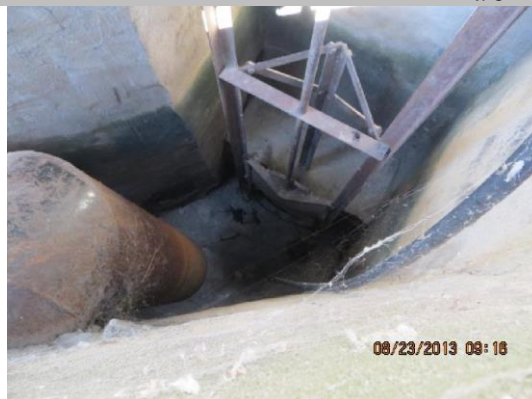
Photo 3 of 3 : UCIP\_FA\_2020\_61991\_30601.jpg

Slide gate inside concrete riser within shed on WS shoulder.

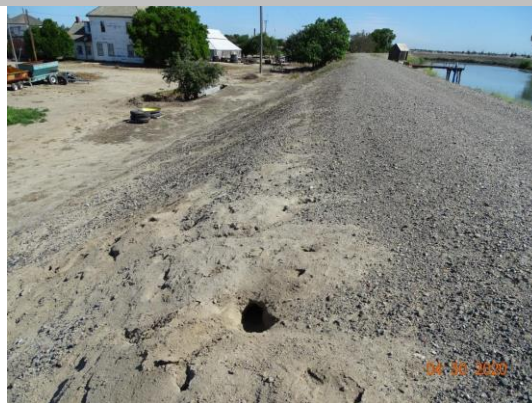
Photo 1 of 1 : FA\_2020\_RD0524\_107\_189\_20200901\_00074.jpg

LM Start	4.70	Rating **	U	Issue No.	189
LM End	4.75	Issue Type +	Ma	Location *	LS
Category	Earthen Levee			GPS Latitude/Longitude	
				Start	End
Item	Animal Control			37.890041 °	37.889395 °
				-121.329565 °	-121.329839 °
DWR ID	DWR_RD0524_01_s_2020_189				
Comment Code					
A3 : No rodents visible, but rodent burrows visible; need to backfill and compact or grout burrows.					
Inspector Comment

View of multiple large animal burrows on the landside slope. Spring 2020

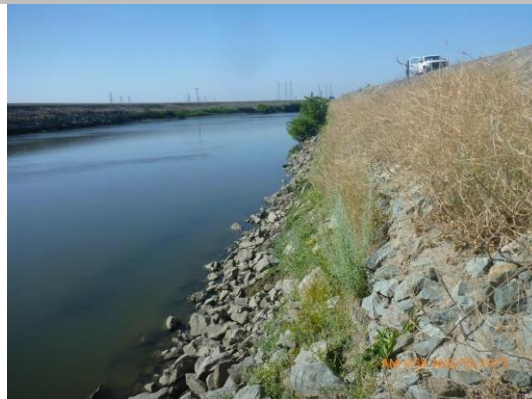
Photo 1 of 1 : LEVAL\_FA\_2020\_523\_4217.jpg

LM Start	4.76	Rating **	M	Issue No.	236
LM End	4.76	Issue Type +	Ma	Location *	WS
Category	Earthen Levee			GPS Latitude/Longitude	
				Start	End
Item	Erosion / Bank Caving			37.889300 °	37.889300 °
				-121.329800 °	-121.329800 °
DWR ID	DWR_RD0524_01_s_2020_236				
Comment Code					
E2 : Schedule repair of erosion site prior to the next inspection.					
Inspector Comment					
2017 Storm Damage Site, ID No. 523, LMA-429, Slope protection repairs are needed along the waterside slope due to erosion and riprap displacement from high water.

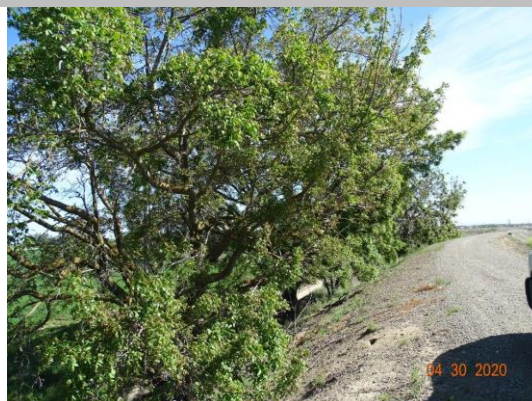
Photo 1 of 1 : FA\_2020\_RD0524\_107\_84\_20200901\_00040.jpg

LM Start	4.91	Rating **	M	Issue No.	84
LM End	4.94	Issue Type +	Ma	Location *	LS
Category	Earthen Levee			GPS Latitude/Longitude	
				Start	End
Item	Trim / Thin Trees			37.887564 °	37.887184 °
				-121.331259 °	-121.331697 °
DWR ID	DWR_RD0524_01_s_2012_84				
Comment Code					
T3 : Trim and thin trees to allow visibility of the ground and room to flood fight.					
Inspector Comment					
Untrimmed trees on landside slope.

View of trees that need to be trimmed on landside slope. Spring 2020

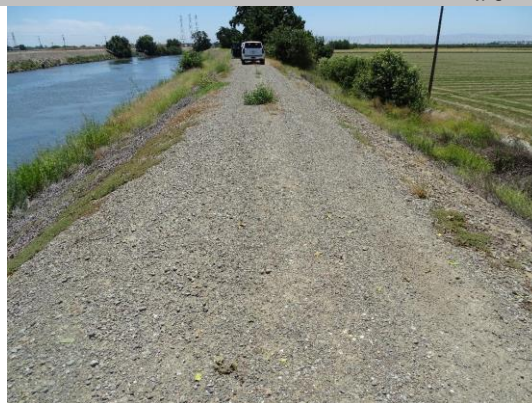
Photo 1 of 3 : UCIP\_FA\_2020\_61998\_89476.jpg

LM Start	5.01	Rating **	M	Issue No.	985	
LM End	5.01	Issue Type +	En	Location *		
Category	Supplemental			GPS Latitude/Longitude		
				Start		End
Item	DWR UCIP Field Study			37.886221 °	37.886221 °	
				-121.332063 °	-121.332063 °	
DWR ID	20647					
Comment Code						
Inspector Comment						
DS_ID:20647 FS_ID:61998 EP_NO: N/A Repair Type: Non-Urgent EVAL Issue: Pipe Not Found Crossing Status: Not Found UCIP Comments: 06/24/2020 Record updated from No Action Needed to Non-Urgent. Crossing not found. No permit has been identified authorizing pipe. (D.Sanoski - DWR UCIP)						
FIELD_STRUCT_DESC: 5-inch pipe of an unknown or purpose material through the levee, 3 feet below the crown. Pump house on the landside (LS). [Additional Reference(s): USACE San Joaquin O&M Manual 7, April 1964, (HLM 5.07)]. FS Date: 6/24/2020 2:52:00 PM

Top of Levee: view of crown.

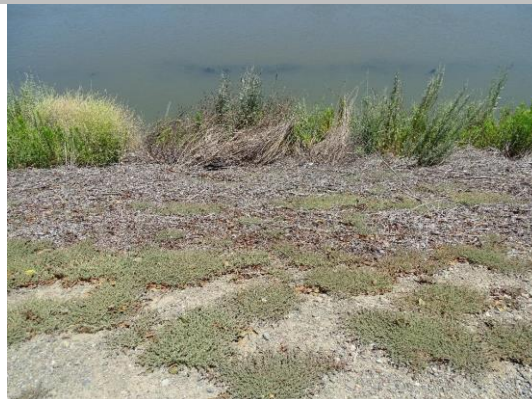
Photo 2 of 3 : UCIP\_FA\_2020\_61998\_89477.jpg

Water-Side: view of WS slope.

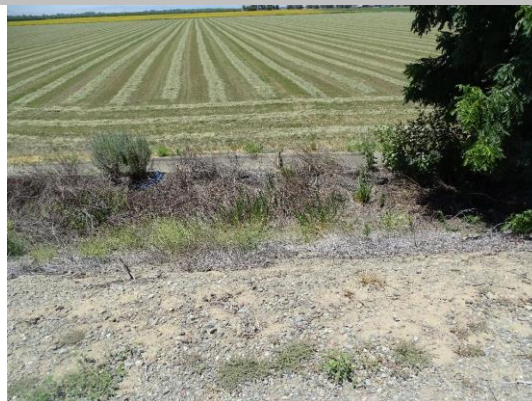
Photo 3 of 3 : UCIP\_FA\_2020\_61998\_89478.jpg

Land-Side: view of LS slope.

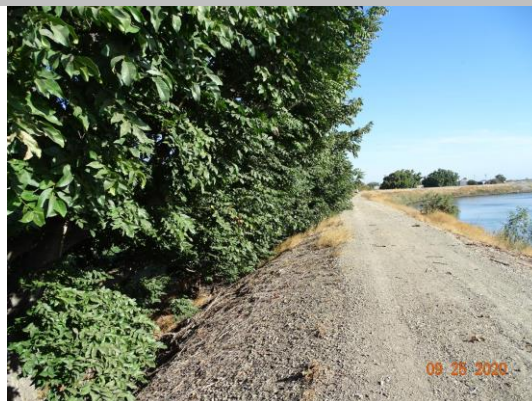
Photo 1 of 1 : FA\_2020\_RD0524\_107\_188\_20201005\_00221.jpg

LM Start	5.06	Rating **	U	Issue No.	188
LM End	5.08	Issue Type +	Ma	Location *	LS
Category	Earthen Levee			GPS Latitude/Longitude	
				Start	End
Item	Trim / Thin Trees			37.885565 °	37.885280 °
				-121.332165 °	-121.332183 °
DWR ID	DWR_RD0524_01_s_2014_188				
Comment Code					
T3 : Trim and thin trees to allow visibility of the ground and room to flood fight.					
Inspector Comment					
Walnut trees on landside slope and toe.

View of large untrimmed walnut trees on landside slope. Fall 2020

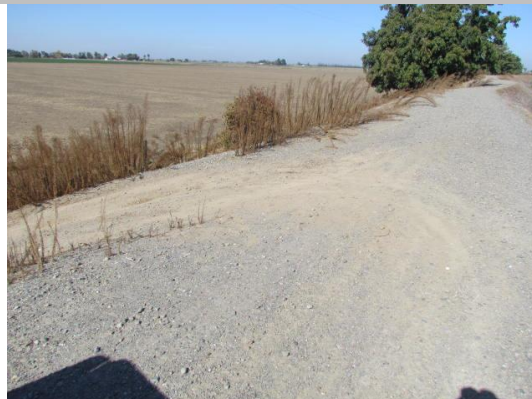
Photo 1 of 1 : FA\_2020\_RD0524\_107\_115\_20200901\_00053.jpg

LM Start	5.19	Rating **	M	Issue No.	115
LM End	5.19	Issue Type +	En	Location *	LS
Category	Earthen Levee			GPS Latitude/Longitude	
				Start	End
Item	Encroachments			37.883587 °	37.883587 °
				-121.332100 °	-121.332100 °
DWR ID	DWR_RD0524_01_s_2012_115				
Comment Code					
RA : Ramp					
Inspector Comment

Looking northwest at slope damage on landward slope.

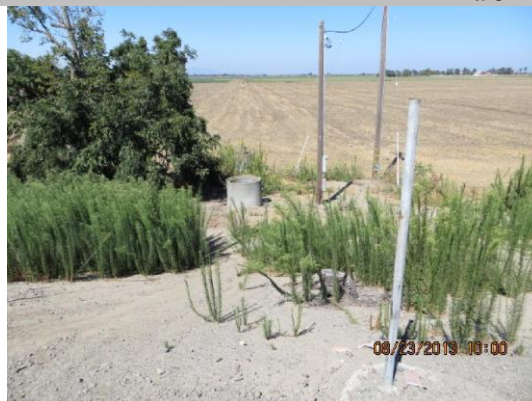
Photo 1 of 3 : UCIP\_FA\_2020\_62002\_30682.jpg

Comment Code						
Inspector Comment						
DS_ID:20629 FS_ID:62002 EP_NO: N/A Repair Type: Non-Urgent EVAL Issue: Unauthorized Encroachment, installed decades prior Crossing Status: Found UCIP Comments: 06/24/2020 Record updated from No Action Needed to Non-Urgent. Unauthorized encroachment recorded in Levee Log prior to 2011. No permit has been identified authorizing pipe. (D.Sanoski - DWR UCIP)  FIELD_STRUCT_DESC: 14-inch irrigation pipe of an unknown material through the levee, 15 feet below the crown. Pump house foundation on the waterside (WS) slope. 11-foot by 12-foot concrete sump on the WS shoulder. 4-foot diameter concrete standpipe on the landside (LS) toe. [Additional Reference(s): DWR Levee Log, 2004. USACE San Joaquin O&M Manual 7, April 1964, (HLM 5.26)]. FS Date: 6/24/2020 2:52:00 PM

4-foot diameter concrete standpipe on LS toe.

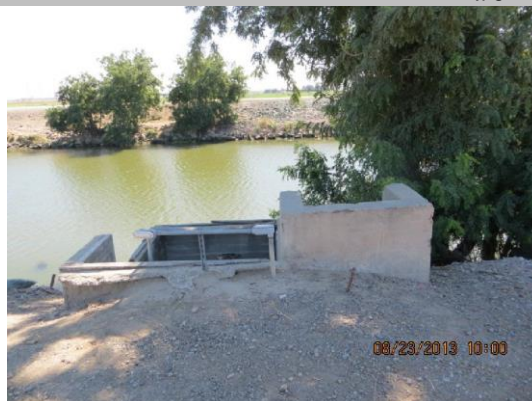
Photo 2 of 3 : UCIP\_FA\_2020\_62002\_30681.jpg

Slant pump on concrete foundation on WS slope.

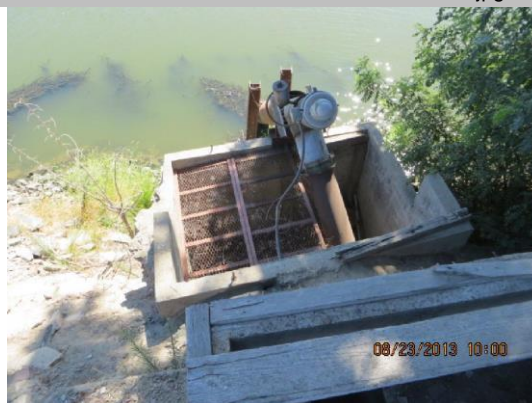
Photo 3 of 3 : UCIP\_FA\_2020\_62002\_30680.jpg

Slant pump on concrete foundation on WS slope.

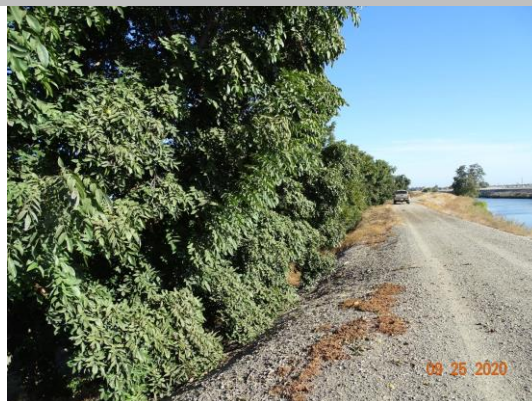
Photo 1 of 1 : FA\_2020\_RD0524\_107\_91\_20201005\_00220.jpg

LM Start	5.28	Rating **	U	Issue No.	91
LM End	5.33	Issue Type +	Ma	Location *	LS
Category	Earthen Levee			GPS Latitude/Longitude	
				Start	End
Item	Trim / Thin Trees			37.882380 °	37.881737 °
				-121.332605 °	-121.332772 °
DWR ID	DWR_RD0524_01_f _ 2020_91				
Comment Code					
T3 : Trim and thin trees to allow visibility of the ground and room to flood fight.					
Inspector Comment					
Trim walnut trees on the levee slope.

View of large untrimmed walnut trees on landside slope. Fall 2020

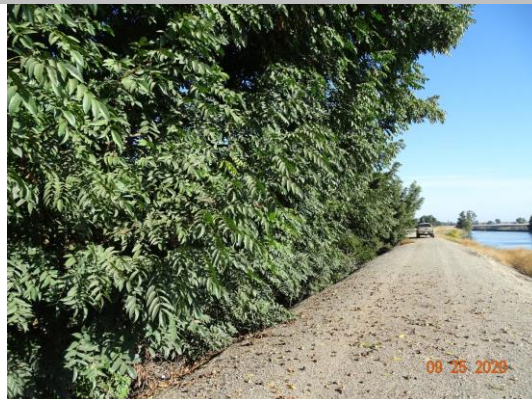
Photo 1 of 1 : FA\_2020\_RD0524\_107\_932\_20201005\_00219.jpg

LM Start	5.38	Rating **	U	Issue No.	932
LM End	5.41	Issue Type +	Ma	Location *	LS
Category	Earthen Levee			GPS Latitude/Longitude	
				Start	End
Item	Trim / Thin Trees			37.880945 °	37.880522 °
				-121.332837 °	-121.332918 °
DWR ID	DWR_RD0524_01_s_2012_932				
Comment Code					
T3 : Trim and thin trees to allow visibility of the ground and room to flood fight.					
Inspector Comment					
Trim walnut trees on the levee slope.

View of large untrimmed walnut trees on landside slope. Fall 2020

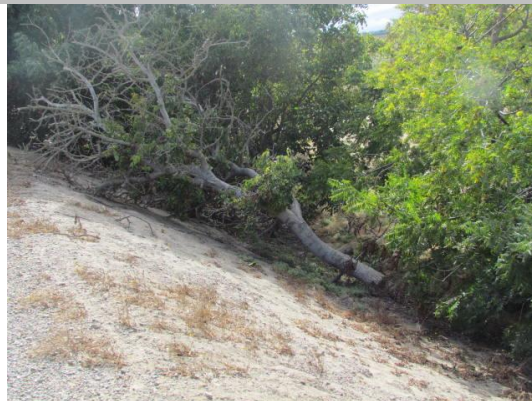
Photo 1 of 1 : FA\_2020\_RD0524\_107\_178\_20200901\_00069.jpg

LM Start	5.40	Rating **	M	Issue No.	178
LM End	5.40	Issue Type +	Ma	Location *	LS
Category	Earthen Levee			GPS Latitude/Longitude	
				Start	End
Item	Encroachments			37.880719 °	37.880719 °
				-121.332899 °	-121.332899 °
DWR ID	DWR_RD0524_01_f_2014_178				
Comment Code					
TR : Tree or limb					
Inspector Comment					
Tree limbs on landside toe.

Looking south at downed tree on landward slope.

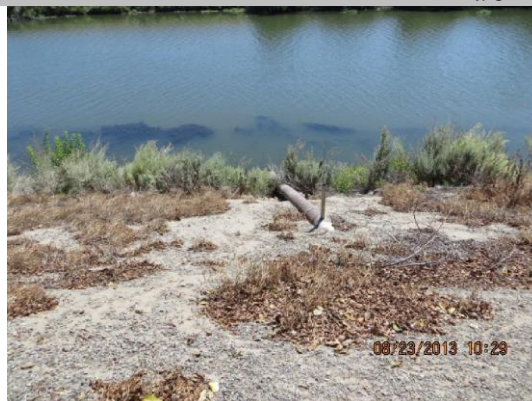
Photo 1 of 3 : UCIP\_FA\_2020\_62007\_30689.jpg

Comment Code					
Inspector Comment					
DS_ID:20630 FS_ID:62007 EP_NO: N/A Repair Type: Non-Urgent EVAL Issue: Pipe Damage Crossing Status: Found UCIP Comments: 06/24/2020 Record updated from Urgent to Non-Urgent. Pipe damage visible on WS. Limited inspection on LS due to overgrown vegetation. Unauthorized encroachment recorded in Levee Log prior to 2011. No permit has been identified authorizing pipe. Crossing appears abandoned. (D.Sanoski - DWR UCIP) 10/2/2018 Same as last inspection. Holes present in pipe pose a potential threat to levee's internal integrity. Recommend video inspection (D. Sanoski - DWR UCIP).11/16/2016 same as previous inspection hole in pipe is still present on WS near toe. This pipe does not appear to be in use. Need to contact owner to determine status of crossing. If the crossing is abandoned or still in use, owner will need to coordinate with the CVFPB to comply with Title 23 requirements. (O. Magana - DWR UCIP)08/23/2013 flap gate damage and does not work at WS toe. Large hole in pipe at WS toe. Pipe appears abandoned and should be done so properly. (W. Wylie - DWR UCIP) FIELD_STRUCT_DESC: *ABANDONED* 1 of 2: 12-inch steel irrigation pipe through the levee, 6 feet below the crown. Pump located on the waterside (WS), no pump found in 2013. Flap gate located on the WS end. [Additional Reference(s): DWR Levee Log, 2004. USACE San Joaquin O&M Manual 7, April 1964, (HLM 5.48) 10-inch pipe listed, Drawing No. 07-04-1490, Sheet 1490/4, (Station 8+01.3)]. FS Date: 6/24/2020 2:53:00 PM

Pipe visible on WS slope.

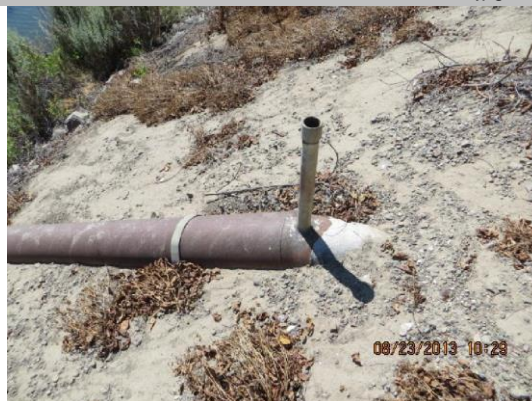
Photo 2 of 3 : UCIP\_FA\_2020\_62007\_30688.jpg

Vent on pipe on WS slope. Possible slurry standpipe that has not yet been used.

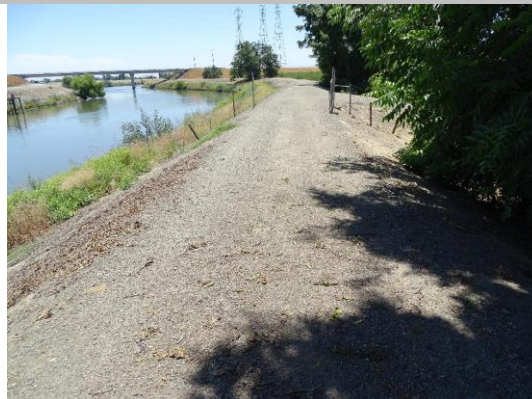
Photo 1 of 3 : UCIP\_FA\_2020\_62011\_89484.jpg

DS\_ID:20659  
FS\_ID:62011  
EP\_NO: N/A  
Repair Type: Non-Urgent  
EVAL Issue: Limited Inspection/No UCIP Evaluation  
Crossing Status: Not Found  
UCIP Comments: 06/24/2020 Record updated from No Action Needed to Non-Urgent. Limited inspection on LS due to overgrown vegetation. Crossing not found. No permit has been identified authorizing pipe. (D.Sanoski - DWR UCIP)  
FIELD\_STRUCT\_DESC: \*REMOVED\* 2 of 2: 10-inch steel drainage pipe through the levee, 6 feet below the crown. Pump on the landside (LS). Flap gate on the waterside (WS) end. [Additional Reference(s): DWR Levee Log, 2004. USACE San Joaquin O&M Manual 7, April 1964, (HLM 5.48)].  
FS Date: 6/24/2020 2:24:00 PM

Top of Levee: view of crown.

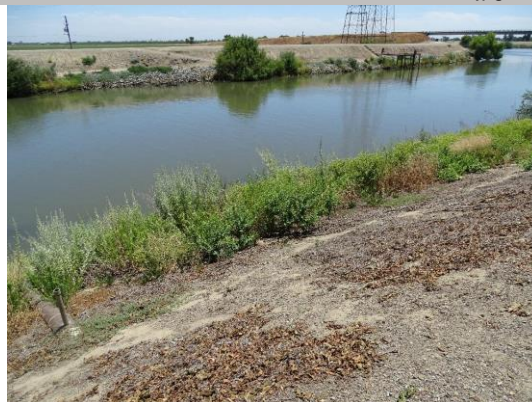
Photo 2 of 3 : UCIP\_FA\_2020\_62011\_89485.jpg

Water-Side: view of WS slope with no sign of pipe.

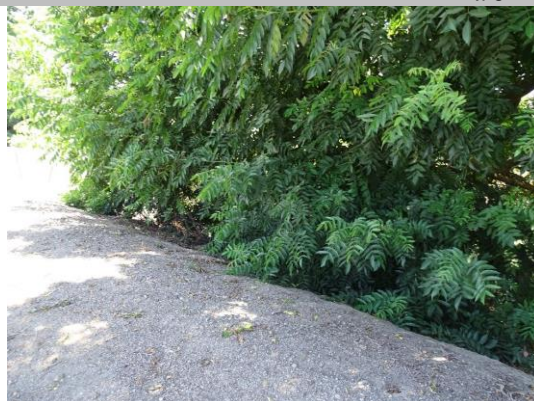
Photo 3 of 3 : UCIP\_FA\_2020\_62011\_89486.jpg

Land-Side: view of LS slope with overgrown vegetation limiting inspection.

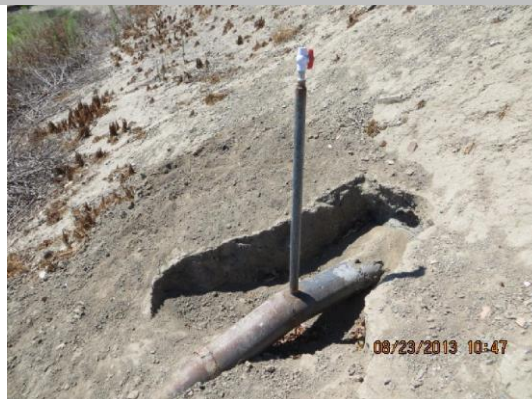
Photo 1 of 3 : UCIP\_FA\_2020\_62013\_37666.jpg

LM Start	5.42	Rating **	M	Issue No.	989	
LM End	5.42	Issue Type +	En	Location *		
Category	Supplemental			GPS Latitude/Longitude		
				Start	End	
Item	DWR UCIP Field Study			37.880358 °	37.880358 °	
				-121.332972 °	-121.332972 °	
DWR ID	24050					
Comment Code						
Inspector Comment						
DS_ID:24050 FS_ID:62013 EP_NO: N/A Repair Type: Non-Urgent EVAL Issue: Limited Inspection/No UCIP Evaluation Crossing Status: Found UCIP Comments: 06/25/2020 Record updated from No Action Needed to Non-Urgent. Limited inspection on LS due to overgrown vegetation. Unauthorized encroachment recorded in Levee Log prior to 2011. No permit has been identified authorizing pipe. (D.Sanoski - DWR UCIP)  FIELD_STRUCT_DESC: 8-inch steel drainage pipe through the levee, 6 feet below the crown. Pipe sleeved through existing 10-inch pipe at same location. FS Date: 6/25/2020 2:24:00 PM

Pipe and vent on WS slope.

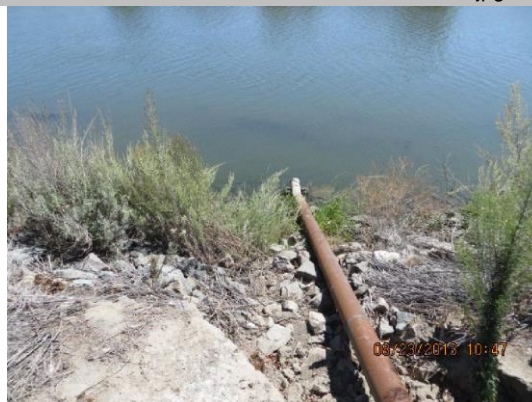
Photo 2 of 3 : UCIP\_FA\_2020\_62013\_37665.jpg

Pipe visible on WS slope.

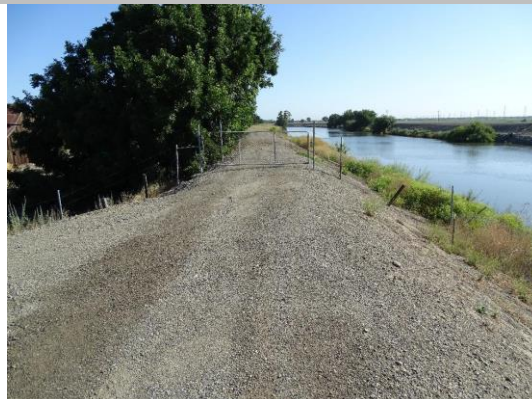
Photo 3 of 3 : UCIP\_FA\_2020\_62013\_89487.jpg

Top of Levee: view of crown.

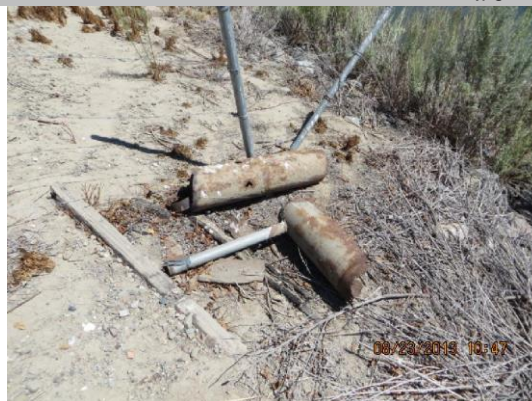
Photo 1 of 3 : UCIP\_FA\_2020\_62014\_30706.jpg

Comment Code						
Inspector Comment						
DS_ID:20631 FS_ID:62014 EP_NO: N/A Repair Type: Non-Urgent EVAL Issue: Limited Inspection/No UCIP Evaluation Crossing Status: Found UCIP Comments: 06/25/2020 Record remains Non-Urgent. Limited inspection on LS due to overgrown vegetation. Unauthorized encroachment recorded in Levee Log prior to 2011. No permit has been identified authorizing pipe. Recommend combining this DSID with 24050 due to same location and 8-inch pipe sleeved through this 10-inch pipe. (D.Sanoski - DWR UCIP) Recent work being done on WS slope. Pipe may still be in use. FIELD_STRUCT_DESC: 10-inch steel drainage pipe through the levee, 6 feet below the crown. Pump not found on the landside (LS). [Additional Reference(s): DWR Levee Log, 2004. USACE San Joaquin O&M Manual 7, April 1964, (HLM 5.50)]. FS Date: 6/25/2020 2:53:00 PM

10-inch pipe debris on the WS slope.

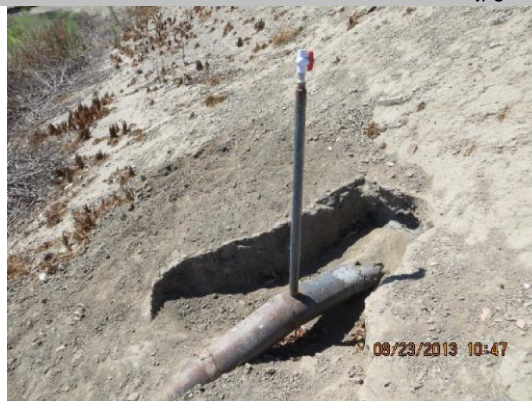
Photo 2 of 3 : UCIP\_FA\_2020\_62014\_30705.jpg

8-inch pipe sleeved through 10-inch pipe with vent on WS slope.

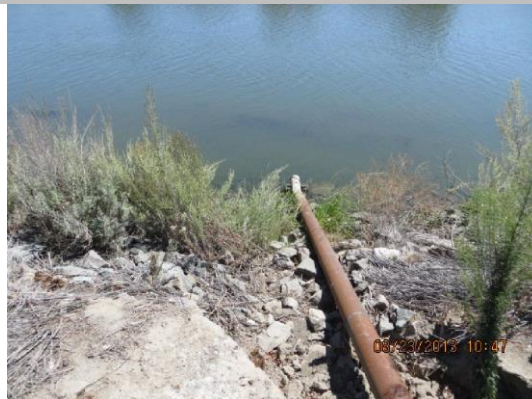
Photo 3 of 3 : UCIP\_FA\_2020\_62014\_30704.jpg

No flap gate on end of pipe at WS toe.

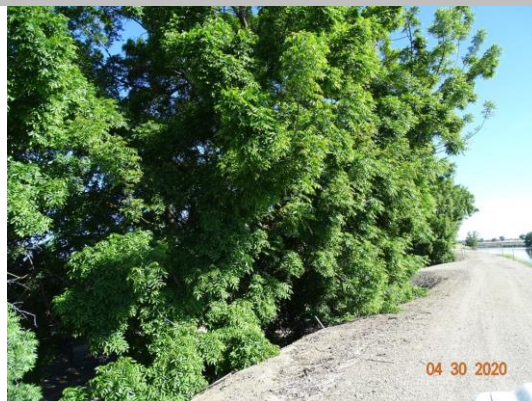
Photo 1 of 1 : FA\_2020\_RD0524\_107\_73\_20200901\_00035.jpg

LM Start	5.43	Rating **	U	Issue No.	73
LM End	5.45	Issue Type +	Ma	Location *	LS
Category	Earthen Levee			GPS Latitude/Longitude	
				Start	End
Item	Trim / Thin Trees			37.880220 °	37.879926 °
				-121.333031 °	-121.333125 °
DWR ID	DWR_RD0524_01_s_2012_73				
Comment Code					
T3 : Trim and thin trees to allow visibility of the ground and room to flood fight.					
Inspector Comment					
Trim walnut trees on the levee slope.

View of trees that need to be trimmed and thinned on landside slope.  
Spring 2020

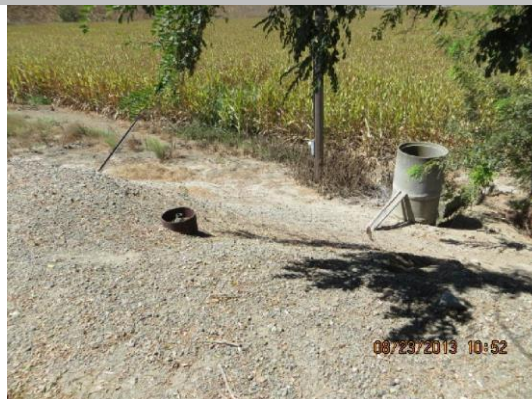
Photo 1 of 3 : UCIP\_FA\_2020\_62015\_30715.jpg

Comment Code						
Inspector Comment						
DS_ID:20632 FS_ID:62015 EP_NO: N/A Repair Type: Non-Urgent EVAL Issue: Unauthorized Encroachment, installed decades prior Crossing Status: Found UCIP Comments: 06/25/2020 Record updated from No Action Needed to Non-Urgent. Unauthorized encroachment recorded in Levee Log prior to 2011. No permit has been identified authorizing pipe. (D.Sanoski - DWR UCIP)  FIELD_STRUCT_DESC: 1 of 2: 12-inch steel irrigation pipe through the levee, 1 foot below the crown. Pump in pump house on the waterside (WS) slope. Concrete headwall on the WS slope. Vent in 12-inch steel standpipe on the landside (LS) shoulder. 42-inch concrete standpipe and power pole on the LS toe. 1.5-inch galvanized iron electrical conduit at same location. [Additional Reference(s): USACE San Joaquin O&M Manual 7, April 1964, (HLM 5.59)]. FS Date: 6/25/2020 2:54:00 PM

Vent in standpipe on LS shoulder. Concrete standpipe on LS toe.

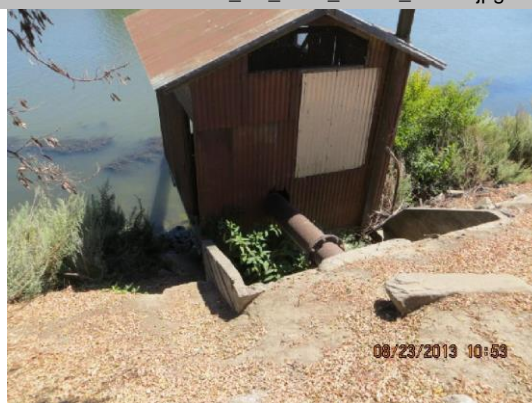
Photo 2 of 3 : UCIP\_FA\_2020\_62015\_30714.jpg

Pumphouse and concrete headwall on WS toe.

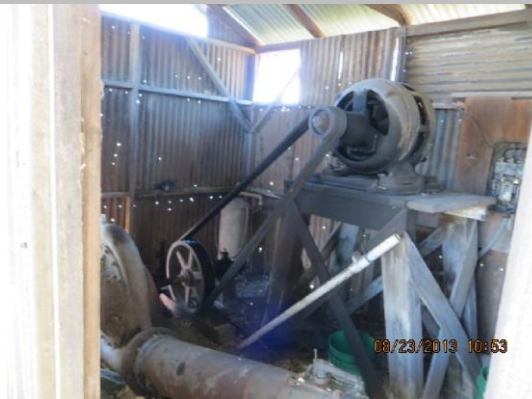
Photo 3 of 3 : UCIP\_FA\_2020\_62015\_30713.jpg

Pump and butterfly valve in pumphouse on WS toe.

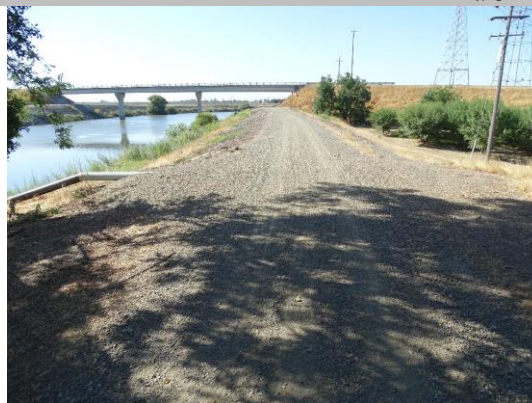
Photo 1 of 3 : UCIP\_FA\_2020\_62017\_89496.jpg

DS\_ID:20658  
FS\_ID:62017  
EP\_NO: N/A  
Repair Type: Non-Urgent  
EVAL Issue: Unauthorized Encroachment, installed decades prior  
Crossing Status: Not Found  
UCIP Comments: 06/25/2020 Record updated from No Action Needed to Non-Urgent. Unauthorized encroachment recorded in Levee Log prior to 2011. No permit has been identified authorizing pipe. (D.Sanoski - DWR UCIP)

Top of Levee: view of crown.

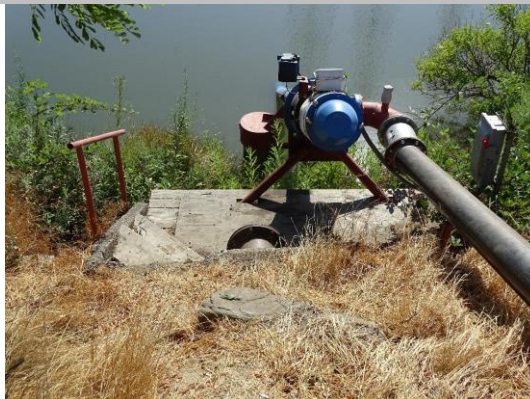
Photo 2 of 3 : UCIP\_FA\_2020\_62017\_89497.jpg

Water-Side: view of WS slope with new assembly and capped 12-inch pipe out of headwall.

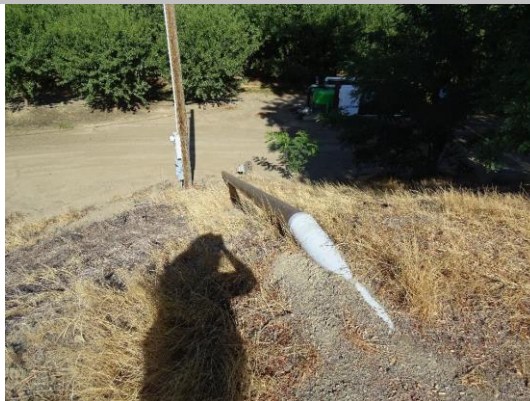
Photo 3 of 3 : UCIP\_FA\_2020\_62017\_89498.jpg

Land-Side: view of LS slope with pipe, powerpole, and filter plant off toe.

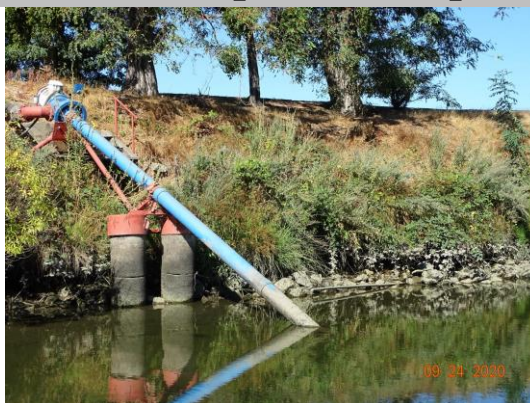
Photo 1 of 2 : SJR2019\_RD0524U01RM46.06\_01.JPG

LM Start	5.53	Rating **	M	Issue No.	6
LM End	5.53	Issue Type +	Ma	Location *	WS
Category	Supplemental			GPS Latitude/Longitude	
				Start	End
Item	DWR Erosion Survey			37.878798 °	37.878798 °
				-121.333111 °	-121.333111 °
DWR ID	RD0524U01RM46.06				
Comment Code					
Inspector Comment					
Site ID: RD0524U01RM46.06 09/24/2020: From 2014 to present, no significant changes were observed during the annual survey. Vegetation is limiting the view but undercutting of the levee toe is still visible. 08/13/2013: Larger trees are at the levee shoulder, and an irrigation pump station is next to the erosion site.

9/24/2020: View of the erosion immediately downstream of irrigation pipe.

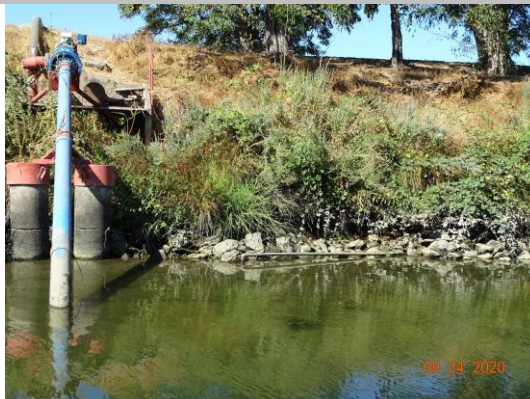
Photo 2 of 2 : SJR2019\_RD0524U01RM46.06\_03.JPG

9/24/2020: Close-up view of the undercutting.

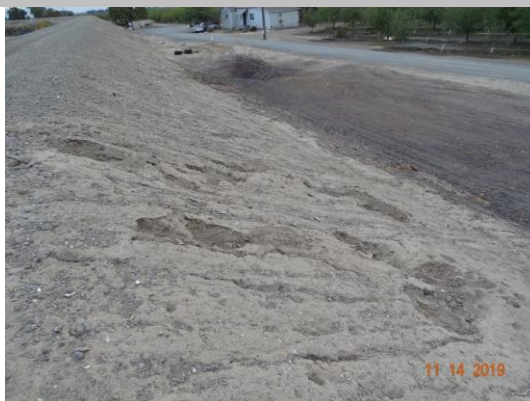
Photo 1 of 1 : FA\_2020\_RD0524\_107\_141\_20200901\_00059.jpg

LM Start	5.64	Rating **	M	Issue No.	141
LM End	5.72	Issue Type +	Ma	Location *	LS
Category	Earthen Levee			GPS Latitude/Longitude	
				Start	End
Item	Animal Control			37.877361 °	37.876251 °
				-121.332368 °	-121.332618 °
DWR ID	DWR_RD0524_01_s_2019_141				
Comment Code					
A3 : No rodents visible, but rodent burrows visible; need to backfill and compact or grout burrows.					
Inspector Comment

View of multiple rodent holes on landside slope. Fall 2019

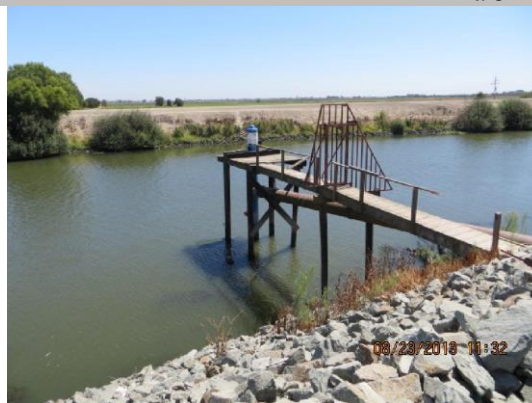
Photo 1 of 3 : UCIP\_FA\_2020\_62021\_31223.jpg

Comment Code						
Inspector Comment						
DS_ID:20633 FS_ID:62021 EP_NO: N/A Repair Type: Non-Urgent EVAL Issue: Unauthorized Encroachment, installed decades prior Crossing Status: Found UCIP Comments: 06/25/2020 Record updated from No Action Needed to Non-Urgent. Unauthorized encroachment recorded in Levee Log prior to 2011. No permit has been identified authorizing pipe. (D.Sanoski - DWR UCIP)  FIELD_STRUCT_DESC: 21-inch steel irrigation pipe through the levee, 7 feet below the crown. Pump on pile structure in stream on the waterside (WS) toe. Timber walkway to the pump. Service pole on the WS shoulder. 5-foot concrete standpipe on the landside (LS) toe. [Additional Reference(s): DWR Levee Log, 2004. USACE San Joaquin O&M Manual 7, April 1964, (HLM 5.71) 20-inch pipe listed]. FS Date: 6/25/2020 2:54:00 PM

Pump on wooden pile structure on WS.

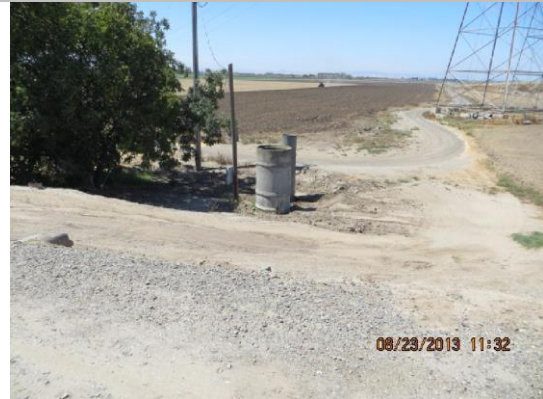
Photo 2 of 3 : UCIP\_FA\_2020\_62021\_31222.jpg

Power pole and concrete standpipe on LS toe.

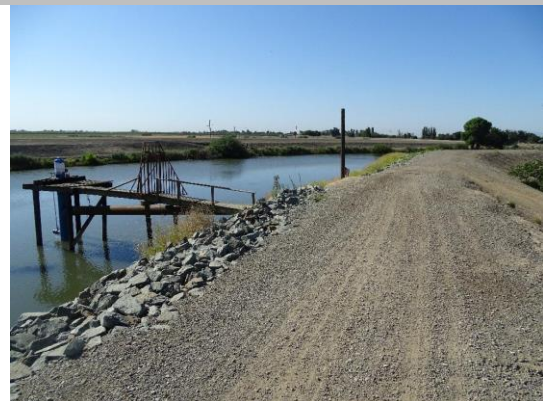
Photo 3 of 3 : UCIP\_FA\_2020\_62021\_89499.jpg

Top of Levee: view of crown.

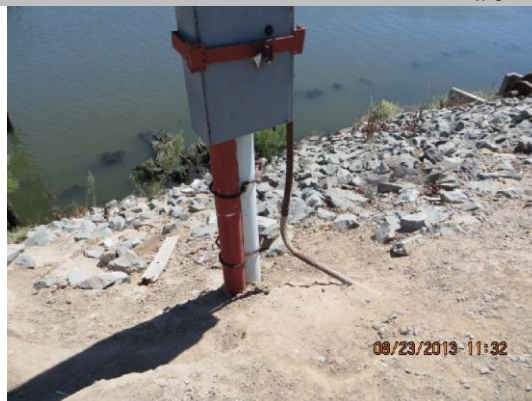
Photo 1 of 3 : UCIP\_FA\_2020\_62030\_37668.jpg

LM Start	5.65	Rating **	M	Issue No.	994	
LM End	5.65	Issue Type +	En	Location *		
Category	Supplemental			GPS Latitude/Longitude		
				Start	End	
Item	DWR UCIP Field Study			37.877147 °	37.877147 °	
				-121.332310 °	-121.332310 °	
DWR ID	24051					
Comment Code						
Inspector Comment						
DS_ID:24051 FS_ID:62030 EP_NO: N/A Repair Type: Non-Urgent EVAL Issue: Unauthorized Encroachment, installed decades prior Crossing Status: Found UCIP Comments: 06/25/2020 Record updated from No Action Needed to Non-Urgent. Unauthorized encroachment recorded in Levee Log prior to 2011. No permit has been identified authorizing pipe. (D.Sanoski - DWR UCIP)  FIELD_STRUCT_DESC: 1.5-inch galvanized iron electrical conduit through the levee, 1.5 feet below the crown. Power pole and meter box on the landside (LS) toe. Electrical box on pole at the waterside (WS) shoulder. FS Date: 6/25/2020 2:55:00 PM

Conduit visible on WS shoulder.

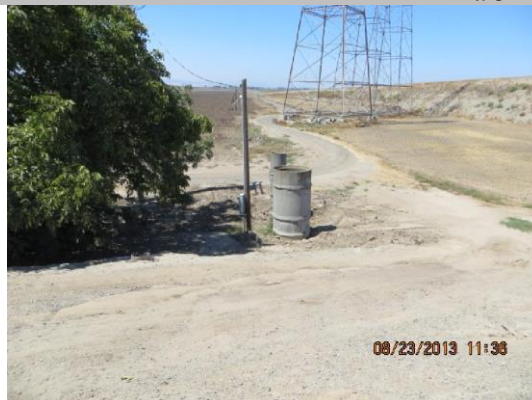
Photo 2 of 3 : UCIP\_FA\_2020\_62030\_37667.jpg

Conduit visible at base of power pole on LS toe.

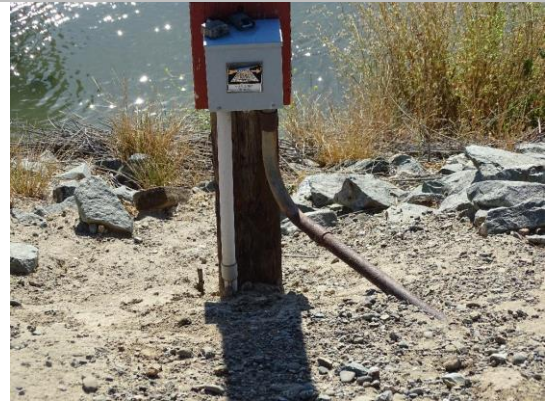
Photo 3 of 3 : UCIP\_FA\_2020\_62030\_89502.jpg

Water-Side: view of electrical conduit through levee.

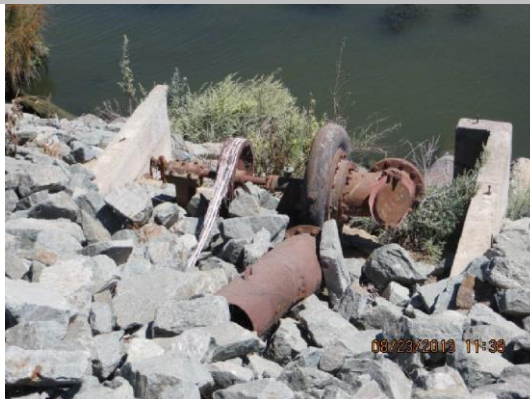
Photo 1 of 3 : UCIP\_FA\_2020\_62116\_30716.jpg

DS\_ID:20634  
FS\_ID:62116  
EP\_NO: N/A  
Repair Type: Non-Urgent  
EVAL Issue: Unauthorized Encroachment, installed decades prior  
Crossing Status: Found  
UCIP Comments: 06/25/2020 Record updated from No Action Needed to Non-Urgent. Unauthorized encroachment recorded in Levee Log prior to 2011. No permit has been identified authorizing pipe. Crossing appears abandoned. (D.Sanoski - DWR UCIP)

Abandoned pump and pipe on WS slope.
