## Flood Control Project Maintenance Levee Inspections

### Fall 2020 Levee Maintenance Deficiency Summary Report

#### San Joaquin River Basin

**Reclamation District No. 0524 Middle Roberts Island**

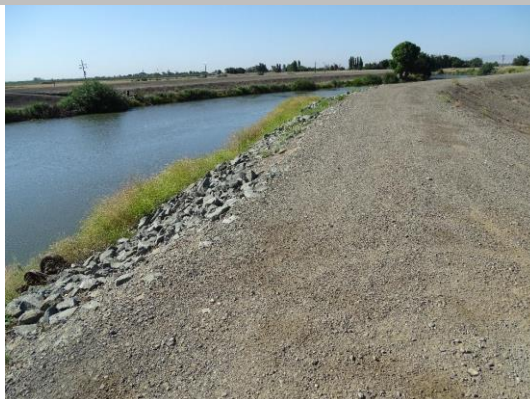
Photo 2 of 3 : UCIP\_FA\_2020\_62116\_89594.jpg

Top of Levee: view of crown.

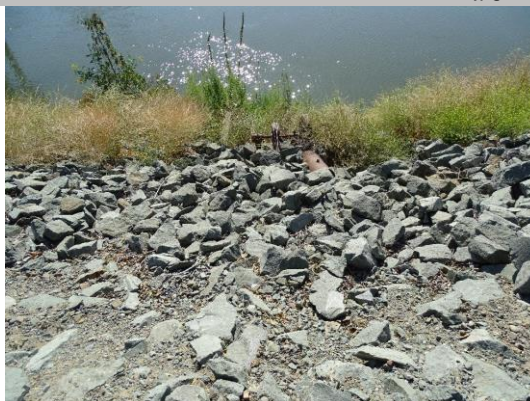
Photo 3 of 3 : UCIP\_FA\_2020\_62116\_89595.jpg

Water-Side: view of WS slope and abandoned pipe and pump.

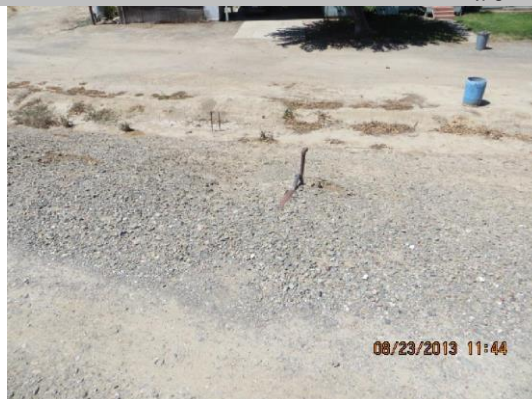
Photo 1 of 3 : UCIP\_FA\_2020\_62117\_30761.jpg

LM Start	5.74	Rating **	M	Issue No.	996	
LM End	5.74	Issue Type +	En	Location *		
Category	Supplemental			GPS Latitude/Longitude		
				Start		End
Item	DWR UCIP Field Study			37.876001 °		37.876001 °
				-121.332725 °		-121.332725 °
DWR ID	20649					
Comment Code						
Inspector Comment						
DS_ID:20649 FS_ID:62117 EP_NO: N/A Repair Type: Non-Urgent EVAL Issue: Unauthorized Encroachment, installed decades prior Crossing Status: Found UCIP Comments: 06/25/2020 Record remains Non-Urgent. Unauthorized encroachment recorded in Levee Log prior to 2011. Crossing appears abandoned. (D.Sanoski - DWR UCIP)  FIELD_STRUCT_DESC: *ABANDONED* 2.25-inch steel conduit for a 1-inch plastic electrical conduit through the levee, 0.25 feet below the crown. Lines exposed on both slopes. [Additional Reference(s): DWR Levee Log, 2004]. FS Date: 6/25/2020 2:55:00 PM

Steel conduit and electrical conduit visible on the LS shoulder.

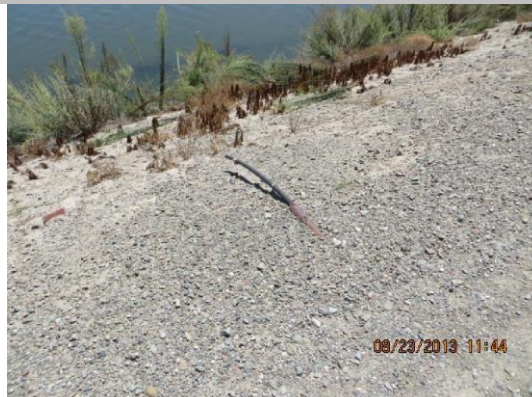
Photo 2 of 3 : UCIP\_FA\_2020\_62117\_30760.jpg

Steel conduit and electrical conduit visible on the WS shoulder.

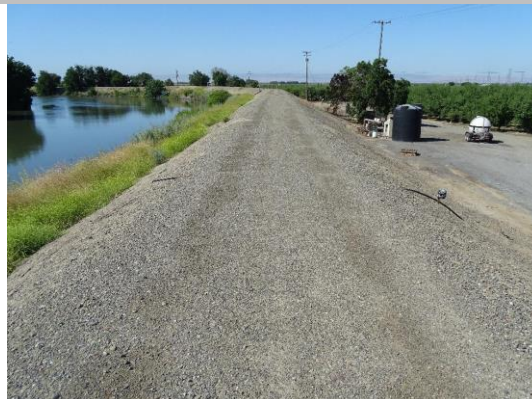
Photo 3 of 3 : UCIP\_FA\_2020\_62117\_89597.jpg

Top of Levee: view of crown.

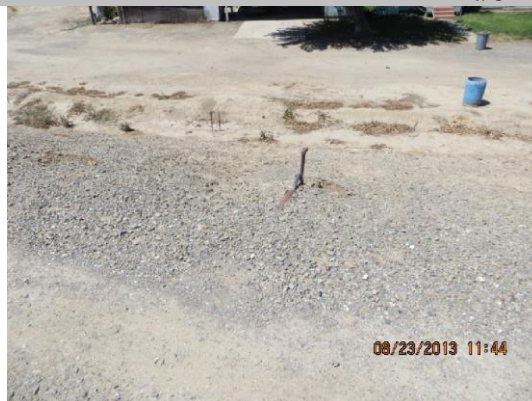
Photo 1 of 3 : UCIP\_FA\_2020\_62119\_30781.jpg

DS\_ID:20635  
 FS\_ID:62119  
 EP\_NO: N/A  
 Repair Type: Non-Urgent  
 EVAL Issue: Unauthorized Encroachment, installed decades prior  
 Crossing Status: Indicator Found  
 UCIP Comments: 06/25/2020 Record remains Non-Urgent.  
 Unauthorized encroachment recorded in Levee Log prior to 2011.  
 Crossing appears abandoned. This record is sleeved through DSID 20649; this record is a duplicate and should be removed. (D.Sanoski - DWR UCIP)  
 FIELD\_STRUCT\_DESC: \*ABANDONED\* 1-inch steel water line through the levee, 1 foot below the crown. Pipe visible only on the landside (LS) shoulder.  
 FS Date: 6/25/2020 2:56:00 PM

Steel waterline visible on LS shoulder.

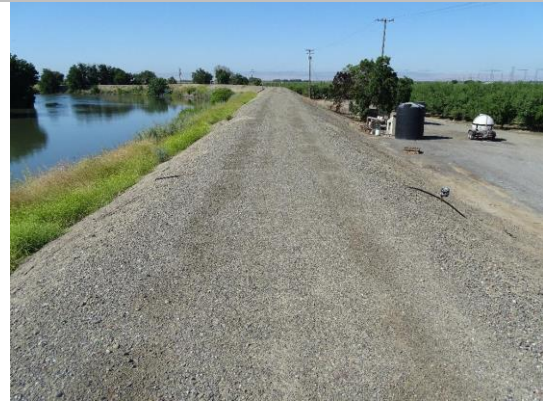
Photo 2 of 3 : UCIP\_FA\_2020\_62119\_89605.jpg

Top of Levee: view of crown.

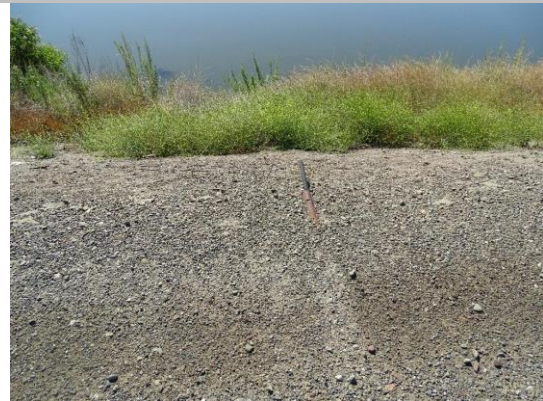
Photo 3 of 3 : UCIP\_FA\_2020\_62119\_89606.jpg

Water-Side: view of WS slope and abandoned conduit.

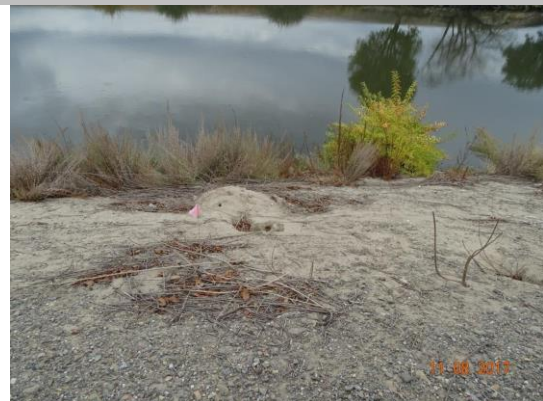
Photo 1 of 1 : FA\_2020\_RD0524\_107\_271\_20200901\_00117.jpg

LM Start	5.76	Rating **	M	Issue No.	271
LM End	5.76	Issue Type +	Ma	Location *	WS
Category	Earthen Levee			GPS Latitude/Longitude	
				Start	End
Item	Animal Control			37.875631 °	37.875631 °
				-121.332907 °	-121.332907 °
DWR ID	DWR_RD0524_01_f_2017_271				
Comment Code					
A3 : No rodents visible, but rodent burrows visible; need to backfill and compact or grout burrows.					
Inspector Comment

Looking east at the waterside slope.

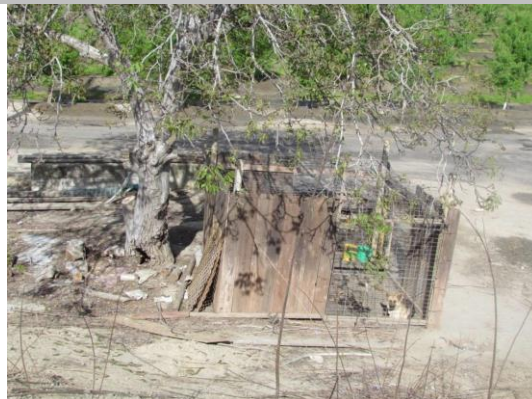
Photo 1 of 1 : FA\_2020\_RD0524\_107\_181\_20200901\_00071.jpg

LM Start	5.77	Rating **	U	Issue No.	181
LM End	5.77	Issue Type +	En	Location *	LS
Category	Earthen Levee			GPS Latitude/Longitude	
				Start	End
Item	Encroachments			37.875545 °	37.875545 °
				-121.332952 °	-121.332952 °
DWR ID	DWR_RD0524_01_s_2017_181				
Comment Code					
BU : Building					
Inspector Comment					
Animal kennels at landside toe.

Looking west at animal pen at landward toe.

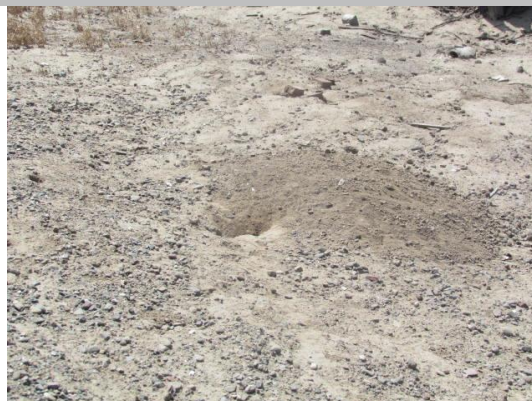
Photo 1 of 1 : FA\_2020\_RD0524\_107\_197\_20200901\_00079.jpg

LM Start	5.77	Rating **	M	Issue No.	197
LM End	5.81	Issue Type +	Ma	Location *	LS
Category	Earthen Levee			GPS Latitude/Longitude	
				Start	End
Item	Animal Control			37.875545 °	37.875076 °
				-121.332952 °	-121.333223 °
DWR ID	DWR_RD0524_01_f_2019_197				
Comment Code					
A3 : No rodents visible, but rodent burrows visible; need to backfill and compact or grout burrows.					
Inspector Comment					
Several rodent holes on landside slope and levee crown. LMA backfilled holes but no rodent control measures are in place.

Looking north at typical view of rodent holes on landward slope.

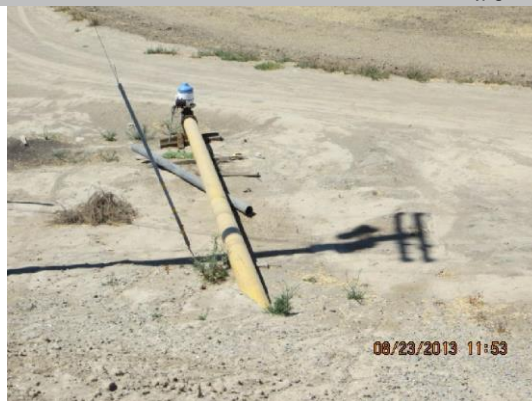
Photo 1 of 3 : UCIP\_FA\_2020\_62120\_30787.jpg

DS\_ID:20650  
FS\_ID:62120  
EP\_NO: N/A  
Repair Type: Non-Urgent  
EVAL Issue: Unauthorized Encroachment, installed decades prior  
Crossing Status: Found  
UCIP Comments: 06/25/2020 Record updated from No Action Needed to Non-Urgent. Unauthorized encroachment recorded in Levee Log prior to 2011. No permit has been identified authorizing pipe. (D.Sanoski - DWR UCIP)

Pipe and pump visible on LS toe.

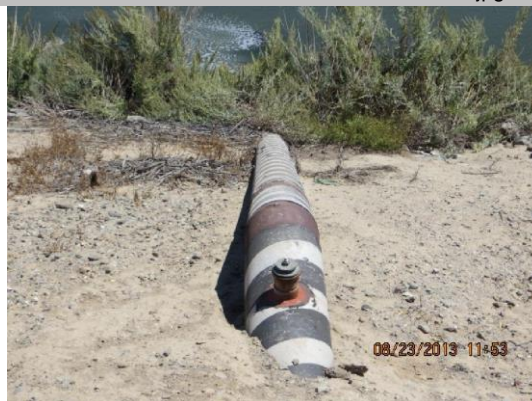
Photo 2 of 3 : UCIP\_FA\_2020\_62120\_30786.jpg

Pipe and siphon breaker visible on WS shoulder.

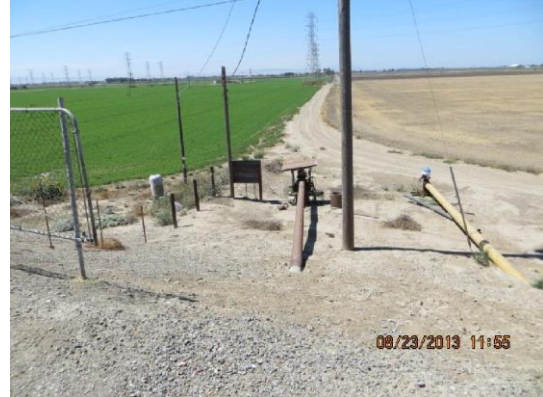
Photo 2 of 3 : UCIP\_FA\_2020\_62121\_30784.jpg

DS\_ID:20636  
FS\_ID:62121  
EP\_NO: N/A  
Repair Type: Non-Urgent  
EVAL Issue: Unauthorized Encroachment, installed decades prior  
Crossing Status: Found  
UCIP Comments: 06/25/2020 Record remains Non-Urgent.  
Unauthorized encroachment recorded in Levee Log prior to 2011. No permit has been identified authorizing pipe. (D.Sanoski - DWR UCIP)  
Apparent leak on WS shoulder at concrete riser. Erosion under pipe. This may have been fixed when the pipe was sleeved with a PVC liner.  
FIELD\_STRUCT\_DESC: 10-inch steel drainage pipe through the levee, 5 feet below the crown. Pump on the landside (LS). Siphon breaker in a 36-inch concrete riser unit on the waterside (WS) shoulder. Power pole at the LS toe. Polyvinyl chloride liner sleeved inside steel pipe.  
[Additional Reference(s): DWR Levee Log, 2004. USACE San Joaquin O&M Manual 7, April 1964, (HLM 5.88)].  
FS Date: 6/25/2020 2:56:00 PM

Pipe, pump, power pole, and meter off LS toe.

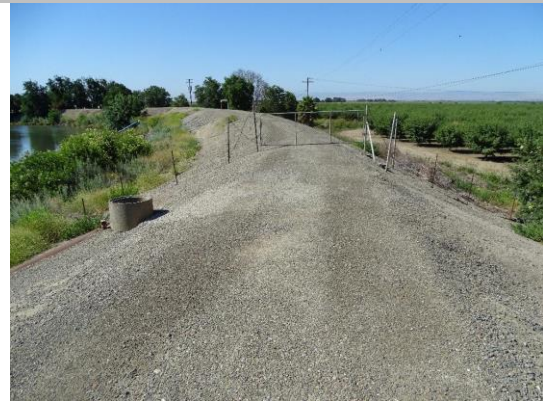
Photo 3 of 3 : UCIP\_FA\_2020\_62121\_89611.jpg

Top of Levee: view of crown.

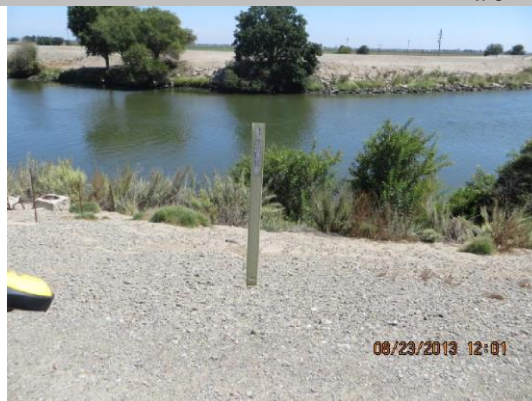
Photo 1 of 3 : UCIP\_FA\_2020\_62122\_31249.jpg

LM Start	5.82	Rating **	M	Issue No.	1000	
LM End	5.82	Issue Type +	En	Location *		
Category	Supplemental			GPS Latitude/Longitude		
				Start		End
Item	DWR UCIP Field Study			37.874829 °		37.874829 °
				-121.333265 °		-121.333265 °
DWR ID	20656					
Comment Code						
Inspector Comment						
DS_ID:20656 FS_ID:62122 EP_NO: N/A Repair Type: Non-Urgent EVAL Issue: Safety Issue Crossing Status: Indicator Found UCIP Comments: 06/25/2020 Record remains Non-Urgent. No inspection records were available to determine status of line through the levee. (D.Sanoski - DWR UCIP) Need to verify gasoline exists and if so improve signage. FIELD_STRUCT_DESC: Gas line marker sign on the waterside (WS) shoulder. FS Date: 6/25/2020 2:57:00 PM

Gasline marker on WS shoulder.

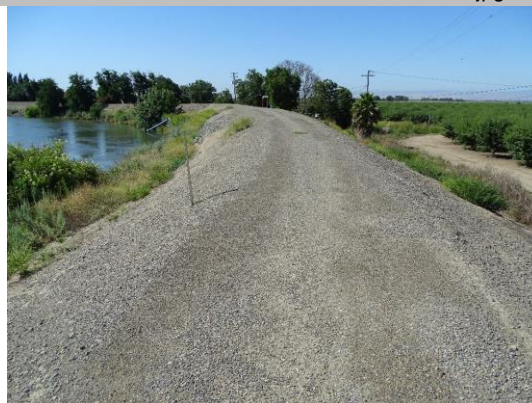
Photo 2 of 3 : UCIP\_FA\_2020\_62122\_89615.jpg

Top of Levee: view of crown.

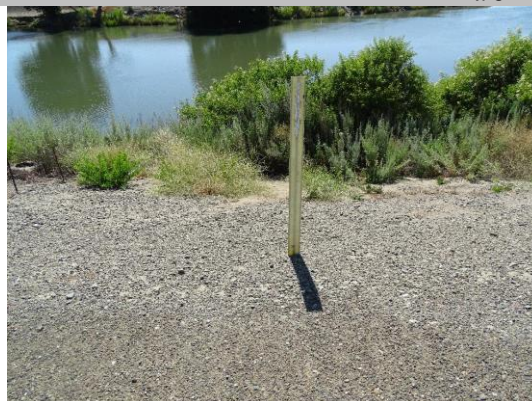
Photo 3 of 3 : UCIP\_FA\_2020\_62122\_89616.jpg

Water-Side: view of WS slope and faded gas marker on shoulder.

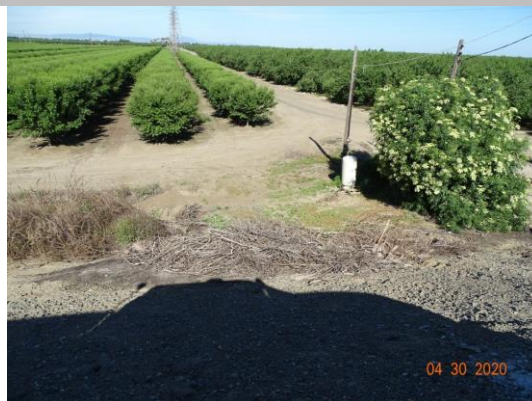
Photo 1 of 1 : FA\_2020\_RD0524\_107\_167\_20200901\_00067.jpg

LM Start	5.83	Rating **	M	Issue No.	167
LM End	5.83	Issue Type +	En	Location *	LS
Category	Earthen Levee			GPS Latitude/Longitude	
				Start	End
Item	Encroachments			37.874789 °	37.874789 °
				-121.333306 °	-121.333306 °
DWR ID	DWR_RD0524_01_s_2020_167				
Comment Code					
PR : Prunings					
Inspector Comment

View of prunings on landside slope. Spring 2020

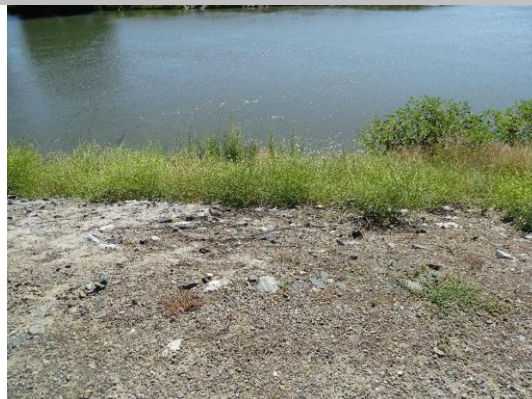
Photo 2 of 3 : UCIP\_FA\_2020\_62123\_89619.jpg

DS\_ID:20637  
FS\_ID:62123  
EP\_NO: N/A  
Repair Type: Non-Urgent  
EVAL Issue: Pipe Not Found  
Crossing Status: Not Found  
UCIP Comments: 06/25/2020 Record updated from No Action Needed to Non-Urgent. Crossing not found. Unauthorized encroachment recorded in Levee Log prior to 2011. No permit has been identified authorizing pipe. (D.Sanoski - DWR UCIP)

Water-Side: view of WS slope with no sign of pipe or concrete structure.

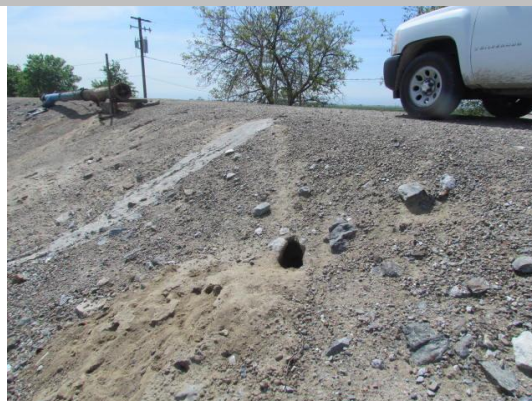
Photo 1 of 1 : FA\_2020\_RD0524\_107\_75\_20200901\_00036.jpg

LM Start	5.86	Rating **	M	Issue No.	75
LM End	5.88	Issue Type +	Ma	Location *	WS
Category	Earthen Levee			GPS Latitude/Longitude	
				Start	End
Item	Animal Control			37.874240 °	37.874002 °
				-121.333187 °	-121.333027 °
DWR ID	DWR_RD0524_01_s_2012_75				
Comment Code					
A1 : Exterminate rodents and backfill and compact or grout burrows.					
Inspector Comment					
Rodent burrows are on waterside and landside levee slopes.

View of rodent holes on waterside slope.

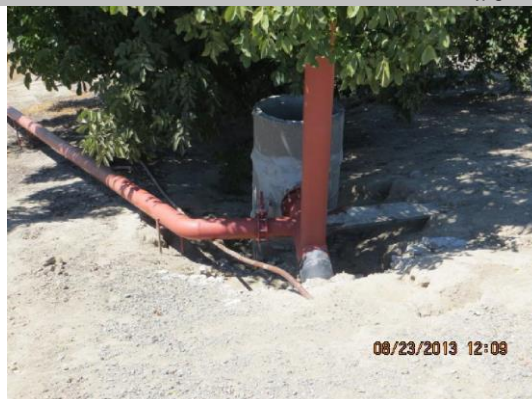
Photo 1 of 3 : UCIP\_FA\_2020\_62124\_30829.jpg

Comment Code						
Inspector Comment						
DS_ID:20638 FS_ID:62124 EP_NO: N/A Repair Type: Non-Urgent EVAL Issue: Unauthorized Encroachment, installed decades prior Crossing Status: Found UCIP Comments: 06/25/2020 Record remains Non-Urgent. Unauthorized encroachment recorded in Levee Log prior to 2011. No permit has been identified authorizing pipe. Erosion has been repaired around pipe. (D.Sanoski - DWR UCIP) Heavy erosion around pipe upstream of standpipe on LS slope. Verify pipe is not leaking and repair erosion on LS slope. FIELD_STRUCT_DESC: 12-inch steel irrigation pipe through the levee, 10 feet below the crown. Slant pump on pier at the waterside (WS) toe. 10-inch steel standpipe on the landside (LS) slope. 42-inch concrete standpipe on the LS slope. Filter plant and power pole on the LS toe. 1.5-inch galvanized iron electrical conduit at same location. [Additional Reference(s): DWR Levee Log, 2004. USACE San Joaquin O&M Manual 7, April 1964, (HLM 5.93)]. FS Date: 6/25/2020 2:57:00 PM

Butterfly valves and standpipes on LS slope along with electrical conduit.

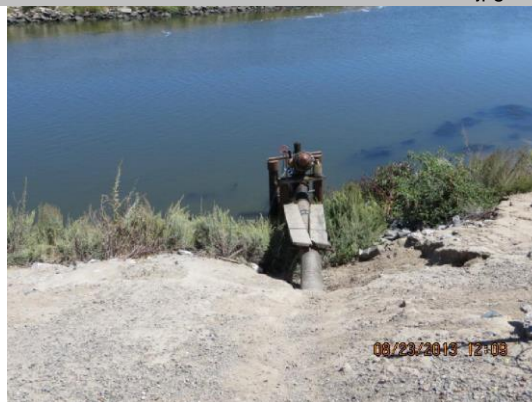
Photo 2 of 3 : UCIP\_FA\_2020\_62124\_30828.jpg

Slant pump on WS toe.

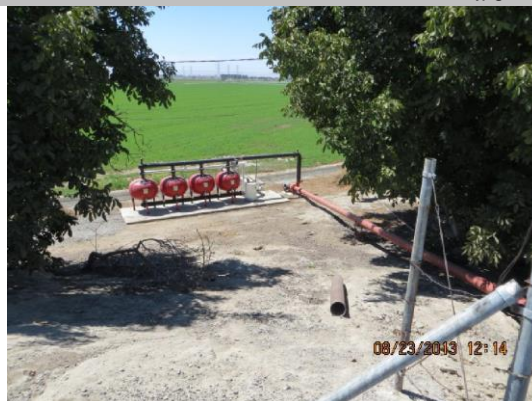
Photo 3 of 3 : UCIP\_FA\_2020\_62124\_30827.jpg

Filter pump on LS toe.

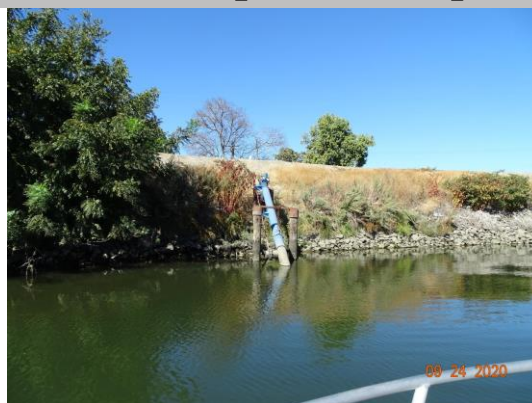
Photo 1 of 2 : SJR2019\_RD0524U01RM46.39\_01.JPG

09/24/2020: From 2013 to present, no significant changes were observed during the annual survey.

08/07/2012: The erosion is near a water-intake structure. Pipe leakage likely caused the erosion.

9/24/2020: Overview of the pipe crossing at the erosion site.

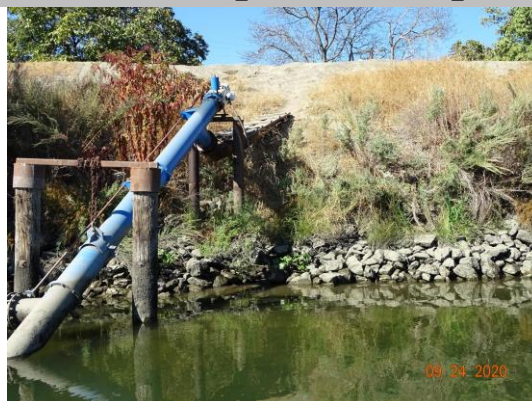
Photo 2 of 2 : SJR2019\_RD0524U01RM46.39\_02.JPG

9/24/2020: Close-up view of the erosion.

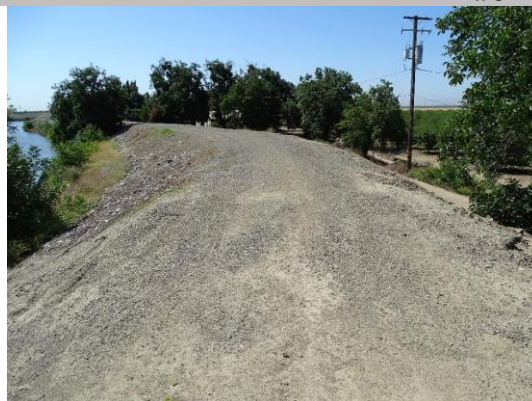
Photo 1 of 3 : UCIP\_FA\_2020\_62125\_89624.jpg

DS\_ID:20639  
FS\_ID:62125  
EP\_NO: N/A  
Repair Type: Non-Urgent  
EVAL Issue: Pipe Not Found  
Crossing Status: Not Found  
UCIP Comments: 06/25/2020 Record updated from No Action Needed to Non-Urgent. Crossing not found. Unauthorized encroachment recorded in Levee Log prior to 2011. No permit has been identified authorizing pipe. (D.Sanoski - DWR UCIP)

Top of Levee: view of crown.

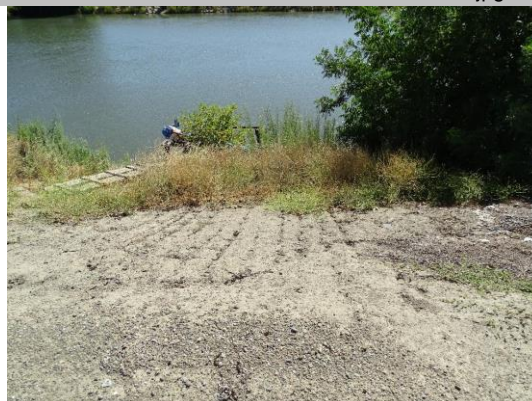
Photo 2 of 3 : UCIP\_FA\_2020\_62125\_89625.jpg

Water-Side: view of WS slope with no sign of crossing.

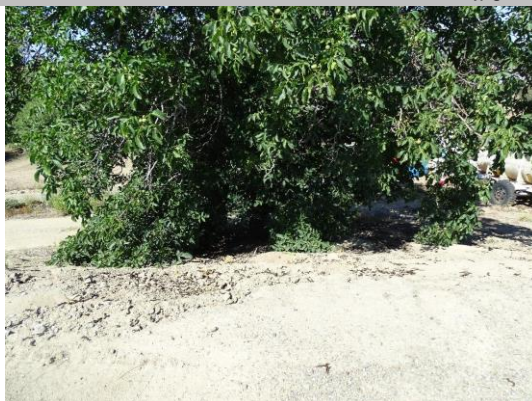
Photo 3 of 3 : UCIP\_FA\_2020\_62125\_89626.jpg

Land-Side: view of LS slope with no sign of crossing.

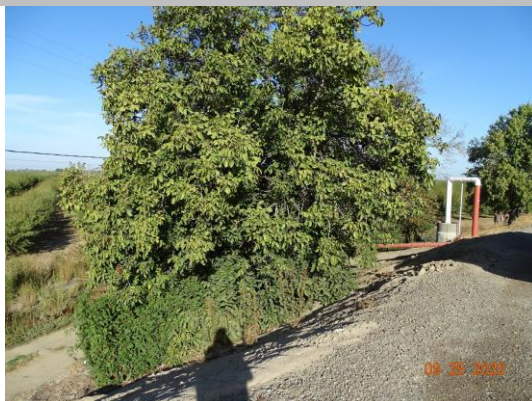
Photo 1 of 1 : FA\_2020\_RD0524\_107\_98\_20201005\_00217.jpg

LM Start	5.87	Rating **	M	Issue No.	98
LM End	5.87	Issue Type +	Ma	Location *	LS
Category	Earthen Levee			GPS Latitude/Longitude	
				Start	End
Item	Trim / Thin Trees			37.874085 °	37.874085 °
				-121.333154 °	-121.333154 °
DWR ID	DWR_RD0524_01_s_2012_98				
Comment Code					
T1 : Trim trees to at least five feet above ground level.					
Inspector Comment					
Untrimmed walnut tree on landside slope.

View of large untrimmed walnut tree on landside slope. Fall 2020

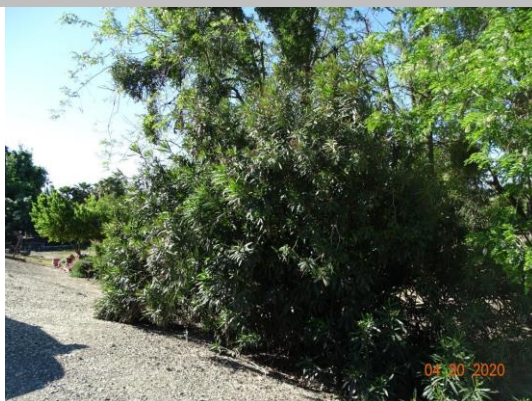
Photo 1 of 1 : FA\_2020\_RD0524\_107\_200\_20200901\_00082.jpg

LM Start	5.92	Rating **	U	Issue No.	200
LM End	5.92	Issue Type +	En	Location *	LS
Category	Earthen Levee			GPS Latitude/Longitude	
				Start	End
Item	Vegetation			37.873623 °	37.873623 °
				-121.332585 °	-121.332585 °
DWR ID	DWR_RD0524_01_f_2015_200				
Comment Code					
V6 : Landscaping					
Inspector Comment					
Oleander bush on landside slope.

View of oleander on landside slope. Spring 2020

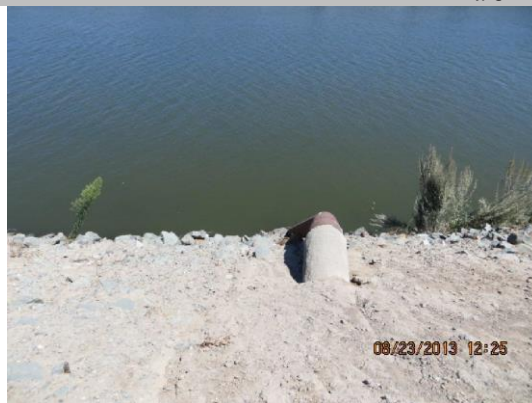
Photo 1 of 3 : UCIP\_FA\_2020\_62126\_30843.jpg

LM Start	6.08	Rating **	M	Issue No.	1004
LM End	6.08	Issue Type +	En	Location *	
Category	Supplemental			GPS Latitude/Longitude	
				Start	End
Item	DWR UCIP Field Study			37.872060 °	37.872060 °
				-121.330512 °	-121.330512 °
DWR ID	20640				
Comment Code					
Inspector Comment					
DS_ID:20640 FS_ID:62126 EP_NO: N/A Repair Type: Non-Urgent EVAL Issue: Unauthorized Encroachment, installed decades prior Crossing Status: Found UCIP Comments: 06/25/2020 Record updated from No Action Needed to Non-Urgent. Unauthorized encroachment recorded in Levee Log prior to 2011. (D.Sanoski - DWR UCIP)  FIELD_STRUCT_DESC: 14-inch concrete encased steel drainage pipe through the levee, 3.5 feet below the crown. Pump in drainage ditch 500 feet off the landside (LS) toe. FS Date: 6/25/2020 2:58:00 PM

Pipe visible on WS shoulder.

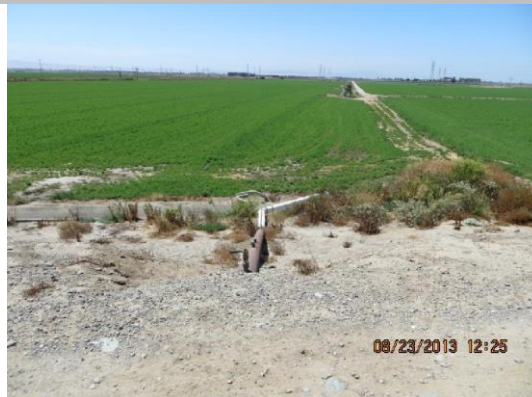
Photo 2 of 3 : UCIP\_FA\_2020\_62126\_30842.jpg

Pipe and siphon breaker visible on LS shoulder. Pump in canal 500-feet off LS toe.

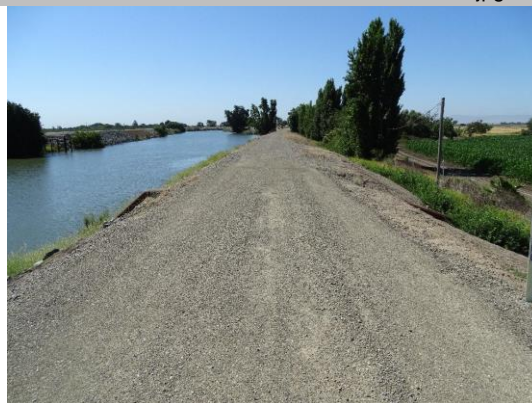
Photo 3 of 3 : UCIP\_FA\_2020\_62126\_89627.jpg

Top of Levee: view of crown.

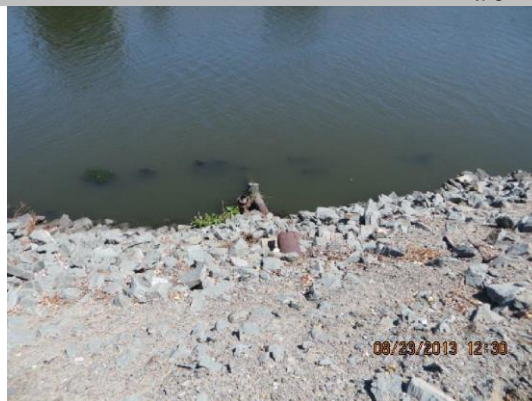
Photo 1 of 3 : UCIP\_FA\_2020\_62127\_30910.jpg

Comment Code						
Inspector Comment						
DS_ID:20641 FS_ID:62127 EP_NO: N/A Repair Type: Non-Urgent EVAL Issue: Unauthorized Encroachment, installed decades prior Crossing Status: Found UCIP Comments: 06/25/2020 Record remains Non-Urgent. Unauthorized encroachment recorded in Levee Log prior to 2011. No permit has been identified authorizing pipe. Crossing appears abandoned. (D.Sanoski - DWR UCIP) FIELD_STRUCT_DESC: *ABANDONED* 10-inch irrigation pipe of an unknown material through the levee, 12 feet below the crown. Pump on the waterside (WS) slope. [Additional Reference(s): DWR Levee Log, 2004. USACE San Joaquin O&M Manual 7, April 1964, (HLM 6.22)]. FS Date: 6/25/2020 2:58:00 PM

Pump and open pipe visible on WS slope.

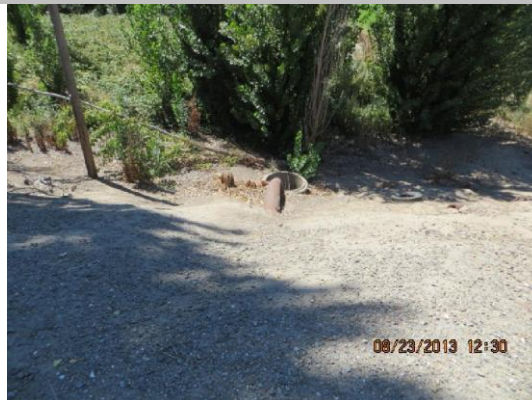
Photo 2 of 3 : UCIP\_FA\_2020\_62127\_30909.jpg

Pipe and concrete standpipe visible on LS toe.

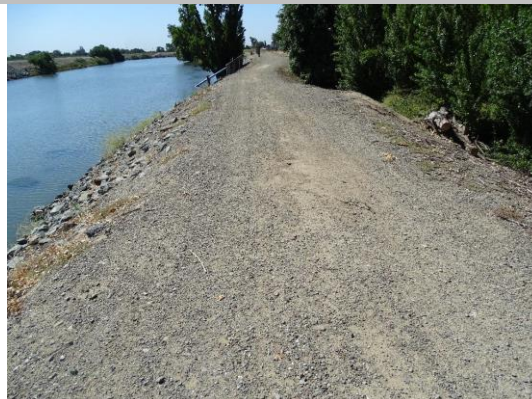
Photo 3 of 3 : UCIP\_FA\_2020\_62127\_89630.jpg

Top of Levee: view of crown.

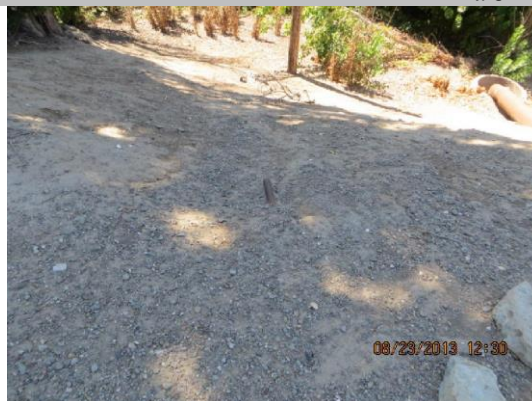
Photo 1 of 3 : UCIP\_FA\_2020\_62128\_37670.jpg

DS\_ID:24052  
 FS\_ID:62128  
 EP\_NO: N/A  
 Repair Type: Non-Urgent  
 EVAL Issue: Unauthorized Encroachment, installed decades prior  
 Crossing Status: Found  
 UCIP Comments: 06/25/2020 Record remains Non-Urgent.  
 Unauthorized encroachment recorded in Levee Log prior to 2011. No permit has been identified authorizing pipe. Crossing appears abandoned. (D.Sanoski - DWR UCIP)

FIELD\_STRUCT\_DESC: \*ABANDONED\* 1.75-inch galvanized iron electrical conduit through the levee, 1 foot below the crown. Power pole on the landside (LS) toe.  
 FS Date: 6/25/2020 2:58:00 PM

Pipe visible on LS slope.

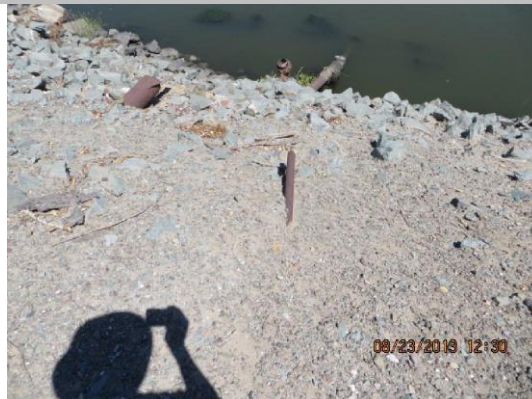
Photo 2 of 3 : UCIP\_FA\_2020\_62128\_37669.jpg

Pipe visible on WS slope.

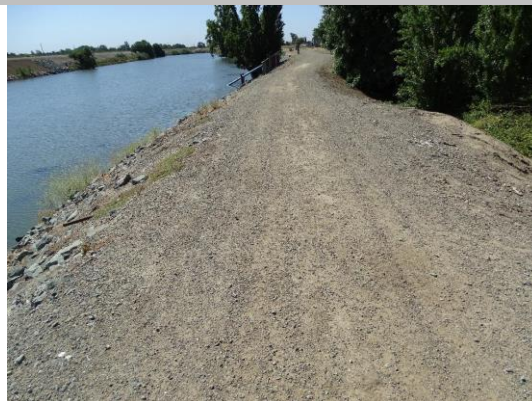
Photo 3 of 3 : UCIP\_FA\_2020\_62128\_89633.jpg

Top of Levee: view of crown.

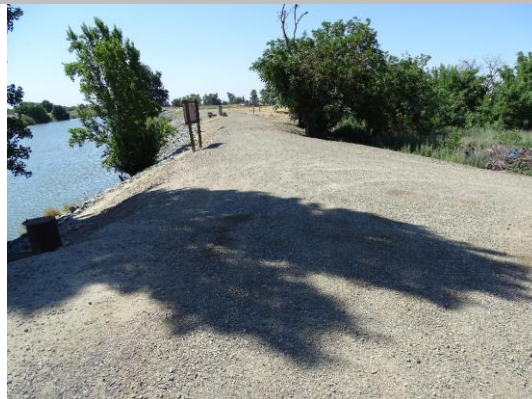
Photo 2 of 3 : UCIP\_FA\_2020\_62130\_89639.jpg

Top of Levee: view of crown.

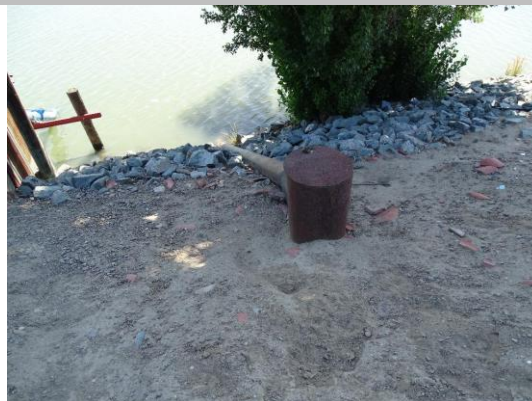
Photo 3 of 3 : UCIP\_FA\_2020\_62130\_89640.jpg

Water-Side: view of WS slope with pipe and new siphon breaker box on shoulder.
