Flood Control Project Maintenance Levee Inspections

Fall 2021 Levee Maintenance Deficiency Summary Report

San Joaquin River Basin

Reclamation District No. 0524 Middle Roberts Island

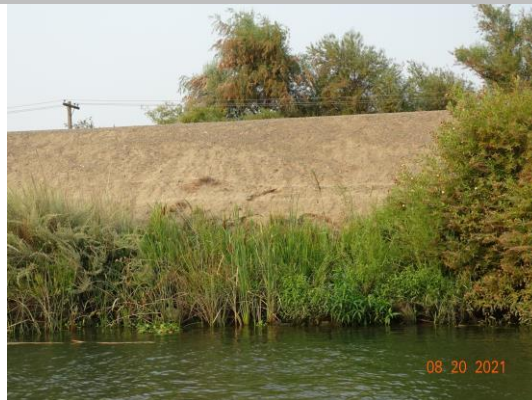
Photo 2 of 2 : SJR2021_RD0524U01RM40.85_1.JPG

LM Start	0.18	Rating **	U	Issue No.	9 (cont)
LM End	0.19	Issue Type +	Ma	Location *

8/20/2021: Close-up view of the erosion.

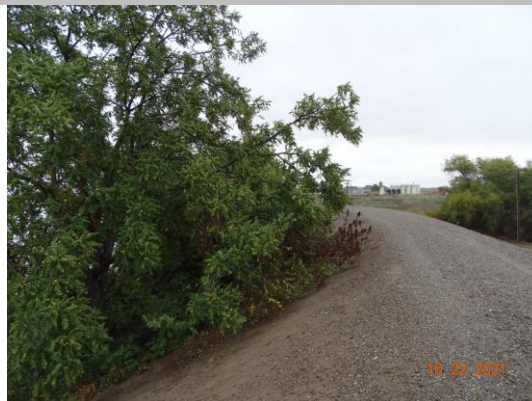
Photo 1 of 1 : FA_2021_RD0524_107_201_20211025_00337.jpg

LM Start	0.23	Rating **	M	Issue No.	201
LM End	0.23	Issue Type +	Ma	Location *	WS
Category	Earthen Levee			GPS Latitude/Longitude	
				Start	End
Item	Trim / Thin Trees			37.938648 °	37.938648 °
				-121.343480 °	-121.343480 °
DWR ID	DWR_RD0524_01_f_2016_201				
Comment Code					
T1 : Trim trees to at least five feet above ground level.					
Inspector Comment

View of tree on waterside slope looking upstream. Fall 2021

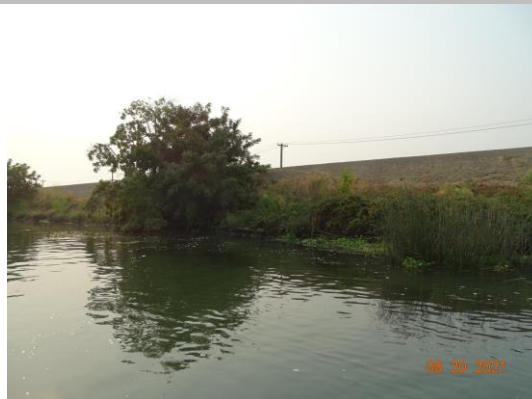
Photo 1 of 2 : SJR2021_RD0524U01RM40.93_02.JPG

LM Start	0.34	Rating **	M	Issue No.	1	
LM End	0.35	Issue Type +	Ma	Location *		
Category	Supplemental			GPS Latitude/Longitude		
				Start		End
Item	DWR Erosion Survey			37.938461 °	37.938461 °	
				-121.341526 °	-121.341526 °	
DWR ID	RD0524U01RM40.93					
Comment Code						
Inspector Comment						
Site ID: RD0524U01RM40.93						
08/20/2021: From 2018 to present, no significant changes were observed during the annual survey.						
09/13/2017: There are two pocket erosions at the site; both erosions are around 10 ft long and 6 ft high.

08/20/2021: View of the erosion looking upstream.

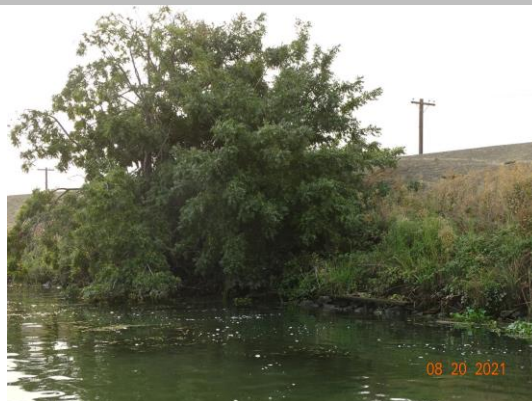
Photo 2 of 2 : SJR2021_RD0524U01RM40.93_01.JPG

08/20/2021: Front view of the one of the erosion pockets.

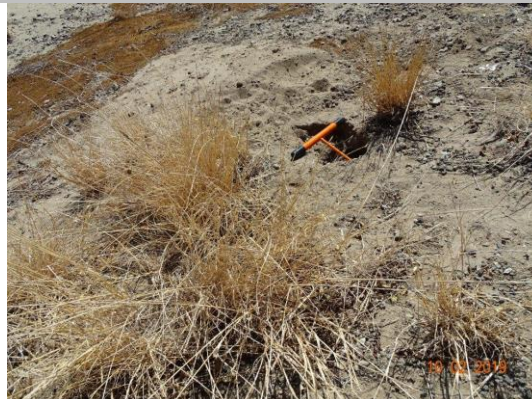
Photo 1 of 1 : FA_2021_RD0524_107_125_20210913_00063.jpg

LM Start	0.35	Rating **	U	Issue No.	125
LM End	0.35	Issue Type +	Ma	Location *	LS
Category	Earthen Levee			GPS Latitude/Longitude	
				Start	End
Item	Animal Control			37.938470 °	37.938470 °
				-121.341390 °	-121.341390 °
DWR ID	DWR_RD0524_01_f_2019_125				
Comment Code					
A3 : No rodents visible, but rodent burrows visible; need to backfill and compact or grout burrows.					
Inspector Comment

View of large rodent hole on landside slope. Fall 2019

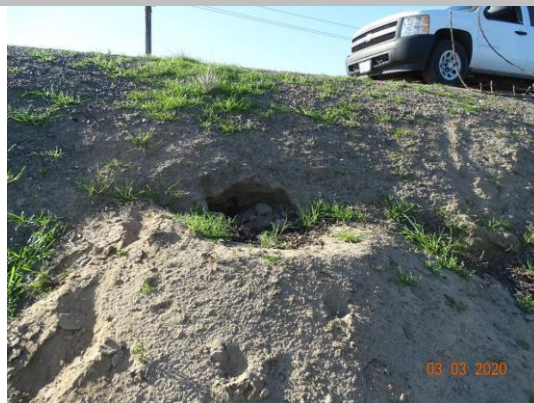
Photo 1 of 1 : FA_2021_RD0524_107_122_20210913_00062.jpg

LM Start	0.36	Rating **	U	Issue No.	122
LM End	0.36	Issue Type +	Ma	Location *	WS
Category	Earthen Levee			GPS Latitude/Longitude	
				Start	End
Item	Animal Control			37.938509 °	37.938509 °
				-121.341297 °	-121.341297 °
DWR ID	DWR_RD0524_01_f_2019_122				
Comment Code					
A3 : No rodents visible, but rodent burrows visible; need to backfill and compact or grout burrows.					
Inspector Comment

View of large animal burrow on waterside slope. Spring 2020

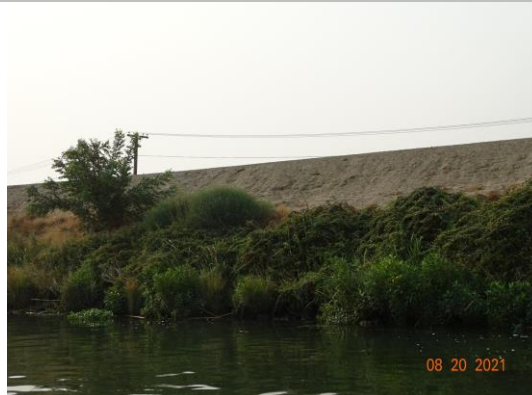
Photo 1 of 2 : SJR2021_RD0524U01RM40.99_01.JPG

LM Start	0.40	Rating **	U	Issue No.	4	
LM End	0.41	Issue Type +	Ma	Location *		
Category	Supplemental			GPS Latitude/Longitude		
				Start		End
Item	DWR Erosion Survey			37.938608 °		37.938608 °
				-121.340498 °		-121.340498 °
DWR ID	RD0524U01RM40.99					
Comment Code						
Inspector Comment						
Site ID: RD0524U01RM40.99						
08/20/2021: From 2013 to present, no significant changes were observed during the annual survey. A small erosion repair site is located immediately downstream.						
08/07/2012: The erosion is at the upper levee slope, and likely caused by slope slip. The lower levee slope is covered with dense vegetation.

08/20/2021: Overview of the erosion which is just upstream of a small erosion repair.

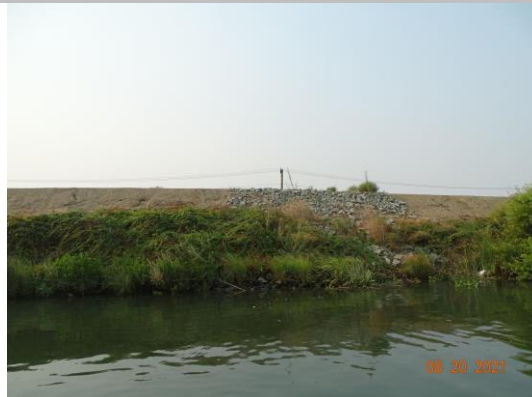
Photo 2 of 2 : SJR2021_RD0524U01RM40.99_02.JPG

08/20/2021: Close-up view of the erosion on the upper levee slope.

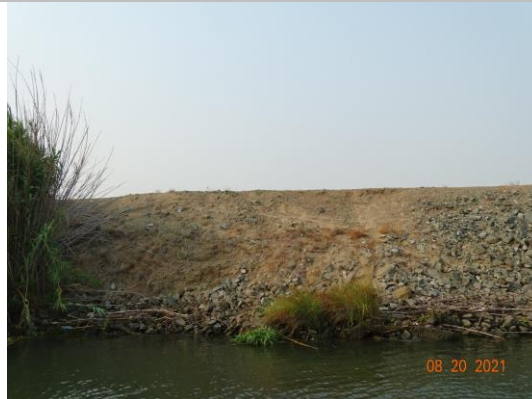
Photo 2 of 2 : SJR2021_RD0524U01RM41.26_02.JPG

LM Start	0.63	Rating **	M	Issue No.	2	
LM End	0.64	Issue Type +	Ma	Location *		
Category	Supplemental			GPS Latitude/Longitude		
				Start		End
Item	DWR Erosion Survey			37.938247 °		37.938247 °
				-121.336503 °		-121.336503 °
DWR ID	RD0524U01RM41.26					
Comment Code						
Inspector Comment						
Site ID: RD0524U01RM41.26						
08/20/2021: From 2018 to present, no significant changes were observed during the annual survey.						
09/13/2017: The erosion was discovered by levee inspection. The erosion site is immediately downstream of tall vegetation.

08/20/2021: Close-up view of the erosion.

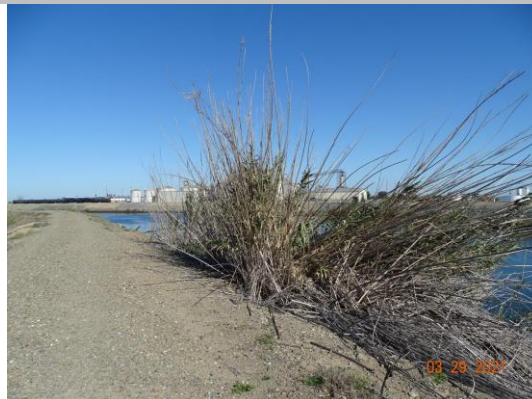
Photo 1 of 1 : FA_2021_RD0524_107_11_20210913_00021.jpg

LM Start	0.63	Rating **	U	Issue No.	11
LM End	0.64	Issue Type +	Ma	Location *	WS
Category	Earthen Levee			GPS Latitude/Longitude	
				Start	End
Item	Vegetation			37.938232 °	37.938160 °
				-121.336484 °	-121.336357 °
DWR ID	DWR_RD0524_01_s_2012_11				
Comment Code					
V2 : Remove the wild growth other than native grasses from the levee slopes.					
Inspector Comment					
Arundo on waterside slope.

View of Arundo on waterside slope. Spring 2021

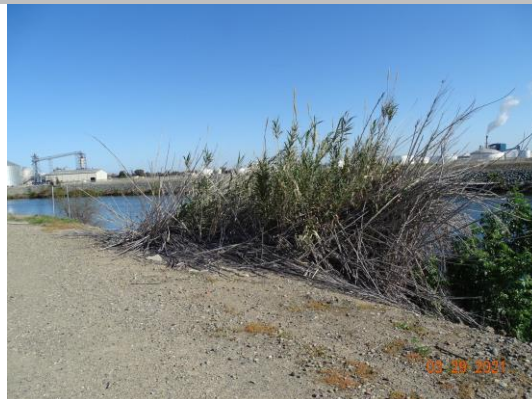
Photo 1 of 1 : FA_2021_RD0524_107_14_20210913_00027.jpg

LM Start	0.68	Rating **	U	Issue No.	14
LM End	0.68	Issue Type +	Ma	Location *	WS
Category	Earthen Levee			GPS Latitude/Longitude	
				Start	End
Item	Vegetation			37.937739 °	37.937739 °
				-121.335762 °	-121.335762 °
DWR ID	DWR_RD0524_01_s_2012_14				
Comment Code					
V2 : Remove the wild growth other than native grasses from the levee slopes.					
Inspector Comment					
Arundo on waterside slope.

View of Arundo along the waterside shoulder. Spring 2021

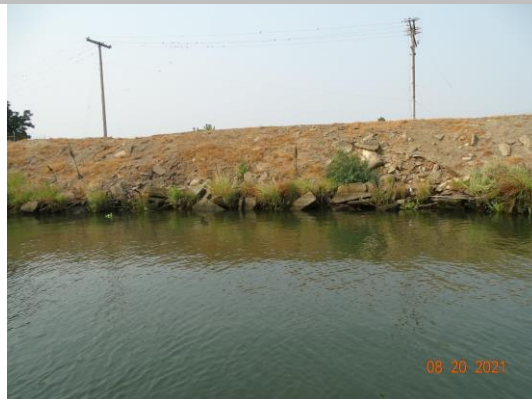
Photo 1 of 2 : SJR2021_RD0524U01RM41.34_01.JPG

LM Start	0.70	Rating **	M	Issue No.	3	
LM End	0.71	Issue Type +	Ma	Location *		
Category	Supplemental			GPS Latitude/Longitude		
				Start	End	
Item	DWR Erosion Survey			37.937577 °	37.937577 °	
				-121.335491 °	-121.335491 °	
DWR ID	RD0524U01RM41.34					
Comment Code						
Inspector Comment						
Site ID: RD0524U01RM41.34						
08/20/2021: During the annual erosion survey the erosion length was extended by 35 feet to 50 feet.						
09/24/2020: From 2018 to present, no significant changes were observed during the annual survey.						
09/13/2017: Pocket erosion above the protected levee toe.

8/20/2021: Front view of the erosion.

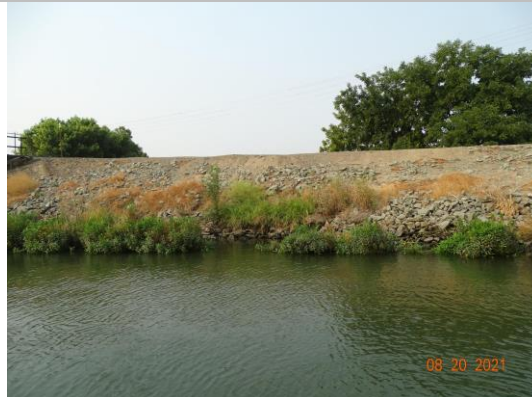
Photo 1 of 1 : SJR2021_RD0524U01RM41.36_01.JPG

LM Start	0.71	Rating **	M	Issue No.	13
LM End	0.73	Issue Type +	Ma	Location *	
Category	Supplemental			GPS Latitude/Longitude	
				Start	End
Item	DWR Erosion Survey			37.937222 °	37.937222 °
				-121.335277 °	-121.335277 °
DWR ID	RD0524U01RM41.36				
Comment Code					
Inspector Comment					
Site ID: RD0524U01RM41.36					
08/20/2021: From 2016 to present, no significant changes were observed during the annual survey. Some of the old riprap has been displaced and doesn't provide adequate protection.					
06/24/2015: The erosion site is immediately downstream of the RR bridge.

08/20/2021: Overview of the erosion.

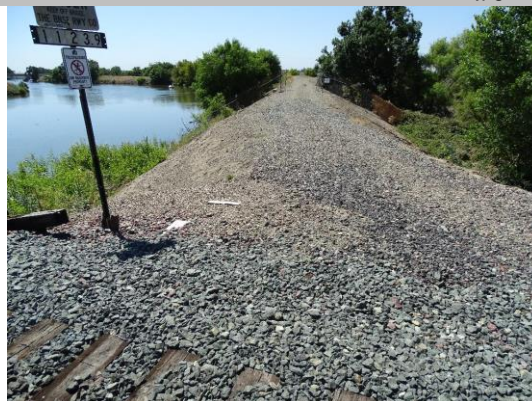
Photo 1 of 3 : UCIP_FA_2021_61917_89277.jpg

Comment Code						
Inspector Comment						
DS_ID:20595 FS_ID:61917 EP_NO: N/A Repair Type: Non-Urgent EVAL Issue: Unauthorized Encroachment, installed decades prior Crossing Status: Indicator Found UCIP Comments: 06/23/2020 Record remains Non-Urgent. Unauthorized encroachment recorded in Levee Log prior to 2011. Found a telephone utility box at the same location. (D.Sanoski - DWR UCIP) FIELD_STRUCT_DESC: 2.5-inch telephone conduit of an unknown material through the levee, 2 feet below the crown and under the channel. Conduit visible on the waterside (WS) shoulder. [Additional Reference(s): DWR Levee Log, 2004 (HLM 0.78)]. FS Date: 6/23/2020 2:32:00 PM

Top of Levee: view of crown.

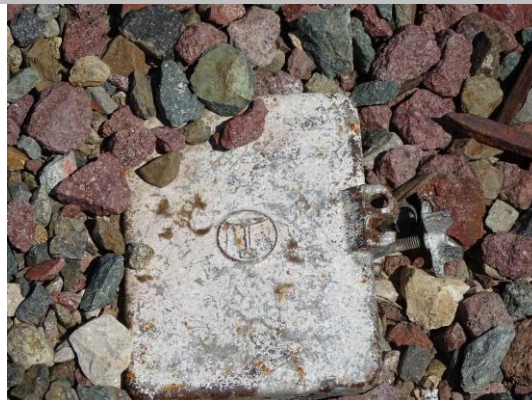
Photo 2 of 3 : UCIP_FA_2021_61917_89280.jpg

Water-Side: view of telephone cable box.

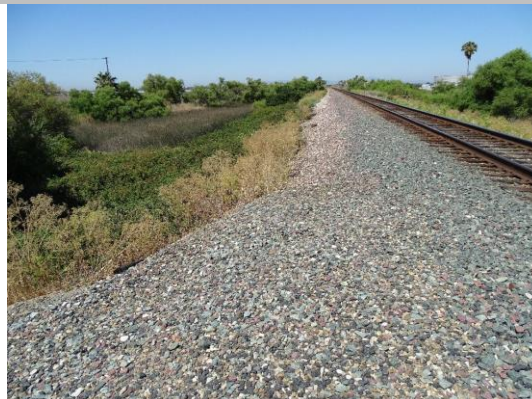
Photo 3 of 3 : UCIP_FA_2021_61917_89279.jpg

Land-Side: view of LS slope.

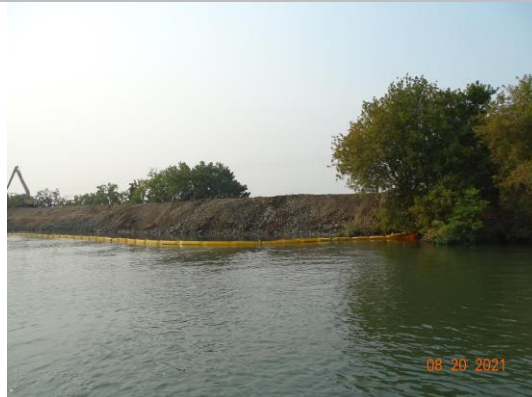
Photo 1 of 2 : SJR2021_RD0524U01RM41.44_01.JPG

LM Start	0.83	Rating **	U	Issue No.	12	
LM End	0.84	Issue Type +	Ma	Location *		
Category	Supplemental			GPS Latitude/Longitude		
				Start	End	
Item	DWR Erosion Survey			37.935838 °	37.935838 °	
				-121.334408 °	-121.334408 °	
DWR ID	RD0524U01RM41.44					
Comment Code						
Inspector Comment						
Site ID: RD0524U01RM41.44 08/20/2021: Erosion site is planned for repair 09/24/2020: From 2014 to present, no significant changes were observed during the annual survey. The vegetation is tall and limiting the view of the erosion. 08/13/2013: Site was discovered during boat survey. The dense vegetation blocks a clear view of the erosion. Size of erosion site was very roughly estimated.

08/20/2021: View of erosion repair.

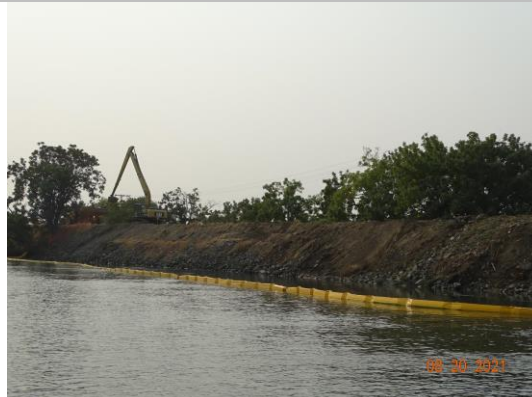
Photo 2 of 2 : SJR2021_RD0524U01RM41.44_02.JPG

08/20/2021: View of erosion repair.

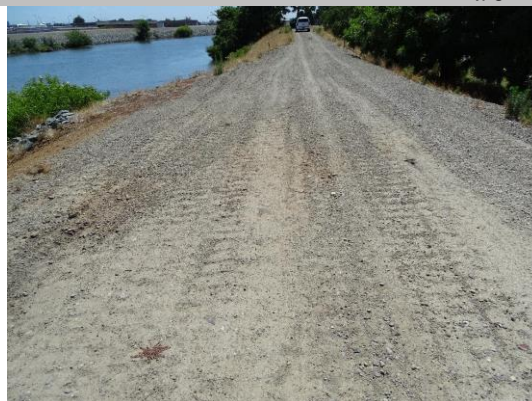
Photo 1 of 3 : UCIP_FA_2021_70214_89284.jpg

DS_ID:20597
FS_ID:70214
EP_NO: N/A
Repair Type: Non-Urgent
EVAL Issue: Unauthorized Encroachment, installed decades prior
Crossing Status: Found
UCIP Comments: 06/23/2020 Record remains Non-Urgent. No permit has been identified authorizing pipe. Crossing appears abandoned. Location updated to be at LM 0.92. (D.Sanoski - DWR UCIP)
11/16/2016 - Location may be at LM 0.92 (37.935267, -121.332985) rather than LM 0.974. Need to field verify (DWR UCIP - thatch)
8/16/2013 - Pipe abandoned and should be done so properly. (DWR UCIP -wwylie)
FIELD_STRUCT_DESC: *ABANDONED* 14-inch irrigation pipe of an unknown material through the levee, 6 feet below the crown. Concrete pad for pump on the waterside (WS) shoulder. No pump or other appurtenances remain. [Additional Reference(s): DWR Levee Log, 2004 (HLM 0.93). USACE San Joaquin O&M Manual, Unit 7, April 1964, Revised 29 December 2016, (0.93), listed as 14-inch pipe].

Top of Levee: view of crown.

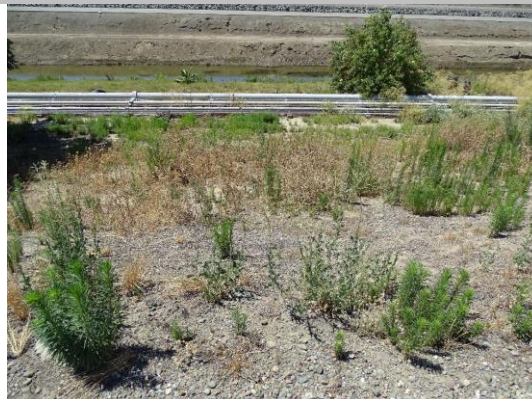
Photo 3 of 3 : UCIP_FA_2021_70214_89286.jpg

Land-Side: view of LS slope.

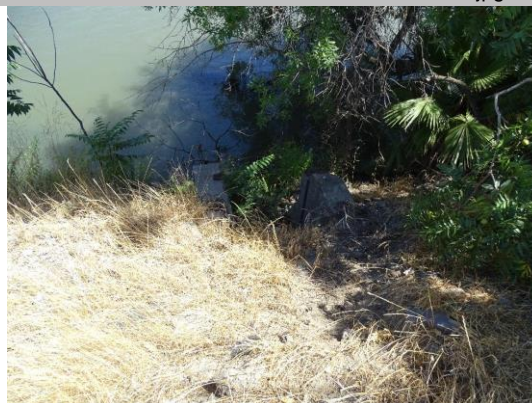
Photo 2 of 3 : UCIP_FA_2021_70216_89288.jpg

DS_ID:20598
FS_ID:70216
EP_NO: N/A
Repair Type: Non-Urgent
EVAL Issue: Unauthorized Encroachment, installed decades prior
Crossing Status: Found
UCIP Comments: 06/23/2020 Record updated from No Action Needed to Non-Urgent. No permit has been identified authorizing pipe. Crossing appears abandoned. Recommend owner to contact CVFPB to abandon or remove pipe from levee. (D.Sanoski - DWR UCIP)
FIELD_STRUCT_DESC: *ABANDONED* 36-inch drainage pipe of an unknown material through the levee, 15 feet below the crown. Landside (LS) end is not visible. Concrete headwall at outlet on the waterside (WS) slope is visible. Pipe appears to be abandoned in place. Slide gate on the WS removed. [Additional Reference(s): DWR Levee Log, 2004 (HLM 0.99). USACE San Joaquin O&M Manual, Unit 7, April 1964, Revised 29 December 2016, (0.99), listed as 36-inch pipe].
FS Date: 6/23/2020 2:32:00 PM

Water-Side: view of WS slope.

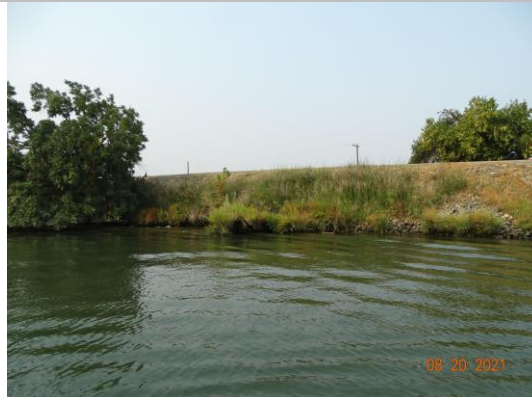
Photo 1 of 2 : SJR2021_RD0524U01RM41.79_01.JPG

08/20/2021: From 2011 to present, no significant changes were observed during the annual survey. Minimal vegetation covers the upper levee slope. The lower slope is covered with medium dense vegetation. Riprap is visible in some areas.

8/20/2021: Erosion visible on the upper levee slope.

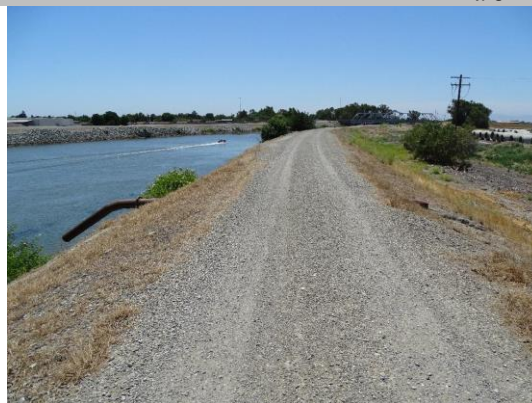
Photo 1 of 3 : UCIP_FA_2021_70217_89309.jpg

Comment Code						
Inspector Comment						
DS_ID:20602 FS_ID:70217 EP_NO: N/A Repair Type: Non-Urgent EVAL Issue: Unauthorized Encroachment, installed decades prior Crossing Status: Found UCIP Comments: 06/23/2020 Record remains Non-Urgent. No permit has been identified authorizing pipe. Crossing appears abandoned. (D.Sanoski - DWR UCIP) 10/2/2018 Pipe appears abandoned, but both the pipe and levee appear in good condition; downgrading to Non-Urgent (D. Sanoski - DWR UCIP).11/16/2016 same as previous inspection both ends are open. This pipe does not appear in use. Need to contact owner to determine status of crossing. If the crossing is abandoned or in use, owner will need to coordinate with the CVFPB to comply with Title 23 requirements. (O. Magana - DWR UCIP)08/16/2013 Pipe appears to be open on both ends. Abandoned and should be done so properly. (W. Wylie - DWR UCIP) FIELD_STRUCT_DESC: *ABANDONED* 12-inch steel drainage pipe through the levee, 3.5 feet below the crown. Pipe is opened on the waterside (WS) and landside (LS) ends. The pump house referenced in O&M manual is missing from the LS (2013). [Additional Reference(s): DWR Levee Log, 2004 (HLM 1.31). USACE San Joaquin O&M Manual, Unit 7, April 1964, Revised 29 December 2016, (1.31), listed as 12-inch pipe]. FS Date: 6/23/2020 2:35:00 PM

Top of Levee: view of crown.

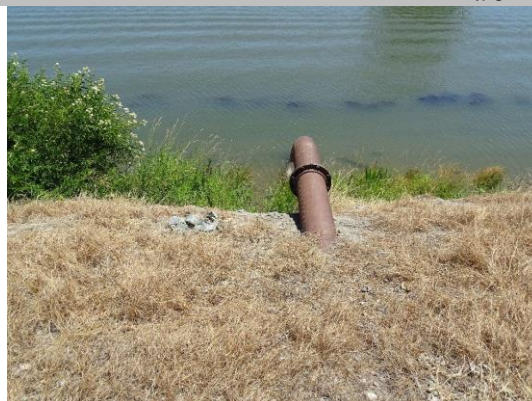
Photo 2 of 3 : UCIP_FA_2021_70217_89310.jpg

Water-Side: view of WS slope and abandoned pipe.

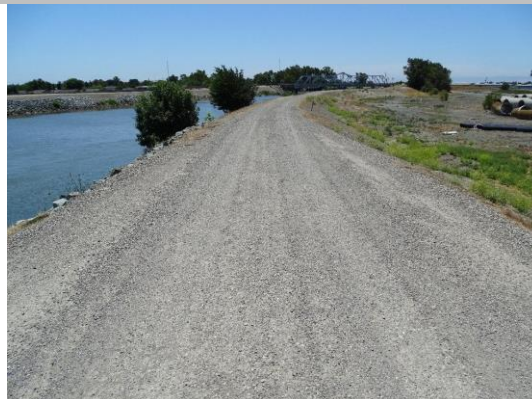
Photo 1 of 3 : UCIP_FA_2021_70218_89312.jpg

LM Start	1.32	Rating **	M	Issue No.	938	
LM End	1.32	Issue Type +	En	Location *		
Category	Supplemental			GPS Latitude/Longitude		
				Start	End	
Item	DWR UCIP Field Study			37.931592 °	37.931592 °	
				-121.328229 °	-121.328229 °	
DWR ID	20603					
Comment Code						
Inspector Comment						
DS_ID:20603 FS_ID:70218 EP_NO: N/A Repair Type: Non-Urgent EVAL Issue: Pipe Not Found Crossing Status: Not Found UCIP Comments: 06/23/2020 Record updated from No Action Needed to Non-Urgent. Crossing not found. No permit has been identified authorizing pipe. (D.Sanoski - DWR UCIP) FIELD_STRUCT_DESC: 2-inch galvanized iron pipe of unknown purpose through the levee, 4 feet below the crown. [Additional Reference(s): DWR Levee Log, 2004 (HLM 1.38). USACE San Joaquin O&M Manual, Unit 7, April 1964, Revised 29 December 2016, (1.38), listed as 2-inch pipe]. FS Date: 6/23/2020 2:35:00 PM

Top of Levee: view of crown.

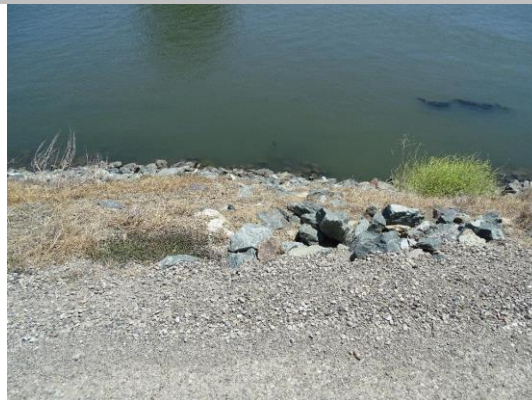
Photo 2 of 3 : UCIP_FA_2021_70218_89313.jpg

Water-Side: view of WS slope.

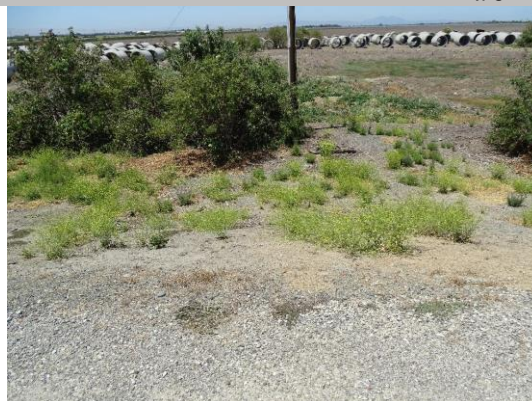
Photo 3 of 3 : UCIP_FA_2021_70218_89314.jpg

Land-Side: view of LS slope with no sign of concrete pad and pump.

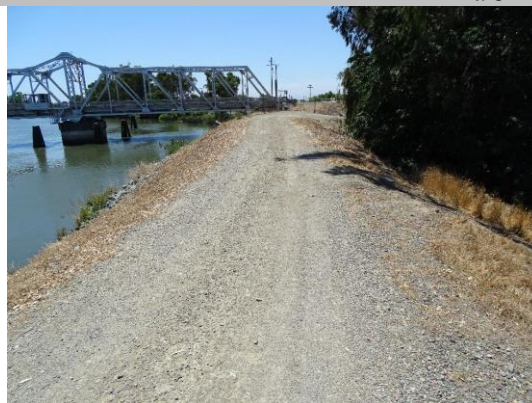
Photo 1 of 3 : UCIP_FA_2021_61929_89315.jpg

DS_ID:24031
 FS_ID:61929
 EP_NO: 898
 Repair Type: Non-Urgent
 EVAL Issue: Compliant
 Crossing Status: Indicator Found
 UCIP Comments: 06/23/2020 Record remains No Action Needed. No issues observed during inspection. (D.Sanoski - DWR UCIP)

FIELD_STRUCT_DESC: Submarine telephone cable through the levee, 2 feet below the crown. Telephone pole with conduit visible off landside (LS) toe. (Submarine cable authorized under Permit No. 898, 1971 - PT&T).
 FS Date: 6/23/2020 2:36:00 PM

Top of Levee: view of crown.

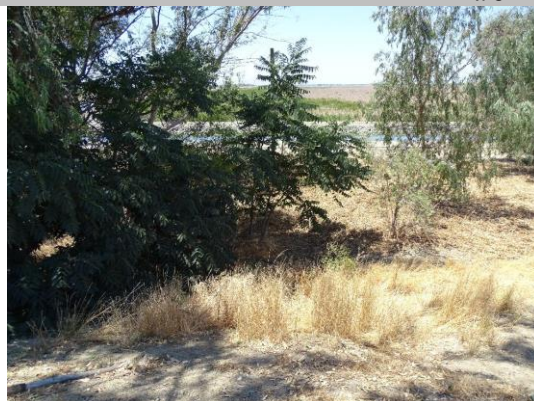
Photo 2 of 3 : UCIP_FA_2021_61929_89316.jpg

Land-Side: view of LS slope and telephone off toe.

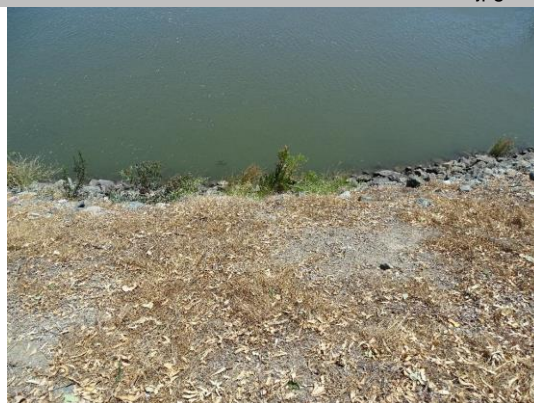
Photo 3 of 3 : UCIP_FA_2021_61929_89317.jpg

Water-Side: view of WS slope.

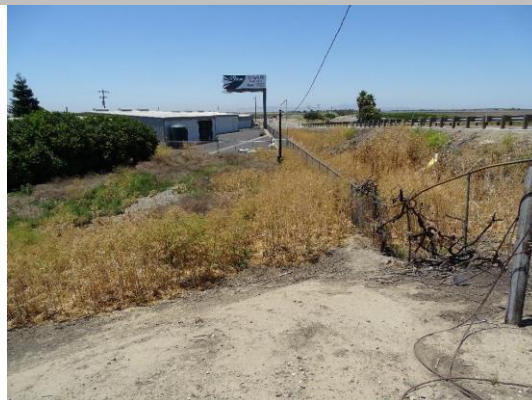
Photo 2 of 3 : UCIP_FA_2021_70220_89327.jpg

Land-Side: view of LS slope.

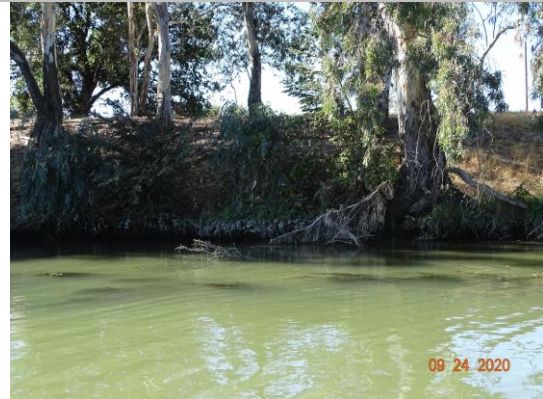
Photo 2 of 3 : SJR2021_RD0524U01RM42.2_05.JPG

Comment Code
Inspector Comment
Site ID: RD0524U01RM42.2
08/20/2021: During the annual erosion survey the length has been increased to 500 feet.
09/24/2020: From 2013 to present, no significant changes were observed during the annual survey. Several erosion pockets and undermining of the levee toe visible.
08/07/2012: The site has been visited by boat survey. No significant change observed
08/23/2011: No significant change observed on site. Trees concerned still in place.
09/07/2010: No significant change observed on site. The concern here is the undermining of the levee toe where most of trees are. There are erosion pockets lined along the lower slope and at the base of the trees, exposing tree roots. There is minimal slope protection.
08/29/2009: The lower slope is lined with minor erosion pockets; some tree roots are exposed; there is visible undermining of the levee toe; site is immediately upstream of the Highway 4 Bridge; the bridge is possibly causing a scour to occur, eroding the bank.

9/24/2020: Visible undermining of the levee toe.

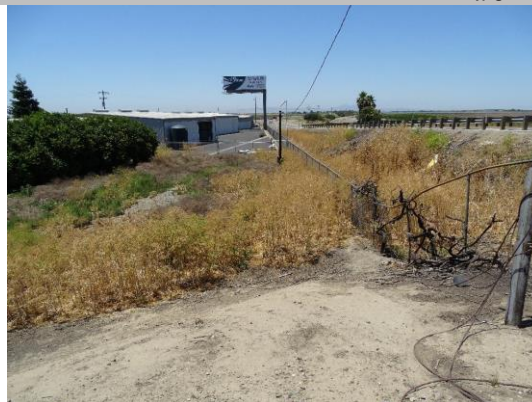
Photo 2 of 3 : UCIP_FA_2021_61933_89330.jpg

Comment Code						
Inspector Comment						
DS_ID:20644 FS_ID:61933 EP_NO: 16937 Repair Type: Non-Urgent EVAL Issue: Pipe Not Found Crossing Status: Not Found UCIP Comments: 06/23/2020 Record updated from No Action Needed to Non-Urgent. Crossing not found. (D.Sanoski - DWR UCIP) FIELD_STRUCT_DESC: 16-inch high-density polyethylene communications conduit through the levee, 40 feet below the crown. Four 4.25-inch ducts sleeved through 16-inch conduit. (16-inch pipe authorized under Permit No. 16937, 1999 - Pacific Bell). [Additional Reference(s): DWR Levee Log, 2004 (HLM 1.57), listed as Fiber optics cable crossing.] FS Date: 6/23/2020 2:37:00 PM

Land-Side: view of LS slope.

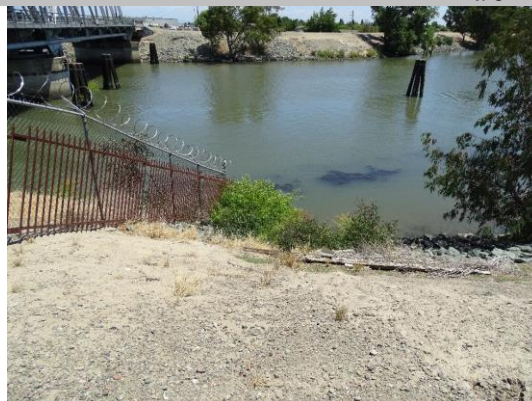
Photo 3 of 3 : UCIP_FA_2021_61933_89331.jpg

Water-Side: view of WS slope.

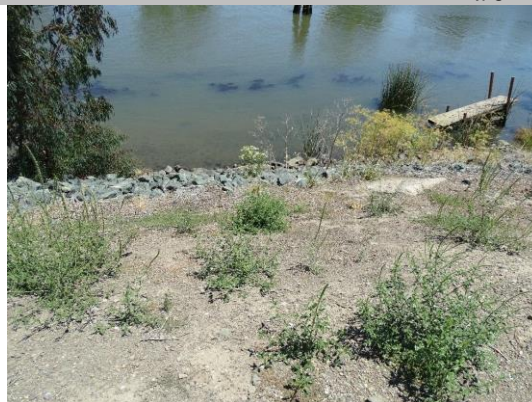
Photo 2 of 3 : UCIP_FA_2021_70221_89333.jpg

Water-Side: view of WS slope.

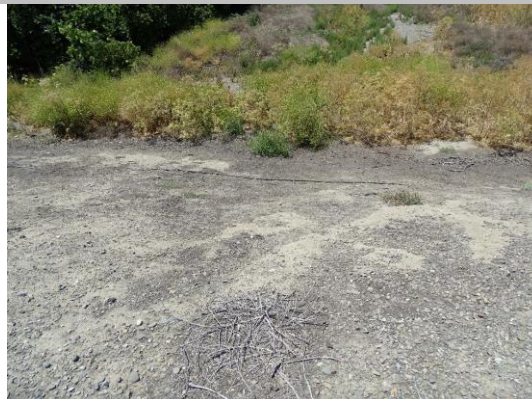
Photo 3 of 3 : UCIP_FA_2021_70221_89334.jpg

Land-Side: view of LS slope.

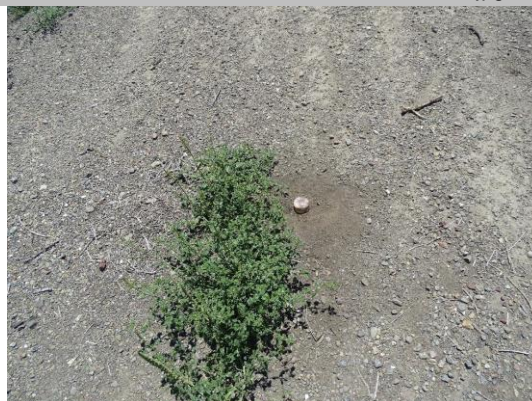
Photo 2 of 3 : UCIP_FA_2021_61935_89338.jpg

DS_ID:20607
 FS_ID:61935
 EP_NO: N/A
 Repair Type: Non-Urgent
 EVAL Issue: Unauthorized Encroachment, installed decades prior
 Crossing Status: Found
 UCIP Comments: 06/23/2020 Record updated from No Action Needed to Non-Urgent. Found 2-inch PVC pipe up through center of crown; unsure of alignment of pipe or if related to this crossing. Unauthorized encroachment recorded in Levee Log prior to 2011. Crossing appears abandoned. Recommend owner to contact CVFPB to abandon or remove pipe from levee. (D.Sanoski - DWR UCIP)
 FIELD_STRUCT_DESC: *ABANDONED* 2-inch pipe of an unknown material or purpose through the levee, 3.5 feet below the crown.
 [Additional Reference(s): DWR Levee Log, 2004 (HLM 1.57).].
 FS Date: 6/23/2020 2:38:00 PM

Top of Levee: view of pvc pipe cap.

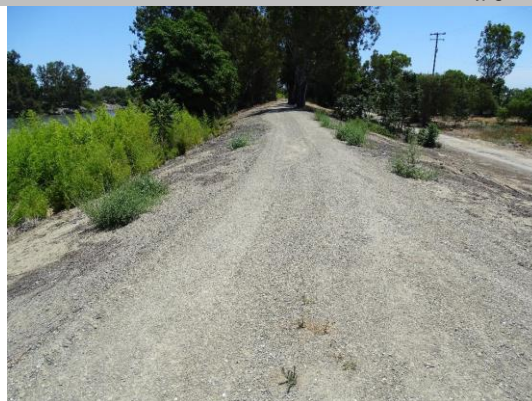
Photo 1 of 3 : UCIP_FA_2021_70222_89340.jpg

DS_ID:20608
 FS_ID:70222
 EP_NO: N/A
 Repair Type: Non-Urgent
 EVAL Issue: Pipe Not Found
 Crossing Status: Not Found
 UCIP Comments: 06/23/2020 Record updated from No Action Needed to Non-Urgent. Crossing not found. No permit has been identified authorizing pipe. (D.Sanoski - DWR UCIP)
 FIELD_STRUCT_DESC: 6-inch irrigation pipe of an unknown material through the levee, 3.5 feet below the crown. Pump on the waterside (WS). Open on the WS end. Rusting out on the landside (LS). Pipe exposed on the landside (LS) slope. Could not locate, 3/92. [Additional Reference(s): DWR Levee Log, 2004 (HLM 1.61). USACE San Joaquin O&M Manual, Unit 7, April 1964, Revised 29 December 2016, (1.61), listed as 6-inch pipe].
 FS Date: 6/23/2020 2:38:00 PM

Top of Levee: view of crown.

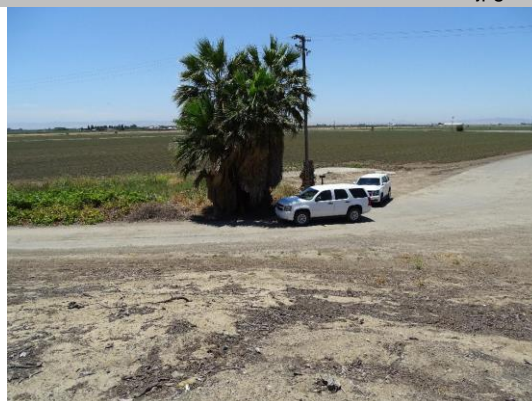
Photo 2 of 3 : UCIP_FA_2021_70222_89341.jpg

Land-Side: view of LS slope.

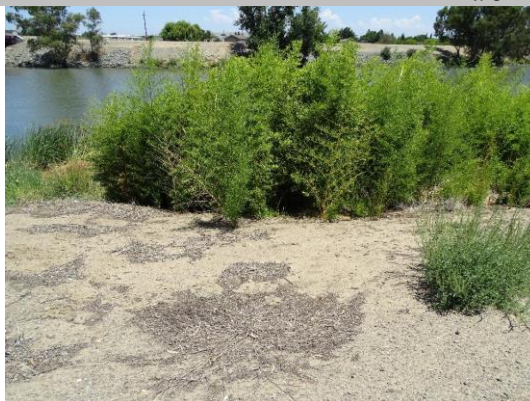
Photo 3 of 3 : UCIP_FA_2021_70222_89342.jpg

Water-Side: view of WS slope and no sign of pump.

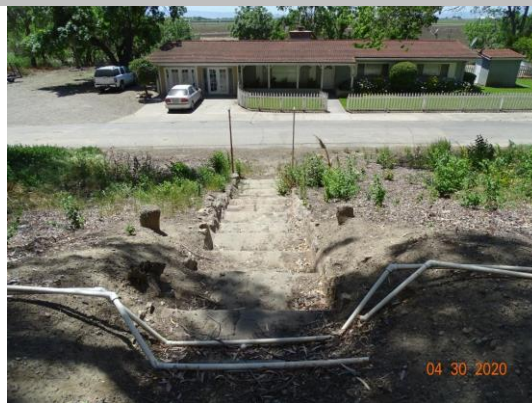
Photo 1 of 1 : FA_2021_RD0524_107_267_20210913_00092.jpg

LM Start	1.67	Rating **	M	Issue No.	267
LM End	1.67	Issue Type +	En	Location *	LS
Category	Earthen Levee			GPS Latitude/Longitude	
				Start	End
Item	Encroachments			37.927014 °	37.927014 °
				-121.326858 °	-121.326858 °
DWR ID	DWR_RD0524_01_s_2020_267				
Comment Code					
ST : Stairway					
Inspector Comment

View of concrete stairs on landside slope. Spring 2020

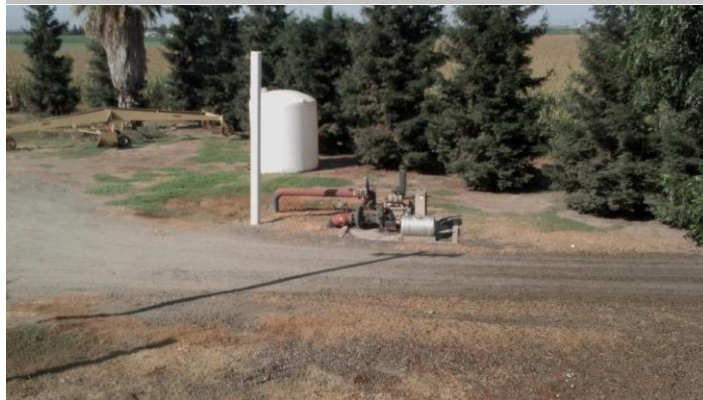
Photo 2 of 3 : UCIP_FA_2021_61937_37123.jpg

Pumping plant off LS toe.

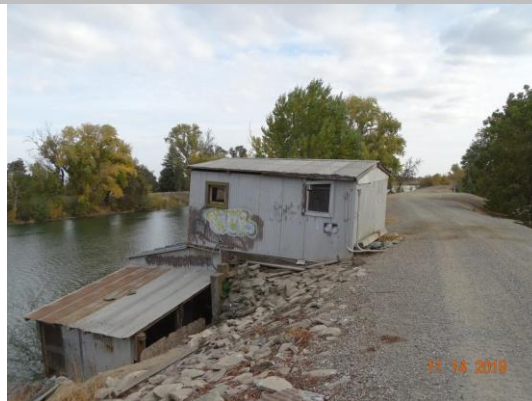
Photo 1 of 1 : FA_2021_RD0524_107_148_20210913_00065.jpg

LM Start	1.81	Rating **	U	Issue No.	148
LM End	1.81	Issue Type +	En	Location *	WS
Category	Earthen Levee			GPS Latitude/Longitude	
				Start	End
Item	Encroachments			37.925457 °	37.925457 °
				-121.325332 °	-121.325332 °
DWR ID	DWR_RD0524_01_f _ 2019_148				
Comment Code					
BU : Building					
Inspector Comment					
Pump house on waterside shoulder. Fall 2019

View of pump house on waterside shoulder. Fall 2019

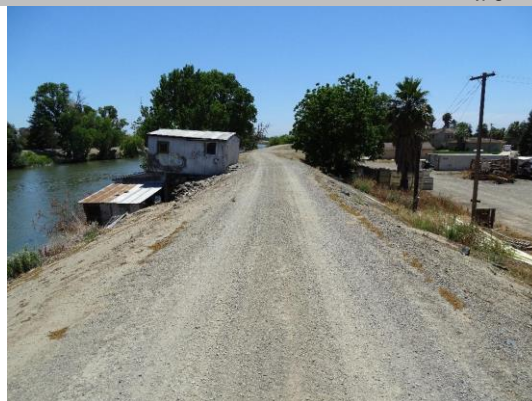
Photo 1 of 3 : UCIP_FA_2021_70223_89346.jpg

Comment Code						
Inspector Comment						
DS_ID:20662 FS_ID:70223 EP_NO: N/A Repair Type: Non-Urgent EVAL Issue: Unauthorized Encroachment, installed decades prior Crossing Status: Found UCIP Comments: 06/23/2020 Record updated from No Action Needed to Non-Urgent. No permit has been identified authorizing pipe. (D.Sanoski - DWR UCIP) FIELD_STRUCT_DESC: 1.25-inch electrical conduit of an unknown material through the levee, 6 inches below the crown. Conduit visible at power pole on the landside (LS) toe and at corner of pump house on the waterside (WS) shoulder. [Additional Reference(s): DWR Levee Log, 2004 (HLM 1.83). USACE San Joaquin O&M Manual, Unit 7, April 1964, Revised 29 December 2016, (1.83), listed as a 14-inch pipe, 20 feet below the crown]. FS Date: 6/23/2020 2:39:00 PM

Overview of Levee: view of levee.

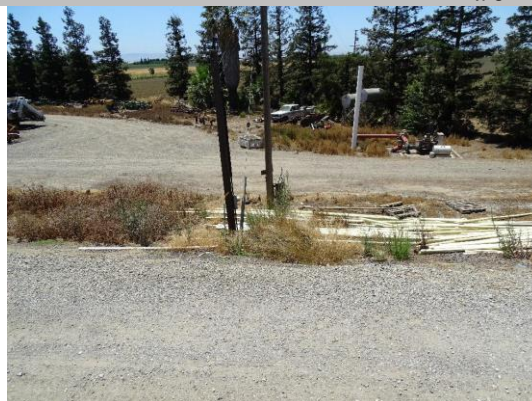
Photo 3 of 3 : UCIP_FA_2021_70223_89349.jpg

Land-Side: view of LS slope and poles on LS toe.

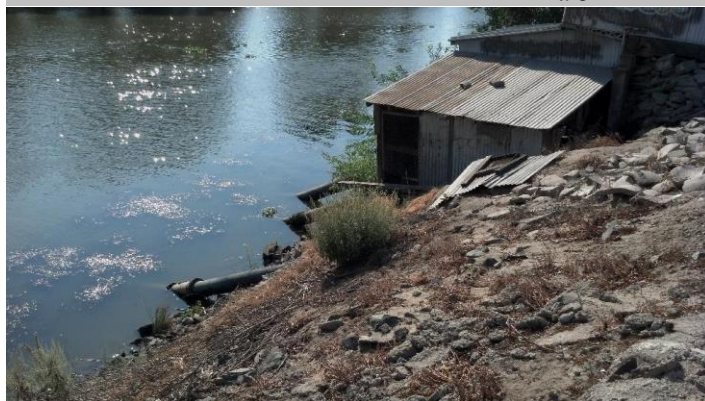
Photo 1 of 3 : UCIP_FA_2021_61940_29962.jpg

DS_ID:20609
FS_ID:61940
EP_NO: N/A
Repair Type: Non-Urgent
EVAL Issue: Unauthorized Encroachment, installed decades prior
Crossing Status: Found
UCIP Comments: 06/23/2020 Record remains Non-Urgent.
Unauthorized encroachment recorded in Levee Log prior to 2011. No permit has been identified authorizing pipe. (D.Sanoski - DWR UCIP)
Pipe appears abandoned and if so should be done so properly.
FIELD_STRUCT_DESC: 14-inch irrigation pipe of an unknown material through the levee, 20 feet below the crown. 2 pumps and gate valves discharge into surge tank in pump house on the waterside (WS) slope. Concrete distribution box removed from the WS slope. Abandoned 36-inch diameter concrete standpipe on the landside (LS) toe next to service pole. [Additional Reference(s): DWR Levee Log, 2004. USACE San Joaquin O&M Manual 7, April 1964, (HLM 1.83)].
FS Date: 6/23/2020 2:39:00 PM

Pipes and pumphouse on WS slope.

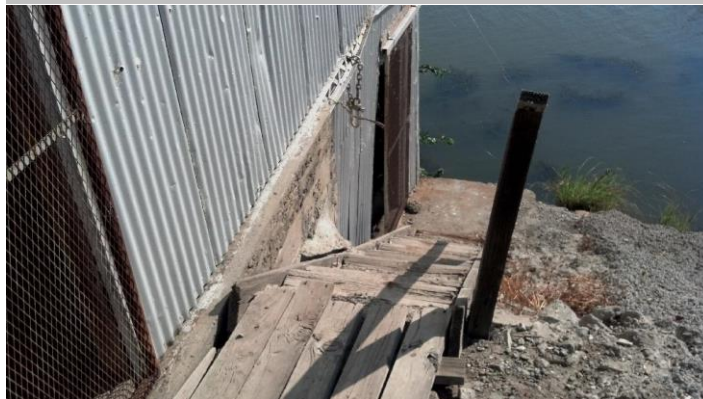
Photo 2 of 3 : UCIP_FA_2021_61940_29961.jpg

Steps to pump on WS slope.

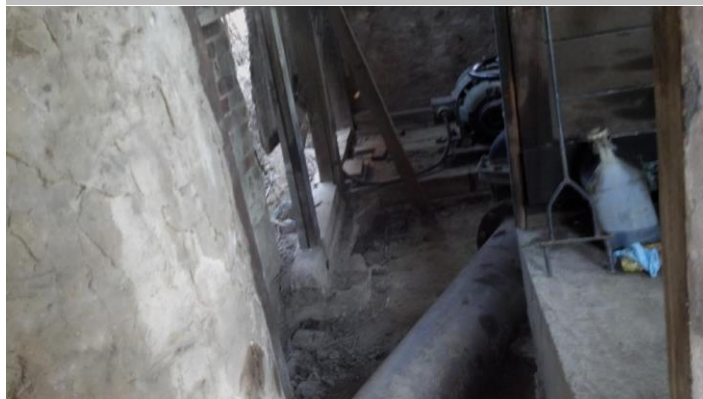
Photo 3 of 3 : UCIP_FA_2021_61940_29960.jpg

Pipes at connection to concrete surge box on WS inside pumphouse.

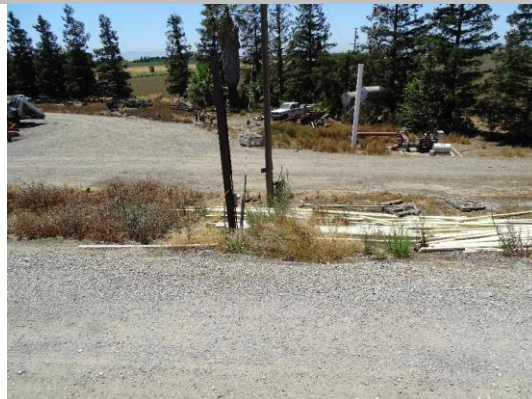
Photo 3 of 3 : UCIP_FA_2021_70224_89352.jpg

Comment Code						
Inspector Comment						
DS_ID:20661 FS_ID:70224 EP_NO: N/A Repair Type: Non-Urgent EVAL Issue: Unauthorized Encroachment, installed decades prior Crossing Status: Found UCIP Comments: 06/23/2020 Record updated from No Action Needed to Non-Urgent. No permit has been identified authorizing pipe. (D.Sanoski - DWR UCIP) FIELD_STRUCT_DESC: 1.25-inch electrical conduit of an unknown material through the levee, 6 inches below the crown. Conduit visible at power pole on the landside (LS) toe and at corner of pump house on the waterside (WS) shoulder. [Additional Reference(s): DWR Levee Log, 2004 (HLM 1.83). USACE San Joaquin O&M Manual, Unit 7, April 1964, Revised 29 December 2016, (1.83), listed as a 14-inch pipe, 20 feet below the crown]. FS Date: 6/23/2020 2:39:00 PM

Land-Side: view of LS slope and poles on toe.

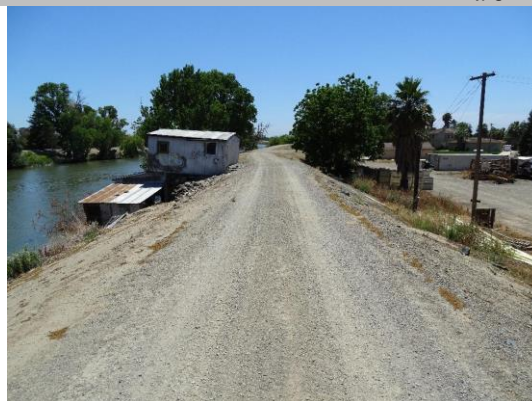
Photo 1 of 3 : UCIP_FA_2021_70225_89357.jpg

DS_ID:24033
 FS_ID:70225
 EP_NO: N/A
 Repair Type: Non-Urgent
 EVAL Issue: Alignment Missing
 Crossing Status: Found
 UCIP Comments: 06/23/2020 Record remains Non-Urgent. Crossing appears abandoned. Alignment missing. (D.Sanoski - DWR UCIP)
 08/20/2013 Pipes appear abandoned and should be removed from levee. (W.Wylie - DWR UCIP)
 FIELD_STRUCT_DESC: *ABANDONED* One 1-inch and two 0.75-inch polyvinyl chloride conduits of an unknown purpose through the levee, 6 inches below the crown.
 FS Date: 6/23/2020 2:40:00 PM

Overview of Levee: view of levee.

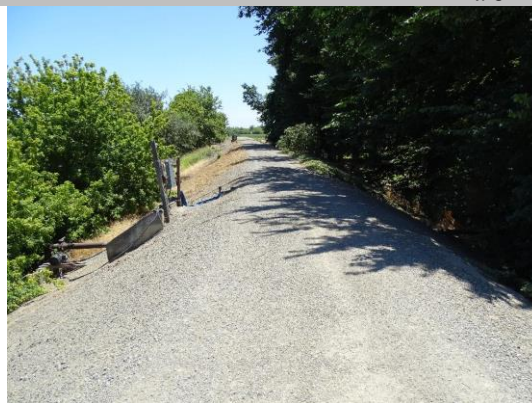
Photo 1 of 3 : UCIP_FA_2021_70226_89363.jpg

LM Start	1.99	Rating **	M	Issue No.	950	
LM End	1.99	Issue Type +	En	Location *		
Category	Supplemental			GPS Latitude/Longitude		
				Start		End
Item	DWR UCIP Field Study			37.923022 °	37.923022 °	
				-121.323953 °	-121.323953 °	
DWR ID	24035					
Comment Code						
Inspector Comment						
DS_ID:24035 FS_ID:70226 EP_NO: N/A Repair Type: Non-Urgent EVAL Issue: Unauthorized Encroachment, installed decades prior Crossing Status: Found UCIP Comments: 06/23/2020 Record remains Non-Urgent. No permit has been found authorizing this pipe through the levee. (D.Sanoski - DWR UCIP) 08/20/2013 No permit identified for this crossing. (W.Wylie - DWR UCIP) FIELD_STRUCT_DESC: 3-inch polyvinyl chloride domestic non-potable water line through the levee, at an unknown depth. Pump on concrete pad at the waterside (WS) toe. FS Date: 6/23/2020 2:40:00 PM

Top of Levee: view of crown.

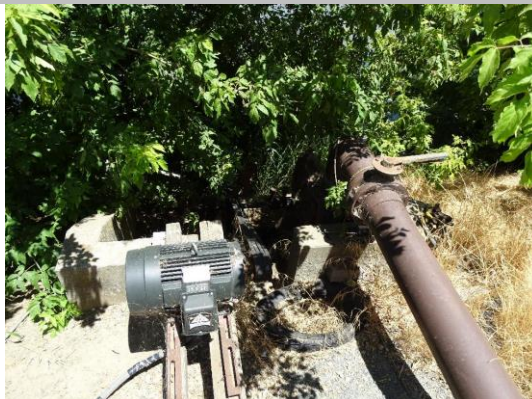
Photo 2 of 3 : UCIP_FA_2021_70226_89364.jpg

Water-Side: view of WS slope and pvc found within the overgrown tree on slope.

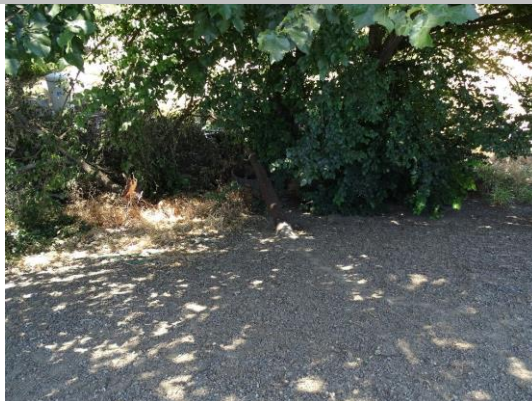
Photo 3 of 3 : UCIP_FA_2021_70226_89365.jpg

Land-Side: view of LS slope with pvc pipe at toe.

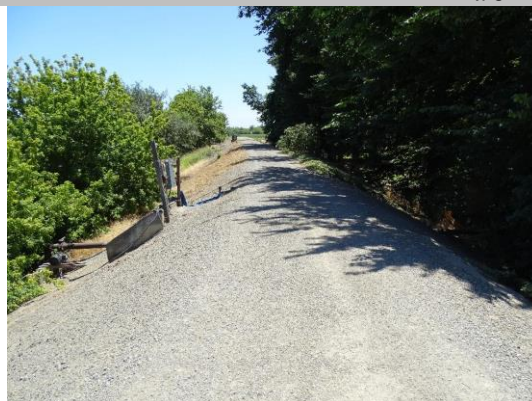
Photo 1 of 3 : UCIP_FA_2021_70227_89366.jpg

Comment Code						
Inspector Comment						
DS_ID:24034 FS_ID:70227 EP_NO: N/A Repair Type: Non-Urgent EVAL Issue: Unauthorized Encroachment, installed decades prior Crossing Status: Found UCIP Comments: 06/23/2020 Record updated from No Action Needed to Non-Urgent. No permit has been identified authorizing pipe. (D.Sanoski - DWR UCIP) FIELD_STRUCT_DESC: 1.25-inch electrical conduit of an unknown material through the levee, 2 inches below the crown. Pump on the waterside (WS) slope. Power pole and meter at the landside (LS) toe. [Additional Reference(s): DWR Levee Log, 2004 (HLM 2.02), listed as 10-inch pipe. USACE San Joaquin O&M Manual, Unit 7, April 1964, Revised 29 December 2016, (2.02), listed as 10-inch pipe]. FS Date: 6/23/2020 2:40:00 PM

Top of Levee: view of crown.

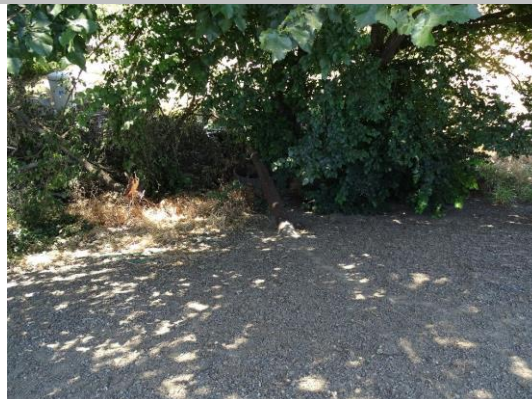
Photo 3 of 3 : UCIP_FA_2021_70227_89367.jpg

Land-Side: view of LS slope.

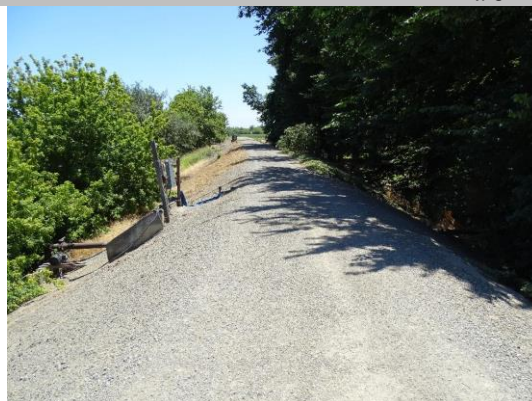
Photo 1 of 3 : UCIP_FA_2021_70228_89360.jpg

DS_ID:20610
 FS_ID:70228
 EP_NO: N/A
 Repair Type: Non-Urgent
 EVAL Issue: Unauthorized Encroachment, installed decades prior
 Crossing Status: Found
 UCIP Comments: 06/23/2020 Record updated from No Action Needed to Non-Urgent. No permit has been identified authorizing pipe.
 (D.Sanoski - DWR UCIP)
 FIELD_STRUCT_DESC: 10-inch steel irrigation pipe through the levee, 10 feet below the crown. 8-inch polyvinyl chloride pipe sleeved through 10-inch pipe. Two concrete platforms for pump and pump house on the waterside (WS) slope. 5-foot by 10-foot concrete distribution box and 36-inch concrete standpipe at the landside (LS) toe. Power pole at the LS toe. Concrete filled tire stairs on both slopes. [Additional Reference(s): DWR Levee Log, 2004 (HLM 2.02). USACE San Joaquin O&M Manual, Unit 7, April 1964, Revised 29 December 2016, (2.02), listed as 10-inch pipe].
 FS Date: 6/23/2020 2:40:00 PM

Top of Levee: view of crown.

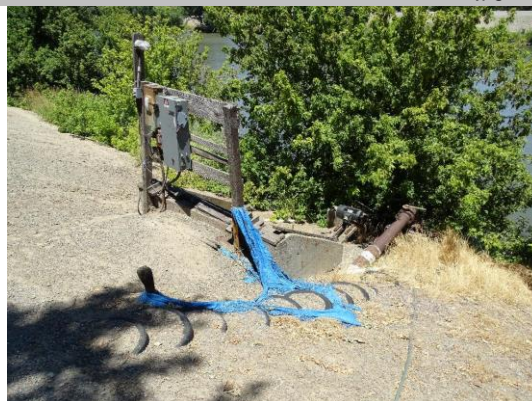
Photo 2 of 3 : UCIP_FA_2021_70228_89361.jpg

Water-Side: view of WS slope with pipe and pump.

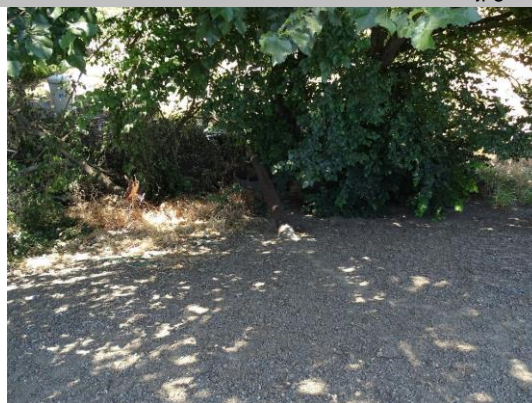
Photo 3 of 3 : UCIP_FA_2021_70228_89362.jpg

Land-Side: view of LS slope and pipe with concrete standpipe.

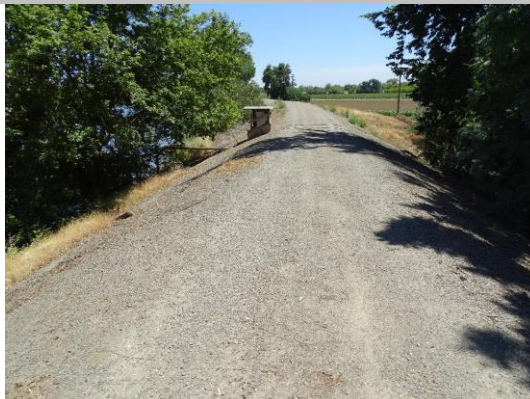
Photo 1 of 3 : UCIP_FA_2021_61945_89369.jpg

LM Start	2.03	Rating **	M	Issue No.	953	
LM End	2.03	Issue Type +	En	Location *		
Category	Supplemental			GPS Latitude/Longitude		
				Start	End	
Item	DWR UCIP Field Study			37.922535 °	37.922535 °	
				-121.323568 °	-121.323568 °	
DWR ID	24036					
Comment Code						
Inspector Comment						
DS_ID:24036 FS_ID:61945 EP_NO: N/A Repair Type: Non-Urgent EVAL Issue: Unauthorized Encroachment Crossing Status: Found UCIP Comments: 06/23/2020 Record remains Non-Urgent. No permit has been found authorizing this pipe through the levee. Crossing appears abandoned. (D.Sanoski - DWR UCIP) 08/20/2013 Pipe abandoned and should be done so properly. Holes visible throughout exposed pipe. (W.Wylie - DWR UCIP) FIELD_STRUCT_DESC: 5-inch wrapped steel irrigation pipe through the levee, 6 feet below the crown. No pump or other appurtenances found. FS Date: 6/23/2020 2:41:00 PM

Top of Levee: view of crown with pipe pipe out of slope on WS.

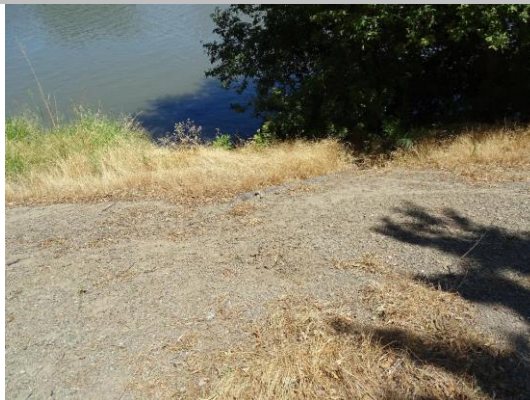
Photo 2 of 3 : UCIP_FA_2021_61945_89371.jpg

Water-Side: view of WS slope and abandoned pipe in slope.

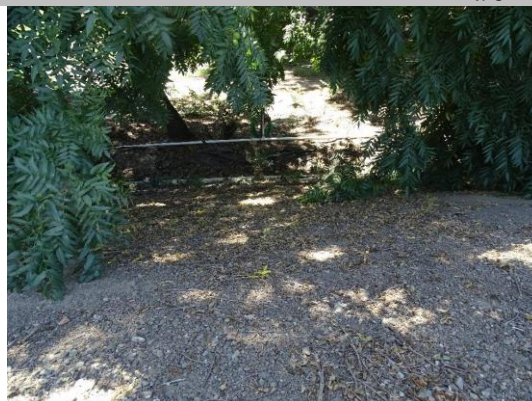
Photo 3 of 3 : UCIP_FA_2021_61945_89370.jpg

Land-Side: view of LS slope with no sign of pipe.

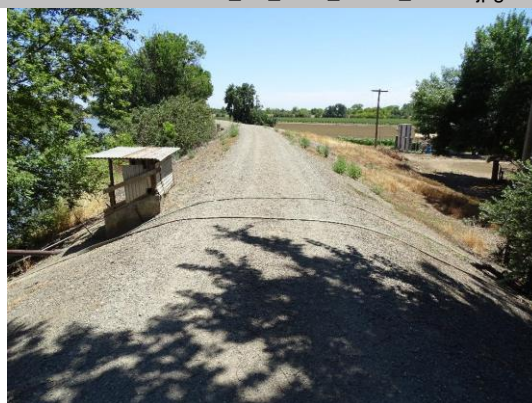
Photo 1 of 3 : UCIP_FA_2021_61946_89372.jpg

DS_ID:20611
 FS_ID:61946
 EP_NO: N/A
 Repair Type: Non-Urgent
 EVAL Issue: Unauthorized Encroachment, installed decades prior
 Crossing Status: Found
 UCIP Comments: 06/23/2020 Record updated from No Action Needed to Non-Urgent. No permit has been identified authorizing pipe.
 (D.Sanoski - DWR UCIP)
 FIELD_STRUCT_DESC: 6-inch irrigation pipe of an unknown material through the levee, 3.5 feet below the crown. 4.5-inch polyvinyl chloride irrigation pipe sleeved through 6-inch pipe. Pump on concrete slab on the waterside (WS) slope. 6-foot by 6-foot brick distribution box and power pole at the landside (LS) toe. [Additional Reference(s): DWR Levee Log, 2004 (HLM 2.06). USACE San Joaquin O&M Manual, Unit 7, April 1964, Revised 29 December 2016, (2.06), listed as 6-inch pipe].
 FS Date: 6/23/2020 2:41:00 PM

Top of Levee: view of crown.

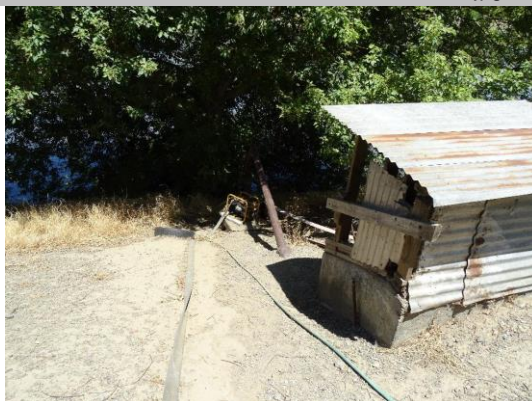
Photo 2 of 3 : UCIP_FA_2021_61946_89373.jpg

Water-Side: view of WS slope with pipe and pumphouse.

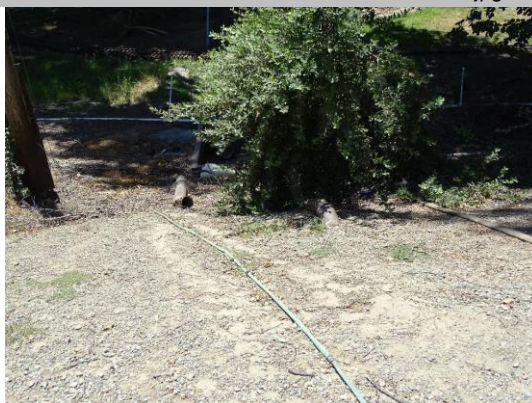
Photo 3 of 3 : UCIP_FA_2021_61946_89374.jpg

Land-Side: view of LS slope with pipe out of slope.

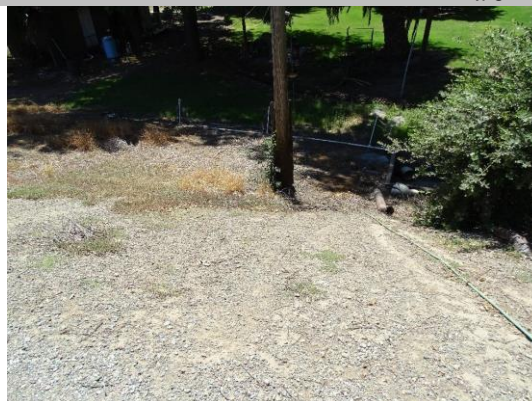
Photo 3 of 3 : UCIP_FA_2021_70229_89379.jpg

Land-Side: view of LS slope and powerpole at toe.

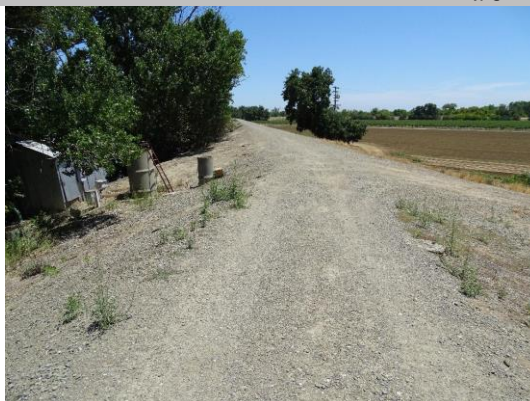
Photo 1 of 3 : UCIP_FA_2021_70230_89380.jpg

LM Start	2.07	Rating **	M	Issue No.	956	
LM End	2.07	Issue Type +	En	Location *		
Category	Supplemental			GPS Latitude/Longitude		
				Start		End
Item	DWR UCIP Field Study			37.922080 °		37.922080 °
				-121.323118 °		-121.323118 °
DWR ID	24038					
Comment Code						
Inspector Comment						
DS_ID:24038 FS_ID:70230 EP_NO: N/A Repair Type: Non-Urgent EVAL Issue: Unauthorized Encroachment Crossing Status: Found UCIP Comments: 06/23/2020 Record remains Non-Urgent. No permit has been identified authorizing pipe. (D.Sanoski - DWR UCIP) 08/20/2013 No permit identified for this crossing. (W.Wylie - DWR UCIP) FIELD_STRUCT_DESC: 6-inch steel irrigation pipe through the levee, at an unknown depth. Vent, meter, butterfly valve, and pump at pump house on the waterside (WS) slope. FS Date: 6/23/2020 2:42:00 PM

Top of Levee: view of crown.
