Flood Control Project Maintenance Levee Inspections

Fall 2021 Levee Maintenance Deficiency Summary Report

San Joaquin River Basin

Reclamation District No. 0524 Middle Roberts Island

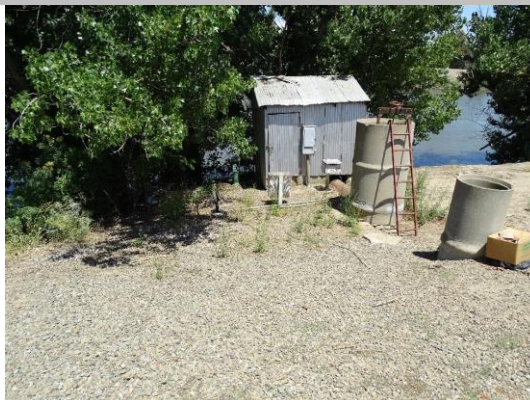
Photo 2 of 3 : UCIP_FA_2021_70230_89381.jpg

Water-Side: view of Ws slope and pipe out of pumphouse.

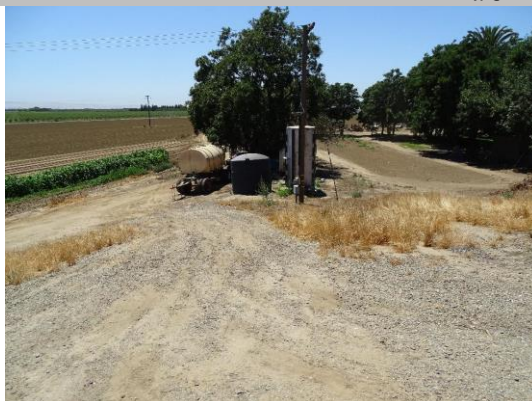
Photo 3 of 3 : UCIP_FA_2021_70230_89382.jpg

Land-Side: view of LS slope and pipe at toe connected to tank.

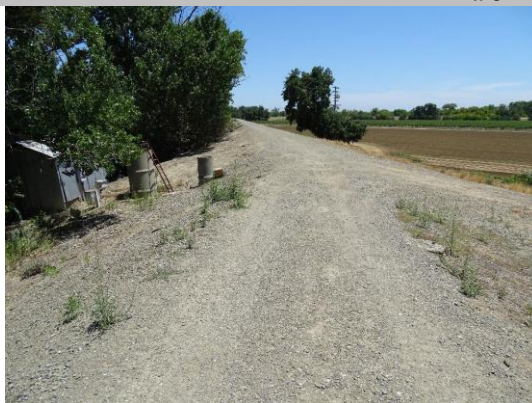
Photo 1 of 3 : UCIP_FA_2021_70231_89383.jpg

DS_ID:24039
 FS_ID:70231
 EP_NO: N/A
 Repair Type: Non-Urgent
 EVAL Issue: Unauthorized Encroachment, installed decades prior
 Crossing Status: Found
 UCIP Comments: 06/23/2020 Record updated from No Action Needed to Non-Urgent. No permit has been identified authorizing pipe. Electrical conduit for the 20-inch pipe (DSID 20612). (D.Sanoski - DWR UCIP)
 FIELD_STRUCT_DESC: 3.5-inch polyvinyl chloride electrical conduit through the levee, at an unknown depth. Provides power for pump house on the waterside (WS) slope. Power pole on the landside (LS) toe. [Additional Reference(s): DWR Levee Log, 2004 (HLM 2.10 - listed as 20-inch pipe). USACE San Joaquin O&M Manual, Unit 7, April 1964, Revised 29 December 2016, (2.10), listed as 20-inch pipe].
 FS Date: 6/23/2020 2:42:00 PM

Top of Levee: view of crown.

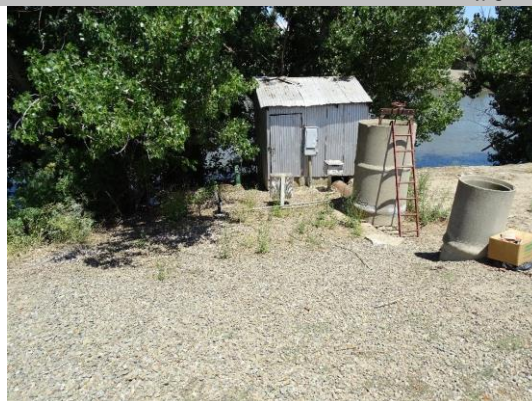
Photo 2 of 3 : UCIP_FA_2021_70231_89384.jpg

Water-Side: view of WS slope and electrical conduit out of panel on pumphouse.

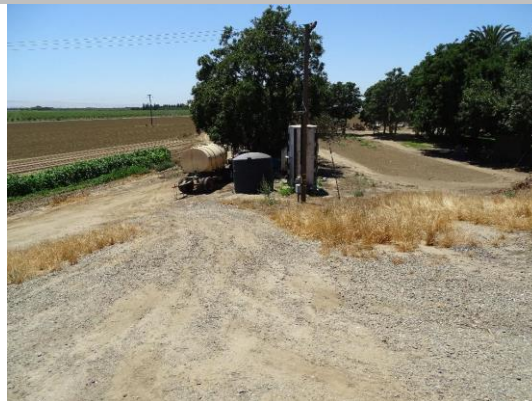
Photo 3 of 3 : UCIP_FA_2021_70231_89385.jpg

Land-Side: view of LS slope and electrical conduit into panel at powerpole at toe.

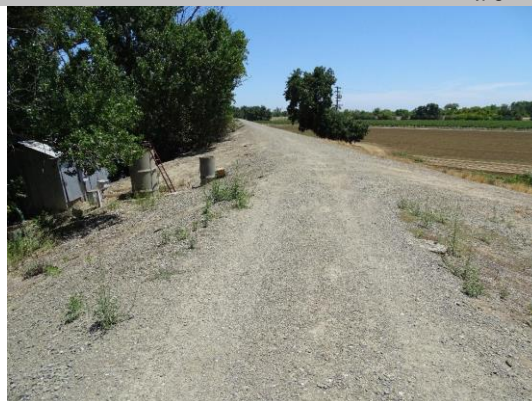
Photo 1 of 3 : UCIP_FA_2021_70232_89386.jpg

Comment Code						
Inspector Comment						
DS_ID:20612 FS_ID:70232 EP_NO: N/A Repair Type: Non-Urgent EVAL Issue: Unauthorized Encroachment, installed decades prior Crossing Status: Found UCIP Comments: 06/23/2020 Record remains Non-Urgent. No permit has been identified authorizing pipe. There was no hole next to standpipe present at time of inspection. (D.Sanoski - DWR UCIP) 08/20/2013 Soil excavated from cover over pipe on WS next to concrete riser. May indicate a leak or other problem. (W.Wylie - DWR UCIP) FIELD_STRUCT_DESC: 20-inch steel irrigation pipe through the levee, 15 feet below the crown. Pump in pump house on the waterside (WS) slope. Slide gate in 4-foot diameter concrete standpipe on the WS slope with secondary concrete standpipe. Polyvinyl chloride standpipe visible 350 feet off the landside (LS) toe. [Additional Reference(s): DWR Levee Log, 2004 (HLM 2.10). USACE San Joaquin O&M Manual, Unit 7, April 1964, Revised 29 December 2016, (2.10), listed as 20-inch pipe]. FS Date: 6/23/2020 2:23:00 PM

Top of Levee: view of crown.

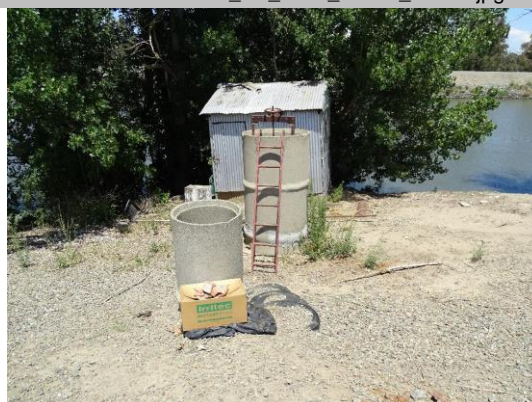
Photo 2 of 3 : UCIP_FA_2021_70232_89387.jpg

Water-Side: view of WS slope with concrete standpipes, pumphouse, and pipe on slope.

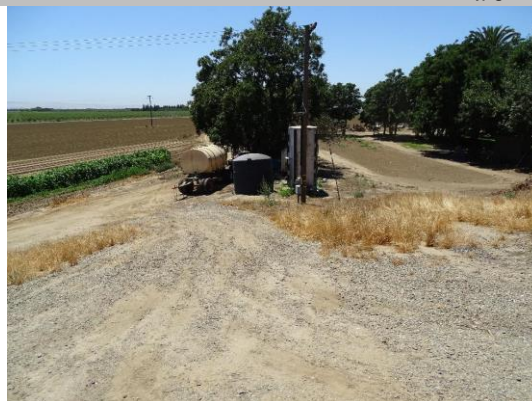
Photo 3 of 3 : UCIP_FA_2021_70232_89388.jpg

Land-Side: view of LS slope and riser 350 feet off of toe.

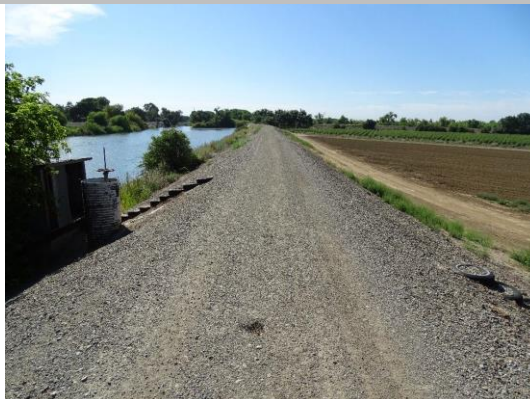
Photo 1 of 3 : UCIP_FA_2021_70233_89389.jpg

DS_ID:20613
FS_ID:70233
EP_NO: N/A
Repair Type: Non-Urgent
EVAL Issue: Unauthorized Encroachment, installed decades prior
Crossing Status: Found
UCIP Comments: 06/24/2020 Record updated from No Action Needed to Non-Urgent. No permit has been identified authorizing pipe.
(D.Sanoski - DWR UCIP)
FIELD_STRUCT_DESC: 12-inch steel irrigation pipe through the levee, 14 feet below the crown. Pump in pump house on the waterside (WS) slope. Slide gate in 36-inch corrugated metal riser unit on the WS slope. 36-inch concrete riser unit off the landside (LS) toe. 1.75-inch galvanized iron electrical conduit at same location. [Additional Reference(s): DWR Levee Log, 2004 (HLM 2.15). USACE San Joaquin O&M Manual, Unit 7, April 1964, Revised 29 December 2016, (2.15), listed as 24-inch pipe].
FS Date: 6/24/2020 2:22:00 PM

Top of Levee: view of crown.

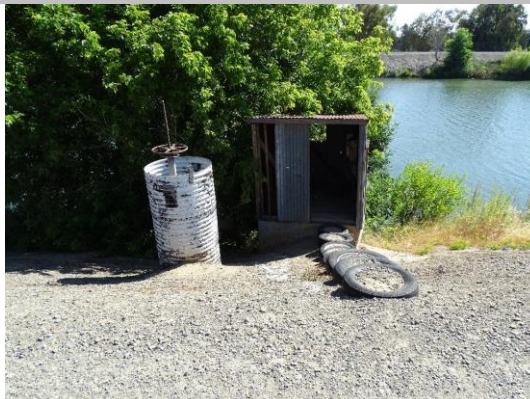
Photo 2 of 3 : UCIP_FA_2021_70233_89390.jpg

Water-Side: view of WS slope, pumphouse, and riser on slope.

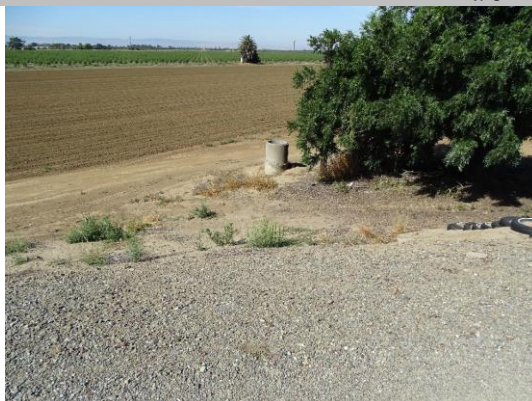
Photo 3 of 3 : UCIP_FA_2021_70233_89391.jpg

Land-Side: view of LS slope and concrete riser off of toe.

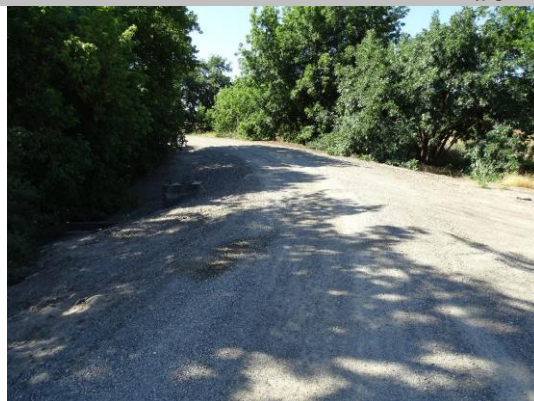
Photo 1 of 3 : UCIP_FA_2021_61955_89398.jpg

Comment Code						
Inspector Comment						
DS_ID:24040 FS_ID:61955 EP_NO: N/A Repair Type: Non-Urgent EVAL Issue: Unauthorized Encroachment Crossing Status: Found UCIP Comments: 06/24/2020 Record remains Non-Urgent. No permit has been found authorizing this pipe through the levee. Crossing appears abandoned. Unclear if 12-inch pipe discharging into distribution box on LS toe is related to this crossing. (D.Sanoski - DWR UCIP) 08/20/2013 Need to determine type of abandonment for pipe at this location. (W.Wylie - DWR UCIP) FIELD_STRUCT_DESC: *ABANDONED* Pump pad on the landside (LS) shoulder with 4-foot by 9-foot brick distribution box on the waterside (WS) slope. No pipe visible. 4-foot by 9-foot brick distribution box on the LS toe. FS Date: 6/24/2020 2:43:00 PM

Top of Levee: view of crown.

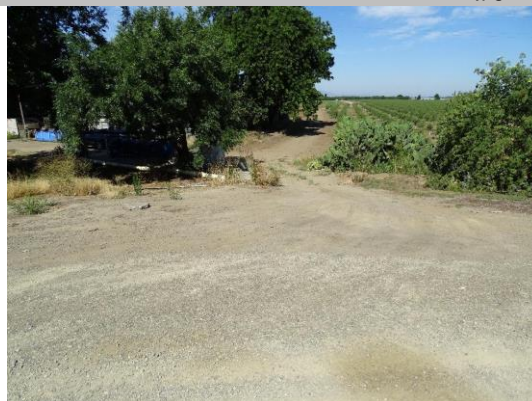
Photo 3 of 3 : UCIP_FA_2021_61955_89400.jpg

Land-Side: view of LS slope.

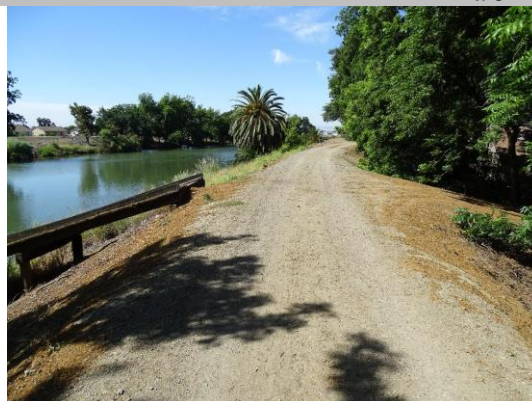
Photo 1 of 3 : UCIP_FA_2021_70235_89401.jpg

Comment Code					
Inspector Comment					
DS_ID:20615 FS_ID:70235 EP_NO: N/A Repair Type: Non-Urgent EVAL Issue: Unauthorized Encroachment, installed decades prior Crossing Status: Found UCIP Comments: 06/24/2020 Record updated from No Action Needed to Non-Urgent. No permit has been identified authorizing pipe. (D.Sanoski - DWR UCIP) FIELD_STRUCT_DESC: 14-inch steel irrigation pipe through the levee, 12 feet below the crown. Pump in pump house on pile structure in stream. Timber drive ramp to the pump house. Air release valve on landside (LS) toe. [Additional Reference(s): DWR Levee Log, 2004 (HLM 2.71). USACE San Joaquin O&M Manual, Unit 7, April 1964, Revised 29 December 2016, (2.71), listed as 14-inch pipe]. FS Date: 6/24/2020 2:43:00 PM

Top of Levee: view of crown.

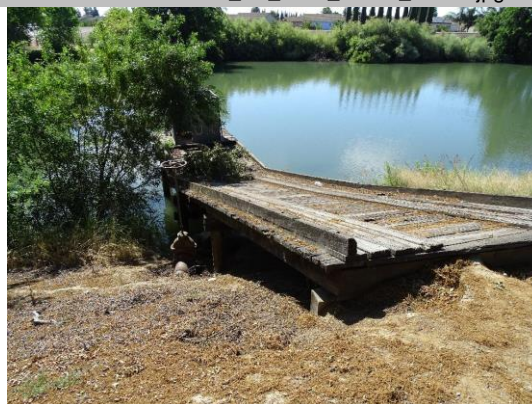
Photo 2 of 3 : UCIP_FA_2021_70235_89402.jpg

Water-Side: view of WS slope and wooden ramp, pipe, and pump.

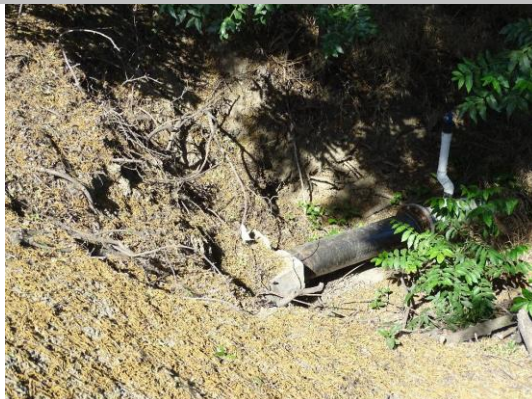
Photo 3 of 3 : UCIP_FA_2021_70235_89405.jpg

Land-Side: view of new pipe configuration out of levee toe.

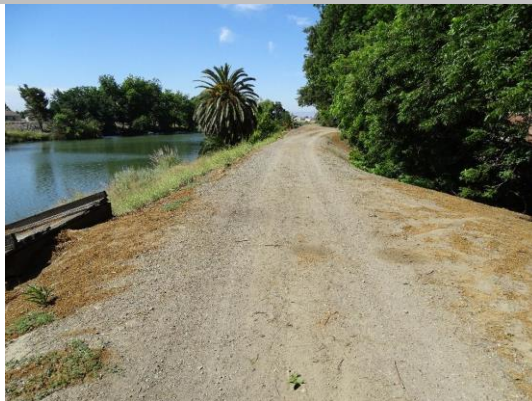
Photo 1 of 3 : UCIP_FA_2021_61957_89406.jpg

DS_ID:24041
 FS_ID:61957
 EP_NO: N/A
 Repair Type: Non-Urgent
 EVAL Issue: Unauthorized Encroachment, installed decades prior
 Crossing Status: Found
 UCIP Comments: 06/24/2020 Record updated from No Action Needed to Non-Urgent. No permit has been identified authorizing pipe.
 Associated the DSID 20615. (D.Sanoski - DWR UCIP)
 FIELD_STRUCT_DESC: 1.5-inch galvanized iron electrical conduit through the levee, 2 feet below the crown. Pump on pier with a power pole and meter on the landside (LS) toe.
 FS Date: 6/24/2020 2:43:00 PM

Top of Levee: view of crown.

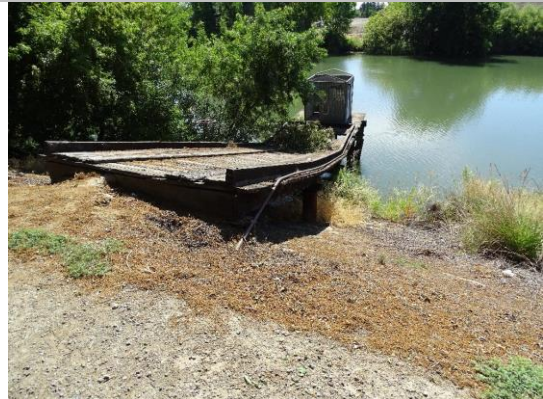
Photo 2 of 3 : UCIP_FA_2021_61957_89407.jpg

Water-Side: view of WS slope and electrical conduit into levee.

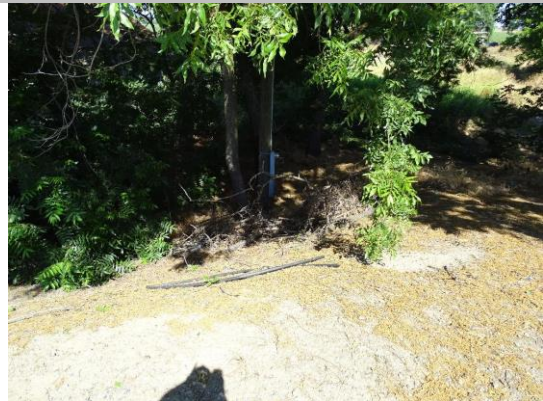
Photo 3 of 3 : UCIP_FA_2021_61957_89408.jpg

Land-Side: view of LS slope and powerpole at toe.

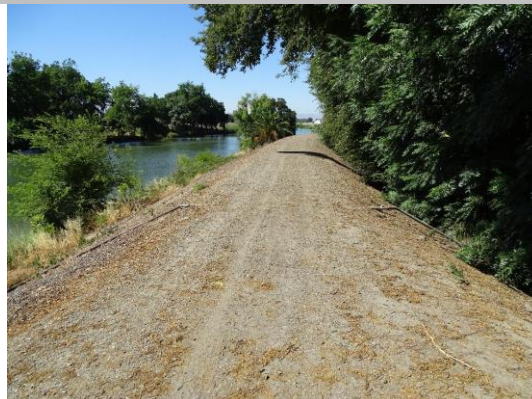
Photo 1 of 3 : UCIP_FA_2021_61958_89409.jpg

DS_ID:20616
FS_ID:61958
EP_NO: N/A
Repair Type: Non-Urgent
EVAL Issue: Unauthorized Encroachment, installed decades prior
Crossing Status: Found
UCIP Comments: 06/24/2020 Record remains Non-Urgent.
Unauthorized encroachment recorded in Levee Log prior to 2011.
Crossing appears abandoned. Holes in pipe on WS slope. (D.Sanoski - DWR UCIP)
08/20/2013 No permit identified for crossing. Unknown use. Pipe should be removed. (W.Wylie - DWR UCIP)
FIELD_STRUCT_DESC: *ABANDONED* 3-inch galvanized iron pipe of an unknown purpose through the levee, 0.3 feet below the crown. Valve removed on the landside (LS) shoulder. [Additional Reference(s): DWR Levee Log, 2004 (HLM 2.75)].
FS Date: 6/24/2020 2:44:00 PM

Top of Levee: view of crown with pipes into levee on both sides of crown.

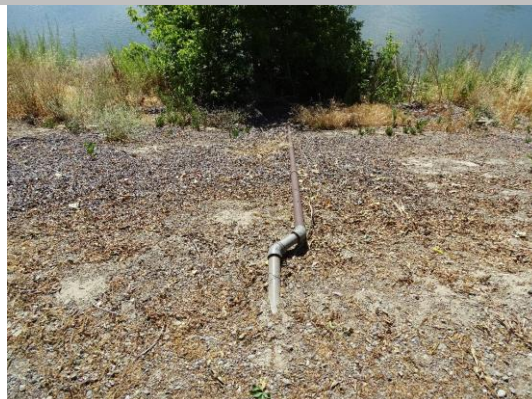
Photo 2 of 3 : UCIP_FA_2021_61958_89410.jpg

Water-Side: view of WS slope and abandoned pipe with visible holes.

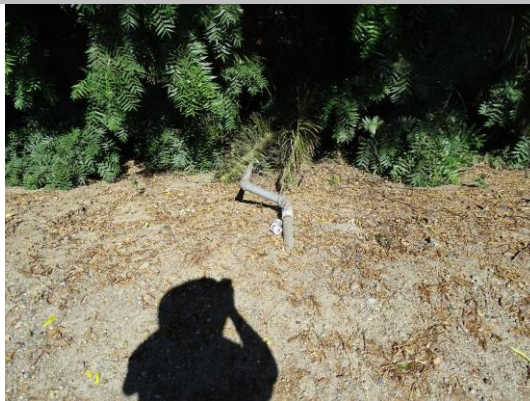
Photo 3 of 3 : UCIP_FA_2021_61958_89411.jpg

Land-Side: view of LS slope with pipe out of slope.

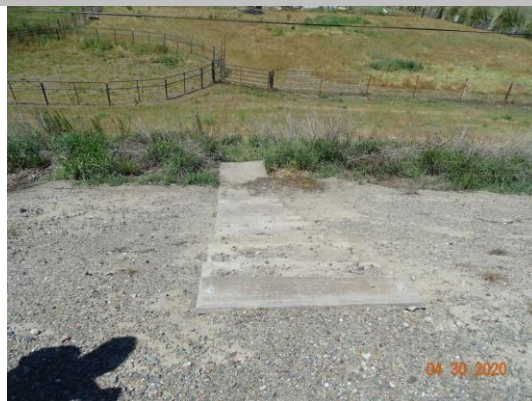
Photo 1 of 1 : FA_2021_RD0524_107_223_20210913_00083.jpg

LM Start	2.91	Rating **	M	Issue No.	223
LM End	2.91	Issue Type +	En	Location *	LS
Category	Earthen Levee			GPS Latitude/Longitude	
				Start	End
Item	Encroachments			37.913745 °	37.913745 °
				-121.324404 °	-121.324404 °
DWR ID	DWR_RD0524_01_s _ 2020_223				
Comment Code					
ST : Stairway					
Inspector Comment

View of stairs cut into levee landside slope. Spring 2020

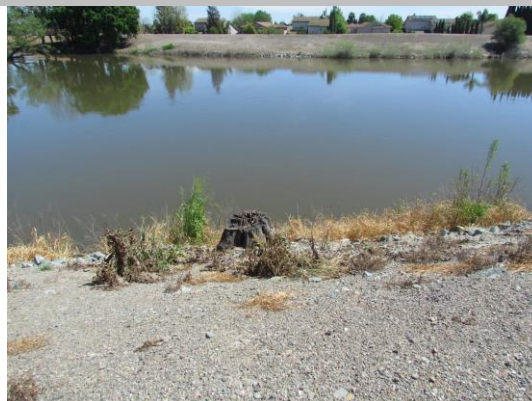
Photo 1 of 1 : FA_2021_RD0524_107_161_20210913_00068.jpg

LM Start	2.91	Rating **	N	Issue No.	161
LM End	2.91	Issue Type +	Ma	Location *	WS
Category	Earthen Levee			GPS Latitude/Longitude	
				Start	End
Item	Trim / Thin Trees			37.913733 °	37.913733 °
				-121.324398 °	-121.324398 °
DWR ID	DWR_RD0524_01_s _ 2017_161				
Comment Code					
T5 : Tree stumps.					
Inspector Comment

Looking east at large tree stump on waterward shoulder.

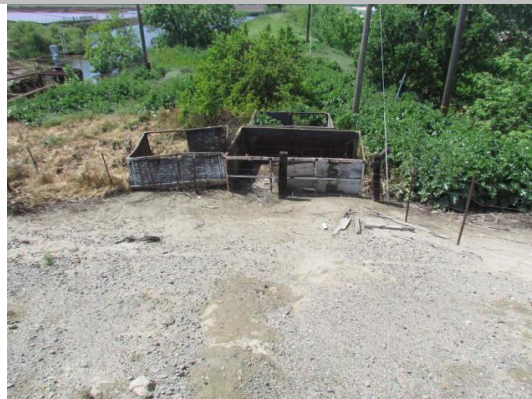
Photo 1 of 1 : FA_2021_RD0524_107_210_20210913_00076.jpg

LM Start	2.94	Rating **	M	Issue No.	210
LM End	2.94	Issue Type +	En	Location *	LS
Category	Earthen Levee			GPS Latitude/Longitude	
				Start	End
Item	Encroachments			37.913198 °	37.913198 °
				-121.324490 °	-121.324490 °
DWR ID	DWR_RD0524_01_s_2016_210				
Comment Code					
GA : Garbage					
Inspector Comment					
Old containers at landside toe.

Looking west at abandoned containers at landward toe.

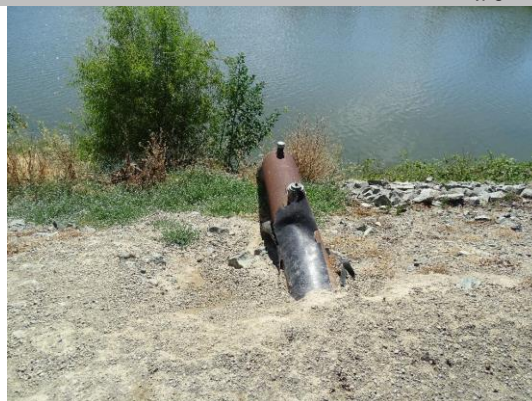
Photo 2 of 3 : UCIP_FA_2021_61959_89413.jpg

Comment Code						
Inspector Comment						
DS_ID:20617 FS_ID:61959 EP_NO: N/A Repair Type: Non-Urgent EVAL Issue: Unauthorized Encroachment, installed decades prior Crossing Status: Indicator Found UCIP Comments: 06/24/2020 Record remains Non-Urgent. No permit has been identified authorizing pipe. (D.Sanoski - DWR UCIP) 08/20/2013 Review crossing with inspector as records indicate that this should be an 8-inch pipe through levee 3.0 feet below crown, pump on landward side. Siphon breaker on the waterward slope. Originally included in the 1964 O&M manual. (W.Wylie - DWR UCIP) FIELD_STRUCT_DESC: 16-inch wrapped steel storm discharge pipe through the levee, 1.5 feet below the crown. Pump on steel pile structure at drainage canal off landside (LS) toe. [Additional Reference(s): DWR Levee Log, 2004 (HLM 2.99, listed as 8-inch pipe). USACE San Joaquin O&M Manual, Unit 7, April 1964, Revised 29 December 2016, (2.99), listed as 9-inch pipe]. FS Date: 6/24/2020 2:44:00 PM

Water-Side: view of WS slope with pipe out of slope.

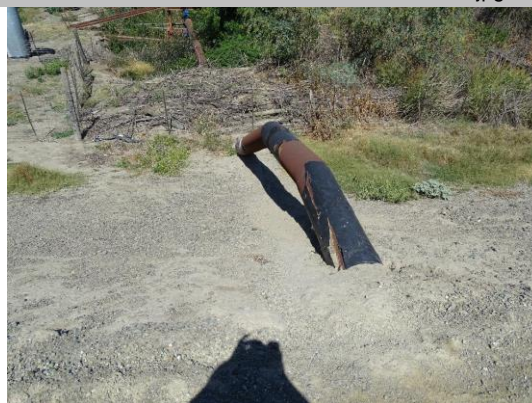
Photo 3 of 3 : UCIP_FA_2021_61959_89414.jpg

Land-Side: view of LS slope and pipe out of slope.

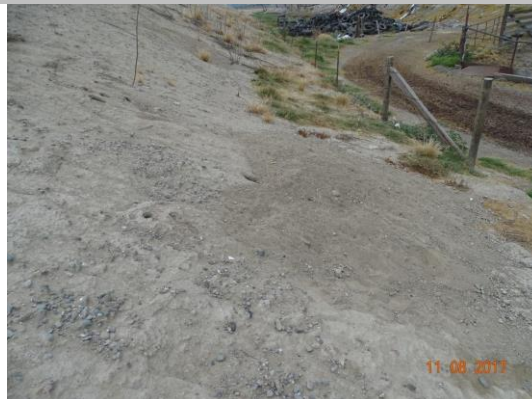
Photo 1 of 1 : FA_2021_RD0524_107_925_20210913_00108.jpg

LM Start	3.10	Rating **	M	Issue No.	925
LM End	3.27	Issue Type +	Ma	Location *	LS
Category	Earthen Levee			GPS Latitude/Longitude	
				Start	End
Item	Animal Control			37.910946 °	37.908602 °
				-121.325147 °	-121.325395 °
DWR ID	DWR_RD0524_01_s_2012_925				
Comment Code					
A1 : Exterminate rodents and backfill and compact or grout burrows.					
Inspector Comment					
Several rodent holes on levee slopes.

Looking southwest at the landside slope.

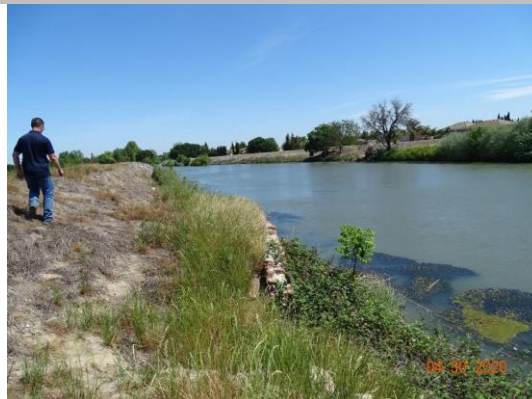
Photo 1 of 1 : FA_2021_RD0524_107_220_20210913_00079.jpg

LM Start	3.12	Rating **	M	Issue No.	220
LM End	3.12	Issue Type +	En	Location *	WS
Category	Earthen Levee			GPS Latitude/Longitude	
				Start	End
Item	Encroachments			37.910786 °	37.910786 °
				-121.325243 °	-121.325243 °
DWR ID	DWR_RD0524_01_s_2020_220				
Comment Code					
RW : Retaining Wall					
Inspector Comment					
Old retaining wall made of bricks on waterside slope in poor condition.

View of damaged retaining wall on waterside slope. Approximately 30 ft. long, 8 ft. high and 20 ft. from waterside hinge. Spring 2020

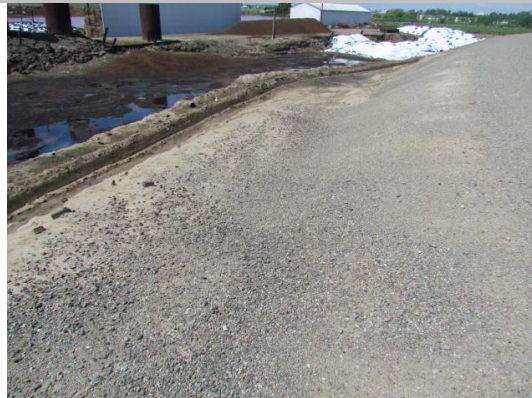
Photo 1 of 1 : FA_2021_RD0524_107_211_20210913_00077.jpg

LM Start	3.18	Rating **	M	Issue No.	211
LM End	3.18	Issue Type +	En	Location *	LS
Category	Earthen Levee			GPS Latitude/Longitude	
				Start	End
Item	Encroachments			37.909945 °	37.909945 °
				-121.325543 °	-121.325543 °
DWR ID	DWR_RD0524_01_f_2020_211				
Comment Code					
RA : Ramp					
Inspector Comment					
Unauthorized ramp on landside slope.

Looking northwest at unauthorized ramp on landward slope.

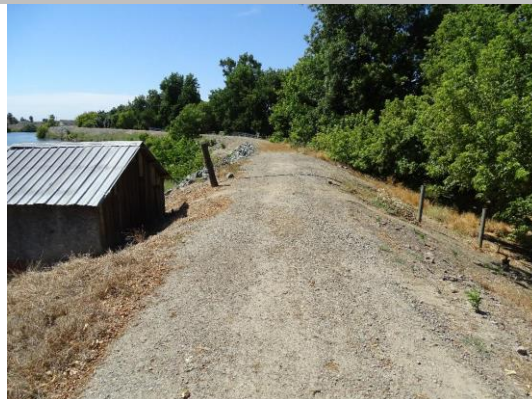
Photo 1 of 3 : UCIP_FA_2021_70236_89415.jpg

DS_ID:20618
FS_ID:70236
EP_NO: N/A
Repair Type: Non-Urgent
EVAL Issue: Unauthorized Encroachment, installed decades prior
Crossing Status: Found
UCIP Comments: 06/24/2020 Record updated from Urgent to Non-Urgent. No permit has been identified authorizing pipe. Erosion repaired since last inspection. (D.Sanoski - DWR UCIP)
10/2/2018 Same as previous inspection with severe LS slope integrity issues (D. Sanoski - DWR UCIP).
11/16/2016 same as previous inspection erosion is still present on LS toe and slope. Owner will need to coordinate with CVFPB to address erosion issue on LS toe. (O. Magana - DWR UCIP)08/20/2013
Extensive erosion on LS toe at distribution box due to failure of box/pipe connection. Erosion on LS slope do to recently repaired leak at gate valve. (W. Wylie - DWR UCIP)
FIELD_STRUCT_DESC: 14-inch steel irrigation pipe through the levee, 7 feet below the crown. Pump house located on the waterside (WS) slope. Gate valve located on the landside (LS) slope. 4-foot by 4-foot brick distribution box, built in 1918, located on the LS toe. This site was used to manufacture brick back in 1918, and some of the appurtenances that remain are still in use (distribution box and ditch).

Top of Levee: view of crown.

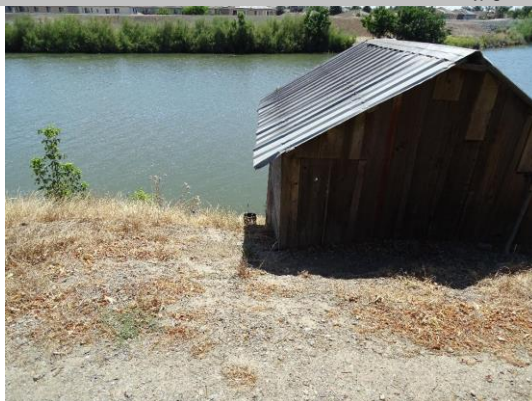
Photo 2 of 3 : UCIP_FA_2021_70236_89416.jpg

Water-Side: view of WS slope and pumphouse.

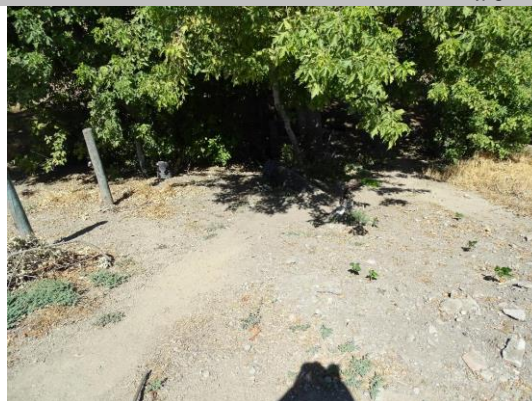
Photo 3 of 3 : UCIP_FA_2021_70237_89421.jpg

LM Start	3.35	Rating **	M	Issue No.	966
LM End	3.35	Issue Type +	En	Location *	
Category	Supplemental			GPS Latitude/Longitude	
				Start	End
Item	DWR UCIP Field Study			37.907503 °	37.907503 °
				-121.325420 °	-121.325420 °
DWR ID	24042				
Comment Code					
Inspector Comment					
DS_ID:24042 FS_ID:70237 EP_NO: N/A Repair Type: Non-Urgent EVAL Issue: Unauthorized Encroachment, installed decades prior Crossing Status: Found UCIP Comments: 06/24/2020 Record updated from No Action Needed to Non-Urgent. No permit has been identified authorizing pipe. Associated with DSID 20618. (D.Sanoski - DWR UCIP) FIELD_STRUCT_DESC: 1.5-inch galvanized iron electrical conduit through the levee, 3 feet below the crown. Power pole on the landside (LS) toe. Pump house on the waterside (WS) shoulder. FS Date: 6/24/2020 2:45:00 PM

Land-Side: view of LS slope.

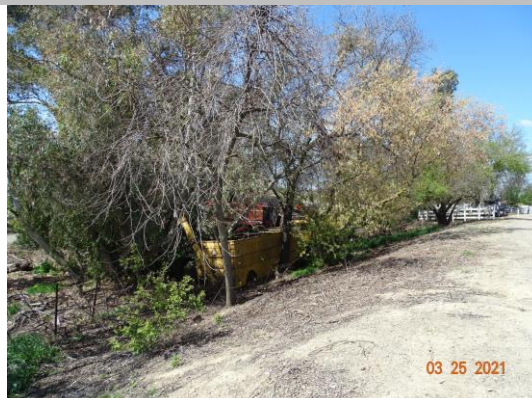
Photo 1 of 1 : FA_2021_RD0524_107_213_20210913_00078.jpg

LM Start	3.44	Rating **	U	Issue No.	213
LM End	3.46	Issue Type +	En	Location *	LS
Category	Earthen Levee			GPS Latitude/Longitude	
				Start	End
Item	Encroachments			37.906258 °	37.906126 °
				-121.324735 °	-121.324532 °
DWR ID	DWR_RD0524_01_s_2020_213				
Comment Code					
EQ : Equipment					
Inspector Comment					
Farming equipment being stored within the landside easement. Spring 2021

View of abandoned farm equipment within the landside easement.
Spring 2021

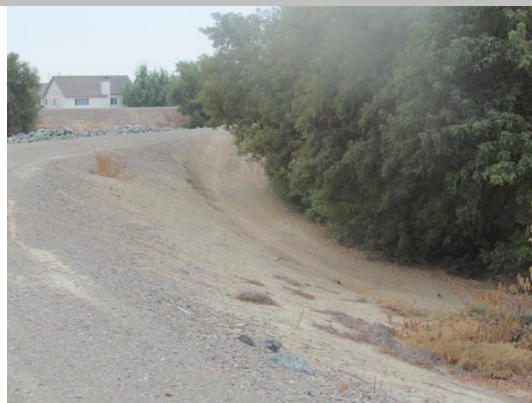
Photo 1 of 1 : FA_2021_RD0524_107_265_20210913_00091.jpg

LM Start	3.52	Rating **	M	Issue No.	265
LM End	3.52	Issue Type +	En	Location *	LS
Category	Earthen Levee			GPS Latitude/Longitude	
				Start	End
Item	Encroachments			37.905444 °	37.905444 °
				-121.323835 °	-121.323835 °
DWR ID	DWR_RD0524_01_s_2012_265				
Comment Code					
RA : Ramp					
Inspector Comment					
Unauthorized ramp on landside slope.

Looking southeast at unauthorized ramp on landside slope and toe.

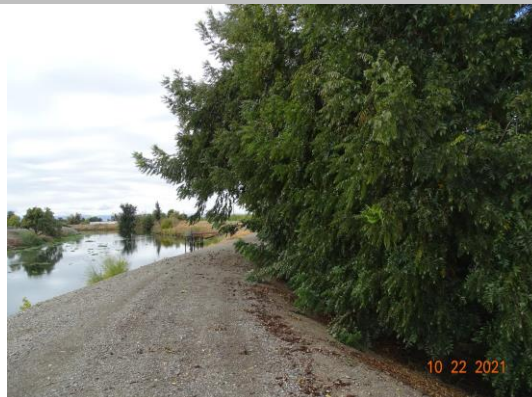
Photo 1 of 1 : FA_2021_RD0524_107_174_20211025_00339.jpg

LM Start	3.59	Rating **	U	Issue No.	174
LM End	3.59	Issue Type +	Ma	Location *	LS
Category	Earthen Levee			GPS Latitude/Longitude	
				Start	End
Item	Trim / Thin Trees			37.904565 °	37.904565 °
				-121.324200 °	-121.324200 °
DWR ID	DWR_RD0524_01_f _ 2021_174				
Comment Code					
T3 : Trim and thin trees to allow visibility of the ground and room to flood fight.					
Inspector Comment

View of untrimmed trees along the landside slope. Fall 2021

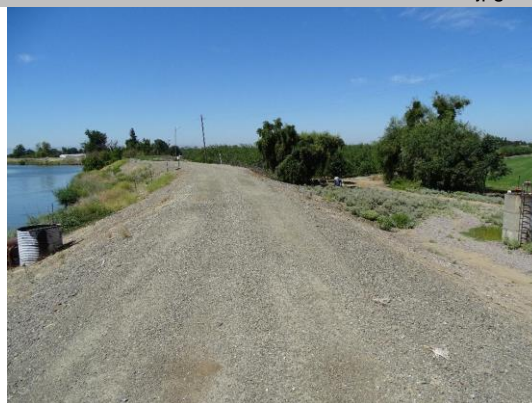
Photo 1 of 3 : UCIP_FA_2021_70238_89422.jpg

Comment Code						
Inspector Comment						
DS_ID:20619 FS_ID:70238 EP_NO: N/A Repair Type: Non-Urgent EVAL Issue: Unauthorized Encroachment, installed decades prior Crossing Status: Found UCIP Comments: 06/24/2020 Record updated from No Action Needed to Non-Urgent. No permit has been identified authorizing pipe. (D.Sanoski - DWR UCIP) FIELD_STRUCT_DESC: 30-inch steel irrigation pipe through the levee, 26.5 feet below the crown. Pump on pile structure in the stream. Steel walkway to the pump on a pier. Slide gate in 66-inch corrugated metal riser unit on the waterside (WS) slope. 5-foot concrete standpipe on the landside (LS) toe. [Additional Reference(s): DWR Levee Log, 2004 (HLM 3.69). USACE San Joaquin O&M Manual, Unit 7, April 1964, Revised 29 December 2016, (3.69), listed as 30-inch pipe]. FS Date: 6/24/2020 2:45:00 PM

Top of Levee: view of crown.

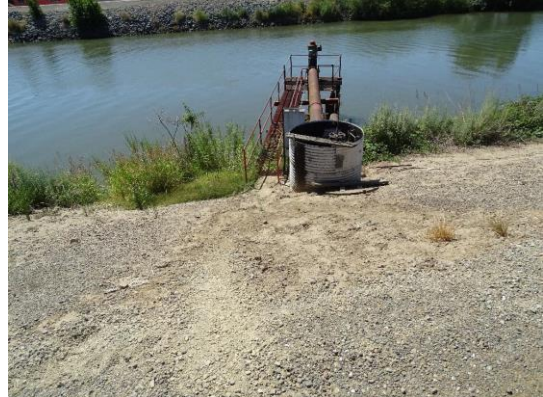
Photo 2 of 3 : UCIP_FA_2021_70238_89423.jpg

Water-Side: view of WS slope and riser with pipe and pump on pier.

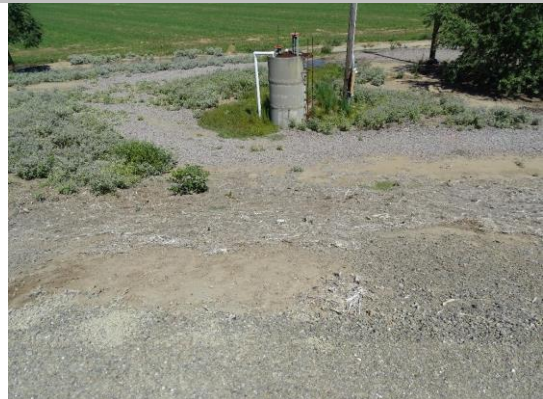
Photo 3 of 3 : UCIP_FA_2021_70238_89424.jpg

Land-Side: view of LS slope and riser on toe.

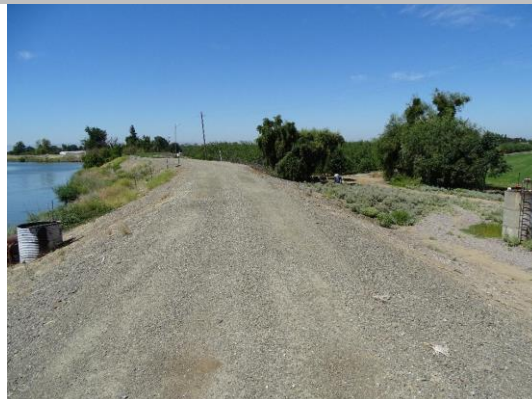
Photo 1 of 3 : UCIP_FA_2021_70239_89425.jpg

LM Start	3.65	Rating **	M	Issue No.	968
LM End	3.65	Issue Type +	En	Location *	
Category	Supplemental			GPS Latitude/Longitude	
				Start	End
Item	DWR UCIP Field Study			37.904097 °	37.904097 °
				-121.325081 °	-121.325081 °
DWR ID	24043				
Comment Code					
Inspector Comment					
DS_ID:24043 FS_ID:70239 EP_NO: N/A Repair Type: Non-Urgent EVAL Issue: Unauthorized Encroachment, installed decades prior Crossing Status: Found UCIP Comments: 06/24/2020 Record updated from No Action Needed to Non-Urgent. No permit has been identified authorizing pipe. Associated with DSID 20619. (D.Sanoski - DWR UCIP) FIELD_STRUCT_DESC: 1.75-inch galvanized iron electrical conduit through the levee, 1 foot below the crown. Power pole on the landside (LS) toe and electrical box on the waterside (WS) slope. FS Date: 6/24/2020 2:46:00 PM

Top of Levee: view of crown.

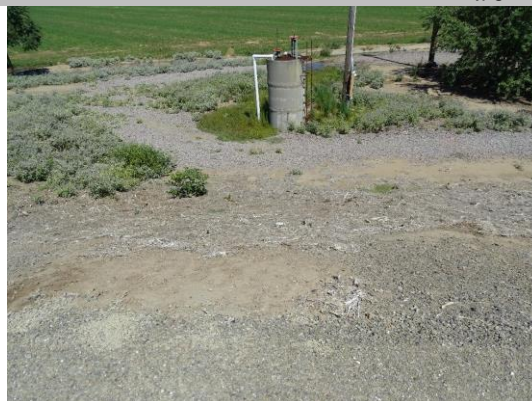
Photo 3 of 3 : UCIP_FA_2021_70239_89427.jpg

Land-Side: view of LS slope.

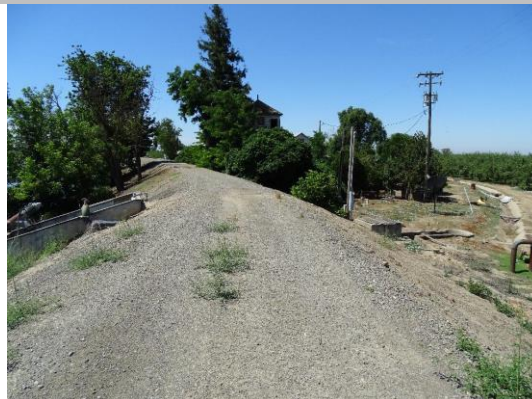
Photo 1 of 3 : UCIP_FA_2021_70240_89430.jpg

Comment Code						
Inspector Comment						
DS_ID:24044 FS_ID:70240 EP_NO: N/A Repair Type: Non-Urgent EVAL Issue: Unauthorized Encroachment Crossing Status: Found UCIP Comments: 06/24/2020 Record remains Non-Urgent. No permit has been found authorizing this pipe through the levee. (D.Sanoski - DWR UCIP) 08/20/2013 No permit identified for this crossing. (W.Wylie - DWR UCIP) FIELD_STRUCT_DESC: 8-inch steel irrigation pipe through the levee, 3 feet below the crown. Adjacent to slant pump and butterfly valve at concrete foundation on the waterside (WS) slope. Pipe connected to filter plant, vents, and butterfly valves on the landside (LS) toe. FS Date: 6/24/2020 2:46:00 PM

Top of Levee: view of crown.

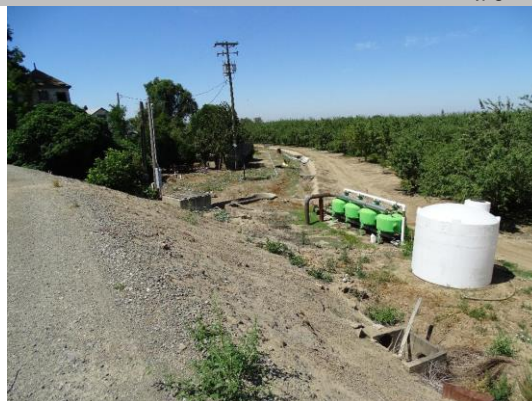
Photo 3 of 3 : UCIP_FA_2021_70240_89431.jpg

Land-Side: view of LS slope and filter plant on toe.

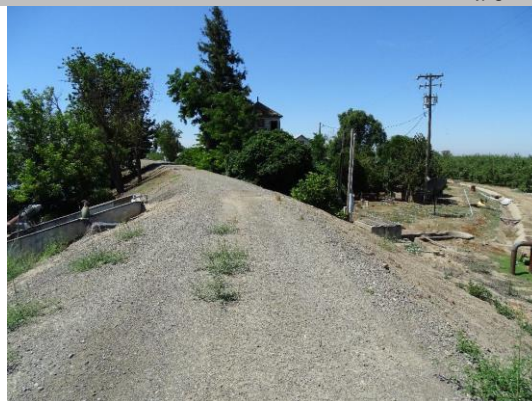
Photo 1 of 3 : UCIP_FA_2021_70241_89434.jpg

DS_ID:20620
 FS_ID:70241
 EP_NO: N/A
 Repair Type: Non-Urgent
 EVAL Issue: Unauthorized Encroachment, installed decades prior
 Crossing Status: Found
 UCIP Comments: 06/24/2020 Record remains Non-Urgent. No permit has been identified authorizing pipe. Crossing appears abandoned. (D.Sanoski - DWR UCIP)
 08/20/2013 Appears abandoned and if so should be done so properly. Evidence of severe internal corrosion in concrete distribution box at LS toe. (W.Wylie - DWR UCIP)
 FIELD_STRUCT_DESC: 12-inch concrete encased steel irrigation pipe through the levee, 10.5 feet below the crown. Pump and gate valve on concrete foundation on the waterside (WS) slope. 6-foot by 6-foot concrete distribution box on the landside (LS) toe. Two concrete cutoff walls. Service pole at the LS toe. [Additional Reference(s): DWR Levee Log, 2004 (HLM 3.83). USACE San Joaquin O&M Manual, Unit 7, April 1964, Revised 29 December 2016, (3.83), listed as 12-inch pipe].

Top of Levee: view of crown.

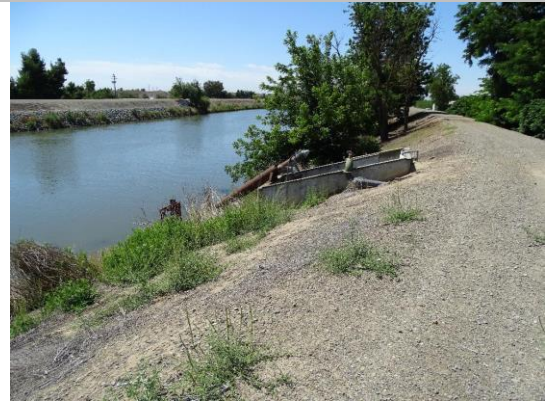
Photo 2 of 3 : UCIP_FA_2021_70241_89436.jpg

Water-Side: view of WS slope.

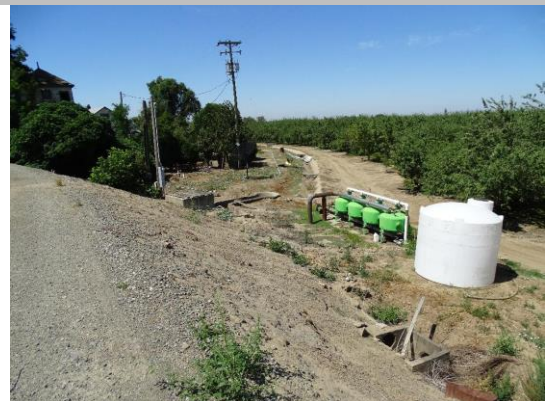
Photo 3 of 3 : UCIP_FA_2021_70241_89435.jpg

Land-Side: view of LS slope.

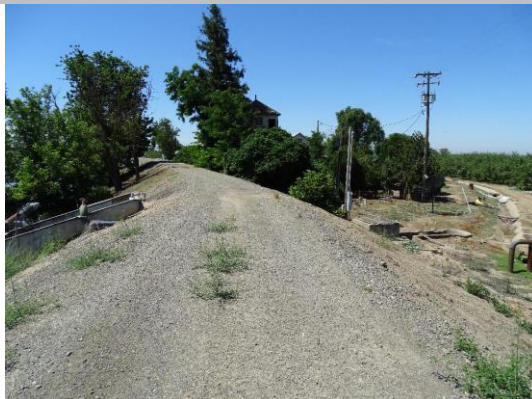
Photo 1 of 3 : UCIP_FA_2021_70242_89437.jpg

Comment Code						
Inspector Comment						
DS_ID:24045						
FS_ID:70242						
EP_NO: N/A						
Repair Type: Non-Urgent						
EVAL Issue: Unauthorized Encroachment, installed decades prior						
Crossing Status: Found						
UCIP Comments: 06/24/2020 Record updated from No Action Needed						
to Non-Urgent. No permit has been identified authorizing pipe.						
Associated with DSID 20620. (D.Sanoski - DWR UCIP)						
FIELD_STRUCT_DESC: 1.25-inch polyvinyl chloride electrical conduit						
through the levee, at an unknown depth. Power pole and meter box on						
the landside (LS) toe. Electrical box inside concrete foundation on the						
waterside (WS) slope.						
FS Date: 6/24/2020 2:47:00 PM

Top of Levee: view of crown.

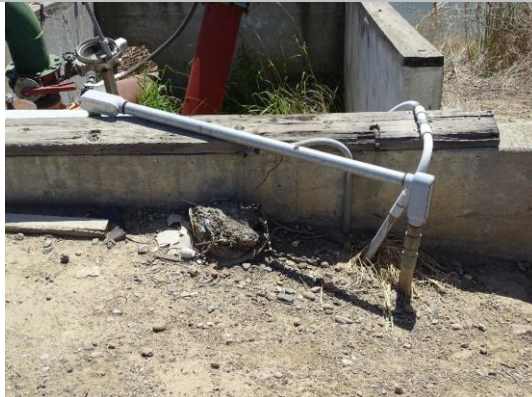
Photo 2 of 3 : UCIP_FA_2021_70242_89438.jpg

Water-Side: view of electrical conduit going through the levee.

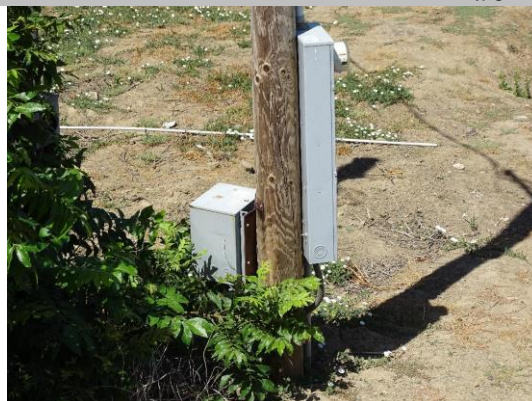
Photo 3 of 3 : UCIP_FA_2021_70242_89439.jpg

Land-Side: view of electrical panels on toe.

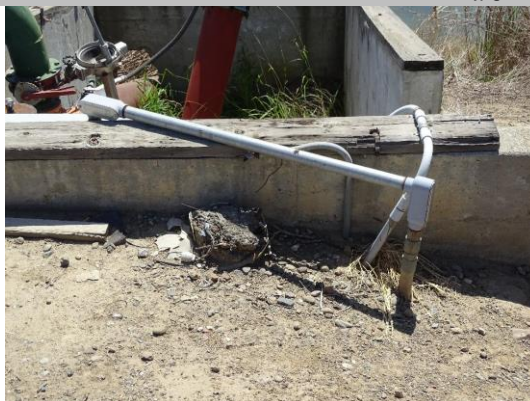
Photo 2 of 3 : UCIP_FA_2021_70243_89441.jpg

DS_ID:24046
 FS_ID:70243
 EP_NO: N/A
 Repair Type: Non-Urgent
 EVAL Issue: Unauthorized Encroachment, installed decades prior
 Crossing Status: Found
 UCIP Comments: 06/24/2020 Record updated from No Action Needed to Non-Urgent. No permit has been identified authorizing pipe.
 Associated with DSID 20620. (D.Sanoski - DWR UCIP)
 FIELD_STRUCT_DESC: 2-inch galvanized iron electrical conduit through the levee, at an unknown depth below the crown. Power pole and meter box on the landside (LS) toe. Electrical box inside concrete foundation on the waterside (WS) slope.
 FS Date: 6/24/2020 2:47:00 PM

Water-Side: view of electrical conduits going through levee.

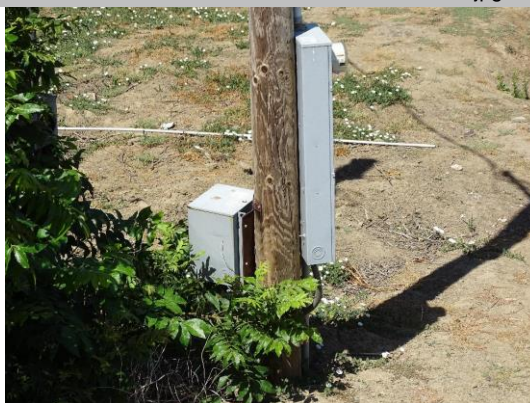
Photo 3 of 3 : UCIP_FA_2021_70243_89442.jpg

Land-Side: view of electrical panels on toe.

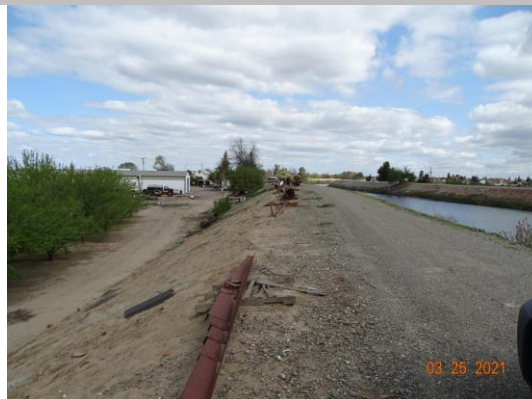
Photo 1 of 1 : FA_2021_RD0524_107_95_20210913_00057.jpg

LM Start	3.86	Rating **	M	Issue No.	95
LM End	3.97	Issue Type +	En	Location *	LS
Category	Earthen Levee			GPS Latitude/Longitude	
				Start	End
Item	Encroachments			37.901354 °	37.899764 °
				-121.326483 °	-121.326589 °
DWR ID	DWR_RD0524_01_f _ 2013_95				
Comment Code					
EQ : Equipment					
Inspector Comment					
Land owner is storing equipment on landside shoulder and landside toe.

View of farm equipment being stored along the landside shoulder.
Spring 2021

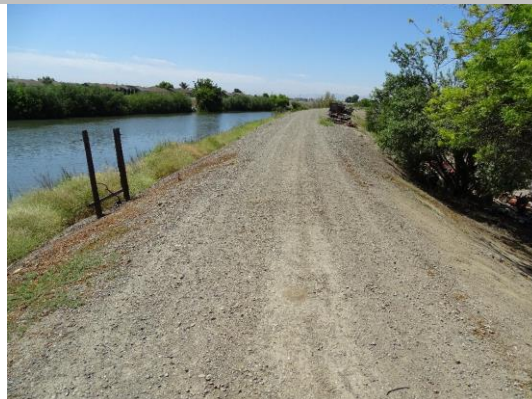
Photo 1 of 3 : UCIP_FA_2021_61968_89443.jpg

Top of Levee: view of crown.

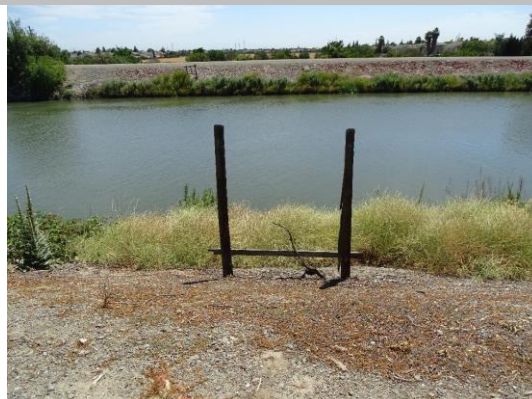
Photo 2 of 3 : UCIP_FA_2021_61968_89444.jpg

Water-Side: view of WS slope and abandoned sign.

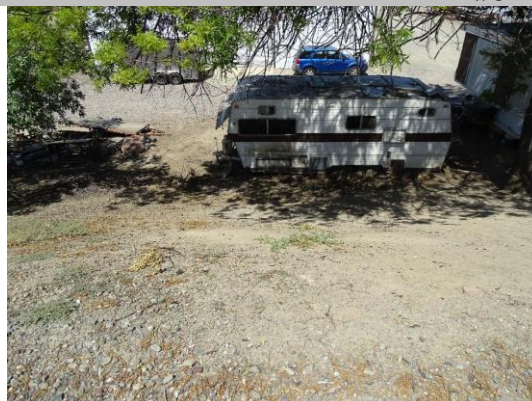
Photo 3 of 3 : UCIP_FA_2021_61968_89445.jpg

Land-Side: view of LS slope.

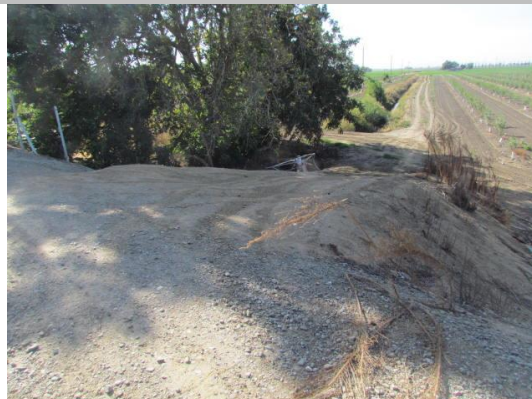
Photo 1 of 1 : FA_2021_RD0524_107_101_20210913_00059.jpg

LM Start	4.02	Rating **	U	Issue No.	101
LM End	4.02	Issue Type +	En	Location *	LS
Category	Earthen Levee			GPS Latitude/Longitude	
				Start	End
Item	Encroachments			37.899027 °	37.899027 °
				-121.326982 °	-121.326982 °
DWR ID	DWR_RD0524_01_s_2012_101				
Comment Code					
RA : Ramp					
Inspector Comment					
Unauthorized ramp. Ramp does not meet Title 23 standard.

Looking west at unauthorized ramp on landside slope.

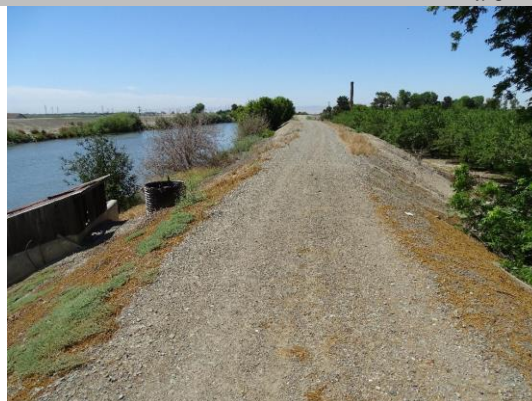
Photo 1 of 3 : UCIP_FA_2021_70244_89449.jpg

Comment Code					
Inspector Comment					
DS_ID:20623 FS_ID:70244 EP_NO: N/A Repair Type: Non-Urgent EVAL Issue: Unauthorized Encroachment, installed decades prior Crossing Status: Found UCIP Comments: 06/24/2020 Record remains Non-Urgent. No permit has been identified authorizing pipe. Appears to be functioning ok with new electrical pipe inside pumphouse. (D.Sanoski - DWR UCIP) 08/20/2013 Appears abandoned and if so should be done so properly. (W.Wylie - DWR UCIP) FIELD_STRUCT_DESC: 8-inch concrete encased steel irrigation pipe through the levee, 9.5 feet below the crown. Pump and gate valve in pump house on the waterside (WS) slope. Slide gate in 42-inch corrugated metal pipe riser unit on the WS slope. Brick standpipe at the toe of the landside (LS) slope. 1.5-inch galvanized iron electrical conduit through the levee, 3 feet below the crown at the same location. [Additional Reference(s): DWR Levee Log, 2004 (HLM 4.08). USACE San Joaquin O&M Manual, Unit 7, April 1964, Revised 29 December 2016, (4.08), listed as 8-inch pipe]. FS Date: 6/24/2020 2:48:00 PM

Top of Levee: view of crown.

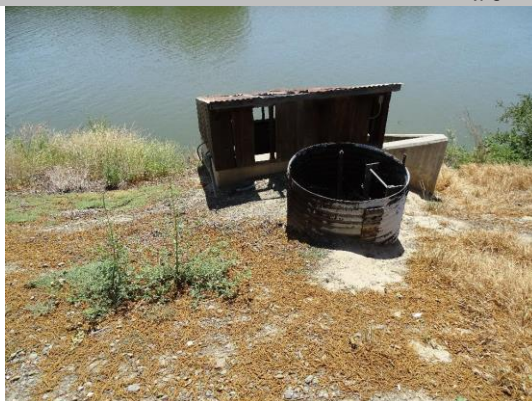
Photo 2 of 3 : UCIP_FA_2021_70244_89450.jpg

LM Start	4.04	Rating **	M	Issue No.	974 (cont)
LM End	4.04	Issue Type +	En	Location *	
Category	Supplemental		GPS Latitude/Longitude		
			Start	End	
Item	DWR UCIP Field Study		37.898853 °	37.898853 °	
			-121.327049 °	-121.327049 °	
DWR ID	20623

Water-Side: view of WS slope with riser and pumphouse.

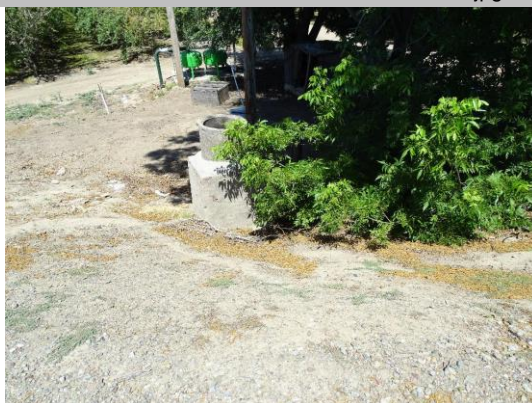
Photo 3 of 3 : UCIP_FA_2021_70244_89451.jpg

Land-Side: view of LS slope with concrete riser on toe.

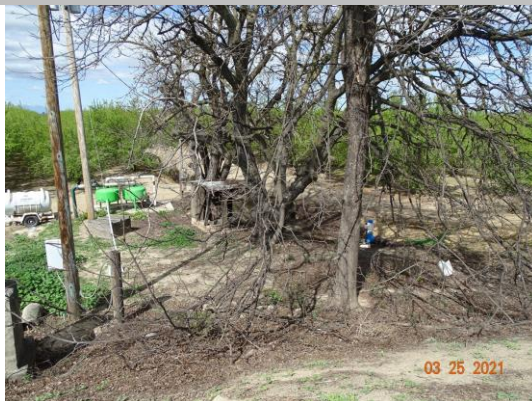
Photo 1 of 1 : FA_2021_RD0524_107_61_20210913_00055.jpg

LM Start	4.04	Rating **	M	Issue No.	61
LM End	4.04	Issue Type +	Ma	Location *	LS
Category	Earthen Levee			GPS Latitude/Longitude	
				Start	End
Item	Trim / Thin Trees			37.898861 °	37.898861 °
				-121.327071 °	-121.327071 °
DWR ID	DWR_RD0524_01_s_2012_61				
Comment Code					
T1 : Trim trees to at least five feet above ground level.					
Inspector Comment

View of untrimmed tree along the landside easement. Spring 2021

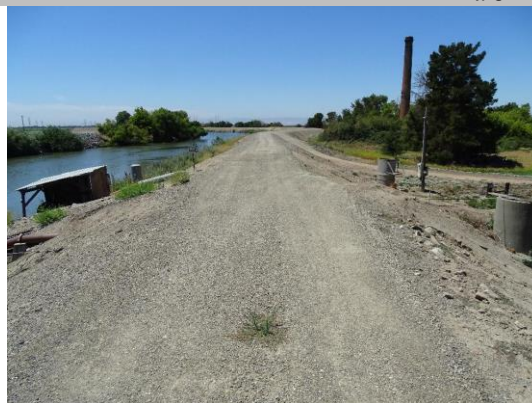
Photo 1 of 3 : UCIP_FA_2021_70245_89452.jpg

Comment Code						
Inspector Comment						
DS_ID:20624 FS_ID:70245 EP_NO: N/A Repair Type: Non-Urgent EVAL Issue: Unauthorized Encroachment, installed decades prior Crossing Status: Found UCIP Comments: 06/24/2020 Record updated from No Action Needed to Non-Urgent. No permit has been identified authorizing pipe. (D.Sanoski - DWR UCIP) FIELD_STRUCT_DESC: 12-inch steel irrigation pipe through the levee, 6 feet below the crown. Pump and gate valve on pile structure in the stream. 6-foot concrete standpipe on the landside (LS) toe. 1-inch galvanized iron electrical conduit at same location. [Additional Reference(s): DWR Levee Log, 2004 (HLM 4.20). USACE San Joaquin O&M Manual, Unit 7, April 1964, Revised 29 December 2016, (4.20), listed as 8-inch pipe]. FS Date: 6/24/2020 2:49:00 PM

Top of Levee: view of crown.

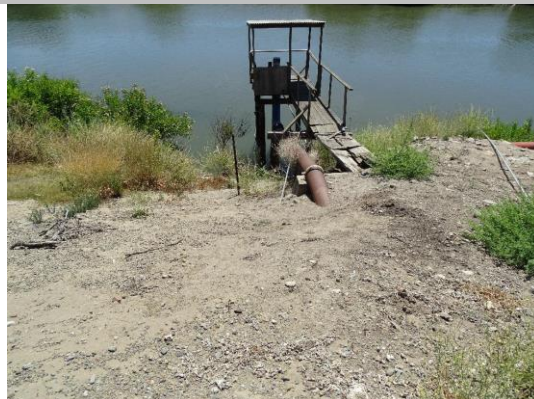
Photo 2 of 3 : UCIP_FA_2021_70245_89453.jpg

LM Start	4.16	Rating **	M	Issue No.	975 (cont)	
LM End	4.16	Issue Type +	En	Location *		
Category	Supplemental			GPS Latitude/Longitude		
				Start	End	
Item	DWR UCIP Field Study			37.897186 °	37.897186 °	
				-121.327874 °	-121.327874 °	
DWR ID	20624

Water-Side: view of WS slope with pipe and pump.

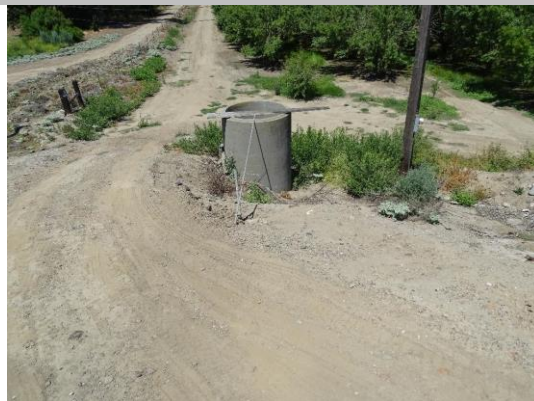
Photo 3 of 3 : UCIP_FA_2021_70245_89454.jpg

Land-Side: view of LS slope with concrete riser on toe.

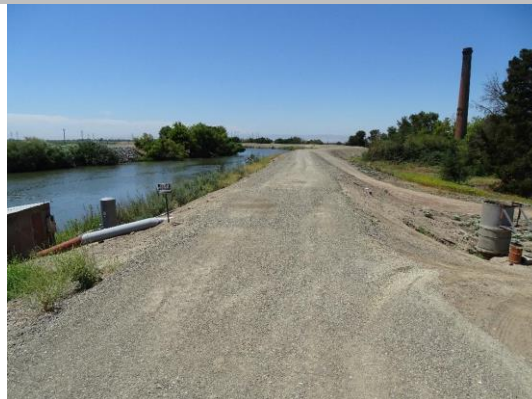
Photo 1 of 3 : UCIP_FA_2021_70246_89455.jpg

DS_ID:20625
FS_ID:70246
EP_NO: N/A
Repair Type: Non-Urgent
EVAL Issue: Unauthorized Encroachment, installed decades prior
Crossing Status: Found
UCIP Comments: 06/24/2020 Record remains Non-Urgent. Portion of pipe with leak replaced, and minor erosion on slope does not appear to be related to any pipe defect, but should still be addressed by District. No permit has been identified authorizing pipe. (D.Sanoski - DWR UCIP)
08/23/2013 Small leak on WS slope causing minor erosion on WS slope. (W.Wylie - DWR UCIP)
FIELD_STRUCT_DESC: 12-inch steel irrigation pipe through the levee, 4.5 feet below the crown. Pump house and gate valve on the waterside (WS) slope. 36-inch concrete standpipe, power pole, and meter on the landside (LS) toe. [Additional Reference(s): DWR Levee Log, 2004 (HLM 4.21). USACE San Joaquin O&M Manual, Unit 7, April 1964, Revised 29 December 2016, (4.21), listed as 12-inch pipe].
FS Date: 6/24/2020 2:49:00 PM

Overview of Levee: view of crown and pipe system on both sides.

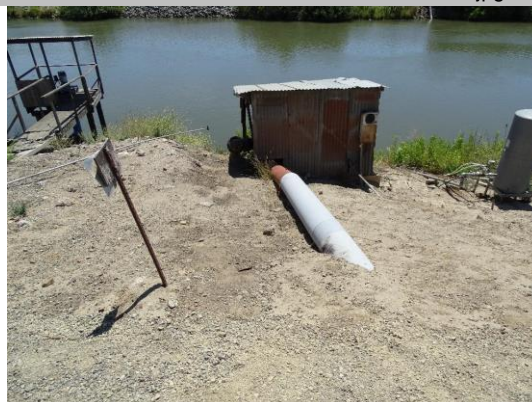
Photo 2 of 3 : UCIP_FA_2021_70246_89456.jpg

Water-Side: view of WS slope with pipe and pumphouse on toe.

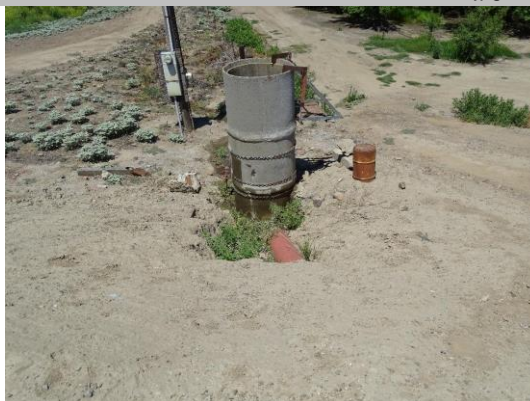
Photo 3 of 3 : UCIP_FA_2021_70246_89457.jpg

Land-Side: view of LS slope with pipe and concrete riser on toe.

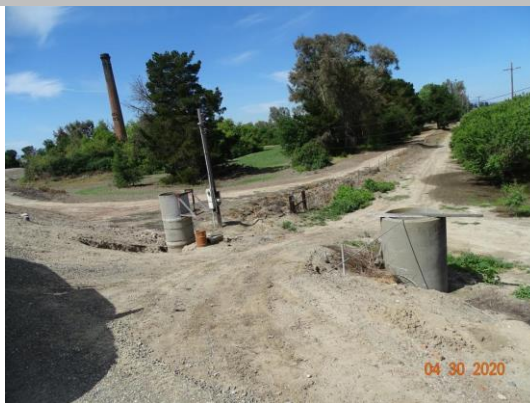
Photo 1 of 1 : FA_2021_RD0524_107_110_20210913_00060.jpg

LM Start	4.16	Rating **	M	Issue No.	110
LM End	4.16	Issue Type +	En	Location *	LS
Category	Earthen Levee			GPS Latitude/Longitude	
				Start	End
Item	Encroachments			37.897103 °	37.897103 °
				-121.327895 °	-121.327895 °
DWR ID	DWR_RD0524_01_s_2012_110				
Comment Code					
RA : Ramp					
Inspector Comment					
One unauthorized ramp on landside slope.

View of an unauthorized ramp on landside slope. Spring 2020

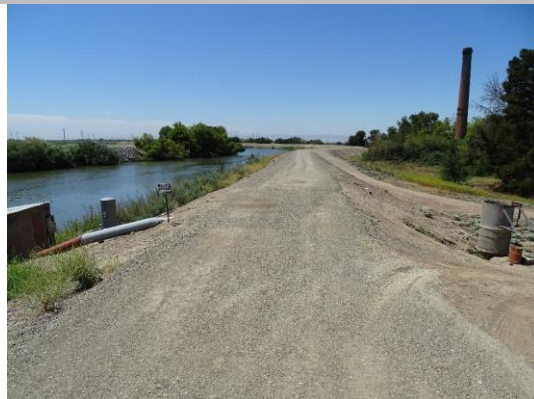
Photo 1 of 3 : UCIP_FA_2021_70250_89458.jpg

Comment Code					
Inspector Comment					
DS_ID:24047 FS_ID:70250 EP_NO: N/A Repair Type: Non-Urgent EVAL Issue: Unauthorized Encroachment, installed decades prior Crossing Status: Found UCIP Comments: 06/24/2020 Record updated from No Action Needed to Non-Urgent. No permit has been identified authorizing pipe. Associated with DSID 20625. (D.Sanoski - DWR UCIP) FIELD_STRUCT_DESC: 1.25-inch galvanized iron electrical conduit through the levee, at an unknown depth. Power pole and meter box on the landside (LS) toe. Electrical box at pump house on the waterside (WS) slope. [Additional Reference(s): DWR Levee Log, 2004 (HLM 4.21). USACE San Joaquin O&M Manual, Unit 7, April 1964, Revised 29 December 2016, (4.21), listed as 12-inch pipe.] FS Date: 6/24/2020 2:49:00 PM

Overview of Levee: view of crown and assembly on both sides.
