Flood Control Project Maintenance Levee Inspections

Fall 2021 Levee Maintenance Deficiency Summary Report

San Joaquin River Basin

Reclamation District No. 0524 Middle Roberts Island

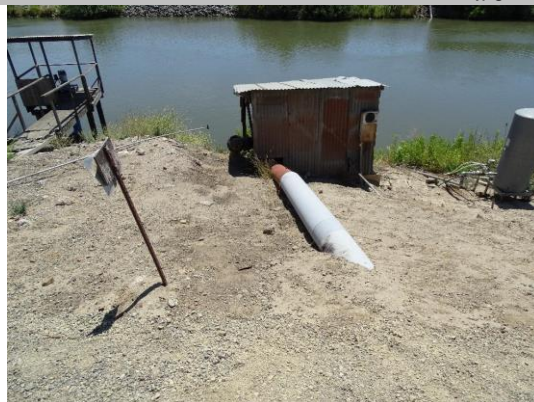
Photo 2 of 3 : UCIP_FA_2021_70250_89459.jpg

Water-Side: view of pipe out of pumphouse.

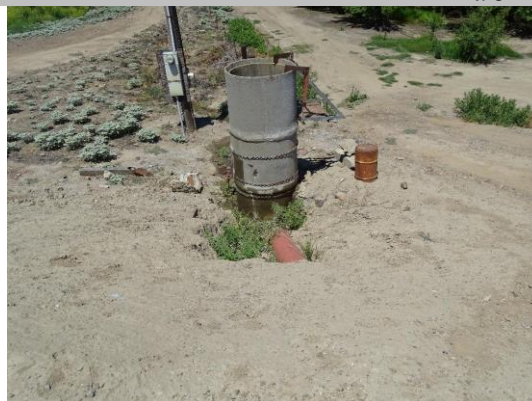
Photo 3 of 3 : UCIP_FA_2021_70250_89460.jpg

Land-Side: view of electrical conduit into powerpole on toe.

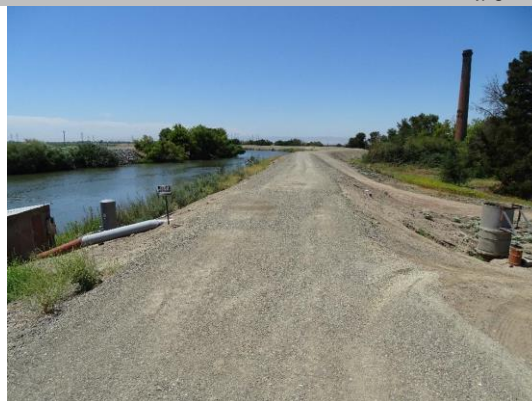
Photo 1 of 3 : UCIP_FA_2021_70249_89461.jpg

DS_ID:24048
FS_ID:70249
EP_NO: N/A
Repair Type: Non-Urgent
EVAL Issue: Unauthorized Encroachment, installed decades prior
Crossing Status: Found
UCIP Comments: 06/24/2020 Record updated from No Action Needed to Non-Urgent. No permit has been identified authorizing pipe.
Associated with DSID 20625. (D.Sanoski - DWR UCIP)
FIELD_STRUCT_DESC: 2-inch polyvinyl chloride electrical conduit through the levee, at an unknown depth. Power pole and meter box on the landside (LS) toe. Pump on the waterside (WS) slope. [Additional Reference(s): DWR Levee Log, 2004 (HLM 4.21). USACE San Joaquin O&M Manual, Unit 7, April 1964, Revised 29 December 2016, (4.21), listed as 12-inch pipe.]
FS Date: 6/24/2020 2:50:00 PM

Overview of Levee: view of crown and assembly on both sides.

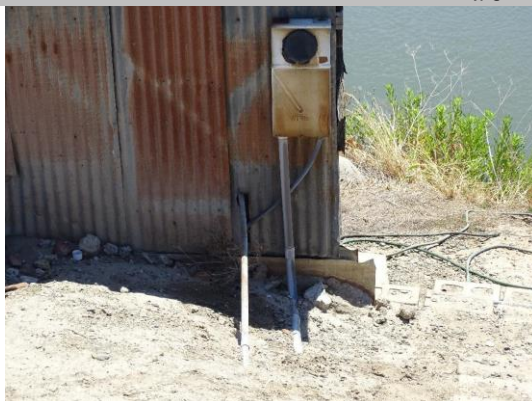
Photo 2 of 3 : UCIP_FA_2021_70249_89462.jpg

Water-Side: view of electrical conduit through the levee.

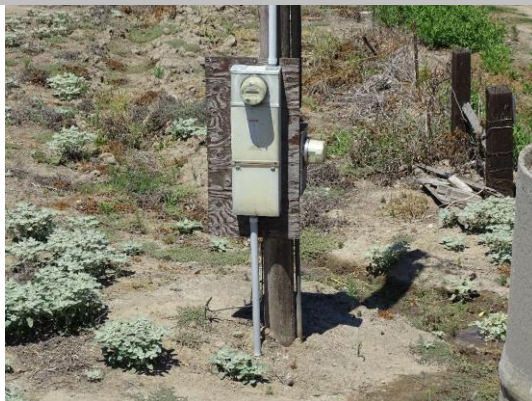
Photo 3 of 3 : UCIP_FA_2021_70249_89463.jpg

Land-Side: view of electrical conduit into panel at powerpole on toe.

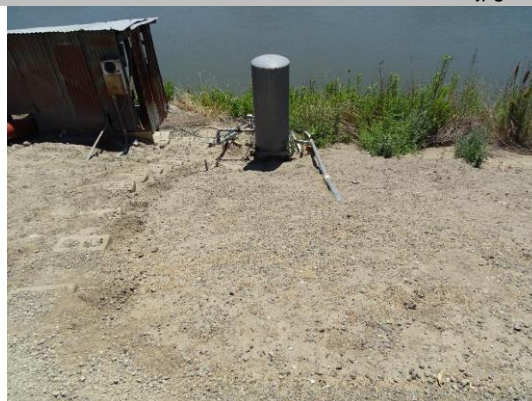
Photo 2 of 3 : UCIP_FA_2021_70248_89465.jpg

Water-Side: view of WS slope and pvc line through the levee.

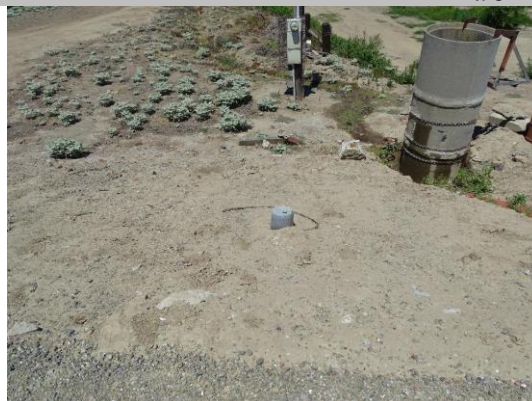
Photo 3 of 3 : UCIP_FA_2021_70248_89466.jpg

Land-Side: view of LS slope and assembly on toe.

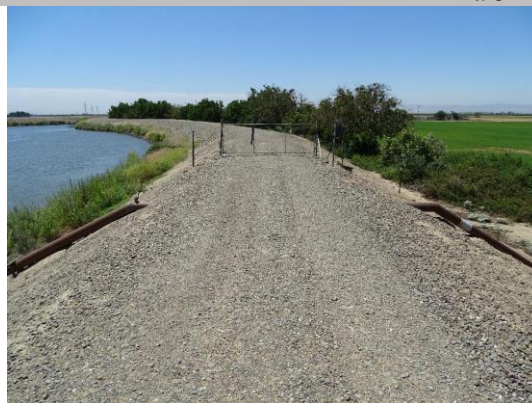
Photo 1 of 3 : UCIP_FA_2021_70247_89467.jpg

DS_ID:20626
FS_ID:70247
EP_NO: N/A
Repair Type: Non-Urgent
EVAL Issue: Unauthorized Encroachment, installed decades prior
Crossing Status: Found
UCIP Comments: 06/24/2020 Record remains Non-Urgent. Small leak has been repaired. No permit has been identified authorizing pipe. (D.Sanoski - DWR UCIP)
08/23/2013 Small leak in pipe on LS slope and pipe slightly crushed on LS toe. (W.Wylie - DWR UCIP)
FIELD_STRUCT_DESC: 10-inch steel drainage pipe through the levee, 3 feet below the crown. Pump in drainage ditch off the landside (LS) toe. Siphon breaker on the waterside (WS) slope. [Additional Reference(s): DWR Levee Log, 2004 (HLM 4.42, listed as 8-inch pipe). USACE San Joaquin O&M Manual, Unit 7, April 1964, Revised 29 December 2016, (4.42), listed as 8-inch pipe].
FS Date: 6/24/2020 2:51:00 PM

Overview of Levee: view of crown and assembly on both sides.

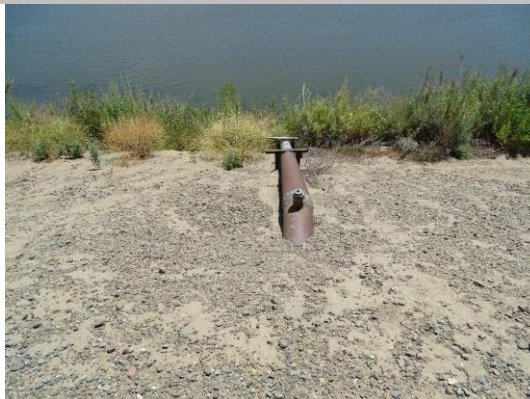
Photo 2 of 3 : UCIP_FA_2021_70247_89468.jpg

Water-Side: view of WS slope and pipe.

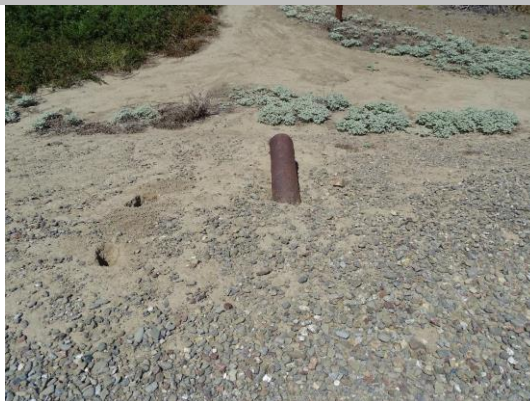
Photo 3 of 3 : UCIP_FA_2021_70247_89469.jpg

Land-Side: view of LS slope and pipe.

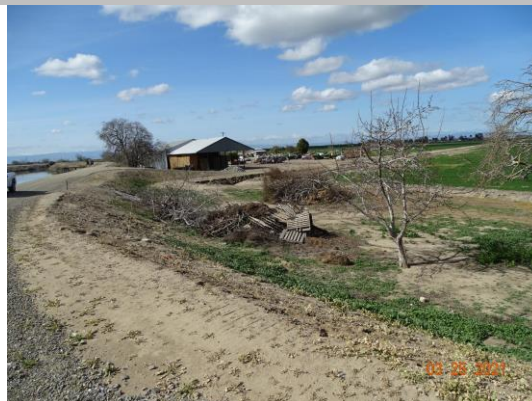
Photo 1 of 1 : FA_2021_RD0524_107_292_20210913_00097.jpg

LM Start	4.56	Rating **	U	Issue No.	292
LM End	4.56	Issue Type +	En	Location *	LS
Category	Earthen Levee			GPS Latitude/Longitude	
				Start	End
Item	Encroachments			37.891825 °	37.891825 °
				-121.328325 °	-121.328325 °
DWR ID	DWR_RD0524_01_s_2021_292				
Comment Code					
PR : Prunings					
Inspector Comment

View of prunings and debris within the landside easement. Spring 2021

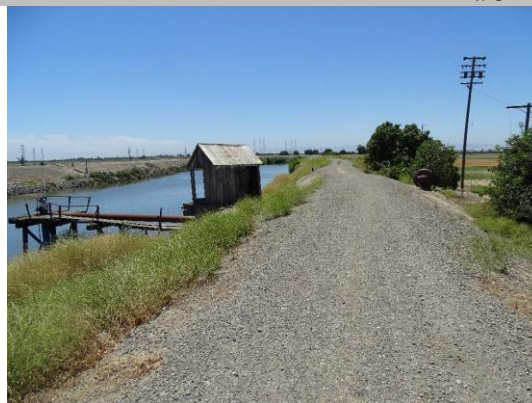
Photo 1 of 3 : UCIP_FA_2021_61991_89470.jpg

Comment Code						
Inspector Comment						
DS_ID:20646 FS_ID:61991 EP_NO: N/A Repair Type: Non-Urgent EVAL Issue: Unauthorized Encroachment, installed decades prior Crossing Status: Found UCIP Comments: 06/24/2020 Record remains Non-Urgent. No permit has been identified authorizing pipe. (D.Sanoski - DWR UCIP) 08/23/2013 Good candidate for video inspection as brick and mortar deteriorating inside tunnel. (W.Wylie - DWR UCIP) FIELD_STRUCT_DESC: 22-inch concrete irrigation pipe through the levee, 12 feet below the crown. Pump on pier at the waterside (WS) toe. 16-inch pipe from pump discharges into a concrete riser unit inside the pump house on the WS shoulder. Brick and mortar channel on the landside (LS) toe. Power pole on LS toe. [Additional Reference(s): DWR Levee Log, 2004 (HLM 4.73), listed as 16-inch pipe. USACE San Joaquin O&M Manual, Unit 7, April 1964, Revised 29 December 2016, (4.73), listed as 14-inch pipe]. FS Date: 6/24/2020 2:51:00 PM

Top of Levee: view of crown.

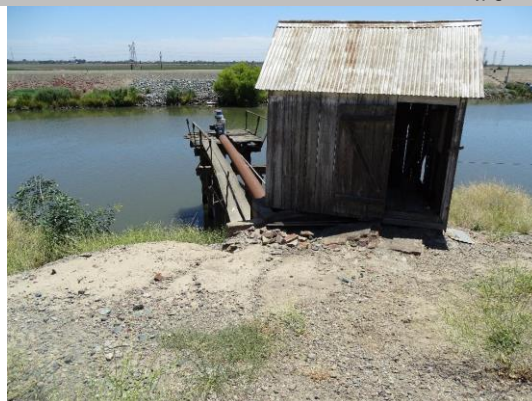
Photo 2 of 3 : UCIP_FA_2021_61991_89471.jpg

Water-Side: view of WS slope with pipe and pumphouse.

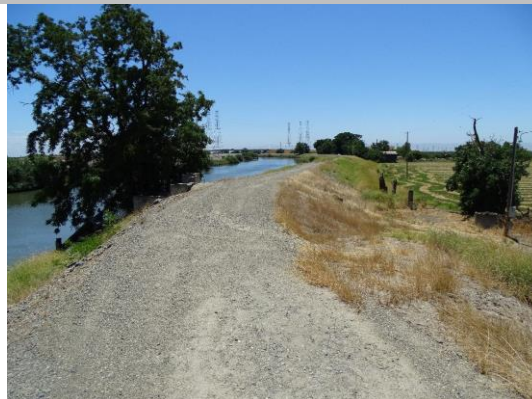
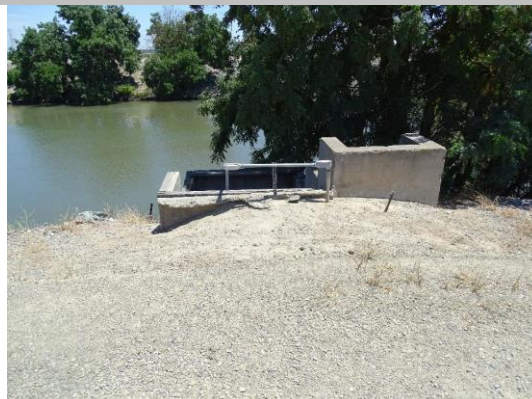
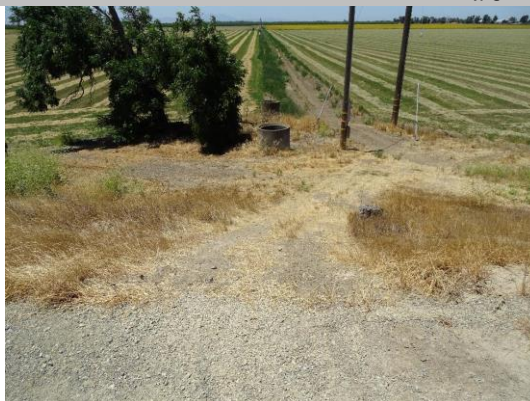
Photo 1 of 3 : UCIP_FA_2021_70251_89479.jpg

Comment Code						
Inspector Comment						
DS_ID:20629 FS_ID:70251 EP_NO: N/A Repair Type: Non-Urgent EVAL Issue: Unauthorized Encroachment, installed decades prior Crossing Status: Found UCIP Comments: 06/24/2020 Record updated from No Action Needed to Non-Urgent. No permit has been identified authorizing pipe. (D.Sanoski - DWR UCIP) FIELD_STRUCT_DESC: 14-inch irrigation pipe of an unknown material through the levee, 15 feet below the crown. Pump house foundation on the waterside (WS) slope. 11-foot by 12-foot concrete sump on the WS shoulder. 4-foot diameter concrete standpipe on the landside (LS) toe. [Additional Reference(s): DWR Levee Log, 2004 (HLM 5.26). USACE San Joaquin O&M Manual, Unit 7, April 1964, Revised 29 December 2016, (5.26), listed as 14-inch pipe]. FS Date: 6/24/2020 2:52:00 PM

Top of Levee: view of crown.

Water-Side: view of WS slope and concrete pump house.

Land-Side: view of LS slope and concrete standpipe on toe.

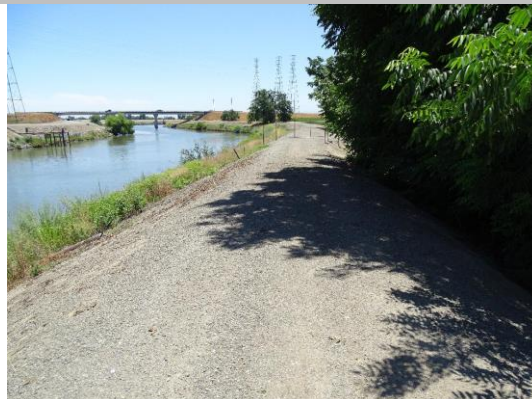
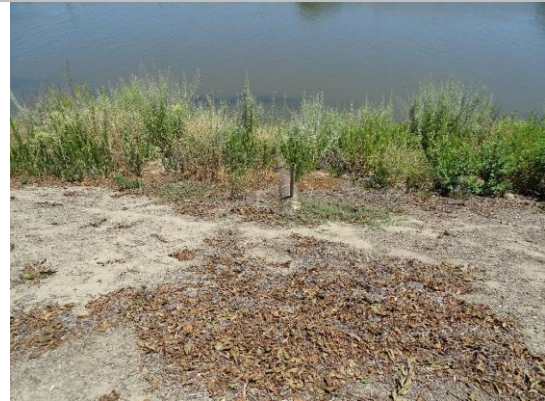
Photo 1 of 3 : UCIP_FA_2021_70252_89482.jpg

DS_ID:20630
FS_ID:70252
EP_NO: N/A
Repair Type: Non-Urgent
EVAL Issue: Pipe Damage
Crossing Status: Found
UCIP Comments: 06/24/2020 Record updated from Urgent to Non-Urgent. Pipe damage visible on WS. Crossing appears abandoned. Limited inspection on LS due to overgrown vegetation. No permit has been identified authorizing pipe. Associated with DSID 20659. (D.Sanoski - DWR UCIP)
10/2/2018 Same as last inspection. Holes present in pipe pose a potential threat to levee's internal integrity. Recommend video inspection (D. Sanoski - DWR UCIP). 11/16/2016 same as previous inspection hole in pipe is still present on WS near toe. This pipe does not appear to be in use. Need to contact owner to determine status of crossing. If the crossing is abandoned or still in use, owner will need to coordinate with the CVFPB to comply with Title 23 requirements. (O. Magana - DWR UCIP) 08/23/2013 flap gate damage and does not work at WS toe. Large hole in pipe at WS toe. Pipe appears abandoned and should be done so properly. (W. Wylie - DWR UCIP)

FIELD_STRUCT_DESC: *ABANDONED* 1 of 2: 12-inch steel irrigation pipe through the levee, 6 feet below the crown. Flap gate located on the WS end. LS end not found. [Additional Reference(s): DWR Levee Log, 2004 (HLM 5.48, listed as 10-inch (DSID 20659)). USACE San Joaquin O&M Manual, Unit 7, April 1964, Revised 29 December 2016, (5.48), listed as 10-inch pipe (DSID 20659). Drawing No. 07-04-1490, Sheet 1490/4, (Station 8+01.3)].
FS Date: 6/24/2020 2:53:00 PM

Top of Levee: view of crown.

Water-Side: view of WS slope and pipe.

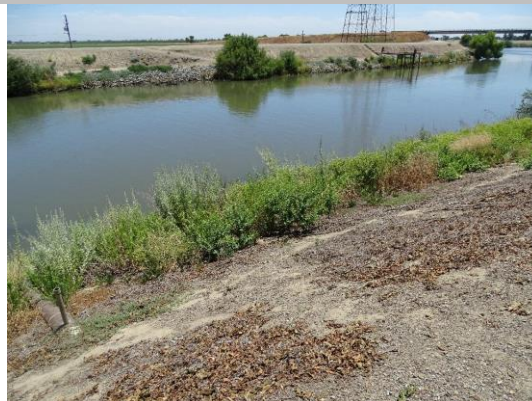
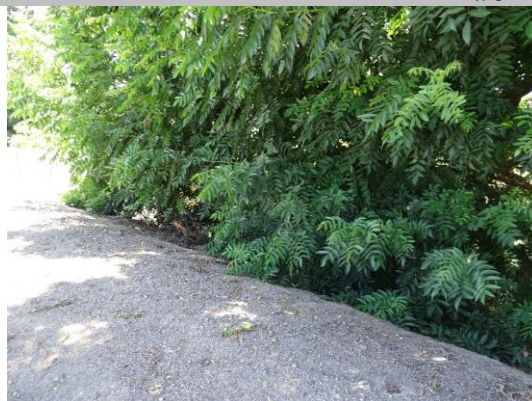
Photo 1 of 3 : UCIP_FA_2021_62011_89484.jpg

DS_ID:20659
FS_ID:62011
EP_NO: N/A
Repair Type: Non-Urgent
EVAL Issue: Limited Inspection/No UCIP Evaluation
Crossing Status: Not Found
UCIP Comments: 06/24/2020 Record updated from No Action Needed to Non-Urgent. Crossing appears to have been removed, but needs to be confirmed. Crossing not found. Limited inspection on LS due to overgrown vegetation. No permit has been identified authorizing pipe. (D.Sanoski - DWR UCIP)
FIELD_STRUCT_DESC: *REMOVED* 2 of 2: 10-inch steel drainage pipe through the levee, 6 feet below the crown. Pump on the landside (LS). Flap gate on the waterside (WS) end. [Additional Reference(s): DWR Levee Log, 2004 (HLM 5.48). USACE San Joaquin O&M Manual, Unit 7, April 1964, Revised 29 December 2016, (5.48), listed as 10-inch pipe].
FS Date: 6/24/2020 2:24:00 PM

Top of Levee: view of crown.

Water-Side: view of WS slope.

Land-Side: view of LS slope.

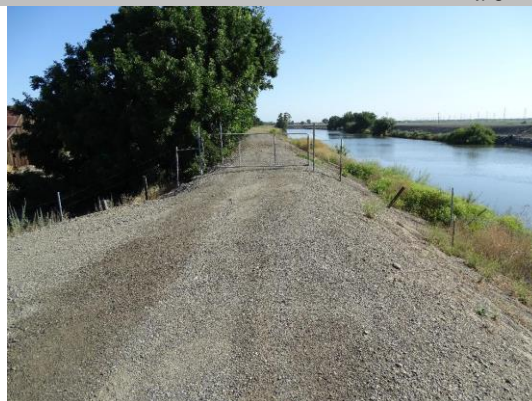
Photo 1 of 3 : UCIP_FA_2021_70253_89487.jpg

DS_ID:24050
 FS_ID:70253
 EP_NO: N/A
 Repair Type: Non-Urgent
 EVAL Issue: Limited Inspection/No UCIP Evaluation
 Crossing Status: Found
 UCIP Comments: 06/25/2020 Record updated from No Action Needed to Non-Urgent. Limited inspection on LS due to overgrown vegetation. No permit has been identified authorizing pipe. Associated with DSID 20631. (D.Sanoski - DWR UCIP)
 FIELD_STRUCT_DESC: 8-inch steel drainage pipe through the levee, 6 feet below the crown. Pipe sleeved through existing 10-inch pipe at same location (DSID 20631). [Additional Reference(s): DWR Levee Log, 2004 (HLM 5.50), listed as 10-inch pipe (DSID 20631). USACE San Joaquin O&M Manual, Unit 7, April 1964, Revised 29 December 2016, (5.50), listed as 10-inch pipe (DSID 20631).]
 FS Date: 6/25/2020 2:24:00 PM

Top of Levee: view of crown.

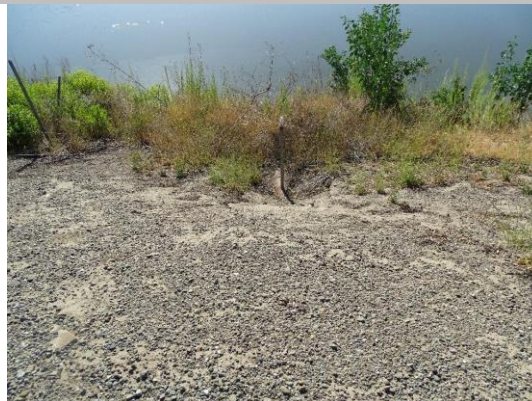
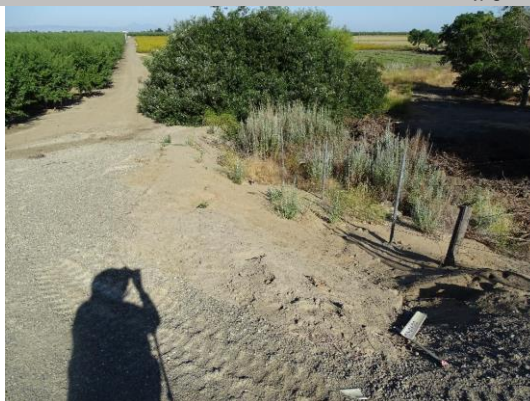
Photo 1 of 3 : UCIP_FA_2021_70254_89490.jpg

DS_ID:20631
FS_ID:70254
EP_NO: N/A
Repair Type: Non-Urgent
EVAL Issue: Limited Inspection/No UCIP Evaluation
Crossing Status: Found
UCIP Comments: 06/25/2020 Record remains Non-Urgent. Limited inspection on LS due to overgrown vegetation. No permit has been identified authorizing pipe. Associated with DSID 24050, 8-inch pipe sleeved through this 10-inch pipe. (D.Sanoski - DWR UCIP)
08/23/2013 Recent work being done on WS slope. Pipe may still be in use. (W.Wylie - DWR UCIP)
FIELD_STRUCT_DESC: 10-inch steel drainage pipe through the levee, 6 feet below the crown. 8-inch pipe (DSID 24050) sleeved through this pipe. [Additional Reference(s): DWR Levee Log, 2004 (HLM 5.50). USACE San Joaquin O&M Manual, Unit 7, April 1964, Revised 29 December 2016, (5.50), listed as 10-inch pipe].
FS Date: 6/25/2020 2:53:00 PM

Top of Levee: view of crown.

Water-Side: view of WS slope and pipe.

Land-Side: view of LS slope with no sign of inlet pipe due to overgrown vegetation limiting inspection.

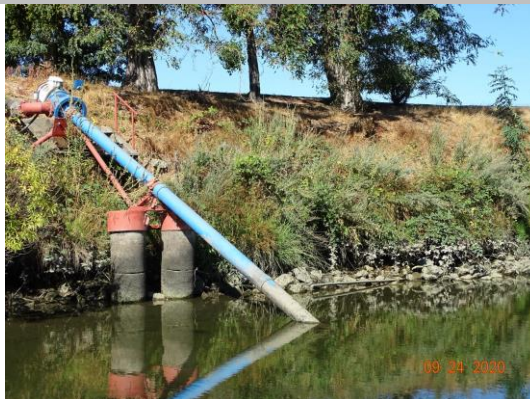
Photo 1 of 2 : SJR2021_RD0524U01RM46.06_01.JPG

LM Start	5.53	Rating **	M	Issue No.	10	
LM End	5.54	Issue Type +	Ma	Location *		
Category	Supplemental			GPS Latitude/Longitude		
				Start	End	
Item	DWR Erosion Survey			37.878798 °	37.878798 °	
				-121.333111 °	-121.333111 °	
DWR ID	RD0524U01RM46.06					
Comment Code						
Inspector Comment						
Site ID: RD0524U01RM46.06						
08/20/2021: During the erosion survey, the erosion length was increased to 75 feet.						
09/24/2020: From 2014 to present, no significant changes were observed during the annual survey. Vegetation is limiting the view but undercutting of the levee toe is still visible.						
08/13/2013: Larger trees are at the levee shoulder, and an irrigation pump station is next to the erosion site.

9/24/2020: View of the erosion immediately downstream of irrigation pipe.

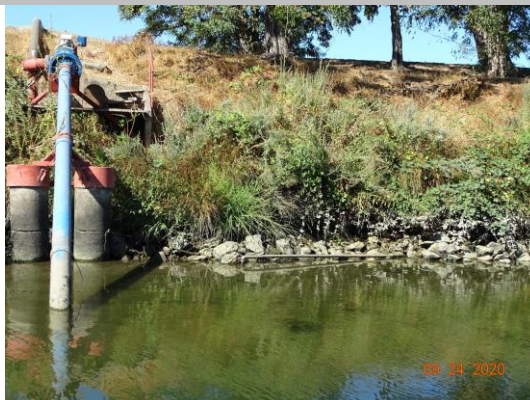
Photo 2 of 2 : SJR2021_RD0524U01RM46.06_03.JPG

9/24/2020: Close-up view of the undercutting.

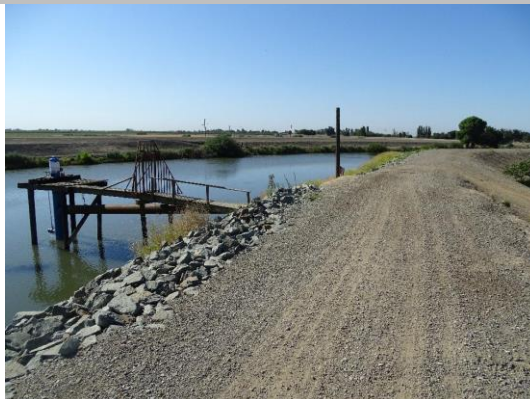
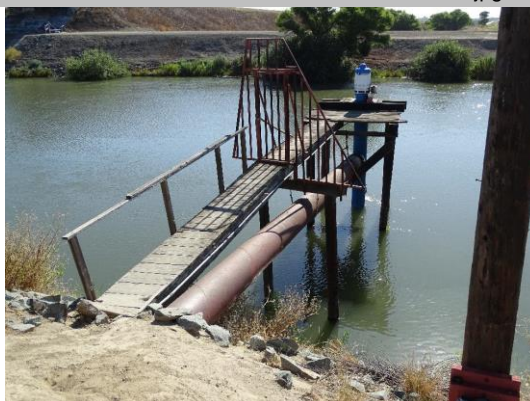
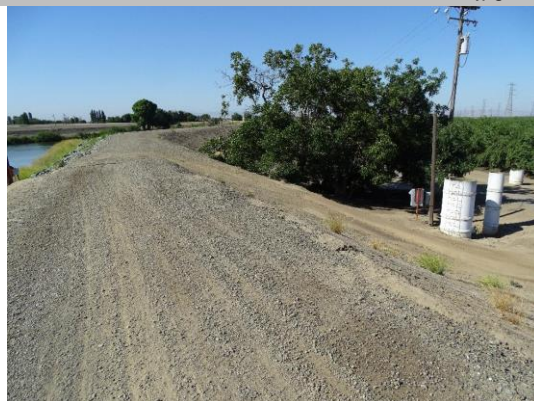
Photo 1 of 3 : UCIP_FA_2021_70258_89499.jpg

DS_ID:20633
FS_ID:70258
EP_NO: N/A
Repair Type: Non-Urgent
EVAL Issue: Unauthorized Encroachment, installed decades prior
Crossing Status: Found
UCIP Comments: 06/25/2020 Record updated from No Action Needed to Non-Urgent. No permit has been identified authorizing pipe.
(D.Sanoski - DWR UCIP)
FIELD_STRUCT_DESC: 21-inch steel irrigation pipe through the levee, 7 feet below the crown. Pump on pile structure in stream on the waterside (WS) toe. Timber walkway to the pump. Service pole on the WS shoulder. 5-foot concrete standpipe on the landside (LS) toe.
[Additional Reference(s): DWR Levee Log, 2004 (HLM 5.71, listed as 20-inch pipe). USACE San Joaquin O&M Manual, Unit 7, April 1964, Revised 29 December 2016, (5.71), listed as 20-inch pipe].
FS Date: 6/25/2020 2:54:00 PM

Top of Levee: view of crown.

Water-Side: view of WS slope and pipe, walkway, and pump.

Land-Side: view of LS slope and concrete standpipe on toe.

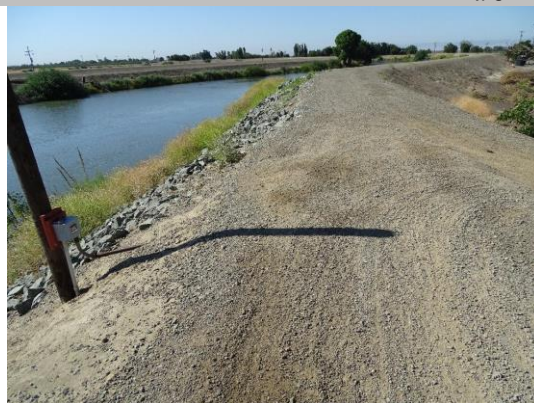
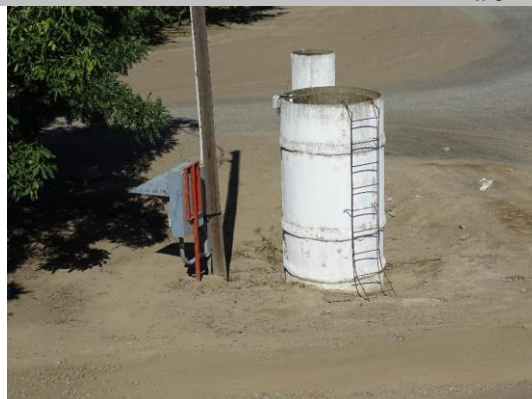
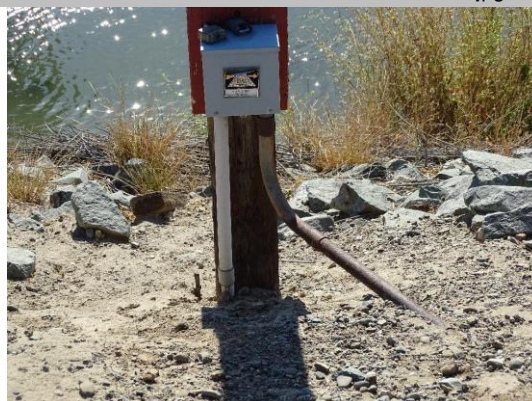
Photo 1 of 3 : UCIP_FA_2021_70260_89503.jpg

DS_ID:24051
 FS_ID:70260
 EP_NO: N/A
 Repair Type: Non-Urgent
 EVAL Issue: Unauthorized Encroachment, installed decades prior
 Crossing Status: Found
 UCIP Comments: 06/25/2020 Record updated from No Action Needed to Non-Urgent. No permit has been identified authorizing pipe.
 (D.Sanoski - DWR UCIP)
 FIELD_STRUCT_DESC: 1.5-inch galvanized iron electrical conduit through the levee, 1.5 feet below the crown. Power pole and meter box on the landside (LS) toe. Electrical box on pole at the waterside (WS) shoulder. [Additional Reference(s): DWR Levee Log, 2004 (HLM 5.71, listed as 20-inch pipe (DSID 20633)). USACE San Joaquin O&M Manual, Unit 7, April 1964, Revised 29 December 2016, (5.71), listed as 20-inch pipe (DSID 20633)].
 FS Date: 6/25/2020 2:55:00 PM

Top of Levee: view of crown.

Land-Side: view of electrical conduit into panel at powerpole on toe.

Water-Side: view of electrical conduit through levee.

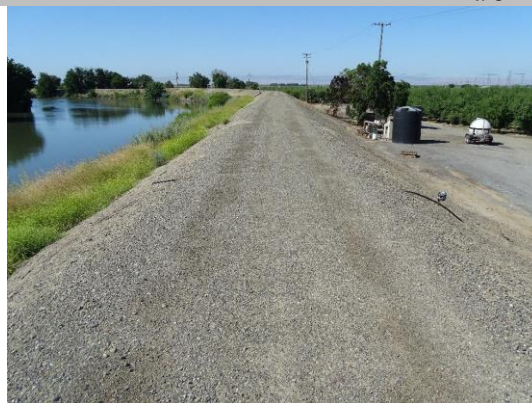
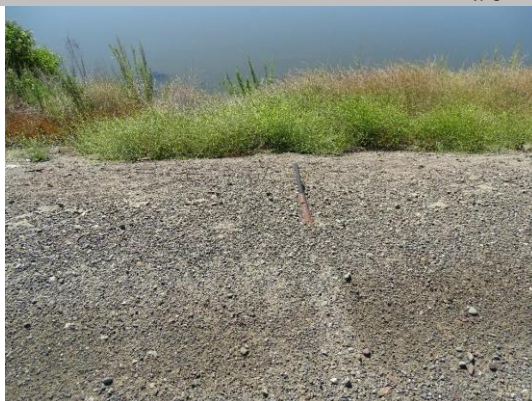
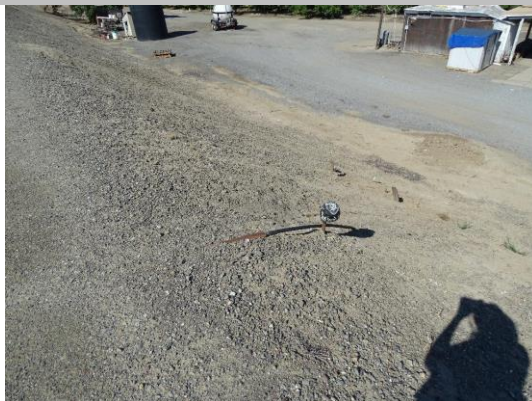
Photo 1 of 3 : UCIP_FA_2021_62117_89597.jpg

Comment Code						
Inspector Comment						
DS_ID:20649 FS_ID:62117 EP_NO: N/A Repair Type: Non-Urgent EVAL Issue: Unauthorized Encroachment, installed decades prior Crossing Status: Found UCIP Comments: 06/25/2020 Record remains Non-Urgent. Unauthorized encroachment recorded in Levee Log prior to 2011. Crossing appears abandoned and should be done so properly. (D.Sanoski - DWR UCIP) 08/23/2013 Abandoned and should be done so properly. (W.Wylie - DWR UCIP) FIELD_STRUCT_DESC: *ABANDONED* 2.25-inch steel conduit for a 1-inch plastic electrical conduit through the levee, 1 feet below the crown. Lines exposed on both slopes. [Additional Reference(s): DWR Levee Log, 2004 (HLM 5.80, listed as 1-inch electrical line)]. FS Date: 6/25/2020 2:55:00 PM

Top of Levee: view of crown.

Water-Side: view of WS slope and abandoned conduit.

Land-Side: view of LS slope and abandoned conduit.

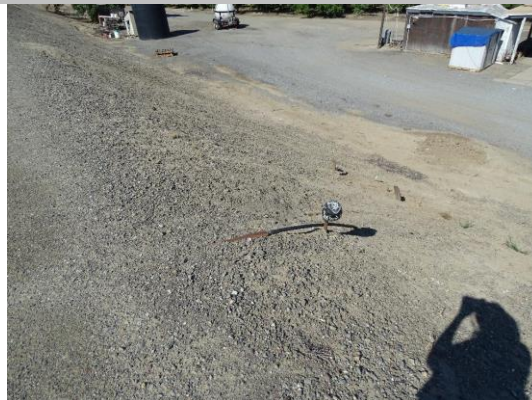
Photo 2 of 3 : UCIP_FA_2021_62119_89607.jpg

LM Start	5.74	Rating **	M	Issue No.	991	
LM End	5.74	Issue Type +	En	Location *		
Category	Supplemental			GPS Latitude/Longitude		
				Start	End	
Item	DWR UCIP Field Study			37.876001 °	37.876001 °	
				-121.332725 °	-121.332725 °	
DWR ID	20635					
Comment Code						
Inspector Comment						
DS_ID:20635 FS_ID:62119 EP_NO: N/A Repair Type: Non-Urgent EVAL Issue: Unauthorized Encroachment, installed decades prior Crossing Status: Found UCIP Comments: 06/25/2020 Record remains Non-Urgent. Unauthorized encroachment recorded in Levee Log prior to 2011. Crossing appears abandoned. (D.Sanoski - DWR UCIP) 08/23/2013 Appears abandoned and should be done so properly. (W.Wylie - DWR UCIP) FIELD_STRUCT_DESC: *ABANDONED* 1-inch steel water line through the levee, 1 foot below the crown. Pipe visible only on the lanside (LS) shoulder. FS Date: 6/25/2020 2:56:00 PM

Land-Side: view of LS slope and abandoned pipe.

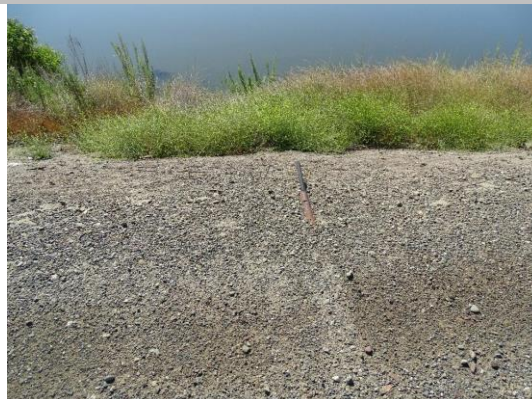
Photo 3 of 3 : UCIP_FA_2021_62119_89606.jpg

Water-Side: view of WS slope.

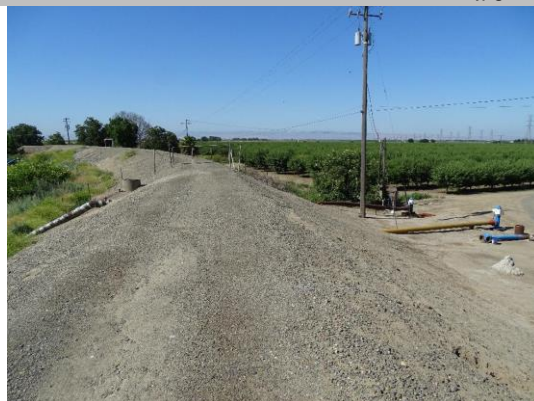
Photo 1 of 3 : UCIP_FA_2021_70262_89608.jpg

LM Start	5.81	Rating **	M	Issue No.	992	
LM End	5.81	Issue Type +	En	Location *		
Category	Supplemental			GPS Latitude/Longitude		
				Start		End
Item	DWR UCIP Field Study			37.875011 °	37.875011 °	
				-121.333235 °	-121.333235 °	
DWR ID	20650					
Comment Code						
Inspector Comment						
DS_ID:20650 FS_ID:70262 EP_NO: N/A Repair Type: Non-Urgent EVAL Issue: Unauthorized Encroachment, installed decades prior Crossing Status: Found UCIP Comments: 06/25/2020 Record updated from No Action Needed to Non-Urgent. No permit has been identified authorizing pipe. (D.Sanoski - DWR UCIP) FIELD_STRUCT_DESC: 12-inch steel storm drainage pipe through the levee, 5 feet below the crown. Pump on the landside (LS) toe. Siphon breaker on the waterside (WS) shoulder. Power pole at the LS toe. [Additional Reference(s): DWR Levee Log, 2004 (HLM 5.88)]. FS Date: 6/25/2020 2:56:00 PM

Overview of Levee: view of assembly on both sides of levee.

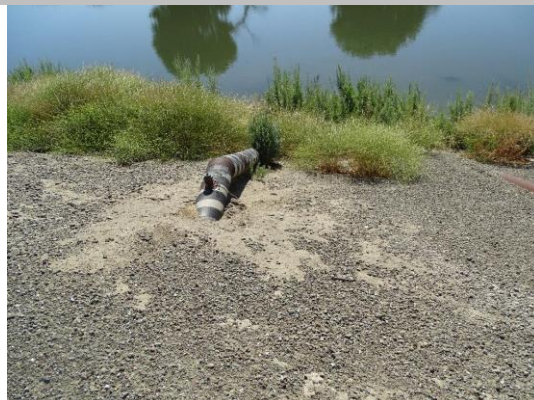
Photo 2 of 3 : UCIP_FA_2021_70262_89609.jpg

Water-Side: view of WS slope and pipe.

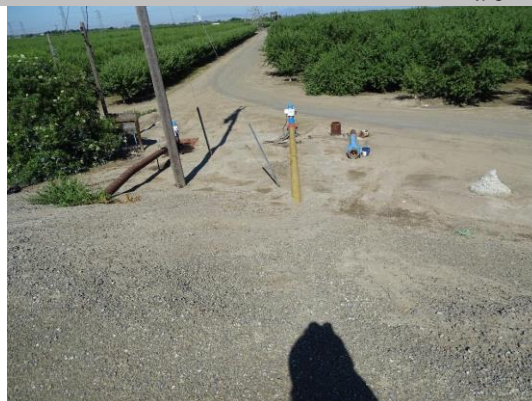
Photo 3 of 3 : UCIP_FA_2021_70262_89610.jpg

Land-Side: view of LS slope and pipe with pump.

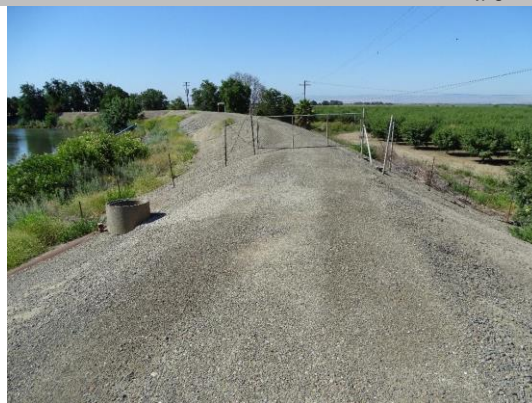
Photo 1 of 3 : UCIP_FA_2021_70263_89611.jpg

DS_ID:20636
FS_ID:70263
EP_NO: N/A
Repair Type: Non-Urgent
EVAL Issue: Unauthorized Encroachment, installed decades prior
Crossing Status: Found
UCIP Comments: 06/25/2020 Record remains Non-Urgent. No permit has been identified authorizing pipe. (D.Sanoski - DWR UCIP)
08/23/2013 Apparent leak on WS shoulder at concrete riser. Erosion under pipe. This may have been fixed when the pipe was sleeved with a PVC liner. (W.Wylie - DWR UCIP)
FIELD_STRUCT_DESC: 10-inch steel drainage pipe through the levee, 5 feet below the crown. Pump on the landside (LS). Siphon breaker in a 36-inch concrete riser unit on the waterside (WS) shoulder. Power pole at the LS toe. Polyvinyl chloride liner sleeved inside steel pipe.
[Additional Reference(s): DWR Levee Log, 2004 (HLM 5.88). USACE San Joaquin O&M Manual, Unit 7, April 1964, Revised 29 December 2016, (5.88), listed as 10-inch pipe].
FS Date: 6/25/2020 2:56:00 PM

Top of Levee: view of crown.

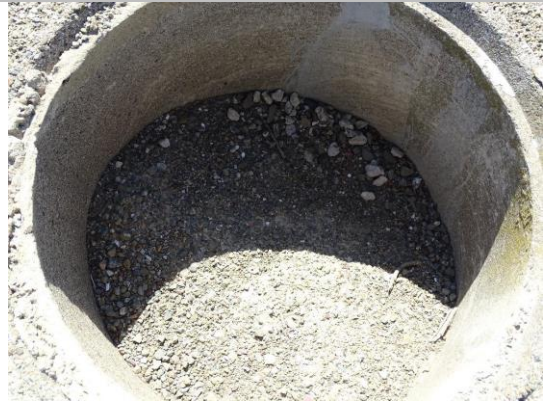
Photo 2 of 3 : UCIP_FA_2021_70263_89613.jpg

Water-Side: view of filled-in standpipe.

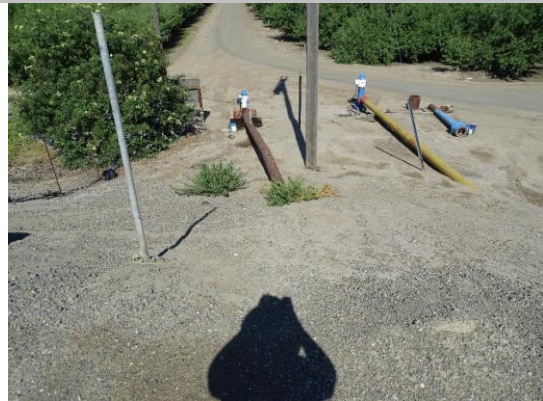
Photo 3 of 3 : UCIP_FA_2021_70263_89614.jpg

Land-Side: view of LS slope and pipe with pump.

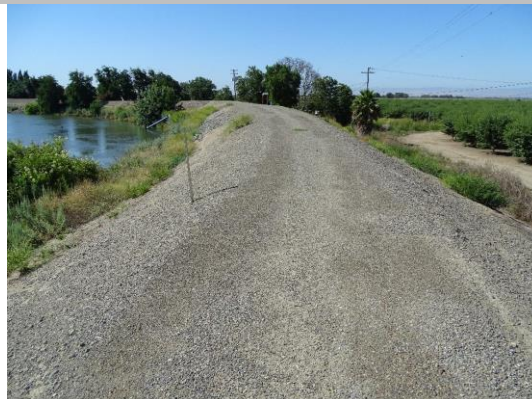
Photo 1 of 3 : UCIP_FA_2021_62122_89615.jpg

LM Start	5.82	Rating **	M	Issue No.	994	
LM End	5.82	Issue Type +	En	Location *		
Category	Supplemental			GPS Latitude/Longitude		
				Start		End
Item	DWR UCIP Field Study			37.874829 °	37.874829 °	
				-121.333265 °	-121.333265 °	
DWR ID	20656					
Comment Code						
Inspector Comment						
DS_ID:20656 FS_ID:62122 EP_NO: N/A Repair Type: Non-Urgent EVAL Issue: Safety Issue Crossing Status: Indicator Found UCIP Comments: 06/25/2020 Record remains Non-Urgent. No inspection records were available to determine status of line through the levee. (D.Sanoski - DWR UCIP) 08/23/2013 Need to verify gasline exists and if so improve signage. (W.Wylie - DWR UCIP) FIELD_STRUCT_DESC: Gas line marker sign on the waterside (WS) shoulder. FS Date: 6/25/2020 2:57:00 PM

Top of Levee: view of crown.

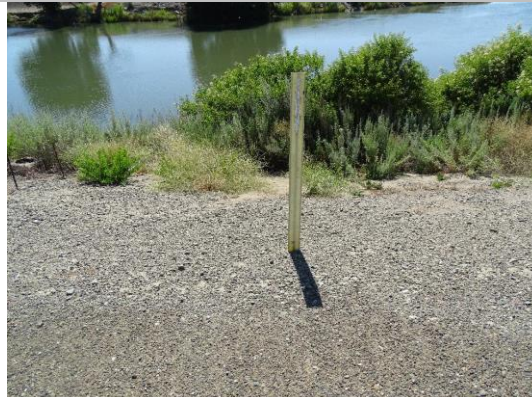
Photo 2 of 3 : UCIP_FA_2021_62122_89616.jpg

Water-Side: view of WS slope and faded gas marker on shoulder.

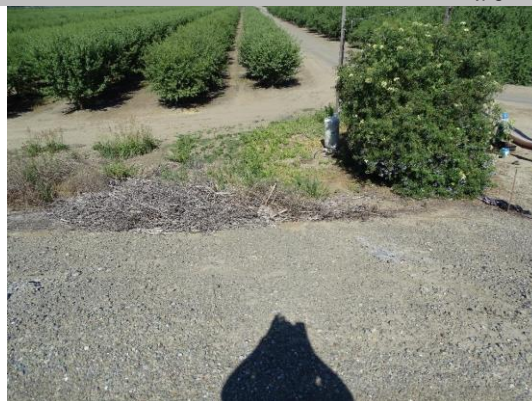
Photo 3 of 3 : UCIP_FA_2021_62122_89617.jpg

Land-Side: view of LS slope with no gas marker.

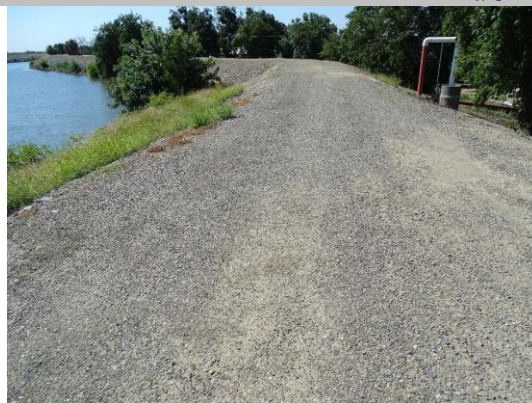
Photo 1 of 3 : UCIP_FA_2021_70265_89618.jpg

DS_ID:20637
 FS_ID:70265
 EP_NO: N/A
 Repair Type: Non-Urgent
 EVAL Issue: Pipe Not Found
 Crossing Status: Not Found
 UCIP Comments: 06/25/2020 Record updated from No Action Needed to Non-Urgent. Crossing not found. Geophysical results did not confirm presence of pipe through levee. Record will remain in UCIP's inspection records until future Levee Improvement Project can confirm no crossing was found through the levee. No permit has been identified authorizing pipe. (D.Sanoski - DWR UCIP)
 FIELD_STRUCT_DESC: 12-inch drainage pipe of an unknown material through the levee, 8 feet below the crown. Concrete box structure on the waterside (WS) slope. [Additional Reference(s): DWR Levee Log, 2004 (HLM 5.91). USACE San Joaquin O&M Manual, Unit 7, April 1964, Revised 29 December 2016, (5.91), listed as 12-inch pipe, abandoned].
 FS Date: 6/25/2020 2:57:00 PM

Top of Levee: view of crown.

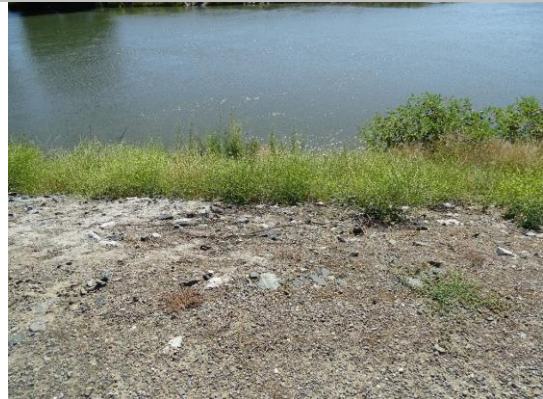
Photo 2 of 3 : UCIP_FA_2021_70265_89619.jpg

Water-Side: view of WS slope with no sign of pipe or concrete structure.

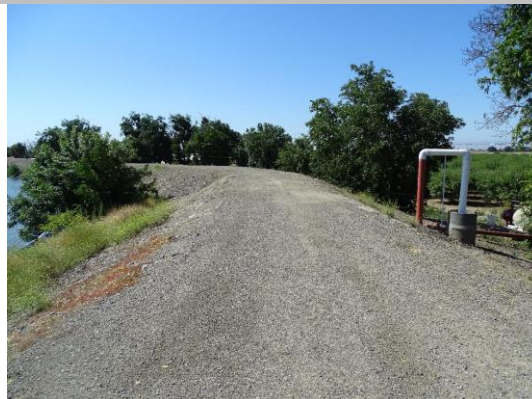
Photo 1 of 3 : UCIP_FA_2021_70266_89621.jpg

Comment Code						
Inspector Comment						
DS_ID:20638 FS_ID:70266 EP_NO: N/A Repair Type: Non-Urgent EVAL Issue: Unauthorized Encroachment, installed decades prior Crossing Status: Found UCIP Comments: 06/25/2020 Record remains Non-Urgent. No permit has been identified authorizing pipe. Erosion has been repaired around pipe. (D.Sanoski - DWR UCIP) 08/23/2013 Heavy erosion around pipe upstream of standpipe on LS slope. Verify pipe is not leaking and repair erosion on LS slope. (W.Wylie - DWR UCIP) FIELD_STRUCT_DESC: 12-inch steel irrigation pipe through the levee, 10 feet below the crown. Slant pump on pier at the waterside (WS) toe. 10-inch steel standpipe on the landside (LS) slope. 42-inch concrete standpipe on the LS slope. Filter plant and power pole on the LS toe. 1.5-inch galvanized iron electrical conduit at same location. [Additional Reference(s): DWR Levee Log, 2004 (HLM 5.93). USACE San Joaquin O&M Manual, Unit 7, April 1964, Revised 29 December 2016, (5.93), listed as 12-inch pipe]. FS Date: 6/25/2020 2:57:00 PM

Top of Levee: view of crown.

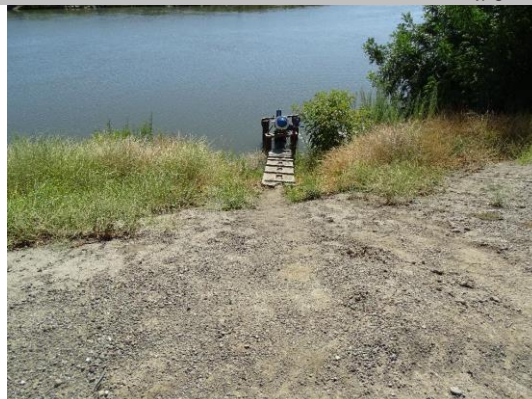
Photo 2 of 3 : UCIP_FA_2021_70266_89622.jpg

Water-Side: view of WS slope with pipe and pump on toe.

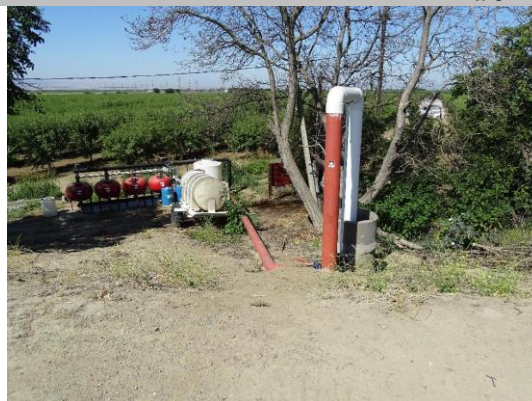
Photo 3 of 3 : UCIP_FA_2021_70266_89623.jpg

Land-Side: view of LS slope with pipe assembly.

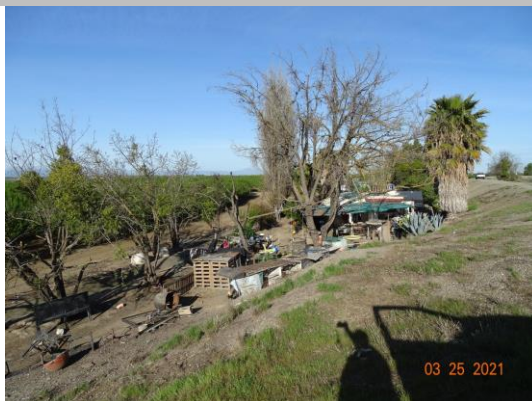
Photo 1 of 1 : FA_2021_RD0524_107_274_20210913_00093.jpg

LM Start	5.93	Rating **	M	Issue No.	274
LM End	6.01	Issue Type +	En	Location *	LS
Category	Earthen Levee			GPS Latitude/Longitude	
				Start	End
Item	Encroachments			37.873556 °	37.872879 °
				-121.332463 °	-121.331125 °
DWR ID	DWR_RD0524_01_f _ 2017_274				
Comment Code					
BU : Building					
Inspector Comment					
Chicken coops at landside toe.

View of chicken coop buildings along landside easement. Spring 2021

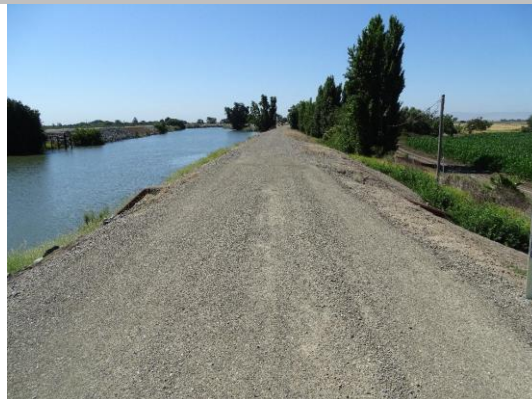
Photo 1 of 3 : UCIP_FA_2021_62126_89627.jpg

LM Start	6.08	Rating **	M	Issue No.	998	
LM End	6.08	Issue Type +	En	Location *		
Category	Supplemental			GPS Latitude/Longitude		
				Start	End	
Item	DWR UCIP Field Study			37.872060 °	37.872060 °	
				-121.330512 °	-121.330512 °	
DWR ID	20640					
Comment Code						
Inspector Comment						
DS_ID:20640 FS_ID:62126 EP_NO: N/A Repair Type: Non-Urgent EVAL Issue: Unauthorized Encroachment, installed decades prior Crossing Status: Found UCIP Comments: 06/25/2020 Record updated from No Action Needed to Non-Urgent. Unauthorized encroachment recorded in Levee Log prior to 2011. (D.Sanoski - DWR UCIP) FIELD_STRUCT_DESC: 14-inch concrete encased steel drainage pipe through the levee, 3.5 feet below the crown. Pump in drainage ditch 500 feet off the landside (LS) toe. [Additional Reference(s): DWR Levee Log, 2004 (HLM 6.15), listed as 6-inch pipe, abandoned.] FS Date: 6/25/2020 2:58:00 PM

Top of Levee: view of crown.

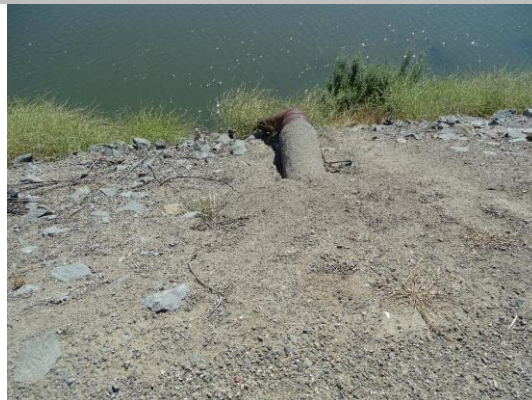
Photo 2 of 3 : UCIP_FA_2021_62126_89628.jpg

Water-Side: view of WS slope and pipe.

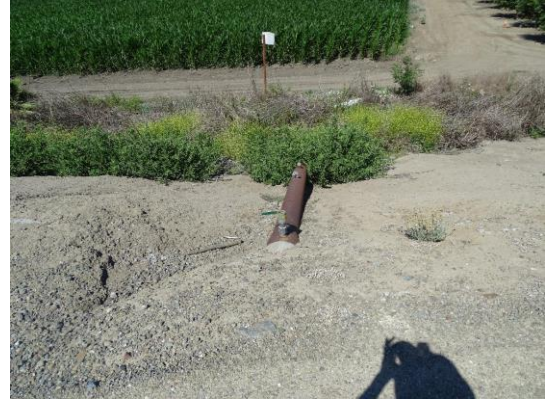
Photo 3 of 3 : UCIP_FA_2021_62126_89629.jpg

Land-Side: view of LS slope and pipe.

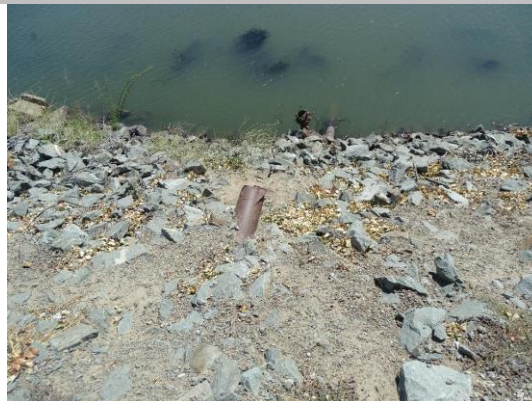
Photo 2 of 3 : UCIP_FA_2021_70268_89631.jpg

Water-Side: view of WS slope and abandoned pipe.

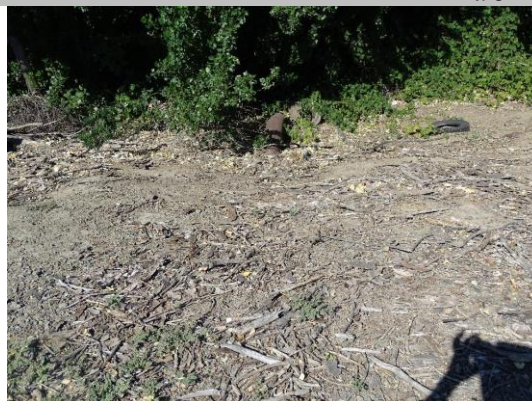
Photo 3 of 3 : UCIP_FA_2021_70268_89632.jpg

Land-Side: view of LS slope and abandoned pipe.

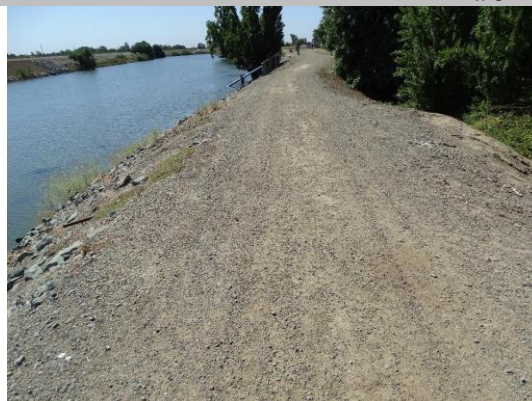
Photo 1 of 3 : UCIP_FA_2021_70269_89633.jpg

DS_ID:24052
 FS_ID:70269
 EP_NO: N/A
 Repair Type: Non-Urgent
 EVAL Issue: Unauthorized Encroachment, installed decades prior
 Crossing Status: Found
 UCIP Comments: 06/25/2020 Record remains Non-Urgent. No permit has been identified authorizing pipe. Crossing appears abandoned. Recommend owner to contact CVFPB to abandon or remove pipe from levee. (D.Sanoski - DWR UCIP)
 08/23/2013 Abandoned and should be done so properly. (W.Wylie - DWR UCIP)
 FIELD_STRUCT_DESC: *ABANDONED* 1.75-inch galvanized iron electrical conduit through the levee, 1 foot below the crown. Power pole on the landside (LS) toe. [Additional Reference(s): DWR Levee Log, 2004 (HLM 6.22), listed as 10-inch pipe.USACE San Joaquin O&M Manual, Unit 7, April 1964, Revised 29 December 2016, (6.22), listed as 10-inch pipe].
 FS Date: 6/25/2020 2:58:00 PM

Top of Levee: view of crown.

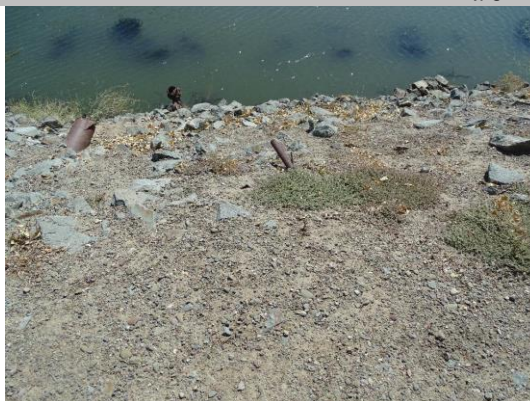
Photo 2 of 3 : UCIP_FA_2021_70269_89634.jpg

Water-Side: view of WS slope and abandoned conduit.

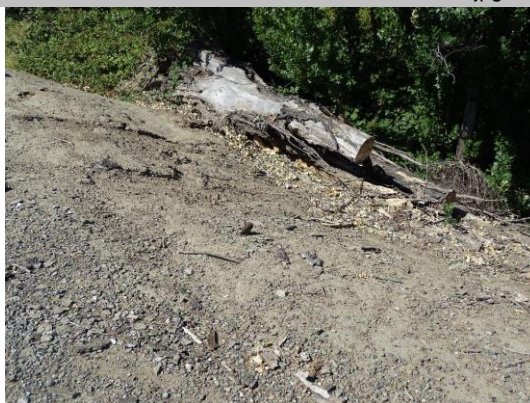
Photo 3 of 3 : UCIP_FA_2021_70269_89635.jpg

Land-Side: view of LS slope and abandoned conduit.

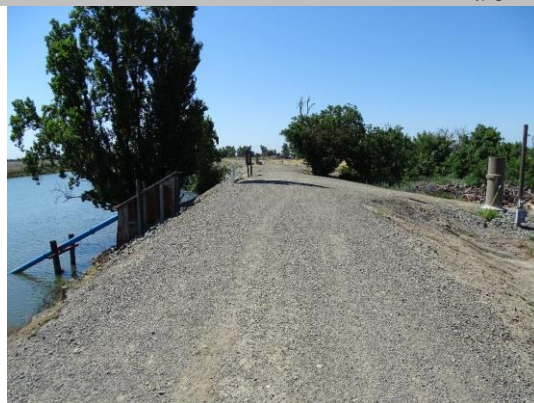
Photo 1 of 3 : UCIP_FA_2021_70270_89636.jpg

Comment Code						
Inspector Comment						
DS_ID:20642 FS_ID:70270 EP_NO: N/A Repair Type: Non-Urgent EVAL Issue: Unauthorized Encroachment, installed decades prior Crossing Status: Found UCIP Comments: 06/25/2020 Record updated from No Action Needed to Non-Urgent. No permit has been identified authorizing pipe. (D.Sanoski - DWR UCIP) FIELD_STRUCT_DESC: 12-inch steel irrigation pipe through the levee, 4 feet below the crown. Pump house on the waterside (WS) slope. 36-inch concrete standpipe at the toe of the landside (LS) slope. 1.5-inch electrical conduit at same location with a JP on the LS toe. [Additional Reference(s): DWR Levee Log, 2004 (HLM 6.26). USACE San Joaquin O&M Manual, Unit 7, April 1964, Revised 29 December 2016, (6.26), listed as 12-inch pipe]. FS Date: 6/25/2020 3:00:00 PM

Overview of Levee: view of crown and assembly on both sides.

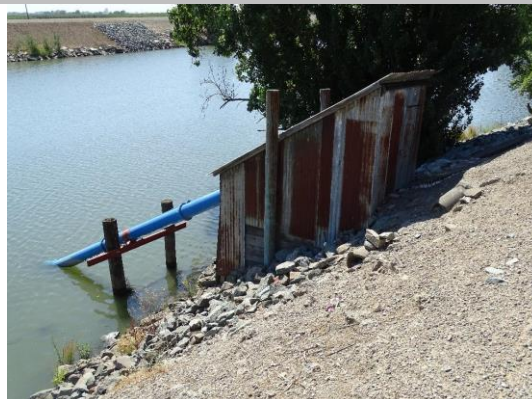
Photo 2 of 3 : UCIP_FA_2021_70270_89637.jpg

Water-Side: view of WS slope with pumphouse and pipe.

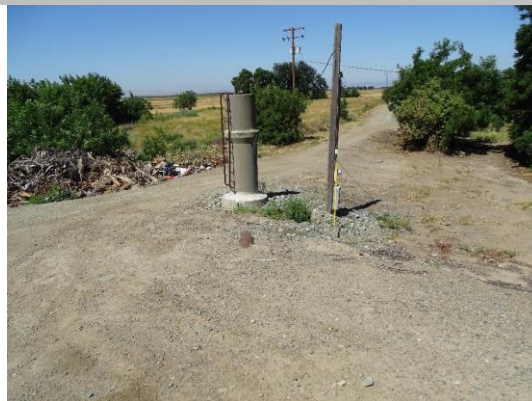
Photo 3 of 3 : UCIP_FA_2021_70270_89638.jpg

Land-Side: view of LS slope with pipe and concrete standpipe on toe.

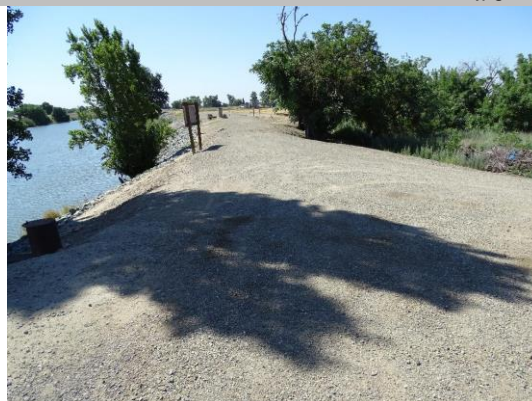
Photo 1 of 3 : UCIP_FA_2021_62130_89639.jpg

LM Start	6.19	Rating **	M	Issue No.	1002	
LM End	6.19	Issue Type +	En	Location *		
Category	Supplemental			GPS Latitude/Longitude		
				Start	End	
Item	DWR UCIP Field Study			37.870498 °	37.870498 °	
				-121.329894 °	-121.329894 °	
DWR ID	20643					
Comment Code						
Inspector Comment						
DS_ID:20643 FS_ID:62130 EP_NO: N/A Repair Type: Non-Urgent EVAL Issue: Unauthorized Encroachment, installed decades prior Crossing Status: Found UCIP Comments: 06/25/2020 Record updated from No Action Needed to Non-Urgent. Unauthorized encroachment recorded in Levee Log prior to 2011. (D.Sanoski - DWR UCIP) FIELD_STRUCT_DESC: 8-inch drainage pipe of an unknown material through the levee, 2 feet below the crown. Pump approximately 1400 feet west of the landside (LS) in drainage ditch. [Additional Reference(s): DWR Levee Log, 2004 (HLM 6.26)]. FS Date: 6/25/2020 3:00:00 PM

Top of Levee: view of crown.

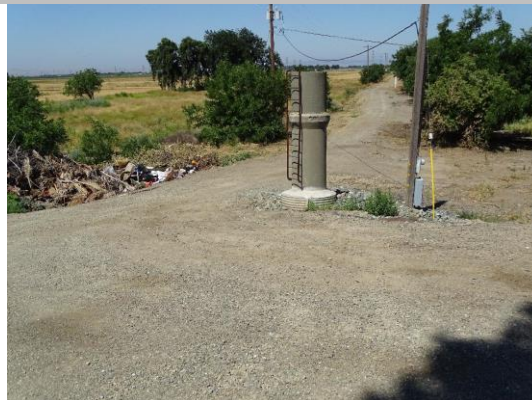
Photo 2 of 3 : UCIP_FA_2021_62130_89641.jpg

Water-Side: view of LS slope.

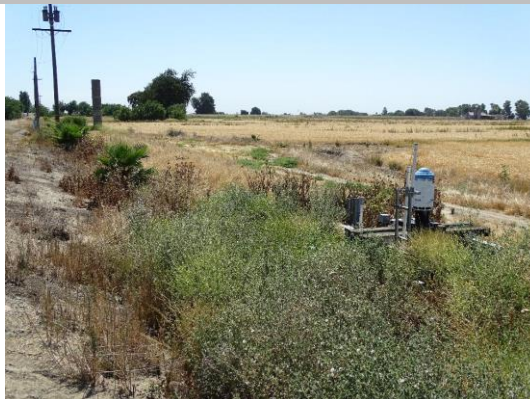
Photo 3 of 3 : UCIP_FA_2021_62130_89642.jpg

Land-Side: view of pump and concrete standpipe approximately 1400 feet off LS toe in drainage ditch.
